Memorandum

SUBJECT: 2013 Fuel Containment Area Water Sampling

Starfield Resources Inc. constructed and operated a lined embankment secondary containment fuel storage area as part of their Ferguson Lake Project. Canadian North Resources and Development Corp. has acquired the property recently and at their request, ERM Rescan visited the Project area August 7 to 9, 2013 to assess the quality of the impounded water and to provide recommendations on its management.

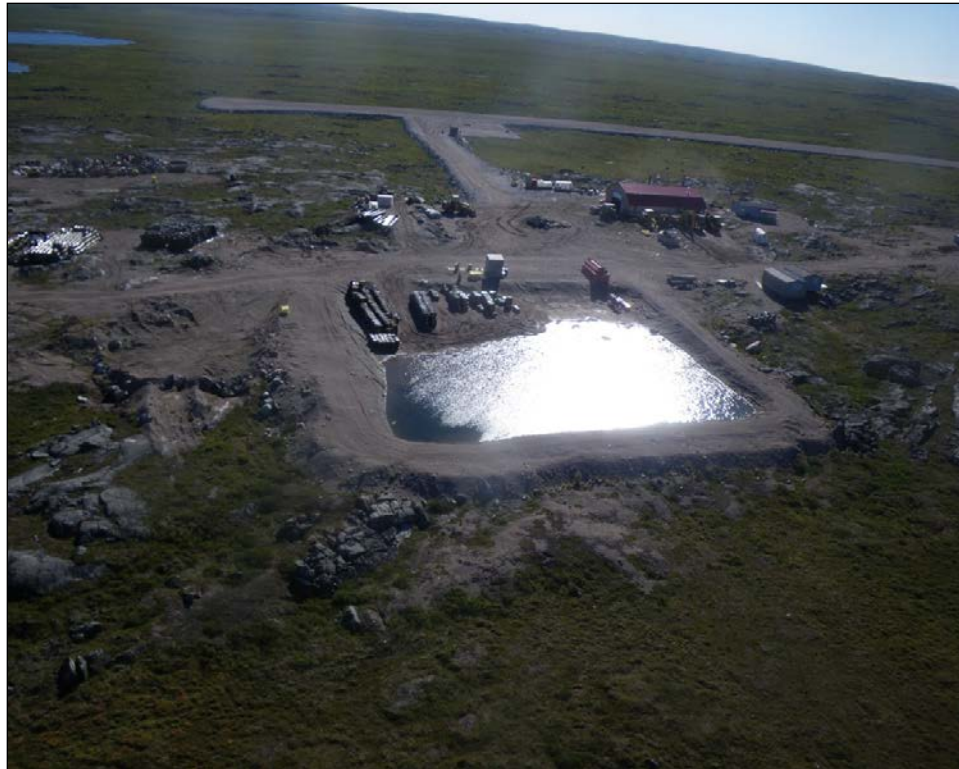
The fuel containment area (FCA) is approximately 40 m × 40 m (Plates 1 and 2). The containment area was constructed using local materials for the embankments and a HDPE liner was welded as the impermeable membrane. The liner was keyed into the top of the embankment and was covered with a non-woven geotextile fabric. A layer of sand and gravel was placed on top of the fabric to form a ramp and a working area within the embankment.

Plate 1. Aerial view of flooded fuel containment area looking south.

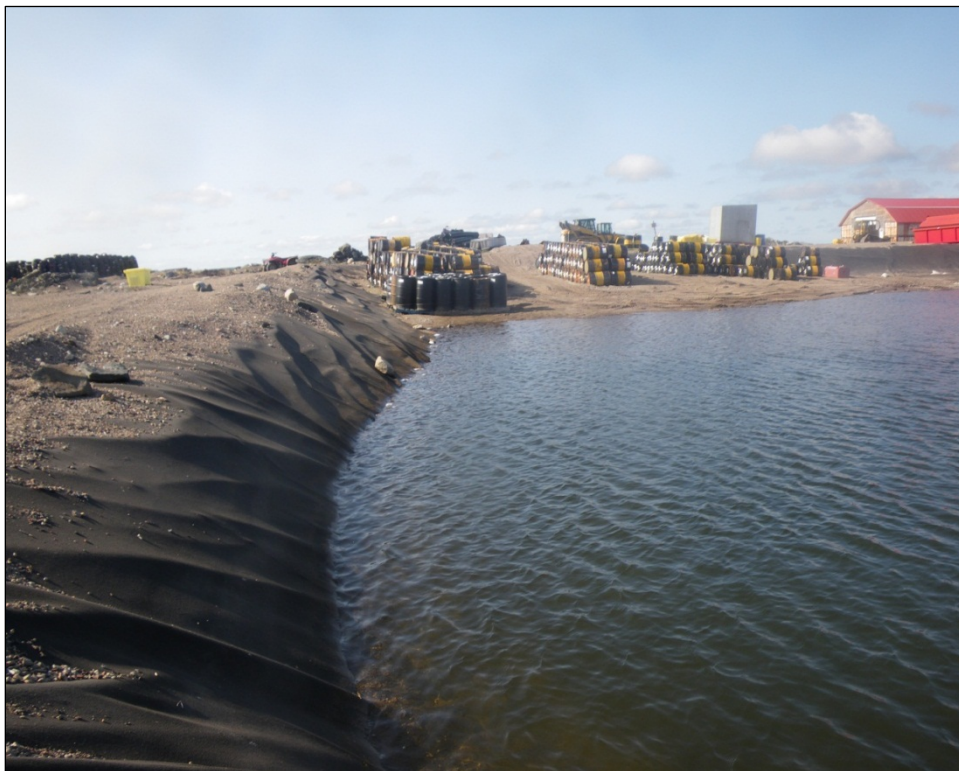
Plate 2. Fuel barrels stored on site at the time of sampling.
