**ABANDONMENT AND RESTORATION PLAN  
HACKETT RIVER  
EXPLORATION PROJECT**

**GLENCORE CANADA CORPORATION**

**Water Licence No. 2BE-HAK0915  
AANDC Land Use Permit No. 2013C0015 (Previously N2010C0015)  
AANDC Lease No. 76F/16-1-7  
KIA Land Use Licence No. KTL304C005-Renewed**

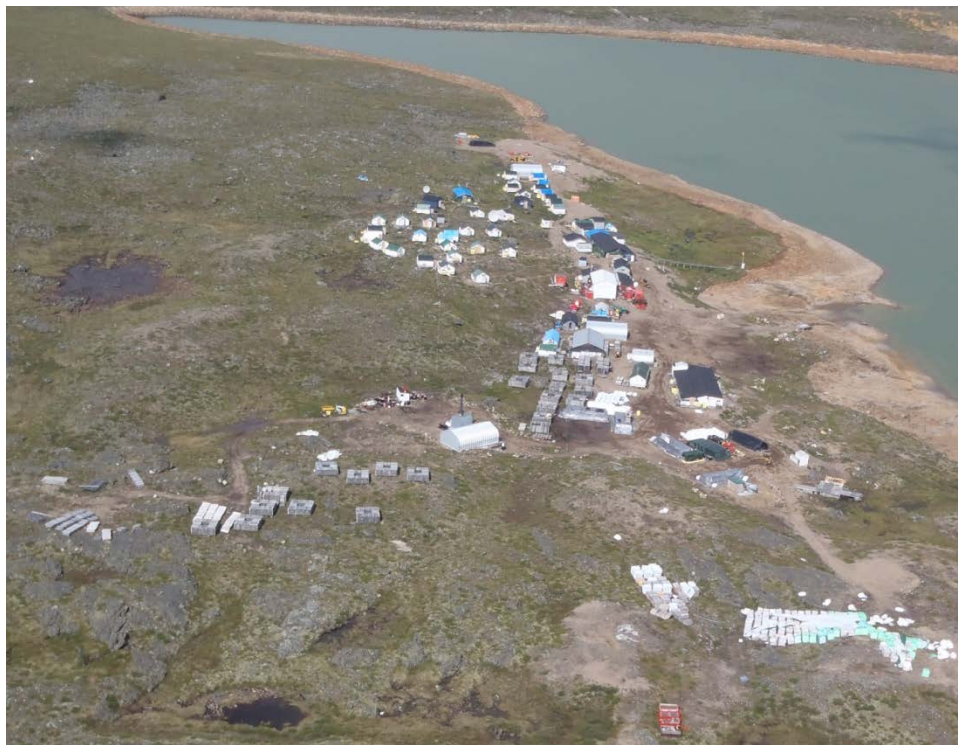
Figure 3 Hackett River Camp, looking northwest (July 2015)

The Project consists of a single exploration camp located on the southwest shore of Camp Lake (Figure 2), a drill laydown area on the southeast shore of Camp Lake (Figure 3), 2 airstrips and 10 mining leases (11,800 ha) and 238 crown mineral claims totaling 199,196 hectares. The camp has a capacity of up to 120 people, all of whom directly support exploration activities including surficial mapping, geophysical surveys, core logging, and diamond drilling and environmental monitoring. The exploration camp is located on AANDC Surface Lease 76F 16-1-4 which permits the presence of mineral exploration camp structures subject to certain terms and conditions.
