SABINA RESOURCES LIMITED

HACKETT RIVER CAMP

ABANDONMENT AND RESTORATION PLAN

July 31, 2004

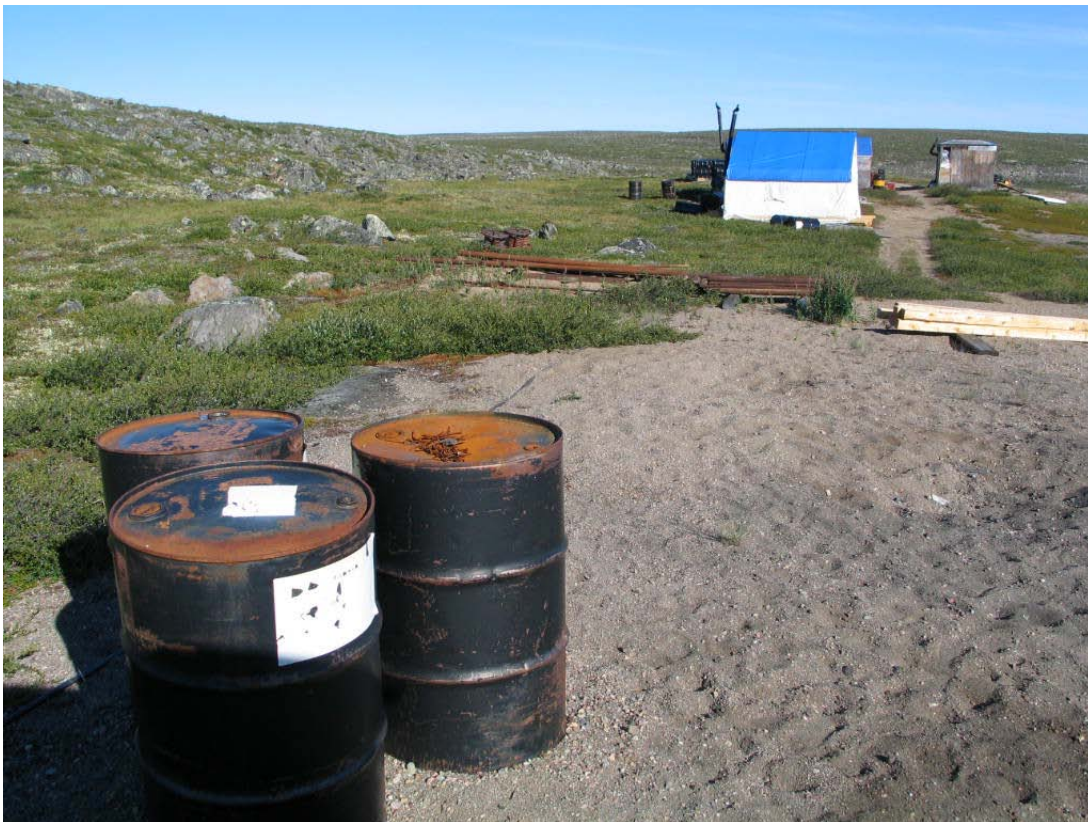
Also in camp were 16 old drums of diesel, some marked NUNA, some containing water and rust. Ten drums containing a mixture of water, fuel and rust were shipped out to Yellowknife for recycling in June. At present 6 drums of these drums are still in camp. Plans are to recover the diesel from these 6 drums or ship the drums to Yellowknife for recycling. Several of the old diesel drums had small oil stained zones near them indicating minor leakage. The oil stained soil has been dug up and placed in plastic sample bags and has been shipped to Yellowknife for disposal. Three of the drums are shown in the following photo along with the remaining rusty drill rods from a much larger pile.

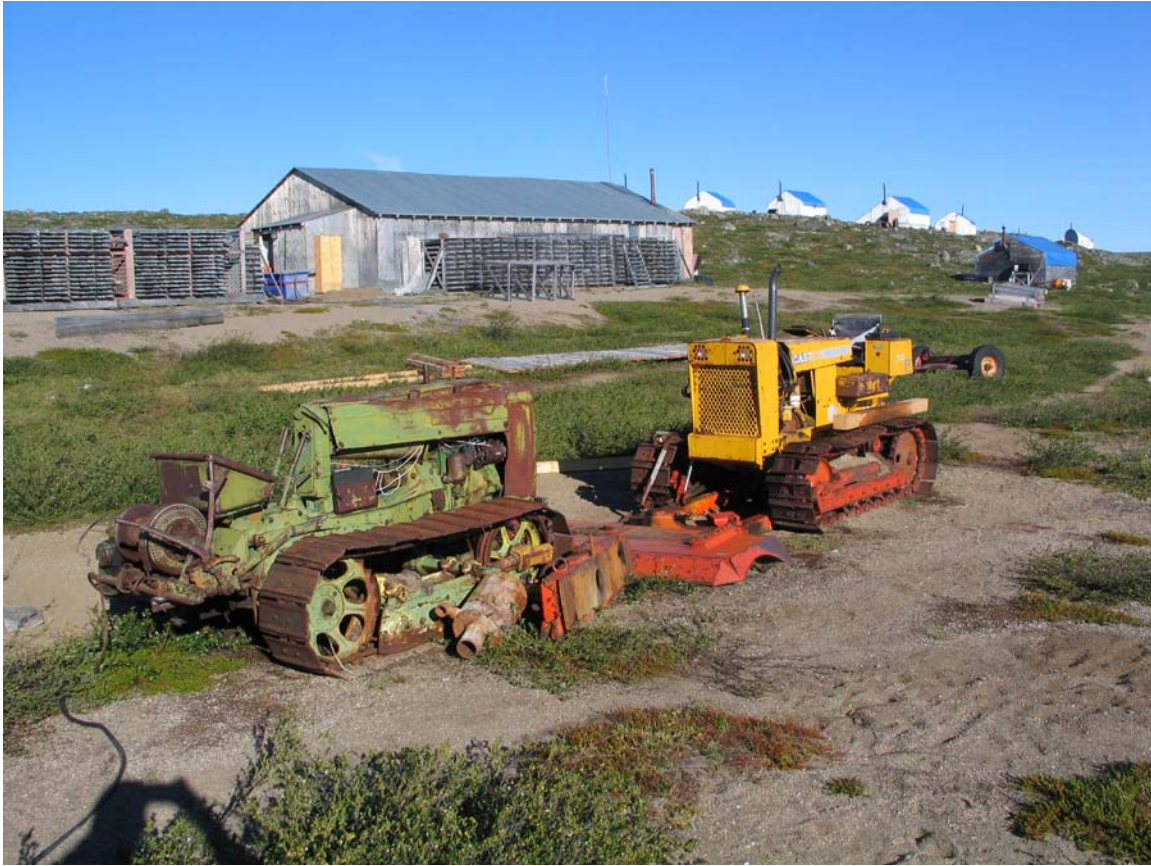
Two abandoned small bulldozers and a wheeled drill rod wagon are located in camp. One of the bulldozer units has been partially dismantled and awaits transport back to Yellowknife for salvage or disposal at the Yellowknife dump. One of the old crawler units might be of interest to the Yellowknife airport as a historic mining relic from the 1930's or 40's. Plans are to dismantle the equipment this year and transport it to Yellowknife in 2005 from a proposed ice airstrip on Camp Lake. A Bombardier track mounted sled located at the esker airstrip south of camp will be serviced this summer and will be available for use during an anticipated early spring drill program on Camp Lake. The following photo shows the 2 small bulldozers and a rod wagon.

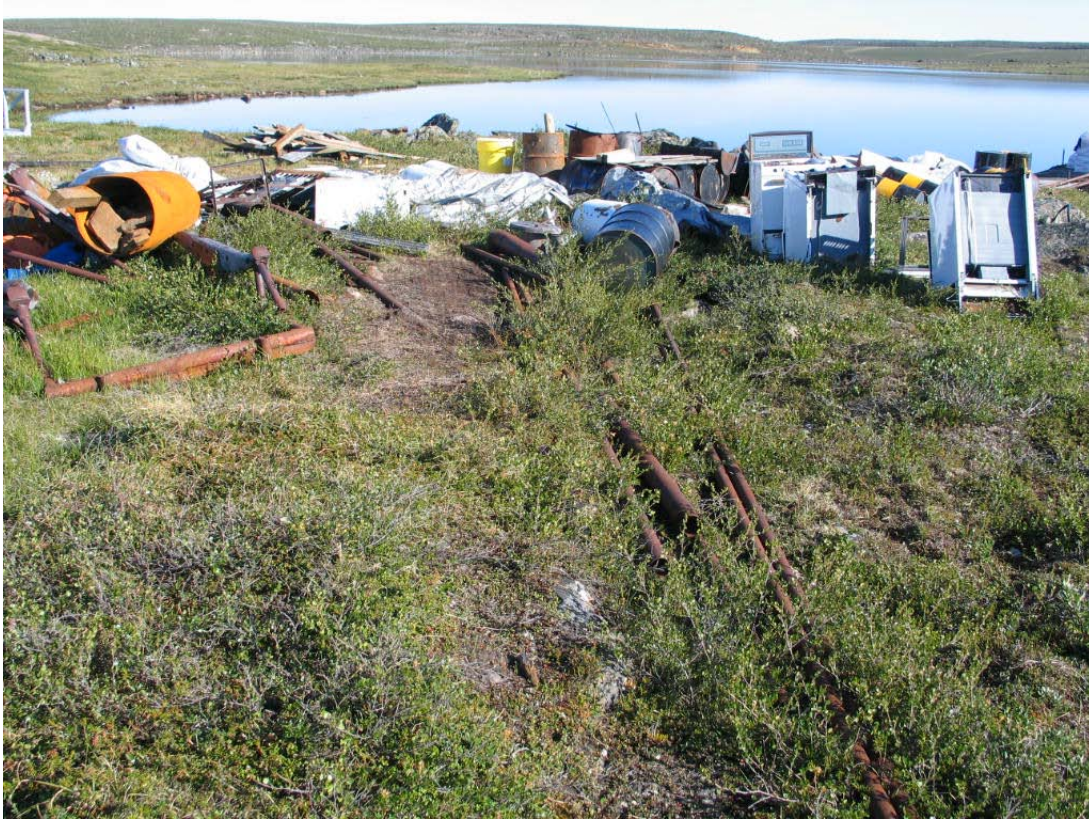
Several Twin Otter loads of old scrap metal in steel drums await transport to Yellowknife for disposal. Another load of abandoned kitchen appliances, (refrigerators, stoves) remain to be transported to Yellowknife for disposal. Other assorted scrap metal consisting of old rusty coil stove elements, worn out metal skimmers and a damaged aluminum boat will also be shipped out as space becomes available on flights to Yellowknife. To date 4 Twin Otter loads of scrap metal, mostly old rusty oil stoves, stove pipe and two refrigerators have been shipped out to Yellowknife for disposal. The following photo shows the pile of scrap metal filled drums and kitchen appliances awaiting transport to Yellowknife.
