RE: July 15 2013 Water Licence Inspection 2BE-PCD0812

WATER LICENCE INSPECTION REPORT

Date: July 15, 2013	Licensee Rep. (Name/Title): N/A
Licensee: De Beers Canada Inc.	Licence No.: 2BE-PCD0812

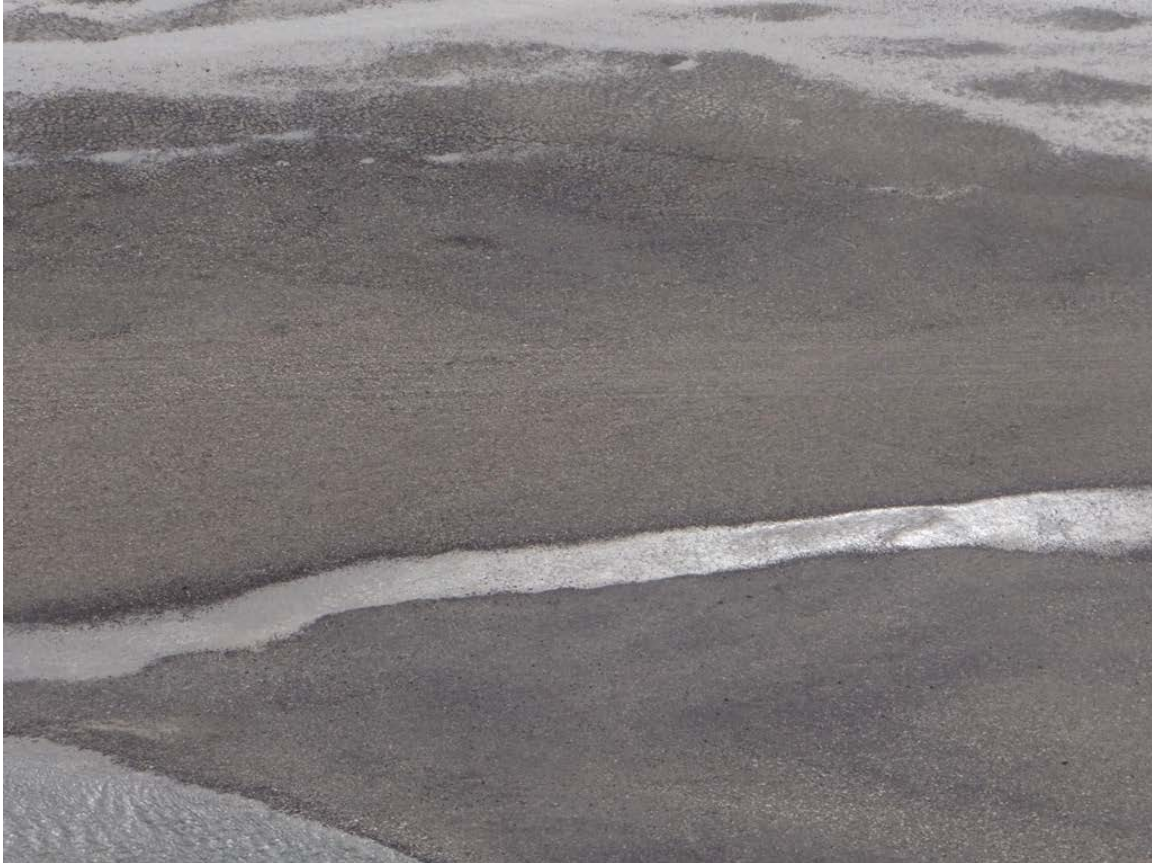
(10) Eden Point camp: N75°04'46.3" W88°24'59.9" (Devon Island): The airstrip at Eden Point camp was located from the air. No camp structures remain. The area was photographed from the air as the pilot was unwilling to land. The camp appears to be completely removed.

Figure 1. Eden Point site. Note faint traces of airstrip. Camp is believed to have been located immediately above the airstrip.

- Documentation with dates and photos of the reclamation of the Eden Point and Muskox Hill Camps.
- Factual documentation of any fuel caches that were established over the term of these projects and the use or removal of the fuel.
- Confirmation that no further camps were established under these projects.
- Confirmation of whether or not any drilling occurred over the term of these projects.
- Land Use Permit numbers or other crown authorizations related to these projects, and any Final Plan /Final Report documents that were submitted in relation to the same.

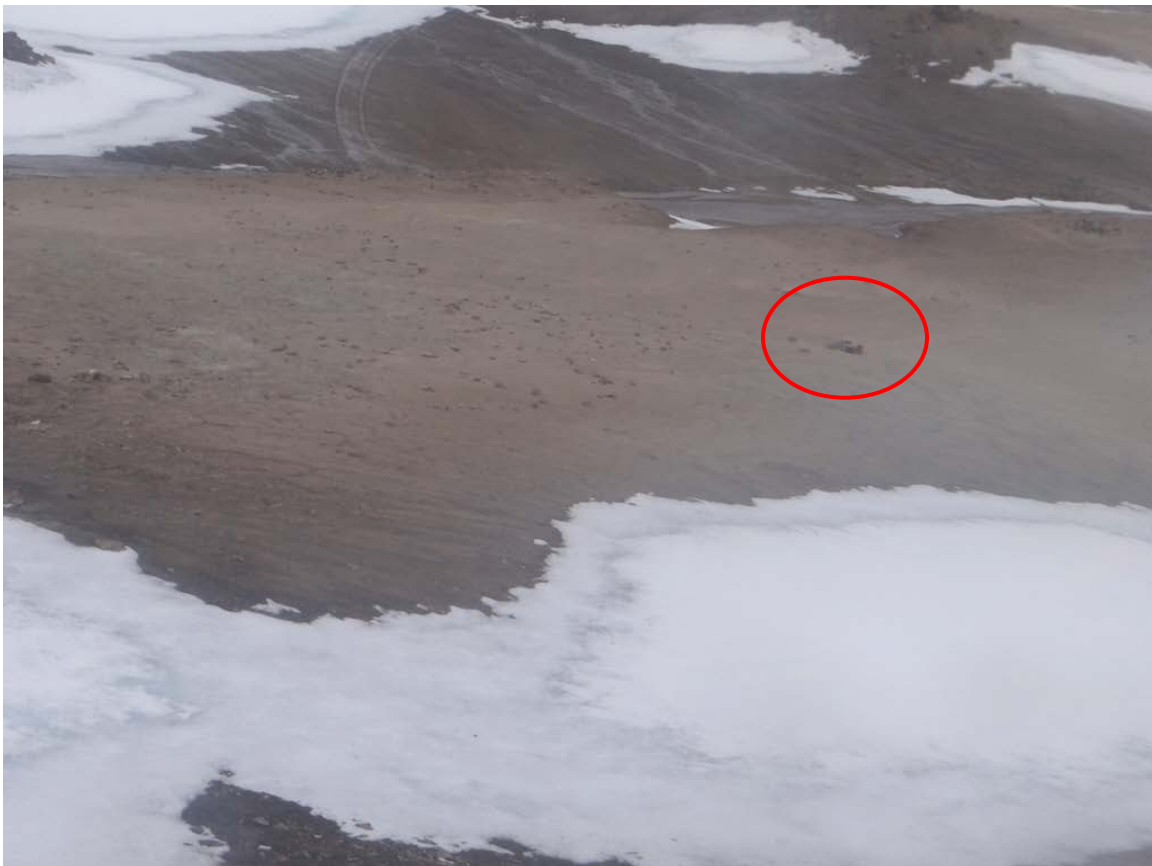
(3) Fly camp-A: N75°26'00", W89°51'00" (Devon Island): The Houghton Crater site was occupied. There are three water licences issued for the same area. At the time of the inspection there were two planes parked on the airstrip preventing us from landing. The location indicated in De Beers' licence is west of the airstrip. There were three crates or boxes (contents unknown) visible from the air at the location indicated in the licence.

Figure 2. Houghton Crater site. Boxes with unknown contents.
