RE: Inspection of Water Licence 2BE-SIL0709, July 7 2013

WATER LICENCE INSPECTION REPORT

Date: July 7, 2013	Licensee Rep. (Name/Title): N/A
Licensee: Strongbow Exploration Inc.	Licence No.: 2BE-SIL0709

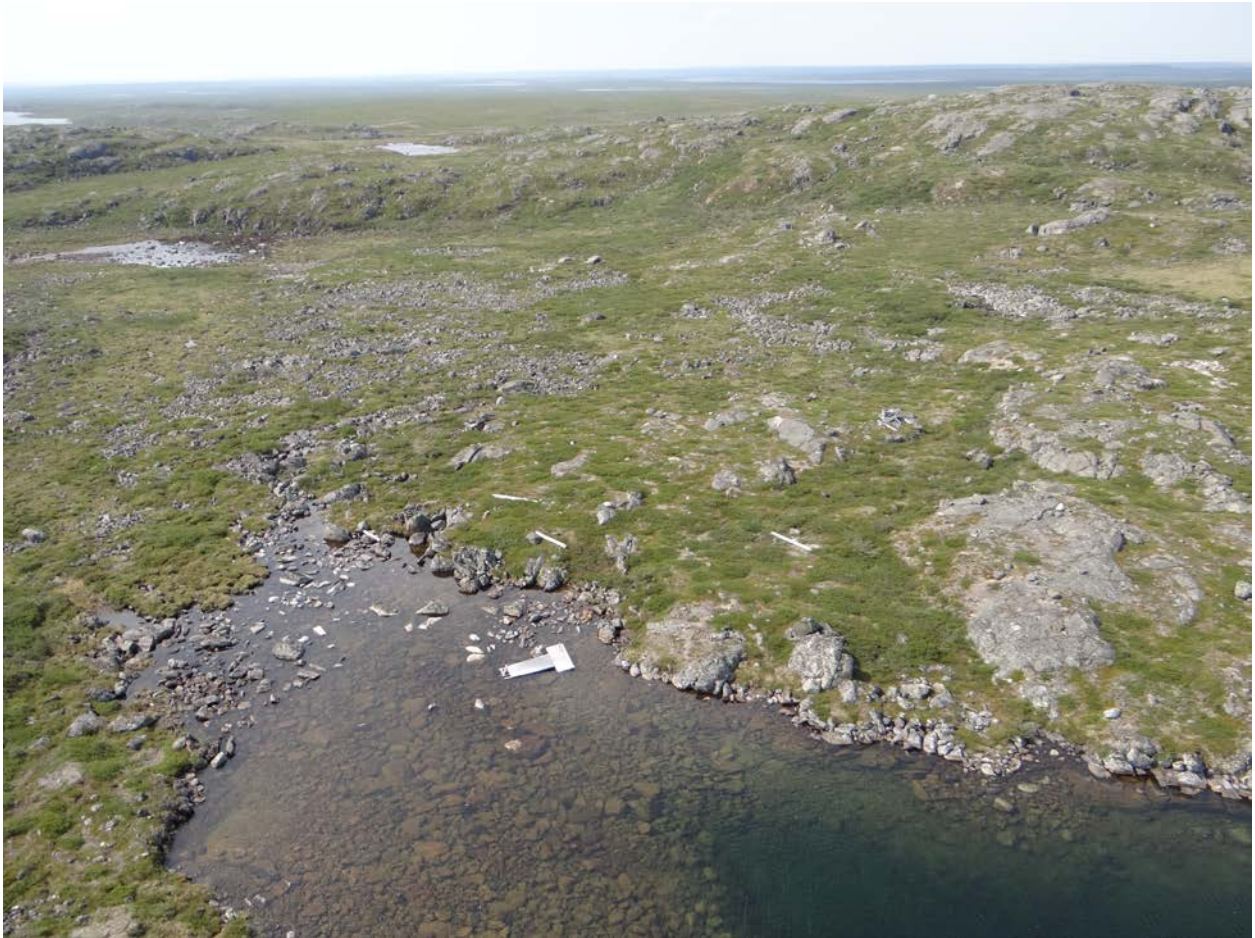
The site at Paleface Lake (N64 48 55.1 W108 00 08.5²) was consistent with Ms. Joy's 2009 findings. Core stacks, timbers, and debris remain scattered, and a dock sits in the water. This is exactly where the 2008 drilling occurred. I cannot determine what debris may have resulted from the more recent drilling activities, however, Strongbow committed in its application to disposing of the existing waste.

Figure 1. Debris evident at Paleface Lake. Two old core stacks visible, but also timbers that may remain from drill set-ups. North Arrow 2008 drilling all occurred in the immediate vicinity.

Materials at Paleface Lake (N64 48 55.1 W108 00 08.5) are also to be removed; Strongbow/North Arrow being the last site occupant.

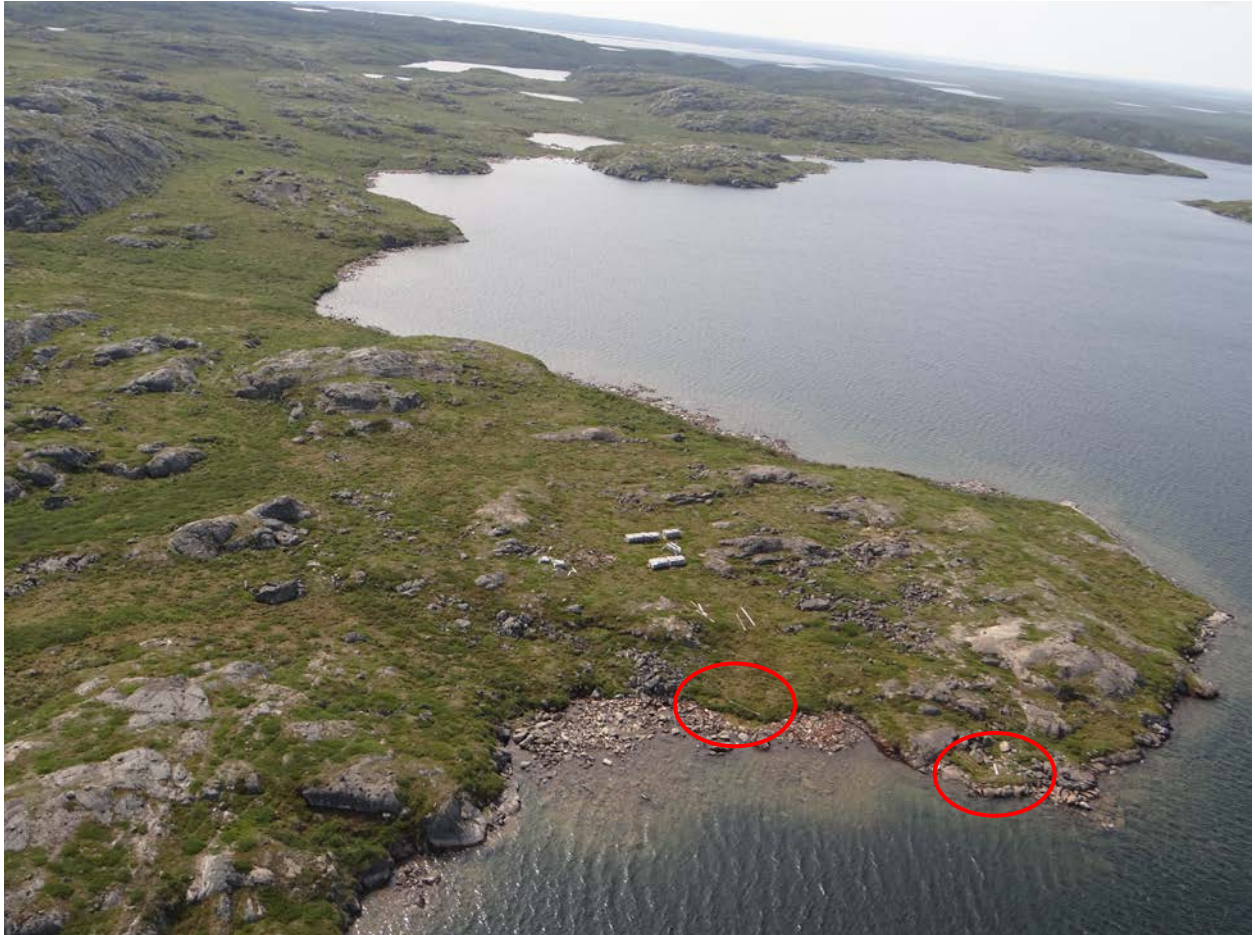
The camp site at Mouse Lake (N64 47 59.4 W107 59 47.2) has improved since Ms. Joy's 2009 visit. The fuel has all been removed, and the larger stacks of timber. Not all timbers were removed, however; debris remains, some now at the water's edge.

Figure 2. Camp location at Mouse Lake. Core stacks sufficient distance from water, but leftover timbers are to be removed.

The Licensee shall complete the reclamation activities as required under Licence 2BE-SIL0709. Any materials not forming part of the core stacks, which are permitted to remain at site, are to be removed. Clean-up shall be conducted during the snow-free period in order to ensure a complete removal of timbers, garbage and debris. If you would like copies of Ms. Joy's 2009 photos.

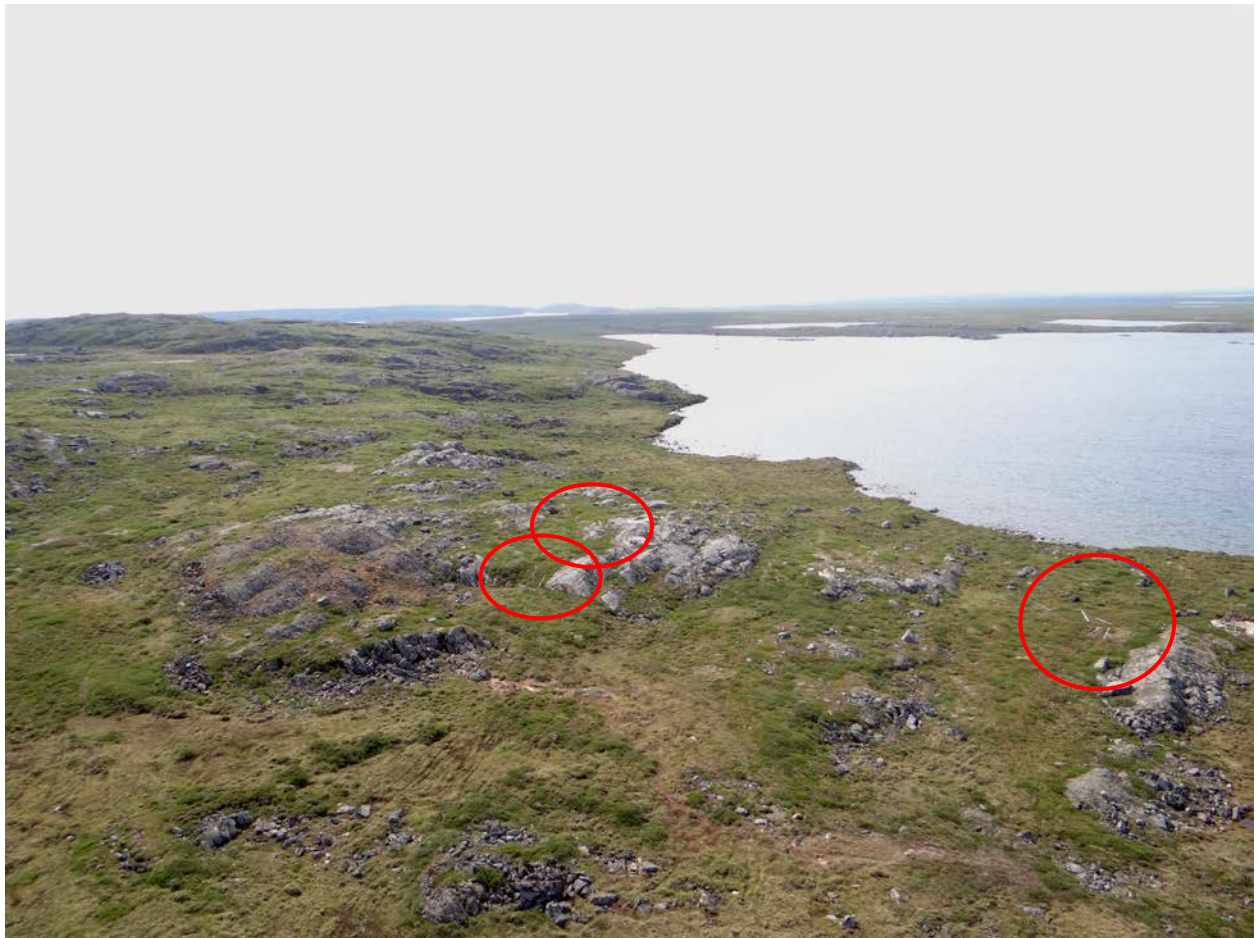
Timbers were also noted nearby on Thlewycho Lake at N64 49 22.0 W108 01 10.6, approximately a kilometer from the drilling at Paleface Lake.

Figure 3. Timbers noted on Thlewycho Lake. More were seen by the water's edge.

Timbers removed from Thlewycho Lake.
