WATER LICENCE INSPECTION FORM

Licensee		Licensee Representative	
Bonito Capital Corps		-	
Licence No. / Expiry		Representative's Title	
2BM-ULU1520		-	
Land / Other Authorizations		Land / Other Authorizations	
-		-	
Date of Inspection		Inspector	
15/07/2015		Eva Paul	
Activities Inspected			
<input checked="" type="checkbox"/> Camp	<input checked="" type="checkbox"/> Drilling	<input type="checkbox"/> Mining	<input type="checkbox"/> Construction
<input type="checkbox"/> Roads/Hauling	<input type="checkbox"/> Other:		<input type="checkbox"/> Reclamation
			<input checked="" type="checkbox"/> Fuel Storage

## 2BM-ULU1520 REPORT OF JULY 15 2015 INSPECTION

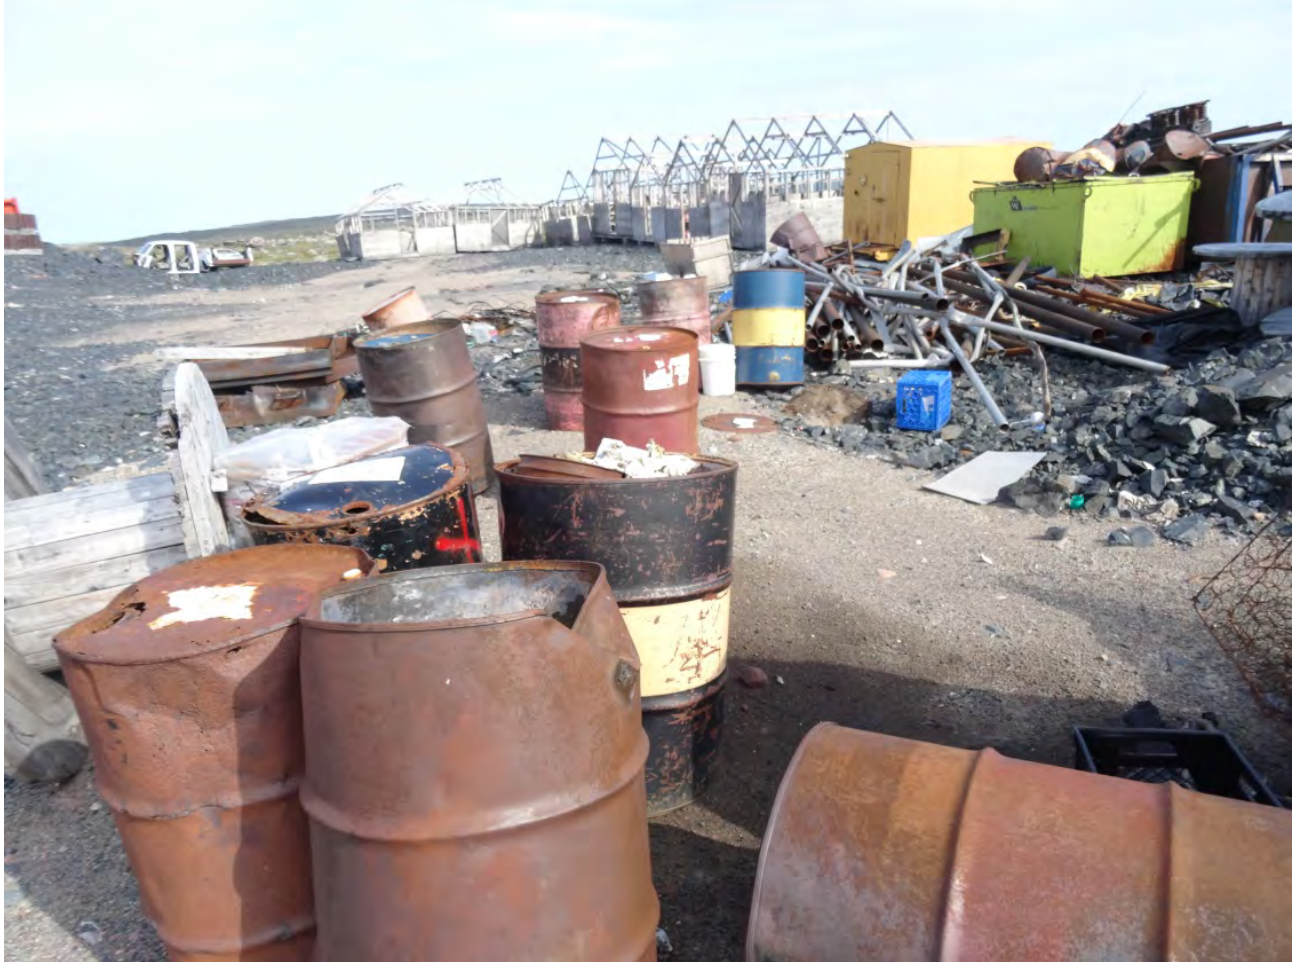
Date	Camera	Inspector	Authorization
July 15, 2015	SONY DSC-HX50V	Eva Paul	2BM-ULU1520
Photo Log # 1		Location (NAD 83 DD MM SS.SS)	
Photo DSC03429		N66 54 29.8	W110 57 49.3

Description: Barrels of unknown waste and staining on the ground found east of the heli-pad.

- 5. All hazardous (and unknown) waste is to be moved into SOUND secondary containment that meets the definition of ‘secondary containment’ in the current licence 2BM-ULU1520. This is to be completed by June 30, 2016.

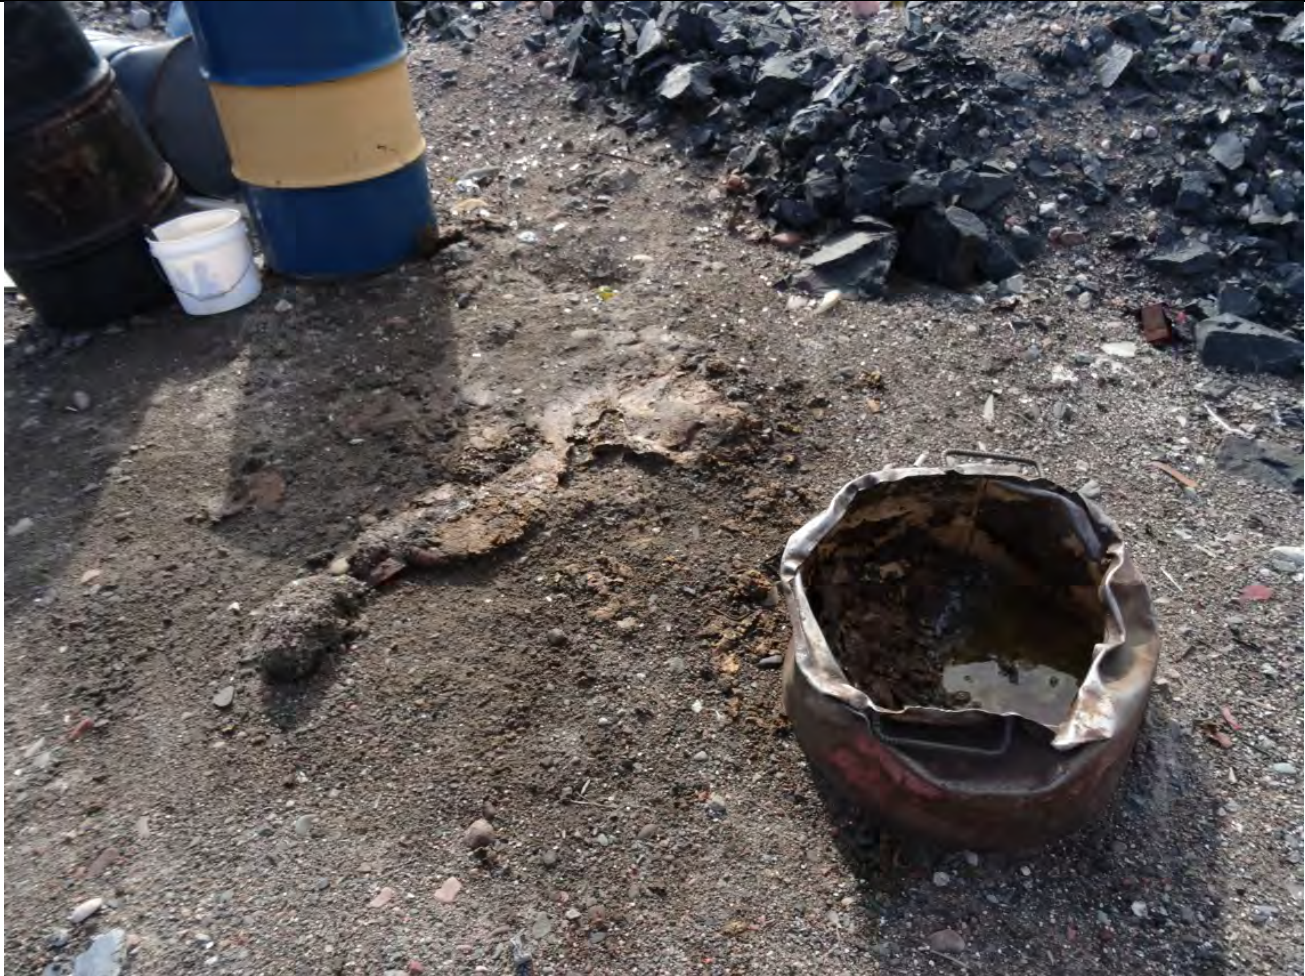
Photo Log # 2	Location (NAD 83 DD MM SS.SS)	
Photo DSC03434	N 66 54 29.7	W110 57 49.5

Description: Unknown waste east of the heli-pad.

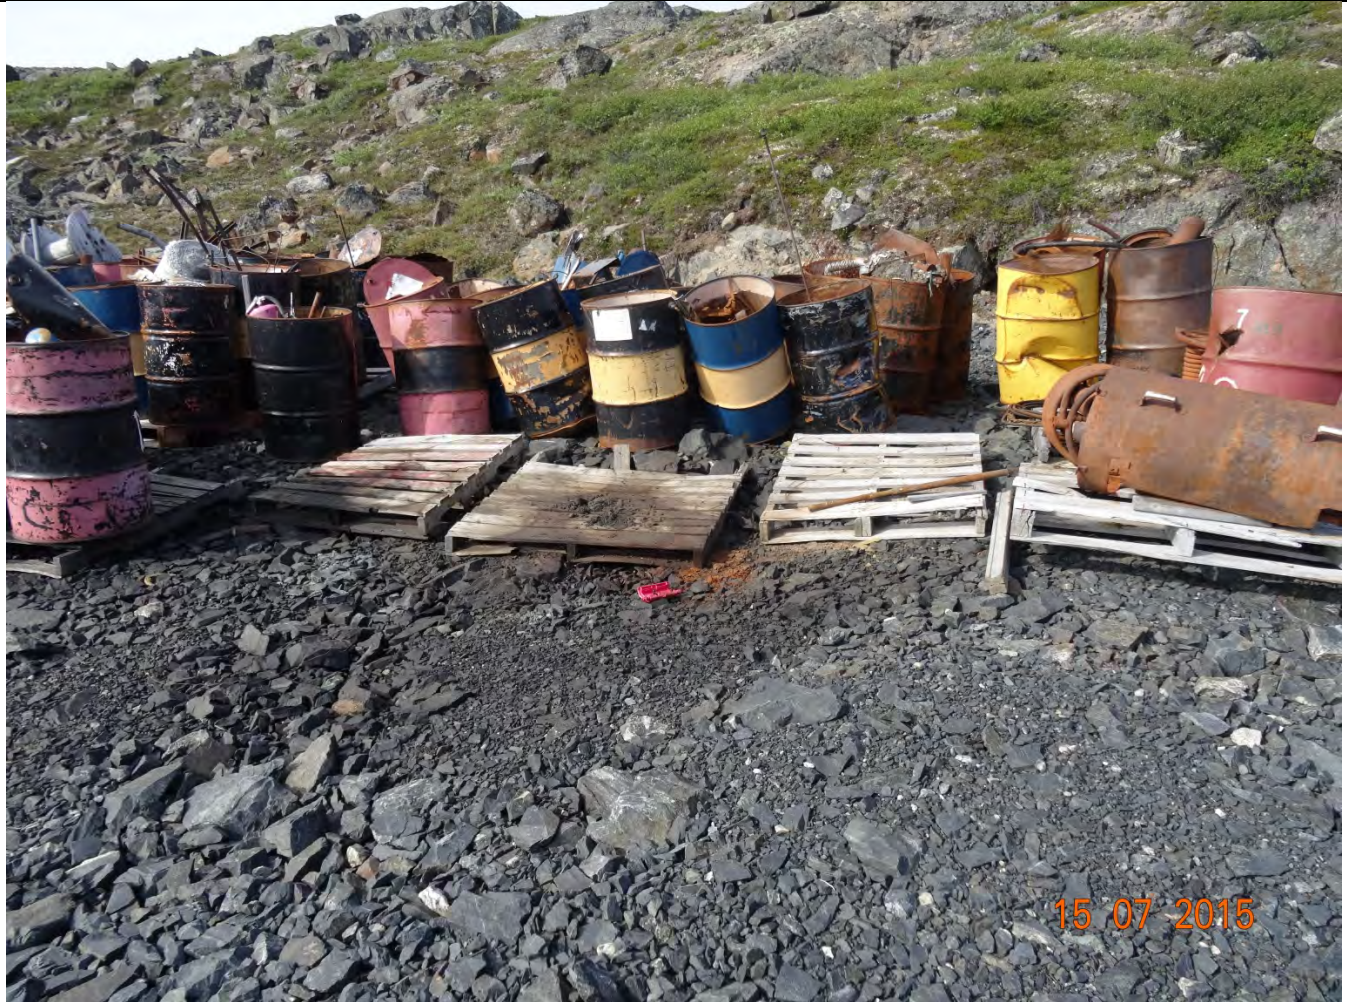
Photo Log # 3

**Description:** Barrels and staining of the ground seen at the mine storage pad. See Photos 5 and 6 for aerial extent.

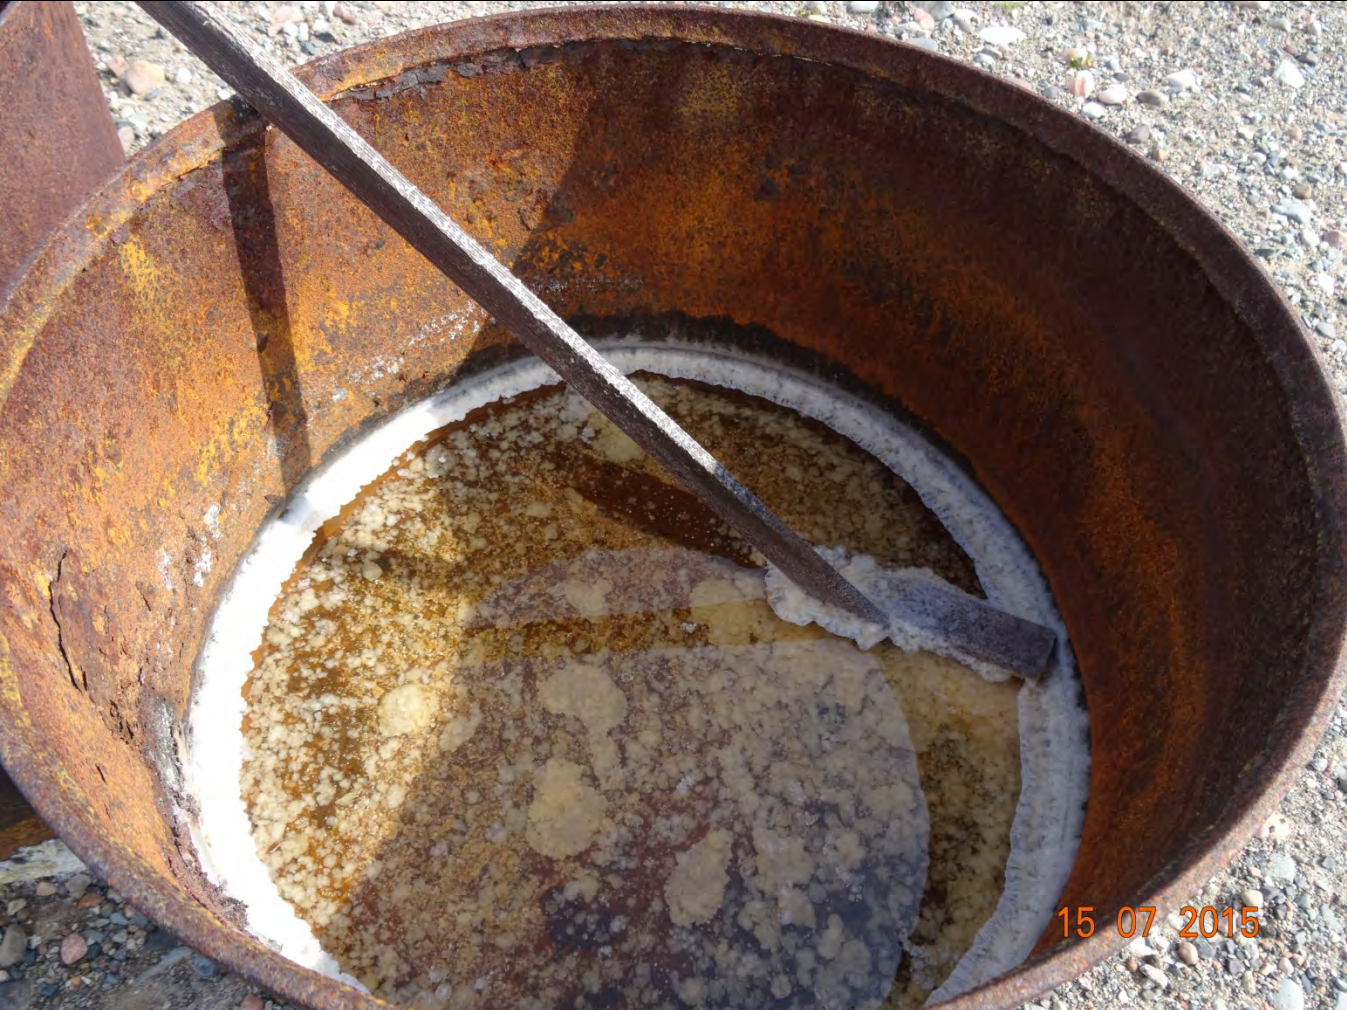
Photo Log # 4

**Description:** One of three barrels of a salt-like substance found by the road at the above coordinates.

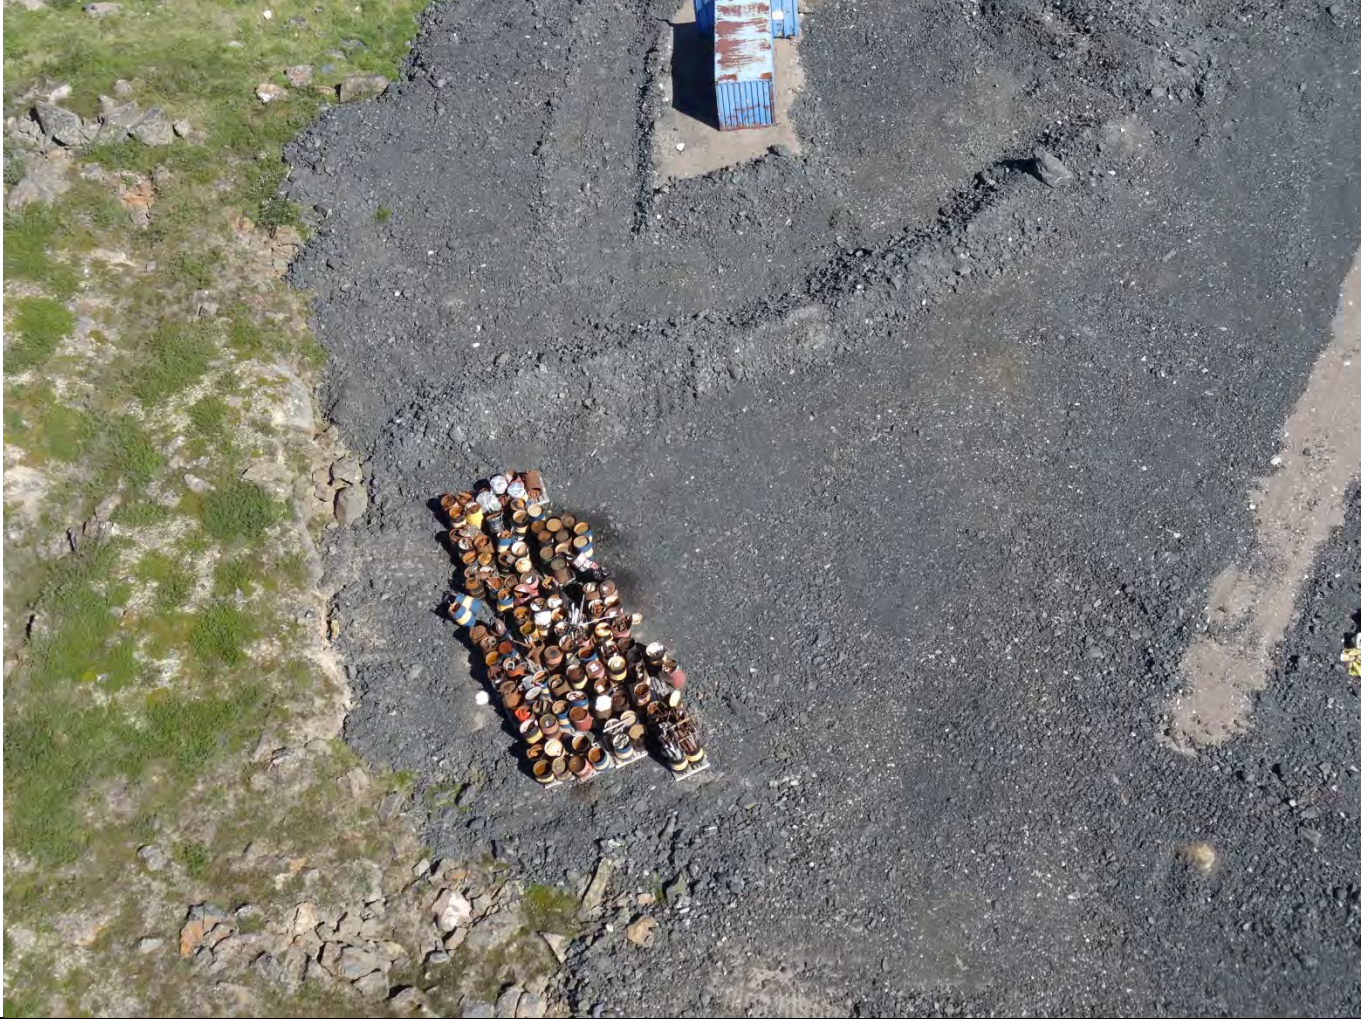
Photo Log # 5

Description: Aerial photo of the mine storage pad taken July 13, 2014 by Eva Paul.

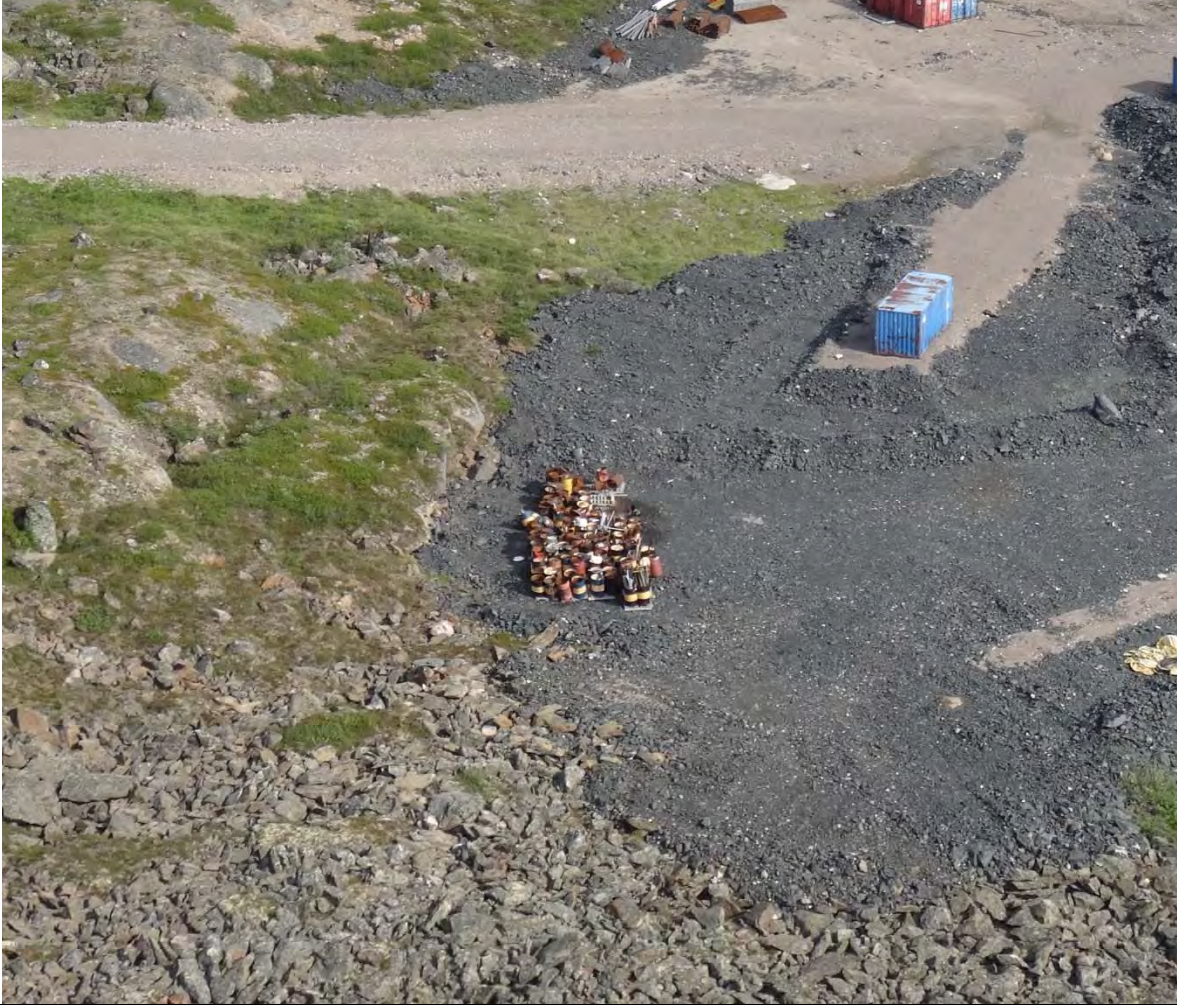
Photo Log # 6

Description: 2015 aerial photo of the mine storage pad. Also see photo 3.

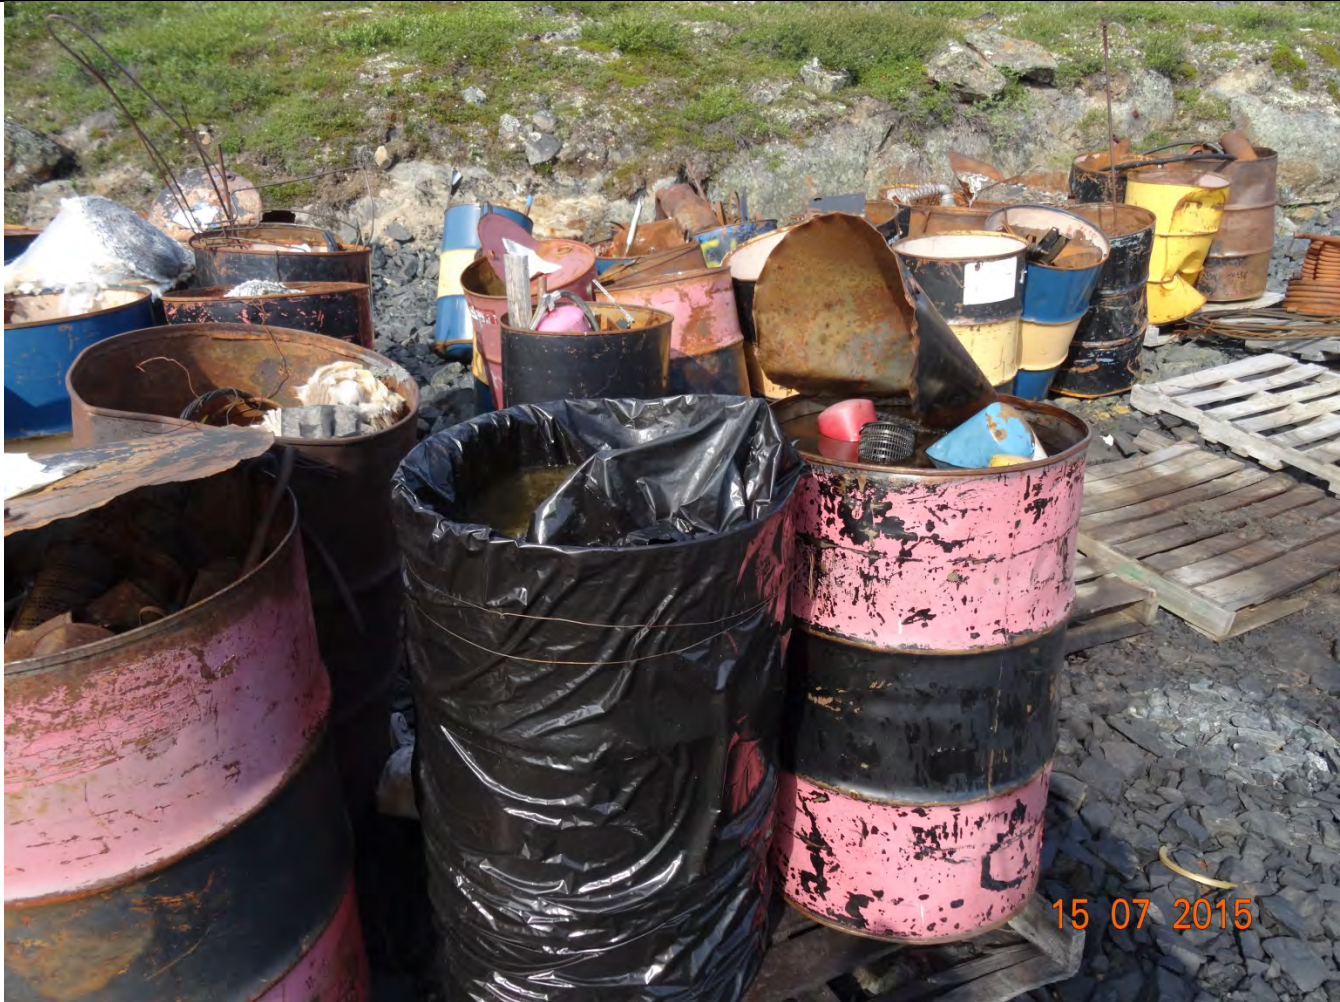
Photo Log # 7

**Description:** Waste barrels at the mine storage pad. Unknown covered waste, oil filters, pallets where waste was removed, and staining is visible on the ground.

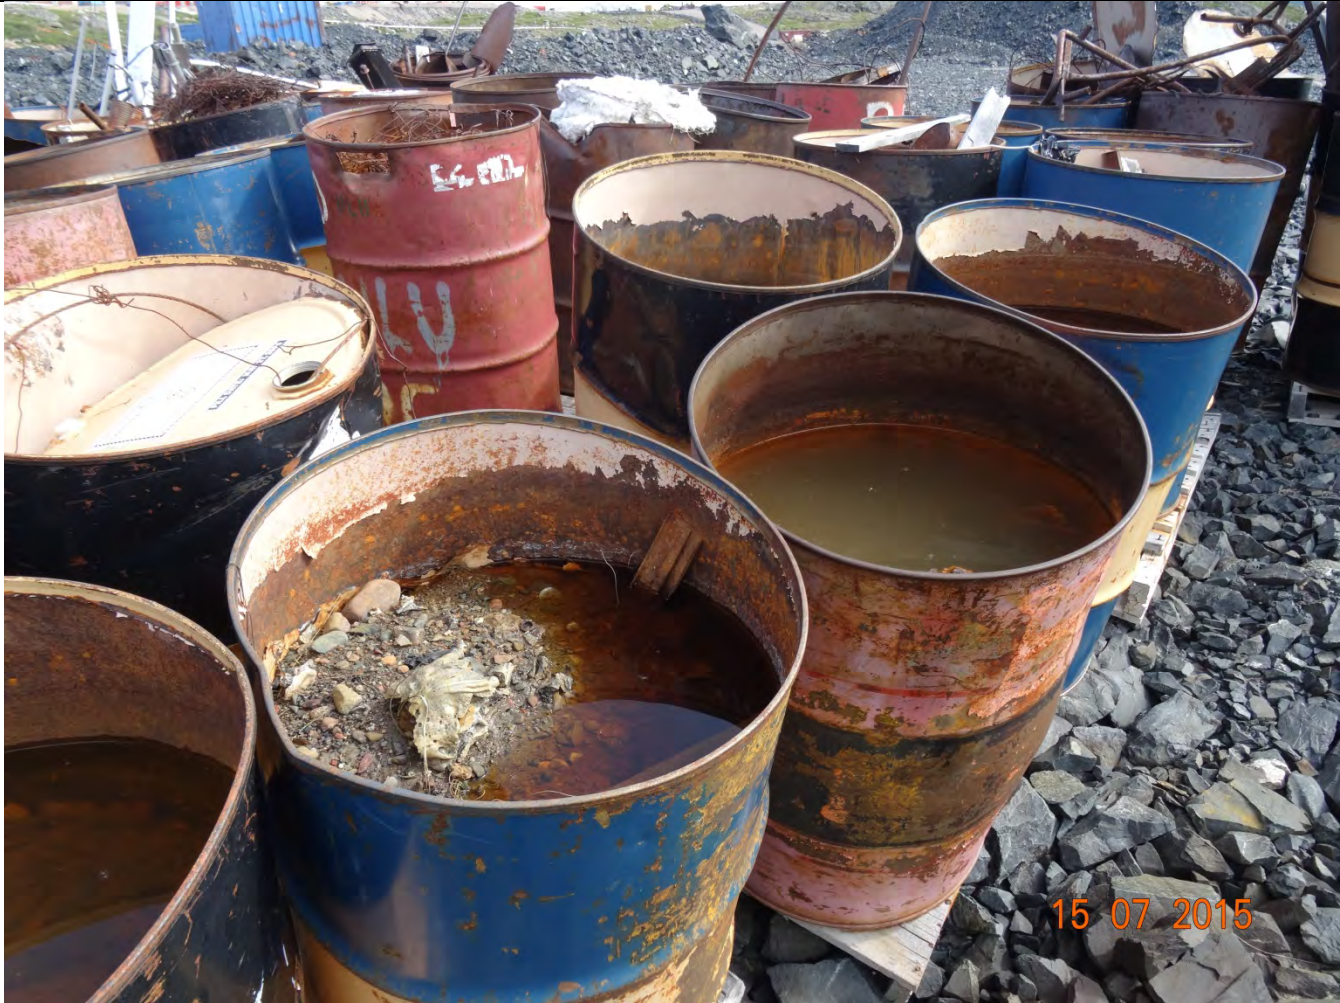
Photo Log # 8

**Description:** Waste barrels at the mine storage pad. Several barrels of soil (possibly contaminated) and metal waste.

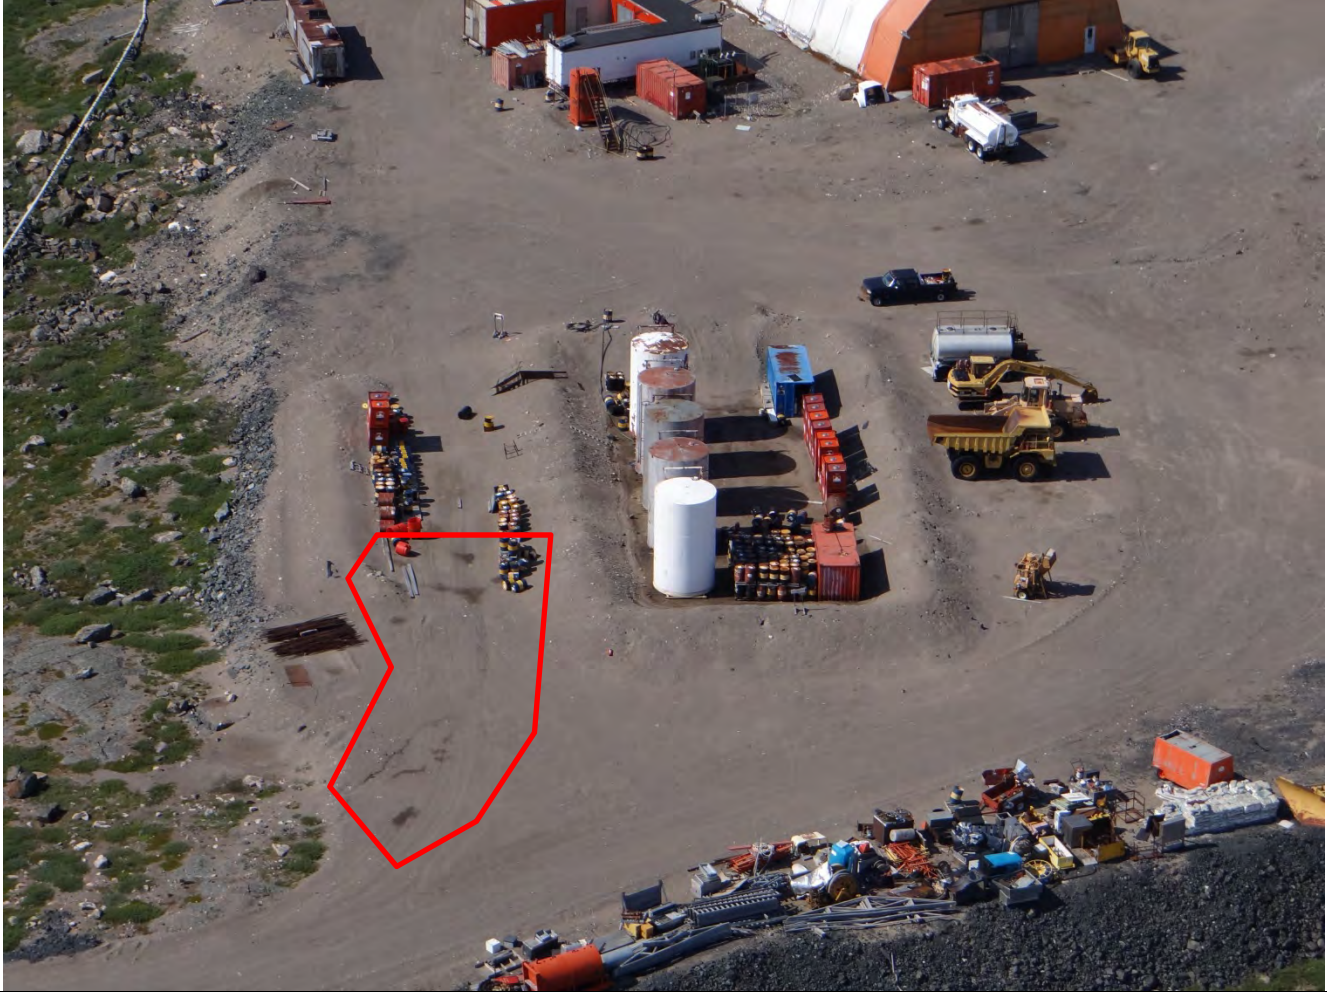
Photo Log # 9

**Description:** Fuel storage pad and main tank farm July 5 2013 (photo by Eva Paul). Some hydrocarbon trail was visible from the pad but did not catch my attention at the time.

- 7. Spills are to be reported and addressed according to the approved Spill Contingency Plan. Steps are to be taken to a) stop the flow of hydrocarbons from the fuel storage pad, b) prevent any further migration of hydrocarbons down-slope from the fuel storage pad, and c) remediate the affected area. This work is to be completed by July 31, 2016 and a confirmatory report submitted to the inspector by August 15, 2016.

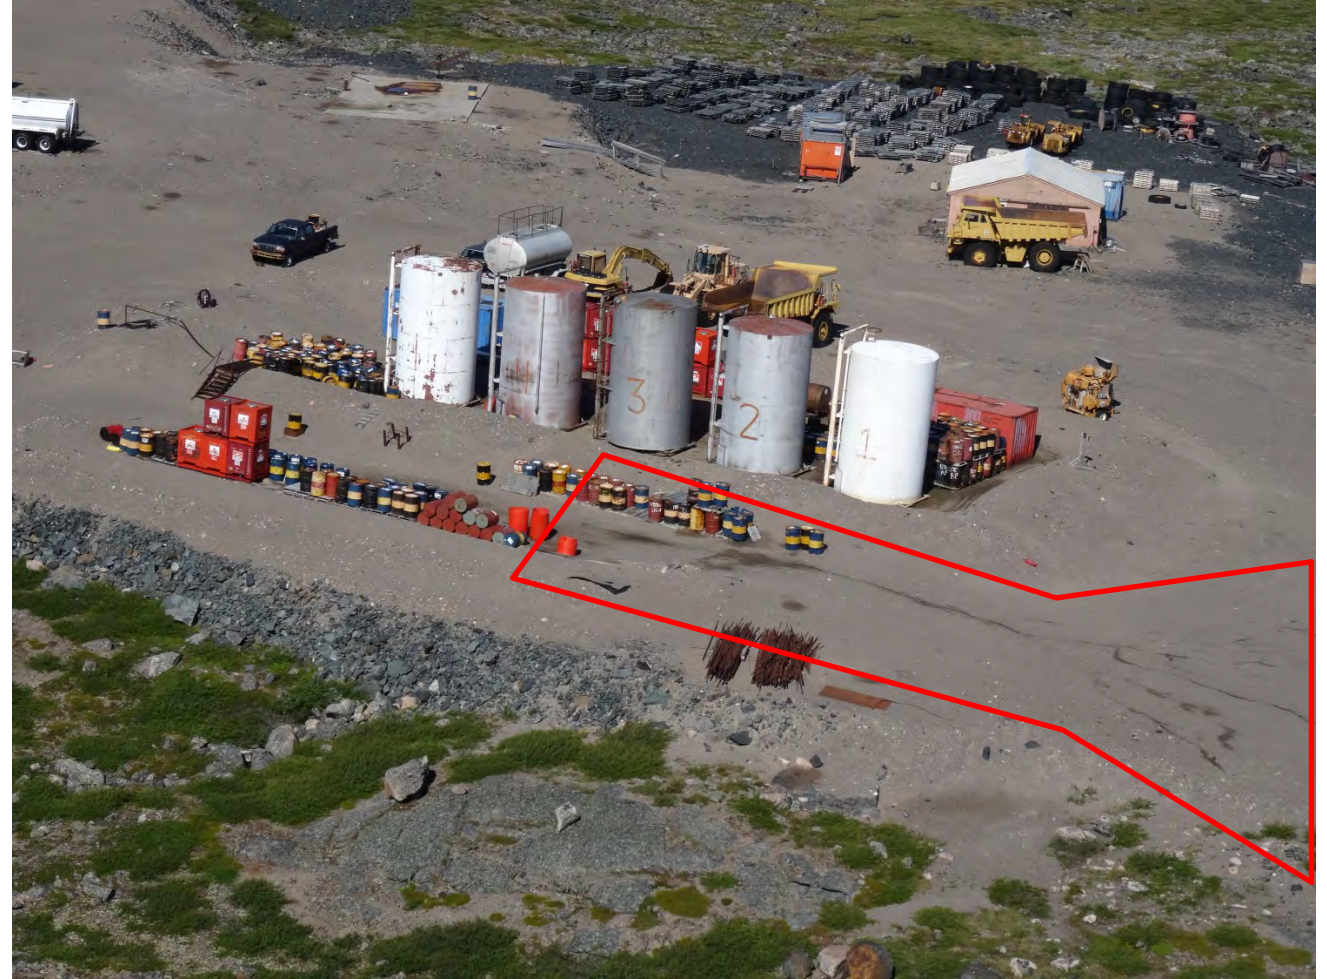
Photo Log # 10

**Description:** Fuel storage pad July 12 2014 (photo by Eva Paul). Hydrocarbon trail from the fuel storage pad was greatly increased from the previous inspection. It was raised as an issue in the 2014 report, and BCC was instructed to remedy the spill according to the spill contingency plan.

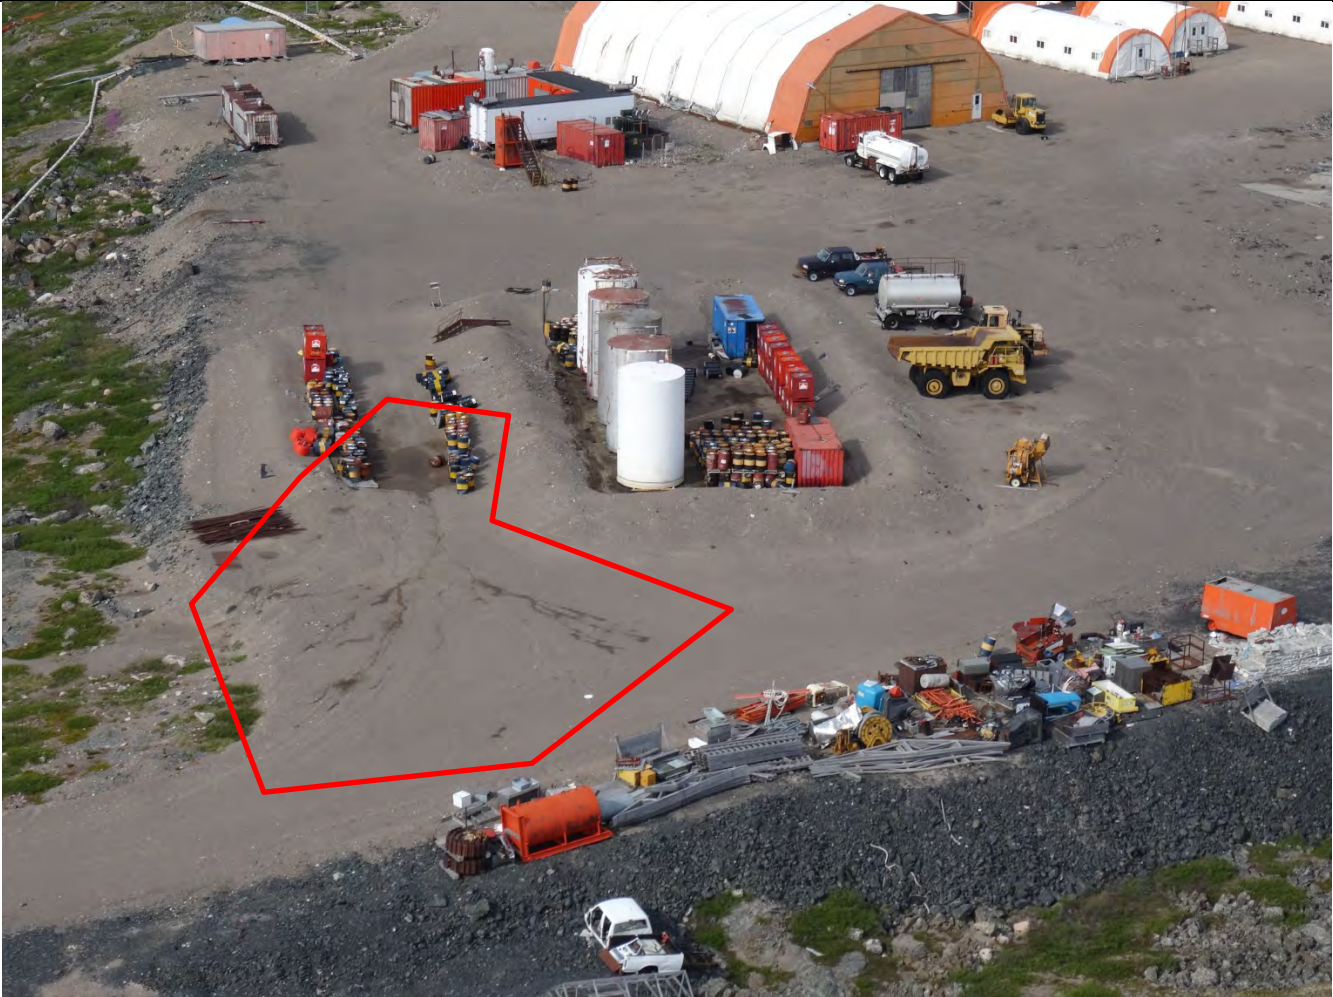
Photo Log # 11

**Description:** Fuel storage pad and main tank farm July 15 2015. No action was taken to address the hydrocarbons leaking from this area. Samples taken during this inspection confirm that the trails are caused by hydrocarbons. Staining within and outside the pad is more extensive and trails are expanded. More barrels have been brought to the pad since the 2014 inspection.

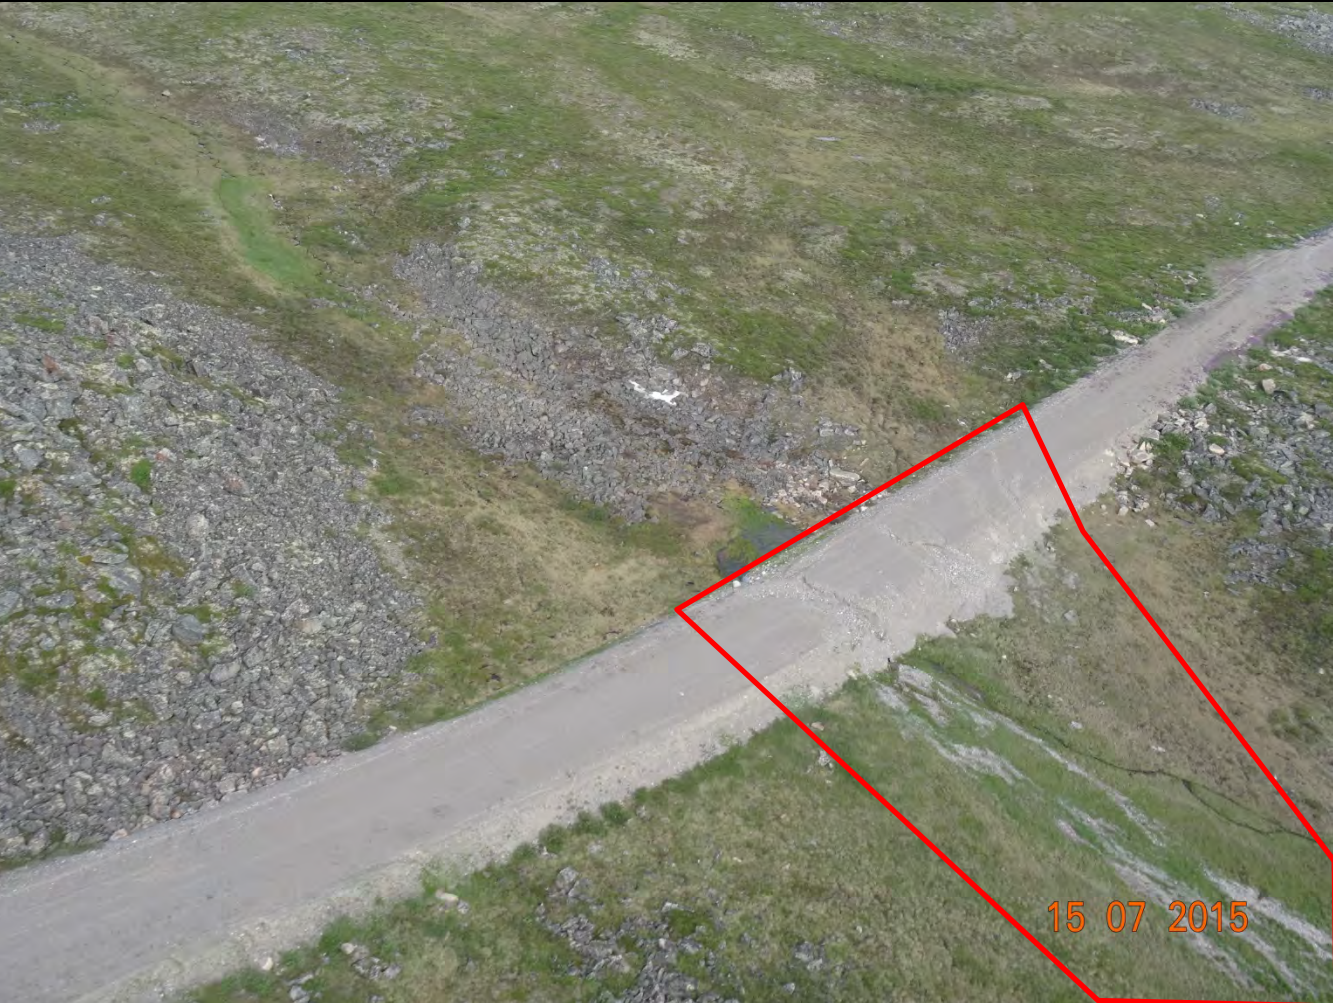
Photo Log # 12

- 5. Wash-outs were noted along the road between the airstrip and camp, particularly in two areas that appear to be drainages with culverts [Photos 12-13]. Sediment trails are evident; no sediment control measures were visible.

**Description:** Wash out on the road from site to the airstrip. Note the trail of sediment apparent on downstream side.

- 4. Establishment (and regular maintenance) of sediment control measures to prevent further sediment loading of streams that have been affected by road deterioration. These measures are to be put in place at freshet 2016.

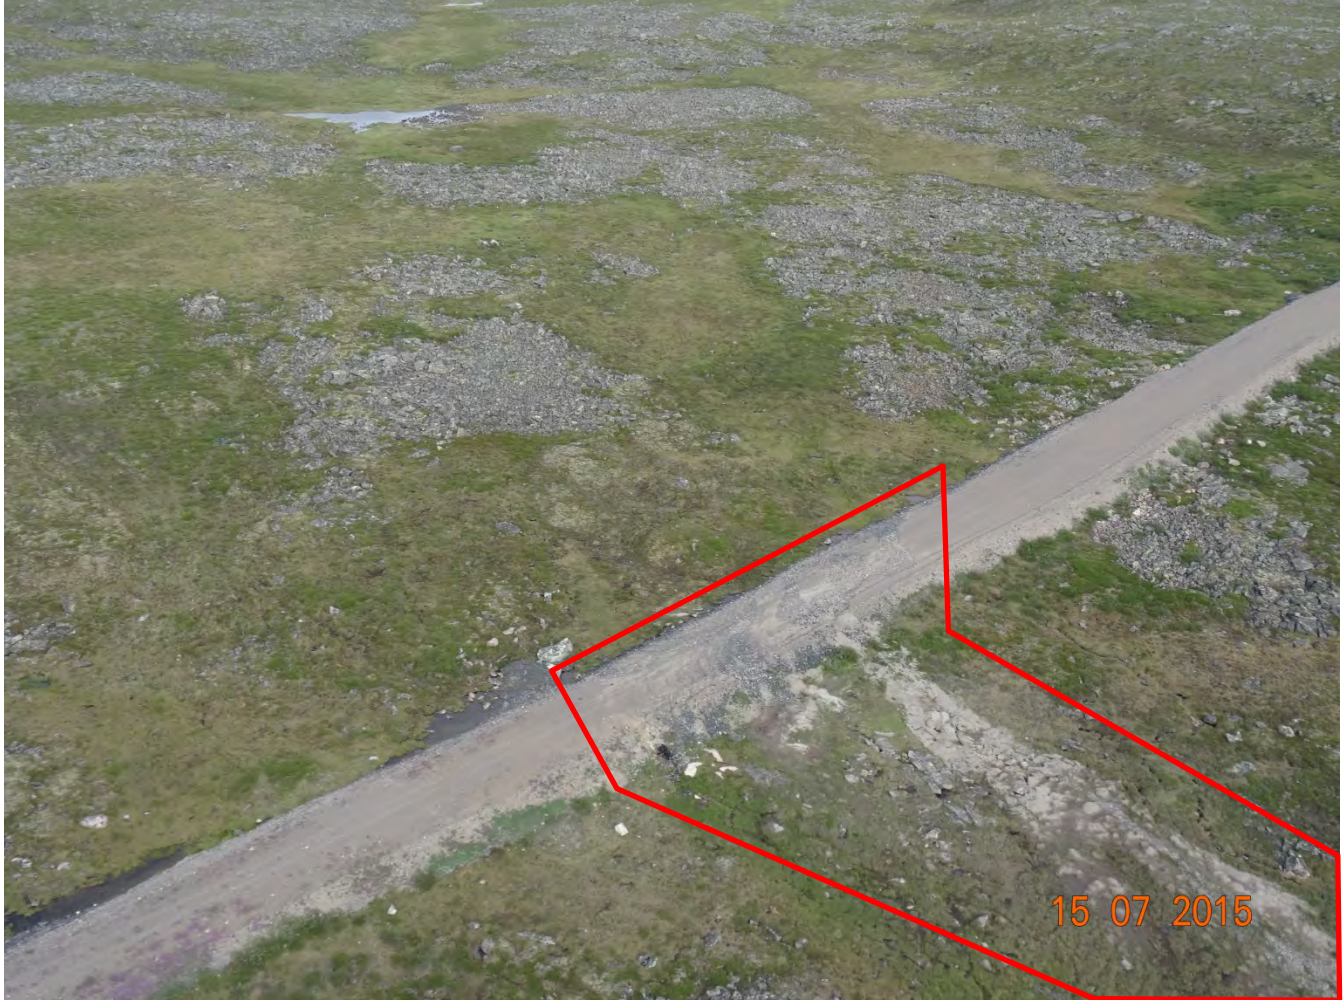
Photo Log # 13

**Description:** Wash out (2) on the road from site to the airstrip. Note the trail of sediment apparent on downstream side.
