**GOVERNMENT OF NUNAVUT
DEPARTMENT OF COMMUNITY AND GOVERNMENT SERVICES**

**STUDY OF THE WETLAND SEWAGE TREATMENT AREA
CORAL HARBOUR, NUNAVUT**

Project No. NTY71091

March 28, 2005

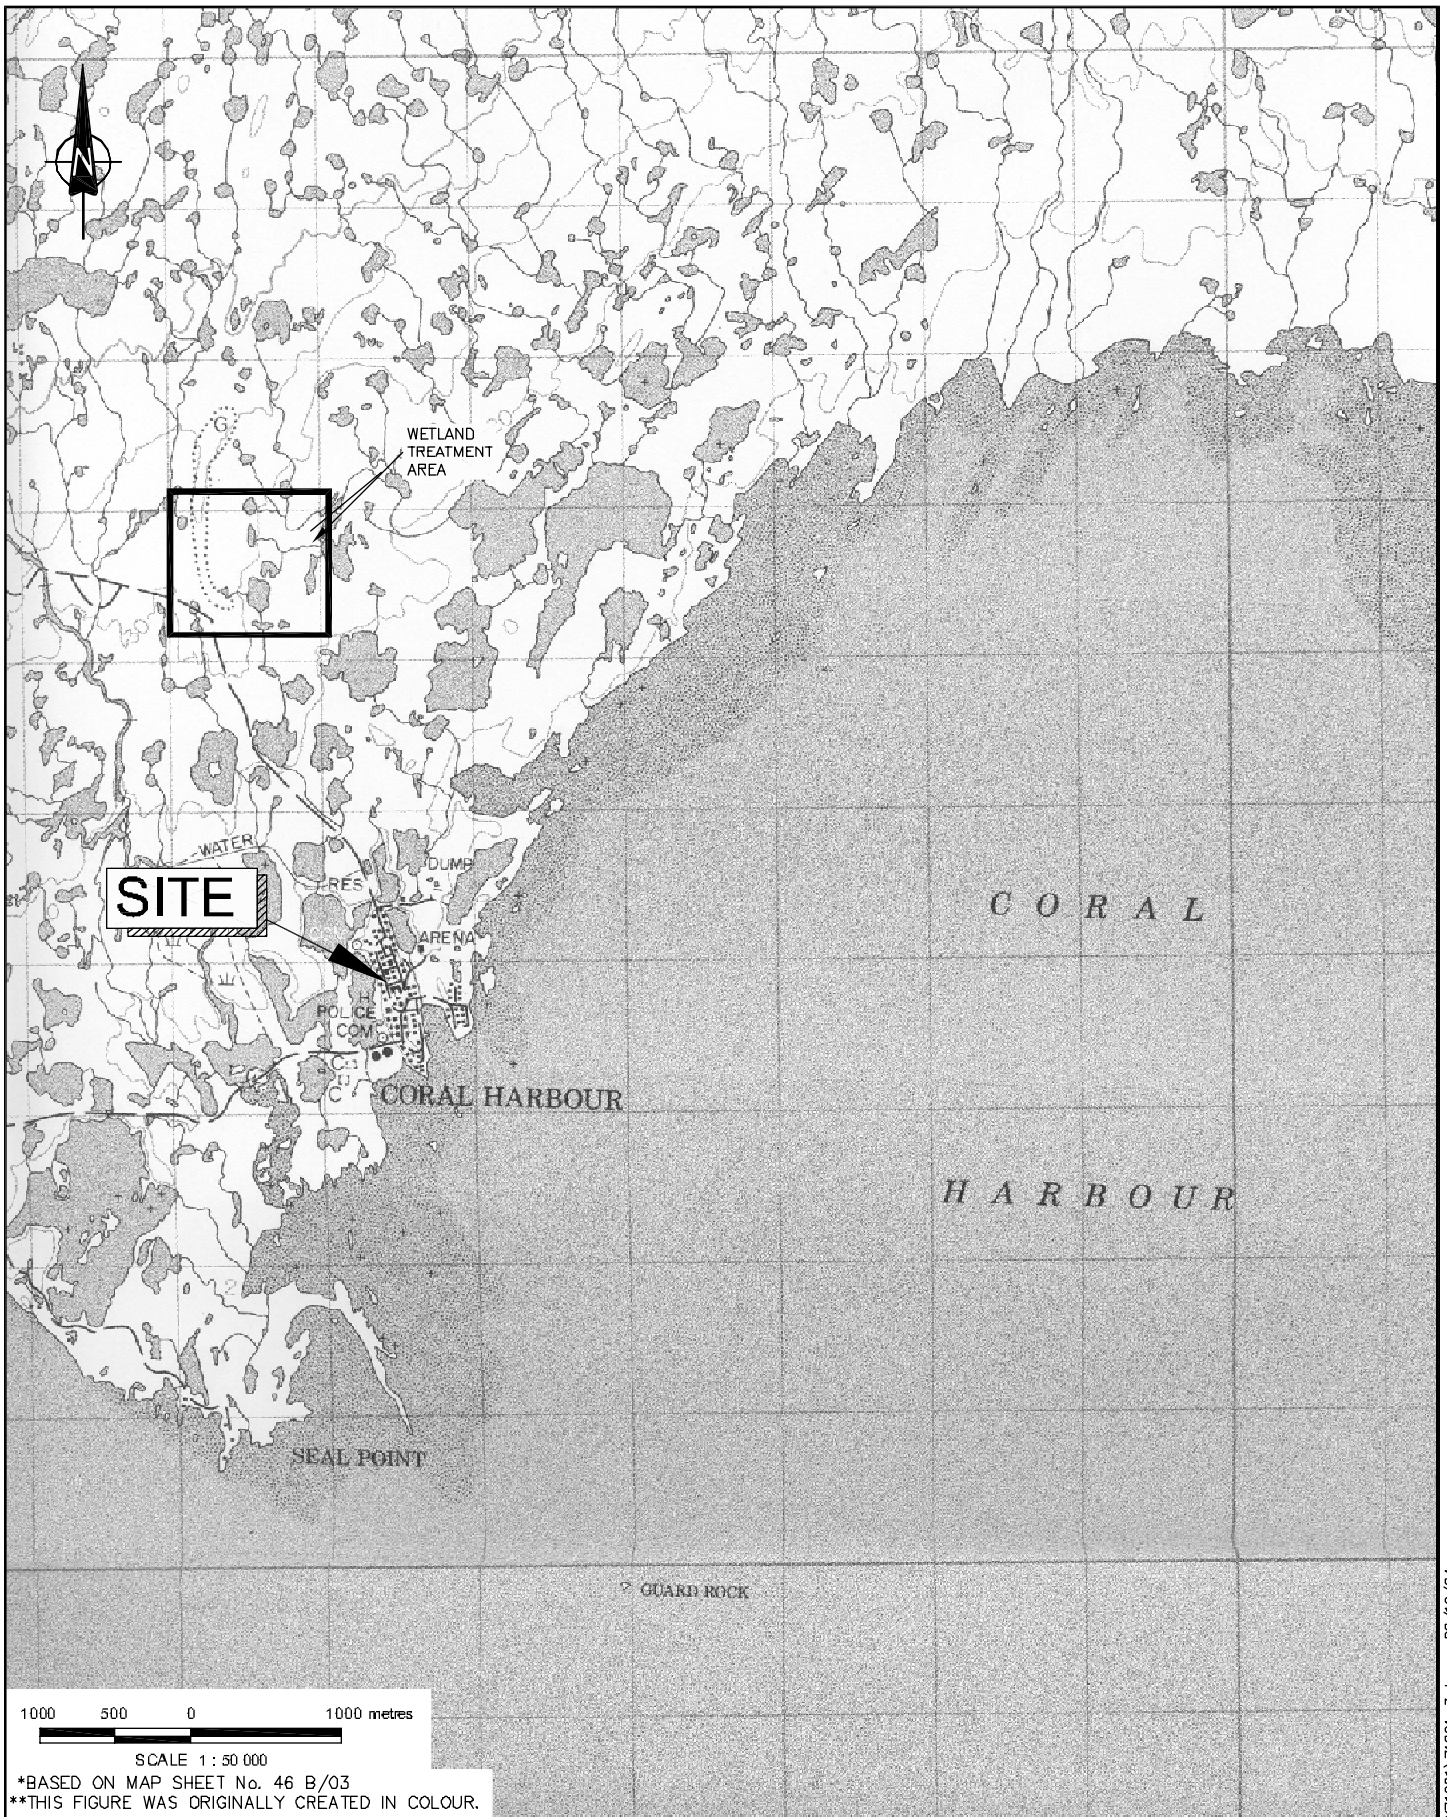
2

CLIENT : GOVERNMENT OF NUNAVUT DEPARTMENT OF COMMUNITY AND GOVERNMENT SERVICES
 TITLE : SITE PLAN
 CORAL HARBOUR SEWAGE SYSTEM
 CORAL HARBOUR, NORTHWEST TERRITORIES

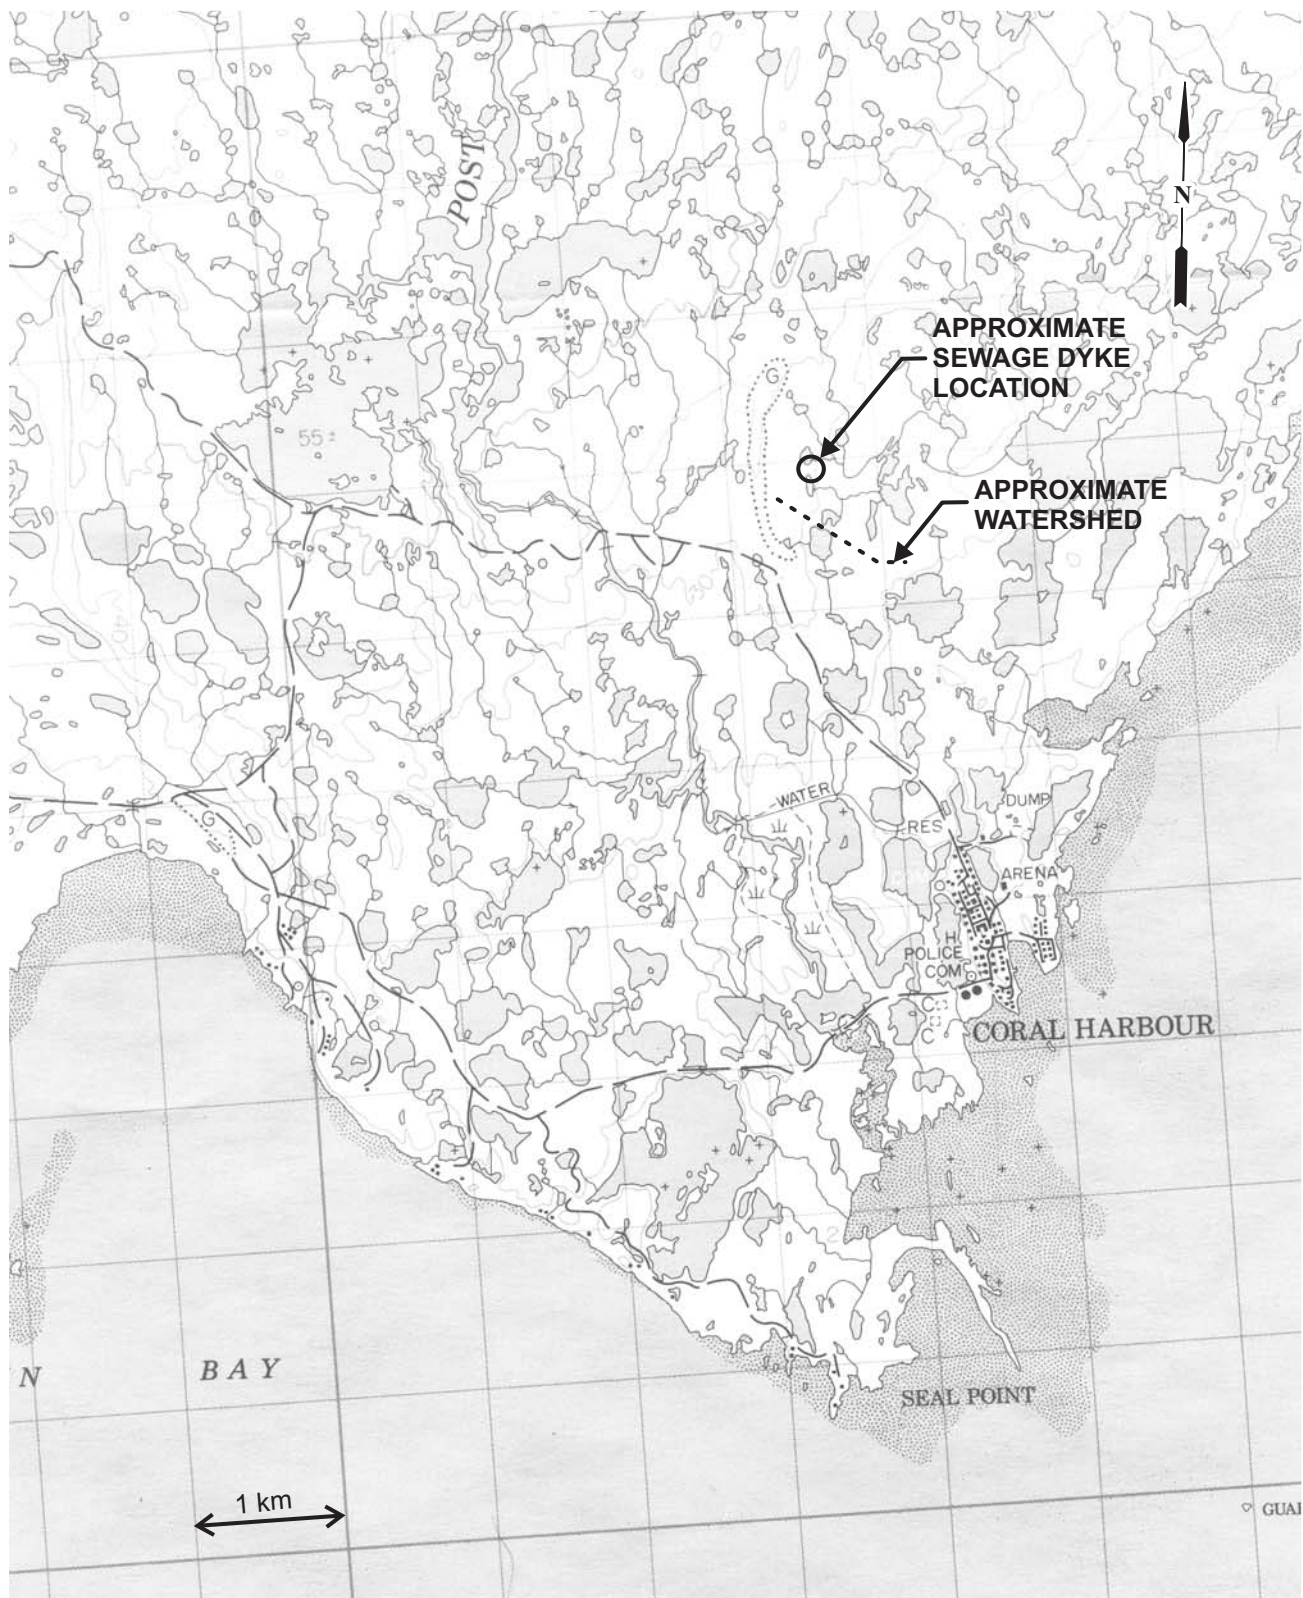
Seven test pits were excavated to determine the subsurface conditions of the site. Approximate test pit locations are presented on Figure 1. The test pits were advanced by a Komatsu 320 excavator operated by Deno Bruce of Coral Harbour. The test pit logs are presented in Appendix B.

Notes: Reproduced from Government of Canada Topographic Map 46B/3
Scale = 1 : 50 000

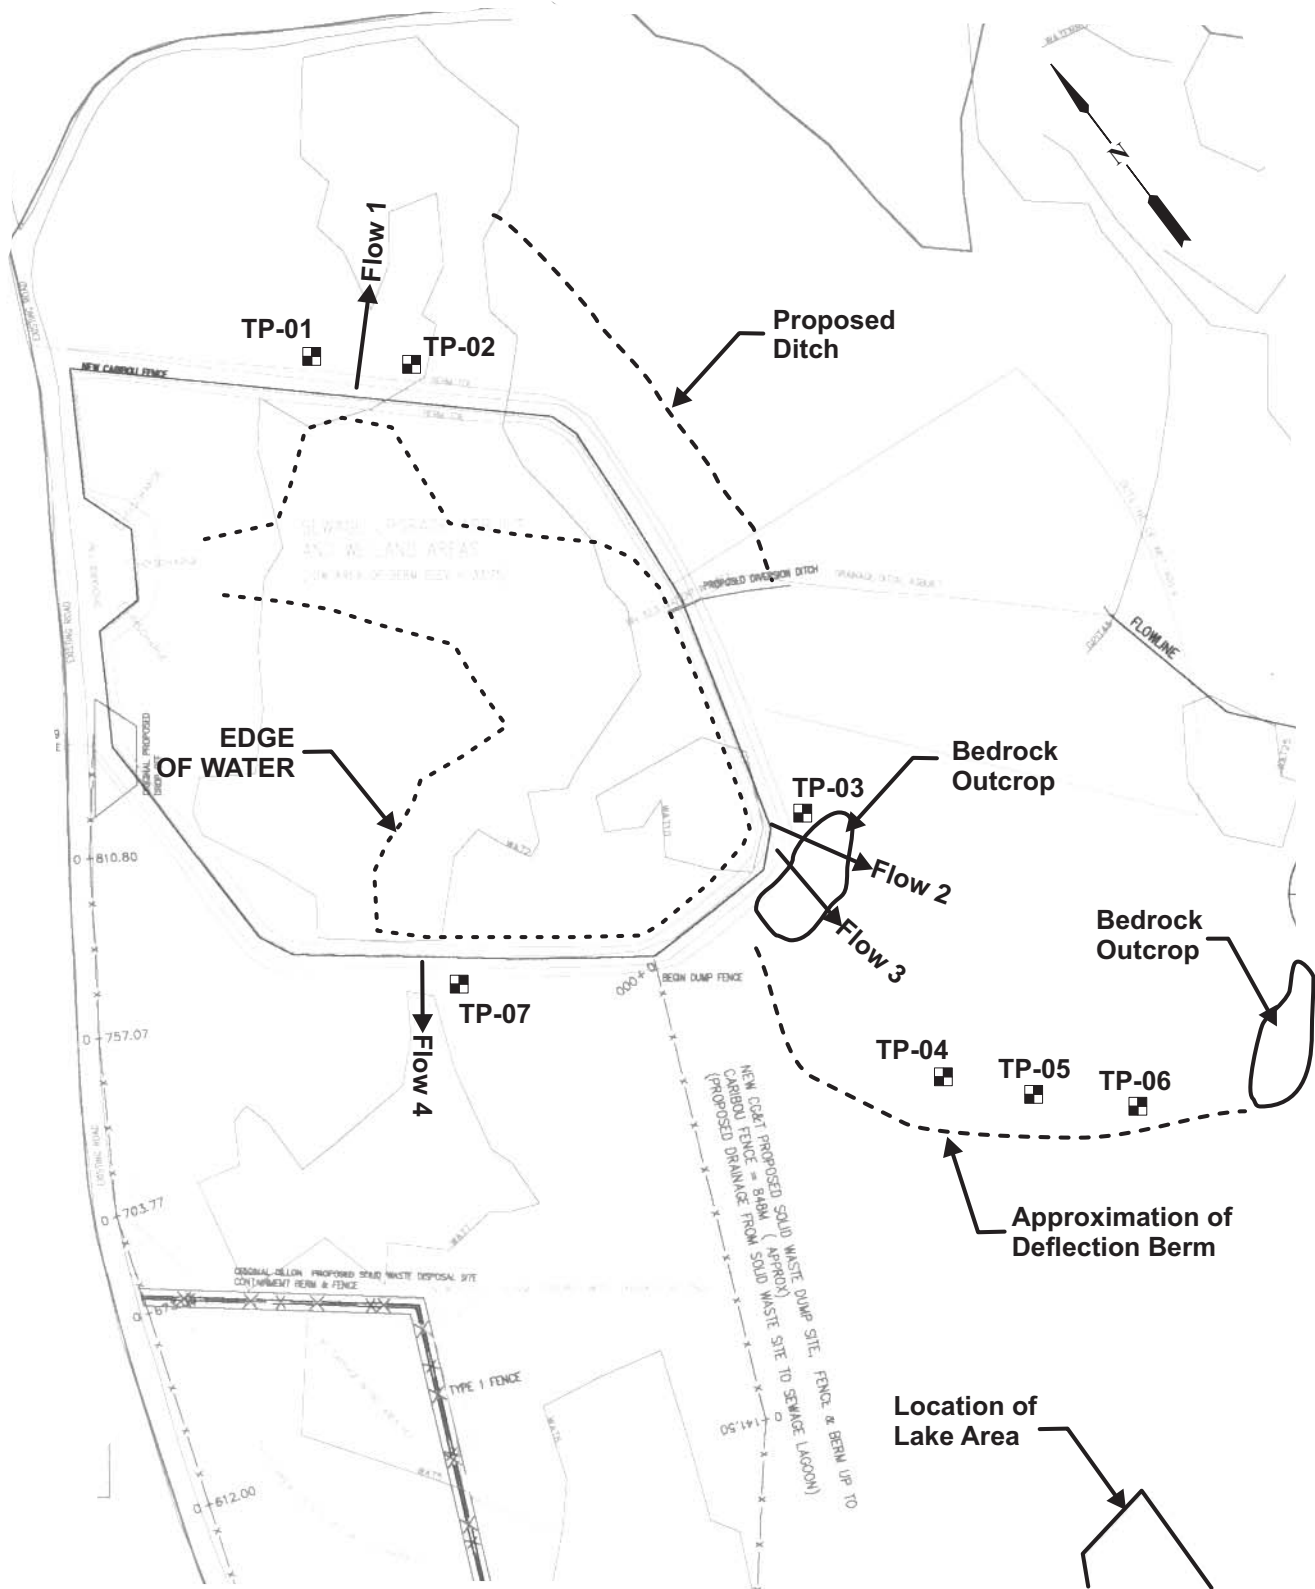
A visual inspection of the sewage lagoon berm was initially completed. A total of four areas of seepage were observed around the berm and are labelled in Figure 2. Sewage is discharged into the lagoon at the west side. The internal topography of the lagoon slopes down from north to south, with an estimated drop in elevation from one end to the other of about 0.5 m. Sewage water accumulates in the south corner of the lagoon. This is the area that was observed to have the most significant seepage through the berm.

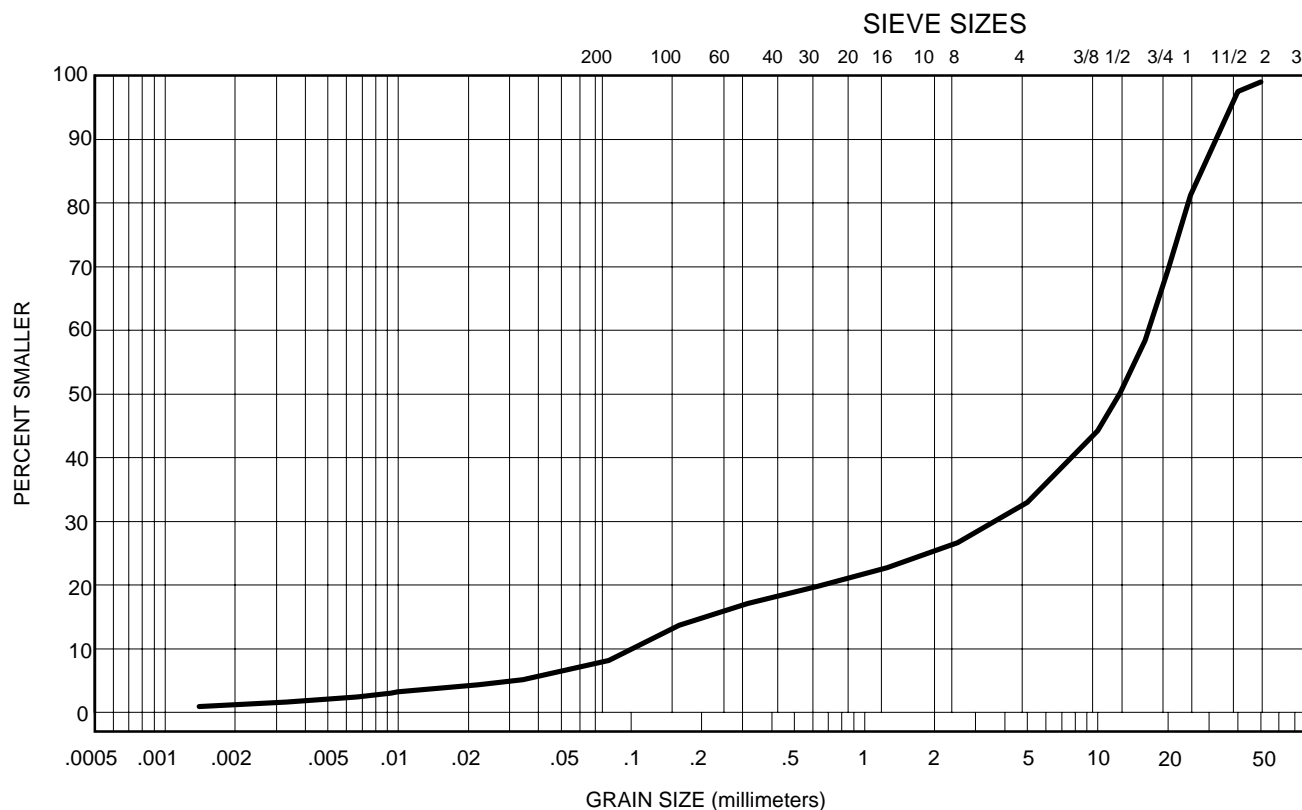
Three soil samples were submitted to EBA's Yellowknife laboratory for testing. These samples included: silt from the beach area, sand from the existing berm, and a mixture of crushed limestone and silt from a borrow source. Testing included the determination of natural moisture contents and gradations. The results are presented in Appendix C.

SIEVE	PERCENTAGE PASSING
40	97
25	81
20	70
16	58
12.5	50
10	44
5	33
2.5	27
1.25	23
0.63	20
0.315	17
0.16	14
0.08	8.1

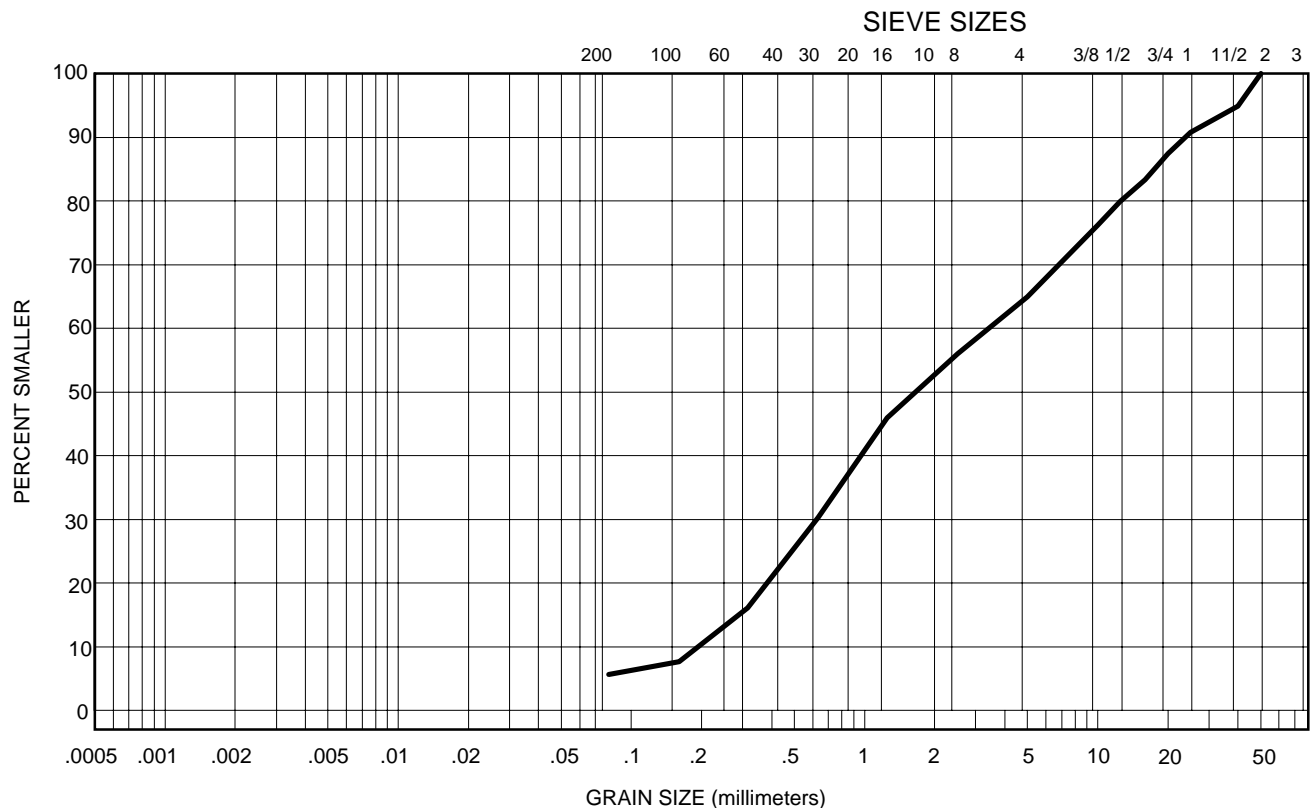
SIEVE	PERCENTAGE PASSING
40	95
25	91
20	87
16	83
12.5	80
10	76
5	65
2.5	56
1.25	46
0.63	30
0.315	16
0.16	8
0.08	5.7

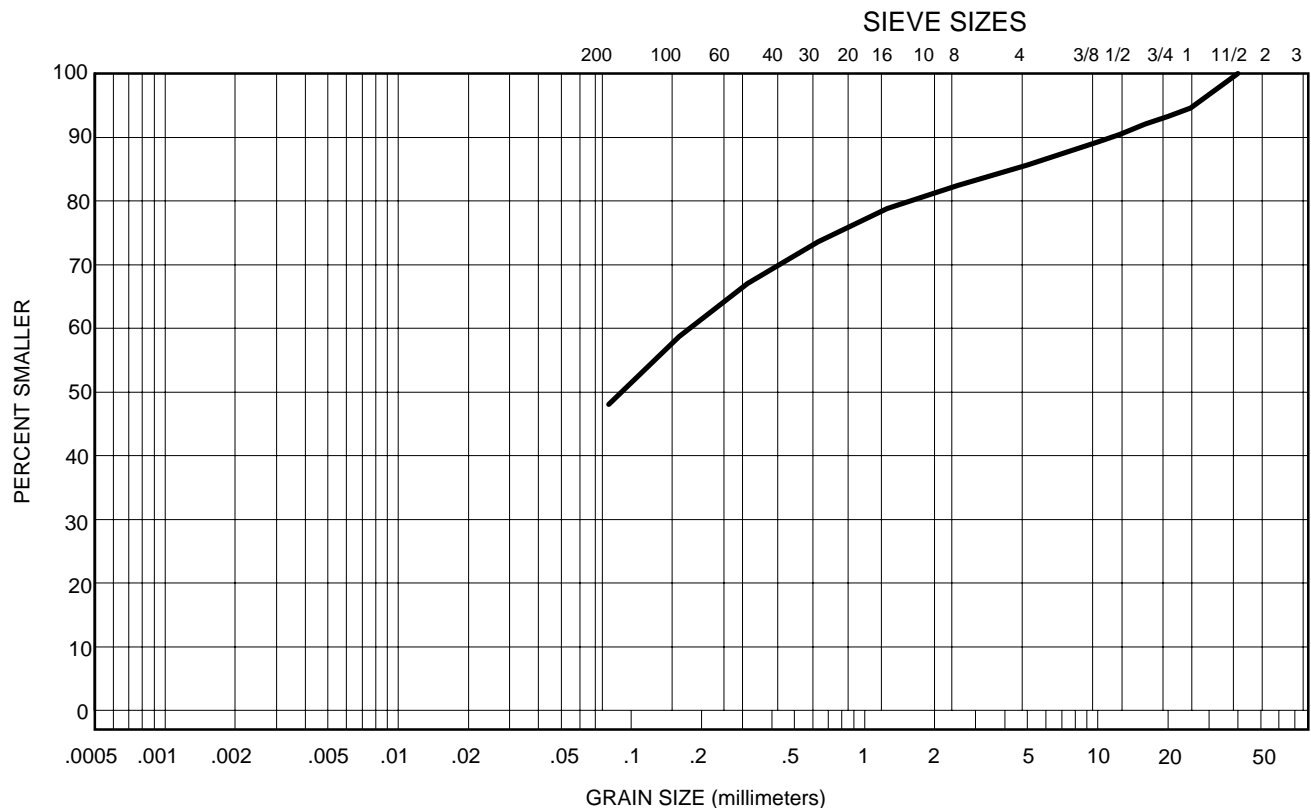
SIEVE	PERCENTAGE PASSING
40	100
25	95
20	93
16	92
12.5	90
10	89
5	86
2.5	82
1.25	79
0.63	74
0.315	67
0.16	59
0.08	48.1

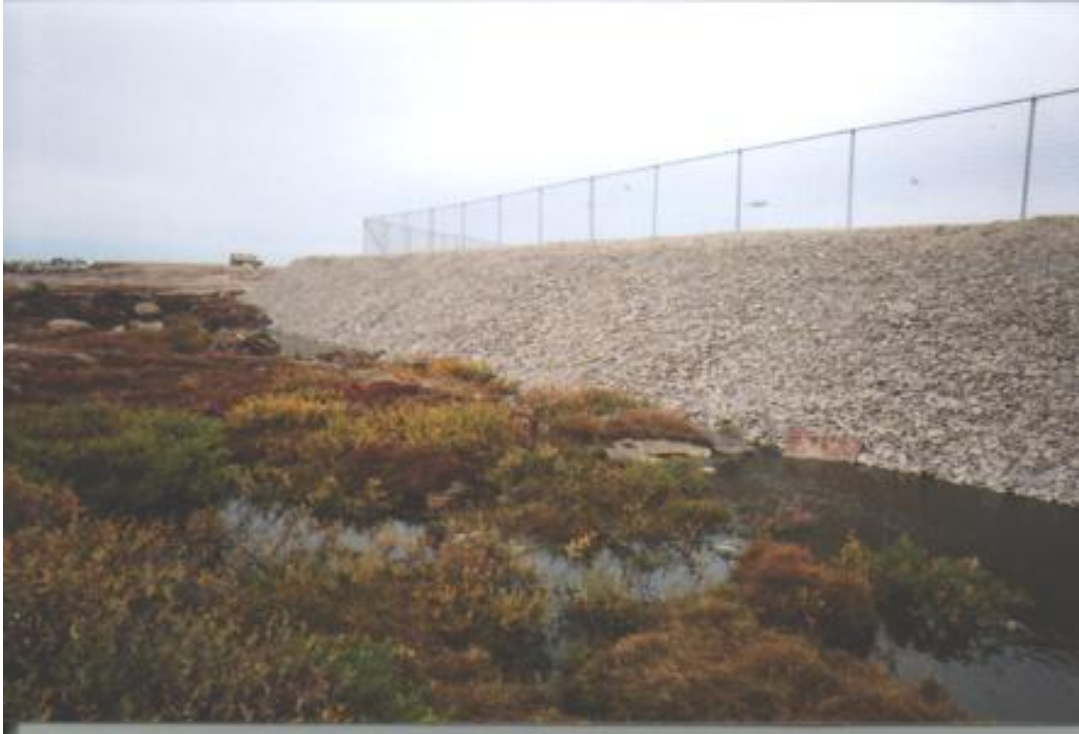
Photo 1

South corner of sewage lagoon at Flow #3 location looking looking towards Flow #4. View of the Sewage Lagoon dyke wall

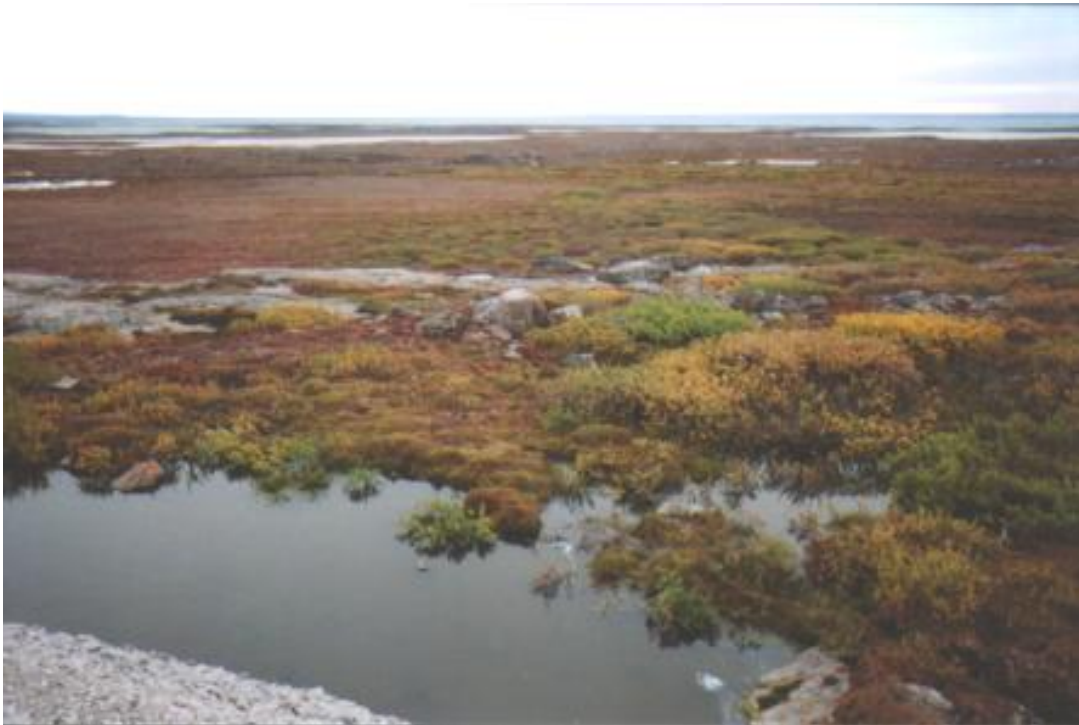
Photo 2

Because the berm is constructed of granular material it is not impermeable. Once water passes through the berm, at the south corner, it flows onto the tundra in two directions. One flow (Flow 2) is southeast onto the tundra, and the other (Flow 3) is south towards the hamlet. Leakage on the northeast and southwest lengths (Flow 1 and 4) of the berm accumulate in local ponded areas as shown in Photos 4 and 5 in Appendix D.

South corner of sewage lagoon ponded water turns into Flow #2 and Flow #3 . Ponded water travels across and around the bedrock outcrop onto tundra

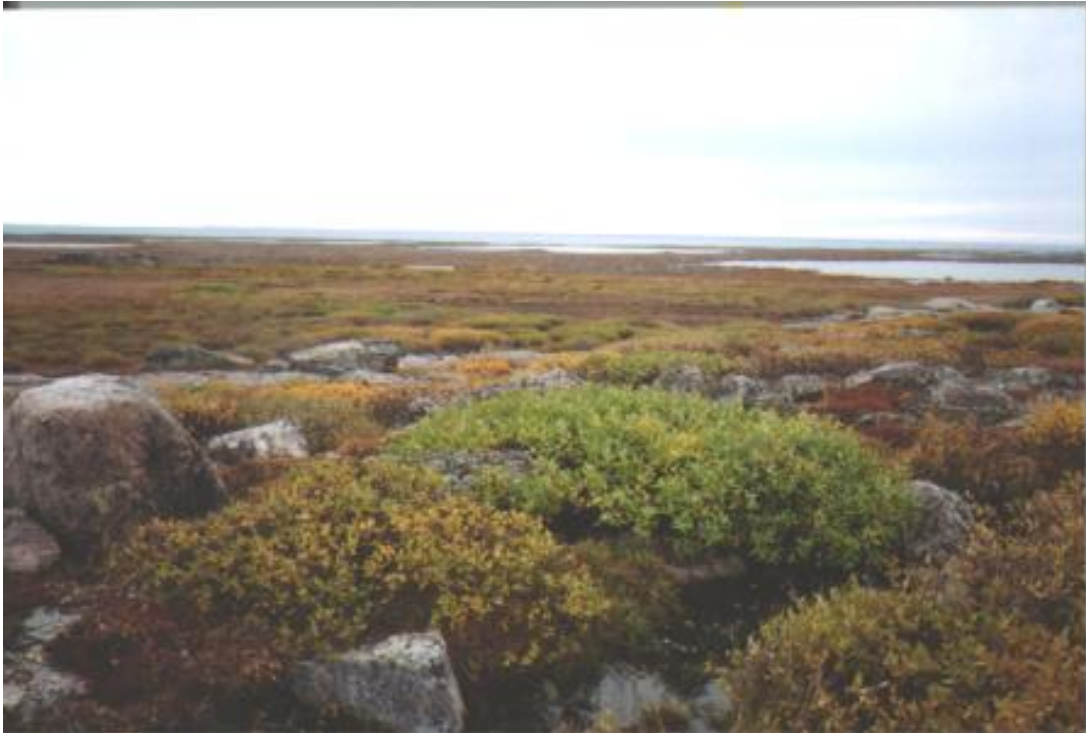
Photo 3

Water flowing around bedrock outcrop (Flow #3) looking south. Ponded water in foreground and runs over bedrock onto tundra. Note lake area and bedrock outcrop in background. Area of possible deflection berm is between outcrops. Area of Test Pits 4 to 6 in approximate centre of background.

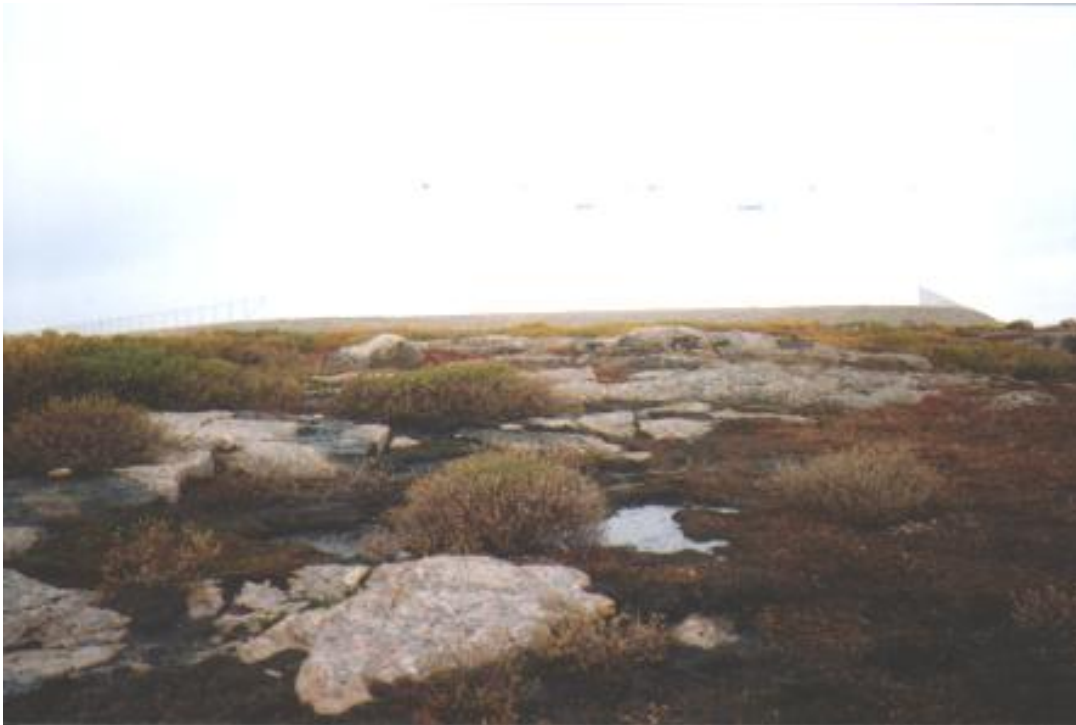
Photo 4

Just beyond bedrock outcrop looking north towards sewage lagoon along Flow #3

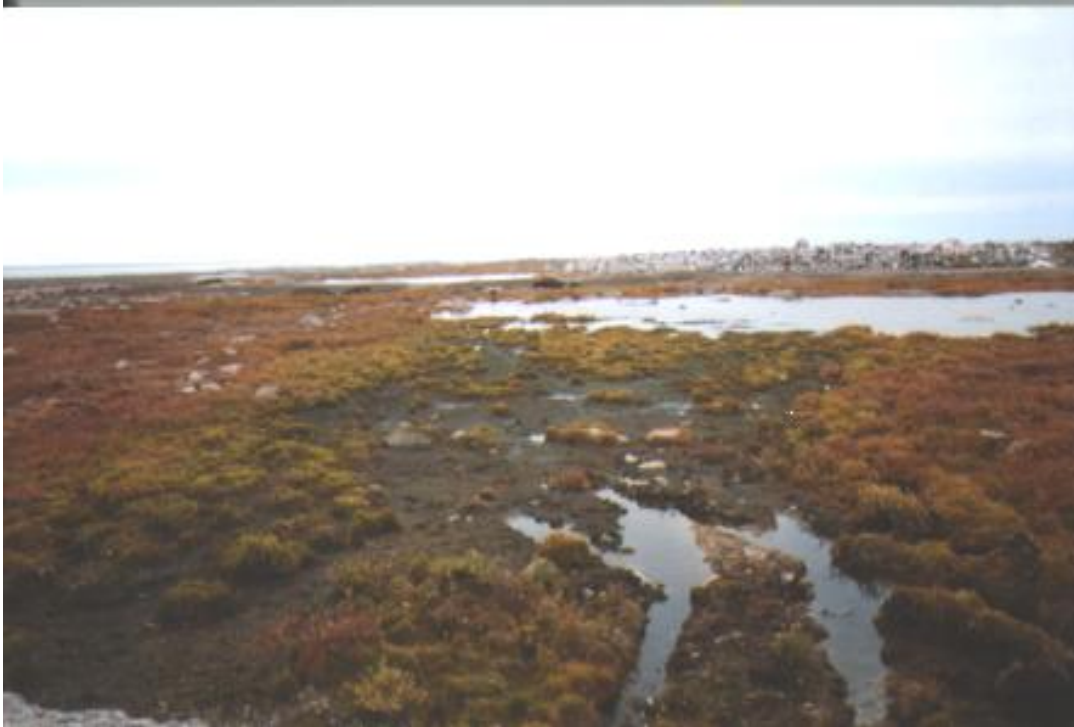
Photo 5

Looking southwest from atop sewage lagoon dyke crest along Flow #4. Water ponds in local low spot. Solid waste dump site in background.

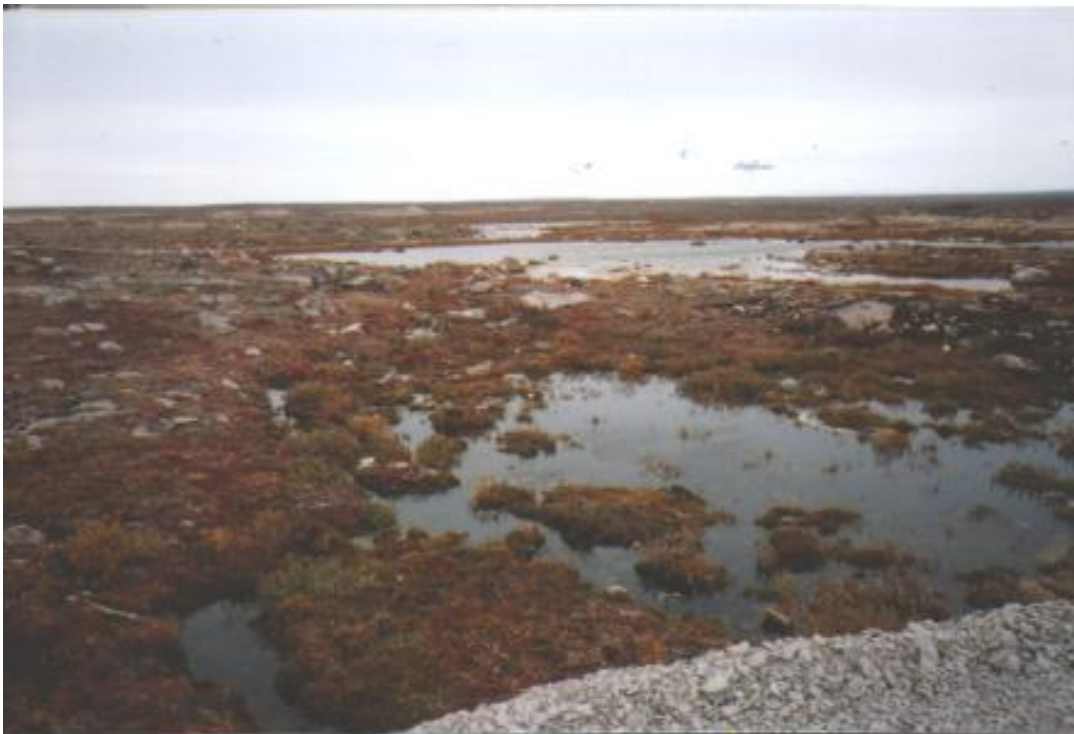
Photo 6

Atop sewage lagoon crest of dyke looking northeast along Flow #1. Water accumulates in local low spot foreground and drains to ponded area in background.
