## WATER LICENCE INSPECTION FORM

| Licensee | | | | Licensee Repre | | e e | | |
|---|---|---|---|---|---|---|---|---|
| Hamlet of Igloo | lik | | | Bhabesh | | | | |
| 3BM-IGL1520 | | Municipal engineer | | | | | | |
| October 5, 2017 Jonathan Mesher | | | | | | | | |

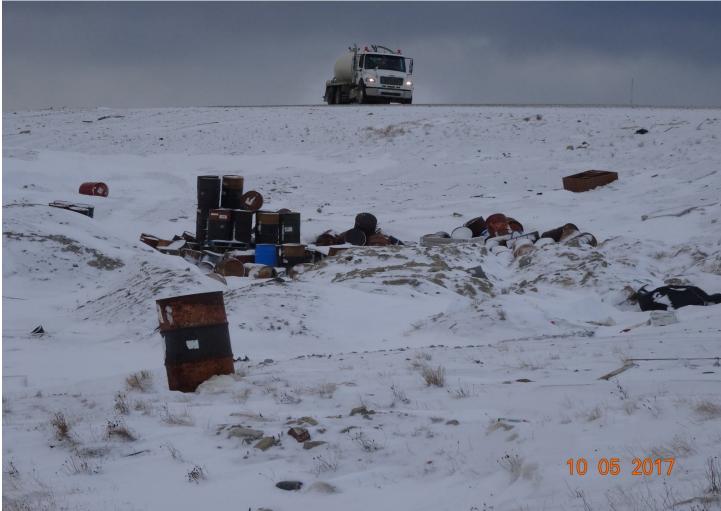
- 9. Metal and hazardous wastes were being segregated in the Metal Storage Area.
- 10. Due to the lack of surface water management it did not appear to the inspector that, the hazardous waste is being segregated and stored in such a manner as to prevent the deposit of deleterious substances into any water. This is in contradiction of Part D, Item 7 of the water licence 3BM-HAL1520. See Figure 1 and 2 for a photo of the current storage or Hazardous waste.

Figure 1: Hazardous waste storage.

"The Licensee shall segregate and store all hazardous materials and/or hazardous waste within the Modified Solid Waste Disposal Facilities in such a manner as to prevent the deposit of deleterious substances into any water, until such a time that the materials have been removed for proper disposal at an approved facility."

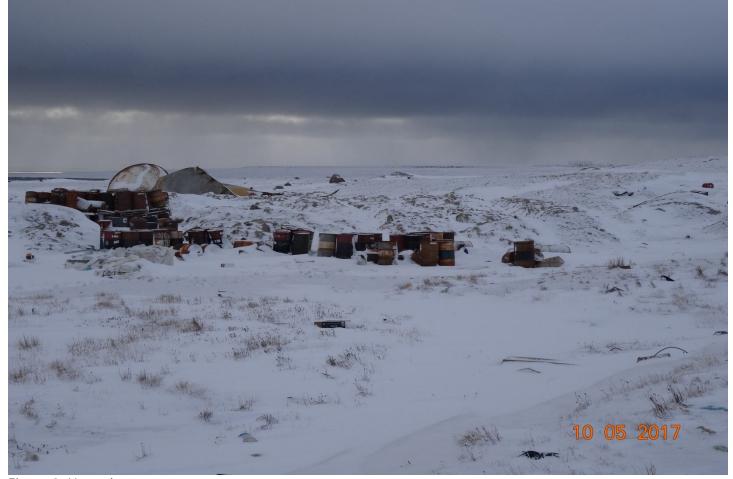
Figure 2: Hazardous waste storage
