June 30, 2004

Re: Leachate problems at the City of Iqaluit Landfill.

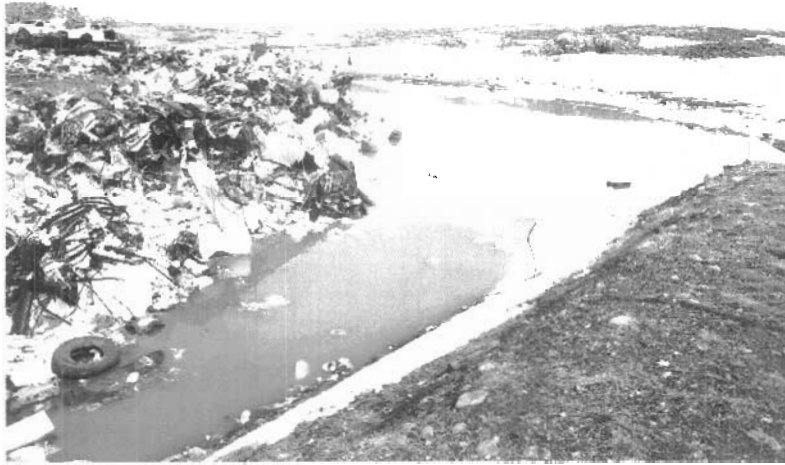
Figure 1. Ponding visible in the Iqaluit Landfill in May 2004.

As identified in the Water Licence Inspection Report delivered to the City of Iqaluit on March 11, 2004 there are significant problems with ponding in the Iqaluit Landfill (figure 1). Since the spring melt which began in May, leachate from the landfill has been flowing over the top of the berm on the south west side of the landfill (figure 2), potentially carrying contaminants out of the landfill and into Koojessie Inlet. In allowing leachate to flow freely out of the Landfill, the City of Iqaluit is in contravention of the Nunavut Waters Nunavut Surface Rights Tribunal Act. The City of Iqaluit needs to control precipitation and runoff entering the Landfill to prevent the transport of contaminants off site. The City has suggested that the leachate problems at the landfill will be addressed in the summer of 2004. If the problem is not addressed, further enforcement action will be necessary.

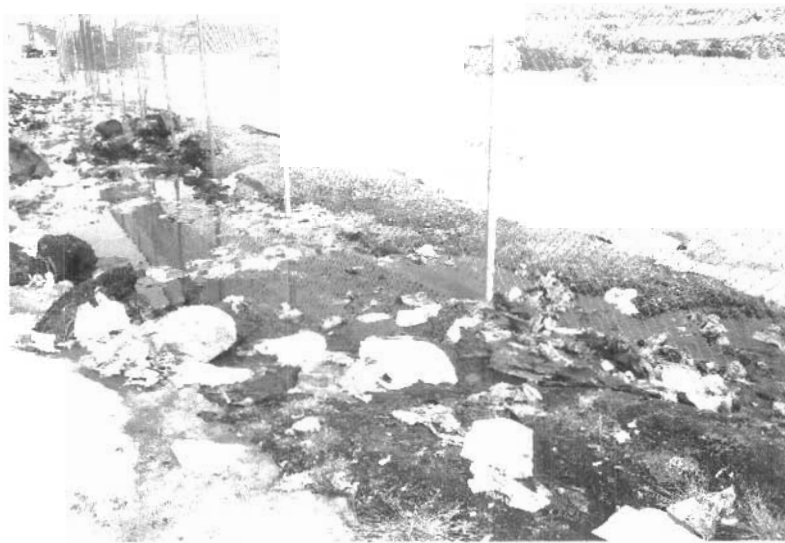
Figure 2. Landfill leachate visible flowing out of the Iqaluit Landfill in May 2004.
