## Water Licence Inspection Report

| City of Iqaluit 3AM-IQA1626 | Shane Turner/ Jeff MacMunn |

On Friday, June 5th, 2026 Inspectors Darren Kennedy and Omer Pasalic of the Crown Indigenous Relations and Northern Affairs Canada, conducted an inspection of the City of Iqaluit – Landfill, Sewage treatment plant and The Wate Treatment Plant, for the purpose of verifying the terms and conditions of City of Iqaluit's water license(3AM-IQA1626)

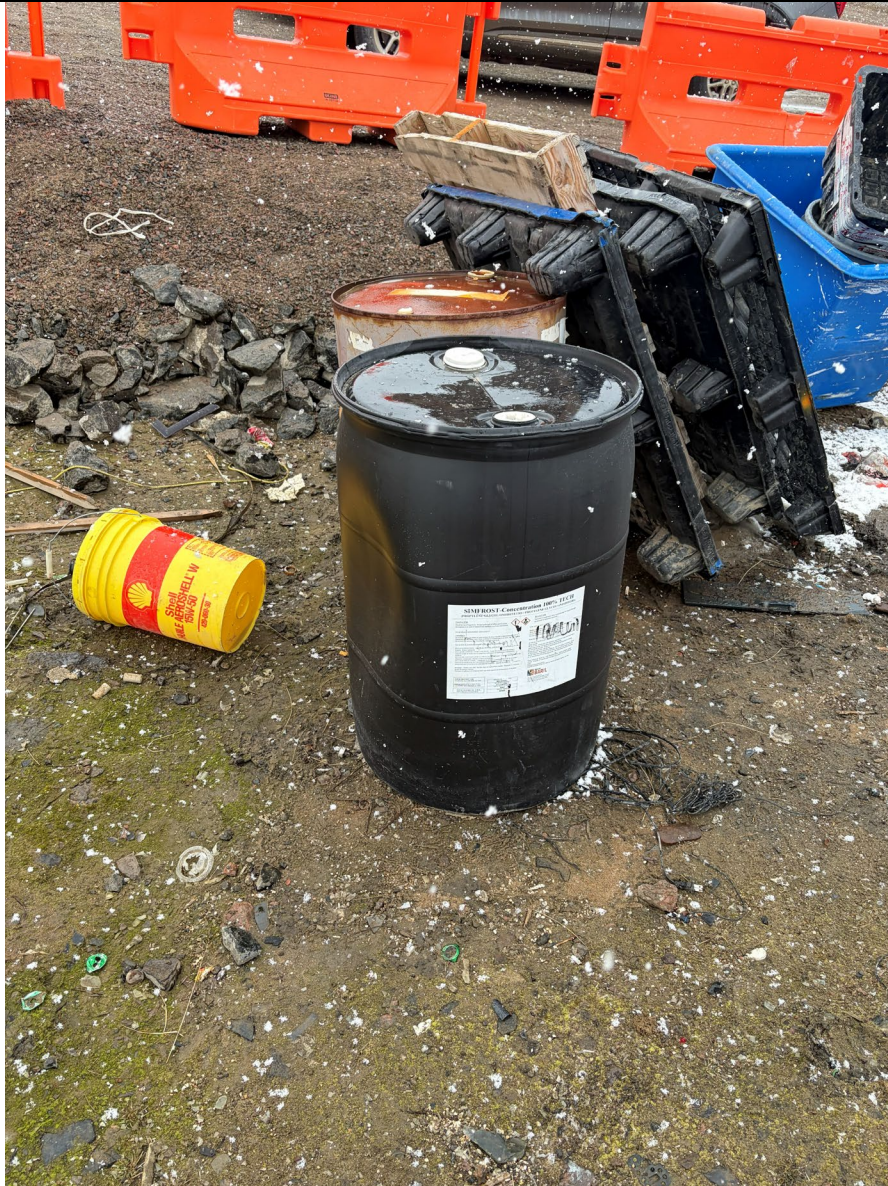
The inspector observed hazardous items, such as drums of fuel and Glycol stored within the perimeters of the Landfill without any sort of containments. The exposure of non-contained items pose potential safety hazards as well as exposure of hazardous fluids leaking into the environment.

West 40 Landfill. Drum of Glycol

- **The Licensee shall contain all hazardous waste found within the Landfill to prevent potential safety hazards as well as potential environmental hazards.**

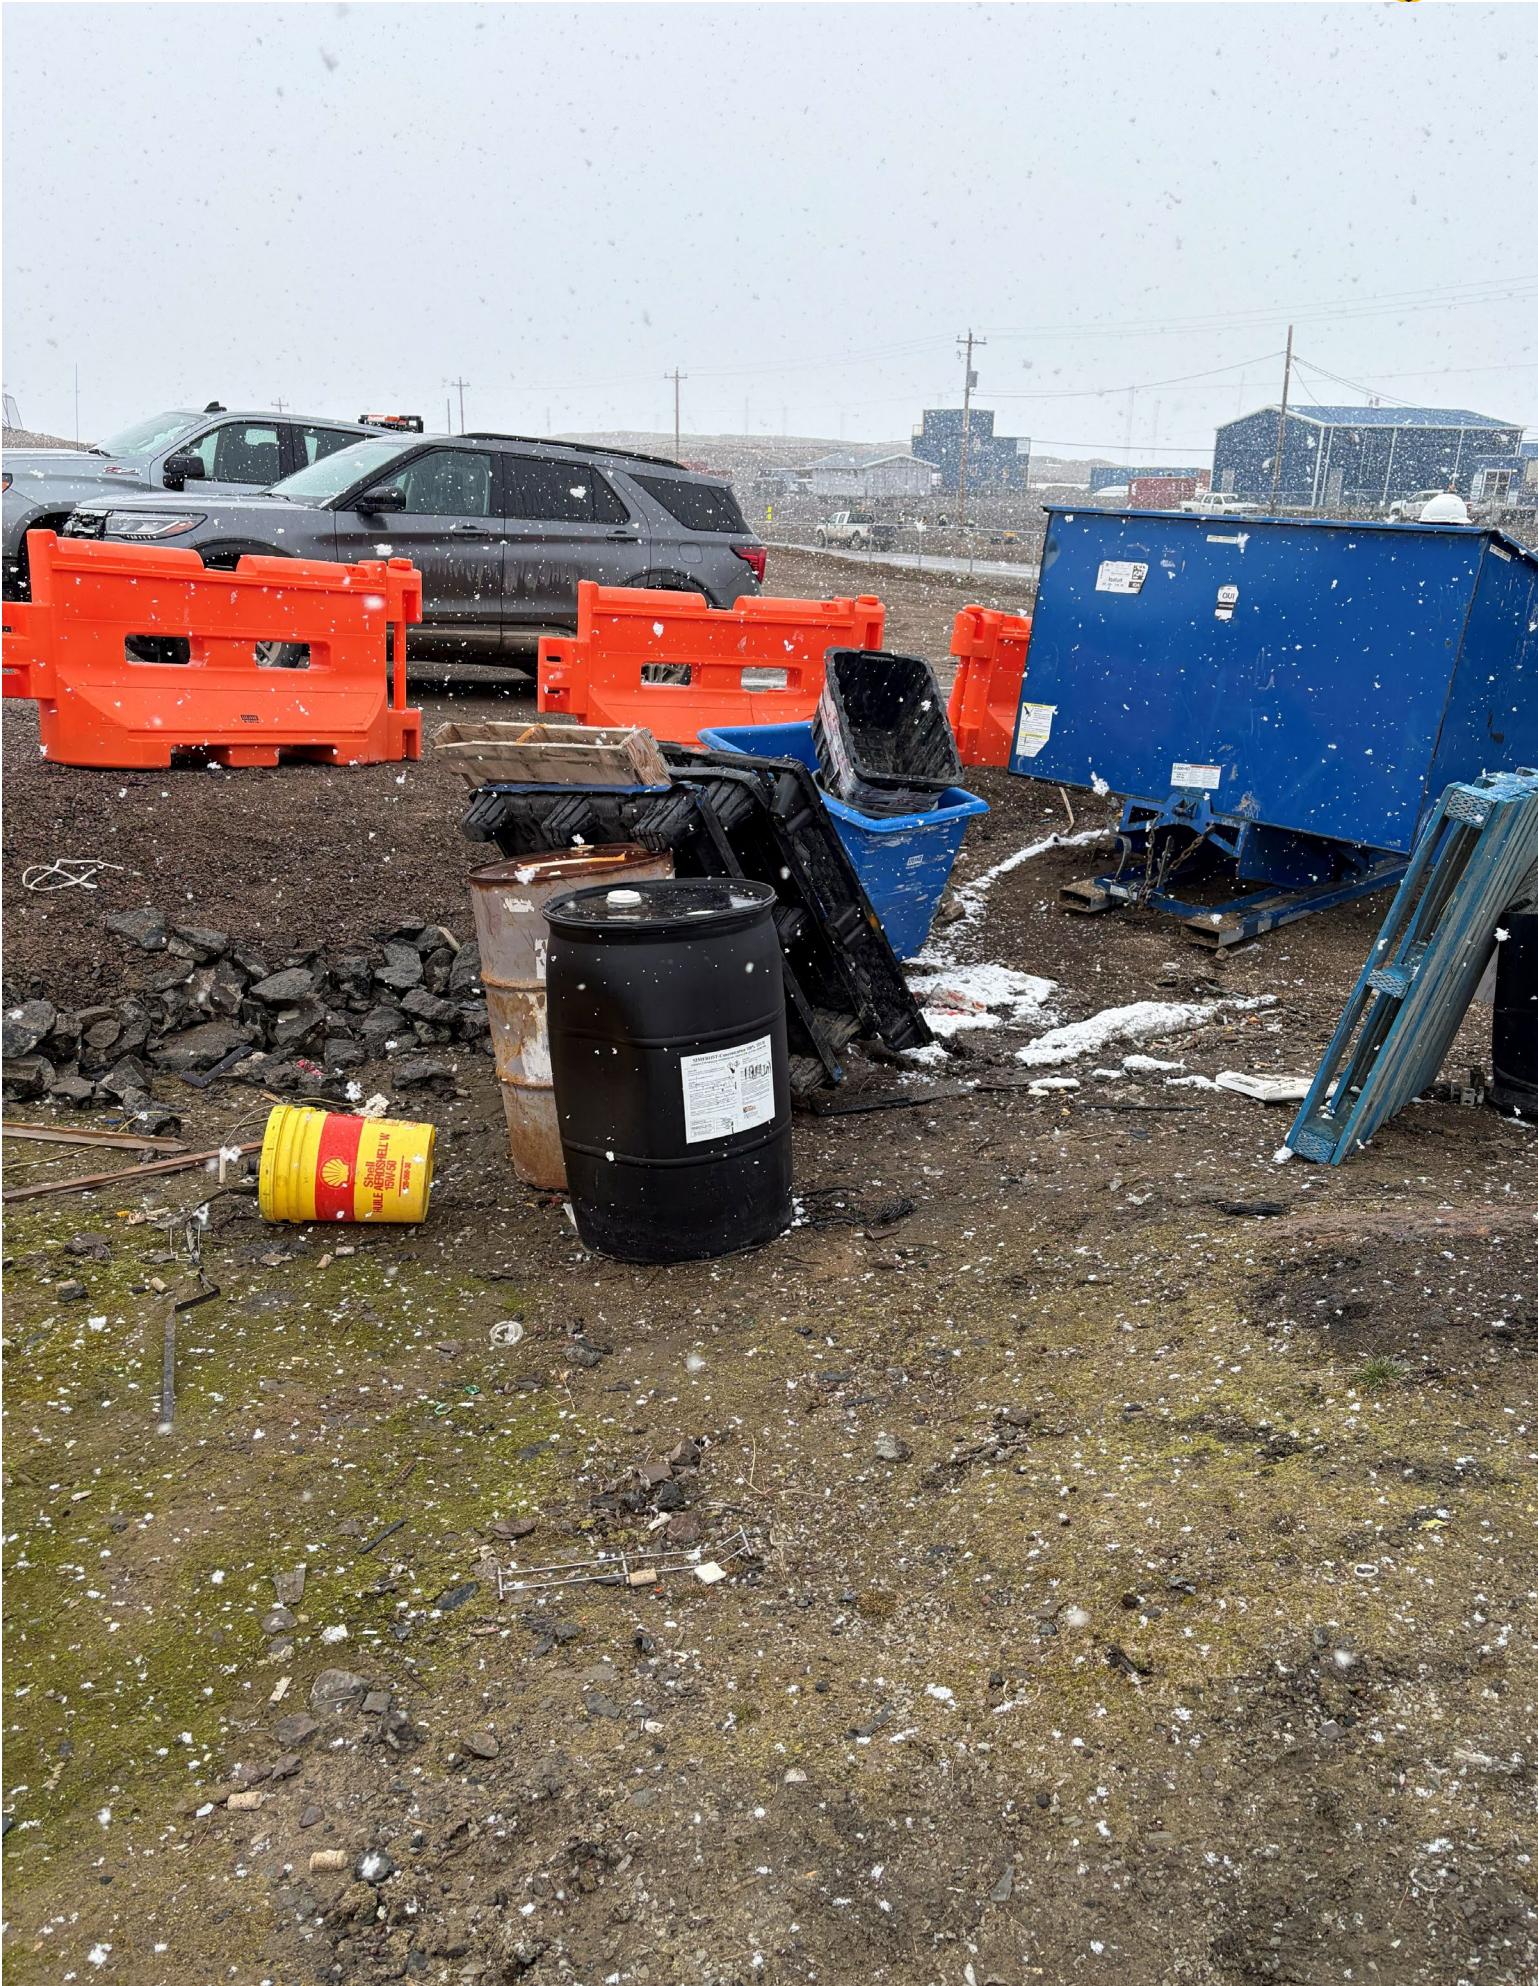
**Description:**  
West 40 Landfill. Drum of glycol and fuel

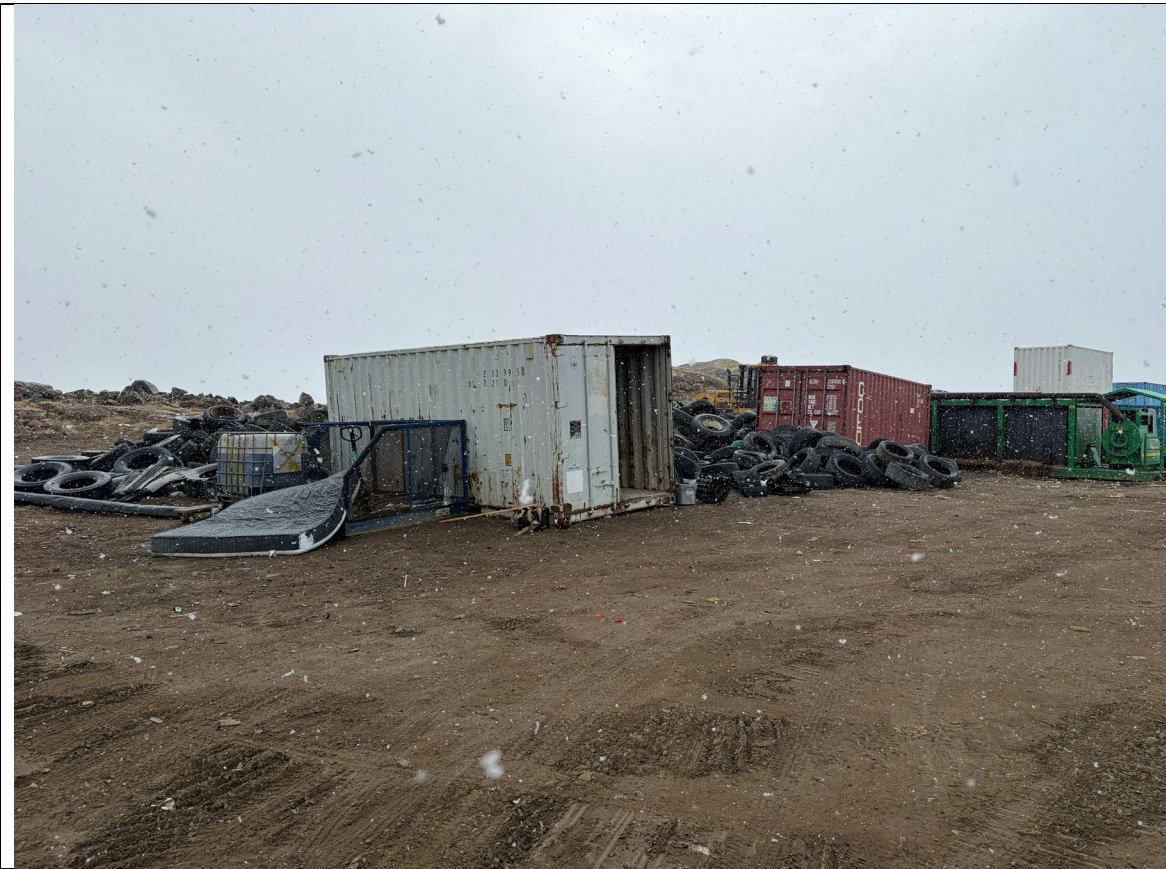
**Description:**  
West 40 Landfill. Tire containment area

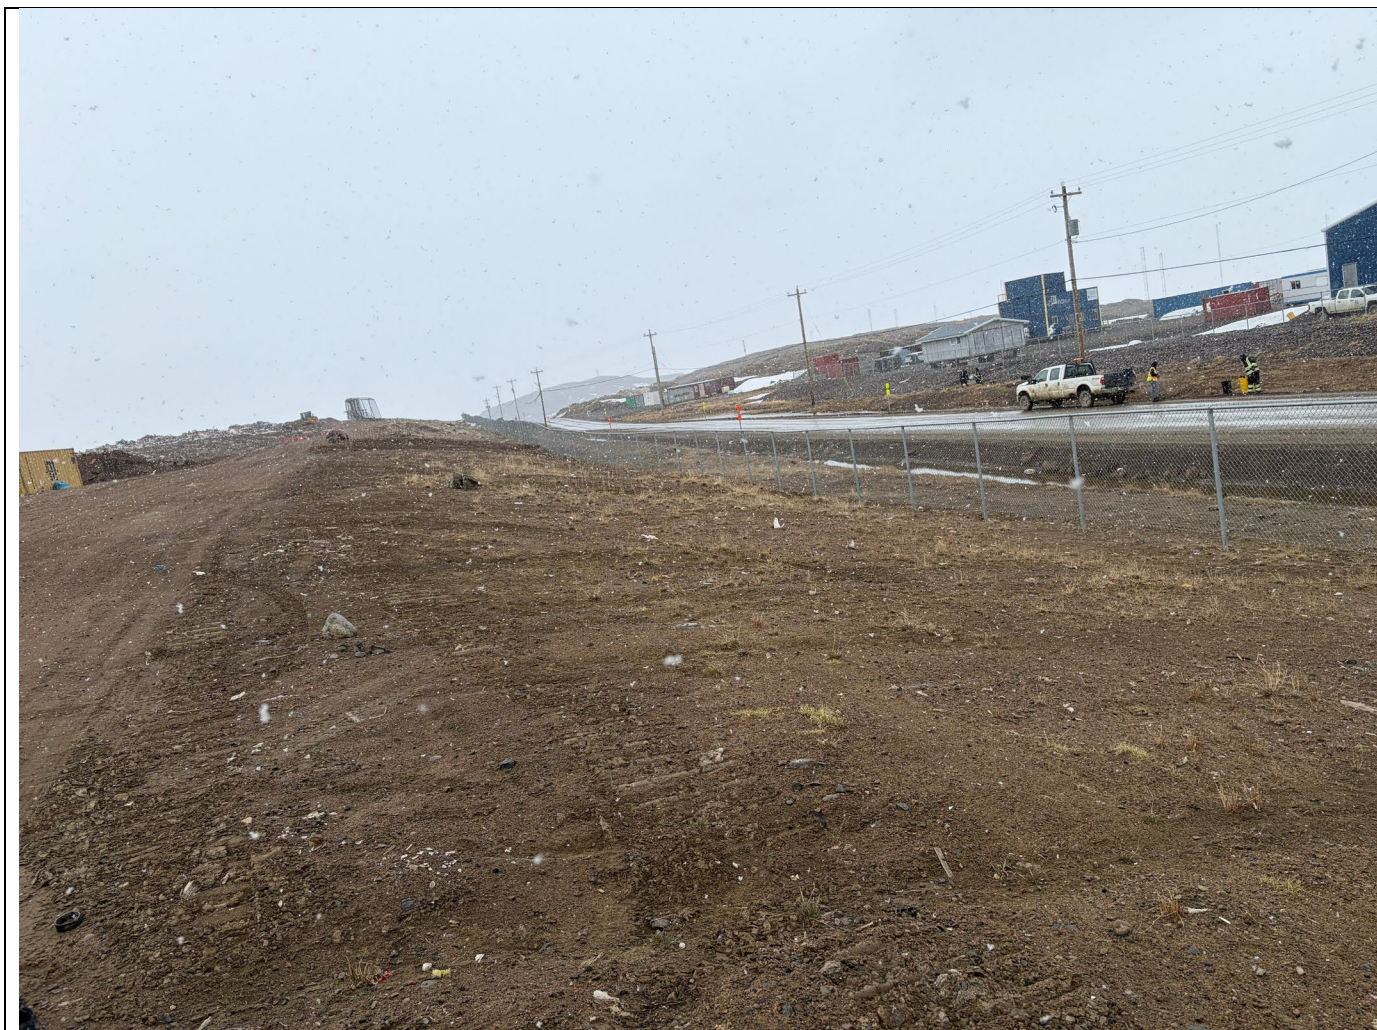
A number of blown refuse, litter and or other garbage were being cleaned up outside of the Landfill and within the surrounding area by City employees. Mr. MacMunn stated that the ongoing efforts are in place to minimize the blown away garbage escaping outside the fenced property. Jeff McMunn also stated that the contract for the upgrading of the fence has been rewarded to a contractor and the work will be starting this summer.

West 40 Landfill. Garbage along fence cleaned up. Crews cleaning outside of the fencing

- **The licensee shall keep collecting all blown away refuse, litter and or garbage adjacent to the Landfill perimeters wherever the refuse, litter and or garbage is found outside the fencing and nearby ditches and does include blown away refuse, litter and or garbage located across the road from the West 40 Landfill.**

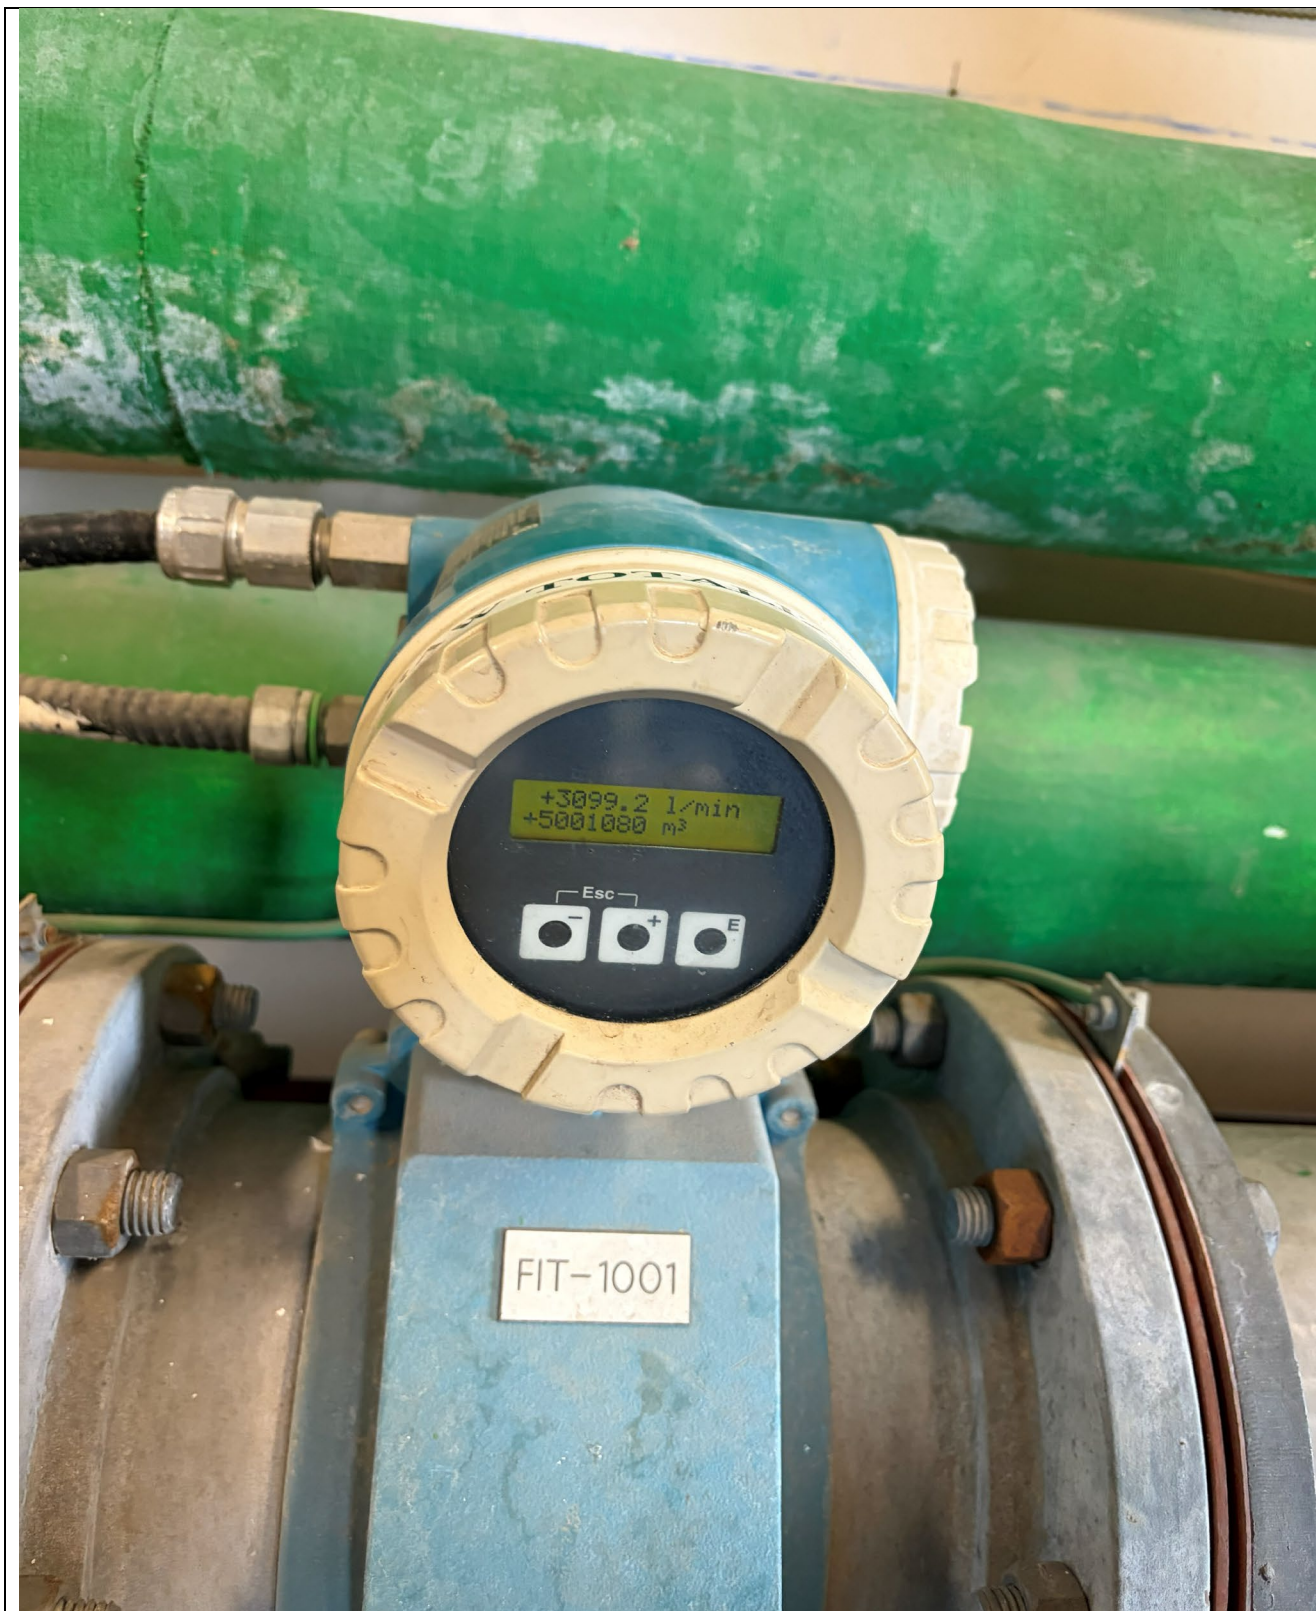
The facility appeared to be operating as per the specifications named within the issued water license. Water meters as well as other operational measurement devices appeared to be operational. No spills, leaks, loose material or any other items of concern were noted at the time of the inspection.

Water treatment plant water intake meter

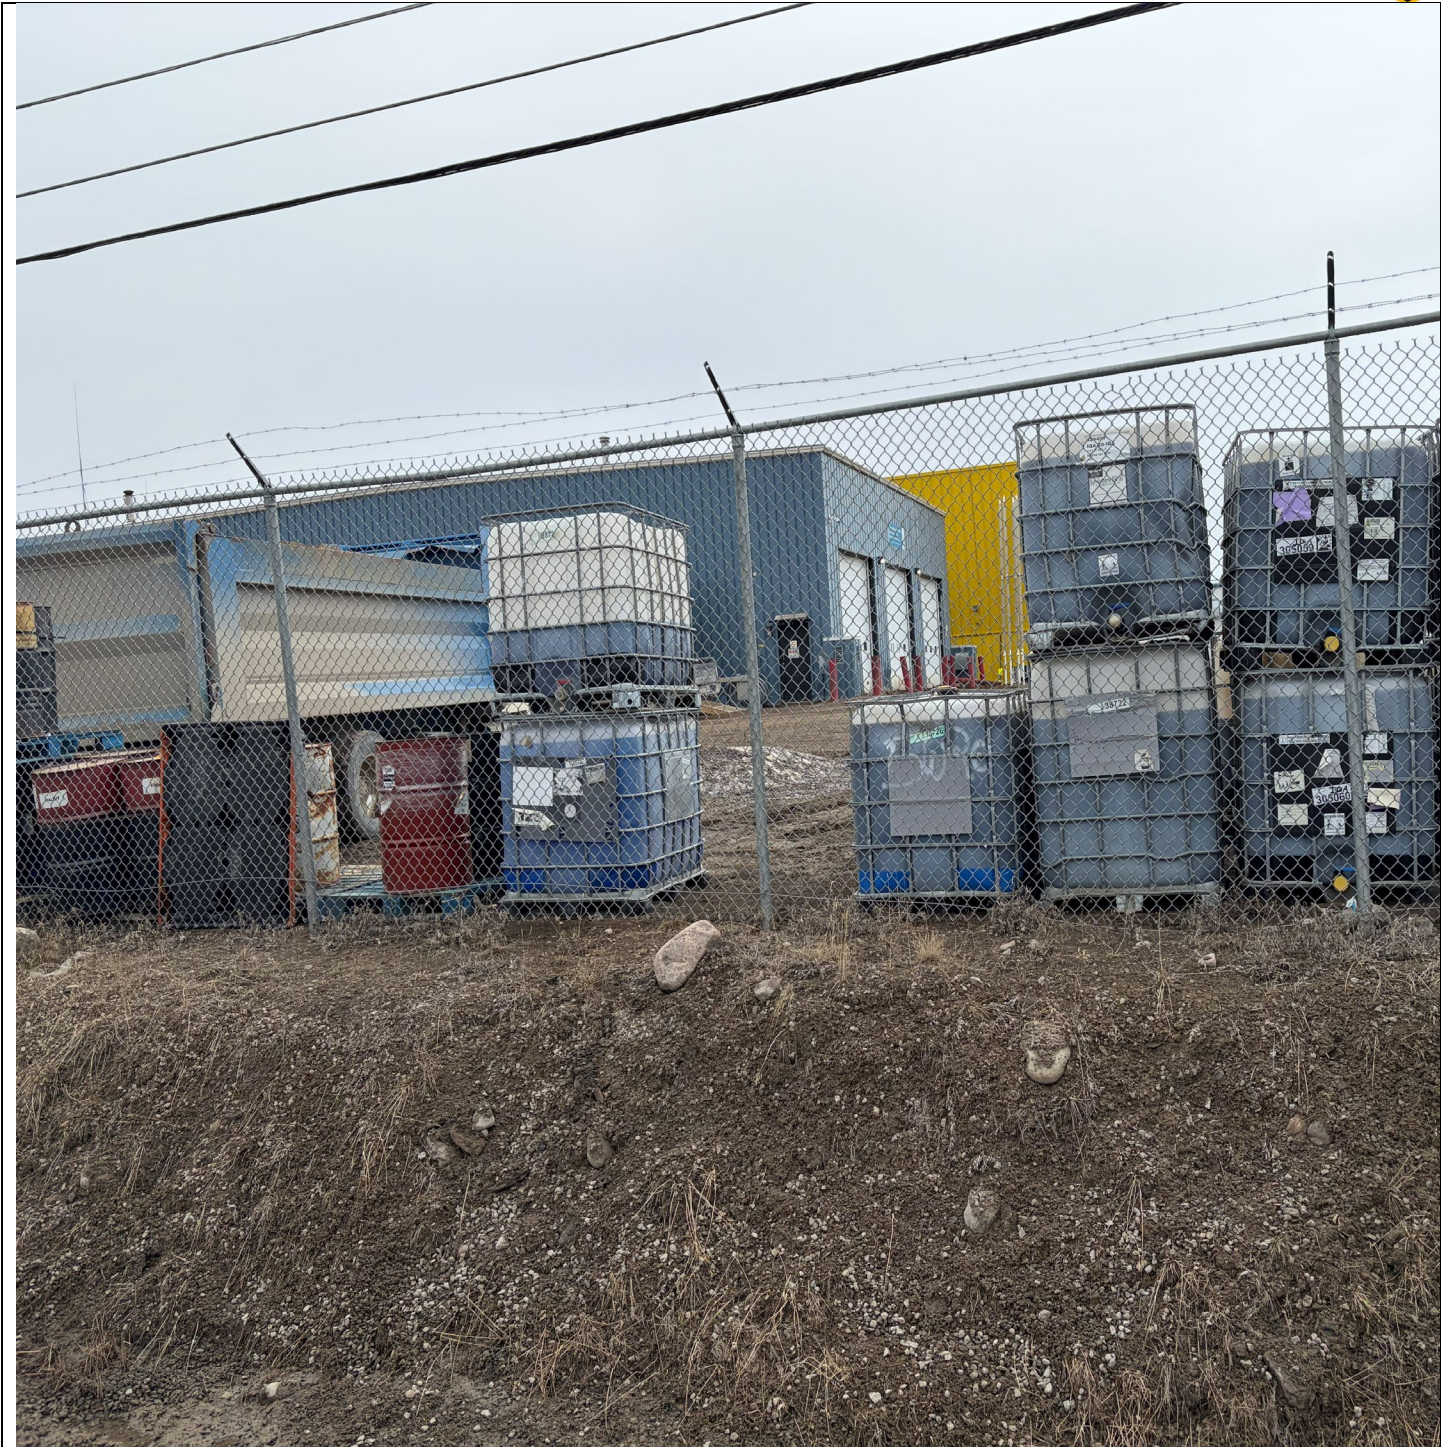
At approximately 1030 hours, while inspecting the creek around the City of Iqaluit garage on federal road it was noticed that totes of oil, anti-freeze and windshield wash left outside the contaminated area ( pictures taken).

Totes of oil, anti-freeze and windshield wash

- **The licensee shall remove the anti-freeze, oil and windshield wash tote that is located at the Federal road garage into the approved hazardous waste containment area ( see Pictures for reference) : “The Permittee shall not allow petroleum**

- **products or chemicals to spread to surrounding lands or into water bodies.**
- **The Licensee shall be afforded reasonable amount of time to complete the tasks named above. The afforded reasonable amount of time shall not exceed after Aug 1st, 2026 as a completion date.**

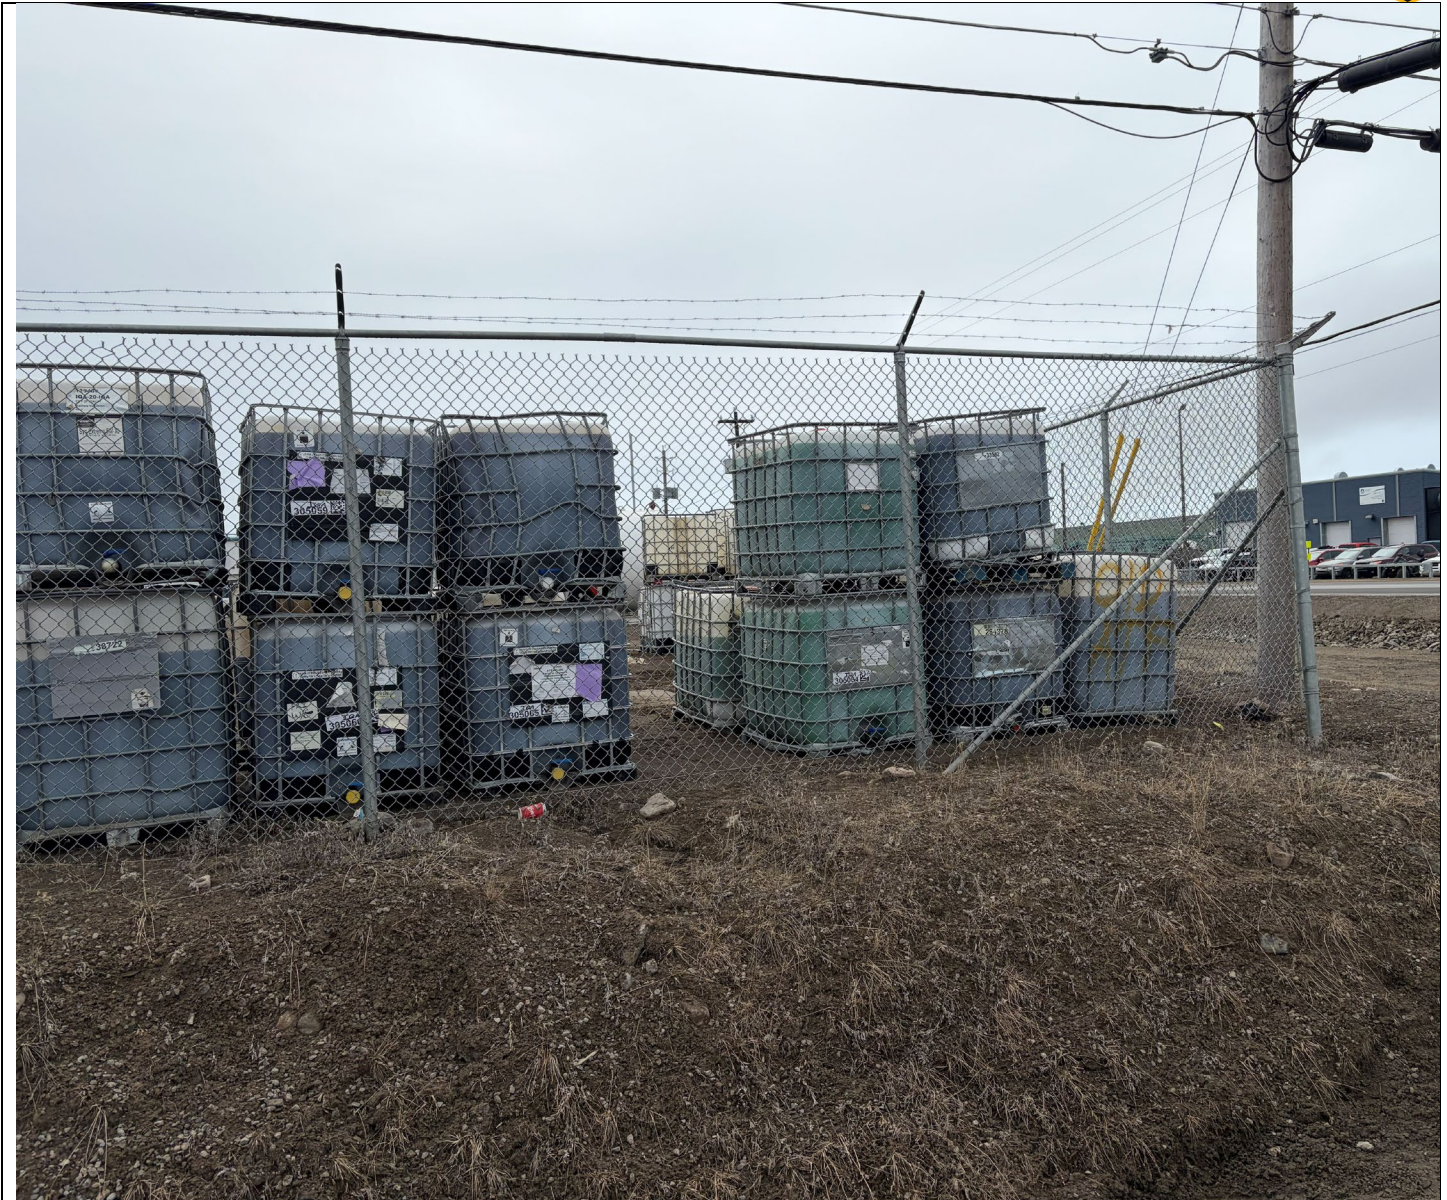
Totes of oil, anti-freeze
