**ANNUAL REPORT
FOR THE MUNICIPALITY OF PANGNIRTUNG, 2022**

YEAR BEING REPORTED: 2022

The following information is compiled pursuant to the requirements of Part A, Item 1 of Water Licence # 3AM-PAN1828 issued to the Municipality of Pangnirtung.

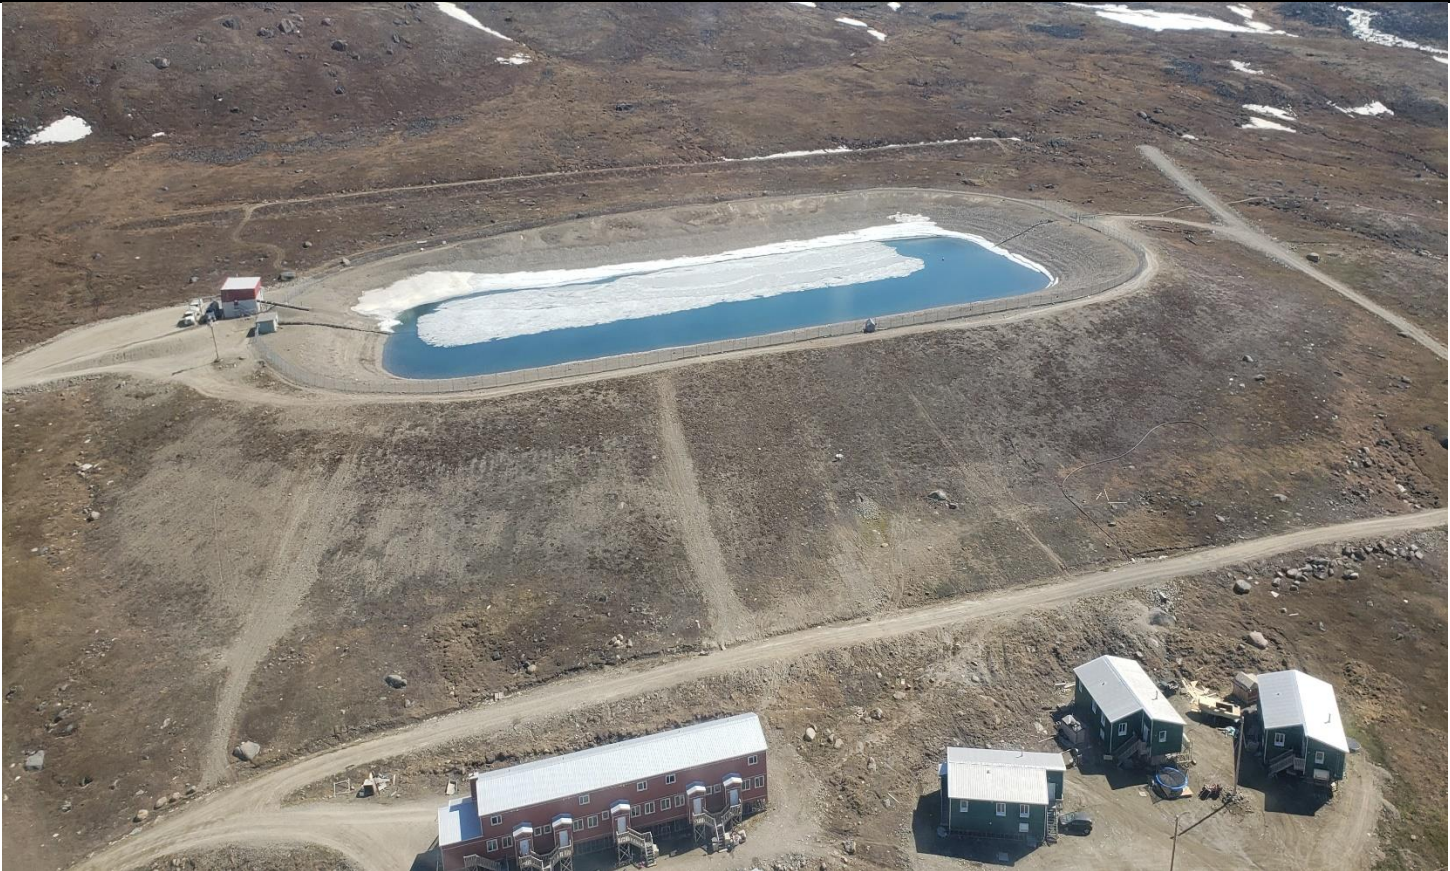
Photo 3

Description: Water Reservoir capacity is 12,000m³ in the summer, and taking in considerations for the 1.8 metres of ice 71,000m³ in winter.

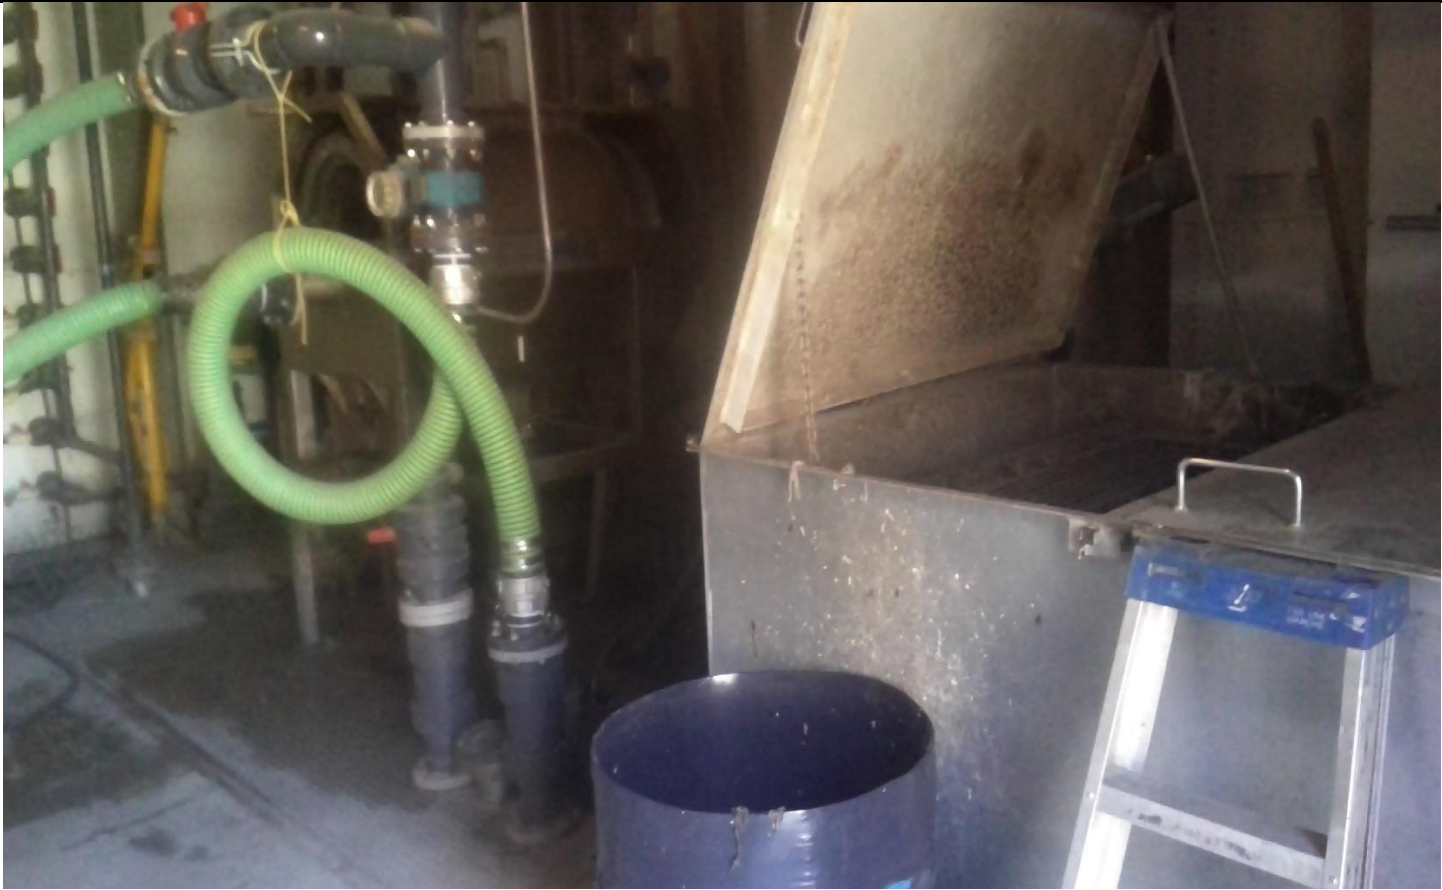
Description: Inside the receiving station of the Waste Water Treatment Facility on the right side of the road.

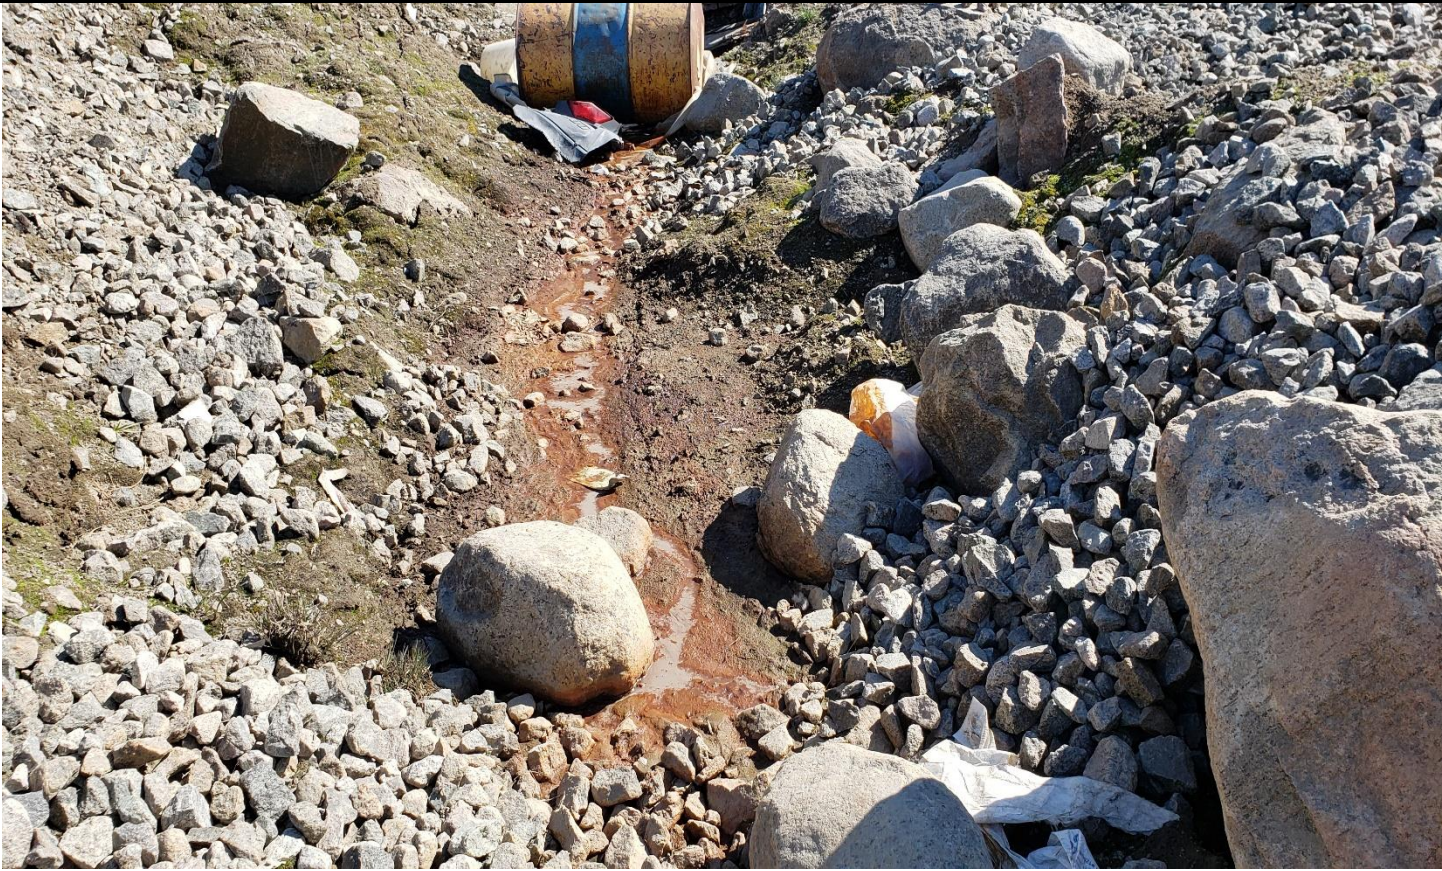
Photo 16

18. A separate and standalone Hazardous Waste non-engineered berm was constructed to address Spill Report 2019-244 (photos 14, 15, & 16). A submission of a Spill Report was requested due to the abundance of leaks, and spills that have damaged the surrounding vegetation and the amount of hazardous waste blowing away from the site (photo 13 &14). The Spill Report was submitted on June 17, 2019. And issued Spill Report number 2019-244. This spill report won't be closed off till the spills has been cleaned up, and a report to confirm that the spill has been cleaned up. It was observed that large spills did occur in the newly built non engineered berm for hazardous waste and still has gone un reported (photo 15). The spill observed appeared to be migrating towards the entrance to the non engineered hazardous waste berm (photo 16).

Description: subsurface water drainage exposed and migrating out of non-engineered berm used to house the hazardous waste. A drum is situated in the drainage ditch, and new spill can be observed migrating towards the drainage ditch.

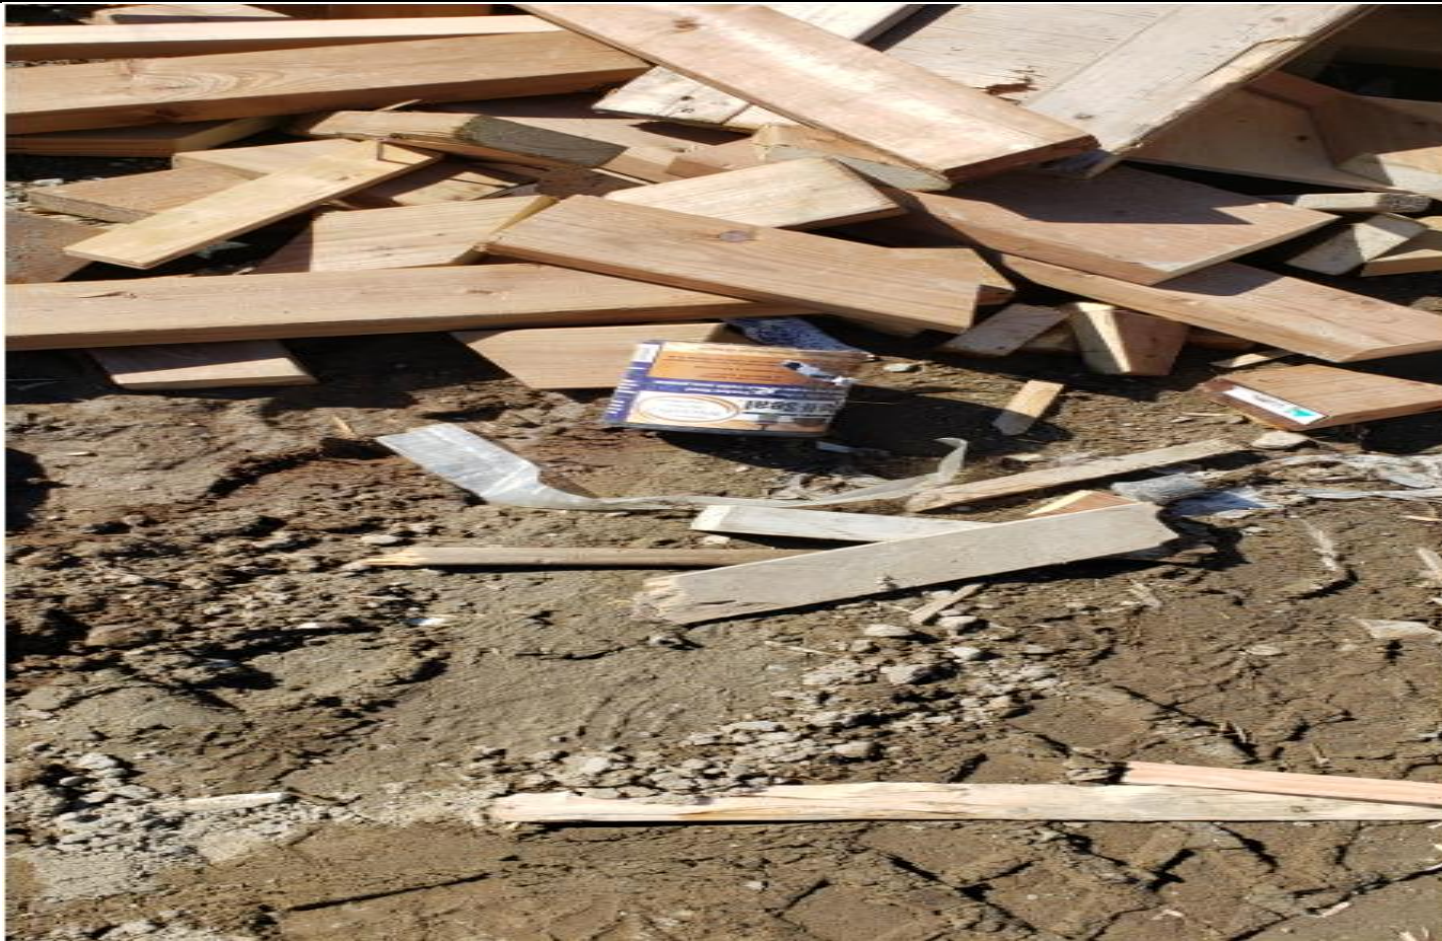
Photo 17

14. Hazardous Waste was found throughout the Bulk woods section such as paint cans, and batteries. A dump fire was reported on December 2, 2022 in Nunatsiq News, it was reported that the dump fire was extinguished on December 5, 2022. A spill report has not yet been submitted to the NT/NU Spills Data base (photo 17).

Description: Bulk Woods section, hazardous waste mixed with bulk woods.

- Provide an action plan to clean up the site of Spill Report 2019-244;
- Find the reason why there is water leaks coming from the water reservoir and repair;
- Repair the walls to the Bulk Metals, and Bulk Woods on the Eastern Wall, so that surface water may not enter the facility;
- Submit spill report for the spills in the newly built non engineered berm for hazardous waste;
- Erect a fence surrounding the Metal and Hazardous Waste Storage Area as per Part E: Item 8;
- Submit a spill report for the dump fire at the Bulk Wood and Hazardous Waste sections of the Solid Waste Facility.

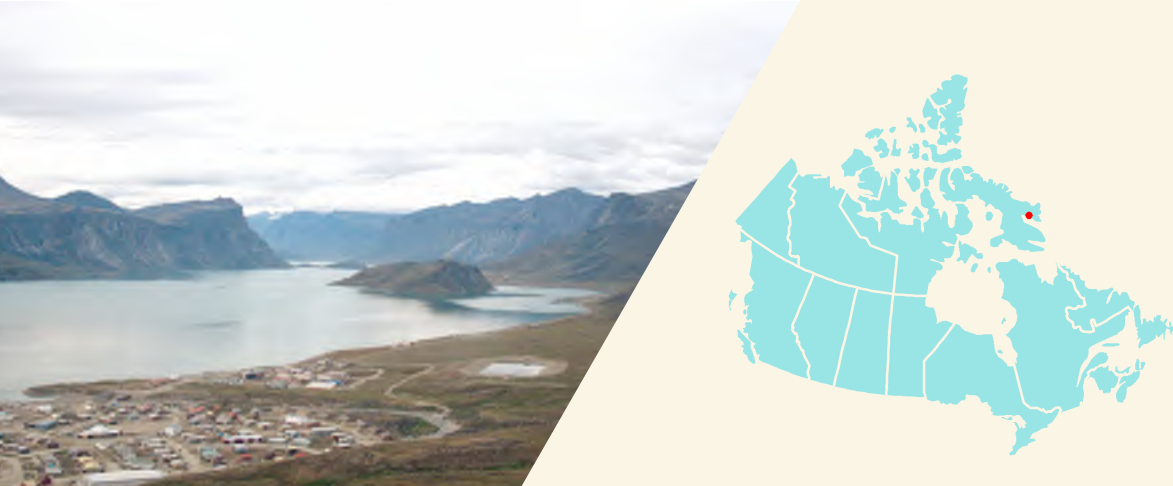
CANADIAN GEOSCIENCE MAP 67
(preliminary version)
SEASONAL SURFACE DISPLACEMENT DERIVED FROM INSAR

PANGNIRTUNG
Nunavut
1:5 000
