WATER LICENCE INSPECTION FORM

Licensee	Licensee Representative
Hamlet of Resolute Bay	Bhabesh Roy
Licence No. / Expiry	Representative's Title
3BM-RUT1520	Municipal Engineer
Land / Other Authorizations	Land / Other Authorizations
Date of Inspection	Inspector
July 21, 2018	Joseph Monteith & Jonathan Mesher
Activities Inspected	
<input type="checkbox"/> Camp	<input type="checkbox"/> Drilling
<input type="checkbox"/> Roads/Hauling	<input type="checkbox"/> Mining
	<input type="checkbox"/> Construction
	<input checked="" type="checkbox"/> Other: Water Treatment Facility, Waste Water Utilidor Hazardous Waste Facility
	<input type="checkbox"/> Reclamation
	<input type="checkbox"/> Fuel Storage

SECTION 1	<input type="checkbox"/> Comments (s. __)	<input type="checkbox"/> Non-Compliance with Act or Licence (s. __)	<input type="checkbox"/> Action Required (s. __)
BACKGROUND <p>The Hamlet of Resolute Bay is located on the south coast of Cornwallis Island on the Perry Channel. The community is approximately 1550 km northwest of Iqaluit. There are three water licenses in this community: The Government of Nunavut (GN) holds the Licence for the airport, the Hamlet of Resolute Bay holds the Licenc

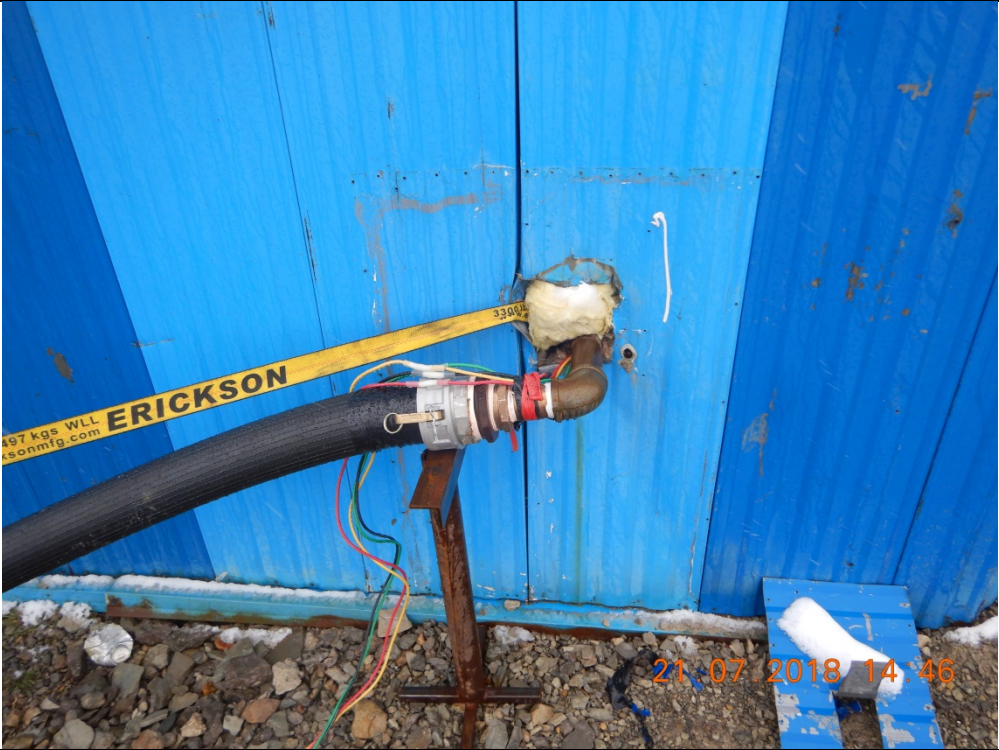
Photo Log #1	Location
Photo 4	Resolute Bay

Description: Bypass Hose for Emergency Bypass to limit odours authorized by Department of Health enters into pump house building to transfer by pipes to the Water Treatment Facility

4. A flexible hose with Fish Mesh Screen was installed to bypass the intake hose and reservoir pipe entry port in the intake structure at Char Lake due to odours from a historical spill that occurred there.
5. Hose was propped upwards to and fixed to a floating wooden structure within Char Lake (See photo 3).
6. From the Pump house, freshwater would be piped to the Water Treatment Plant to be piped to the Water Treatment Centre (See photo 4).

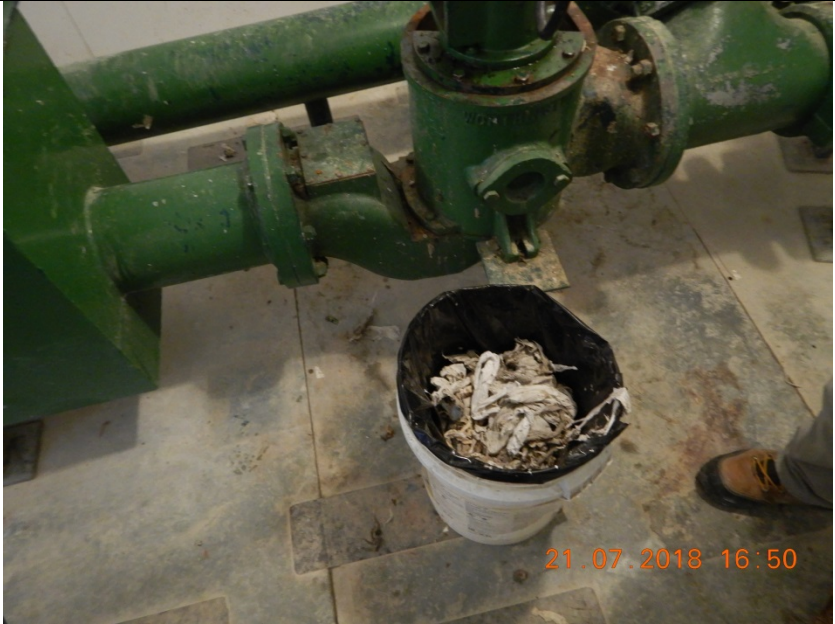
Photo 6

10. An old Trailer Building contains a macerator, which takes any solids such toilet paper, and traps it from being discharged with the waste water. (See photo 6)

Description: Macerator in Old Trailer Building – Solids extracted from Macerator, and deposited into waste bin.
