WATER LICENCE INSPECTION FORM

Licensee	Licensee Representative
Hamlet of Resolute Bay	Gord Marinic
Licence Number	Representative's Title
3BM-RUT2035	Municipal Engineer
Land / Other Authorizations	Land / Other Authorizations
Date of Inspection	Inspector
July 7, 2022	Joseph Monteith
Activities Inspected	
<div><input type="checkbox"/> Camp<input type="checkbox"/> Drilling<input type="checkbox"/> Mining<input type="checkbox"/> Construction<input checked="" type="checkbox"/> Reclamation<input type="checkbox"/> Fuel Storage</div> <div><input type="checkbox"/> Roads/Hauling<input type="checkbox"/> Other: Water use and storage<input type="checkbox"/> Other: Waste Disposal</div>

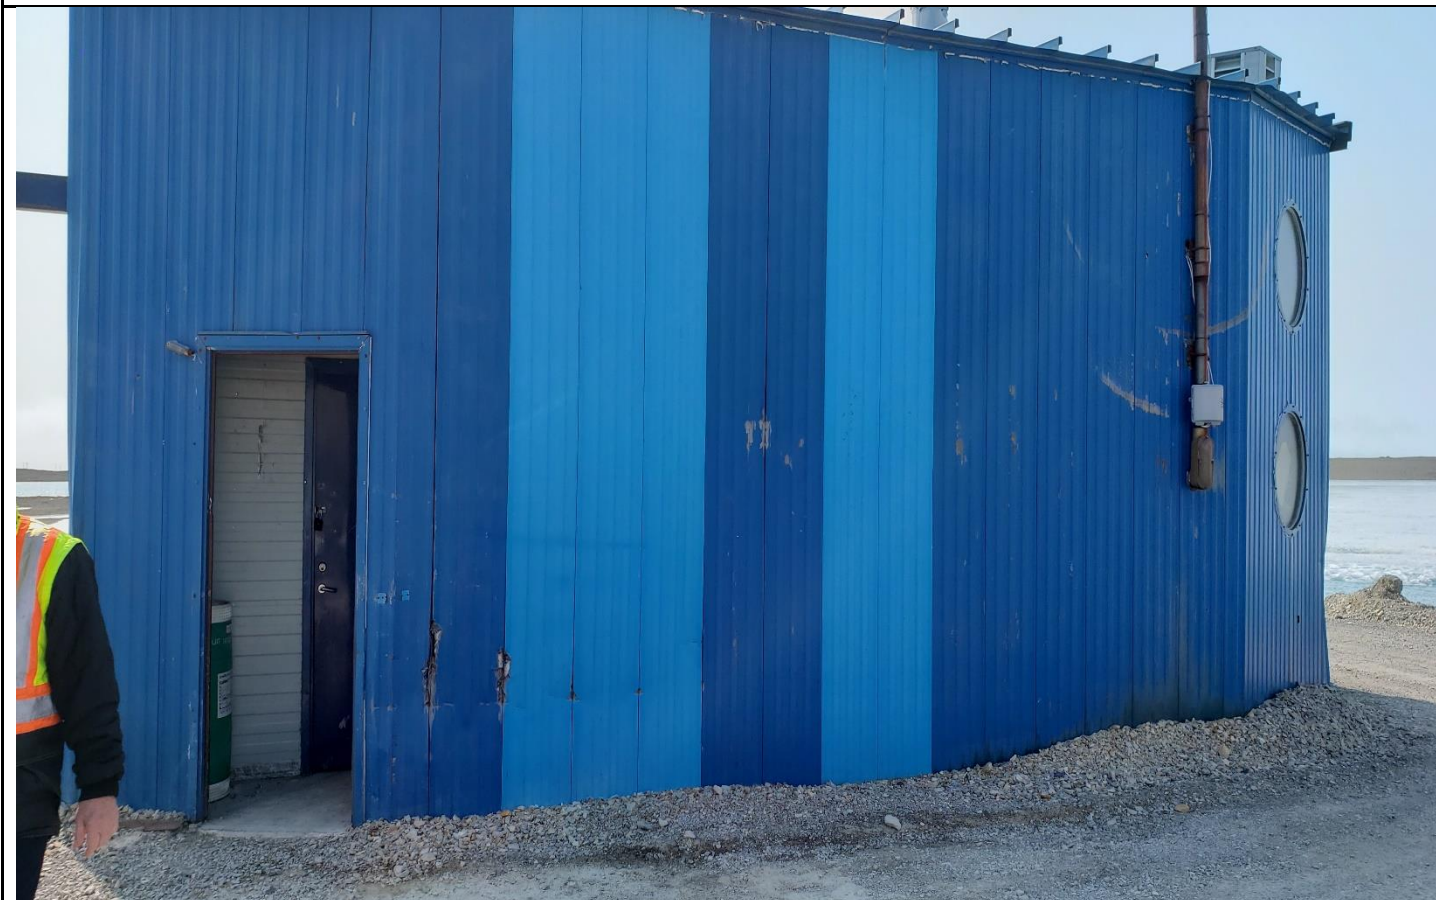
Date	Camera	Inspector	
July 19, 2021	Nikon Cool Pix	Joseph Monteith	
Photo Log #	Location		
Photo 1	Old Pump House, Char Lake, Resolute Bay, NU

1. Old water pump house has been stripped of their internal operating equipment. 2 water boilers is all that is left in the old water pump house. The only equipment that was re used was the storage tank for petroleum products. This is the site of a spill report that has caused the odours to be announced by the public. Construction of a new pump house is completed (photo 2);

Description: Char Lake Water Source, Old Pump House has been decommissioned. Signage observed as Water Source.

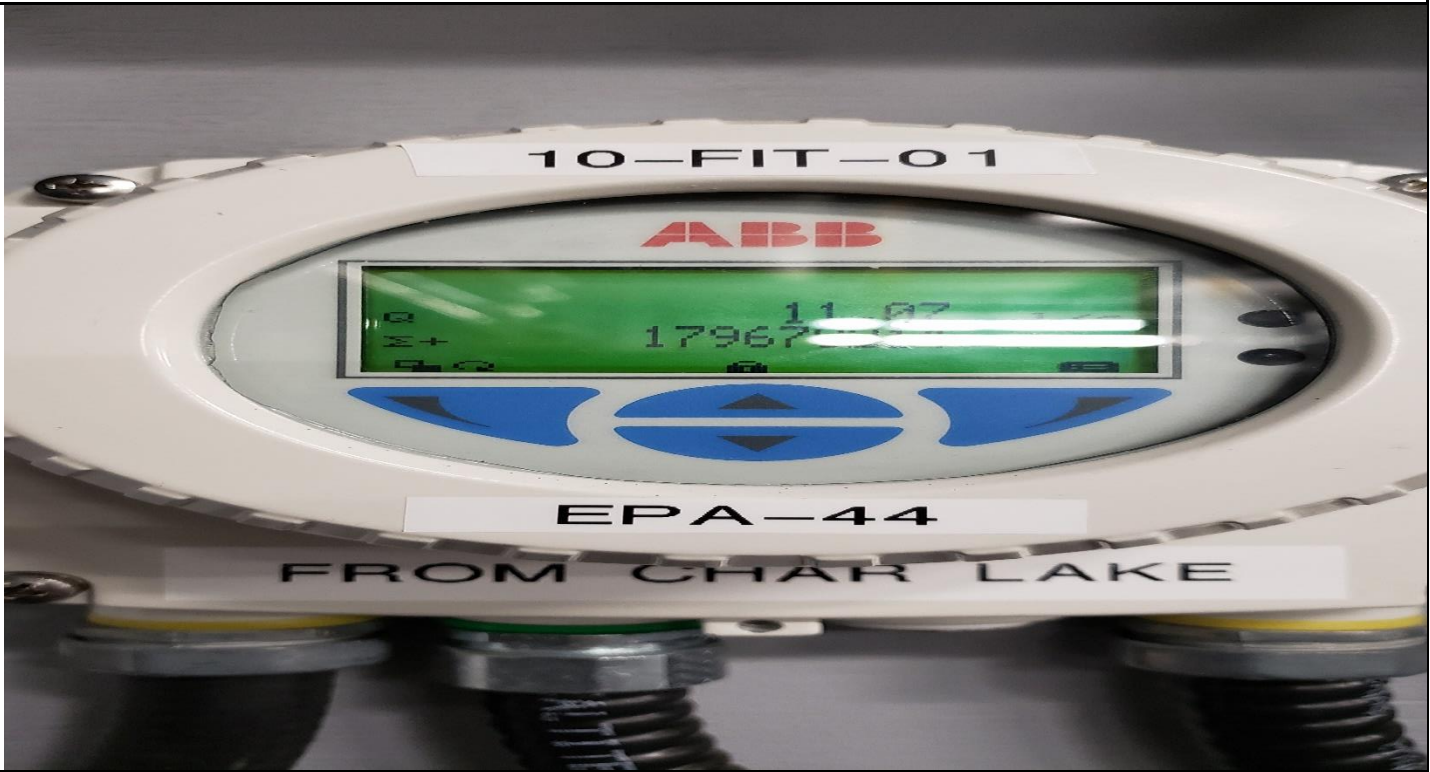
Photo Log #1	Location
Photo 5	Resolute Bay, NU

5. The upgraded Water Treatment Plant contains sump pits, pumps, a chlorine mix pot, 12,300 cubic metre water storage tank, UV Filtration, 3x charcoal filtrations tanks, and 2 x filter tanks and pipes the treated water to the residents by gravity using underground pipes, also trucked water service.
6. Sign of spill next to Fuel Storage Tank(photo 5).
7. New water meter reads 179679814 m³withdrawn (photo 5).
8. No sign of water usage logs.

Description: New water meter from Char Lake to Water Treatment Plant – Meter photo skewed by light reflection. Assumed reading at the time of inspection may read 179679814 m³. Photo taken at Water Treatment Plant.

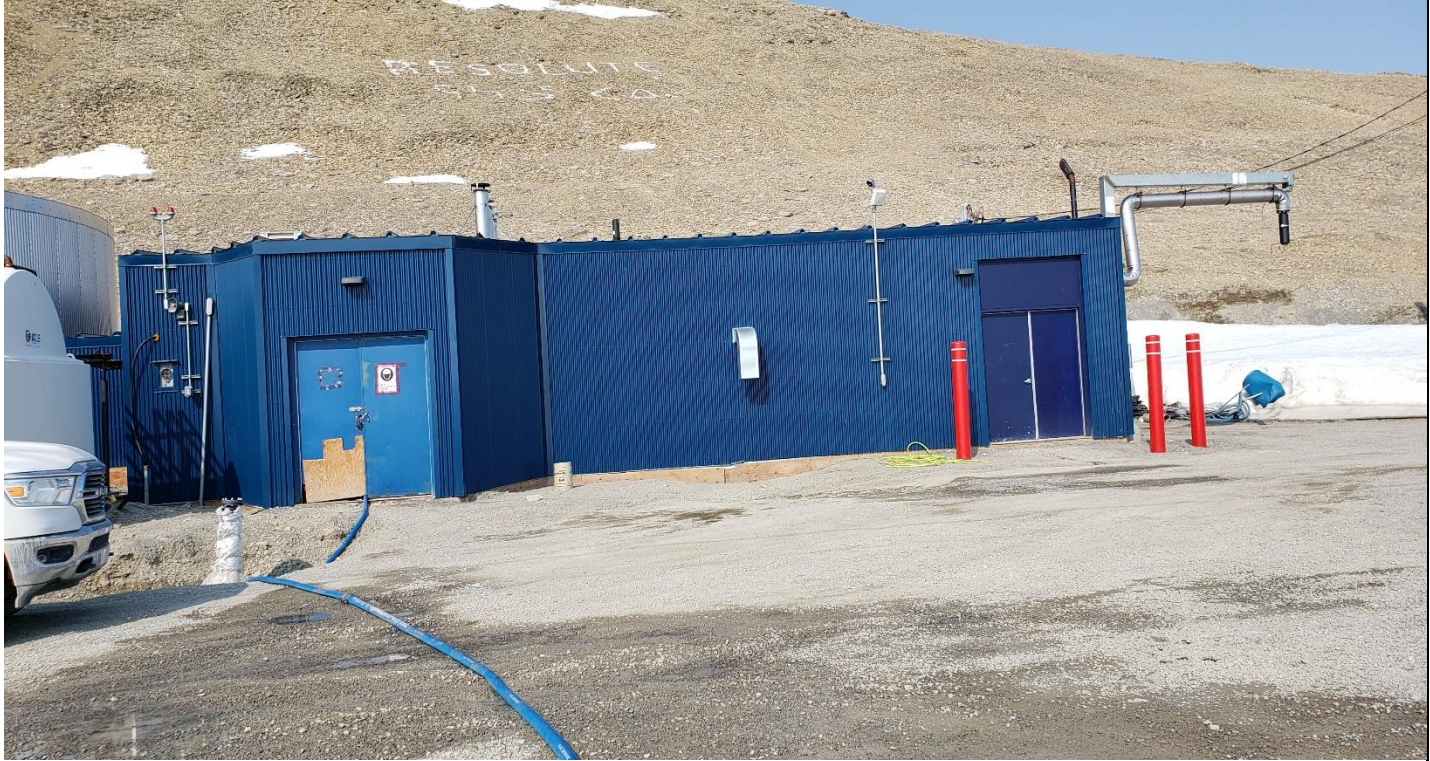
Photo Log #1	Location
Photo 6	Resolute Bay, NU

Description: Water Treatment Plant – Water Storage Reservoir – Capacity 12,500 Cubic Metres. Blue hose used for discharging water from Water Treatment Plant.

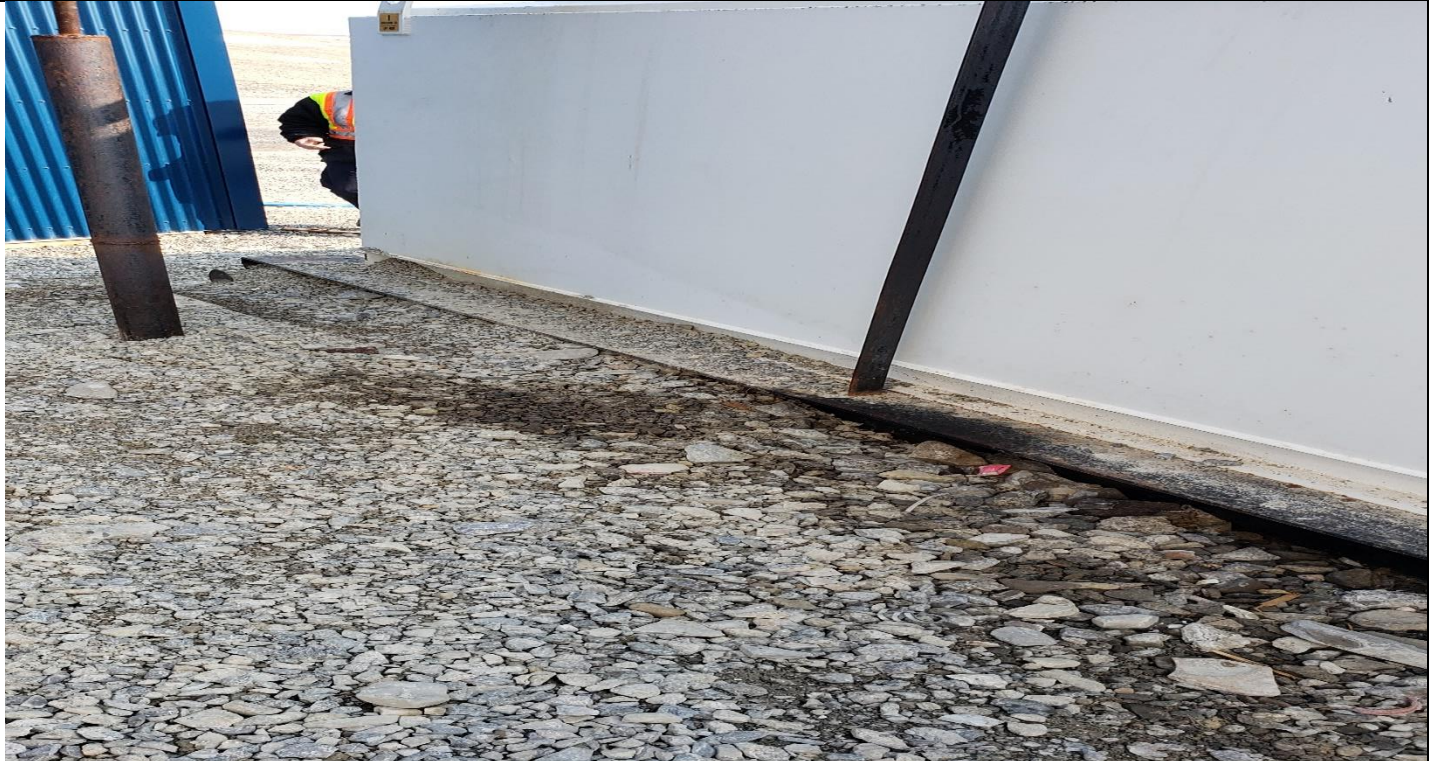
Photo Log #1	Location
Photo 7	Resolute Bay, NU

Description: Water Treatment Plant – Water Storage Reservoir – Capacity 12,500 Cubic Metres. Spill observed next to fuel storage tank. Spill Report and clean up required.

• Submit a spill report for the observation of a spill next to the storage tank for petroleum products at the water treatment facility.
