13 October 2005
YX00748

**Re: Geotechnical Investigation for P- Lake Sewage Lagoon,
Cape Dorset, NU**

1.0 BACKGROUND INFORMATION AND SCOPE OF WORK

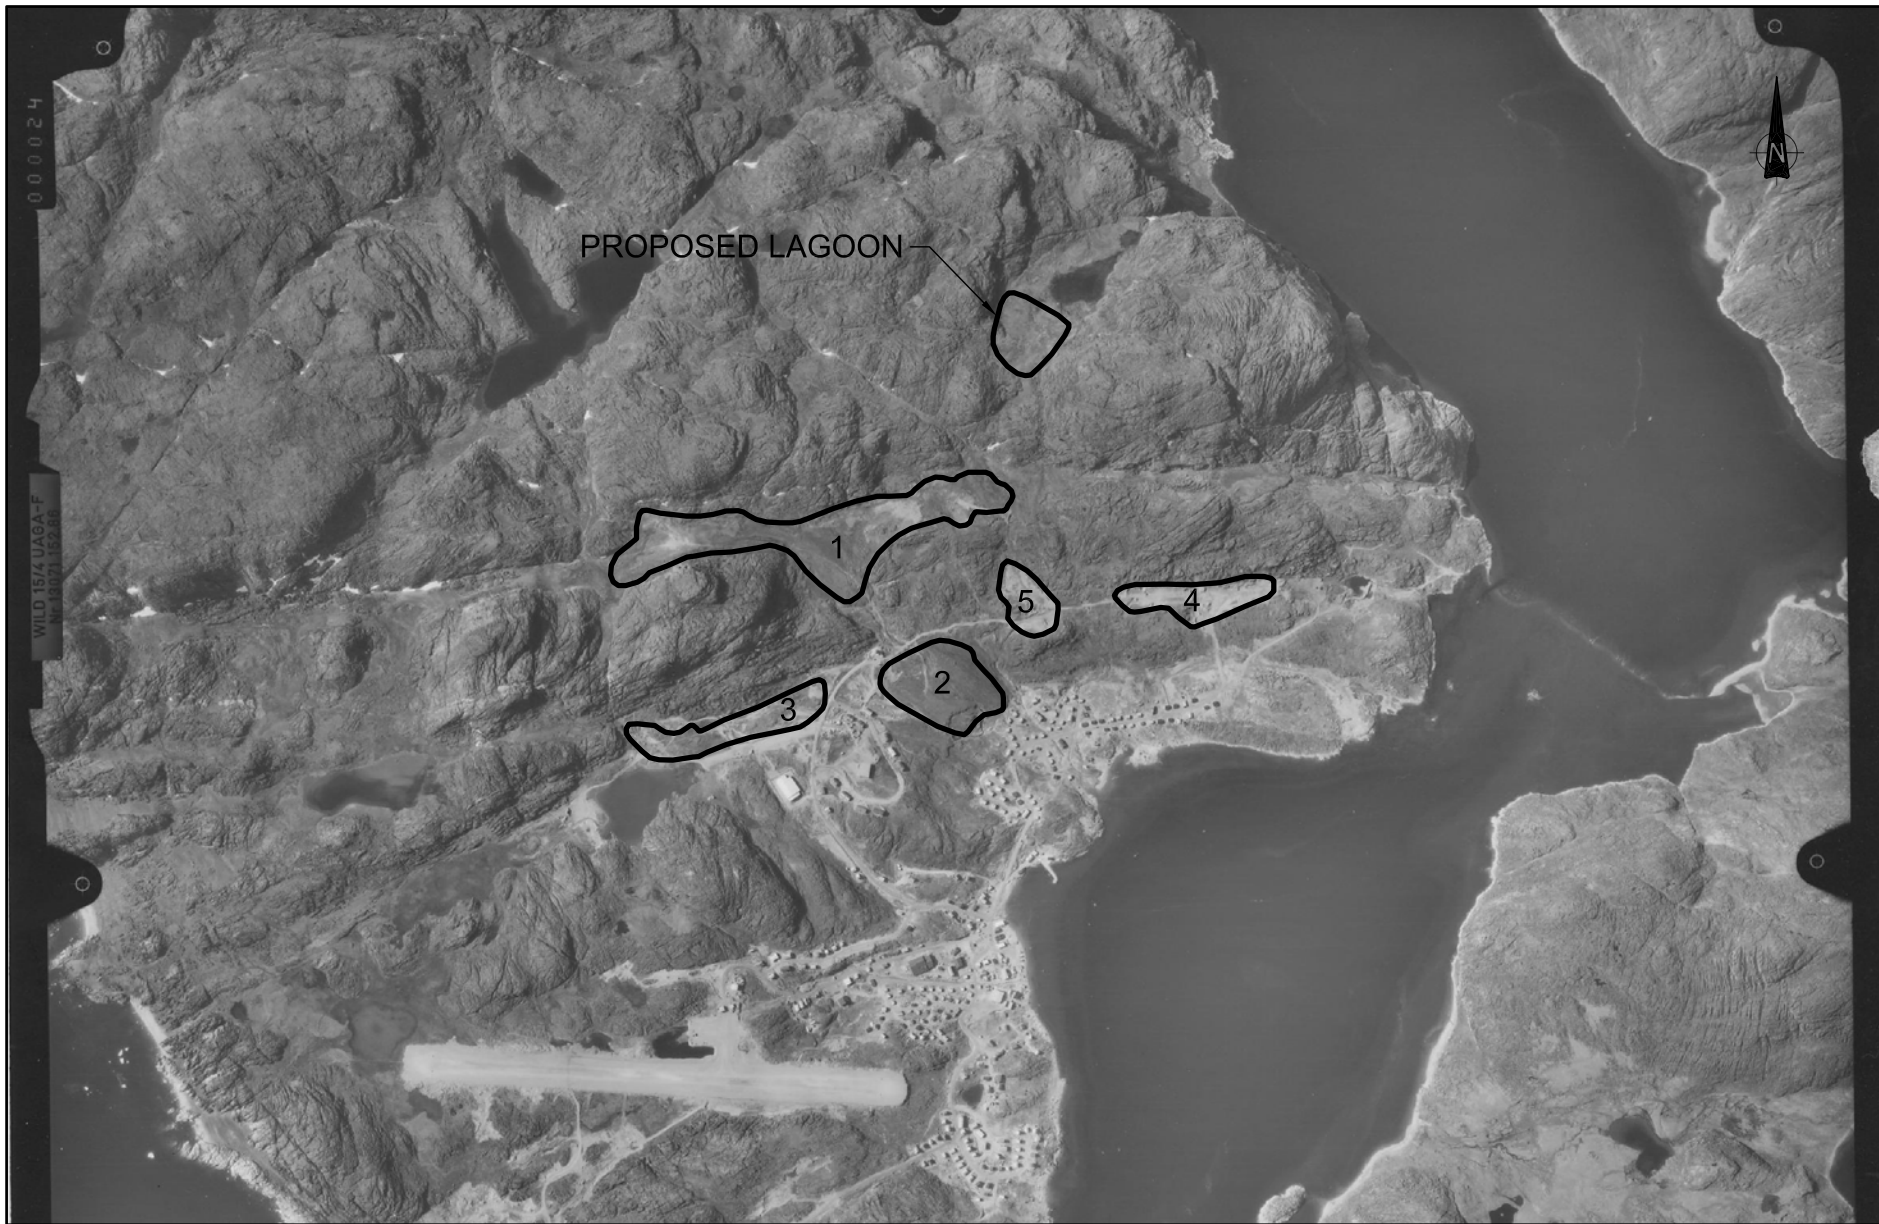
FIGURE 1

REFERENCE AERIAL PHOTO: AS27863-94, 29-08-29, 1:20 000

LOCATION OF PROSPECTIVE
BORROW SOURCES

An examination of the aerial photograph (Figure 1, Appendix A) and field reconnaissance undertaken by AMEC in August 9 and 10, 2005 suggests that majority of the proposed lagoon site is swamp and covered with a thin organic layer (Photographs 1 and 2, Appendix B). The ground surface is strewn with rounded and subrounded boulders and rock fragments (Photograph 3, Appendix B).

Review of the data collected during the site investigations, the existing information and aerial photographs (scale 1: 20000) interpretation allowed the identification of several prospective borrow sources. Borrow Sources 1 through 3 are deemed as potential sources of finer grained soils, while Borrow Sources 4 and 5 are existing borrow pits for sand and gravel. The location of the potential and existing borrow sources are shown on Figure 1, Appendix A.

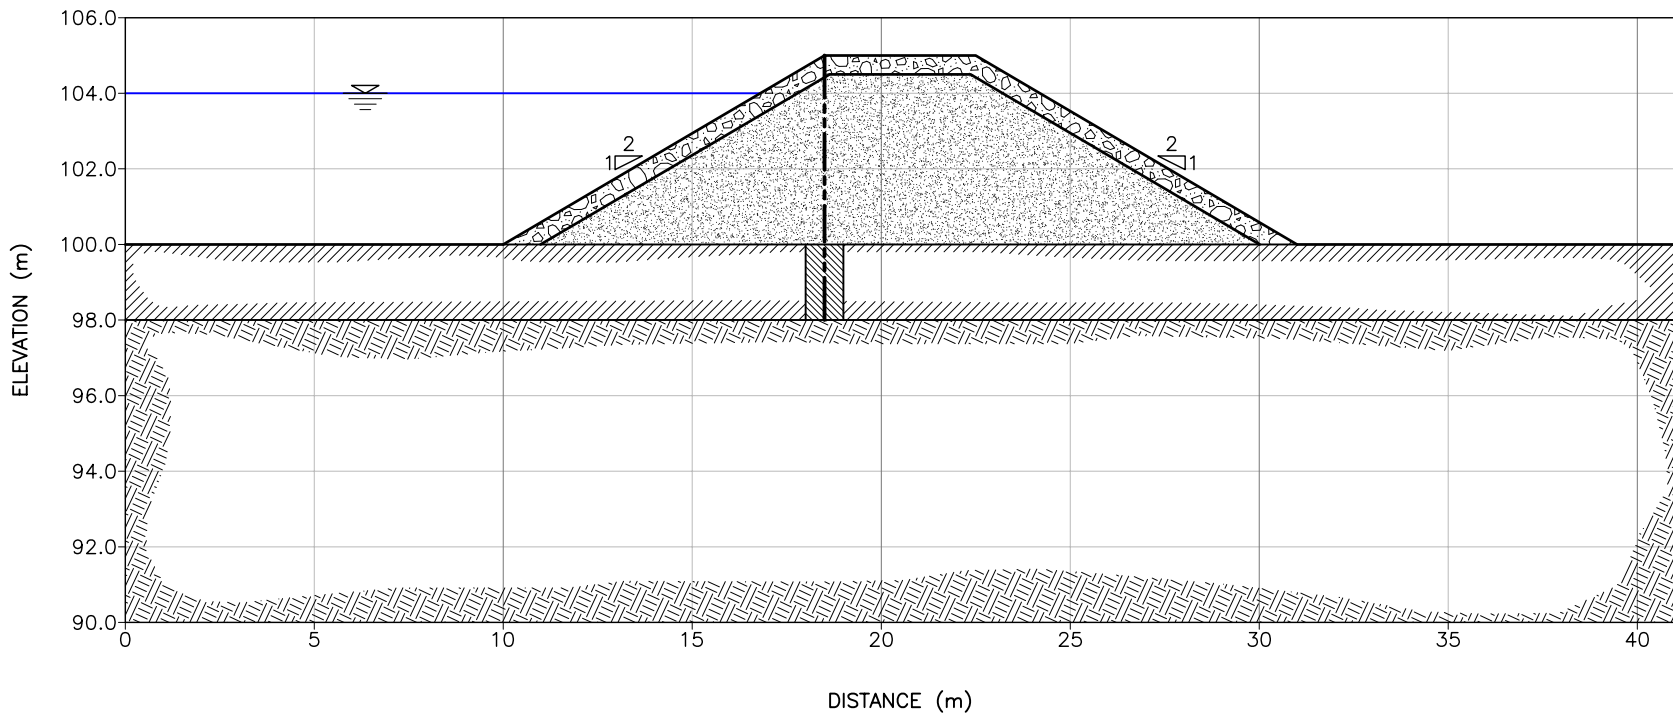
FIGURE 2

PROPOSED DYKE CROSS SECTION

Figure 2 provides a proposed cross section of the sewage dyke as it is designed by DCL. The upstream and downstream slopes of the dyke are 1V:2 H, corresponding to a slope steepness of about 26.5 degrees. The proposed dyke is 5 m high and 4 m wide at the crest.

An appropriate synthetic liner should be installed in a near vertical position to an assumed elevation of 98 m, 2 m below existing ground surface, near the upstream slope (Figure 2, Appendix A). The liner should extend into a 2 m deep excavation below the base of the dyke. The excavation should be backfilled with compacted clayey material or grouted. The liner curtain then goes straight up to the top of the dyke as shown at Figure 2, Appendix A. An alternative liner option is shown at Figure 3, Appendix A. It is understood that the constructability of the alternative option is more favourable however the liner is about twice as long.

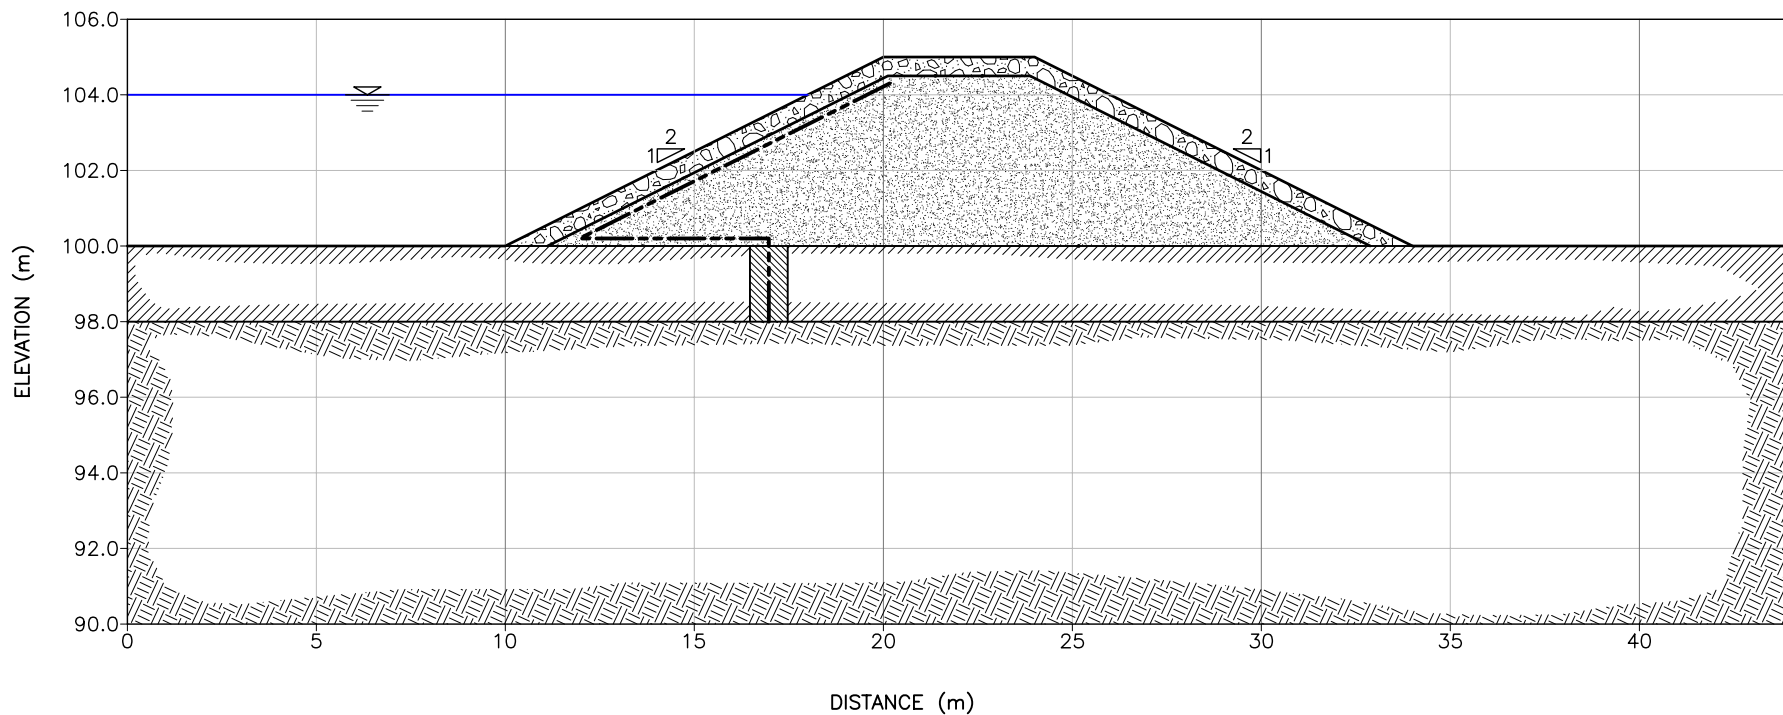
FIGURE 3

ALTERNATIVE DYKE CROSS SECTION

- A waterproof liner is proposed to be placed as shown at Figures 2 or 3, Appendix A.
- The dyke core will be protected with coarse rockfill, about 0.5 m thick.

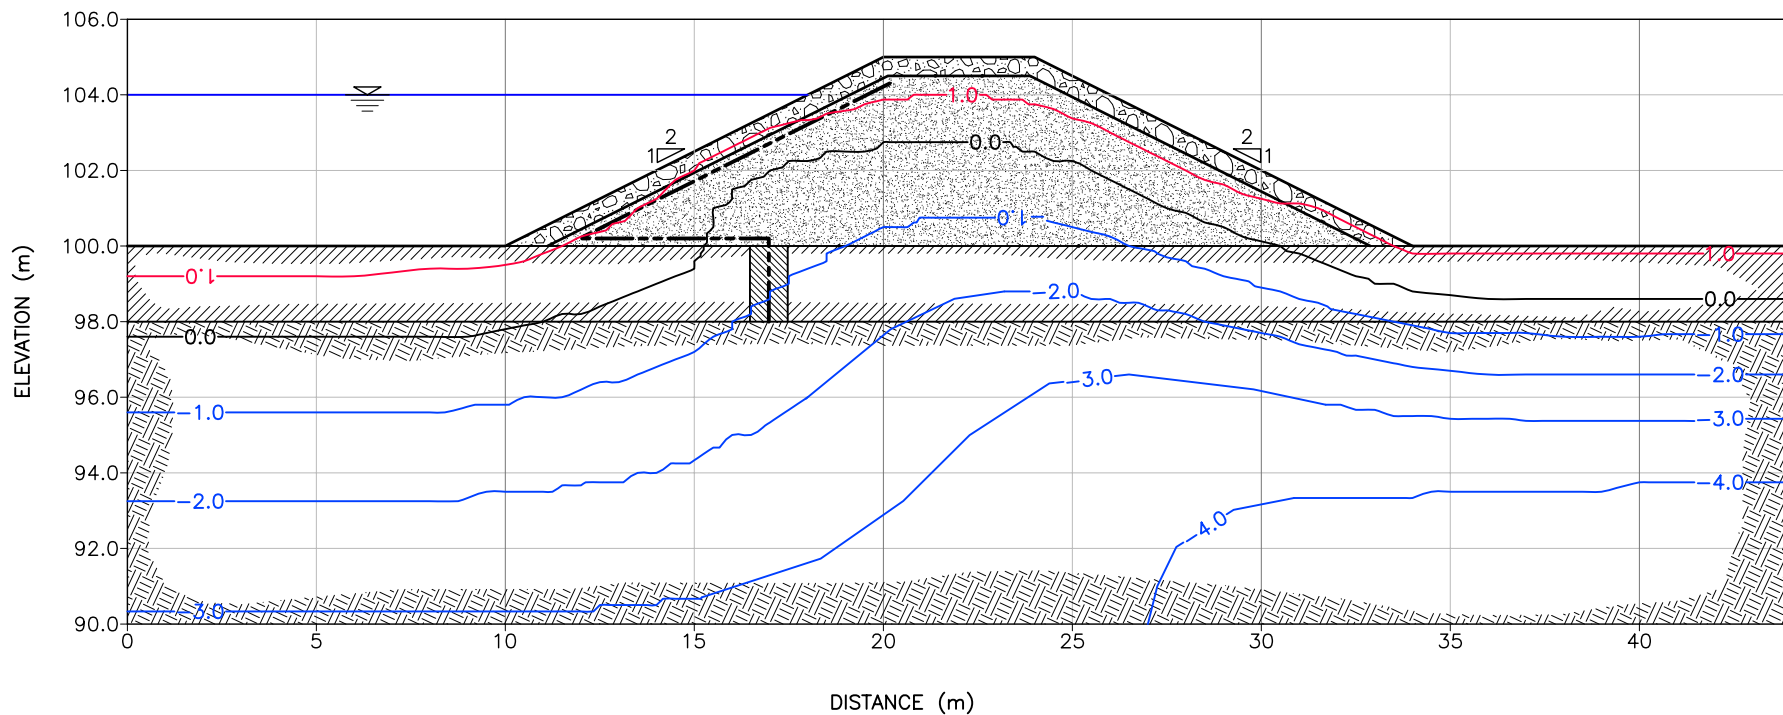
FIGURE 4

DYKE TEMPERATURES AFTER
1 YEAR OF OPERATION

Figure 4, Appendix A shows that after the first year of the dyke operation, the active layer at the dyke crest is about 2 m. The majority of the dyke core has a temperature in a range from 0 °C to -1 °C while the ground temperature under the dyke is about -2 °C. One can see that due to a warming effect of the lagoon water, the ground temperature beyond the upstream slope of the dyke is at about 1 degree warmer than the ground temperature beyond the downstream slope of the dyke.

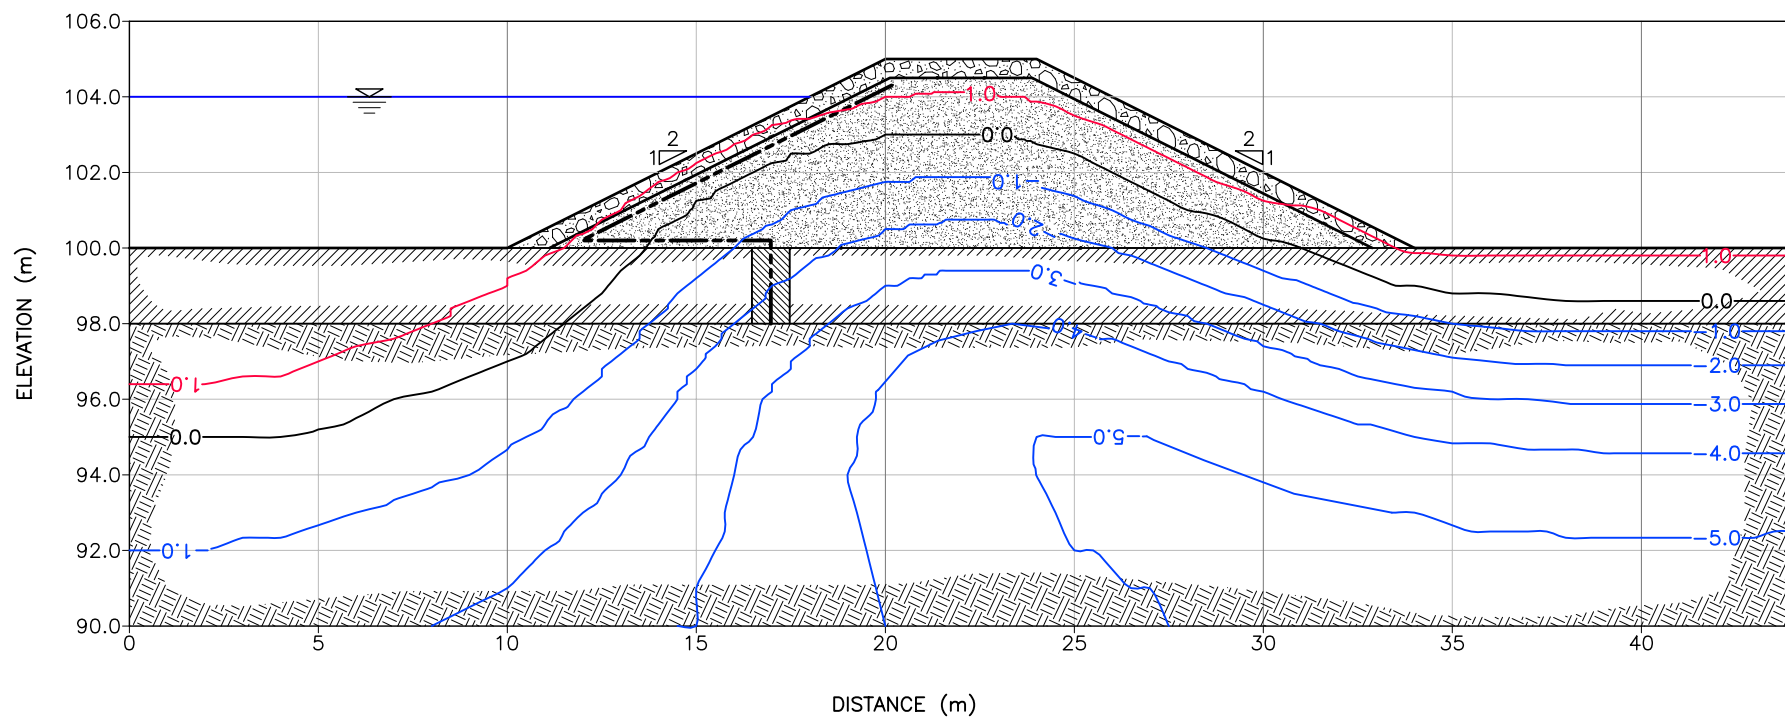
FIGURE 5

**DYKE TEMPERATURES AFTER
5 YEARS OF OPERATION**

Figures 5 through 8 show that no considerable changes of the dyke temperature regime are observed from the fifth to thirtieth year of the dyke operation (dyke temperature remains in a range from 0 °C to -2 °C). It can be observed that a thickness of the unfrozen zone under the lagoon is increased, while the ground temperature under the dyke is decreased down to -5 °C.

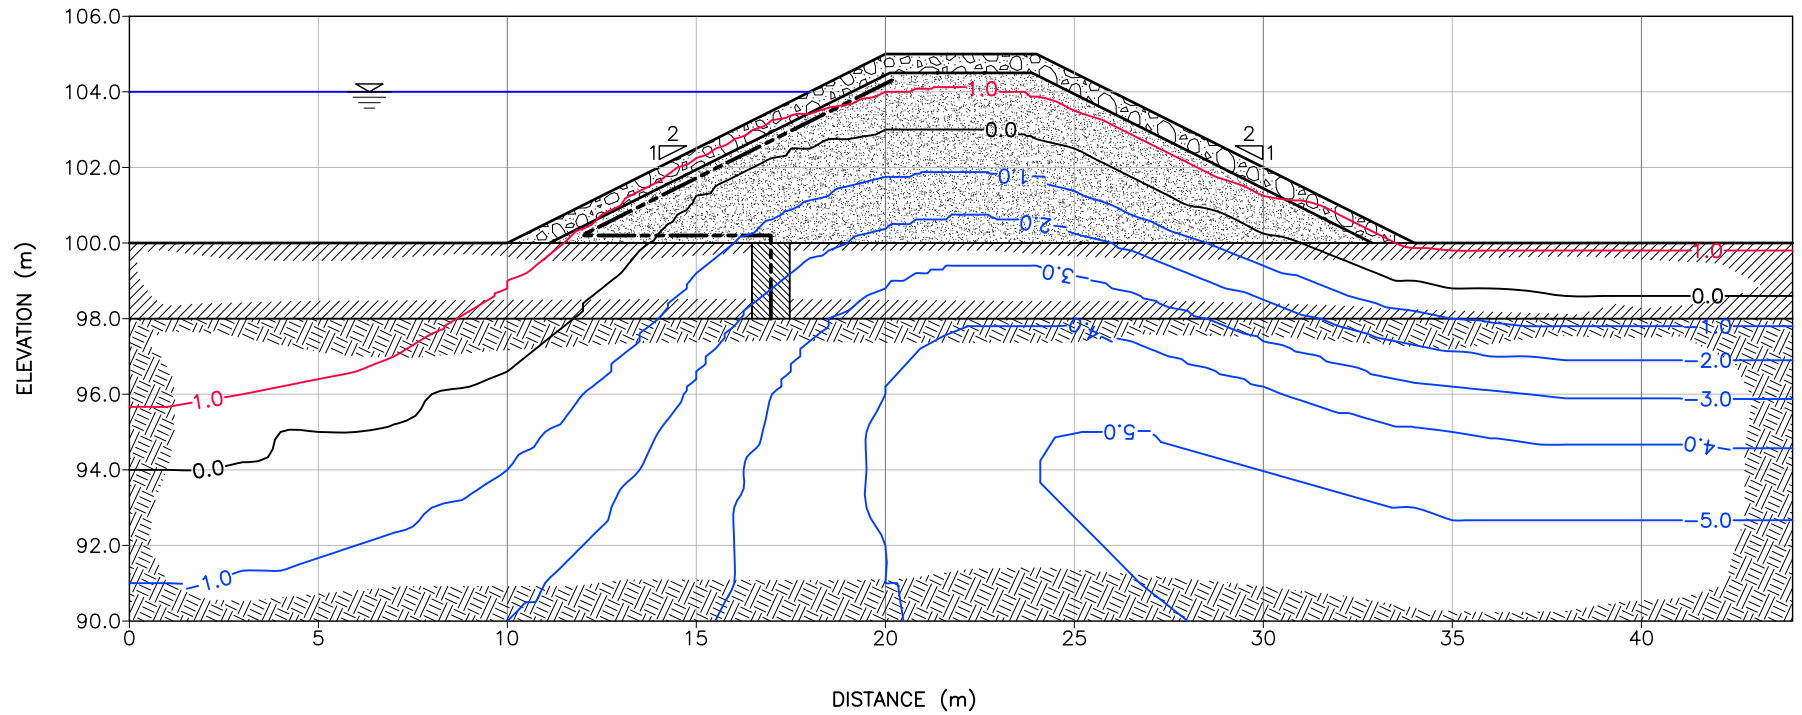
FIGURE 6

**DYKE TEMPERATURES AFTER
10 YEARS OF OPERATION**

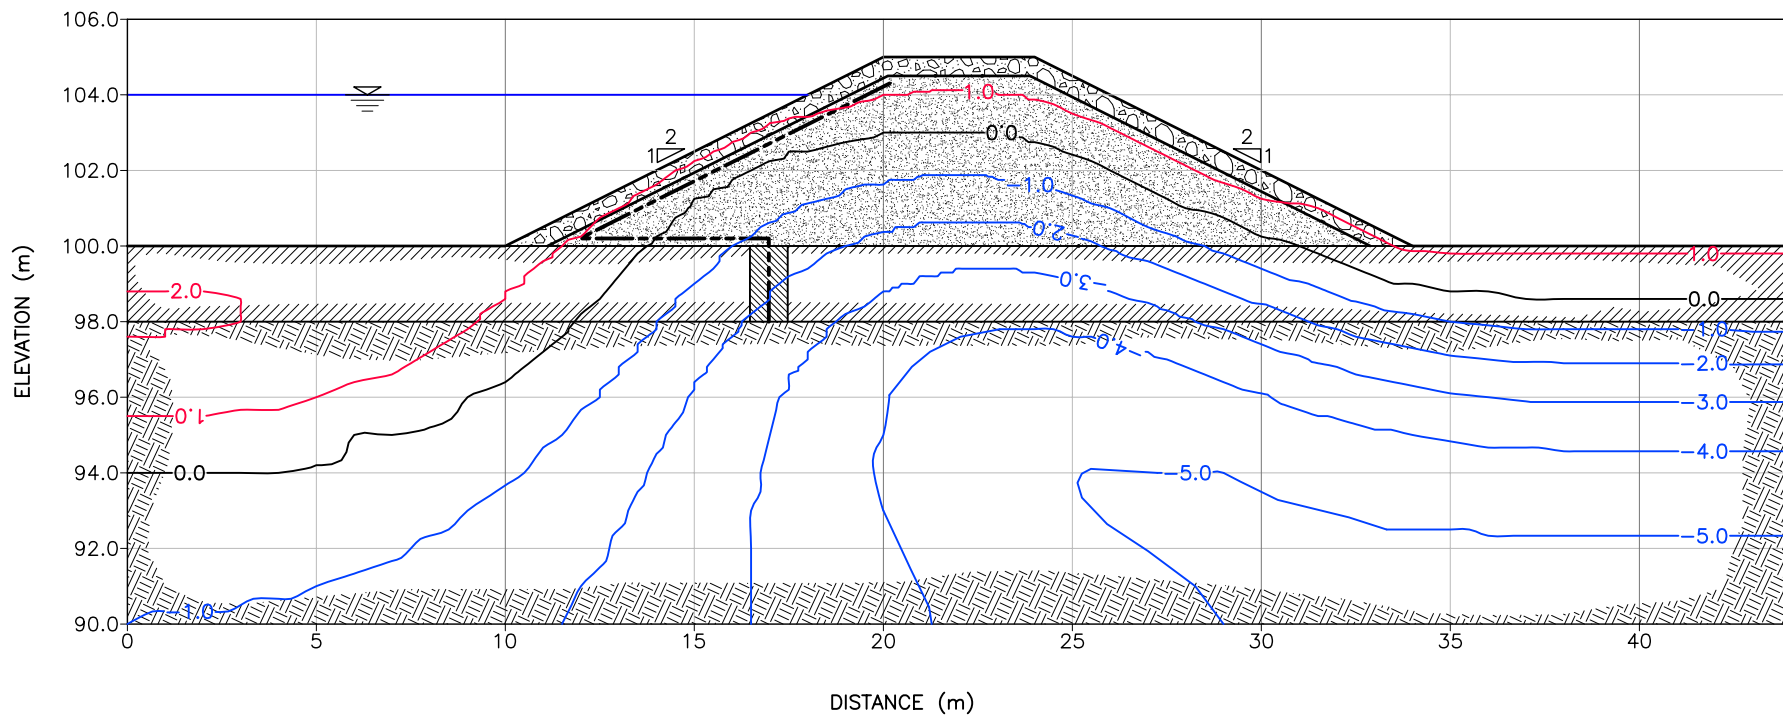
FIGURE 7

DYKE TEMPERATURES AFTER
20 YEARS OF OPERATION

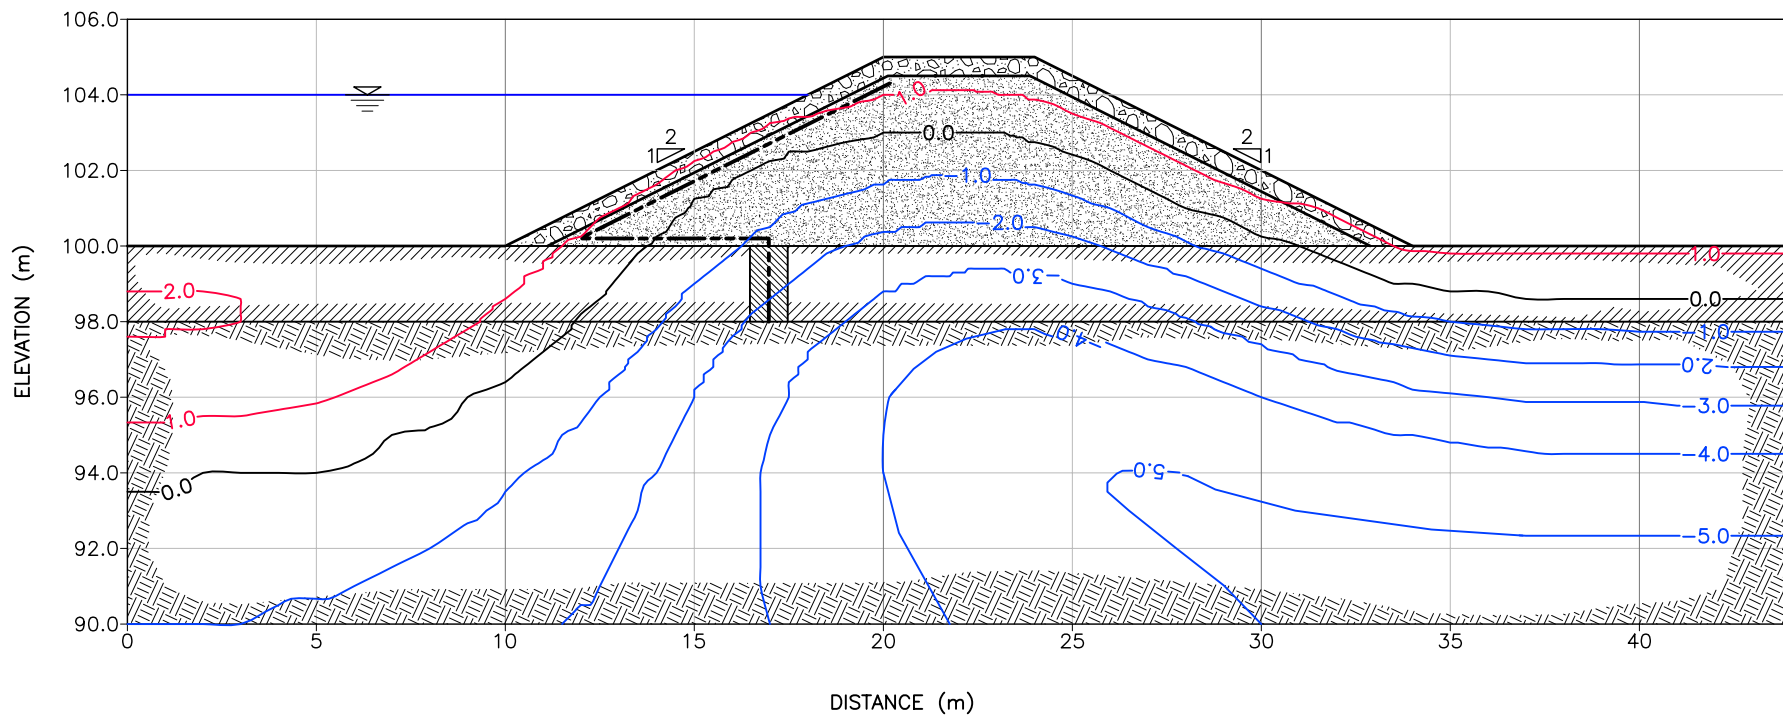
FIGURE 8

**DYKE TEMPERATURES AFTER
30 YEARS OF OPERATION**

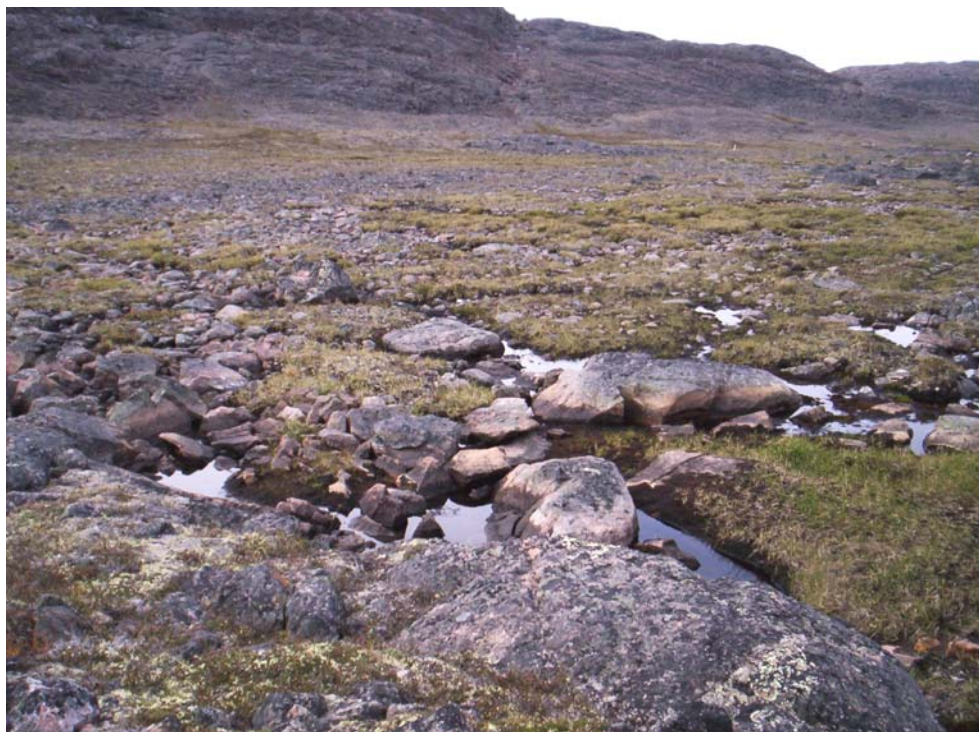
Photograph 3: Lagoon Impoundment, looking north from center.

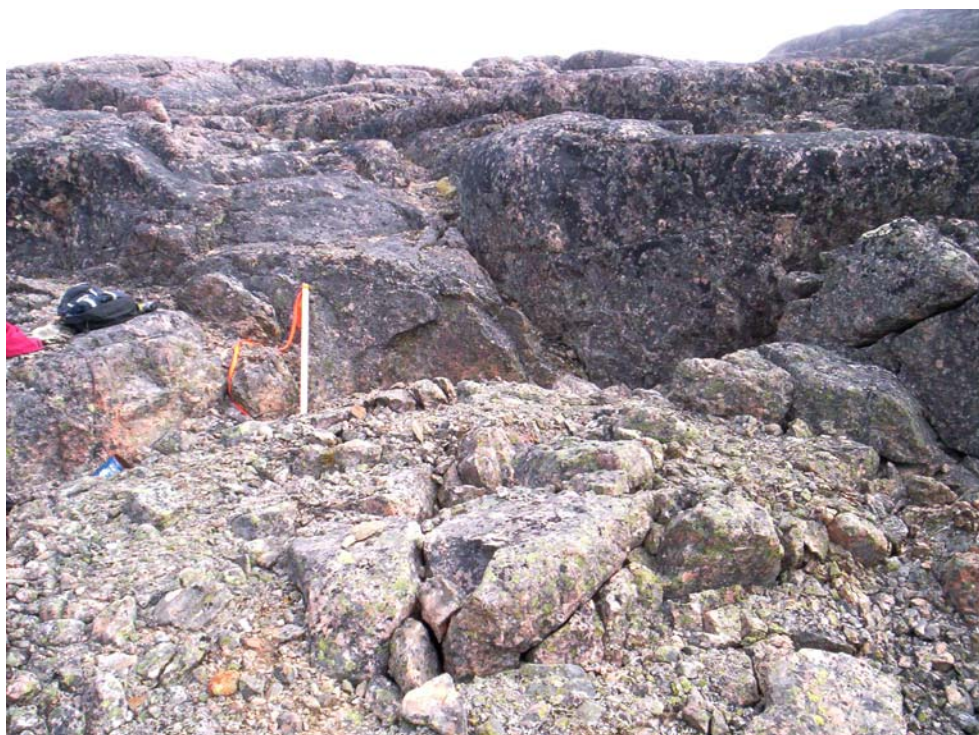
Photograph 4: Southeast corner of Lagoon Impoundment

Bedrock outcrops, as shown at Photograph 4 (Appendix B) surround the proposed lagoon impoundment. It can be seen at the photograph that the bedrock is moderately weathered and fractured.

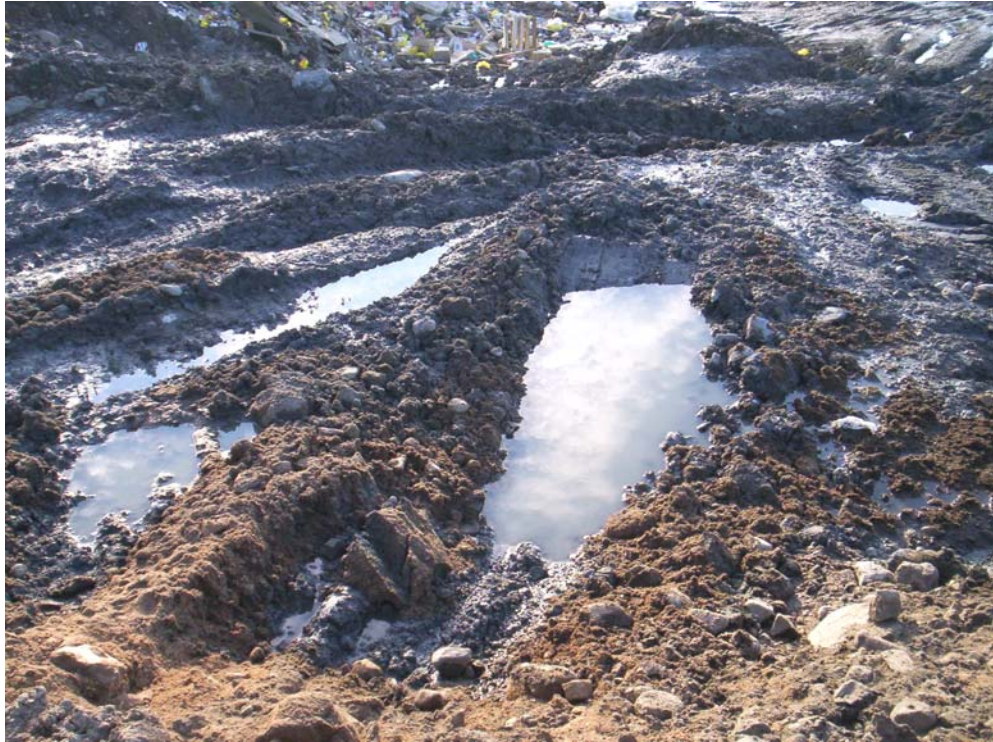
Photograph 5: Potential clay borrow material near community dump.

Results of the field reconnaissance have shown that a clayey material may be found in the vicinity of the community landfill and airport. Photograph 5 (Appendix B) illustrates that the clayey material near the dump could contain numerous inclusions of cobbles and boulders while the clayey soil near the airport is mainly uniform and containing lesser amounts of the coarse material (Photograph 6, Appendix B). Grain size distribution analyses confirm the above

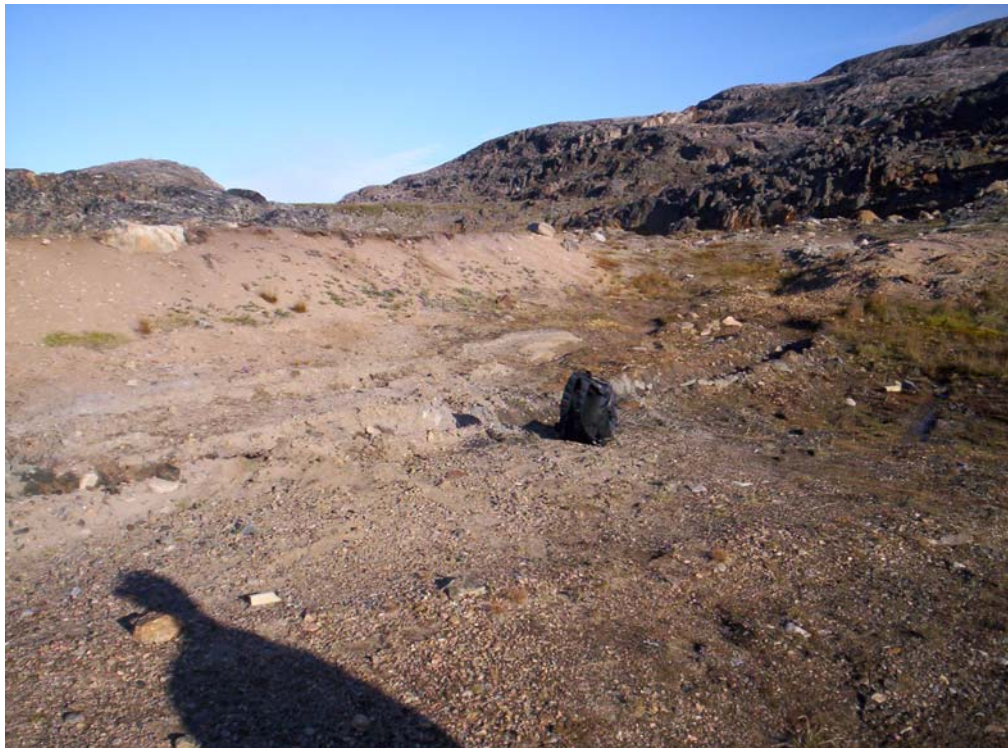
Photograph 6: Potential clay borrow material near airport.

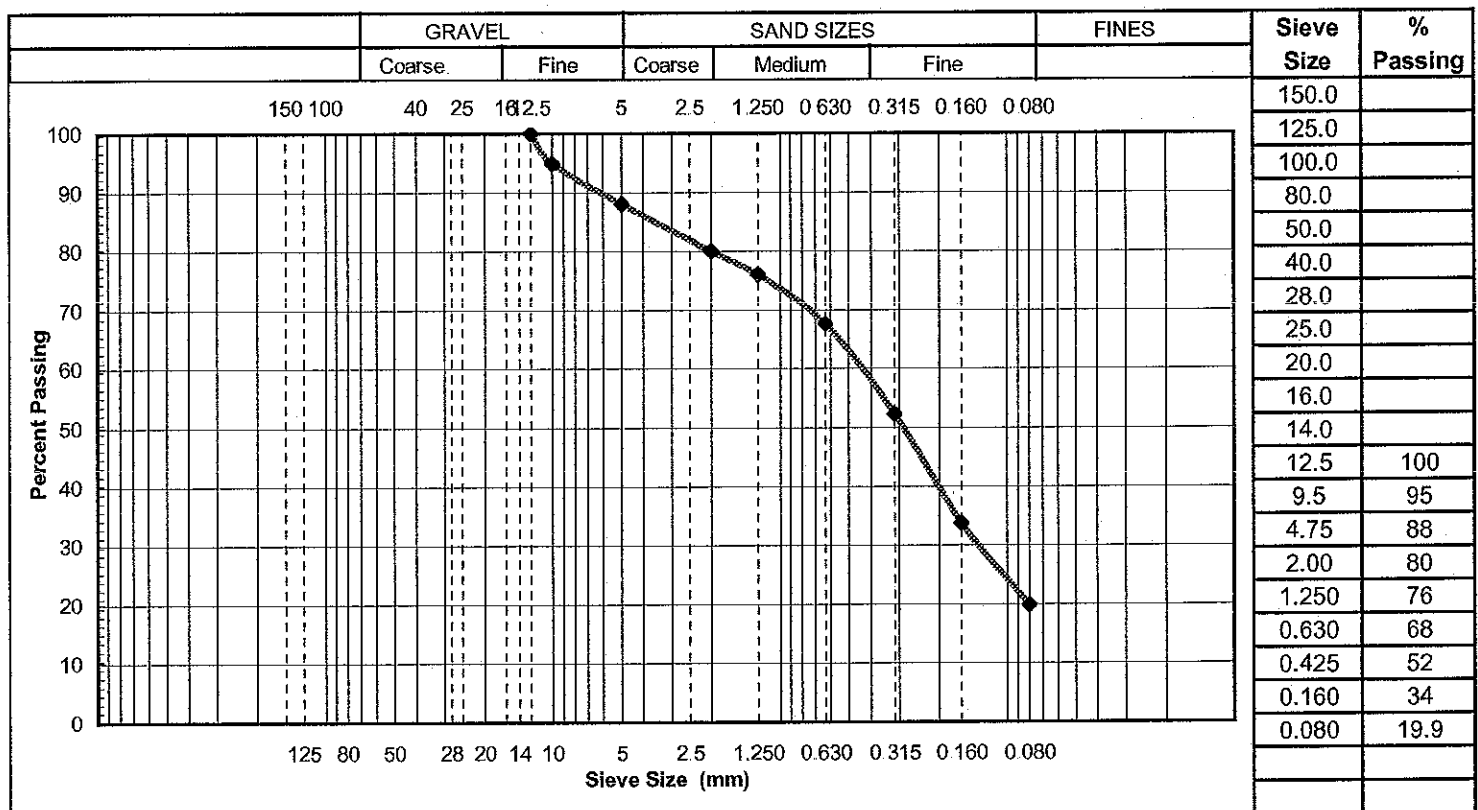
Source: Borrow Pit Cape Dorset, Near CG&S Building , near the airport

Sample Description: Sandy Silty Clay 18W 0425 451 N7 122 814

Comments : Moisture content 14.4%

conclusions. The borrow material near the landfill contains about 35% gravel sizes and about 30% fines; the borrow material near the airport does not contain gravel while the fines contain about 50% (Appendix C).

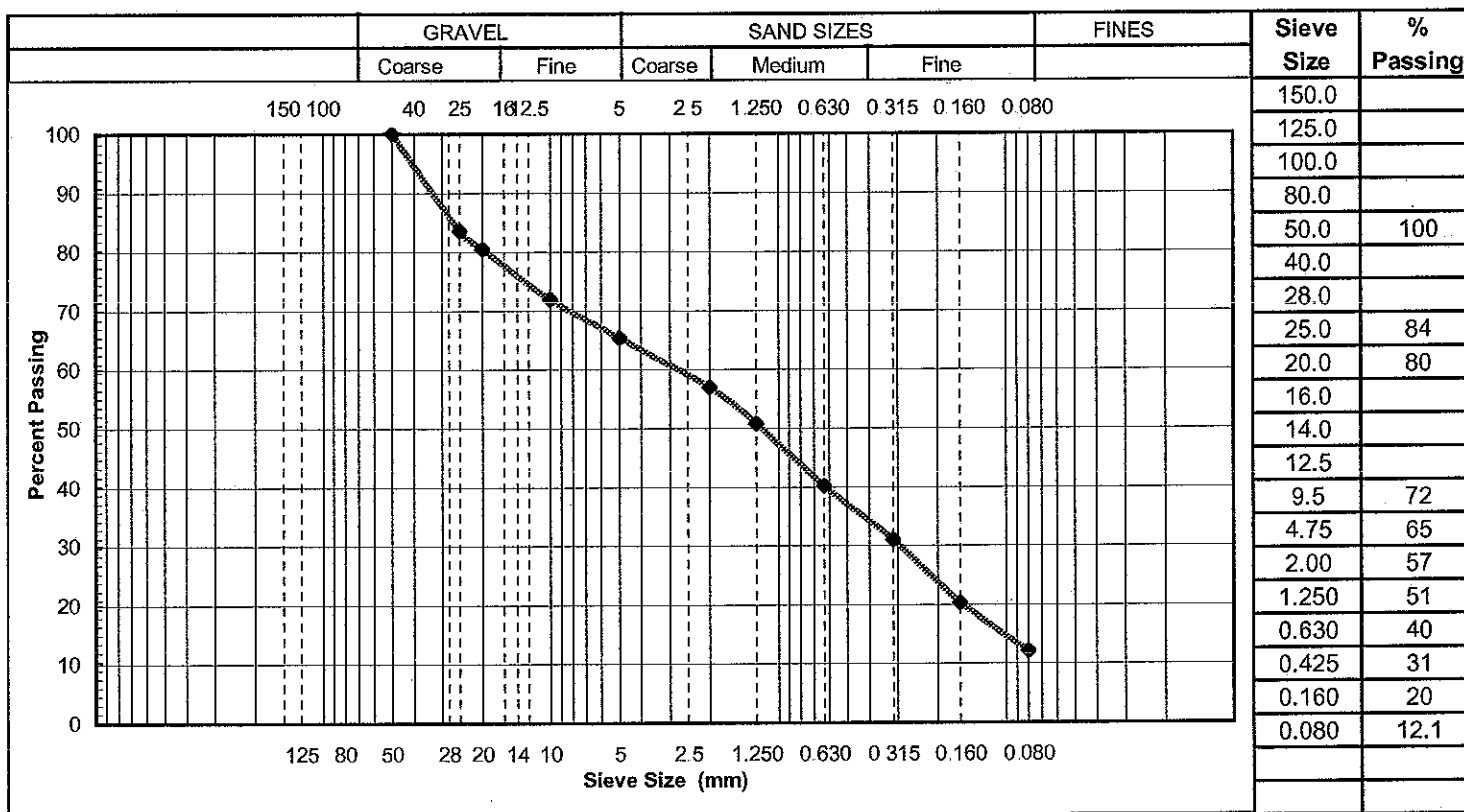
Source: Borrow Pit Cape Dorset, Near Landfill 18W 0423 046 N7 122 801
Sample Description: Sandy Silty Clay
Comments : Moisture content 8.8%
