Schematic Design for the  
Improvements to the Sewage Lagoon and  
Solid Waste Disposal Facility  
The Hamlet of Kugluktuk, Nunavut

December 2005

**Re:** Schematic Design Report  
Sewage and Solid Waste Facilities Design  
Hamlet of Kugluktuk  
File No. N-O 09755

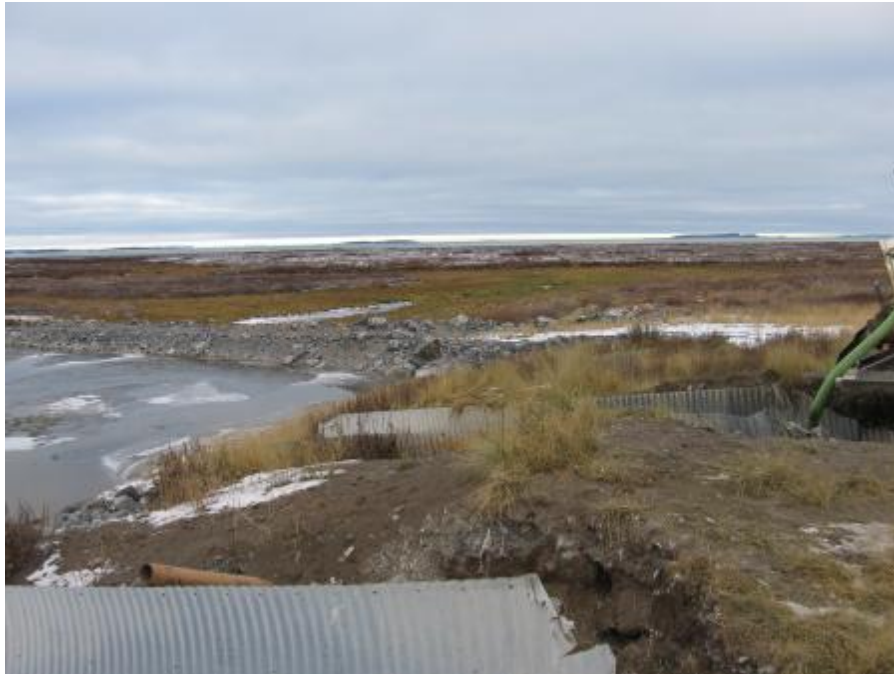
Photo 3 Culverts used as a spillway for truck discharge into the Sewage Lagoon.

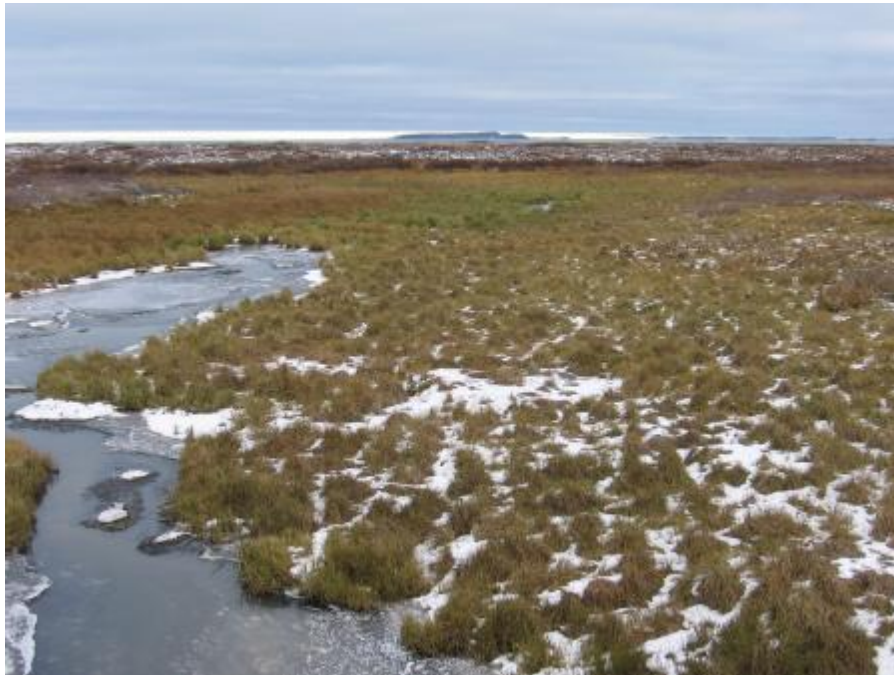
Photo 4 Sewage discharge into wetland draining towards Coronation Gulf.

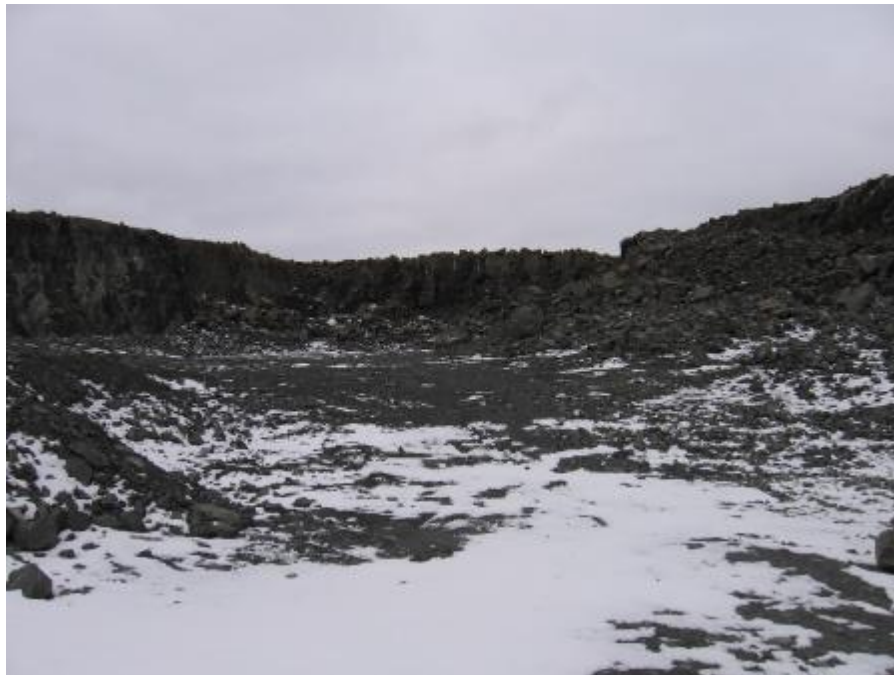
Photo 6 Rock quarry east of the Solid Waste Disposal facility.

Approximately 10,000 m<sup>3</sup> of unsorted blast rock is stockpiled in the Gabro Quarry, approximately 300 m west of the Bulky Metals area, as shown on Figure 3. Appendix B shows details of the quarry (see Photos 6 and 7). The quarry face is in good condition, and there is a huge remaining resource of rock, which could be blasted for production of coarse aggregate or rubble materials.

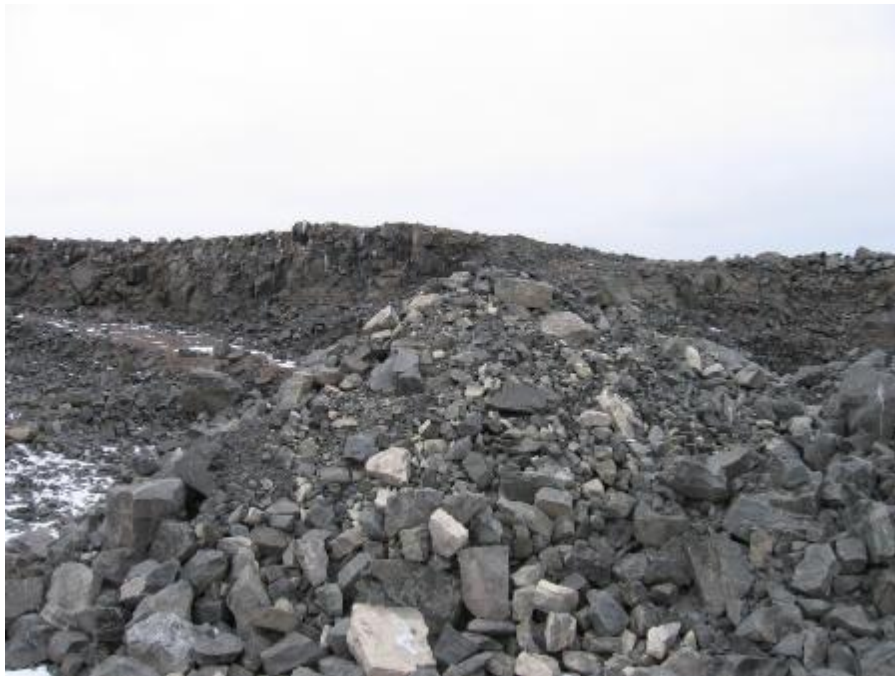
Photo 7      Blasted Gabbro stockpiled at rock quarry.

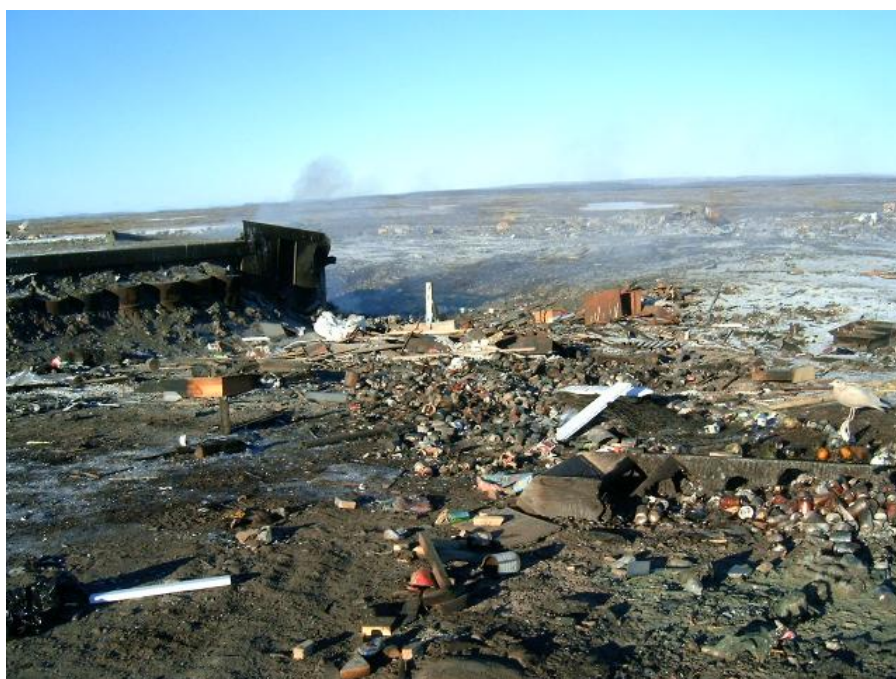
Photo 16 Tipping ramp and burn pit at landfill.

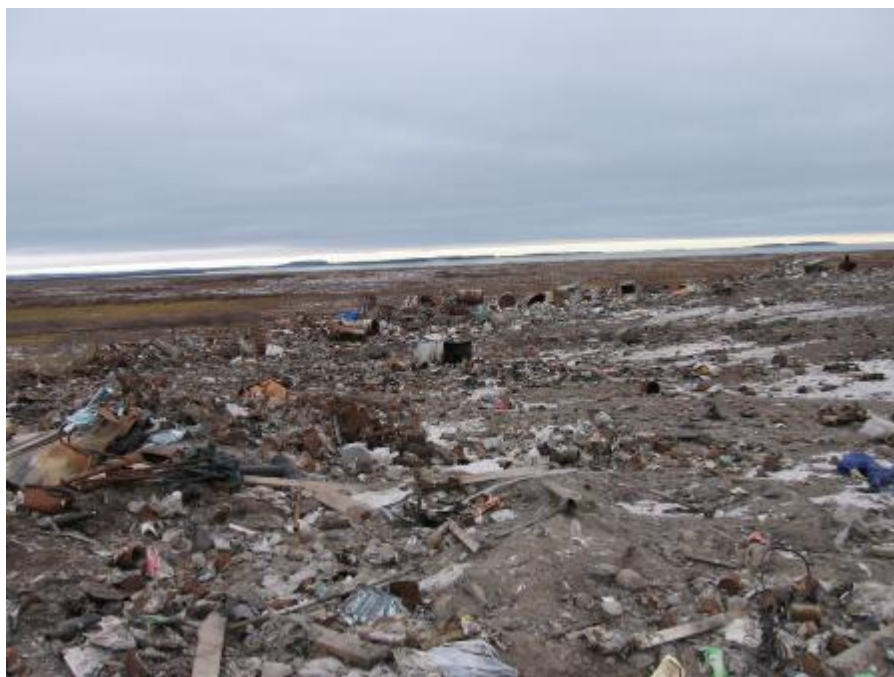
Photo 19      Burned partially crushed waste pushed out of the burn pit and spread across the landfill footprint.

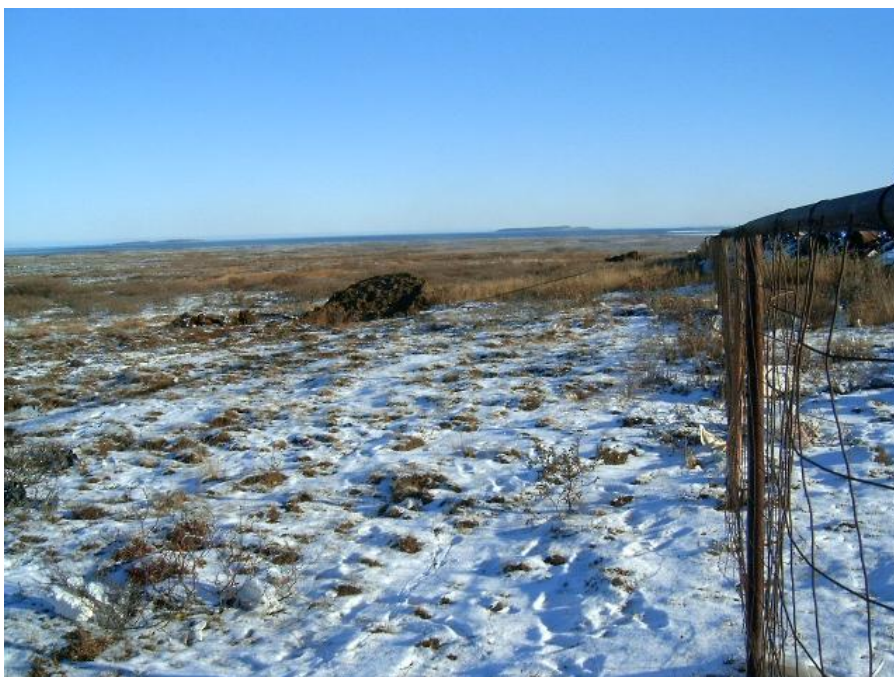
Photo 20      Test pit MSW-1 and MSW-2 excavated north of landfill fence.

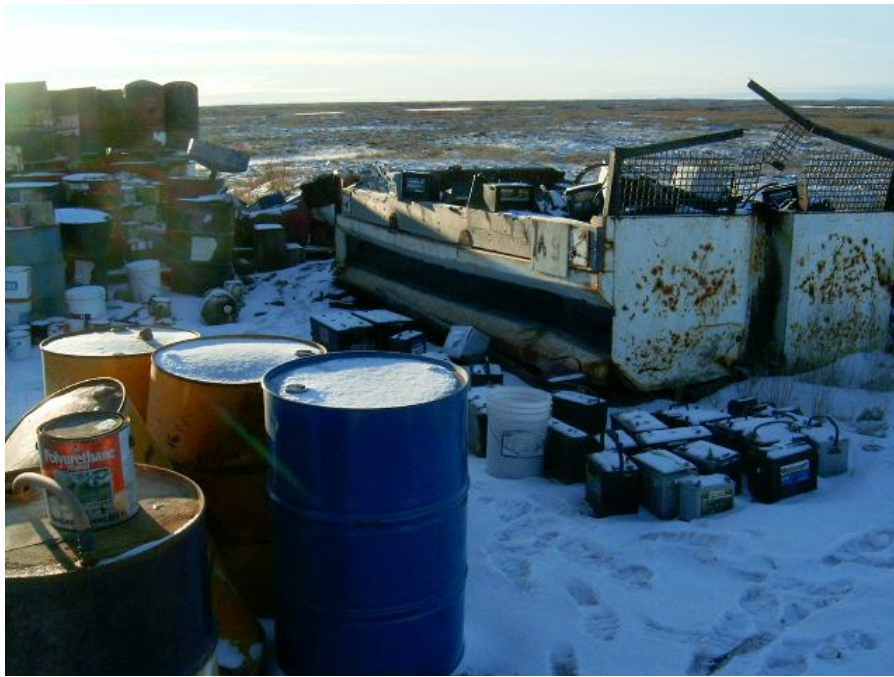
Photo 27 Batteries and waste materials stored in truck box and stacked on ground.
