PRELIMINARY ENGINEERING REPORT

PROJECT NAME
Water Supply Improvements

Kugluktuk, NU

PREPARED FOR
Government of Nunavut, Community & Government Services

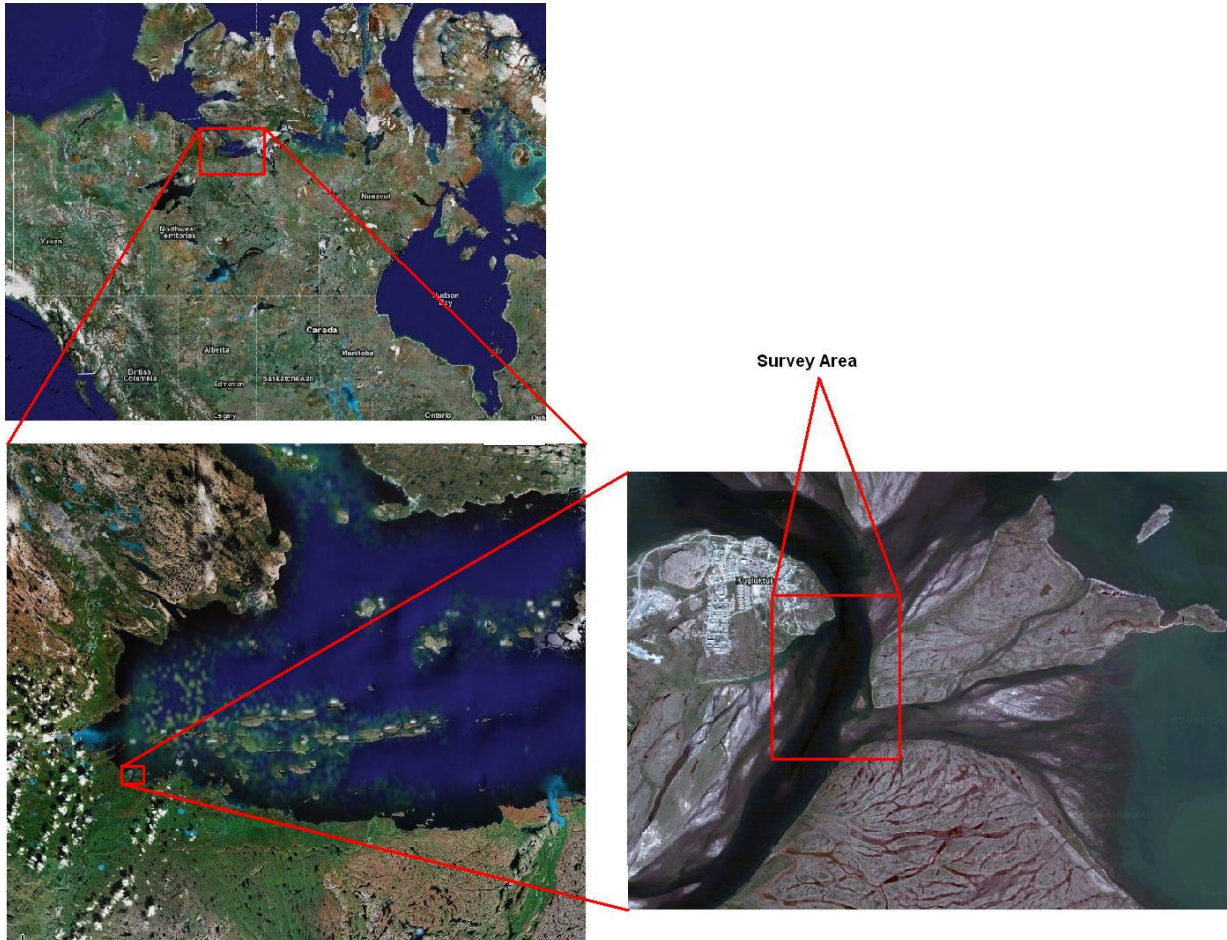
Figure 1: Survey site. Kugluktuk Water Intake Area, Kugluktuk, NU

The survey area was on the Coppermine River adjacent to the hamlet of Kugluktuk, NU, approximately 600km north of Yellowknife, NWT. Figure 1 indicates the approximate site location. Access to the survey area was by snowmobile.

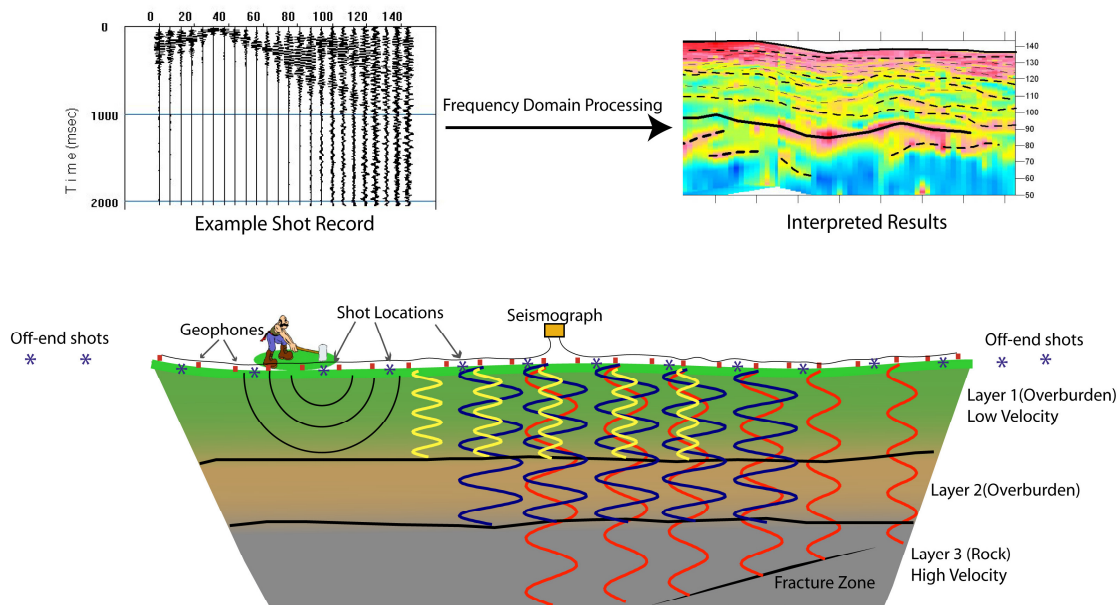
Figure 2: Seismic Resonance Operating Principle.

The method uses the information from an induced seismic signal in the frequency domain instead of the direct time domain as with classic seismic reflection. For both methods, however, the principal physical parameter involved remains the acoustic impedance contrast, which is the product of the seismic velocity and the volumetric mass of the investigated materials. At the interface between two materials with different acoustic impedance, the seismic signal is partially reflected back to the surface. Under specific conditions, the repetition of such reflections leads to the build-up of a resonance signal, whose frequency is related to the depth of the interface and the seismic velocity of the upper material. The resonance frequency is inversely proportional to the reflection time. The first advantage of the use of frequencies instead of reflection times is the amplitude and the repetitive signal, which is less sensitive to the ambient noise and produces a resolution that increases with shallow depths. The second advantage of using resonance frequencies is the ability to resolve very thin layers (contrary to standard reflection).

Interpretation involves identifying trends in the amplitude of reflectors. TISAR reflectors could be from geologic contacts, fractures or voids. As with seismic reflection, the true nature/source of the reflection cannot be certain.

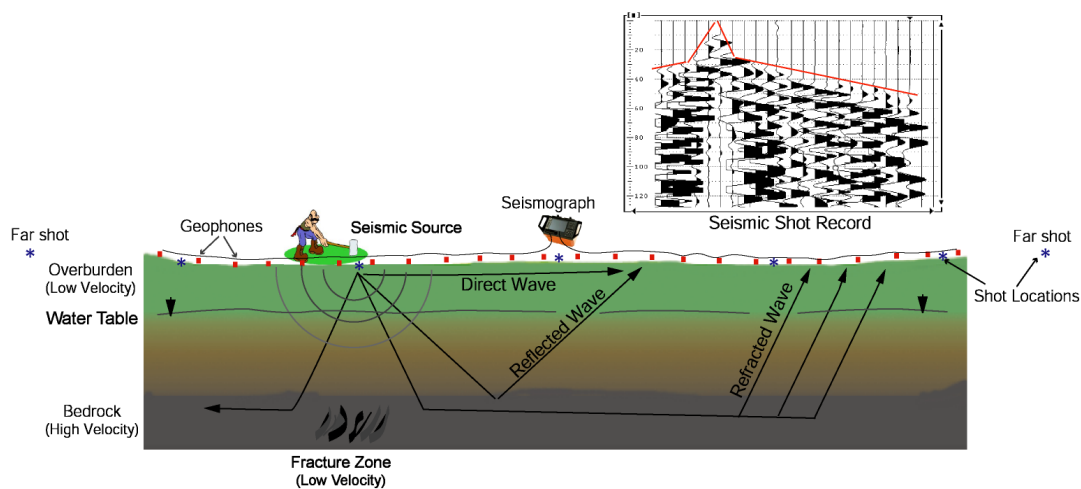
Figure 3: Seismic Refraction Operating Principle

Typically the accuracy of a refraction surveys is $\pm 1\text{m}$ for depths less than 10m and $\pm 20\%$ for depths greater than 10m; however, the depth to bedrock at this particular site was near the limit for accurate mapping as the sledgehammer was barely adequate for the site conditions. The refraction records are also used to measure the overburden velocities to develop a starting model for the resonance analysis.

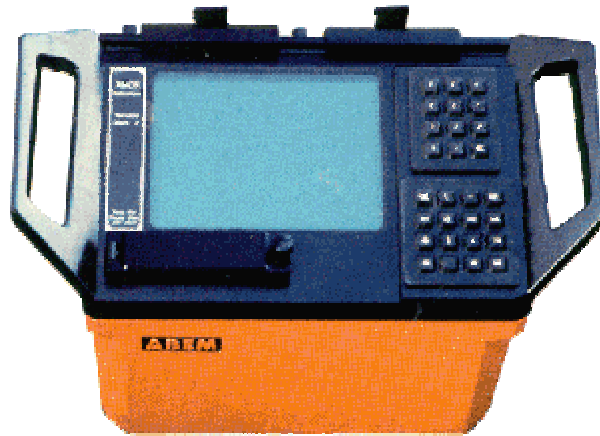
TERRALOC MK6 FEATURES

The Terraloc mark 6 is a high resolution multi-channel seismograph with an 18-bit A/D converter and 3-bit instantaneous floating point (IFP) amplifier. Overall resolution is thus 21 bits. Its dynamic range, 126 dB, eliminates all gain setting hassles and satisfies the most stringent shallow reflection requirements.

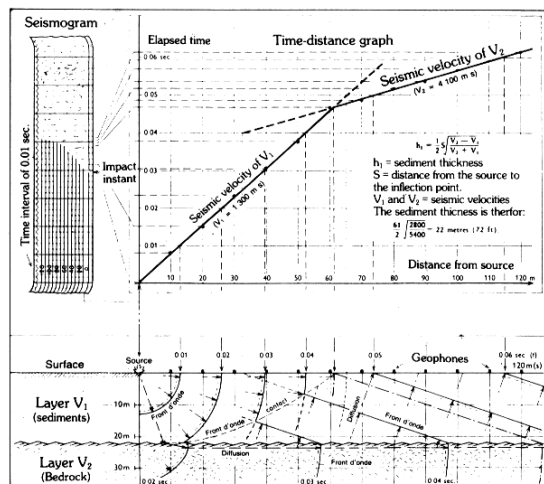
PRINCIPLE OF SEISMIC REFRACTION

Seismic refraction consists of recording the length of time taken for an artificially provoked surface vibration to propagate through the earth. By processing the data, the seismic velocities and depths of the underlying rock layers can be determined. These velocities are characteristic of the nature and quality of the bedrock; a fissured, fractured or sheared rock will be characterized by reduced seismic velocities.

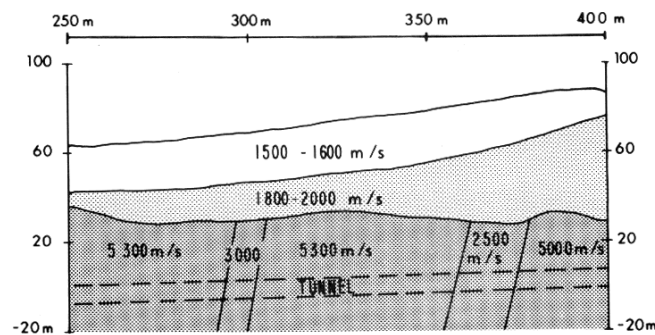
Interpretation results of a seismic profile

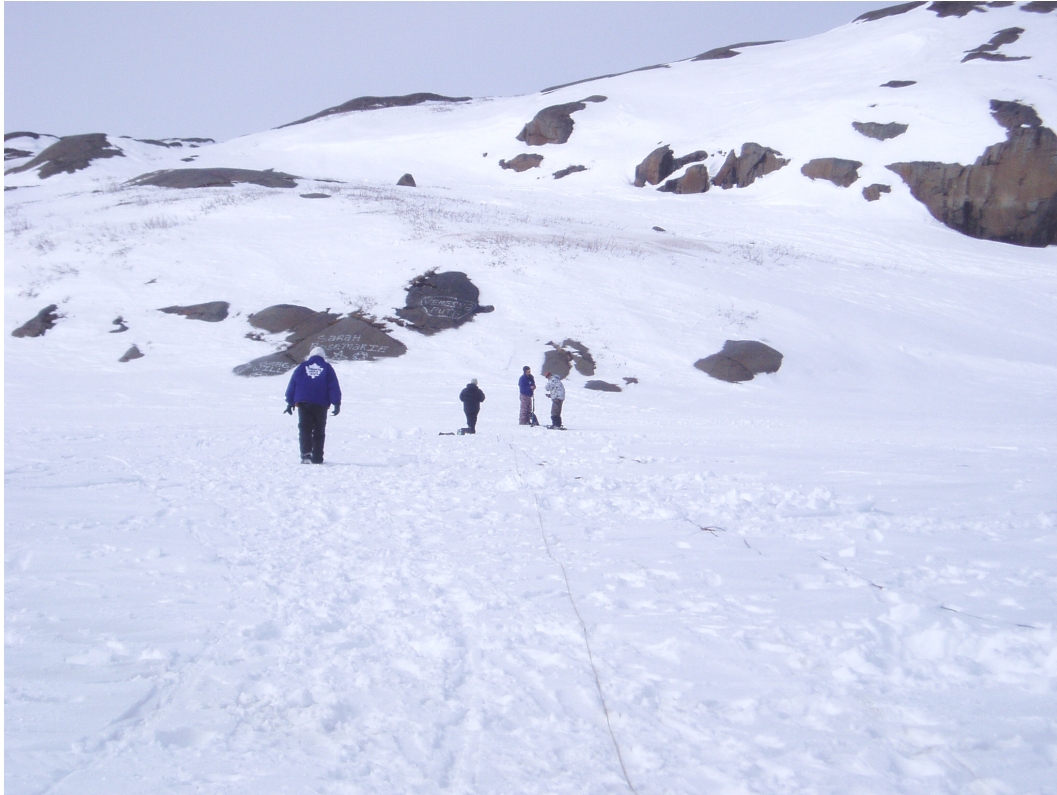
Photo 1: Seismic Profile 1, looking west towards 0+00

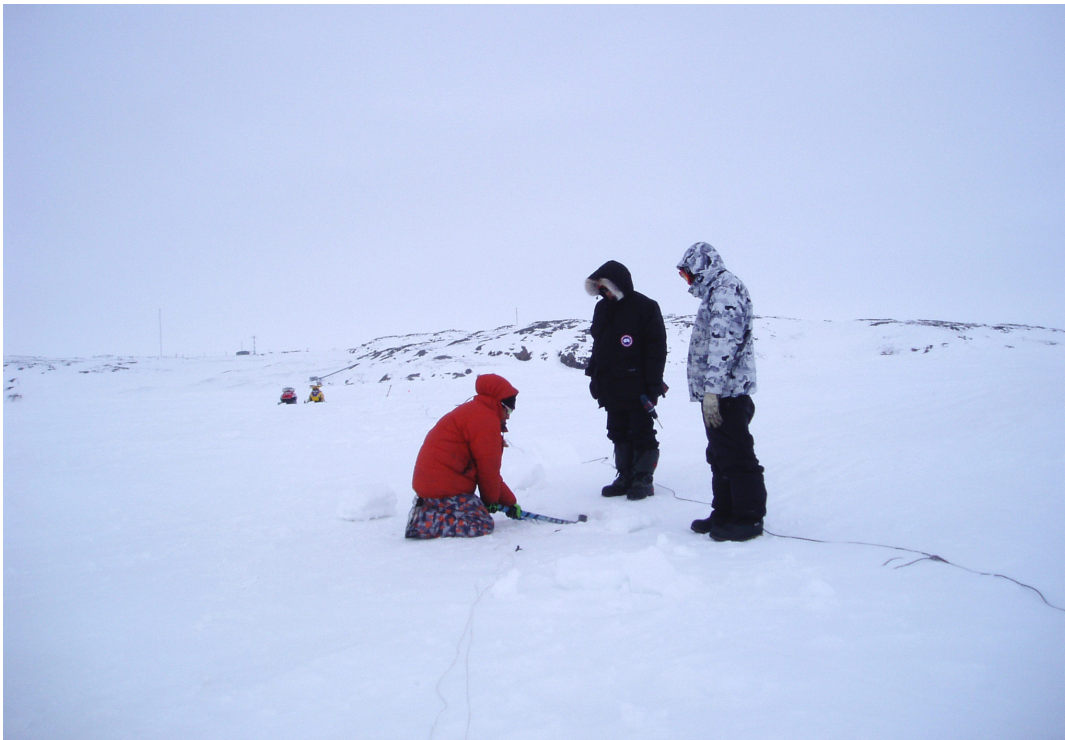
Photo 2: Hammering along seismic profile 1

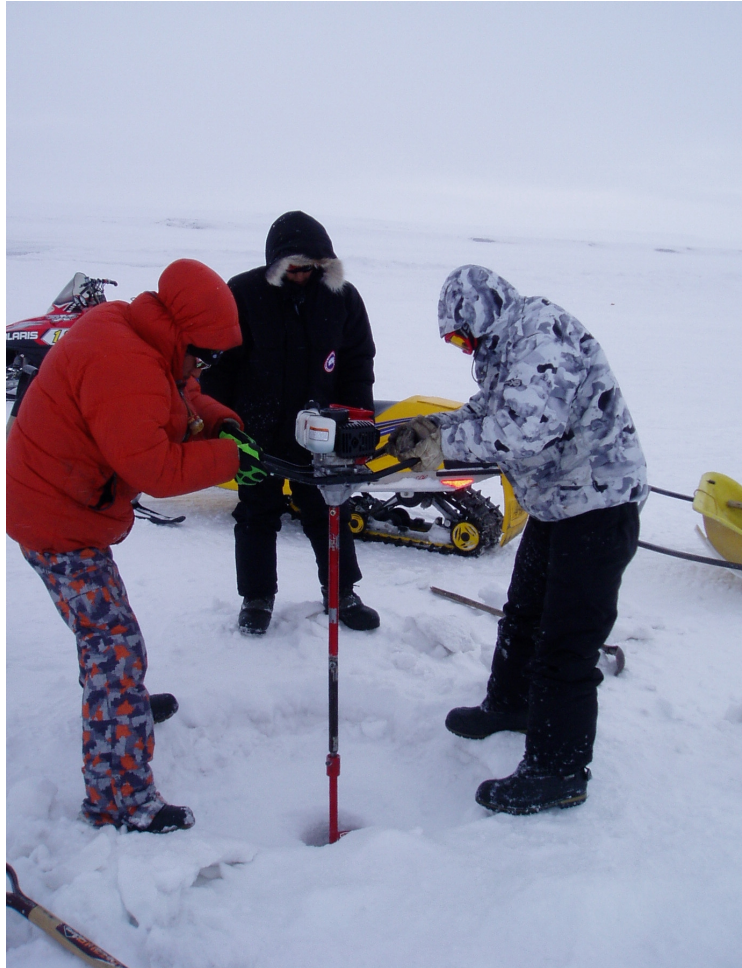
Photo 3: Using the ice auger

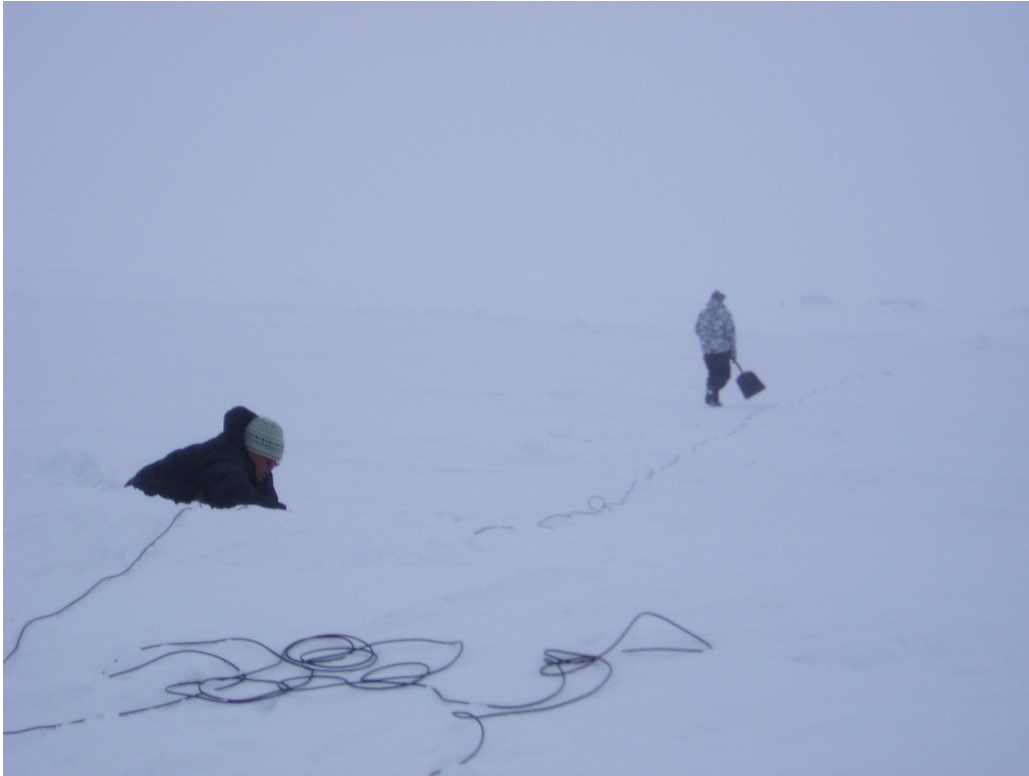
Photo 4: Installation of the geophones and cables

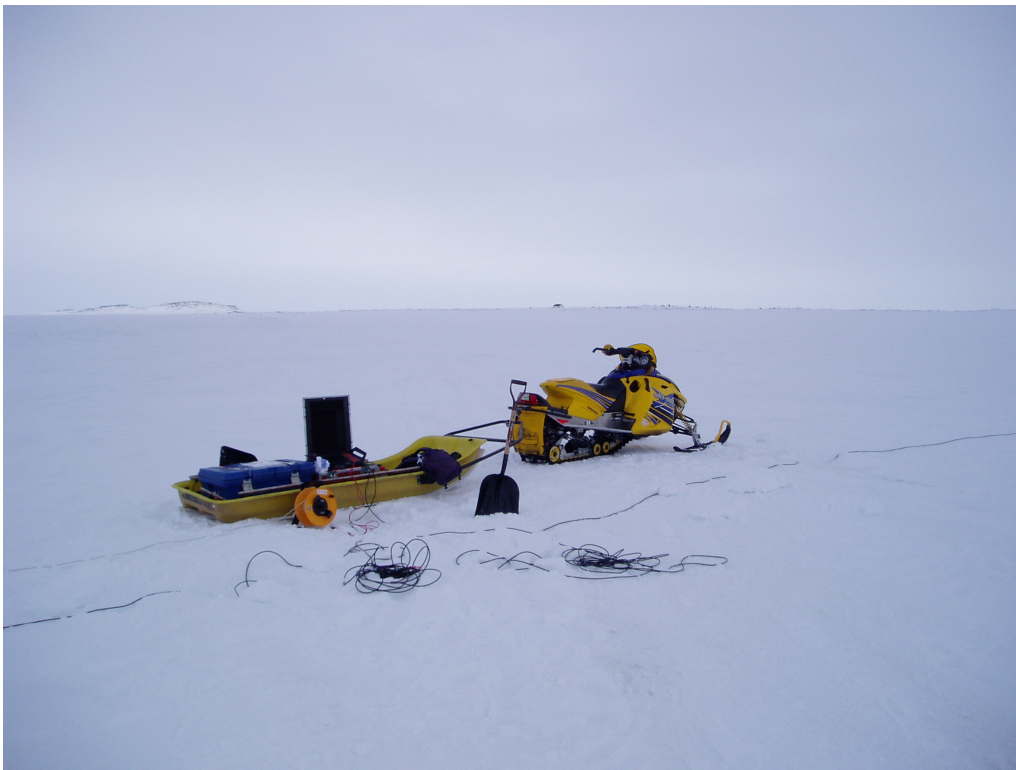
Photo 5: Seismic equipment set-up

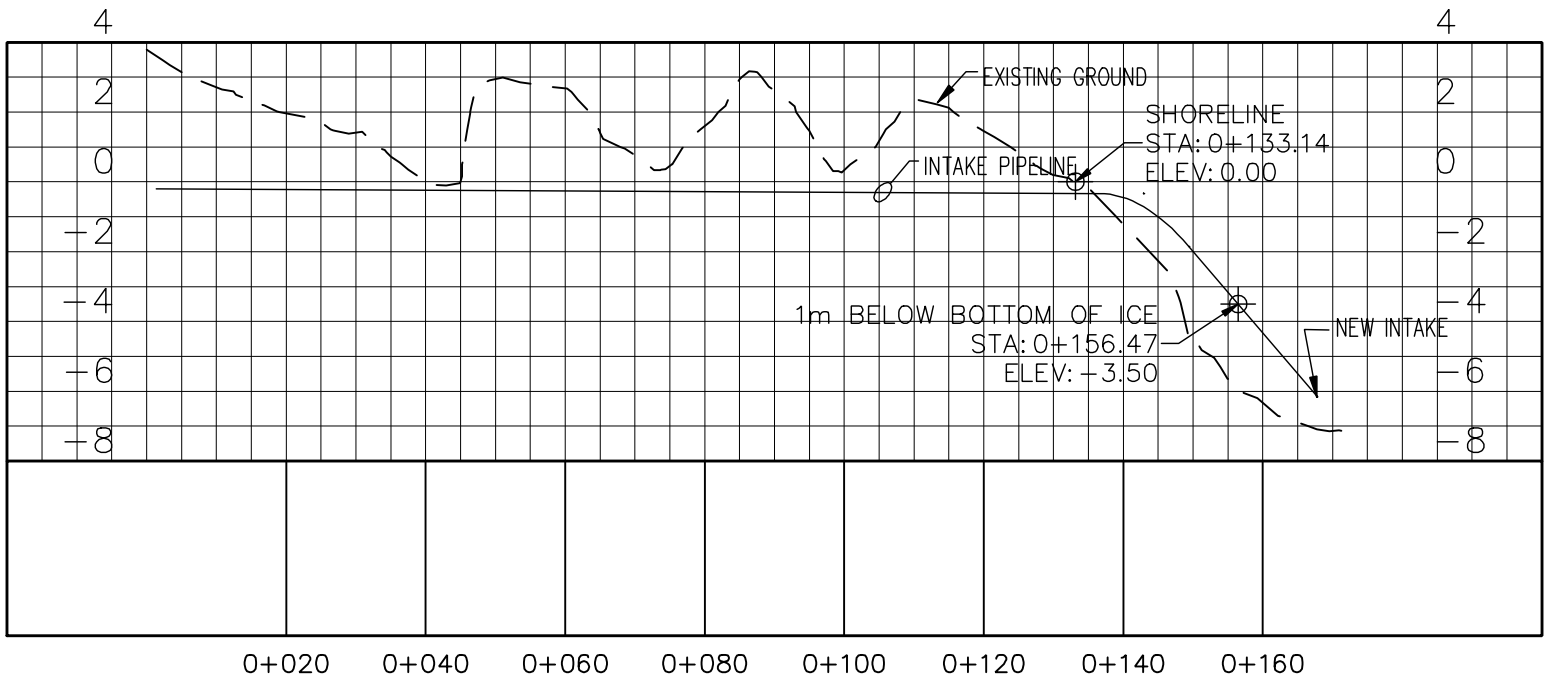
| DWG # | 13655-SK2 | OF | - | REV # | A |

OPTION 3 INTAKE PIPELINE PROFILE

Similar to the previous option, the intake would be located in the hole, with the pumphouse moved back from the riverbank at the current location, but the hole could be reached by running the pipe along the rock face on the shoreline by hanging the pipe to rock anchors. The pipe would be located high enough to protect it from ice damage. Some drilling/blasting may be required to bury

Running the pipe along the shoreline and hanging it from the rock is also a valid cost-effective option. This option has the advantage of having less pipe length with need of protection from ice. It may also have less O&M cost as long sections of berms will not need to be inspected and/or repaired. The hanging pipe support could also be constructed with catwalk system.

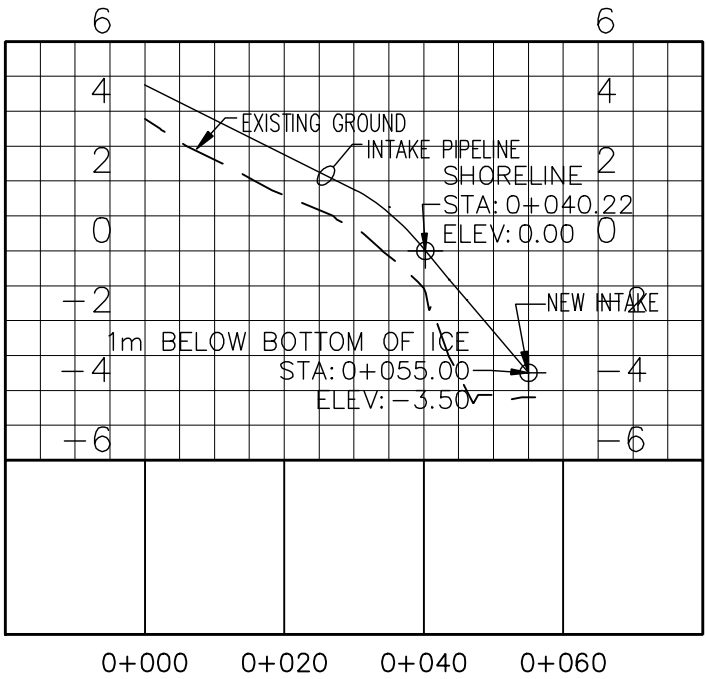
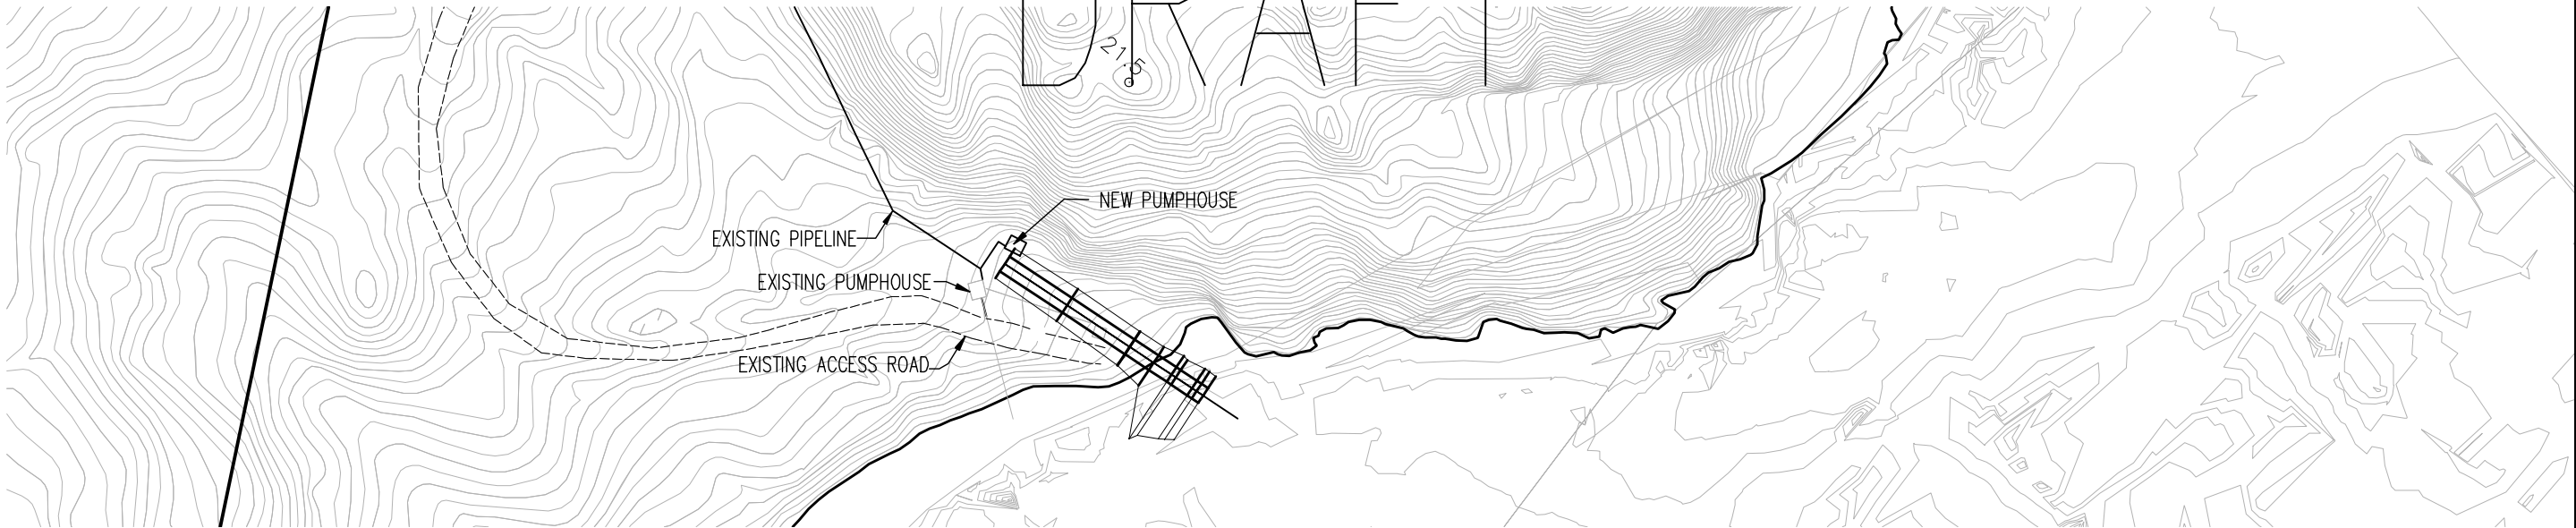
OPTION 4 INTAKE PIPELINE PROFILE
