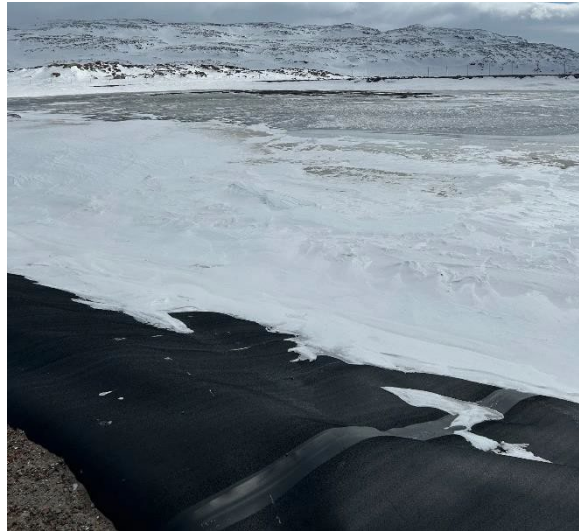
The bubble in the sewage lagoon liner contributed volume to the lagoon resulting in the earlier need for partial decant ahead of the summer thaw. CGS has engaged Dillon Consulting to repair this issue with the lagoon liner. A site visit by the consultant will occur at the end of July 2024 and will continue until work is completed. To repair the liner before freeze up, the work schedule requires the lagoon to be emptied by July 31 2024. To empty the lagoon in time, the decant will continue. Figures 2 and 3 show the bubble in the sewage lagoon's liner as documented in late April 2024.

Figure 2: Kugaaruk Sewage Lagoon Liner Bubble, April 2024

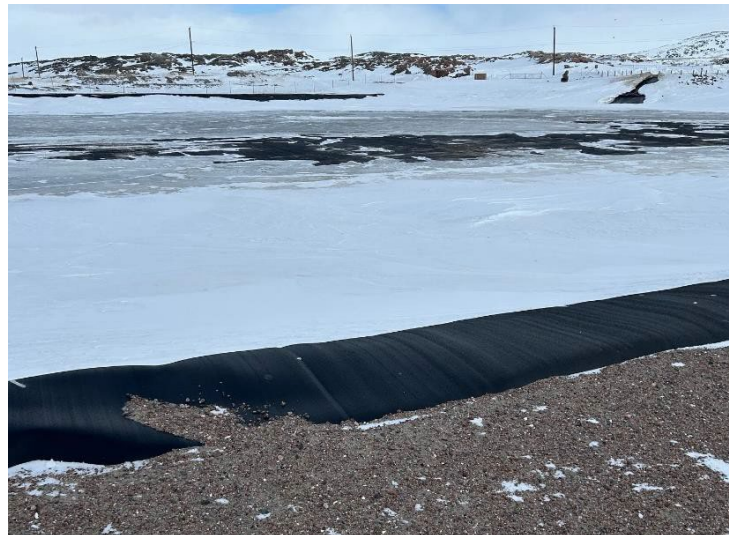
Figure 3: Kugaaruk Sewage Lagoon Liner Bubble, April 2024
