WATER LICENCE INSPECTION FORM

Licensee Government of Nunavut – Department of Transportation and Infrastructure	Licensee Representative Darrin Nichol
Licence No. / Expiry 3BM-YRB2126	Representative’s Title Director of Nunavut Airports
Land / Other Authorizations	Land / Other Authorizations
Date of Inspection July 6, 2025	Inspector Joseph Monteith
Activities Inspected

Inspector Statement
 On July 6, 2025, A Water Licence Inspection was conducted by Water Resource Officer(WRO) Joseph Monteith and WRO Sean Naullaq at the Resolute Bay GN-DOTI Sewage Disposal Facility at Resolute Bay, NU.

Sewage Disposal Facility

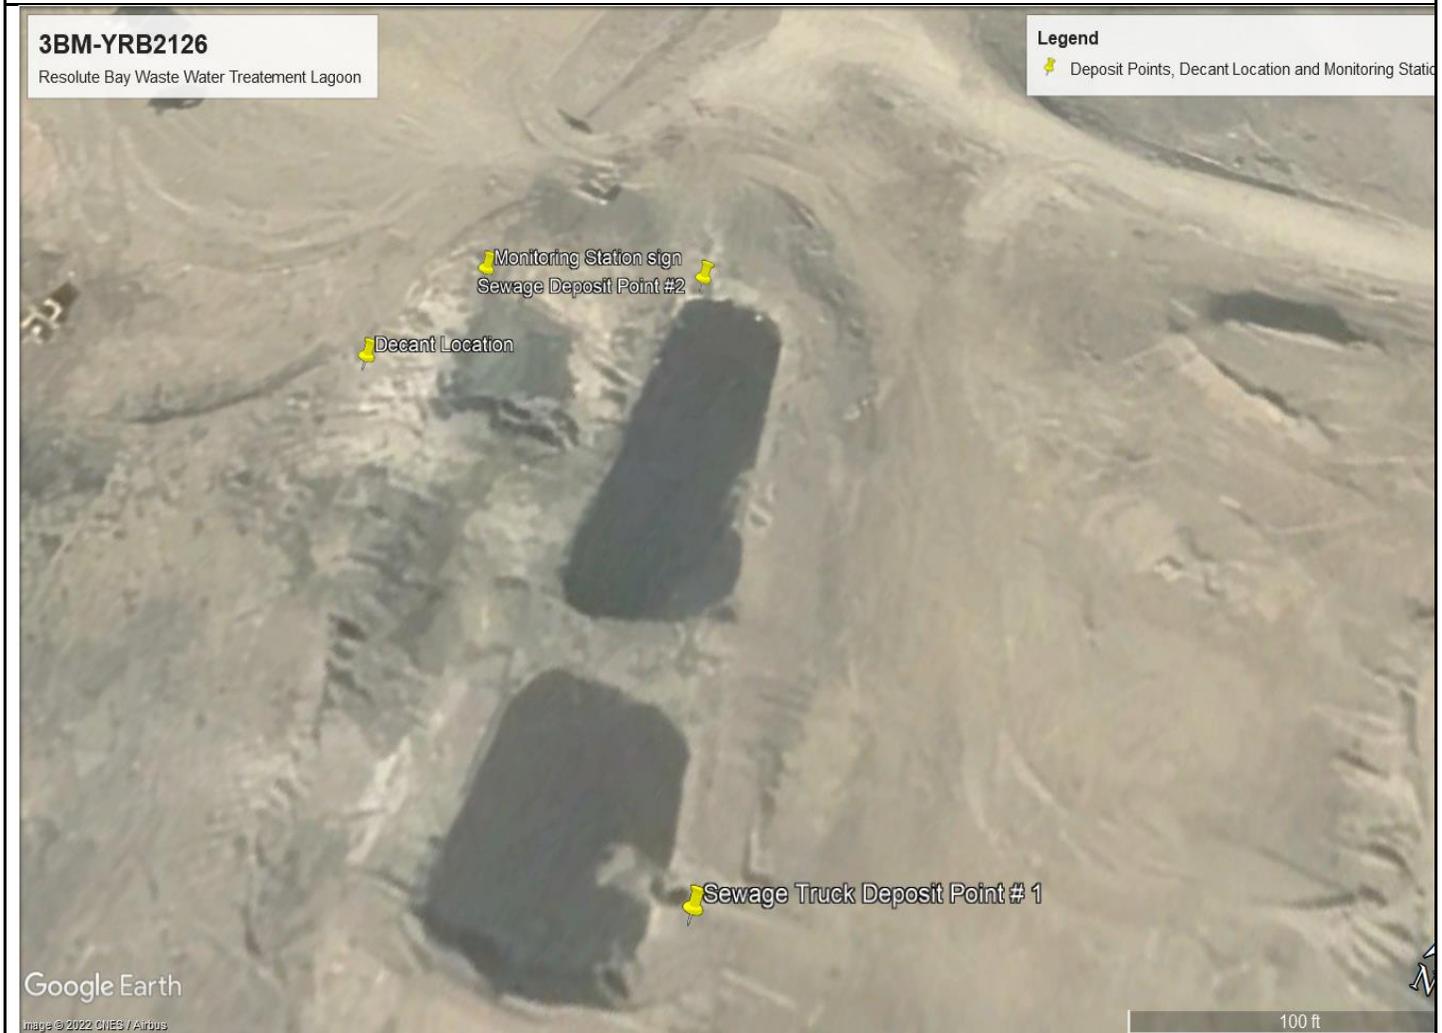
Date	Camera	Inspector
July 6, 2025	Galaxy S11	Joseph Monteith
Photo Log #1	Location	
Photo 1	DOTI Sewage Lagoon, Resolute Bay, NU

Description: Discharge point for non-engineered sewage lagoon. 3 cell sewage lagoon.

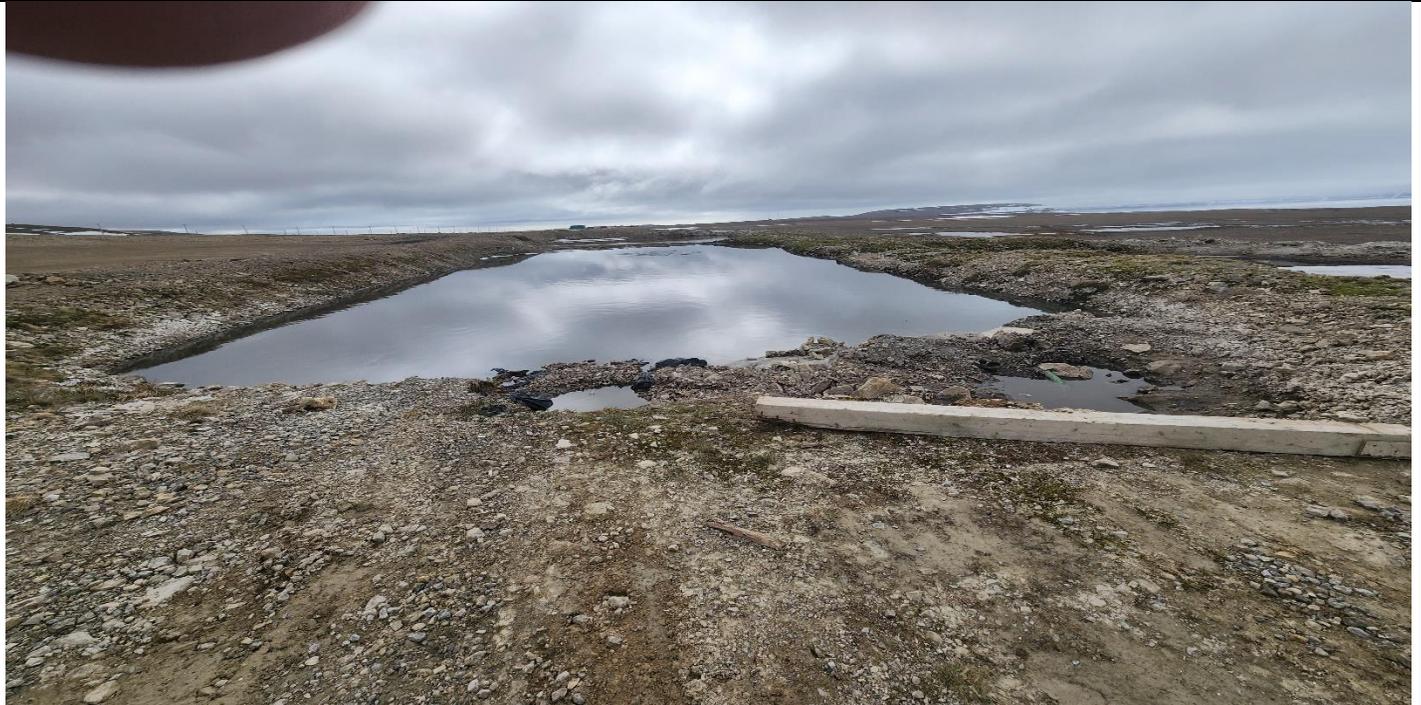
Photo 2

Description: wood for sewage truck appears to be off to the side. Sewage truck appears to deposit in multiple locations, and deposits into the ground causing the puddles along the side of the sewage lagoon.

- decant the sewage lagoon annually ahead of freeze up, so there won't be over filling and over spillage.
- Do not cause puddling during deposit into the sewage lagoon. Erosion of the walls is being compromised as observed in photo 2.

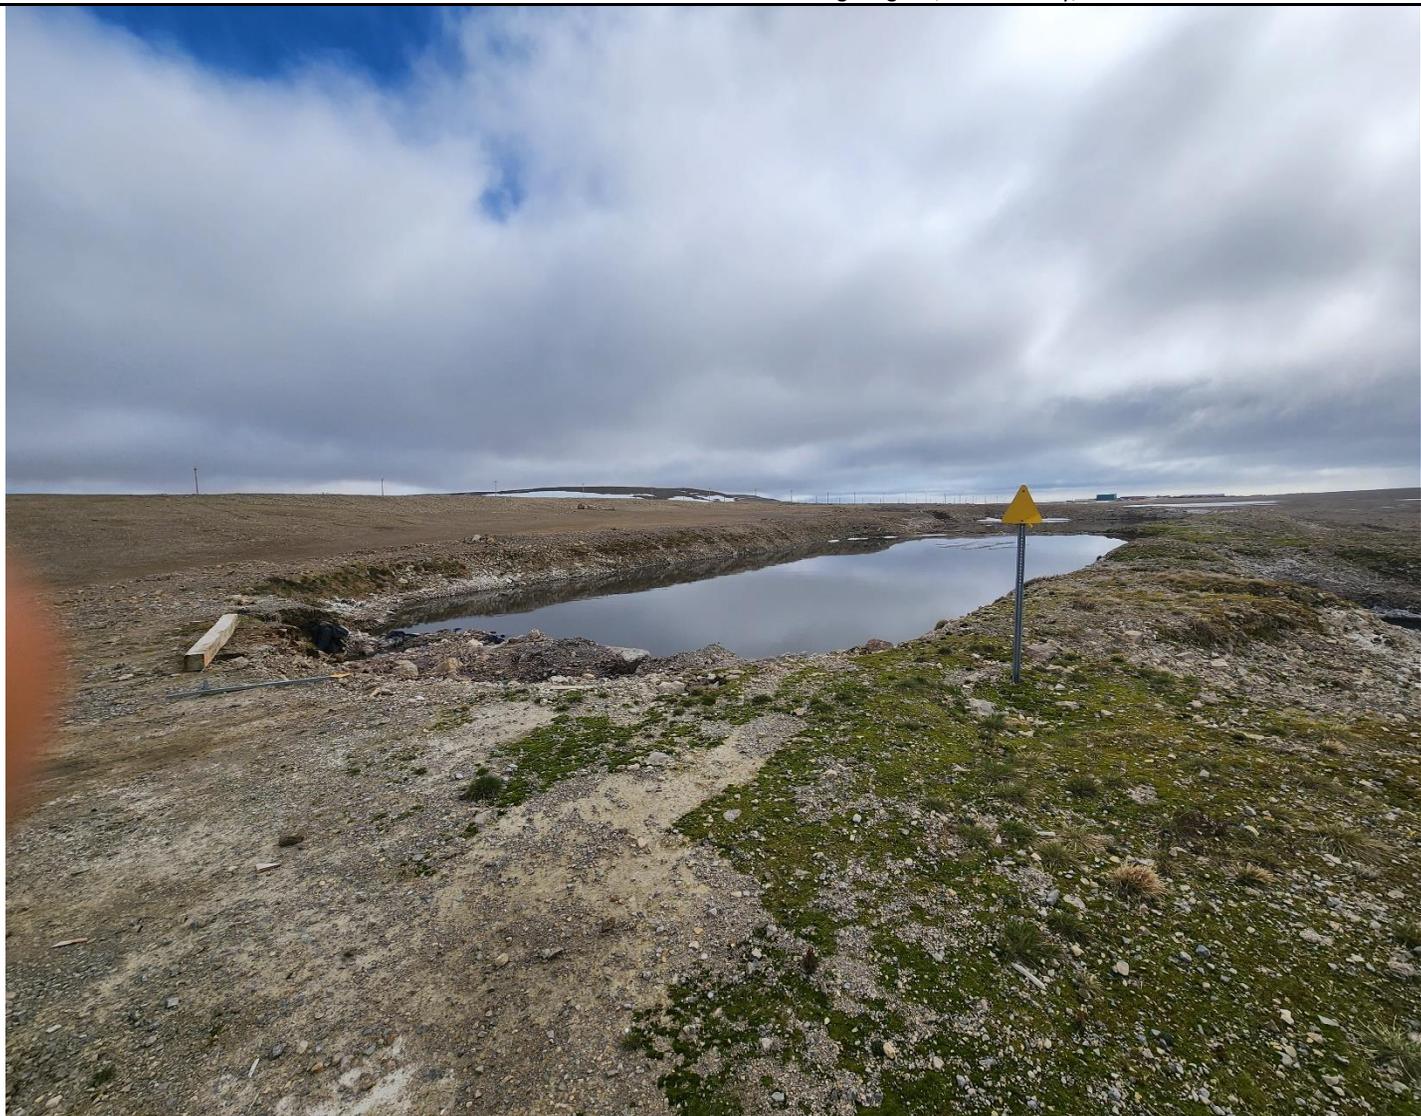
Photo 3

Description: Sign does not have monitoring station label.

- articulate how you calculate the amount of waste deposited into the Sewage Disposal Facility.
- label the two monitoring posts as listed in the water licence

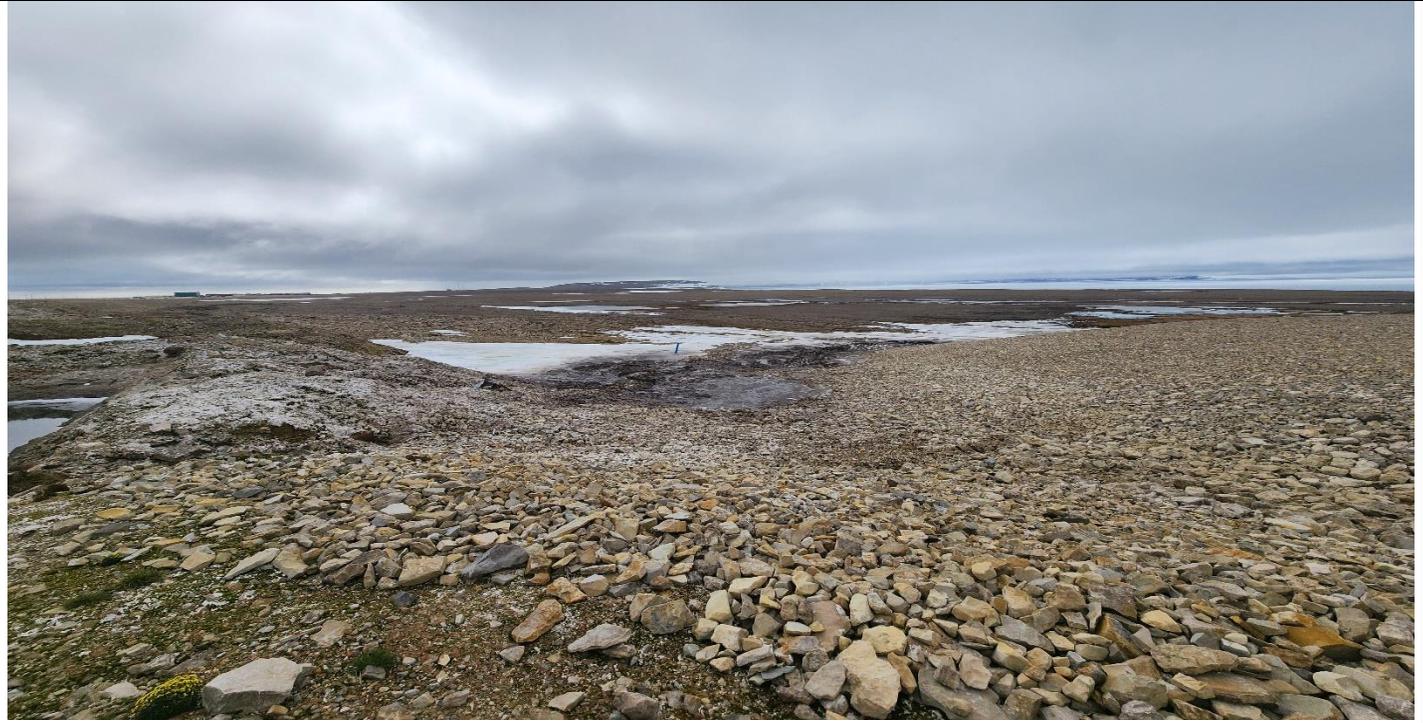
Photo 4

Description: Whitening across the walls of sewage lagoon walls, is signs of overflow of sewage lagoon.

- provide all requirements for submission of Annual Reports
- repair the walls of the Sewage Disposal Facility
- notify WRO Monteith at Joseph.Monteith@rcaanc-cirnac.gc.ca when decanting the Sewage Disposal Facility.

- report to the Spill Line when overflow is observed at the Sewage Disposal Facility within 24 hrs of noticing occurrence
- the Licensee is reminded to remain diligent to prevent wastes from entering water, the environment, and to adhere to the discharge criteria listed in the licence.
