WATER LICENCE INSPECTION FORM

Licensee	Licensee Representative				
Government of Canada, Department of National Defence	William Wyman				
Licence No. / Expiry	Representative's Title				
8BC-SHE1929	Environmental Officer				
Land / Other Authorizations	Land / Other Authorizations				
--					
Date of Inspection	Inspector				
September 13, 2022	Jonathan MESHER				
Activities Inspected					
<input type="checkbox"/> Camp	<input type="checkbox"/> Drilling	<input type="checkbox"/> Mining	<input checked="" type="checkbox"/> Construction	<input type="checkbox"/> Reclamation	<input type="checkbox"/> Fuel Storage
<input type="checkbox"/> Roads/Hauling	<input type="checkbox"/> Other:	<input type="checkbox"/> Other:

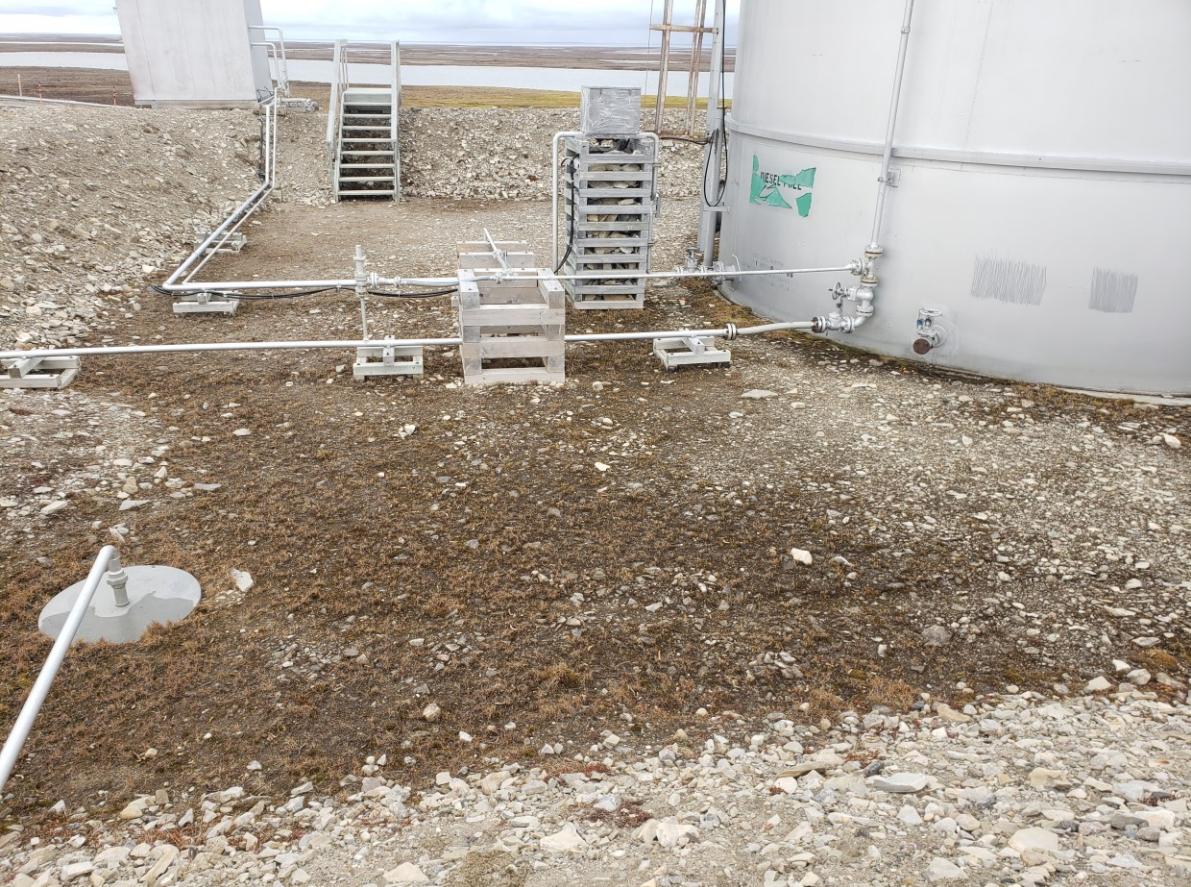
Date	Camera	Inspector	Authorization
	Sony Cyber-shot	J.Mesher	8BC-SHE
Photo Log			
Photo 2

Description: Bulk fuel storage near facility.			
Date	Camera	Inspector	Authorization
	Sony Cyber-shot	J.Mesher	8BC-SHE
Photo Log			
Photo 3

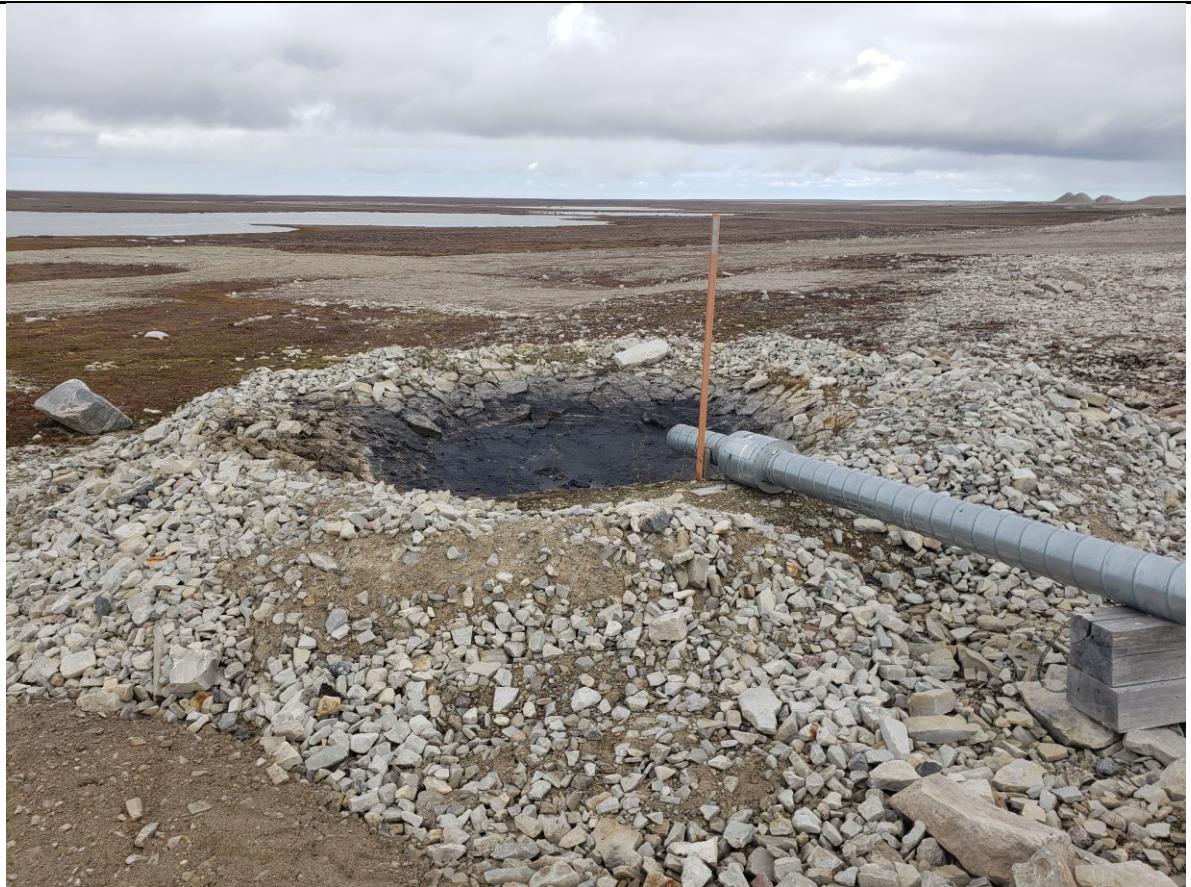
Description: sump.
