**RE:      Post Construction Report for Licence  
8BC-BTN1819**

This letter is a post construction summary of the bridge repair projects as required by Nunavut Water Board (NWB) licence 8BC-BTN1819 (Licence).

Post Construction Summary  
Iqaluit Bridge Repairs, Iqaluit, Nunavut

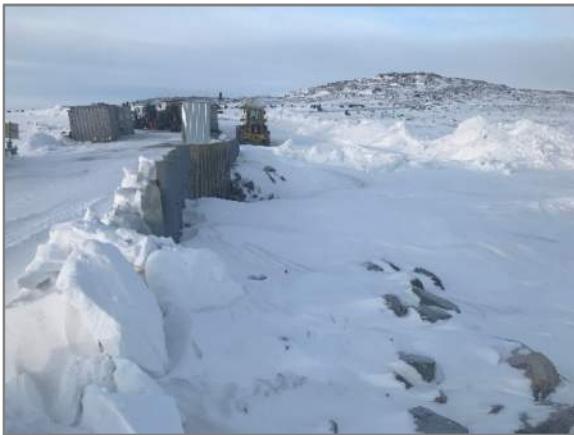
Photo 1: North face of the Road to Nowhere bridge. Heavy equipment and work camp on the west side of the bridge.

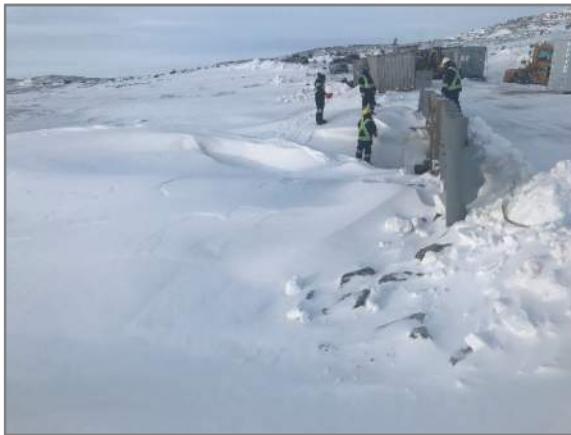
Photo 2: South face of the Road to Nowhere bridge looking west toward the work camp.

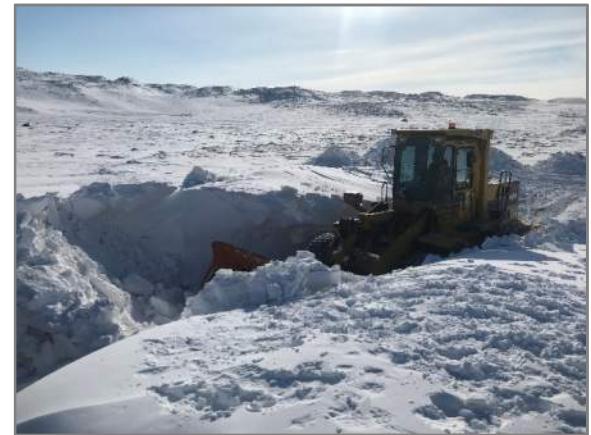
Photo 3: Looking south from the Road to Nowhere bridge at snow clearing activities to access the underside of the bridge.

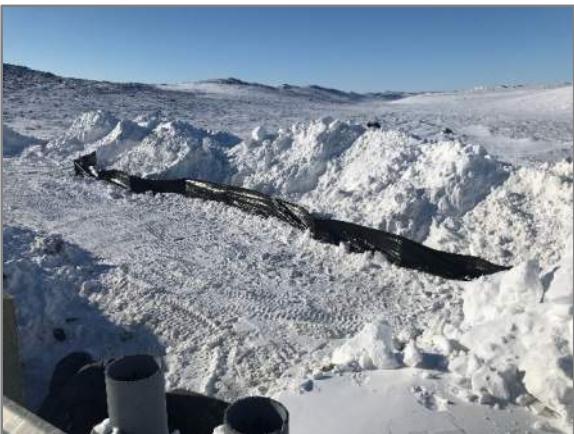
Photo 4: Silt fence installation across the Apex River channel on the north (upstream) side of the Road to Nowhere bridge.

WEST SILT FENCE RESTAPLED THIS MORNING (AND EAST)

FENCE FIXED TODAY! DOUBLE BRACED - SHOULD STAB WELL NOW.

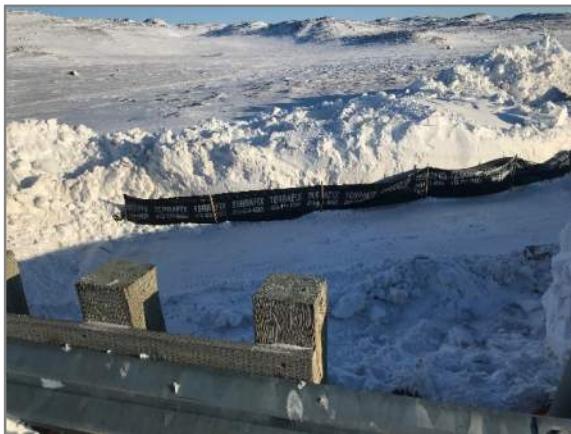
Photo 5: Silt fence installation across the Apex River channel on the south (downstream) side of the Road to Nowhere bridge.

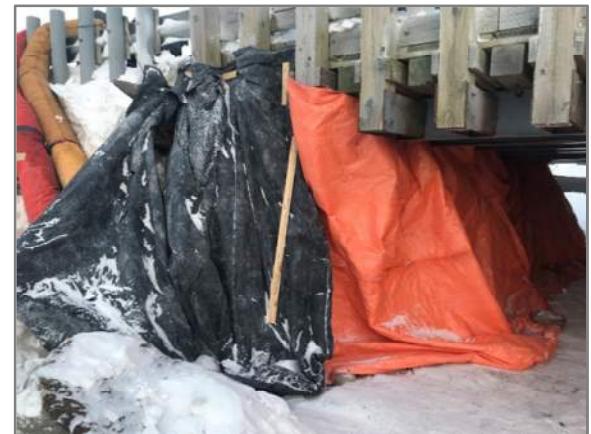
Photo 6: West abutment enclosure for aggregate removal and concrete work.

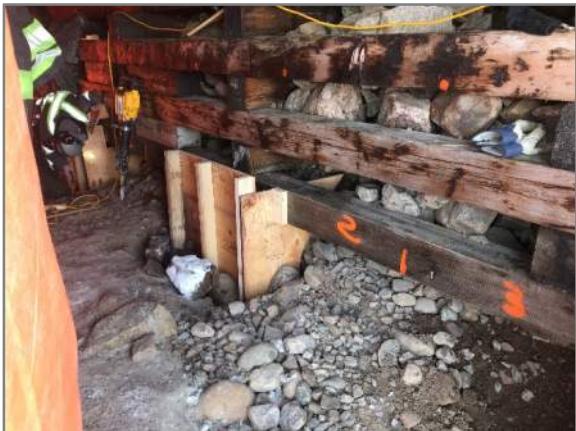
Photo 7: Concrete form installed and awaiting grout on the west abutment of the Road to Nowhere bridge.

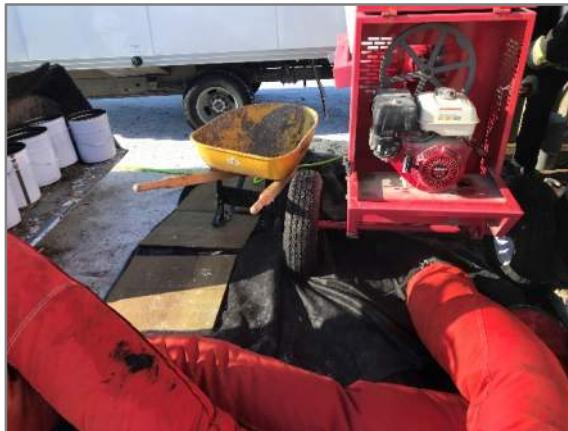
Photo 8: Secondary containment beneath concrete mixer on Road to Nowhere.

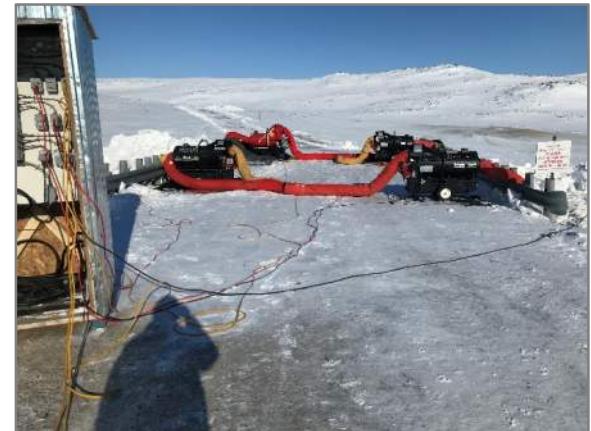
Photo 9: Heating units, with secondary containment, position on the Road to Nowhere bridge.

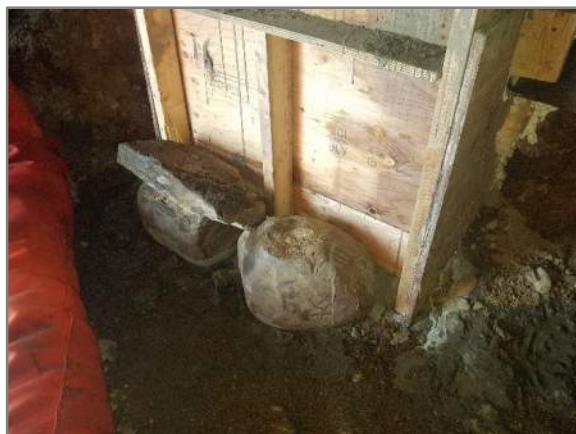
Photo 10: Minor grout seepage after pouring at the Road to Nowhere bridge. Area cleared of excess grout once hardened.

SECTION 21 - LEFT SEAM OF FORMWORK NOT SEALED WHEN CONCRETE WAS POURED. RESULTED IN LEAK DURING POURING.  
- REGROUTED SEAM TO PREVENT LEAK. WILL NEED TO MAKE SURE SURROUNDING CONCRETE IS EXCAVATED WHEN FORM IS REMOVED.

Section 22 leaked while pouring today. Will excavate  
excess concrete when form is removed.

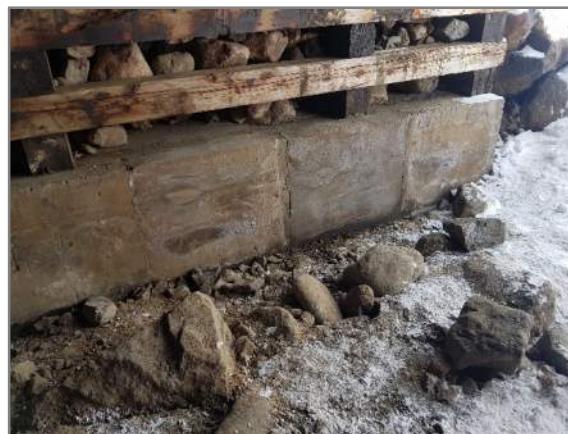
Photo 11: Completed concrete work under the west abutment of the Road to Nowhere bridge.

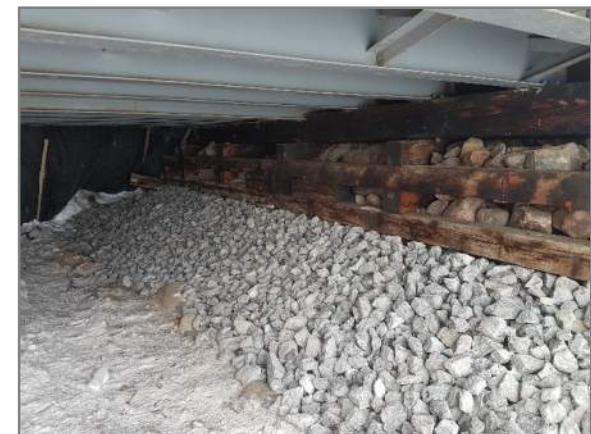
Photo 12: Riprap installed to protect Road to Nowhere bridge abutment concrete footings.

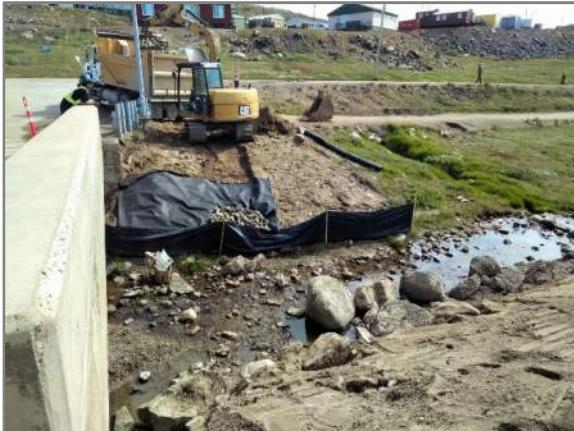
Photo 13: Bank and guide rail repair silt fencing and erosion mitigation measures at the Astro Hill bridge.

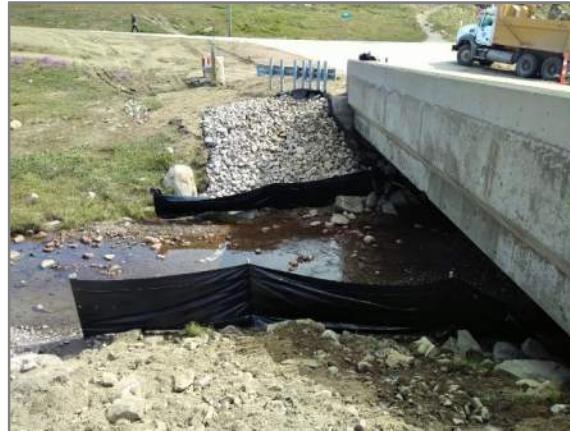
Photo 14: Looking North toward finished bank and guide rail repair at Astro Hill bridge. Silt fence and erosion mitigation measures installed.

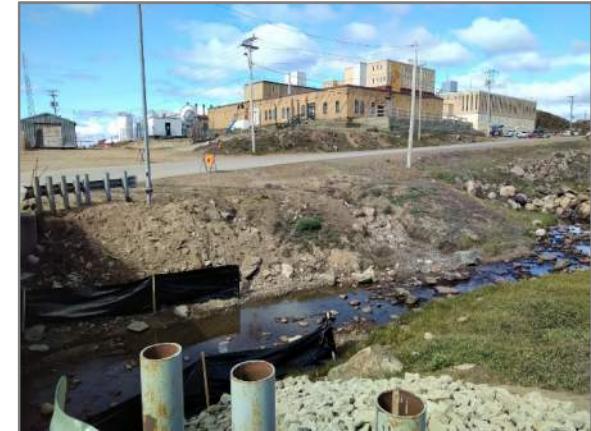
Photo 15: Looking south toward unfinished bank repair at Astro Hill bridge. Silt fence installed.

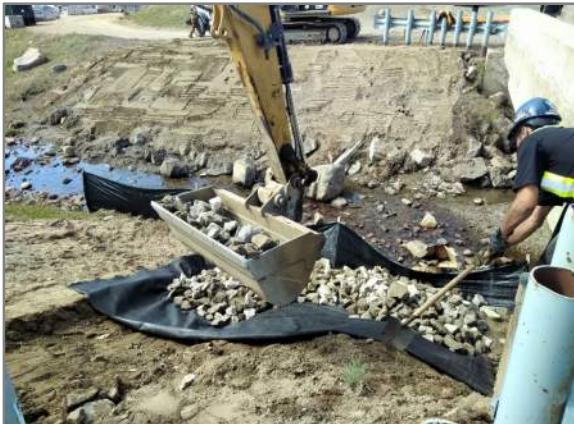
Photo 16: Bank repair in the foreground and graded bank in the background at the Astro Hill bridge.
