## **NANISIVIK MINE, A DIVISION OF CANZINCO LTD.**

### **2007 ANNUAL GEOTECHNICAL INSPECTION**

### **NANISIVIK MINE, NUNAVUT**

PROJECT NO.: 0255-016-03  
DATE: MARCH 26, 2008

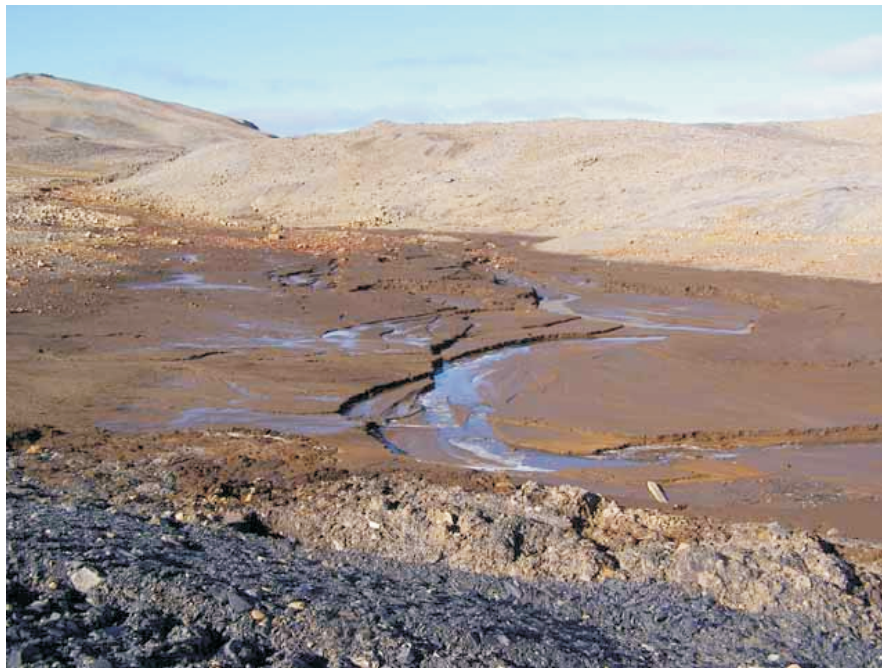
- Dike breached in 2006.
- No ponding observed in 2007.
- Some channelization of sediments upstream of breach has occurred.

Photo 2  
East Adit Treatment Pond.  
Note channelization of remnant sediments upstream of breach.

- No maintenance recommended.

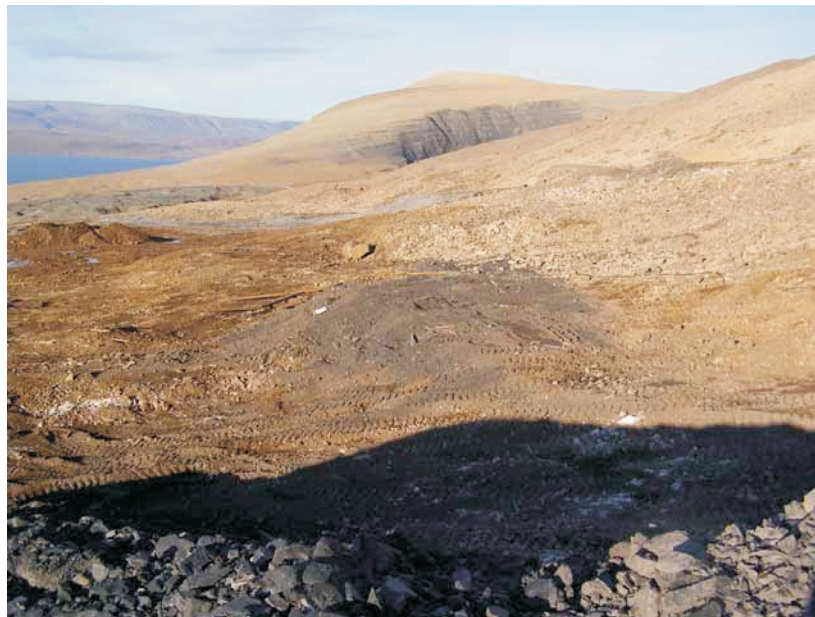
Photo 4  
Former location of Day Tank Farm.  
Note berms have been excavated and liner and tanks have been removed.

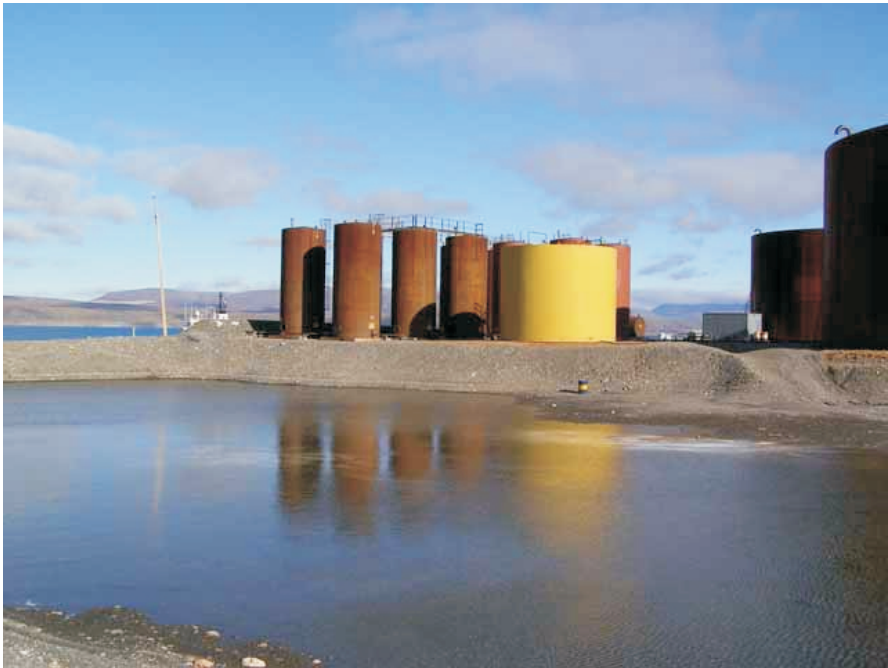
Photo 5  
Main Tank Farm at the port area.  
Note water retained in retention pond.

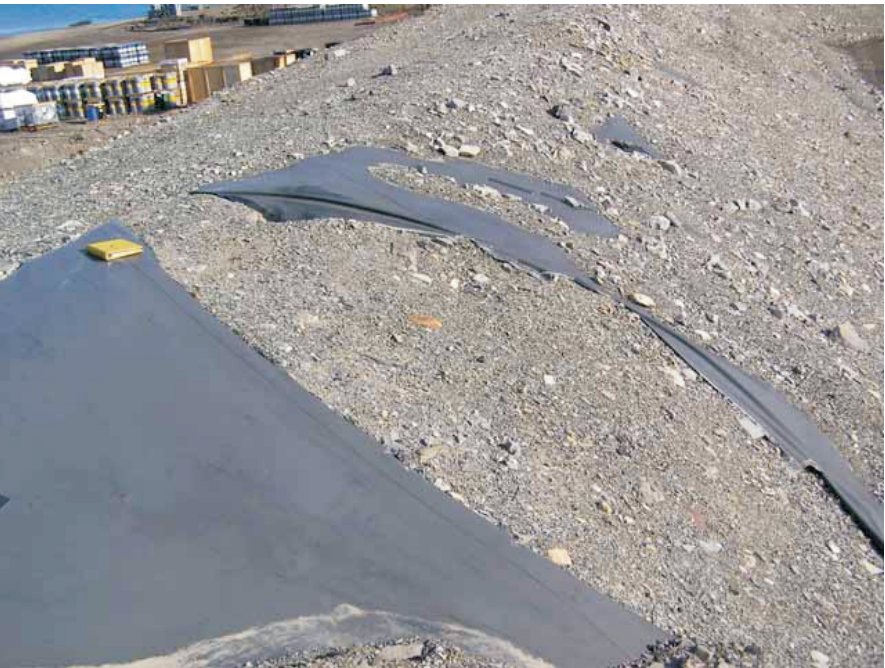
Photo 7  
Exposures and tears of the internal liner.

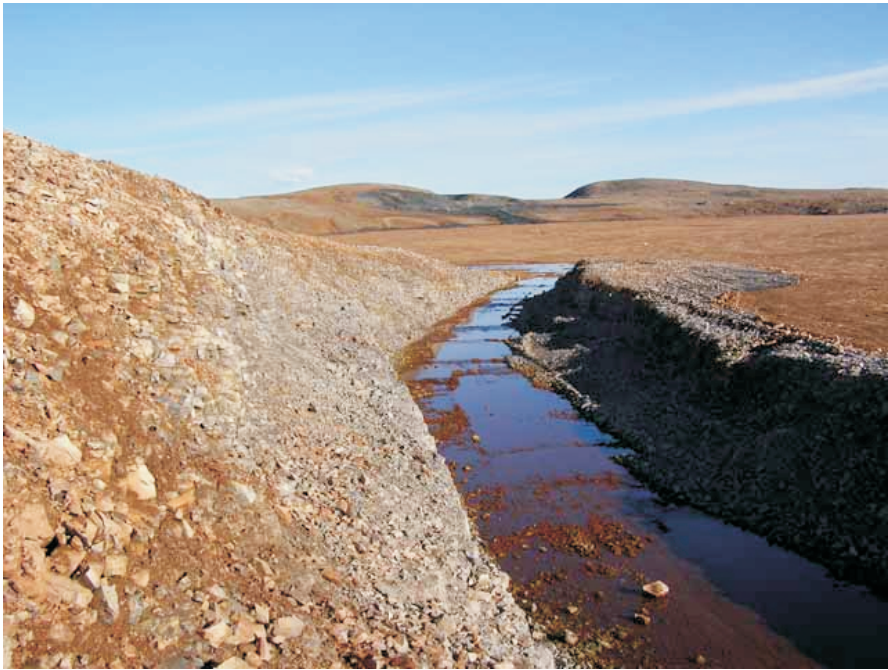
Photo 9  
Flow through entrance area of West Twin Dike Spillway.

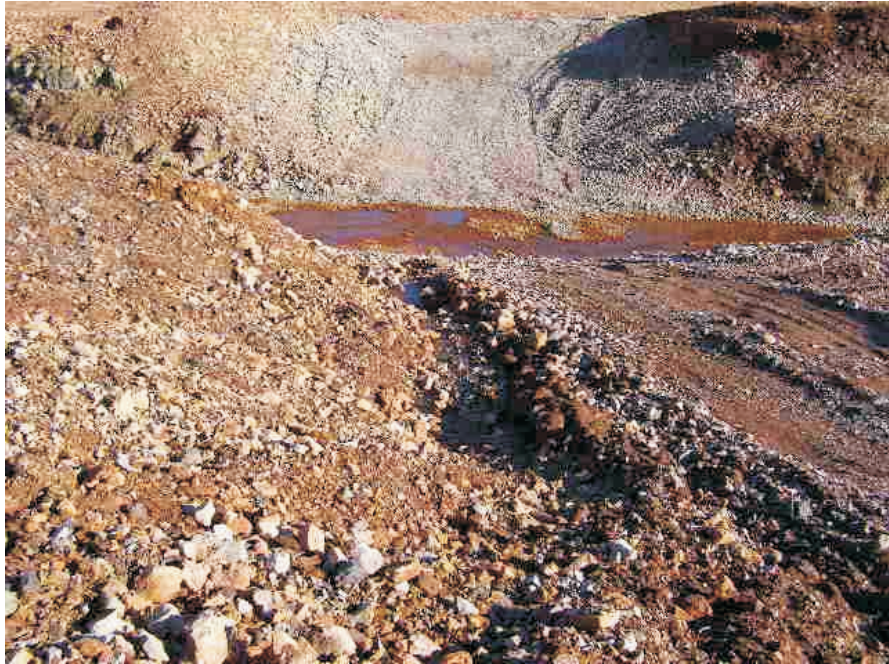
Photo 12  
Access ramp into spillway. Note drainage path along edge of access ramp where flow enters the spillway.

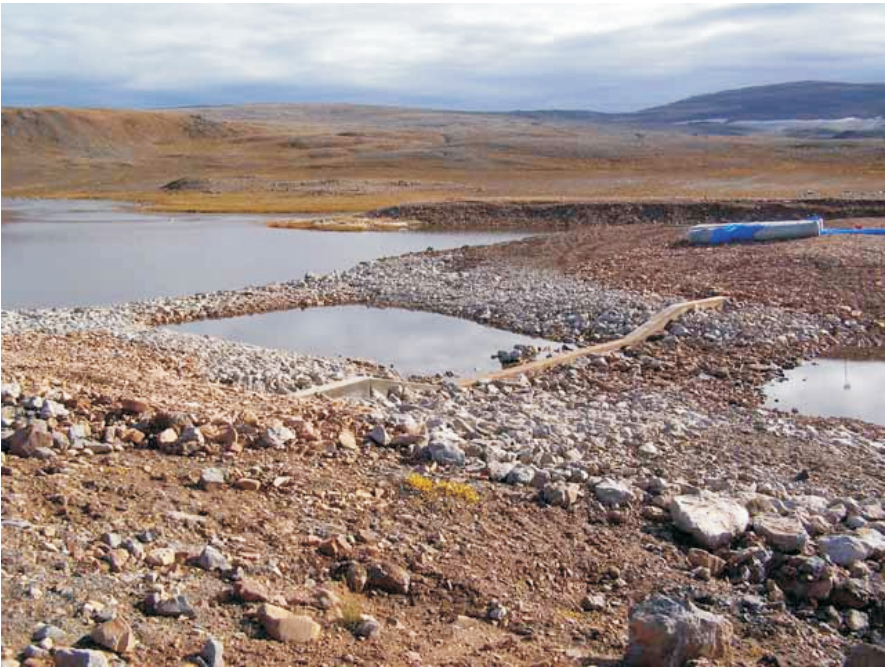
Photo 13  
West Twin Outlet Channel prior to GCL installation.  
Note water level on upstream side of wall approximately 20 cm below crest of wall.

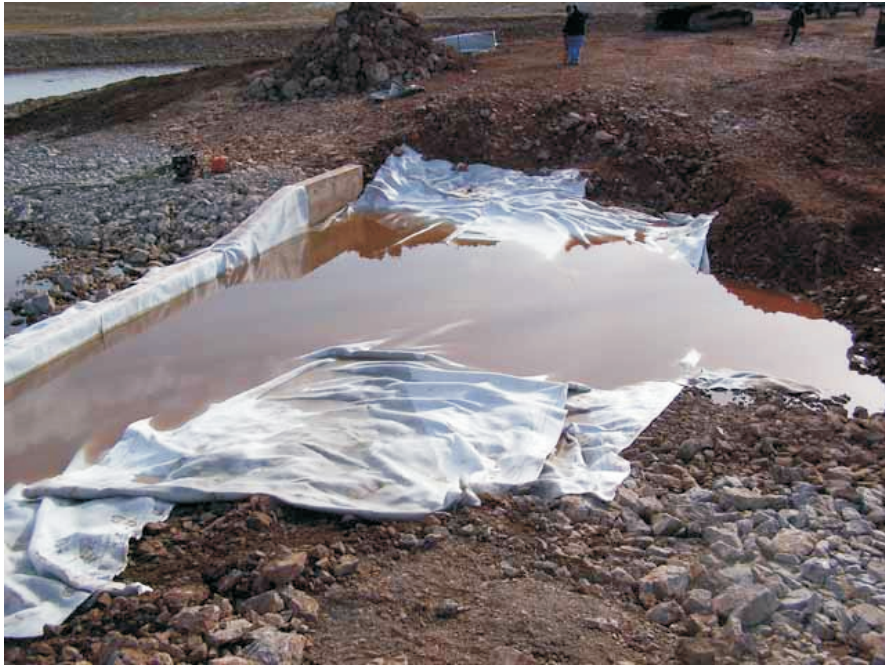
Photo 15  
GCL installed upstream of outlet wall to reduce seepage losses.  
Note embedment of liner in wall abutments.

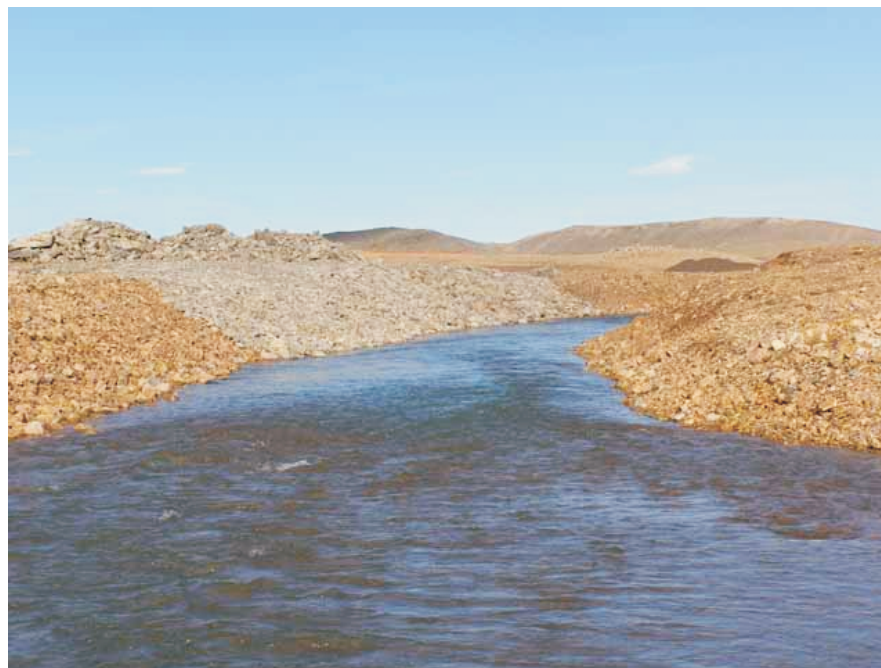
Photo 18  
Flow through East Twin Creek Diversion Channel.  
Note area of channel rehab where light coloured armour rock was placed.

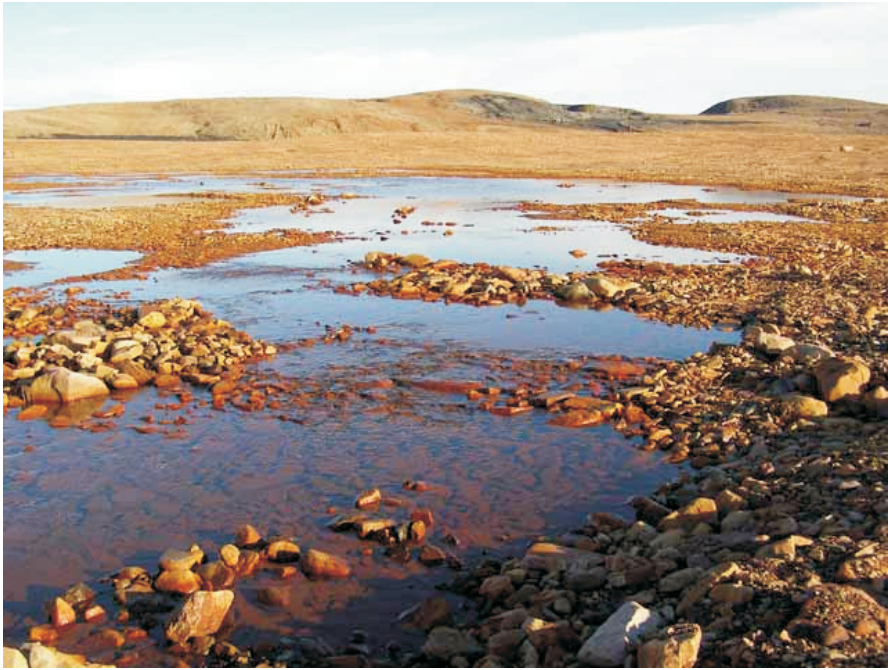
Photo 19  
Small pond on Surface Cell cover at entrance to West Twin Dike Spillway.

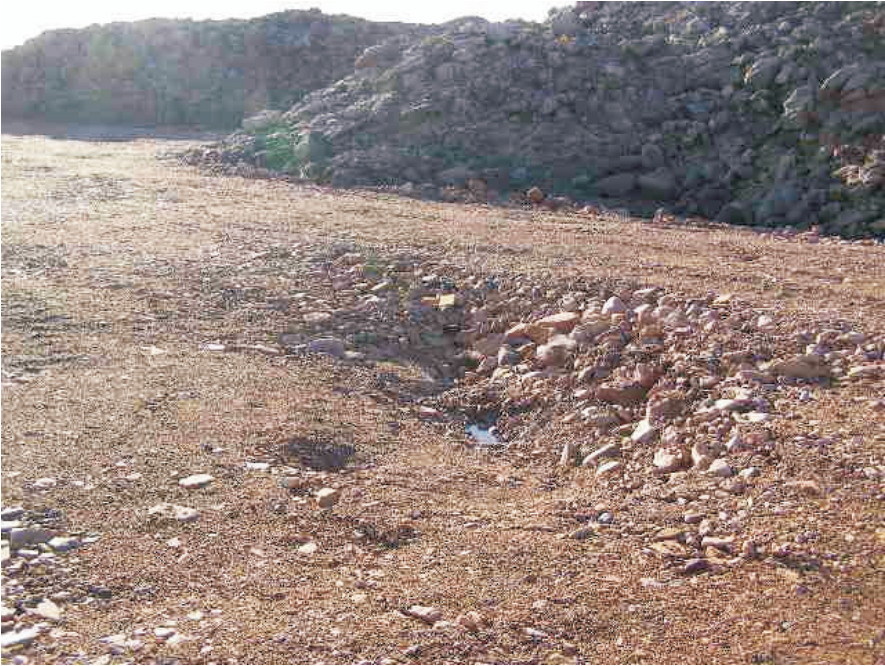
Photo 20  
Thermokarst feature at south edge of Surface Cell cover.

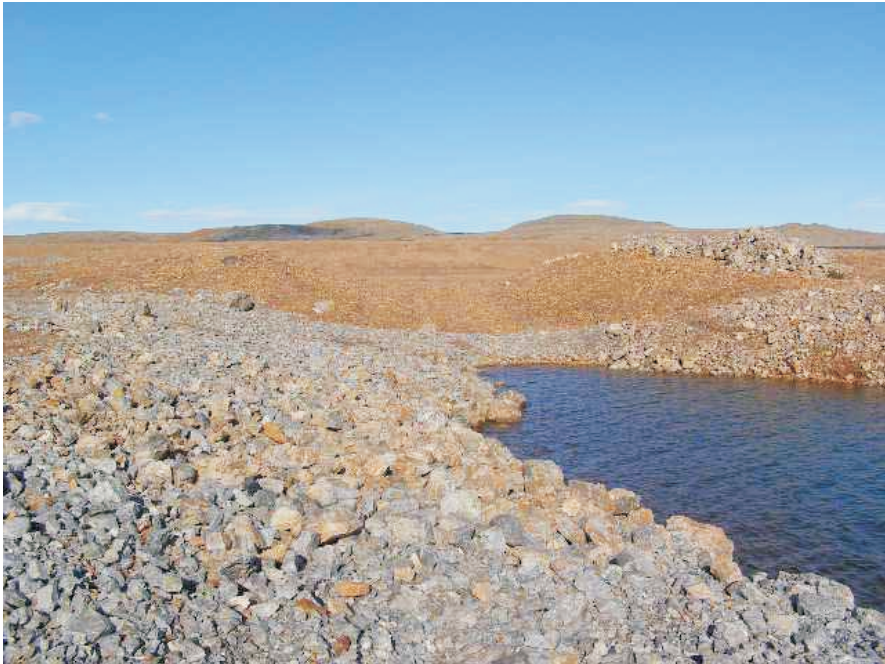
Photo 26  
Rip rapped Test Cell outlet.  
Note riprap only applied to edge of water.

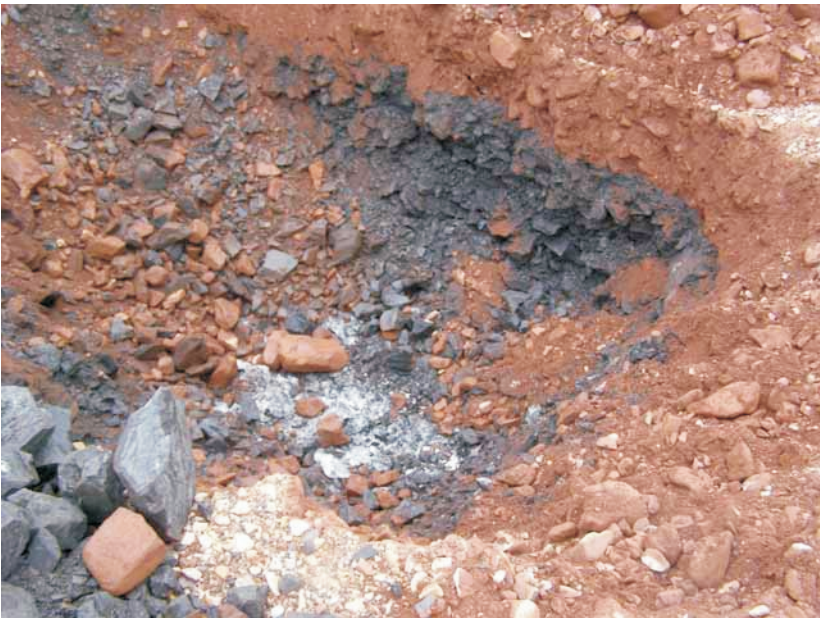
Photo 28  
Test pit excavated through Test Cell cover.  
Note ice in shale at bottom of test pit.

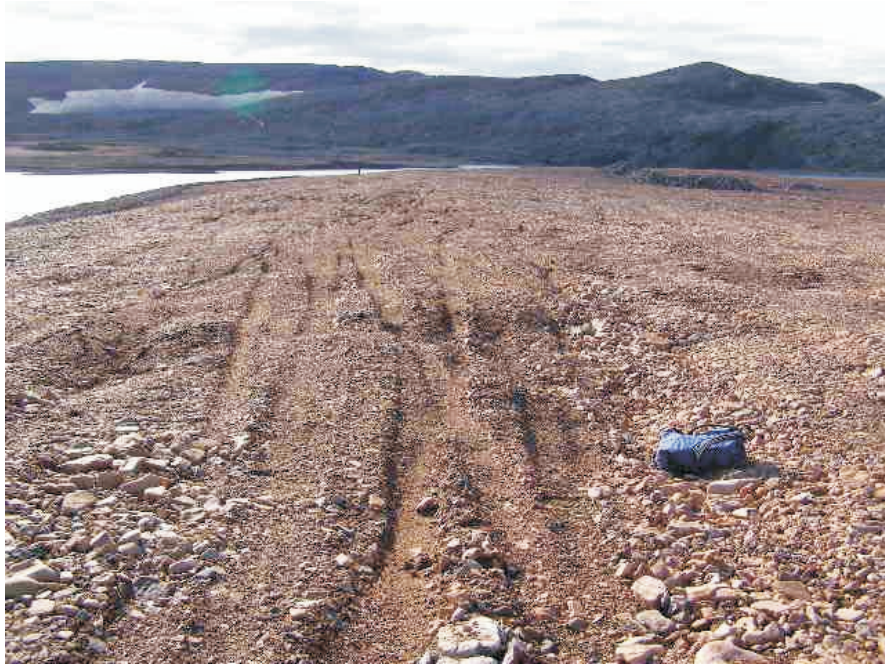
- No erosion of cover observed.
- No ponding on cover observed.
- Cover very undulating along north/south arm of remnant Test Cell dike.
- Outlet of Test Cell armoured to the normal water line.
- Some settlement areas were observed in the cover at the Toe of the West Twin Dike cover.

Photo 29  
Surface of north/south arm of Test Cell dike.  
Note un-evenness and settlement of surface.

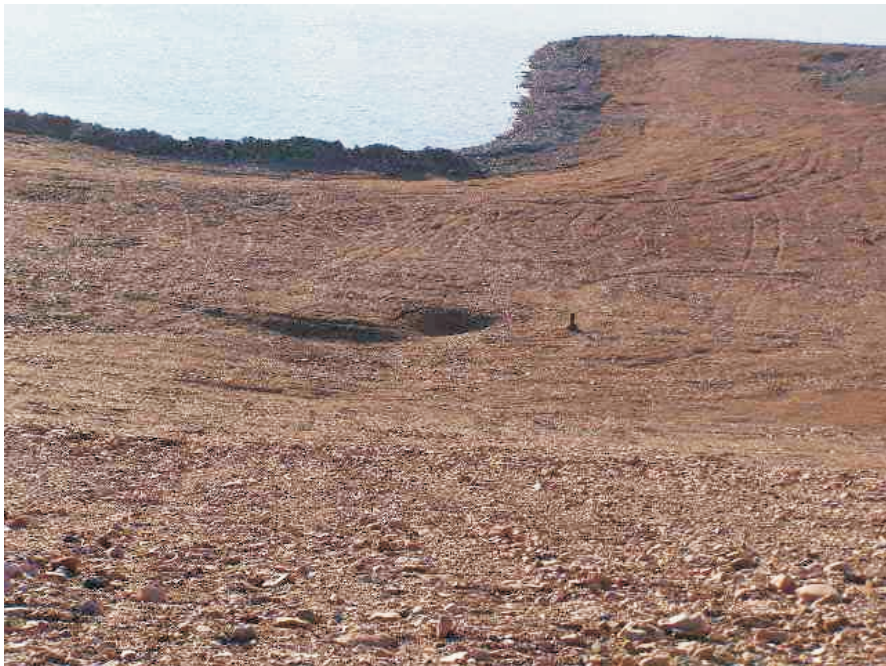
Photo 32  
Thermokarst features adjacent to Thermistor 05-26 at toe of West Twin Dike.  
Note this was an area of excessive shale fill thickness.

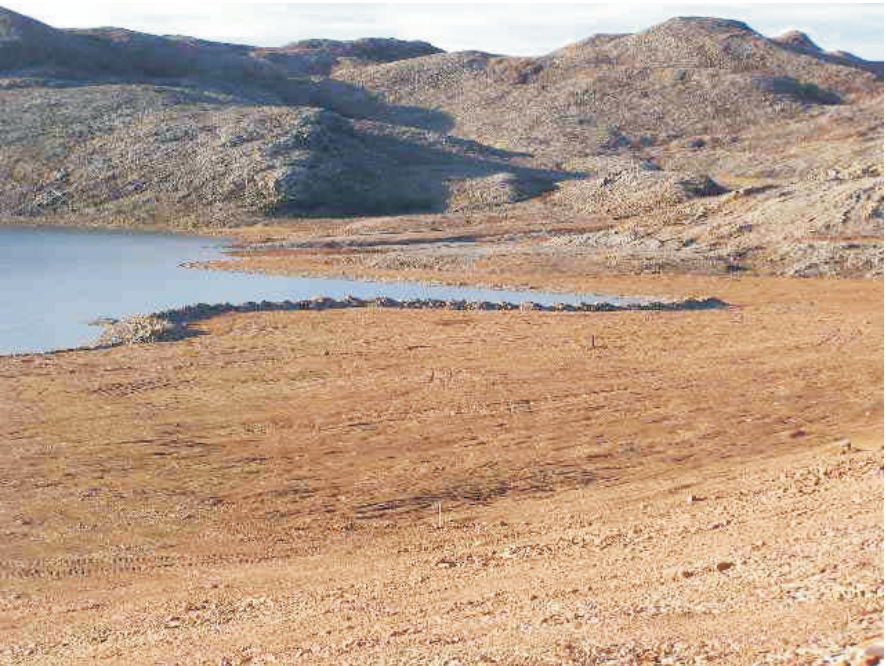
Photo 34  
Riprap stockpiled along shoreline of tailings cover at the toe of the West Twin Dike.

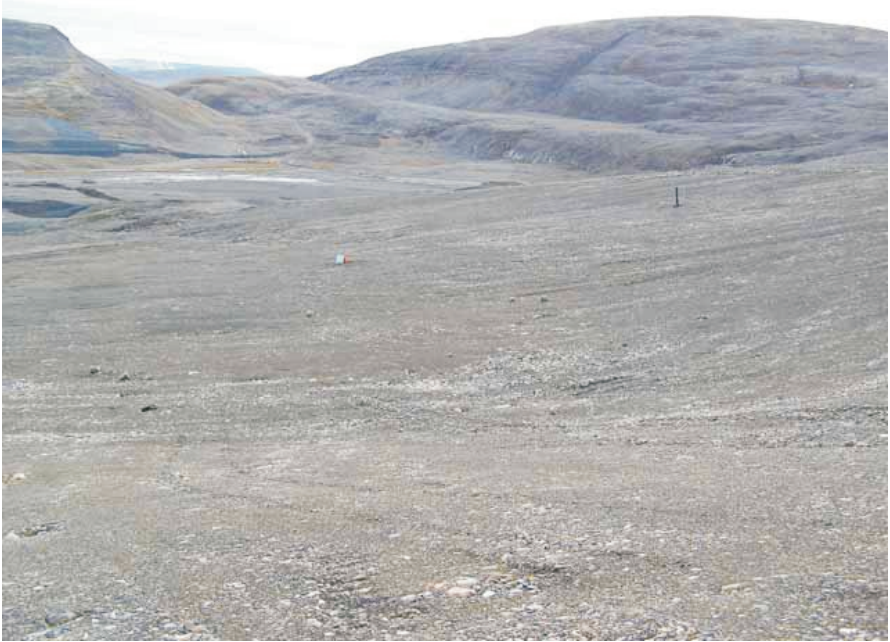
Photo 44  
Middle portion of East Open Pit cover.

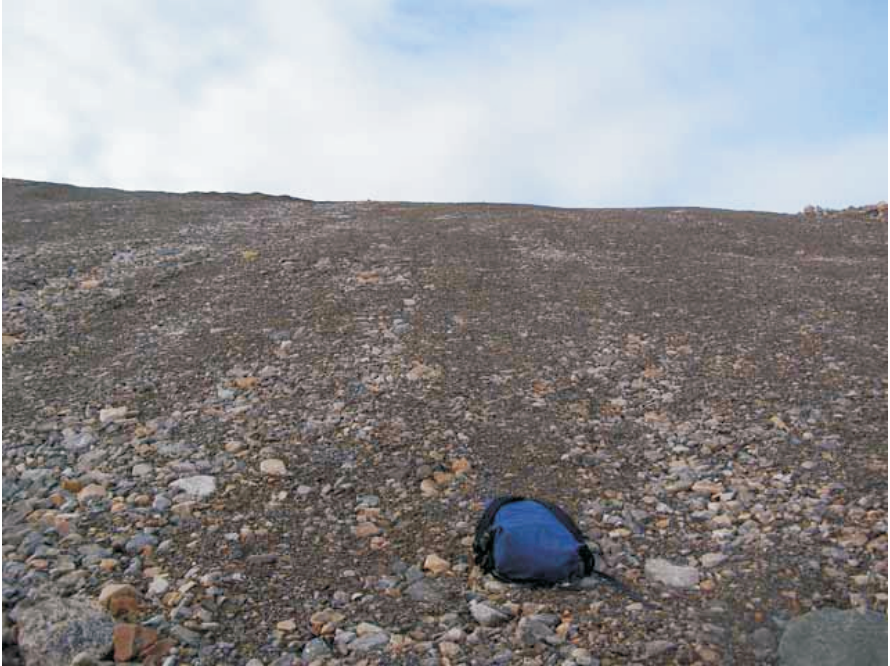
Photo 46  
Looking upslope along steepest area of East Open Pit cover.  
Note no surface erosion observed.

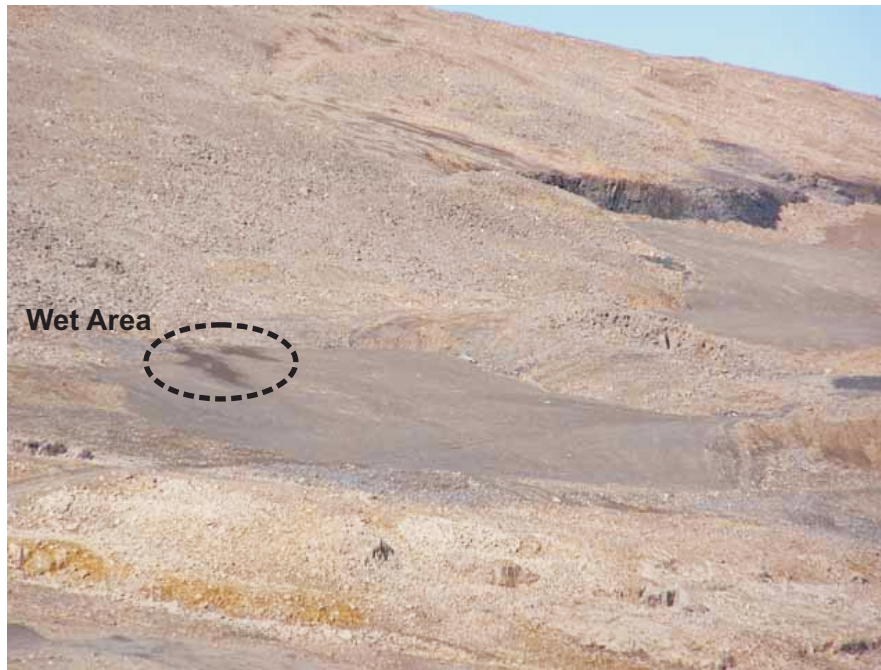
Photo 48  
East Trench cover as seen from Kuhulu Lake road.  
Note the wet area near the top of the cover indicating some minor surface flow.

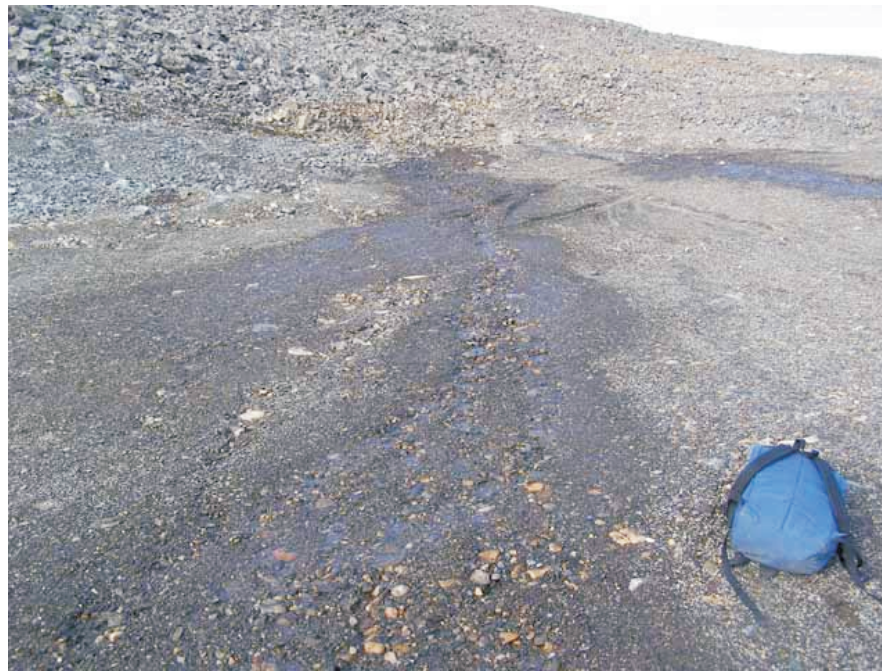
Photo 49  
Very minor rill erosion on surface of East Trench cover.

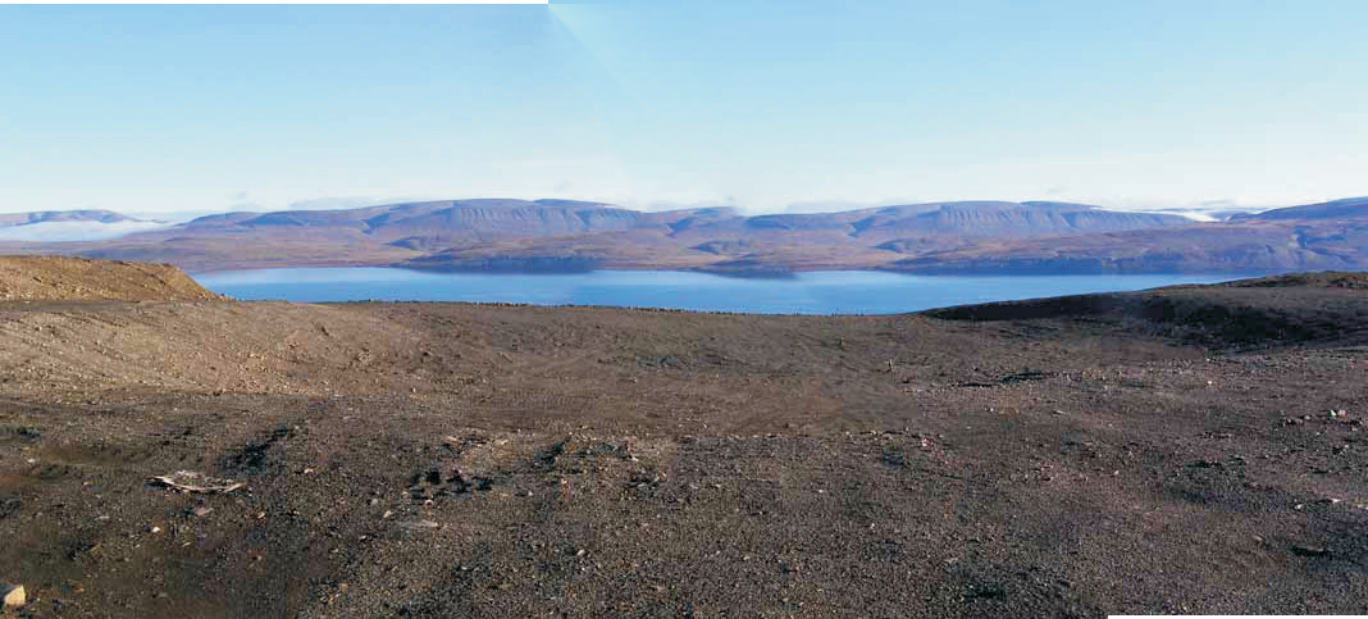
Photo 50  
Oceanview Open Pit cover as seen from south edge of the cover. View looking north.

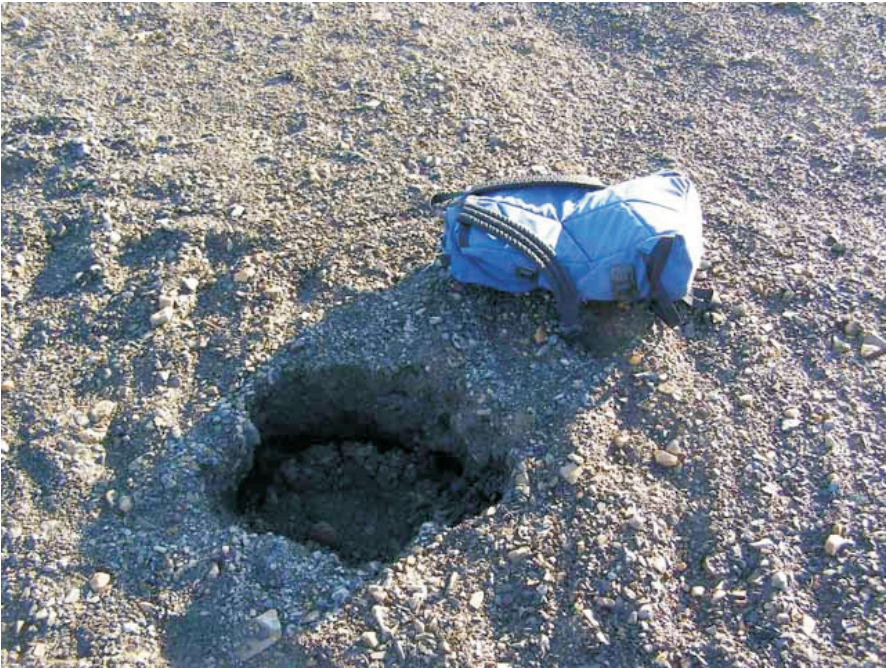
Photo 53  
Small thermokarst feature in southeast corner of Oceanview Open Pit cover.

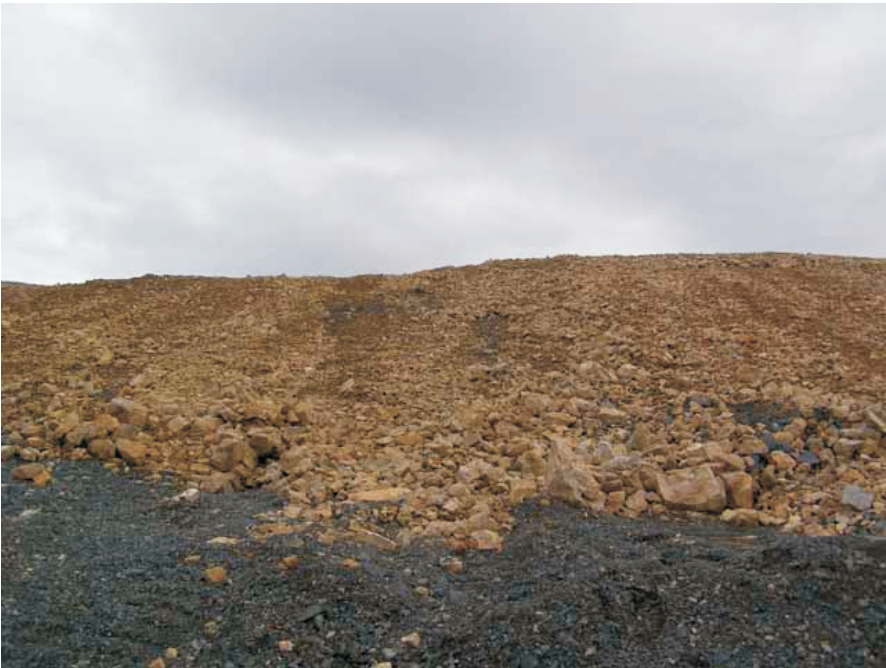
Photo 55  
Armour placed at north edge of Area 14 waste rock cover.

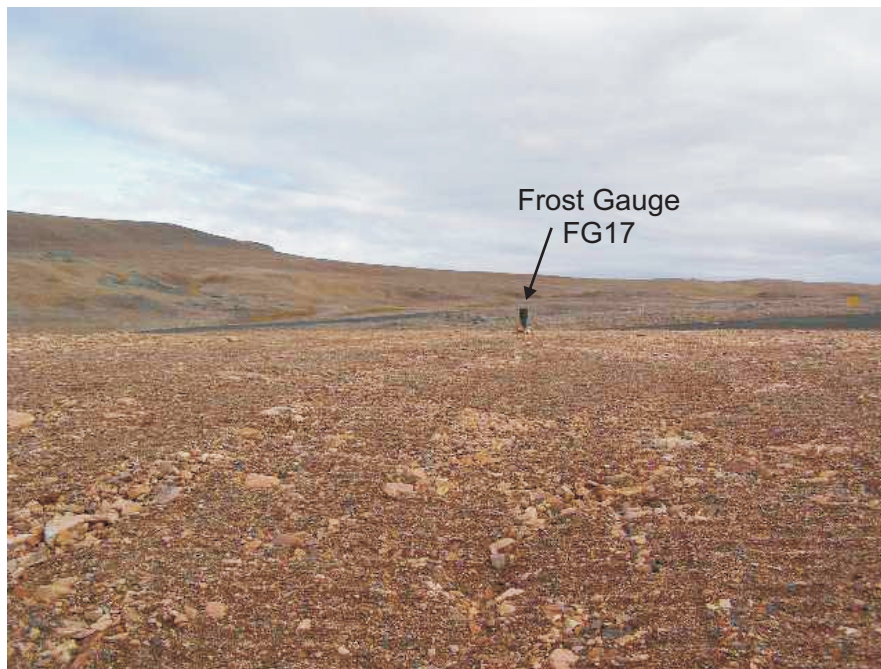
Photo 59  
Surface of Upper Dump Pond tailings cover.  
Note frost gauge FG17 on surface of cover.

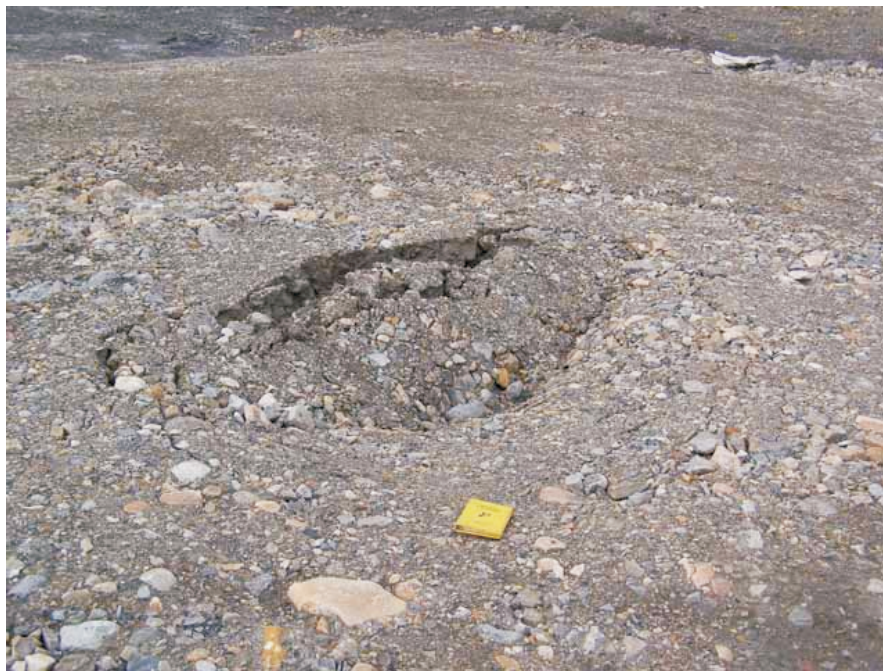
Photo 61  
Thermokarst feature in 17N Portal Cover.

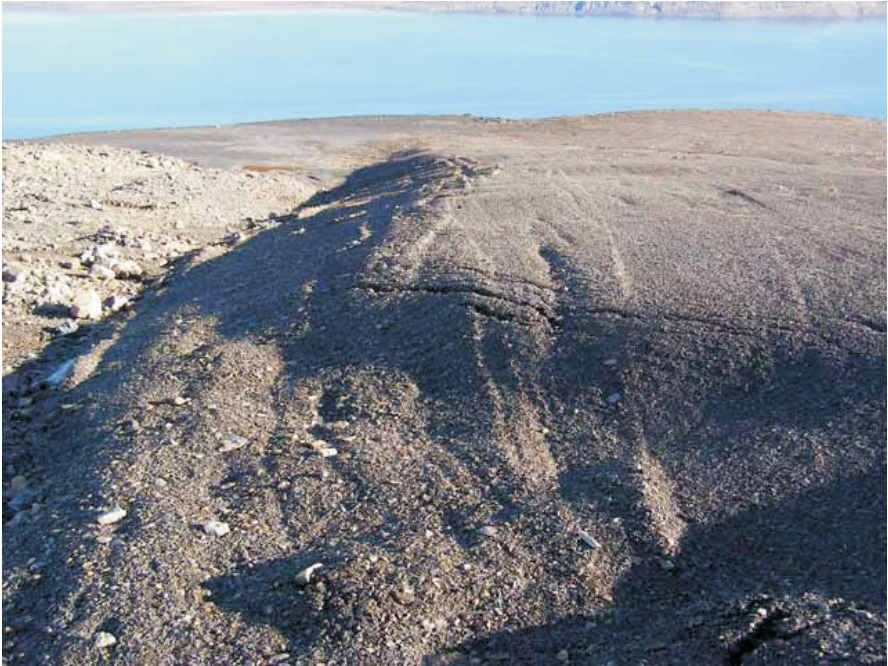
Photo 62  
Settlement depression at the southwest corner of the Oceanview Portal cover.

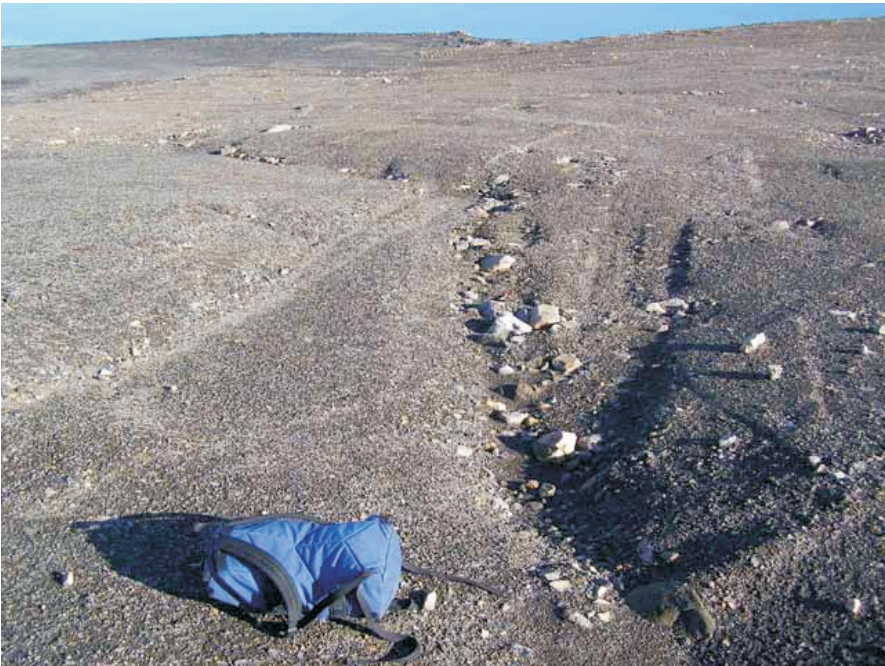
Photo 65  
Minor erosion downslope of the upper corner of the surface water deflection berm.

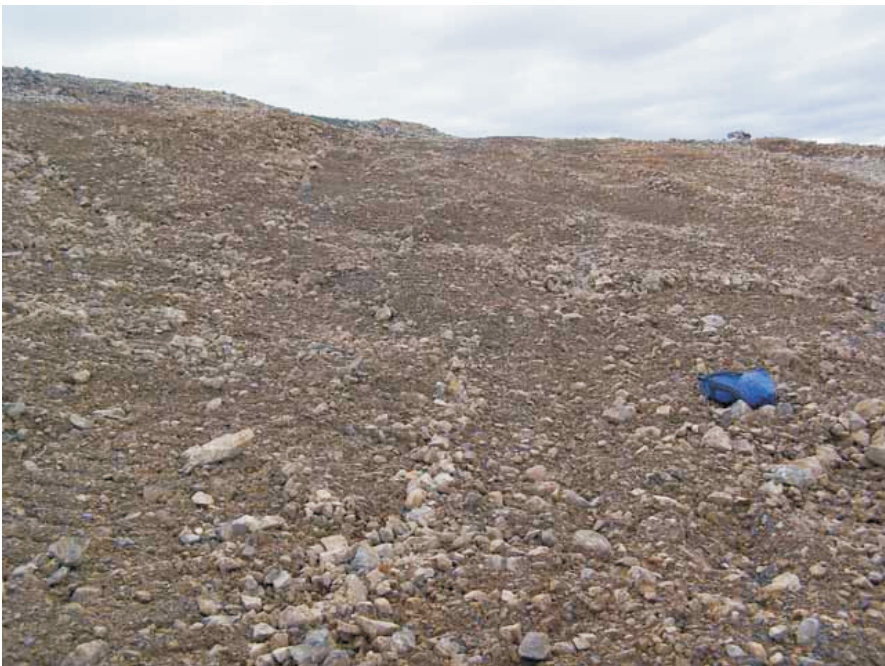
Photo 73  
Area 14 Raise Cover.  
Note armour material applied to surface but no mound constructed.

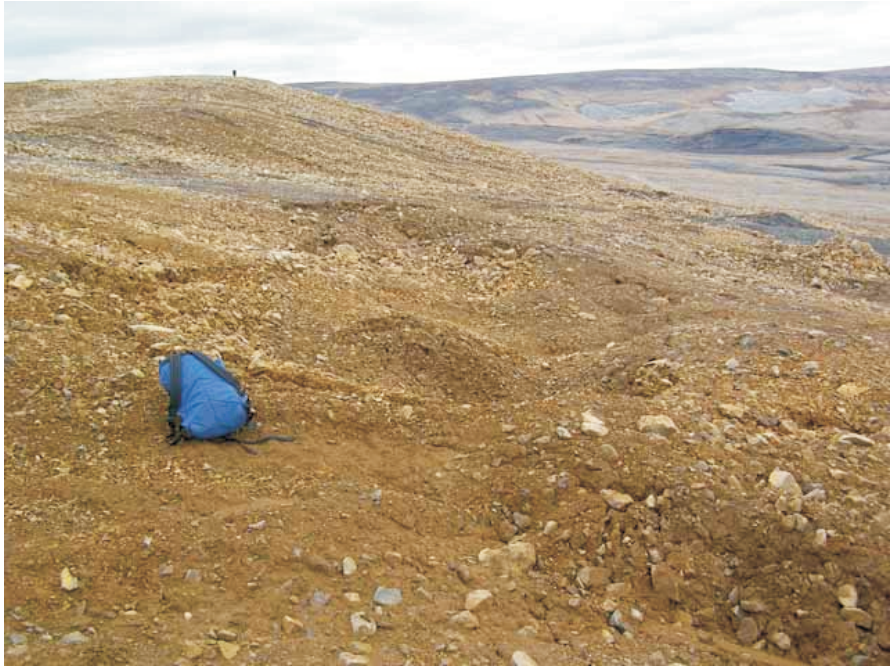
Photo 78  
Minor thermokarsting at Area 14 armour borrow area.

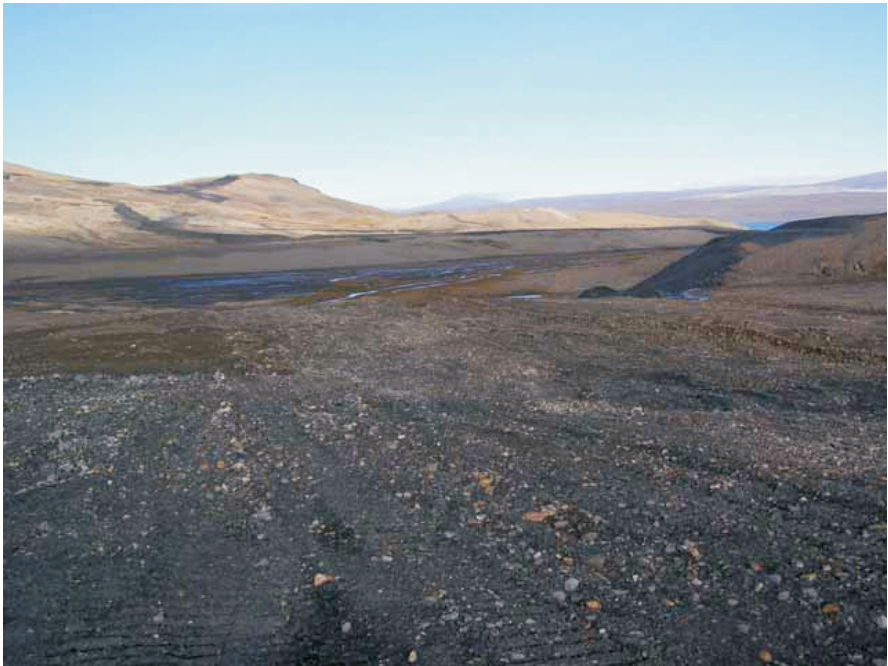
Photo 81  
Kuhulu Lake Road armour material borrow area.  
Note floor of borrow area has been regraded.

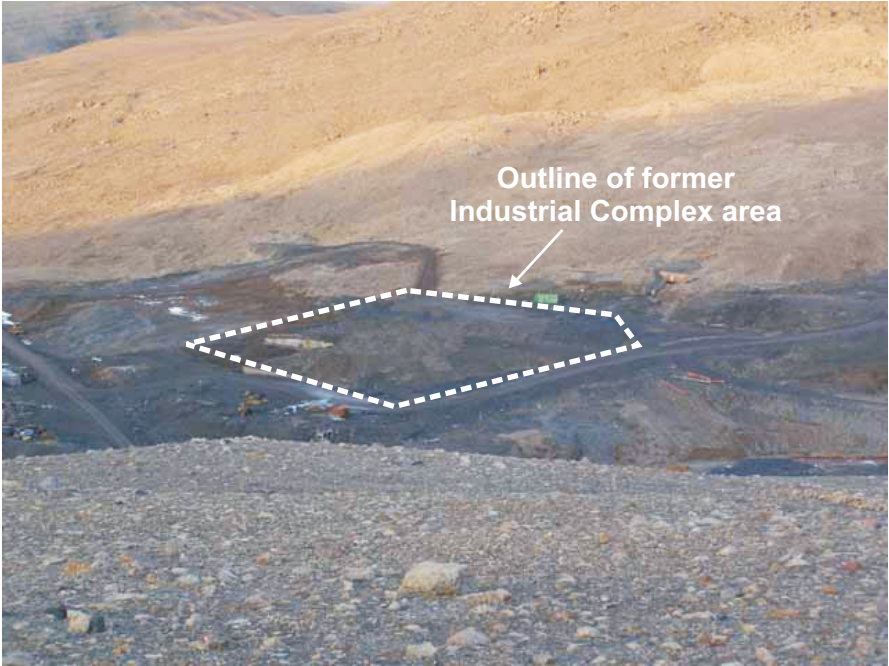
Photo 82  
Industrial Complex as seen from Stol Port.  
Note all infrastructure has been removed and backfilling with metals contaminated soils is ongoing.

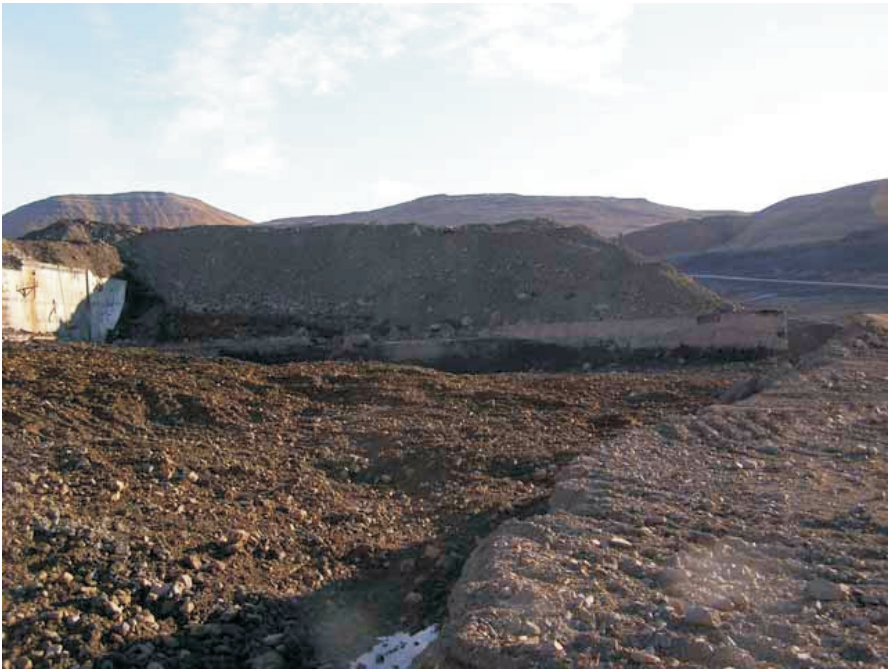
Photo 84  
Northwest corner of Industrial Complex.  
Note hydrocarbon contaminated soil excavation ongoing in this area at the time of the inspection.

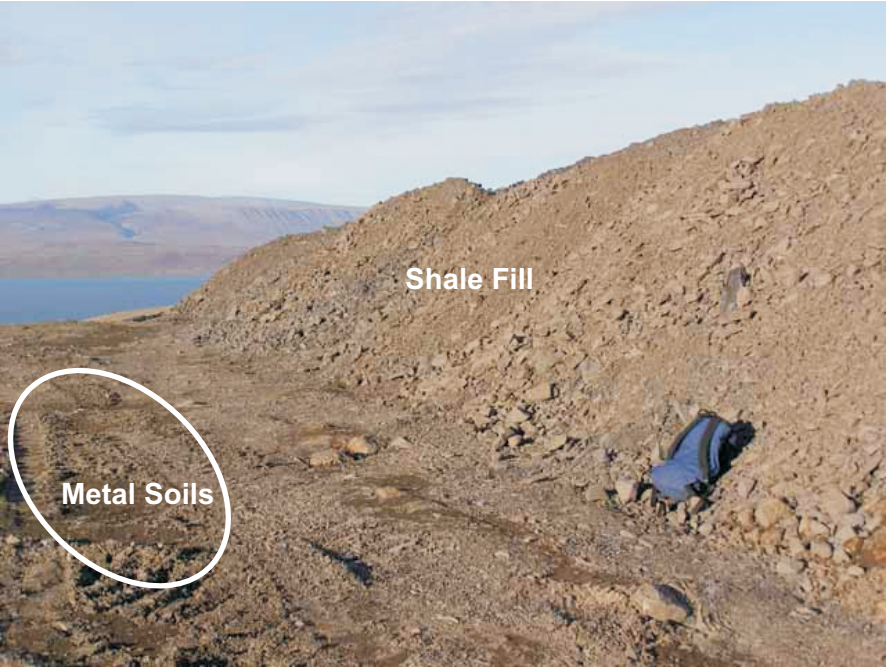
Photo 83  
Stockpiled shale fill on top of metals contaminated soils in Industrial Complex foundation.

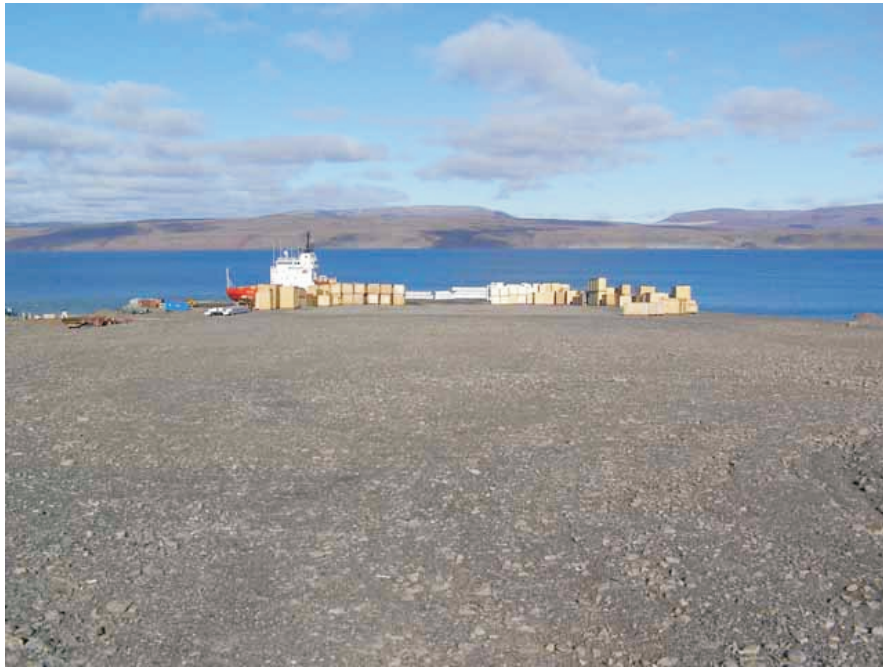
Photo 86  
Surface of Concentrate Storage Shed surficial cover.  
Note this area was being used as a loading area for shipping supplies during the time of the inspection.

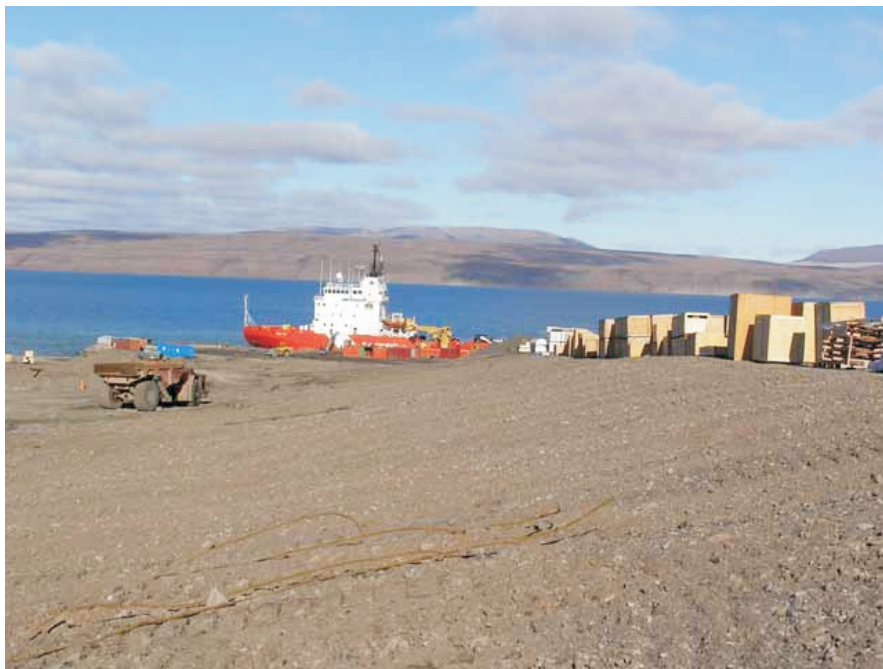
Photo 87  
Side slope of Concentrate Storage Shed surficial cover.
