## **NYRSTAR**

### **NANISIVIK MINE, NUNAVUT**

## **2013 ANNUAL GEOTECHNICAL INSPECTION**

PROJECT NO.: 0255-023  
DATE: February 27, 2014  
DOCUMENT NO.:

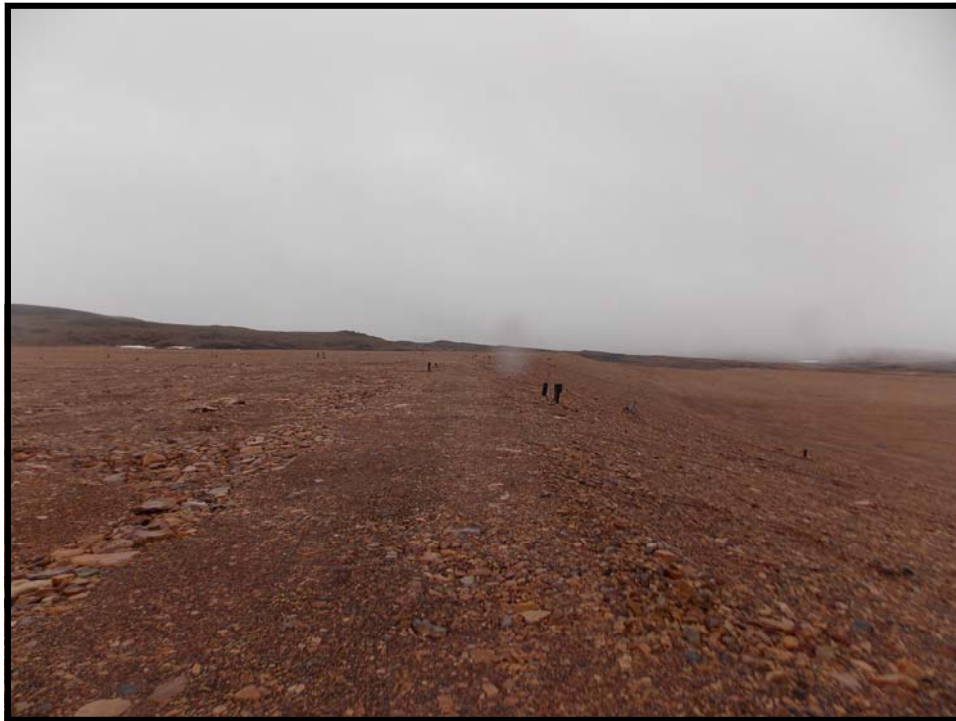
Photo 20. West Twin Dyke—View along crest of dyke looking north.

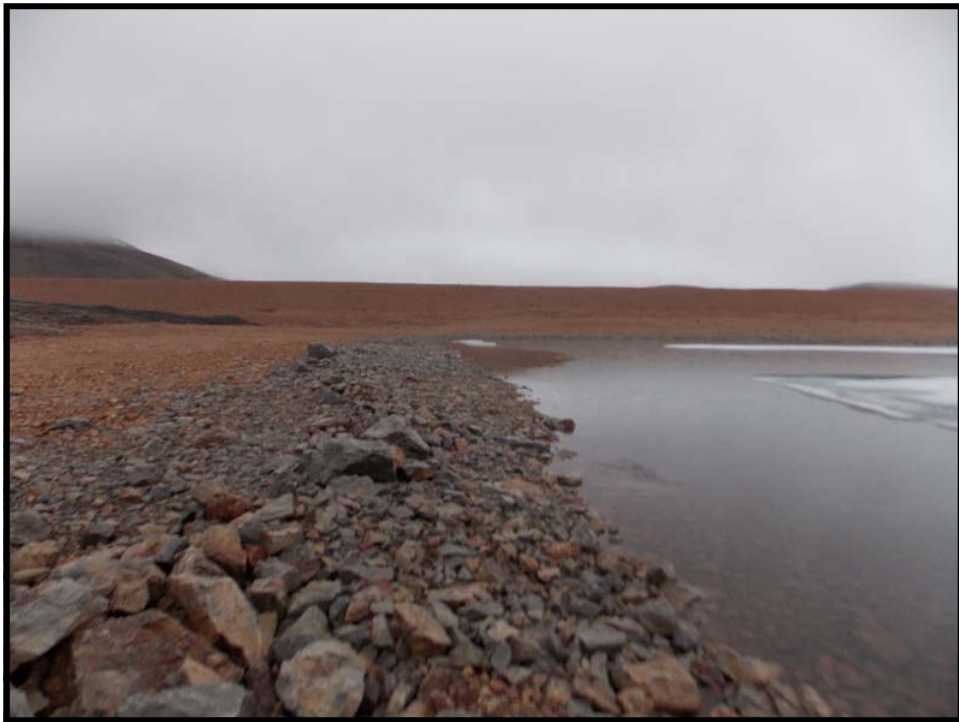
Photo 28. Toe of West Twin Dyke—Armour along shoreline of cover at toe of West Twin Dyke.

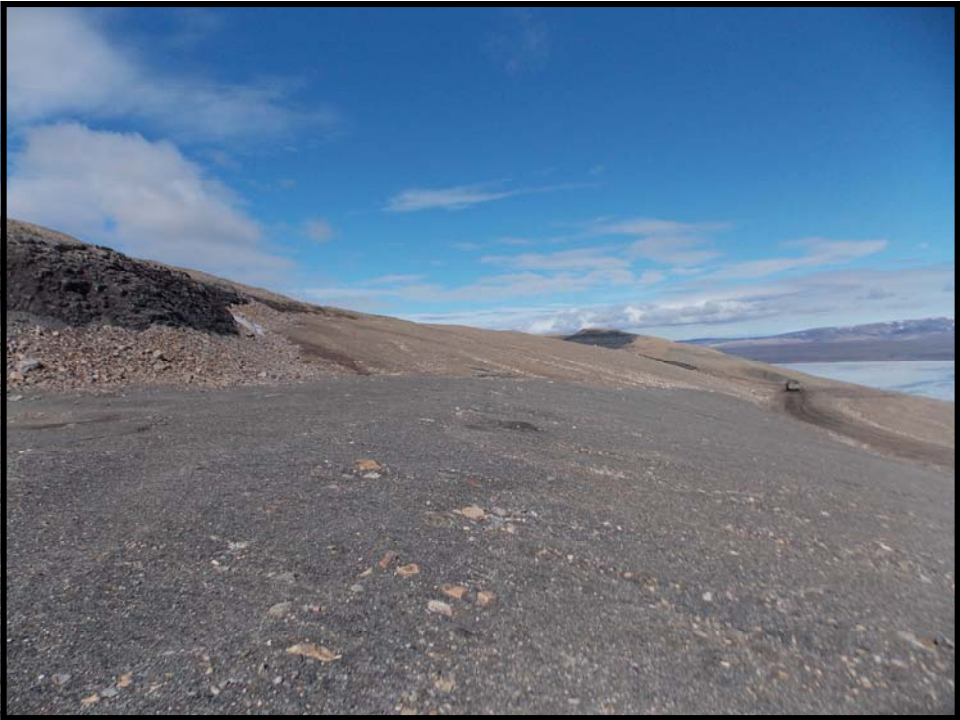
Photo 37. East Open Pit—Sloping upper surface of cover system.

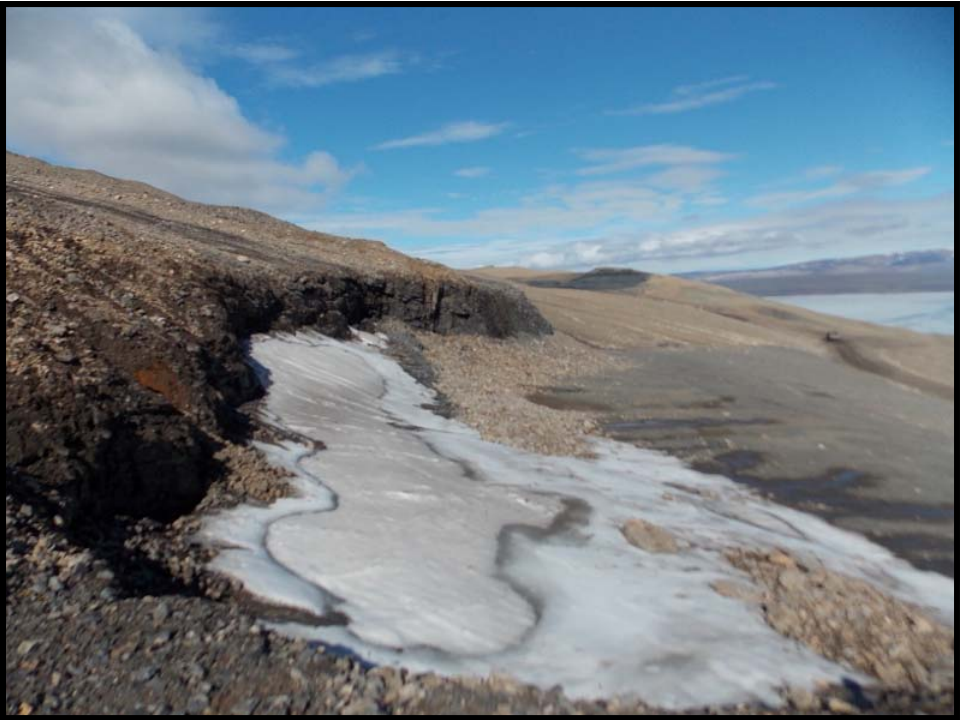
Photo 38. East Open Pit—Remnant highwall.

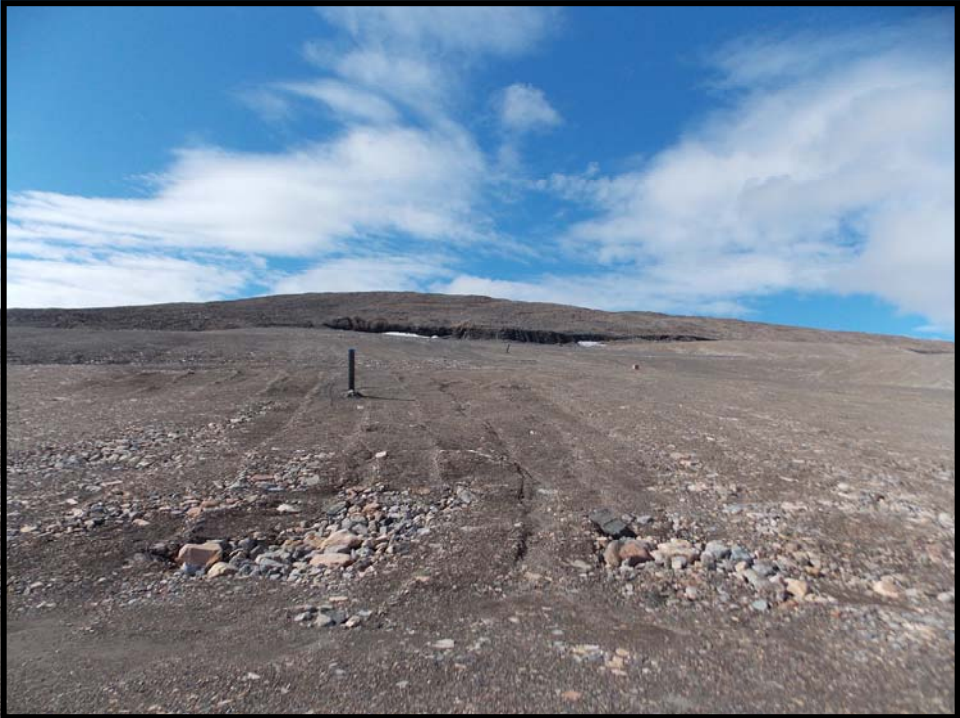
Photo 39. East Open Pit—Looking upslope along surface of cover. Note minor rill erosion.

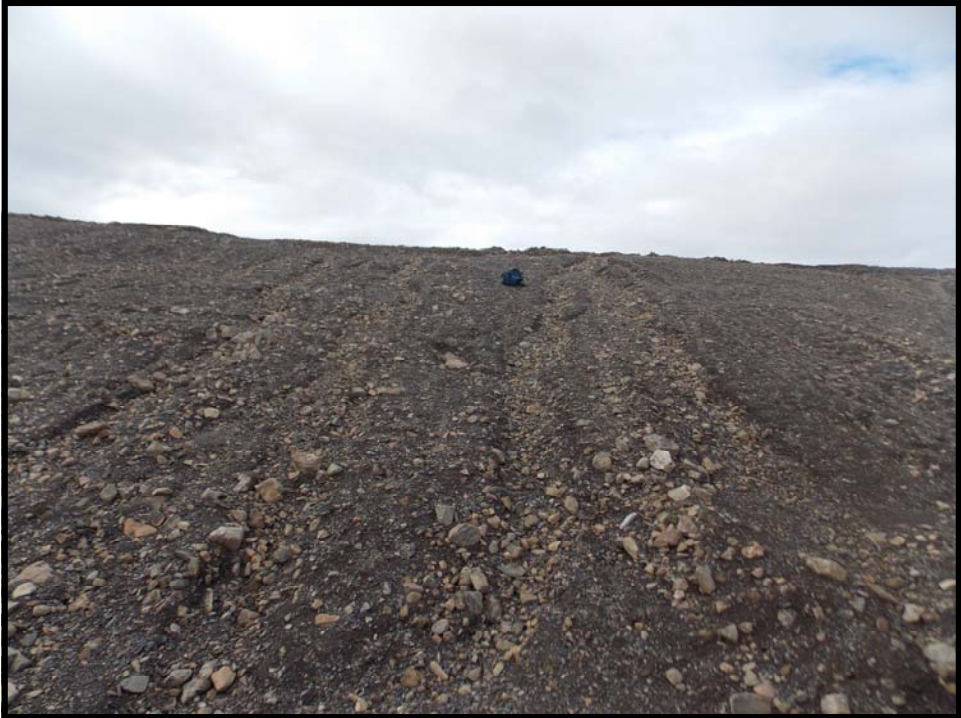
Photo 42. Oceanview Open Pit—Rill erosion along sloping face of cover at SW corner of pit.

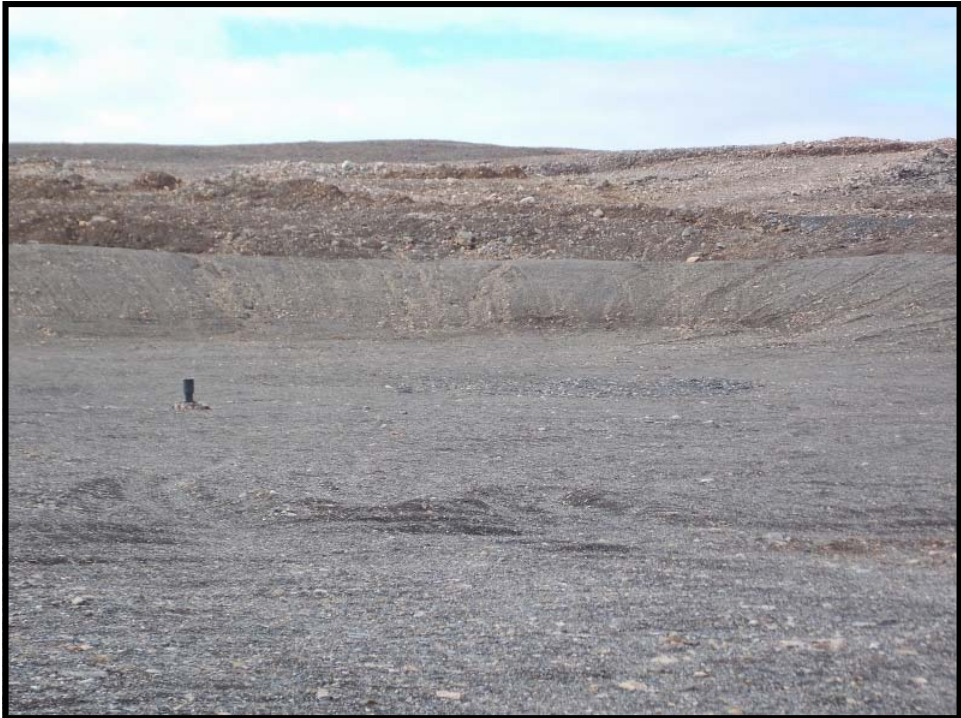
Photo 43. Oceanview Open Pit— Surface of pit cover area.

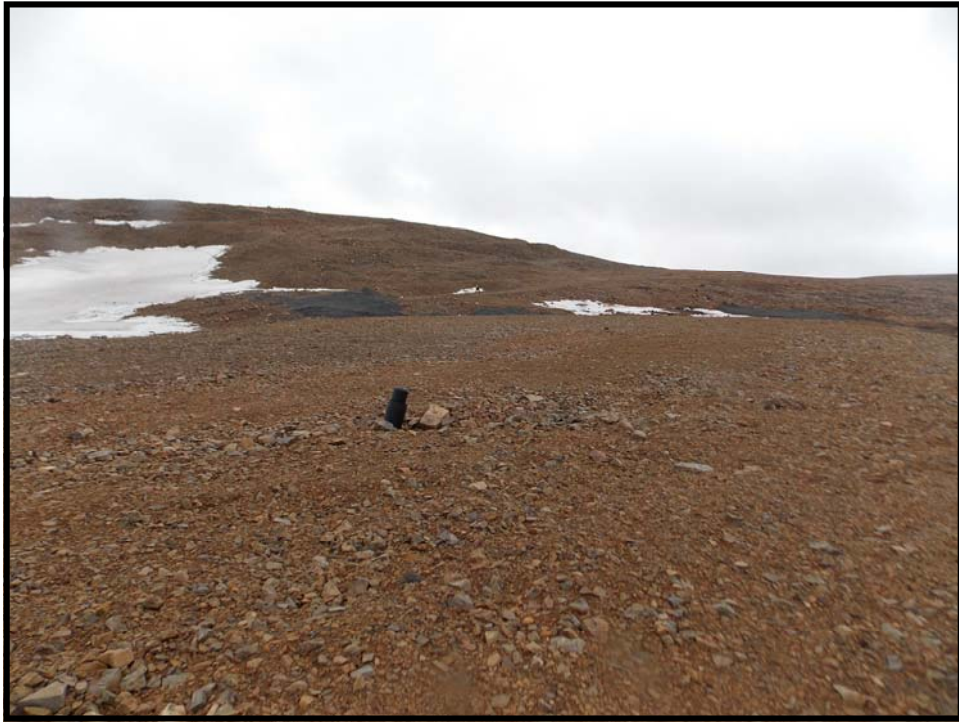
Photo 45. Area 14—Surface of cover.

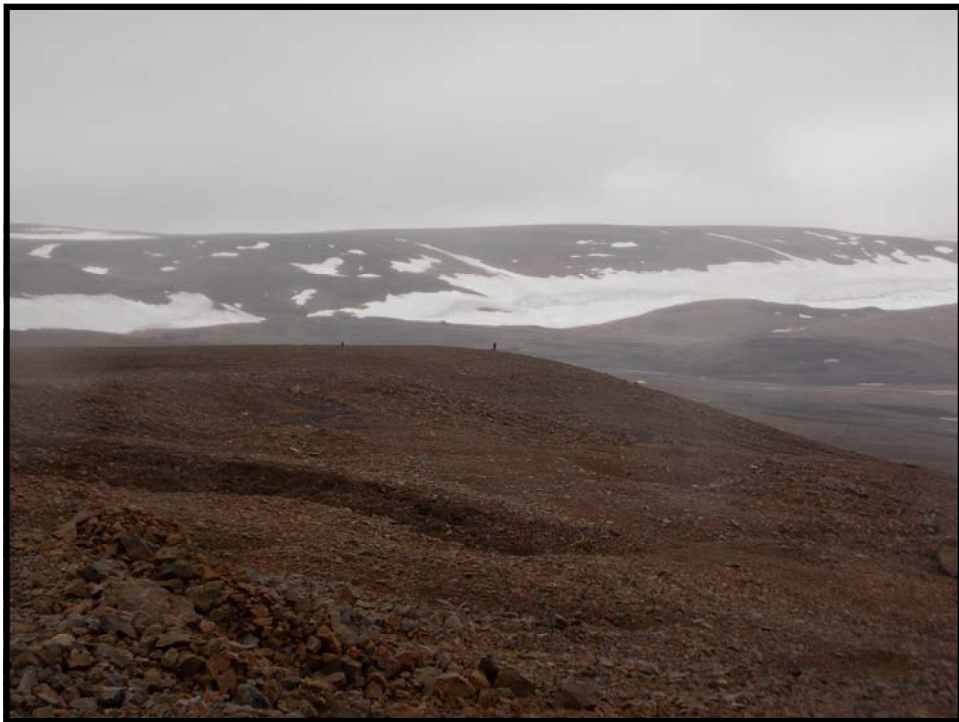
Photo 46. Area 14—General view of cover as seen from Area 14 raise.

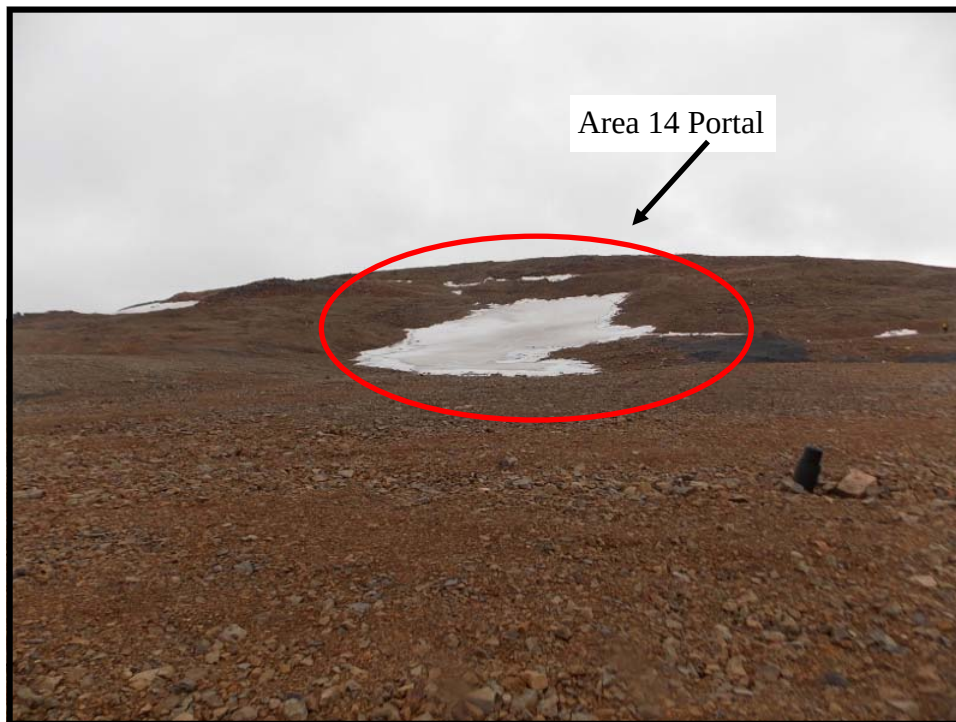
Photo 57. Area 14 Waste Rock cover and Portal.

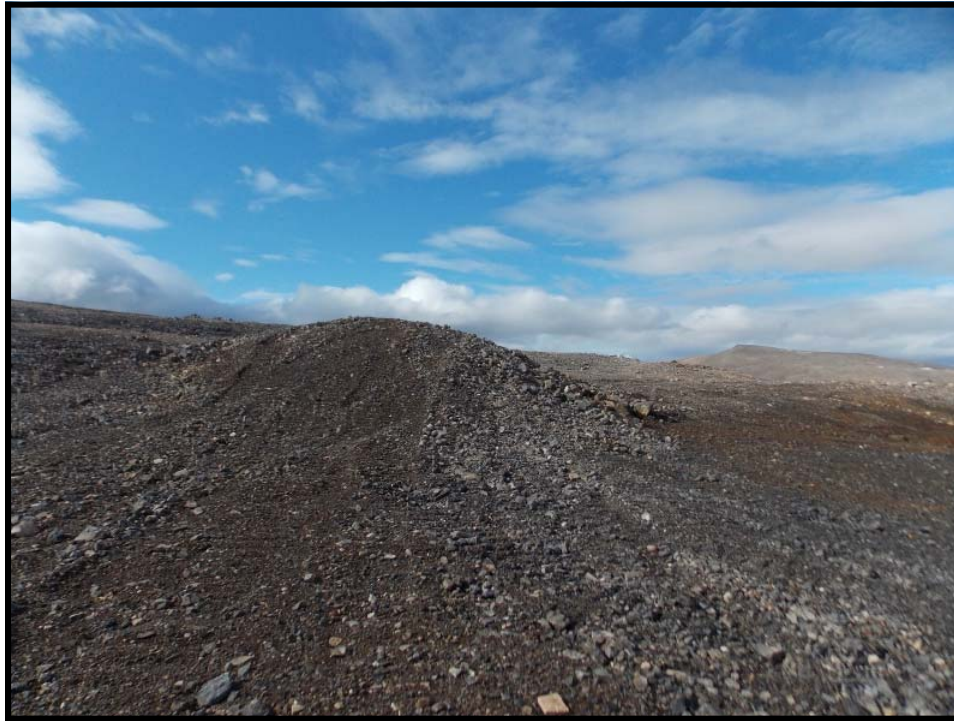
Photo 62. Oceanview West Raise.

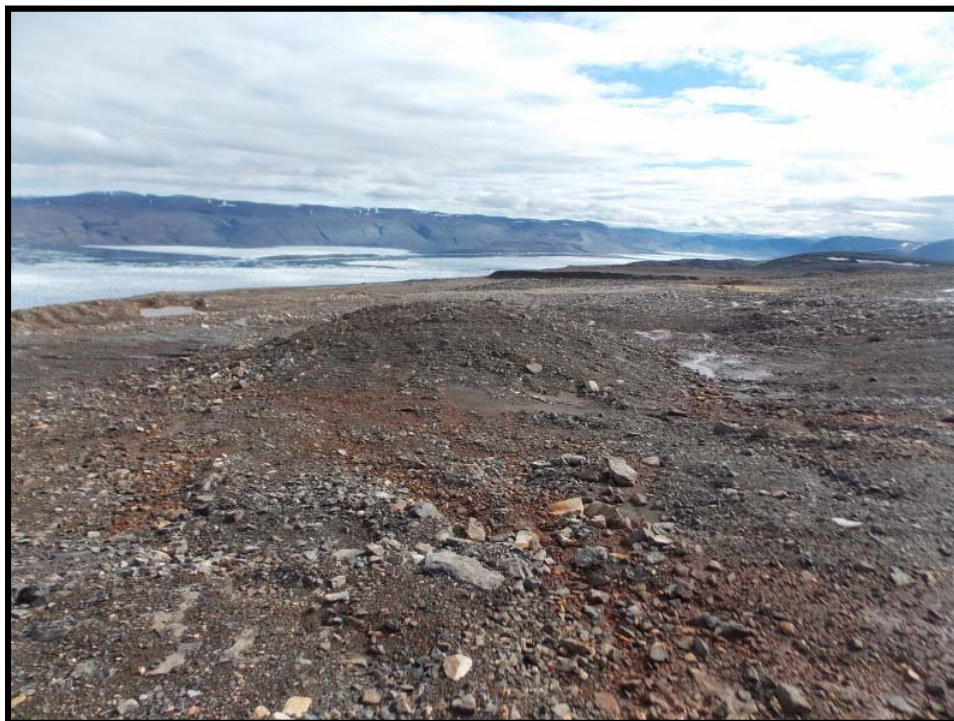
Photo 63. Oceanview East Raise.

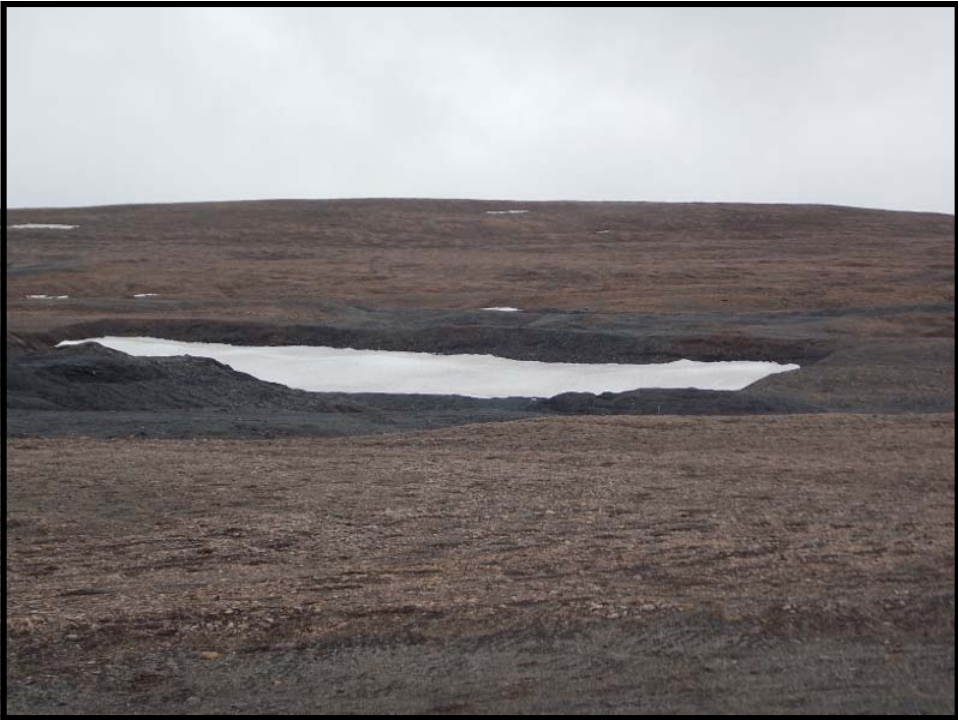
Photo 64. Area 14 Shale Quarry.
