## **NANISIVIK MINE, A DIVISION OF CANZINCO LTD.**

### **2009 ANNUAL GEOTECHNICAL INSPECTION**

### **NANISIVIK MINE, NUNAVUT**

PROJECT NO.: 0255-019-03  
DATE: MARCH 26, 2010

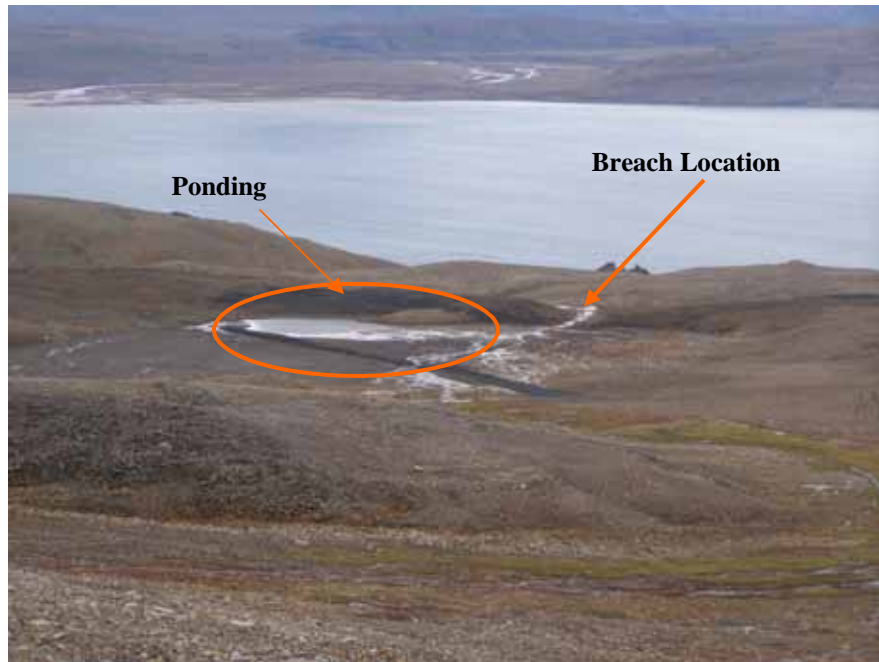
Photo 1 East Adit Retention Pond as seen from EOP Cover.  
Note ponding in northwest corner of area.

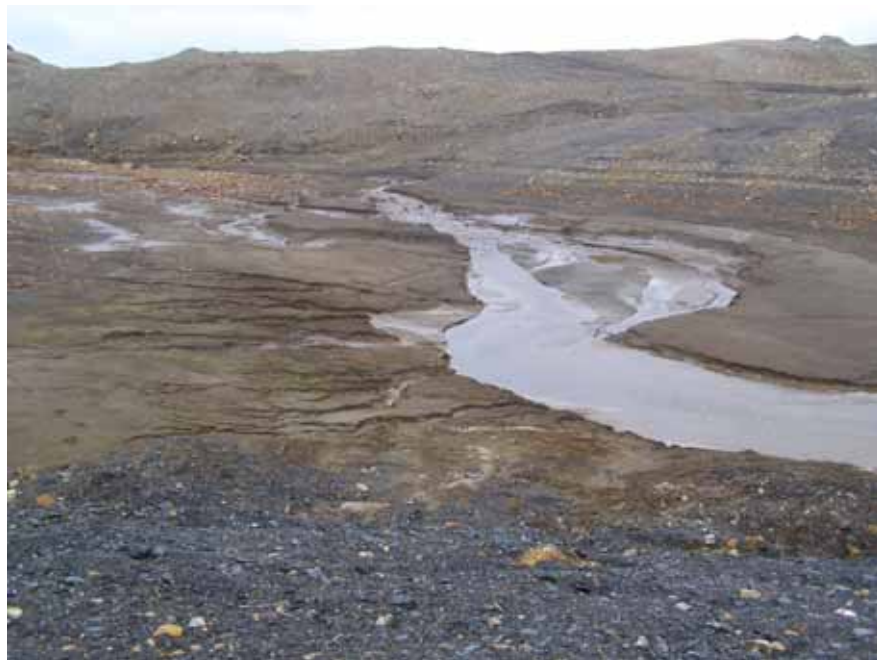
Photo 2 East Adit Treatment Pond.  
Channelized sediments in the bottom of the East Adit treatment pond.

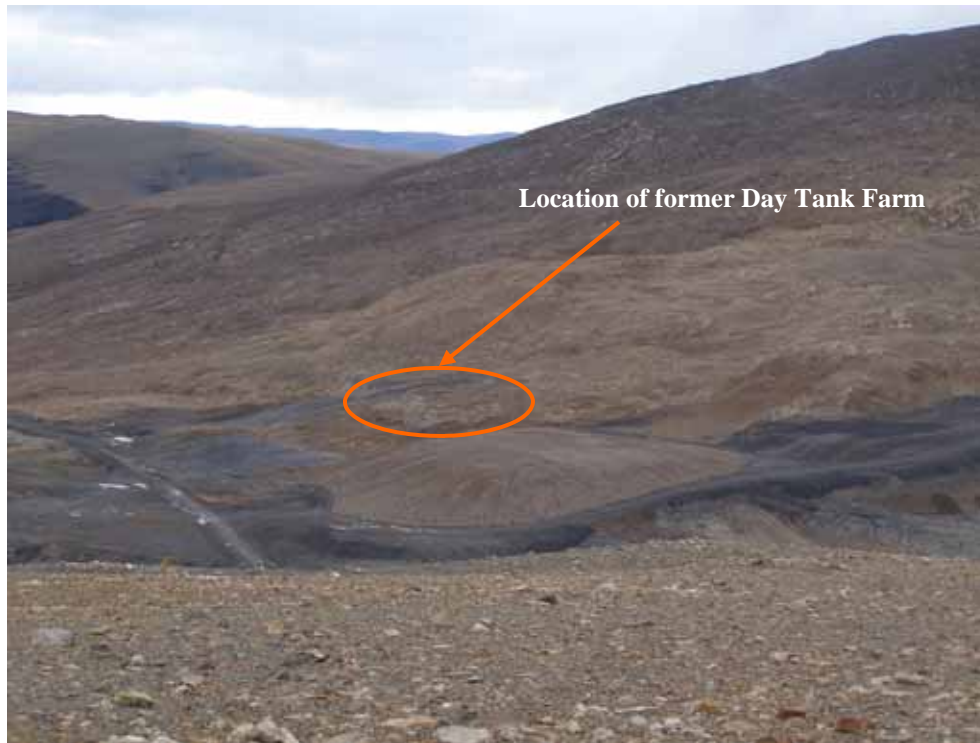
Photo 3 Industrial Complex as seen from Stol Port. Note location of former Day Tank Farm.

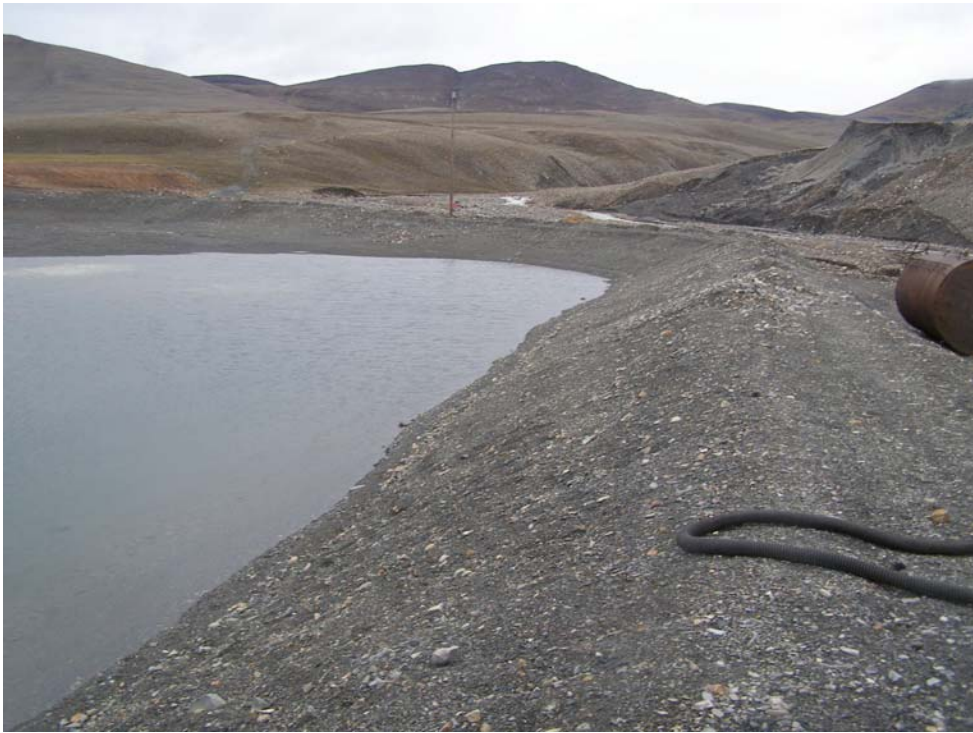
Photo 4 Inside of Main Tank Farm containment berm.  
Note water retained in retention pond.

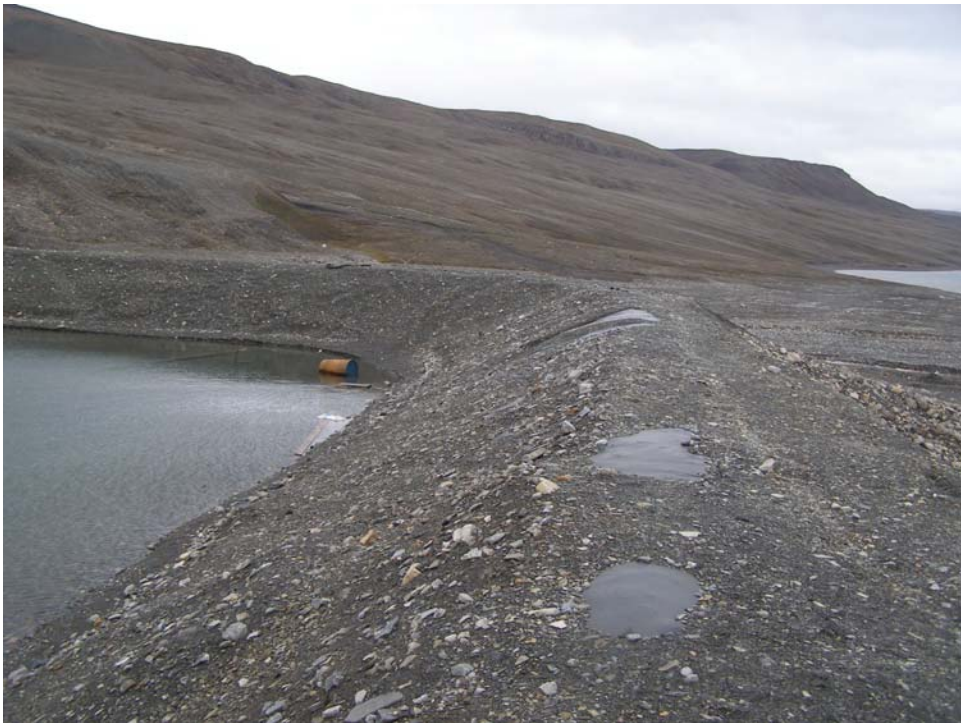
Photo 5 Exposures of internal liner.

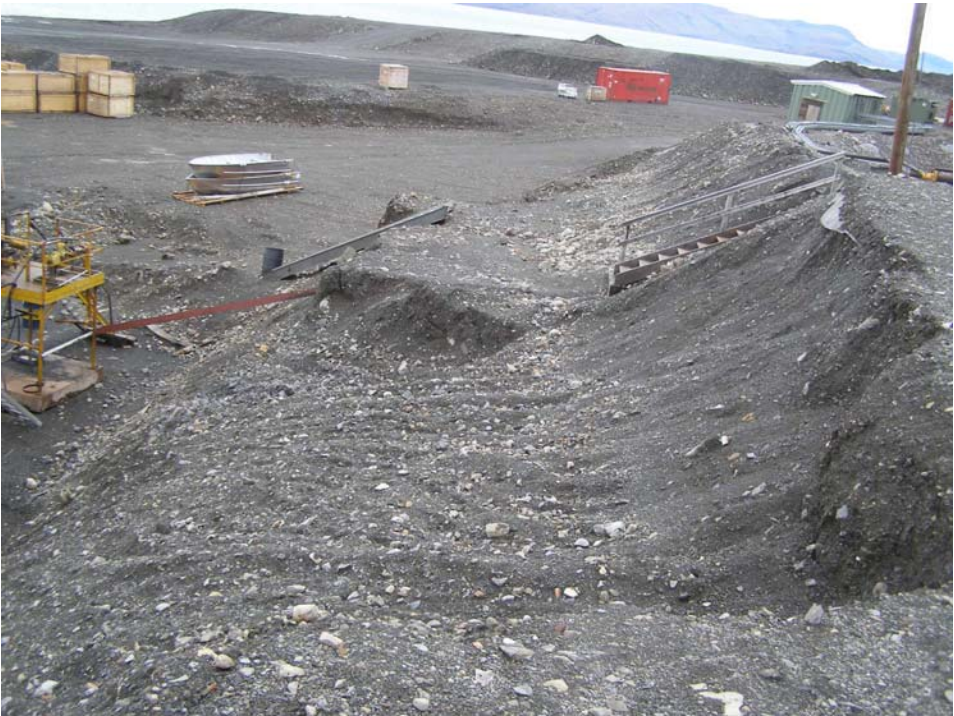
The Main Tank Farm Spill Containment Berm is planned to be removed and remediated in 2010/2011. Considering its imminent removal, no maintenance is considered necessary, despite some minor deficiencies. The East Twin Creek Diversion berm is performing as anticipated and is considered fully remediated. The East Adit Treatment Facility Dikes were breached in 2006. The flow through the Treatment Pond was observed to be relatively unimpeded. However, some ponding was observed in the Retention Pond. Additional grading could be completed to improve drainage through this area and prevent ponding, but given that no negative environmental impacts are known to result from the ponding, additional grading is not considered necessary at this time.

Photo 6 Affected area of Main Tank Farm berm which was partially excavated during reclamation of contaminated soils.

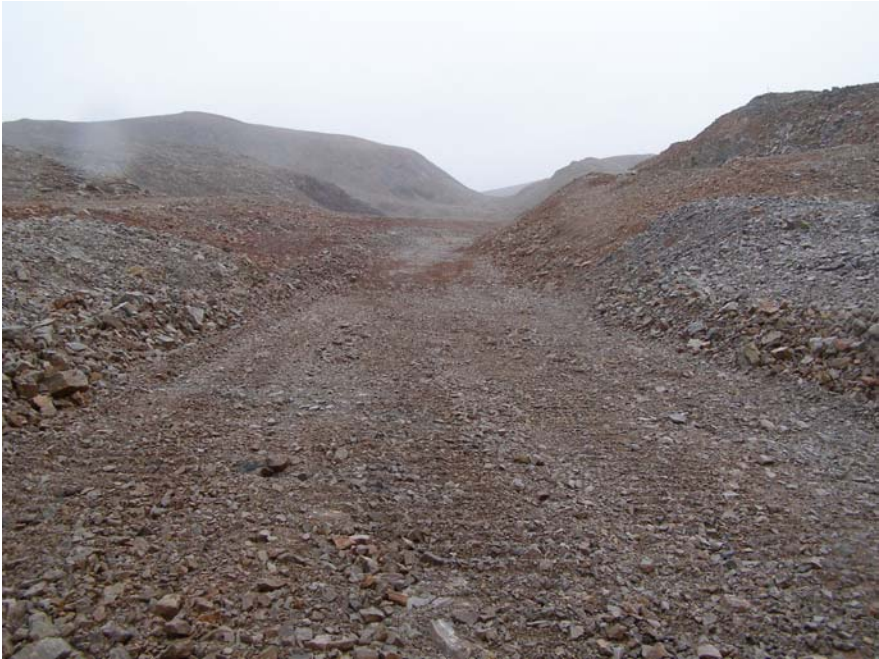
Photo 7 Re-graded bottom of the spillway.

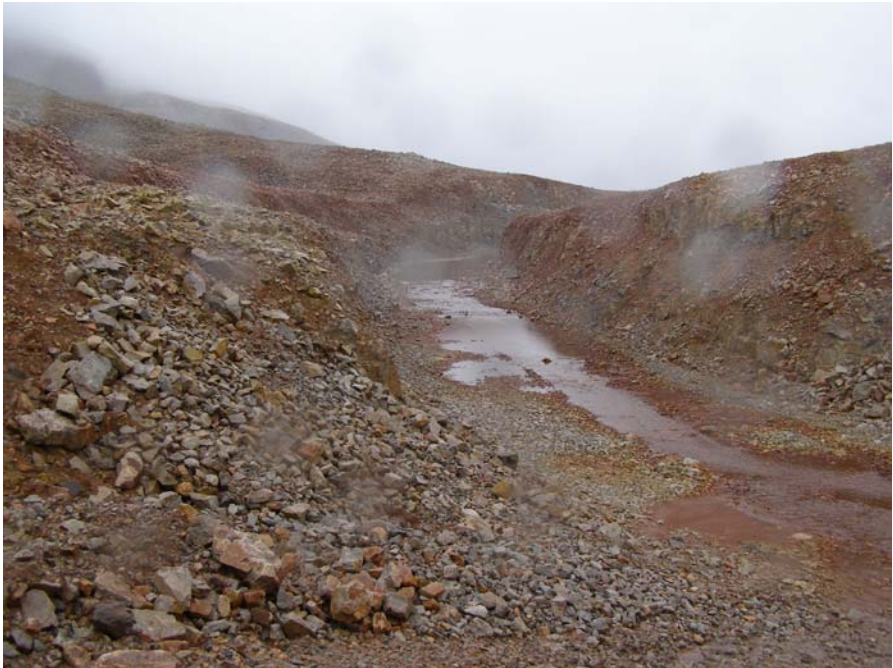
Photo 8 Flow through WT Dike Spillway as seen from bottom of access ramp.

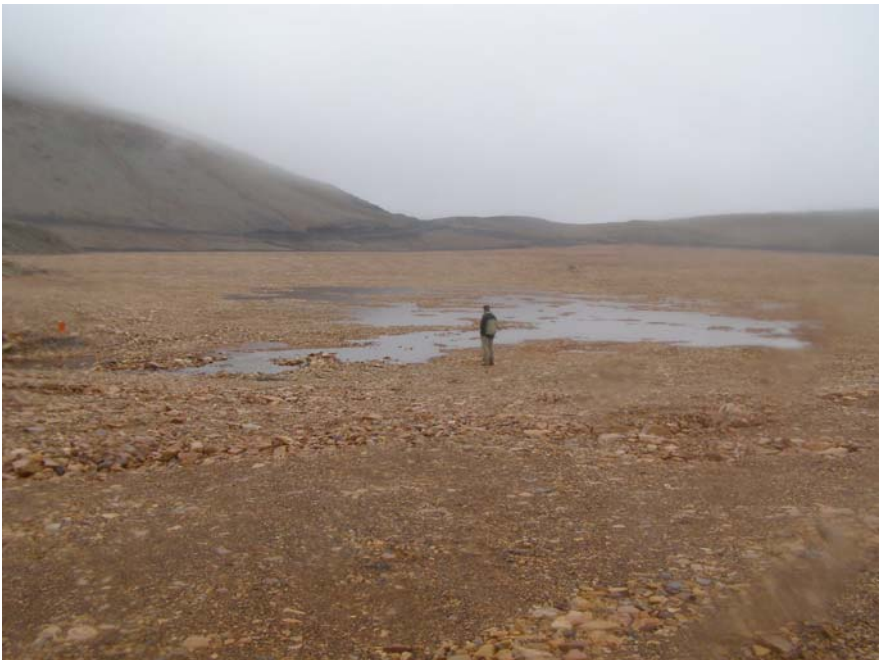
Photo 9 Head pond at spillway entrance. Note presence of exposed armour material in middle of pond which indicates a reduction in the water level of the retained pond.

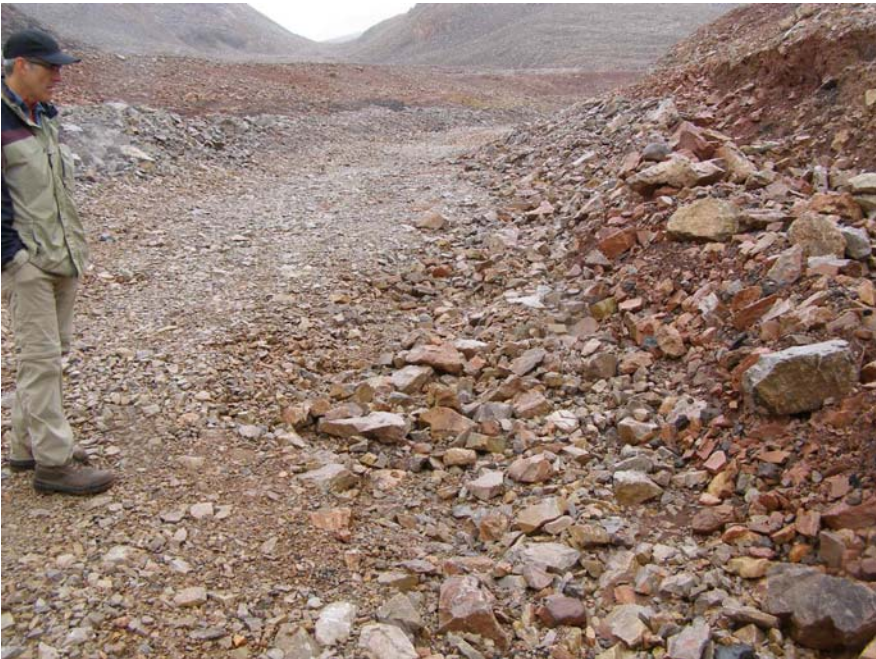
The West Twin Dike Spillway is functioning as intended and only minor deformation in the base and side slopes of the spillway has occurred. Maintenance was expected to be required for the spillway during the initial years following construction given the ground conditions encountered during construction. The maintenance items recommended in 2008 were addressed and appear satisfactory.

Photo 10 Small section of erosion in base of the spillway.

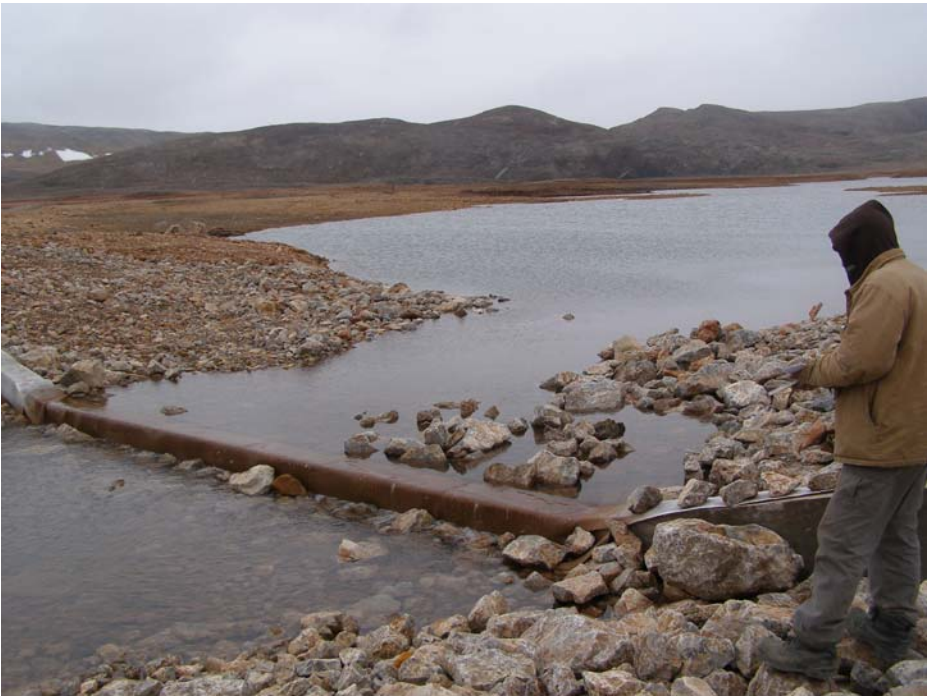
Photo 11 West Twin Outlet Wall in mid-August. Note water is flowing over the wall.

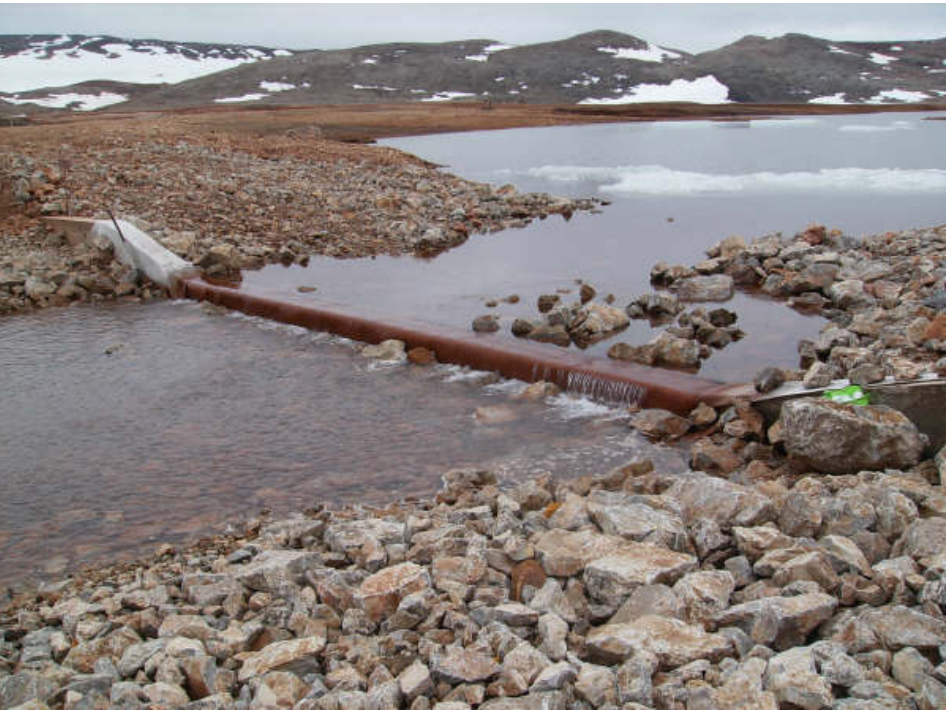
Photo 12 West Twin Outlet Wall in mid-August 2009.

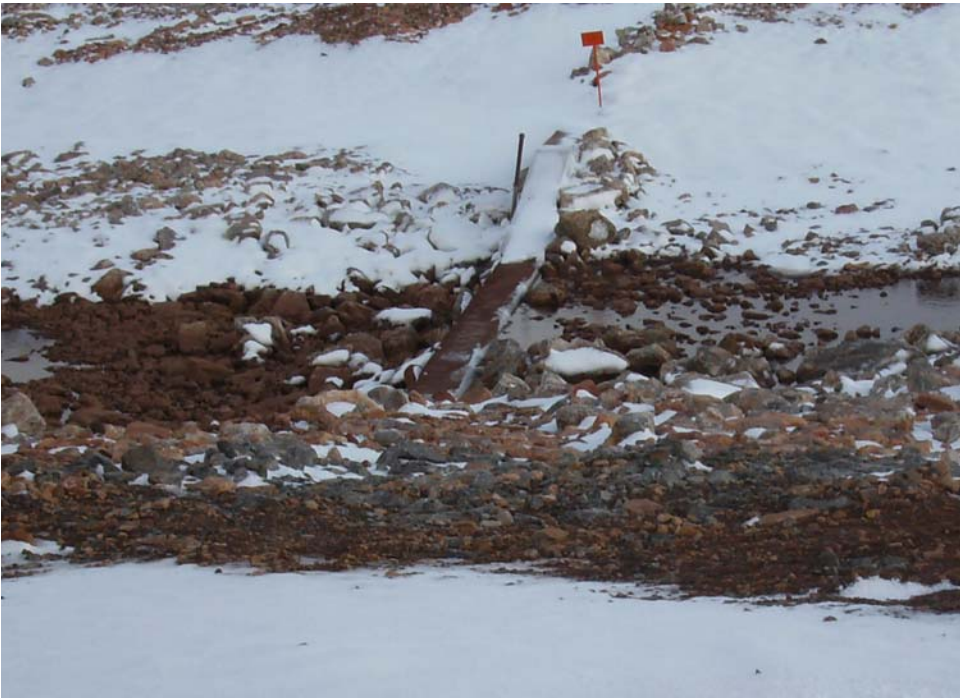
The flow through hydraulic system created by the breach of the East Twin Lake Access Road in 2008 appeared to improve the stability of the water level upstream of wall during periods of regular inflows into the Reservoir. During periods of reduced or no inflow into the Reservoir, which usually occurs in the fall and early winter, the water level in the remnant polishing pond upstream of the wall was observed to be reduced, likely due to seepage losses through the foundation of the wall. However, the water level in the main portion of the Reservoir, upstream of the access road breach was maintained at appropriate levels by the impedance to flow provided by the remnant access road. Based on the water quality measurements collected in 2008 and 2009, the seepage losses through the foundation of the wall do not appear to be affecting the overall performance of the West Twin Area reclamation measures. The seepage losses at the wall should continue to be monitored and additional seepage control measures may be required should the seepage losses be considered excessive (*i.e.*, water levels approaching the design low water level, as illustrated on Drawing 5, during open water season).

Photo 13 West Twin Outlet Wall in early September. Note reduction in water level upstream of wall.

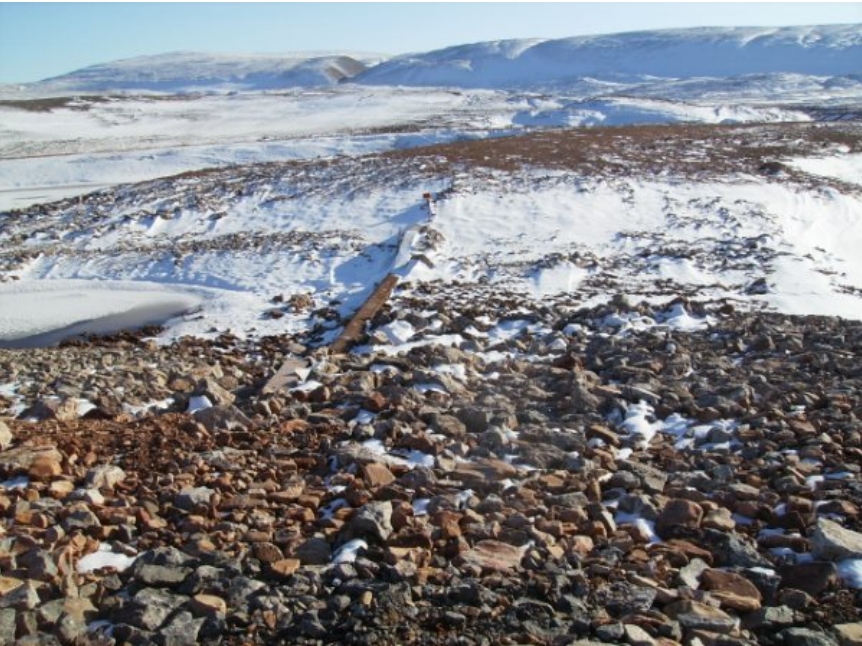
Photo 14 West Twin Outlet Wall in early October 2009. Note reduction in water level upstream of wall.

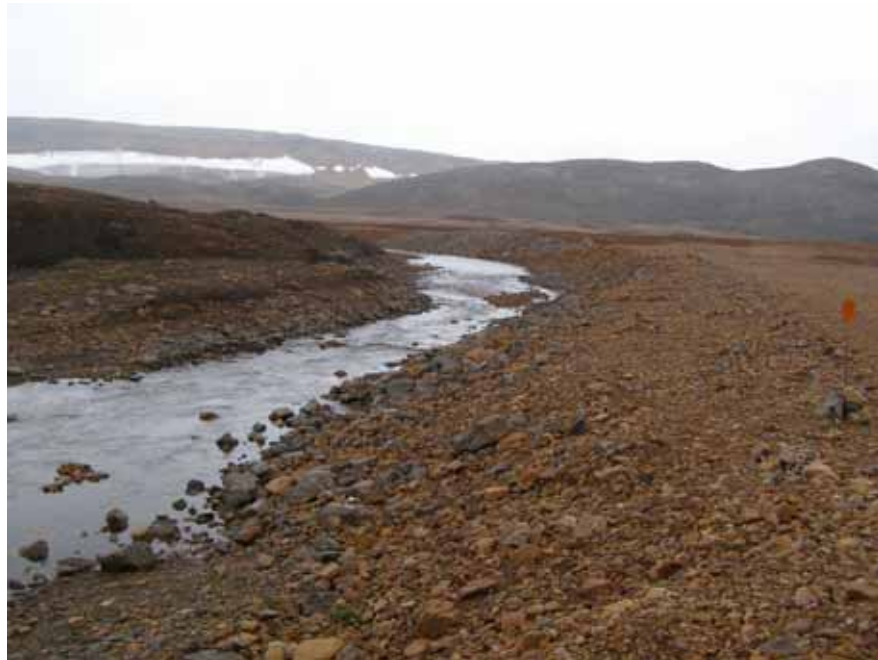
Photo 15 Flow through East Twin Creek Diversion Channel. View looking upstream.

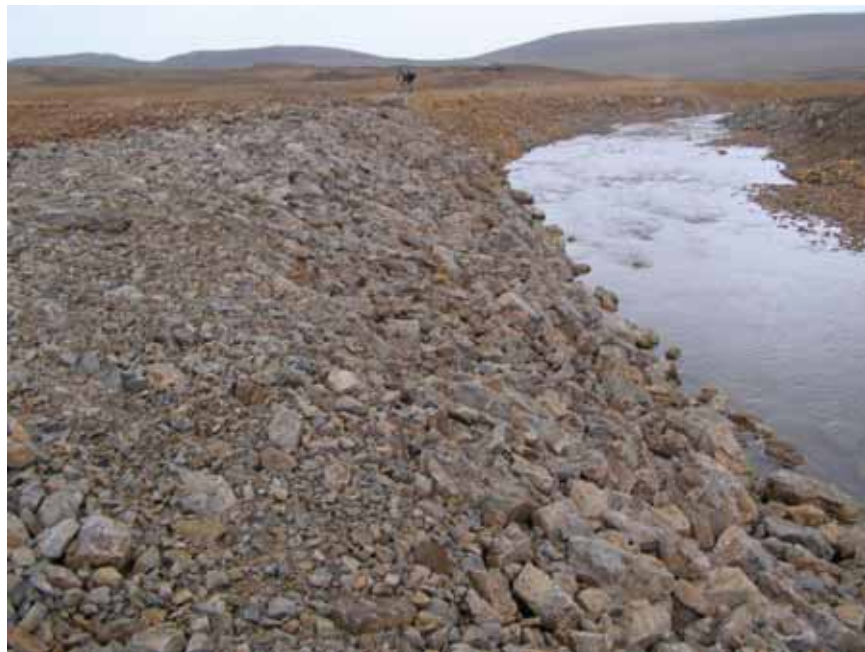
Photo 16 Flow through East Twin Diversion Channel. View looking at left bank and downstream.

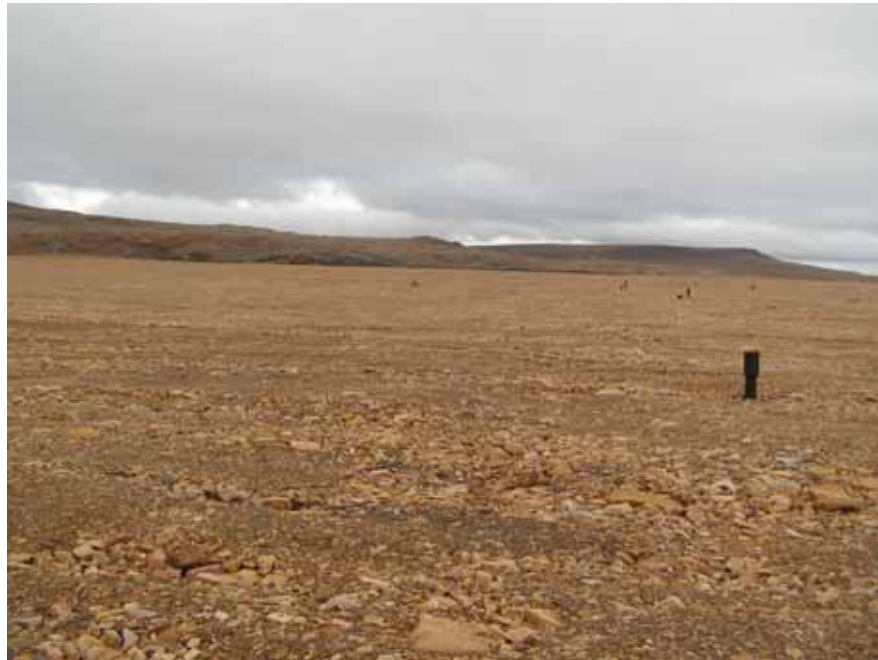
Photo 17 Surface of Surface Cell Cover. View looking north.

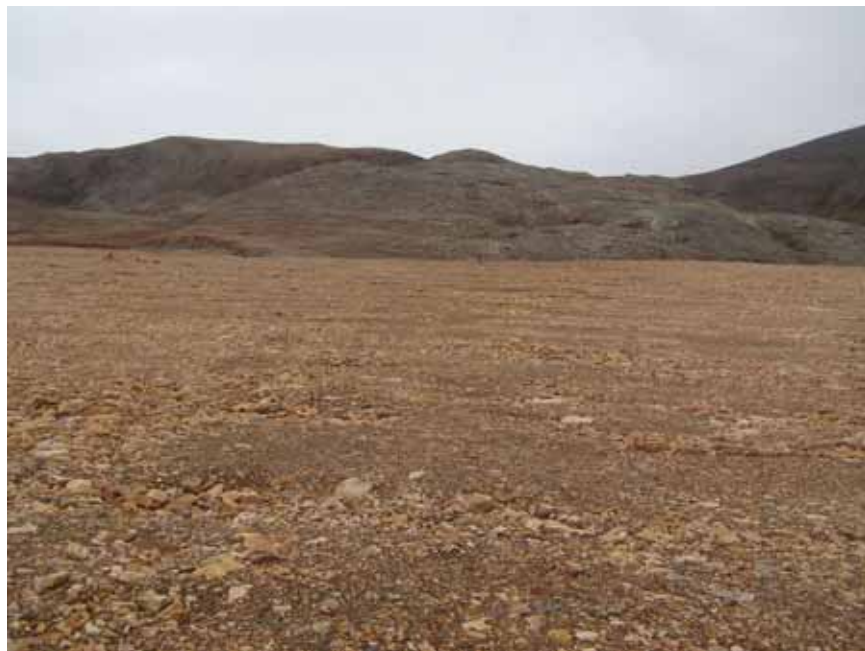
Photo 18 Surface of Surface Cell Cover. View looking south.

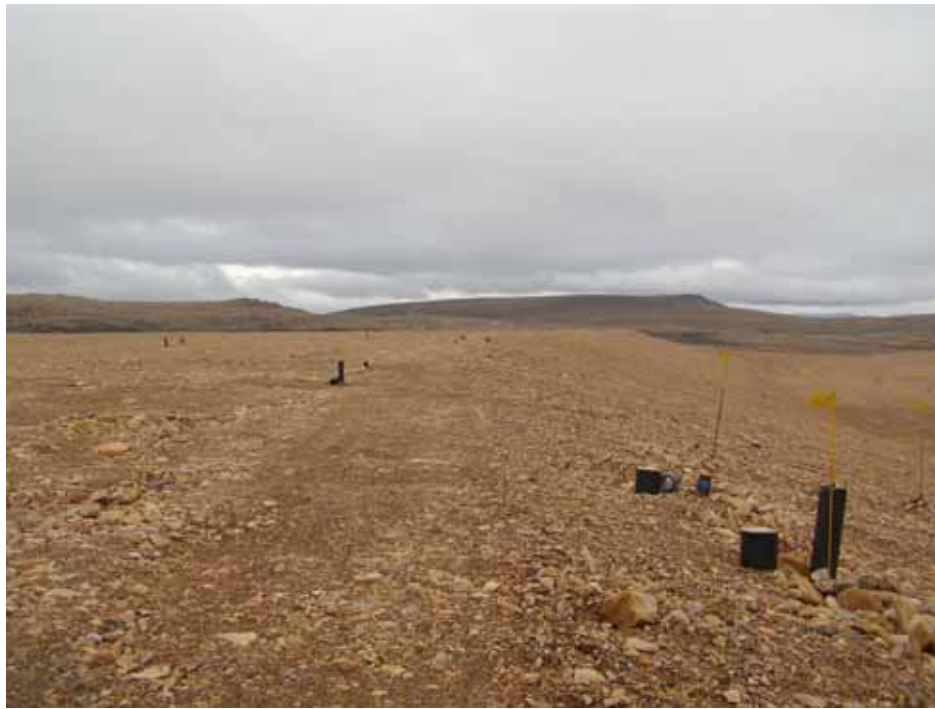
Photo 19 Crest of West Twin Dike. View looking north.

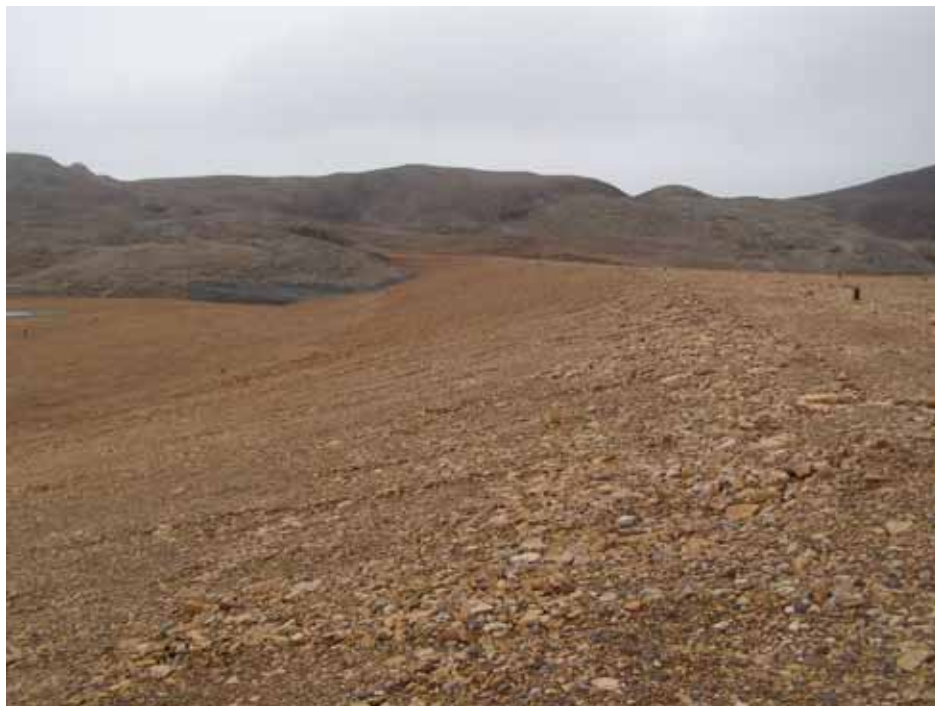
Photo 20 Face of the West Twin Dike. View looking south.

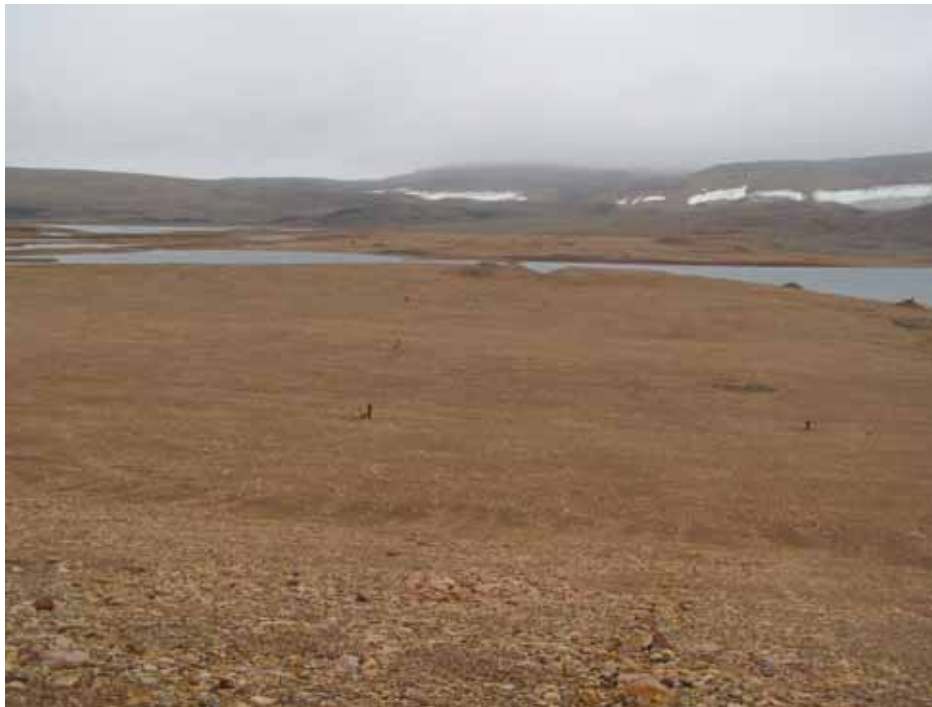
Photo 21 Test Cell cover as seen from the crest of West Twin Dike.

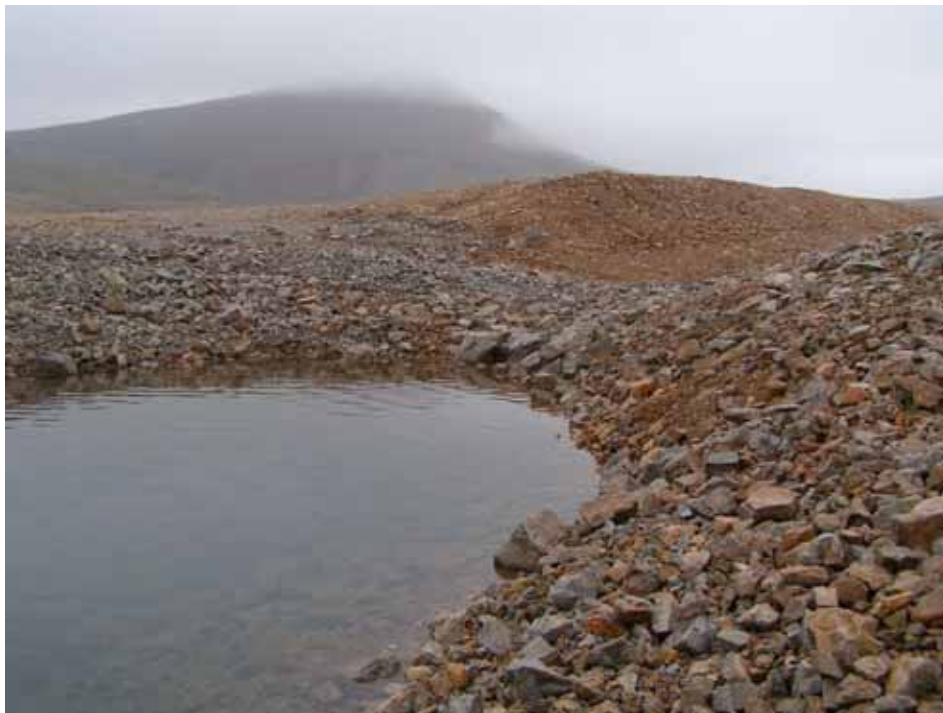
Photo 22 Rip rapped Test Cell outlet. Note riprap extended below water line.

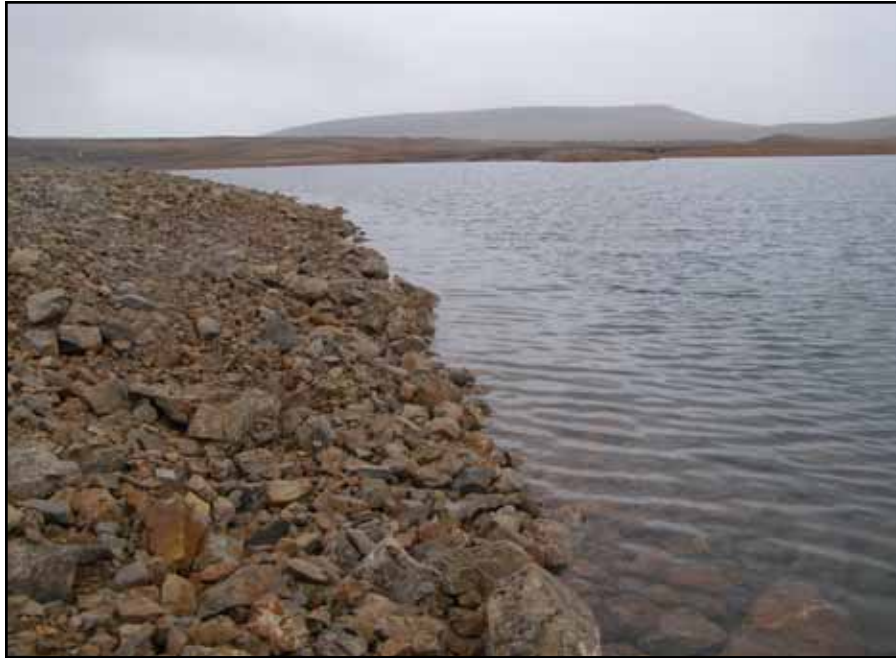
Photo 23 Riprap along toe of North/South arm of Test Cell Dike.

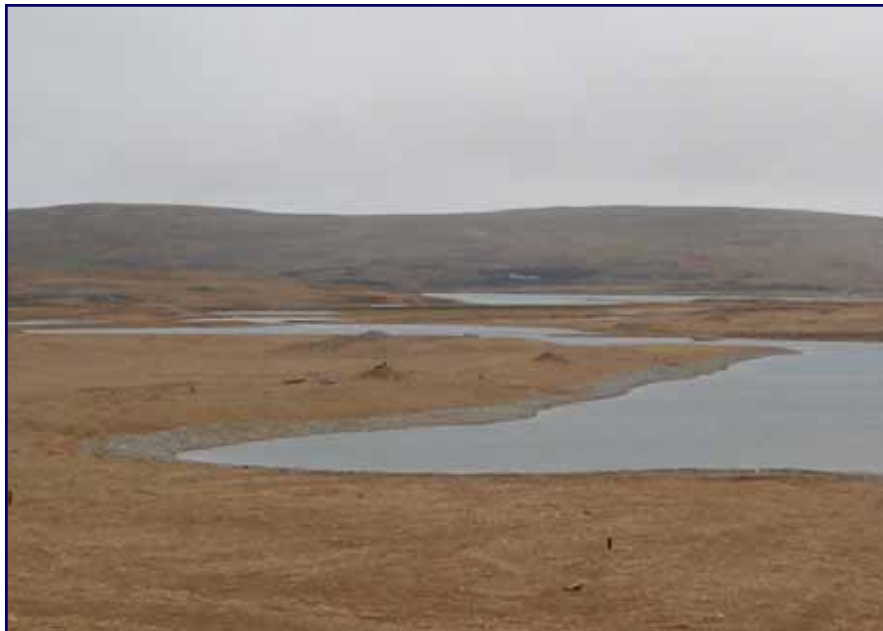
Photo 24 Riprap along toe of East/West arm of Test Cell Dike.

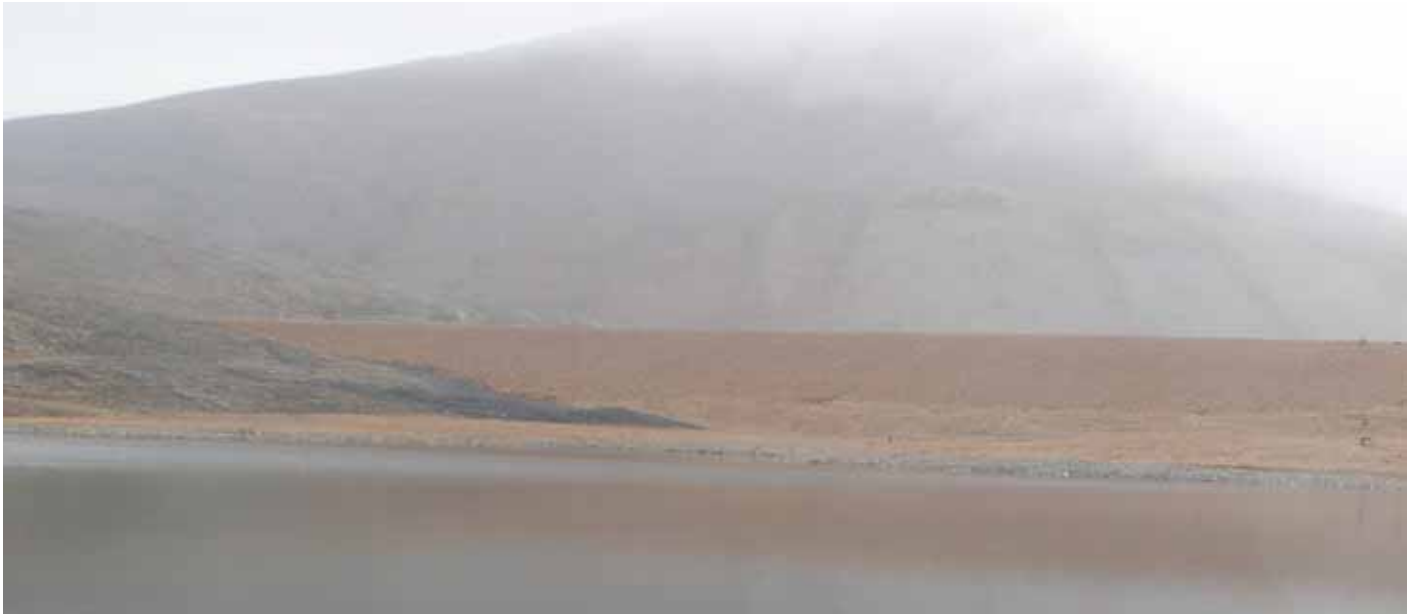
Photo 25 West Twin Dike as seen from the Twin Lakes Delta.

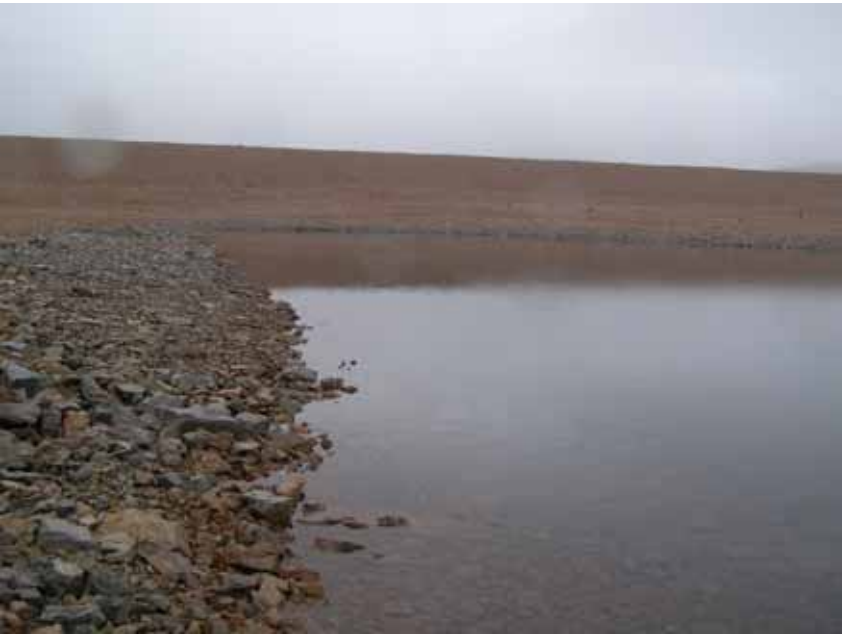
Photo 26 Rip rapped shoreline at Toe of West Twin Dike tailings cover .

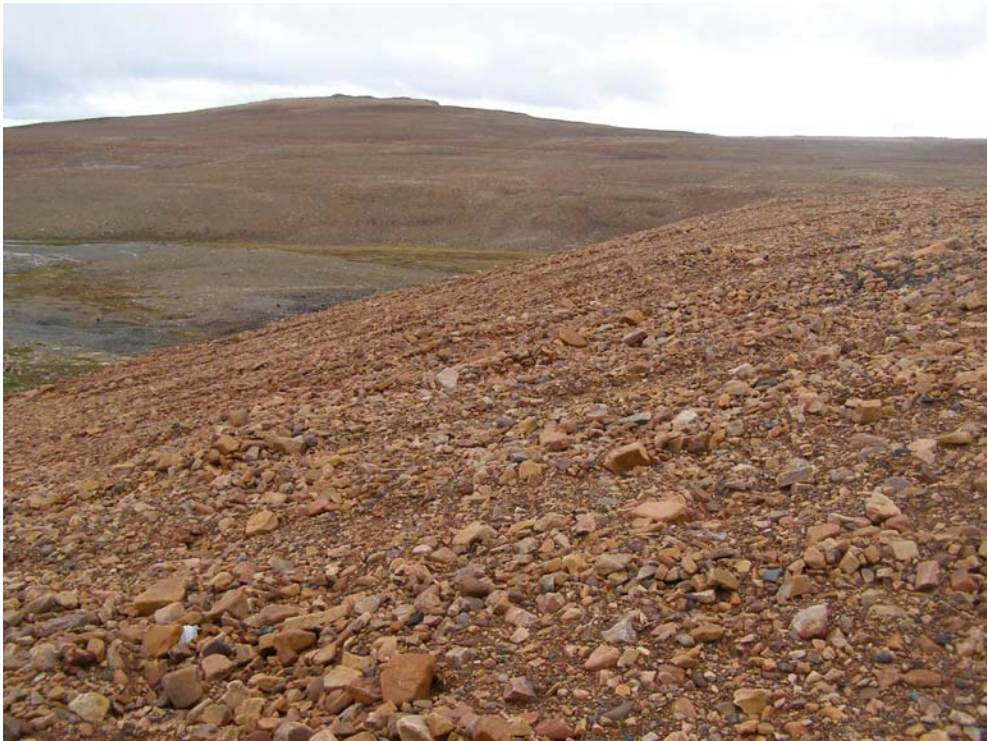
Photo 28 Face of the Landfill cover.

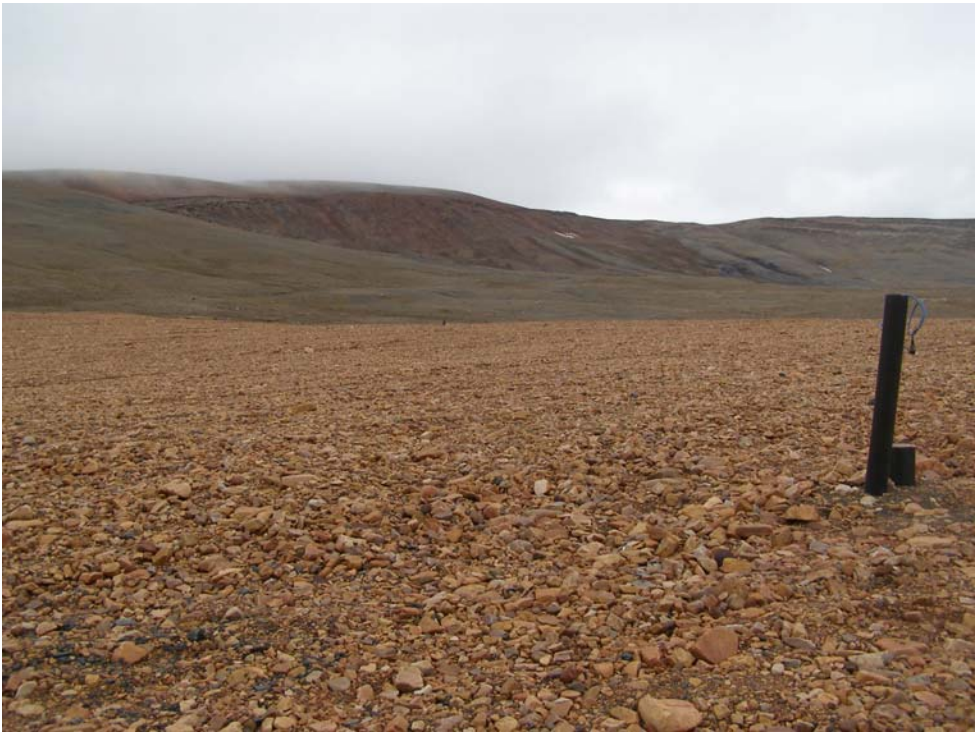
Photo 29 Re-compacted surface of Landfill cover.

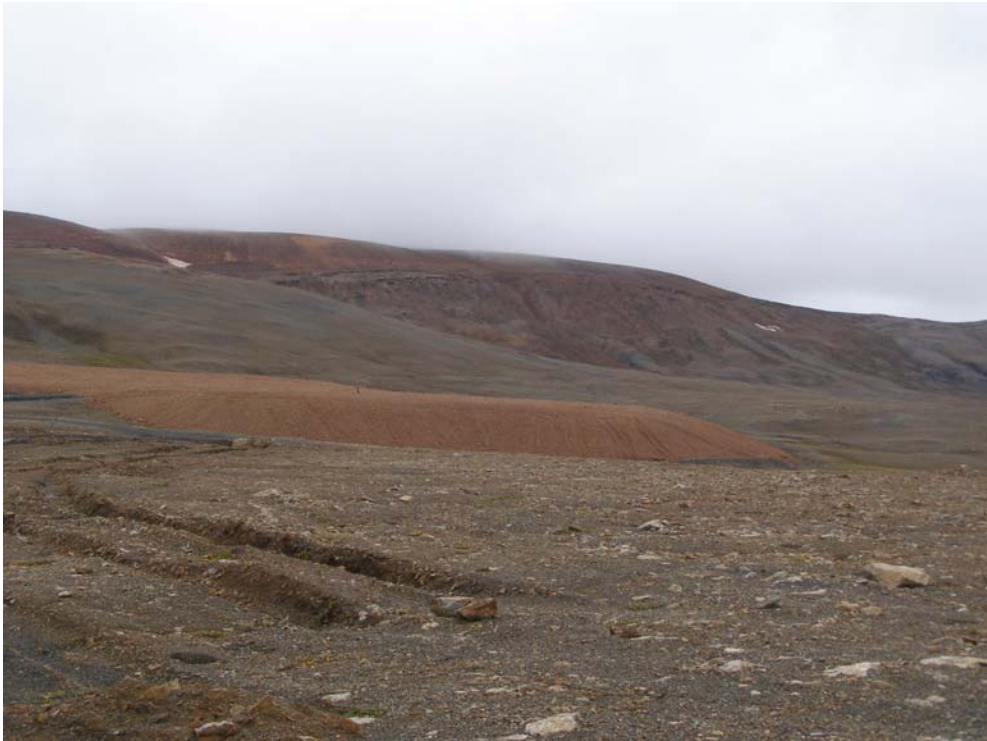
Photo 30 Landfill cover as seen from Stol Port.

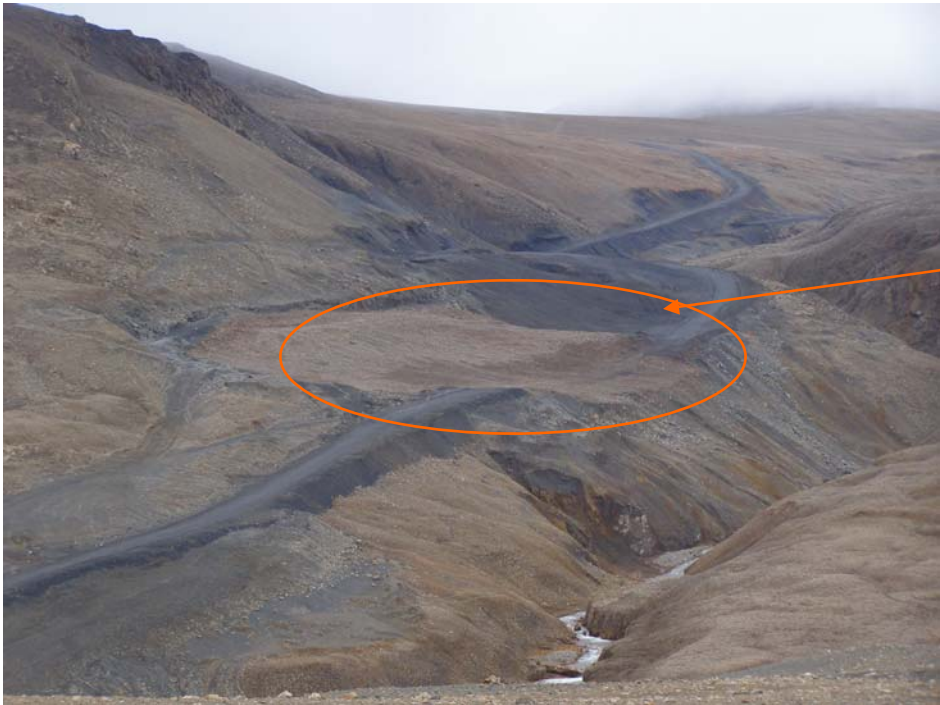
Armour placed on road surface

Photo 31 West Open Pit waste rock cover as seen from Stol Port. Note that the road has been armoured over.

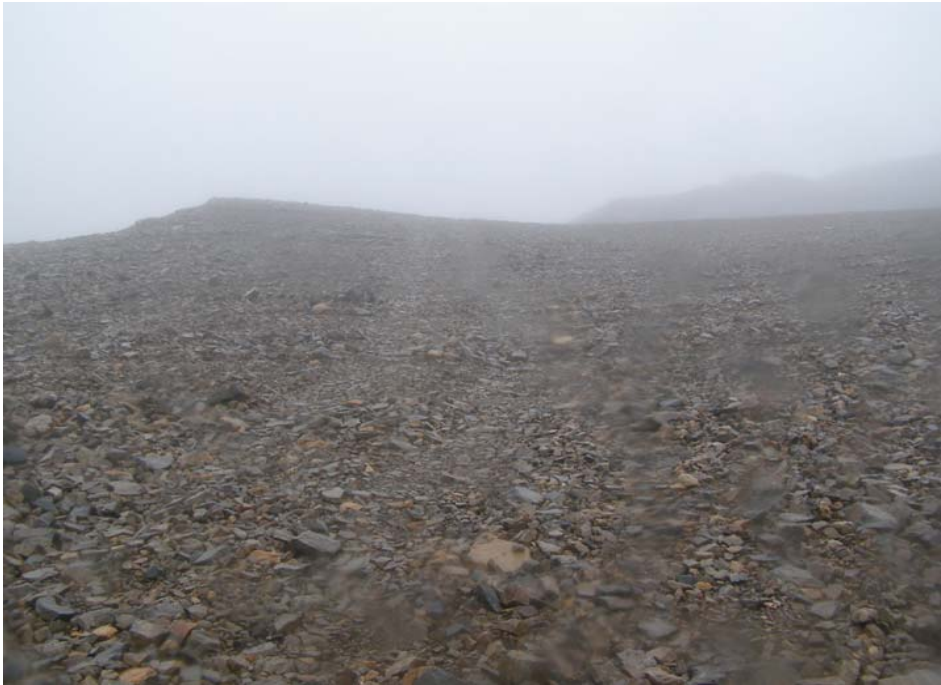
Photo 34 Surface of West Open Pit cover, roadway is armoured as requested in 2008.

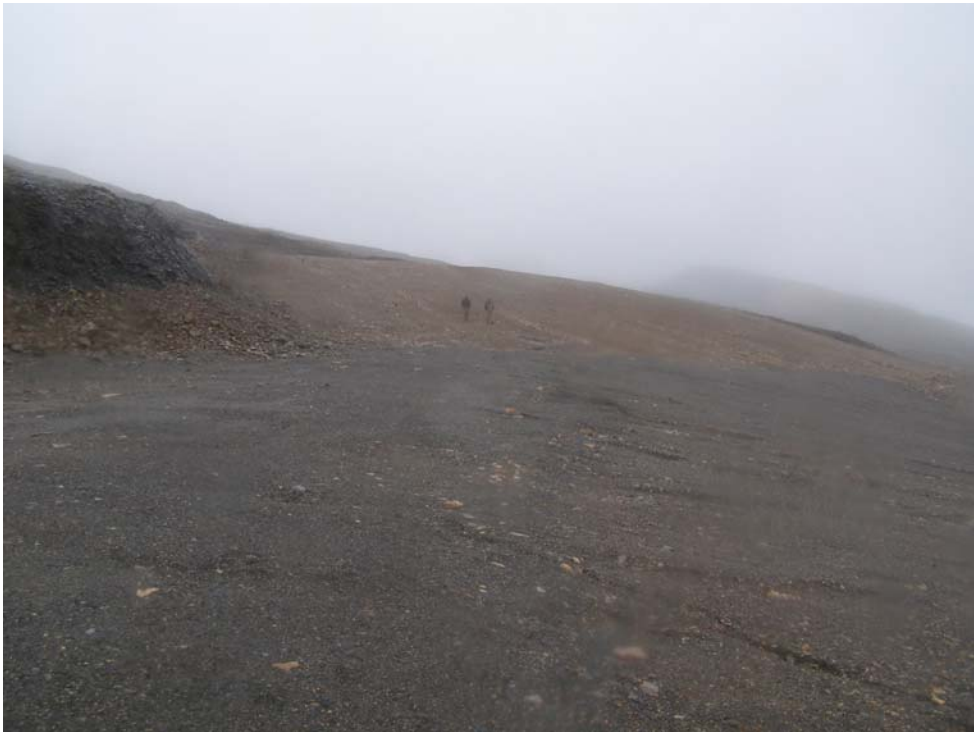
Photo 35 Surface of East Open Pit cover.

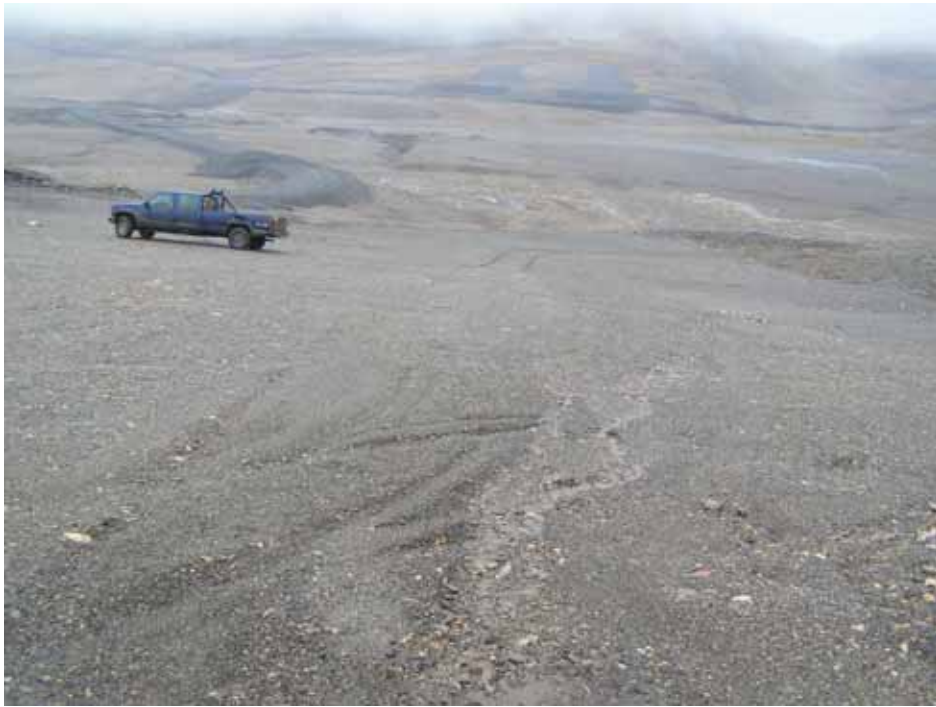
Photo 39 East Trench cover as seen from the upslope area.

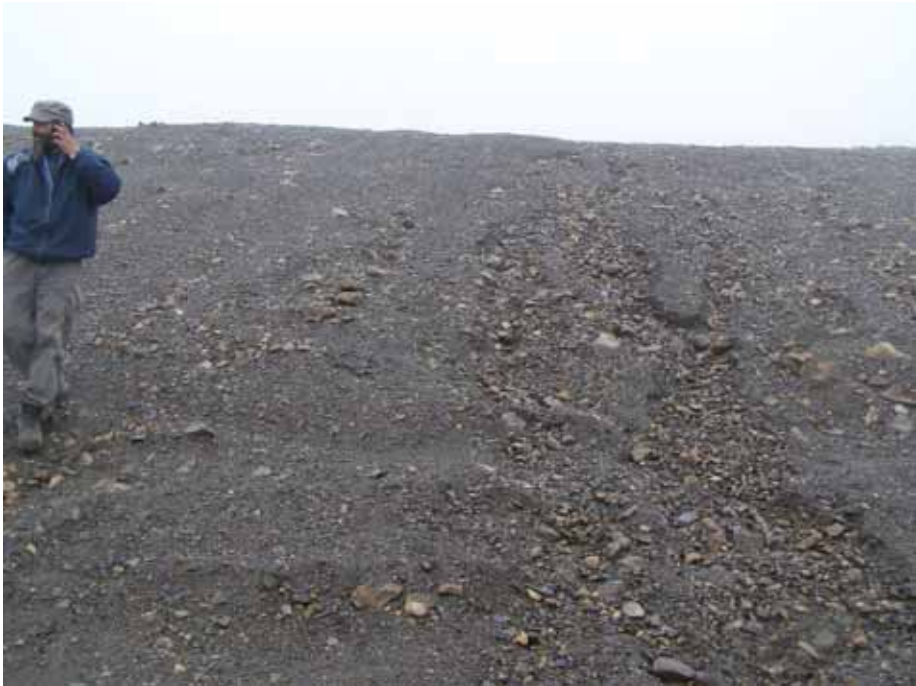
Photo 41 Minor erosion on the south face of the Oceanview Pit Cover.
