## **NANISIVIK MINE, A DIVISION OF CANZINCO LTD.**

### **2009 ANNUAL GEOTECHNICAL INSPECTION**

### **NANISIVIK MINE, NUNAVUT**

PROJECT NO.: 0255-019-03  
DATE: MARCH 26, 2010

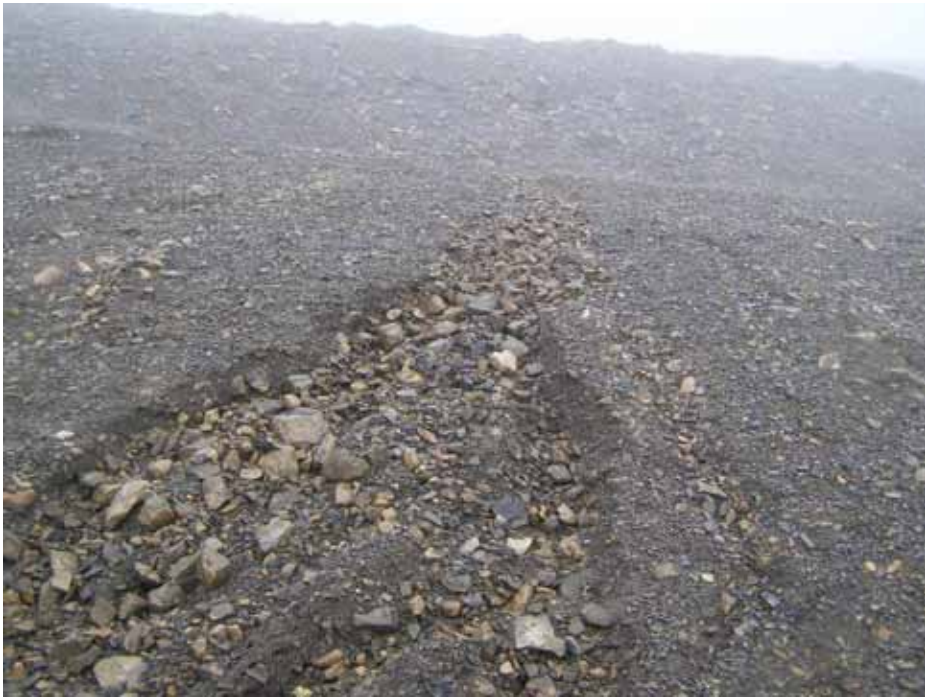
Photo 43 Minor rill erosion in southwest corner of Oceanview Open Pit cover. Note self armouring occurring. Erosion does not appear to have progressed significantly since 2008.

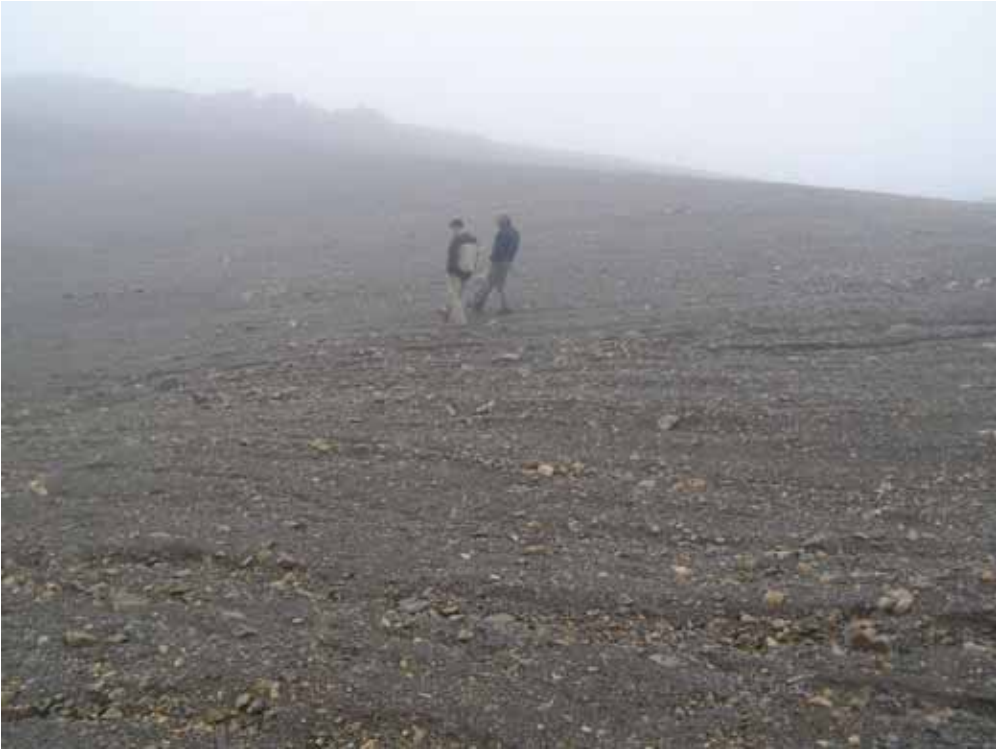
Photo 42 Minor rill erosion occurring on Oceanview Pit cover.

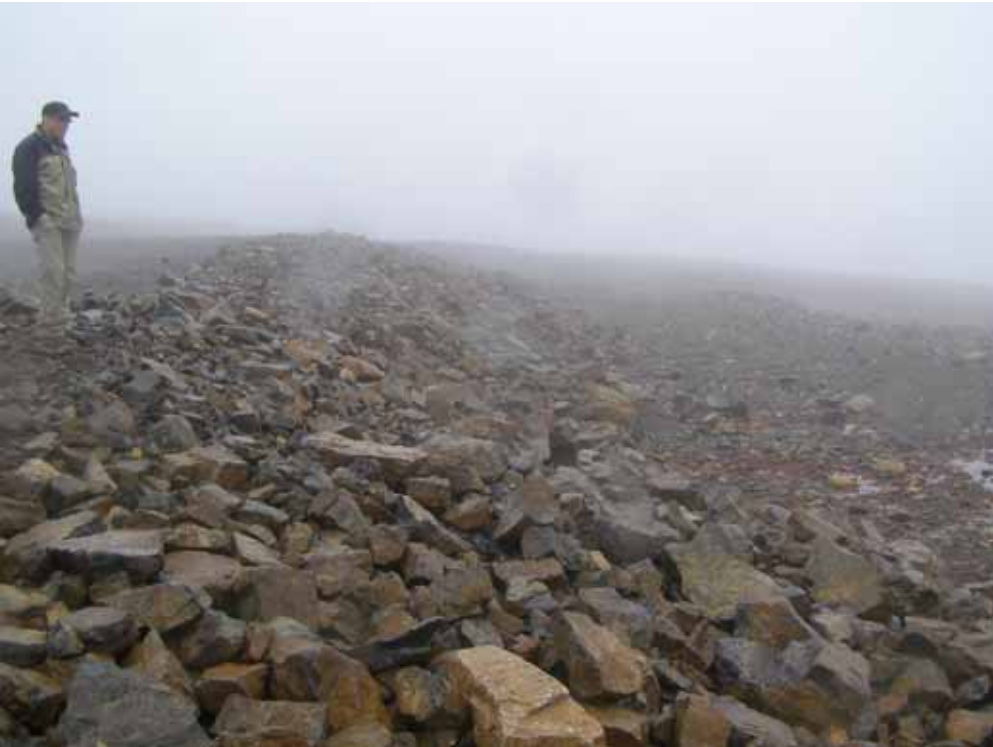
Photo 44 Rockfill placed against the toe of the Oceanview Open Pit cover.

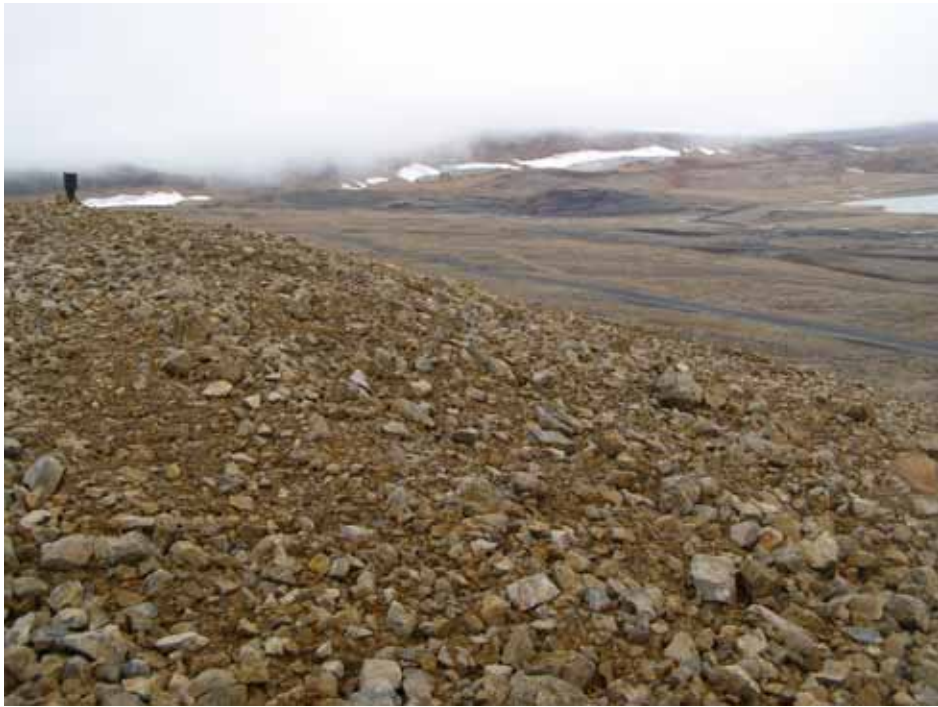
Photo 45 Face of the Area 14 Portal Cover. View looking south. Note frost gauge instrument at the crest of the slope.

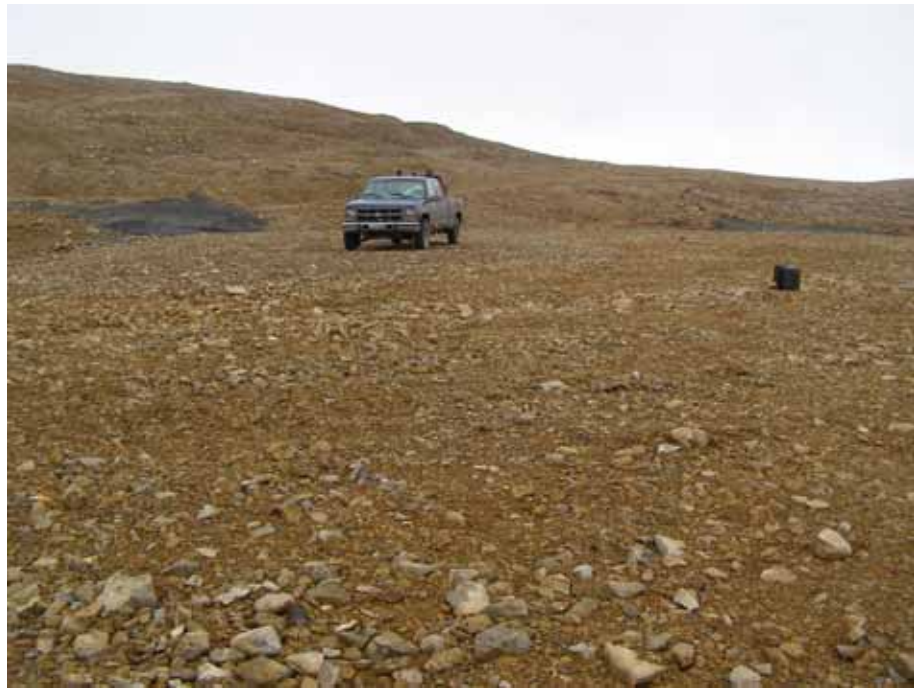
Photo 46 Upper flat surface of the Area 14 waste rock cover.

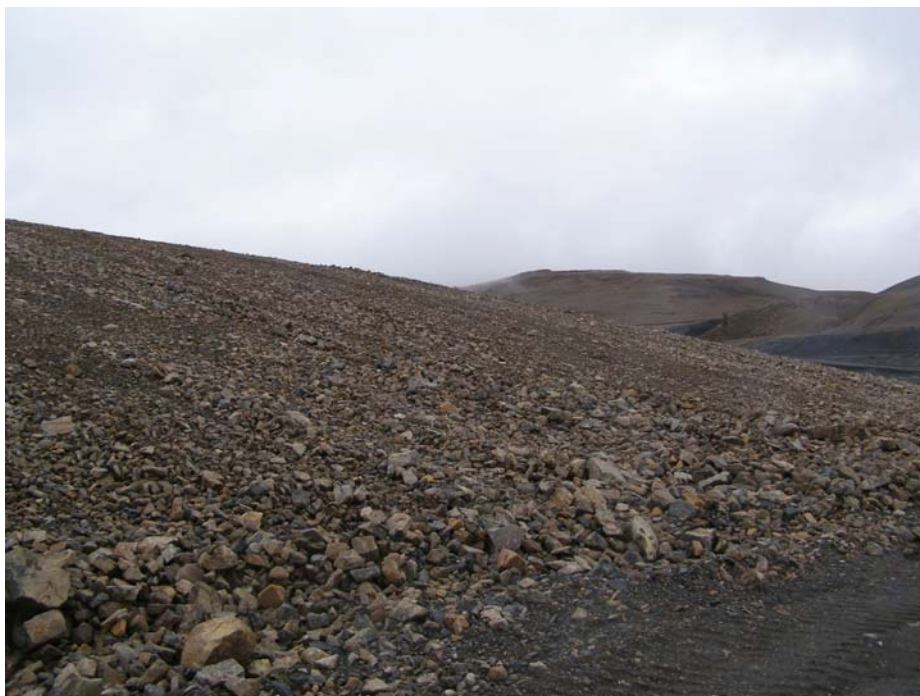
Photo 48 Northeast slope of the Industrial Complex cover.

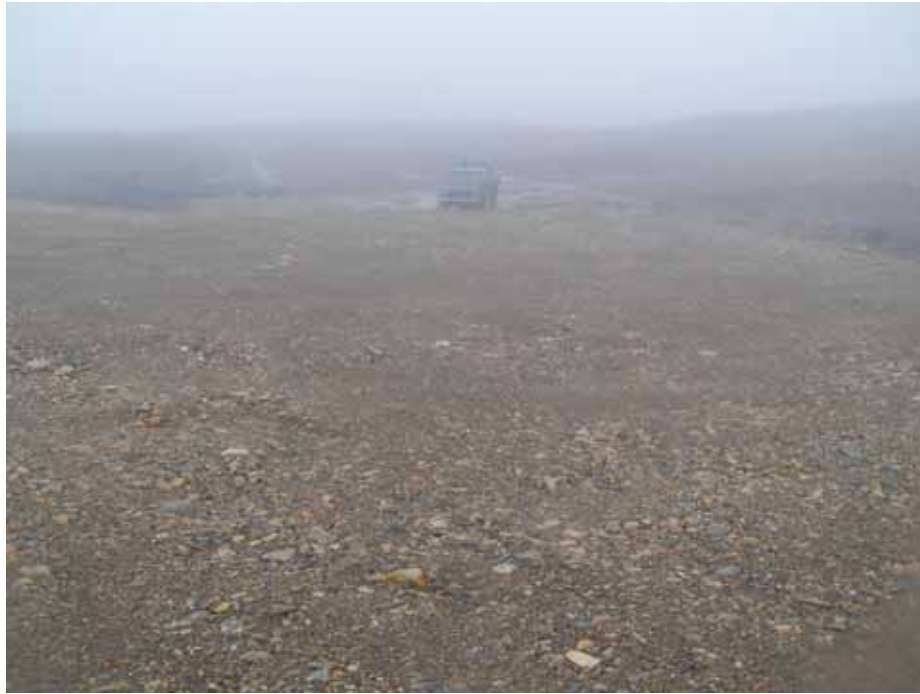
Photo 49 Surface of the 17N Portal Cover looking downslope.

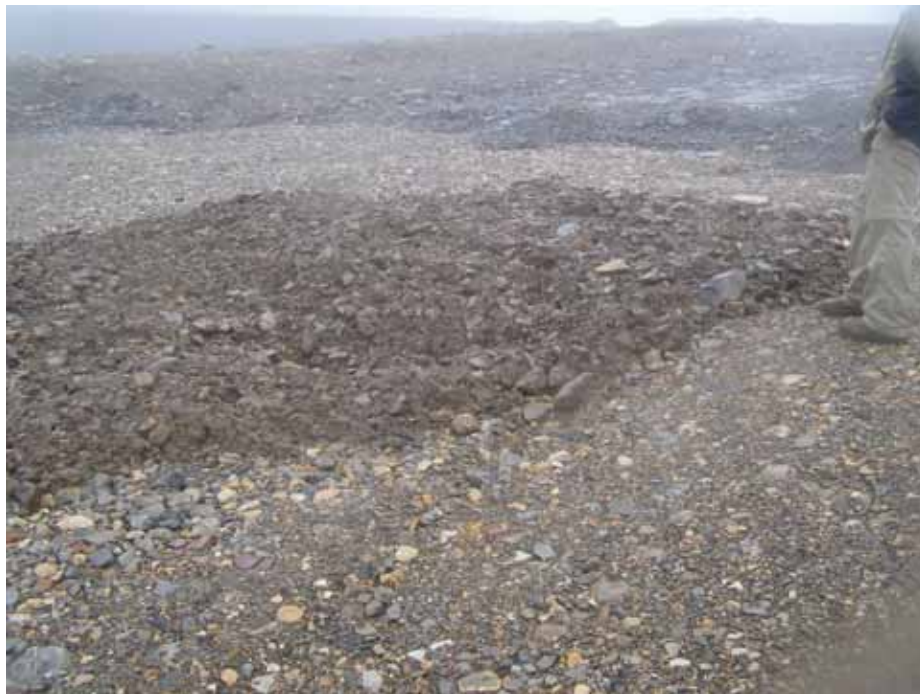
Photo 50 Backfilled thermokarst feature in 17N Portal Cover. Note that it is continuing to show signs of surficial disturbance.

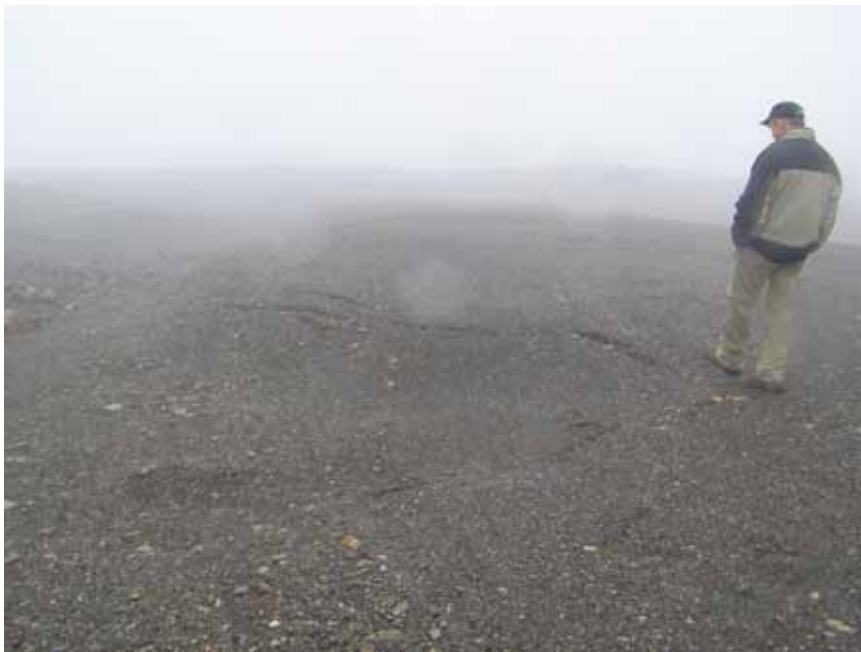
Photo 51 Settlement depression at the southwest corner of the Oceanview Portal cover. Note that the depression does not appear to have progressed since 2008.

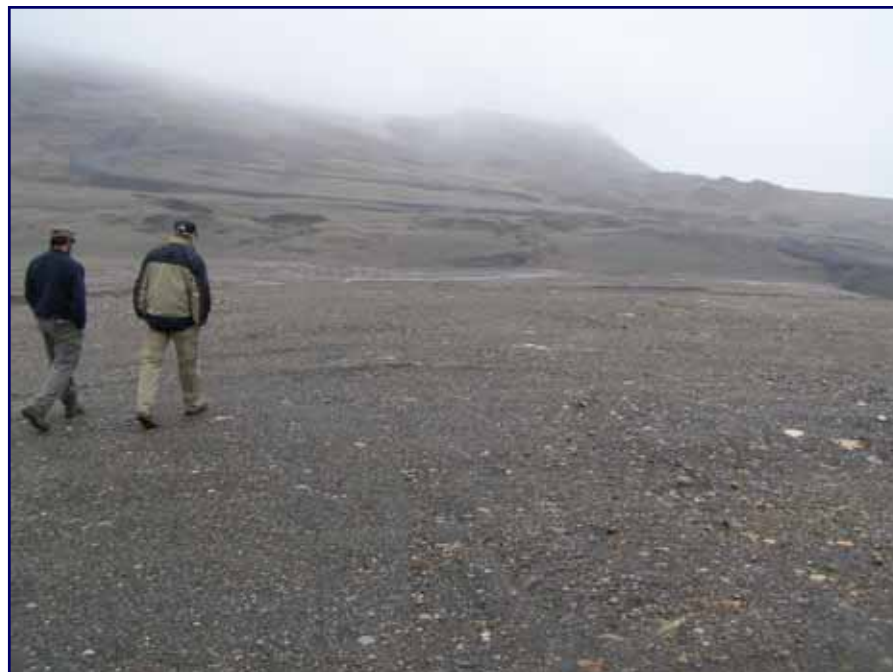
Photo 54 Surface of upper flatter portion of K-Baseline Portal Cover.

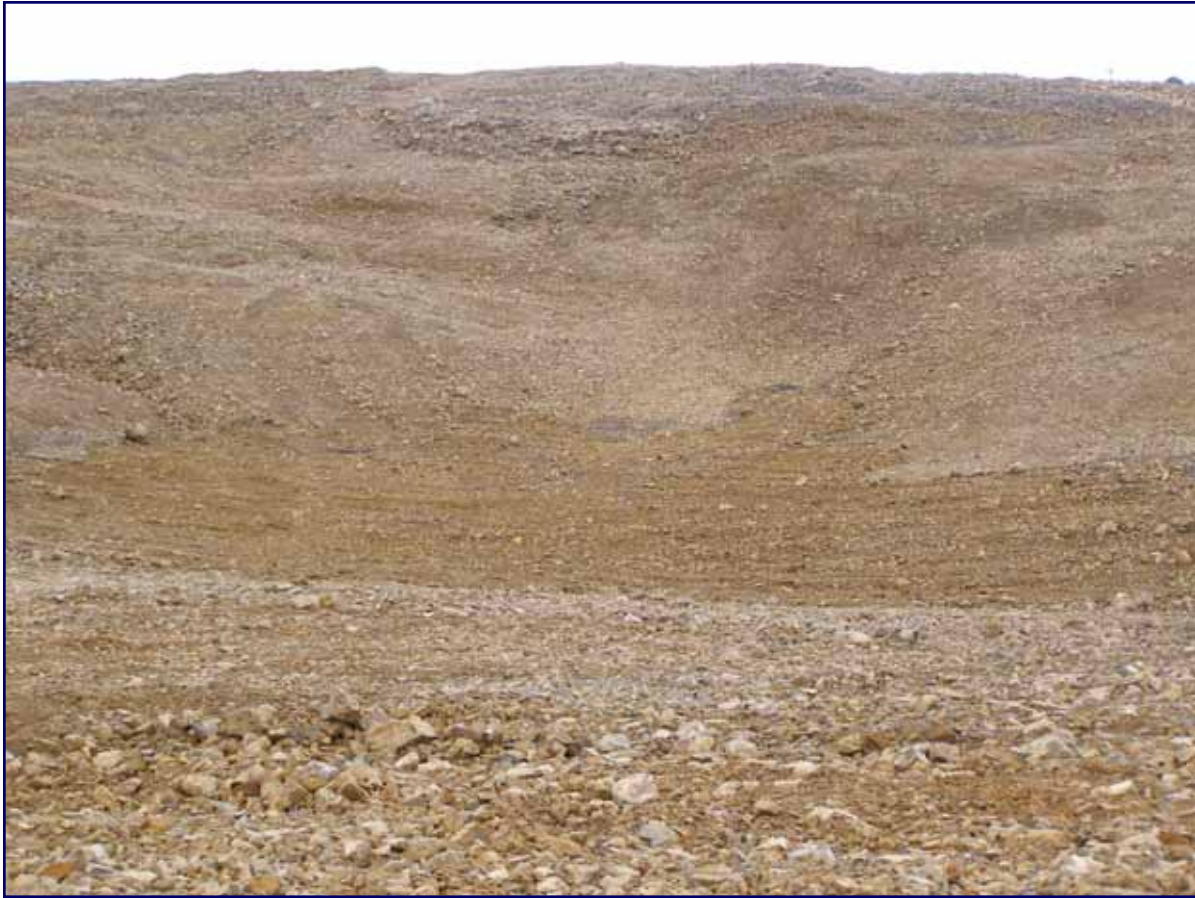
Photo 55 Armoured Surface Area 14 Portal plug.

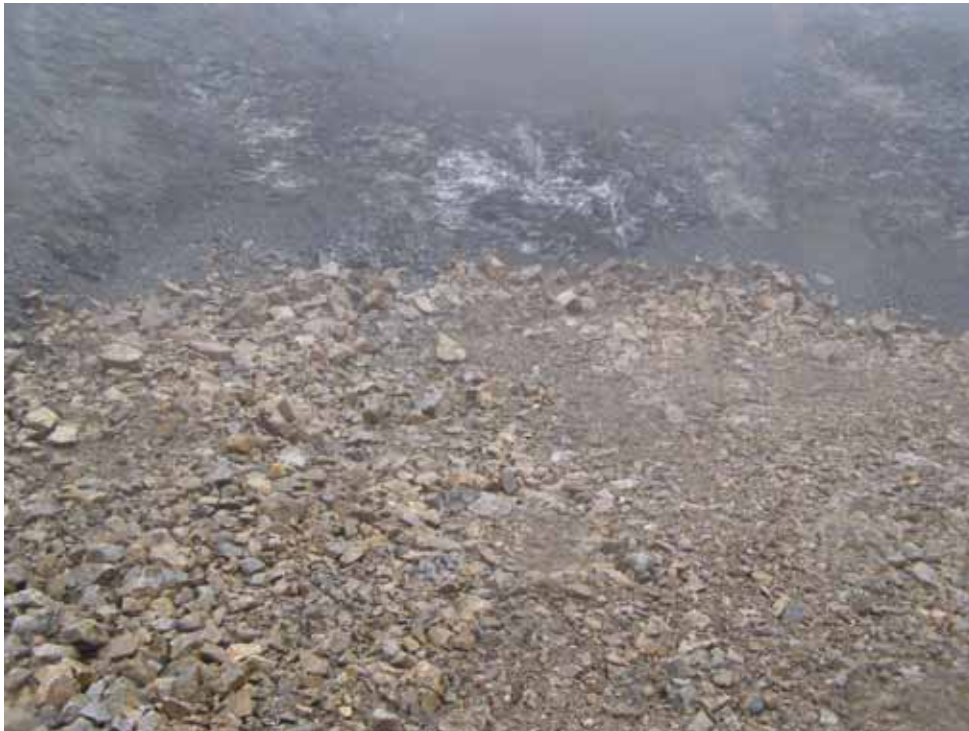
Photo 56 Surface of 09 South Portal Plug where cover butts against crown pillar.

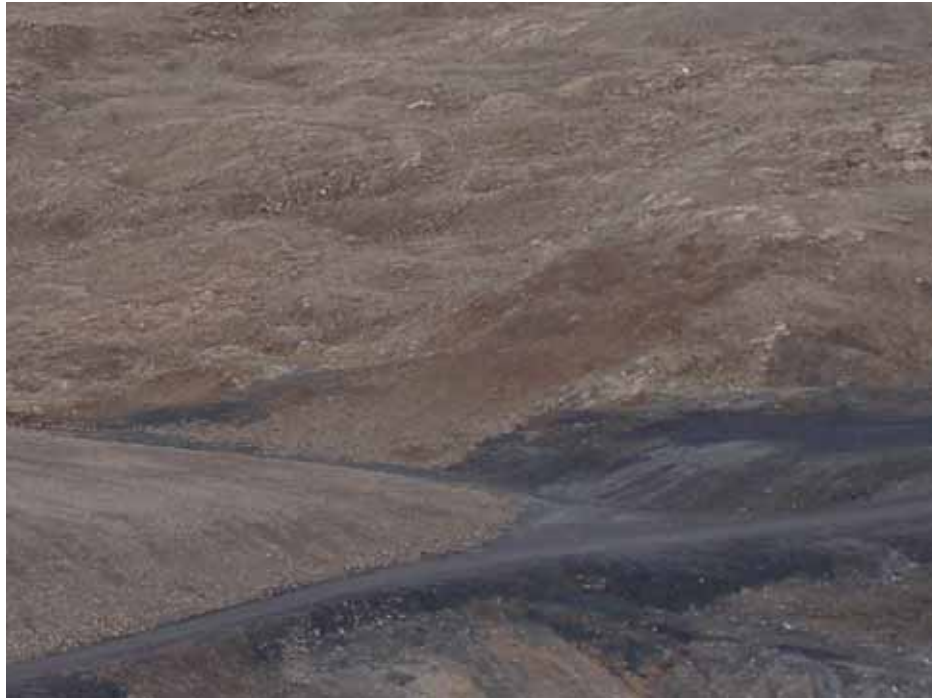
Photo 58 Lower Adit cover as seen from Stol Port.

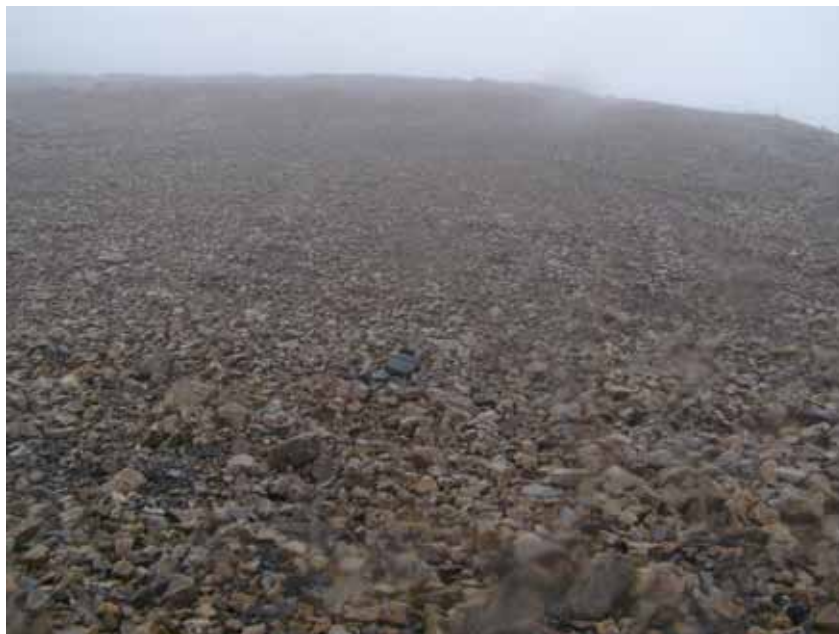
Photo 59 Surface of Lower Adit cover as seen toe area.

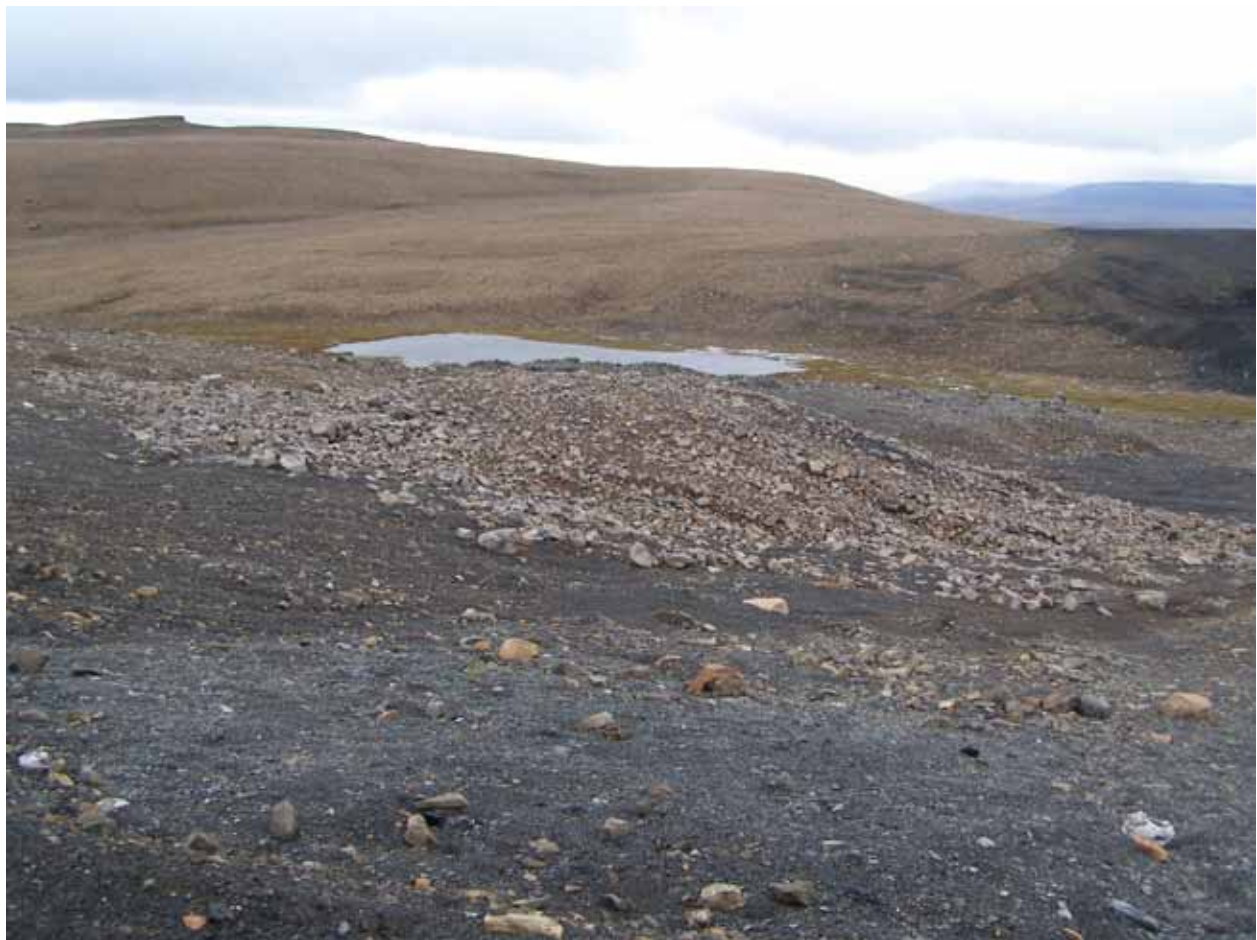
Photo 61 Shale Hill Raise cover.

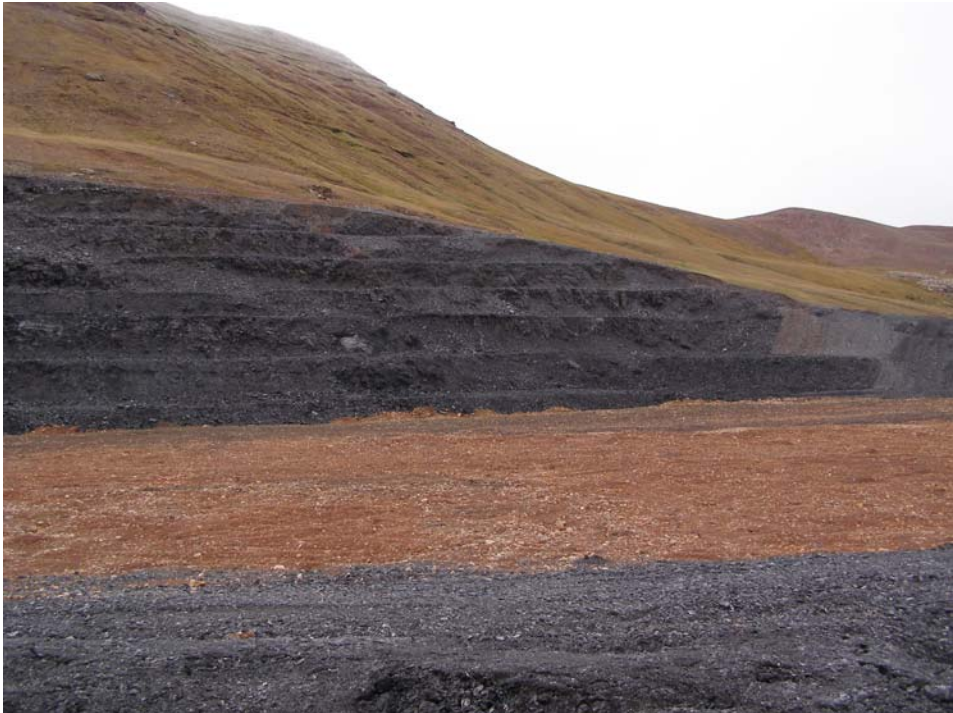
Photo 62 Mt. Fuji shale borrow area. Note that slopes are falling and are naturally reclaiming to the angle of repose.

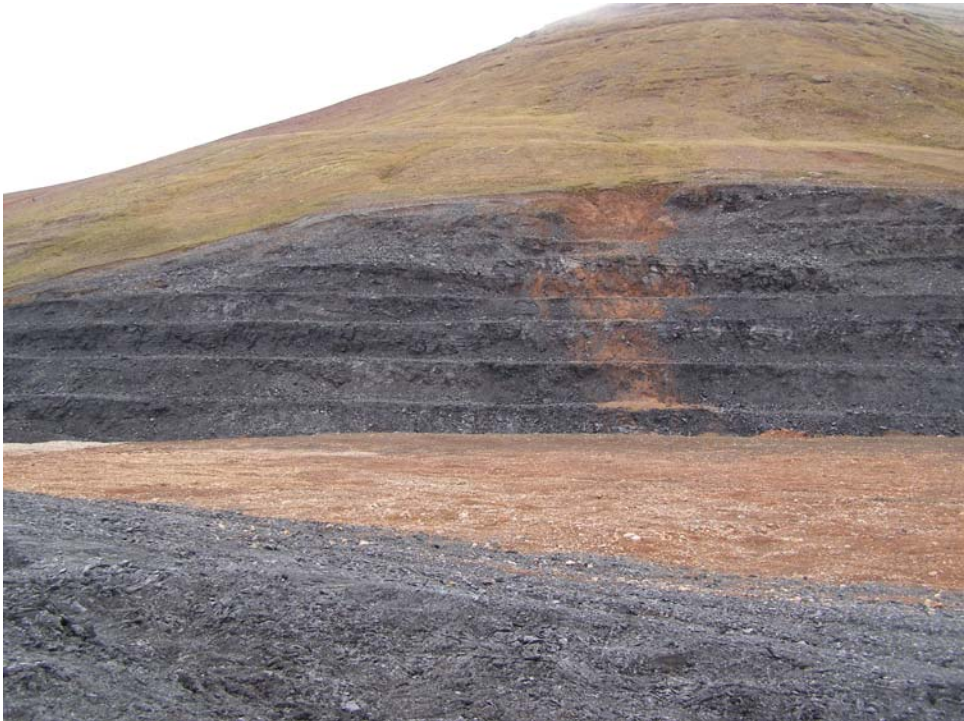
Photo 64 Mt. Fuji shale borrow area. Note the natural cover material is falling down from above over the benches.

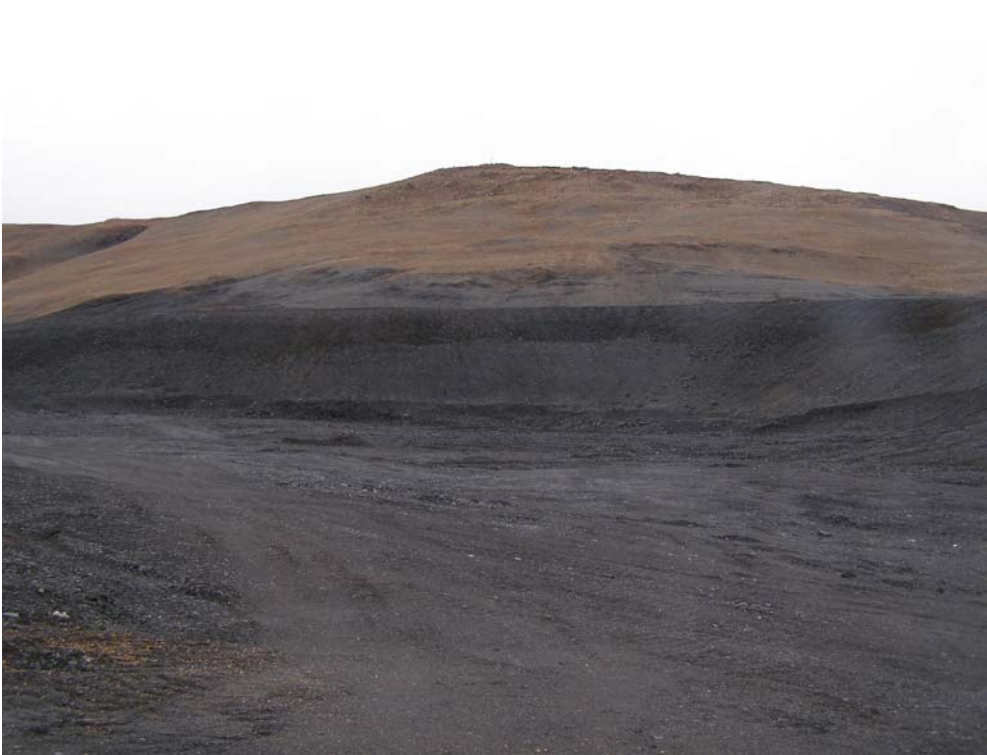
Photo 63 Re-contoured Townsite shale borrow area.

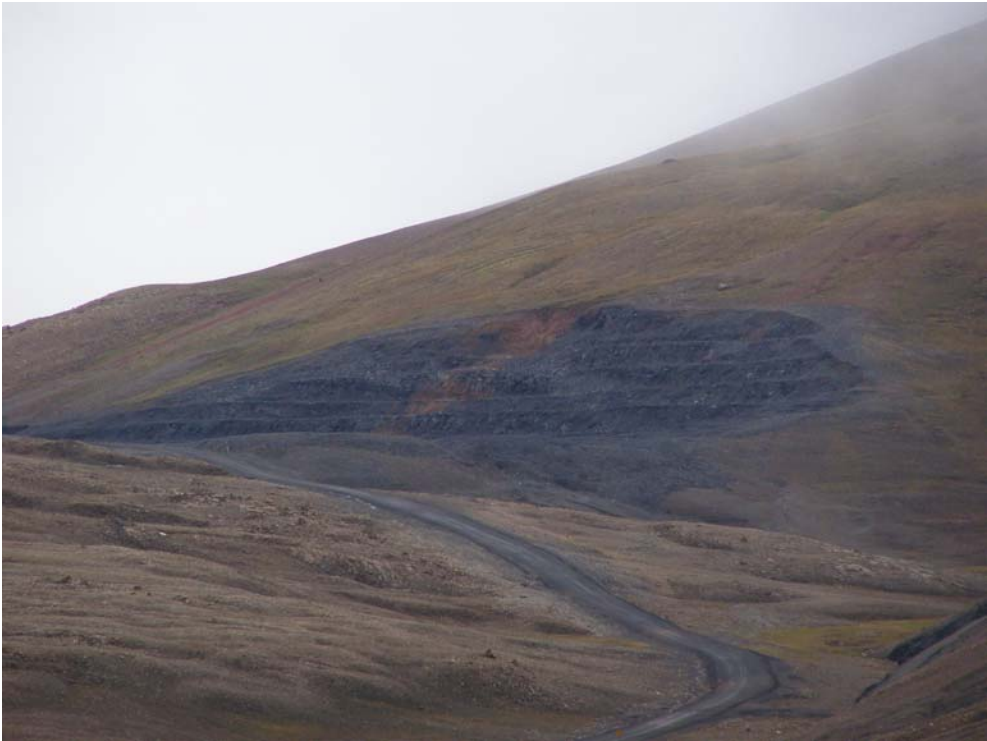
Photo 65 Mt. Fuji shale borrow area as seen from the Stol Port.

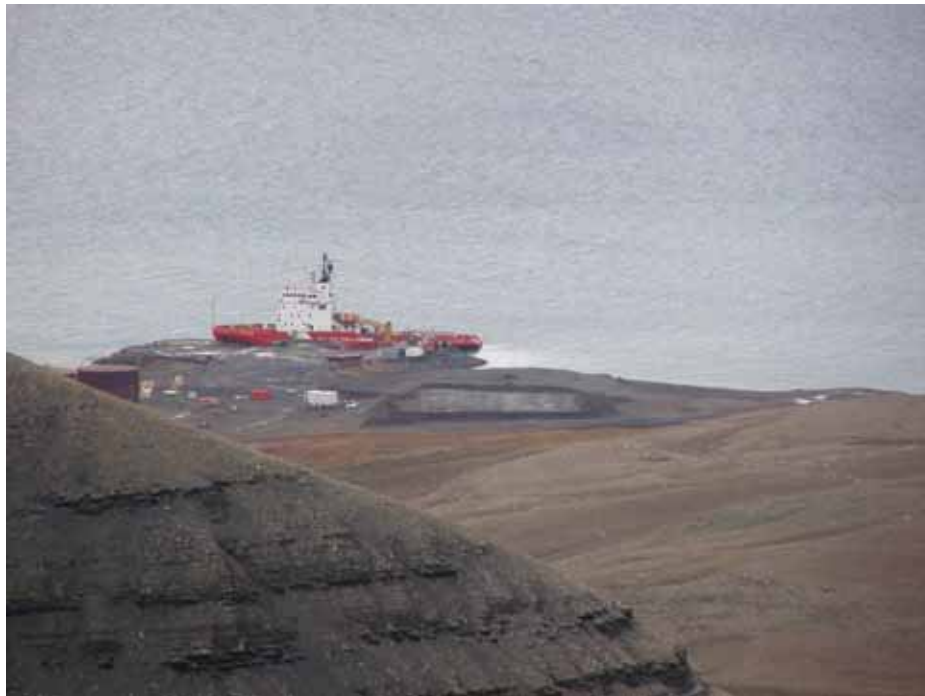
- A portion of the surficial cover over the remnant concrete pad had been removed by the Coast Guard.
- No erosion of the remaining cover was observed.
- No seepage from the cover area was noted.
- No ponding was noted on the surface of the cover or any areas immediately adjacent to the cover.

Photo 66 Concentrate Storage shed floor as seen from Stol Port. Note that a large section has been exposed as the cover was removed.

It was recommended that the removed portion of the Concentrate Storage Shed surficial cover be returned to a satisfactory condition.

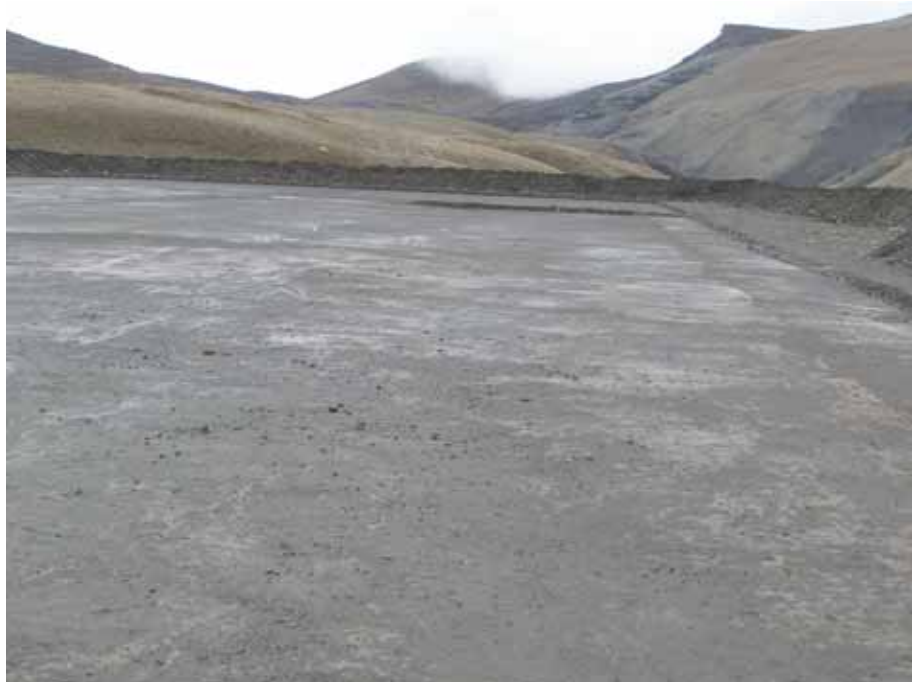
Photo 67 Exposed Concentrate Storage Shed floor. Cover was recently removed by the Coast Guard.
