NANISIVIK MINE, NUNAVUT

2013 ANNUAL GEOTECHNICAL INSPECTION

PROJECT NO.: 0255-023
DATE: February 27, 2014
DOCUMENT NO.:

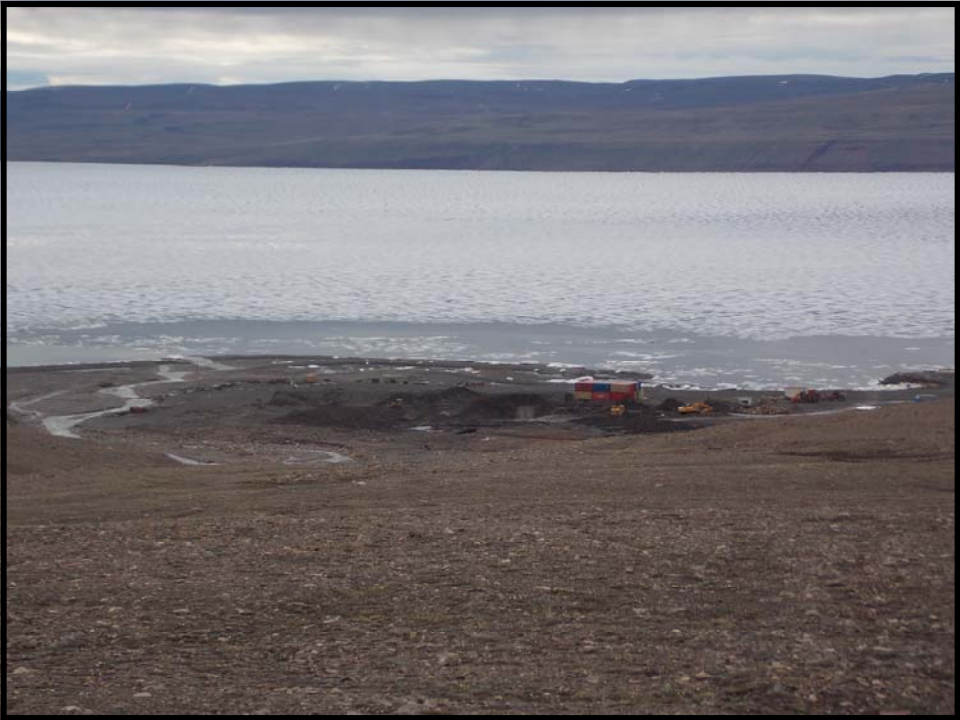
Photo 1. Main Tank Farm—As seen from road up to townsite.

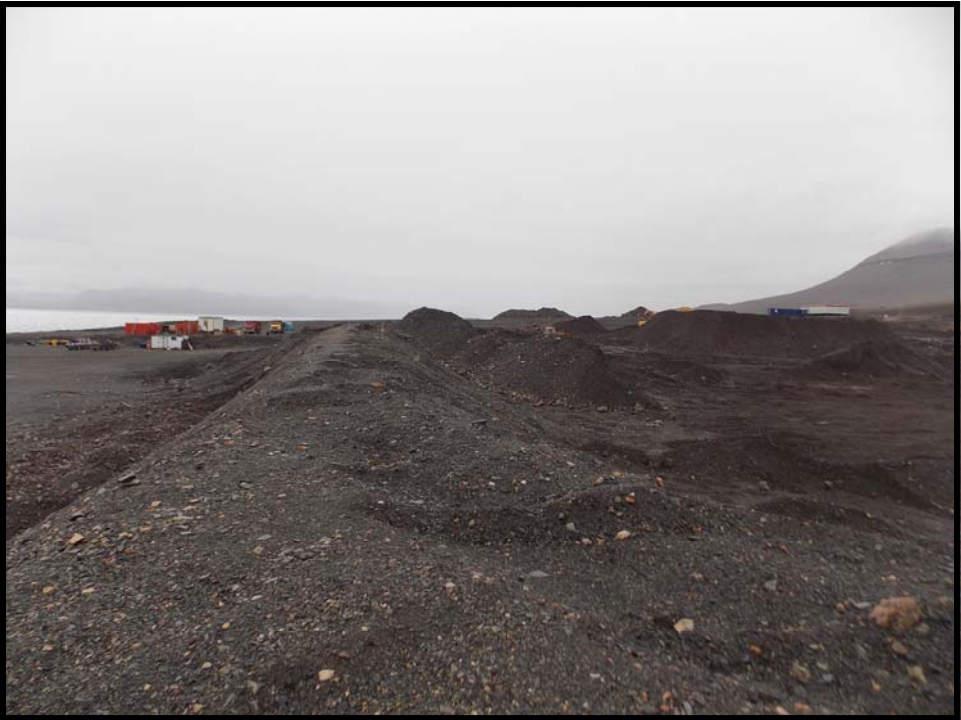
Photo 2. Main Tank Farm—Remnant perimeter dyke in location of old water retention pond.

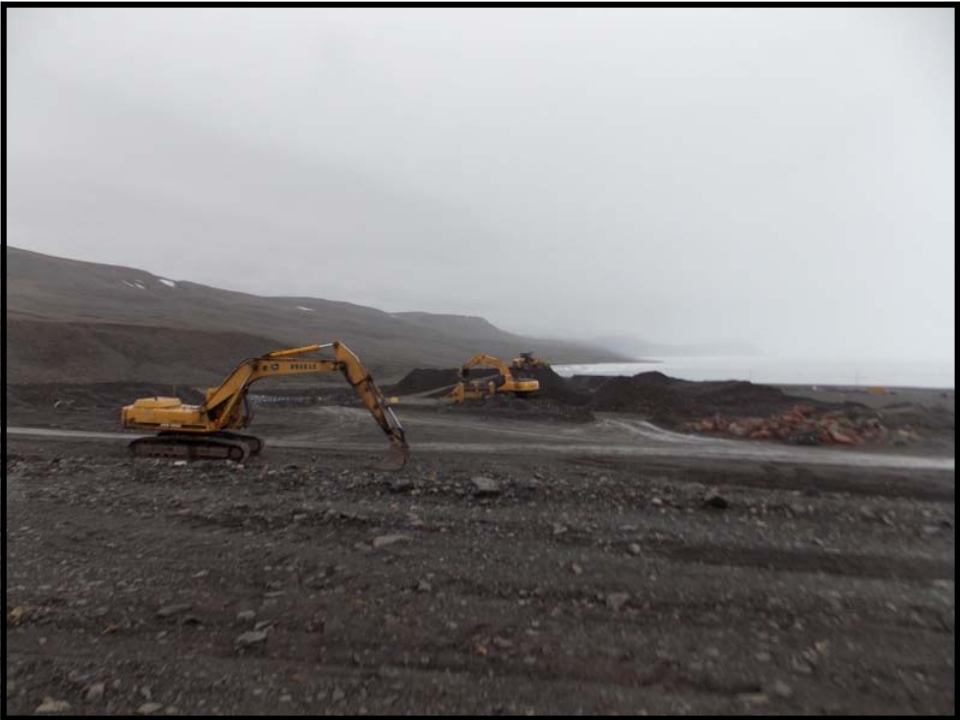
Photo 3. Main Tank Farm and excavation spill pile.

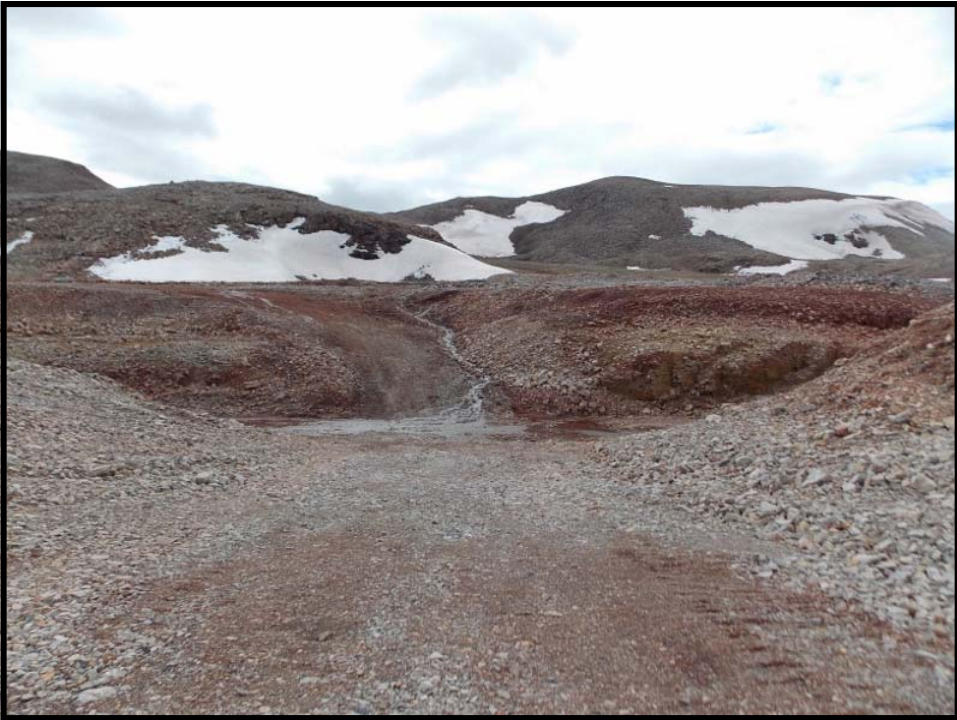
Photo 5. West Twin Dyke Spillway—Ramp into the bottom of the West Twin Dyke Spillway.

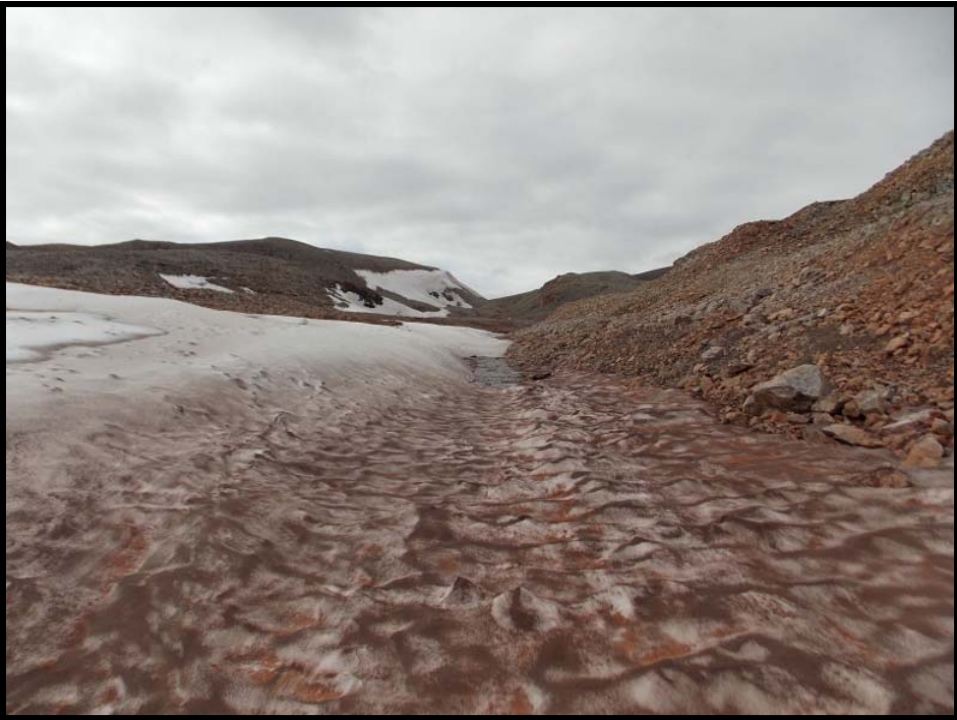
Photo 6. West Twin Dyke Spillway—Looking up gradient.

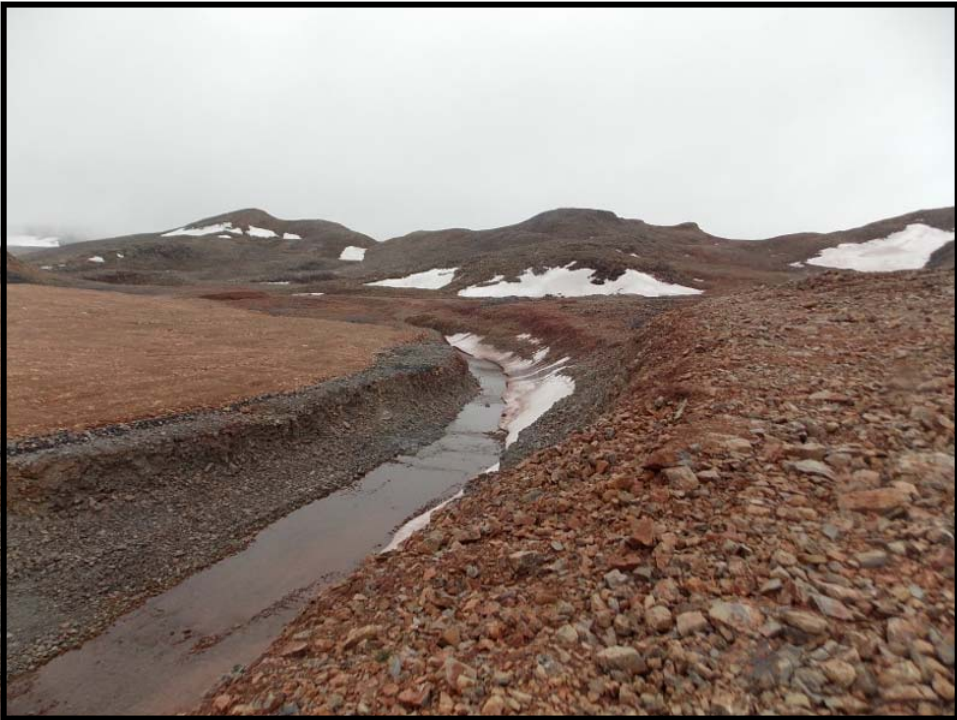
Photo 7. West Twin Dyke Spillway—Looking down gradient.

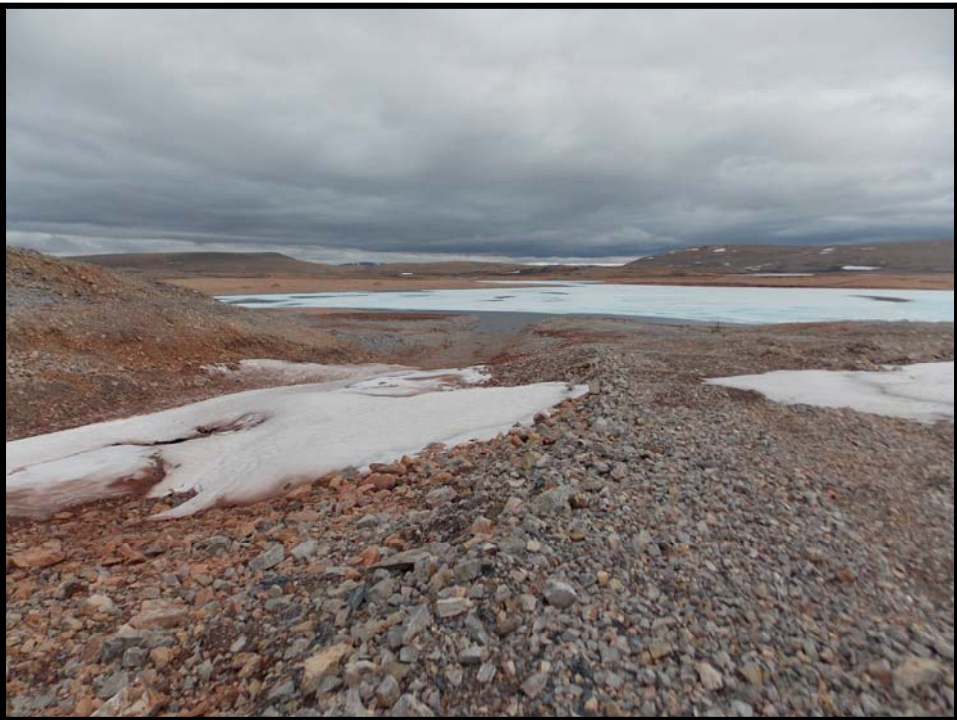
The West Twin Dyke Spillway continues to effectively drain surface water from the Surface Cell cover into the Reservoir and is generally functioning as intended. Some erosion of the side wall was noted in the past, likely in response to elevated flows during freshet. Re-sloping and placement of additional armour in erosion areas was completed during the 2012 inspection. The remediation work was reviewed during the 2013 inspection and was noted to be in good condition.

Photo 8. West Twin Dyke Spillway—Outlet.

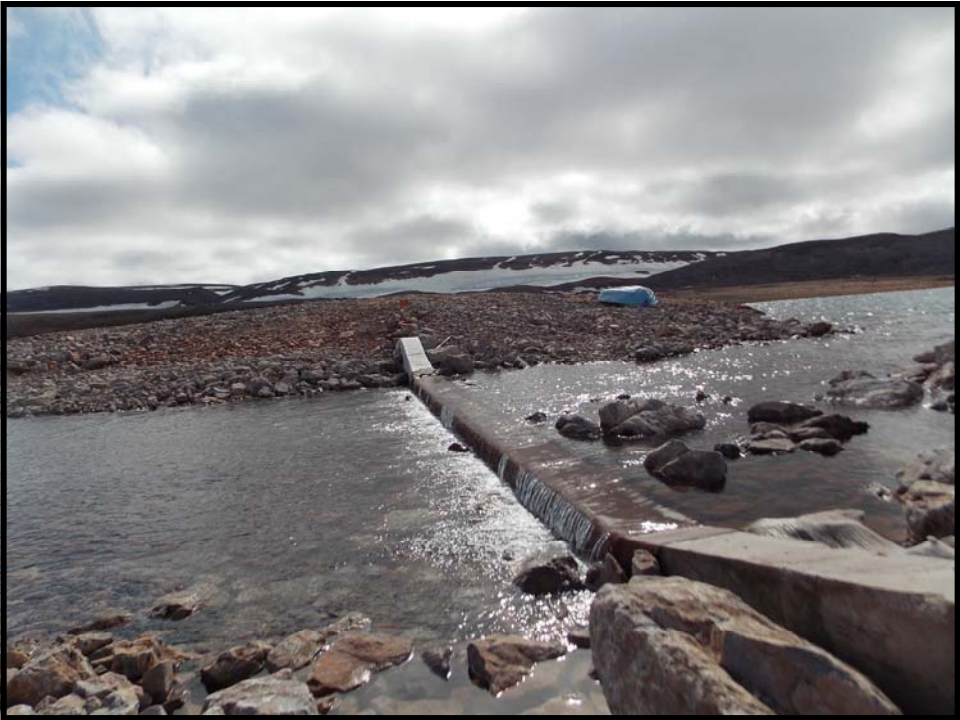
Seepage losses continued at the West Twin Outlet wall in 2013. Despite these seepage losses, the water level in the remnant polishing pond upstream of the wall remained near the invert of the outlet wall throughout the open water season in 2013. The stable water level in the Reservoir is thought to reflect the generally wetter than normal conditions at site in 2013 as opposed to being indicative of reduction in seepage losses. Increased instability in the shoreline of the polishing pond was also noted in 2013. Based on the water quality measurements collected since the East Twin Lake access road was breached in 2008, the seepage losses through the foundation of the wall do not appear to be affecting the overall performance of the West Twin Area reclamation measures. The seepage losses at the wall should continue to be monitored and additional seepage control measures should be considered.

Photo 9. West Twin Outlet Channel—Note water running over wall.

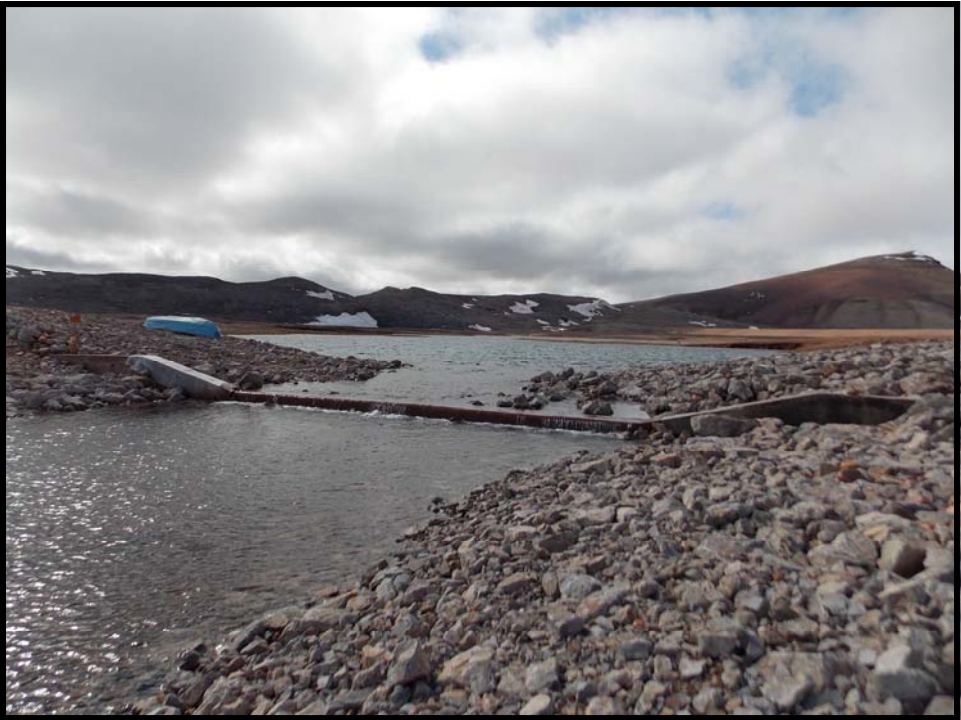
Photo 10. West Twin Outlet Channel—Looking upstream.

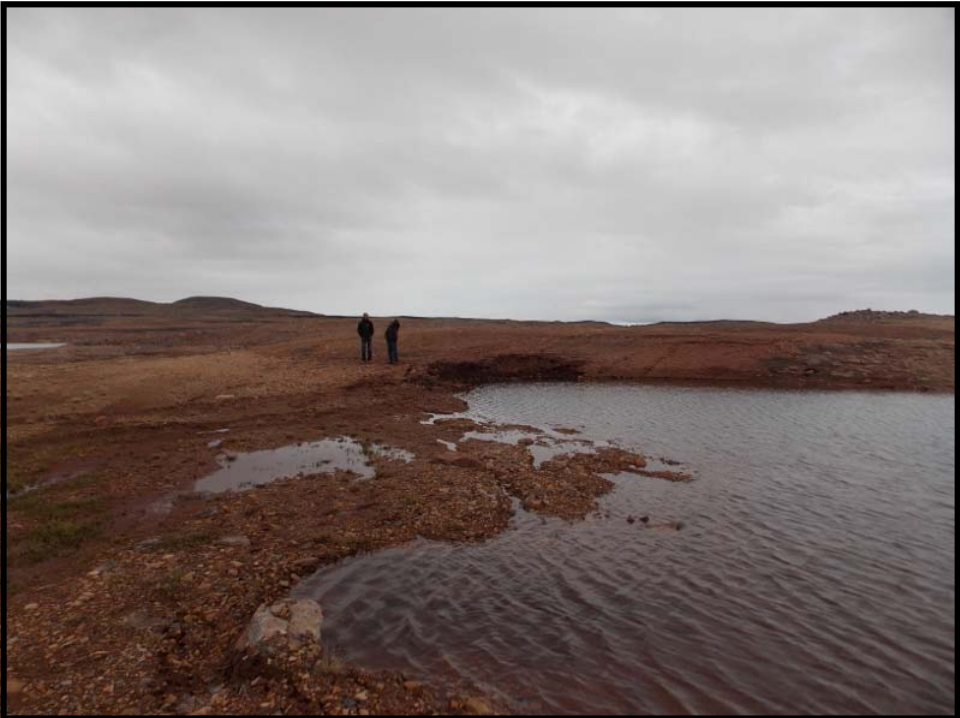
Photo 11. West Twin Outlet Channel—Slumping and thermokarst along shoreline of polishing pond.

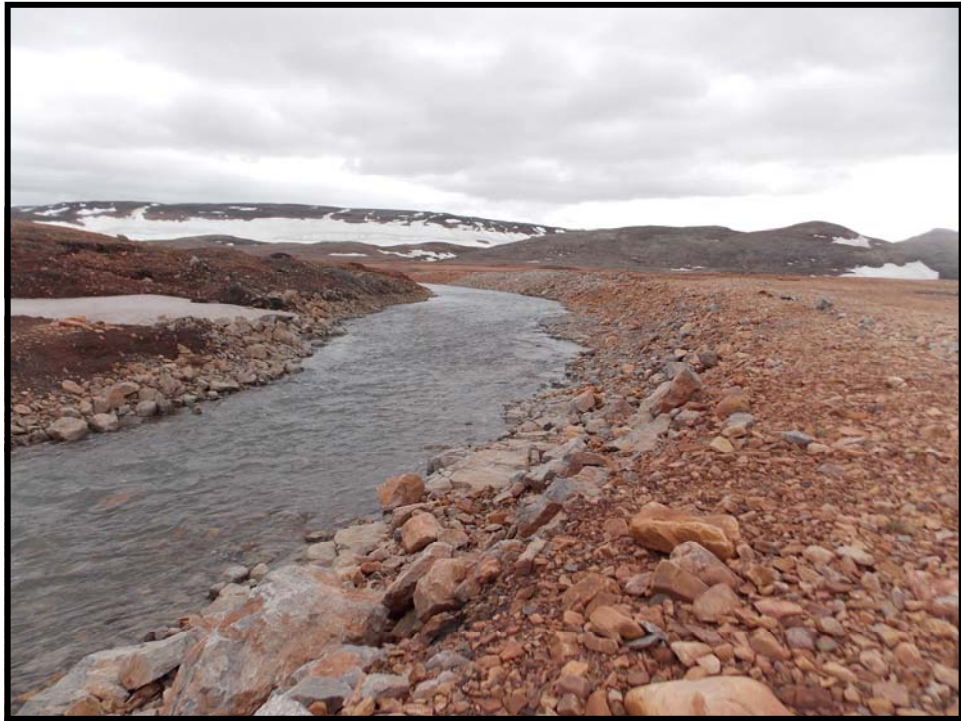
Photo 12. East Twin Creek Diversion Channel—View looking up gradient.

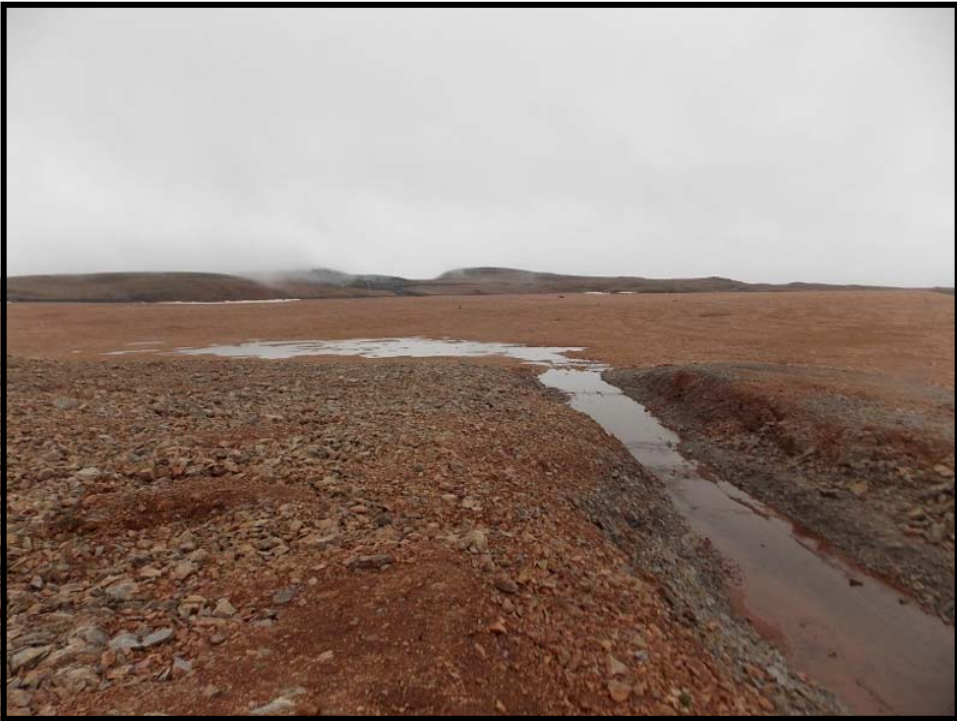
As observed during previous inspections, a small head pond developed on the Surface Cell cover at the spillway inlet. The presence of the head pond is not considered to negatively impact the overall cover performance; hence the elimination of the head pond is not considered necessary. Reduction in pond size may continue over time as the intact rock in the base of the spillway inlet becomes more permeable due to freeze thaw effects.

Photo 15. Surface Cell—General spillway entrance from crest of right bank on spillway.

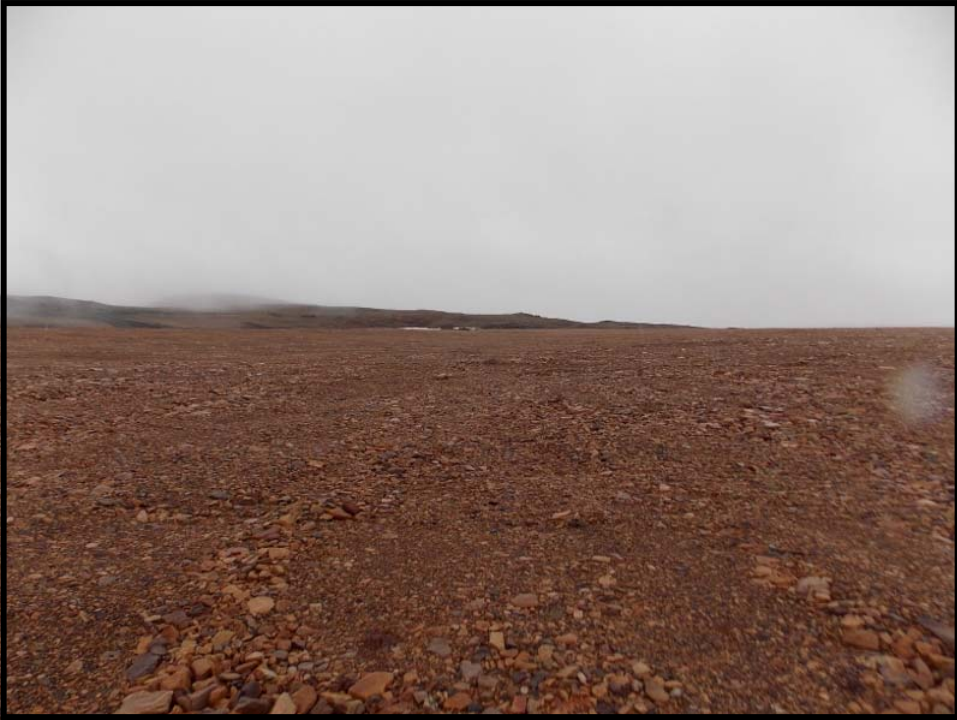
Photo 17. Surface Cell—Cover System.

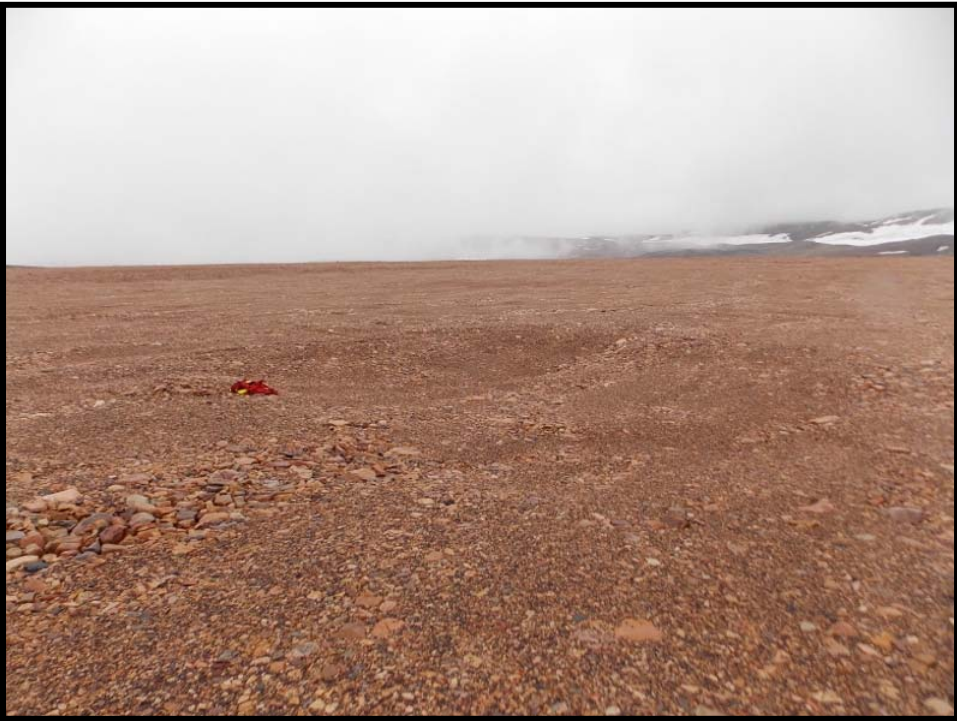
Photo 16. Surface Cell—Settlement area just north of E/W drainage swale.

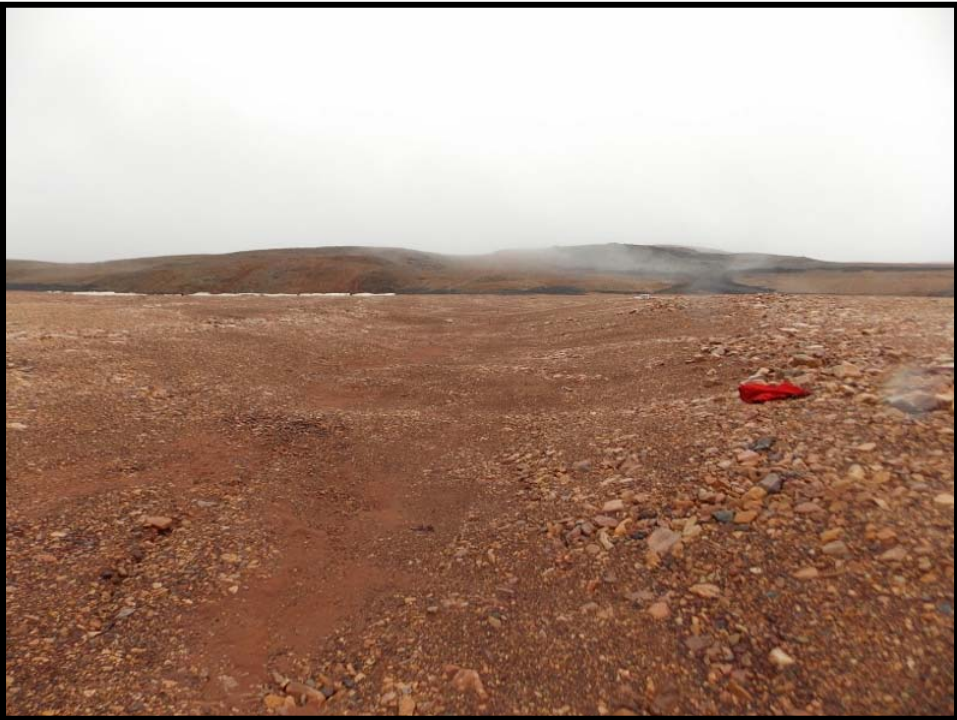
Photo 18. Surface Cell—E/W drainage channel on Surface Cell cover. View looking west.

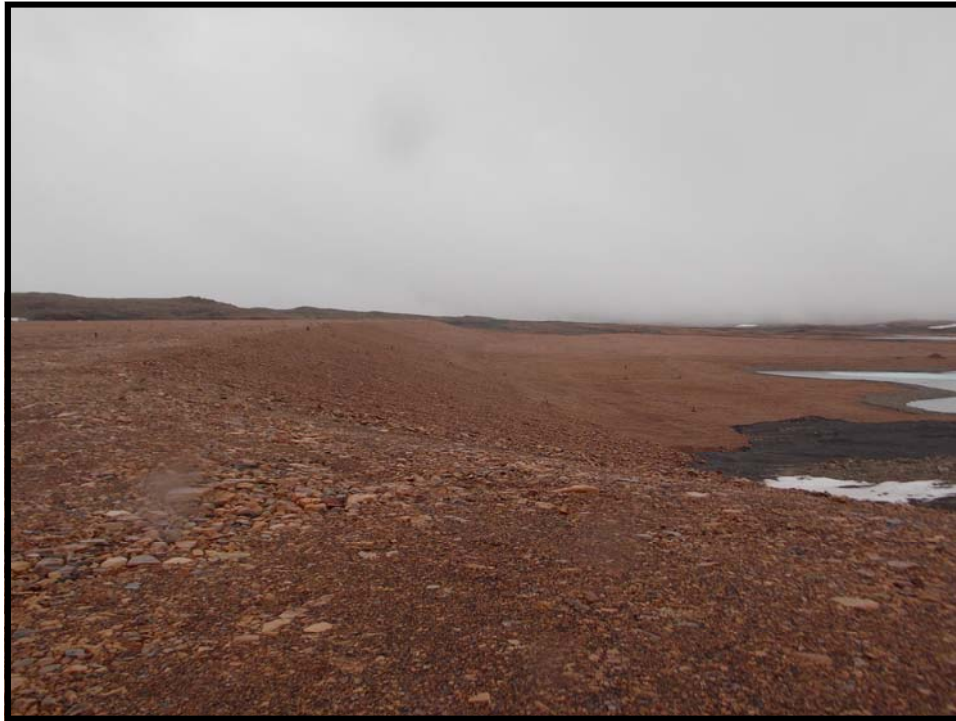
Photo 19. West Twin Dyke—As seen from right (south) abutment.

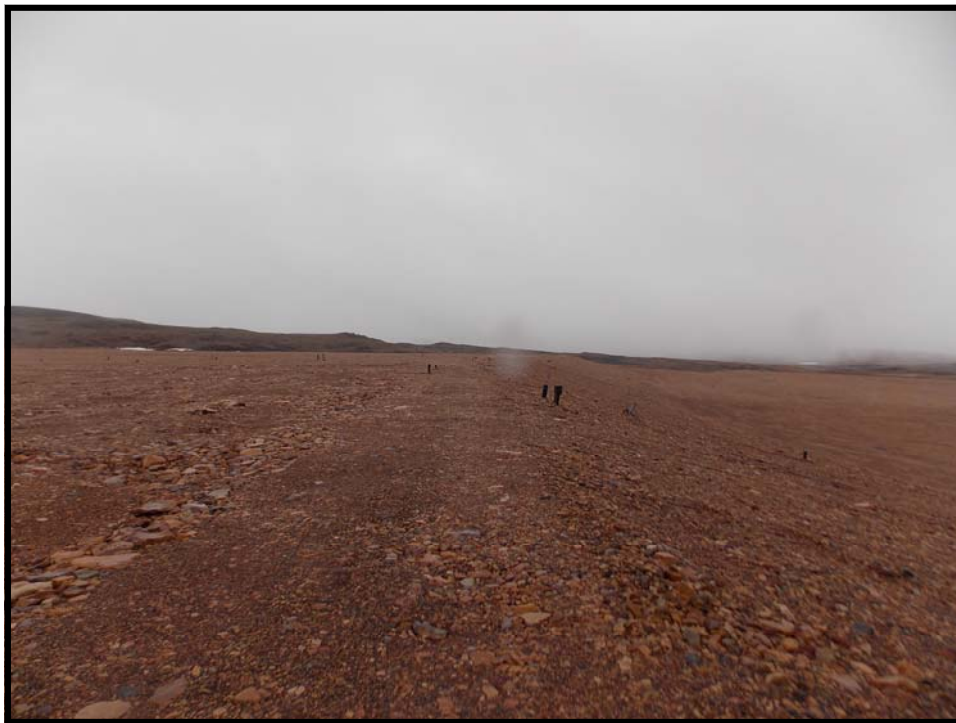
Photo 20. West Twin Dyke—View along crest of dyke looking north.

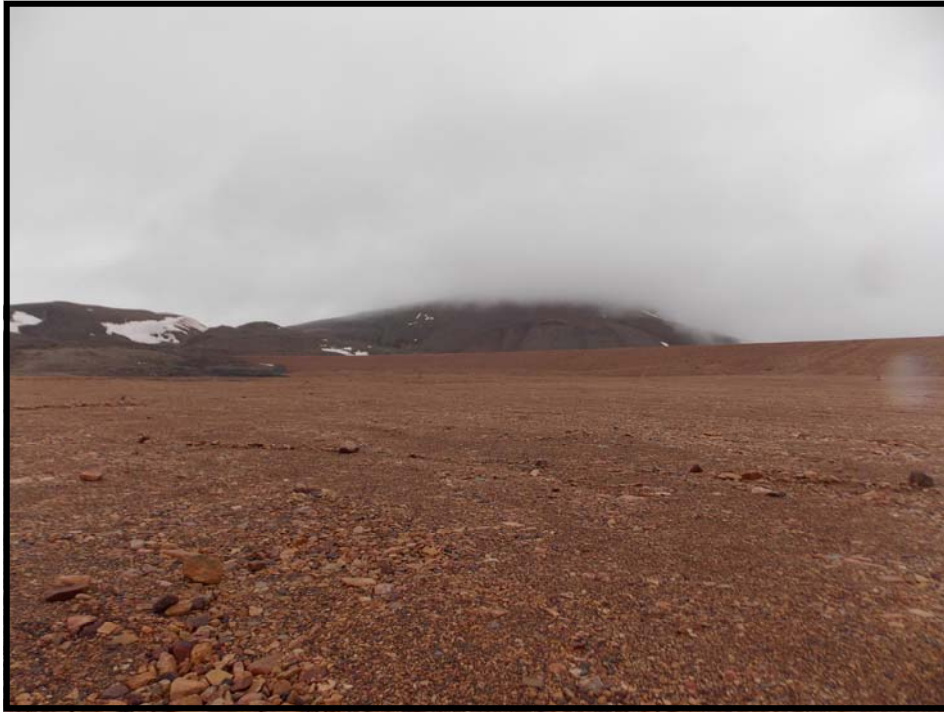
Photo 21. Test Cell—Surface of Test Cell cover.

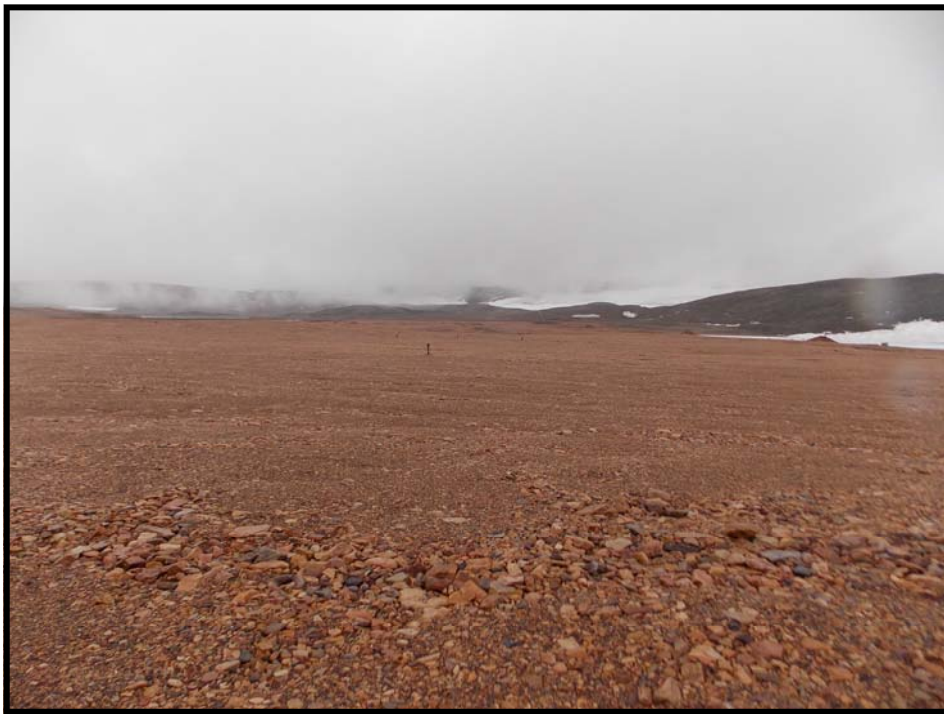
Photo 22. Test Cell—Surface of Test Cell cover.

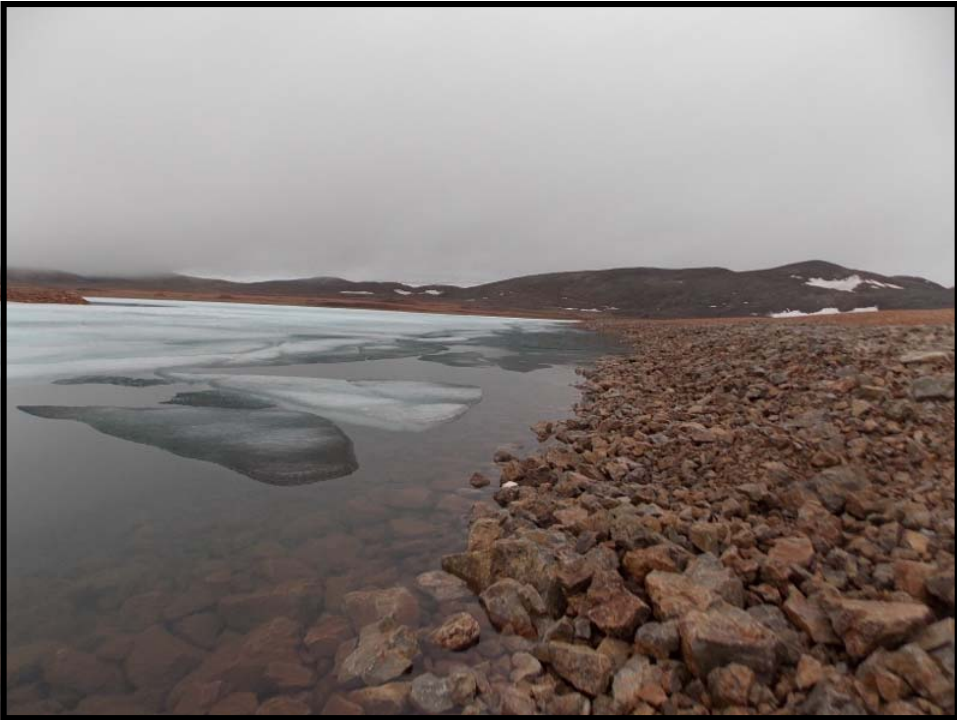
Photo 23. Toe of Test Cell Dyke—At Reservoir edge. Note ice pan on Reservoir.

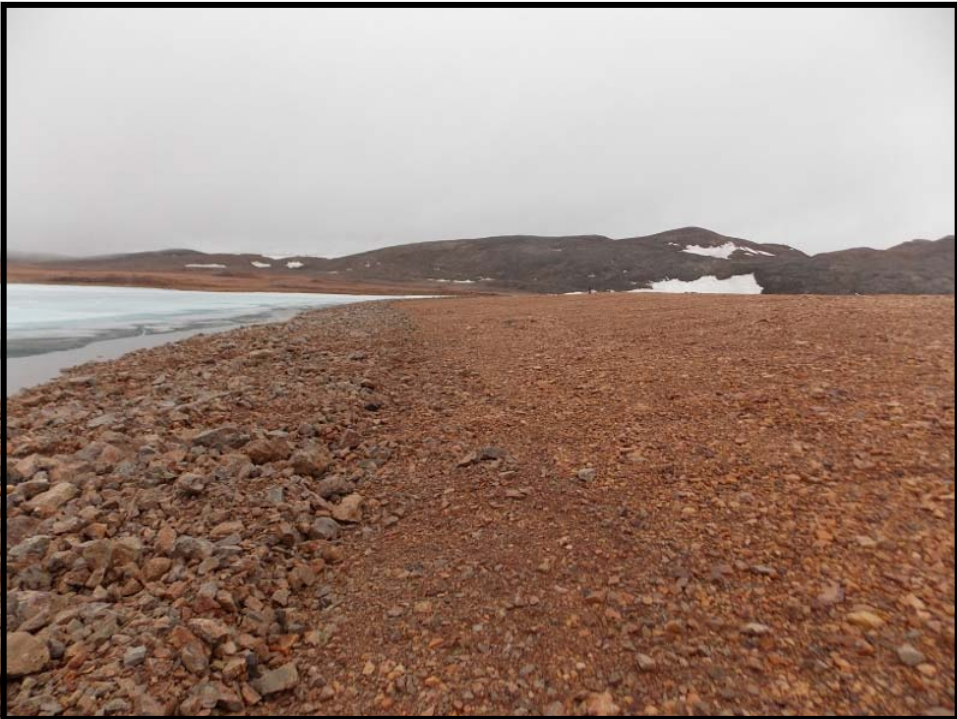
Photo 25. Toe of Test Cell Dyke—North/South arm, view looking south.

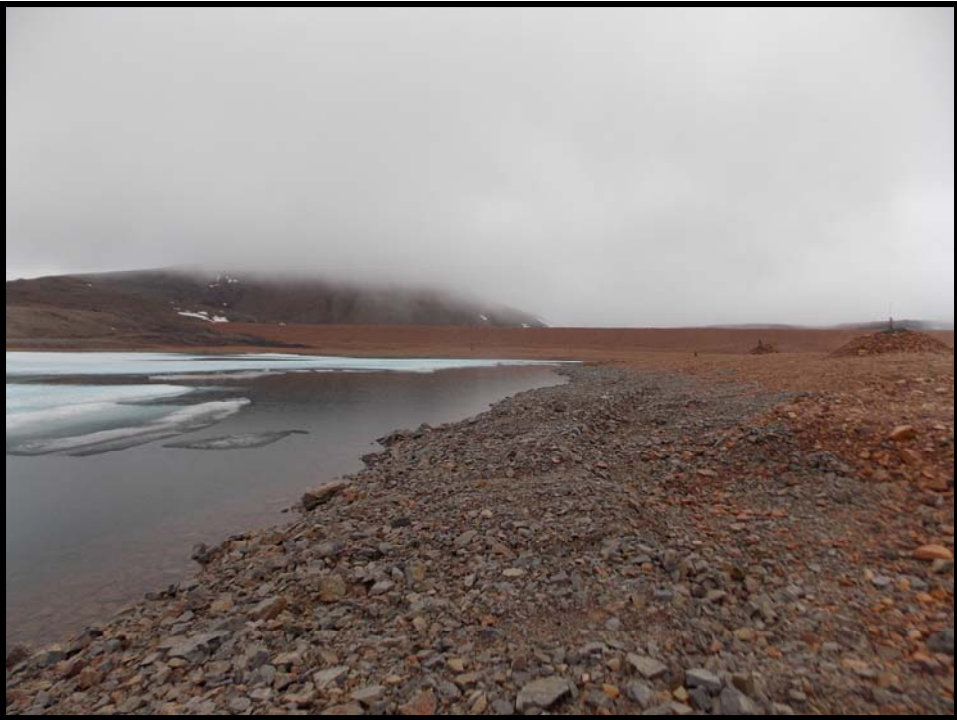
Photo 24. Toe of Test Cell Dyke—Armour along shoreline of cover at toe of Test Cell Dyke. East/West arm, view looking west.

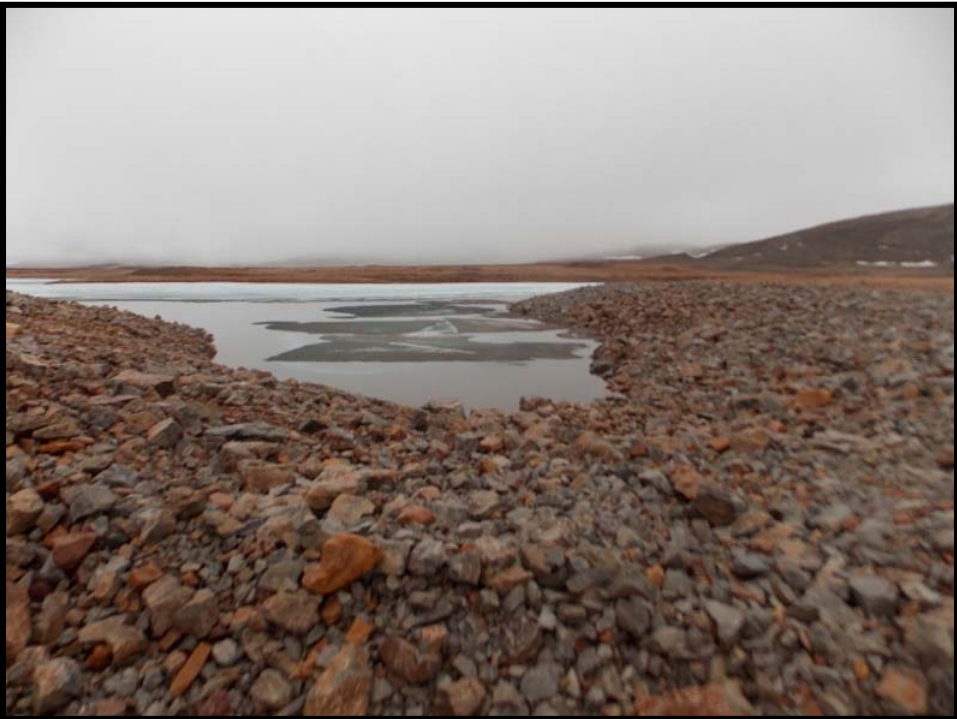
Photo 26. Toe of Test Cell Dyke—Outlet of Test Cell Cover

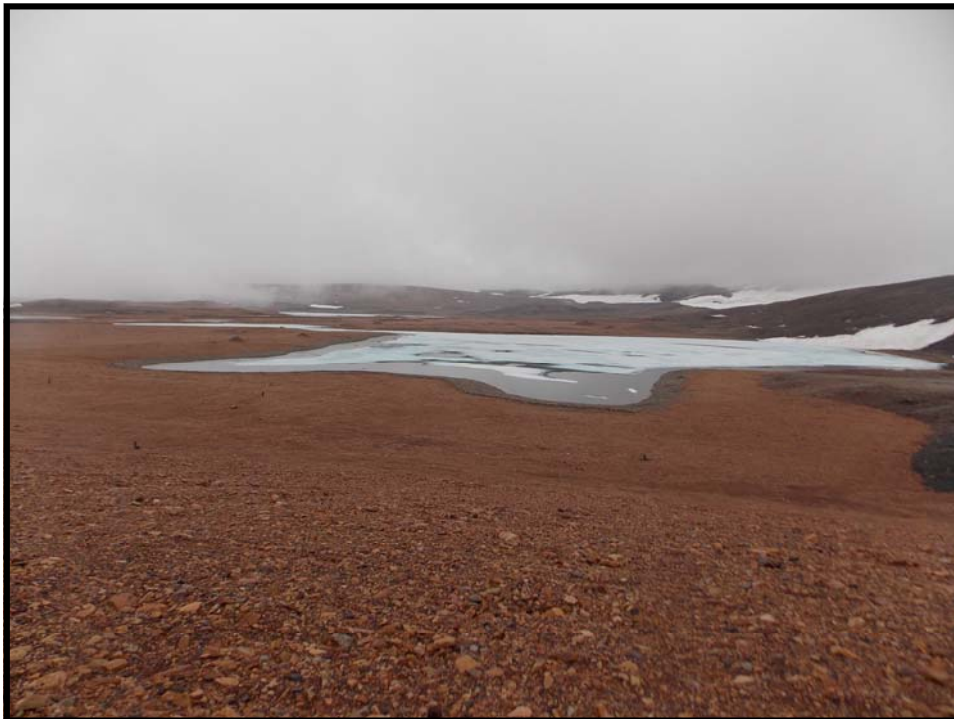
Photo 27. Toe of West Twin Dyke.

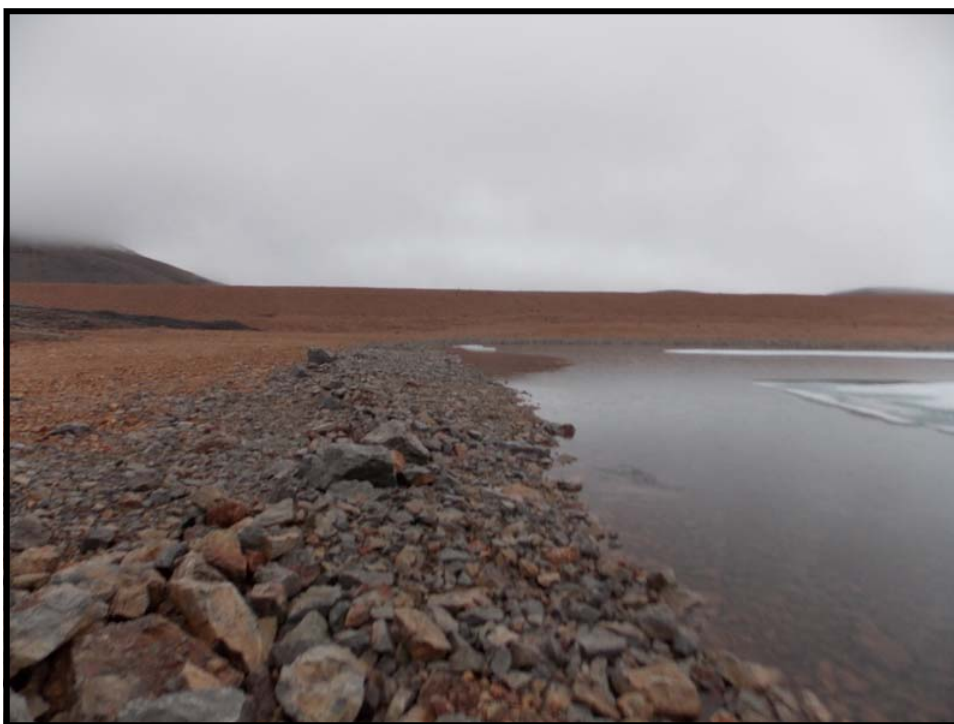
Photo 28. Toe of West Twin Dyke—Armour along shoreline of cover at toe of West Twin Dyke.

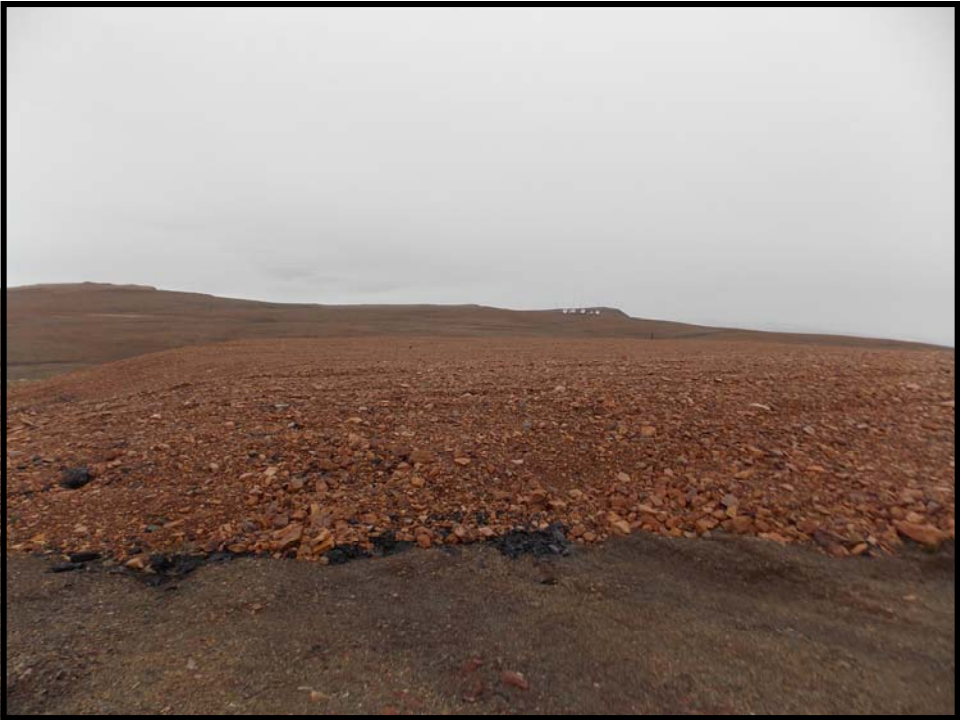
Photo 29. Landfill—Surface of landfill cover.

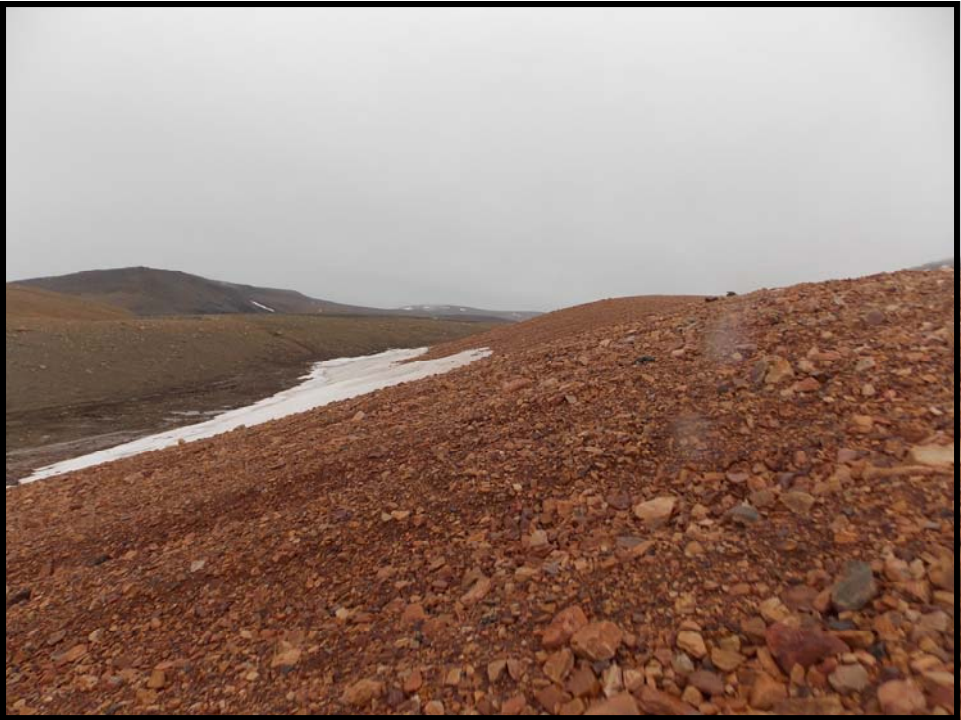
Photo 30. Landfill—Sloping face of cover.

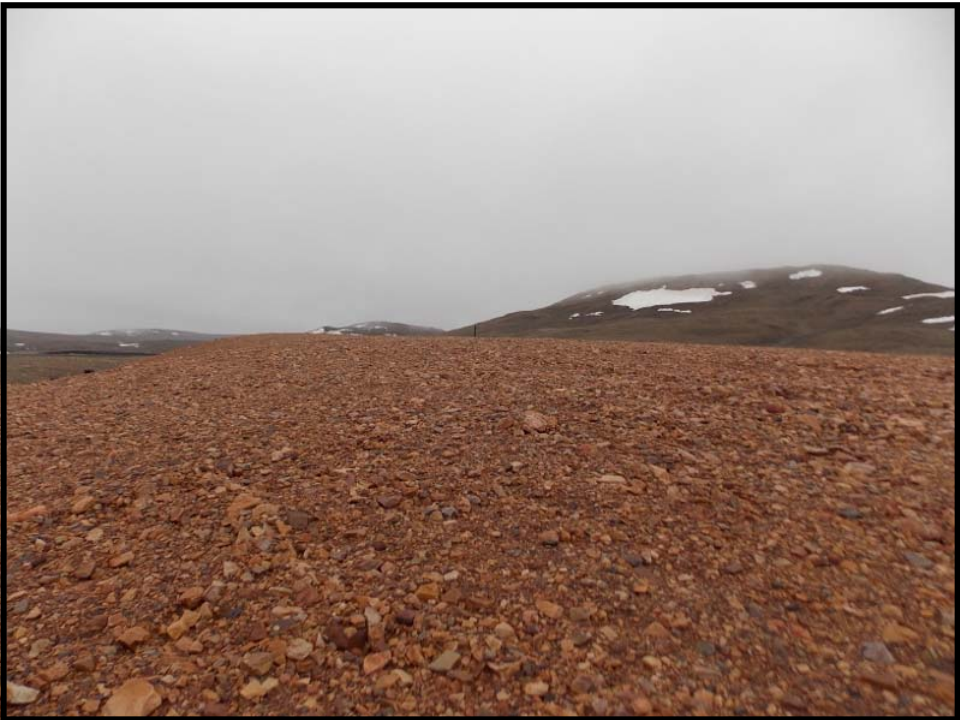
Photo 31. Landfill— Surface of landfill cover.

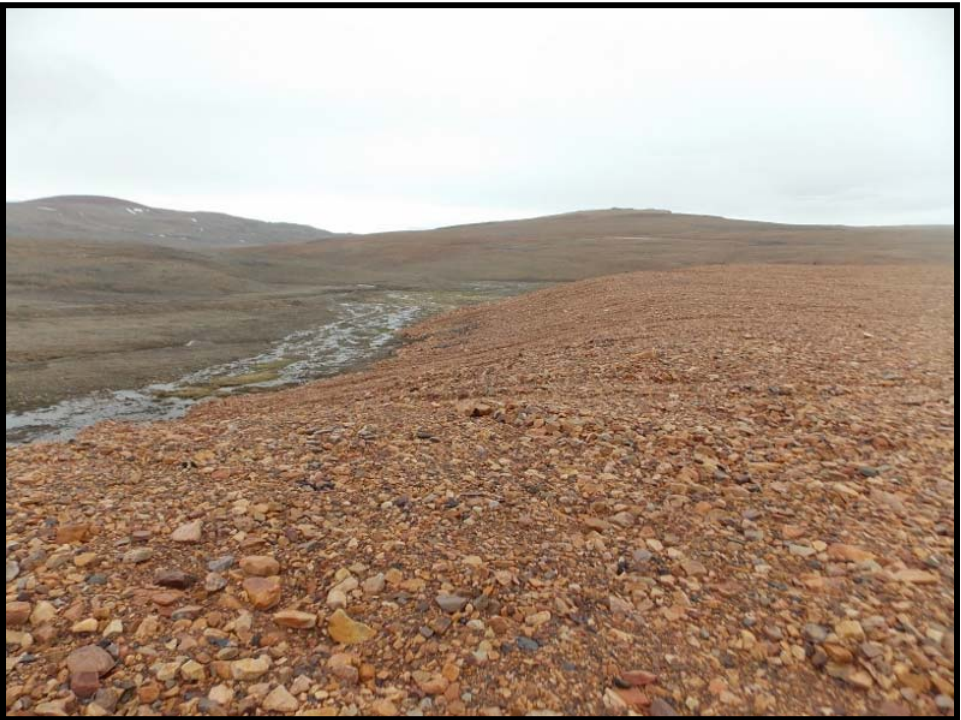
Photo 32. Landfill—Face of landfill cover.

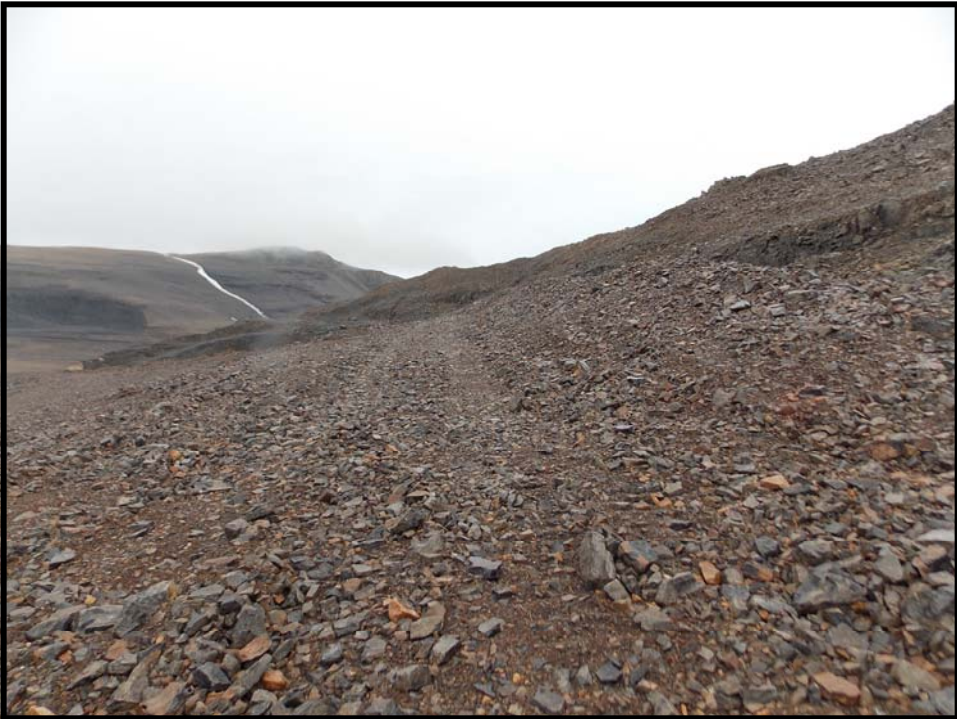
Photo 35. West Open Pit—View west along remnant highwall.

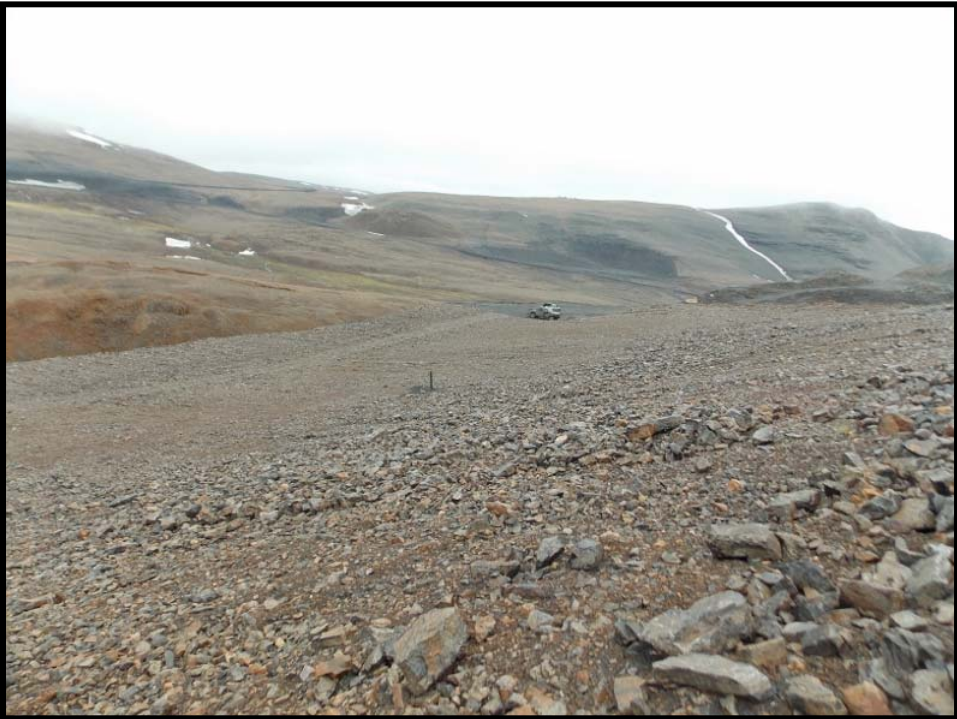
Photo 36. West Open Pit—View looking west along surface of cover.

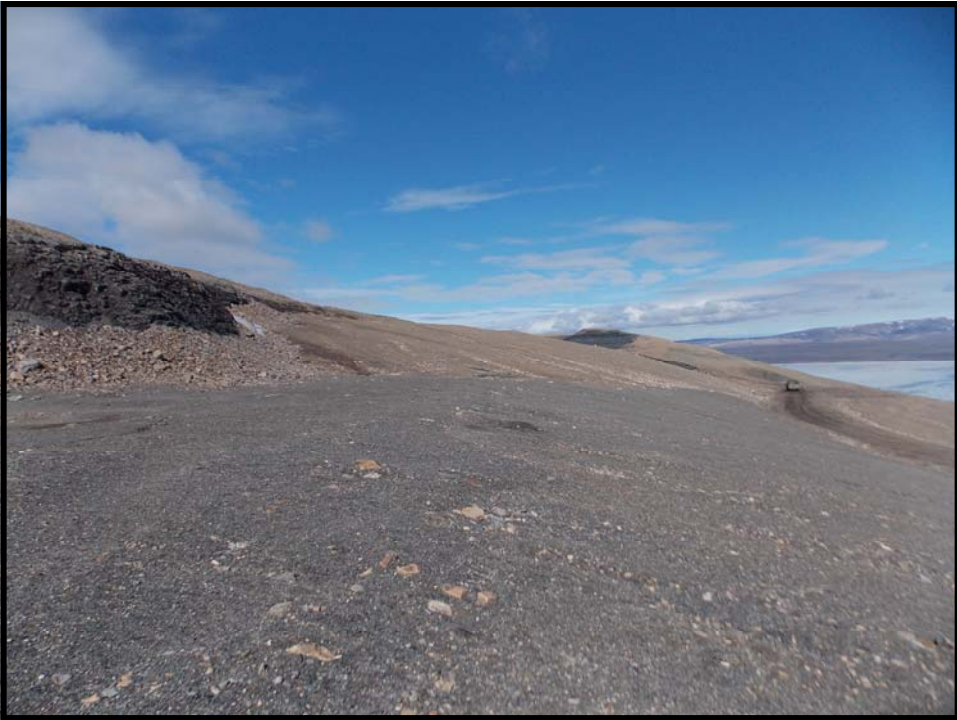
Photo 37. East Open Pit—Sloping upper surface of cover system.
