NANISIVIK MINE, NUNAVUT

2013 ANNUAL GEOTECHNICAL INSPECTION

PROJECT NO.: 0255-023
DATE: February 27, 2014
DOCUMENT NO.:

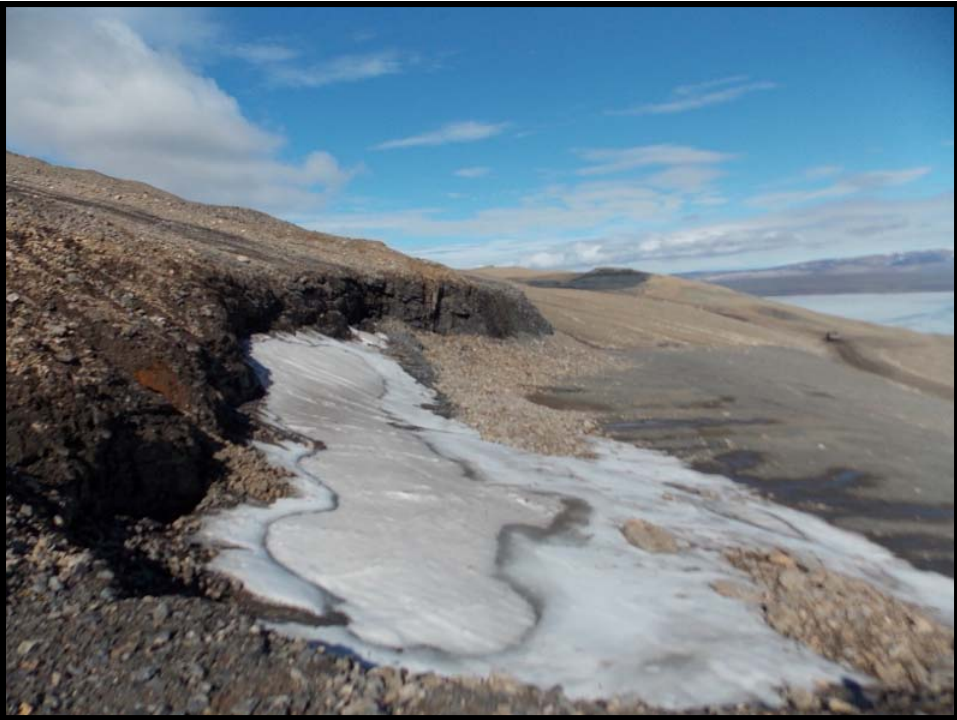
Photo 38. East Open Pit—Remnant highwall.

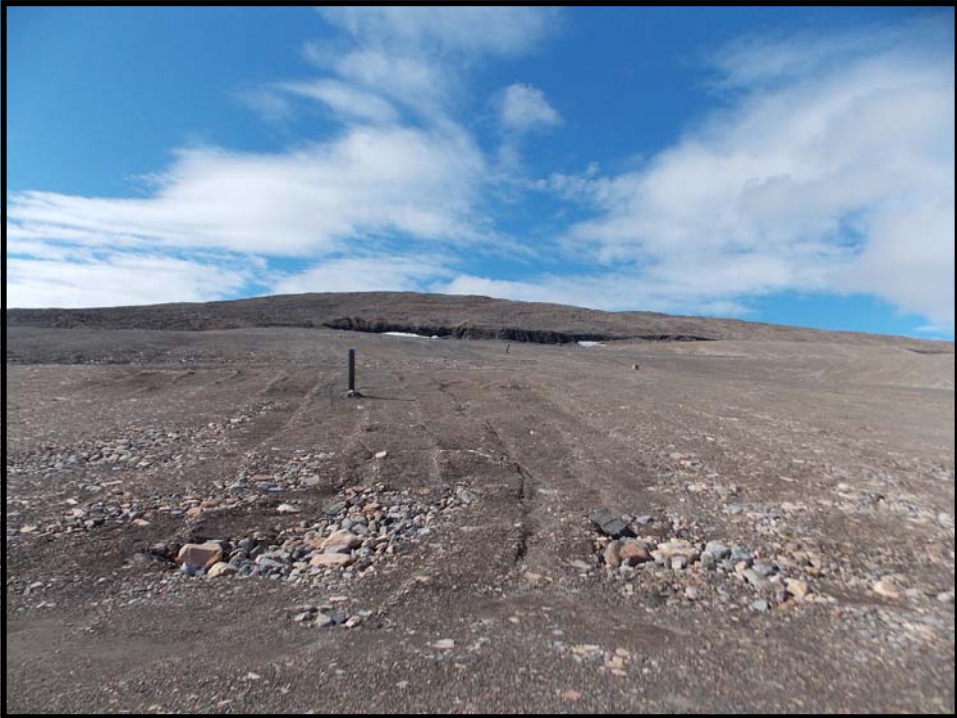
Photo 39. East Open Pit—Looking upslope along surface of cover. Note minor rill erosion.

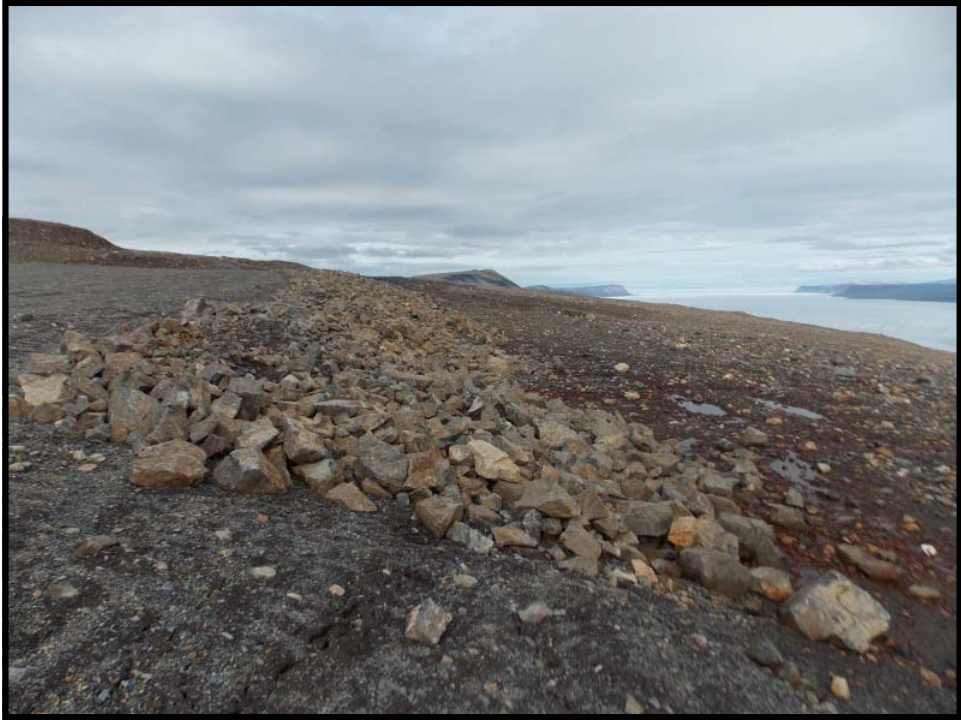
Photo 41. Oceanview Open Pit—Toe area.

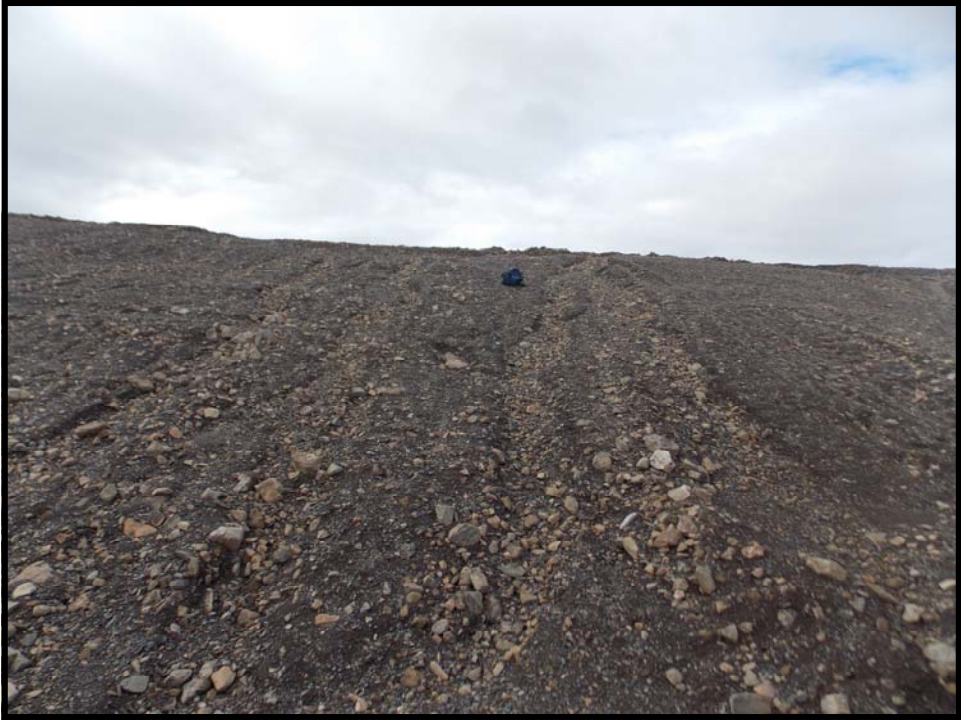
Photo 42. Oceanview Open Pit—Rill erosion along sloping face of cover at SW corner of pit.

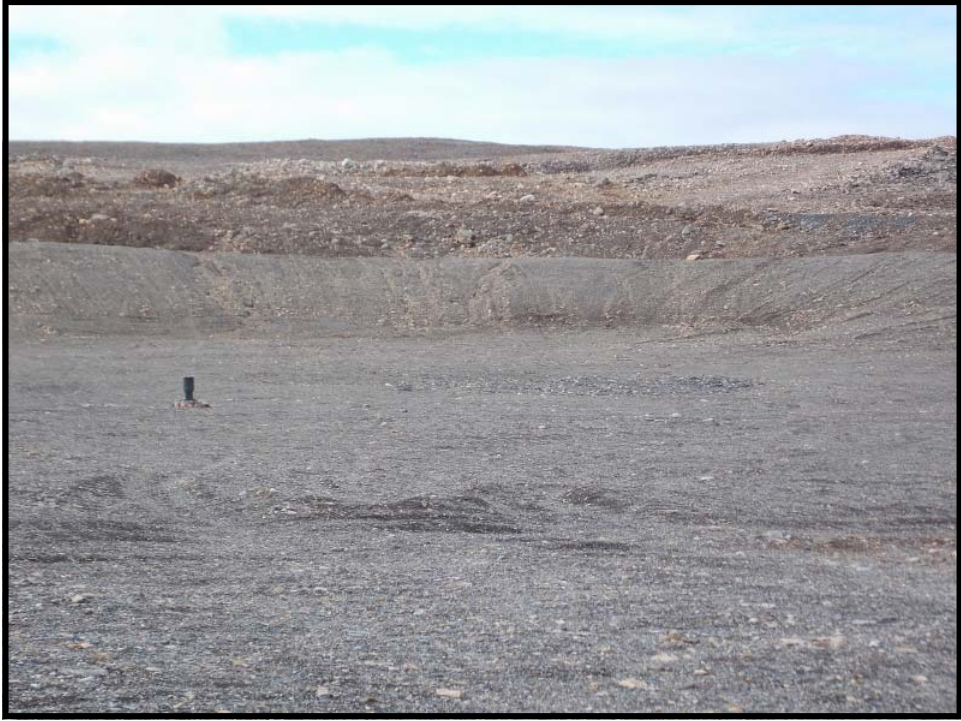
Photo 43. Oceanview Open Pit— Surface of pit cover area.

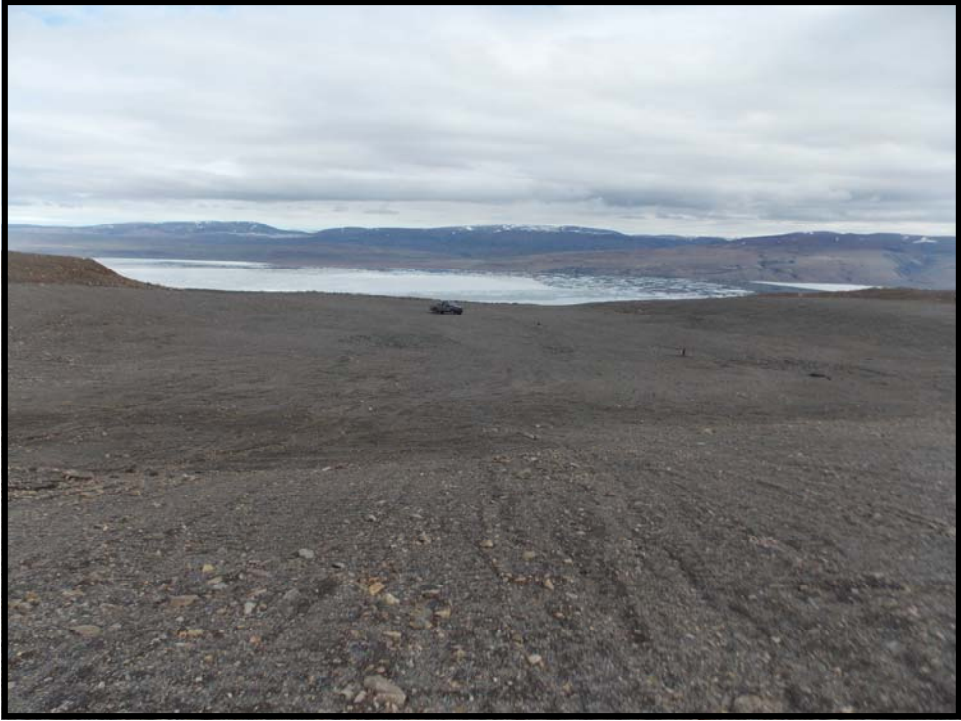
Photo 44. Oceanview Open Pit—Note minor rill erosion.

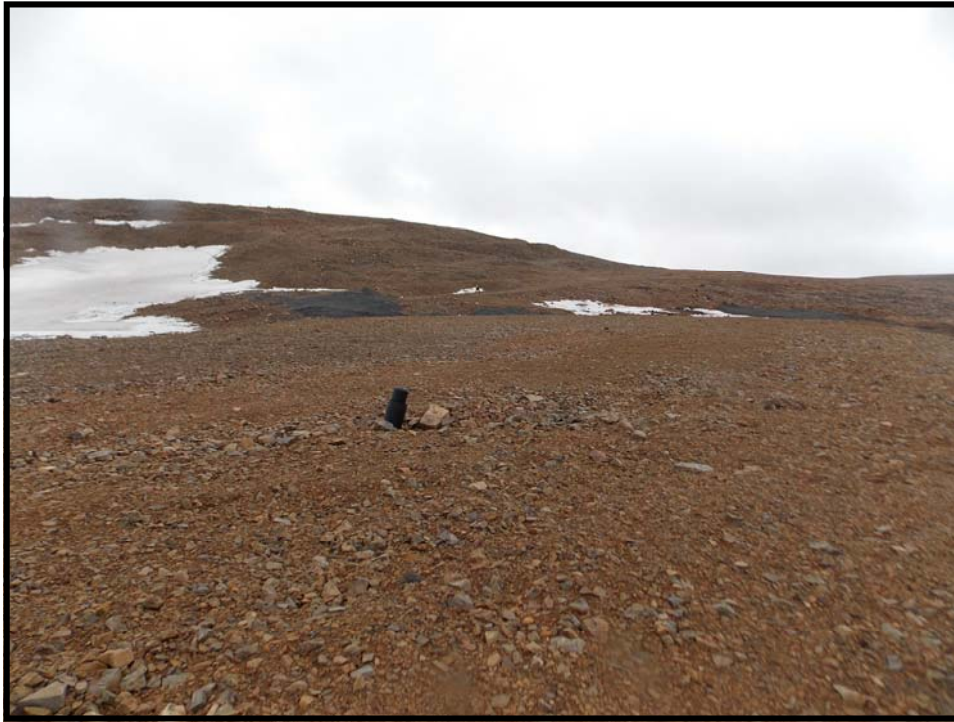
Photo 45. Area 14—Surface of cover.

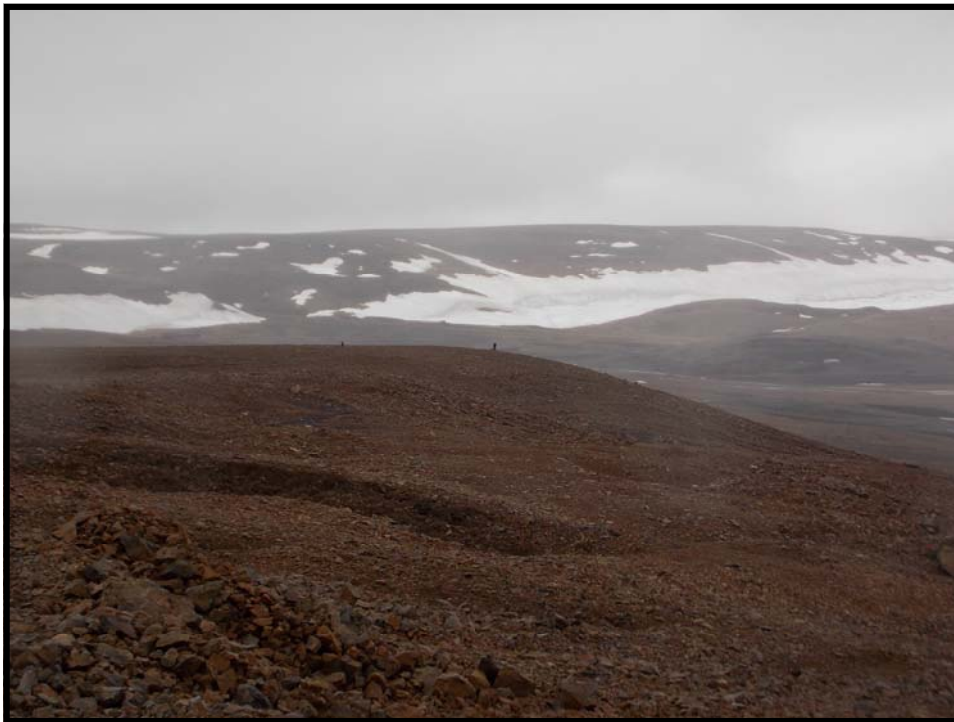
Photo 46. Area 14—General view of cover as seen from Area 14 raise.

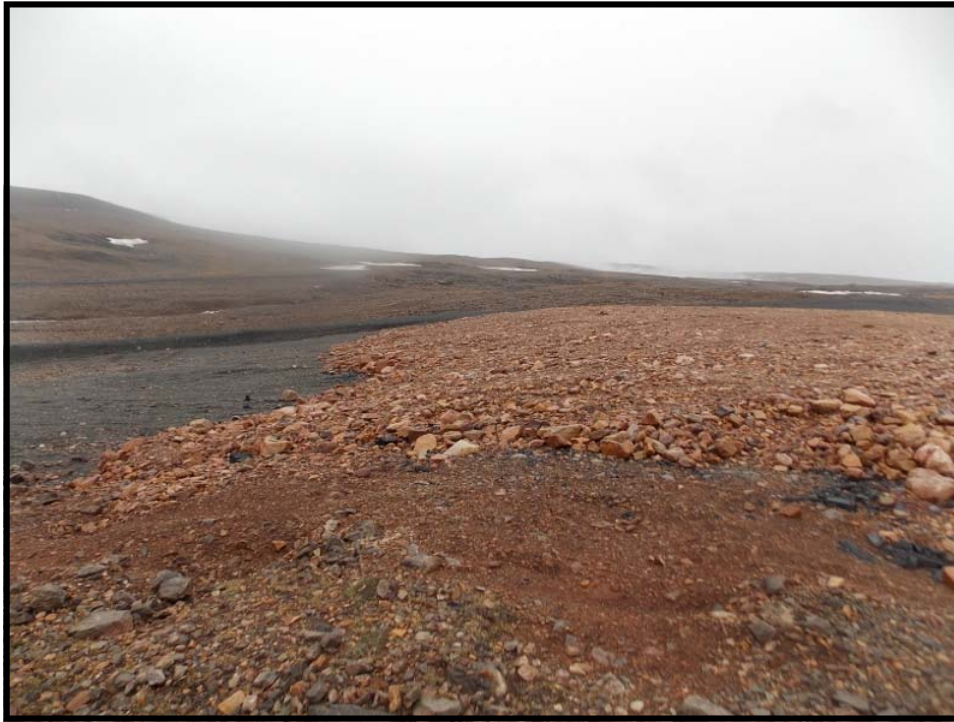
Photo 47. Upper Dump Pond—Sloping face of cover.

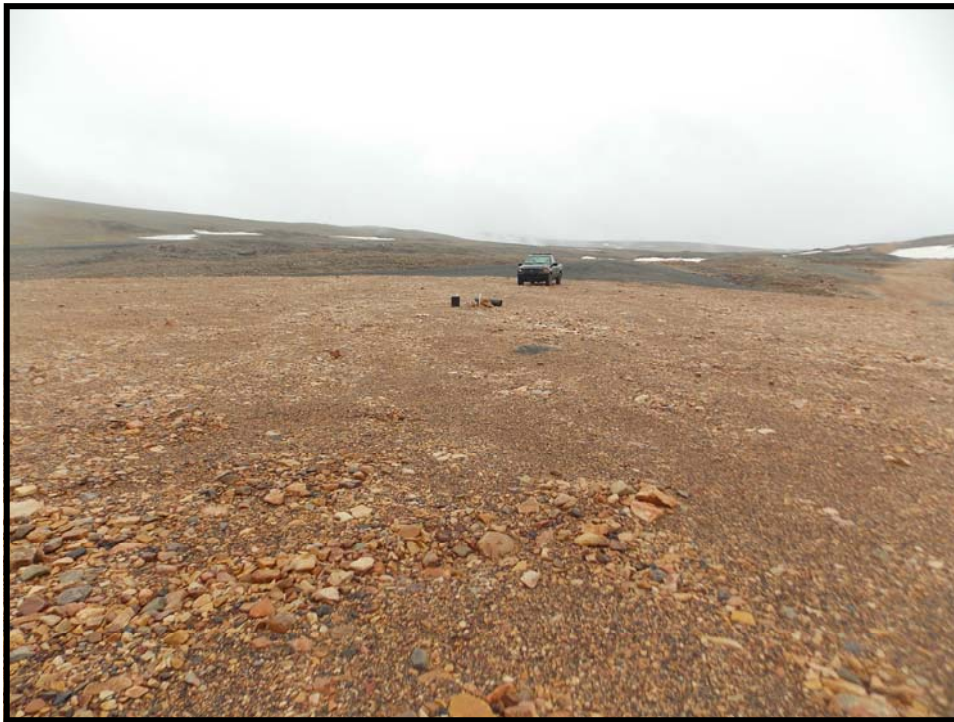
Photo 48. Upper Dump Pond—Monitoring on the surface of cover.

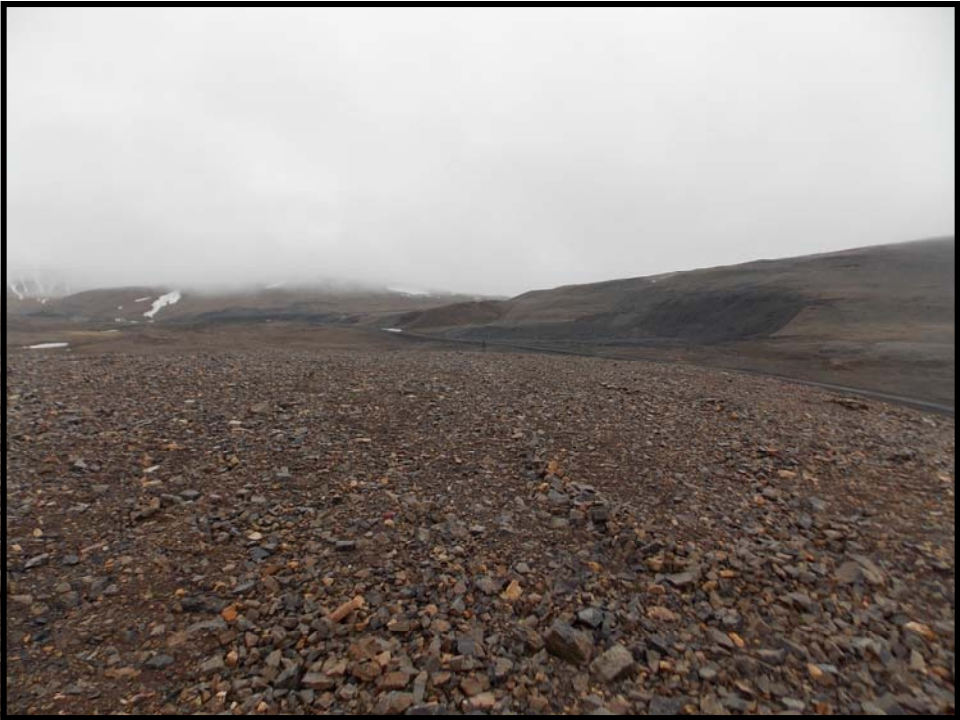
Photo 49. Industrial Complex Cover—View across upper flat portion of cover.

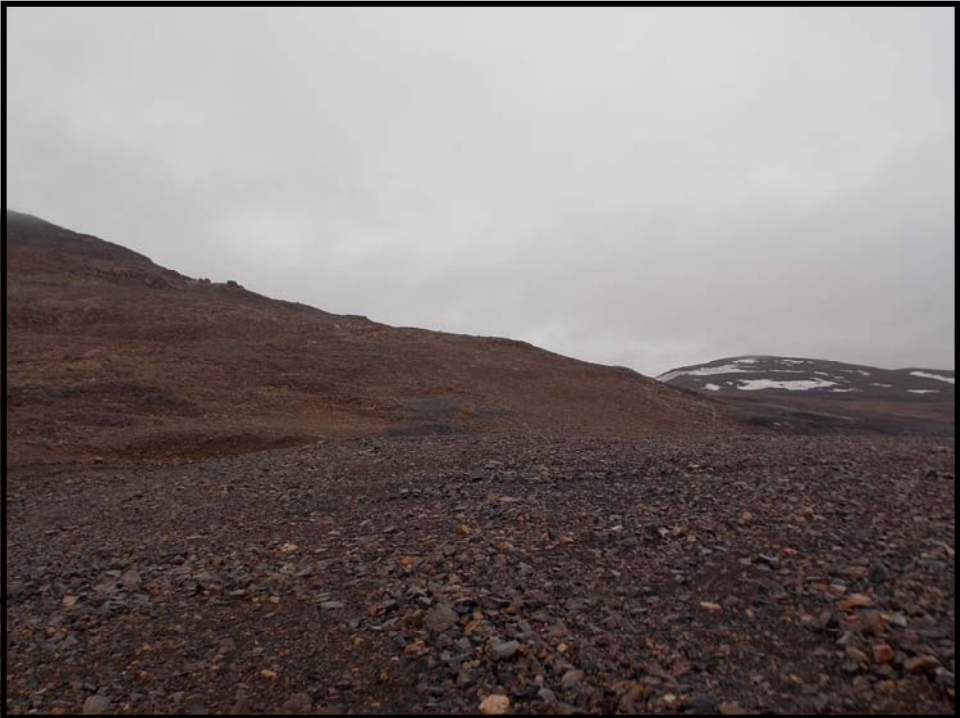
Photo 51. Industrial Complex Cover—View looking from on top of cover.

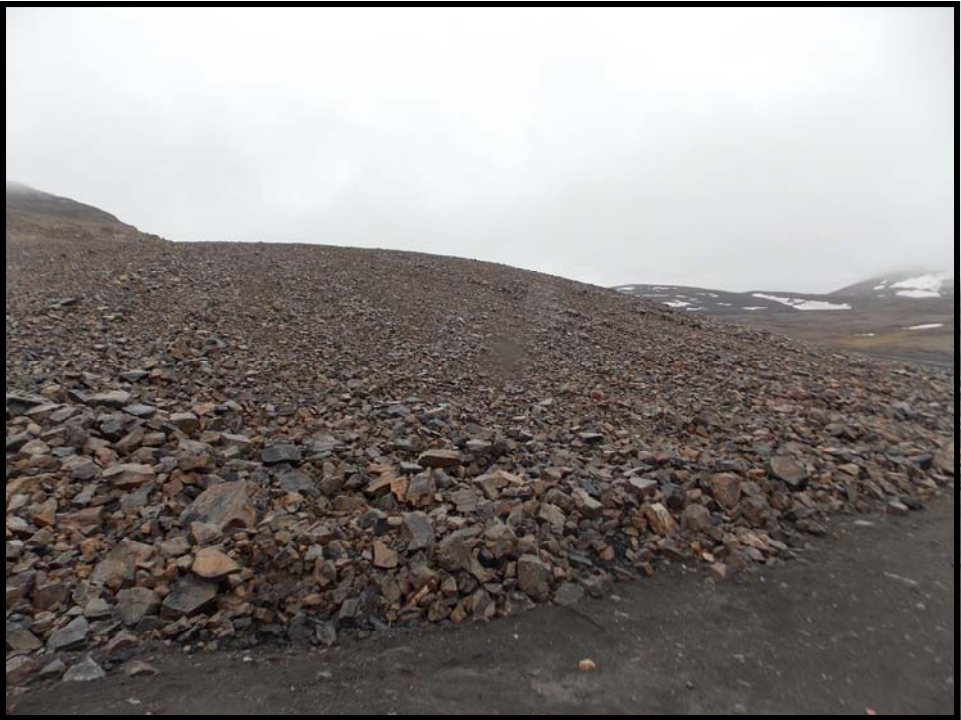
Photo 50. Industrial Complex Cover—Toe of sloping face of cover.

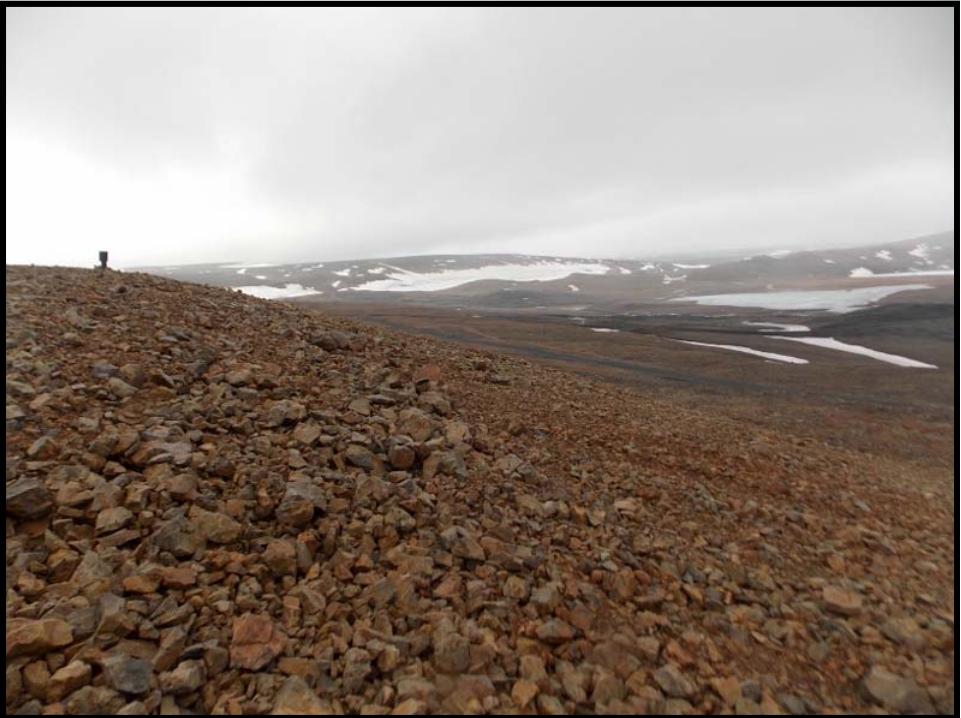
Photo 52. Industrial Complex Cover—Sloping face of cover.

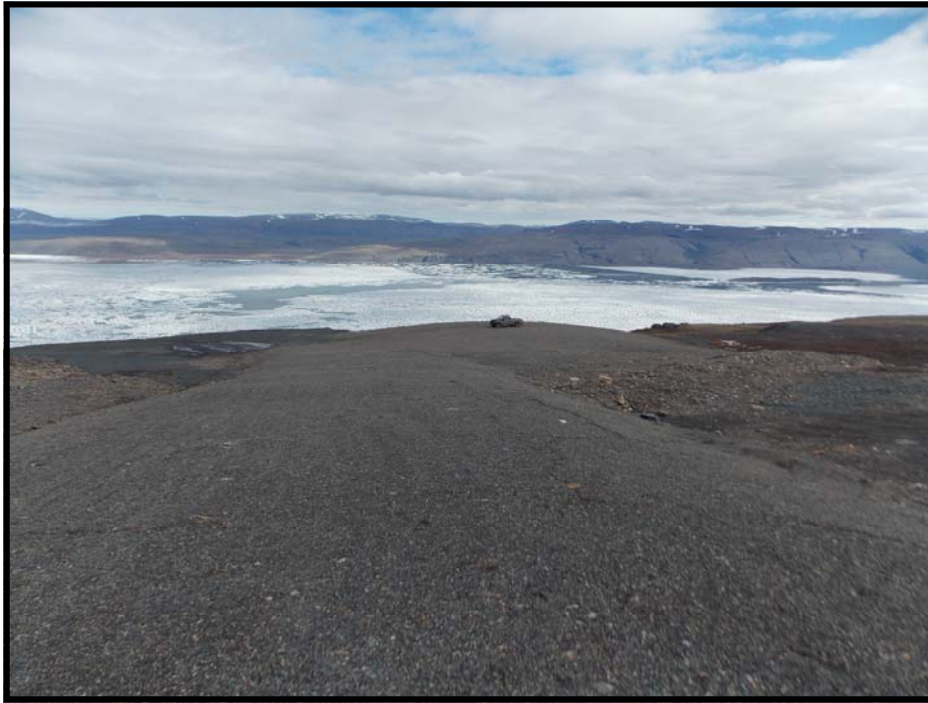
Photo 53. Oceanview Portal—Looking downslope along surface of portal cover.

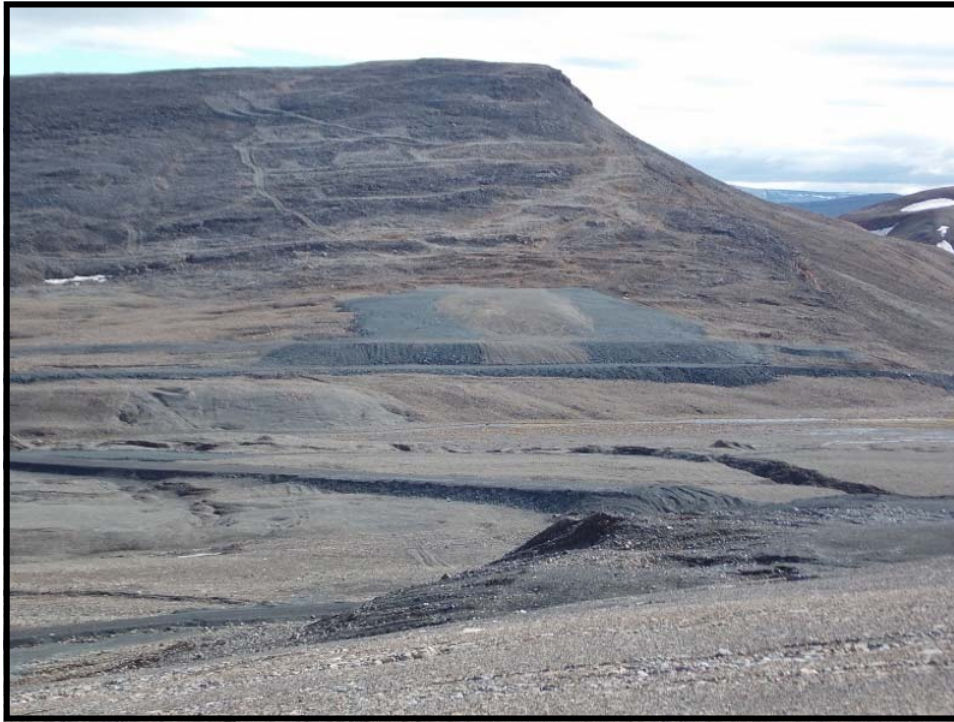
Photo 55. K-Baseline Portal—Surface of cover as seen from East Open Pit

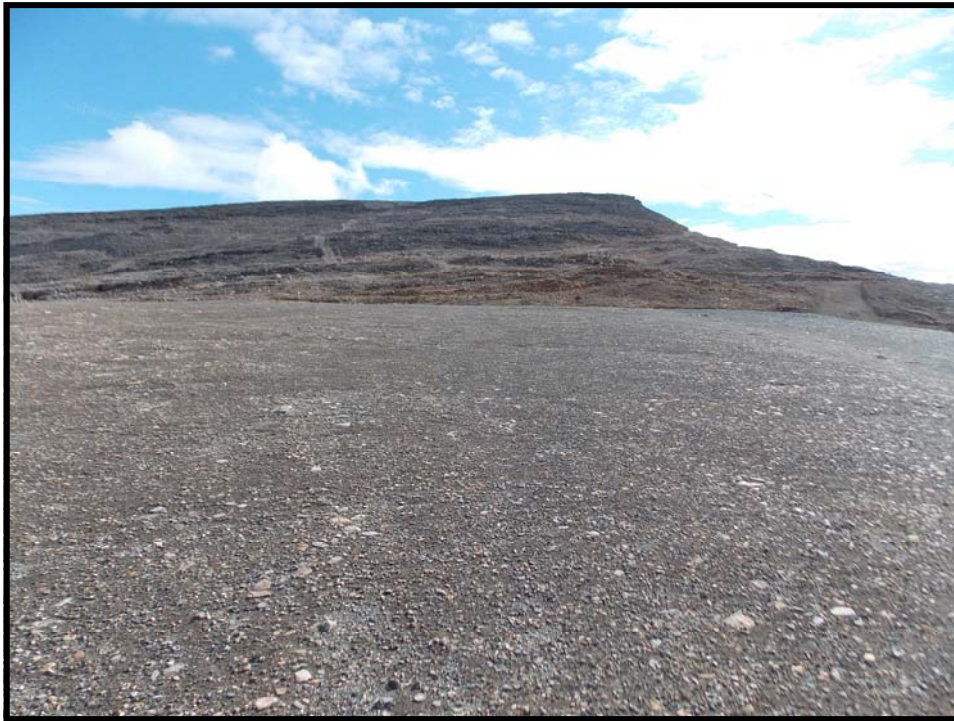
Photo 56. K-Baseline Portal—Upper flatter portion of cover.

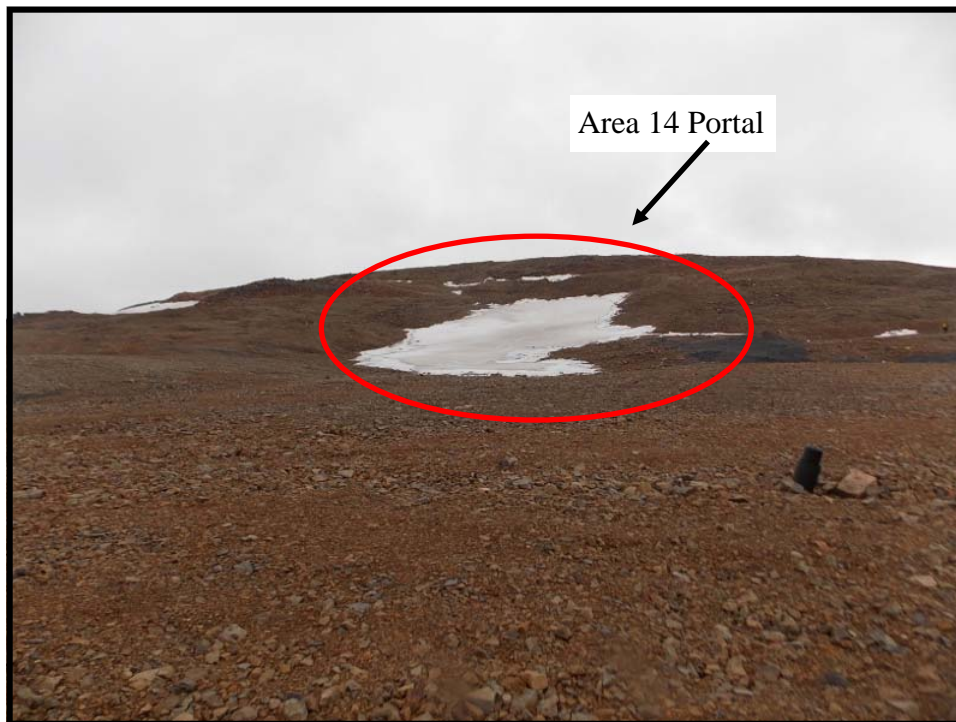
Photo 57. Area 14 Waste Rock cover and Portal.

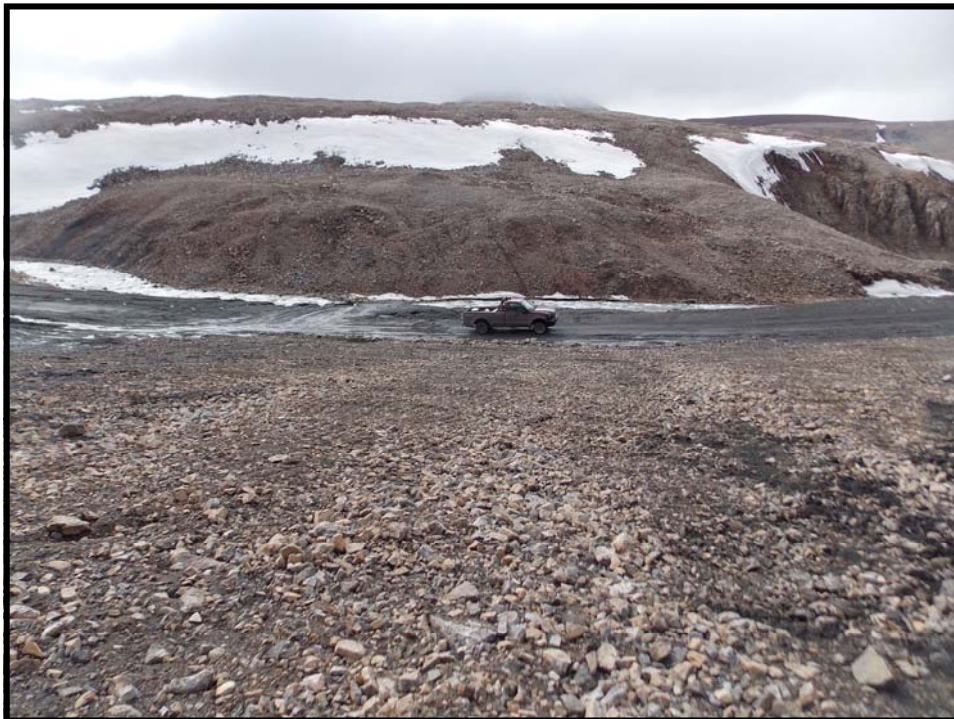
Photo 58. 09S Portal—Looking downslope along surface of cover.

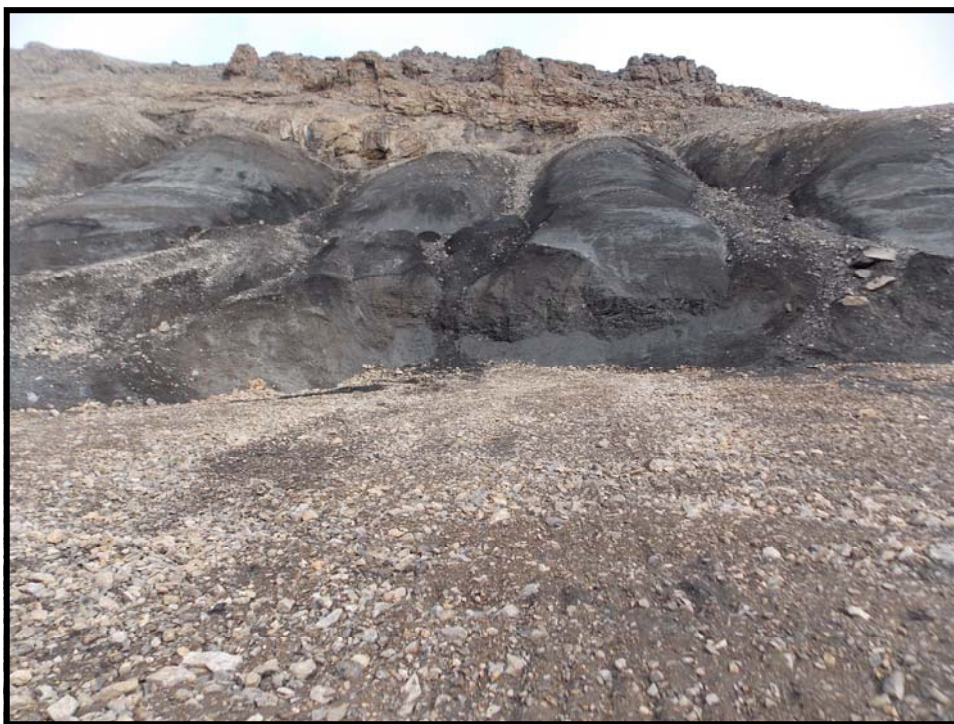
Photo 59. 09S Portal—Looking upslope along surface of cover.

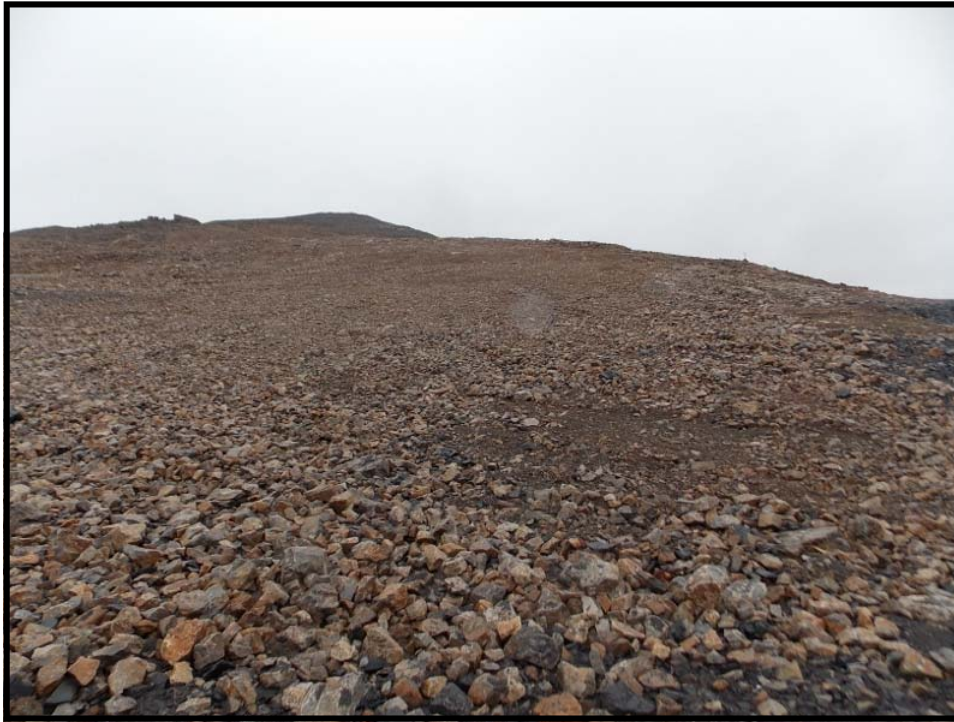
Photo 60. Lower Adit—View looking upslope along surface of cover.

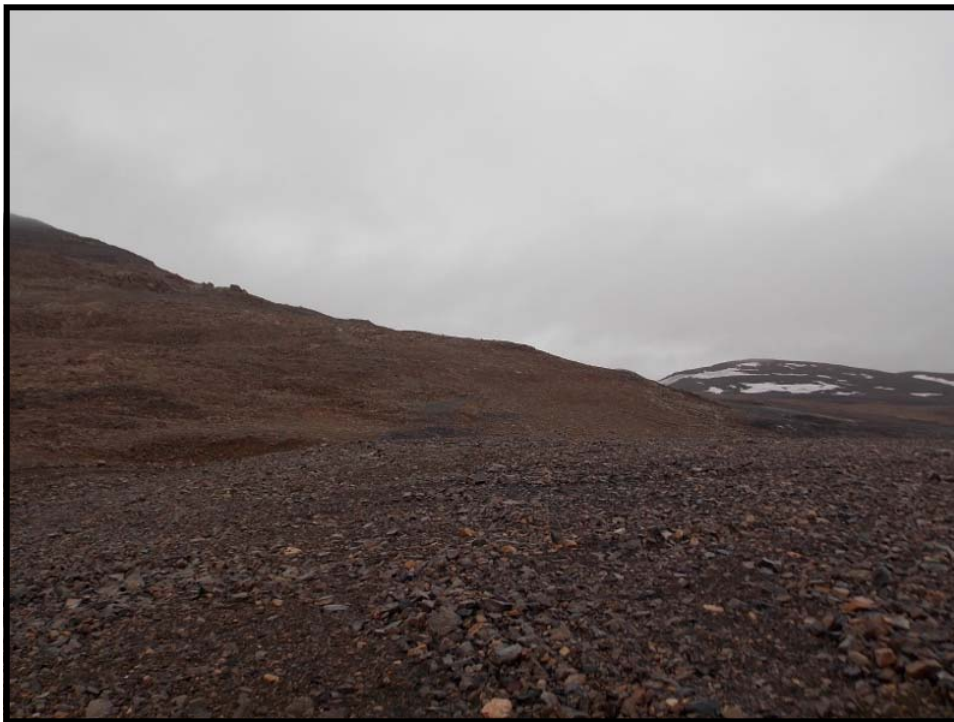
Photo 61. Lower Adit—As seen from top of Industrial Complex cover.

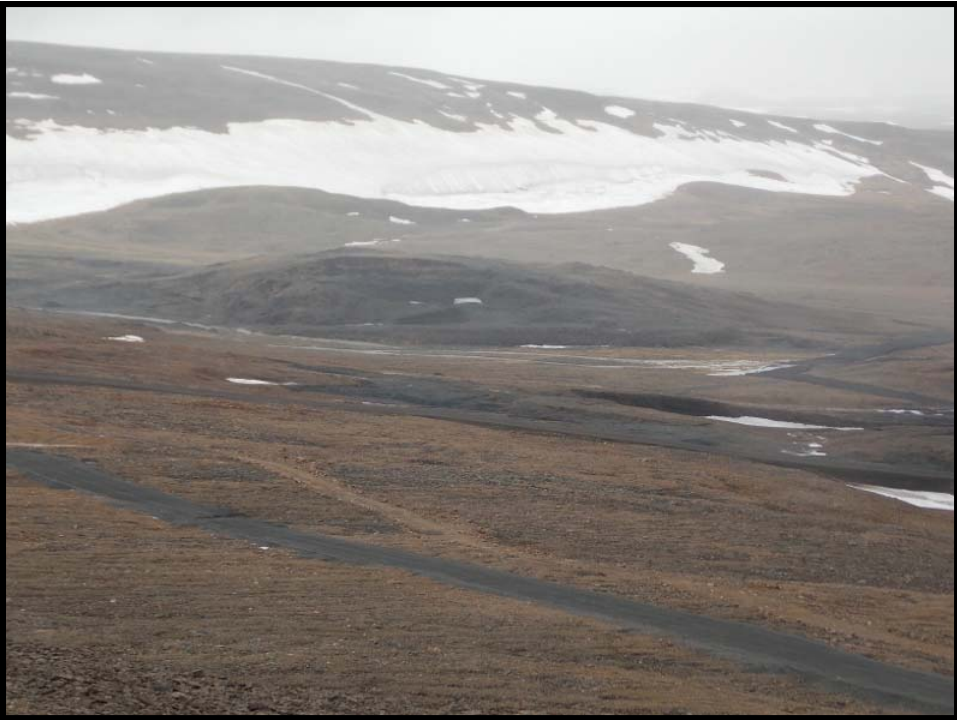
Photo 65. East Twin Shale Quarry—As seen from Area 14 shale quarry.

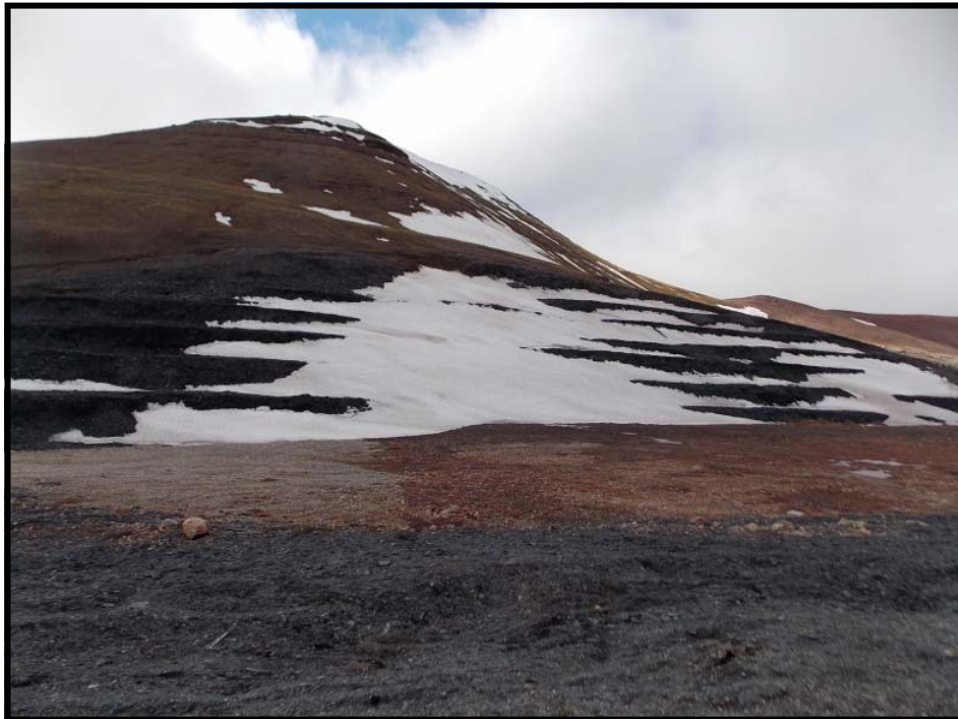
Photo 66. Mt. Fuji Shale Quarry.
