APPENDIX I INSPECTION PHOTOS

PROJECT:	NANISIVIK MINE 2015 ANNUAL GEOTECHNICAL INSPECTION
TITLE:	EAST ADIT TREATMENT FACILITY

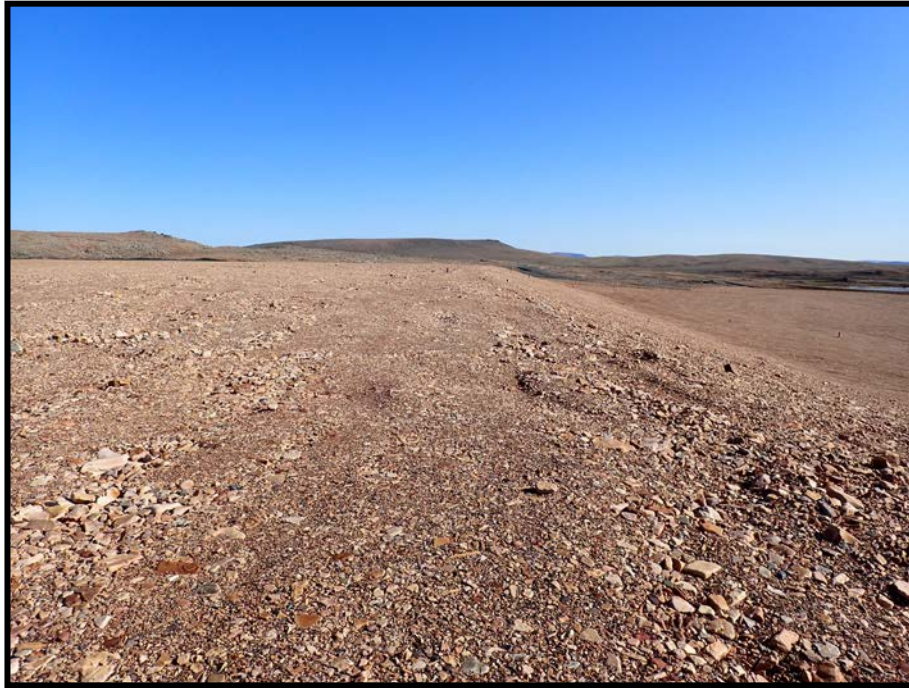
Photo 21. West Twin Dyke—Crest of dyke, view looking north.

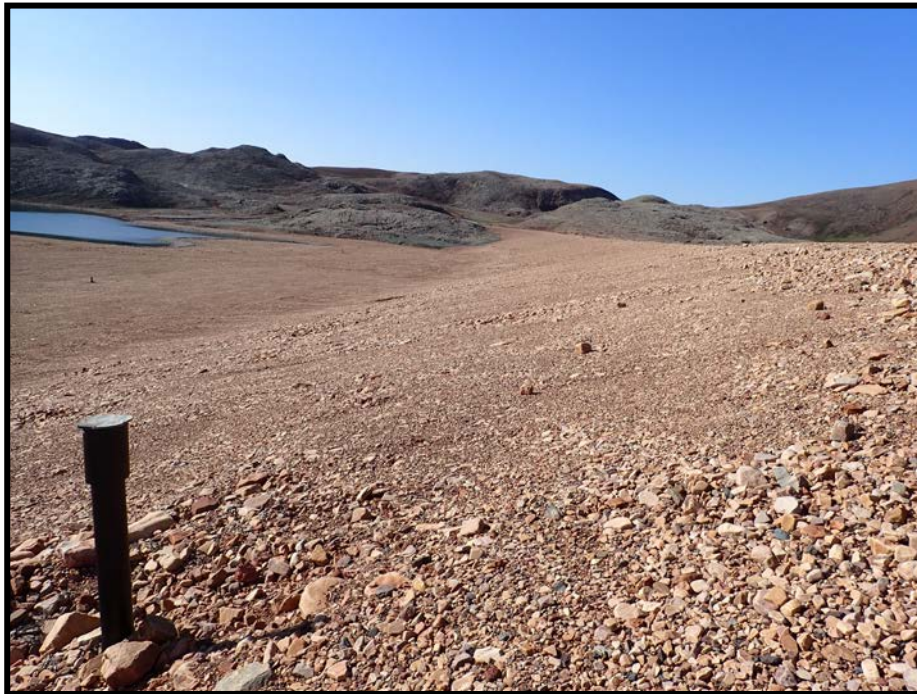
Photo 22. West Twin Dyke—Face of dyke, view looking south.

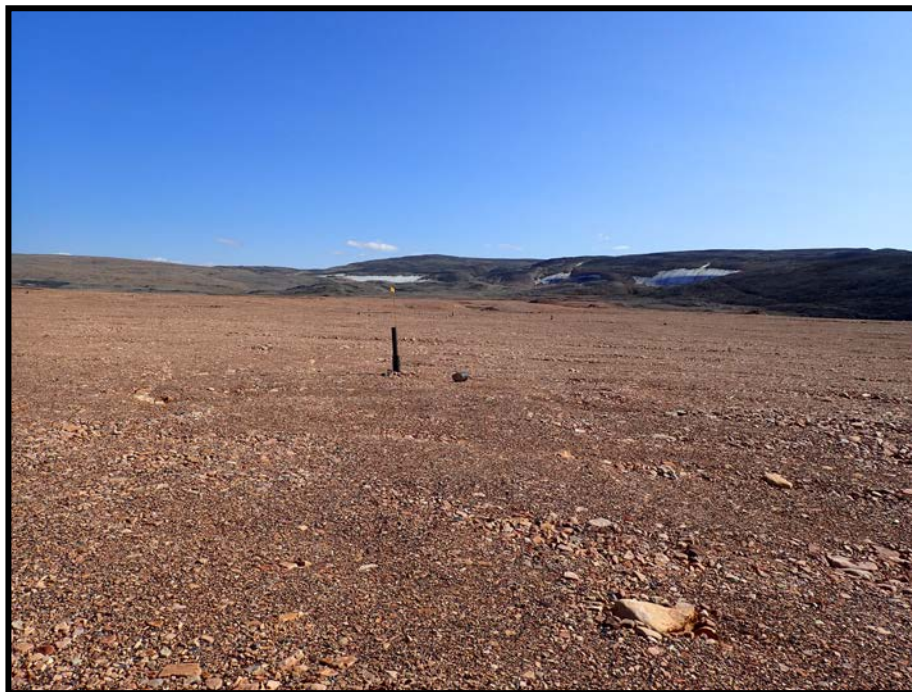
Photo 28. Test Cell—View looking east toward outlet of Test Cell cover system.

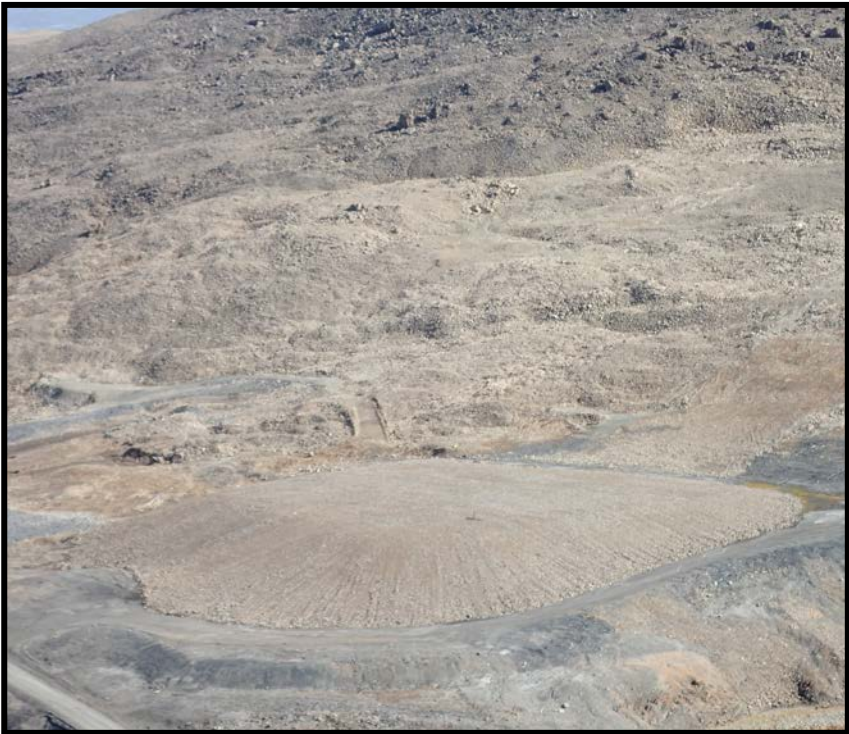
Photo 58. Industrial Complex Cover—Cover system as seen from the communication tower area.

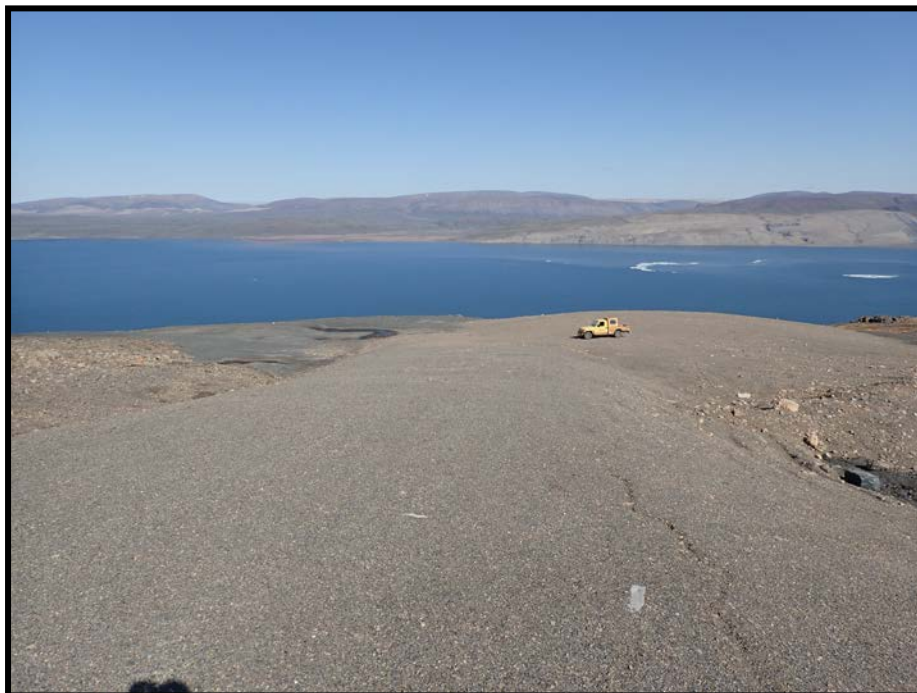
Photo 62. Oceanview Portal—Looking downslope along surface of portal cover.
