## **NYRSTAR**

### **NANISIVIK MINE, NUNAVUT**

## **2015 ANNUAL GEOTECHNICAL INSPECTION**

PROJECT NO.: 0255-026  
DATE: March 30, 2016  
DOCUMENT NO.:

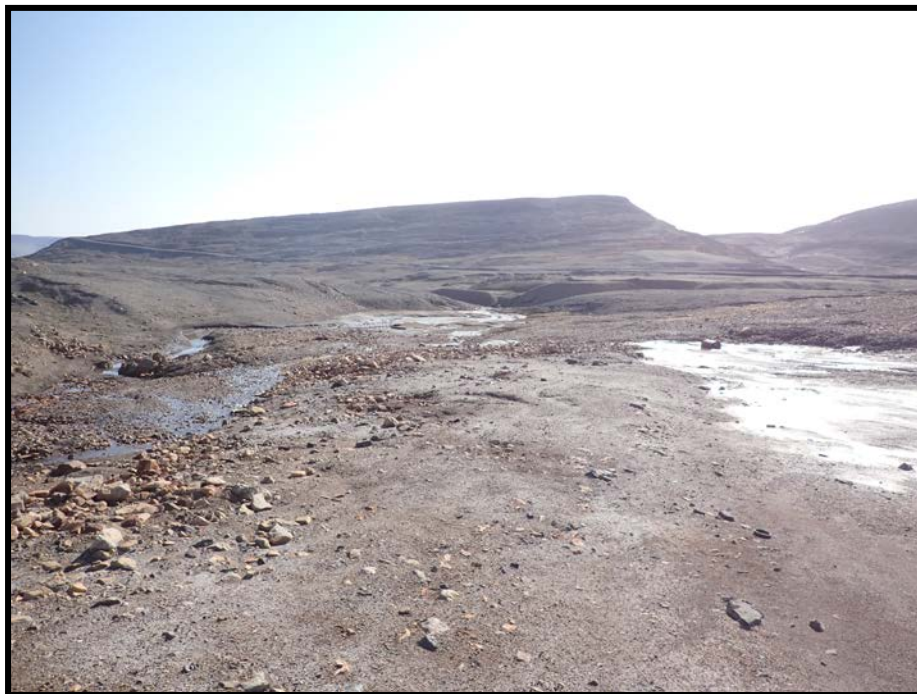
Photo 1. East Adit Treatment Facility—Looking east at breach in East Adit Treatment dyke.

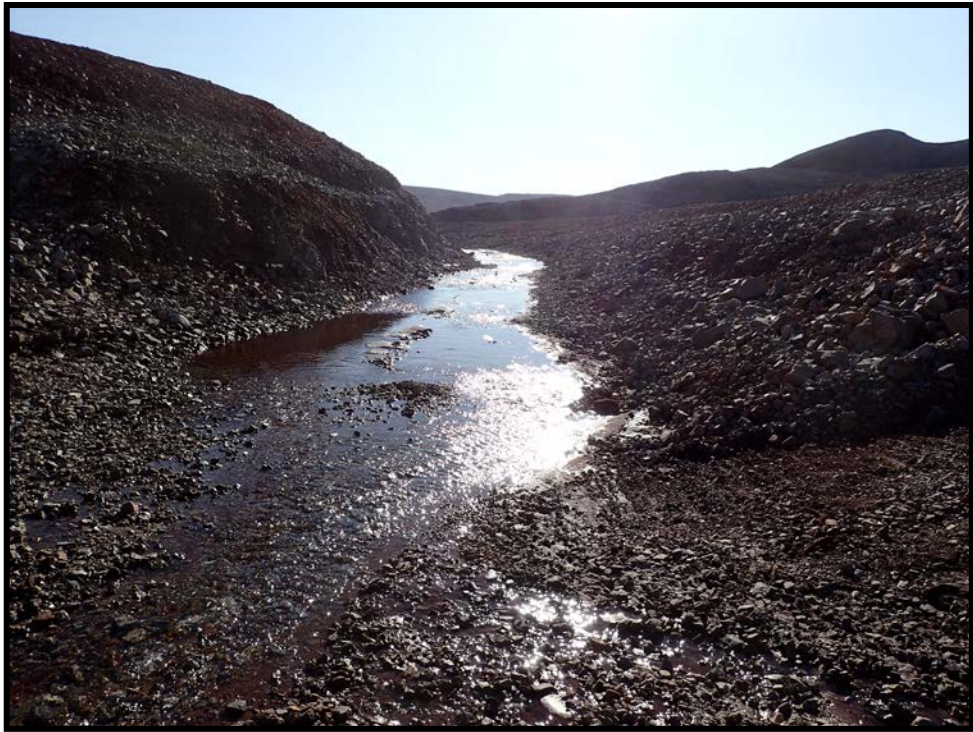
- Erosion of the left bank materials had occurred previously during the year (Photos 5 and 6), during freshet following breaching of the ice-plug at the spillway entrance. During the previous spring (2014), Mr. Lavallee was on-site when the ice-plug breach occurred. The observations collected during this time provide further insight into the erosive event that occurs annually. Based on his observations collected during the event, the flow following the breaching of the ice-plug becomes focused along the left bank at an elevated level 1 to 2 m above the base of the spillway. Draining of the water that backs up on the Surface Cell cover occurred quickly, over a period of less than 4 hours. Some erosion of the bank armour materials occurred before the flow re-entering the spillway towards the outlet, depositing eroded material in the base of the spillway.

Photo 5. West Twin Dyke Spillway—Looking downslope along left edge of ramp on right bank of spillway. Note water flowing along channel.

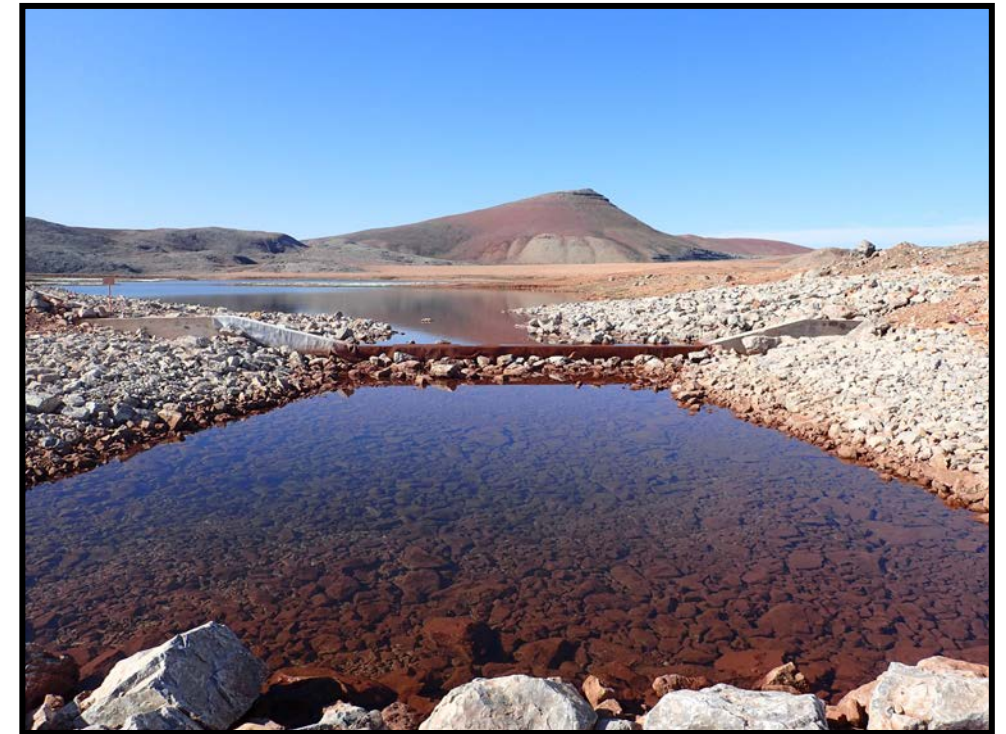
The seepage at the West Twin Outlet Wall seems to have slowed in recent years, as the water level upstream of the wall has been maintained more consistently at or above the invert of the outlet wall. During the inspection, the water level upstream of the wall was noted to be at the elevation of the wall invert. This is considered to be a positive observation with respect to seepage rates given the dry conditions at site through the month of July.

Photo 10. West Twin Outlet Channel—Looking upstream at wall.

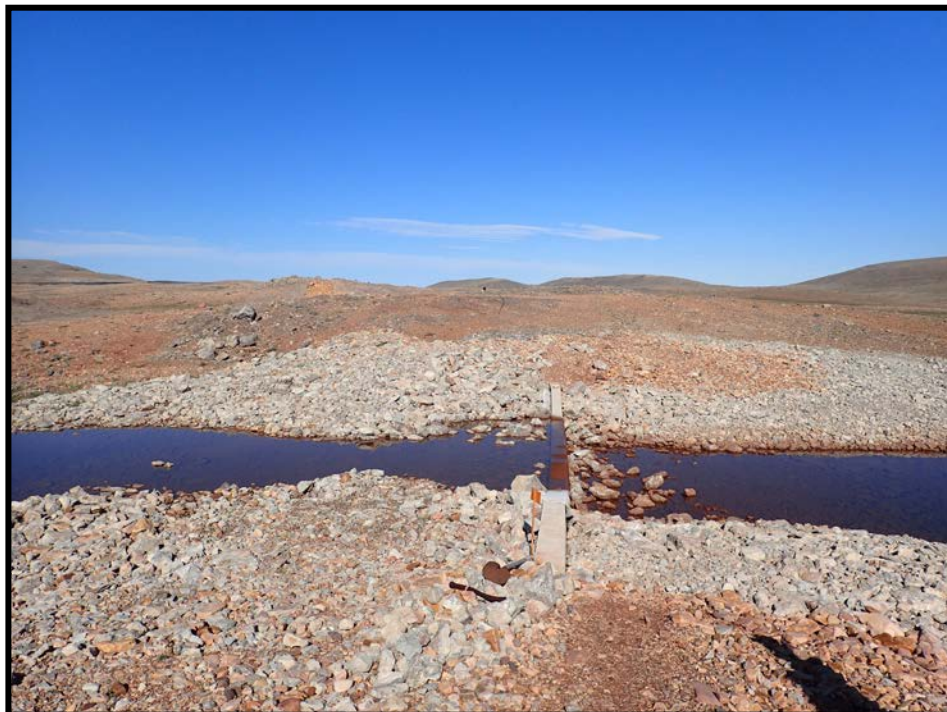
Photo 11. West Twin Outlet Channel—Looking north along wall.

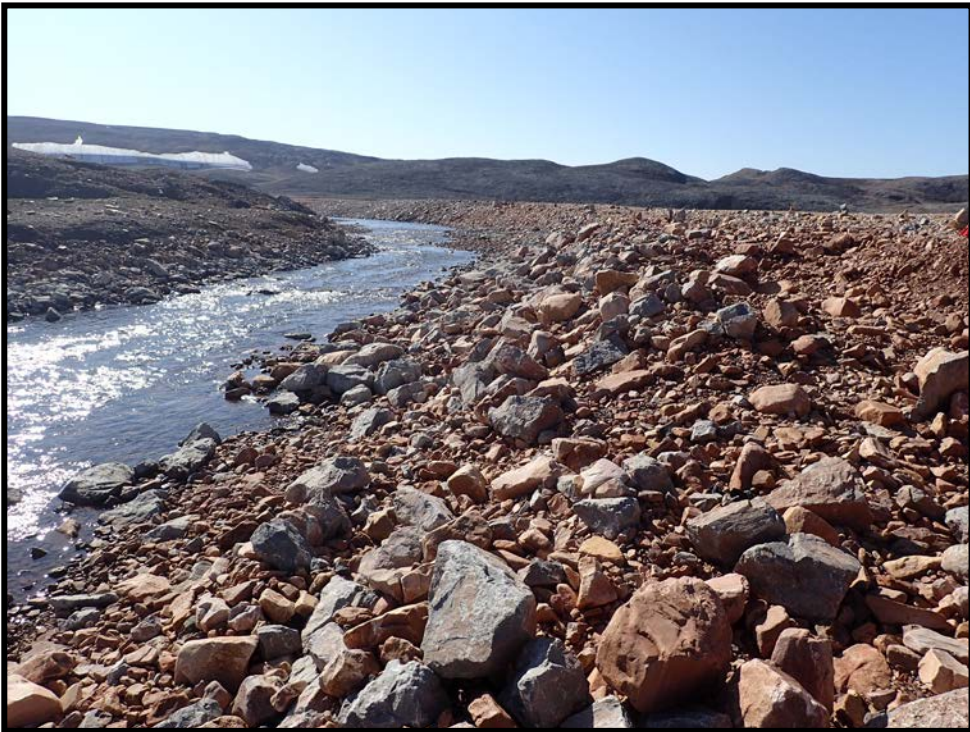
Some erosion at the East Twin Diversion Dyke was noted during the inspection. The erosion was likely due to elevated flows during freshet in combination with snow blockage in the channel. The erosion appeared to be similar to what was observed in 2014. In general, the

Photo 13. East Twin Creek Diversion Channel—View looking up gradient. Upstream of left bank erosion.

dyke remains in stable condition. However, it is recommended that additional re-sloping and armouring of select areas of the channel be undertaken to enhance long term performance. As has been observed during inspections over the past couple of years, seepage was observed at the toe of the East Twin Diversion Dyke in 2014 upstream of the convergence of flow from West Twin. This seepage did not appear to have worsened in 2015, but should continue to be monitored in future inspections.

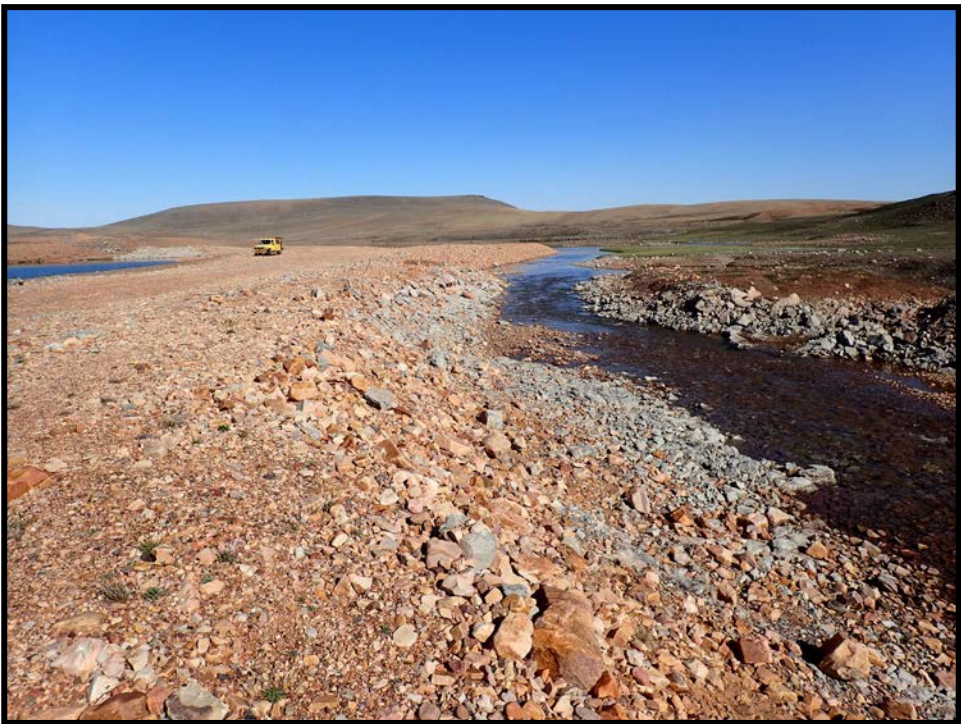
Photo 14. East Twin Creek Diversion Channel– View of area downstream of armoured area. Note bedrock outcrop along face of dyke and in bottom of channel.

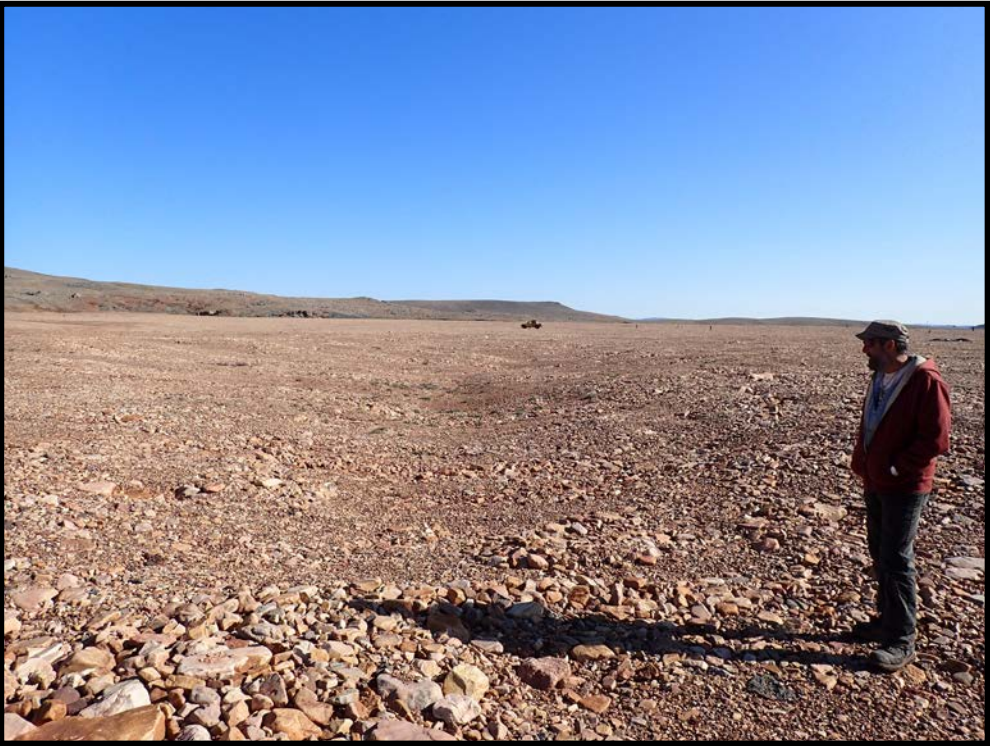
Photo 18. Surface Cell—Settlement area along east edge of main N/S drainage swale. View looking north.

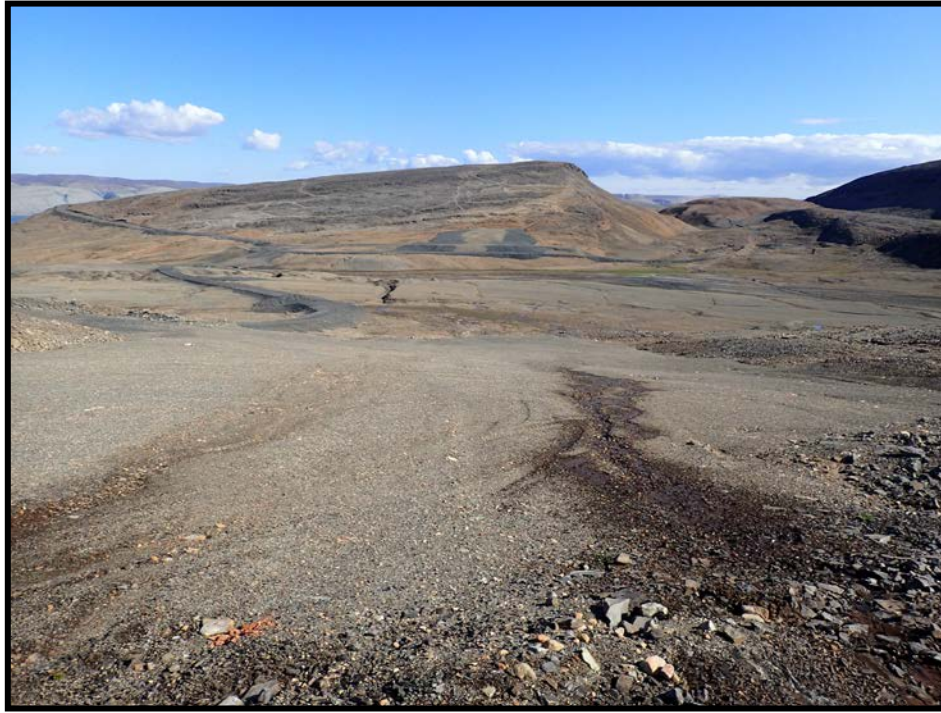
Photo 47. East Trench—Trench cover as seen from upslope edge. Not small flow of water on surface of cover causing minor rill erosion.

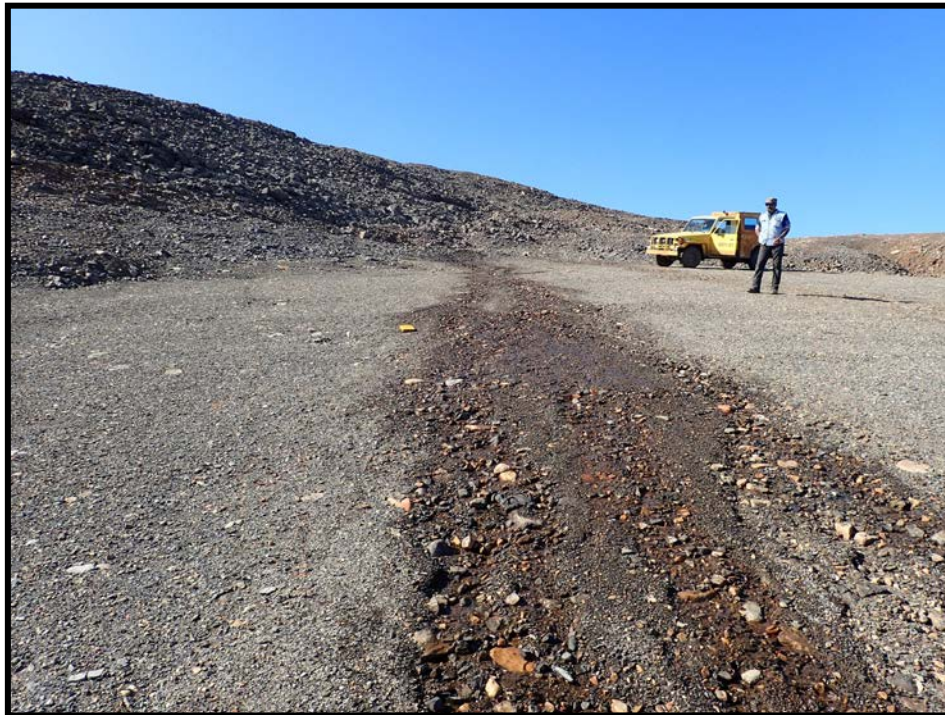
Photo 48. East Trench—Spring water running along surface of cover causing minor rill erosion

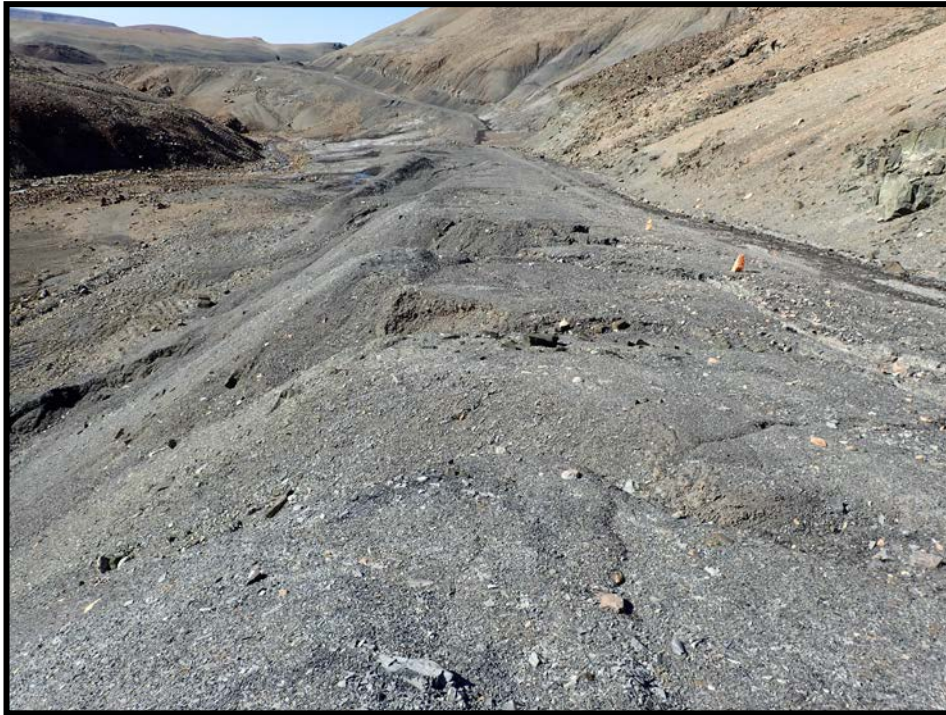
Photo 67. 09S Portal—Eroding road between 09S and 17N portals.
