NYRSTAR

NANISIVIK MINE, NUNAVUT

2016 ANNUAL GEOTECHNICAL INSPECTION

PROJECT NO.: 0255027
DATE: March 7, 2017
DOCUMENT NO.:

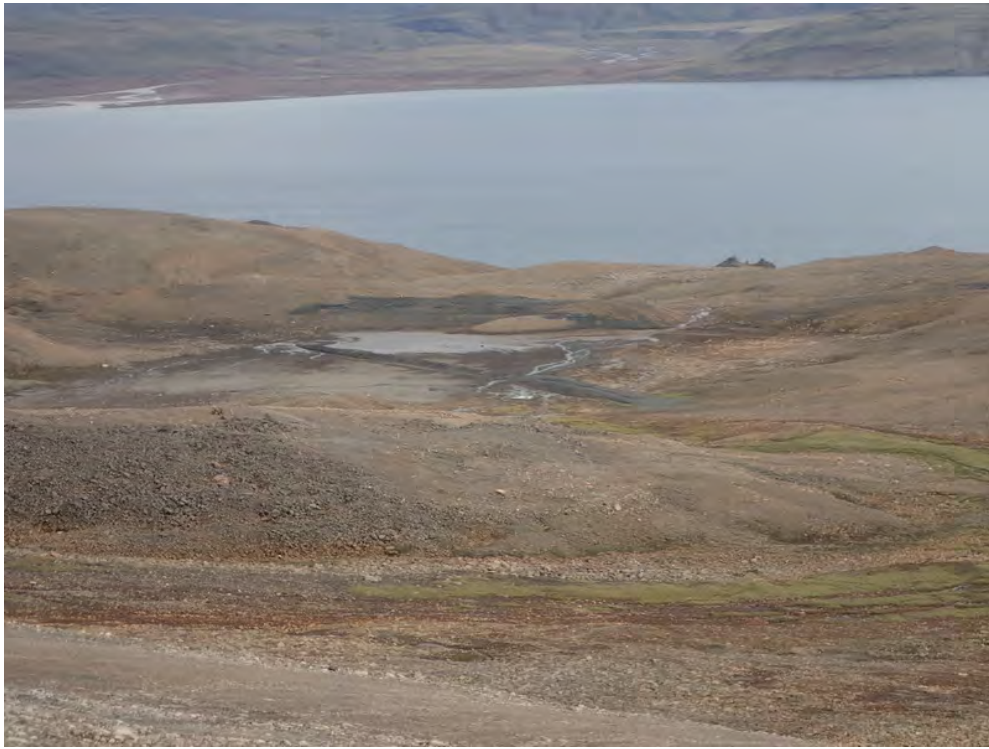
Photo 1. East Adit Treatment Facility—Retention pond area.

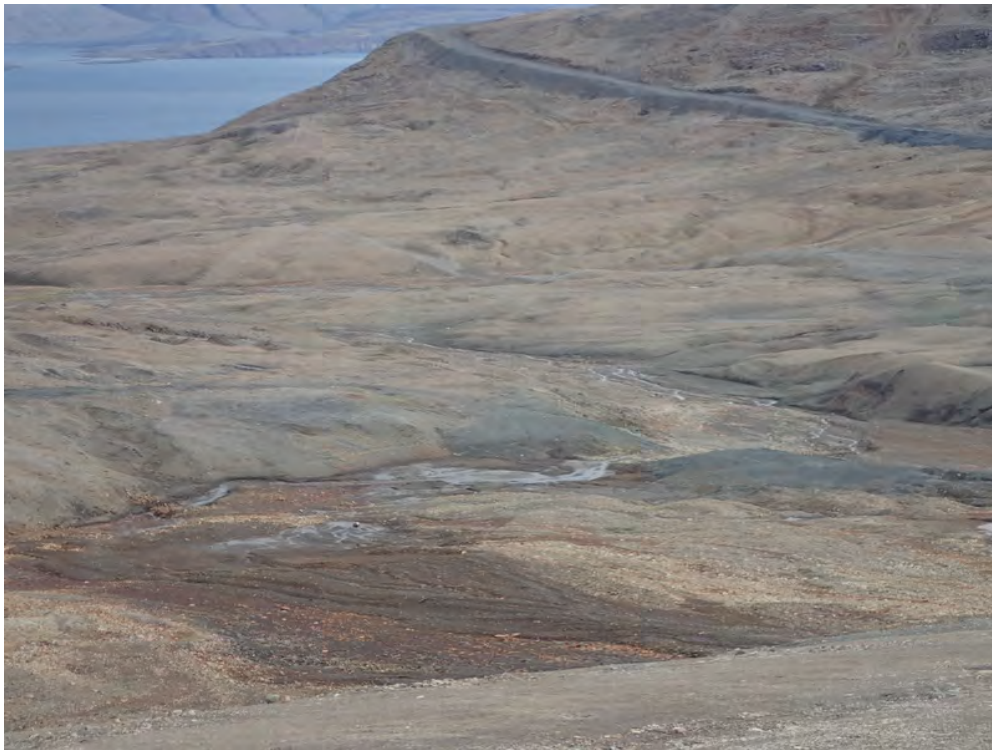
Photo 2. East Adit Treatment Facility—Treatment pond as seen from the East Open Pit.

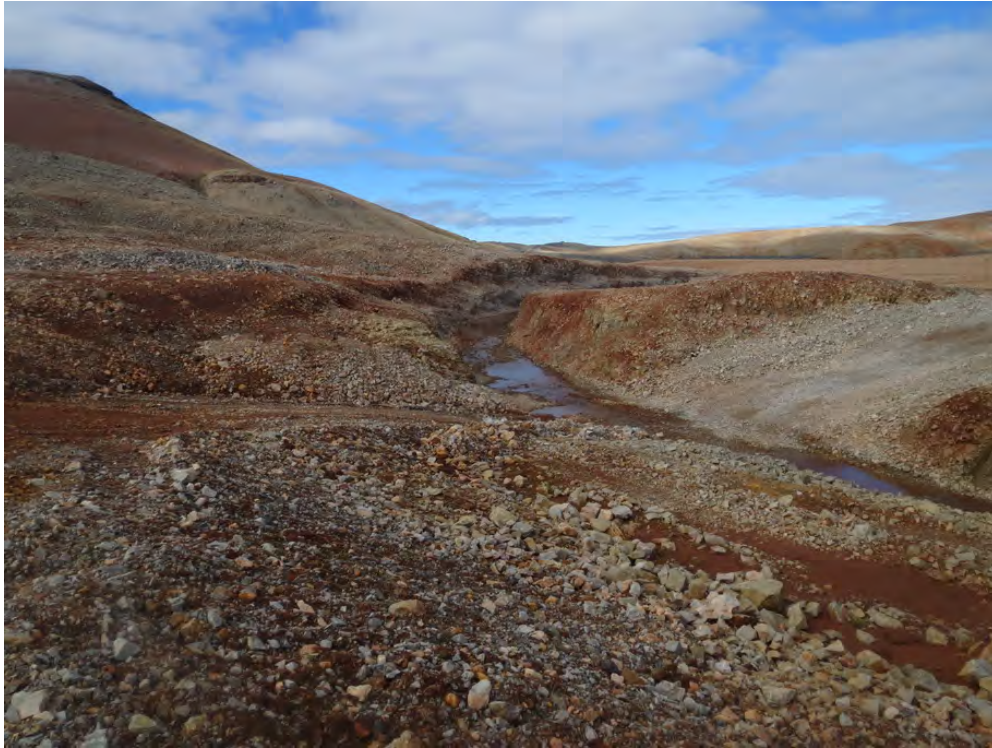
Photo 5. West Twin Dyke Spillway—Spillway as seen from edge of right bank upper slope.

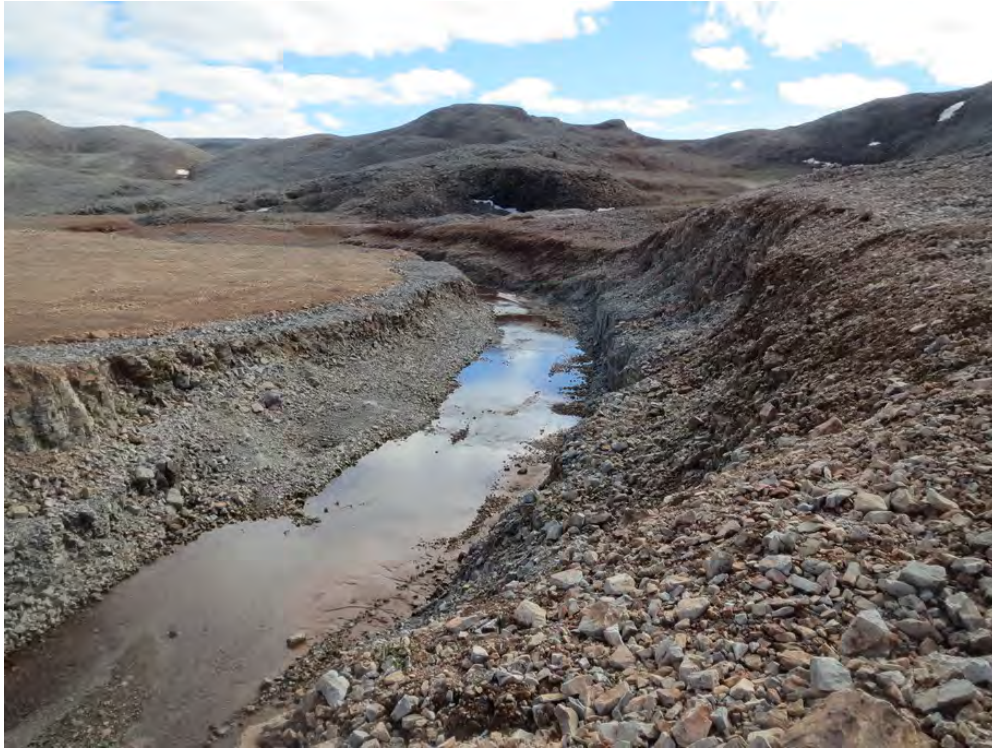
Photo 7. West Twin Dyke Spillway—Flow in bottom of spillway between entrance and access ramp.

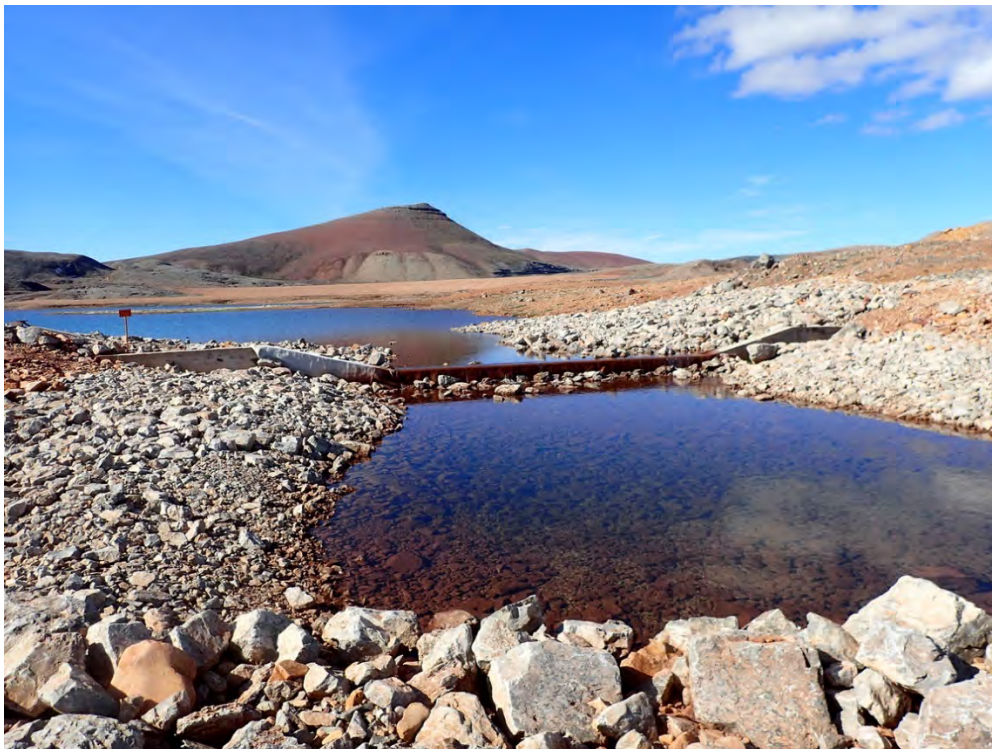
Photo 10. West Twin Lake Outlet Channel—Looking upstream at wall.

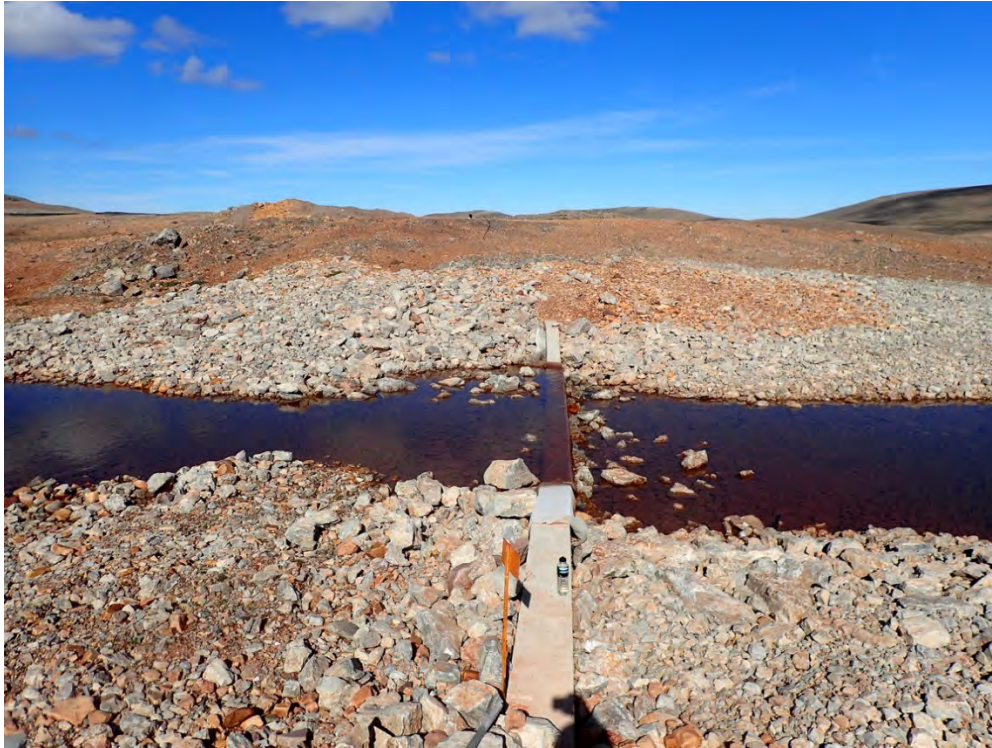
Photo 11. West Twin Lake Outlet Channel—Looking north along wall.

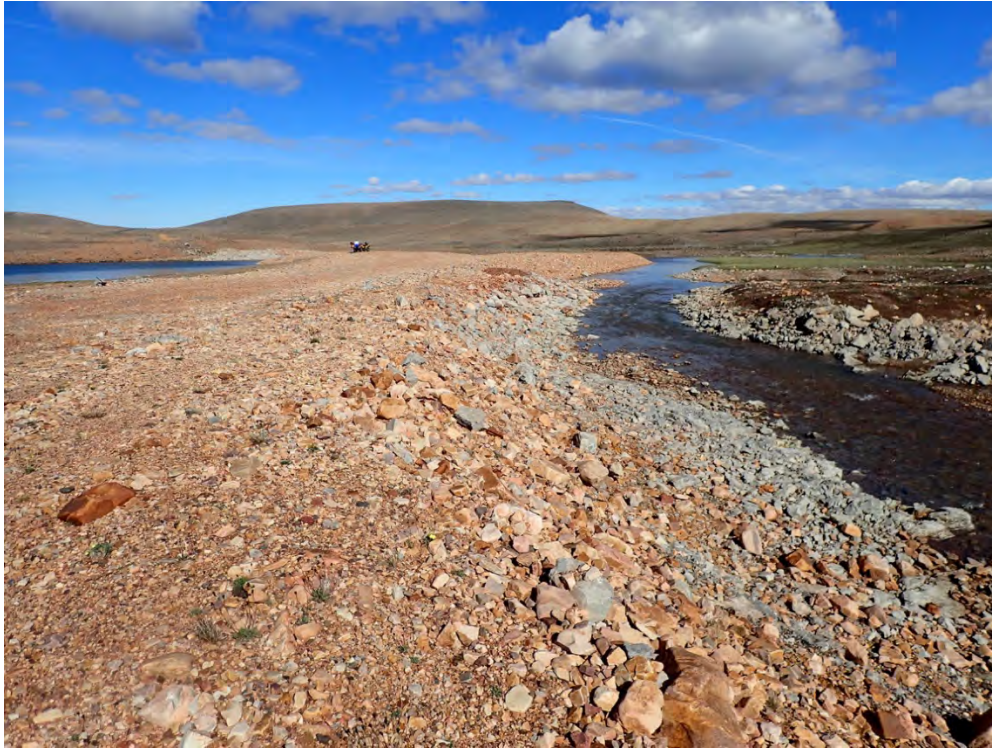
Photo 15. East Twin Creek Diversion Channel —Inside face of dyke.

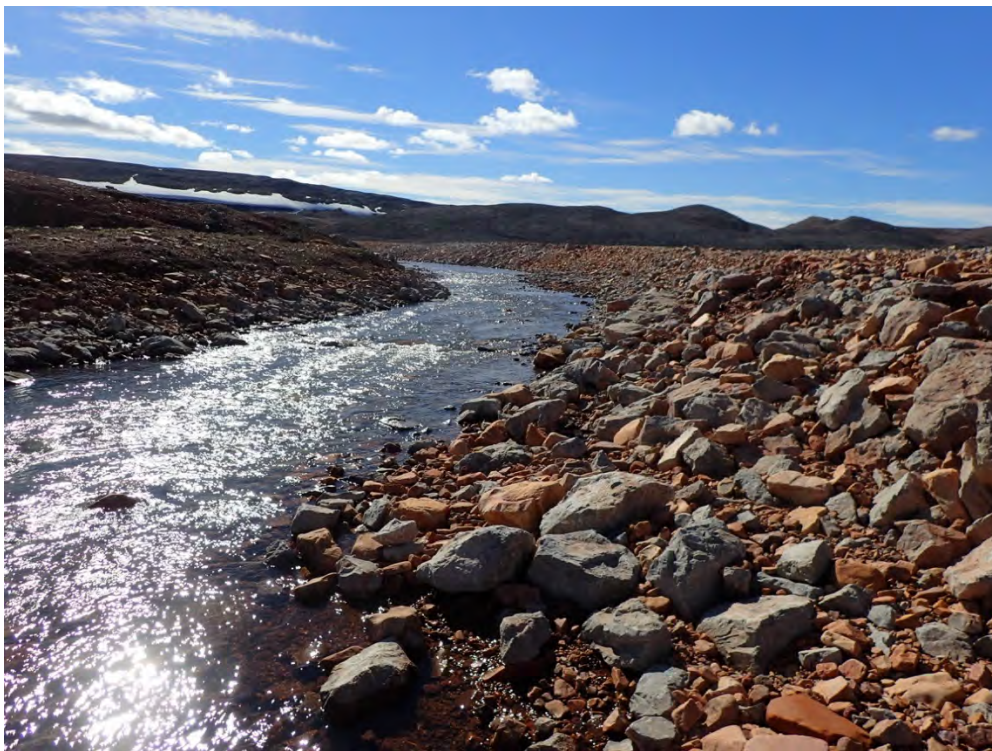
Photo 16. East Twin Creek Diversion Channel —Inside face of dyke.

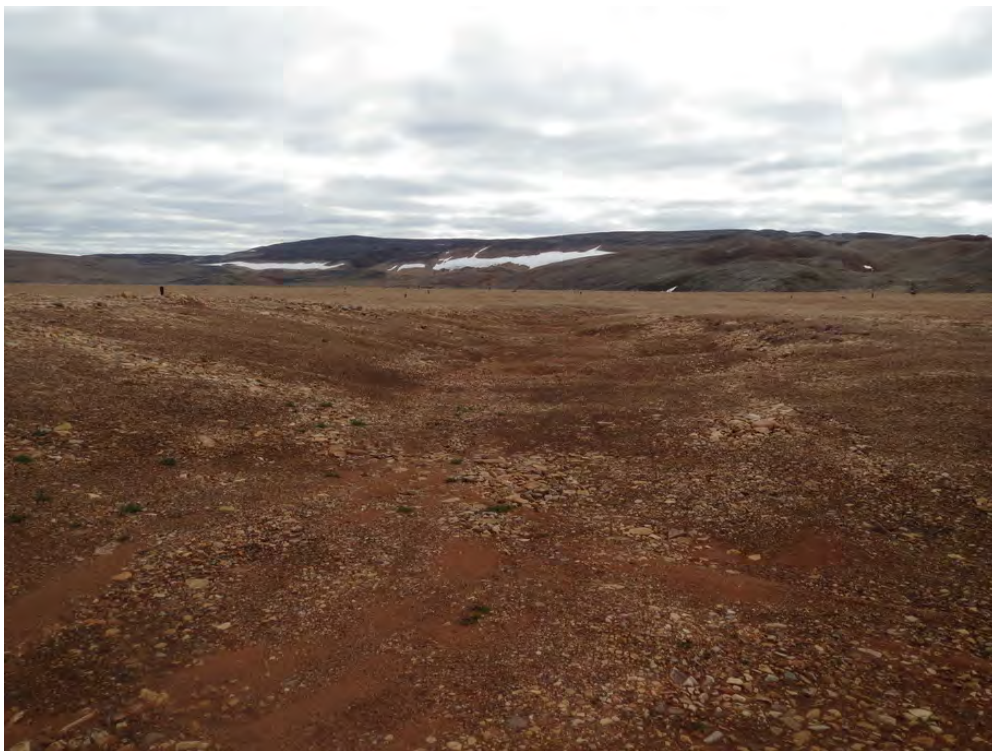
Photo 20. Surface Cell—E/W drainage channel on Surface Cell cover. View looking west.

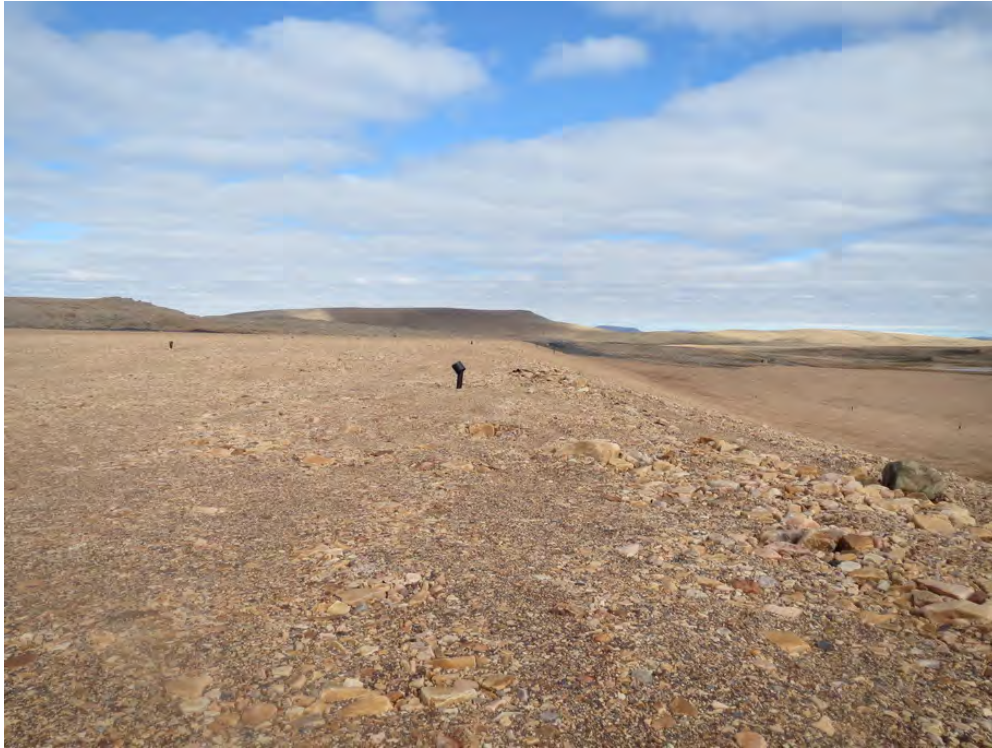
Photo 21. West Twin Dyke—Crest of dyke, view looking north.

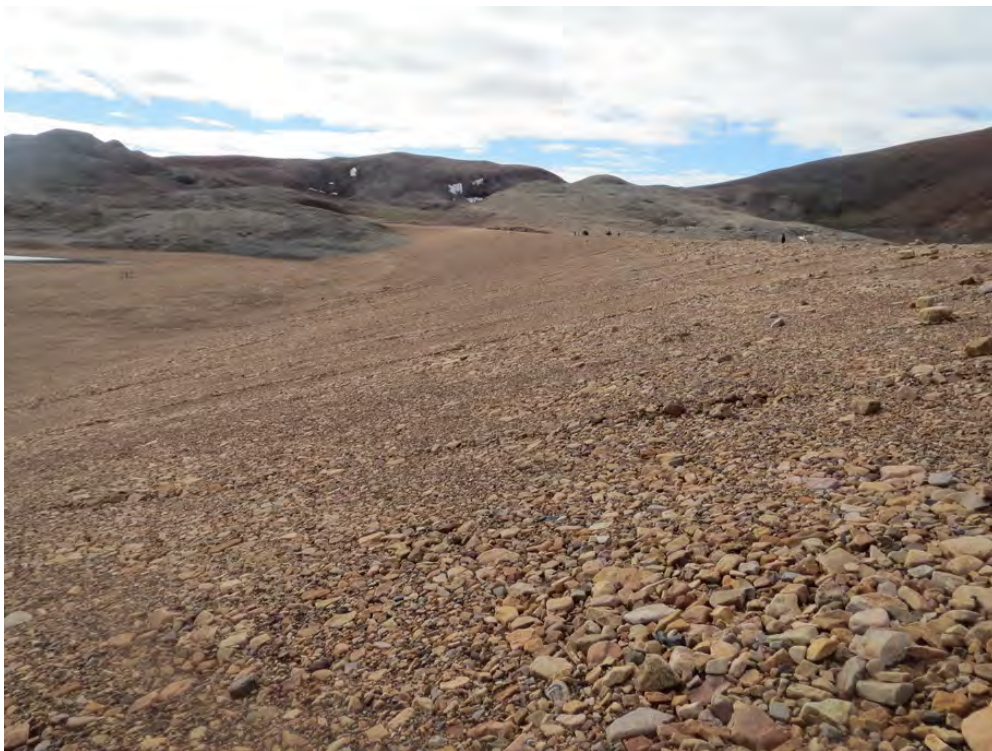
Photo 22. West Twin Dyke—Face of dyke, view looking south.

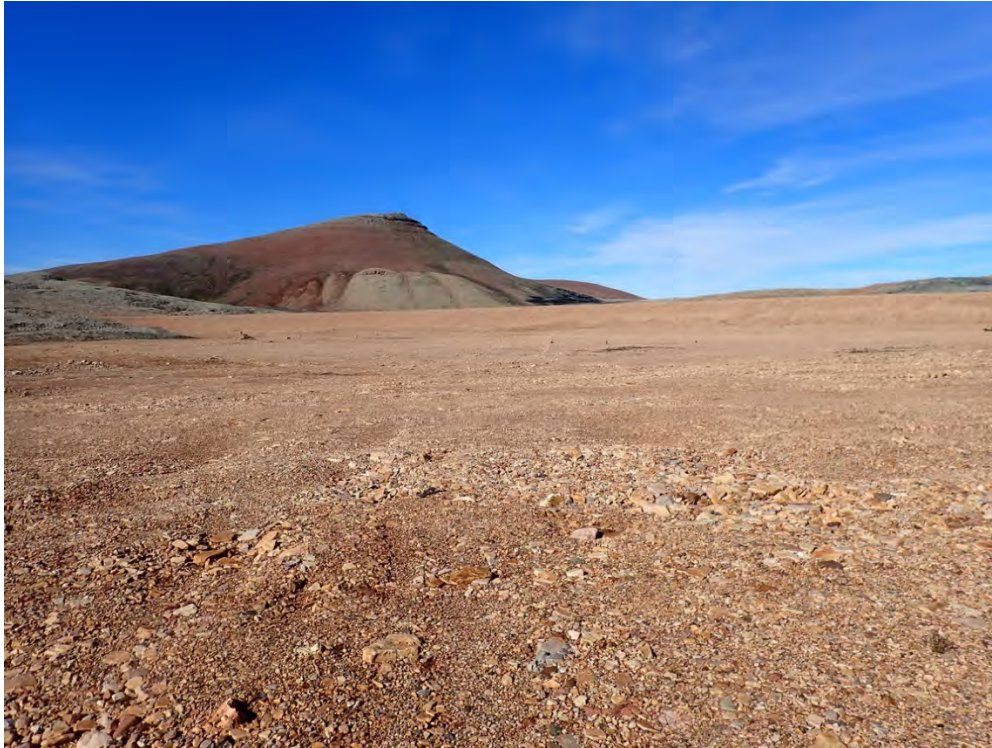
Photo 25. Test Cell—View looking southwest along centre of Test Cell cover system.

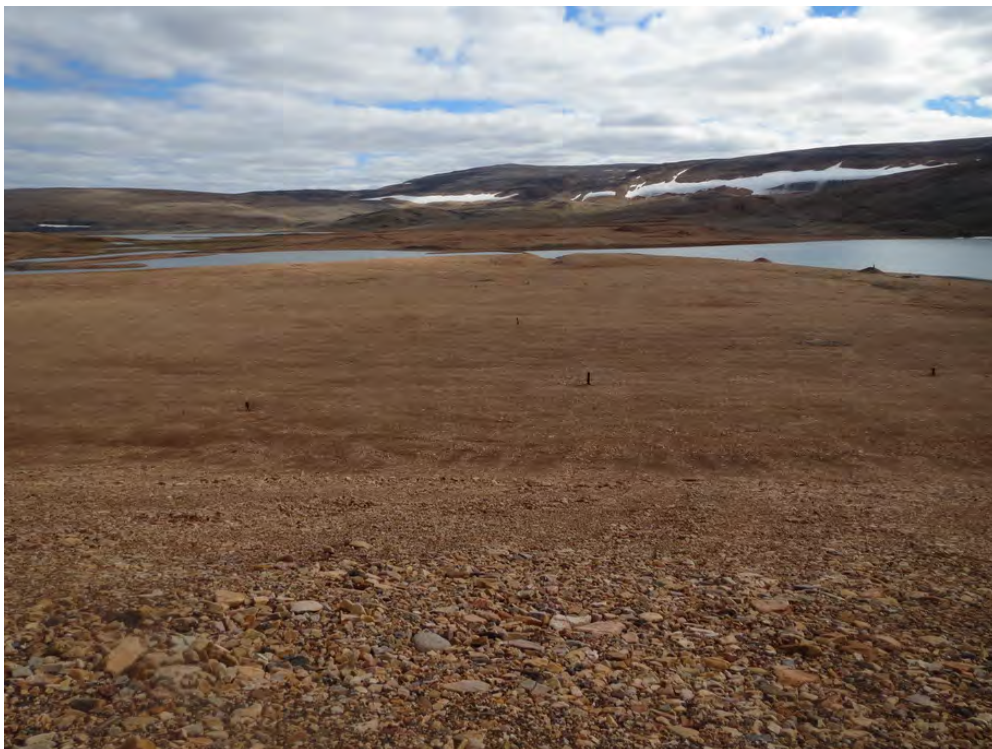
Photo 26. Test Cell—Test Cell area as seen from crest of West Twin Dyke.

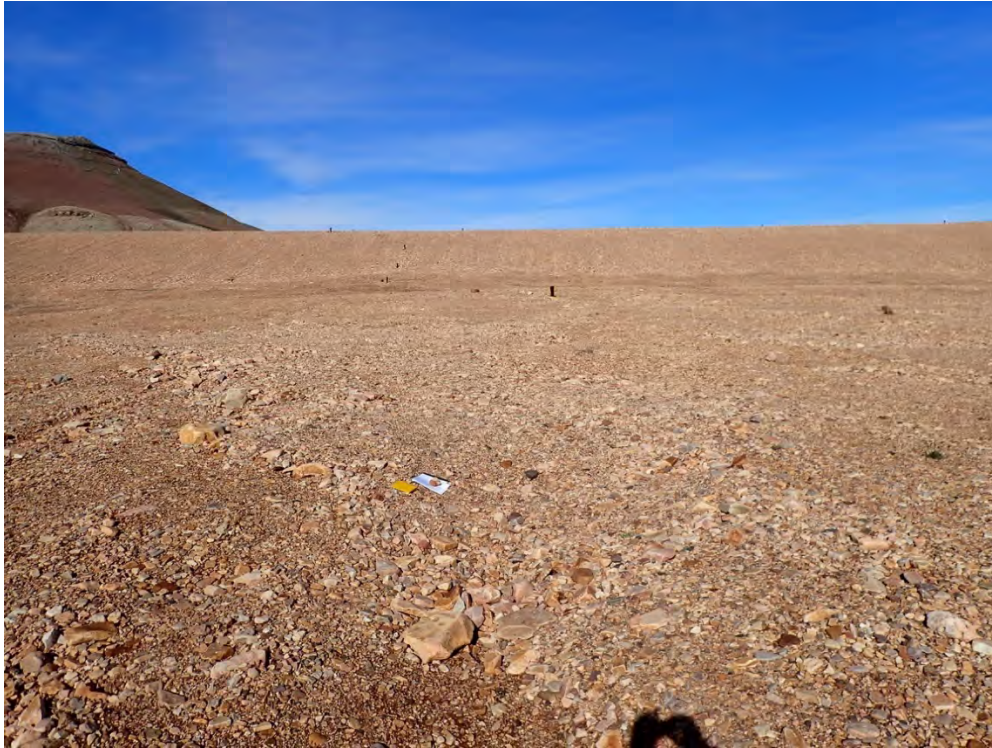
Photo 27. Test Cell—Looking towards toe of West Twin dyke from centre of Test Cell.

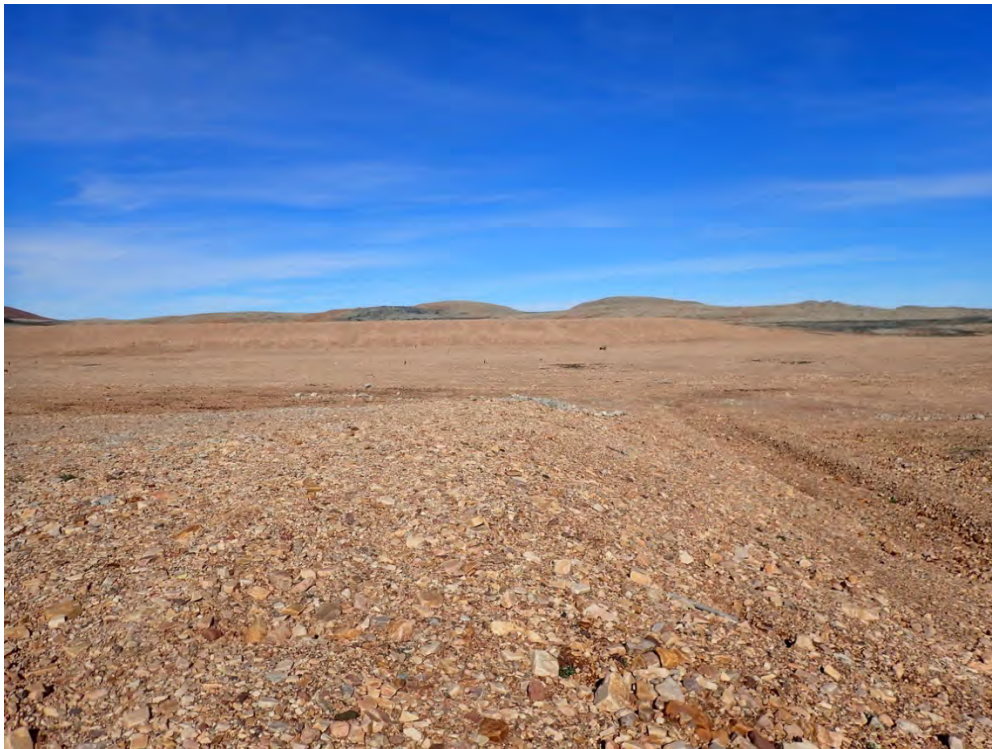
Photo 28. Test Cell—View looking west into centre of Test Cell cover.

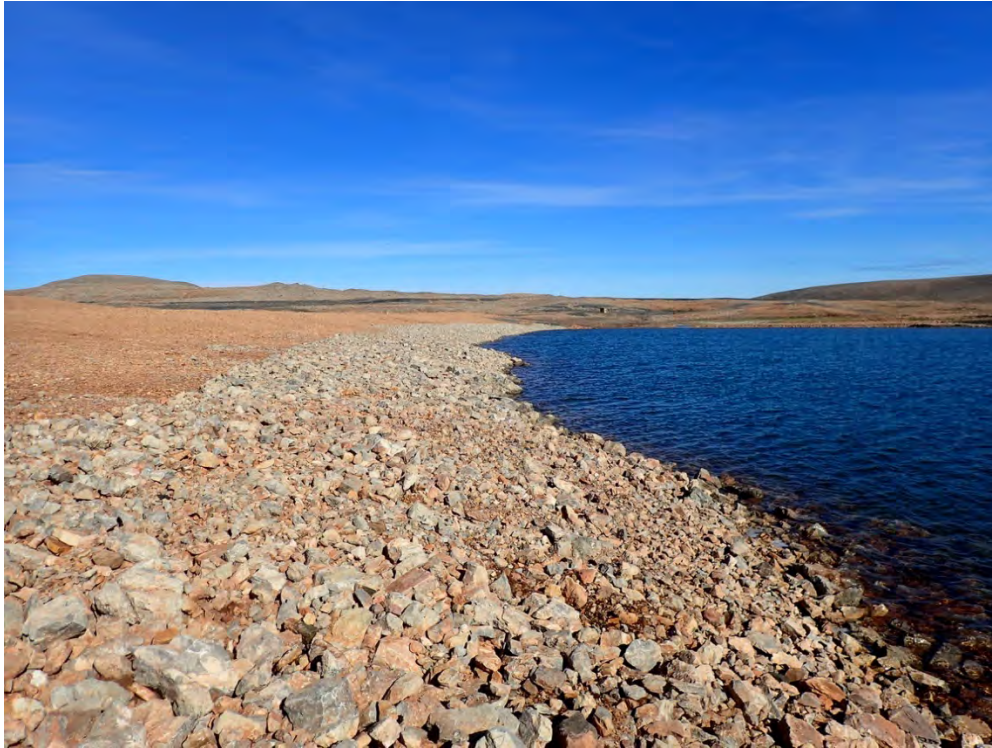
Photo 29. Toe of Test Cell Dyke—Looking north along armoured shoreline at toe of Test Cell Dyke.

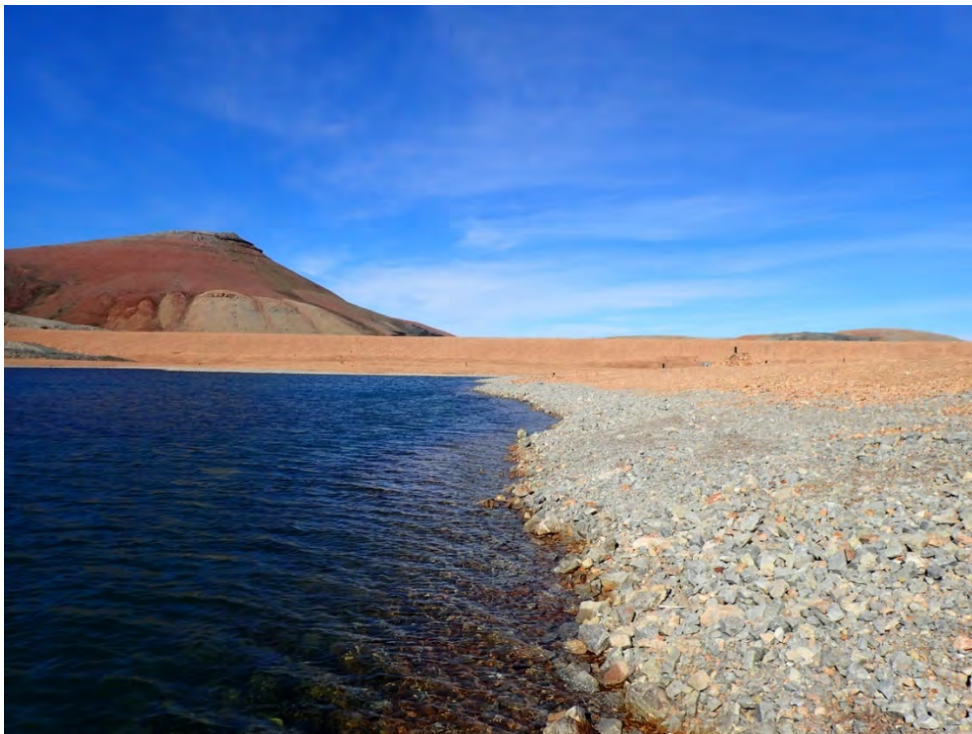
Photo 30. Toe of Test Cell Dyke— Looking west along armoured shoreline at toe of Test Cell Dyke.

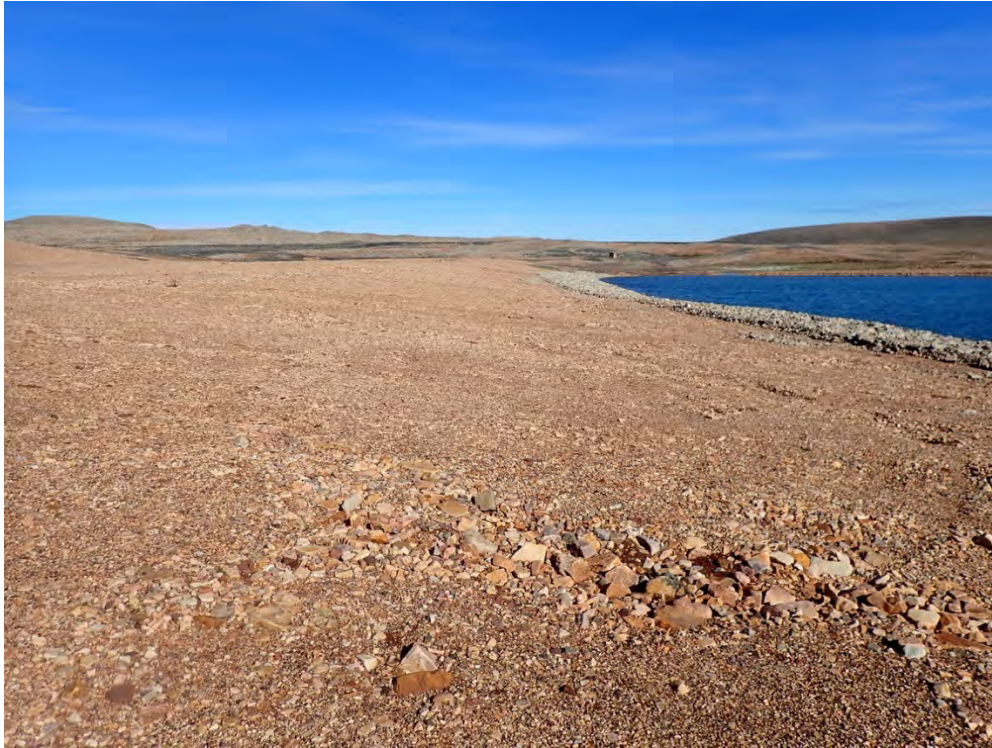
Photo 31. Toe of Test Cell Dyke—Cover along toe of Test Cell Dike. View looking north.

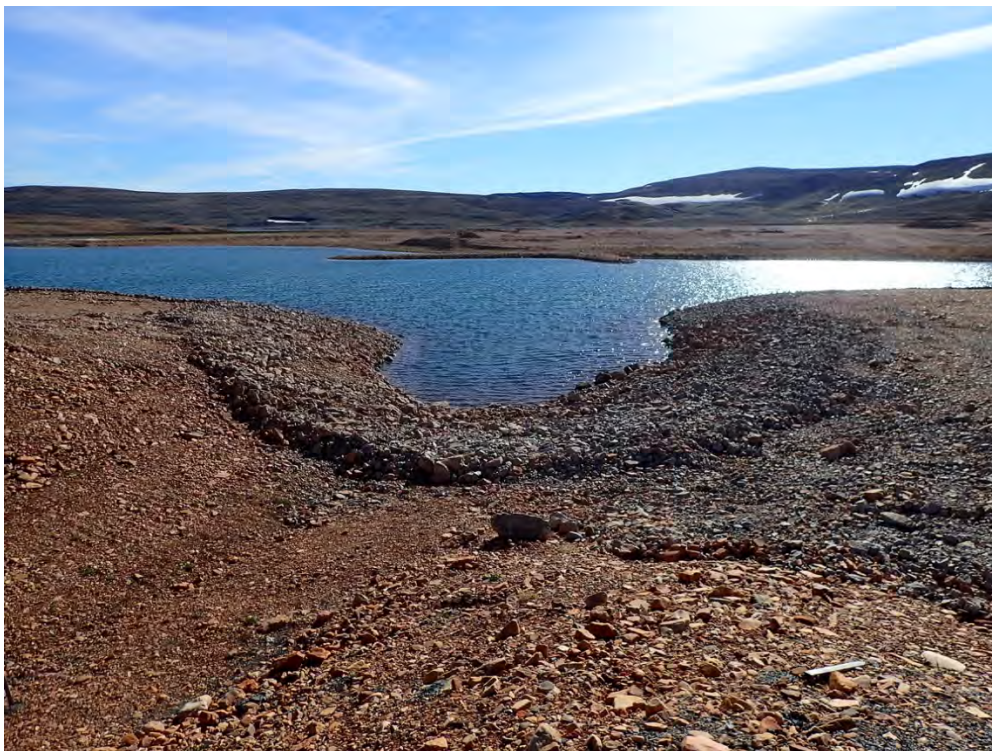
Photo 32. Toe of Test Cell Dyke—Outlet of test cell cover to Reservoir.

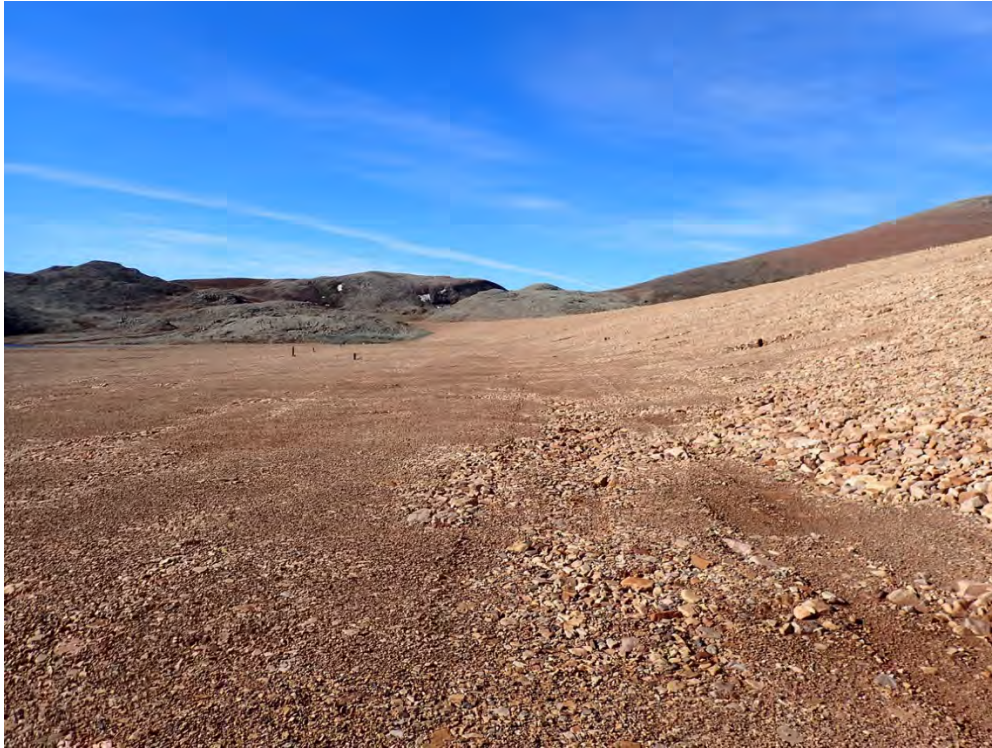
Photo 33. Toe of West Twin Dyke—Toe of West Twin Dyke. View looking south.

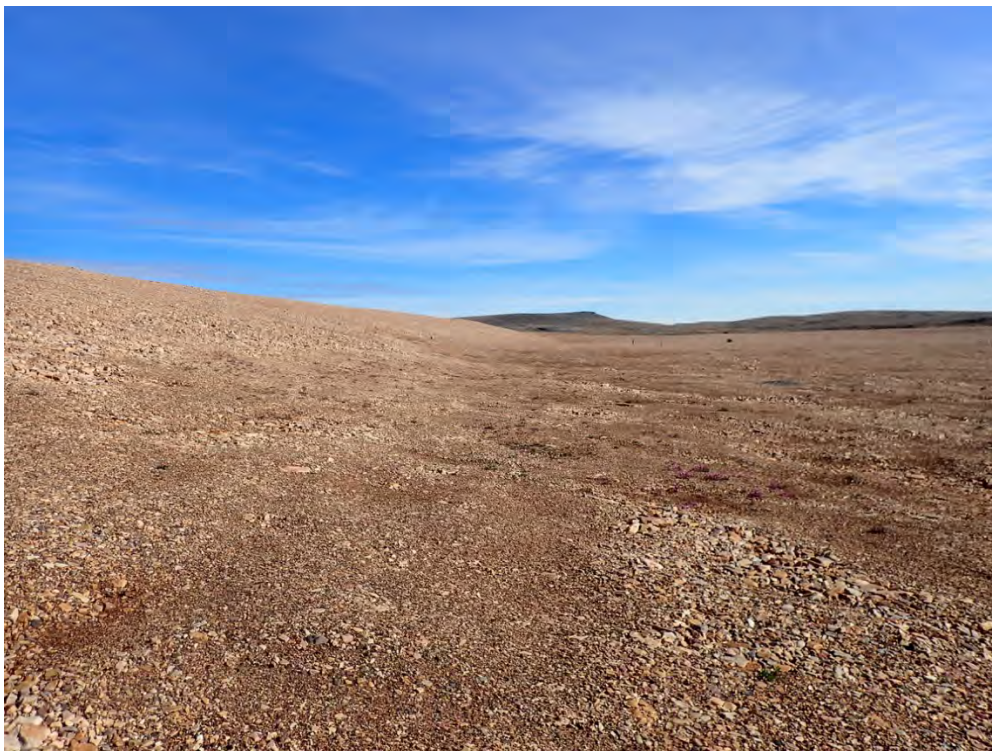
Photo 34. Toe of West Twin Dyke—Toe of West Twin Dyke. View looking north.

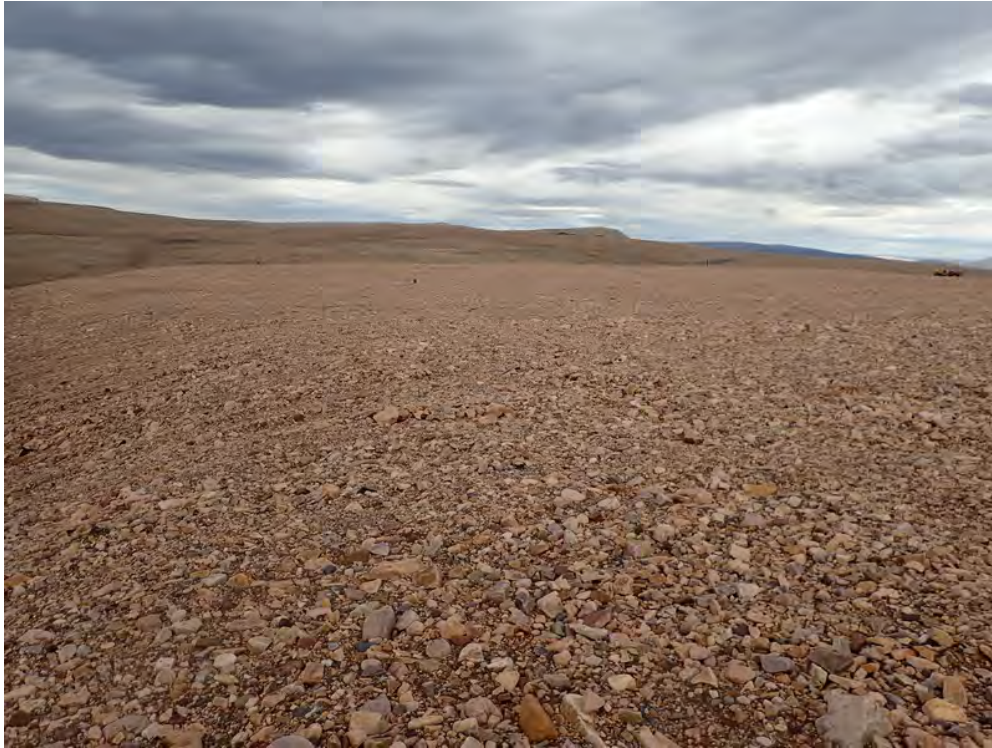
Photo 35. Landfill–Surface of landfill cover system.

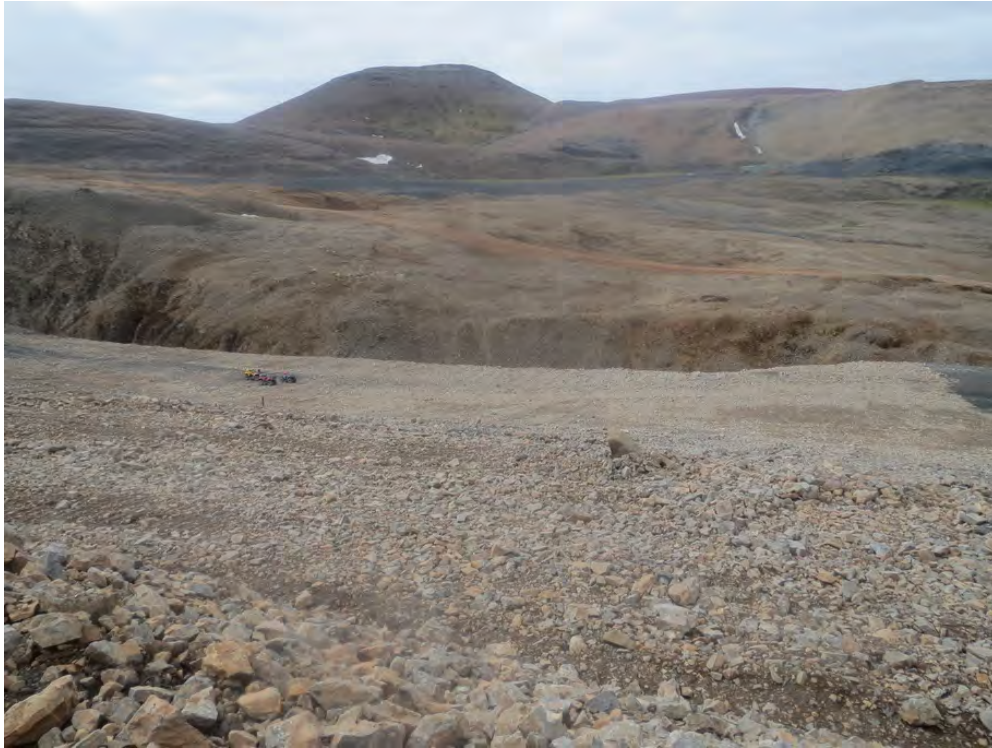
Photo 39. West Open Pit—Surface of cover system looking downslope.

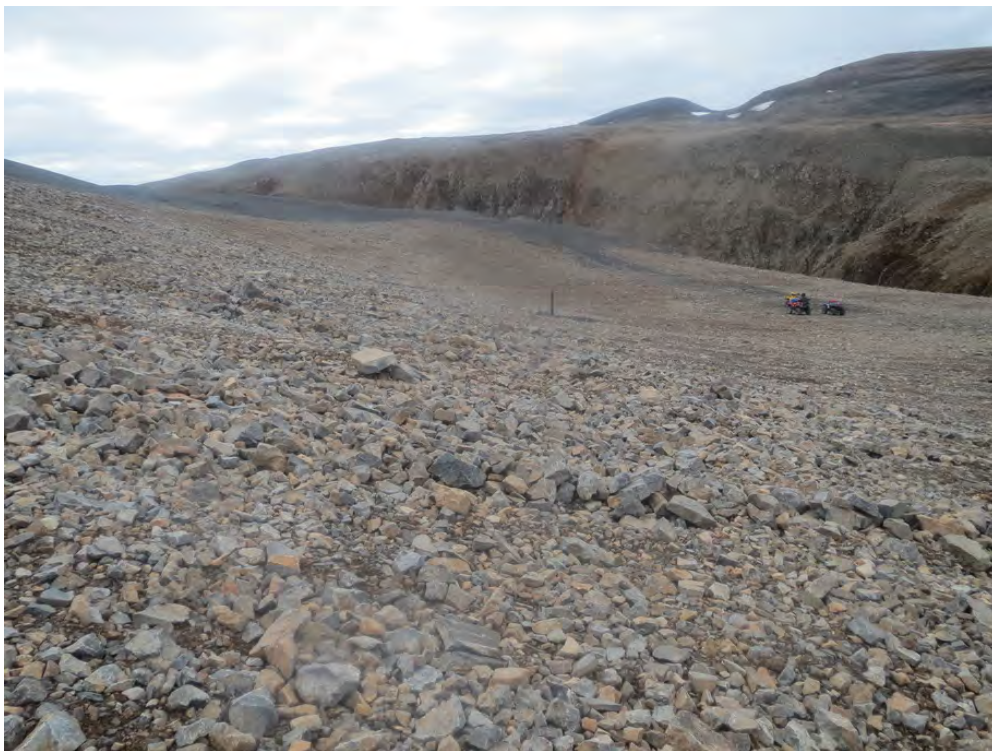
Photo 40. West Open Pit—Sloping face of cover system looking east.

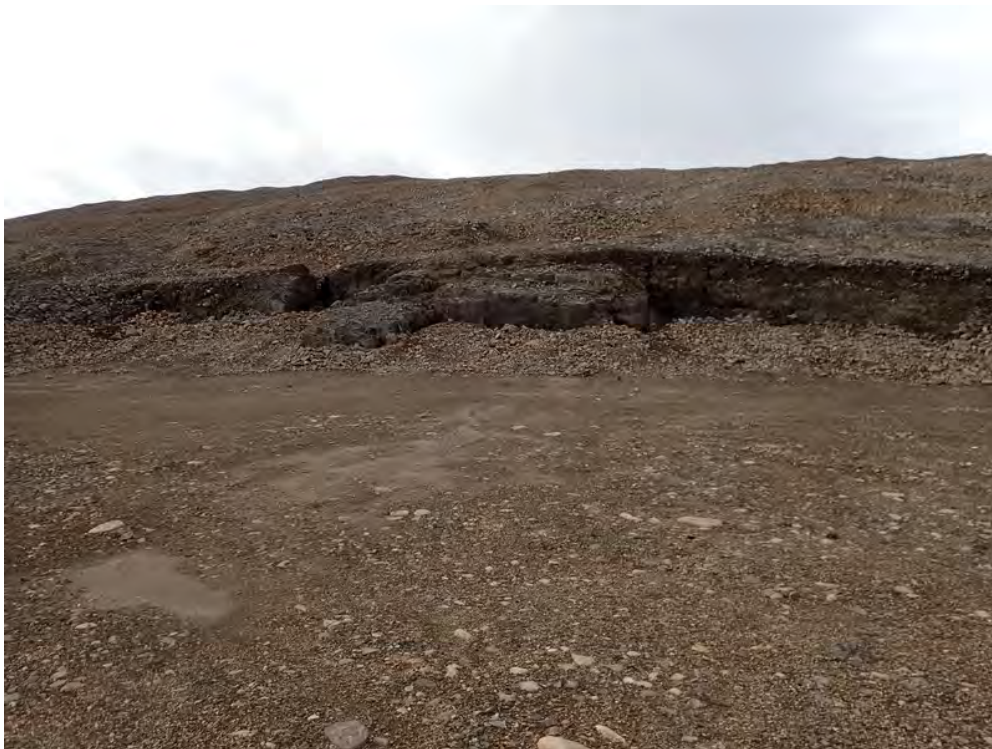
Photo 42. East Open Pit—Face of remnant highwall.

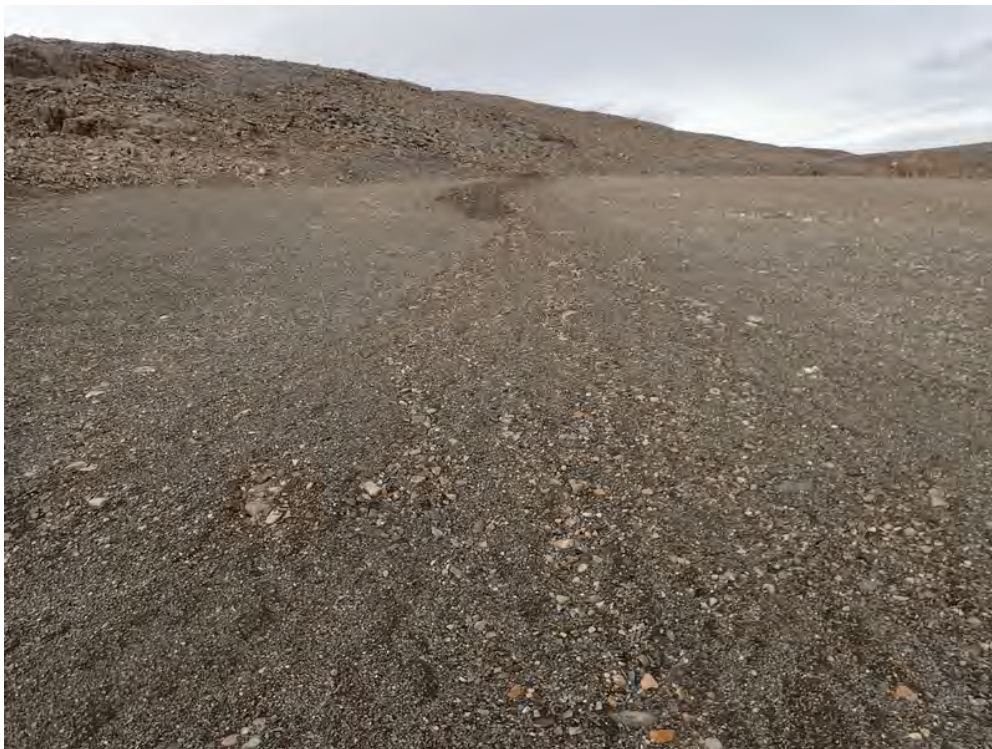
Photo 46. East Trench—Cover system, looking upslope.

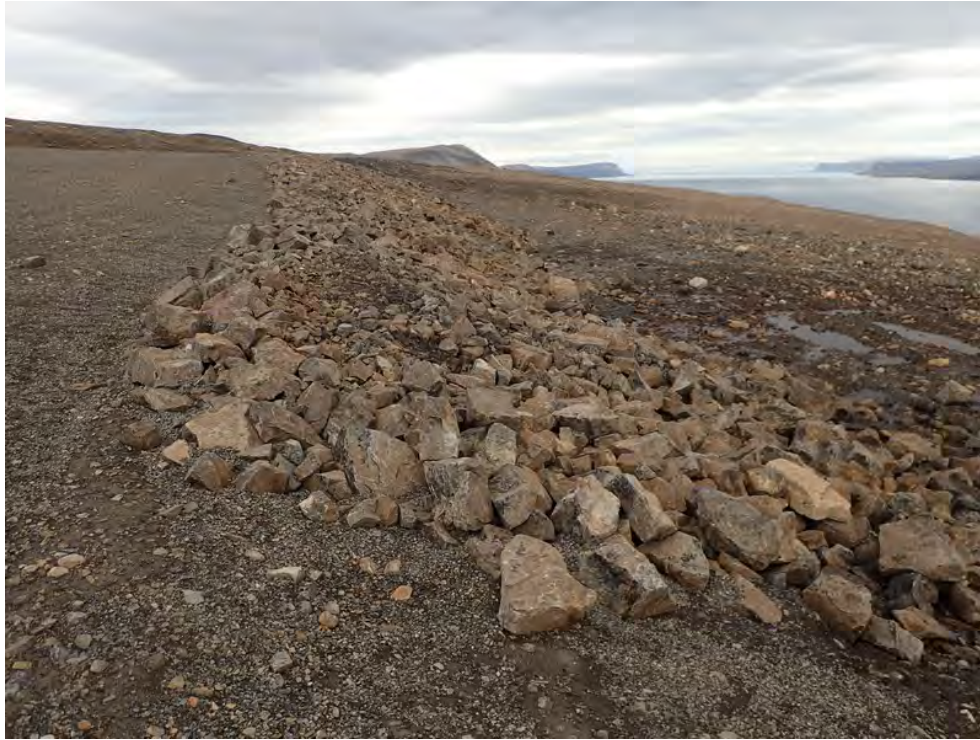
Photo 47. Oceanview Open Pit—Toe of cover system. Note seepage emerging at the bottom of toe.

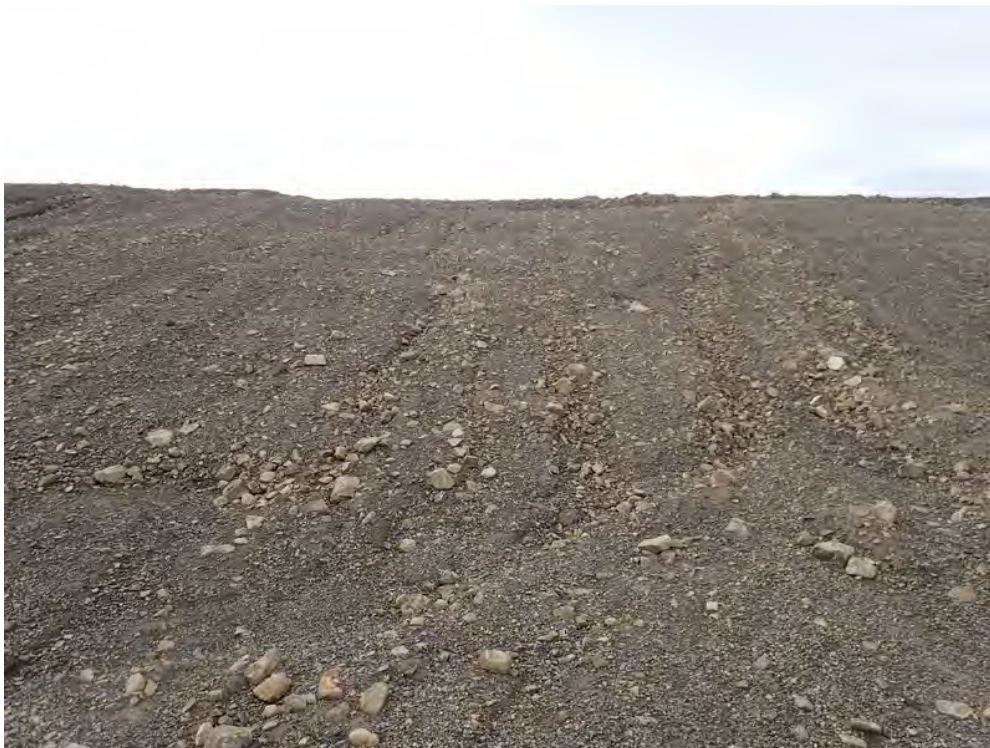
expected to wash away with time. As such, the armour thickness was increased to 0.35 m. The coarse grained fraction of the armour material, which can be observed in Photo 48, is expected to limit the amount of erosion that can occur, without negatively affecting the geothermal performance of the cover.

Photo 48. Oceanview Open Pit—Rill erosion along backslope. Note self armoring that is occurring.

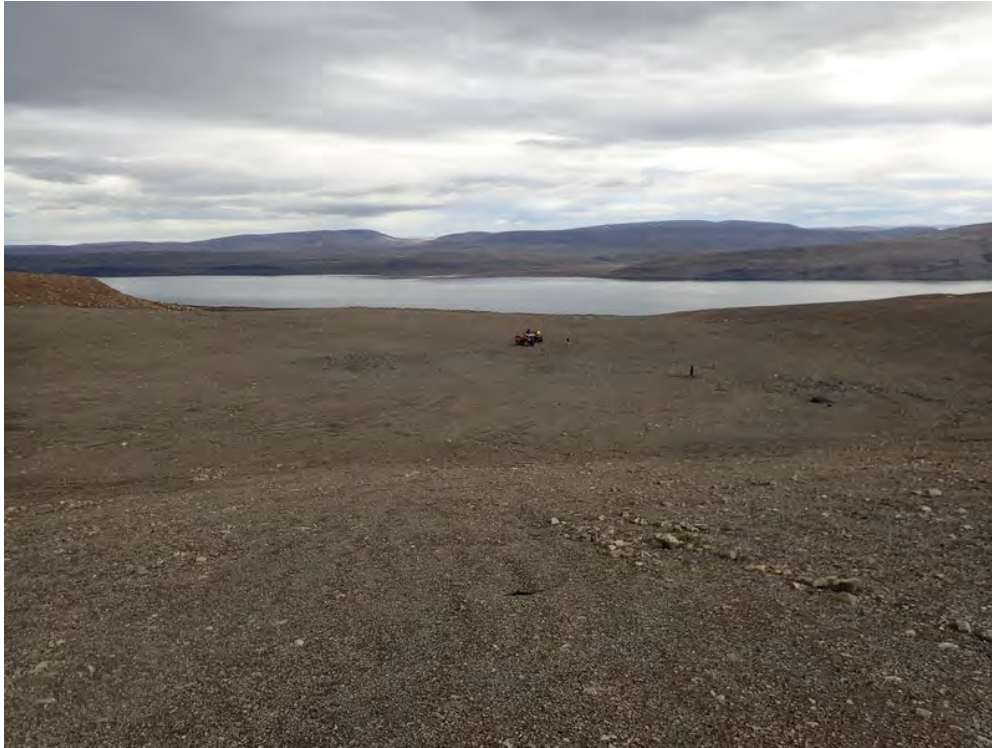
Photo 49. Oceanview Open Pit—Main pit area as seen from backslope.

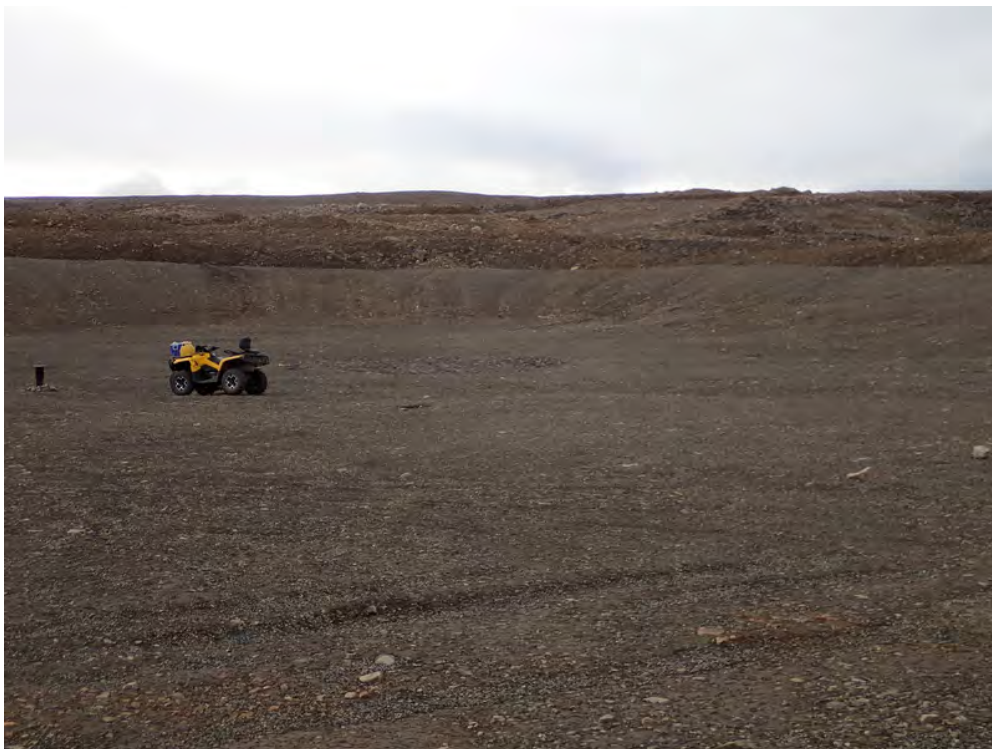
Photo 50. Oceanview Open Pit—Centre of cover system as seen from toe area.
