NYRSTAR

NANISIVIK MINE, NUNAVUT

2016 ANNUAL GEOTECHNICAL INSPECTION

PROJECT NO.: 0255027
DATE: March 7, 2017
DOCUMENT NO.:

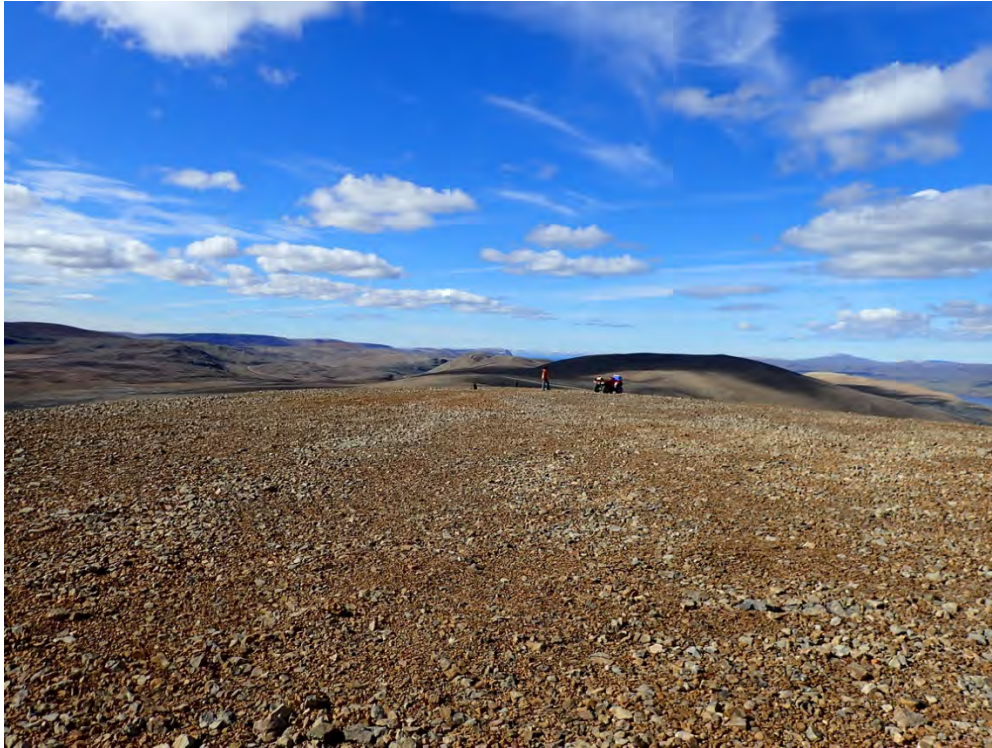
Photo 51. Area 14—Upper flat surface of waste rock cover.

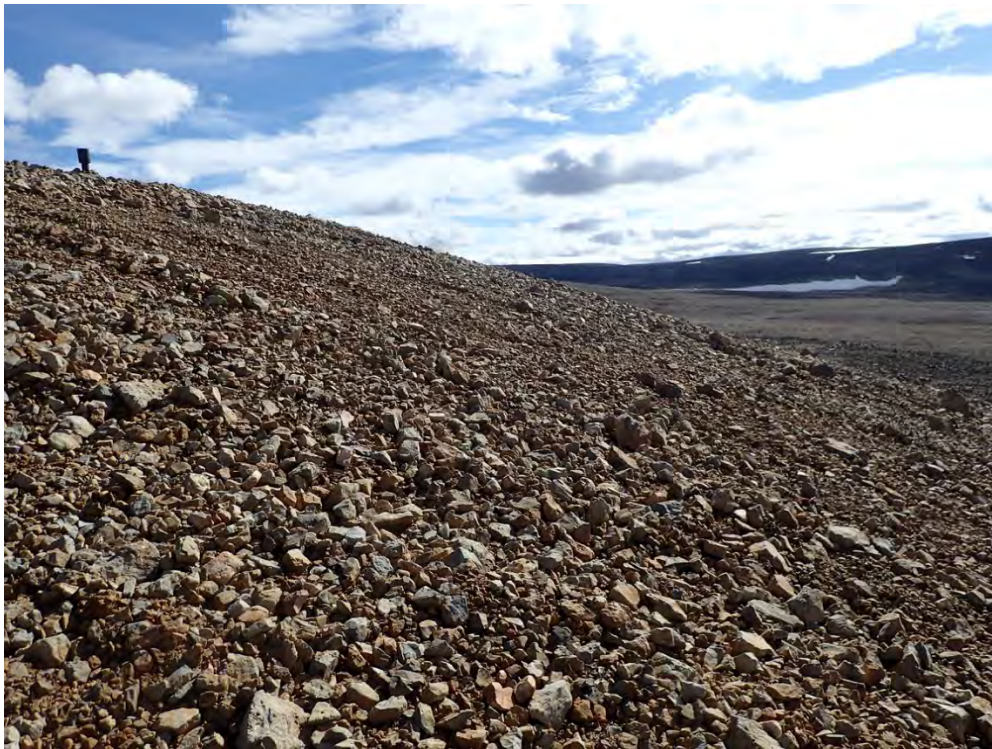
Photo 52. Area 14—Sloping face of waste rock cover.

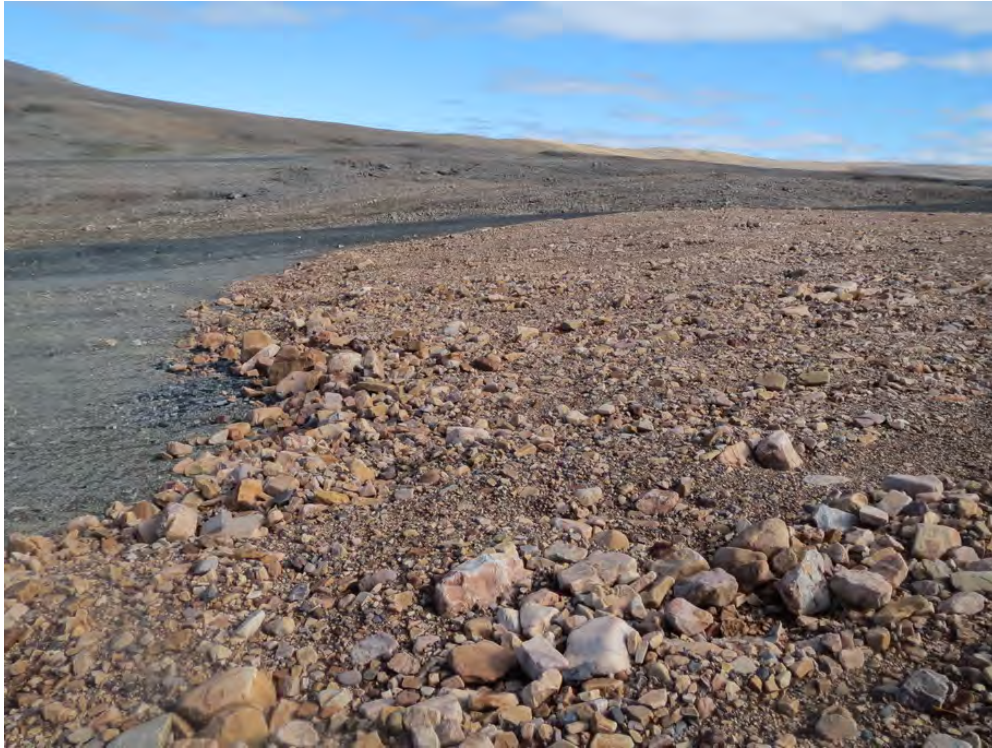
Photo 53. Upper Dump Pond—Edge of cover system.

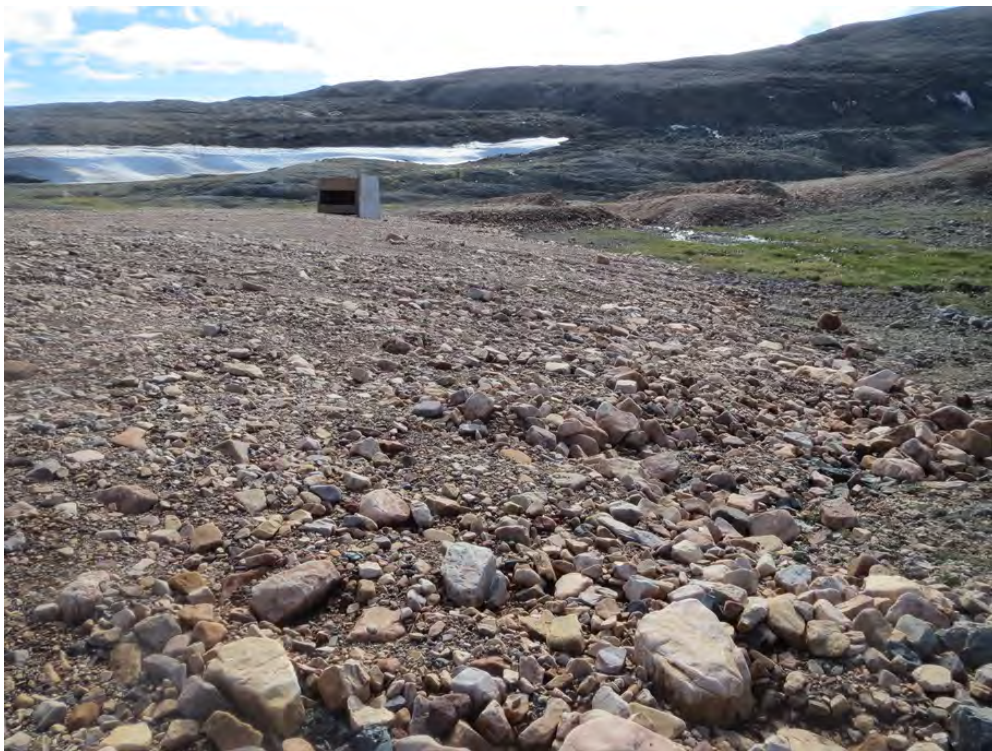
Photo 54. Upper Dump Pond—Edge of cover system.

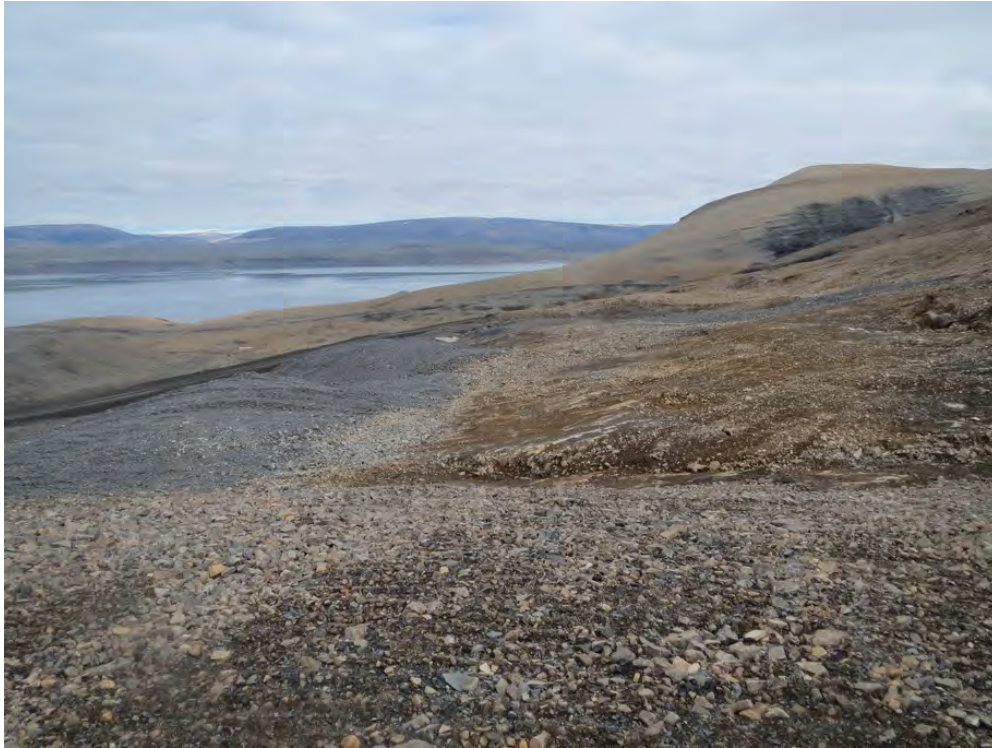
Photo 55. Industrial Complex Cover—View across sloping face of cover.

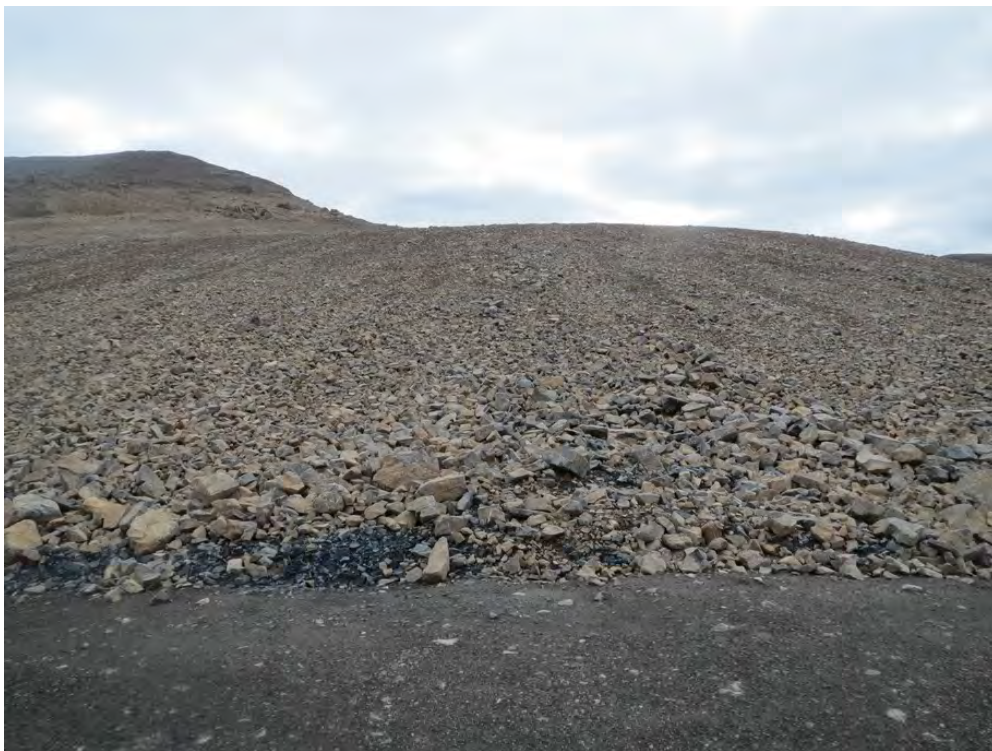
Photo 56. Industrial Complex Cover—Looking upslope from toe of sloping cover system.

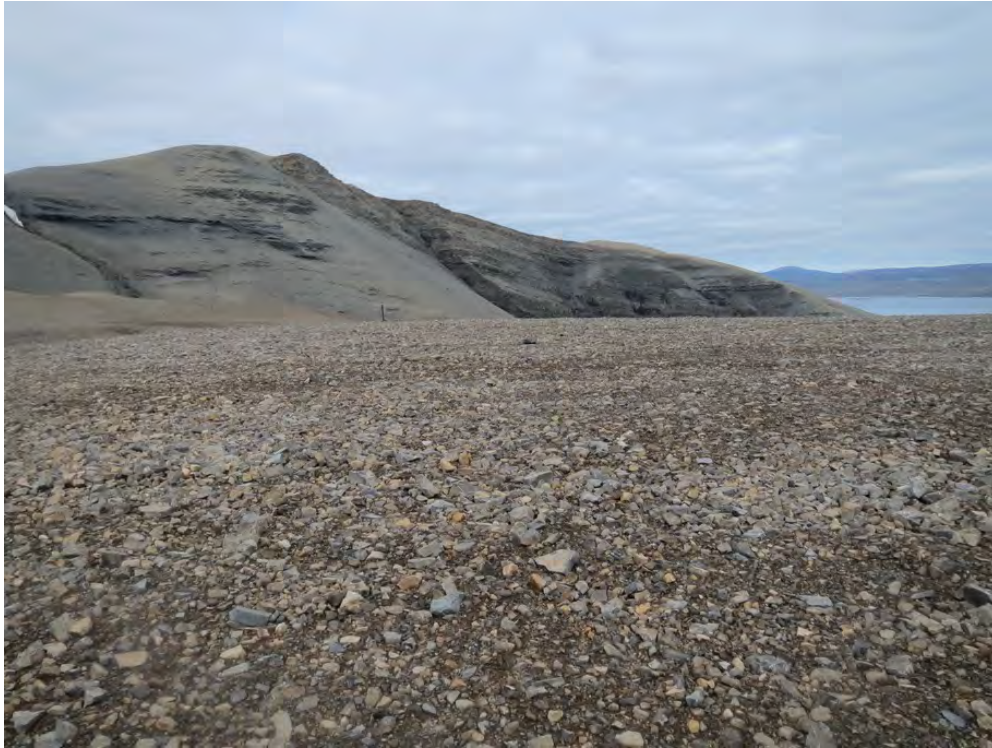
Photo 57. Industrial Complex Cover–Surface of cover system.

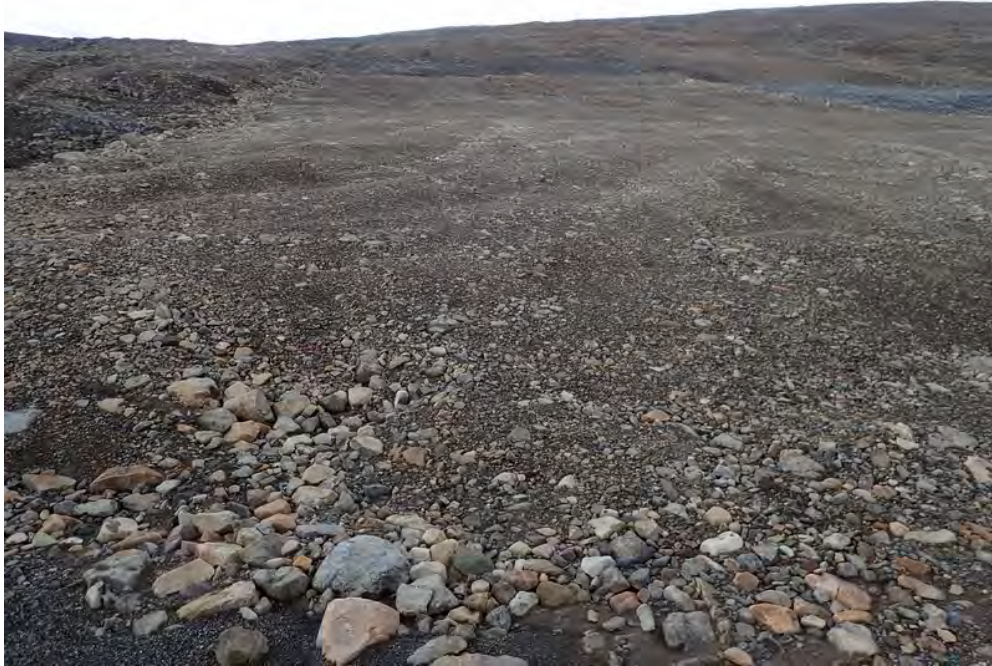
Photo 58. 17N Portal—Looking upslope along surface of cover.

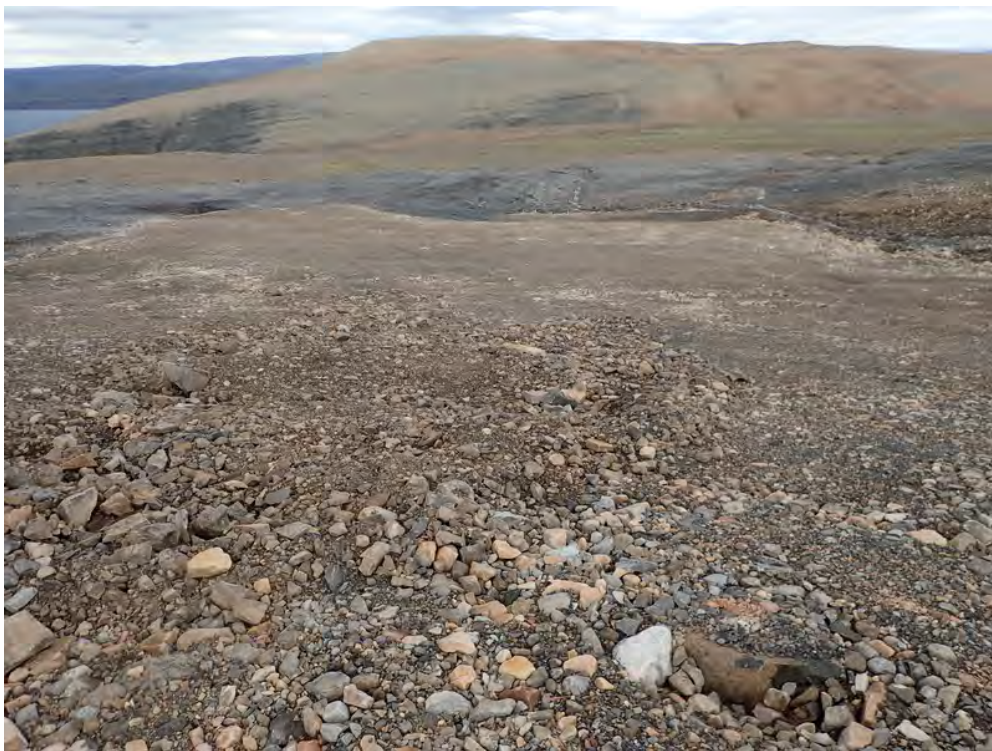
Photo 59. 17N Portal—Looking downslope along surface of cover.

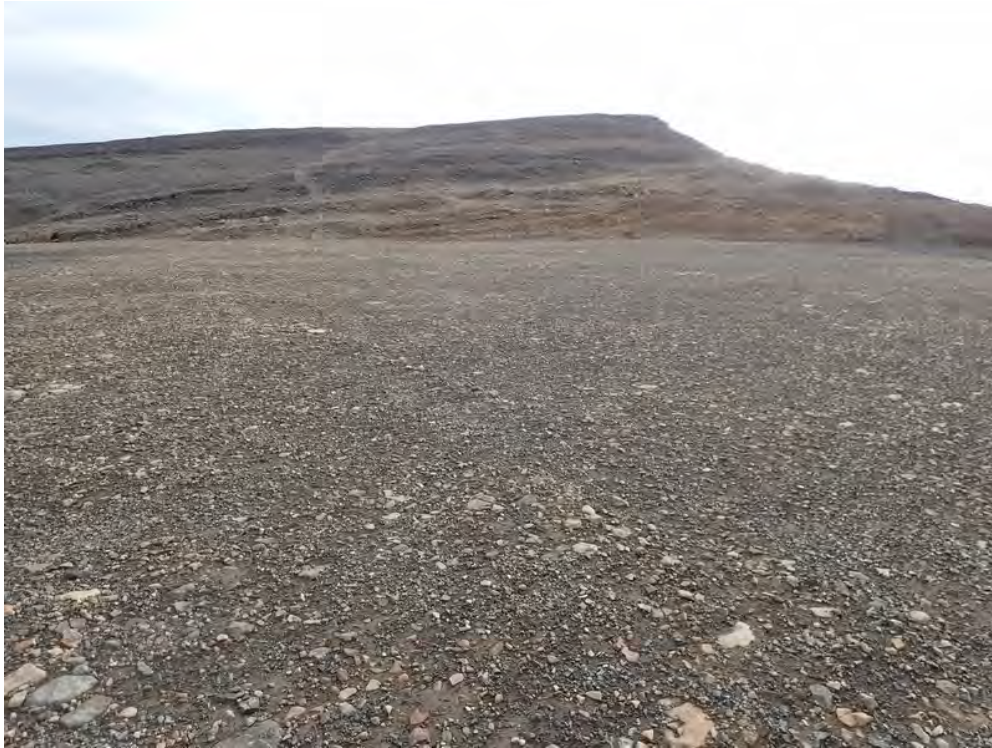
Select photos from the inspection are provided in Appendix I (Photos 62 and 63). The main observations are summarized by the following:

Photo 62. K-Baseline Portal—Surface of cover system.

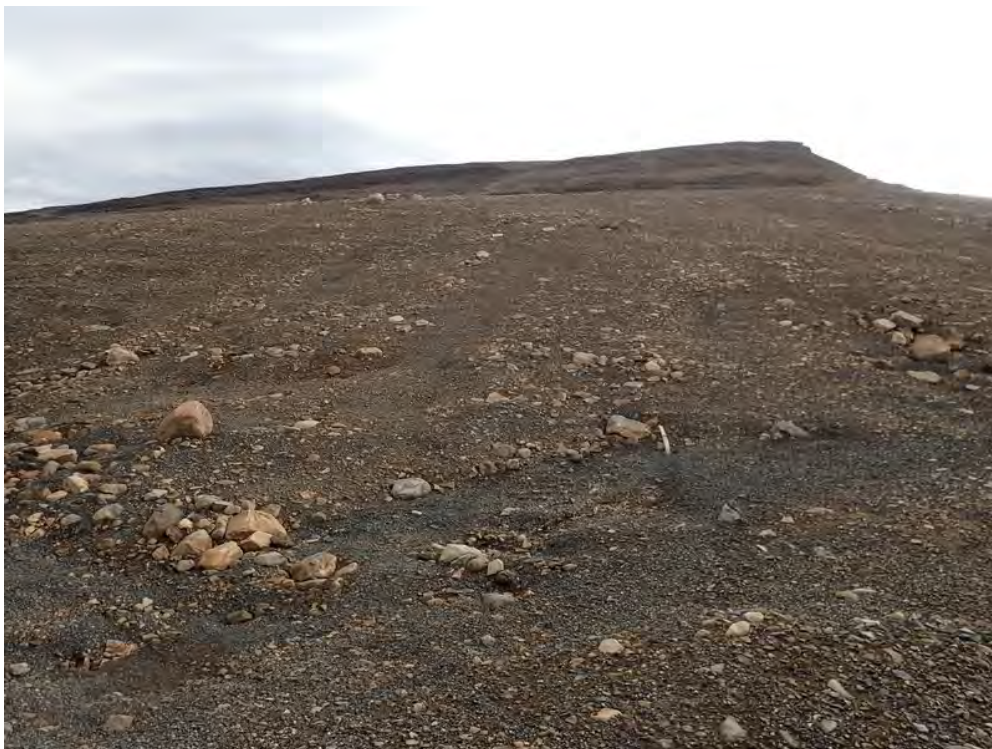
Photo 63. K-Baseline Portal—Sloping face of cover system looking upslope.

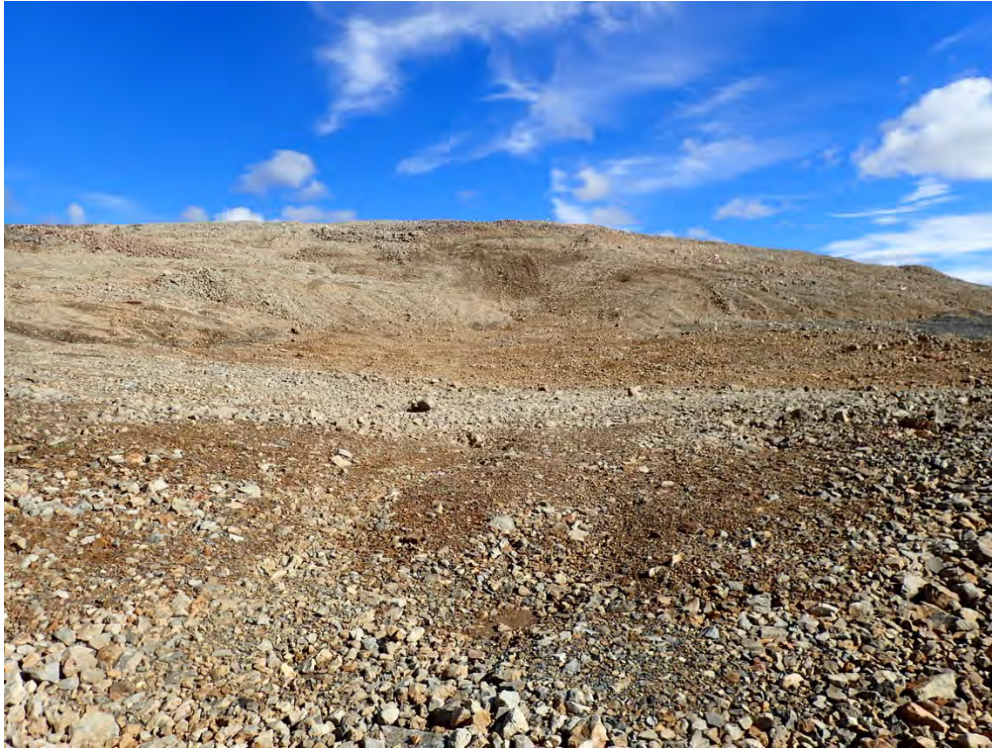
Select photos from the inspection are provided in Appendix I (Photo 64). The main observations are summarized by the following:

Photo 64. Area 14 Portal–Portal entrance.

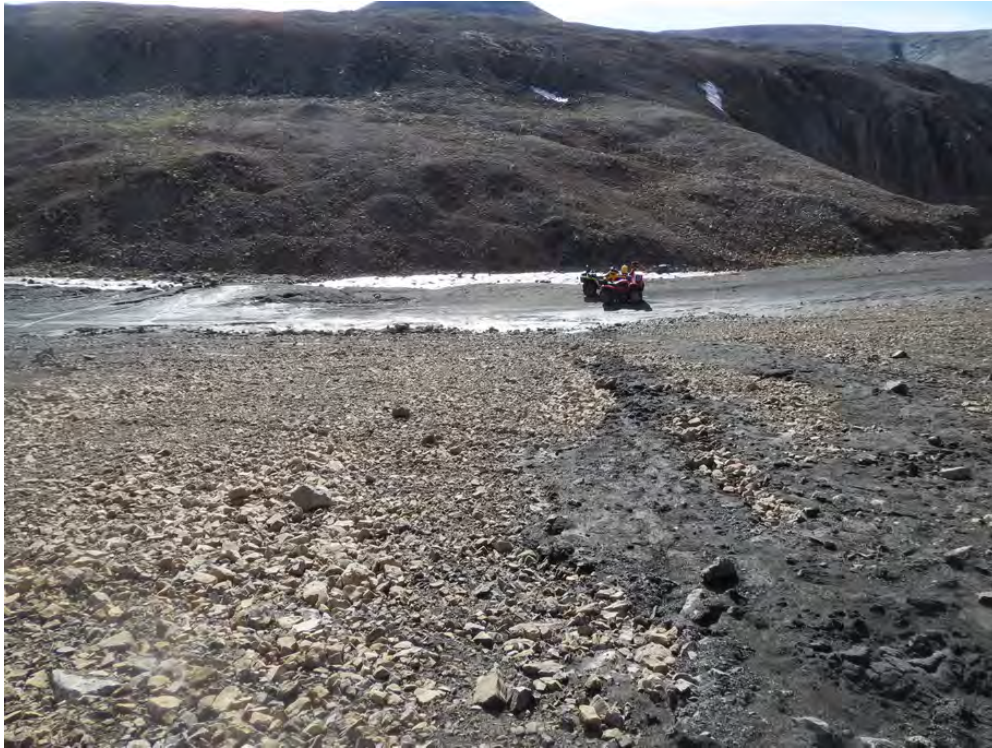
Select photos from the inspection are provided in Appendix I (Photos 65 and 66). The main observations are summarized by the following:

Photo 65. 09S Portal—Portal plug looking downslope.

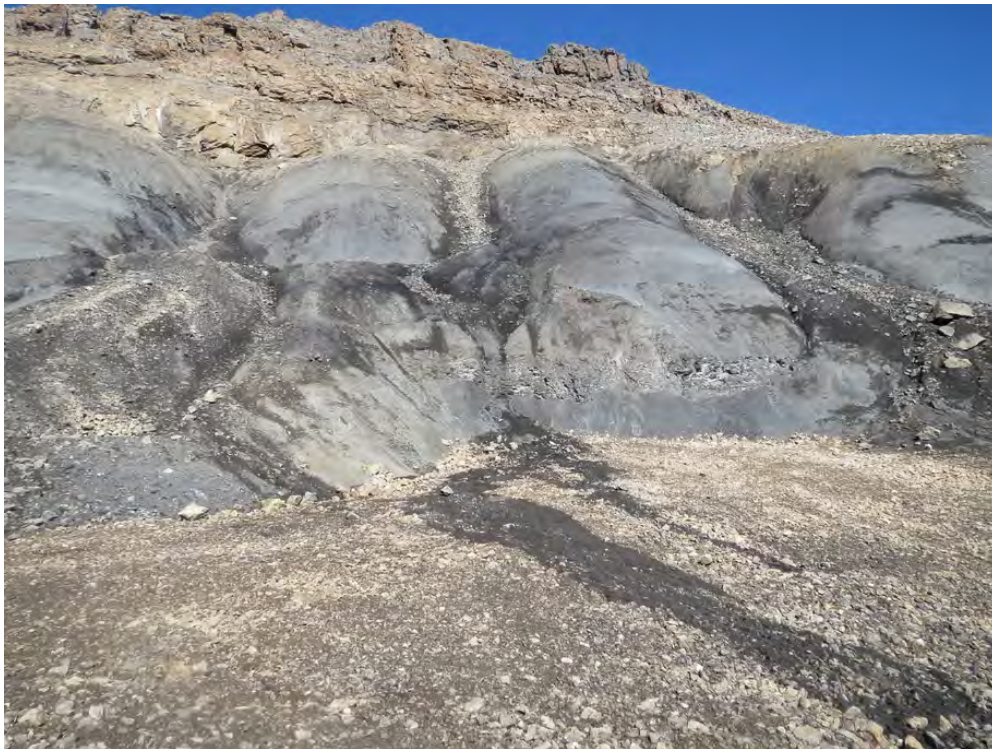
Photo 66. 09S Portal—Looking upslope along surface of cover.

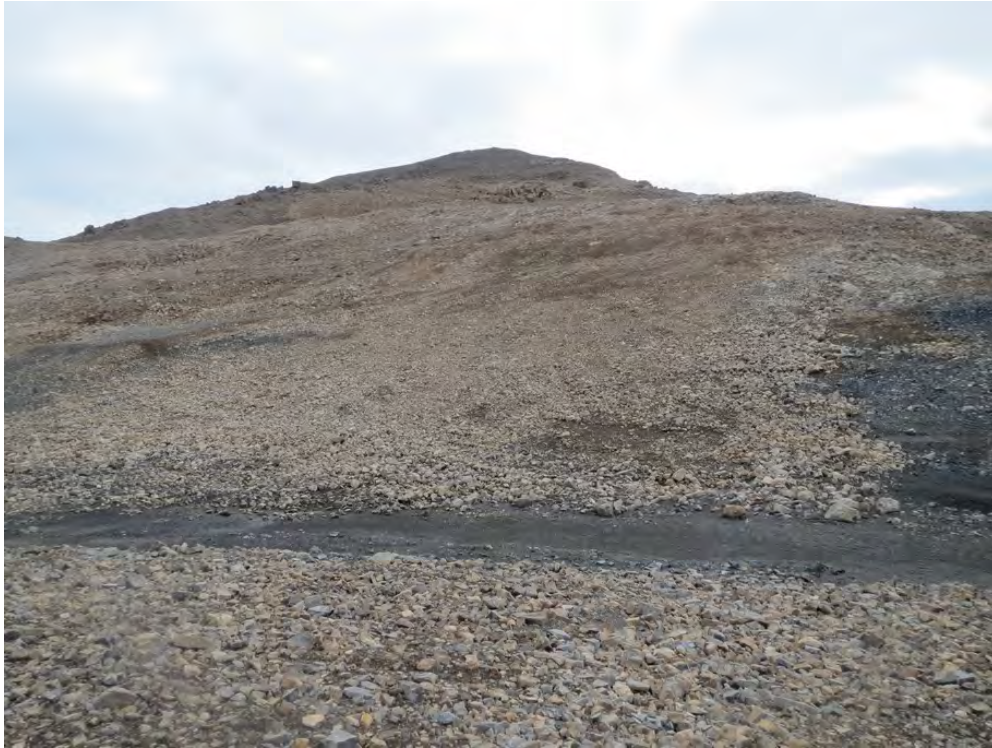
A photo from the inspection is provided in Appendix I (Photo 67). The main observations are summarized by the following:

Photo 67. Lower Adit—As seen from Industrial Complex cover.

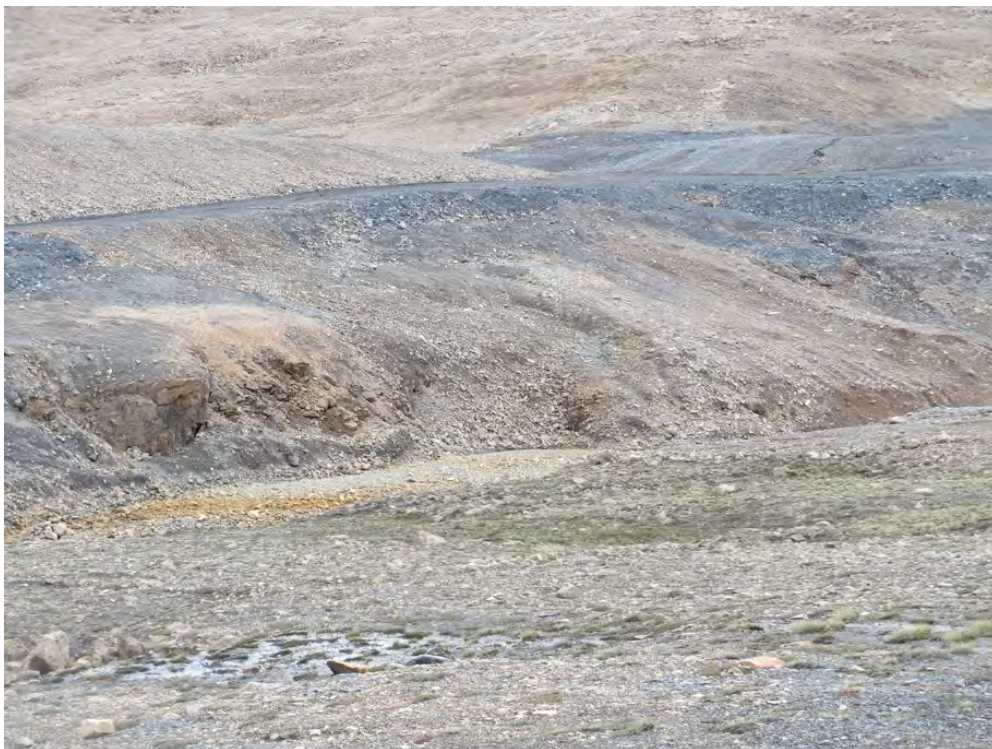
A photo from the inspection is provided in Appendix I (Photo 68). The main inspection observations are summarized by the following:

Photo 68. Mill Portal—Portal plug as seen from right bank of Twin Lakes Creek.

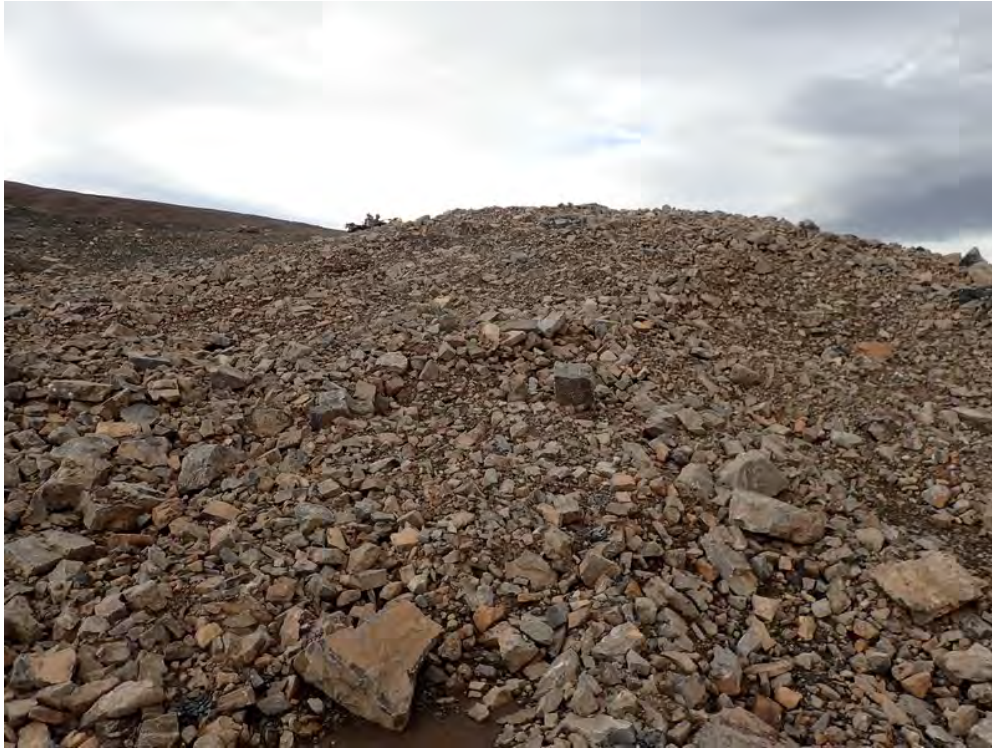
A photo from the inspection is provided in Appendix I (Photo 69). During the inspection, the armour surface appeared to be stable with no visual indications of erosion or surface deformation. As such, no maintenance is recommended.

Photo 69. Shale Hill Raise—Mound over backfilled raise. No settlement has been observed.

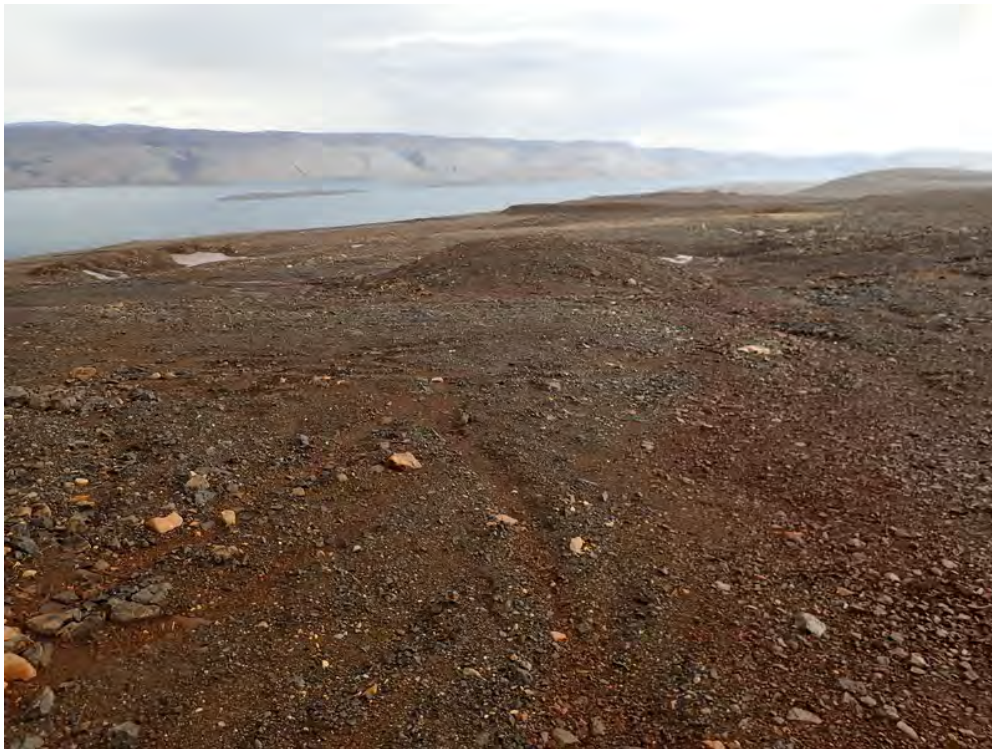
A photo from the inspection is provided in Appendix I (Photo 70). During the inspection, the armour surface appeared to be stable with no visual indications of erosion or surface deformation. As such, no maintenance was recommended.

Photo 70. Oceanview East Raise—Mound over backfilled raise. No settlement has been observed.

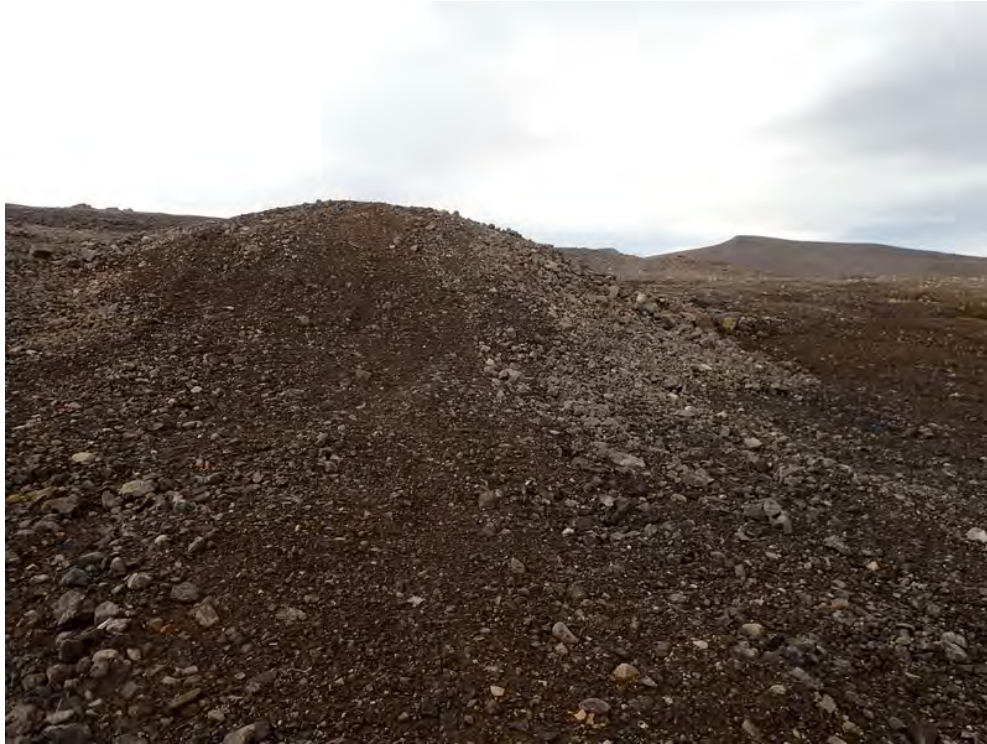
A photo from the inspection is provided in Appendix I (Photo 71). During the inspection, the armour surface appeared to be stable with no visual indications of erosion or surface deformation. As such, no maintenance was recommended.

Photo 71. Oceanview West Raise— Mound over backfilled raise. No settlement has been observed.

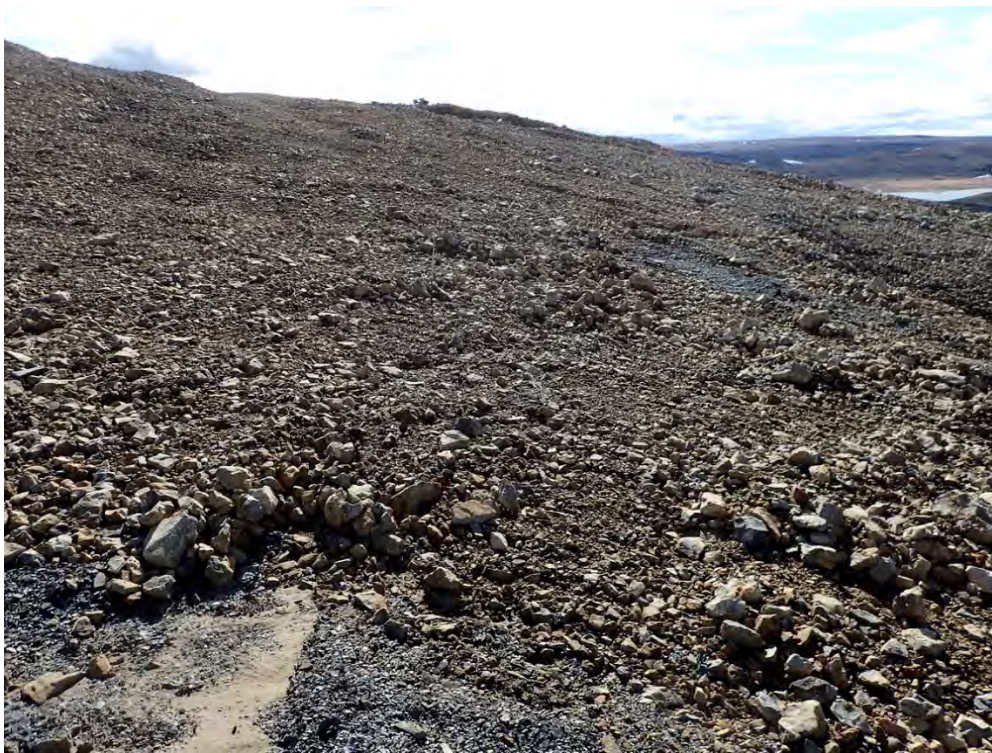
A photo from the inspection is provided in Appendix I (Photo 72). During the inspection, no settlement of the area surrounding the former raise was observed. As such, no maintenance was recommended.

Photo 72. Area 14 Raise—Graded area above backfilled raise.

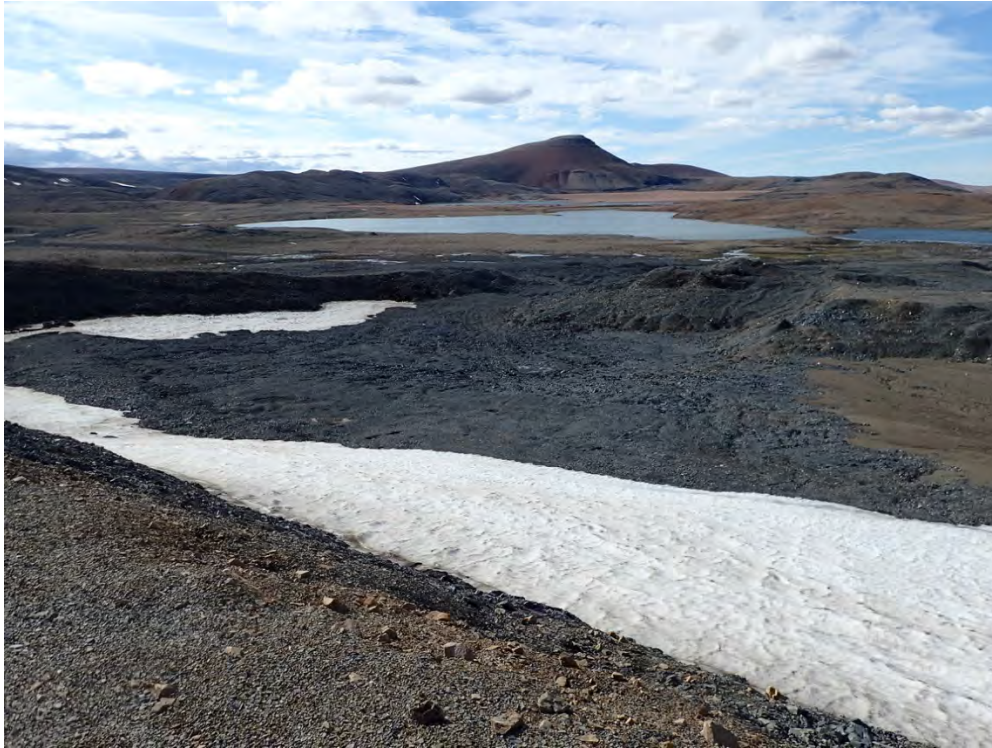
Photo 73. Area 14 Shale Quarry.

Select photos from the inspection are provided in Appendix I (Photos 73 through 76). The main observations are summarized by the following:
