NANISIVIK MINE, NUNAVUT

2017 ANNUAL GEOTECHNICAL INSPECTION

PROJECT NO.: 0255028

DATE: February 23, 2018

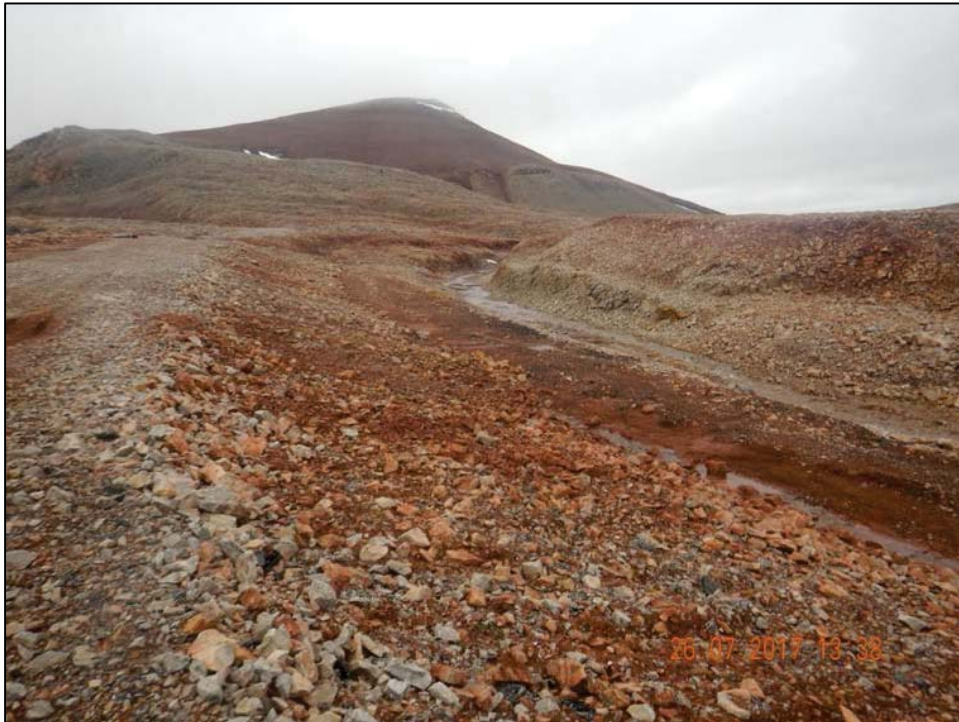
Photo 3. Spillway – View looking upstream from crest of the right bank of spillway.

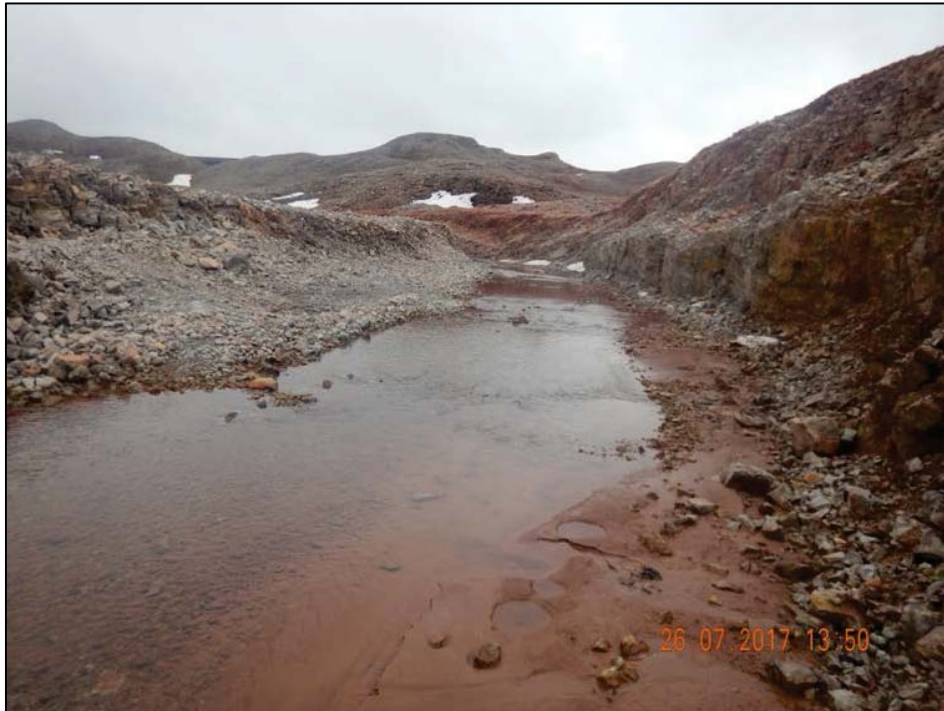
- Some erosion along the base of the spillway channel was observed during this inspection (Photo 7).

Photo 7. Spillway – Flow in bottom of spillway looking downstream.

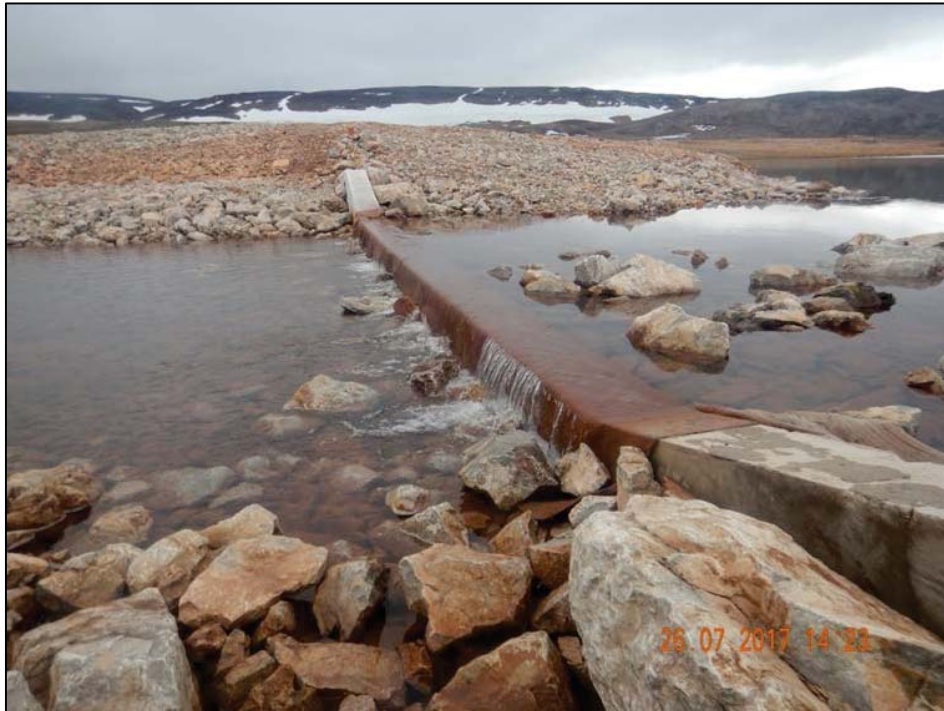
- During the inspection, the water level upstream of the wall was noted to be just above (+4 cm) the elevation of the wall invert. There was no significant cracking visible within the Outlet Wall concrete (Photo 9).
- The seepage at the West Twin Outlet Wall seems to have slowed in recent years, as the water level upstream of the wall has been maintained more consistently at or above the invert of the outlet wall (Drawing 05).
- Slumping and settlement of the perimeter slopes of the upstream Polishing Pond have been noted in recent years, and continued to degrade in 2017 (Photos 10 through 11).

Photo 9. WT Outlet – Outlet wall. Note flow is approximately +4 cm.

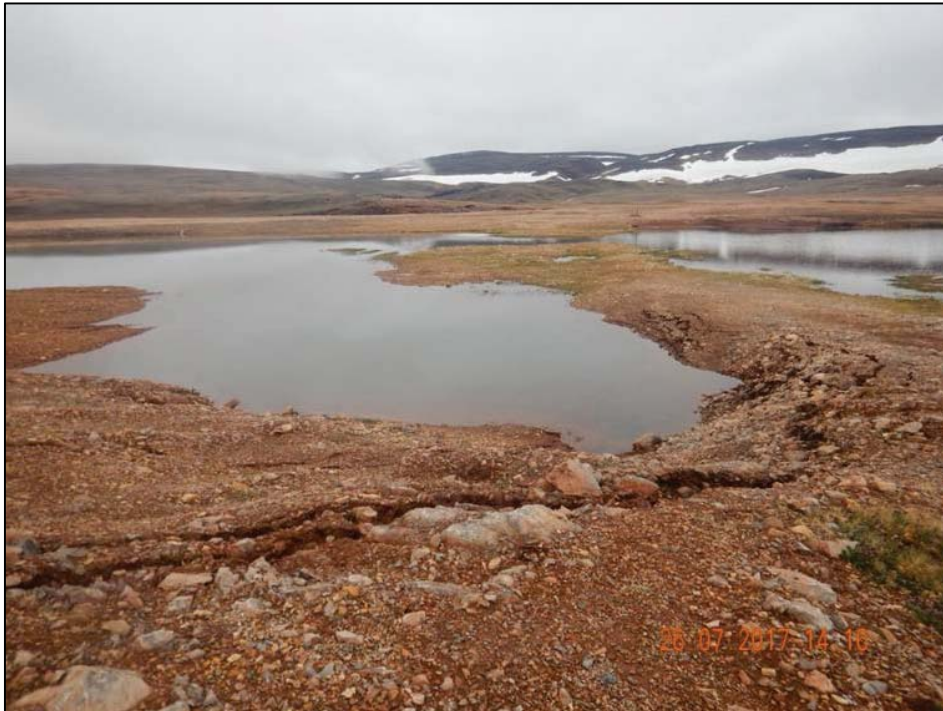
Photo 11. WT Outlet – Unstable slope area along North shoreline of remnant Polishing Pond.

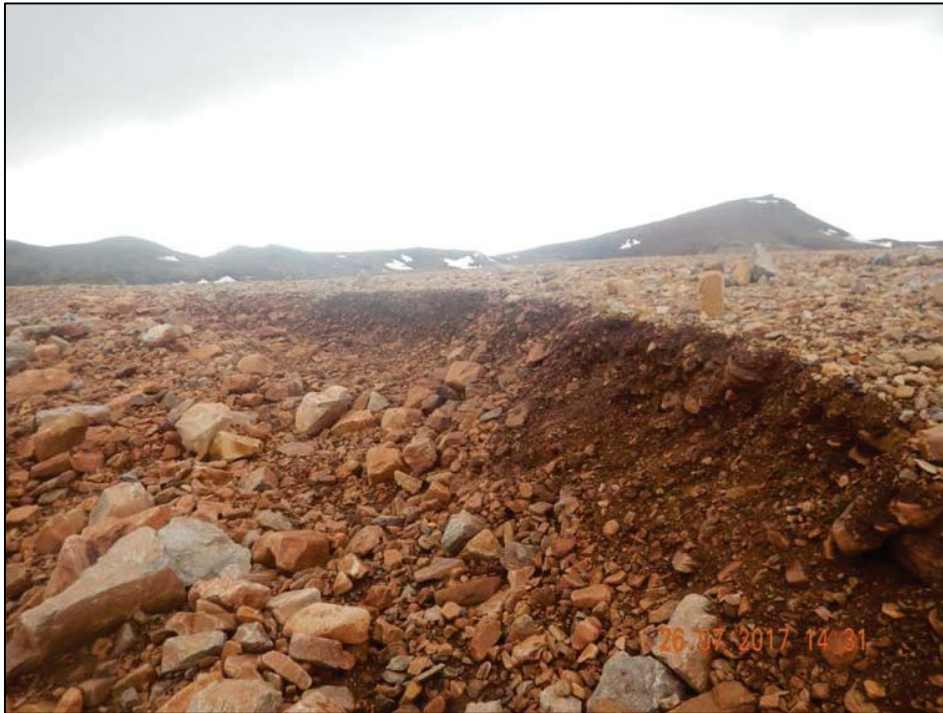
the erosion was found to be in similar condition compared to 2015. The observed erosion at this location (Photo 12 & 13) may be the result of similar flow conditions that contributed to the erosion observed in the West Twin Dyke Spillway. It appears that the flow in East Twin Creek was elevated near the crest of the diversion dyke by snow blockage and concentrated flow resulted in erosion of the berm as it re-entered the main channel of East Twin Creek. It is recommended that the noted area should be re-sloped and additional armour rock should be applied to the entire face of the dyke to enhance long term stability of this area.

Photo 13. ETC Diversion Channel – Erosion area along left bank of diversion channel.

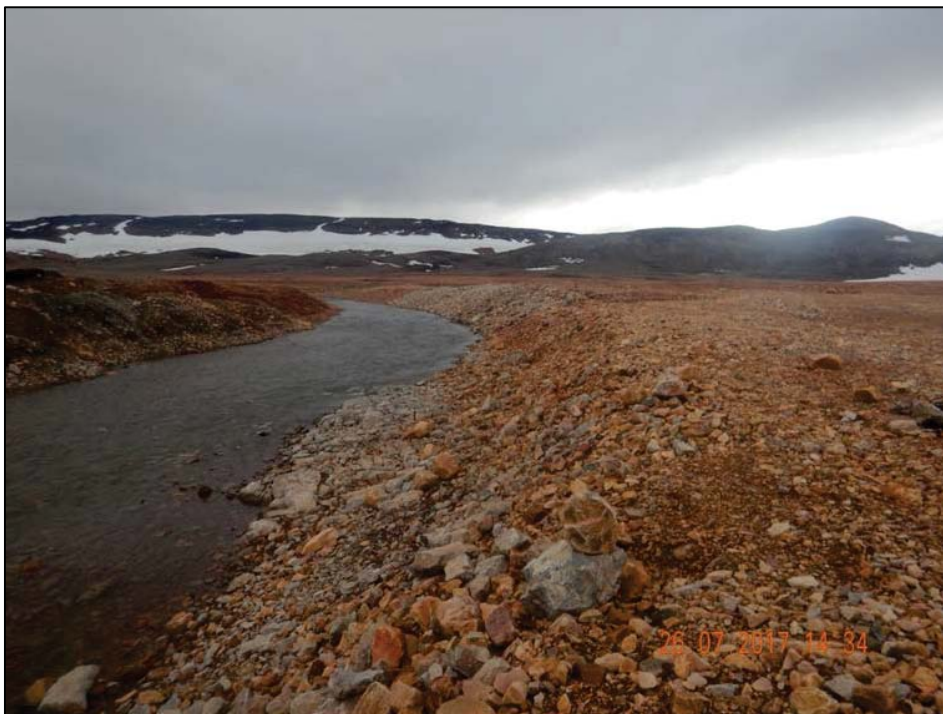
Photo 14. ETC Diversion Channel – Intact left bank looking upstream.

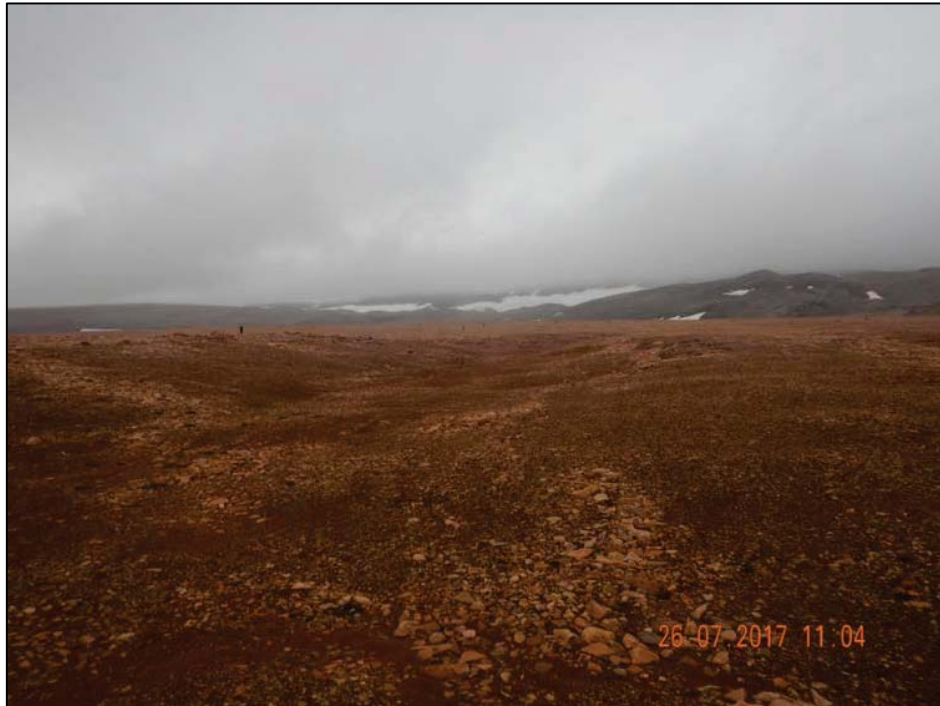
Photo 15. Surface Cell – E/W drainage swale.

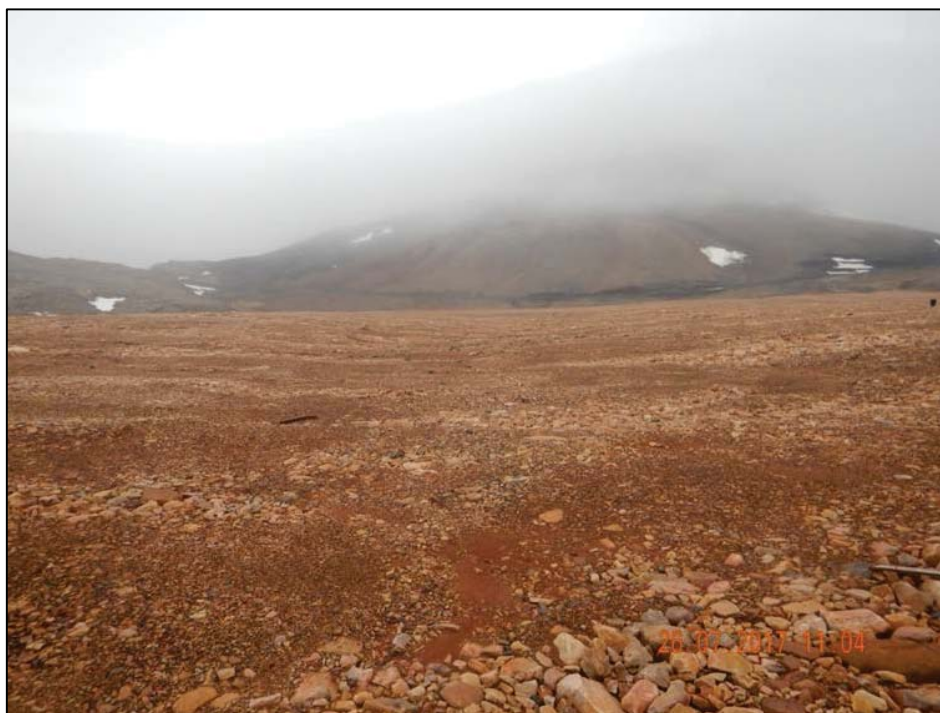
Photo 16. Surface Cell – Secondary drainage swale looking south.

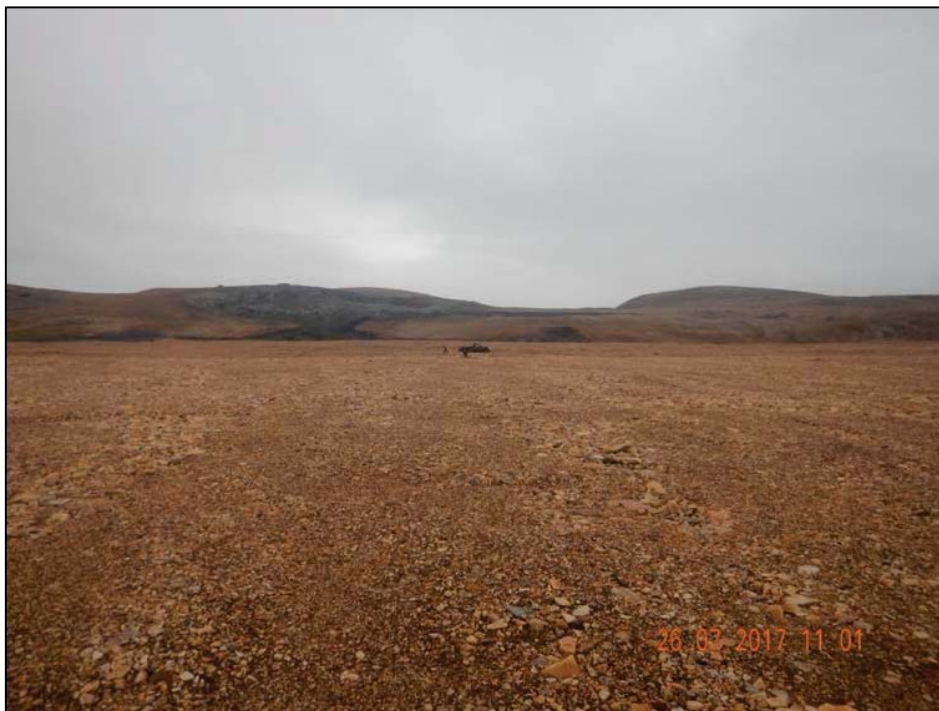
Photo 18. Surface Cell – Surface of cover system looking west.

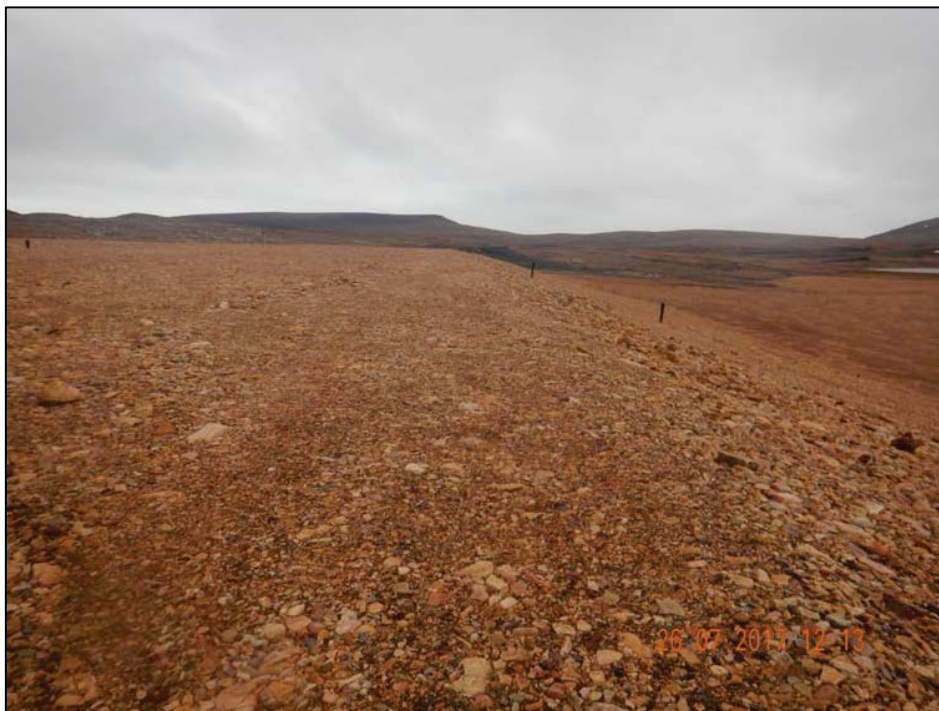
Photo 20. Surface Cell – Crest of WT Dyke. View looking north.

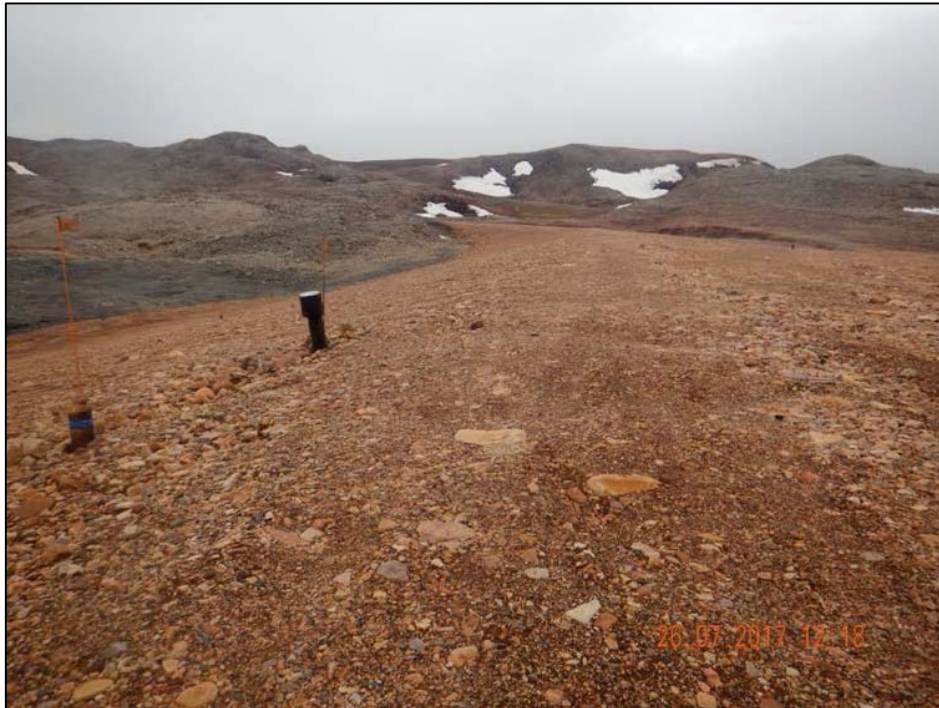
Photo 21. Surface Cell – Crest of WT dyke near south abutment. View looking south.

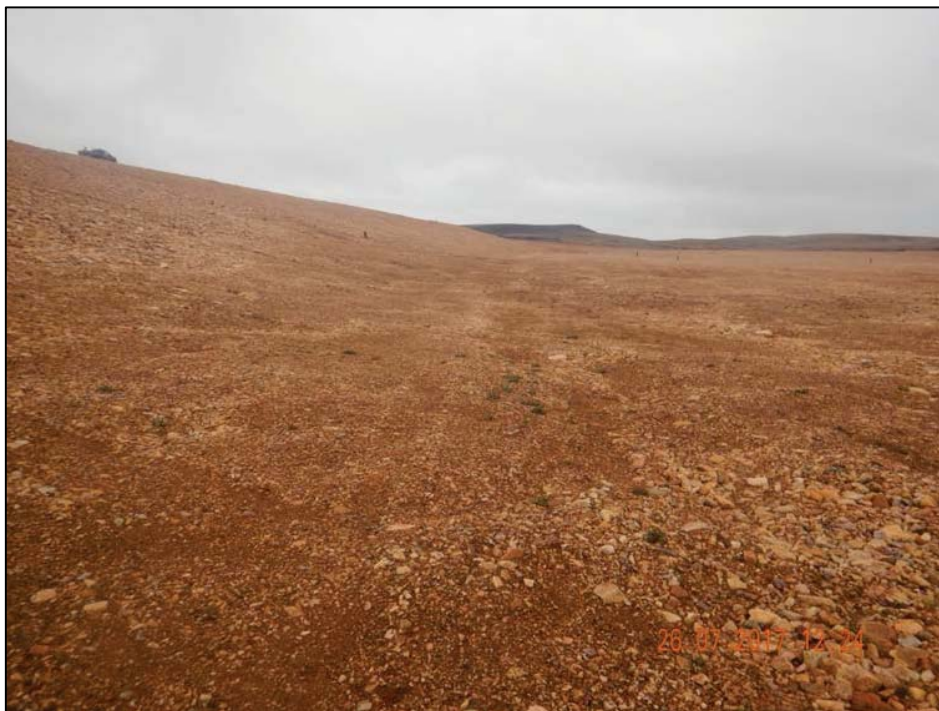
Photo 22. Surface Cell – Toe of WT Dyke as seen from south abutment. View looking north.

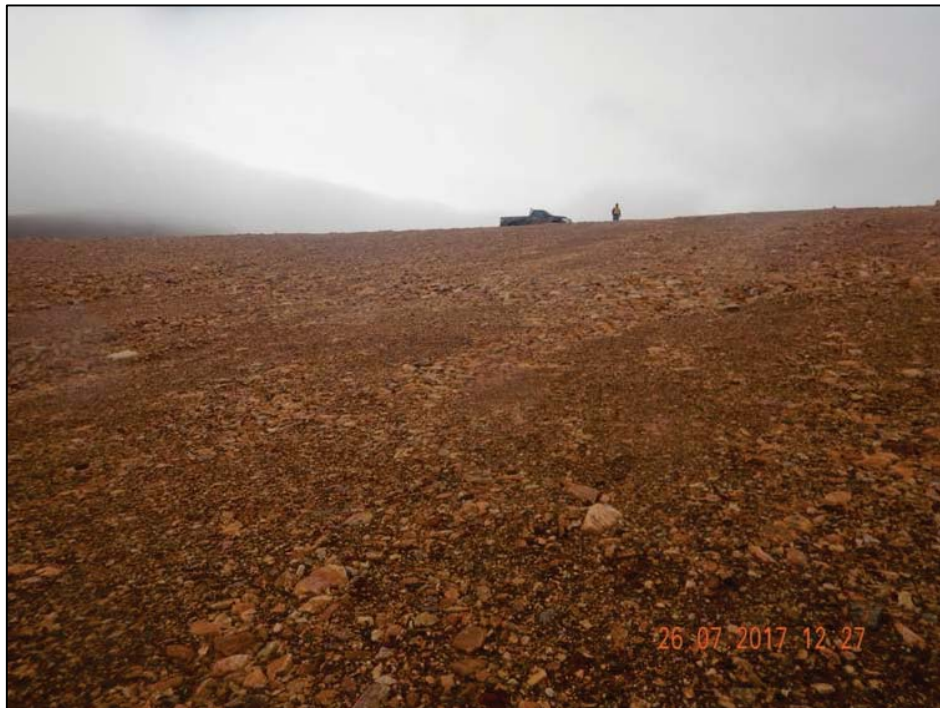
Photo 23. Surface Cell – Face of WT Dyke as seen from toe of dyke.

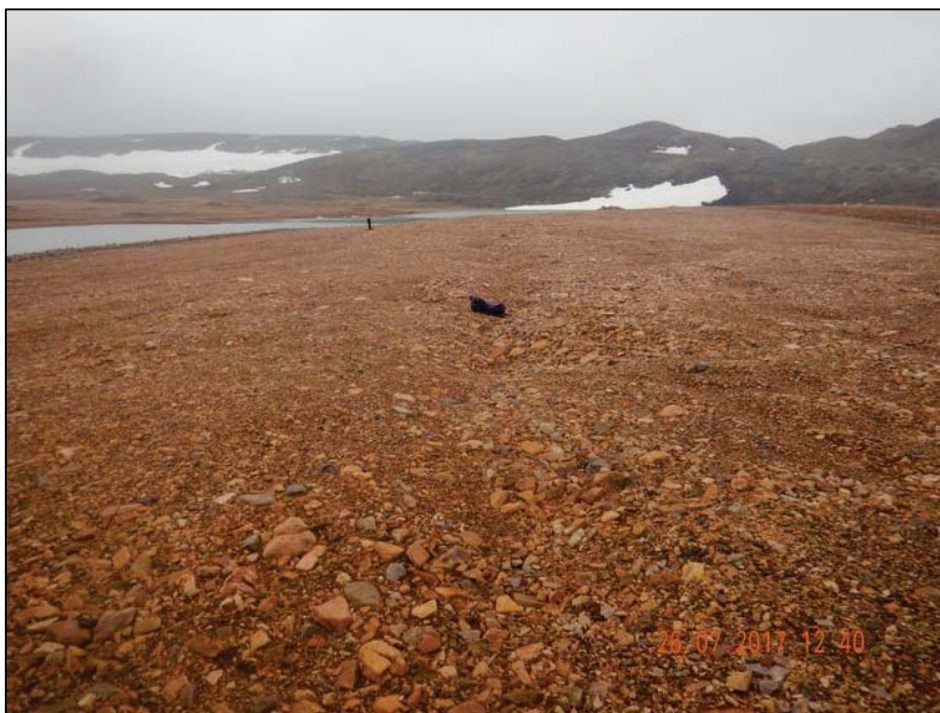
Photo 26. Test Cell – Settlement trough along N/S arm of TC Dyke.

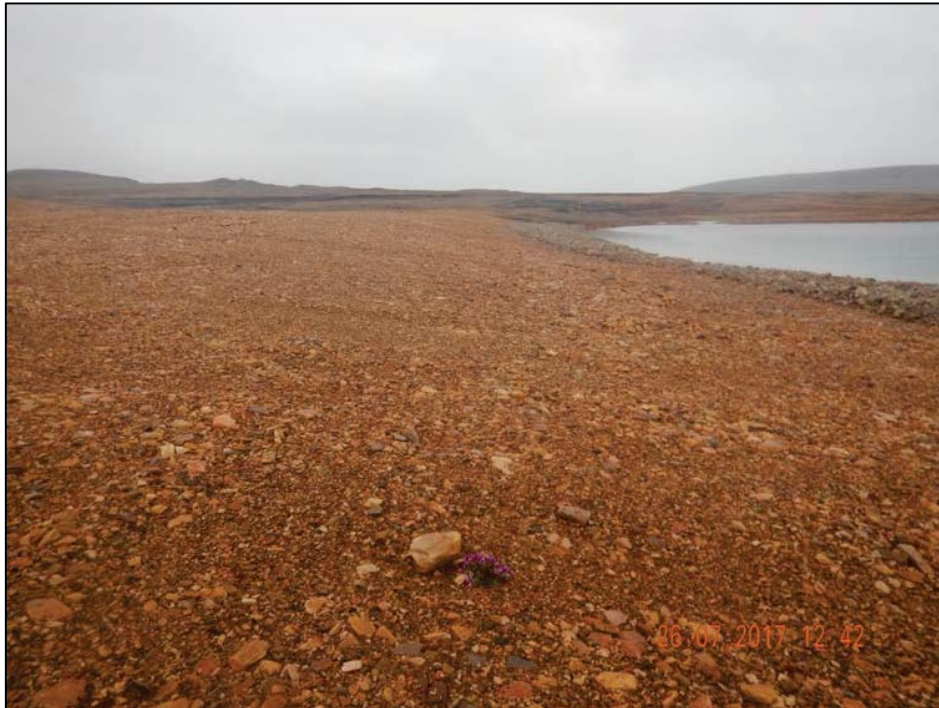
Photo 27. Test Cell – Sloping face of cover along outside face of N/S arm of TC Dyke.

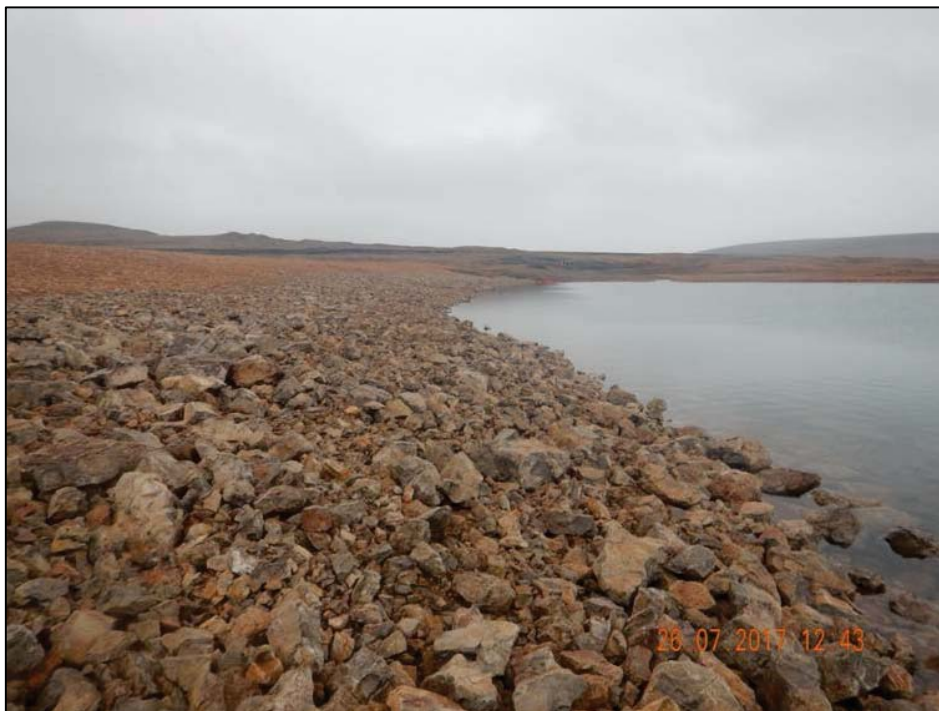
Photo 28. Test Cell – Armour along shoreline of N/S arm of TC Dyke.

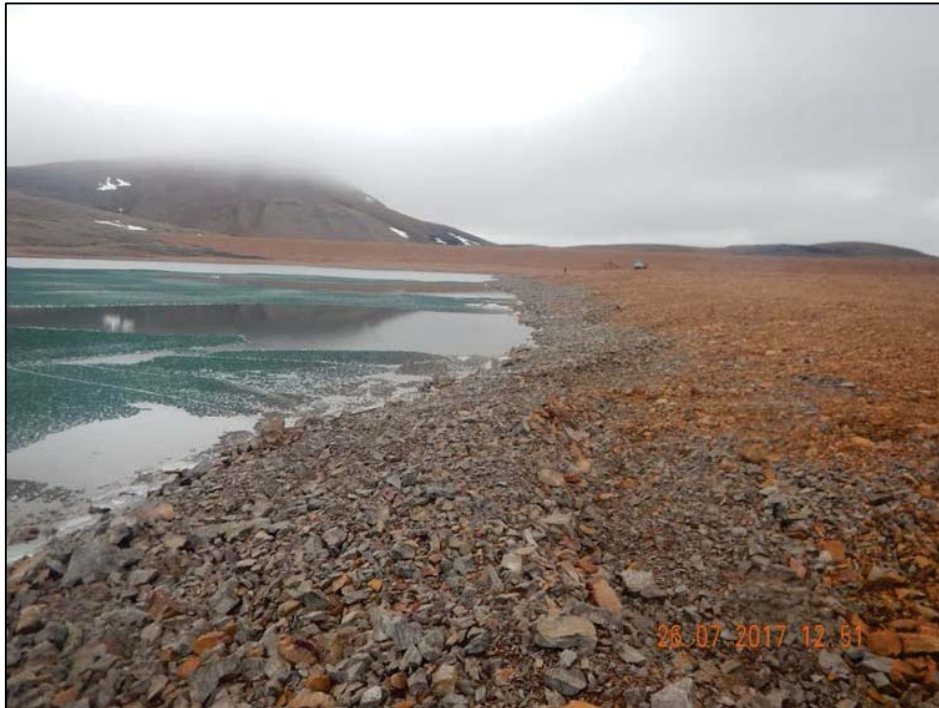
Photo 29. Test Cell – E/W arm of TC Dyke. View looking west along shoreline. Note ice along shoreline.

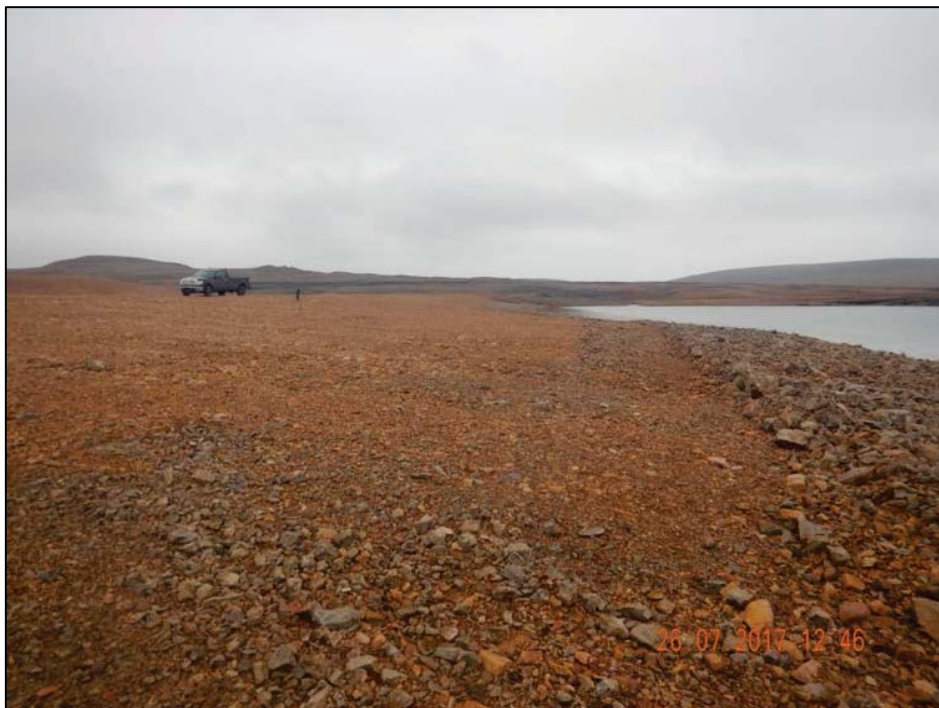
Photo 30. Test Cell – Sloping face of cover along outside face of N/S arm of TC Dyke.

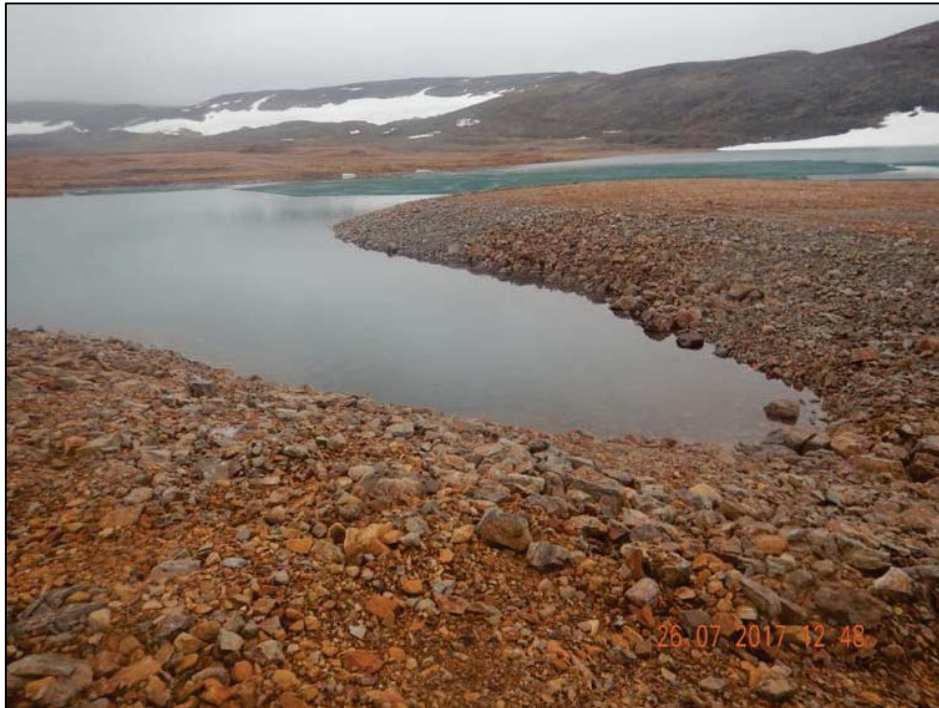
Photo 31. Test Cell – Outlet of T/C Cover.

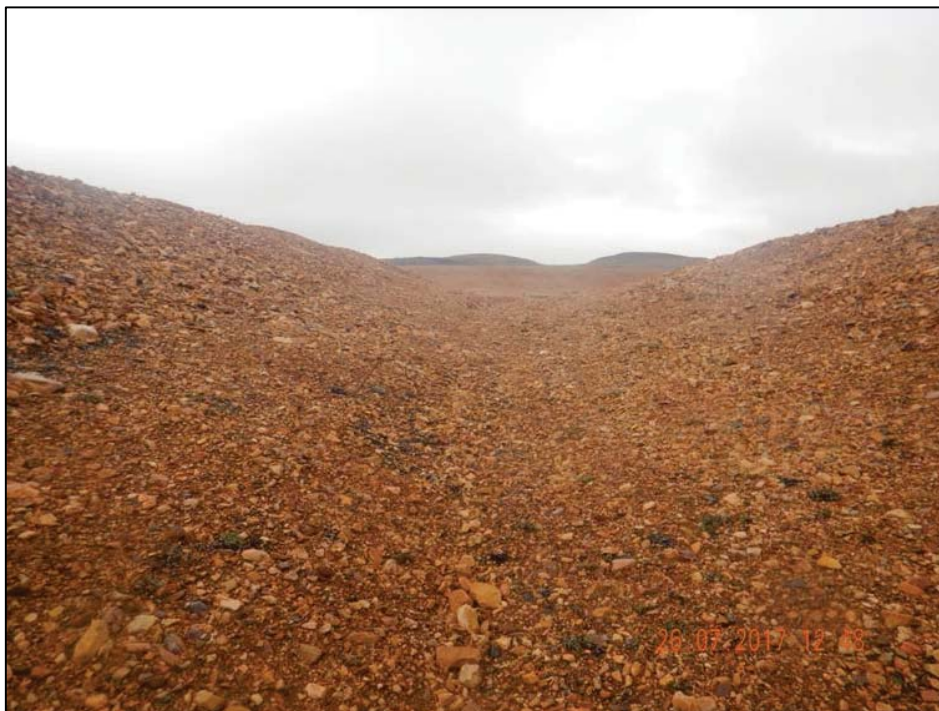
Photo 32. Test Cell – Outlet of T/C Cover.

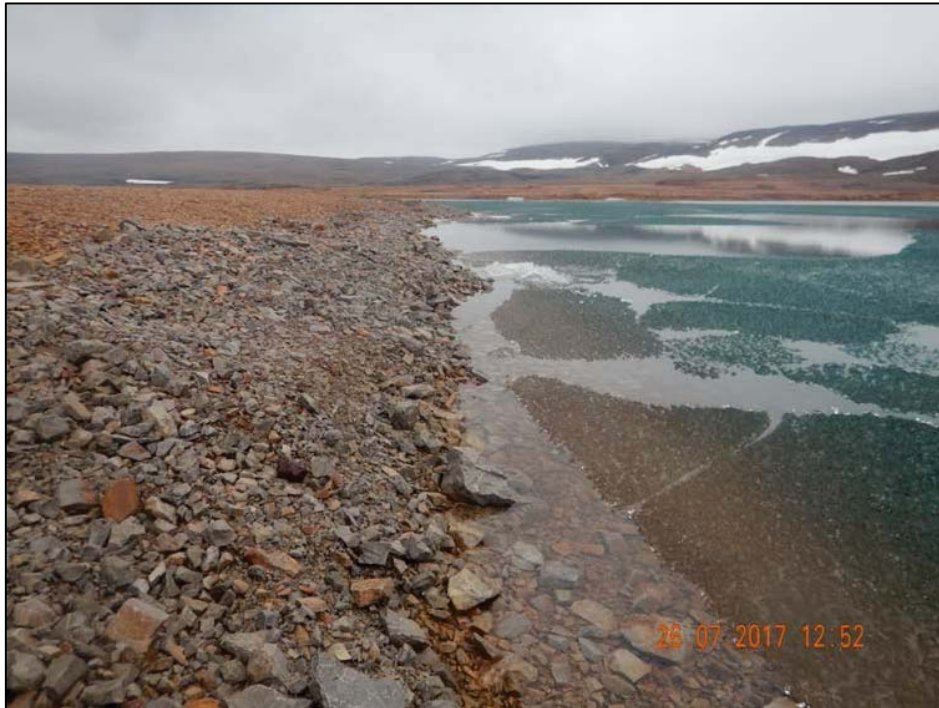
Photo 33. Test Cell – E/W arm of TC Dyke. View looking east along shoreline. Note ice along shoreline.

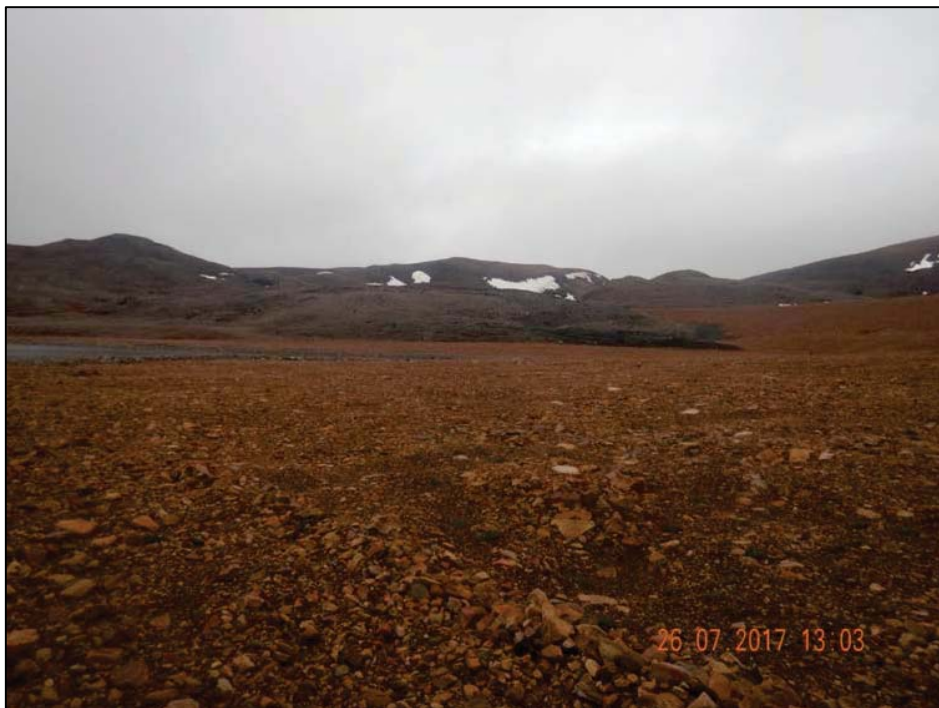
Photo 34. Test Cell – Toe of WT Dyke area.

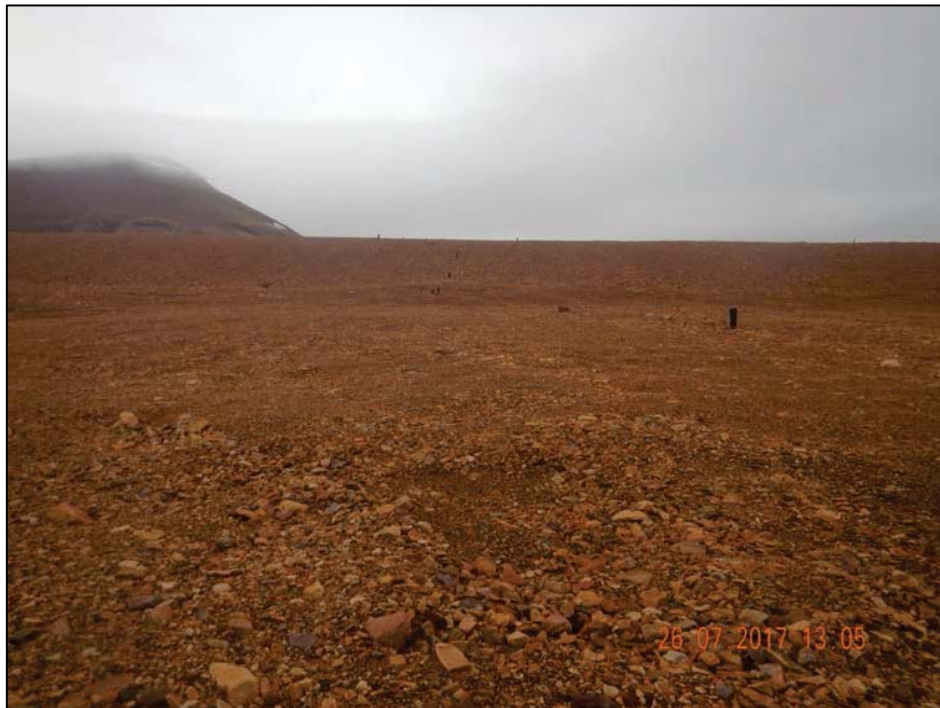
Photo 35. Test Cell – Thermokarst feature at toe of WT Dyke.

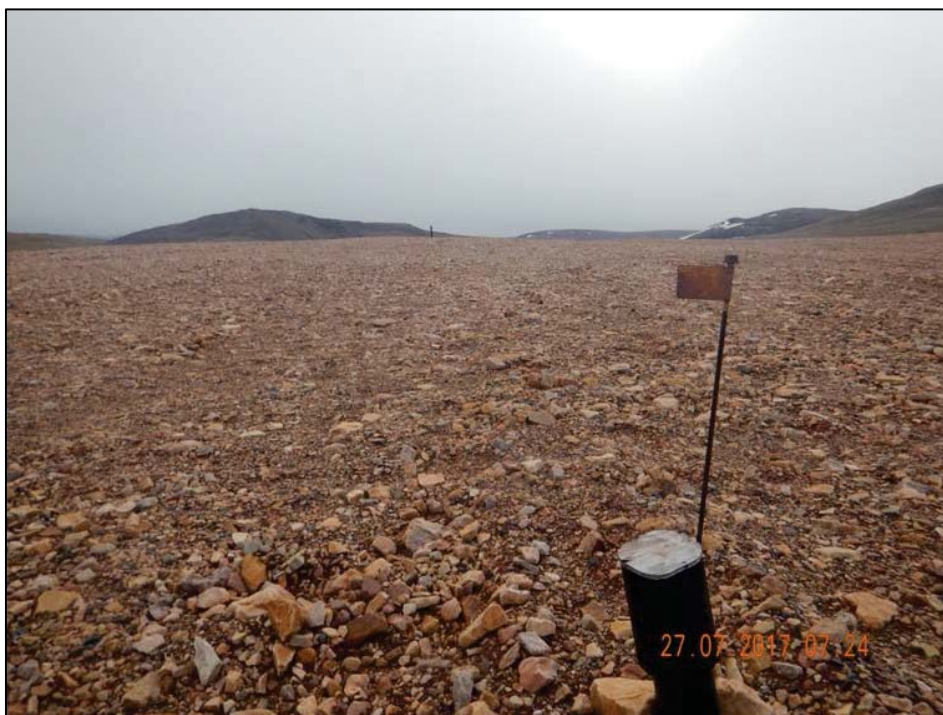
Photo 36. Landfill – Surface of cover system looking back towards thermistor installation.

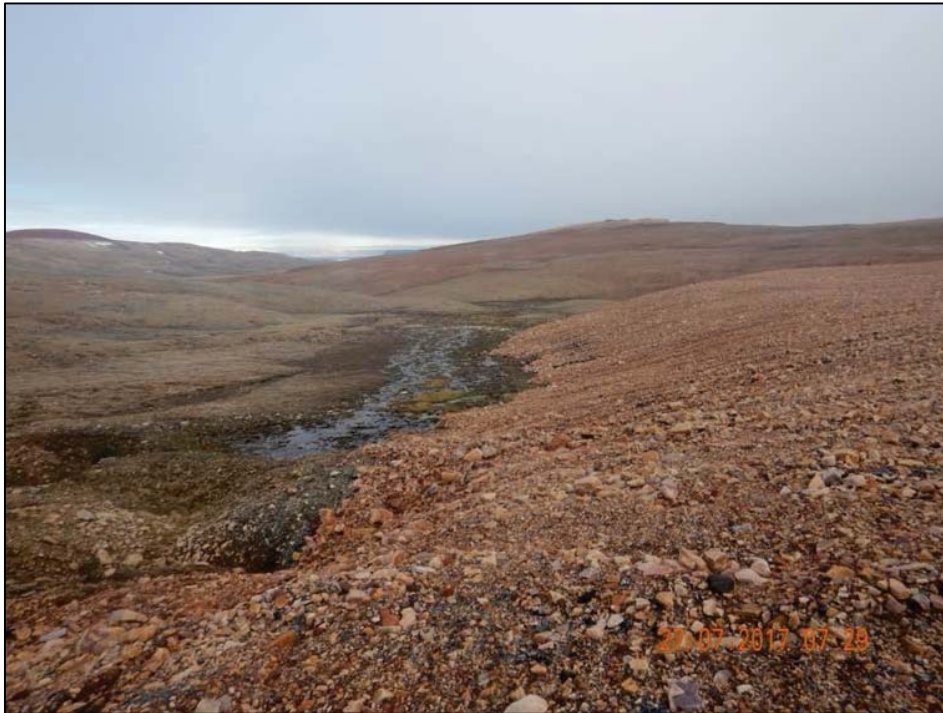
Photo 37. Landfill – Toe area of cover system.

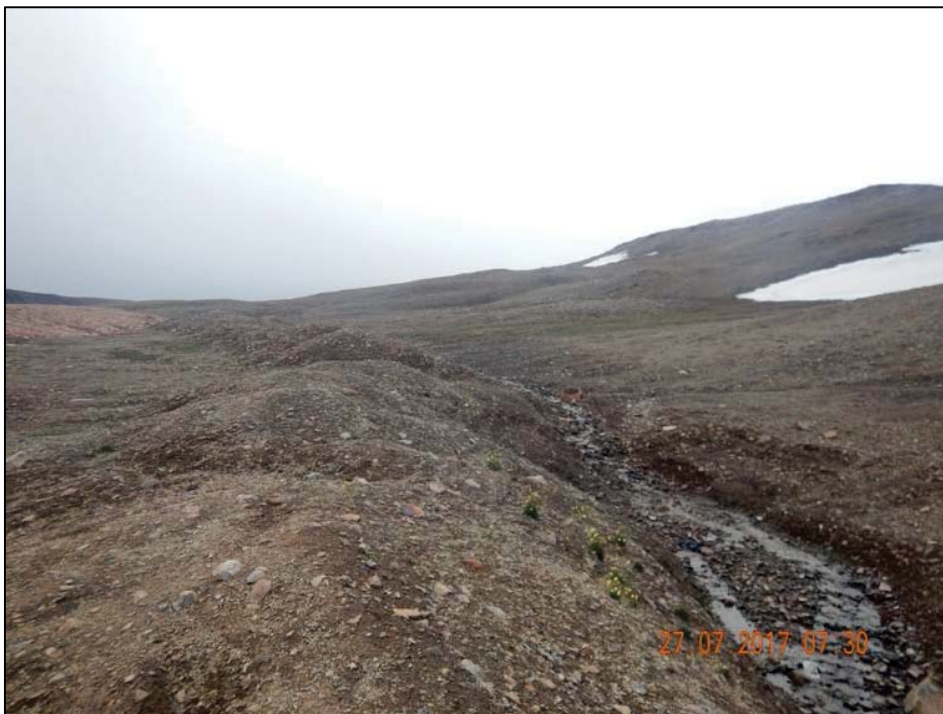
Photo 38. Landfill – Upslope diversion berm.

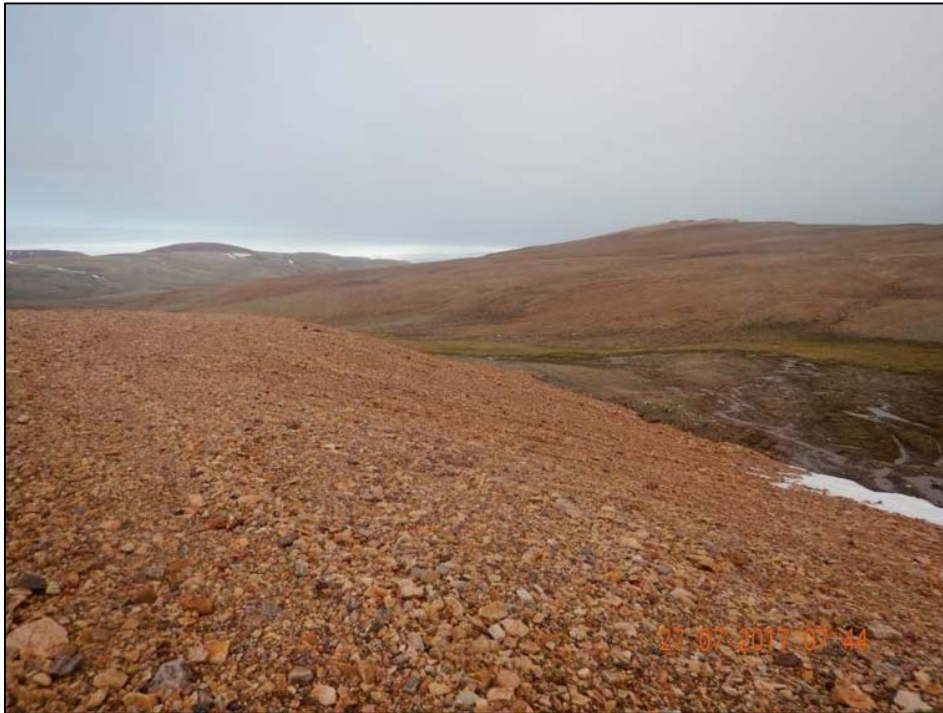
Photo 39. Landfill – Sloping face of cover system.

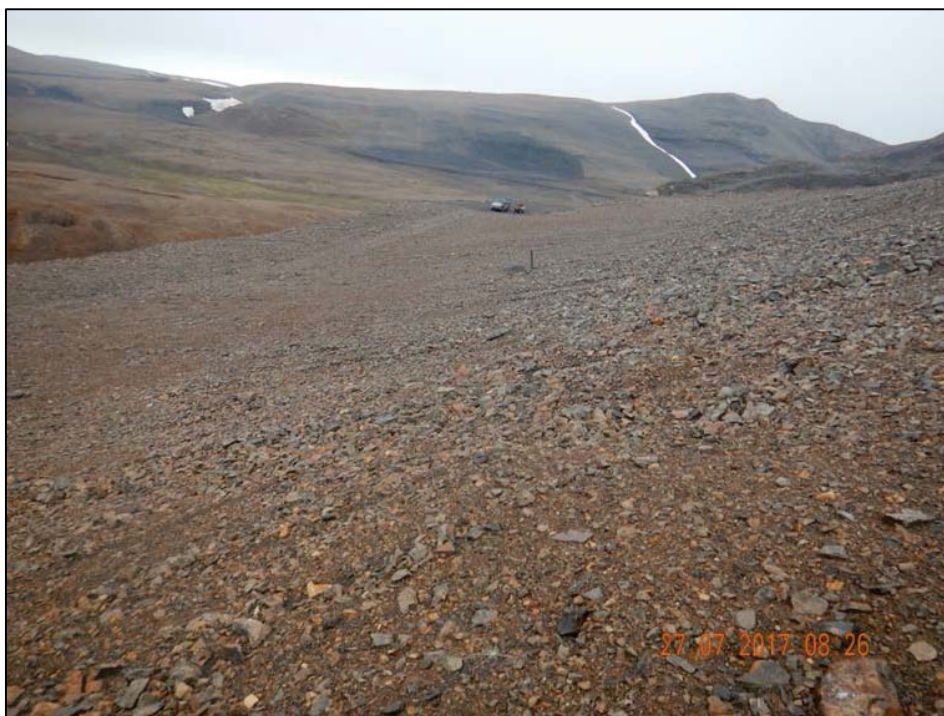
Photo 42. West Open Pit – Sloping face of WOP cover system.

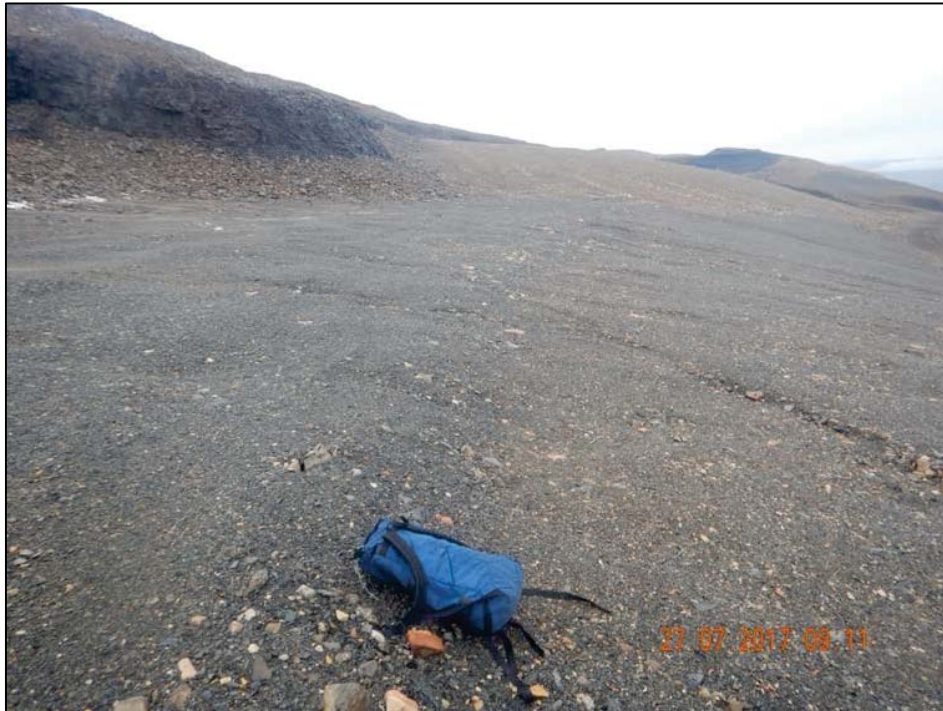
Photo 43. East Open Pit – Settlement trough along upper bench of cover system.

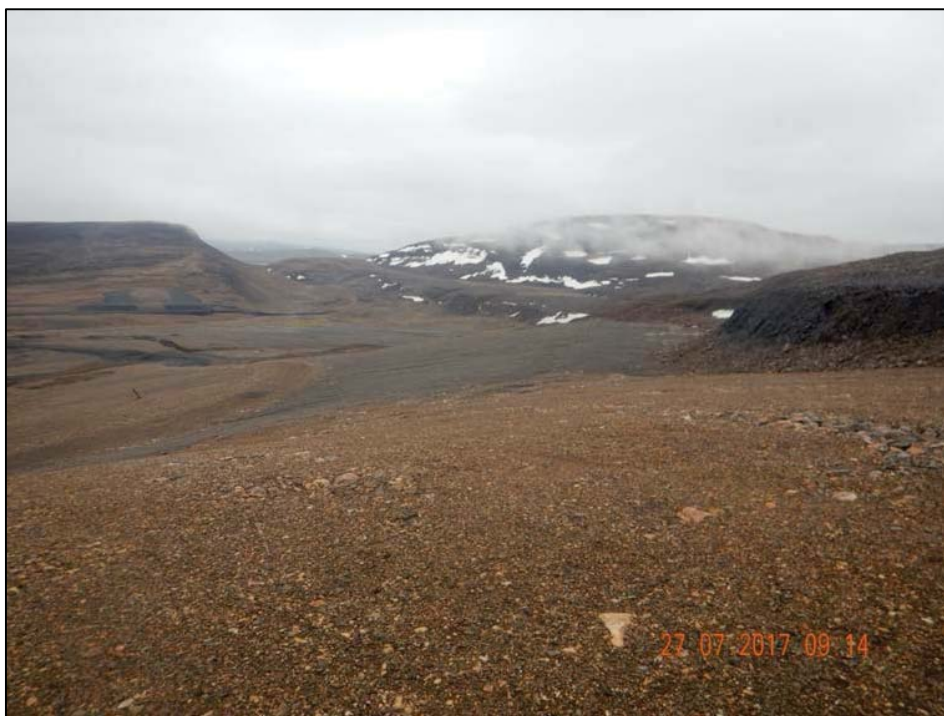
Photo 46. East Open Pit – Sloping face of cover system.

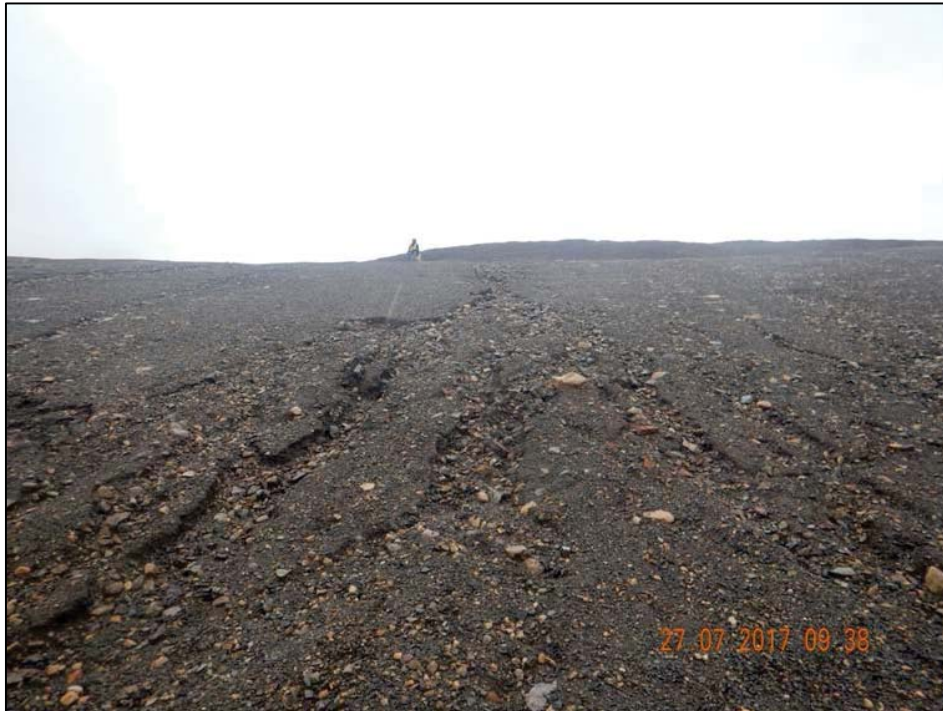
Photo 47. East Open Pit – Self armoured rill erosion channels along lower portion of EOP cover system.

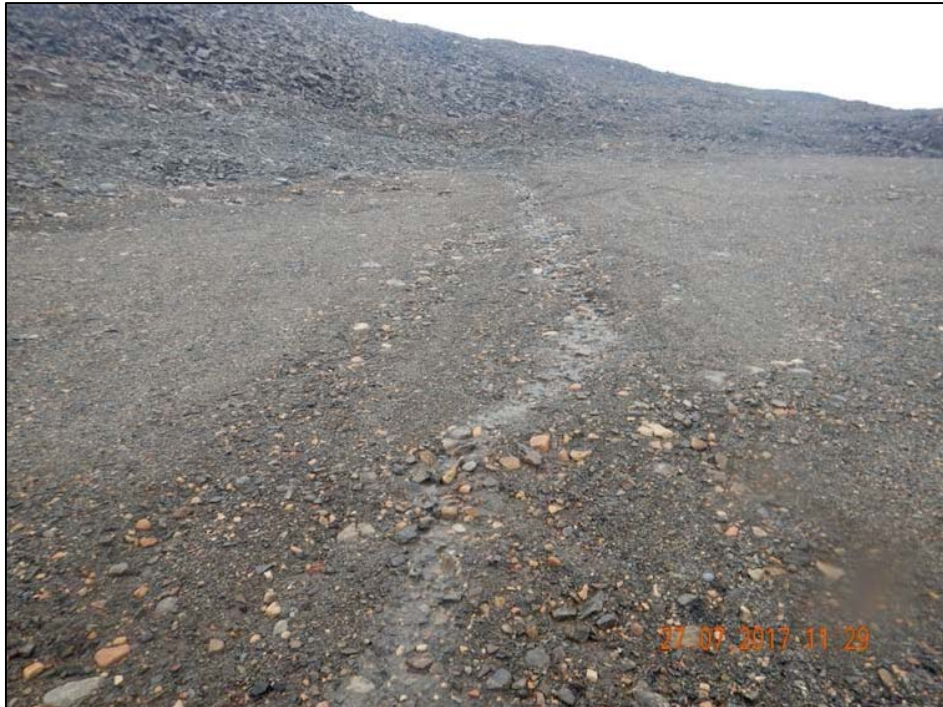
Photo 48. East Open Pit – Rill erosion on surface of cover system view looking upslope.

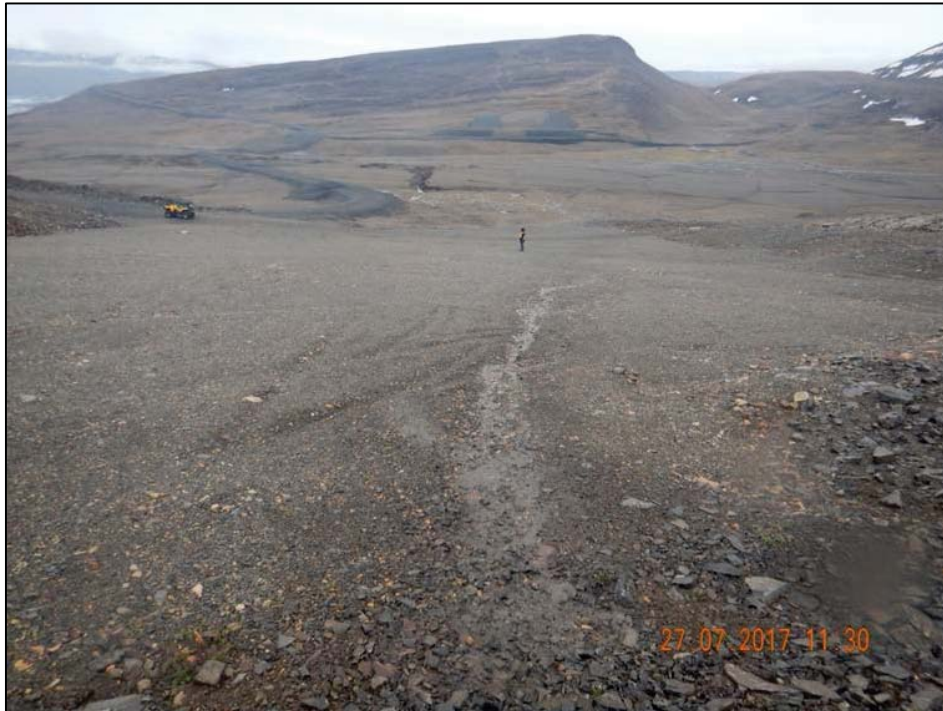
Photo 49. East Trench – Rill erosion on surface of cover system view looking downslope.
