NANISIVIK MINE, NUNAVUT

2017 ANNUAL GEOTECHNICAL INSPECTION

PROJECT NO.: 0255028

DATE: February 23, 2018

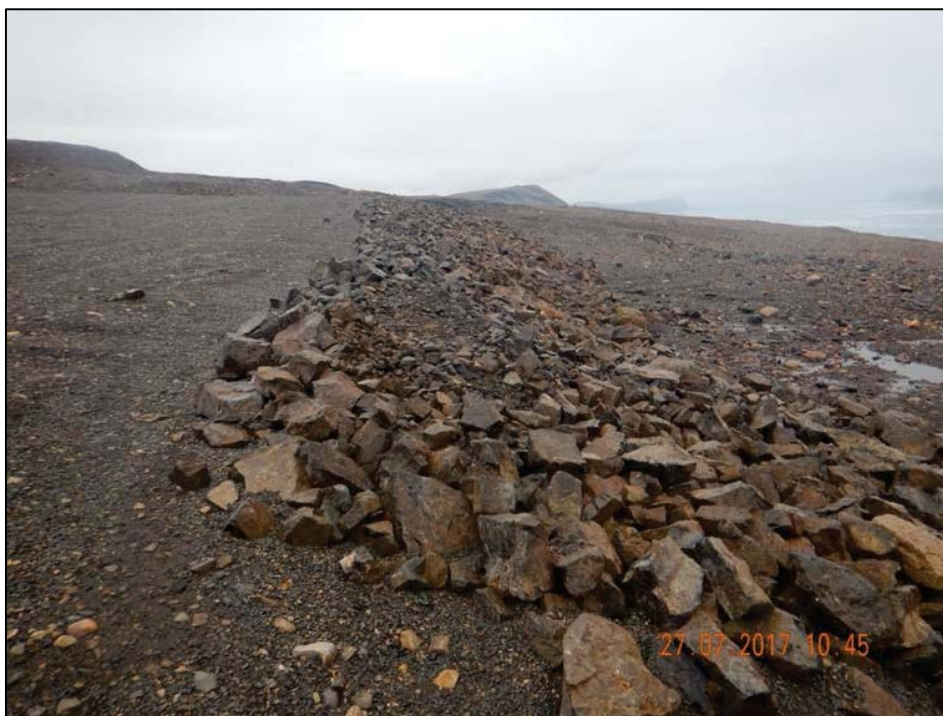
Photo 50. Oceanview Pit – Armoured face of slope at toe of cover system.

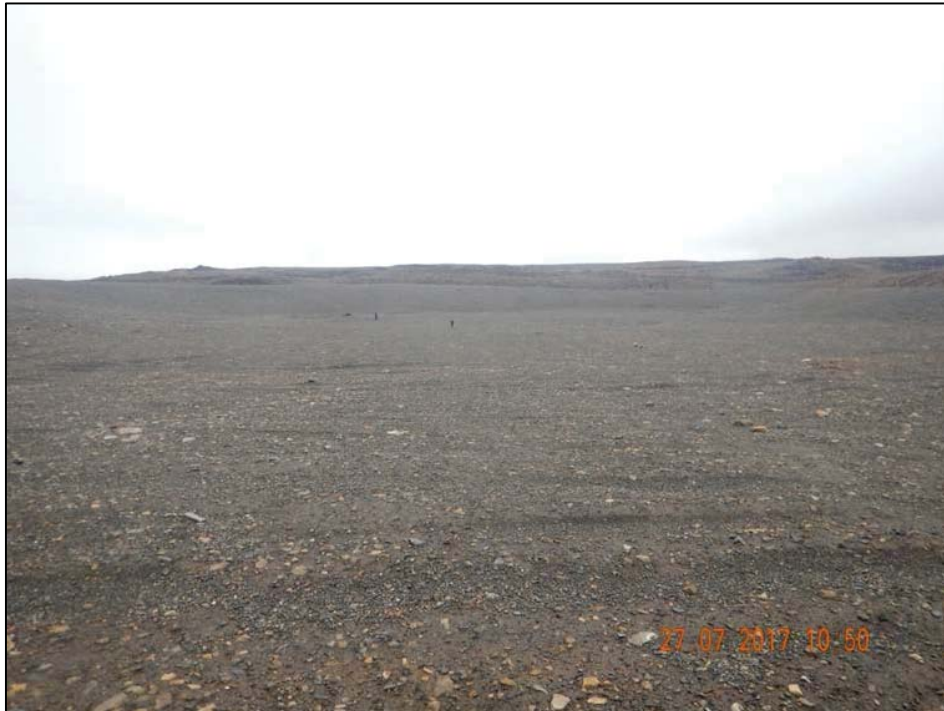
Photo 53. Oceanview Pit – Cover system as seen from toe area.

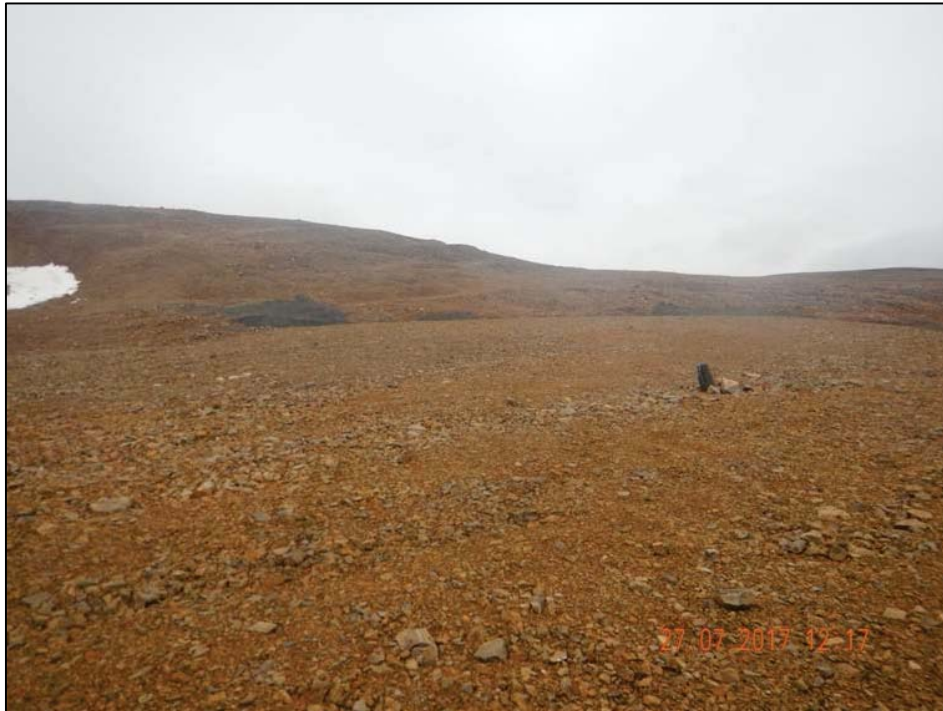
Photo 55. Area 14 – Upper flat surface of waste rock cover.

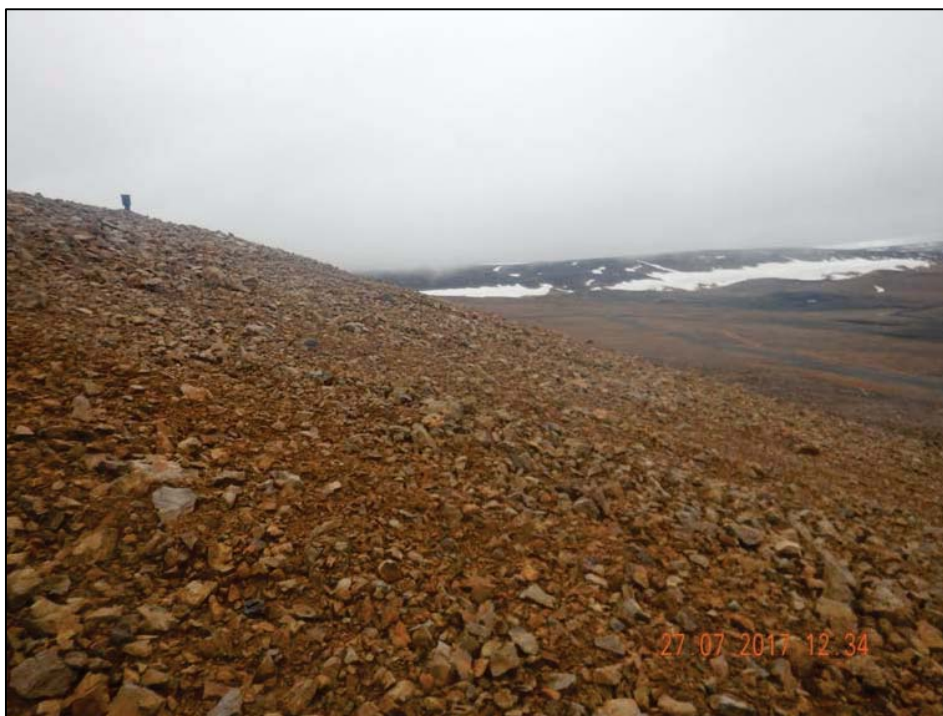
Photo 56. Area 14 – Sloping surface of waste rock cover.

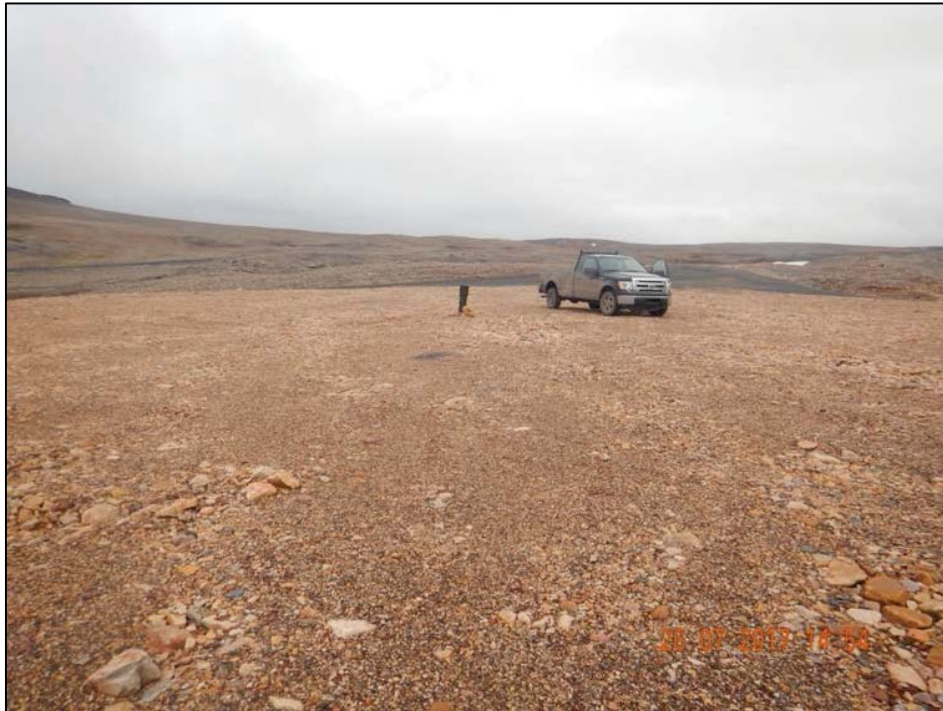
Photo 57. Upper Dump Pond – Surface of cover system.

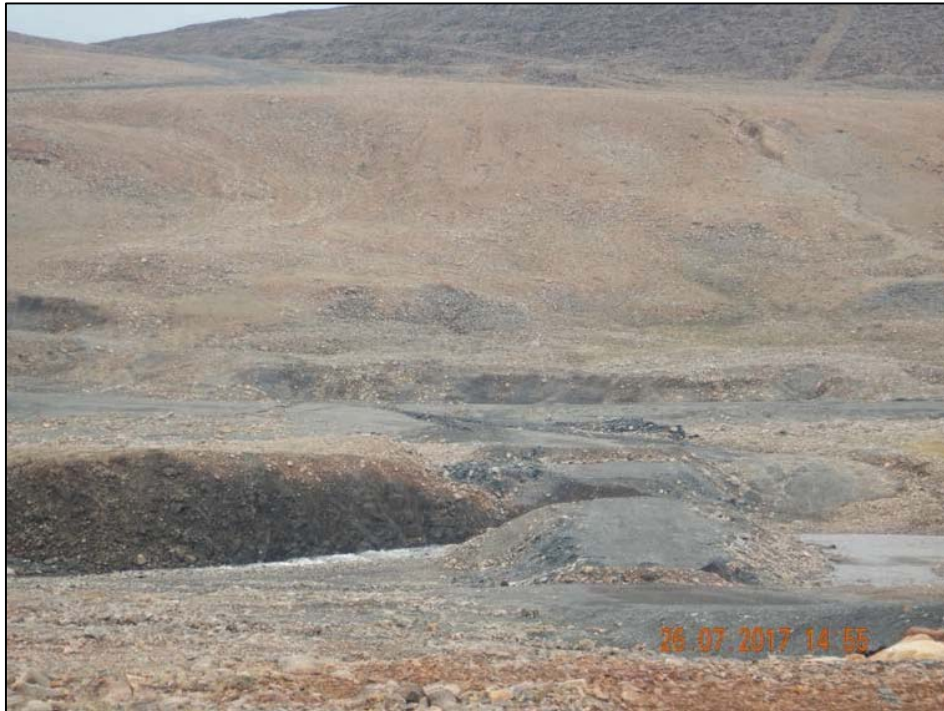
Photo 59. Upper Dump Pond – Breach in road across Twin Lakes Creek.

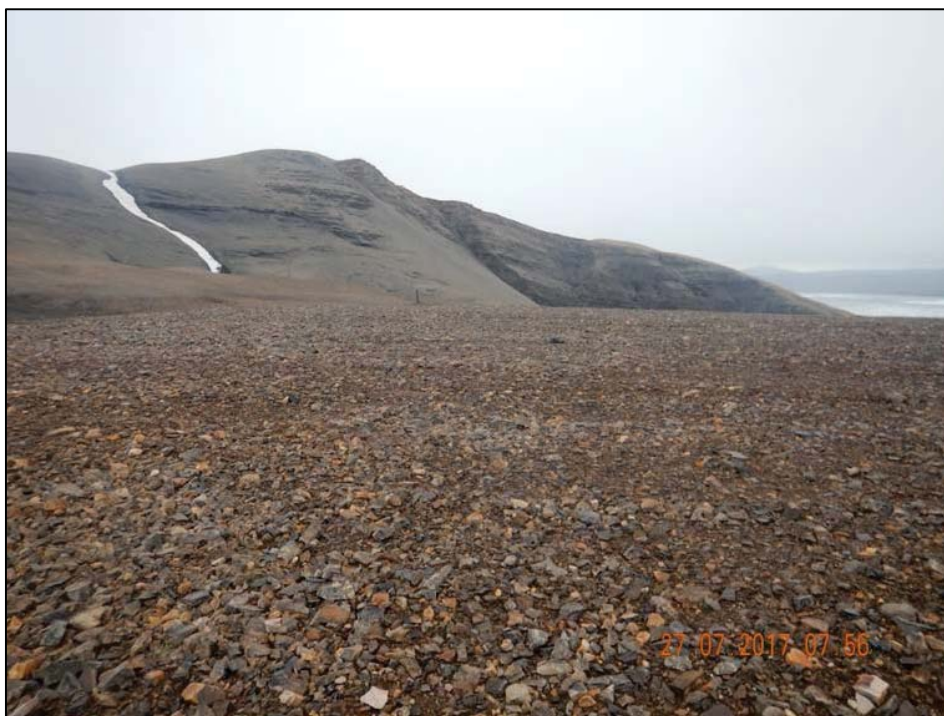
Photo 60. Industrial Complex – Surface of cover system.

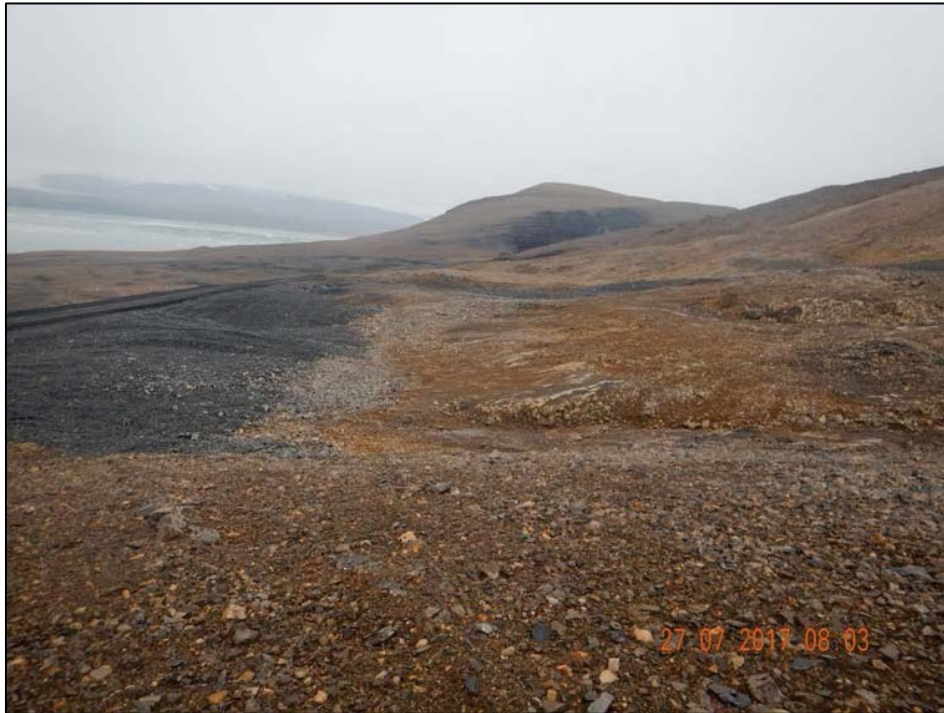
Photo 61. Industrial Complex – Excavated area near old location of warm and cold storage buildings.

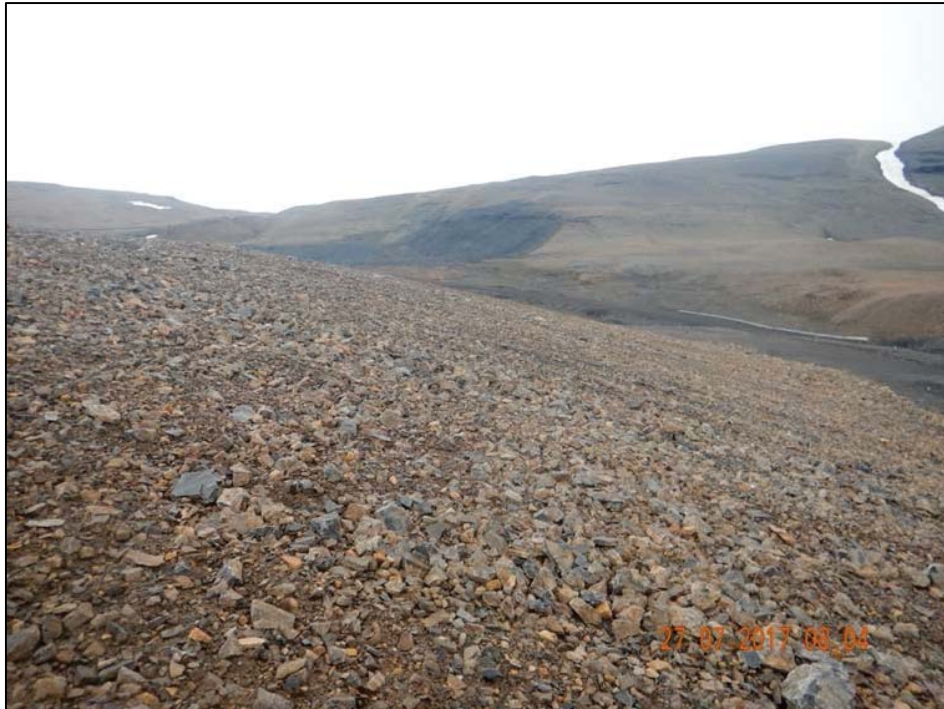
Photo 62. Industrial Complex – Sloping face of IC cover system.

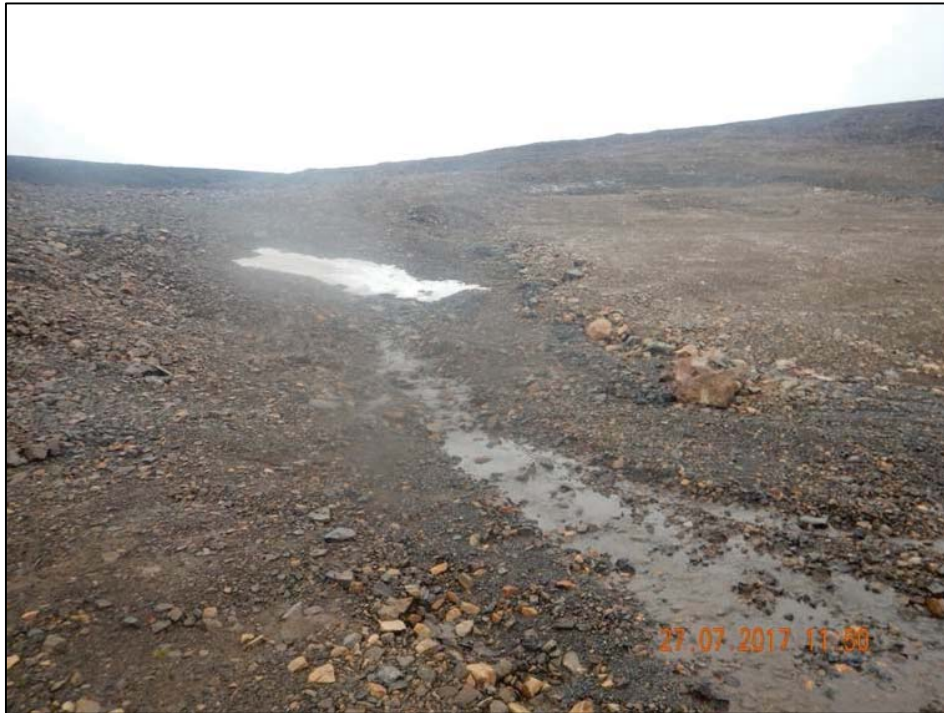
- No erosion of the surface of the cover was observed
- No seepage was observed at the toe of the cover
- A small amount of water was flowing along the east edge of the portal cover at the time of inspection (Photo 63).

Photo 63. 17N Portal – Water running along east edge of portal cover.

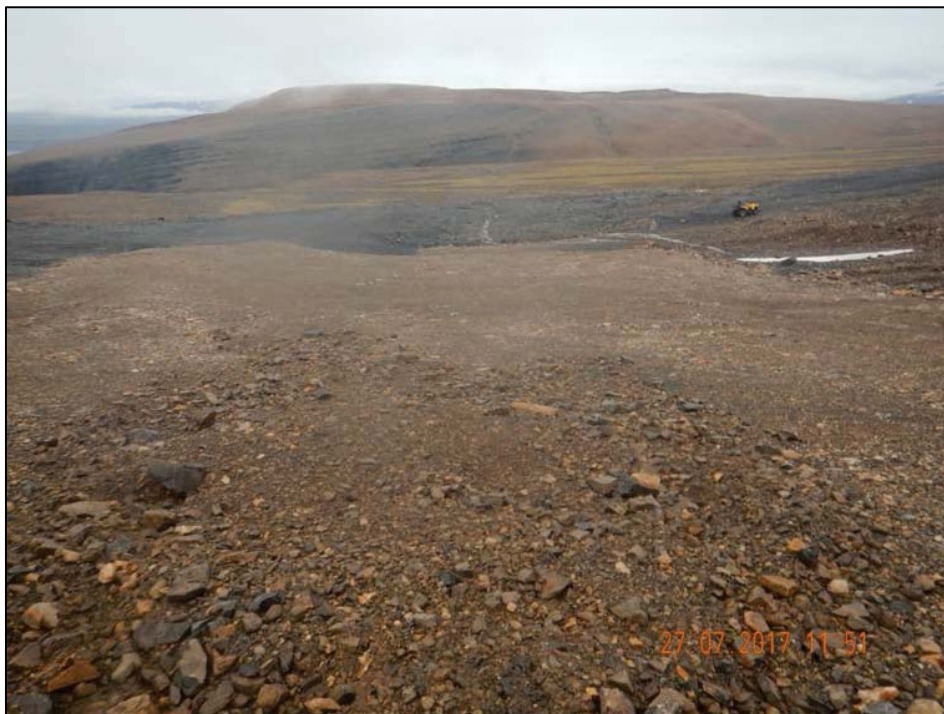
Photo 64. 17N Portal – Sloping surface of portal plug cover. View looking downslope.

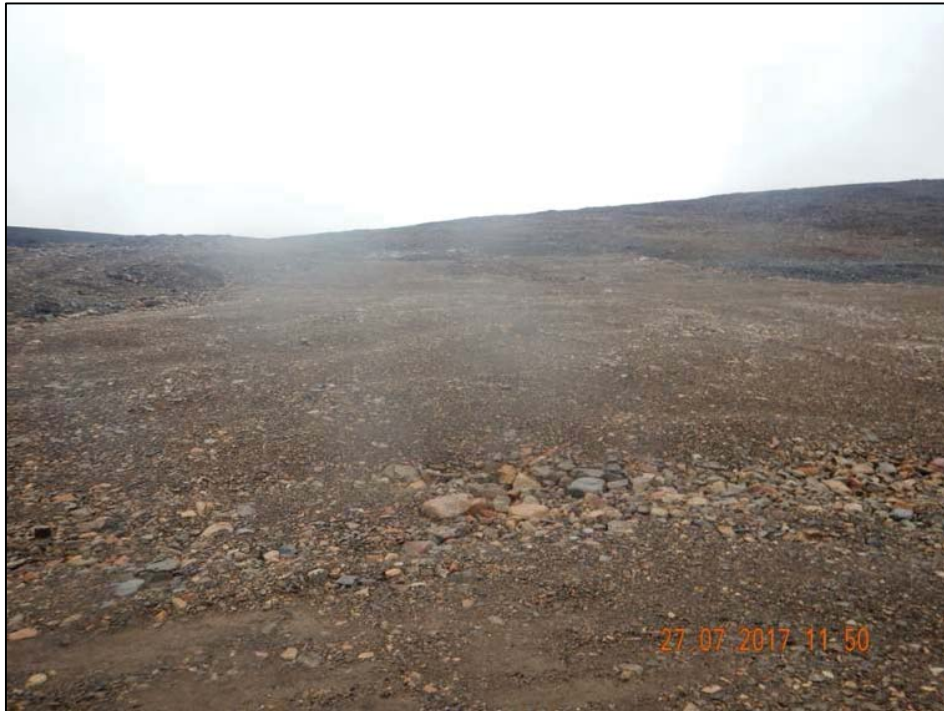
Photo 65. 17N Portal – Sloping surface of portal plug cover. View looking upslope.

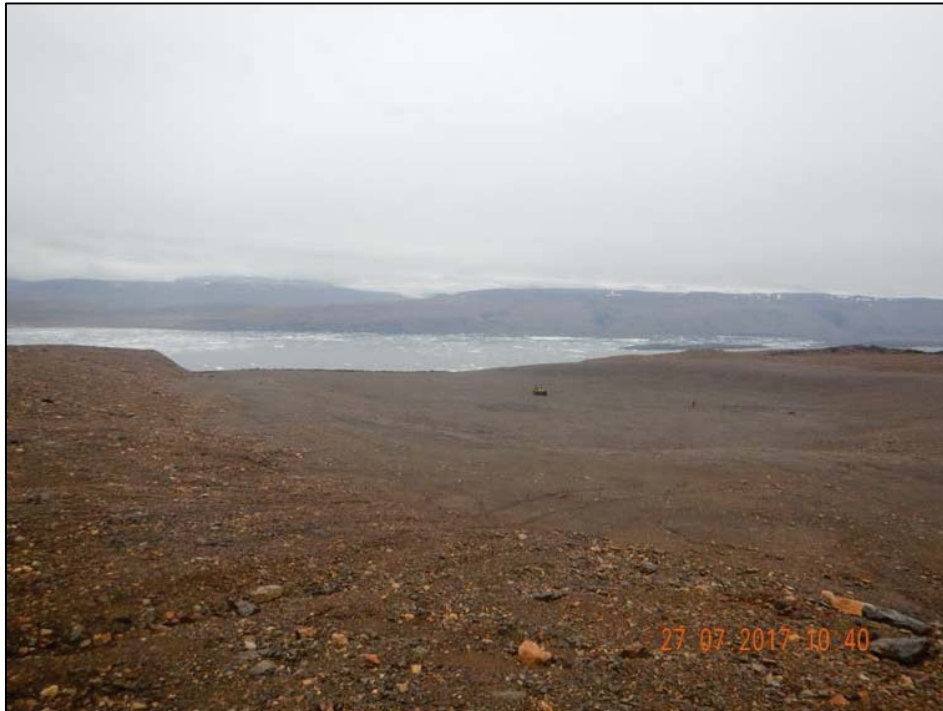
Photo 67. Oceanview Portal – OVP cover system as seen from upslope surface water deflection berm.

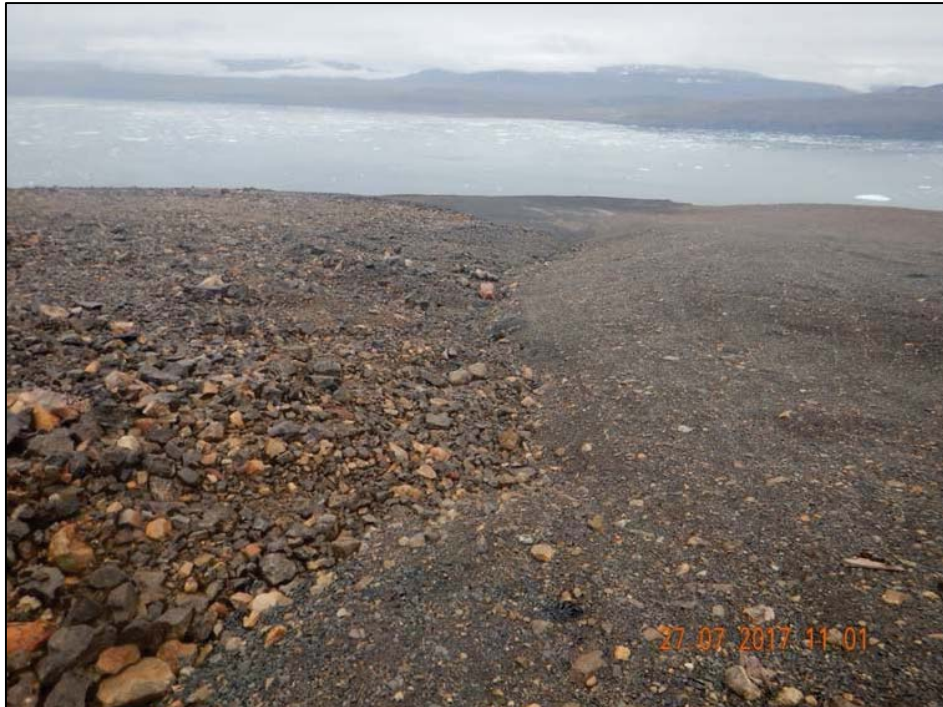
Photo 68. Oceanview Portal – West edge of portal cover. Note old settlement area not showing any signs of ongoing deformation.

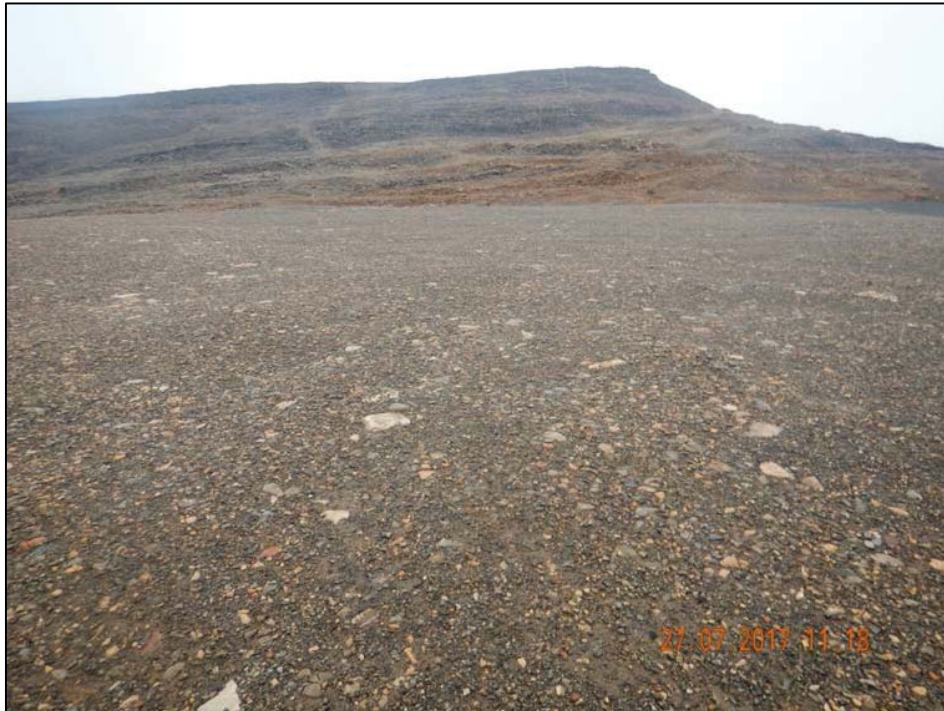
Photo 69. K-Baseline Portal – Upper portion of portal plug cover.

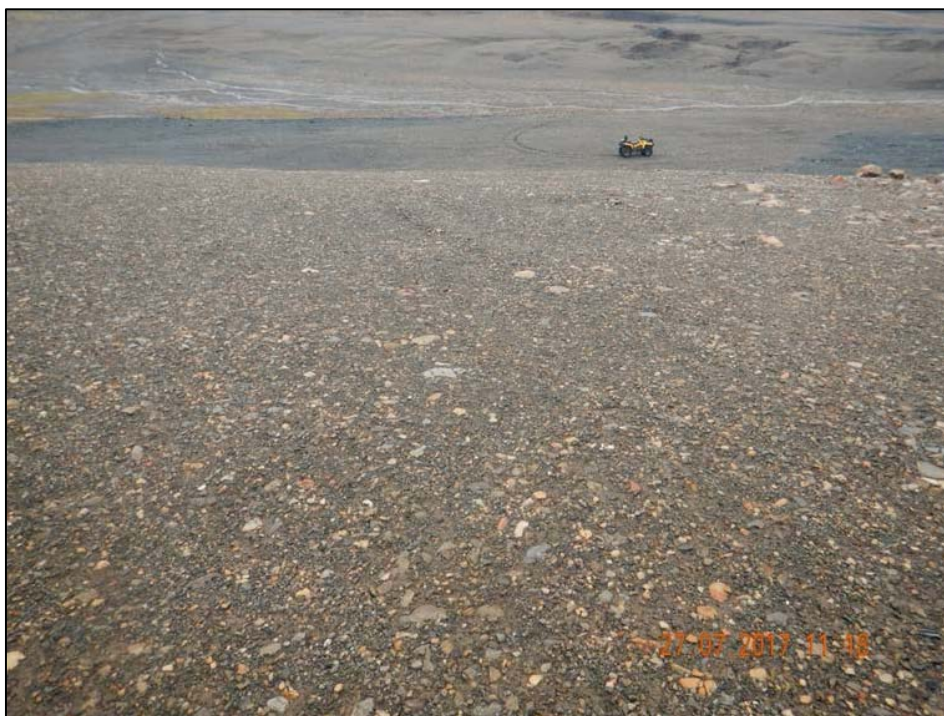
Photo 70. K-Baseline Portal – Lower sloping portion of portal plug cover.

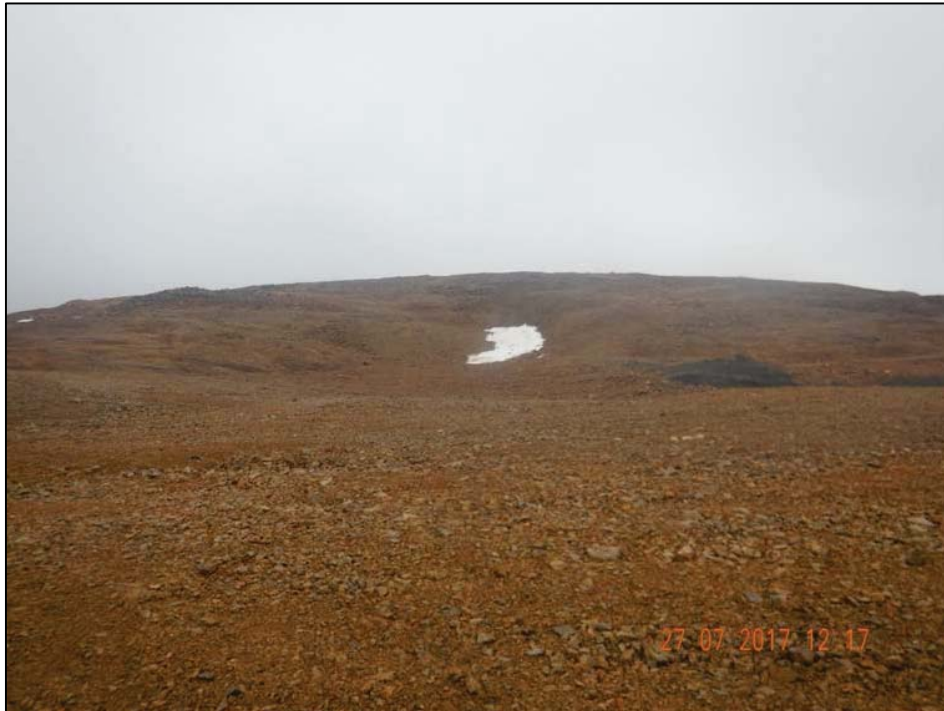
Photo 71. Area 14 Portal – Portal plug cover.

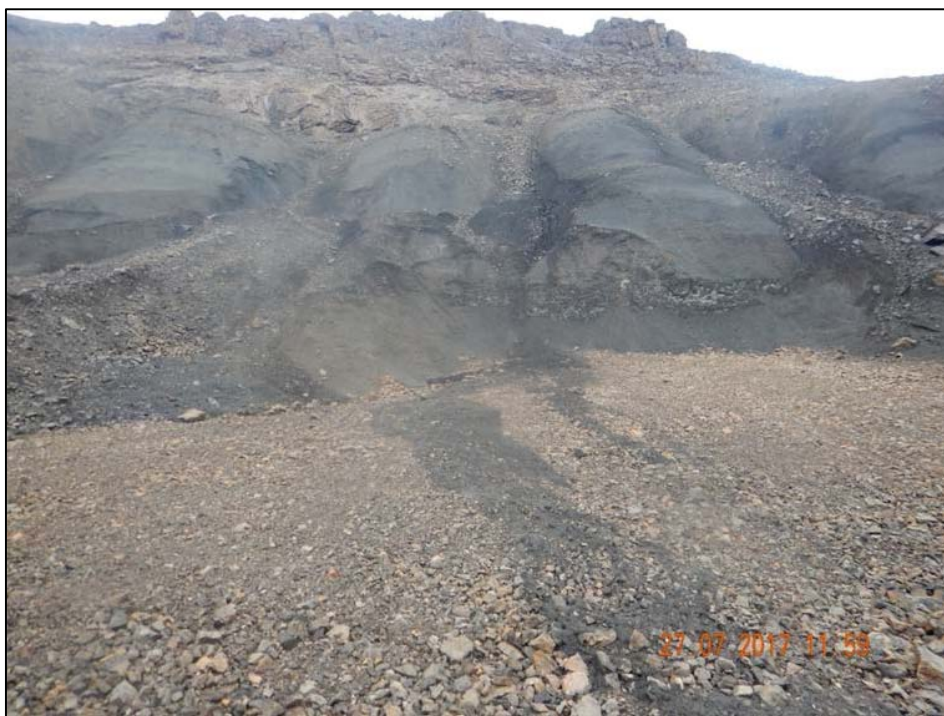
Photo 72. 09S Portal Plug – View looking upslope.

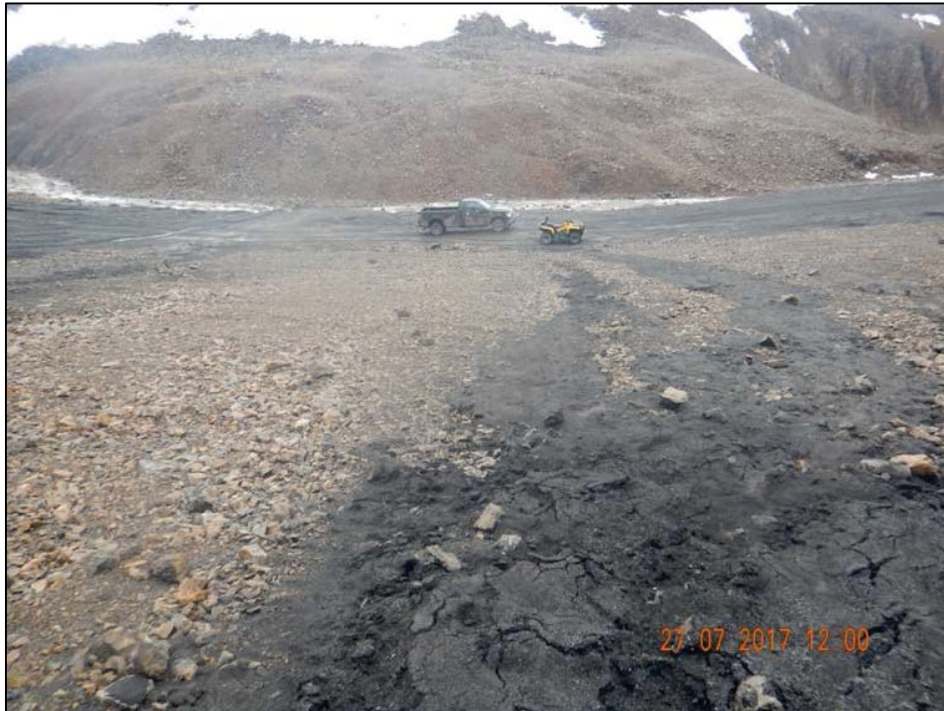
Photo 73. 09S Portal Plug – View looking downslope.

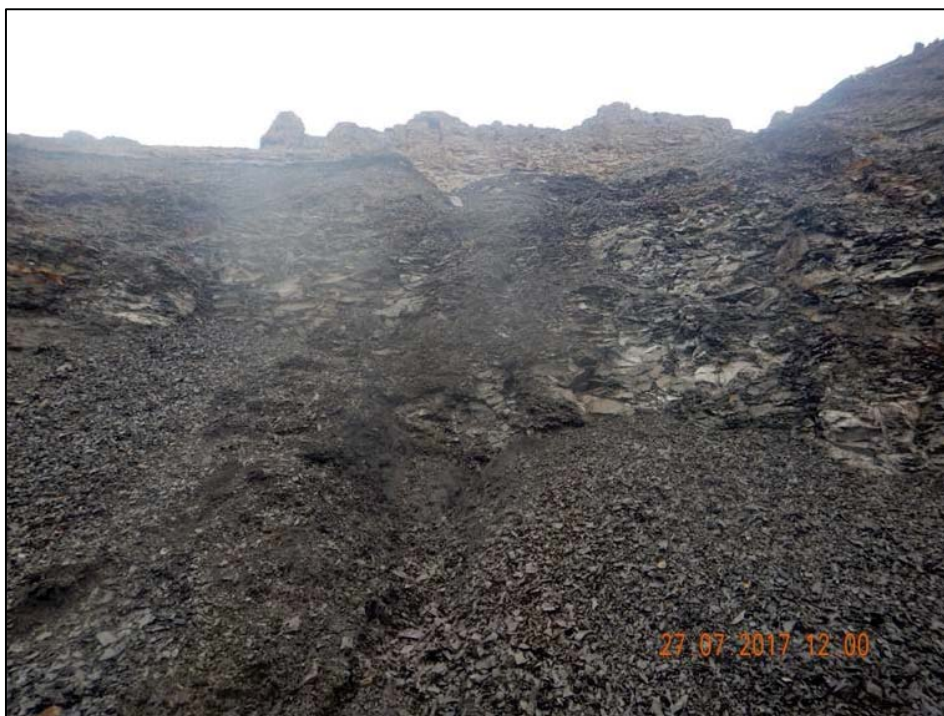
Photo 74. 09S Portal Plug – Looking upslope at rock outcrop above portal plug.

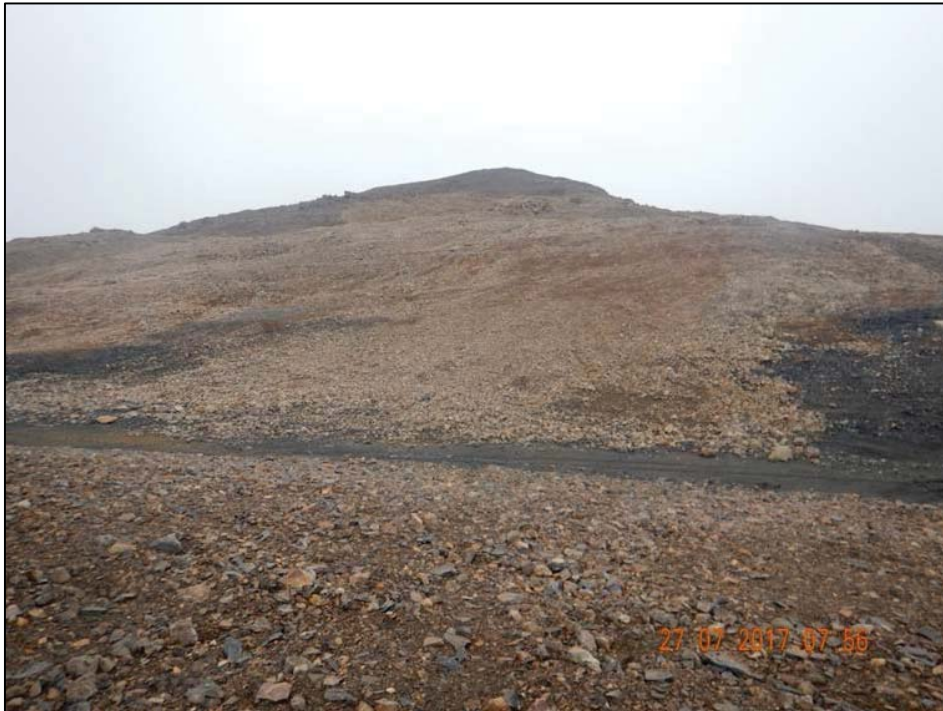
Photo 75. Lower Adit – Sloping face of portal plug.

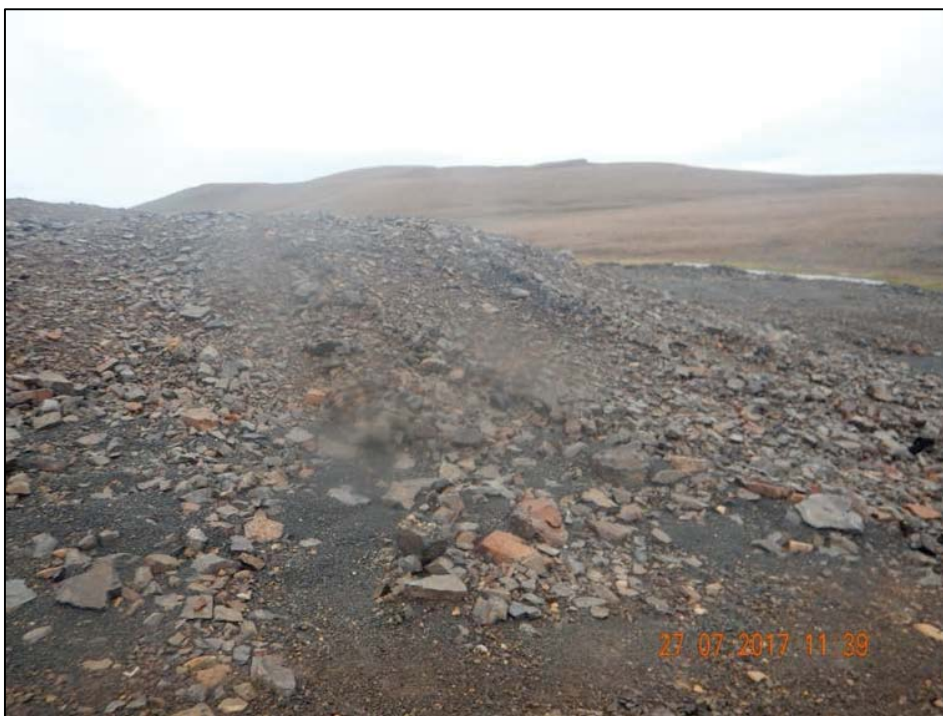
Photo 76. Shale Hill Rise – Surface mound.

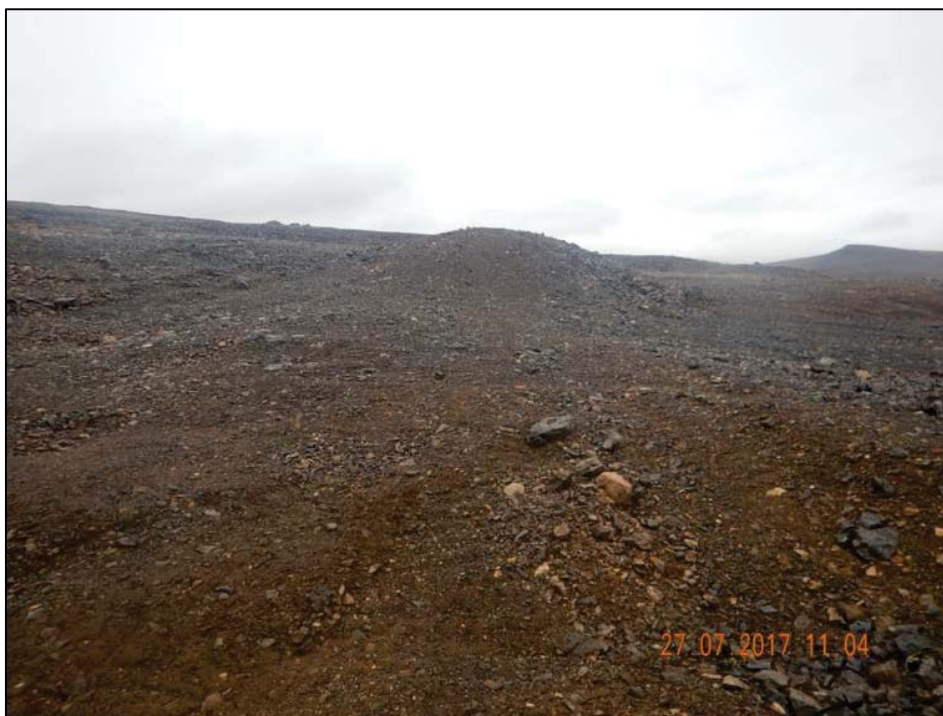
A photo from the inspection is provided in Appendix I (Photo 78). During the inspection, the armour surface appeared to be stable with no visual indications of erosion or surface deformation. As such, no maintenance was recommended.

Photo 78. Oceanview West Raise – West Raise plug and mound.

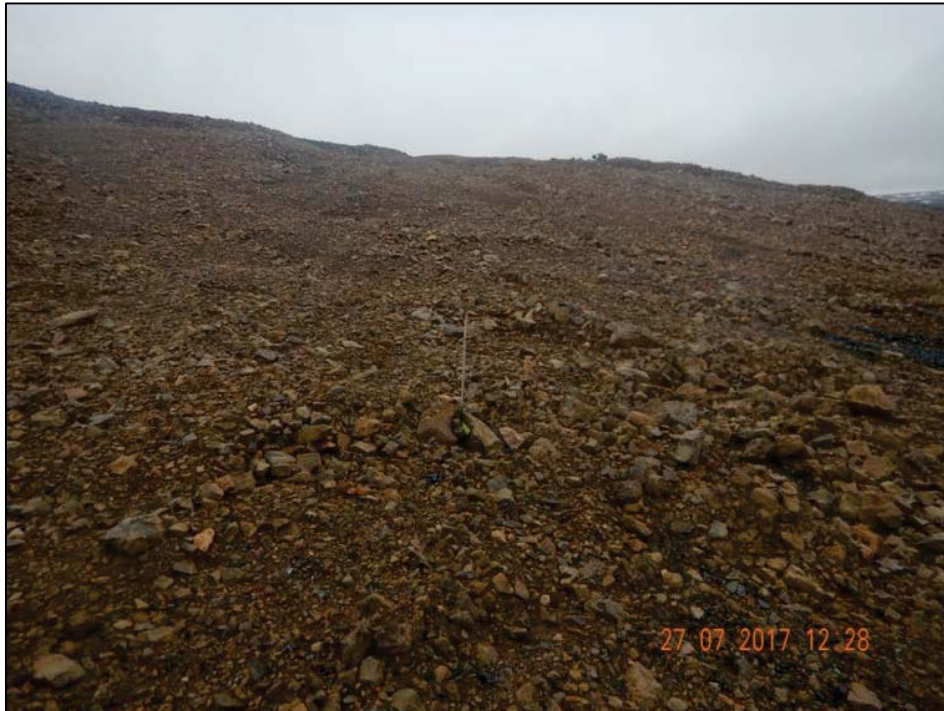
A photo from the inspection is provided in Appendix I (Photo 79). During the inspection, no settlement of the area surrounding the former raise was observed. As such, no maintenance was recommended.

Photo 79. Area 14 – Raise area.

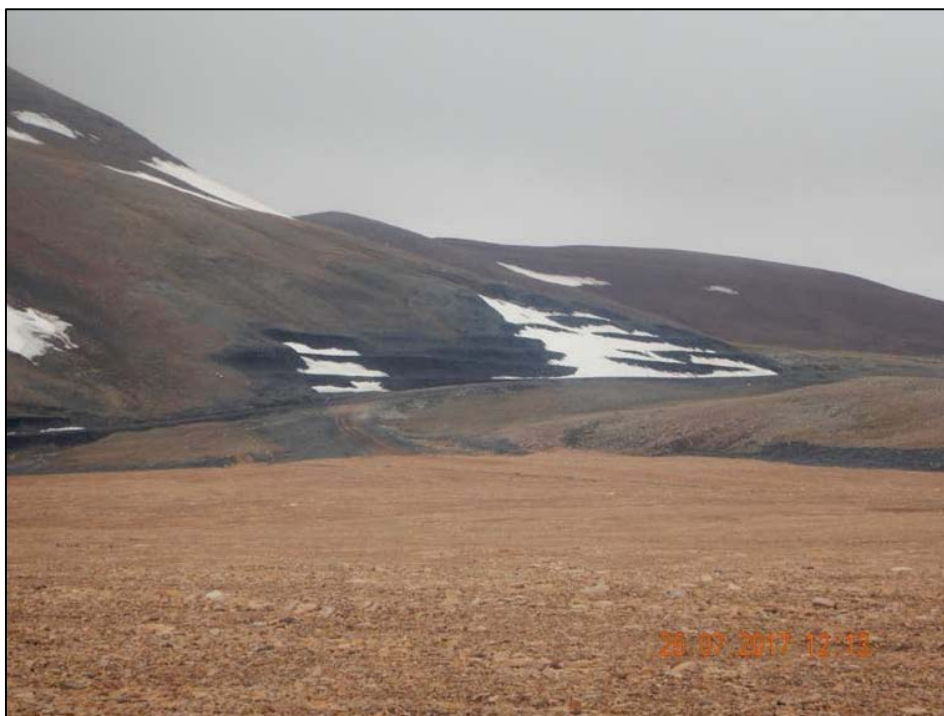
Photo 80. Surface Cell – Mt. Fuji shale quarry as seen from Surface Cell.

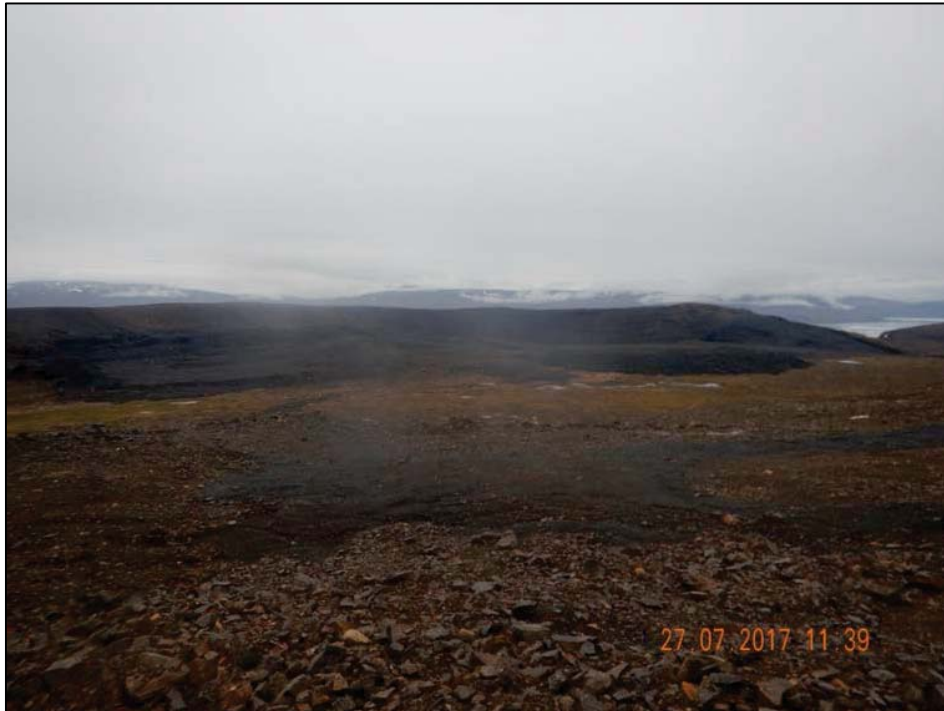
Photo 81. Shale Hill quarry.

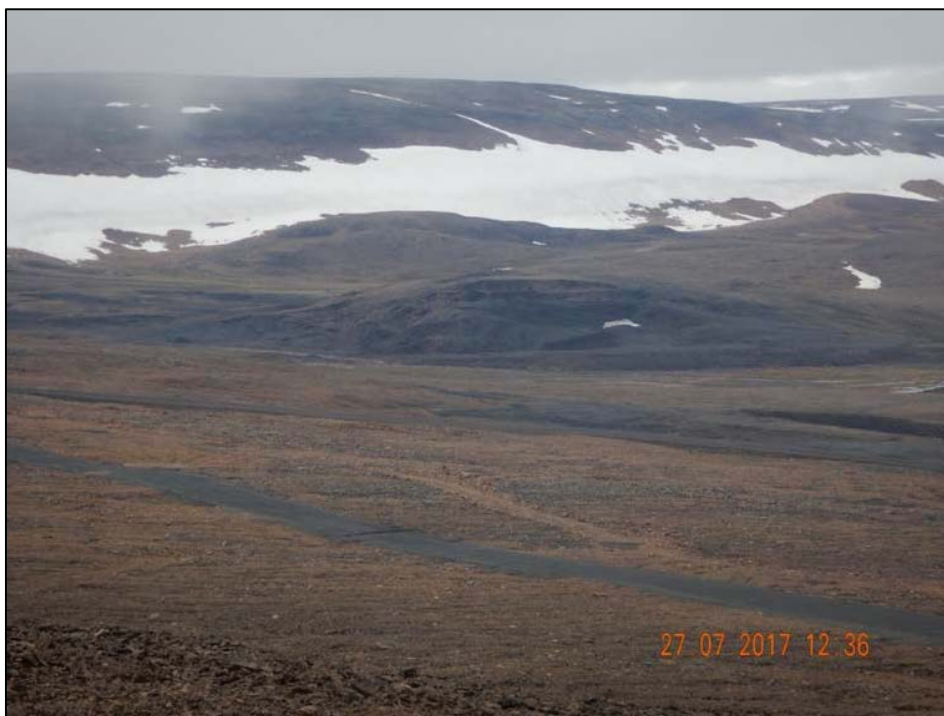
Photo 82. Area 14 – East Twin Shale quarry.
