**NYRSTAR**

**NANISIVIK MINE, NUNAVUT**

**2019 ANNUAL GEOTECHNICAL INSPECTION**

PROJECT NO.: 0255030

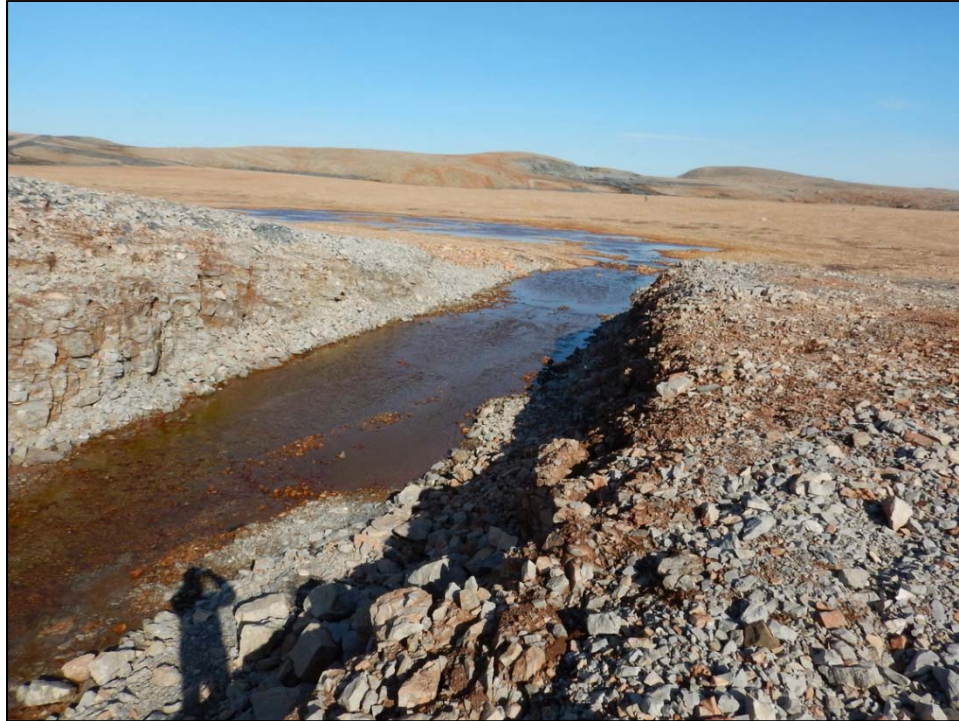
- The upper portion of the spillway (upstream of the access ramp) shows signs of minor erosion of the armour material but remains in satisfactory condition (Photos 4 through 6).

**Photo 4. West Twin Dyke Spillway – On the left bank of the spillway looking upstream at the upper spillway.**

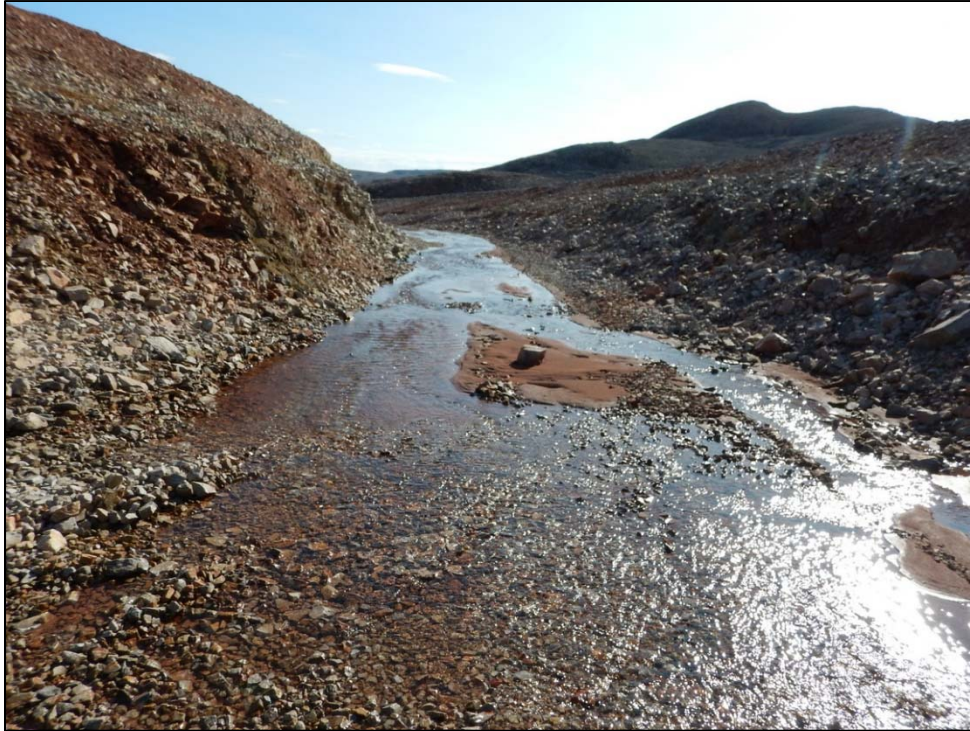
**Photo 5. West Twin Dyke Spillway – Looking downstream from access ramp.**

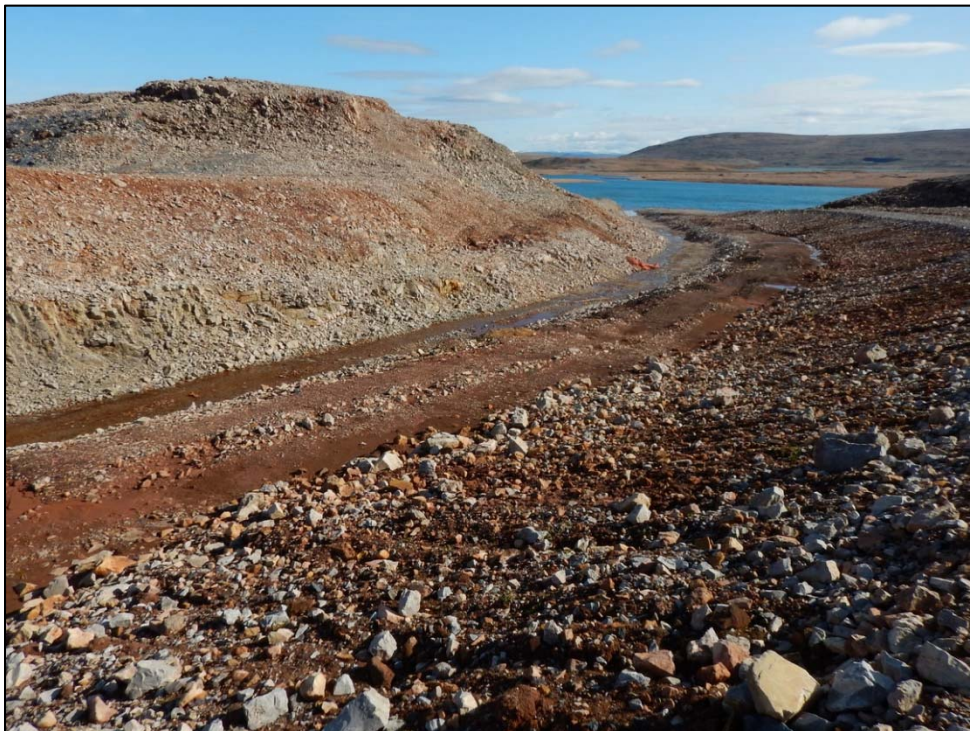
**Photo 6. West Twin Dyke Spillway – On the right bank of the spillway approximately 50 metres downstream of the access ramp looking downstream at an overview of the lower spillway.**

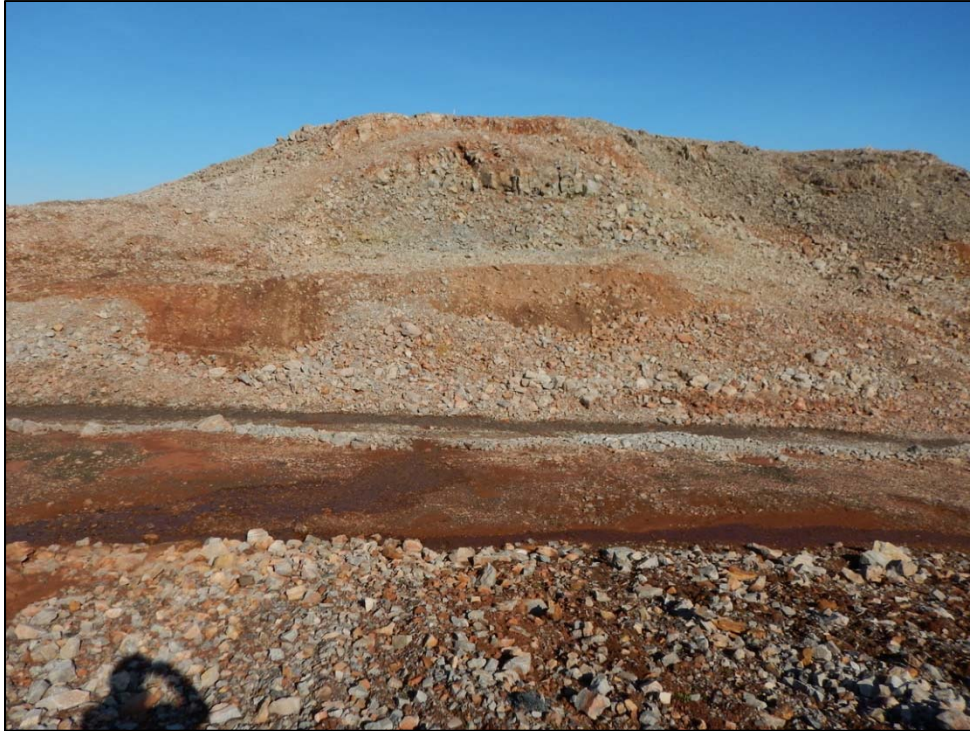
**Photo 7. West Twin Dyke Spillway – On right bank looking at area where 2018 left bank maintenance was performed.**

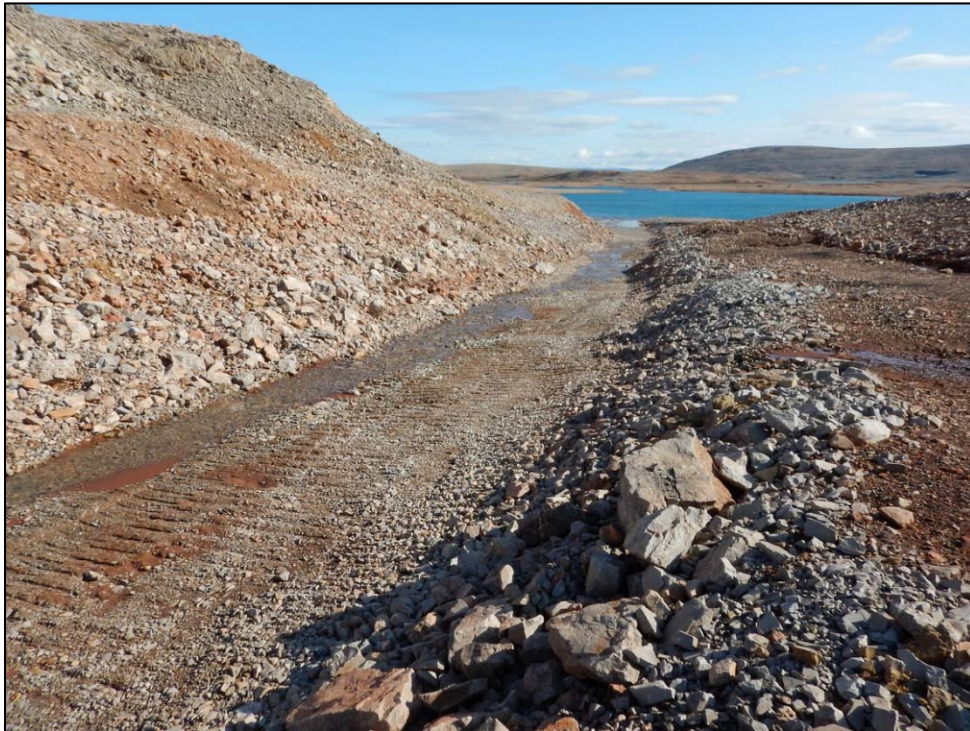
**Photo 8. West Twin Dyke Spillway – On right bank looking downstream along location of 2018 left bank maintenance.**

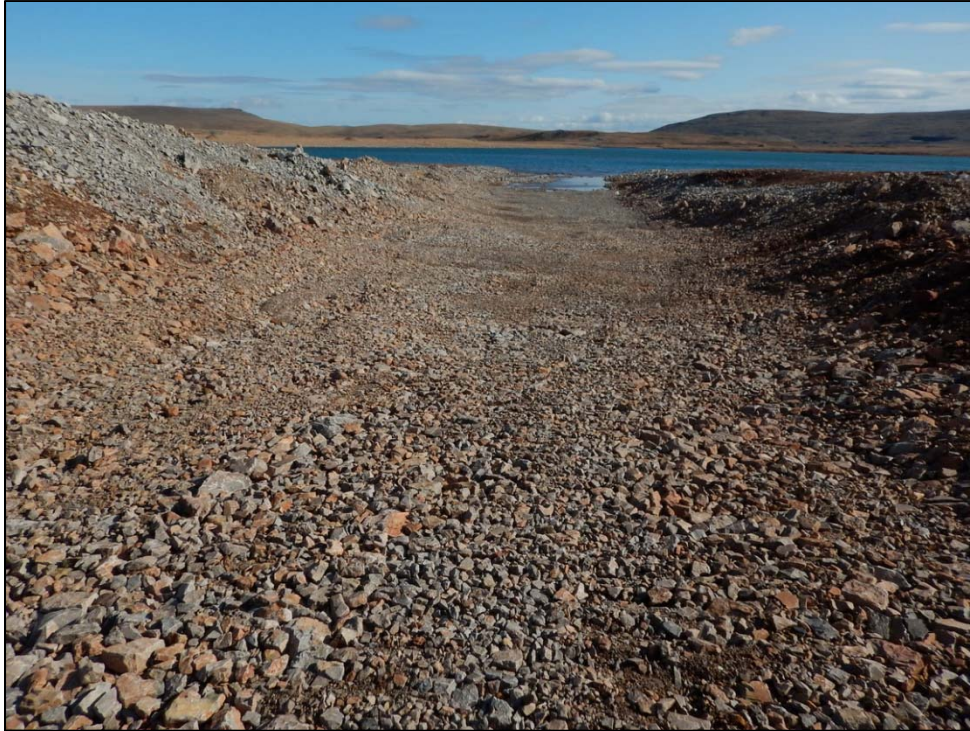
**Photo 9. West Twin Dyke Spillway – Looking downstream at spillway outlet where 2018 maintenance was performed.**

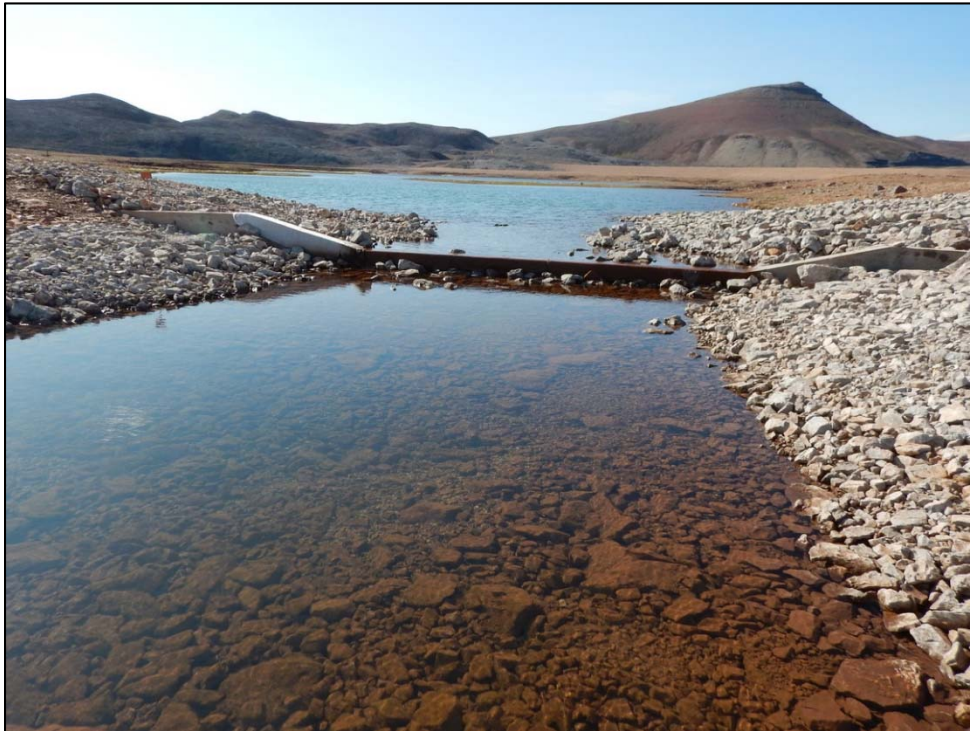
- During the inspection, the water level upstream of the wall was noted to be just above (+2 cm) the elevation of the wall invert (Photos 10 and 11).
- The seepage at the West Twin Outlet Wall seems to have slowed in recent years, as the water level upstream of the wall has been maintained more consistently at or above the invert of the outlet wall.
- Slumping and settlement of the perimeter slopes of the upstream Polishing Pond have been noted in recent years and continued to degrade in 2019 (Photos 13 and 14). The area of active instability has been observed to be further and further away from the outlet wall in recent years. As such, there is limited concern with respect to the instability and its potential impact on the effectiveness of the outlet wall to function as intended, but it should continue to be visually inspected for changes.

**Photo 10. West Twin Outlet Wall – As seen from downstream.**

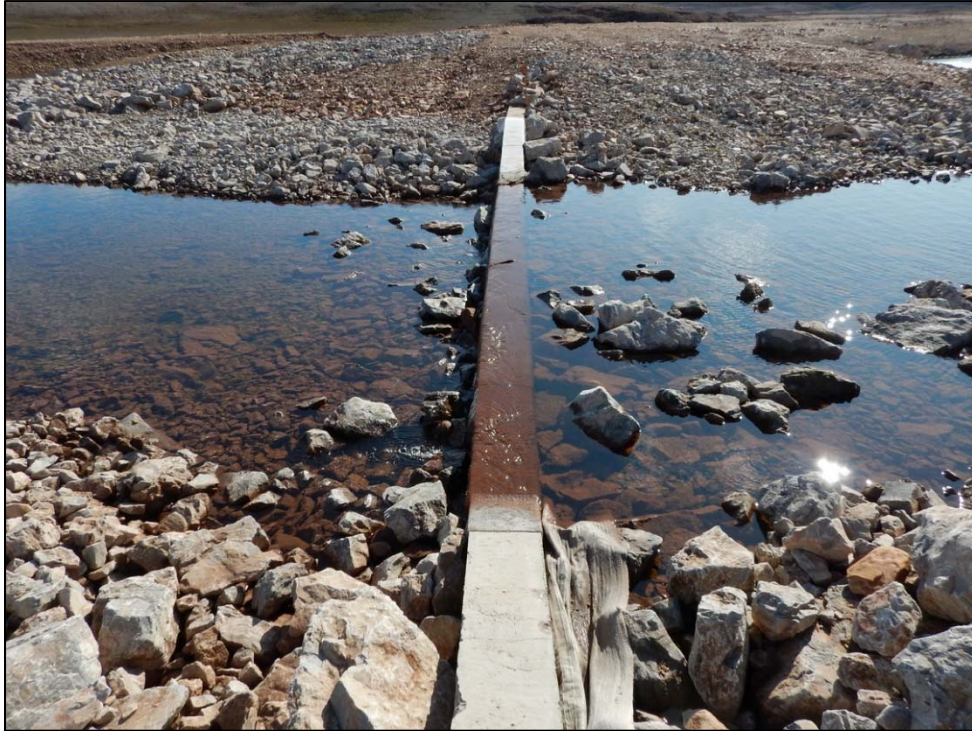
**Photo 11. West Twin Outlet Wall – As seen from left bank.**

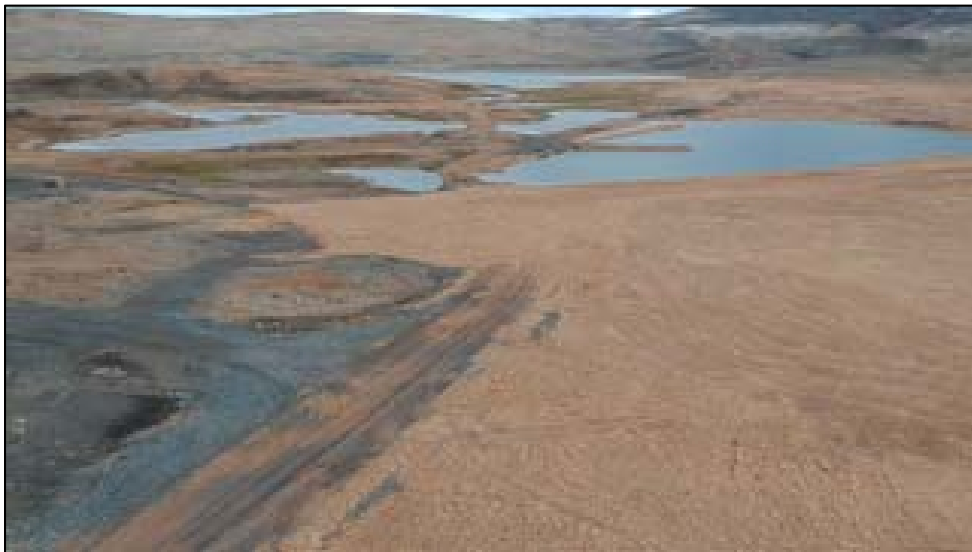
**Photo 12. Reservoir and Polishing Pond – As seen from a drone near the left abutment of the West Twin Dyke.**

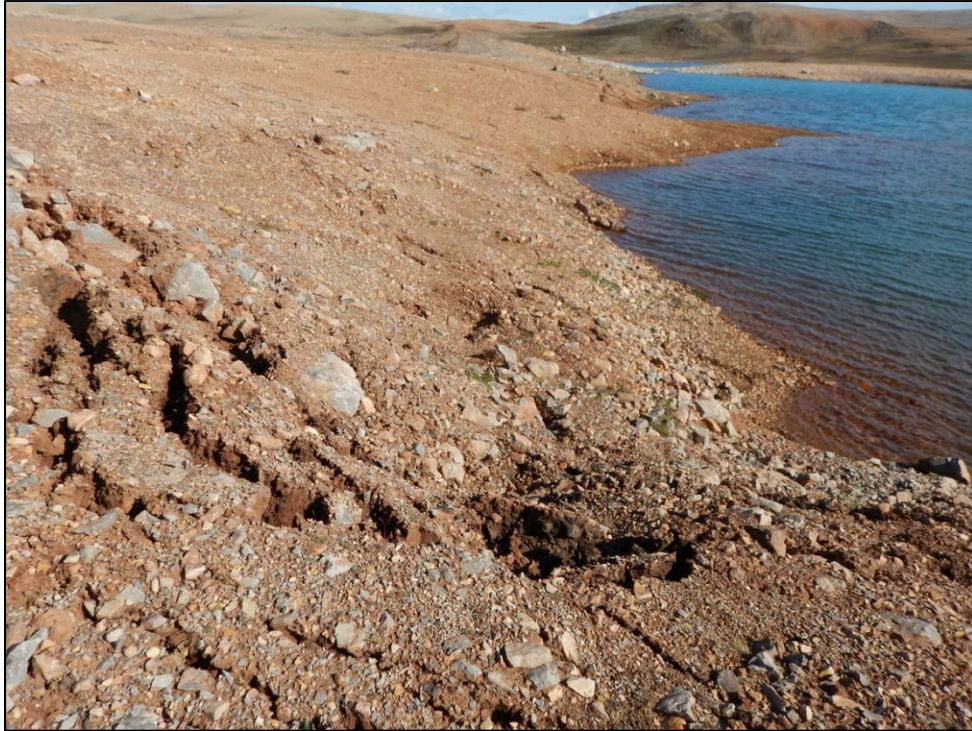
**Photo 13. Polishing Pond – Thermokarsting around Polishing Pond.**

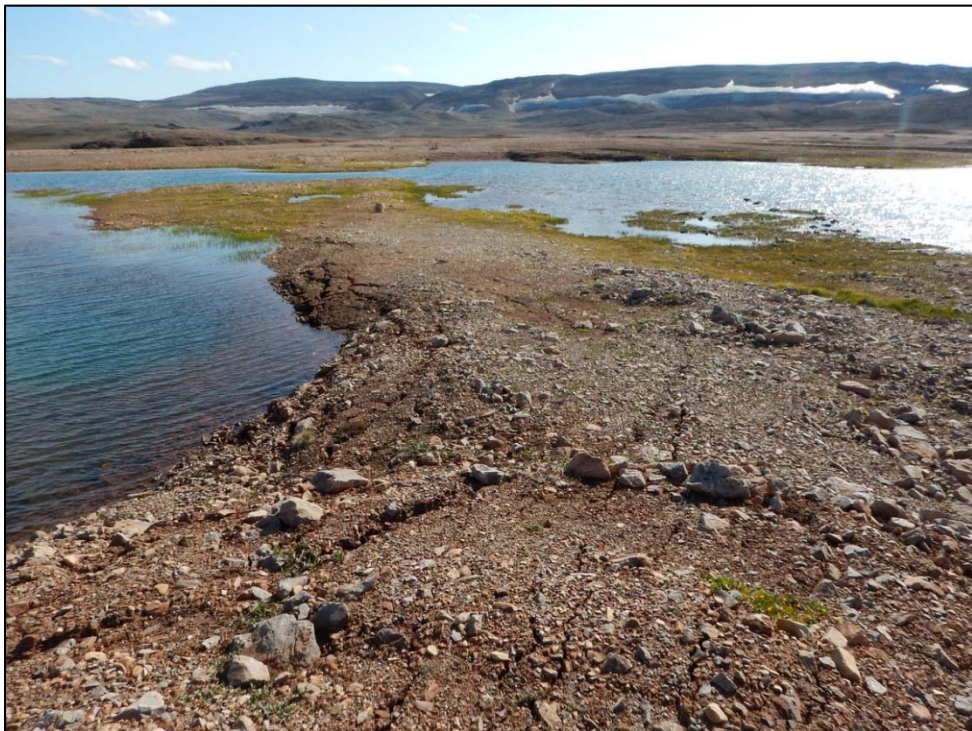
**Photo 14. Polishing Pond – Thermokarsting around Polishing Pond.**

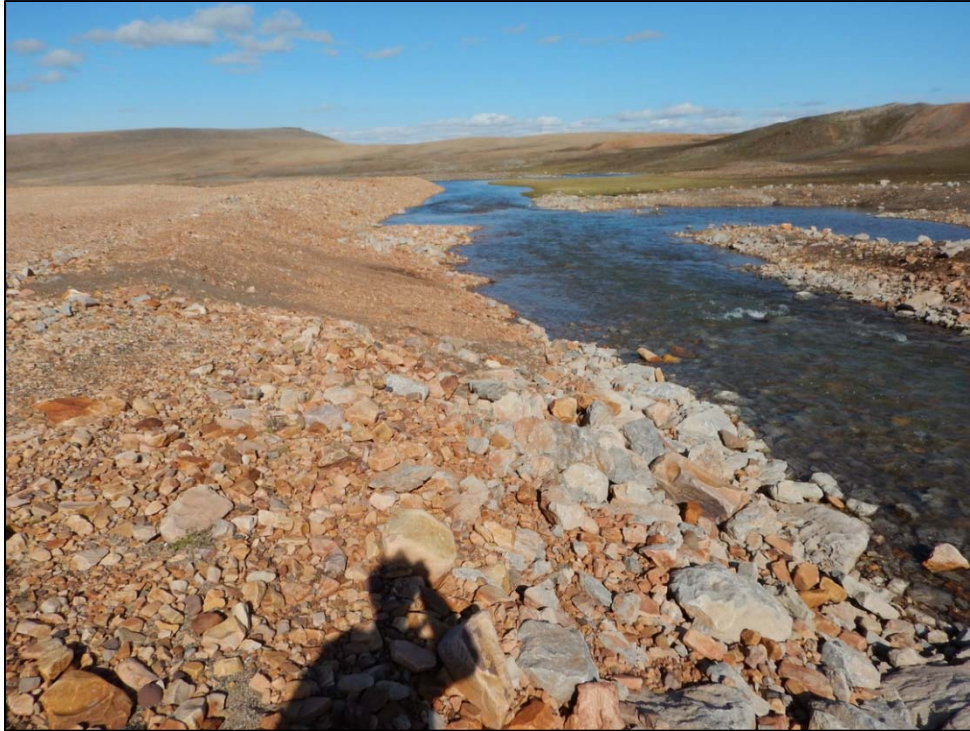
**Photo 15. East Twin Creek Diversion – Looking at area where 2018 left bank maintenance was performed.**

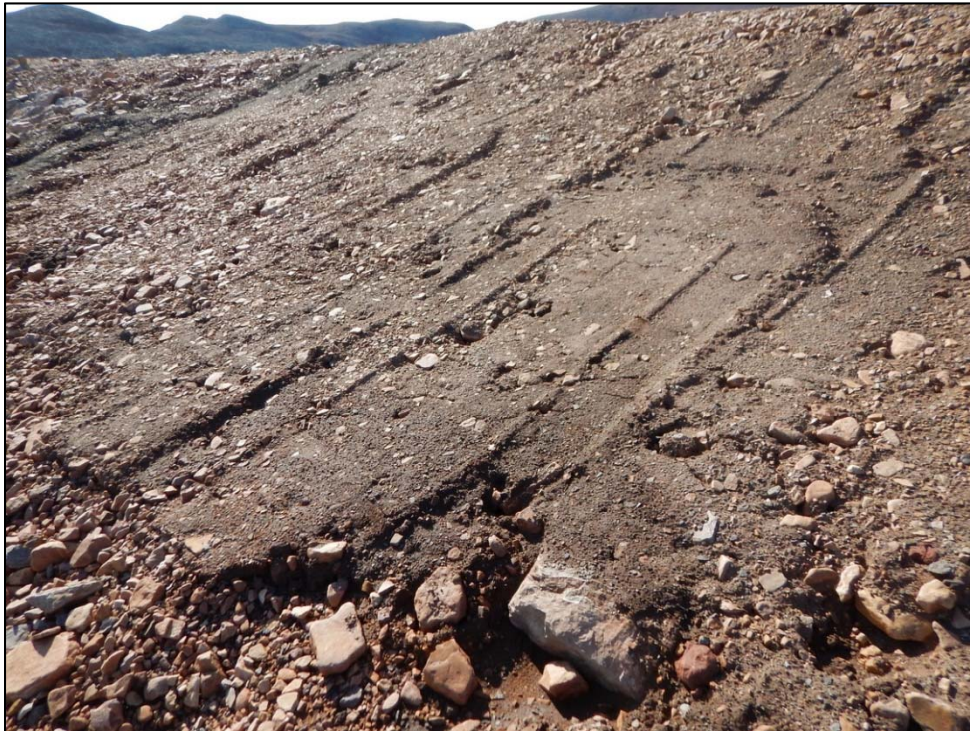
**Photo 16. East Twin Creek Diversion – Looking at area where 2018 left bank maintenance was performed.**

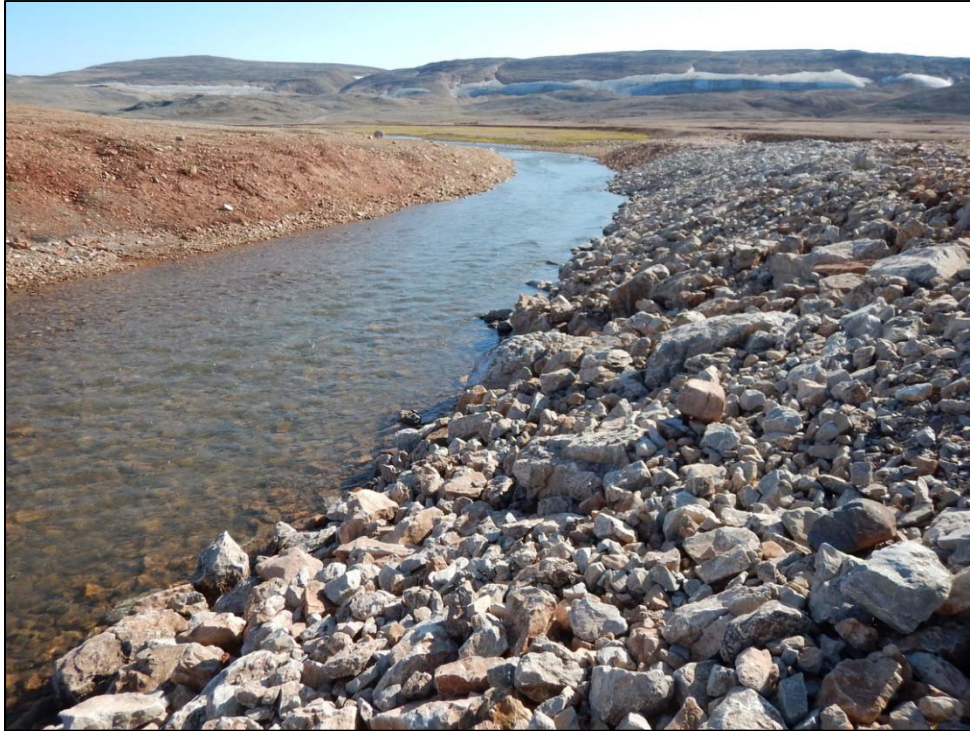
**Photo 17. East Twin Creek Diversion – Looking upstream.**

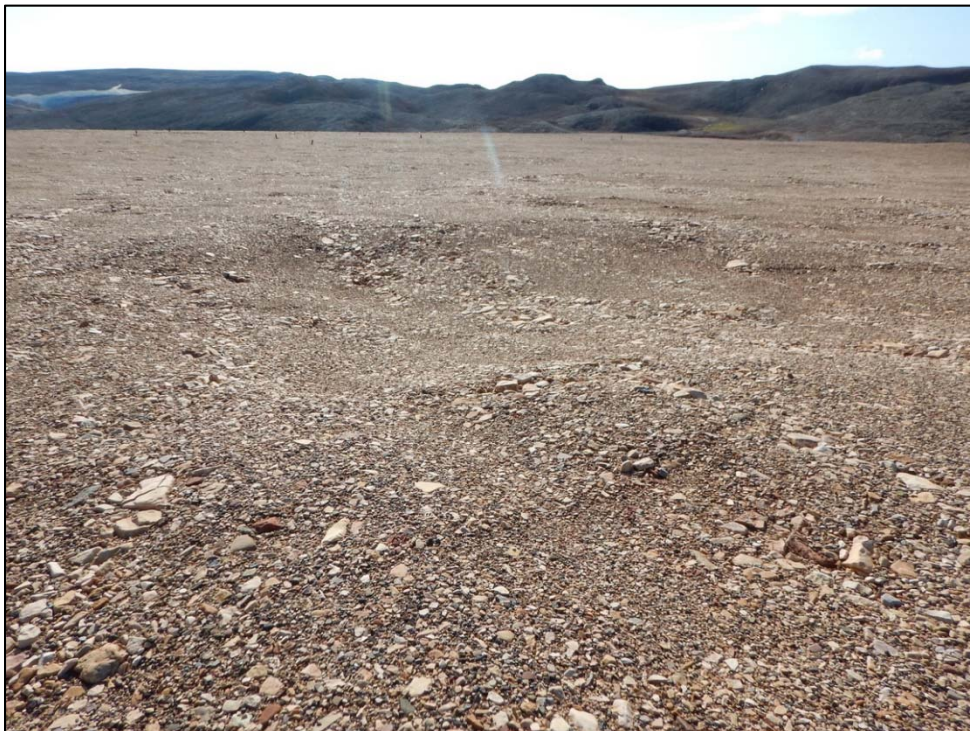
- The head pond at the entrance to the spillway at the south end of the cover was observed to be similar in size compared to previous years.
- As has been observed in previous inspections, some minor thermokarst features were noted along the south shoreline, along the east edge of the main drainage swale and just north of the E/W trench (Photo 18). These localized thermokarsts are not considered to be negatively impacting the overall performance of the cover system. Additionally, the same thermokarst features have been observed in past inspections and do not appear to be changing with time, suggesting they are physically stable.

**Photo 18. Surface Cell Cover System – Minor thermokarsting along main E-W drainage swale.**

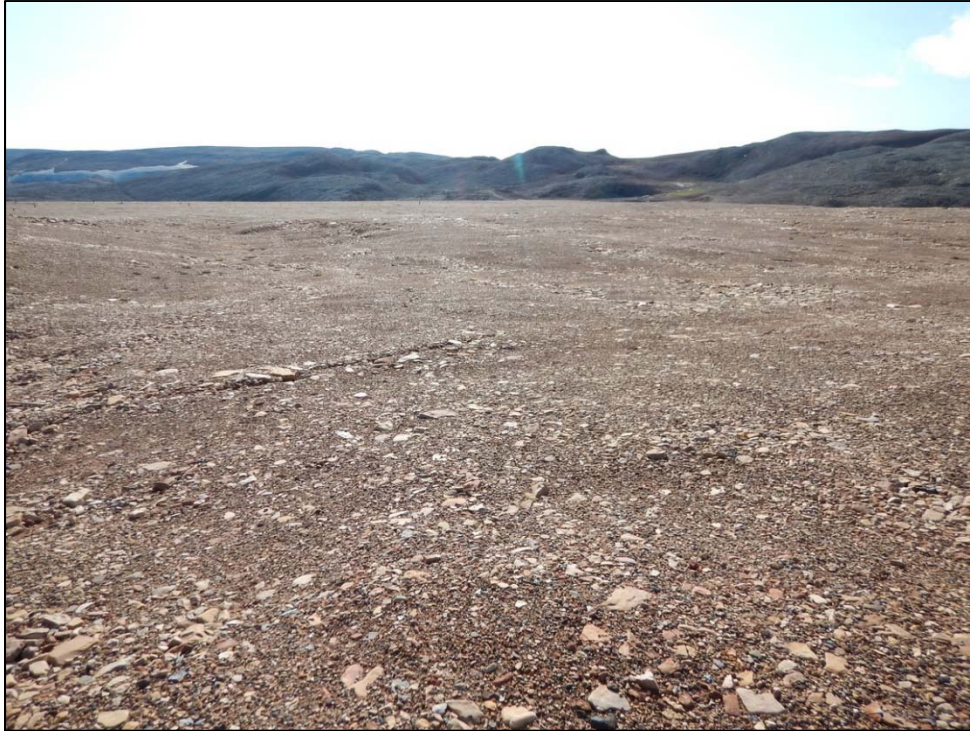
**Photo 19. Surface Cell Cover System – Near north end of cover looking south.**

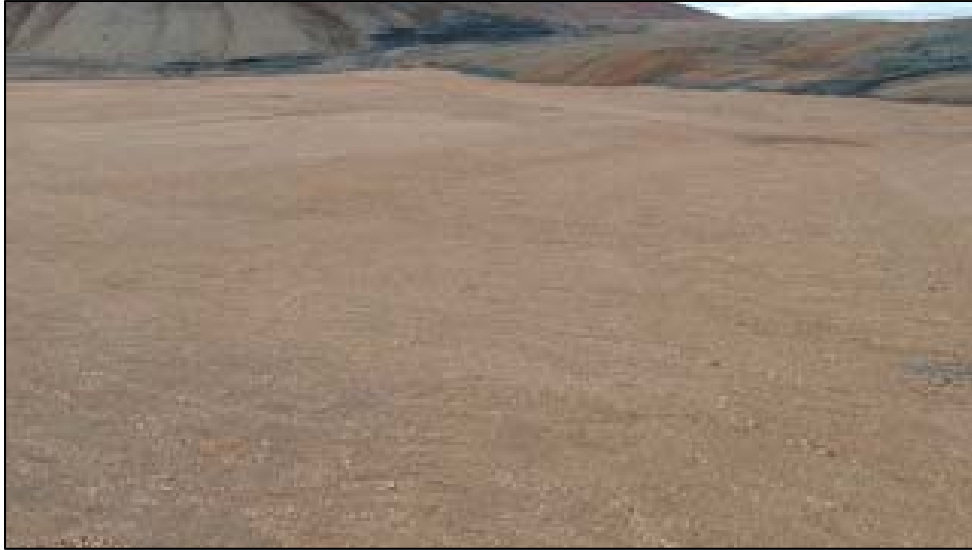
**Photo 23. Surface Cell Cover System – As seen from a drone near the left abutment of the West Twin Dyke.**

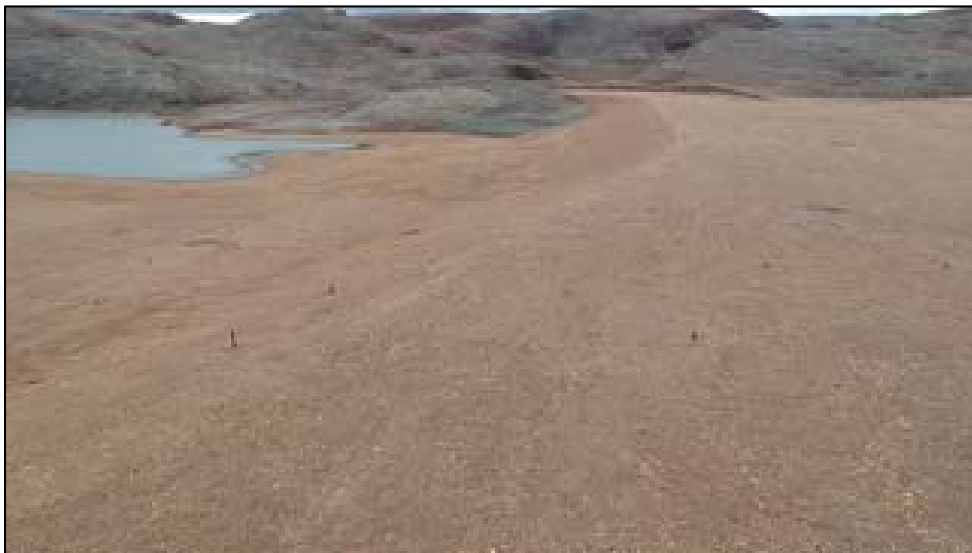
**Photo 24. West Twin Dyke – As seen from a drone near the left abutment.**

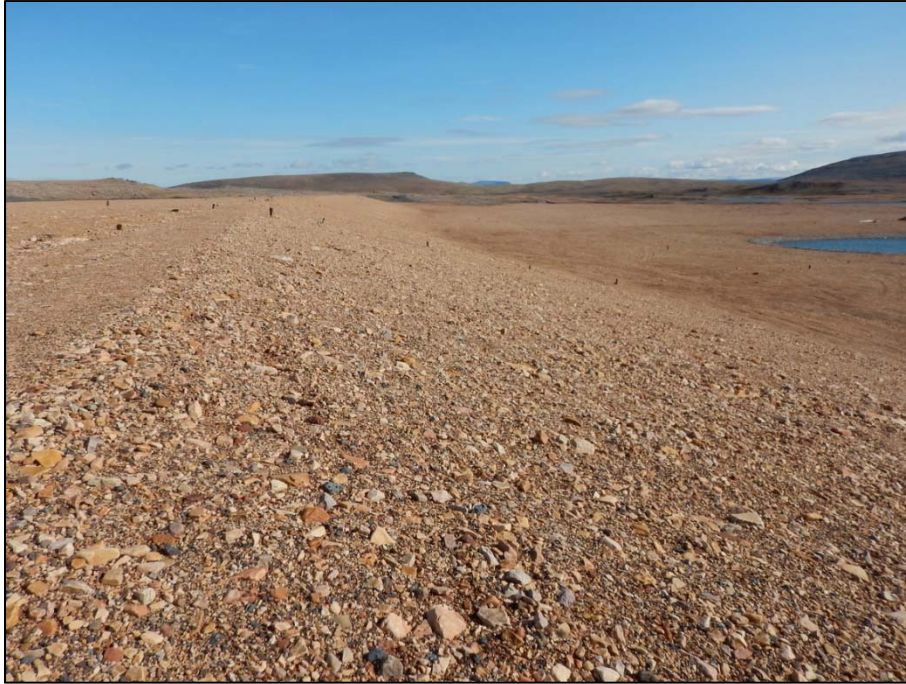
**Photo 25. West Twin Dyke – Looking along the dyke face from the right abutment.**

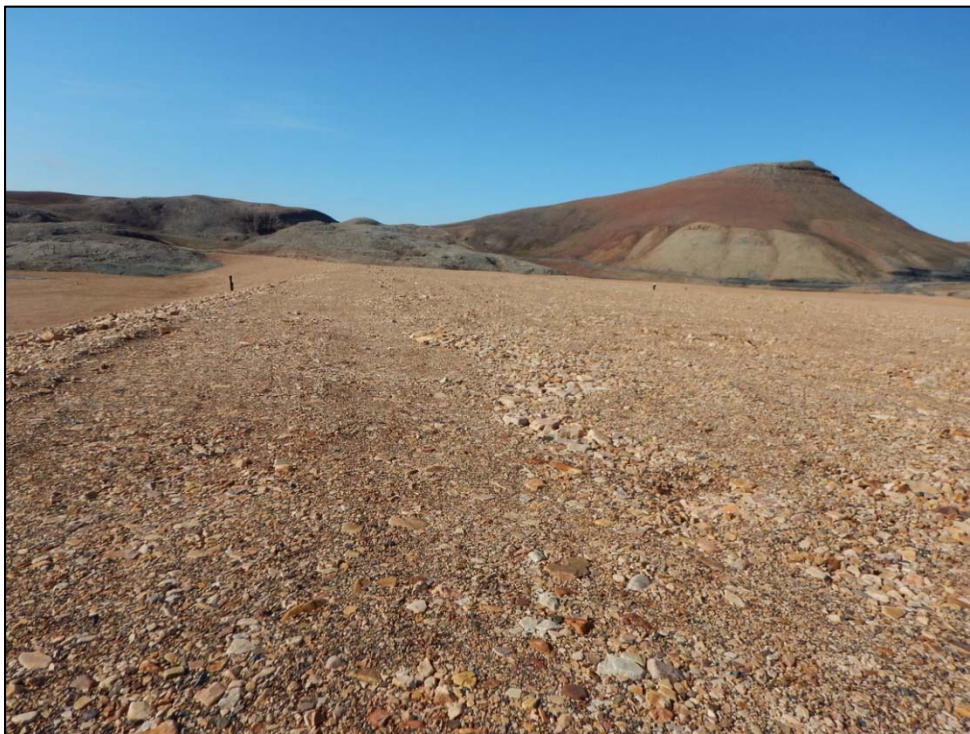
**Photo 26. West Twin Dyke – Looking along the crest of the West Twin Dyke from the left abutment.**

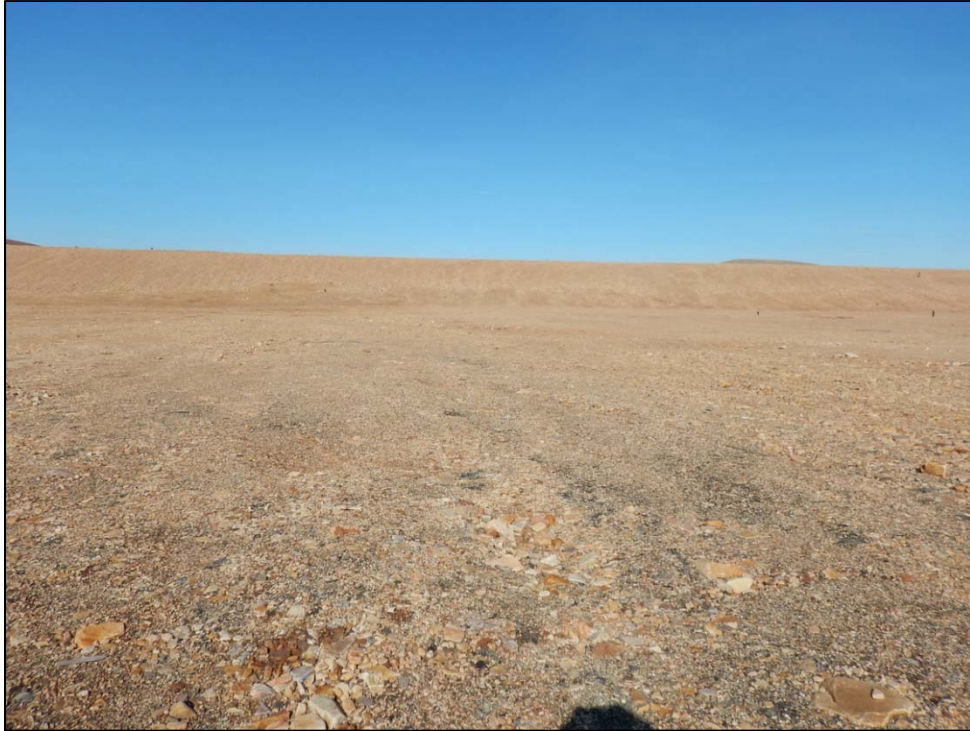
**Photo 27. Test Cell Cover System – West Twin Dyke and Test Cell Cover System.**

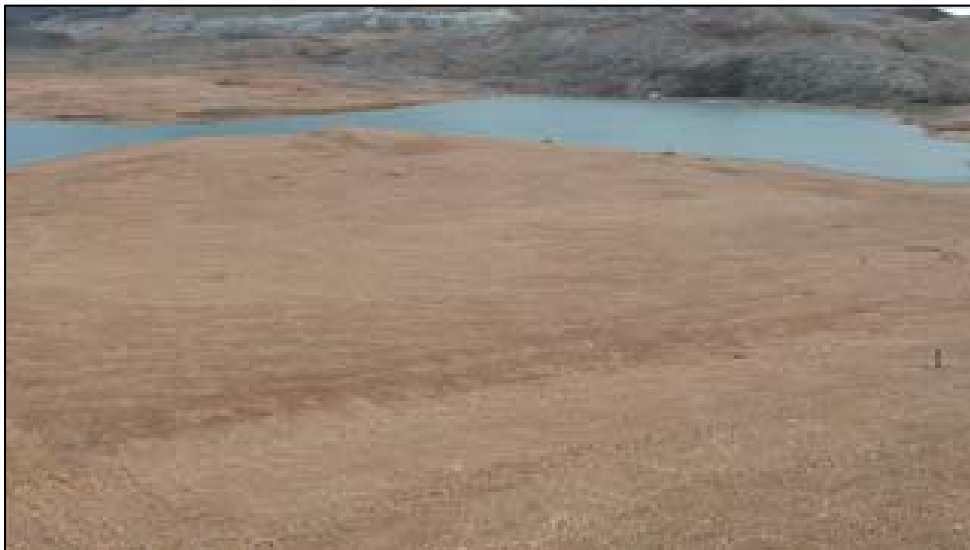
**Photo 28. Test Cell Cover System – As seen from a drone near the left abutment of the West Twin Dyke.**

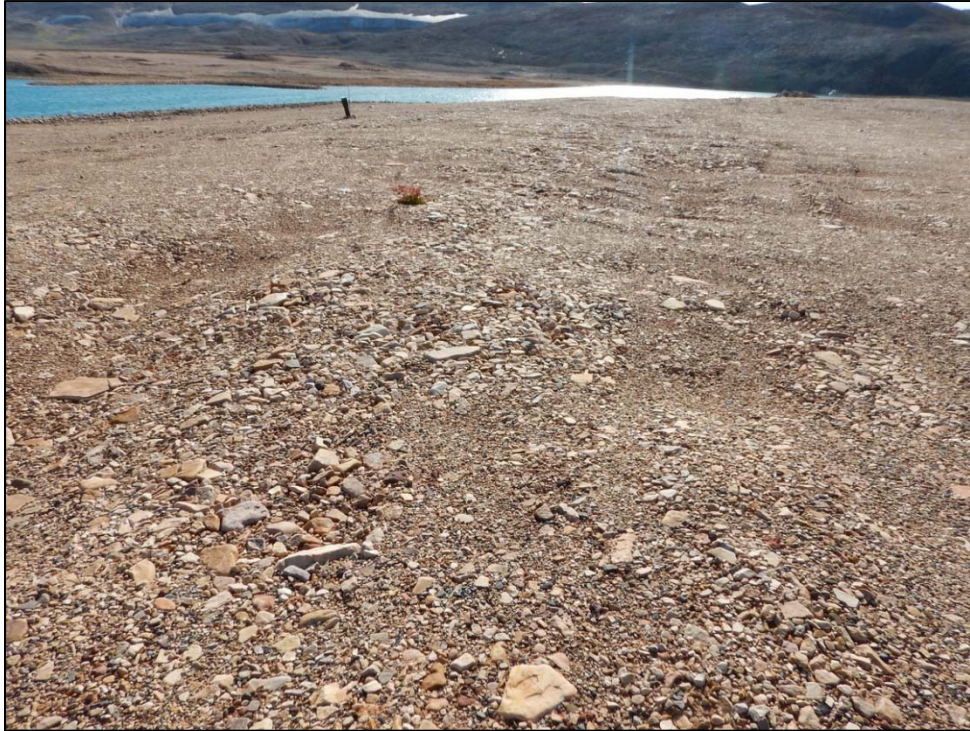
- No erosion or ponding was observed.
- Similar to previous inspection observations, the north-south arm of the Test Cell Dyke and the Test Cell Cover just inside of the dyke remains undulating, suggesting some amount of thaw settlement of the cover materials has occurred (Photo 29). This undulating nature of the cover in this area has not noticeably changed in the last several years and the cover is overbuilt in this area due to grade requirements. The undulating nature is not considered to negatively impact drainage or the thermal performance of the cover and, as such, this area is not of concern.

**Photo 29. Test Cell Cover System – Minor settlement trough along N/S arm of Test Cell Dyke.**

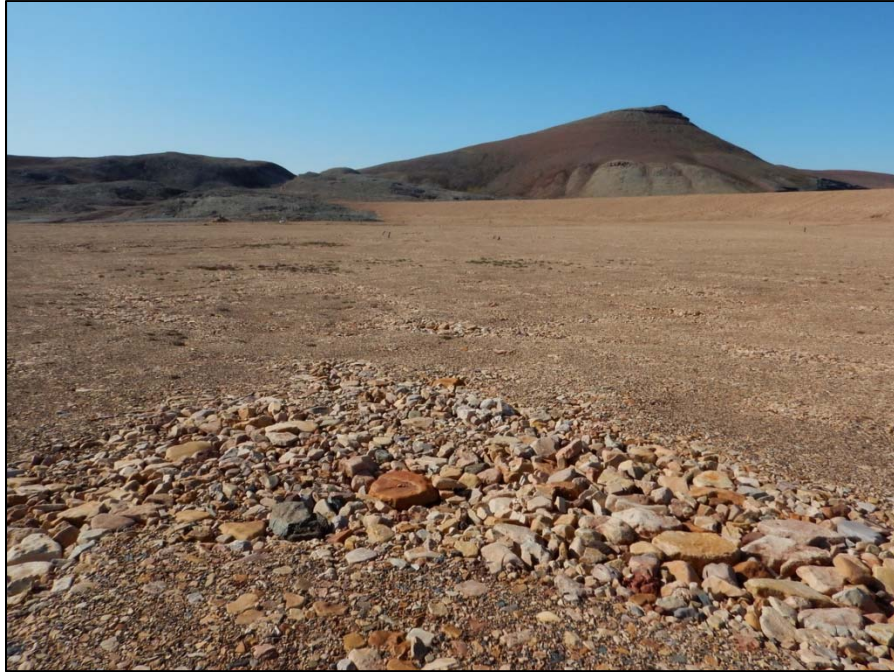
Minor thermal cracks (<20 cm wide and <20 cm deep) were observed in some areas of the cover system but are not considered to be negatively impacting the performance of the cover (Photo 30). Photos 31 and 32 show the overall surface of the cover system.

**Photo 31. Test Cell Cover System – Flat surface of cover system, looking southwest.**

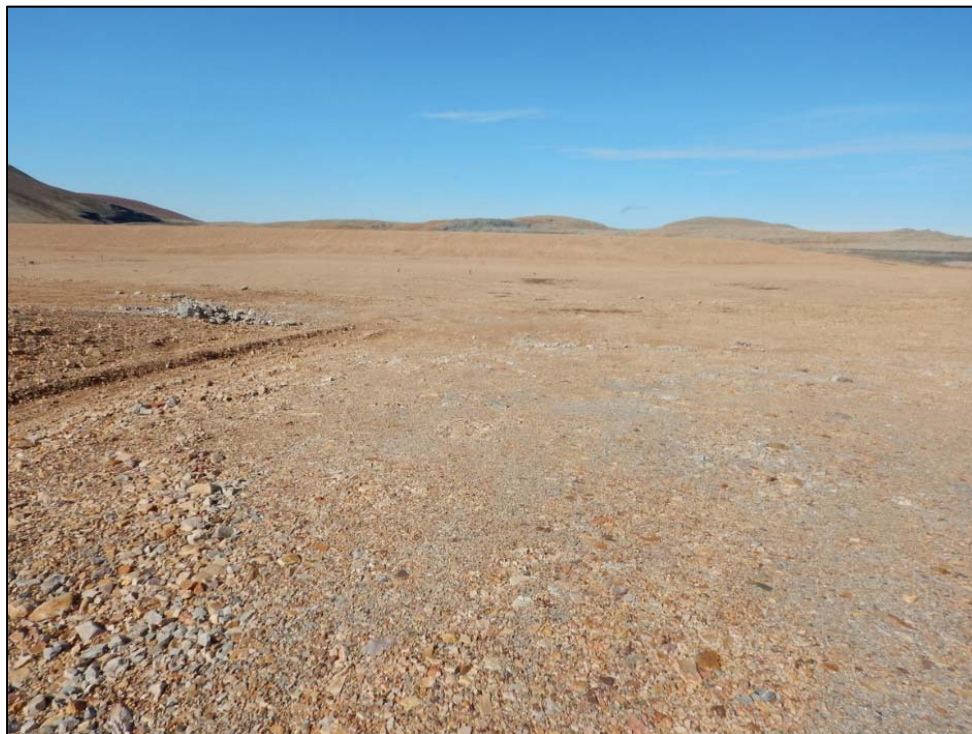
**Photo 32. Test Cell Cover System – Flat surface of cover system, looking northwest from near the breach in the Test Cell Dyke.**

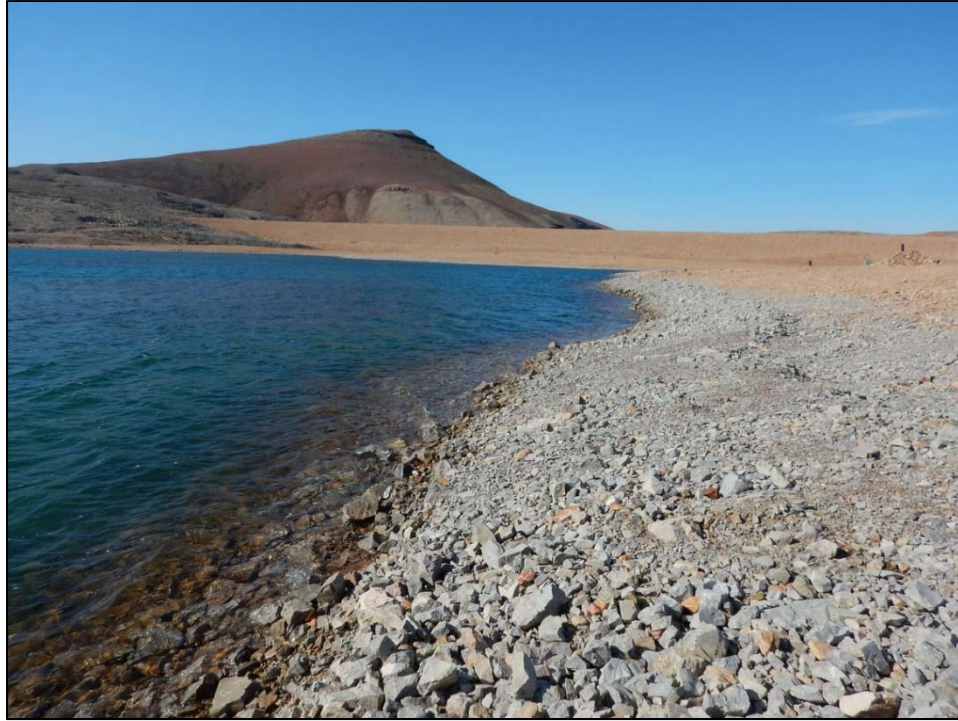
**Photo 33. Test Cell Cover System – Erosion protection along the East Arm of the Test Cell Dyke, view looking northwest.**

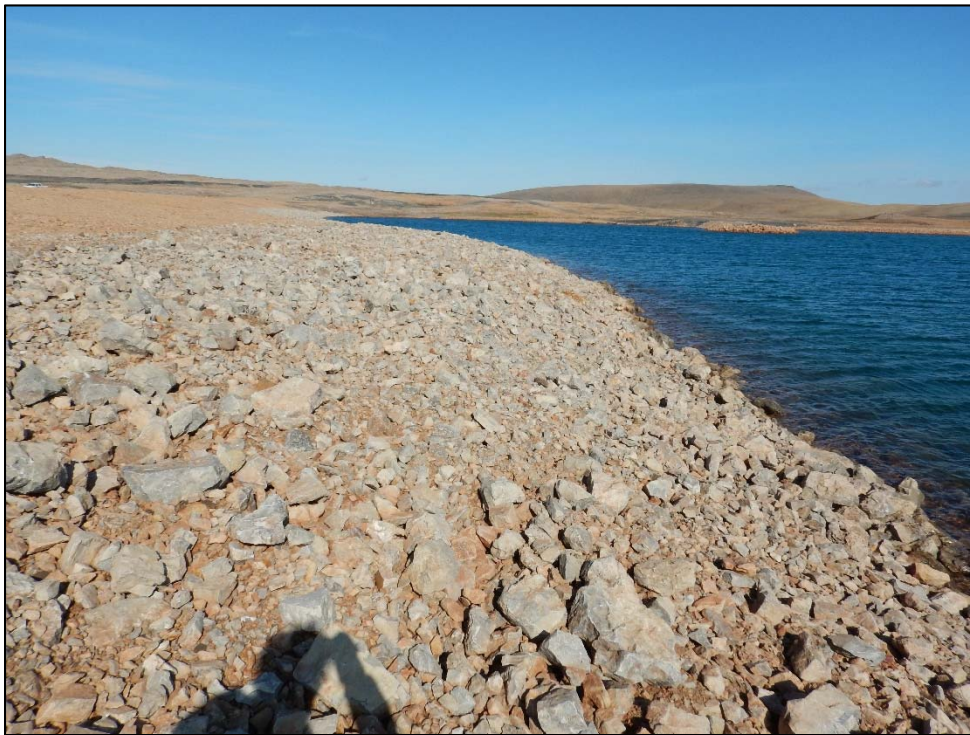
**Photo 34. Test Cell Cover System – Erosion protection along the N/S arm of the Test Cell Dyke, view looking north.**

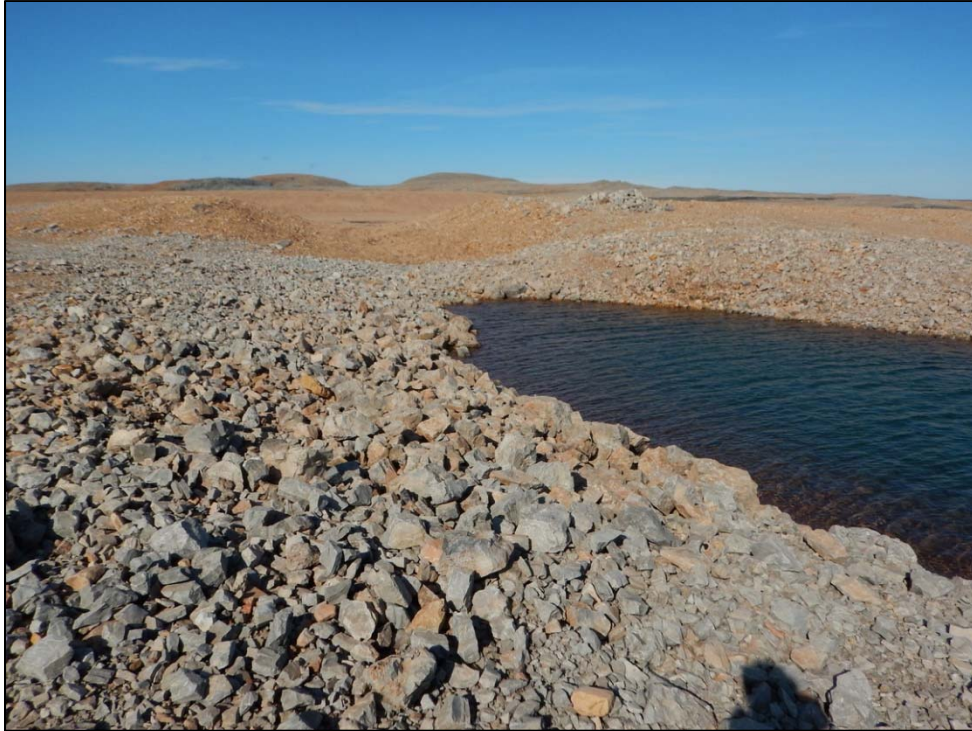
**Photo 35. Test Cell Cover System – Outlet of breach in Test Cell Dyke.**

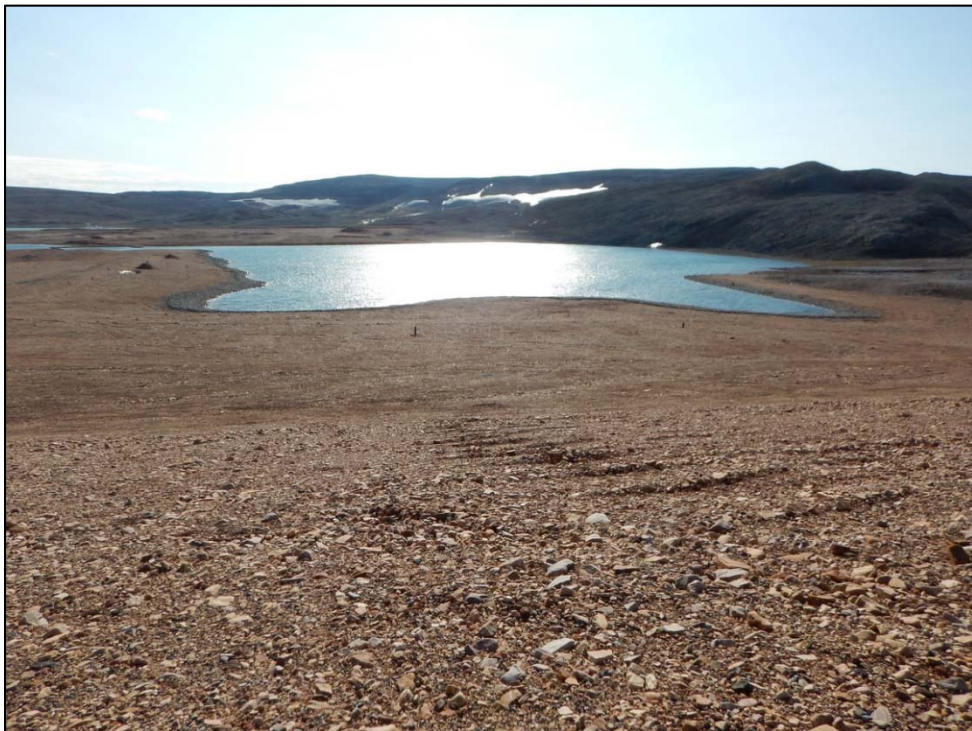
**Photo 36. Toe of West Twin Dyke Tailings Cover – As seen from the West Twin Dyke.**

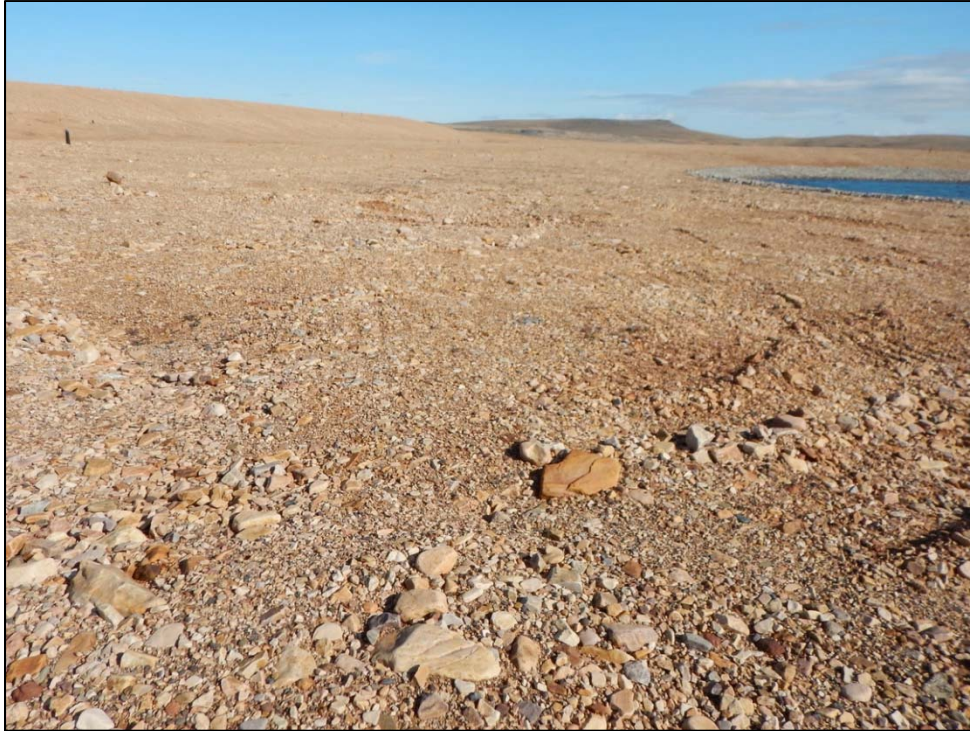
**Photo 37. Toe of West Twin Dyke Tailings Cover – View looking northeast.**

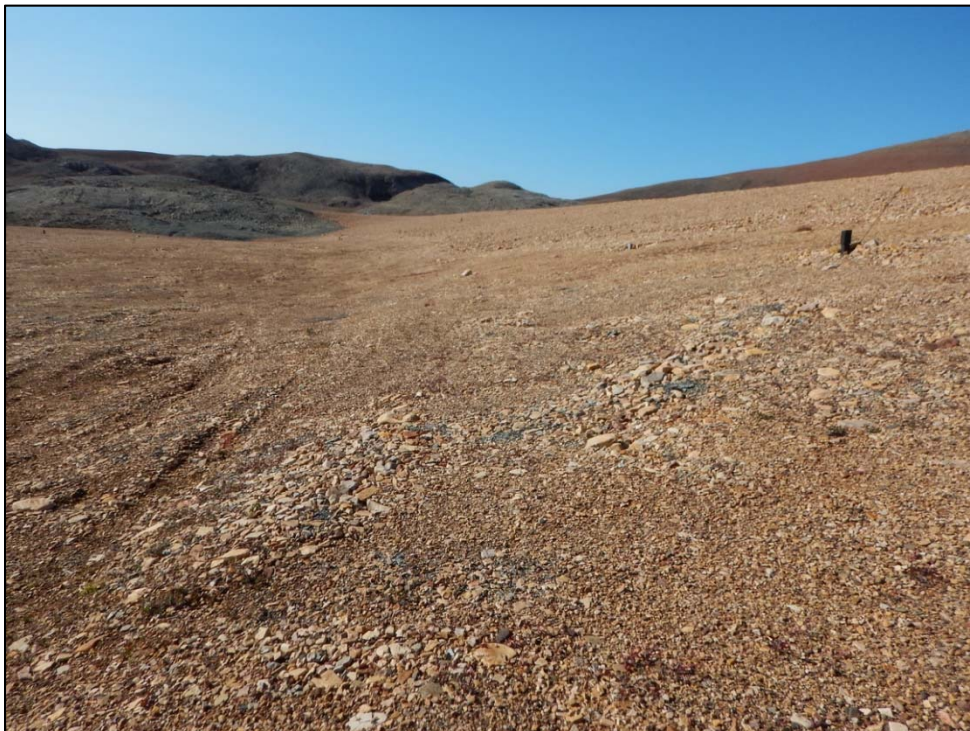
**Photo 38. Toe of West Twin Dyke Tailings Cover – At the toe of the West Twin Dyke looking toward the right abutment.**
