**NYRSTAR**

**NANISIVIK MINE, NUNAVUT**

**2019 ANNUAL GEOTECHNICAL INSPECTION**

PROJECT NO.: 0255030

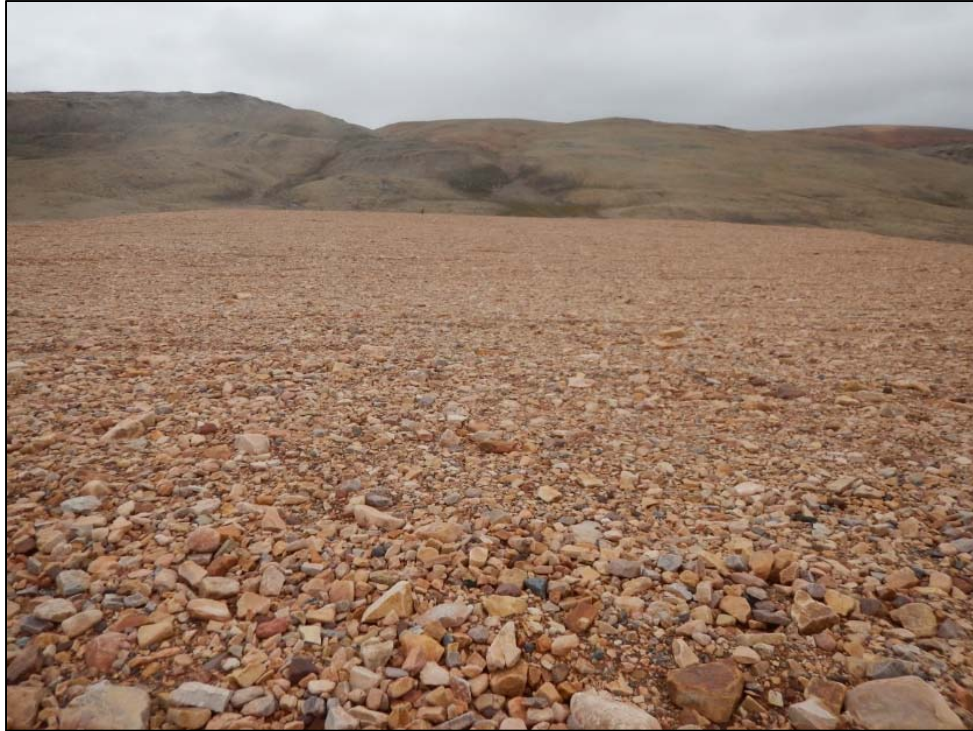
**Photo 39. Landfill – Flat surface of cover system.**

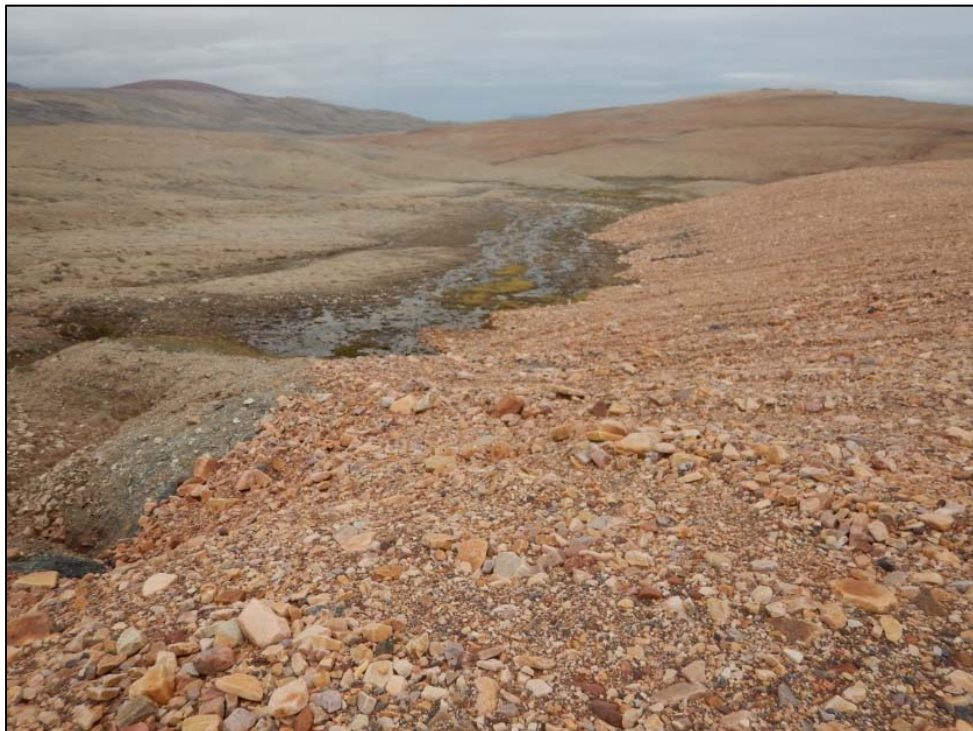
**Photo 40. Landfill – Diverted water flowing around north side of cover system.**

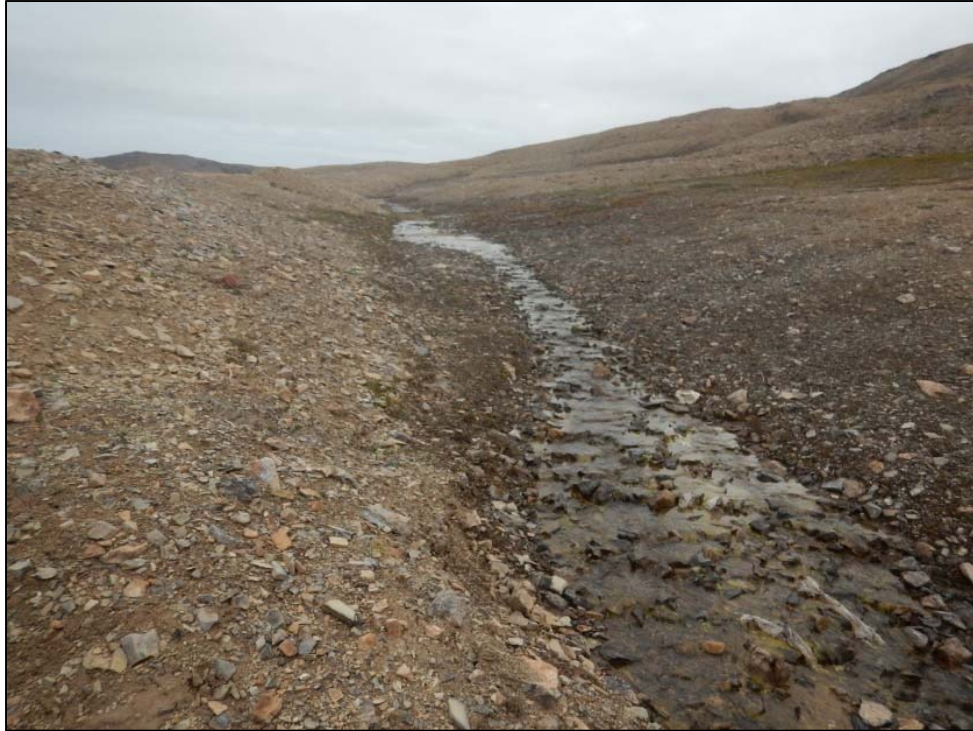
**Photo 41. Landfill – Diversion berm upstream of the landfill.**

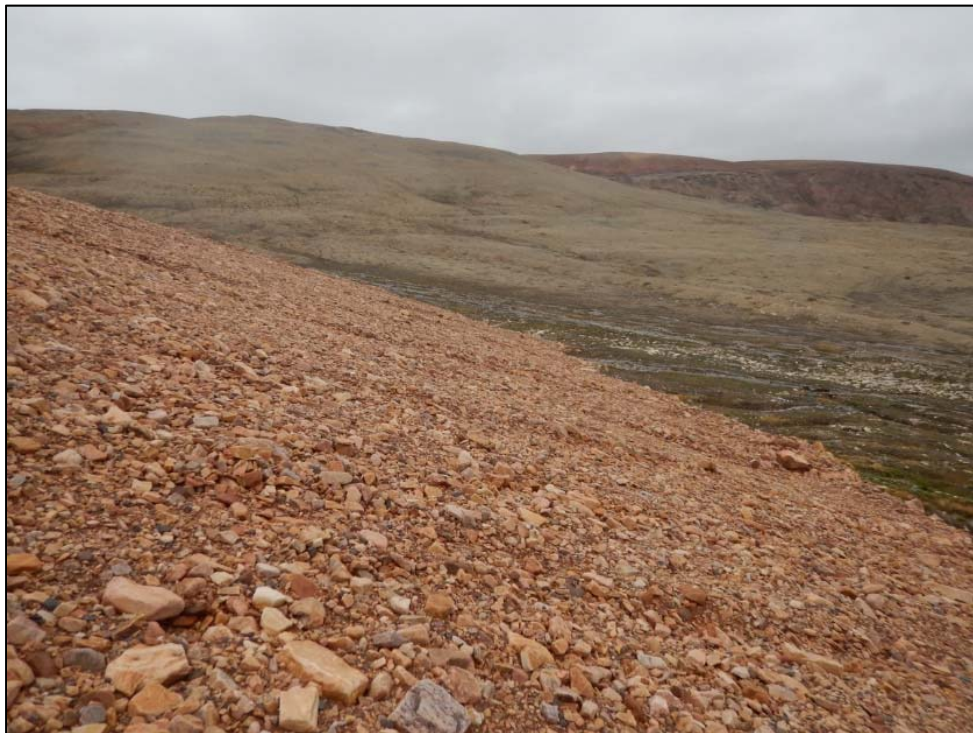
**Photo 42. Landfill – Sloping face of cover system.**

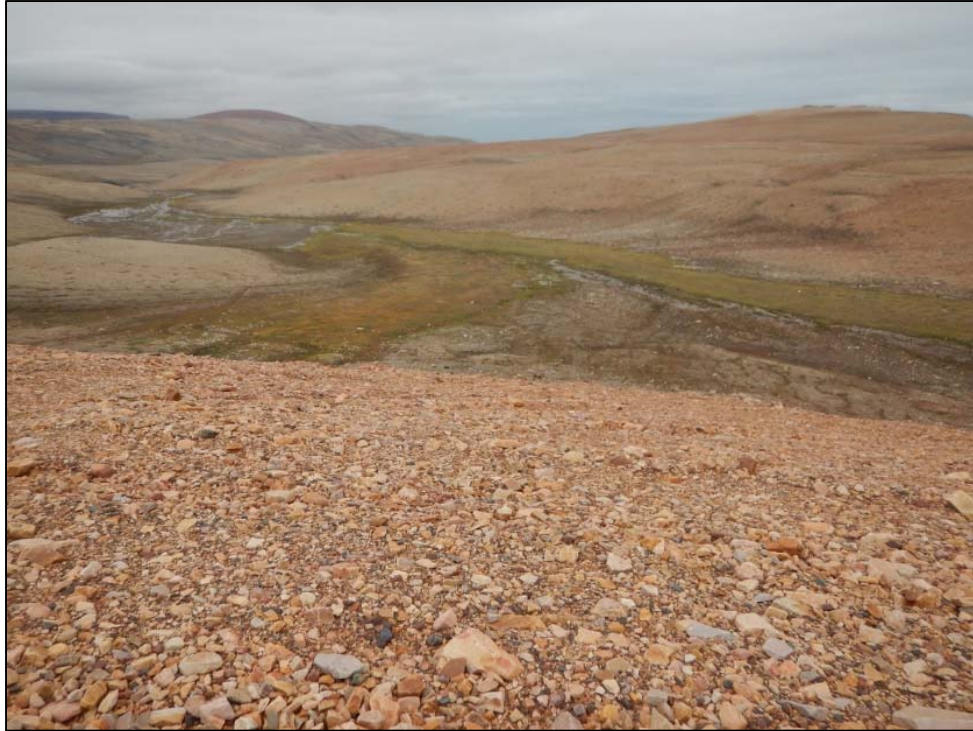
**Photo 43. Landfill – Toe area of the cover system.**

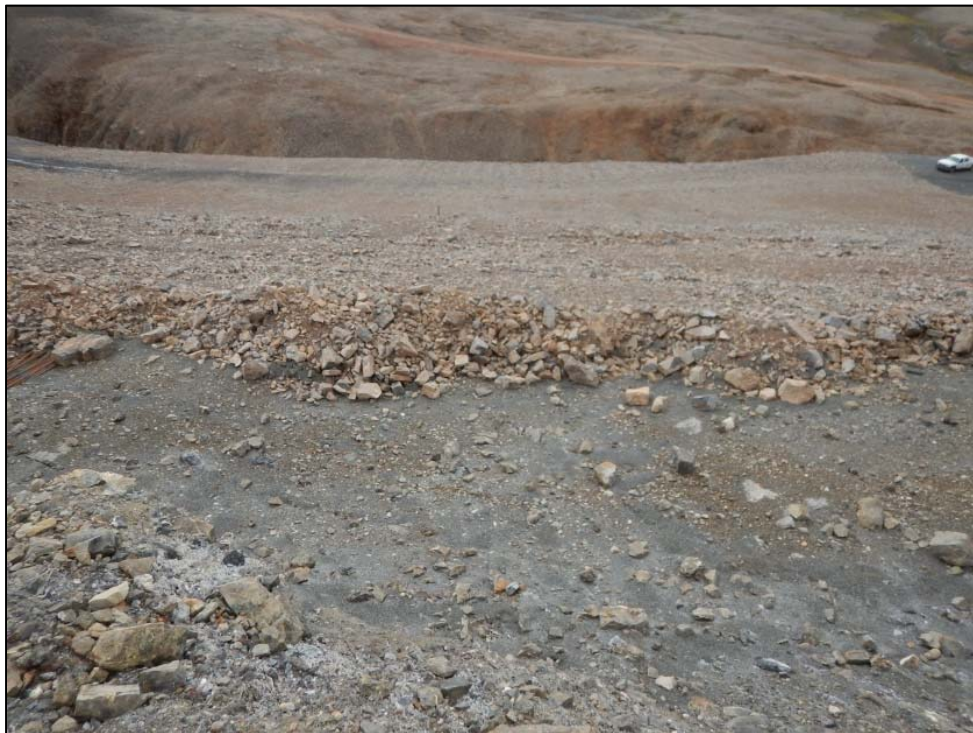
**Photo 44. West Open Pit – Looking downslope from remnant highwall at cover system.**

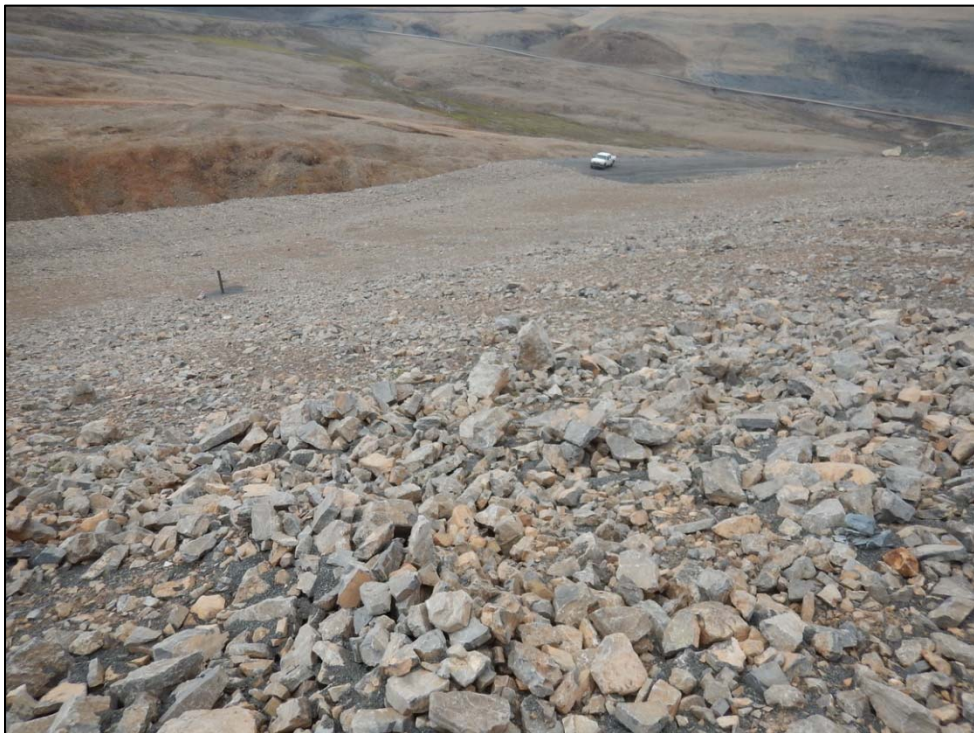
**Photo 46. West Open Pit – Sloping face of cover system.**

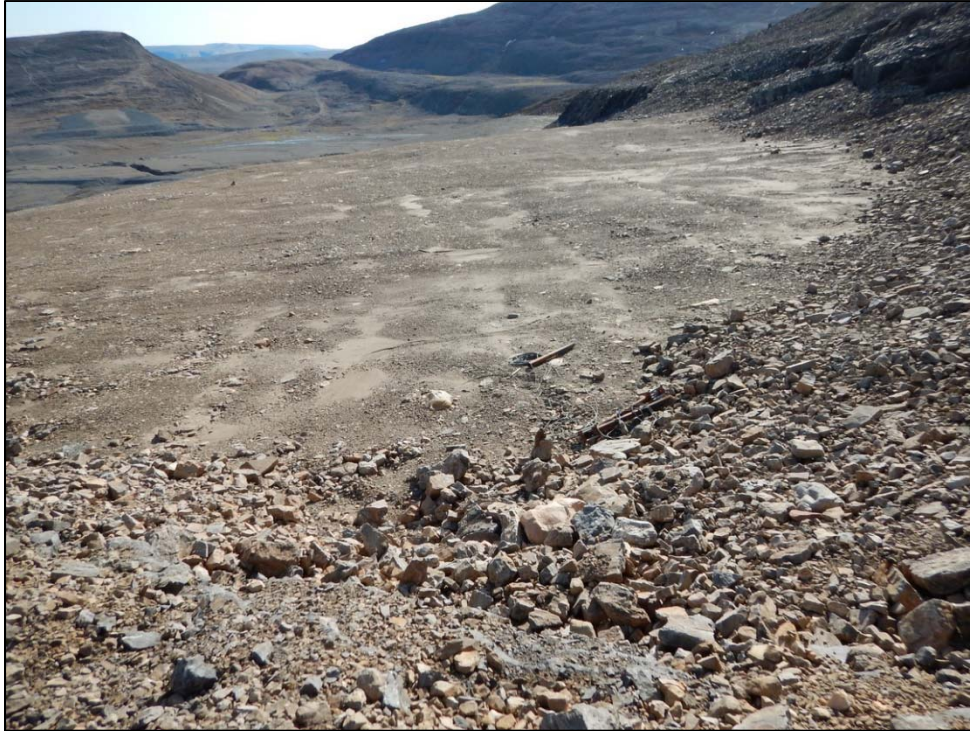
**Photo 48. East Open Pit – Cracking in crown pillar.**

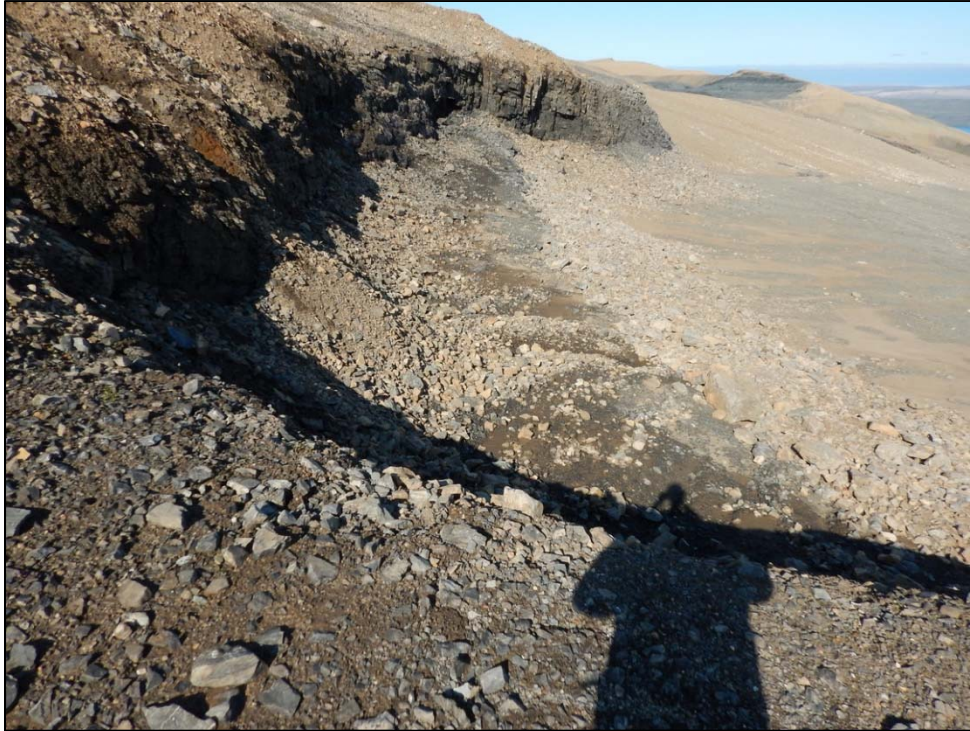
**Photo 49. East Open Pit – Remnant highwall.**

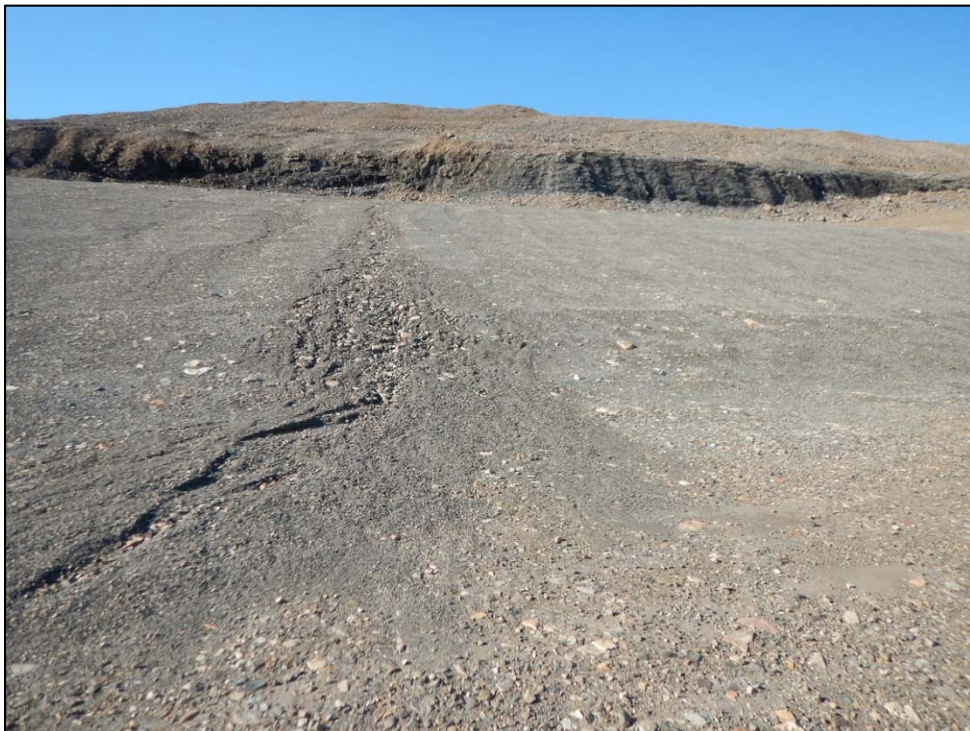
**Photo 50. East Open Pit – Looking upslope at rilling on cover system. Note self-armouring.**

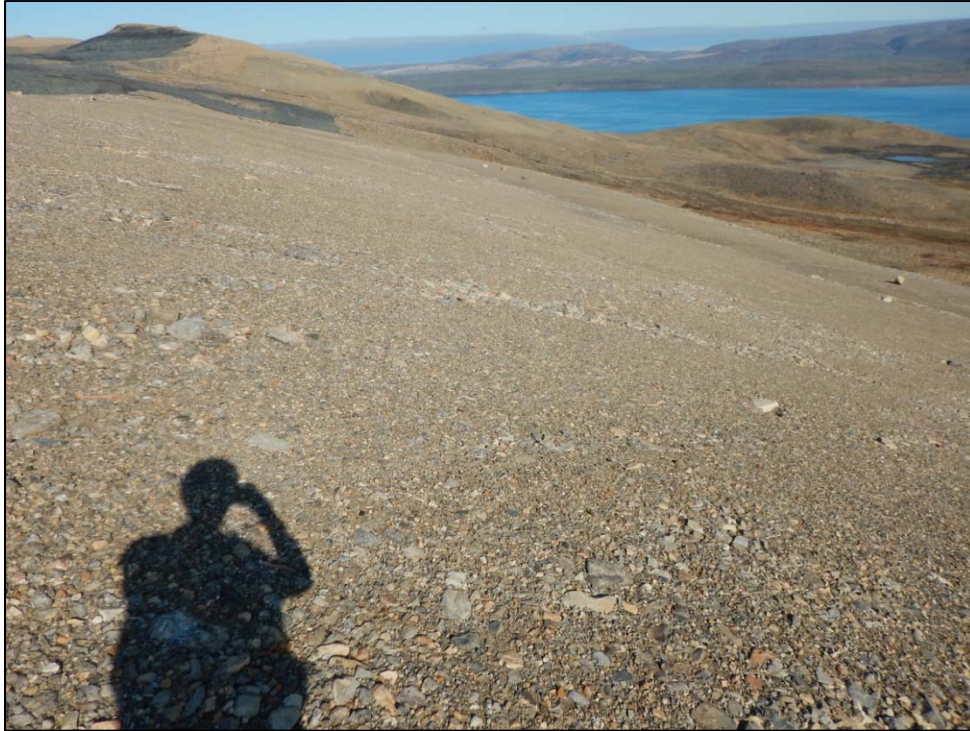
**Photo 51. East Open Pit – Sloping face of lower cover system.**

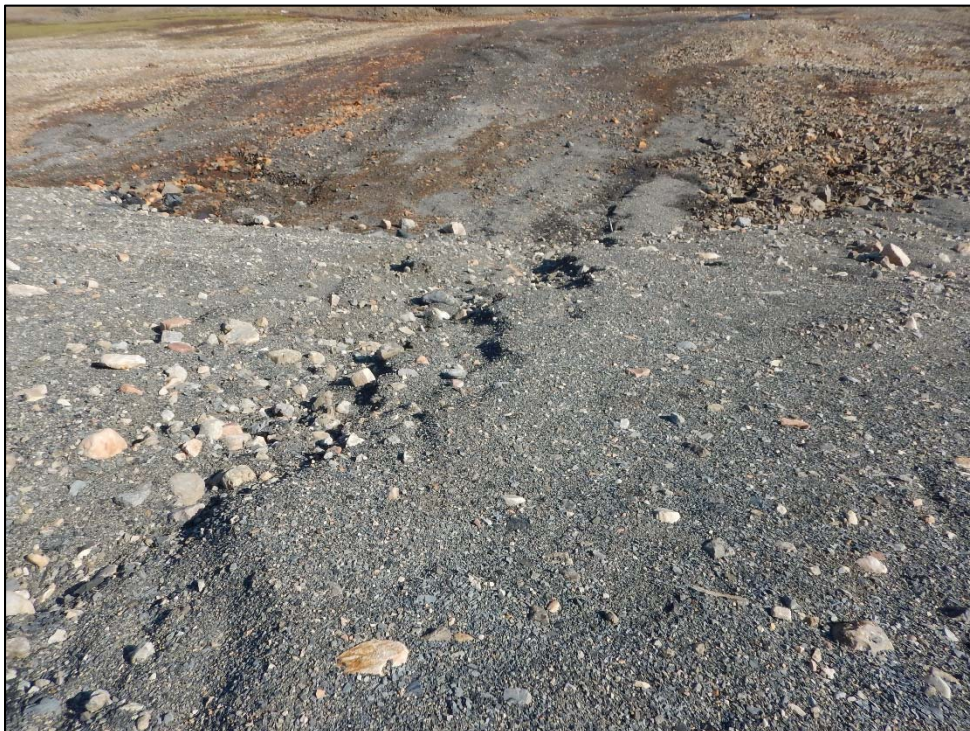
**Photo 52. East Open Pit – Toe of the cover system.**

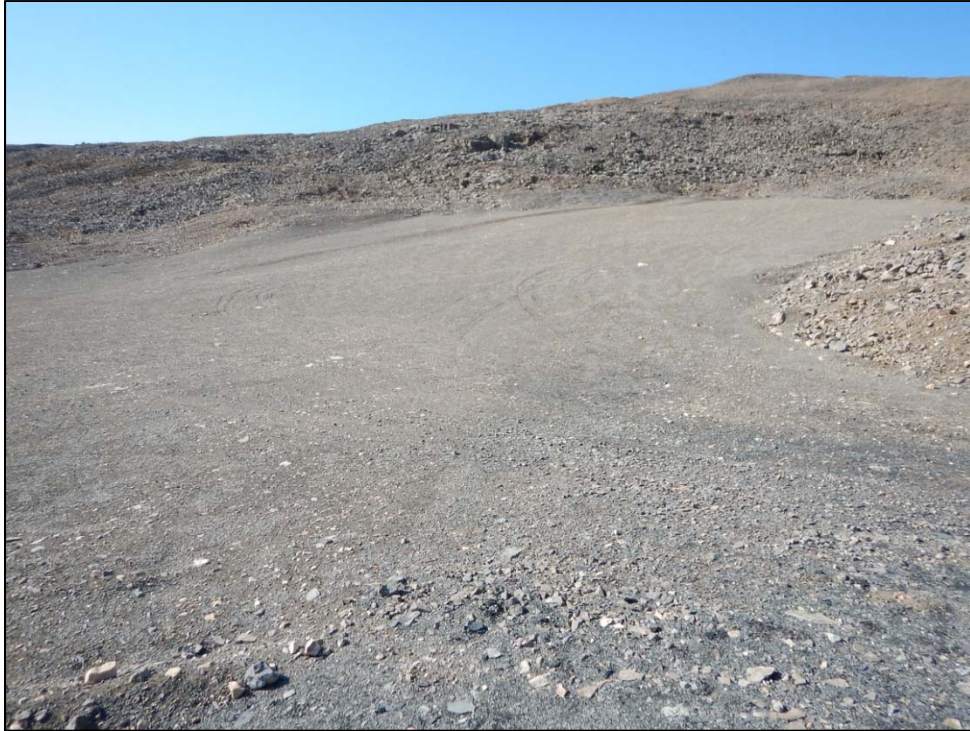
**Photo 53. East Trench – Upper portion of cover system.**

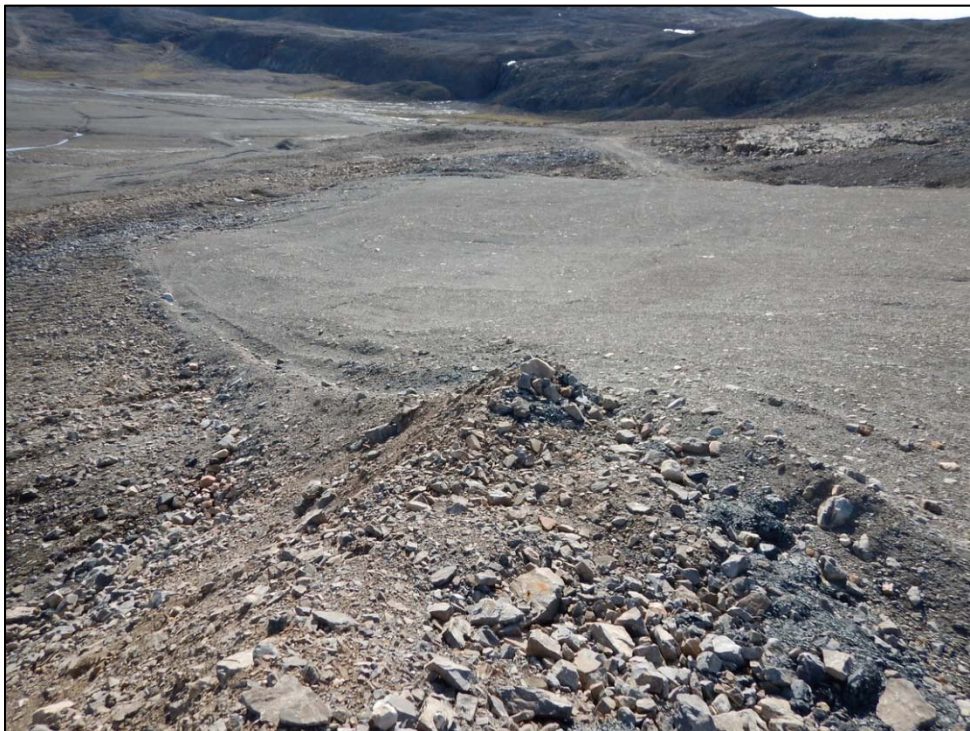
**Photo 54. East Trench – Lower portion of cover system.**

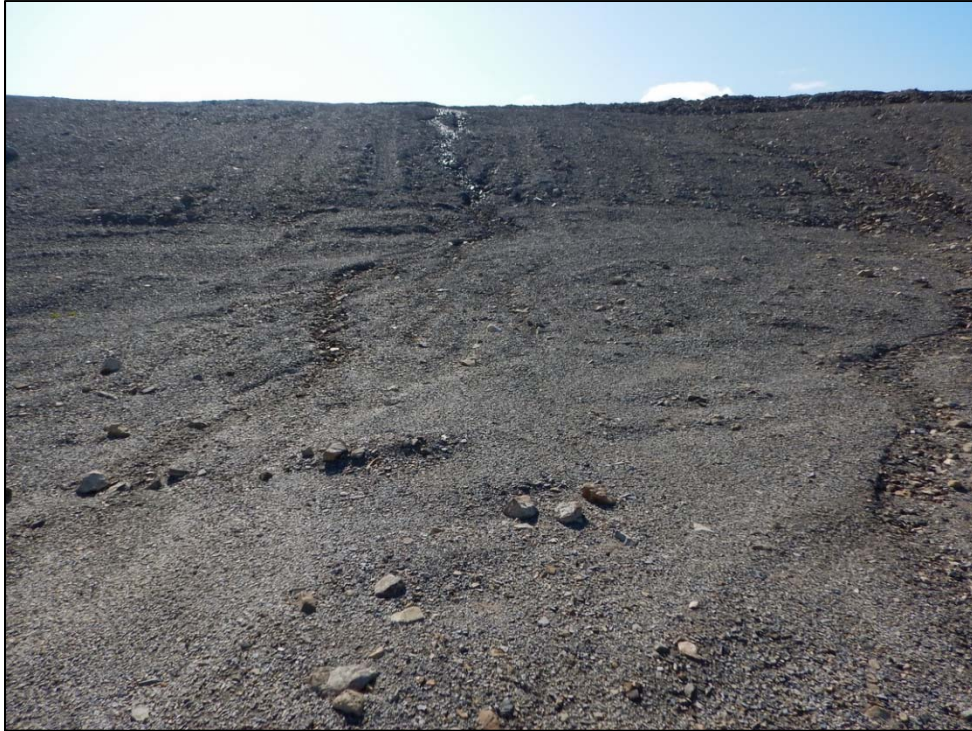
**Photo 55. Oceanview Pit – Rilling on the south end of the cover system.**

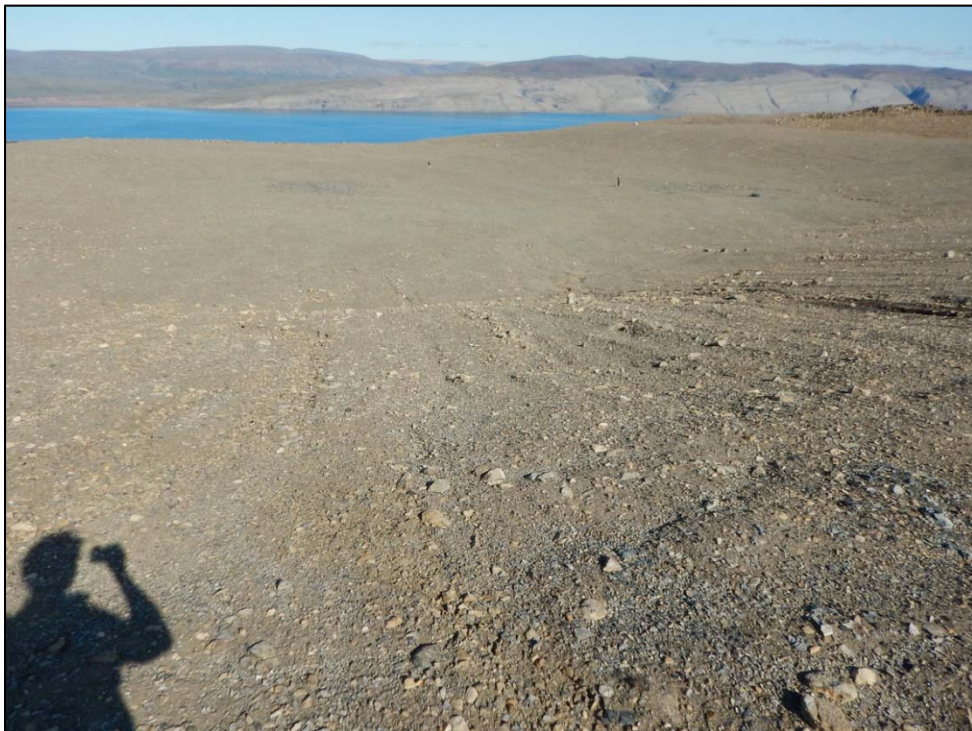
**Photo 56. Oceanview Pit – As seen from south side of cover.**

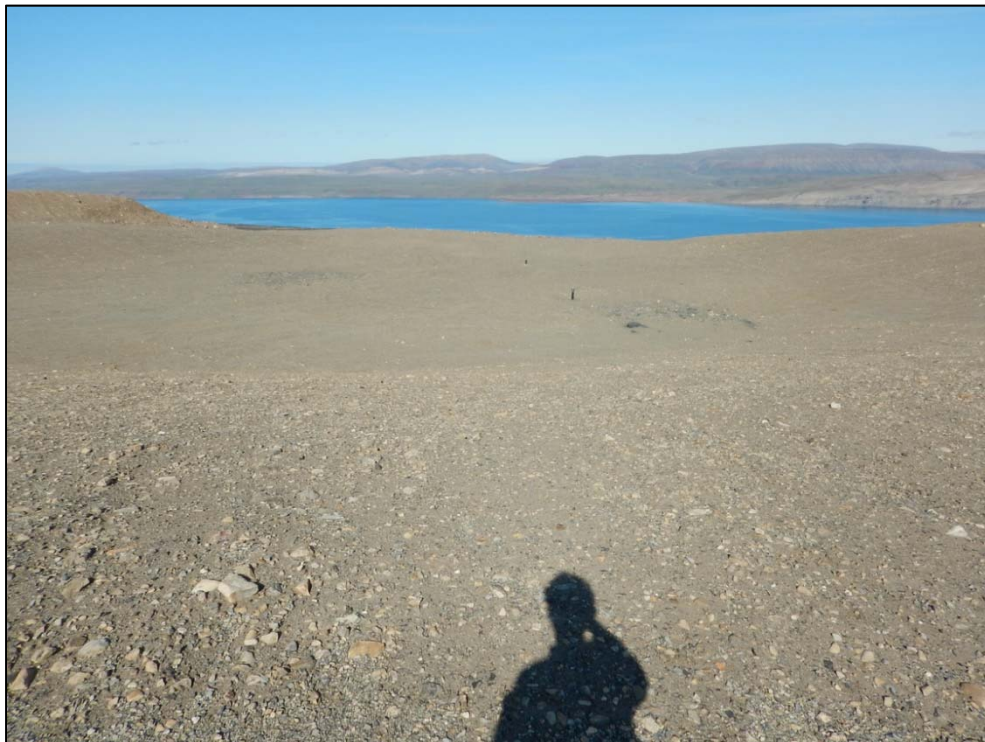
**Photo 58. Oceanview Pit – Cover system as seen from SE corner of cover.**

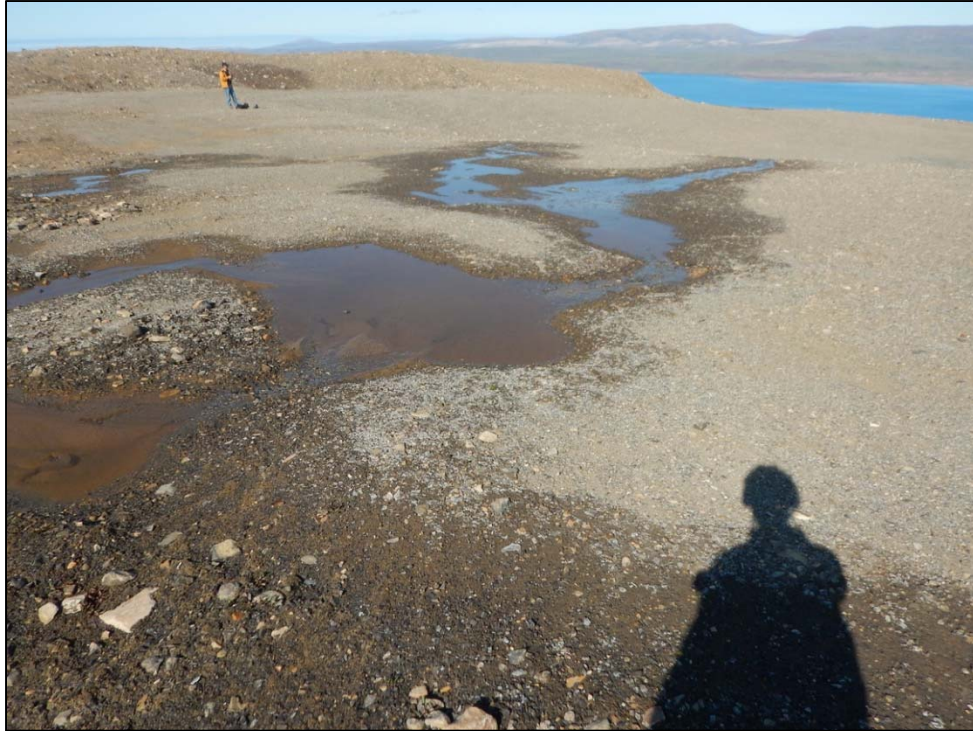
**Photo 59. Oceanview Pit – Seepage flowing into the cover system from upstream.**

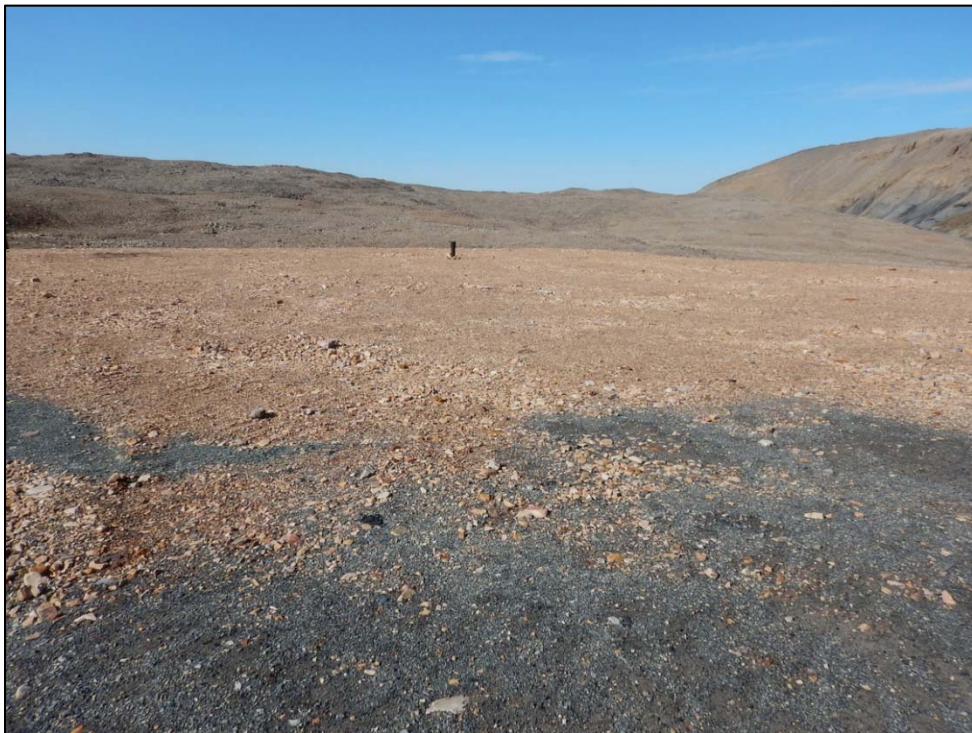
**Photo 60. Upper Dump Pond – Flat surface of thermal cover system.**

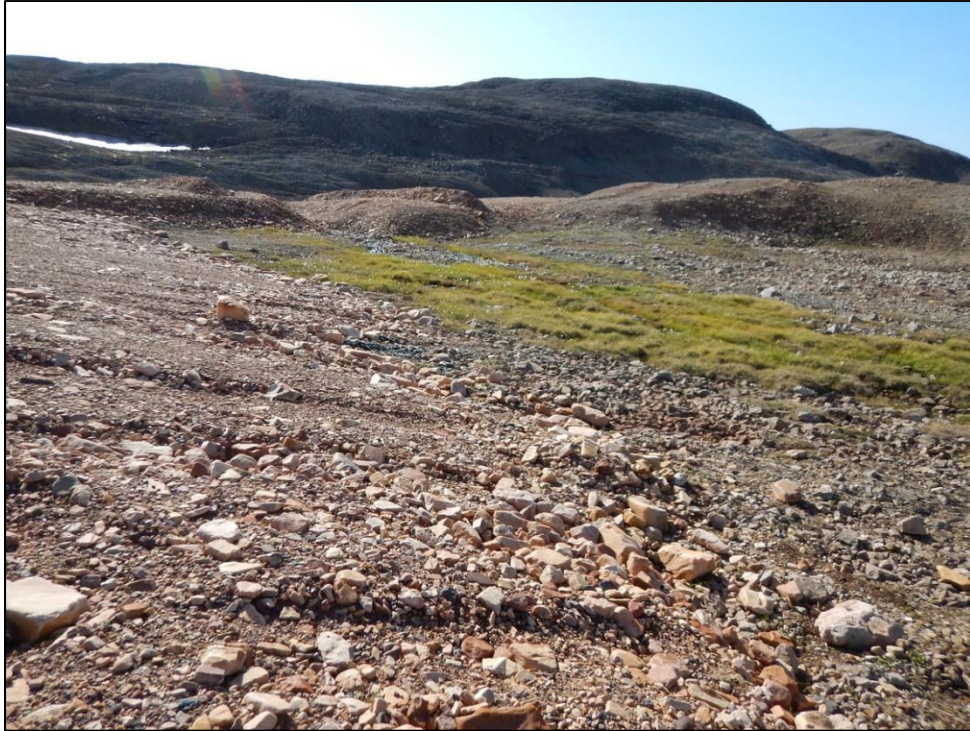
**Photo 61. Upper Dump Pond – Looking upstream at road breach to Townsite.**

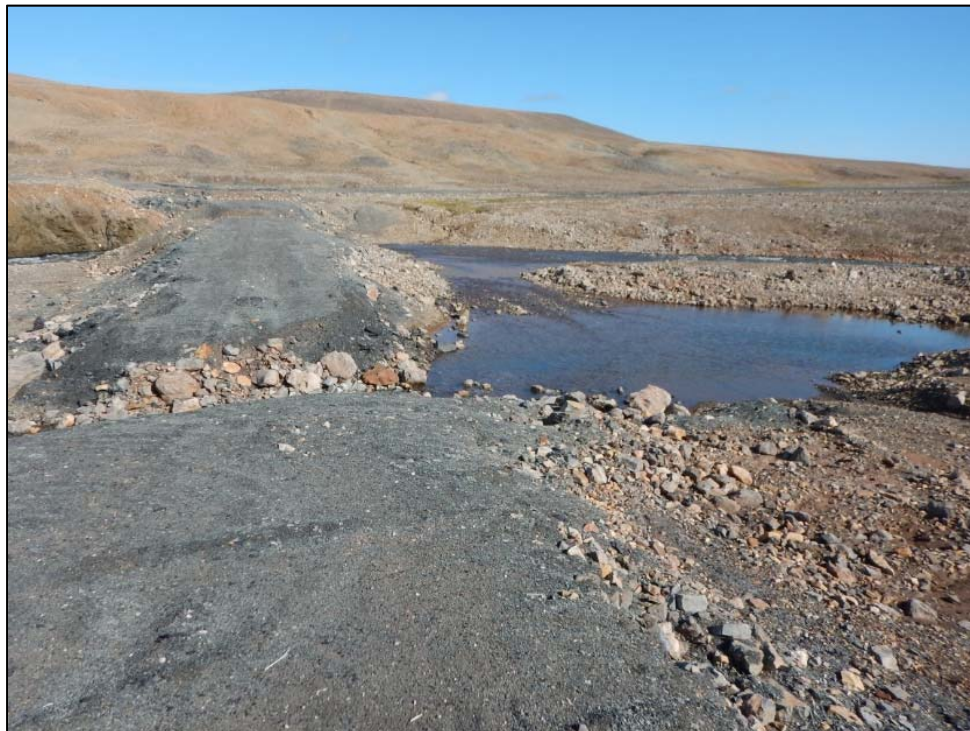
**Photo 62. Upper Dump Pond – Breach in road to mill site.**

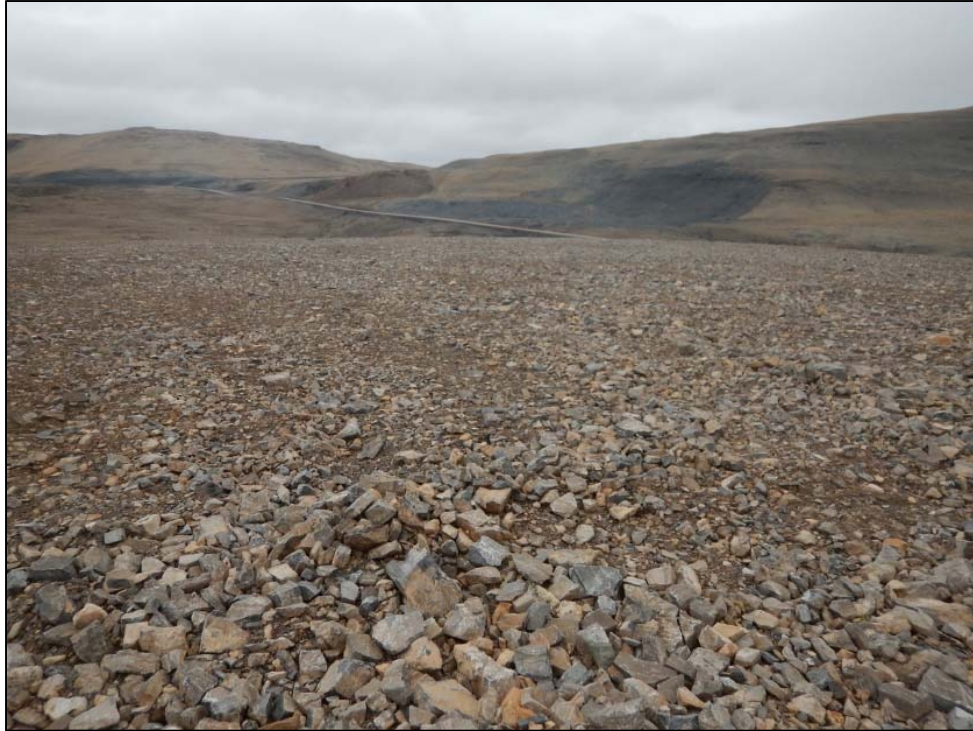
**Photo 63. Industrial Complex – Flat surface of cover system.**

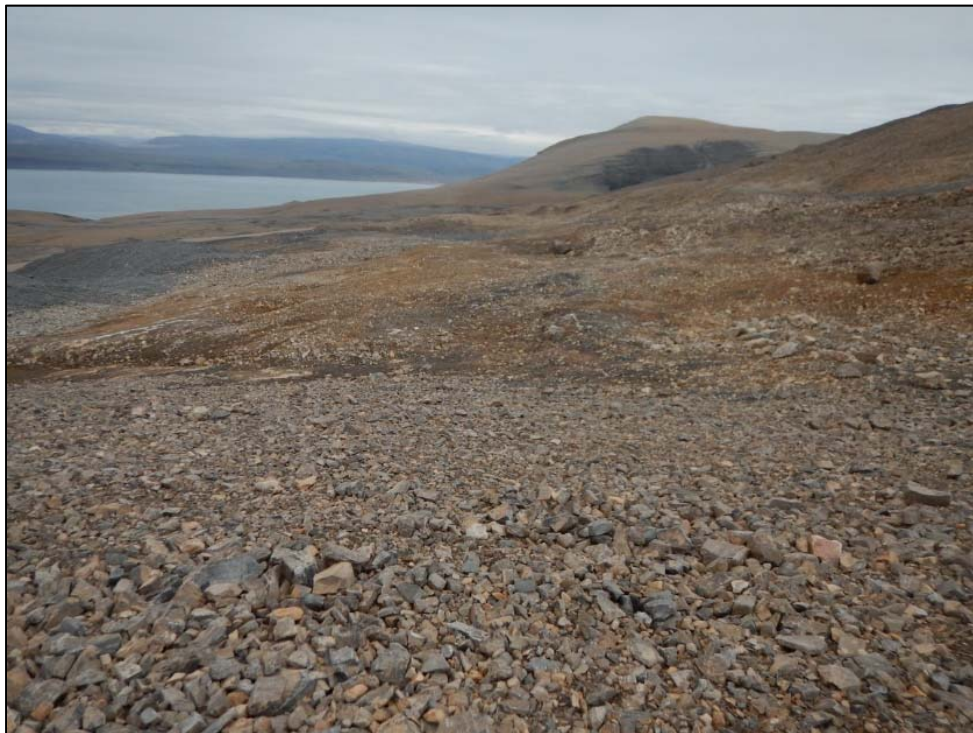
**Photo 64. Industrial Complex – Area of former Day Tank Farm.**

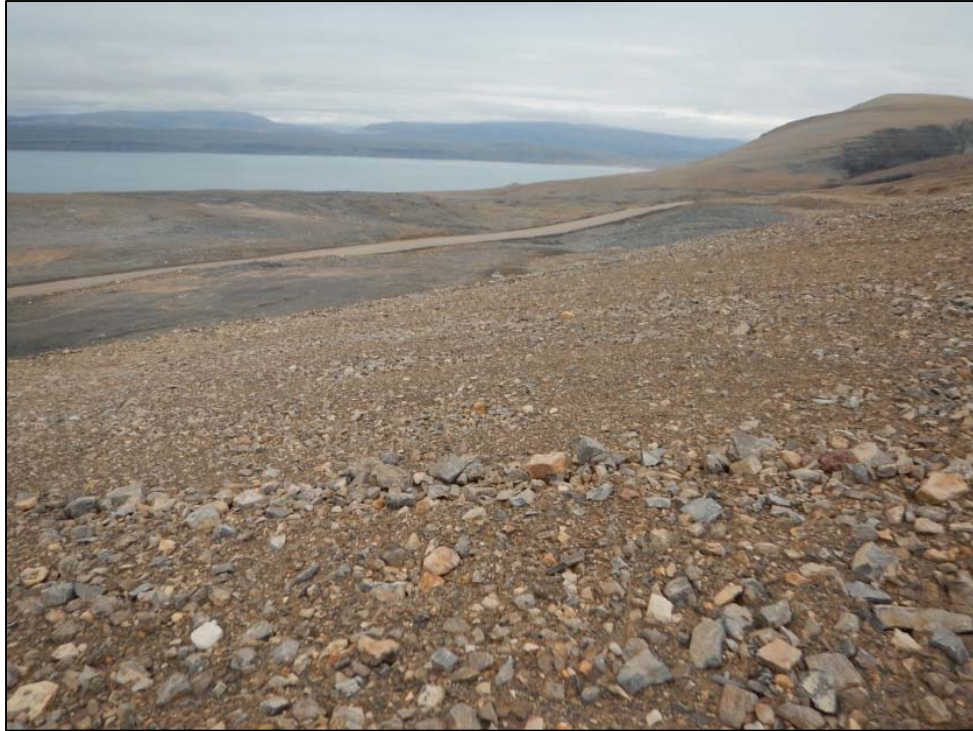
**Photo 65. Industrial Complex – Sloping face of cover system.**

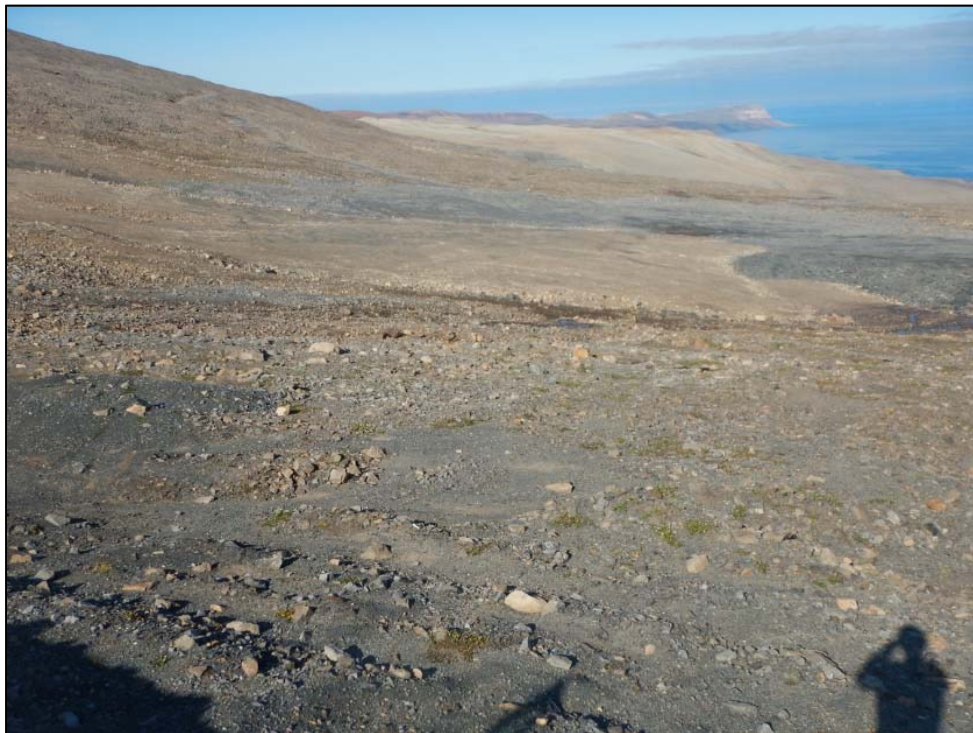
**Photo 66. 17N Portal – As seen from road.**

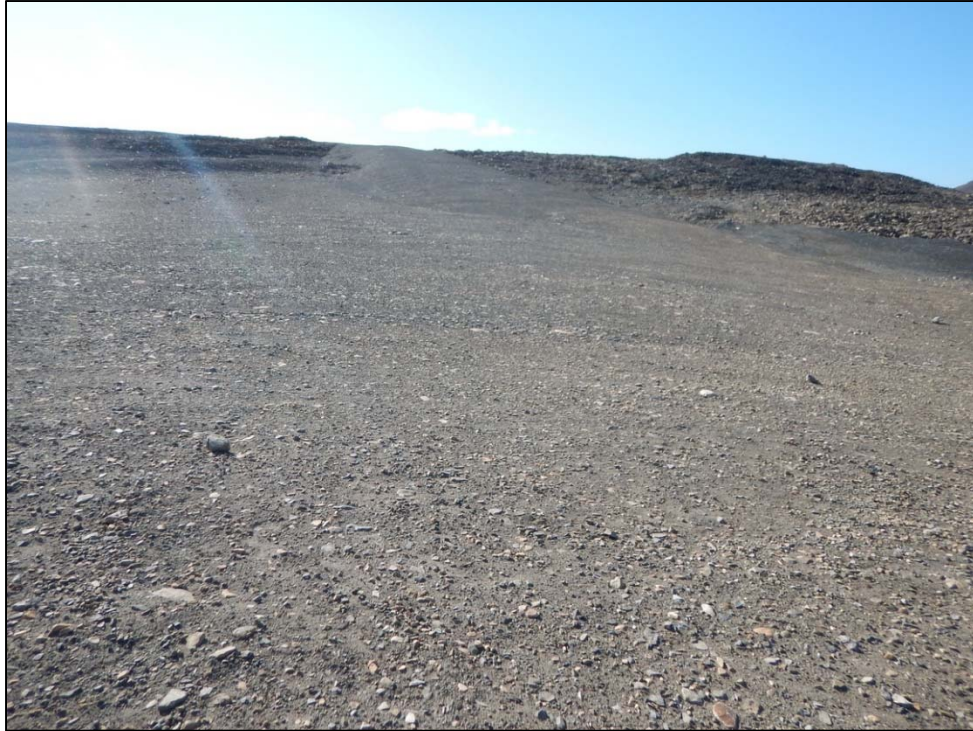
**Photo 67. Oceanview Portal Cover – Looking upslope at cover system.**

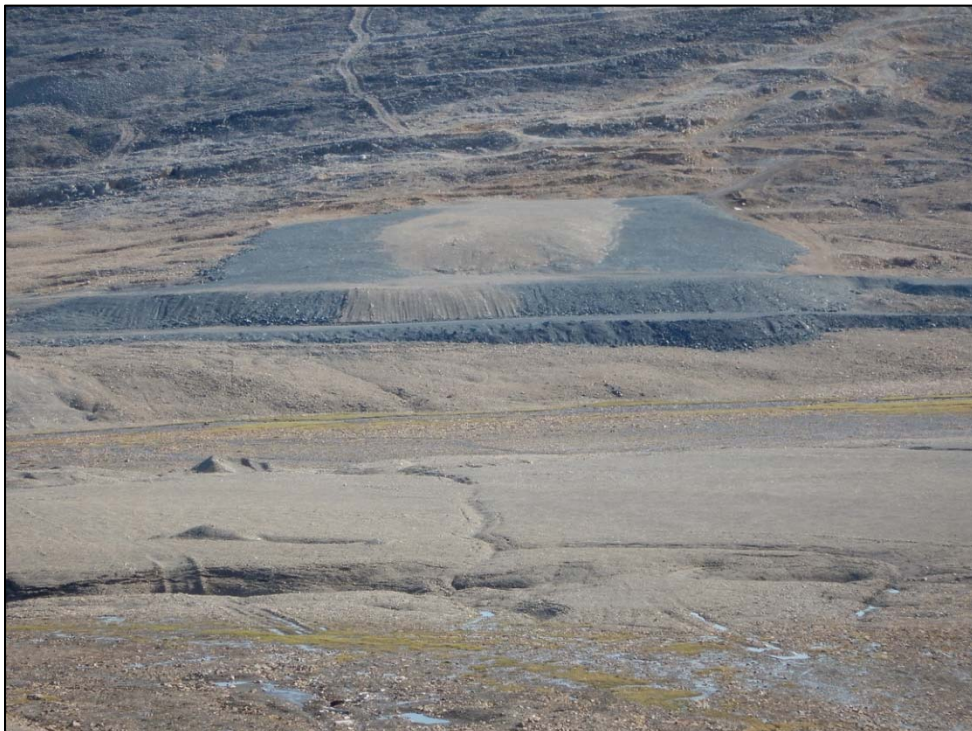
**Photo 68. K-Baseline – As seen from East Trench.**

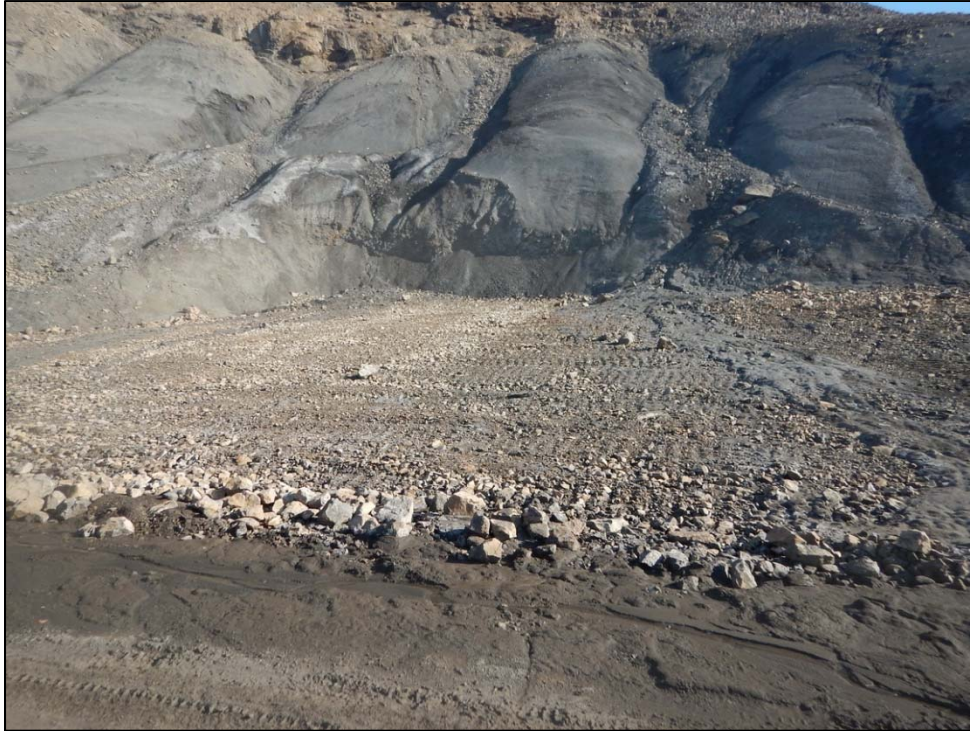
**Photo 69. 09S Portal – Looking upslope at plug.**

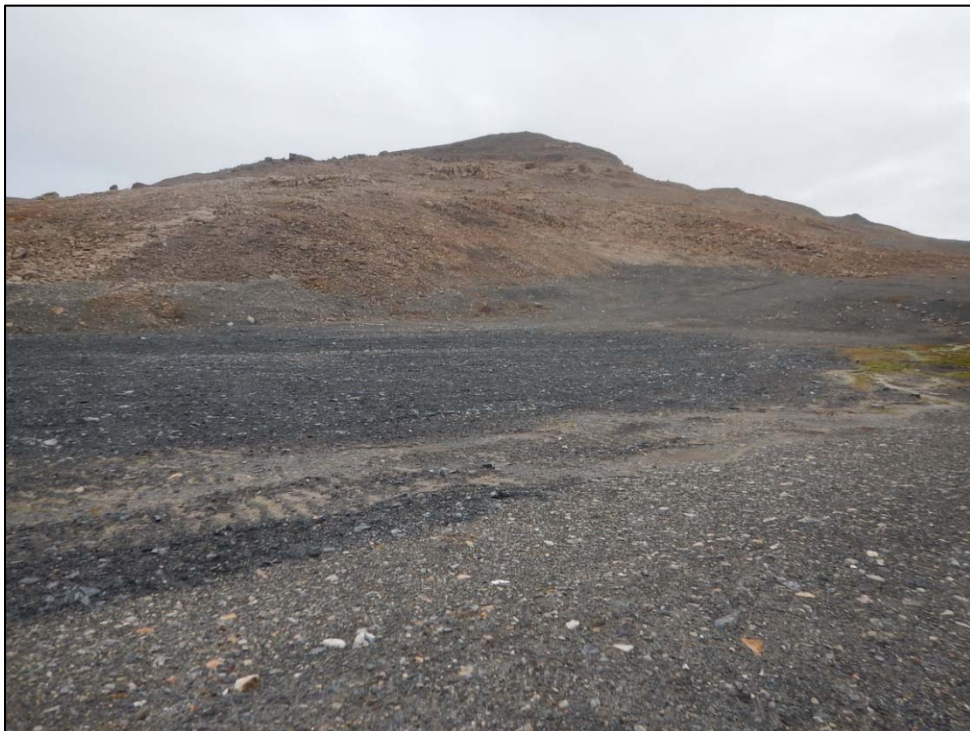
**Photo 70. Lower Adit – Sloping face of cover system.**

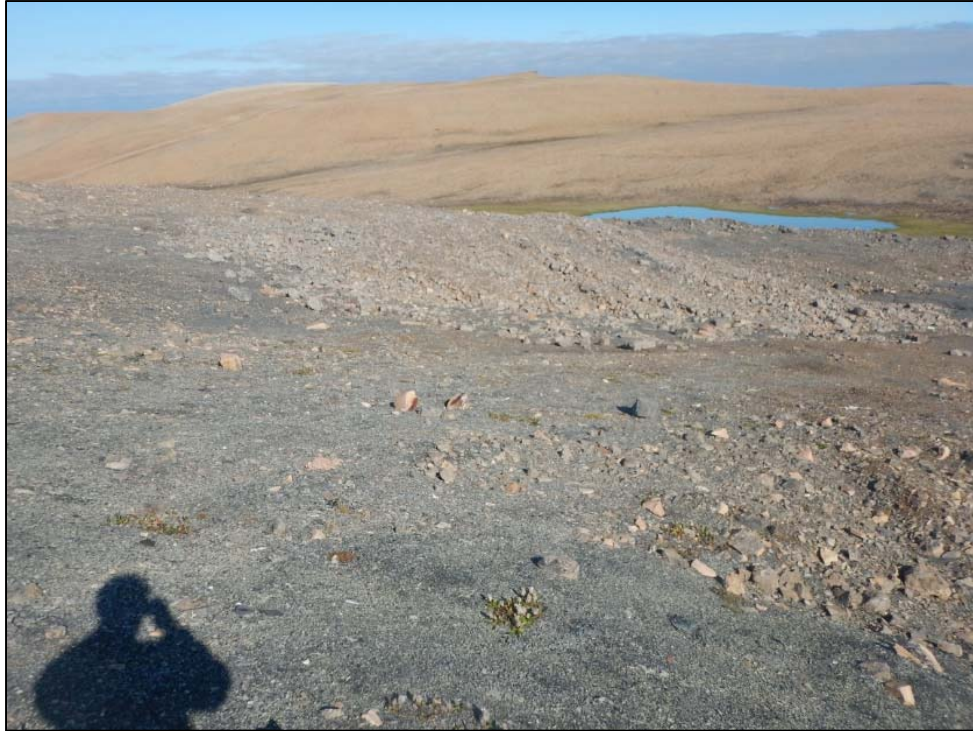
A photo from the inspection is provided in Appendix I (Photo 71). During the inspection, the armour surface appeared to be stable with no visual indications of erosion or surface deformation. As such, no maintenance is recommended.

**Photo 71. Shale Hill Vent Raise – As seen from road.**

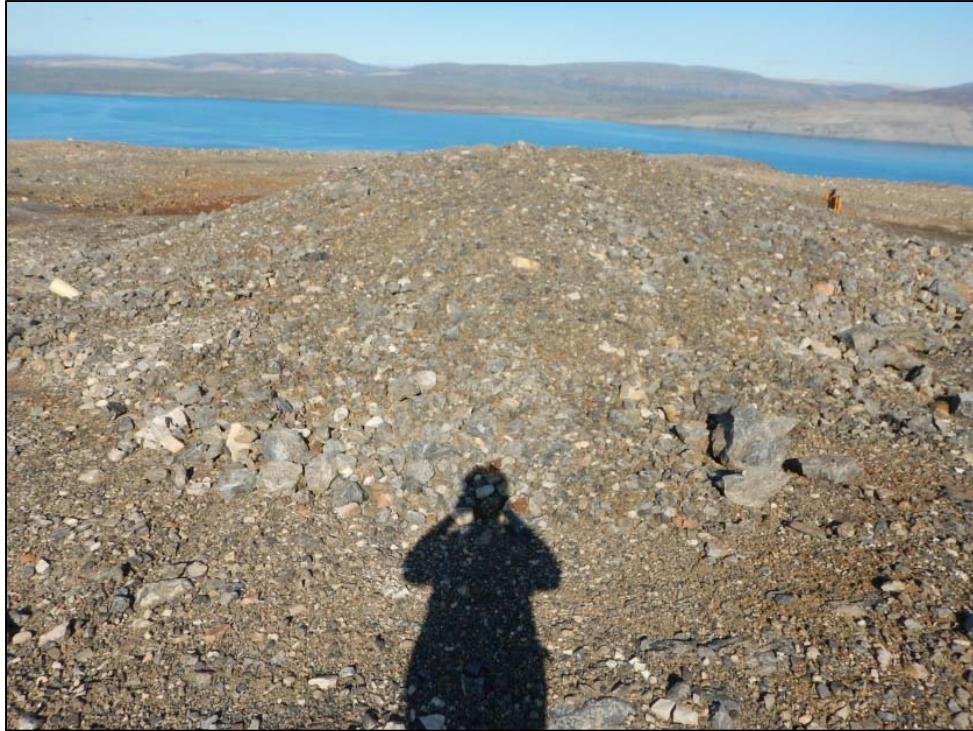
A photo from the inspection is provided in Appendix I (Photo 73). During the inspection, the armour surface appeared to be stable with no visual indications of erosion or surface deformation. As such, no maintenance is recommended.

**Photo 73. Oceanview West Raise – Plug and mound.**
