**NYRSTAR**

**NANISIVIK MINE, NUNAVUT**

**2019 ANNUAL GEOTECHNICAL INSPECTION**

PROJECT NO.: 0255030

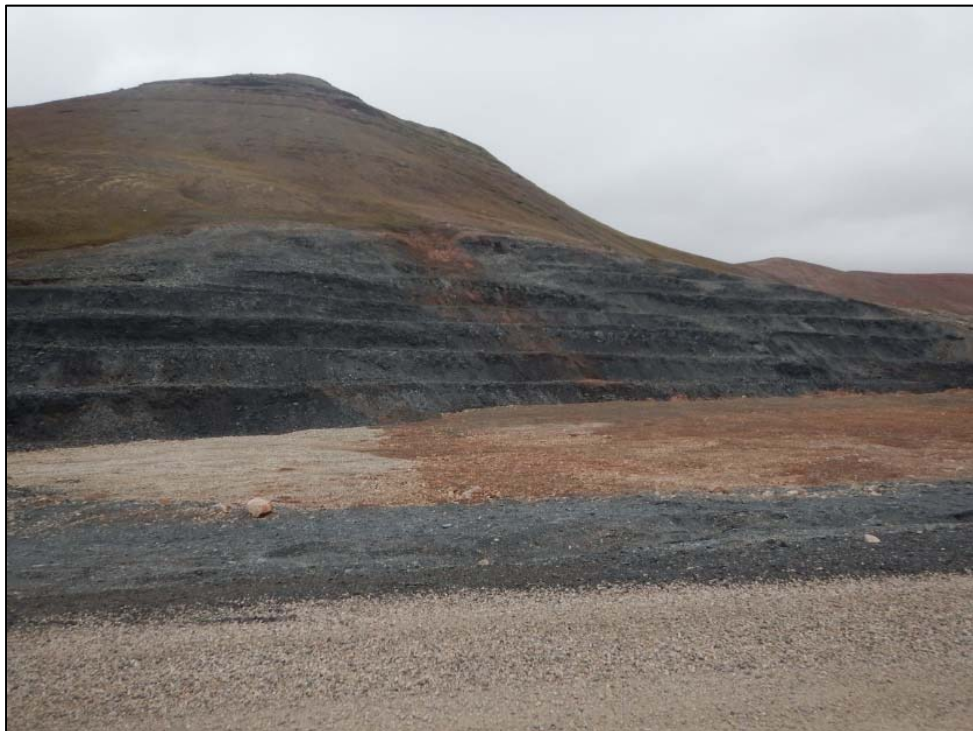
**Photo 74. Mt. Fuji Shale Quarry – As seen from road.**

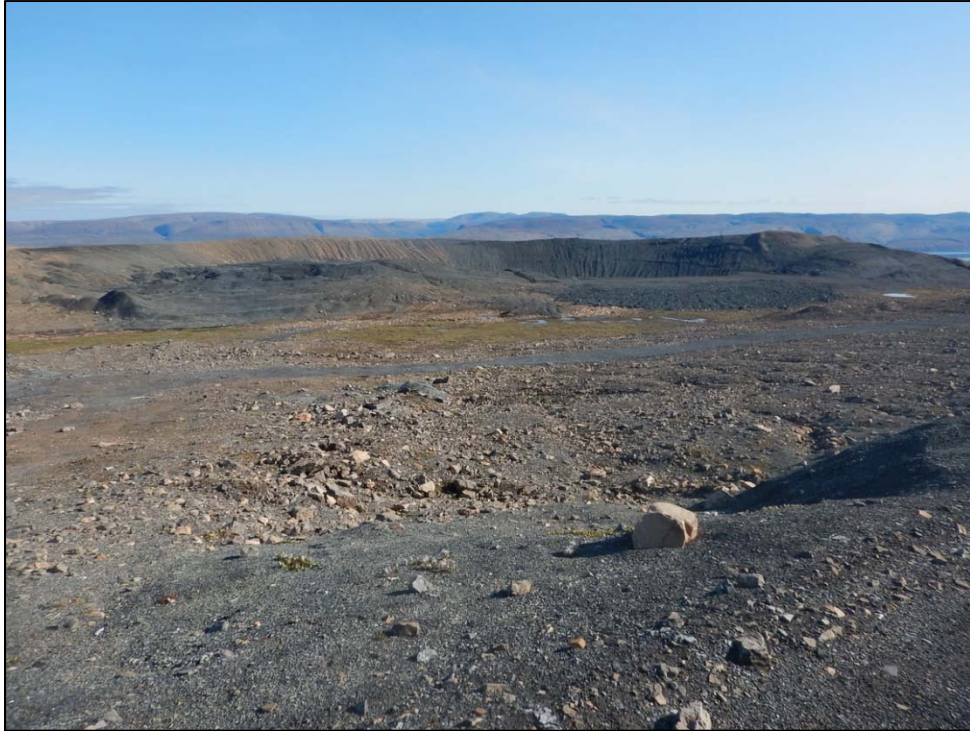
**Photo 75. Shale Hill Borrow Area – As seen from road.**

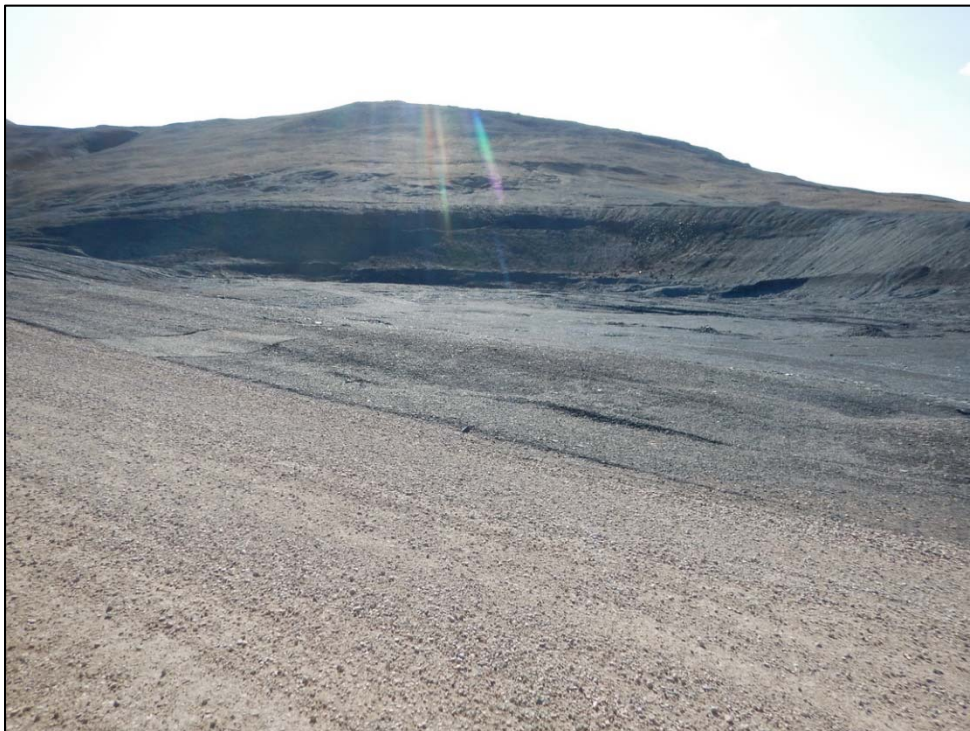
**Photo 76. Townsite Shale Borrow – As seen from road.**

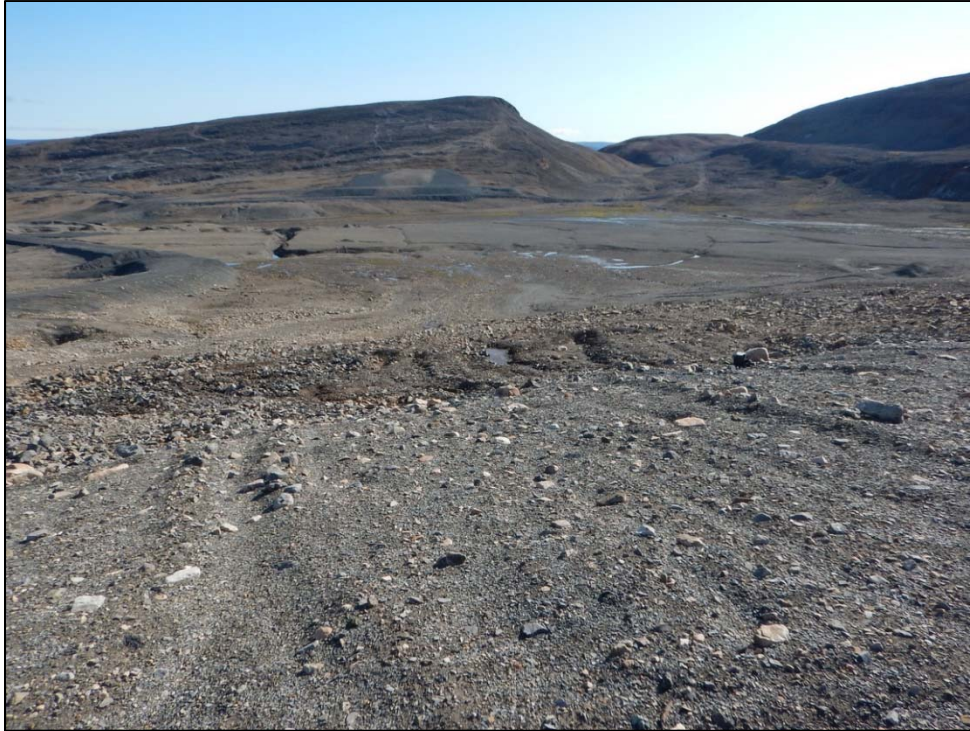
**Photo 77. Chris Creek A Gravel Borrow – As seen from East Trench.**

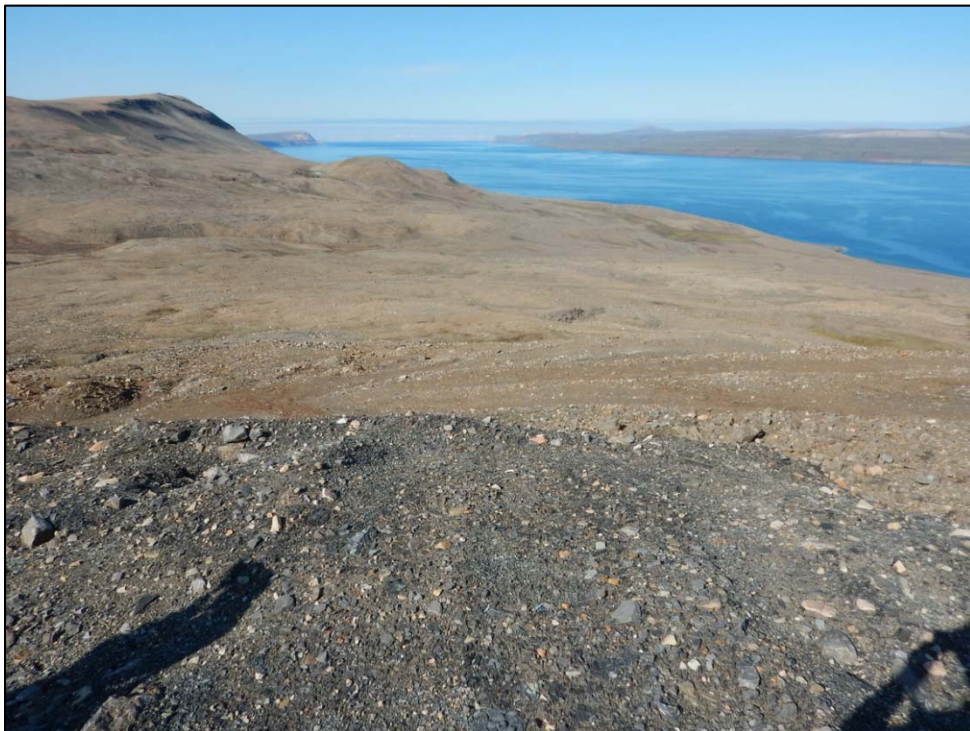
**Photo 78. Chris Creek B Gravel Borrow – As seen from road.**
