CANZINCO MINES LTD.

NANISIVIK MINE, NUNAVUT

2021 ANNUAL GEOTECHNICAL INSPECTION

PROJECT NO.: 0255033

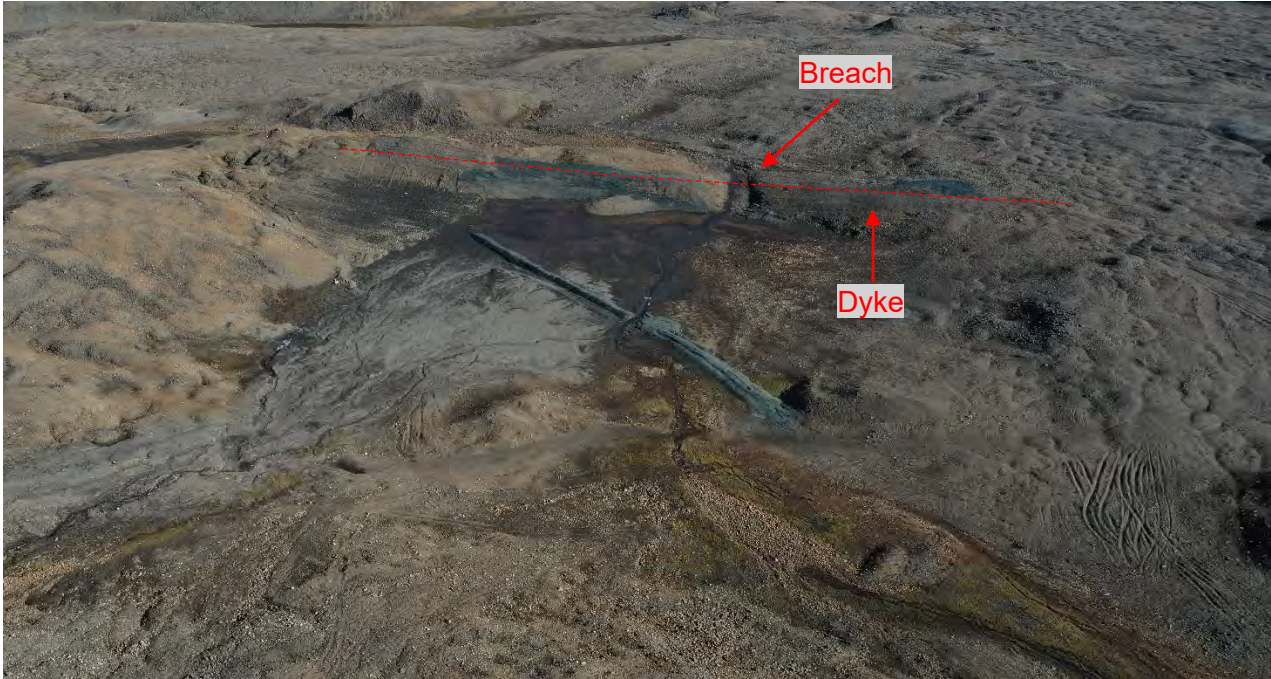
Photo 1. East Adit Treatment Facility - Retention Pond as seen from UAV.

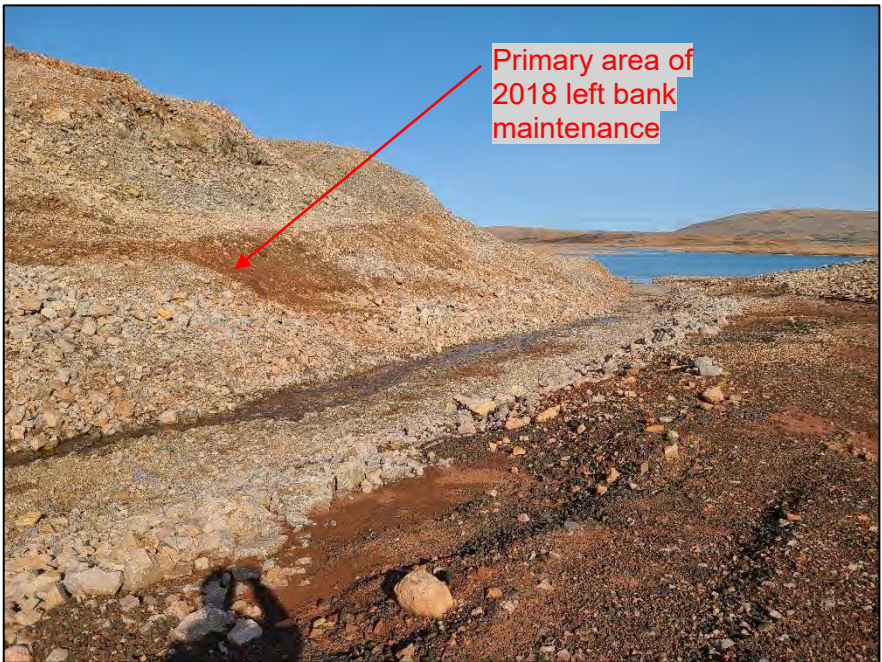
Photo 8. West Twin Dyke Spillway – On right bank looking downstream along location of 2018 left bank maintenance.

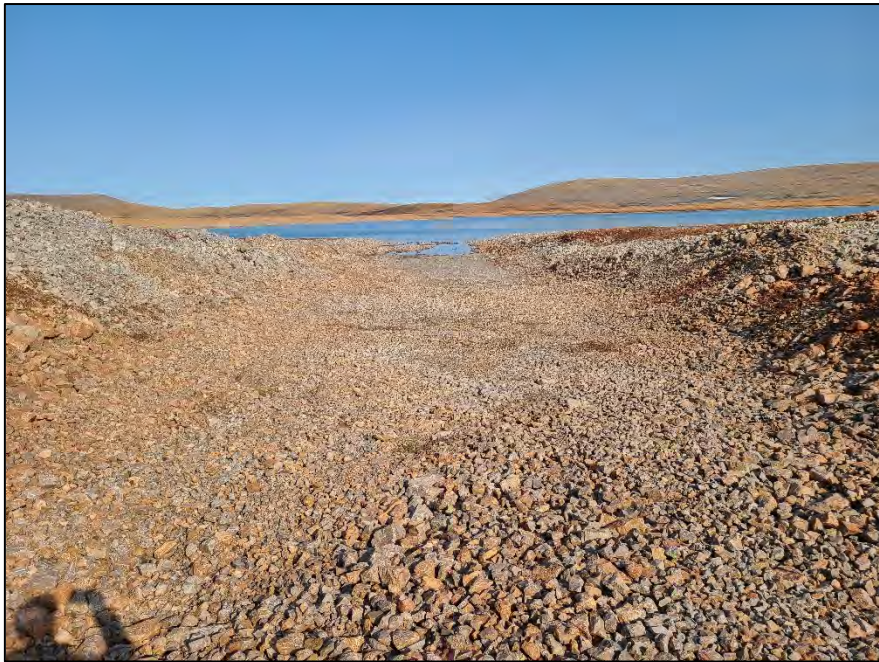
Photo 9. West Twin Dyke Spillway – Looking downstream at spillway outlet where 2018 maintenance was performed.

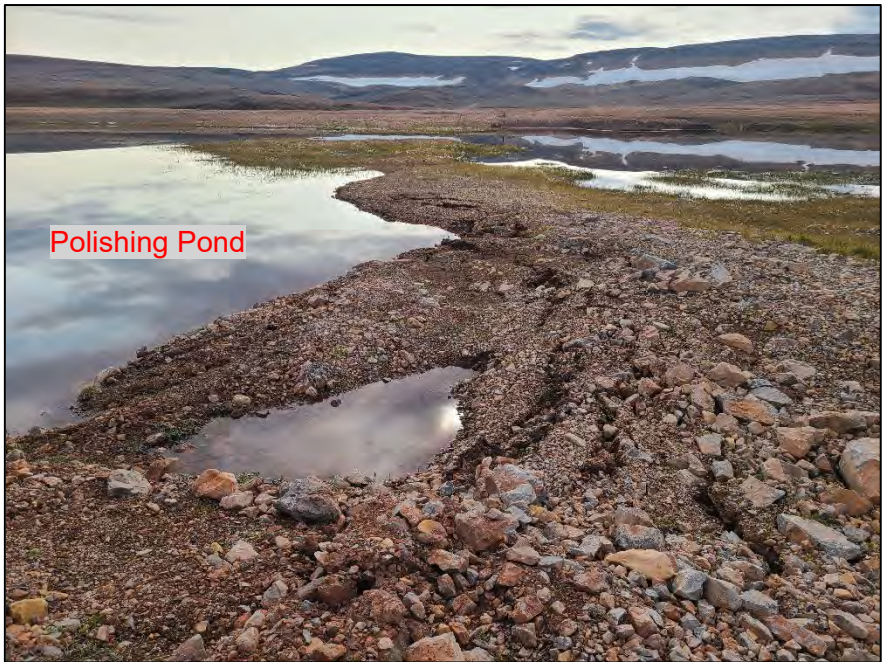
Photo 14. Polishing Pond – Thermokarsting around Polishing Pond.

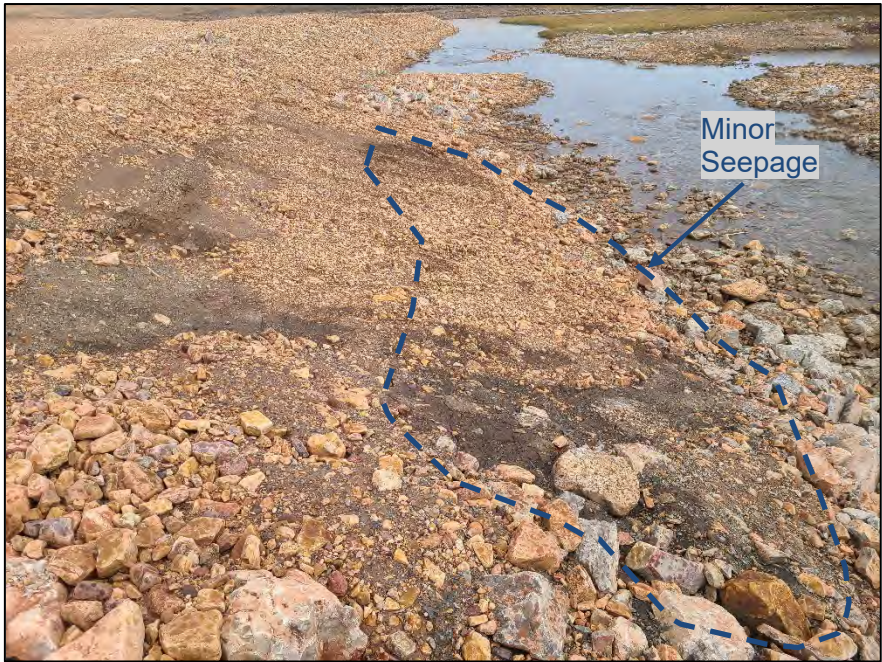
Photo 17. East Twin Creek Diversion – Looking downstream at area where 2018 left bank maintenance was performed.

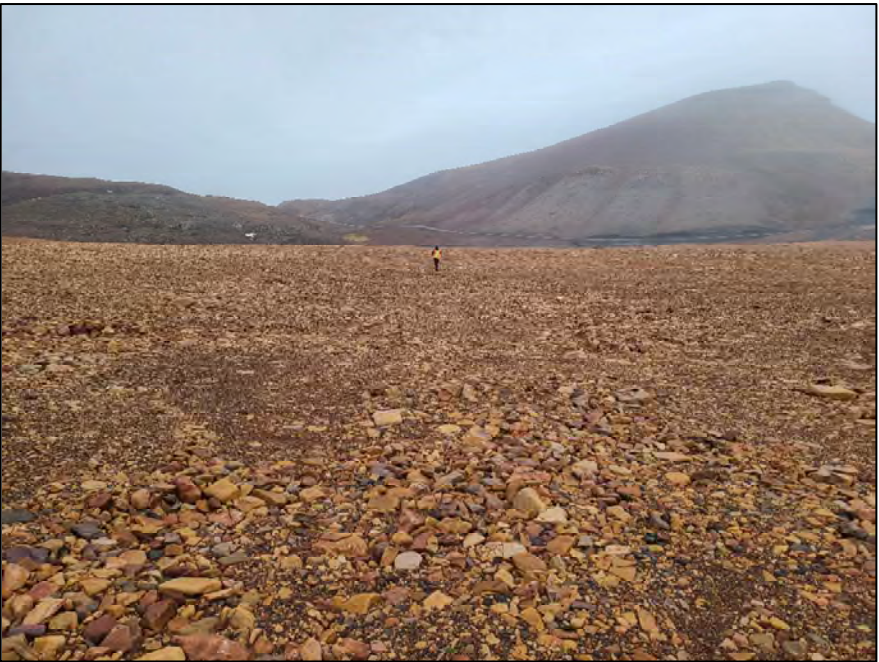
Photo 19. Surface Cell Cover System – Minor thermokarsting along main E-W drainage swale.

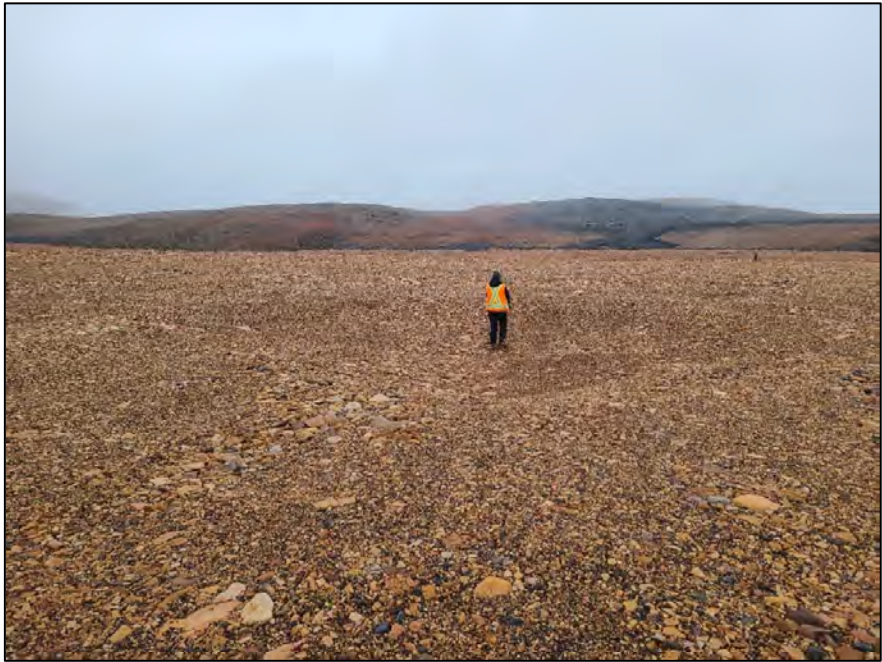
Photo 18. Surface Cell Cover System – Minor thermokarsting along main N-S drainage swale.

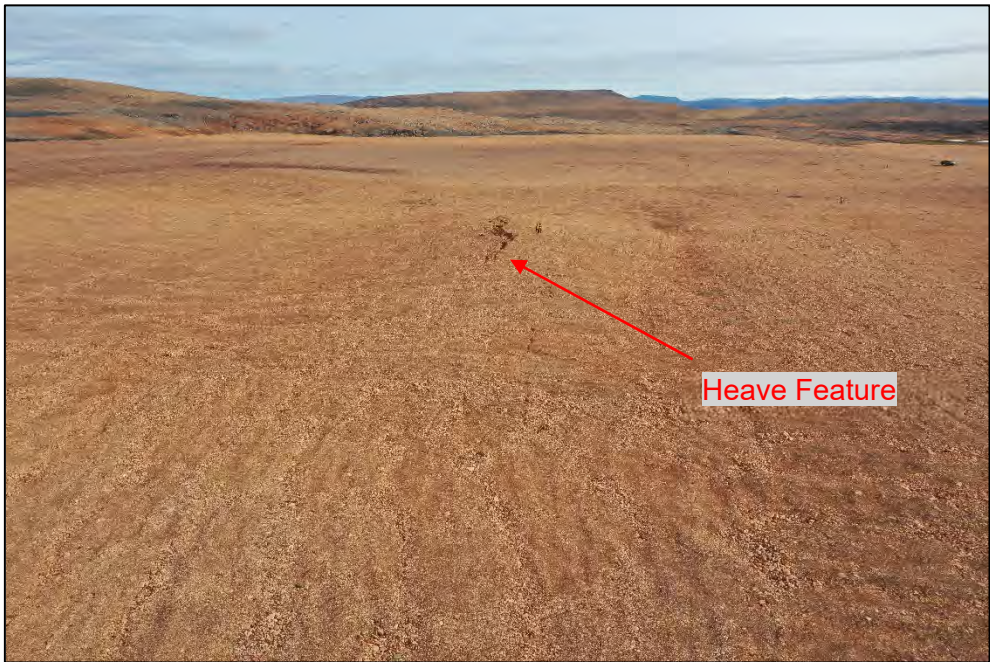
Photo 22. Surface Cell Cover System – Heave feature in the southwest quadrant of the Surface Cell cover system, as seen looking Northeast from UAV.

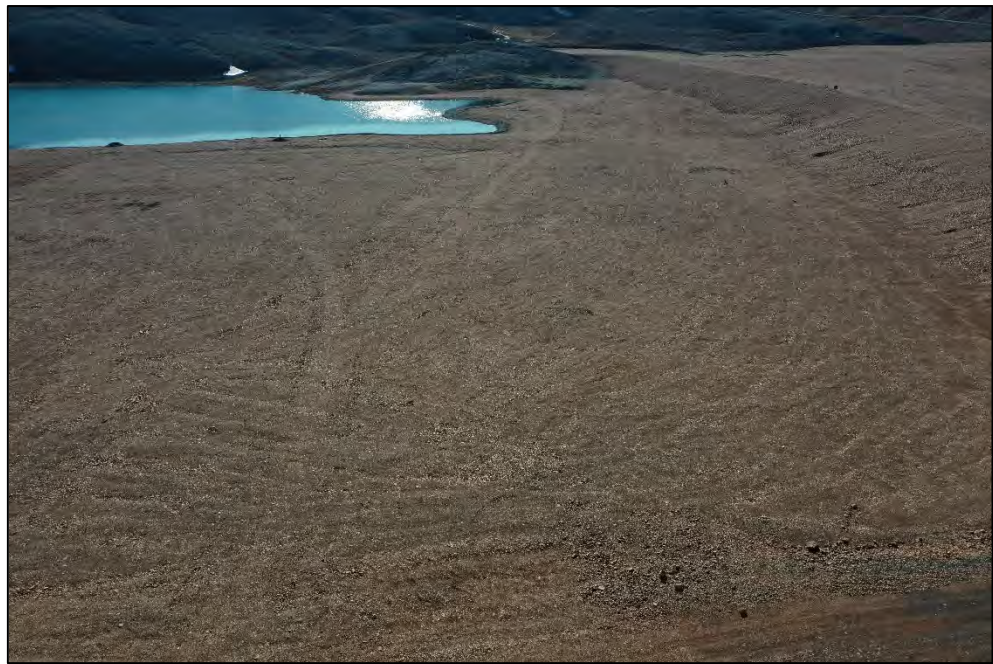
Photo 28. Test Cell Cover System - Looking Southwest across the cover system from UAV near the left abutment of the West Twin Dyke.

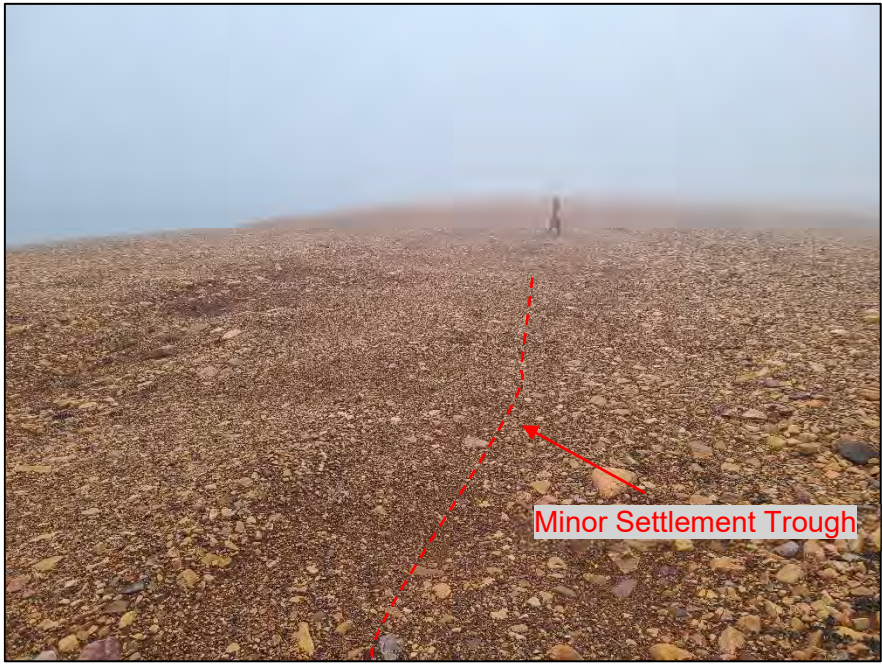
Photo 29. Test Cell Cover System – Minor settlement trough along N/S arm of Test Cell Dyke.

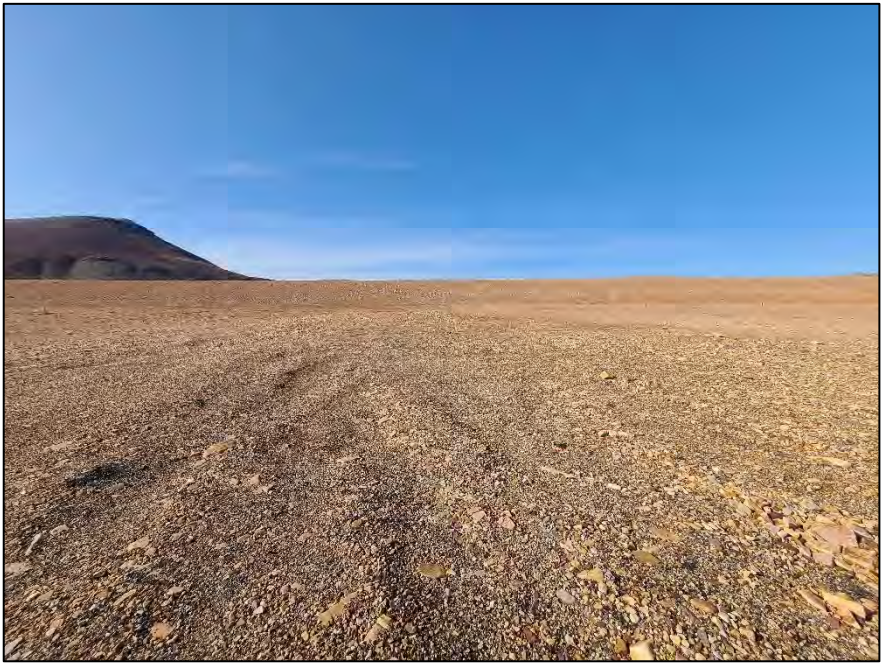
Photo 31. Test Cell Cover System – Flat surface of cover system, looking North. Note minor thermokarsting.

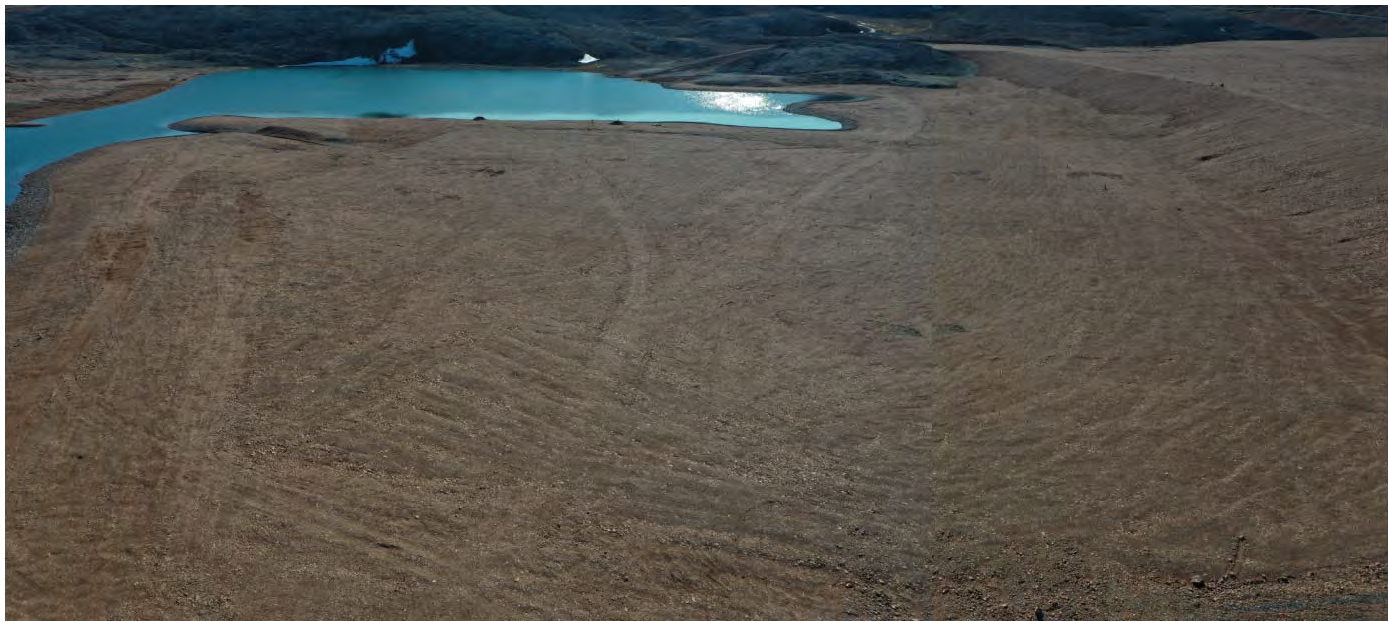
Photo 32. Test Cell Cover System – Composite overview of cover system as seen from UAV.

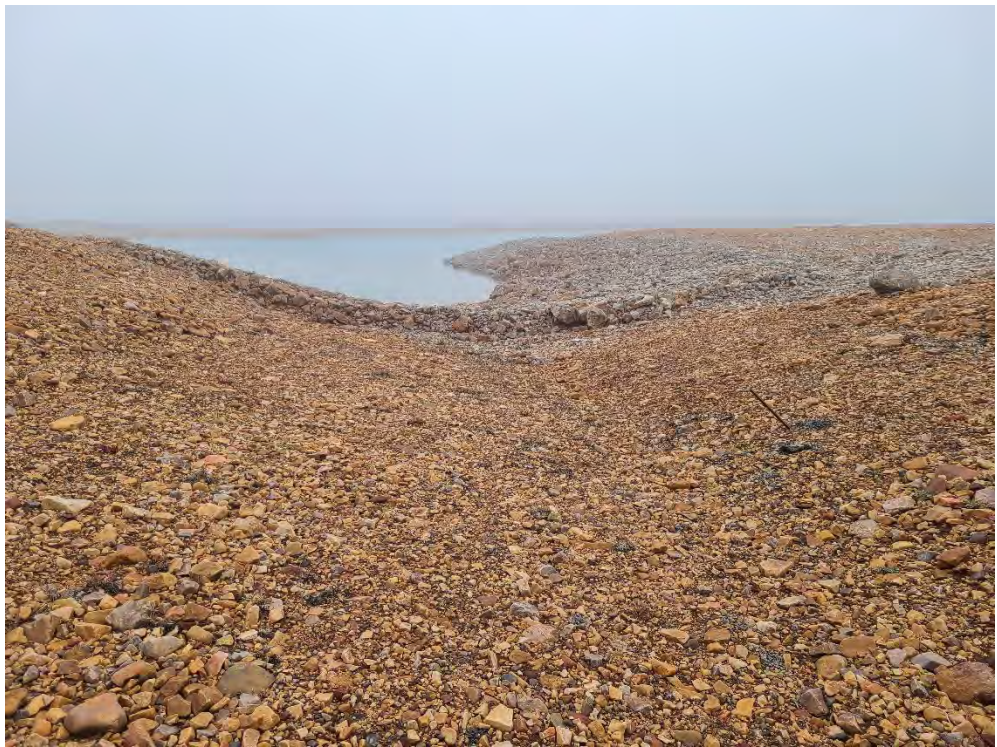
Photo 34. Test Cell Cover System – Outlet of breach in Test Cell Dyke.

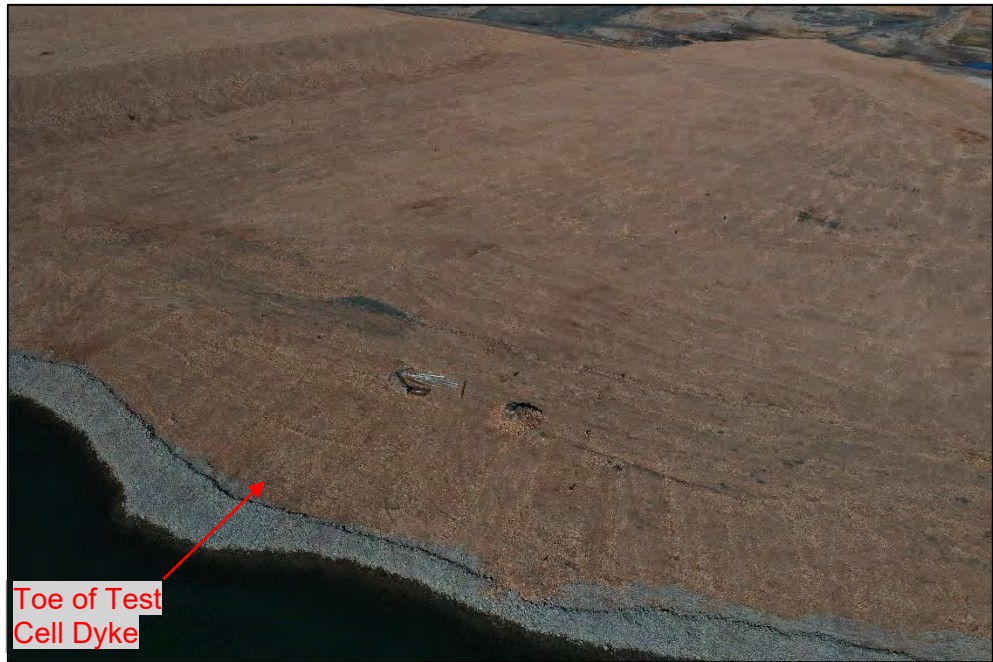
Photo 33. Test Cell Cover System – Toe of the test cell dyke.

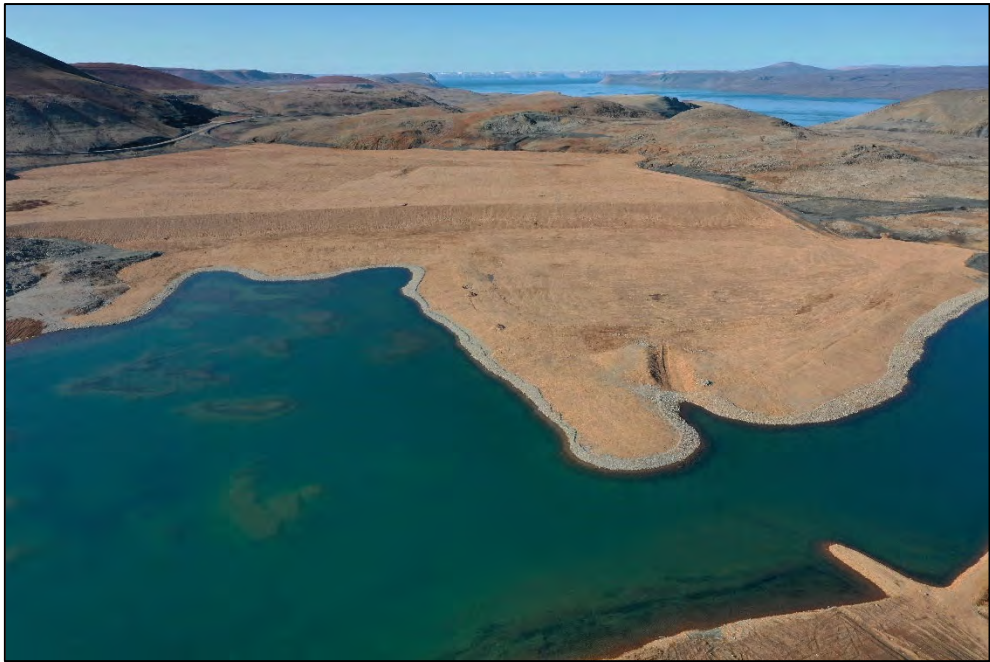
Photo 36. Test Cell Cover System – UAV overview of erosion protection along the toe of the Test Cell Dyke, view looking north.

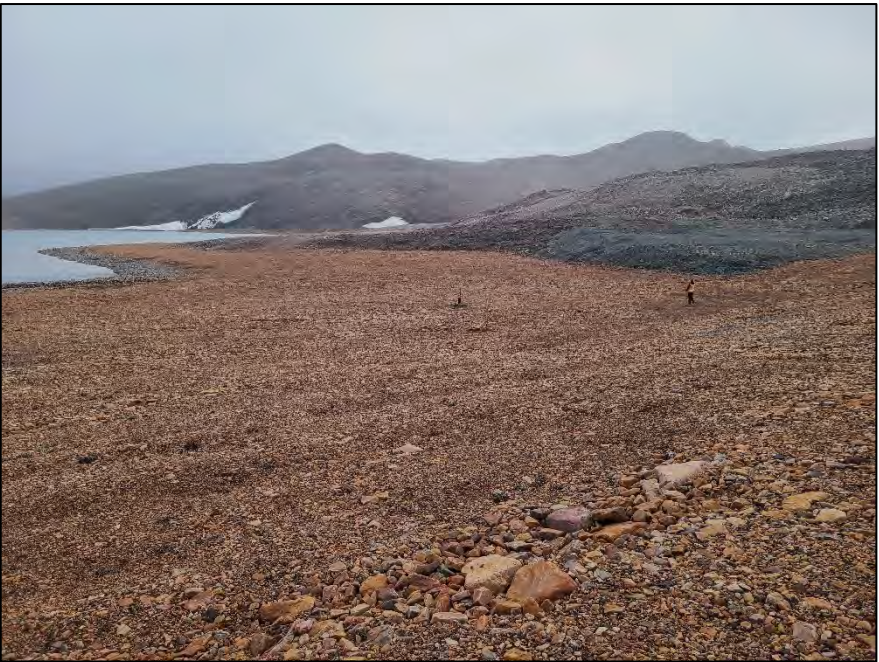
Photo 38. Toe of West Twin Dyke Tailings Cover – Note minor thermokarsting.

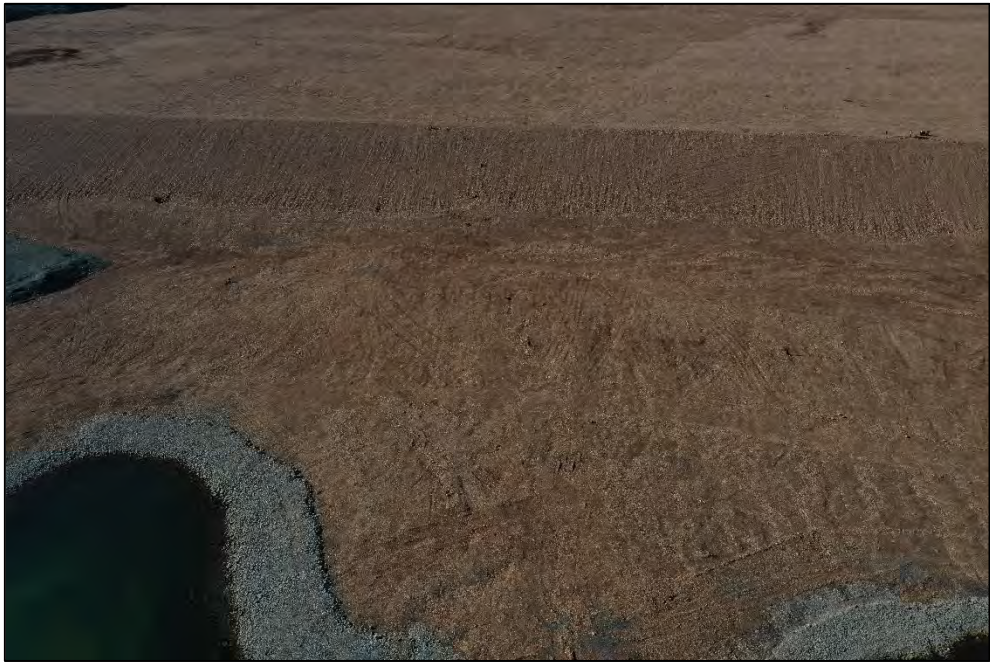
Photo 37. Toe of West Twin Dyke Tailings Cover – As seen from UAV.

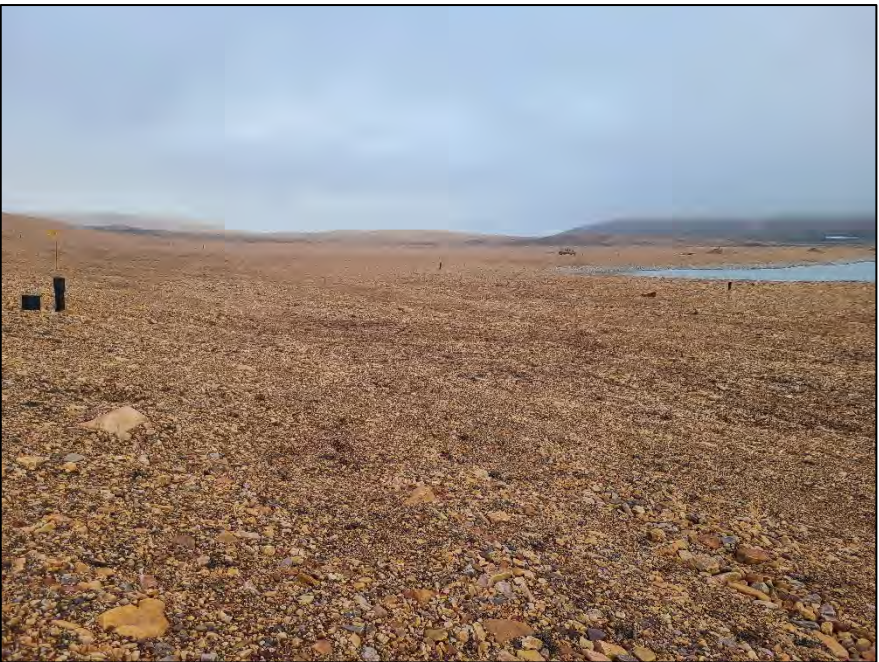
Photo 39. Toe of West Twin Dyke Tailings Cover – Note minor thermokarsting.

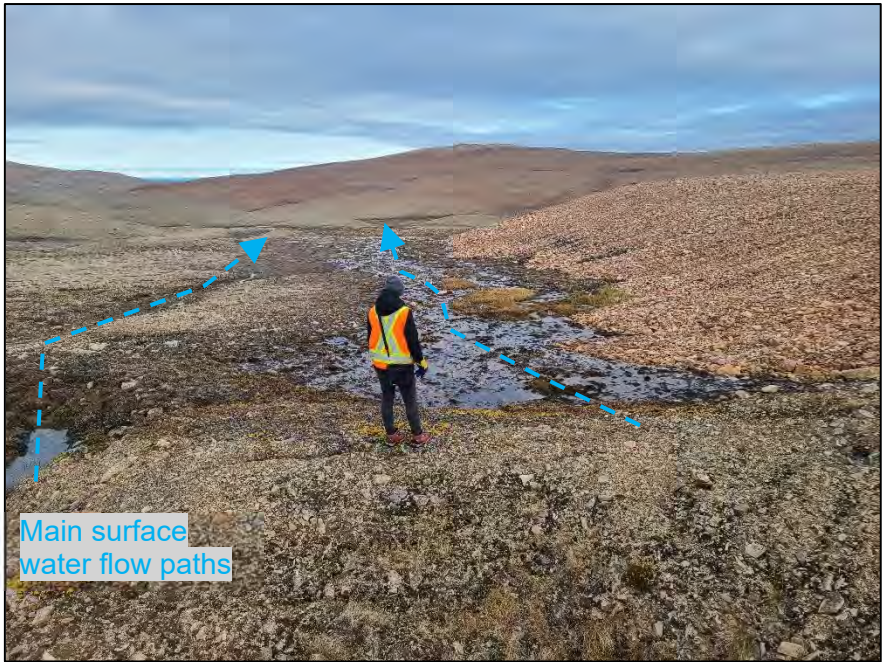
Photo 41. Landfill – Diverted water flowing around north side of cover system.

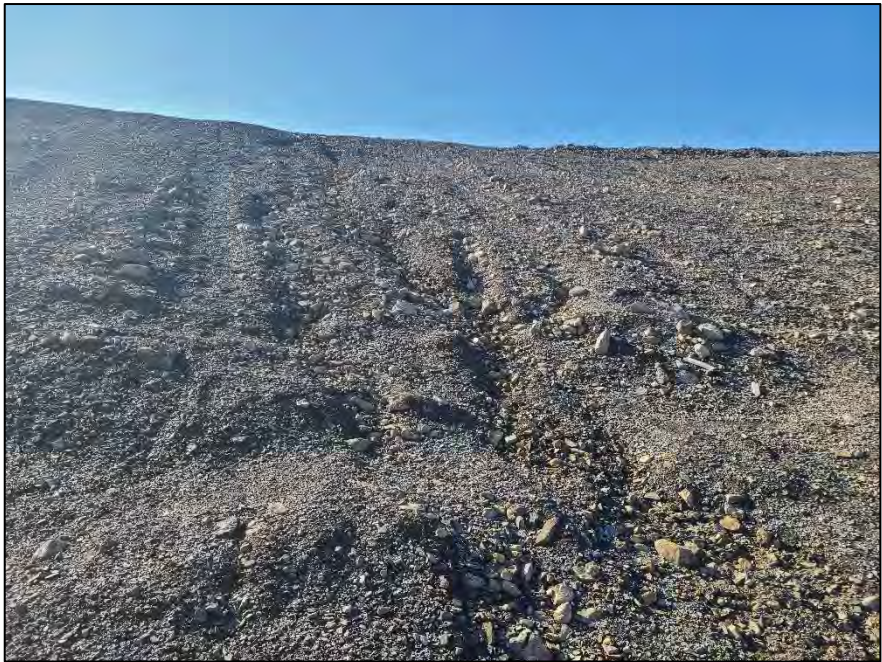
- The upslope water deflection berm appeared to be effective in directing surface water away from the cover, although no flow was observed during the inspection.
- Minor surface erosion (<10 cm deep) was noted along the backslope at the south end of the cover, as has been noted during previous inspections (Photo 55). Some minor ponding of water was observed at the upstream end of the erosion (Photos 56 and 57). The erosion appears to be slowly progressing, based on visual observations, but is not expected to impact the overall performance of the cover system. Self armouring of the erosion areas is occurring as the coarser particles within the armour layer are exposed and concentrated at surface, as anticipated.
- Some seepage was observed at the toe of the cover.

Photo 55. Oceanview Pit – Rilling on the south end of the cover system. Note self-armouring.

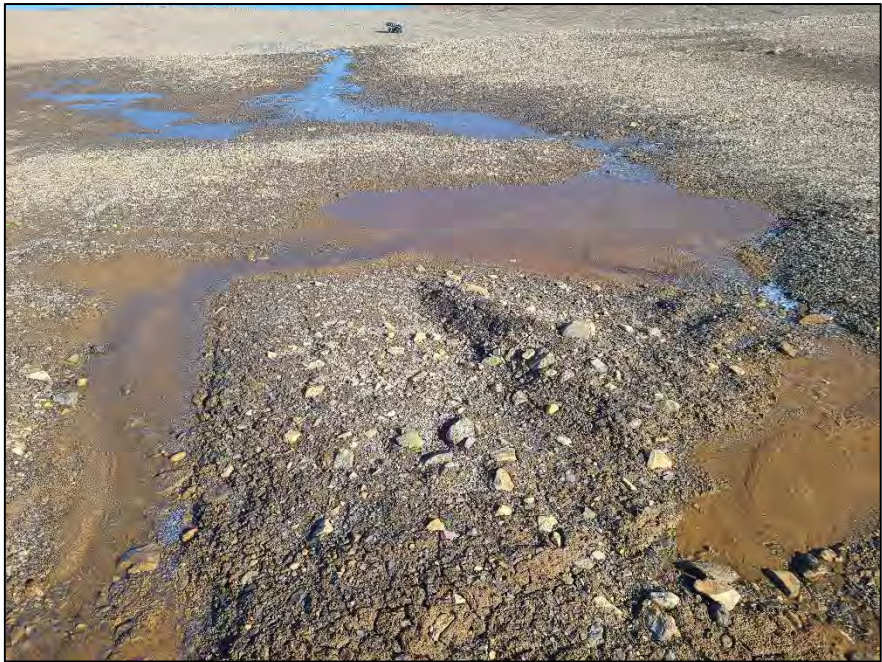
Photo 56. Oceanview Pit – Minor seepage flowing into the cover system from upslope, as seen from the ground.

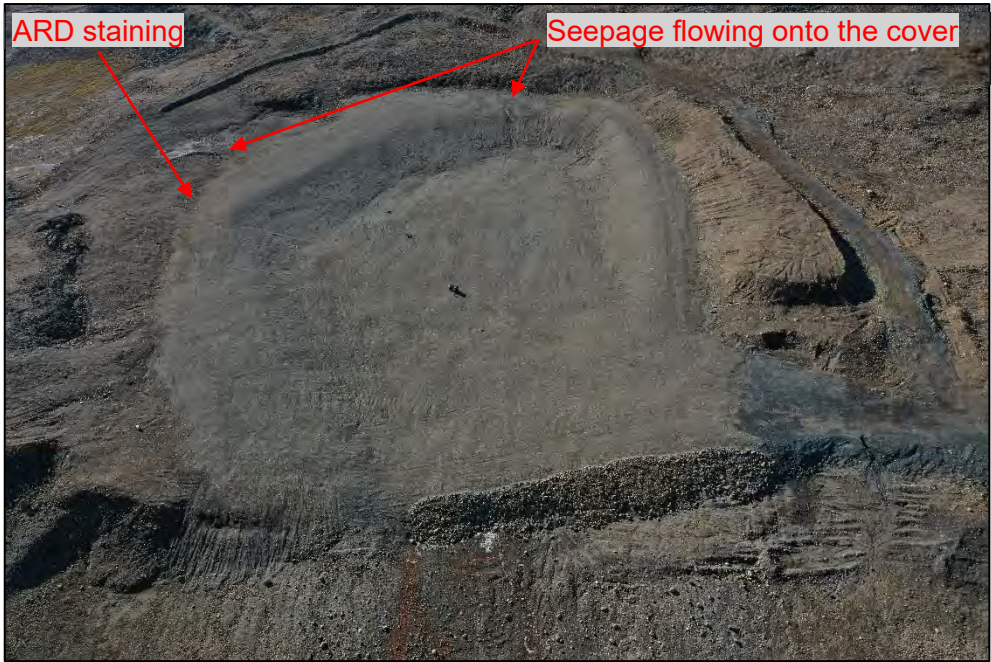
- Some acid rock drainage staining was observed on the east edge of the cover, as it has been during previous inspections (Photo 58). The stained area originates upslope of the extent of the cover and appears to cover a similar extent to what has been observed in previous inspections.
- The minor sinkhole observed in the middle of the cover surface during the 2015 inspection did not appear to have grown since.
- In general, the Oceanview Open Pit cover appears to be in satisfactory condition. As such, no maintenance is recommended. The surficial erosion should continue to be visually monitored for additional progression.

Photo 58. Oceanview Pit – Overview of cover system as seen from UAV.

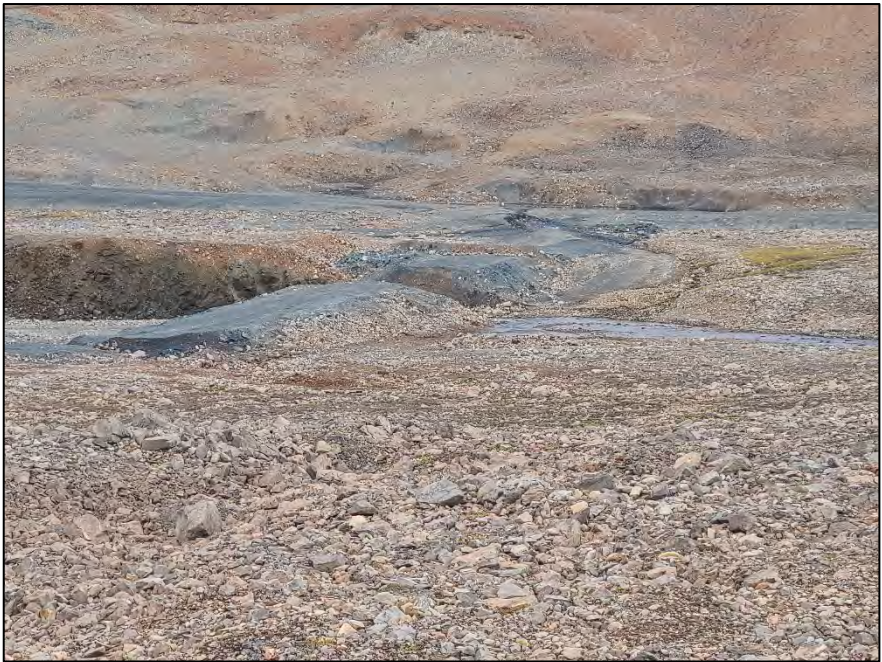
Photo 62. Upper Dump Pond – Constructed breach in road to mill site.

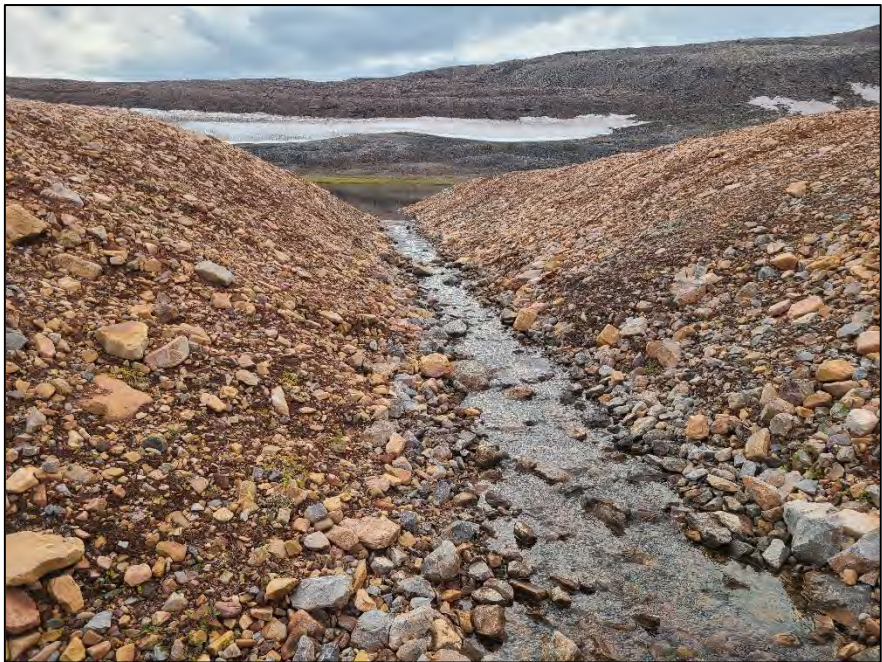
Photo 61. Upper Dump Pond - Looking upstream at constructed breach in road to Townsite.

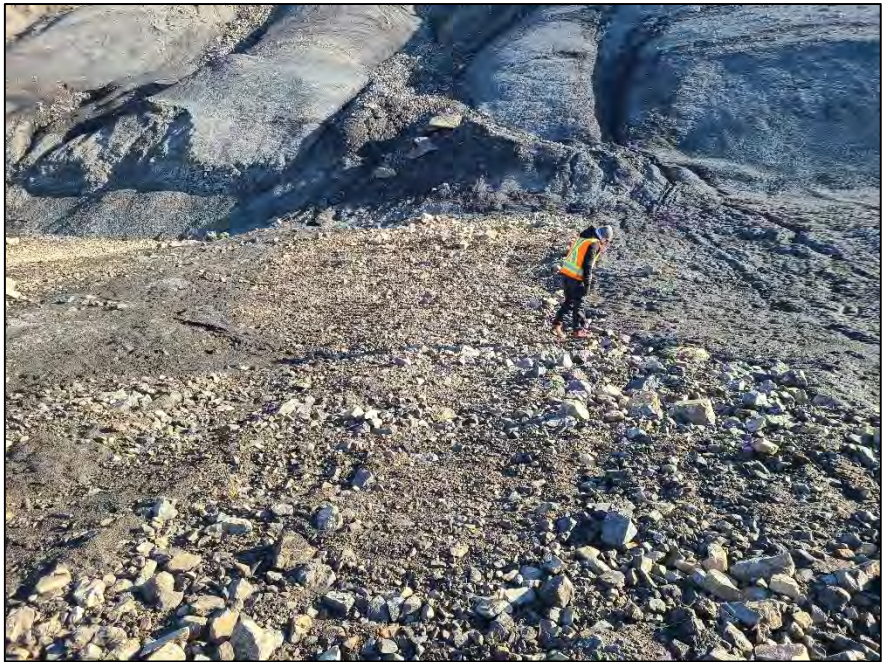
Photo 68. 09S Portal – Looking upslope at plug.

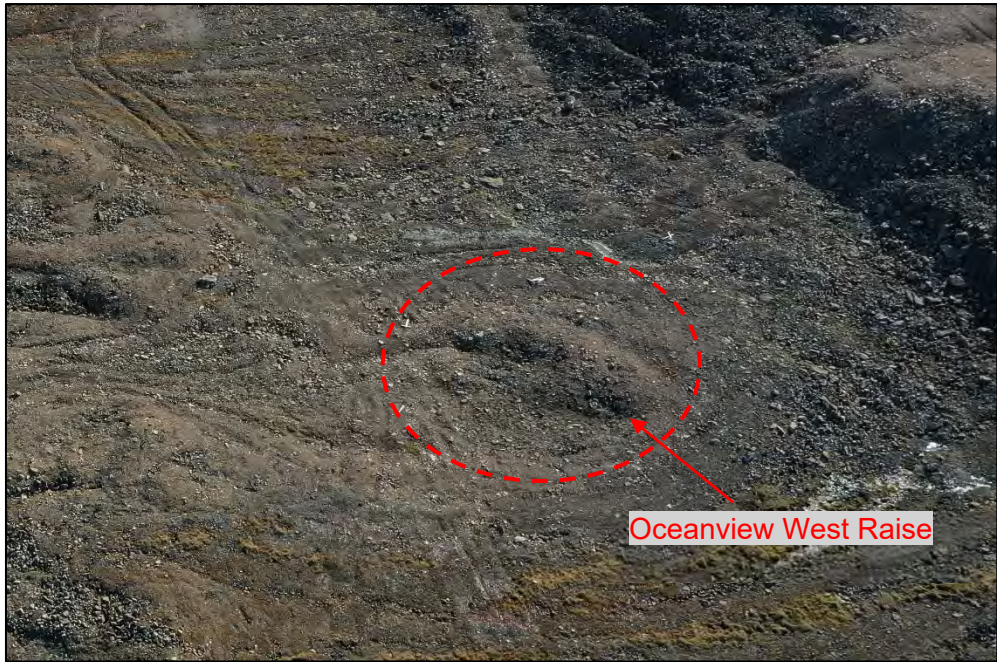
A photo from the inspection is provided in Appendix I (Photo 72). During the inspection, the armour surface appeared to be stable with no visual indications of erosion or surface deformation. As such, no maintenance is recommended.

Photo 72. Oceanview West Raise – Surface plug as seen from UAV.

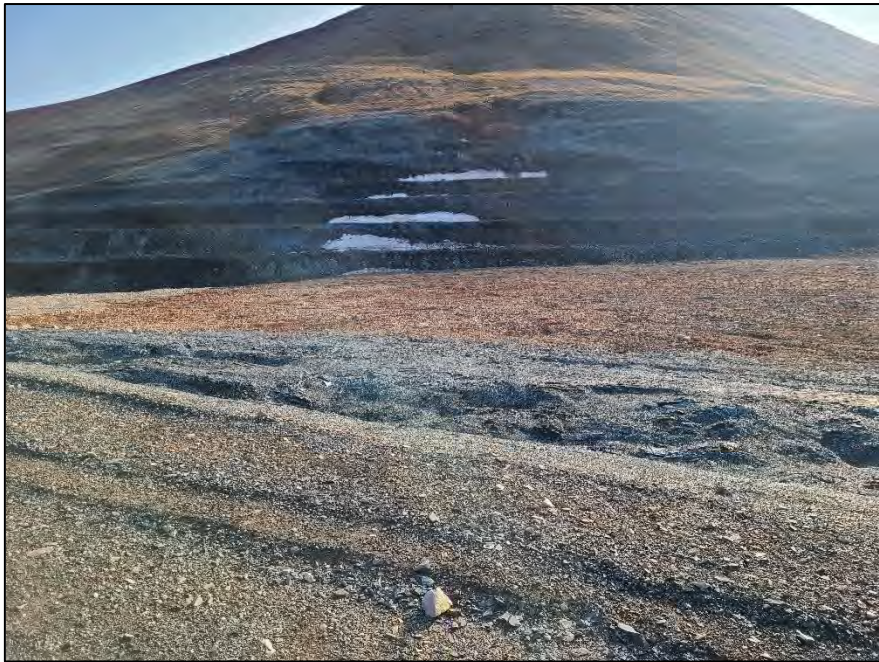
Photo 73. Mt. Fuji Shale Quarry – As seen from road.
