CANZINCO MINES LTD.

NANISIVIK MINE, NUNAVUT

2022 ANNUAL GEOTECHNICAL INSPECTION

PROJECT NO.: 0255034

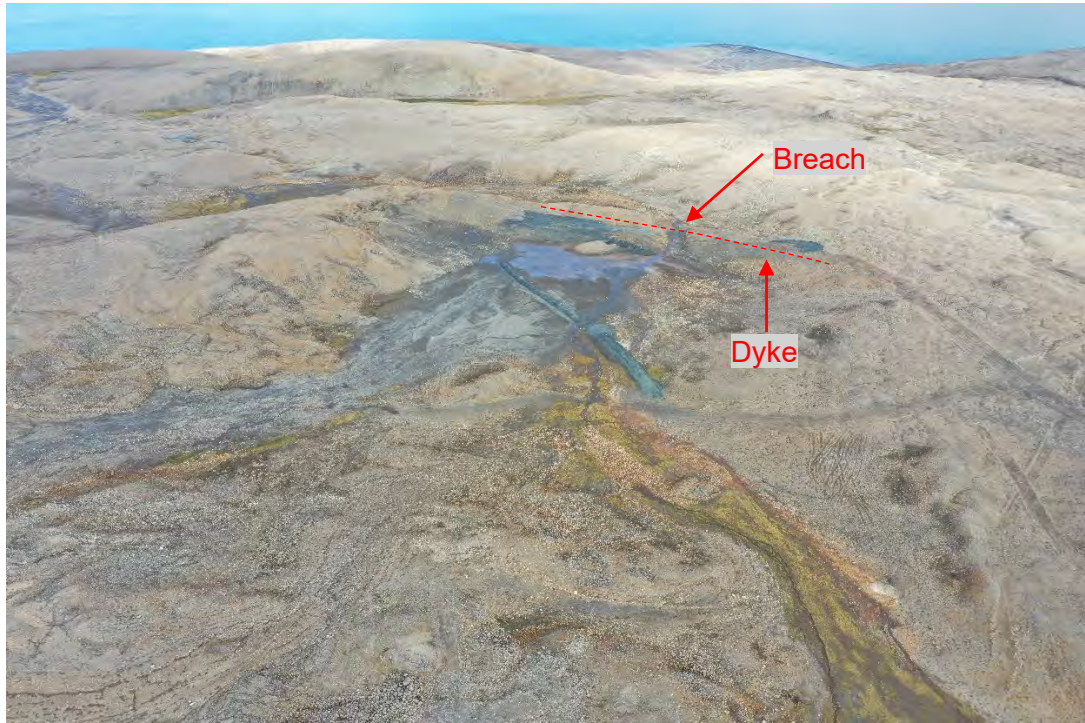
Photo 1. East Adit Treatment Facility - Retention Pond as seen from UAV.

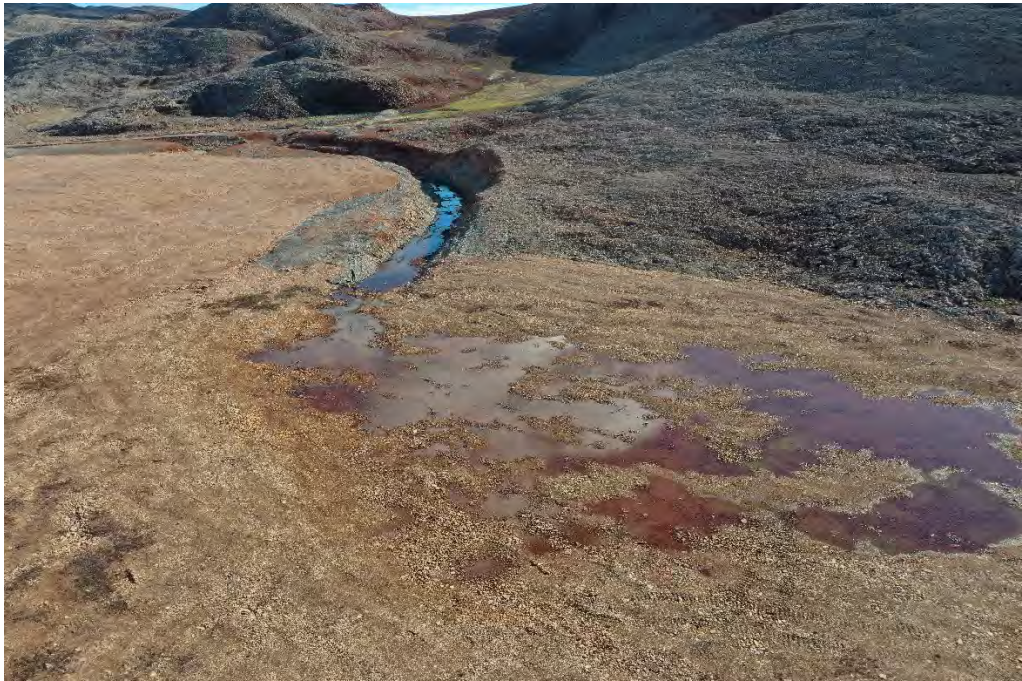
Photo 3. West Twin Dyke Spillway – Small headpond at spillway inlet as seen from UAV.

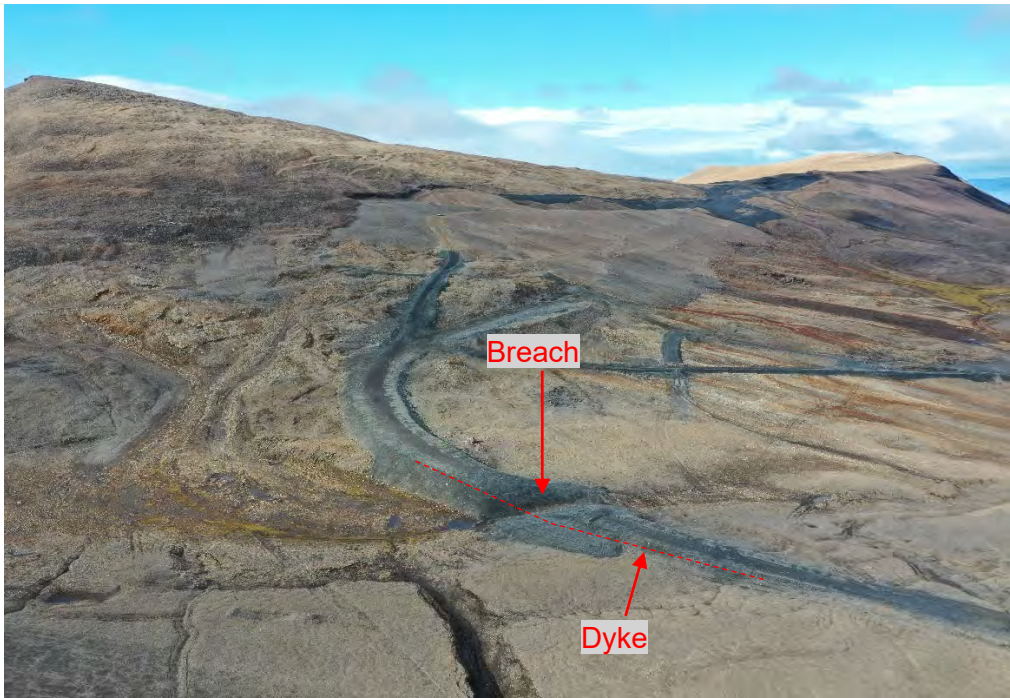
Photo 2. East Adit Treatment Facility - Breach in treatment pond as seen from UAV.

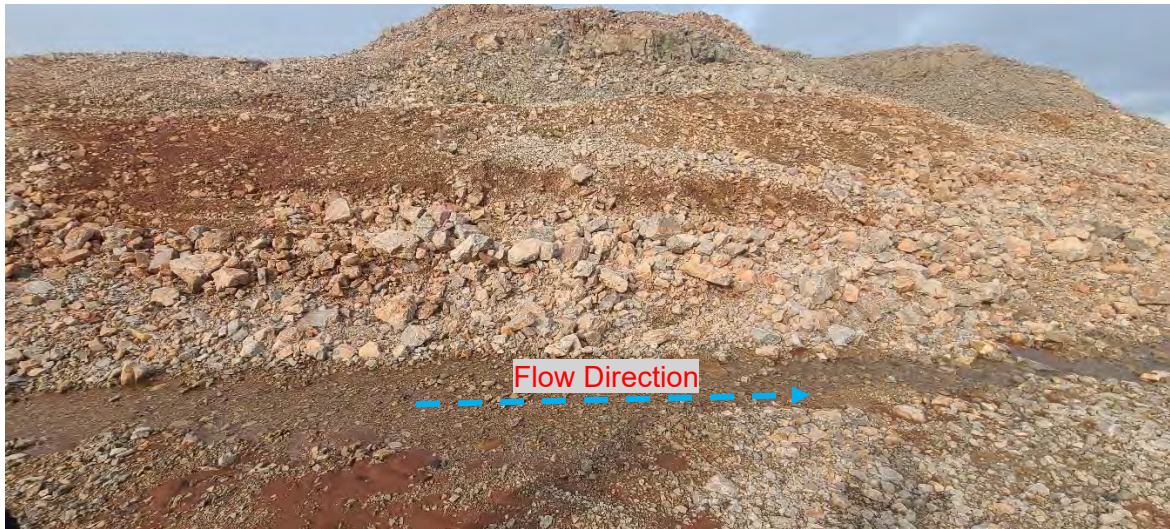
Photo 5. West Twin Dyke Spillway – Secondary area of 2018 left bank maintenance, approximately 100 metres downstream of the access ramp.

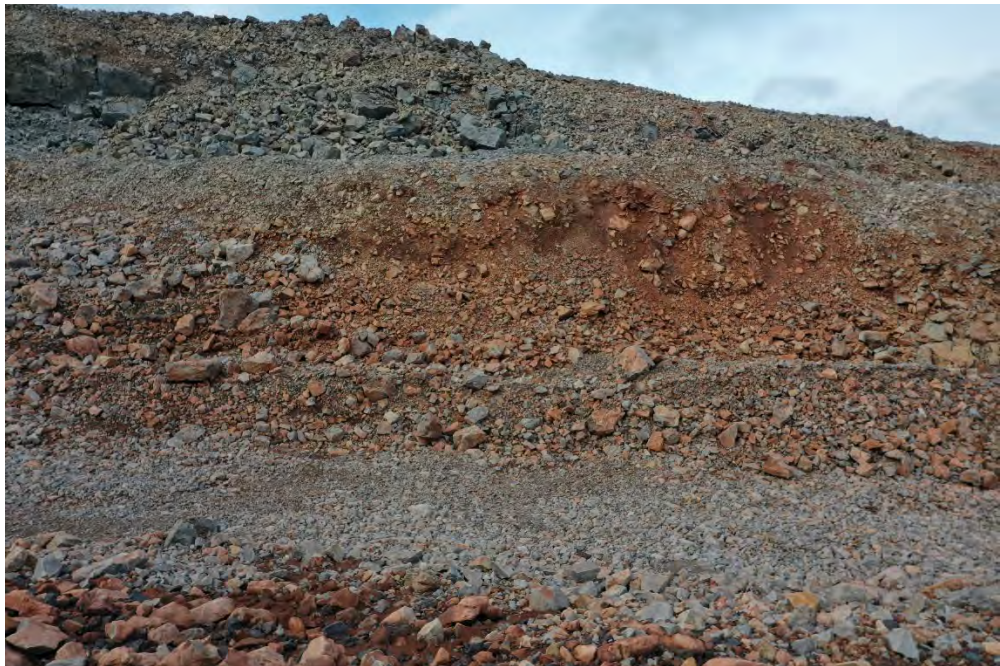
Photo 6. West Twin Dyke Spillway – Primary area of 2018 left bank maintenance.

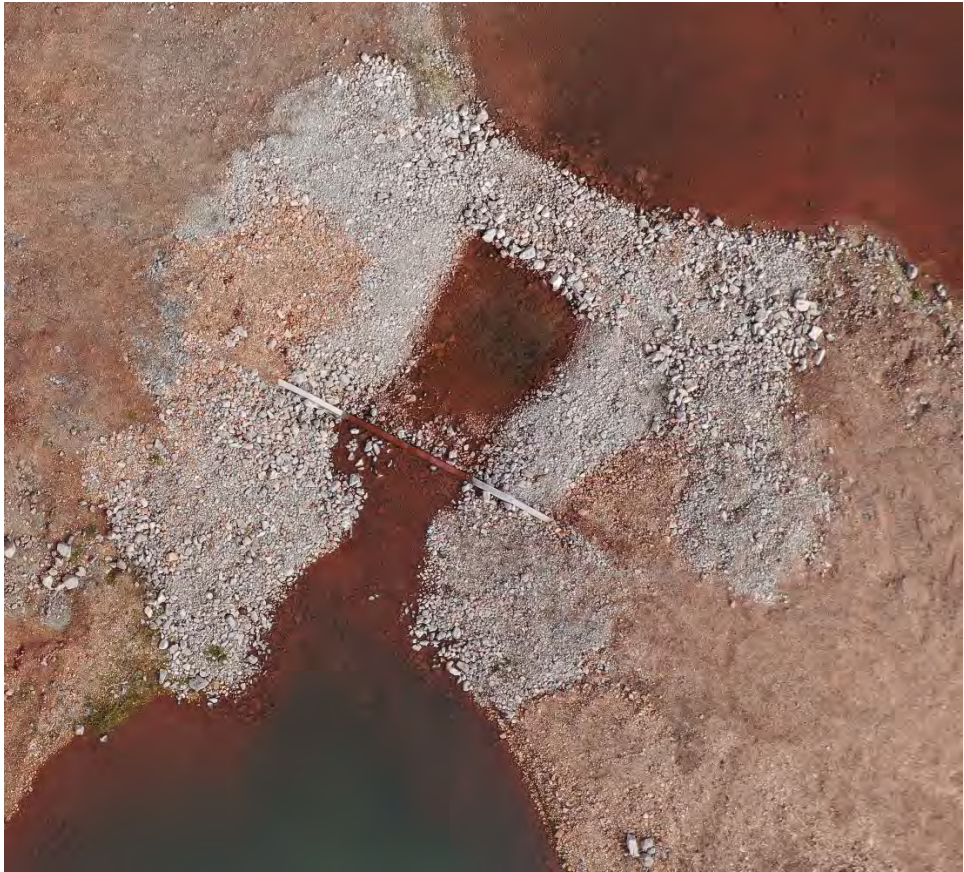
Photo 9. West Twin Outlet Wall – Overhead photo as seen from UAV.

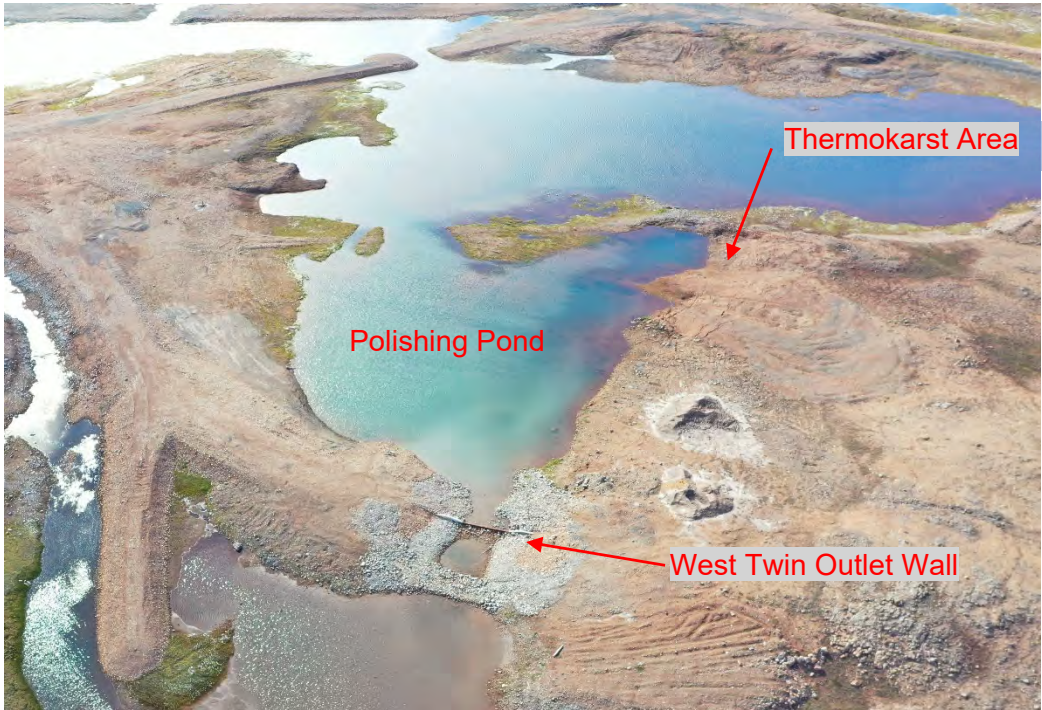
- During the inspection, the water level upstream of the wall was noted to be flowing approximately 0.5 cm above the elevation of the wall invert (Photo 10).
- Slumping and settlement of the perimeter slopes of the upstream Polishing Pond continued to degrade since the 2021 inspection (Photos 11 through 13). The area of active instability remains over 50 m away from the outlet wall area. As such, there is limited

Photo 11. West Twin Outlet Wall – Overview, as seen from UAV.

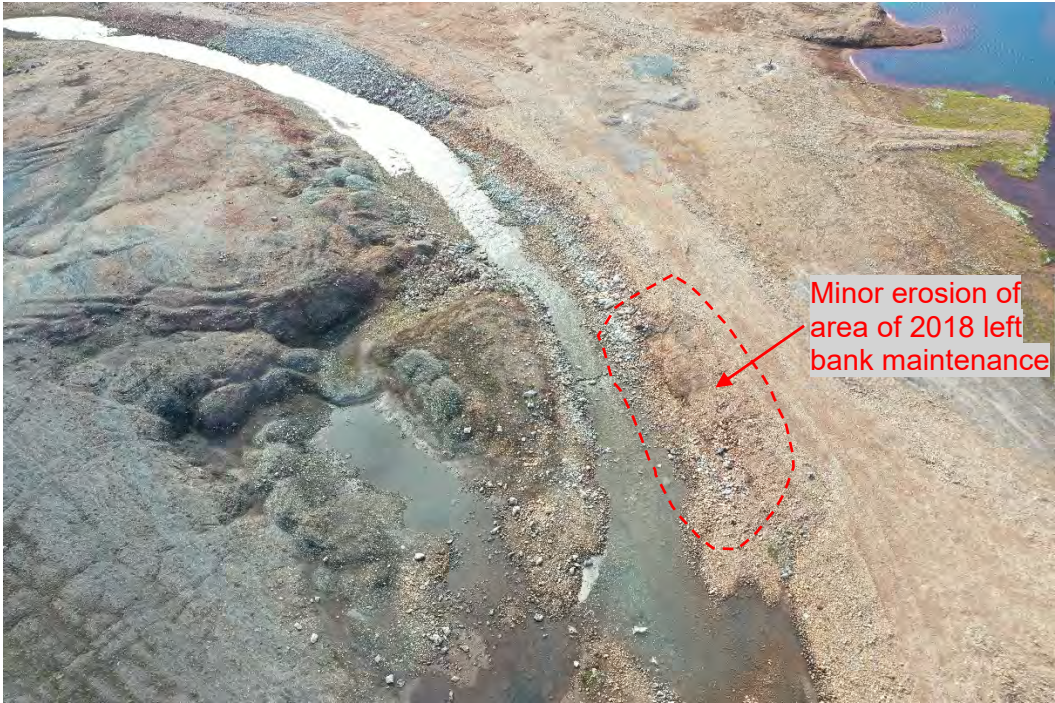
Photo 14. East Twin Creek Diversion – Overview, looking downstream from UAV. Note minor erosion near upper right.

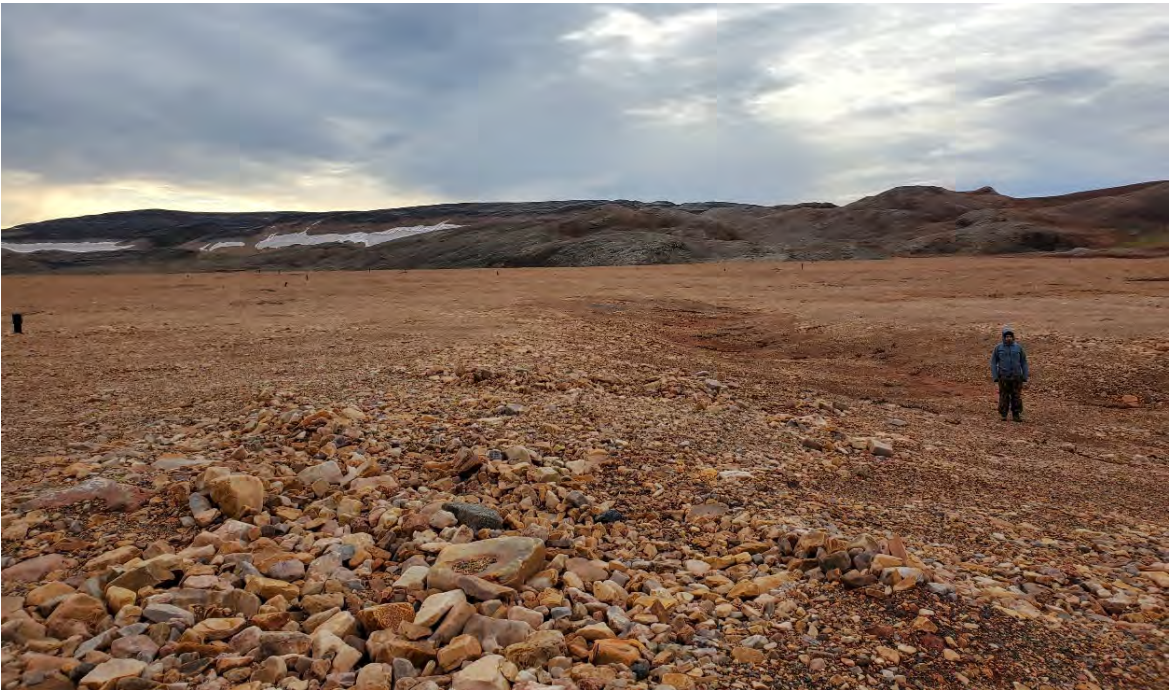
Photo 18. Surface Cell Cover System – Minor thermokarsting along main E-W drainage swale.

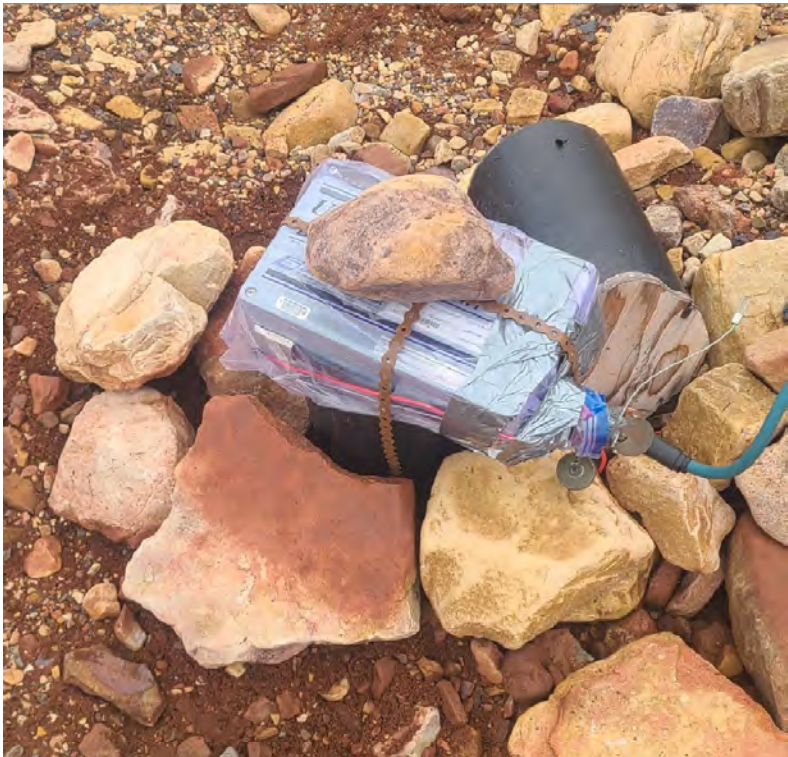
Photo 24. West Twin Dyke – Thermistor datalogger installed at instrument BGC05-15, prior to weatherproofing.

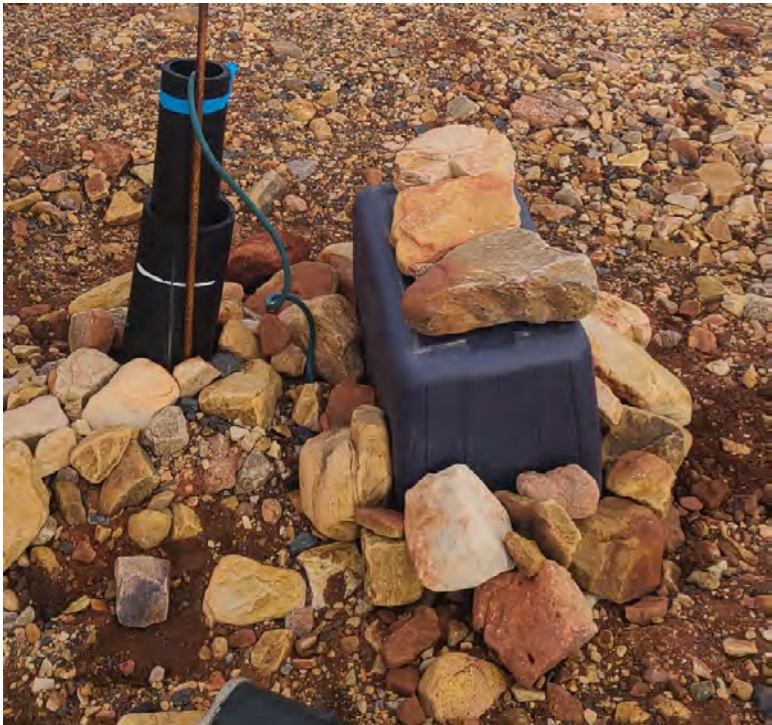
Photo 25. West Twin Dyke – Thermistor datalogger installed at instrument BGC05-15, after weatherproofing.

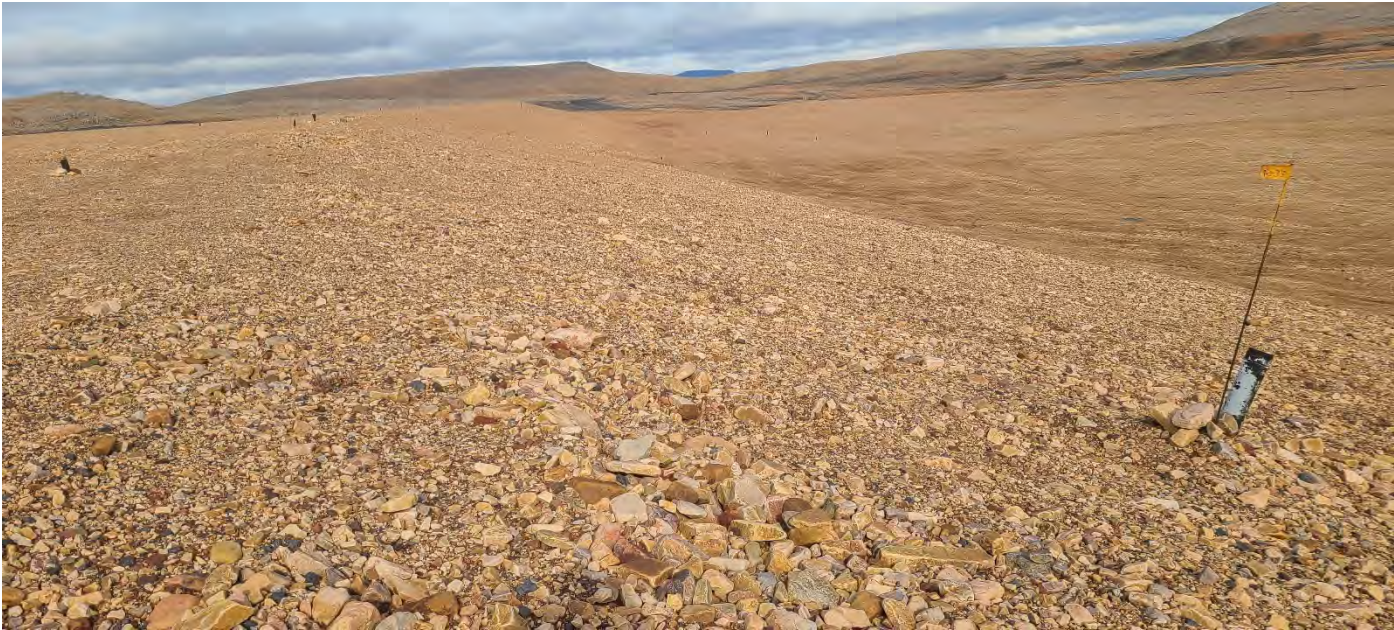
Photo 26. West Twin Dyke – Looking northeast from instrument BGC03-33, showing the smooth dyke face.

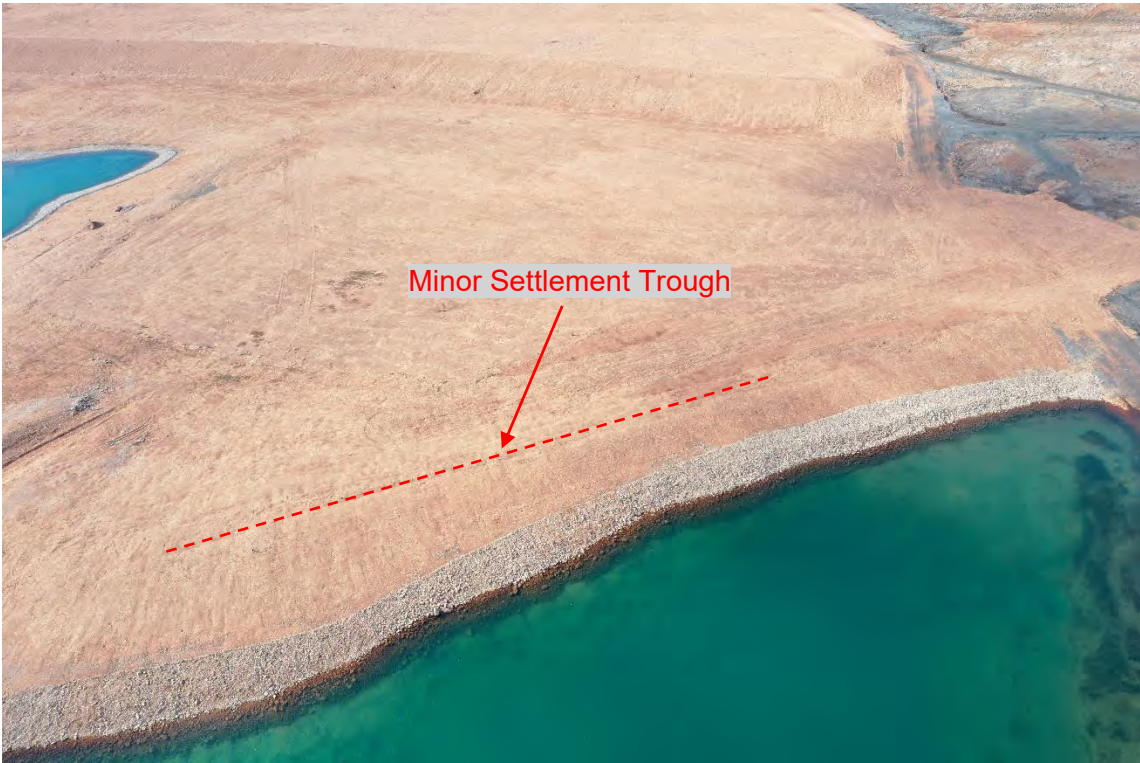
Photo 31. Test Cell Cover System – N/S arm of Test Cell Dyke, as seen from UAV. Note minor settlement trough.

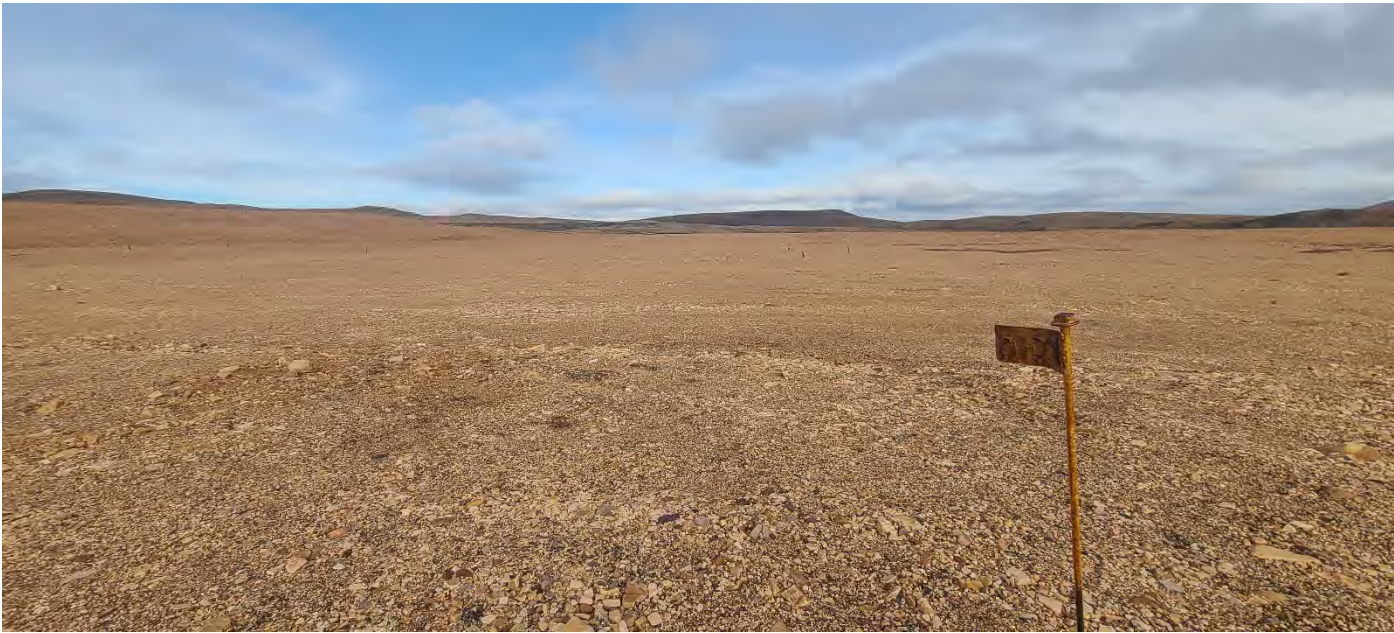
Photo 32. Test Cell Cover System – Flat surface of cover system, looking North from instrument BGC05-29.

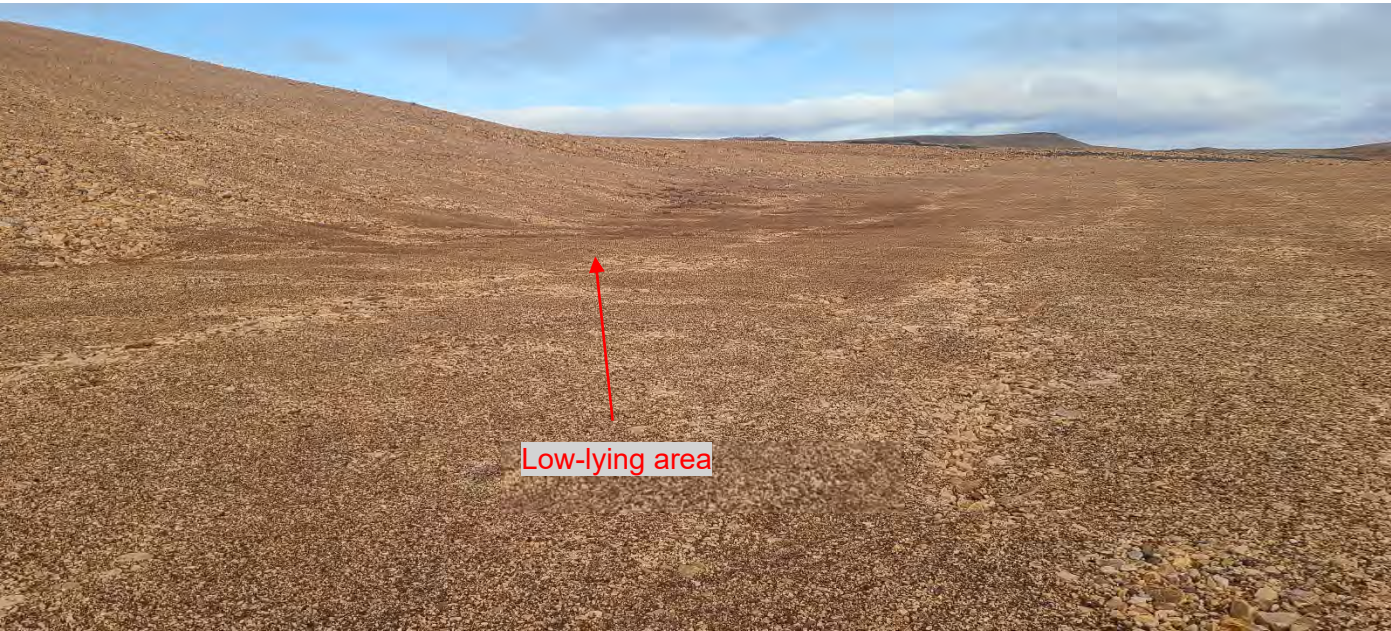
Photo 33. Test Cell Cover System – Low lying area at the toe of the left abutment of the West Twin Dyke.

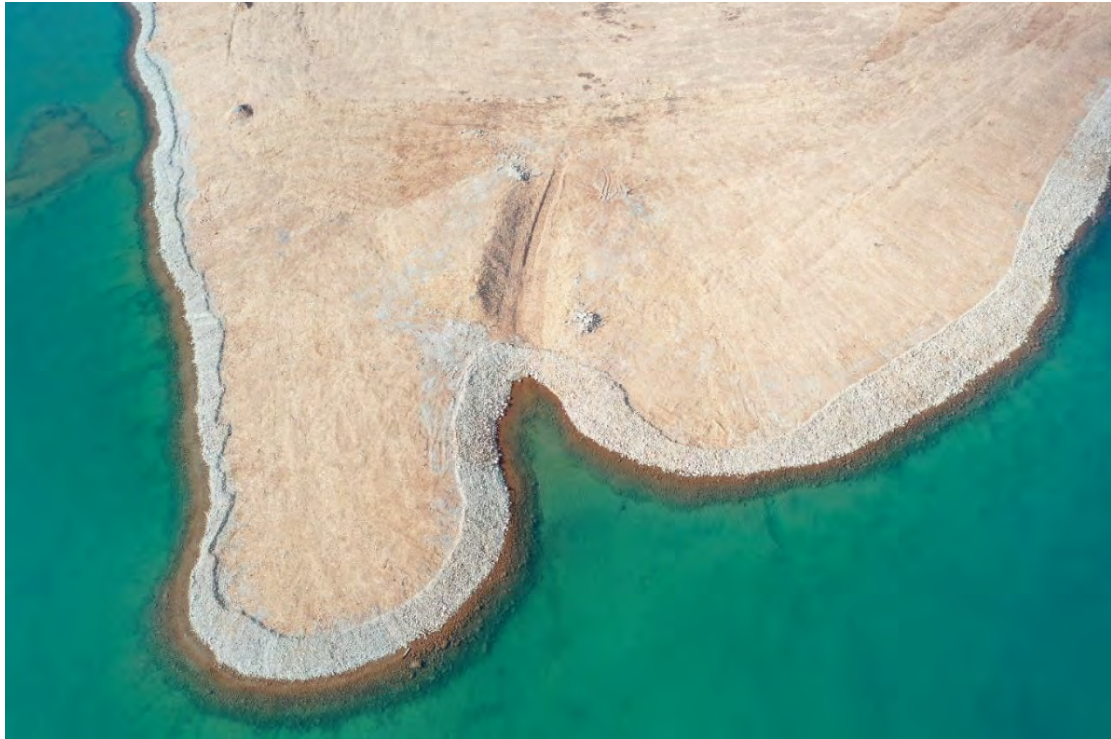
Photo 34. Test Cell Cover System – Breach in Test Cell Dyke as seen from UAV.

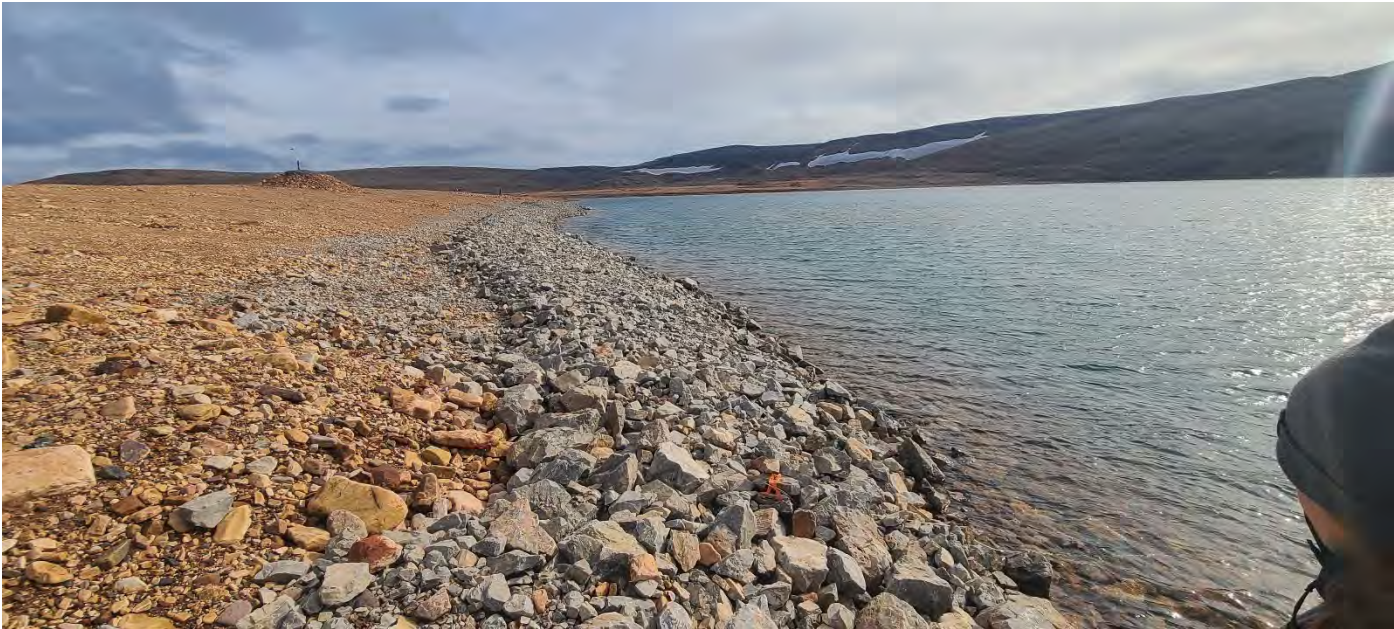
Photo 36. Test Cell Cover System – Erosion protection along the toe of the Test Cell Dyke, view looking East.

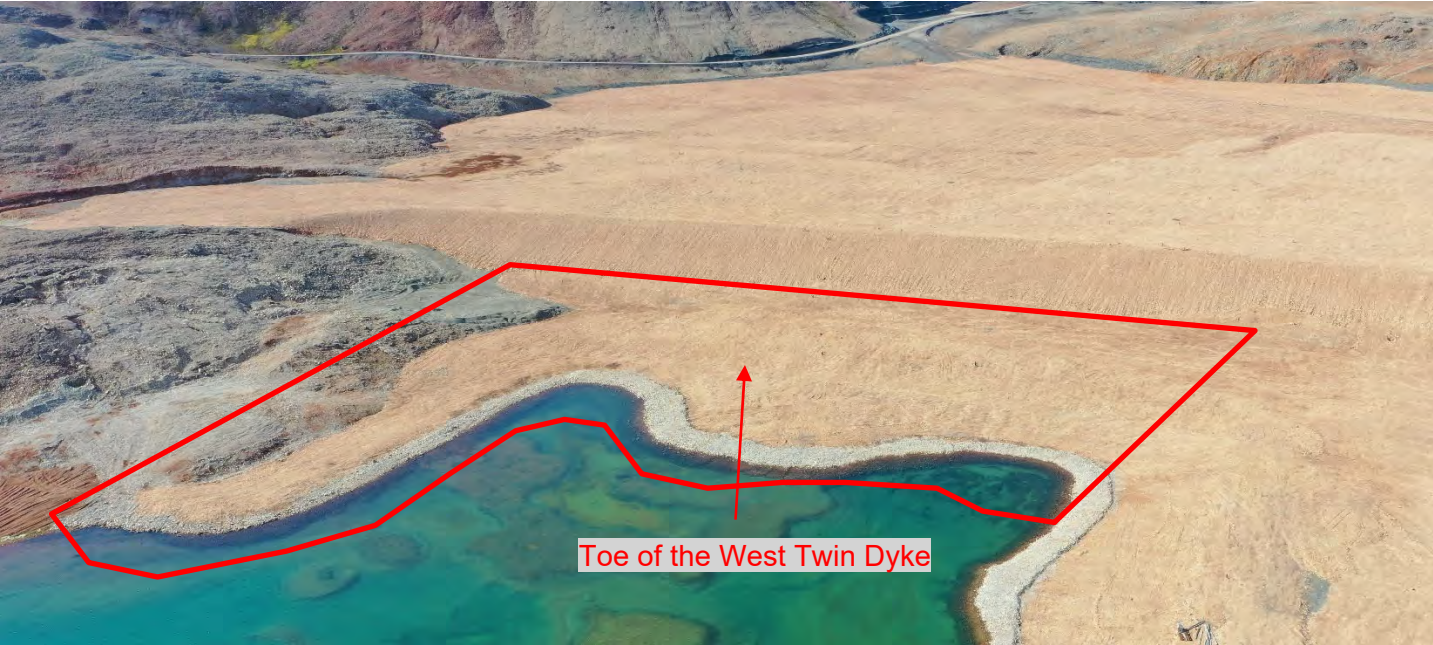
Photo 39. Toe of West Twin Dyke Tailings Cover – Overview as seen from UAV.

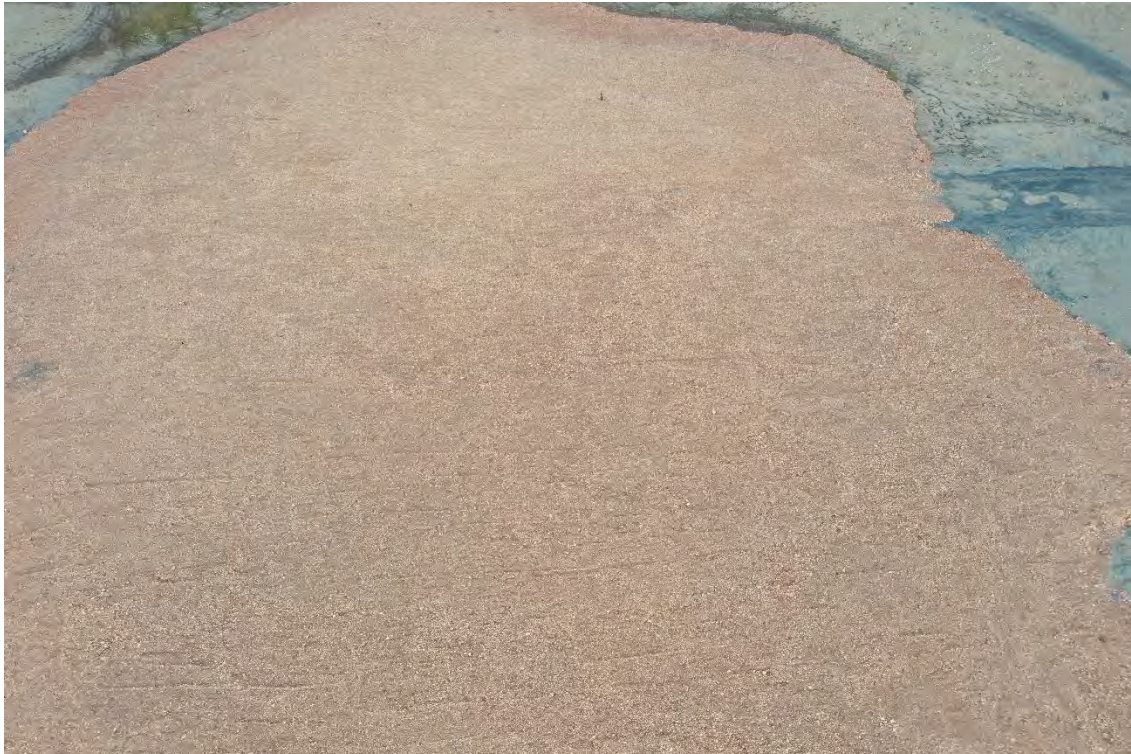
Photo 42. Landfill – Flat surface of cover system. View looking north.

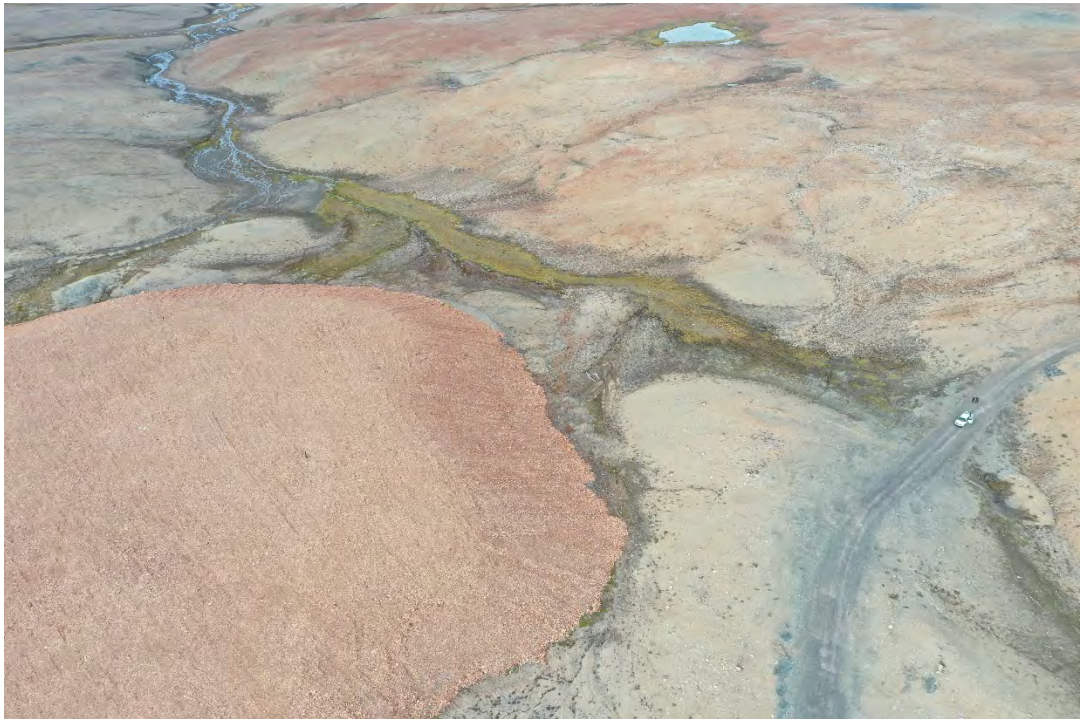
Photo 47. Landfill – Northern toe of cover system as seen from UAV.

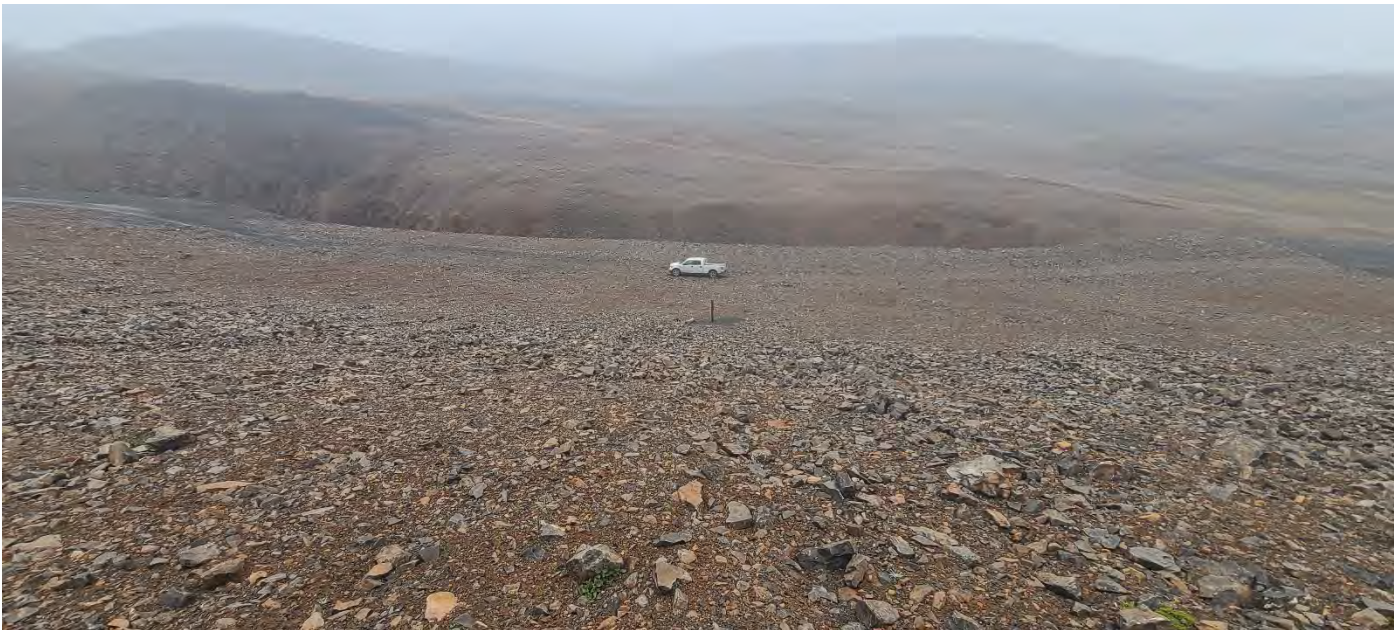
Photo 50. West Open Pit – Surface of cover system looking downslope (south).

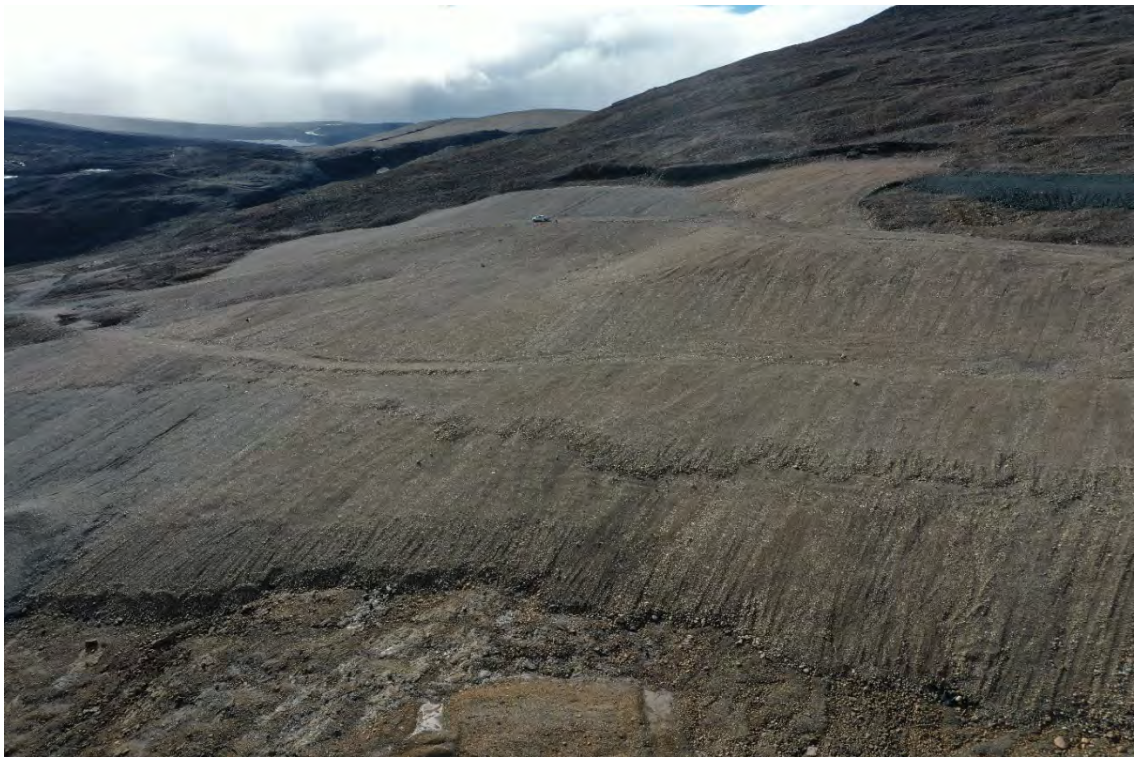
Photo 55. East Open Pit – Overview of eastern portion of the cover system, as seen from UAV.

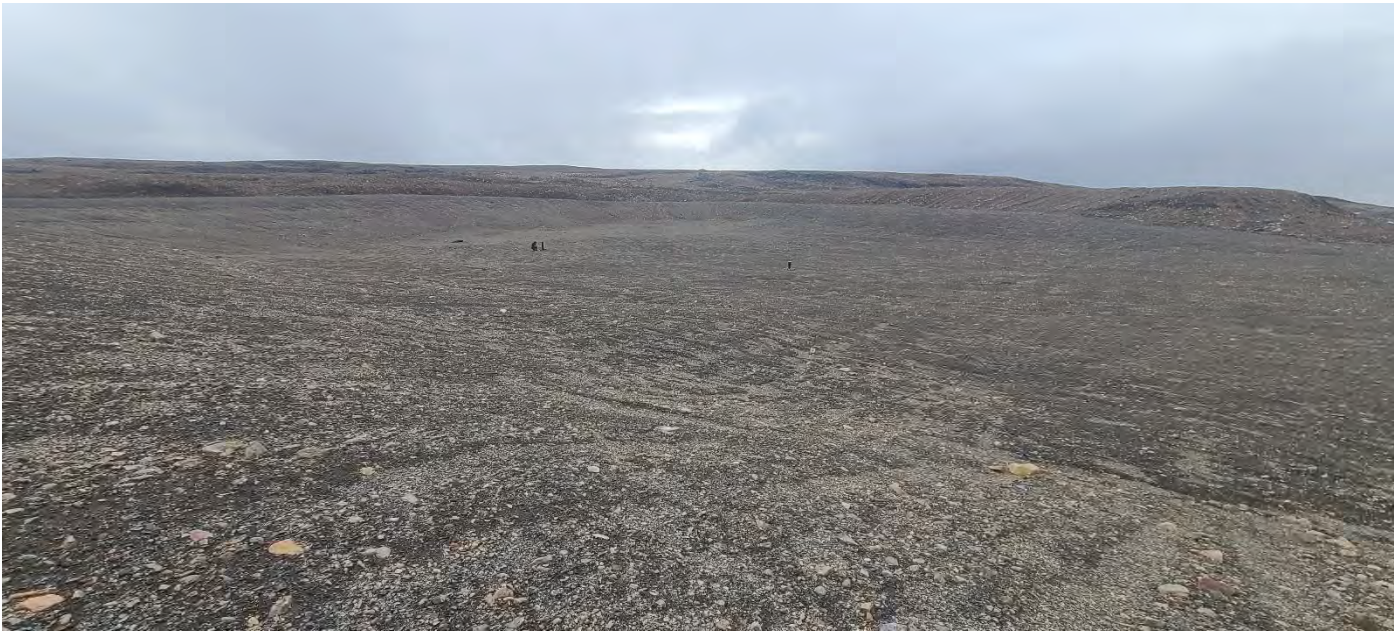
Photo 61. Oceanview Pit – Overview of cover system.

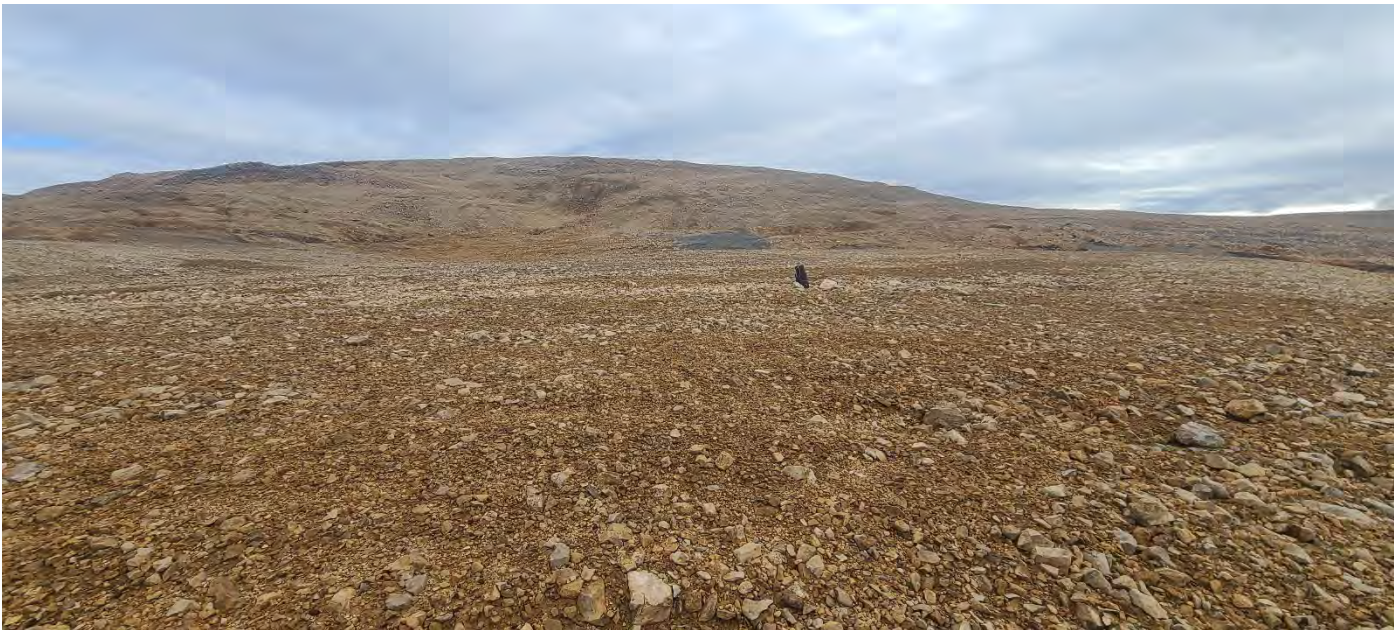
A photo from the inspection is provided in Appendix II (Photo 62). The main observations are summarized by the following:

Photo 62. Area 14 - Overview of flat surface of cover.

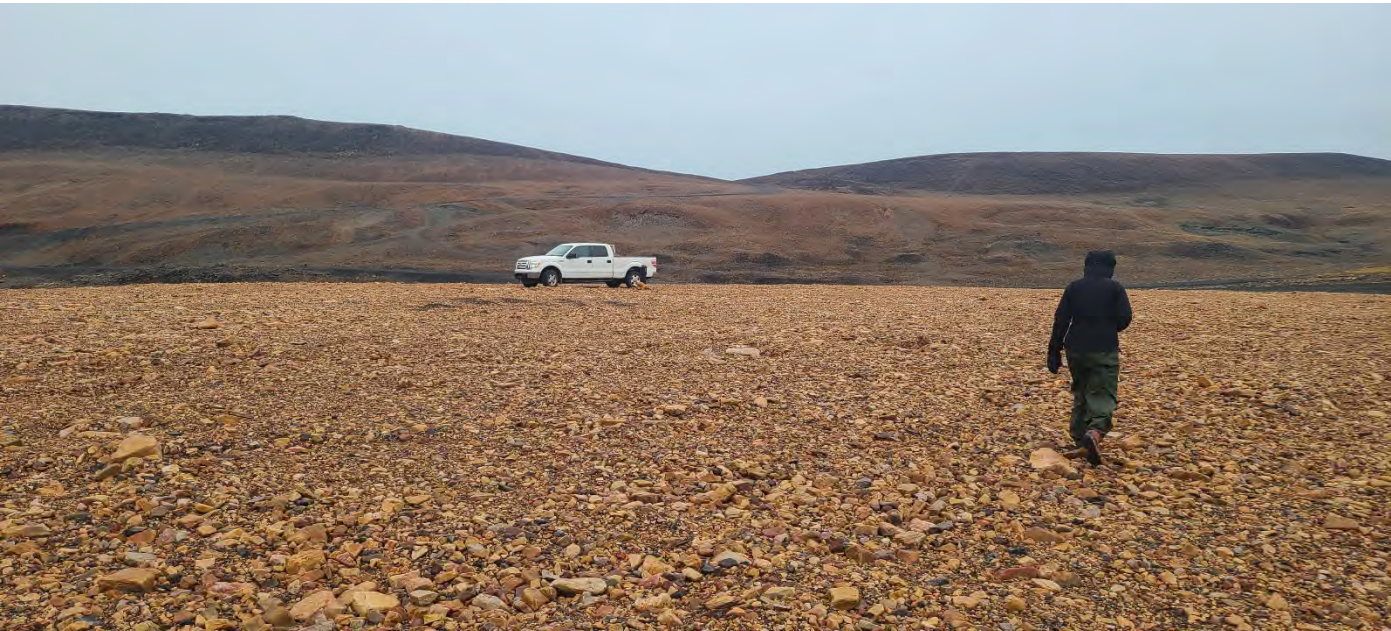
Photo 63. Upper Dump Pond – Flat surface of thermal cover system.

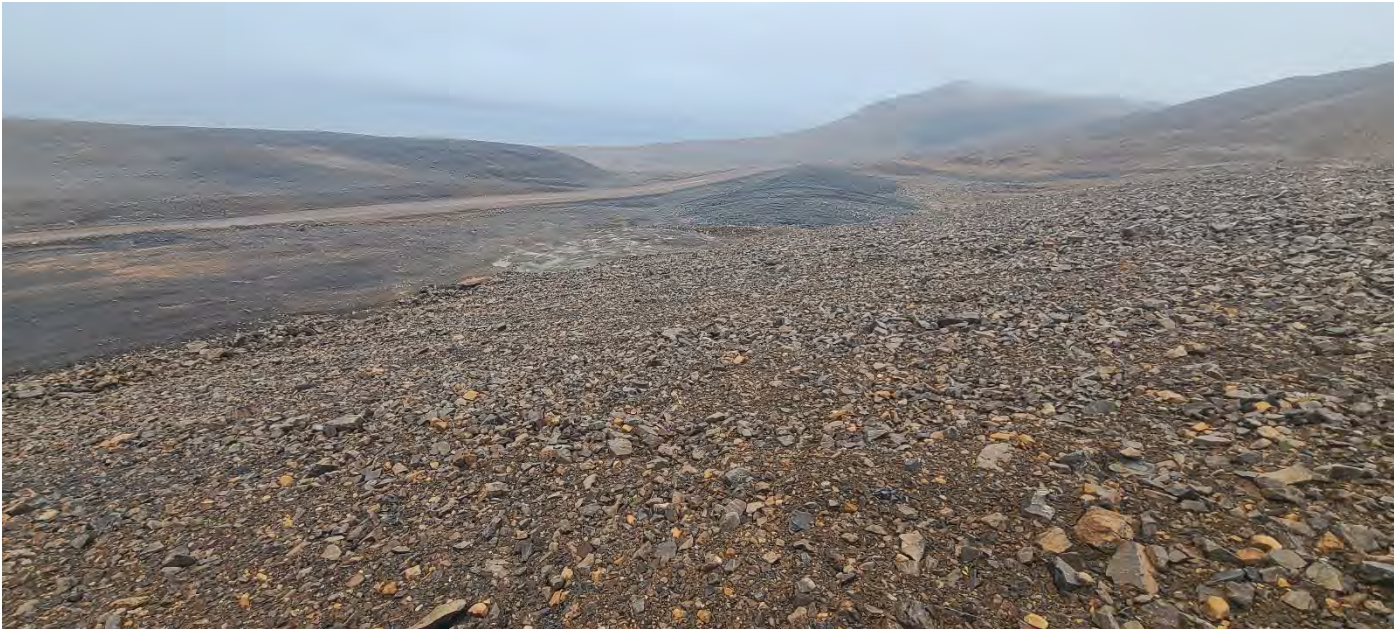
Photo 66. Industrial Complex – Sloping face of cover system.

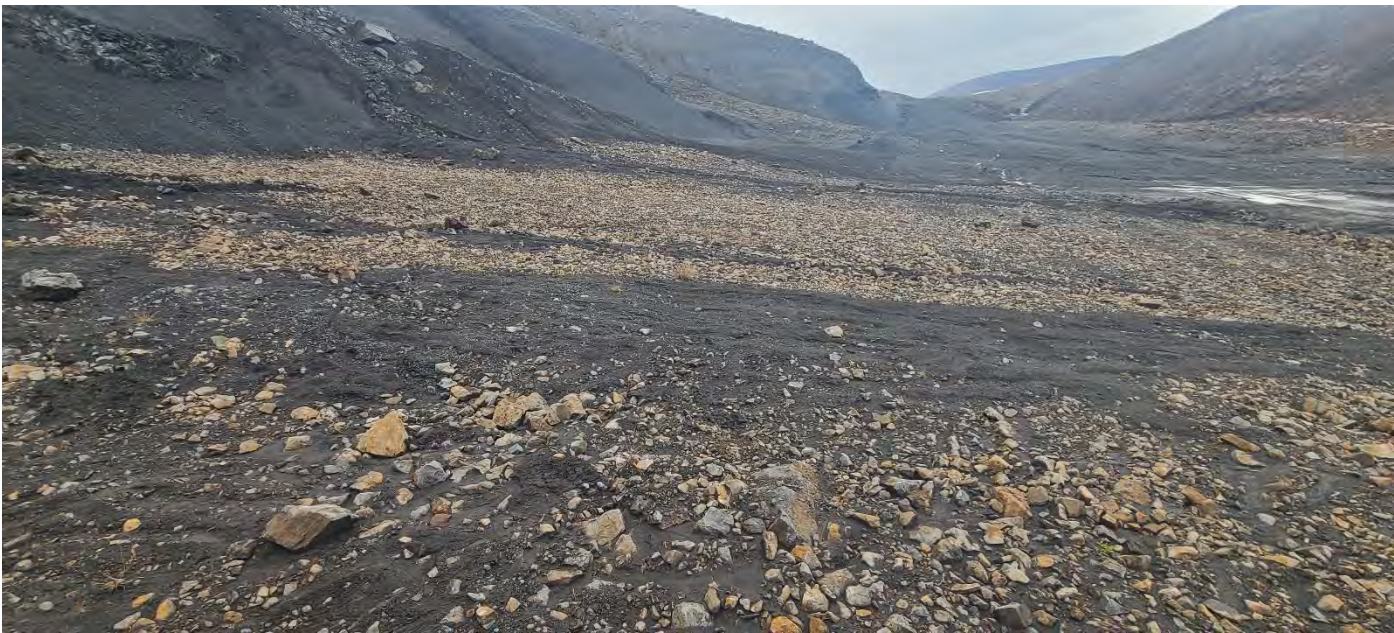
A photo from the inspection is provided in Appendix II (Photo 70). The main observations are summarized by the following:

Photo 70. 09S Portal – Looking along plug.
