CANZINCO MINES LTD.

NANISIVIK MINE, NUNAVUT

2022 ANNUAL GEOTECHNICAL INSPECTION

PROJECT NO.: 0255034

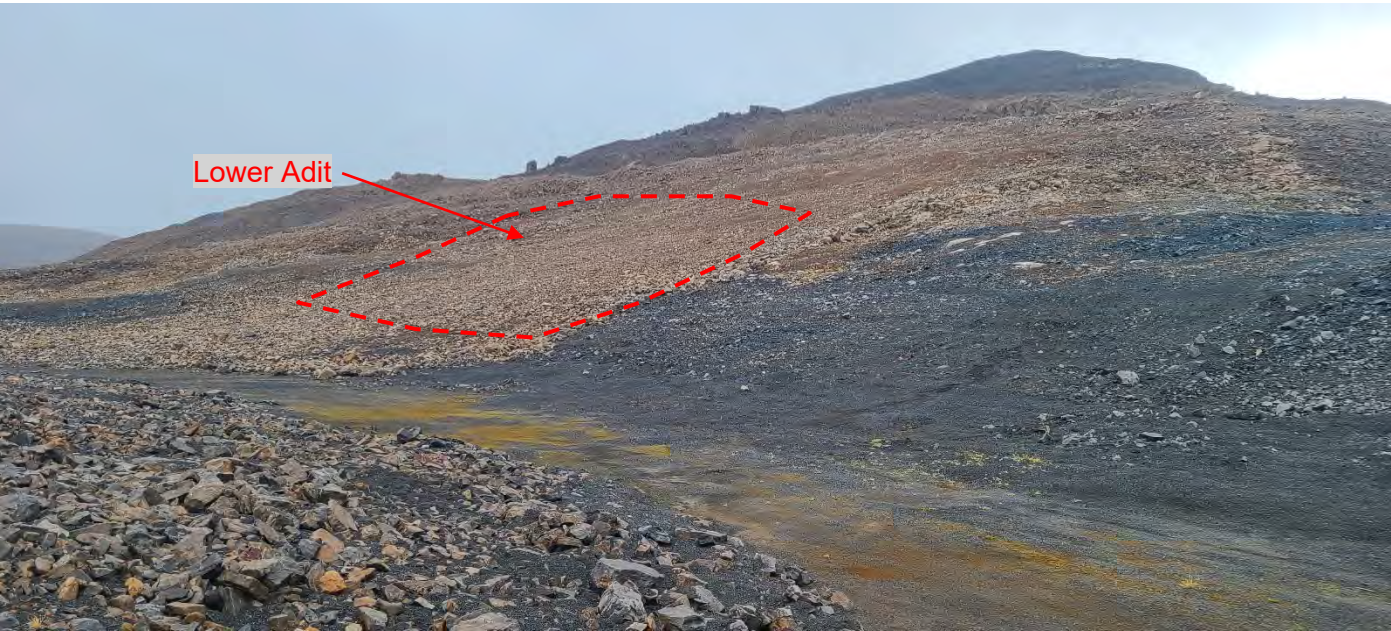
An inspection photo is provided in Appendix II (Photo 71). The main observations are summarized by the following:

Photo 71. Lower Adit – Sloping face of cover system as seen from UAV.

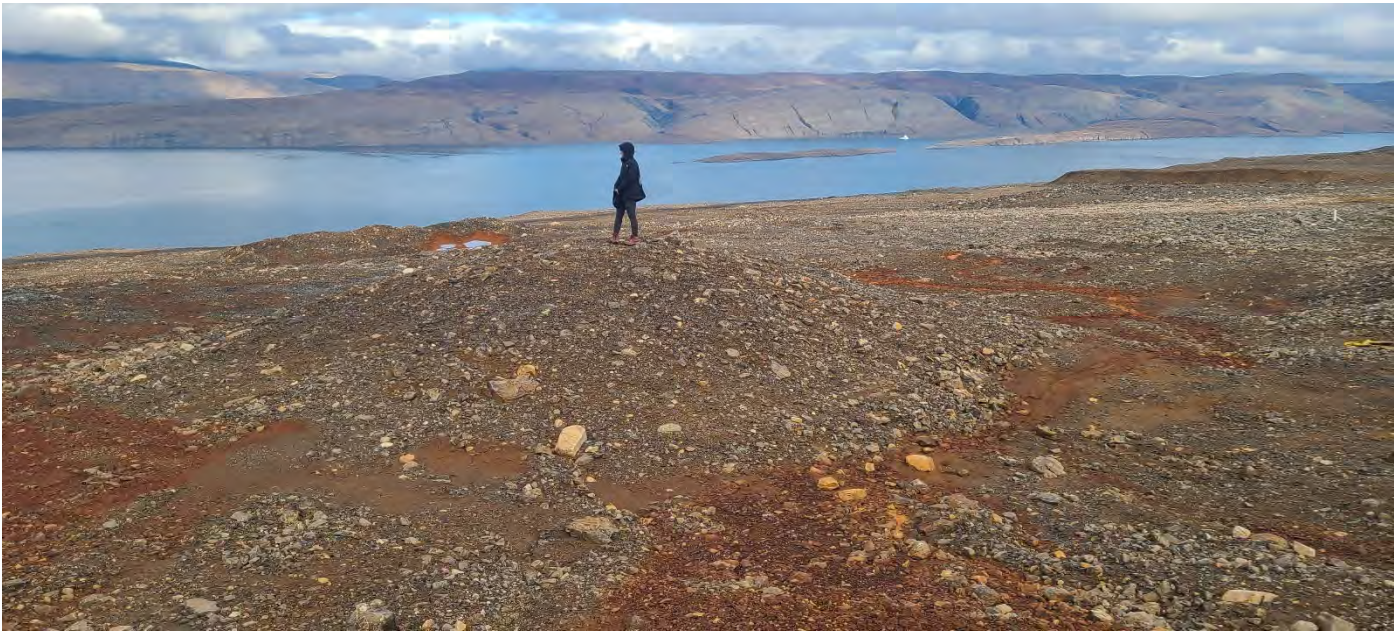
A photo from the inspection is provided in Appendix II (Photo 73). During the inspection, the armour surface appeared to be stable with no visual indications of erosion or surface deformation. As such, no maintenance was recommended.

Photo 73. Oceanview East Raise – Surface plug, view looking north.

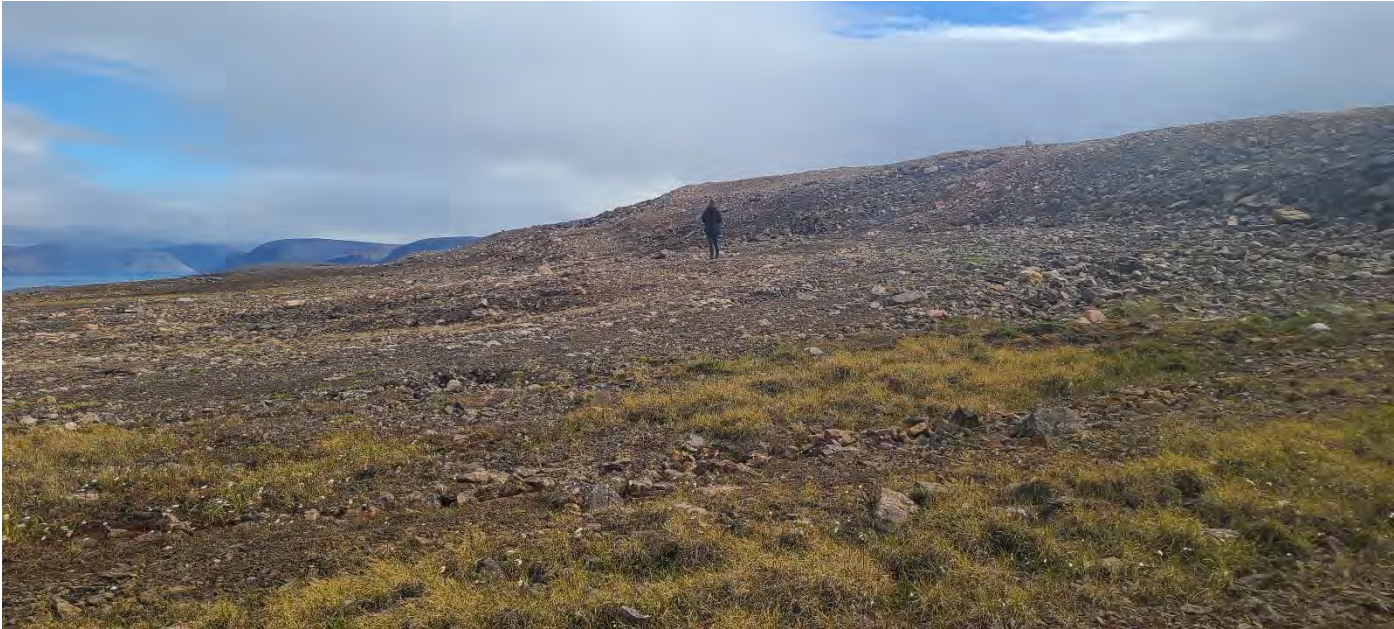
A photo from the inspection is provided in Appendix II (Photo 74). During the inspection, the armour surface appeared to be stable with no visual indications of erosion or surface deformation. As such, no maintenance is recommended.

Photo 74. Oceanview West Raise – Surface plug, view looking east.

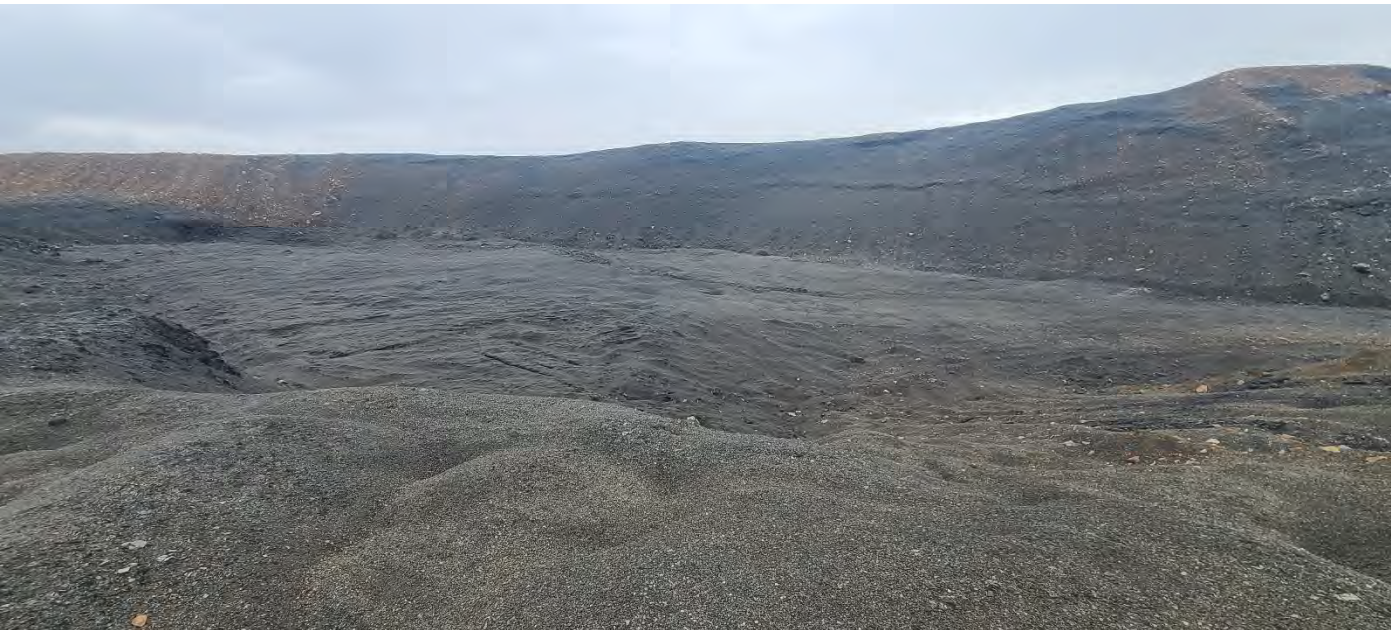
Photo 76. Shale Hill Borrow Area – As seen from road.
