## **NANISIVIK MINE, A DIVISION OF CANZINCO LTD.**

### **2009 ANNUAL GEOTECHNICAL INSPECTION**

### **NANISIVIK MINE, NUNAVUT**

PROJECT NO.: 0255-019-03  
DATE: MARCH 26, 2010

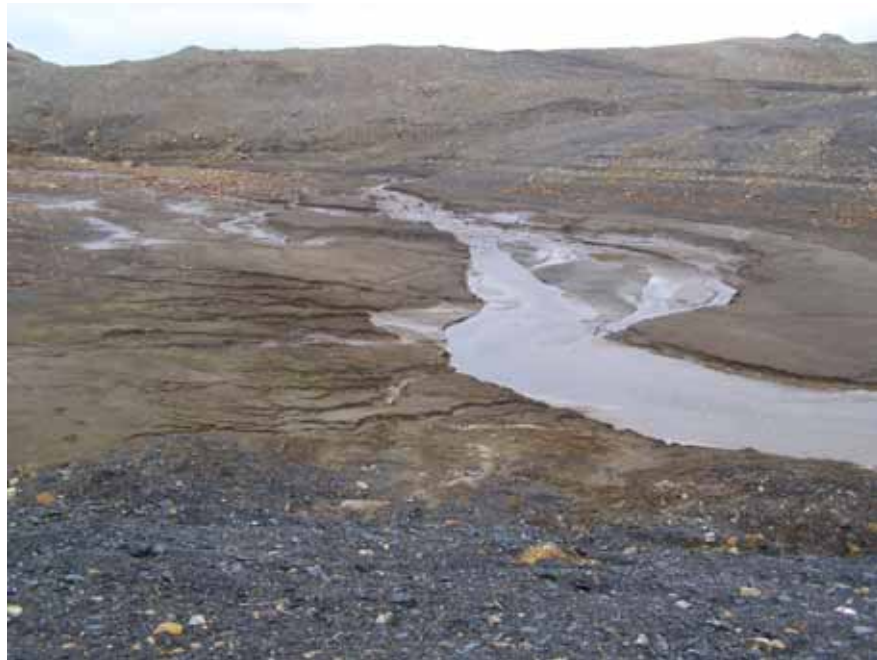
Photo 2 East Adit Treatment Pond.  
Channelized sediments in the bottom of the East Adit treatment pond.

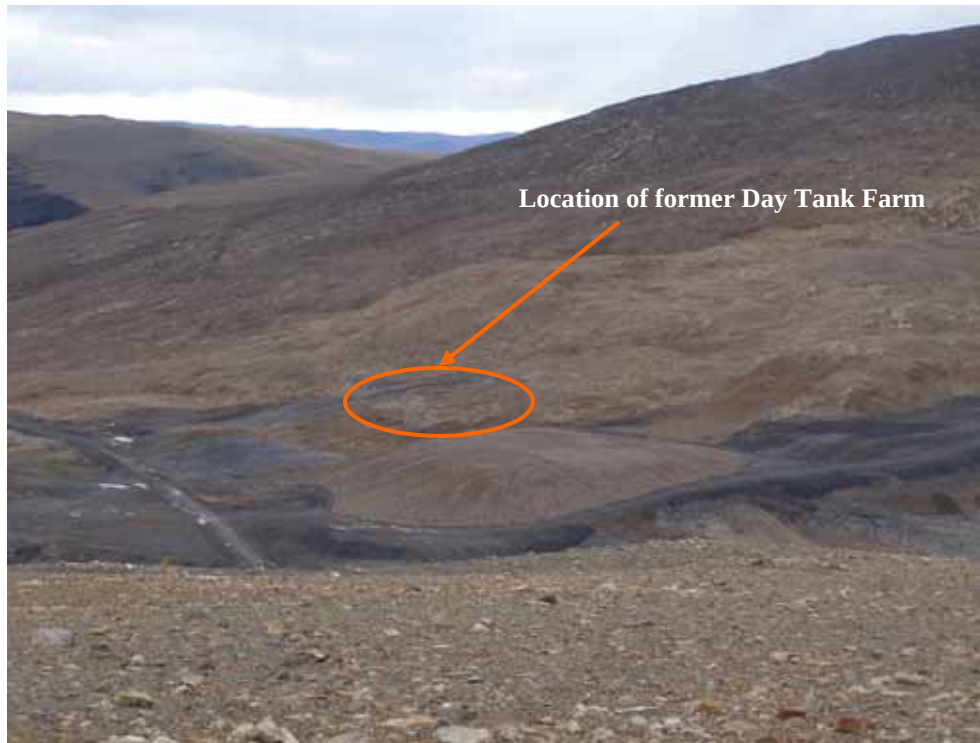
Photo 3 Industrial Complex as seen from Stol Port. Note location of former Day Tank Farm.

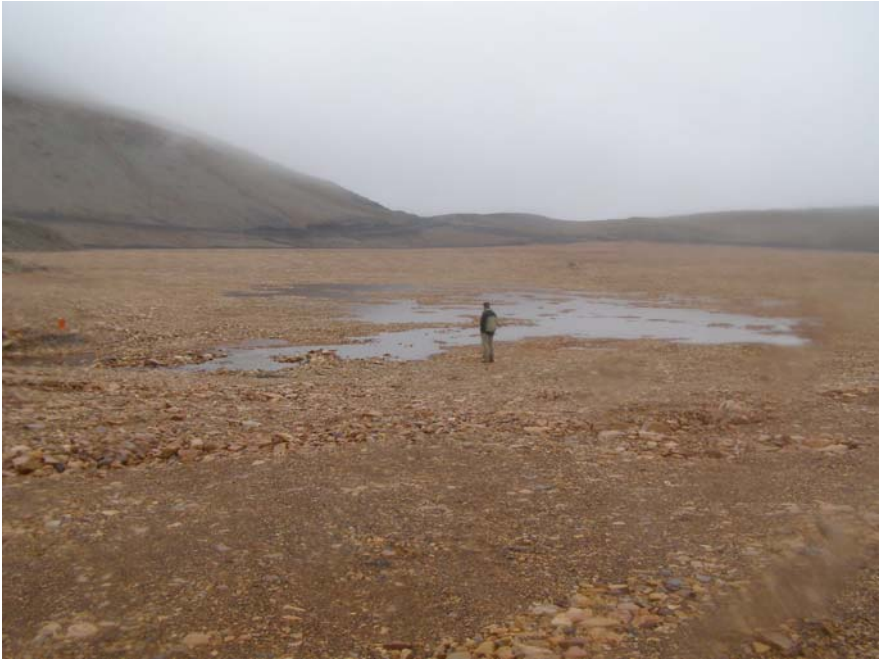
Photo 9 Head pond at spillway entrance. Note presence of exposed armour material in middle of pond which indicates a reduction in the water level of the retained pond.

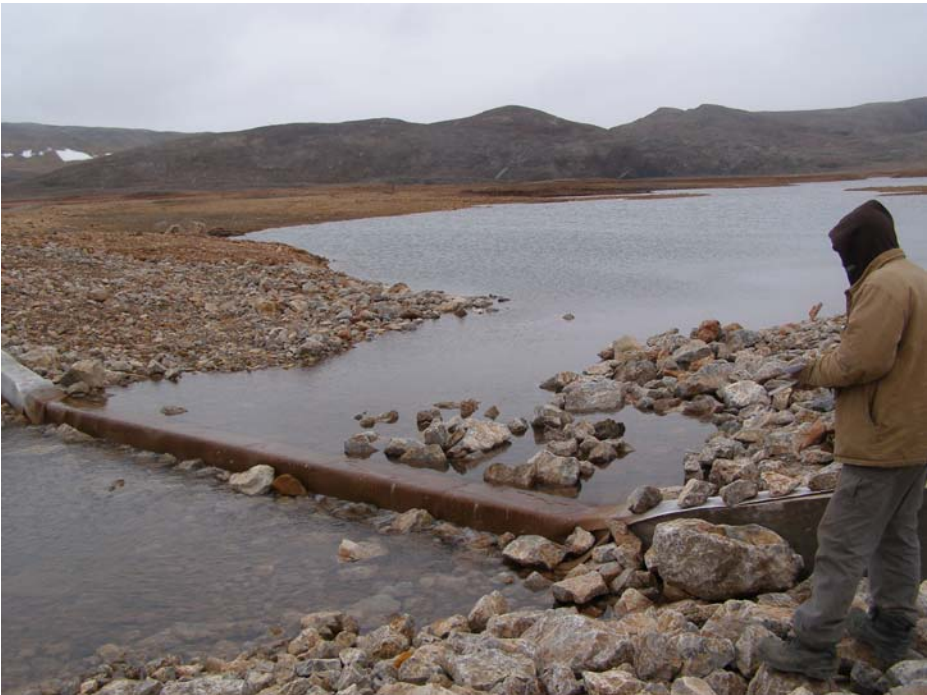
Photo 11 West Twin Outlet Wall in mid-August. Note water is flowing over the wall.

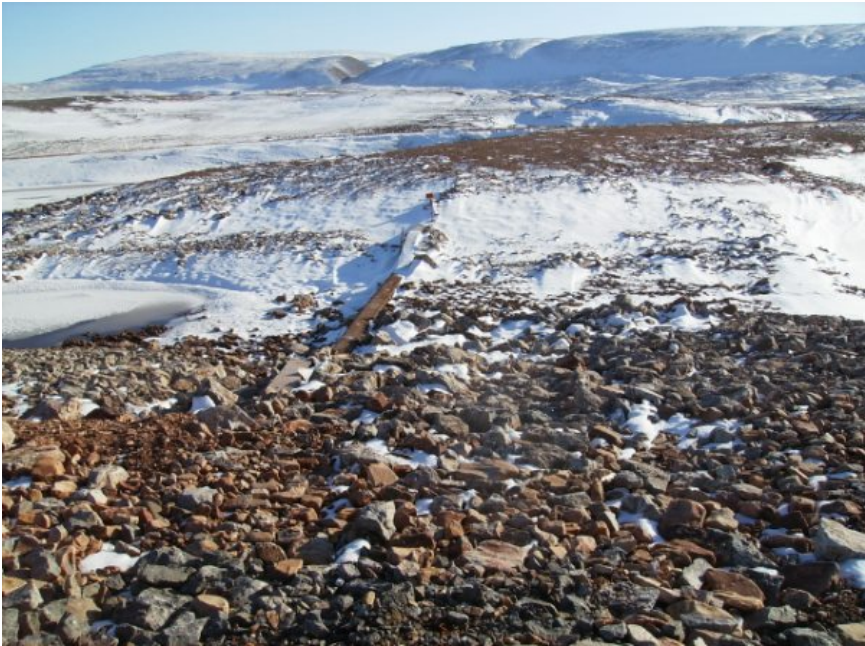
Photo 14 West Twin Outlet Wall in early October 2009. Note reduction in water level upstream of wall.

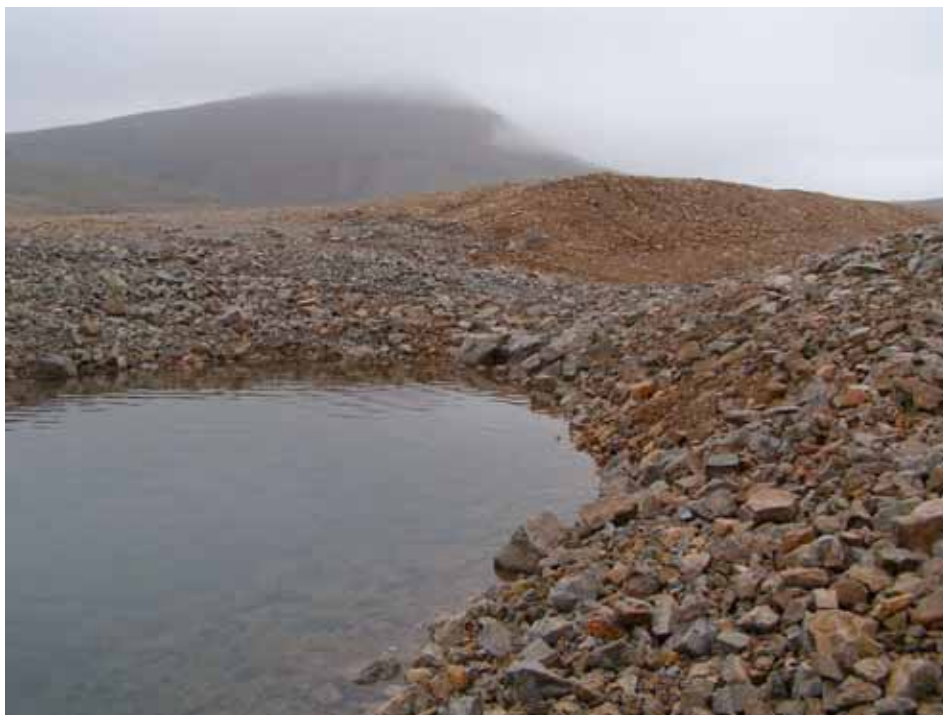
Photo 22 Rip rapped Test Cell outlet. Note riprap extended below water line.

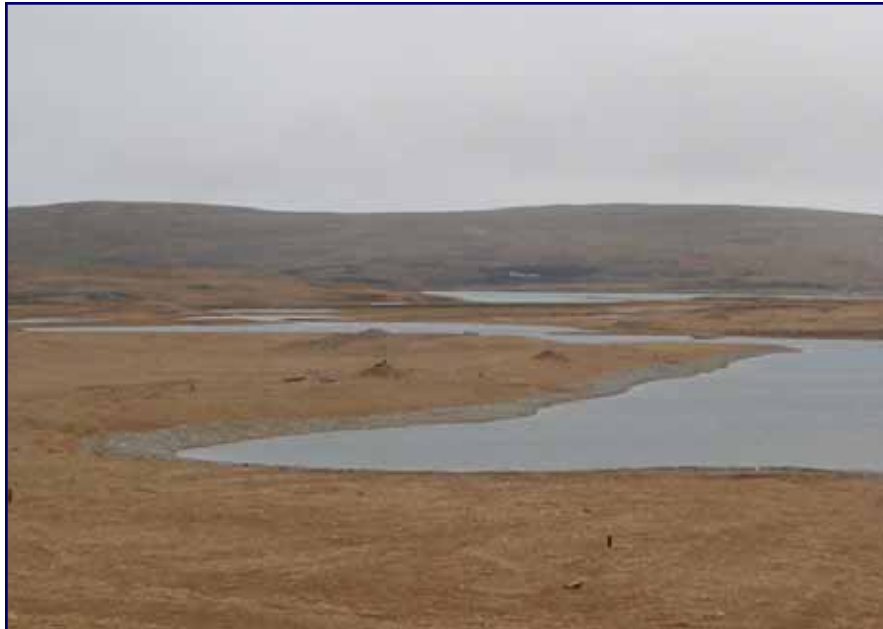
Photo 24 Riprap along toe of East/West arm of Test Cell Dike.

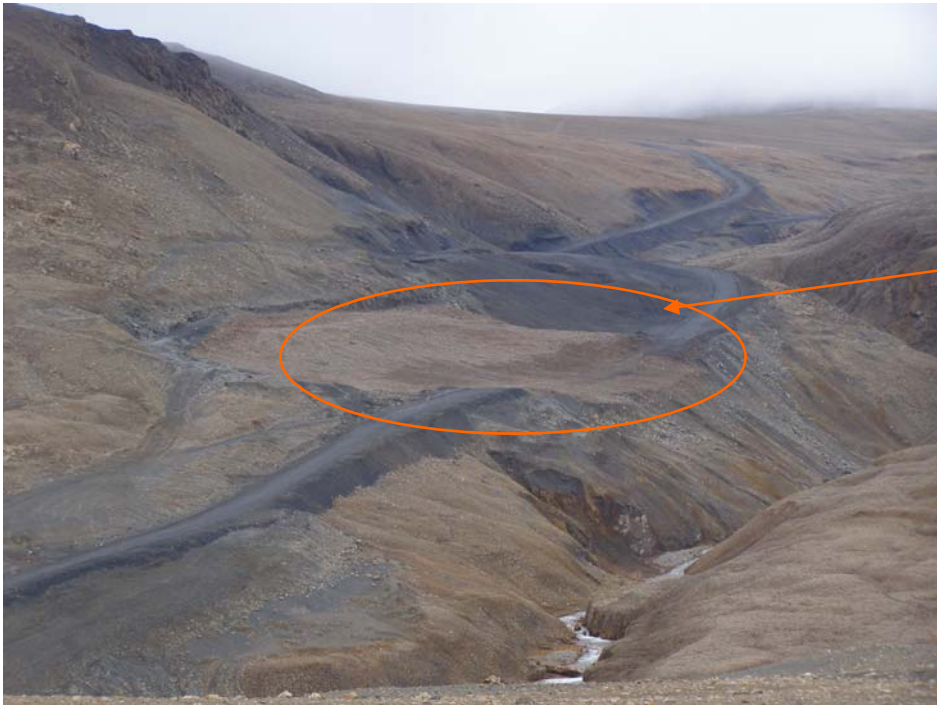
Armour placed on road surface

Photo 31 West Open Pit waste rock cover as seen from Stol Port. Note that the road has been armoured over.

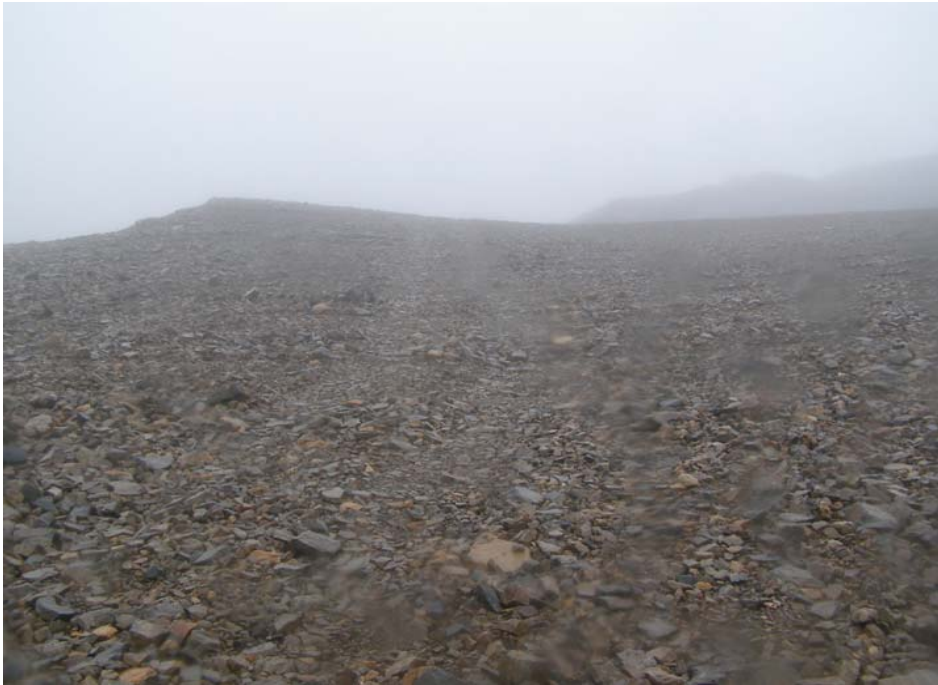
Photo 34 Surface of West Open Pit cover, roadway is armoured as requested in 2008.

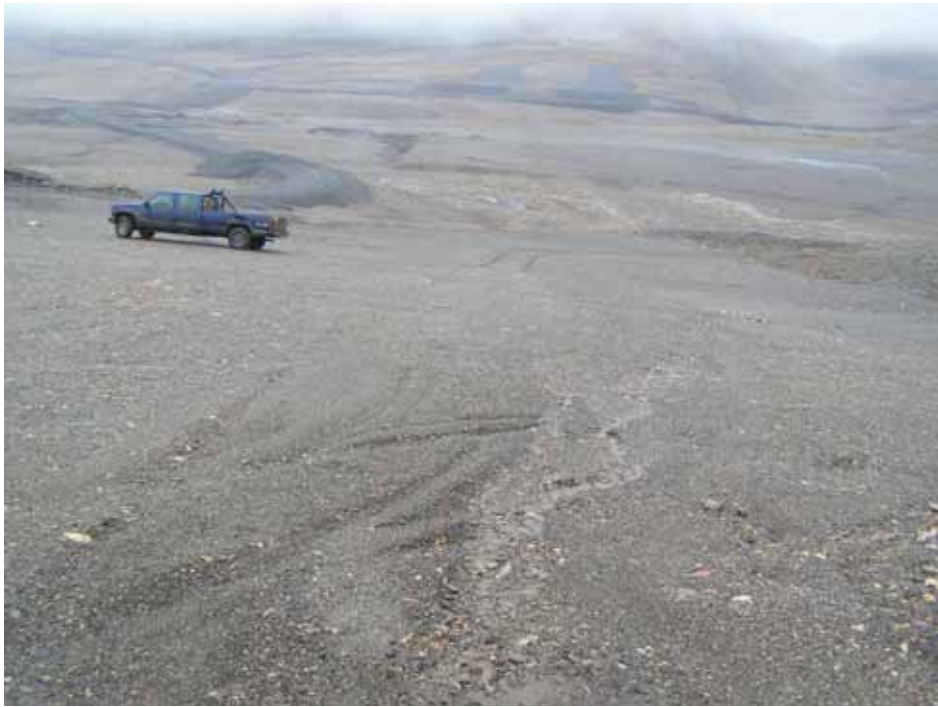
Photo 39 East Trench cover as seen from the upslope area.

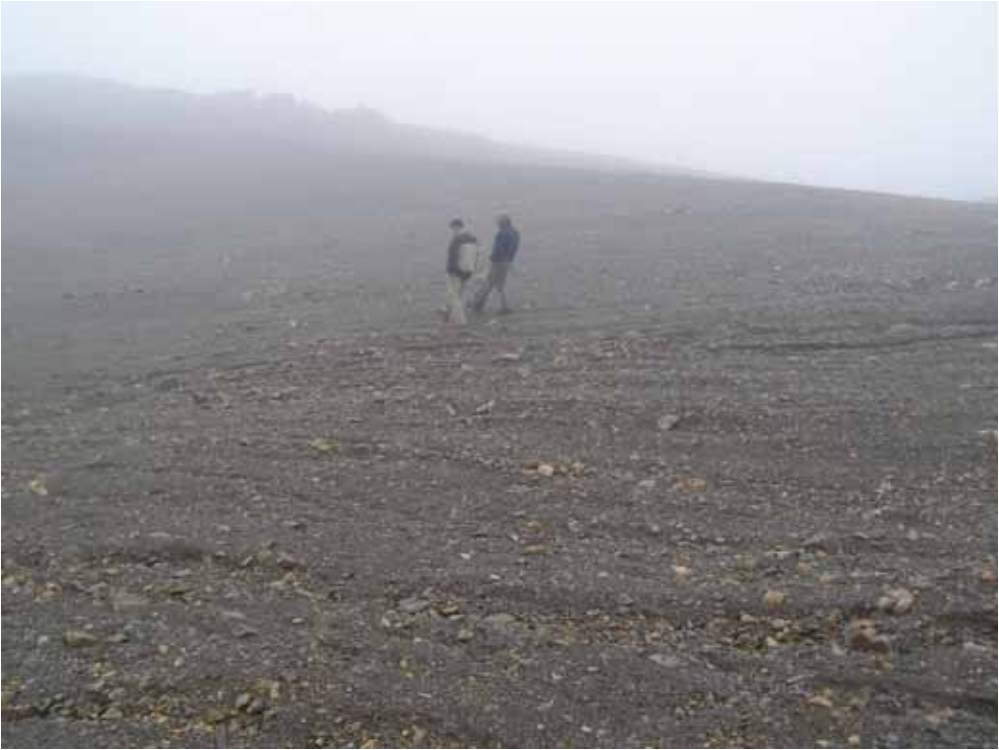
Photo 42 Minor rill erosion occurring on Oceanview Pit cover.

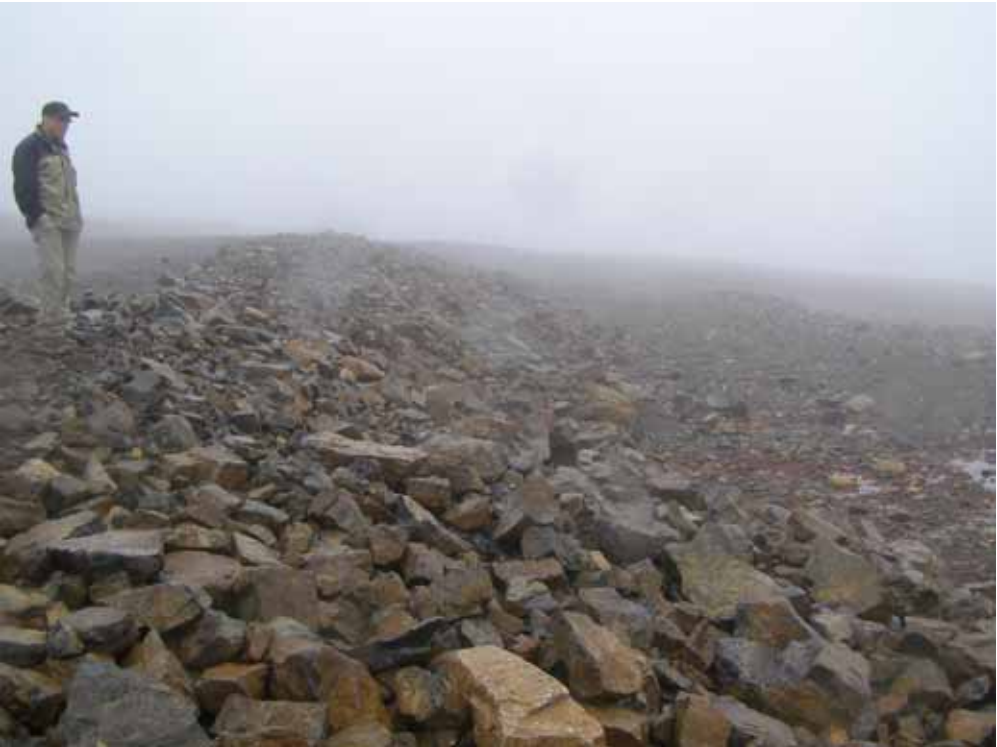
Photo 44 Rockfill placed against the toe of the Oceanview Open Pit cover.

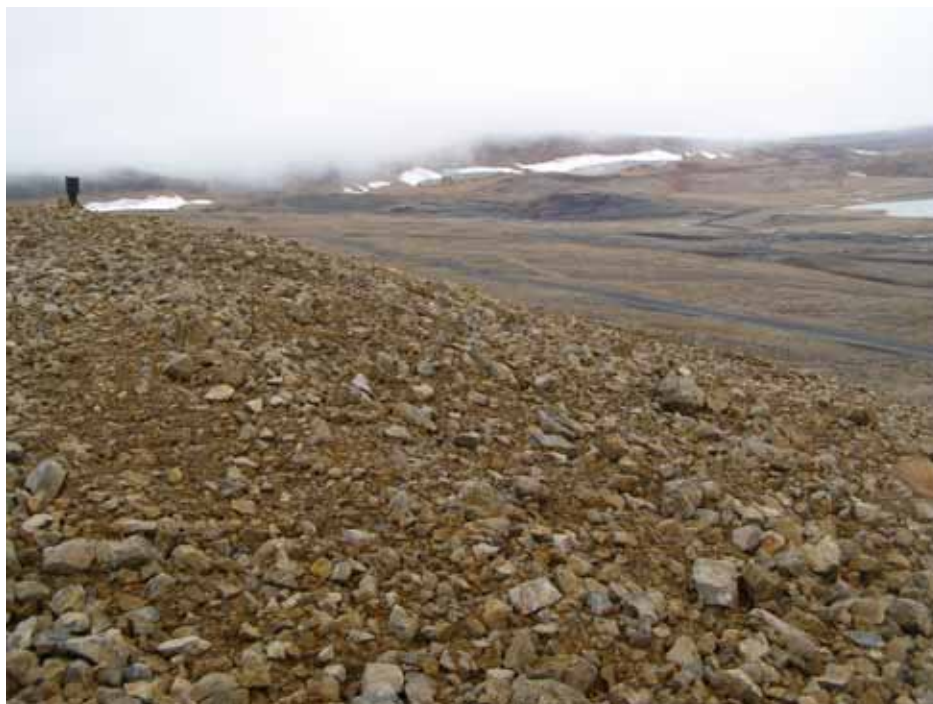
Photo 45 Face of the Area 14 Portal Cover. View looking south. Note frost gauge instrument at the crest of the slope.

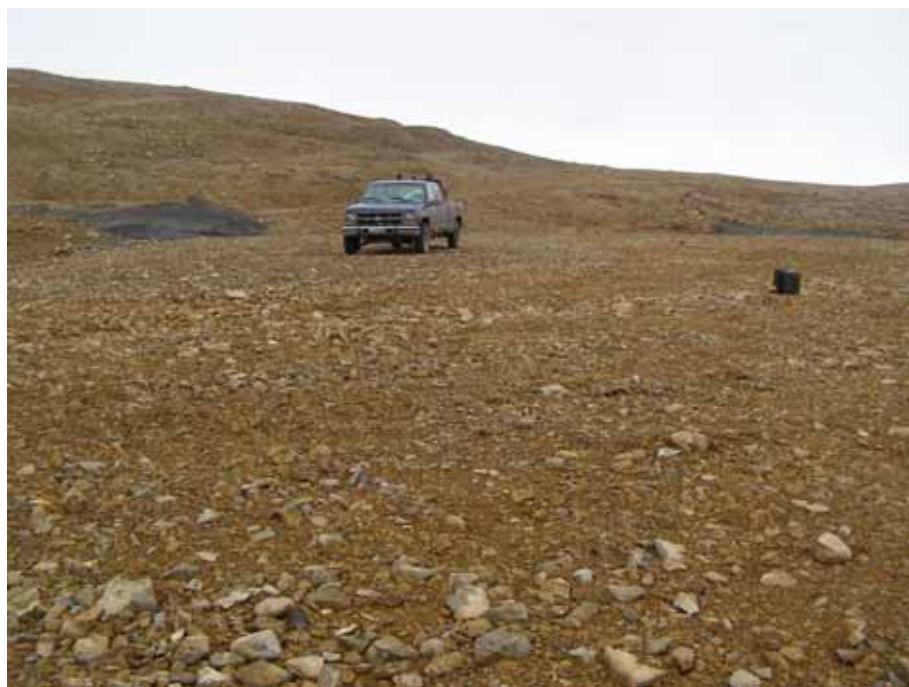
Photo 46 Upper flat surface of the Area 14 waste rock cover.

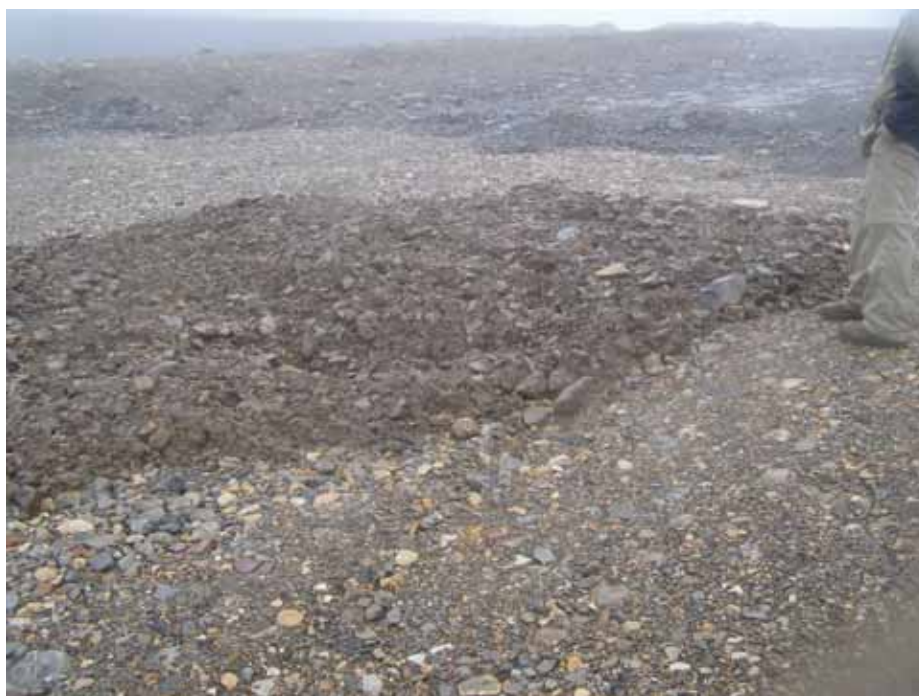
Photo 50 Backfilled thermokarst feature in 17N Portal Cover. Note that it is continuing to show signs of surficial disturbance.

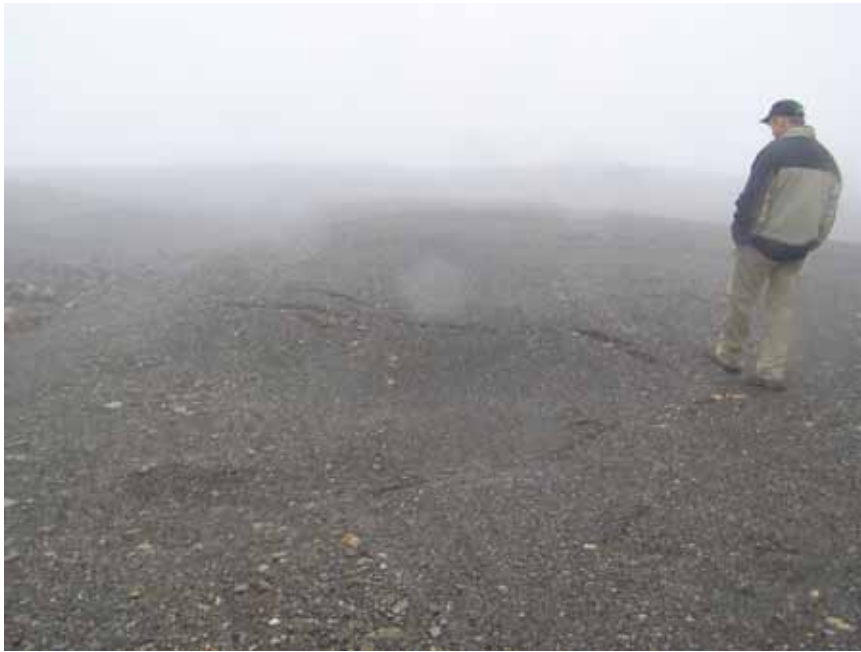
Photo 51 Settlement depression at the southwest corner of the Oceanview Portal cover. Note that the depression does not appear to have progressed since 2008.

| <b>Inspection Item</b> | <b>Recommended Maintenance/ Action items</b> |
|---|---|
| Oceanview Portal | No maintenance required. Continue to visually monitor settlement and cracking areas. |

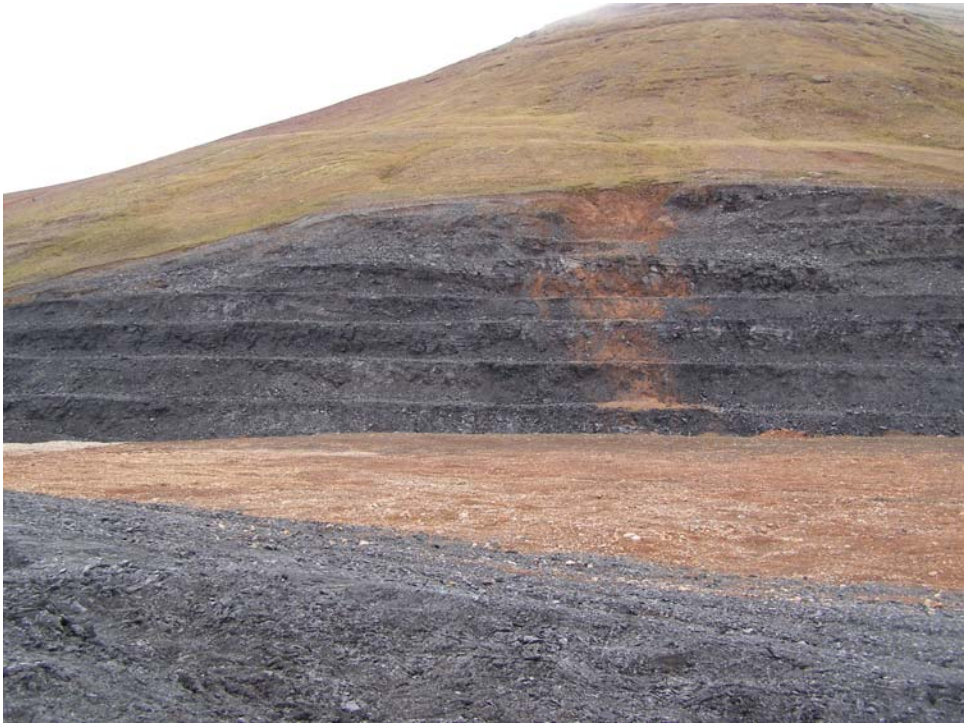
Photo 64 Mt. Fuji shale borrow area. Note the natural cover material is falling down from above over the benches.

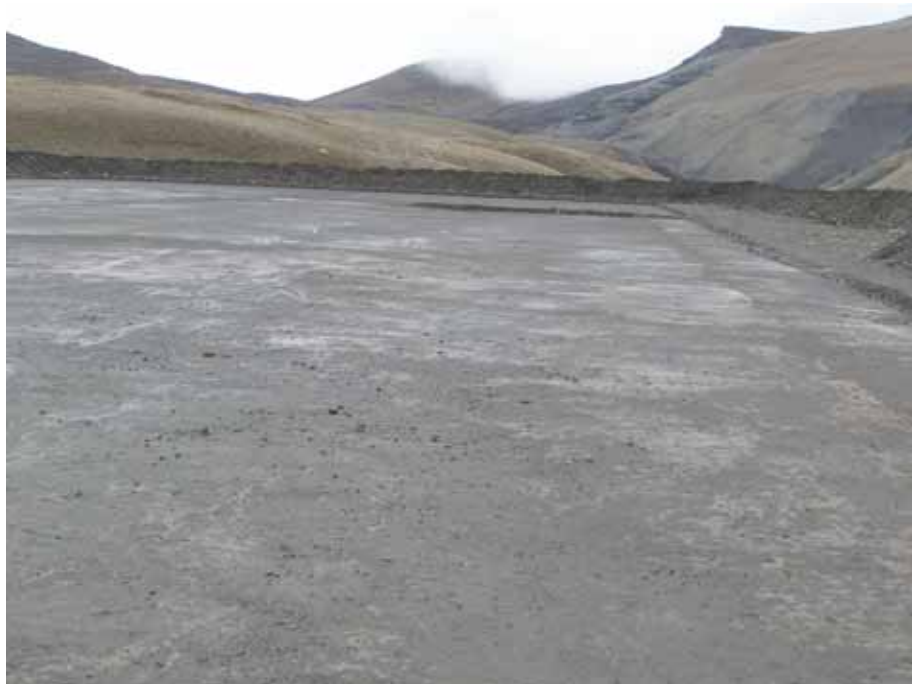
Photo 67 Exposed Concentrate Storage Shed floor. Cover was recently removed by the Coast Guard.

It was recommended that the removed portion of the Concentrate Storage Shed surficial cover be returned to a satisfactory condition.
