NANISIVIK MINE, A DIVISION OF CANZINCO LTD.

2006 ANNUAL GEOTECHNICAL INSPECTION

NANISIVIK MINE, NUNAVUT

PROJECT NO.: 0255-013-08
DATE: JANUARY 10, 2007

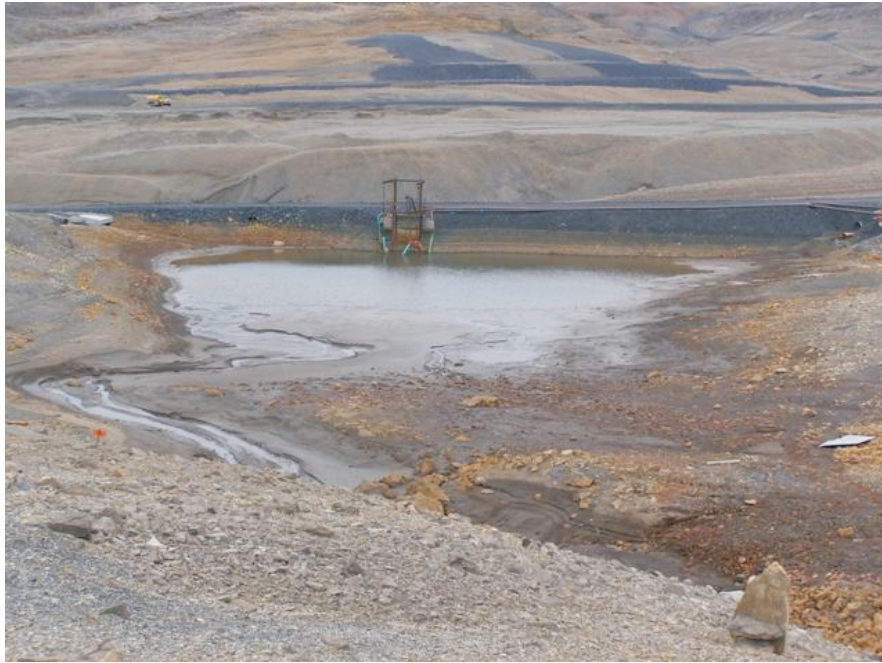
Photo 1
East Adit Treatment Pond and Dike. Note the low water level in the pond.

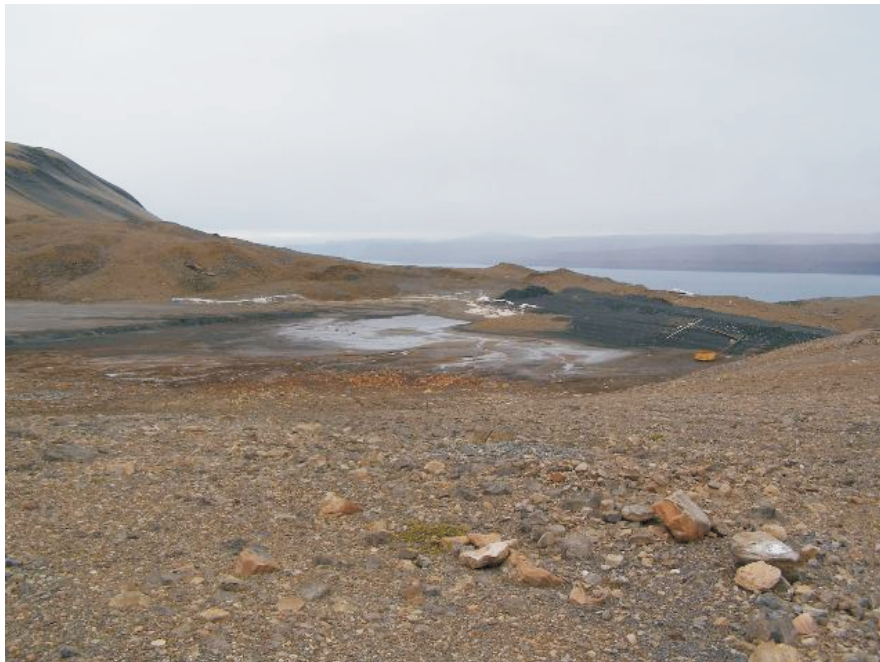
Photo 2
East Adit Retention Pond and Dike. Note the low water level as well.

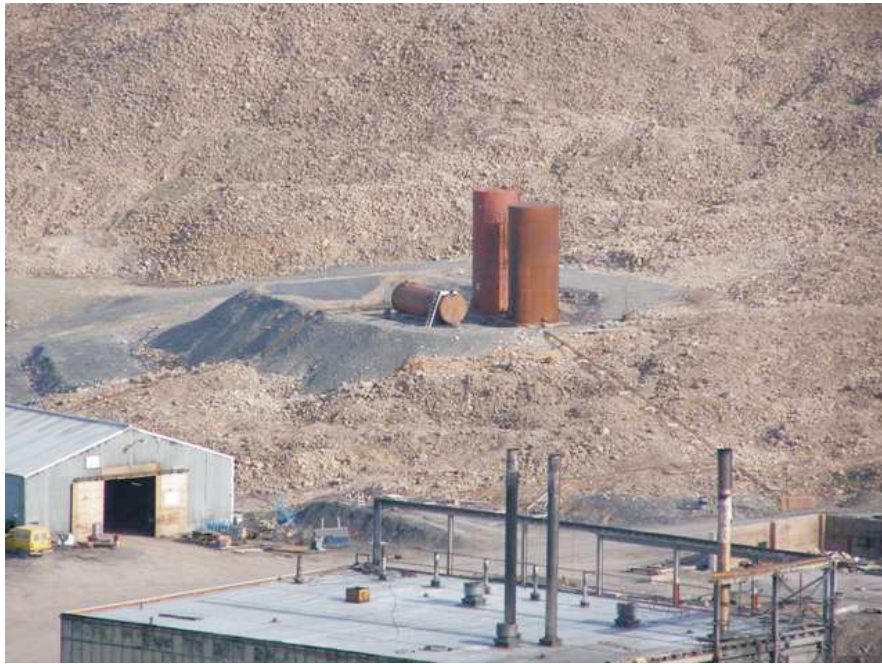
Photo 3
Day tank farm and seepage collection berm.

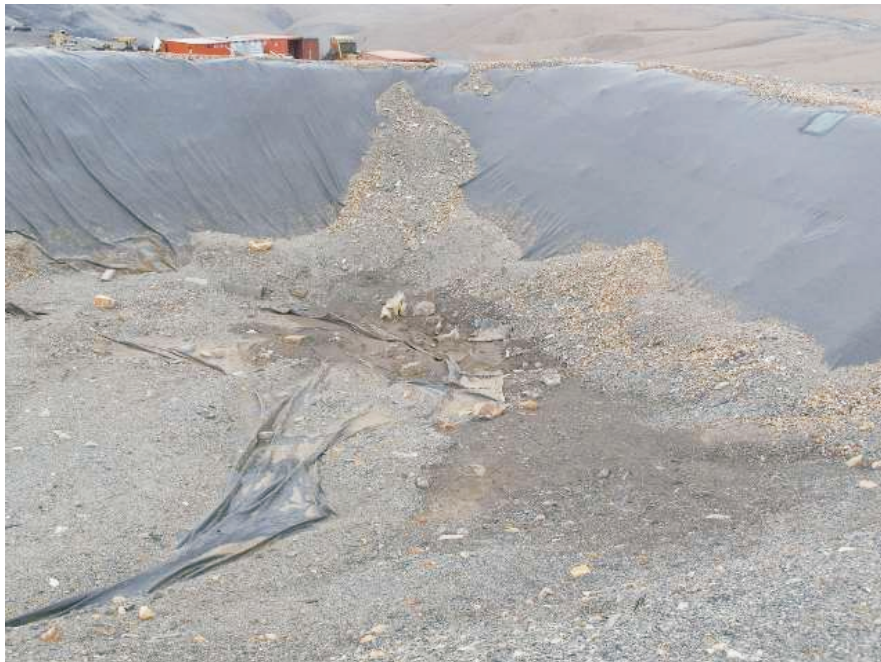
Photo 4
Day tank farm seepage collection berm. Note there is no water in the cell and the disturbed liner in the corner.

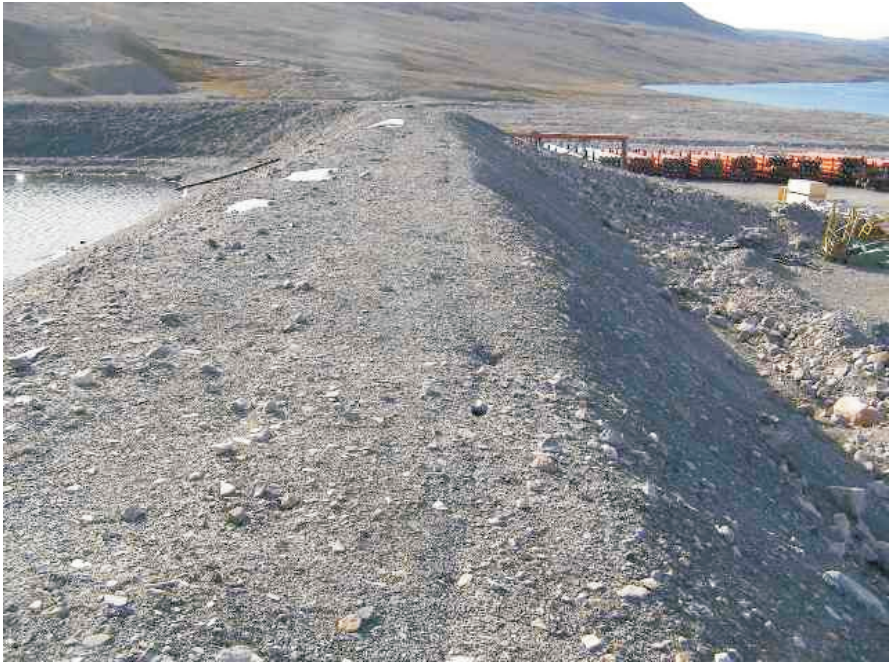
Photo 5
Main tank farm seepage collection berm on the downhill side.

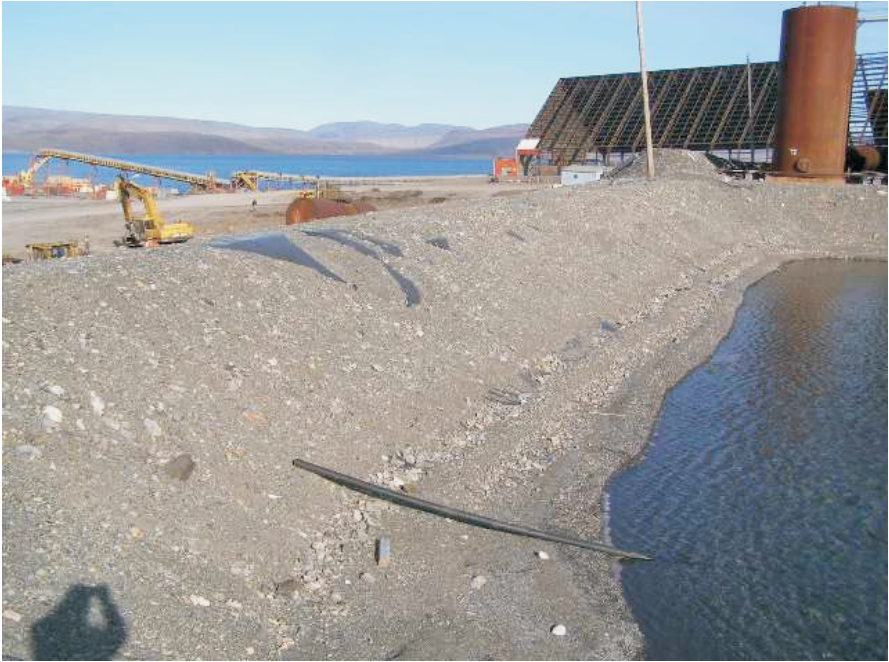
Photo 6
Main tank farm seepage collection berm. Note exposed liner.

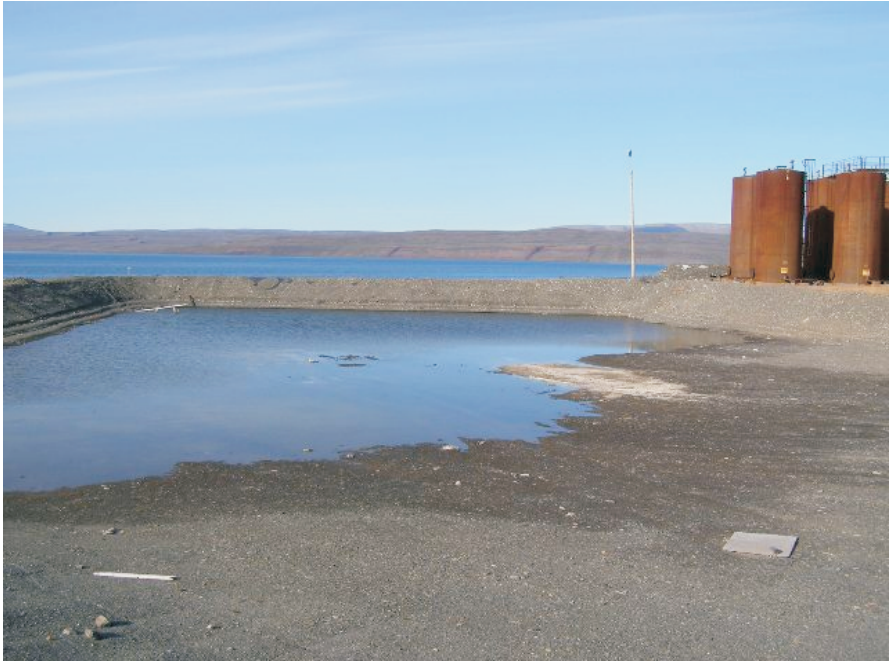
Photo 7
Water in seepage collection pond.

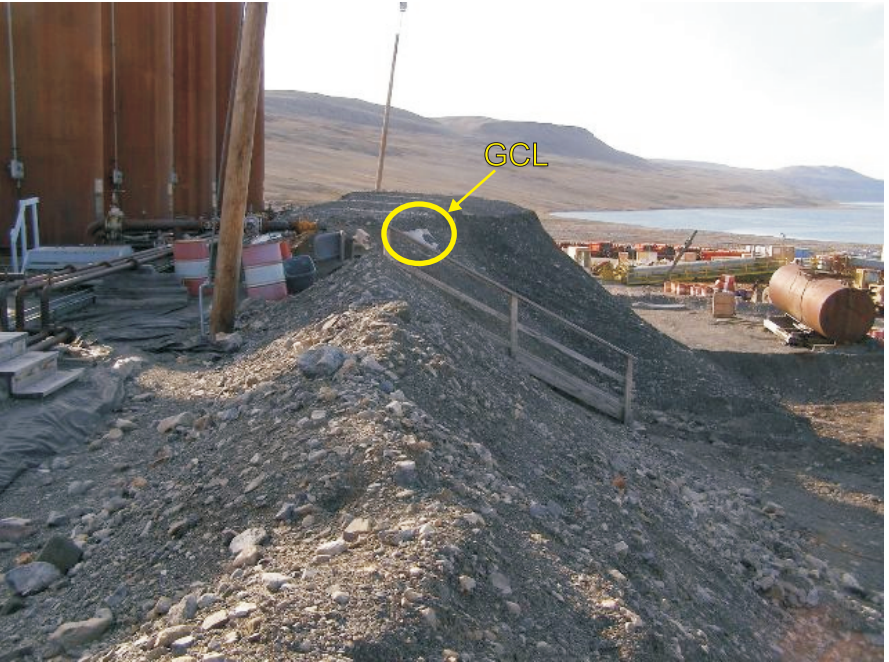
Photo 8
Seepage collection berm. Note a portion has been excavated during removal of hydrocarbon contaminated soils, and exposed the underlying GCL.

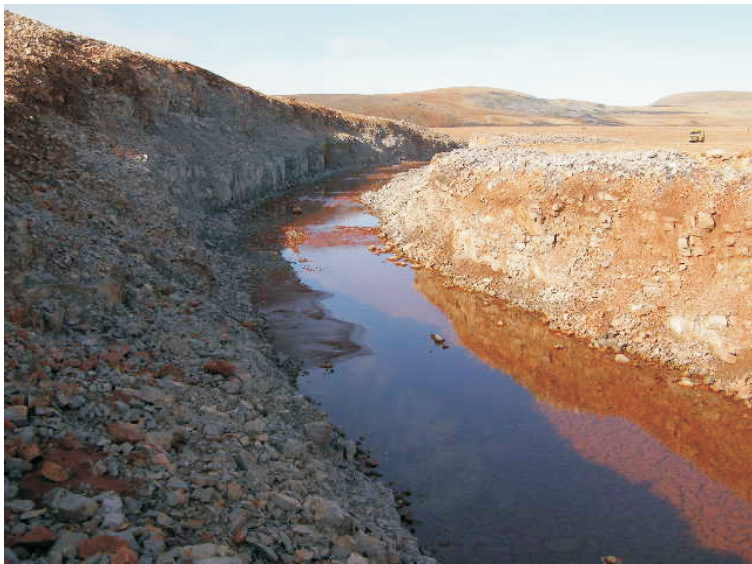
Photo 9
Water running in spillway between inlet and access ramp.

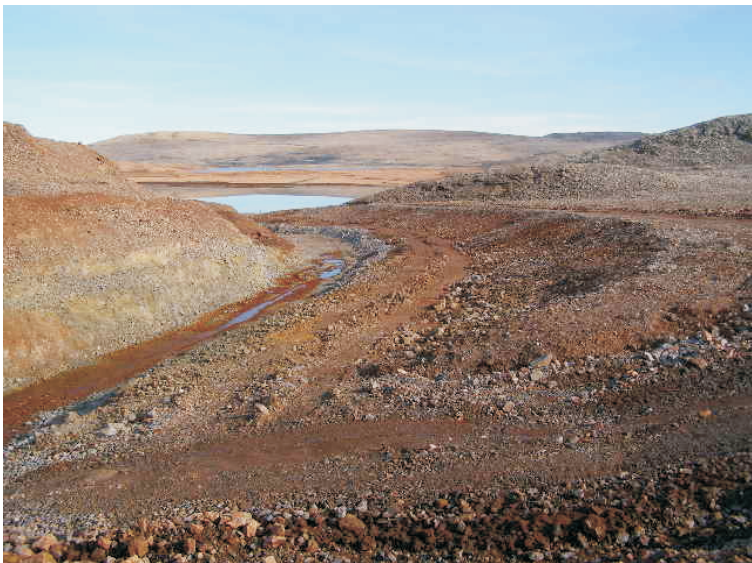
Photo 10
Spillway downstream of access ramp.

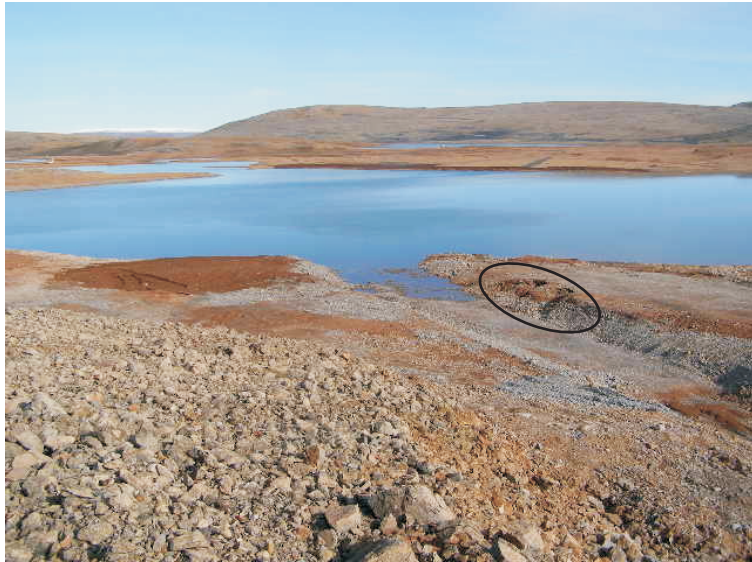
- small pond at inlet, not exceeding 20 cm deep
- some staining on rocks near inlet
- some organic materials growing on rocks at inlet
- bottom of spillway very undulating downslope of access ramp
- thermokarst in spillway side wall near outlet
- some debris continues to fall into spillway in diabase section
- some erosion of access ramp occurring on southwest side
- north side of spillway still needs to be rip rapped

Photo 12
Spillway outlet. Note thermokarsting (circled) along right bank.

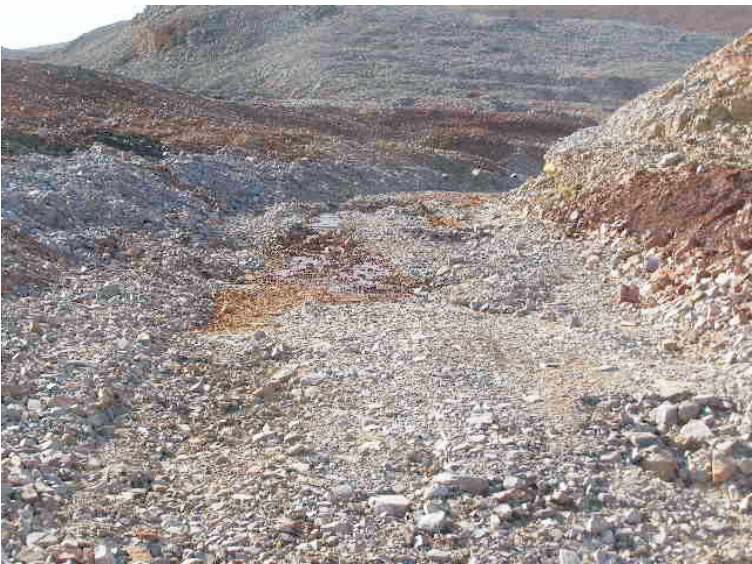
Photo 13
Undulating spillway bottom downstream of access ramp. View looking up gradient.

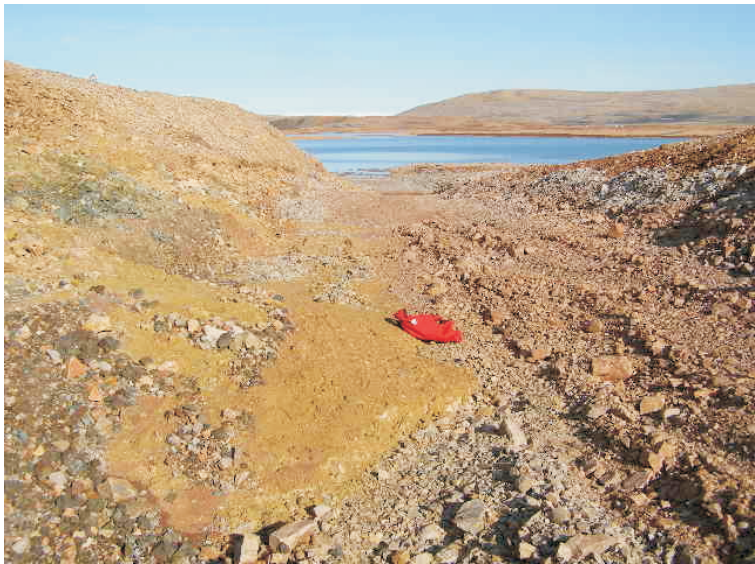
Photo 14
Weathered diabase debris cone in spillway bottom.

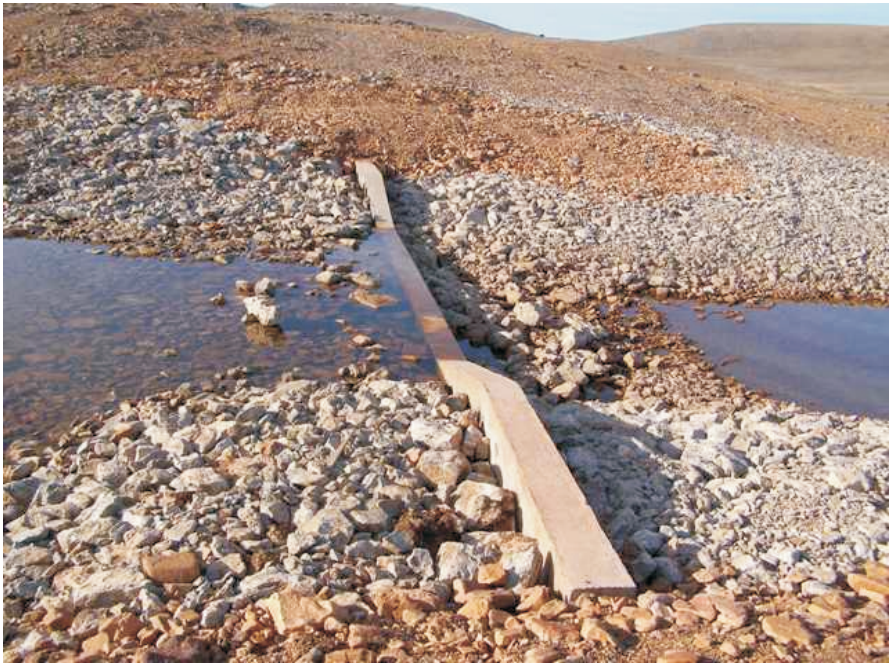
- no erosion of rip rap observed
- some cracking of concrete observed
- water level behind wall appears to decrease with reduced inflows, may indicate seepage beneath or around dike
- rip rap in plunge pool appears to be undersized

Photo 15
Concrete wall at West Twin Outlet Channel.

- place some additional large rip rap in plunge pool
- inspect wall for further cracking/leaks
- monitor water level on pond side of wall to assess leakage

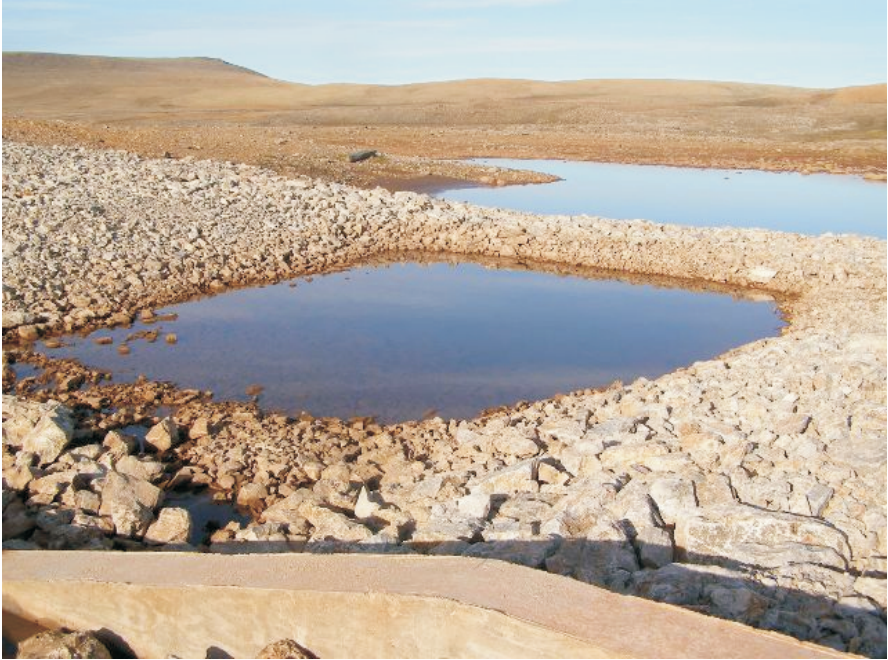
Photo 16
Plunge pool at West Twin Outlet Channel.

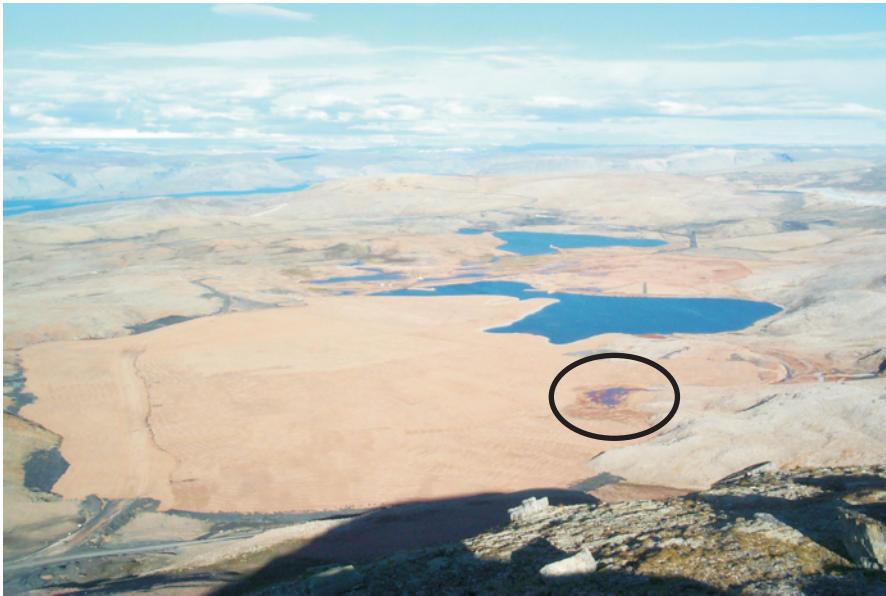
- some cracking and settlement of cover in east/west trench
- one are near north end of cover was not rolled during construction
- small head pond at spillway inlet (approx. 20 cm deep)

Photo 21
Surface Cell and Test Cell covers as seen from Mt. Fuji. Note small head pond (in circle) at spillway inlet.

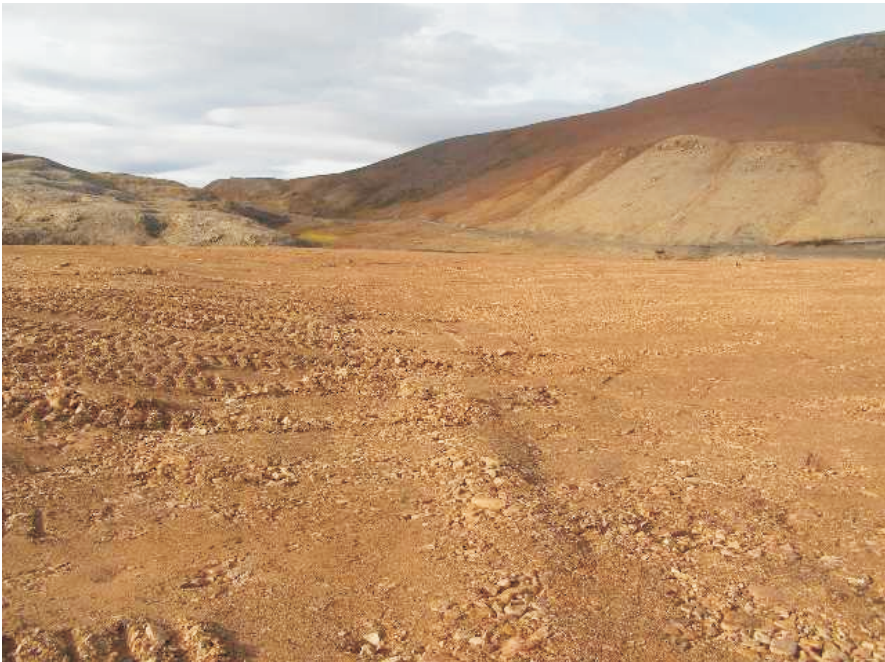
Photo 24
Drainage Swale “B” at Surface Cell.

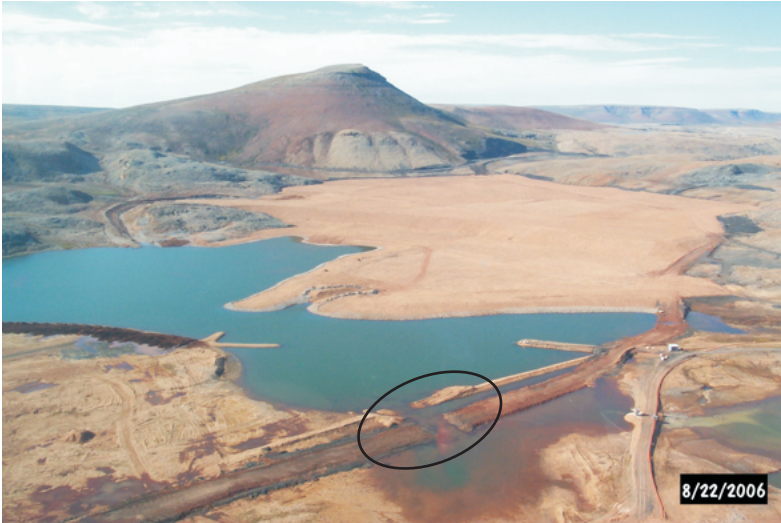
Photo 30
Surface Cell and Test Cell covers. Note breach of rockfill baffle and haul road (in circle).

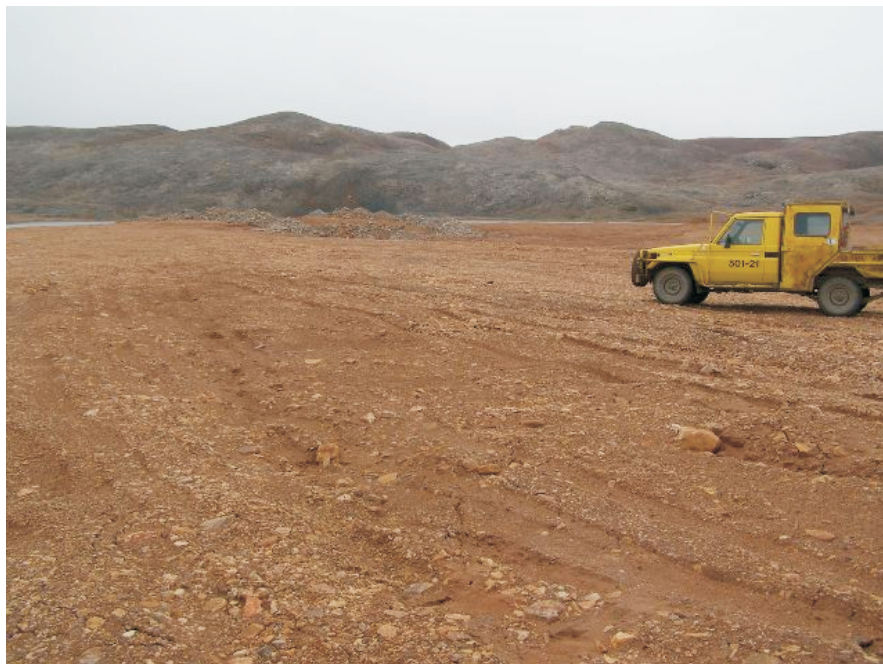
- no erosion of cover observed
- cover very undulating along north south arm of test cell dike
- outlet of test cell remains unarmoured

Photo 32
Surface of crest of north/south arm of Test Cell Dike. Note undulations.

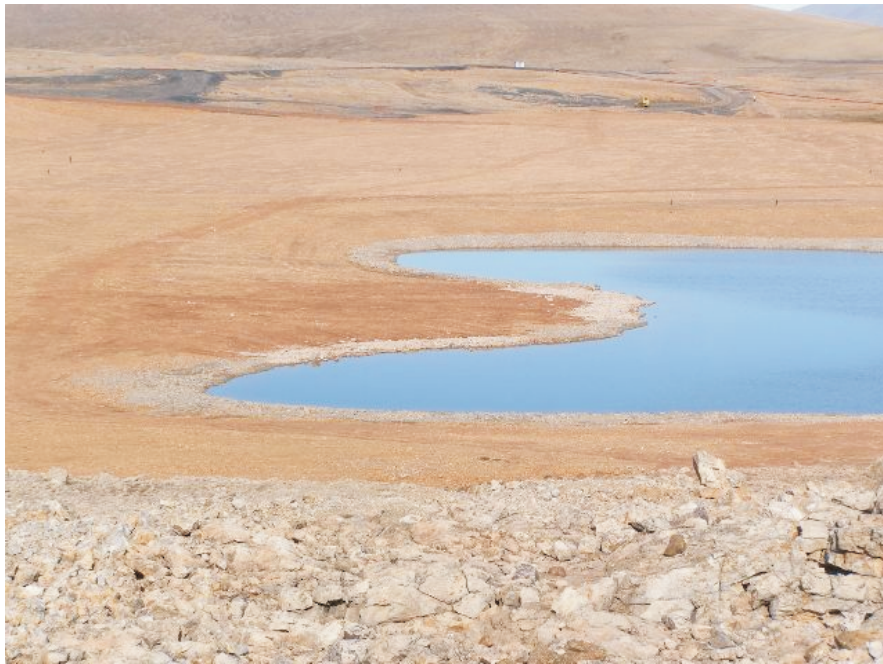
- no erosion of rip rap observed
- rip rap at toe of WT Dike appears to be too thin

Photo 35
Riprap along shoreline at toe of West Twin Dike.

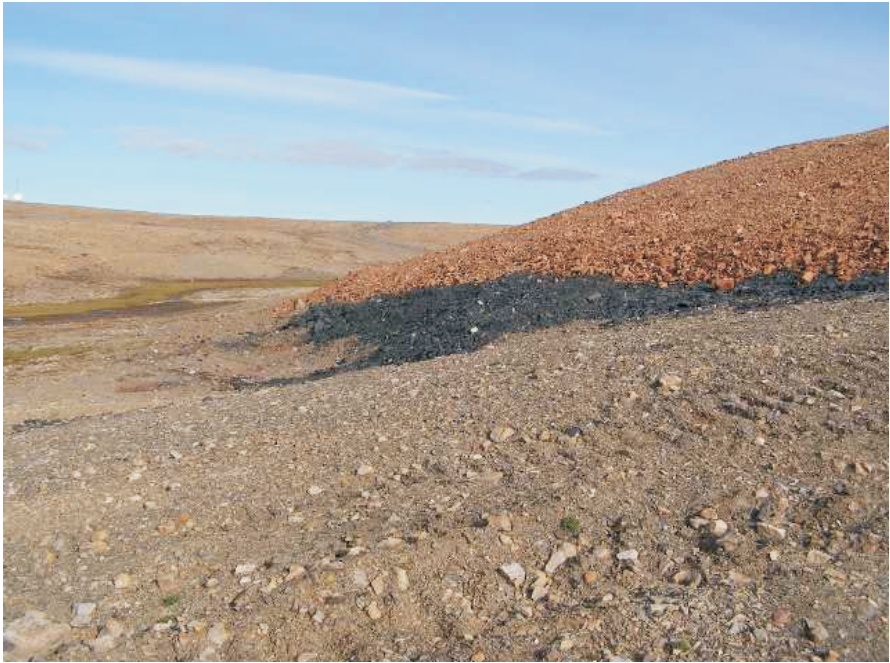
Photo 37
Toe of Landfill cover on west face. Note uncovered shale at toe.

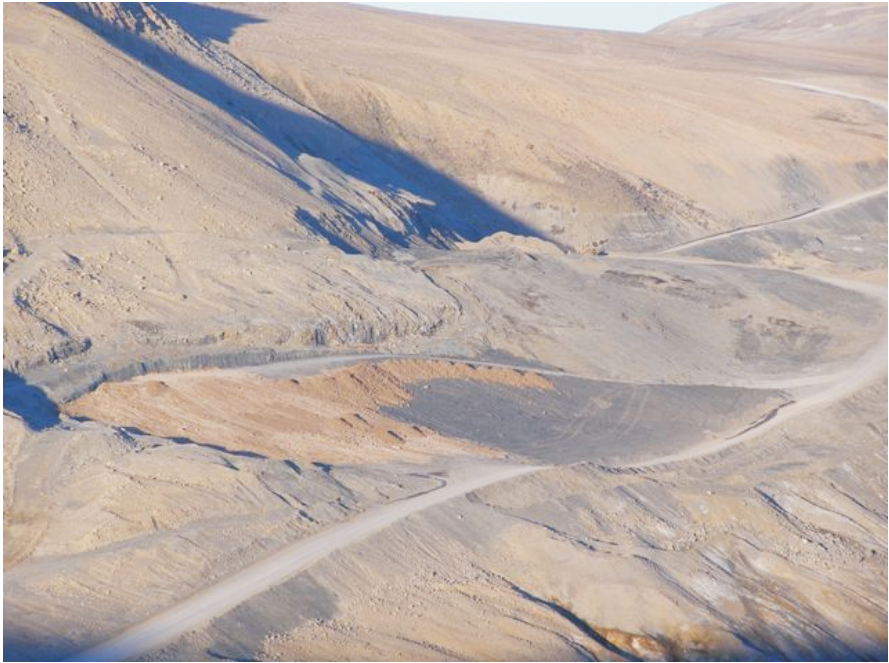
Photo 41
West Open Pit waste rock cover as seen from Stol Port. View looking east. Note armouring still in progress.

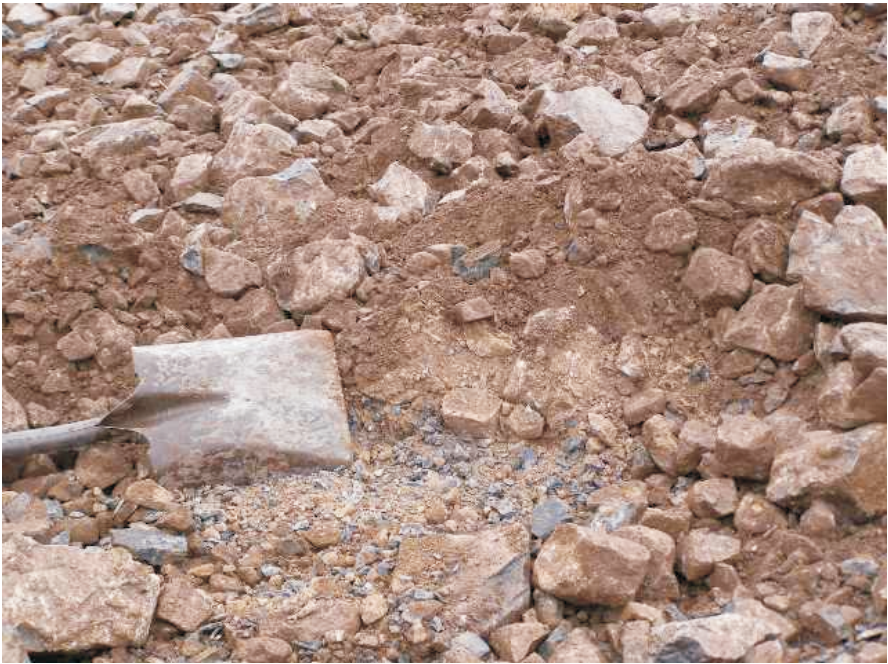
Photo 42
Armour thickness at West Open Pit waste rock cover (~25 cm thick).

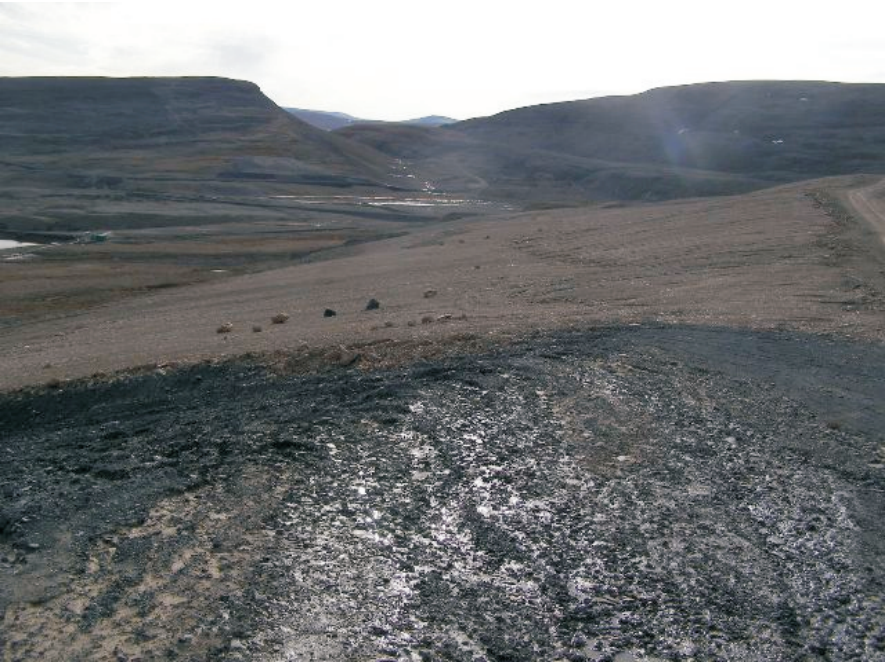
Photo 47
Erosion occurring at west end of East Open Pit cover where armour surface transitions into re-sloped shale surface below road.

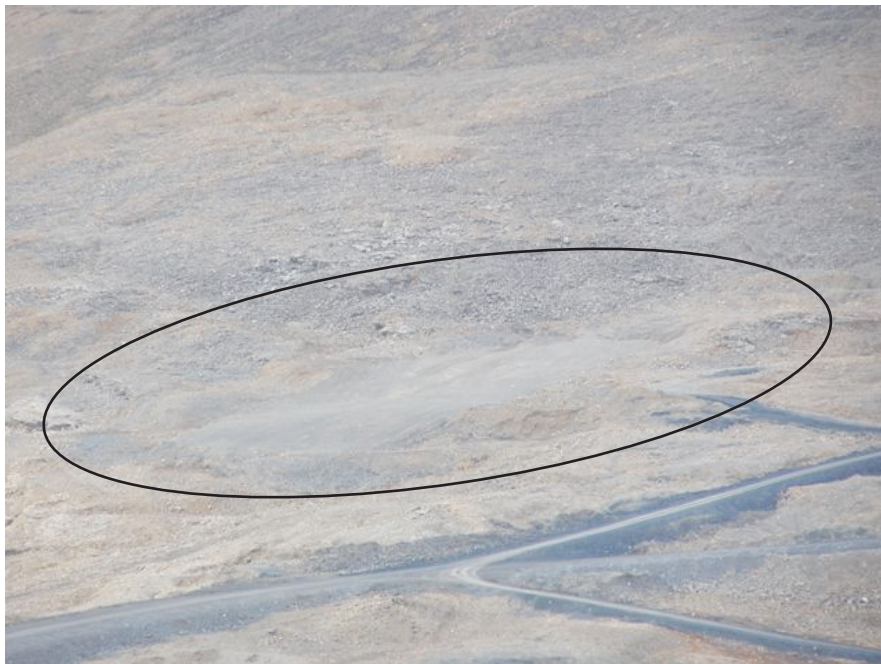
Photo 49
East Trench cover (in circle) as seen from road to Oceanview.

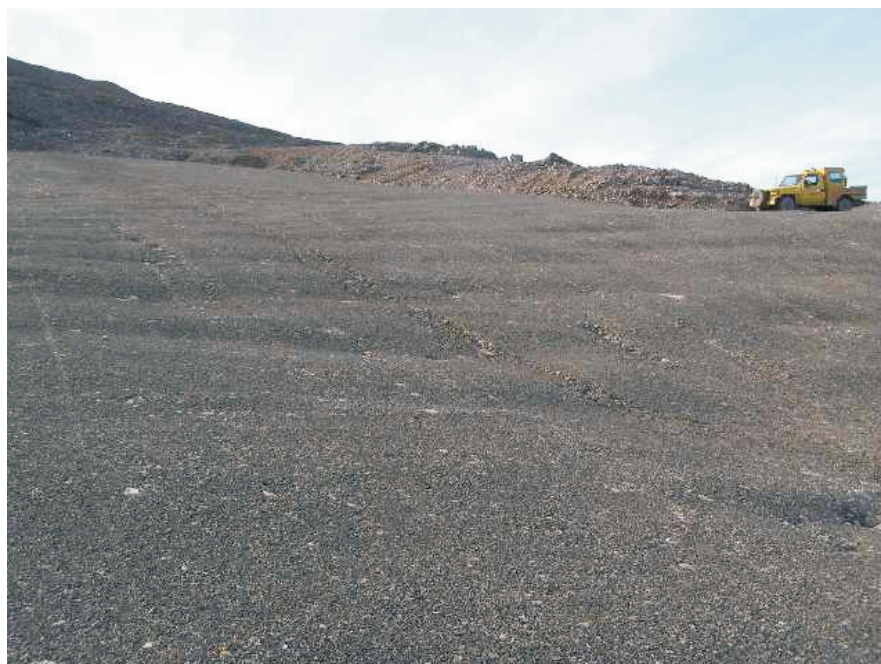
Photo 50
East Trench cover armour surface.

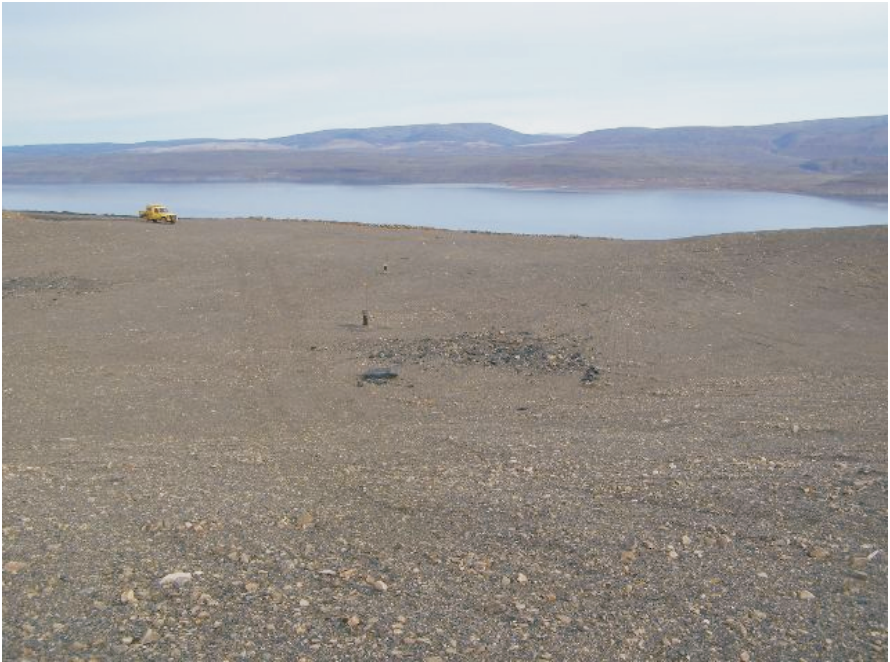
Photo 51
View of bottom of Oceanview Open Pit Waste Rock cover.

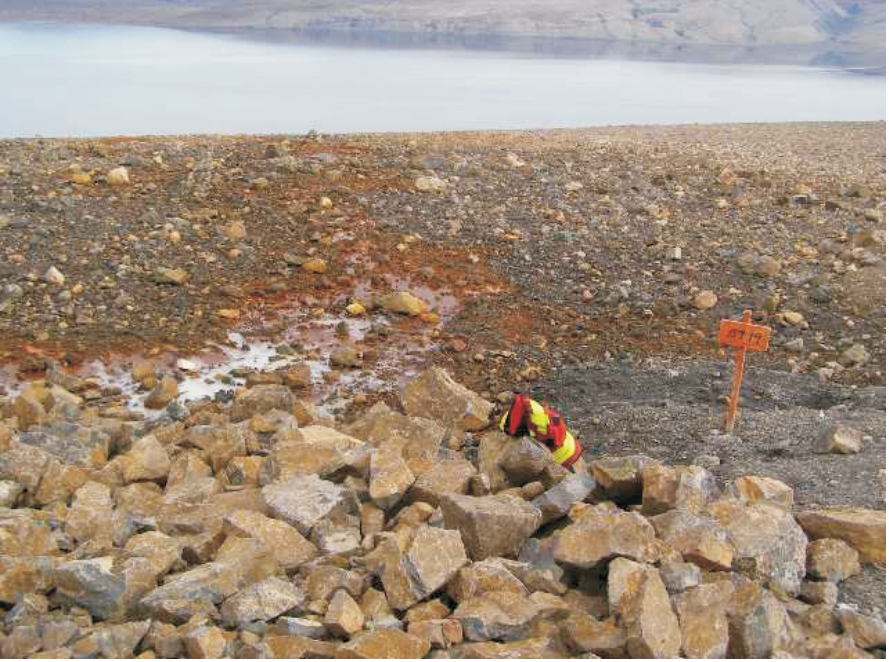
Photo 52
Seepage at toe of Oceanview Open Pit Waste Rock cover.

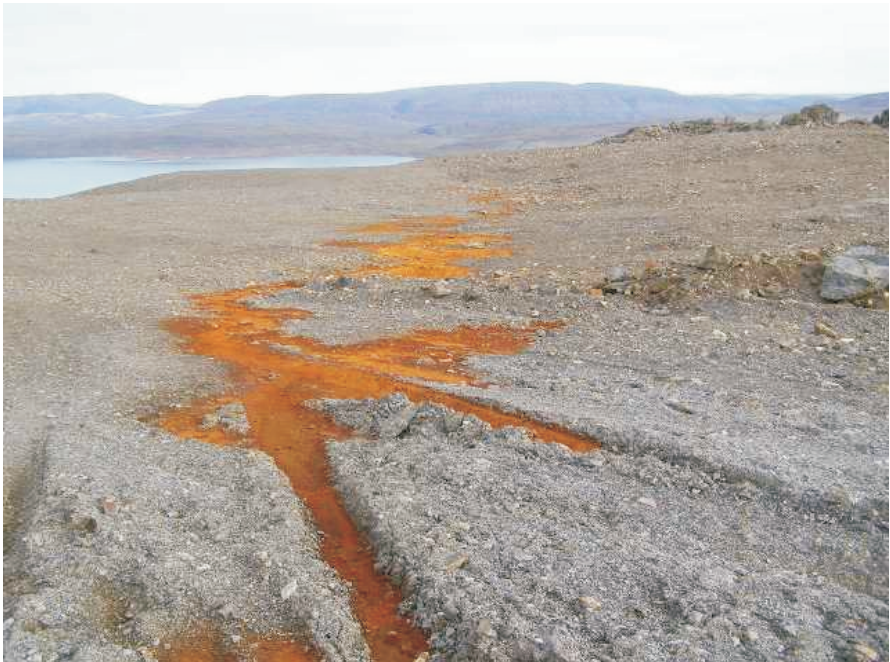
Photo 53
ARD running along east edge of Oceanview Open Pit Waste Rock cover. Note source is upslope of pit.

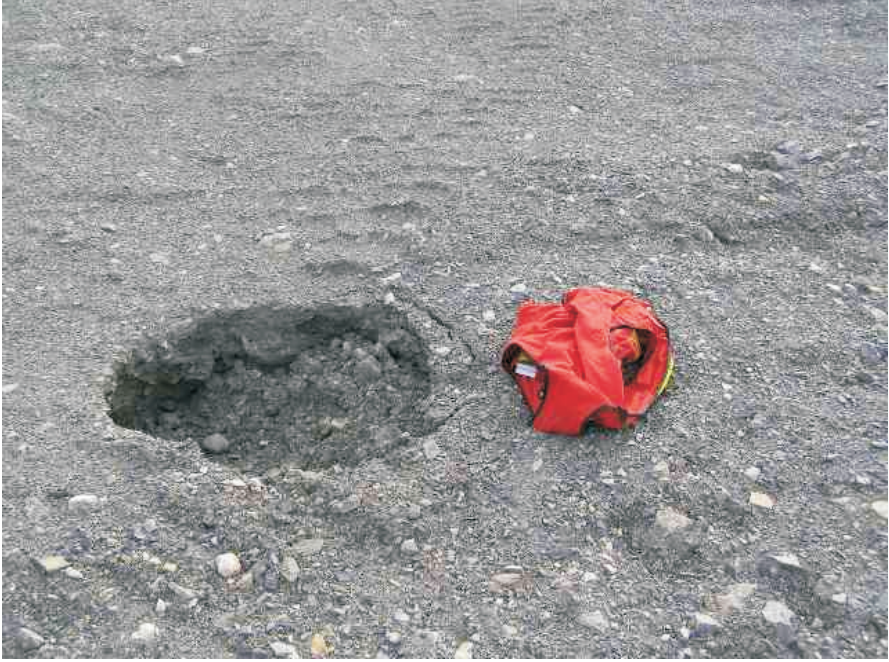
Photo 54
Sinkhole located near north end of Oceanview Open Pit Waste Rock cover.

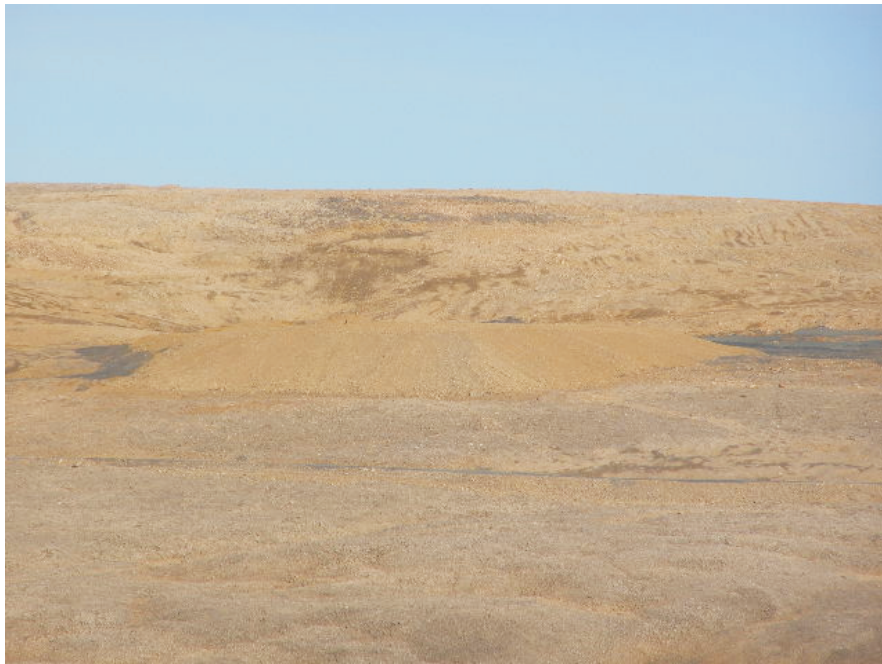
Photo 55
Area 14 waste rock cover.

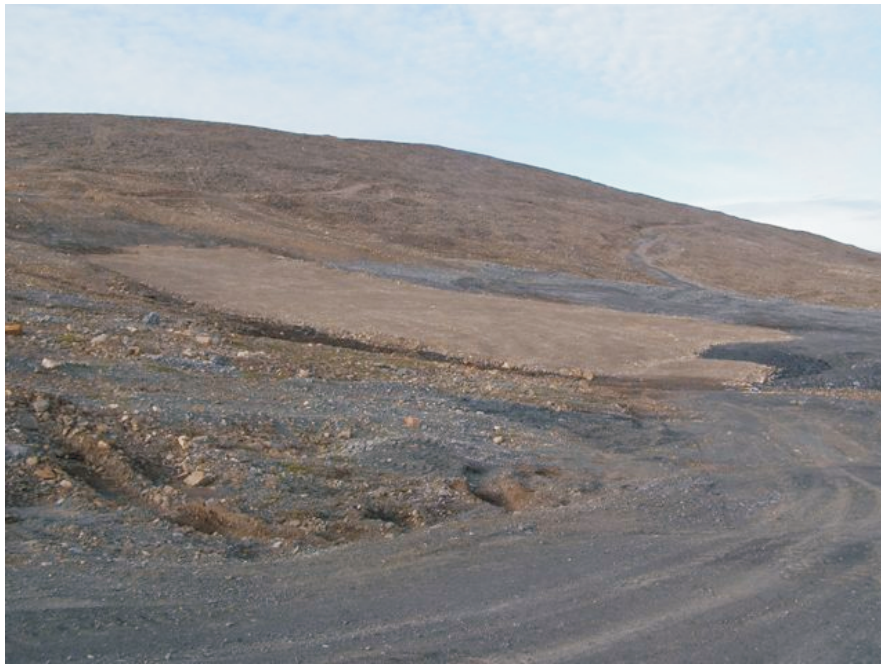
Photo 57
17 North Portal cover.

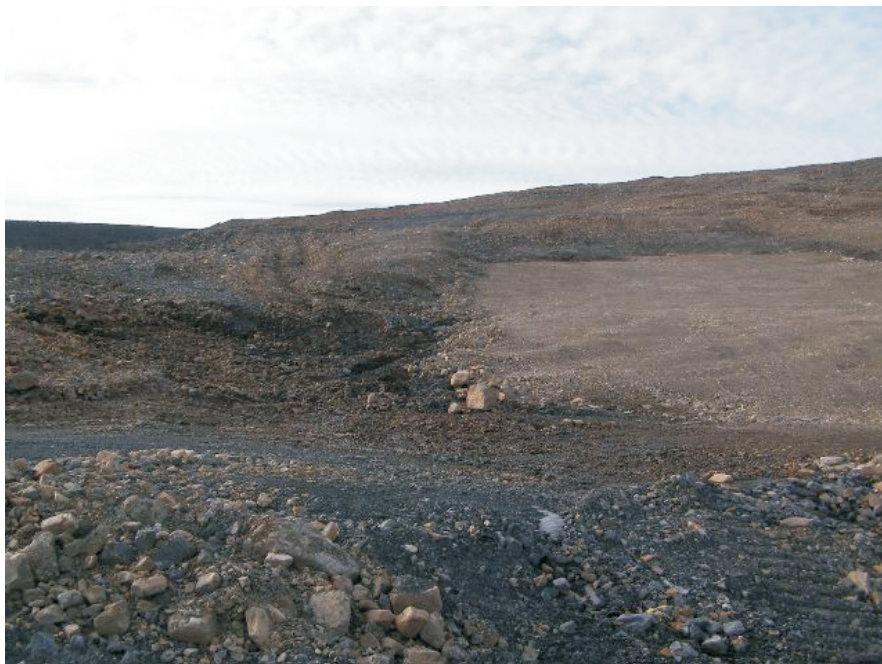
Photo 58
Seepage area at northeast corner of 17 North Portal cover.

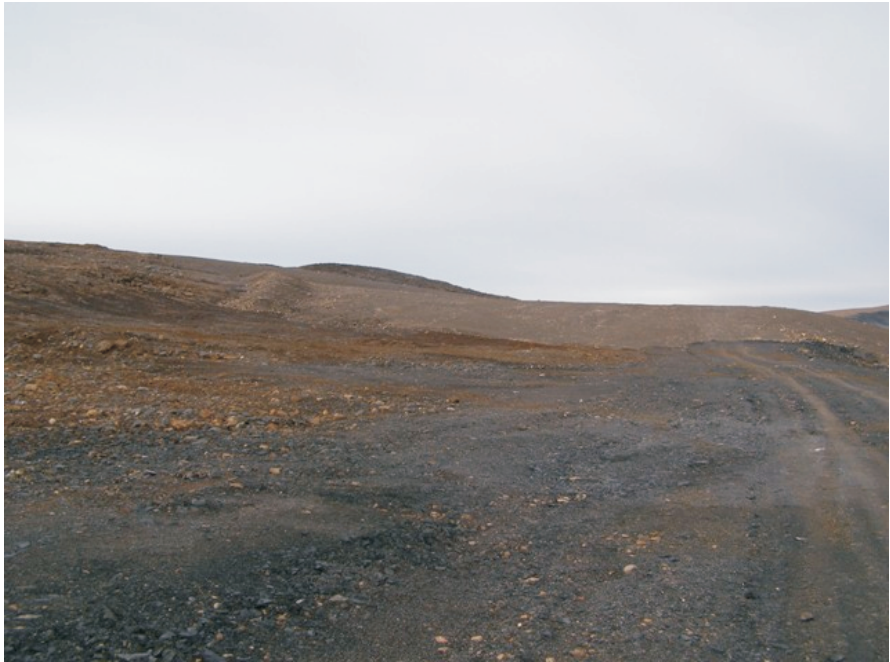
Photo 59
Oceanview Portal cover. Note cover extension at the road and the water deflection berm.

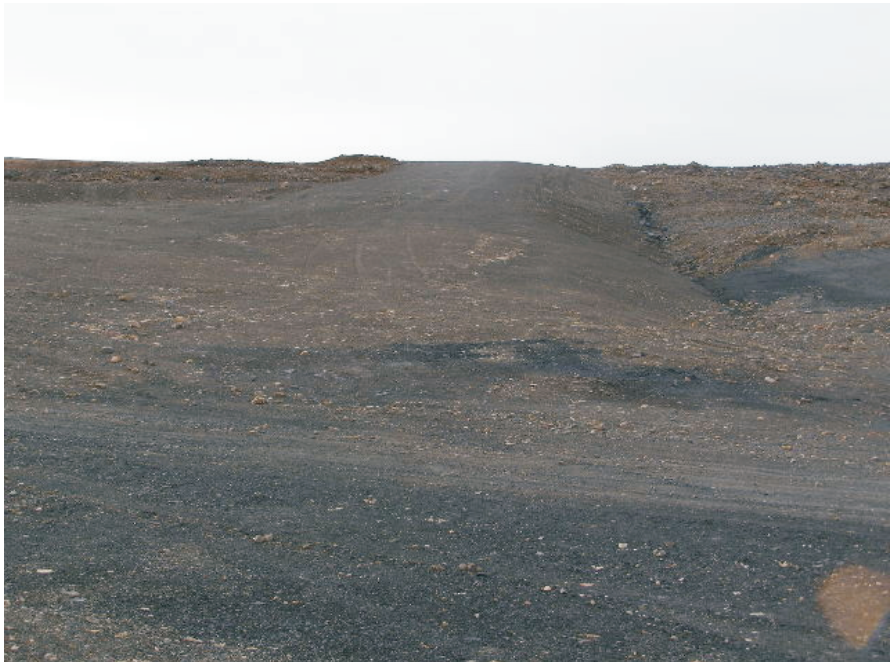
Photo 60
Oceanview Portal cover as seen from road.

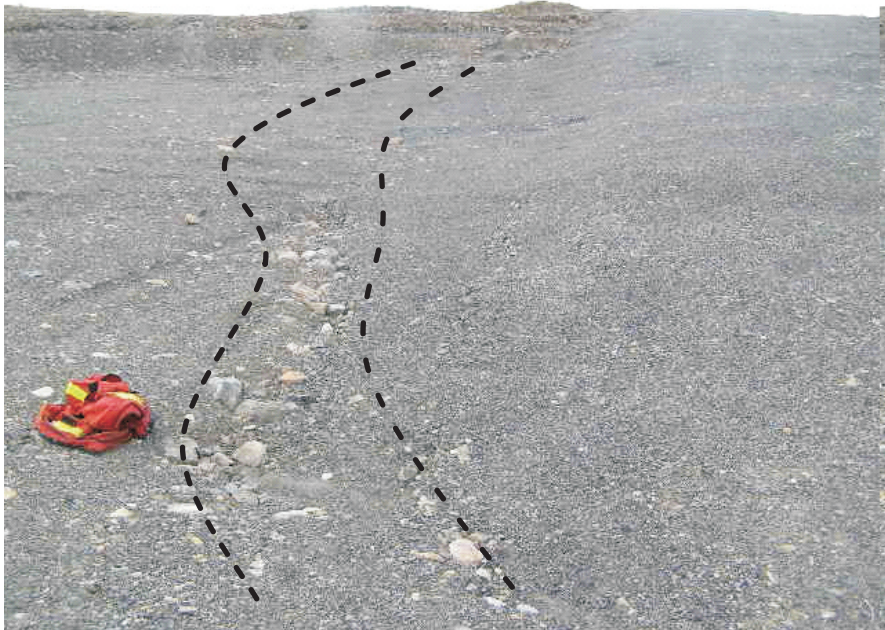
Photo 62
Edge of Oceanview Portal cover. Note minor erosional channel beginning to develop along edge of portal cover.

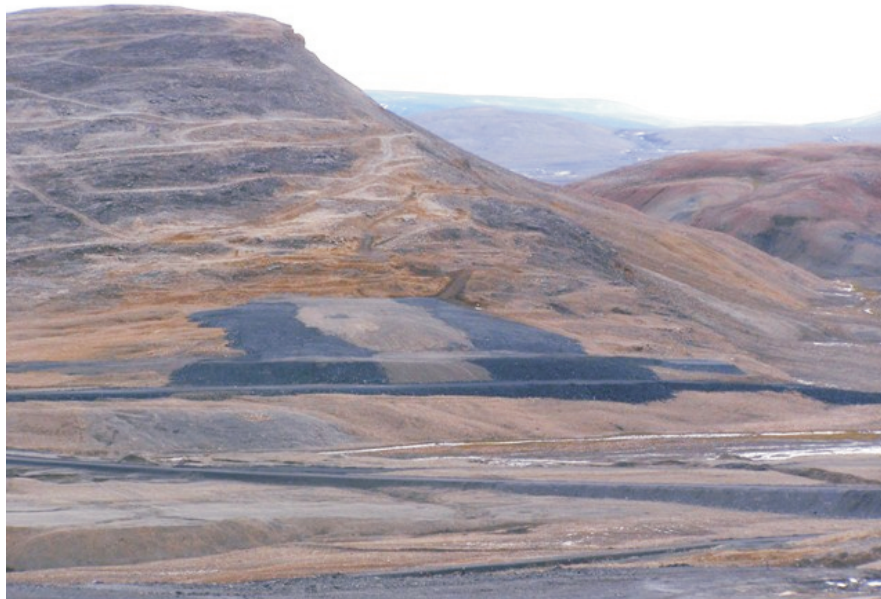
Photo 63
K-Baseline Portal cover as seen from Shale Hill.

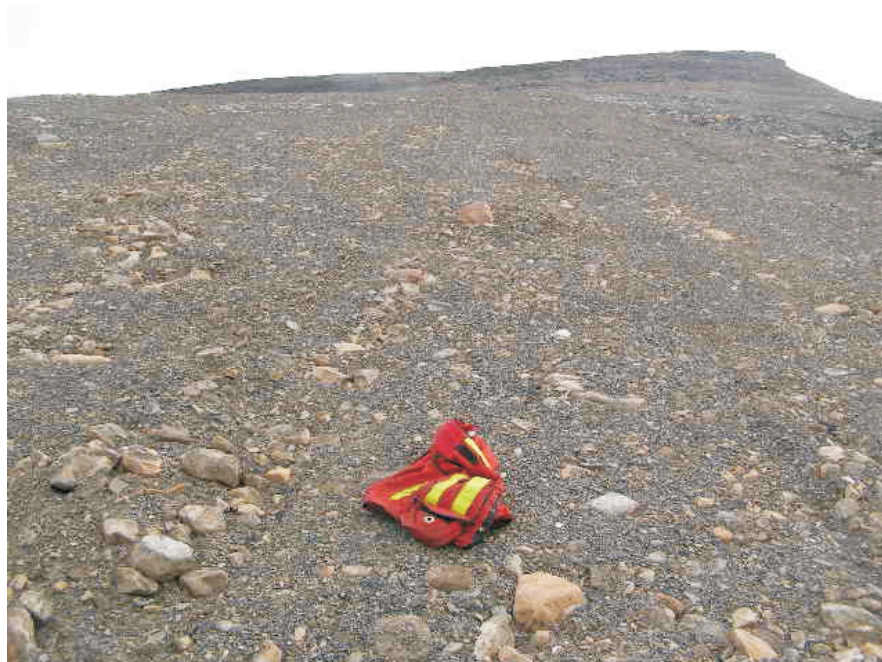
Photo 64
Surface of K-Baseline Portal cover.

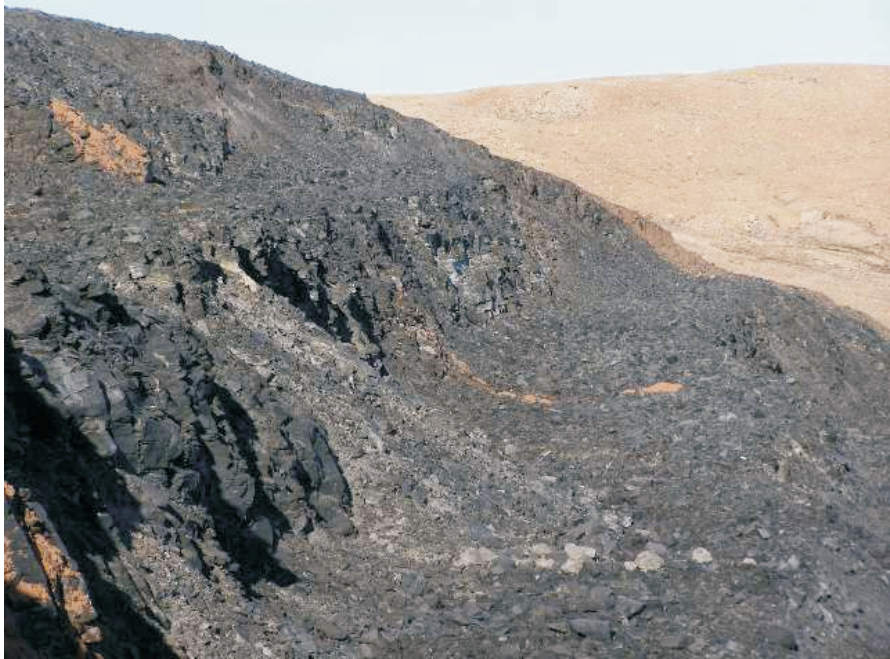
Photo 69
Benches in Mt. Fuji borrow area. Note ravelling occurring onto benches creating a sloping surface.
