NANISIVIK MINE, A DIVISION OF CANZINCO LTD.

2006 ANNUAL GEOTECHNICAL INSPECTION

NANISIVIK MINE, NUNAVUT

PROJECT NO.: 0255-013-08
DATE: JANUARY 10, 2007

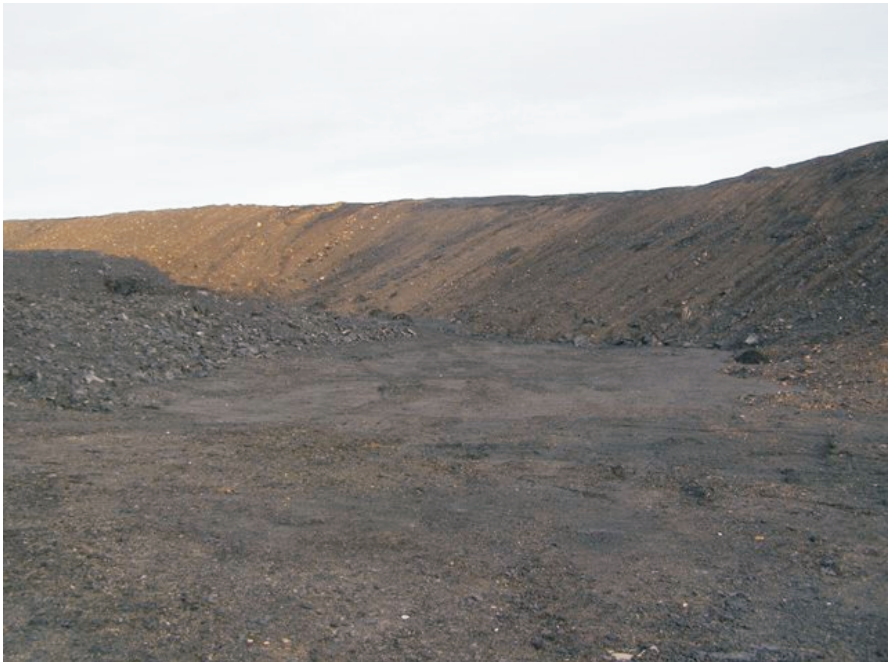
Photo 71
Re-sloped face of Shale Hill borrow area.

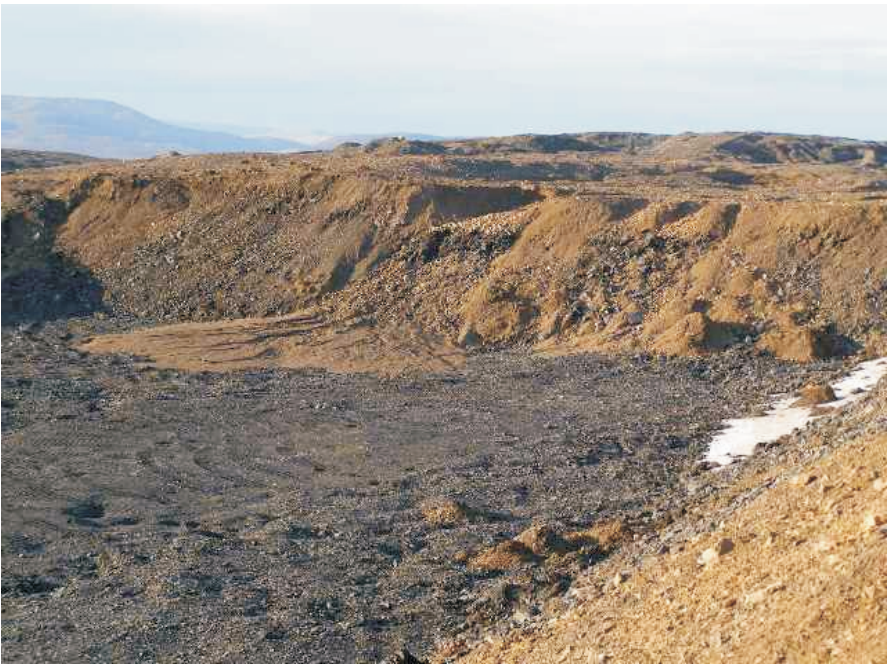
Photo 70
Erosion occurring at north end of Area 14 borrow area.

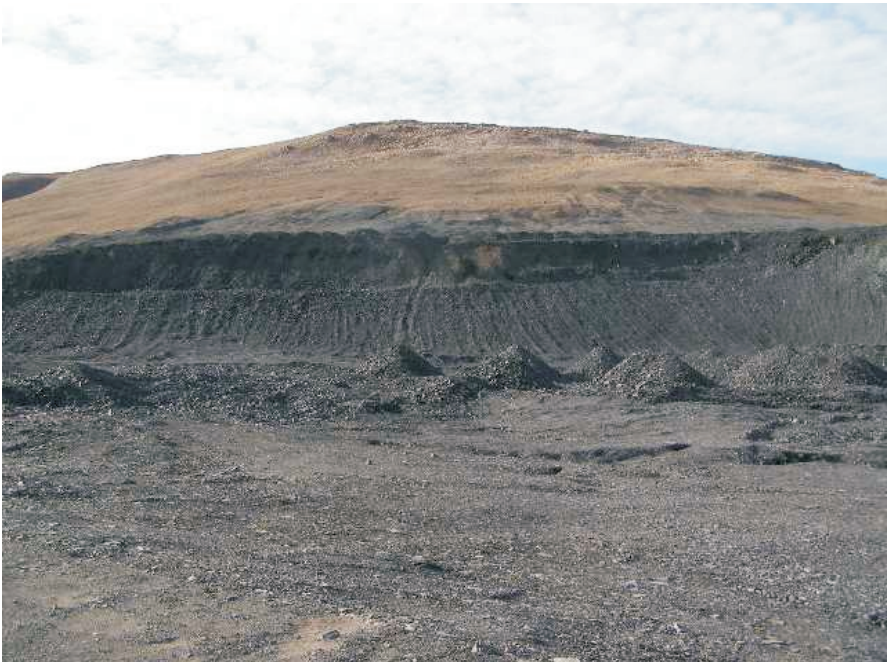
Photo 72
Town site borrow area as seen from road to Mill. Note upper portion of slope still to be re-sloped.

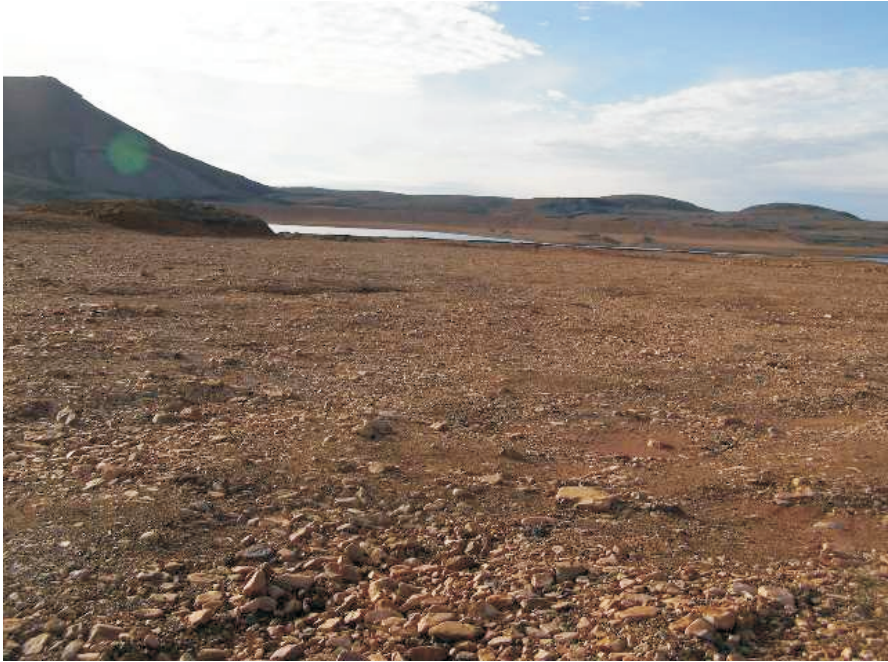
Photo 73
Floor of Twin Lakes sand and gravel deposit.

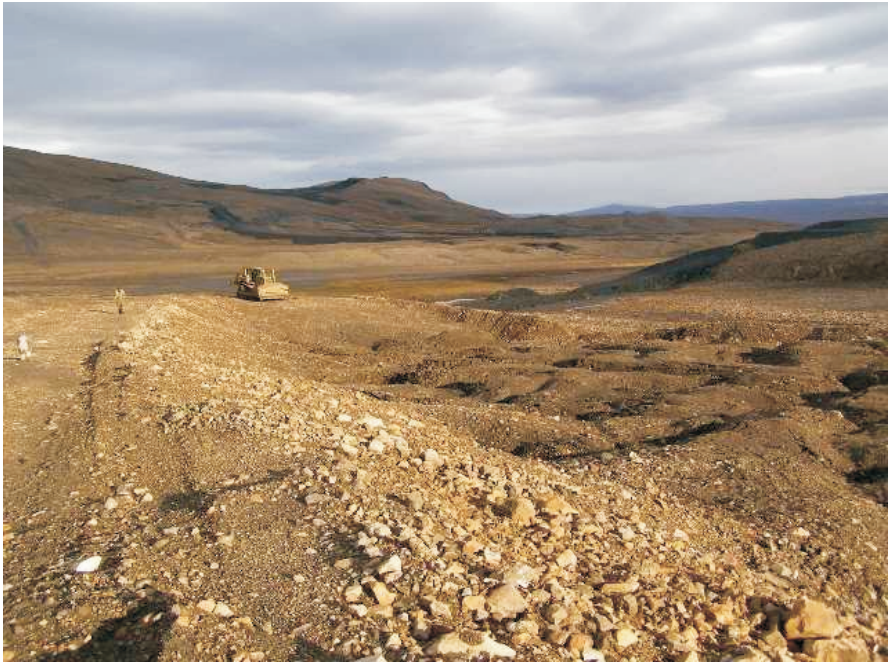
Photo 75
D8 dozer at Kuhulu Lake Road deposit. Note thermokarsting on the right.

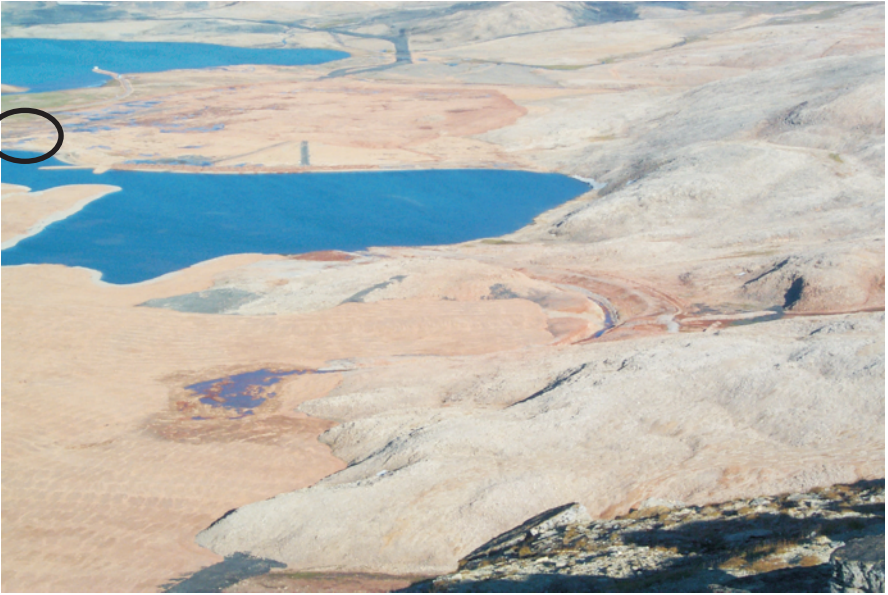
Photo 74
Aerial view of Twin Lakes sand and gravel deposit. Note drainage into Reservoir.

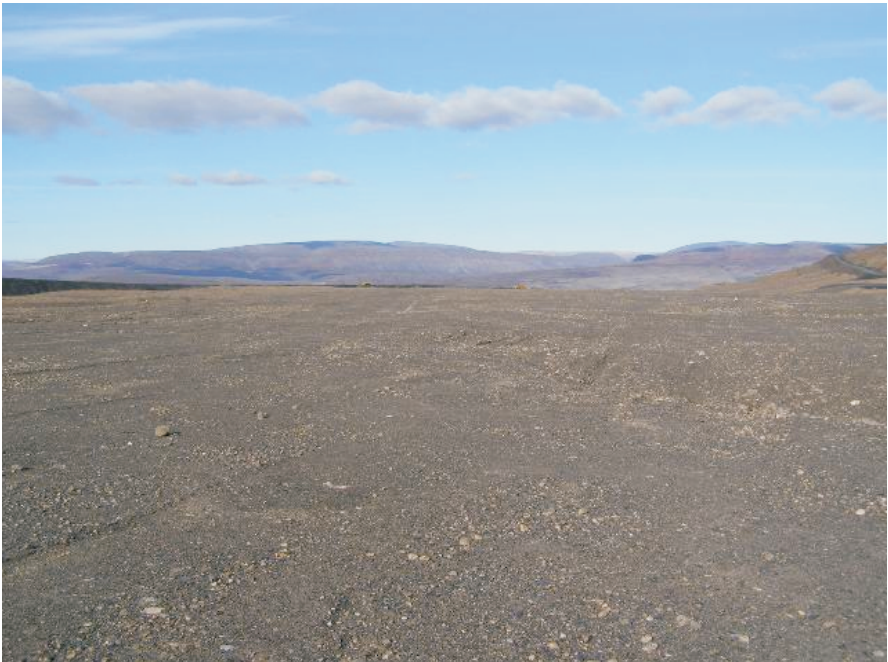
Photo 76
Surface of Chris Creek "A" sand and gravel deposit.

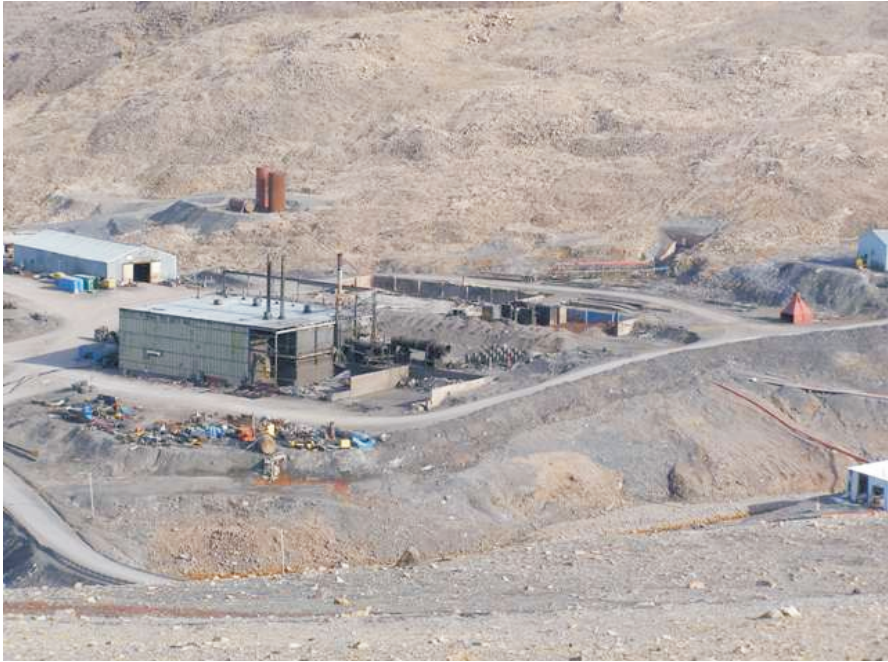
Photo 77
Mill foundation as seen from Stol Port.

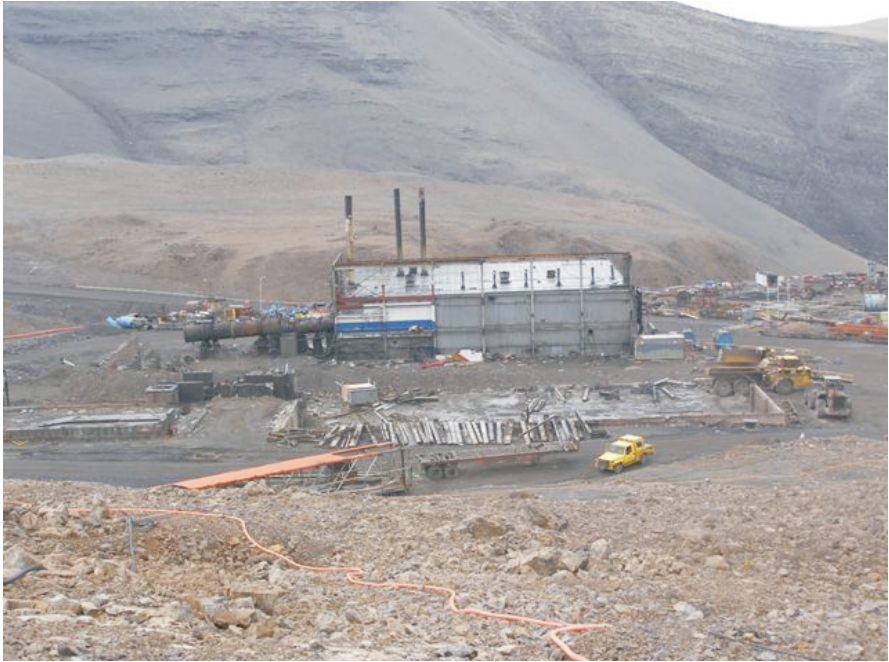
Photo 79
Mill foundation as seen from upslope of Mill area.
