NANISIVIK MINE, NUNAVUT

2013 ANNUAL GEOTECHNICAL INSPECTION

PROJECT NO.: 0255-023
DATE: February 27, 2014
DOCUMENT NO.:

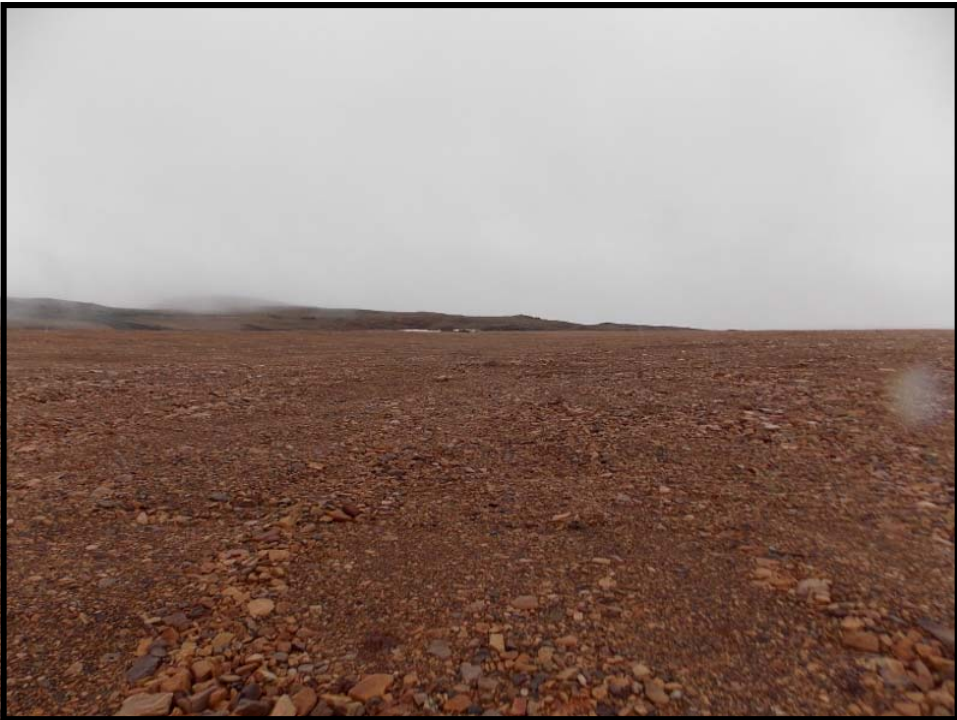
Photo 17. Surface Cell—Cover System.

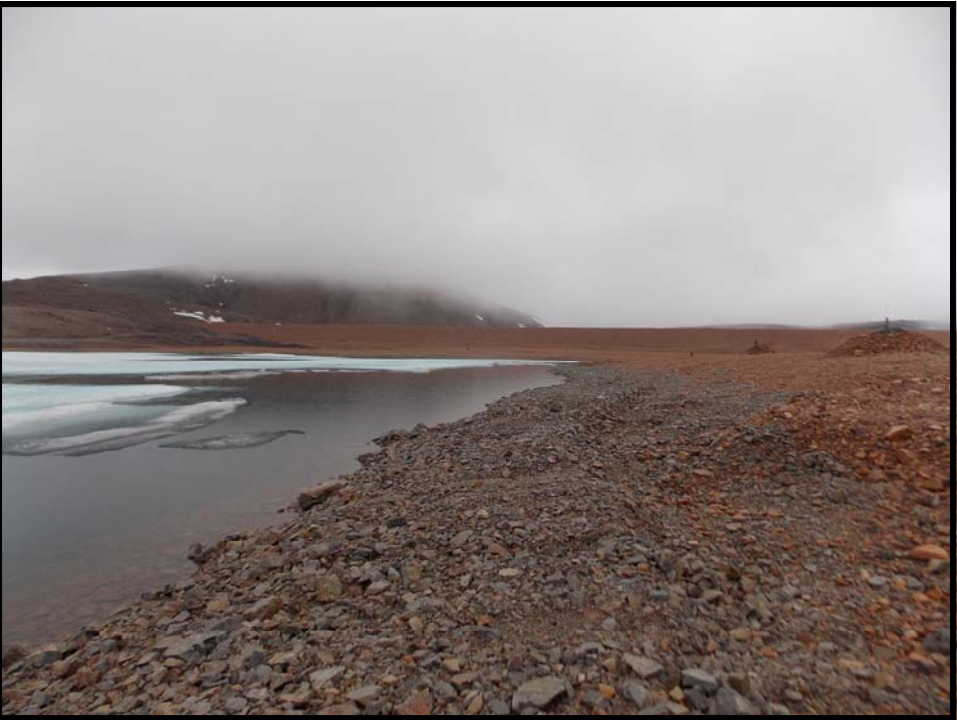
Photo 24. Toe of Test Cell Dyke—Armour along shoreline of cover at toe of Test Cell Dyke. East/West arm, view looking west.

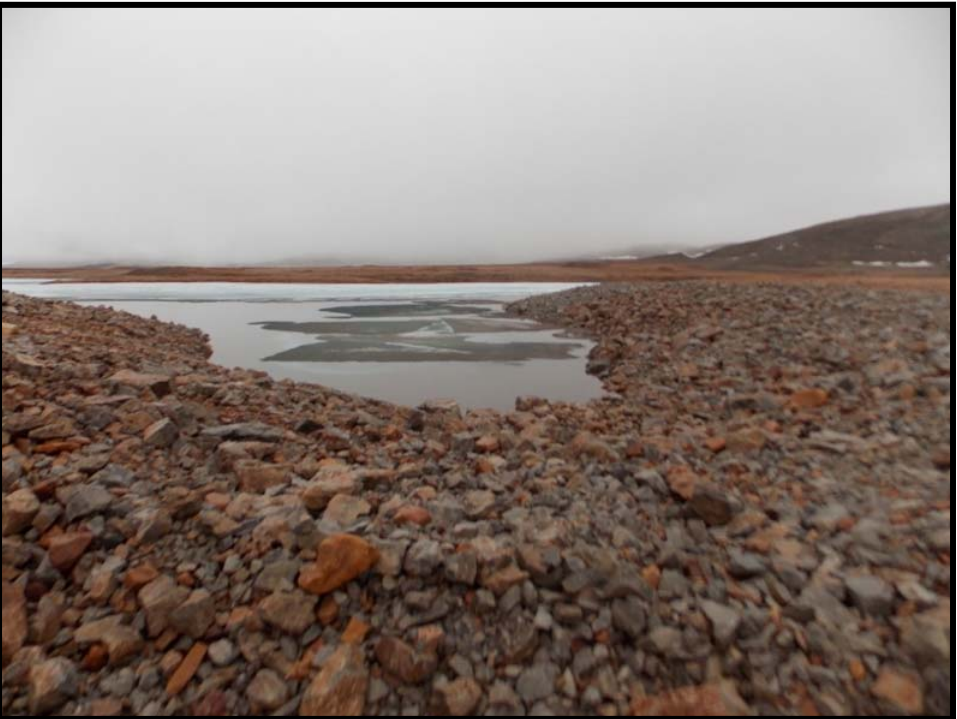
Photo 26. Toe of Test Cell Dyke—Outlet of Test Cell Cover

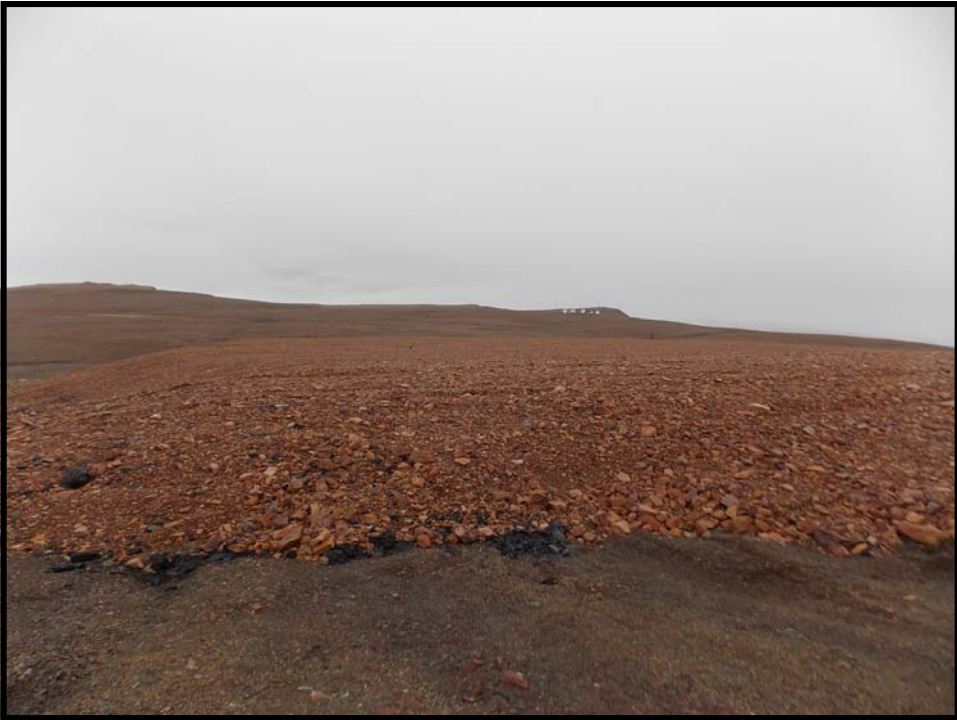
Photo 29. Landfill—Surface of landfill cover.

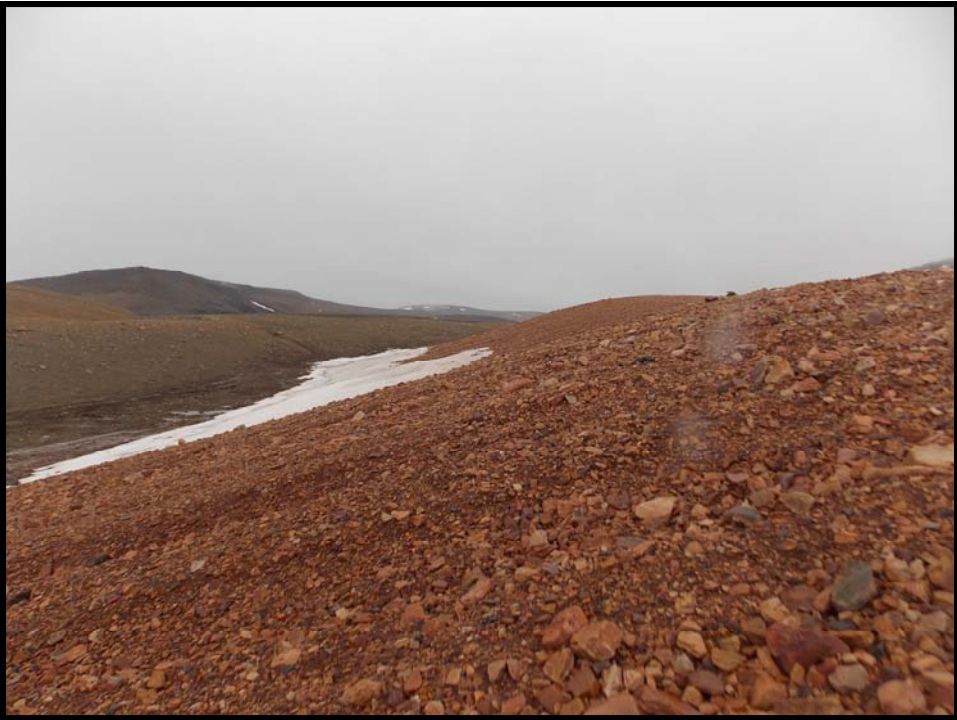
Photo 30. Landfill—Sloping face of cover.

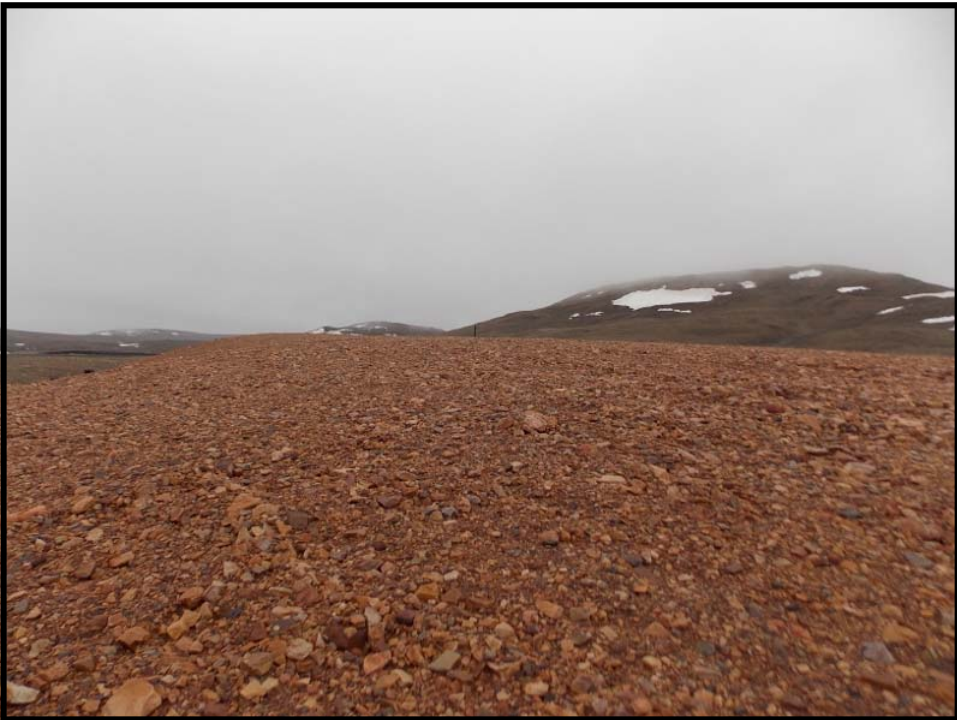
Photo 31. Landfill— Surface of landfill cover.

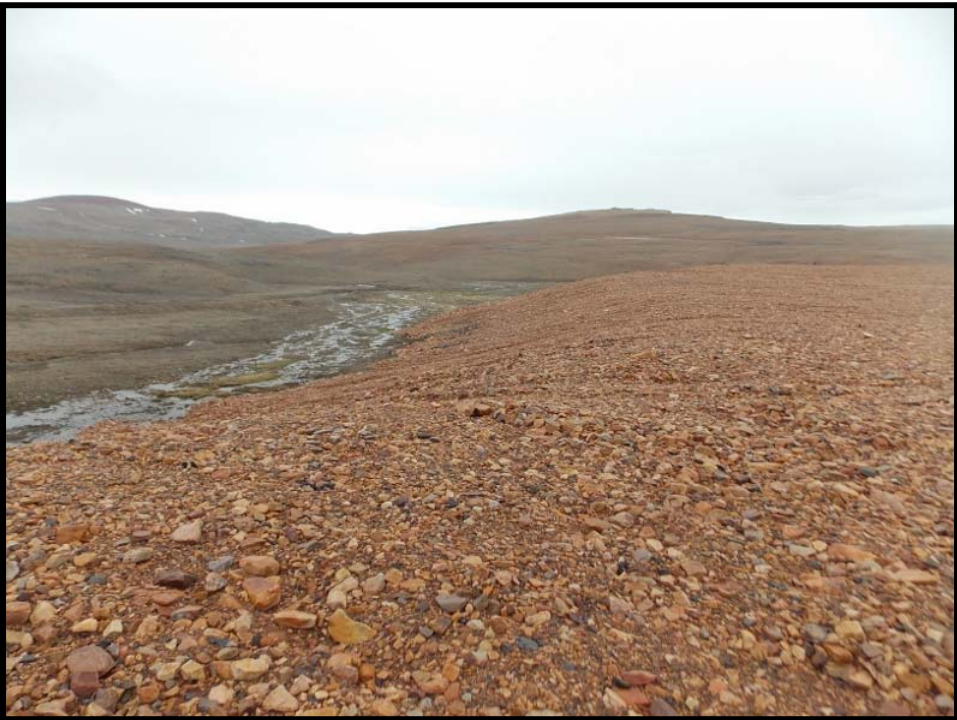
Photo 32. Landfill—Face of landfill cover.

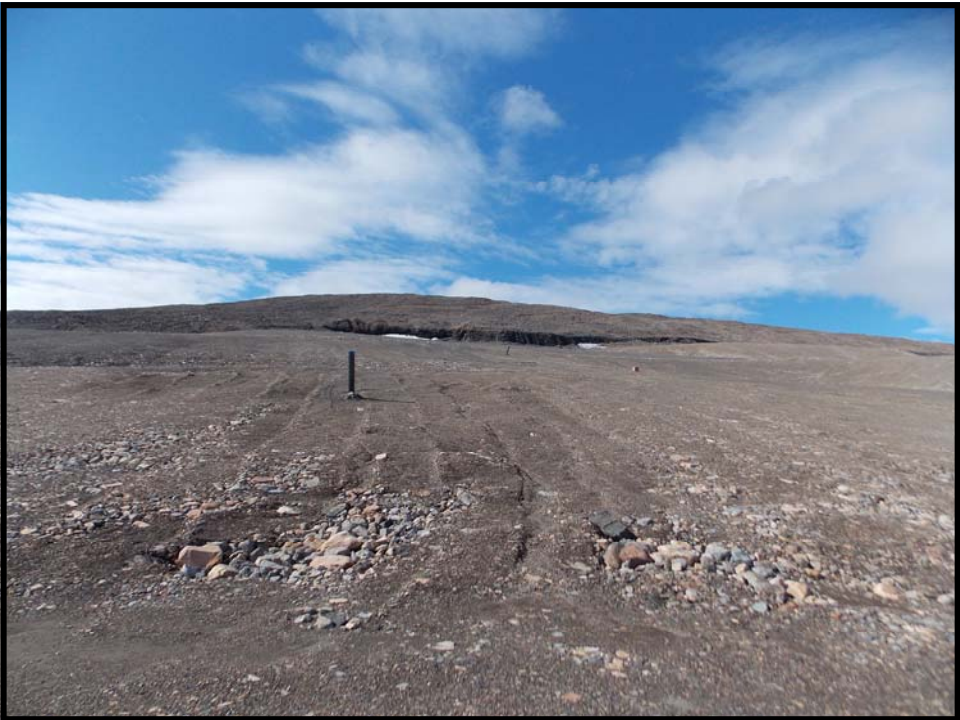
Photo 39. East Open Pit—Looking upslope along surface of cover. Note minor rill erosion.

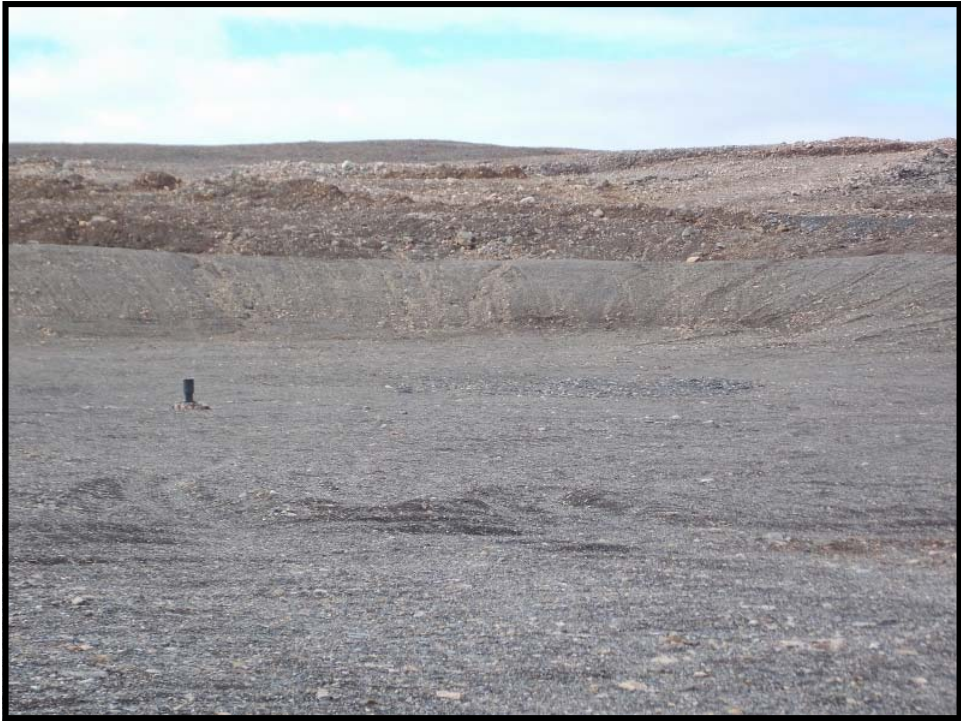
Photo 43. Oceanview Open Pit— Surface of pit cover area.

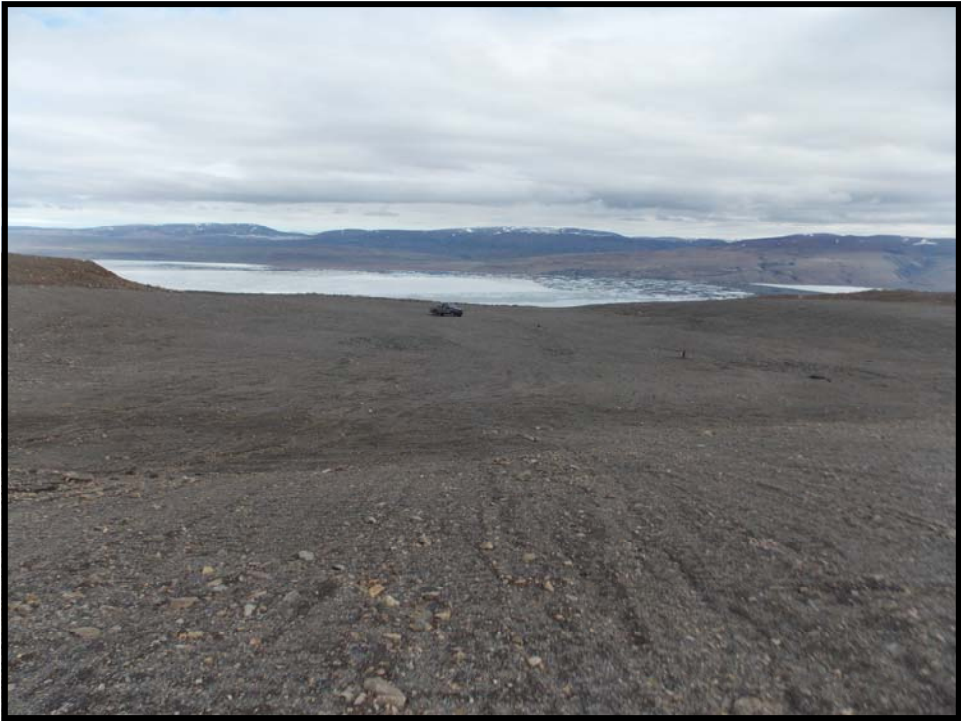
Photo 44. Oceanview Open Pit—Note minor rill erosion.

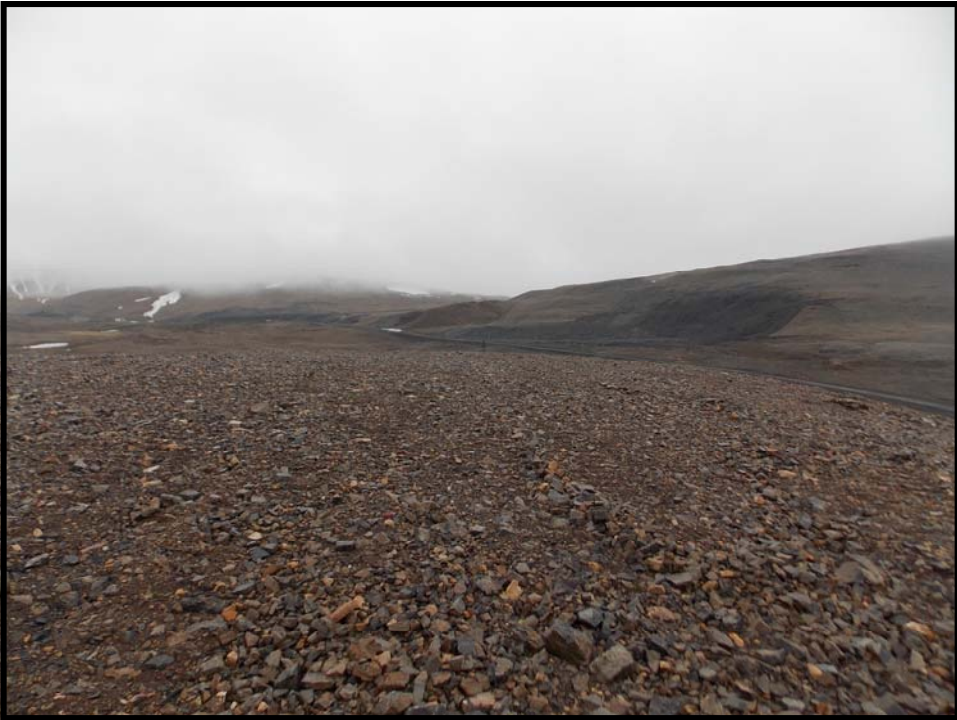
Photo 49. Industrial Complex Cover—View across upper flat portion of cover.

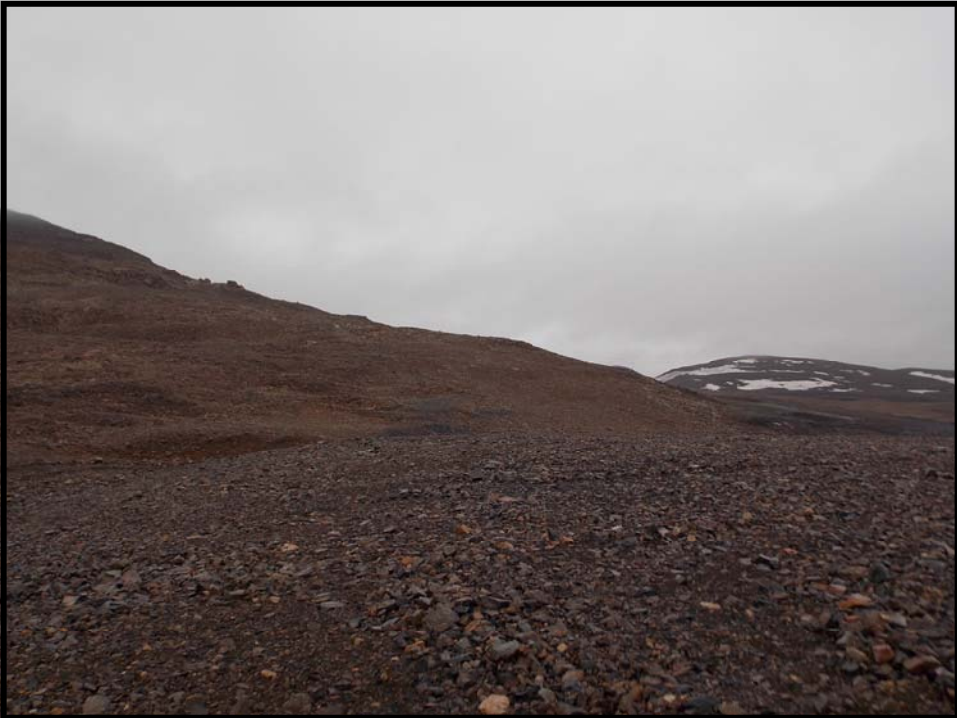
Photo 51. Industrial Complex Cover—View looking from on top of cover.

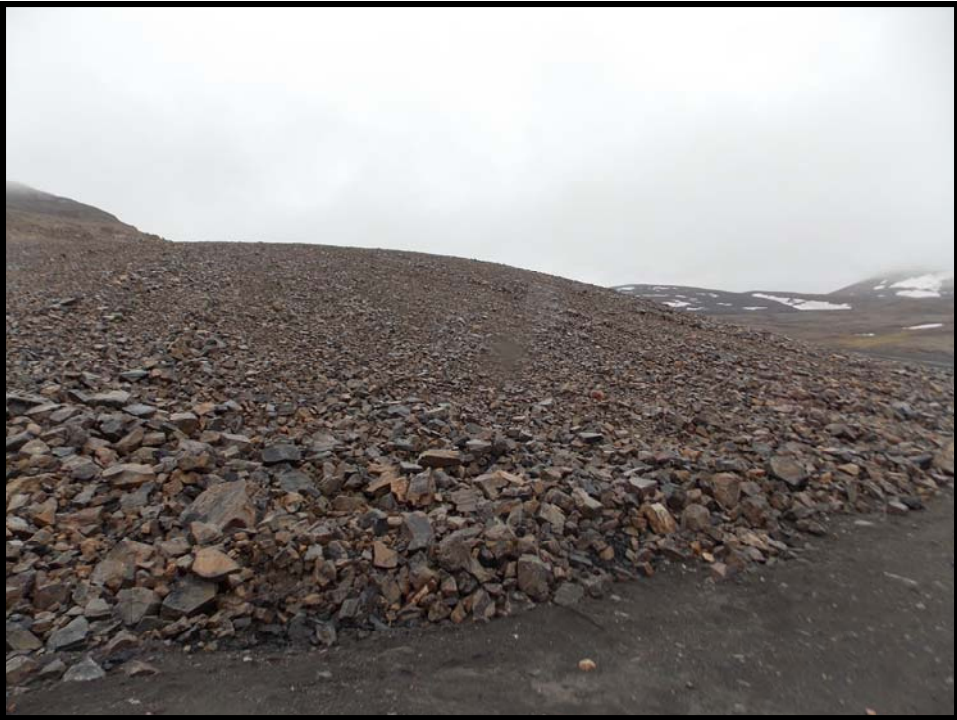
Photo 50. Industrial Complex Cover—Toe of sloping face of cover.

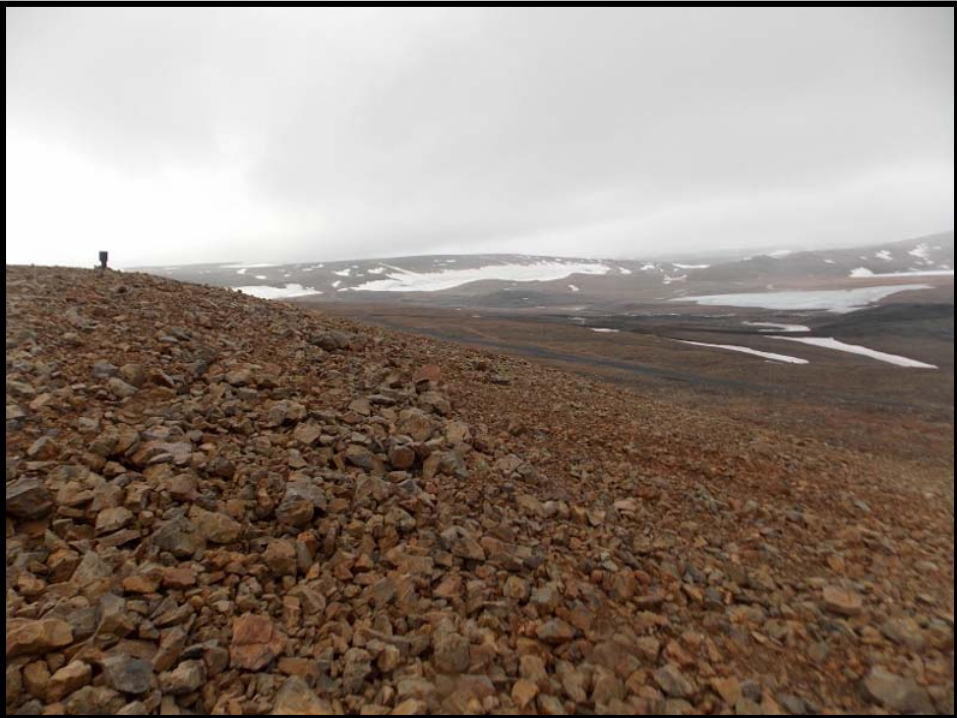
Photo 52. Industrial Complex Cover—Sloping face of cover.

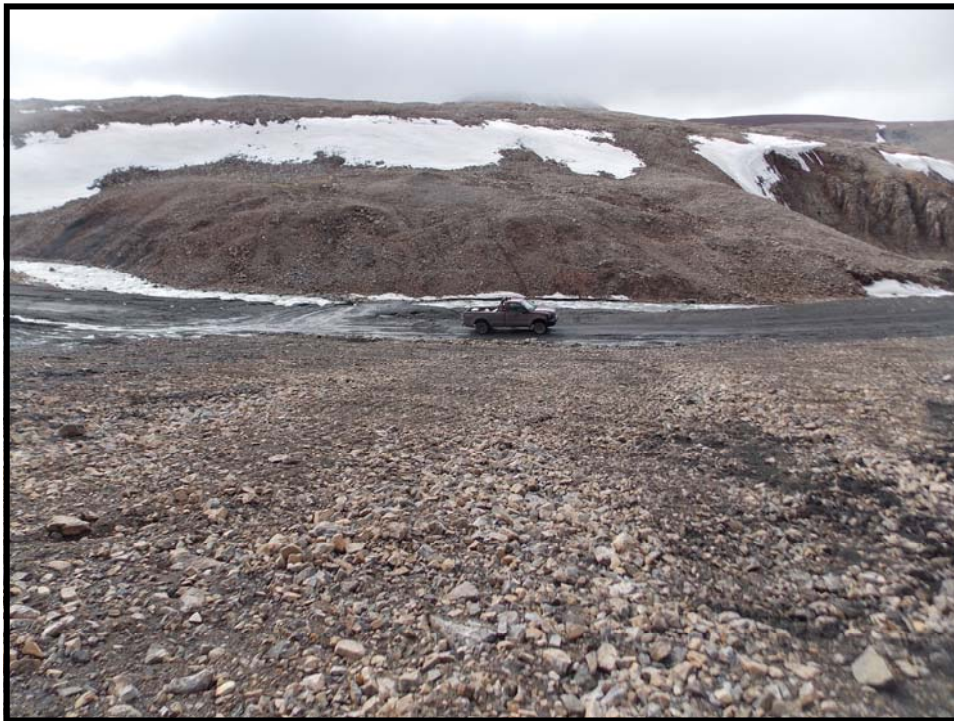
Photo 58. 09S Portal—Looking downslope along surface of cover.

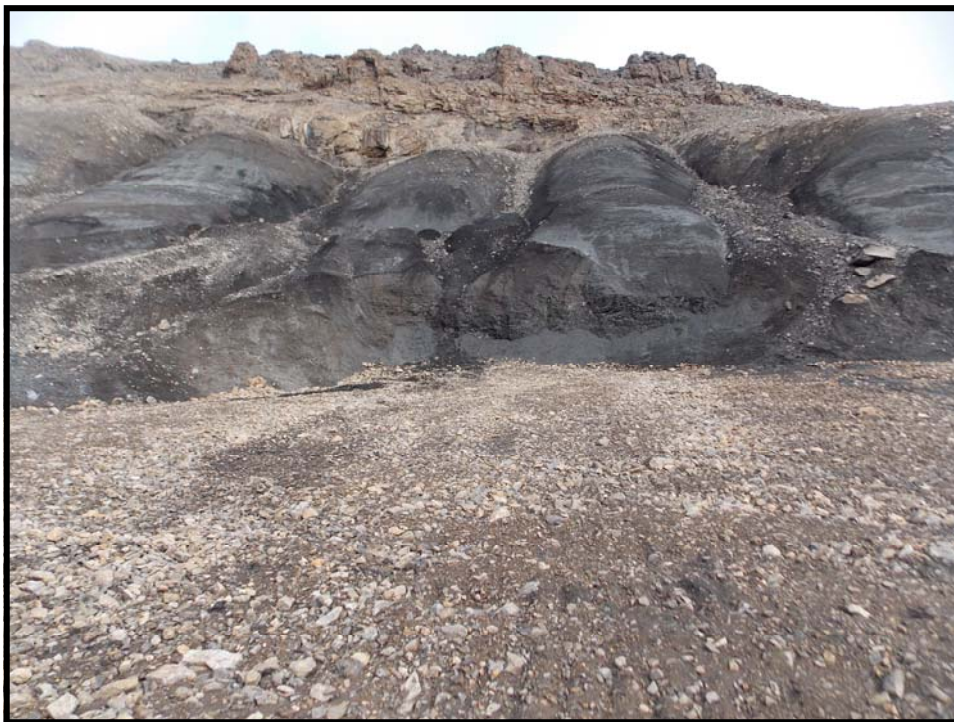
Photo 59. 09S Portal—Looking upslope along surface of cover.
