Report on Post-closure Geotechnical Inspection for Polaris Mine Site in 2005

Reference: **GLL 50508**

December 15, 2005

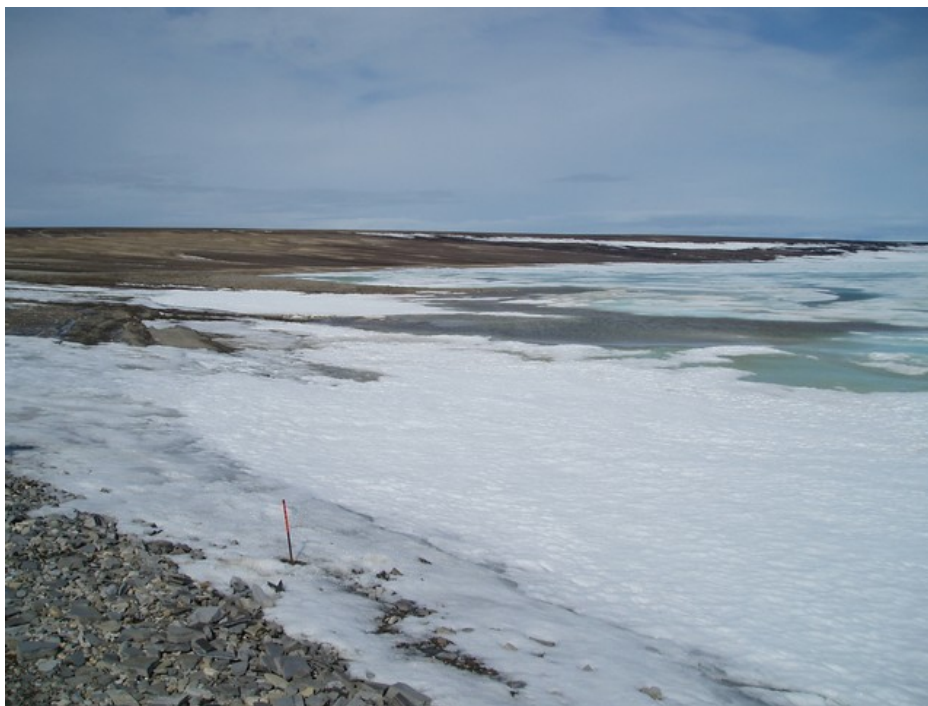
View looking north from the West Quadrant Pin at Station 11.

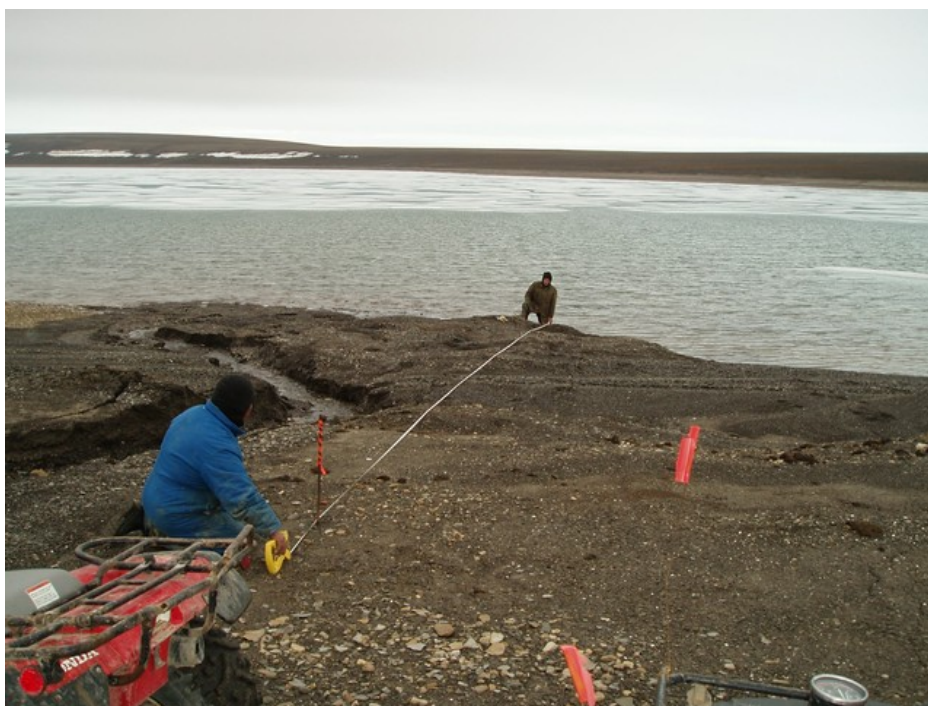
South Quadrant beach at Pin 10 on July 21 2005 – distance to shoreline is 16.4 m.

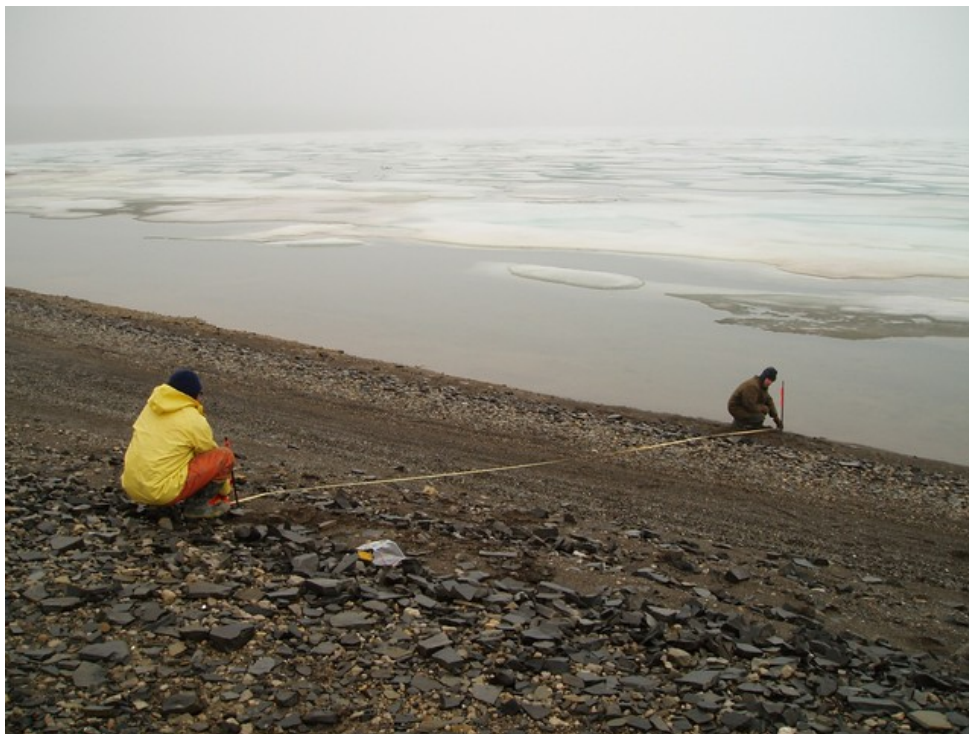
West Quadrant Pin at Station 11 on July 17 2005 – distance to shoreline is 10.3 m.

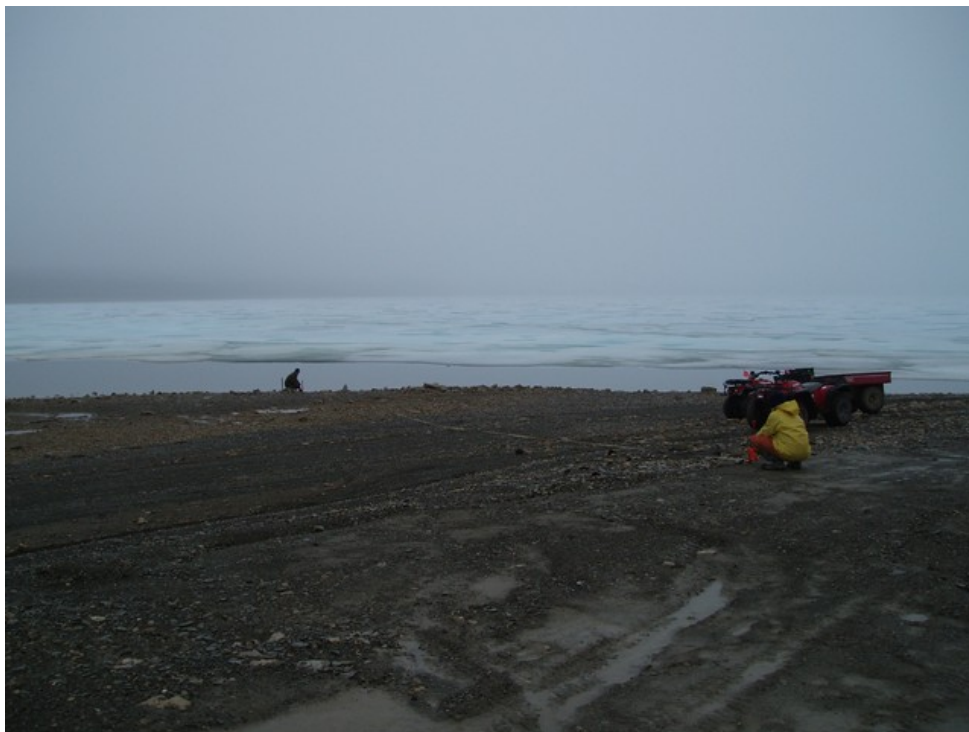
North Quadrant Pin at Station 8 on July 18 2005 – distance to shoreline is 30.4 m.

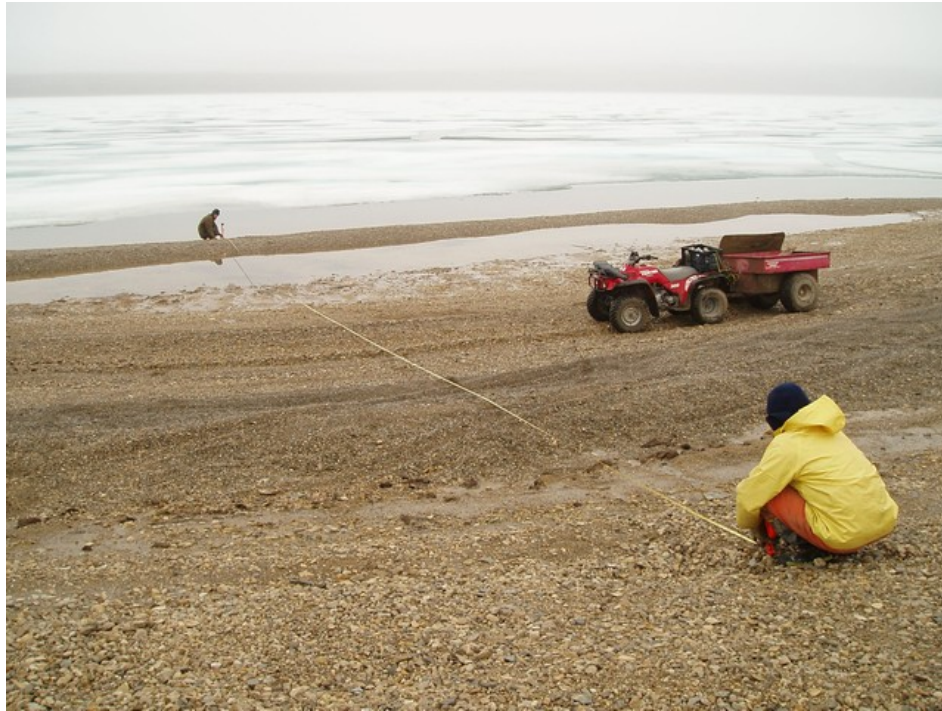
East Quadrant Pin at Station 9 on July 17 2005 – distance to shoreline is 26.7 m.

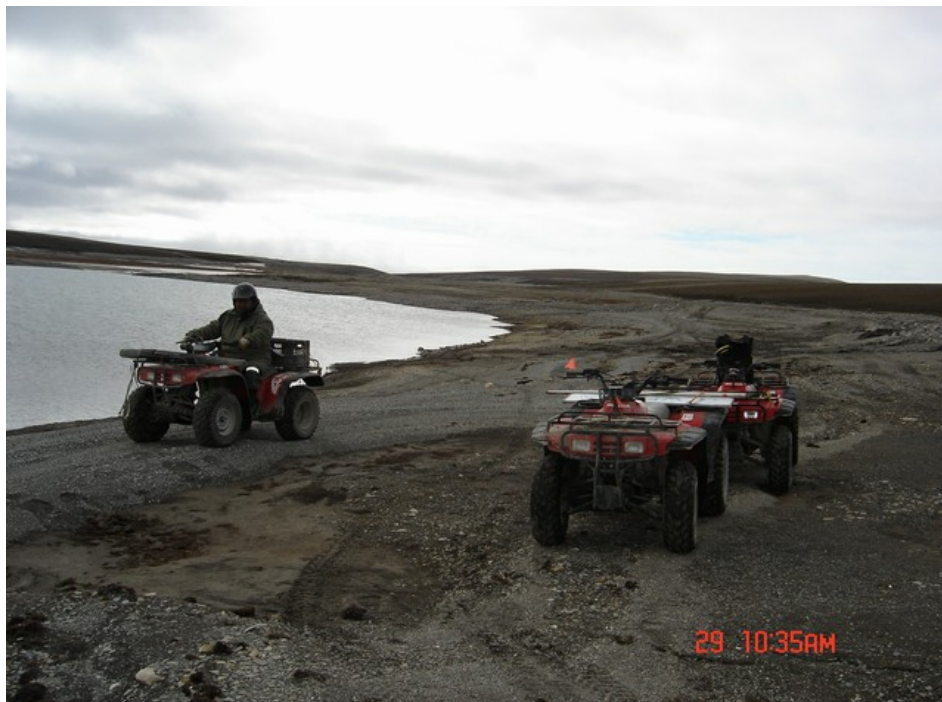
View south from south quadrant pin – Station 10.

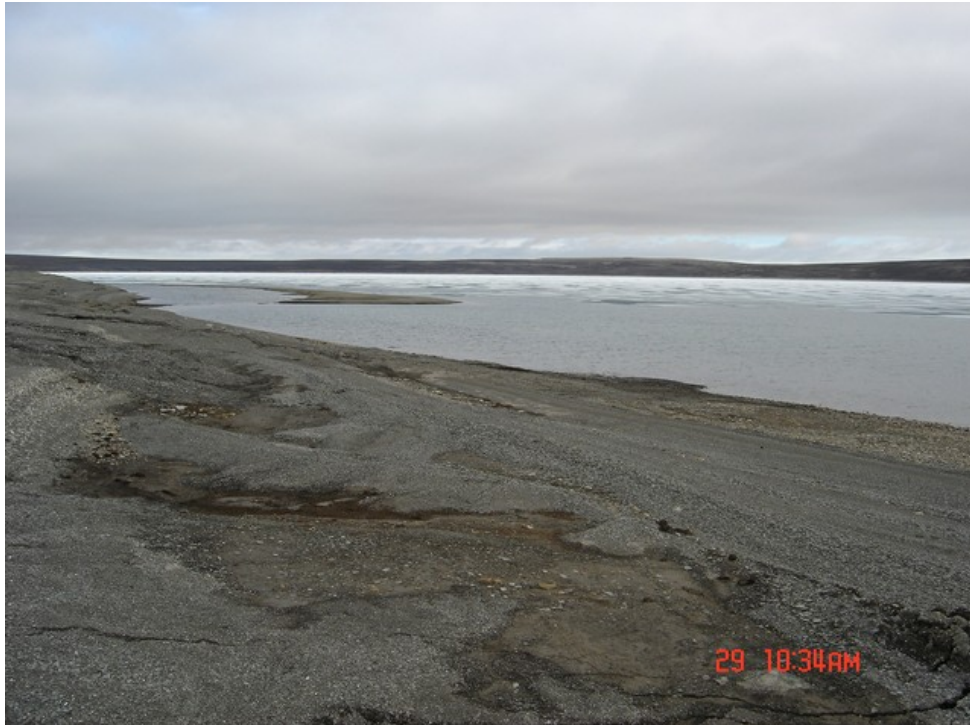
View north at south quadrant pin at Station 10.

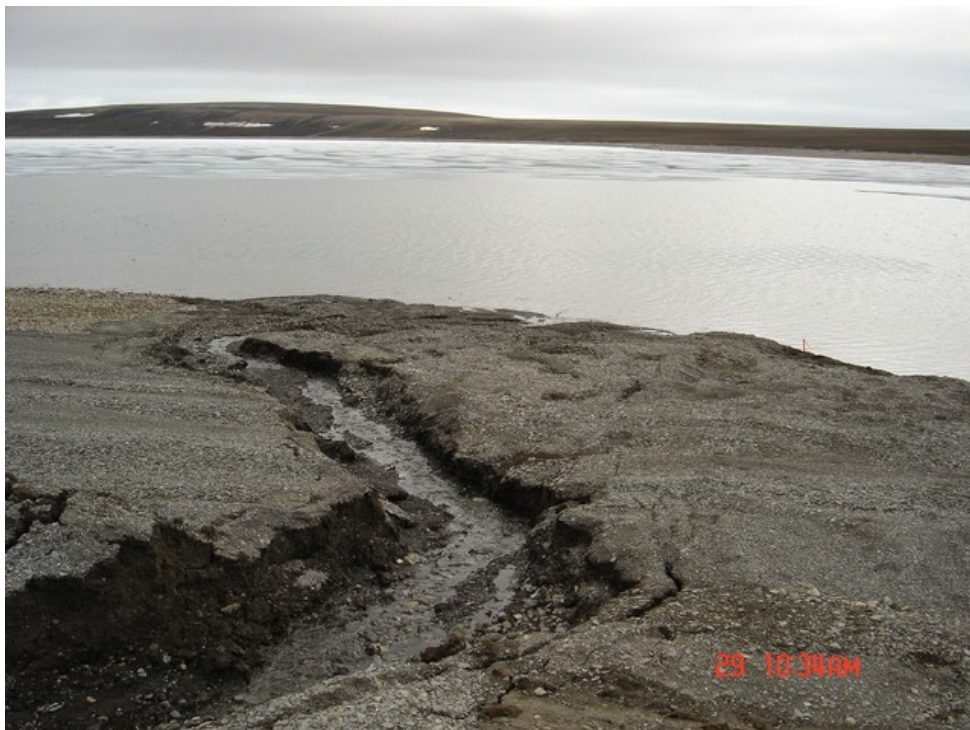
Small drainage which is in the process of forming a stable channel within silty sands and gravels adjacent to the Pin at South Quadrant Station 10.

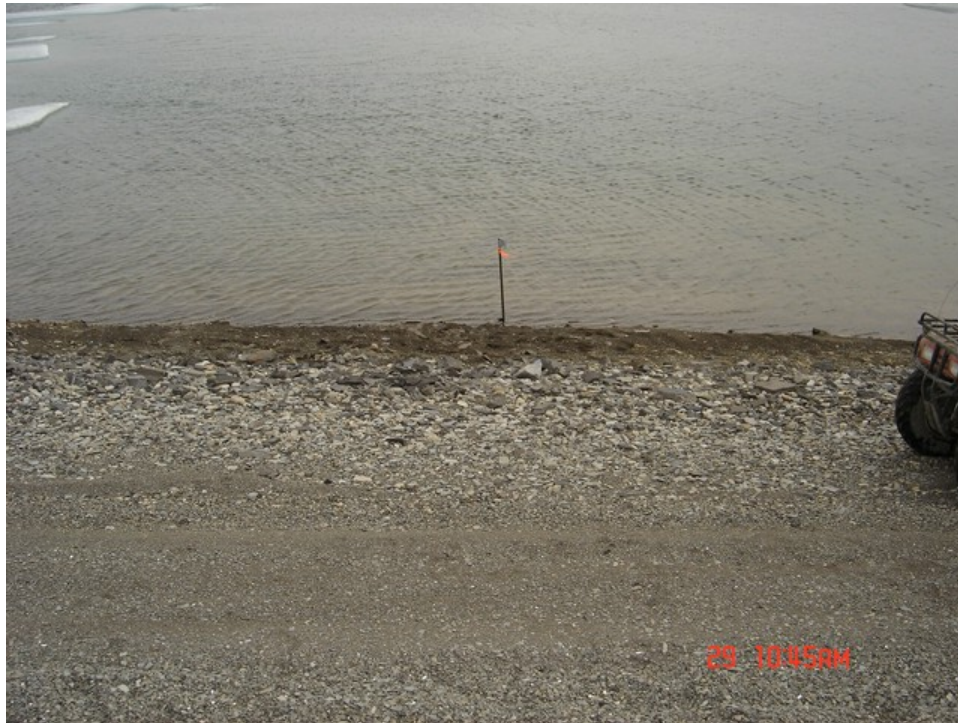
Shoreline peg viewed from erosion pin at West Quadrant Station 11.

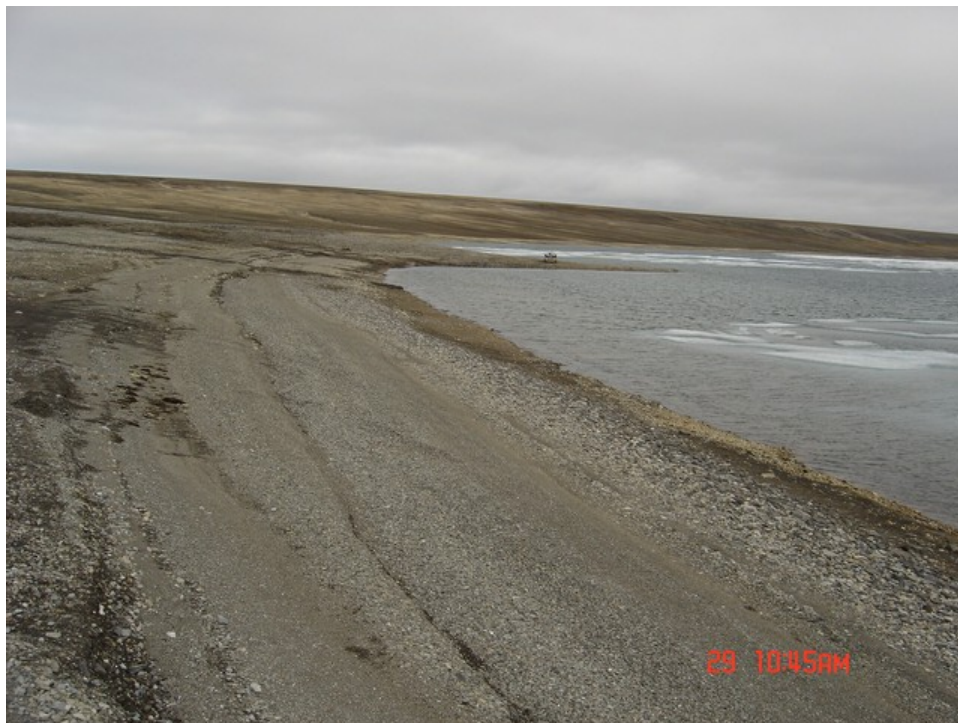
View north at West Quadrant (Station 11) – shoreline appears generally stable with only occasional erosion of small drainages in the lower part of the beach.

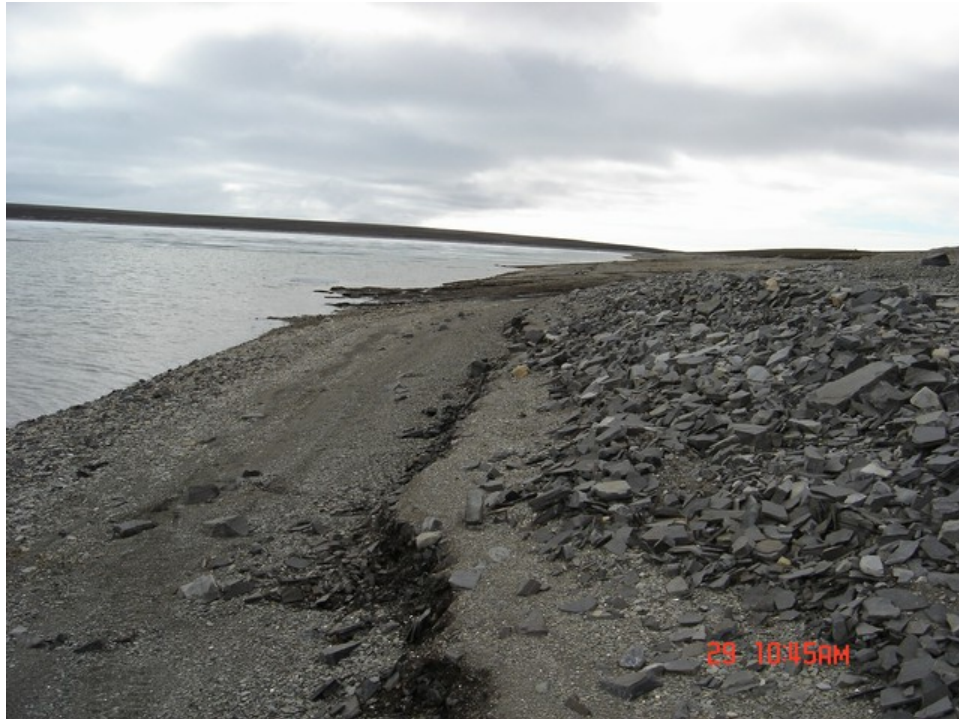
West Quadrant (Station 11) – view south.

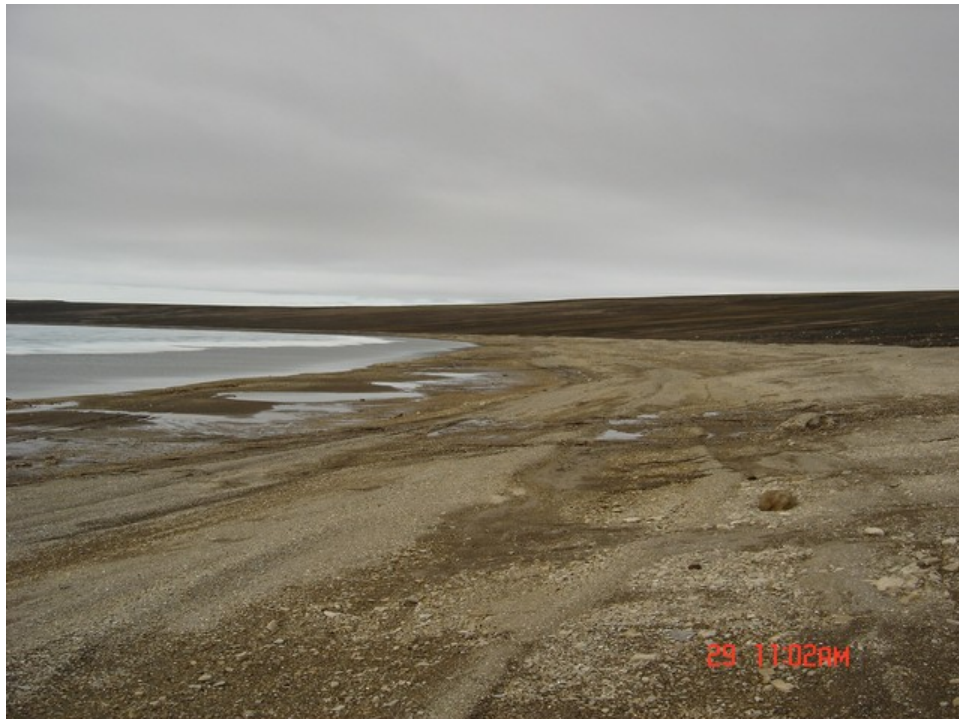
View west at North Quadrant Pin at Station 8 – sediments become more coarse and less subject to minor erosion proceeding north and east from the west quadrant.

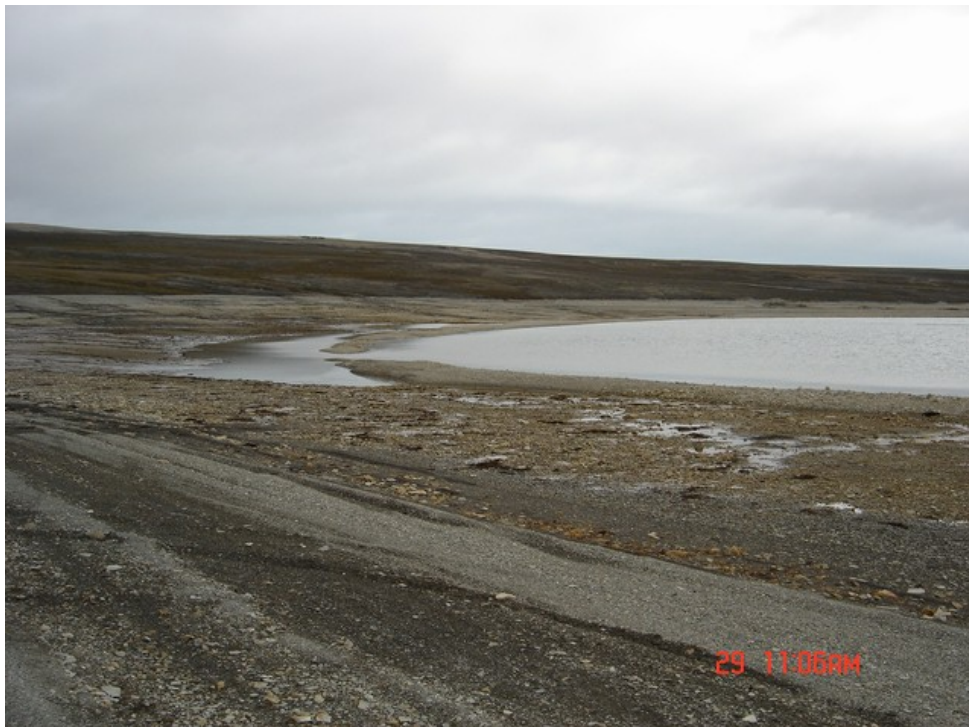
View east at North Quadrant Pin – Station 8.

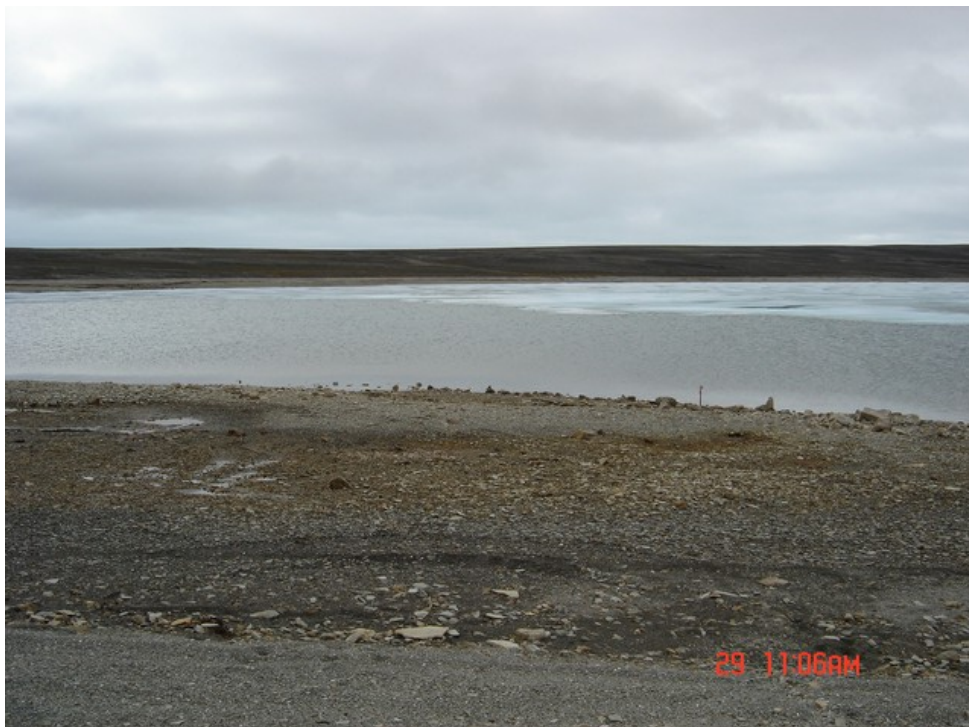
View of shoreline at North Quadrant Pin – Station 8.

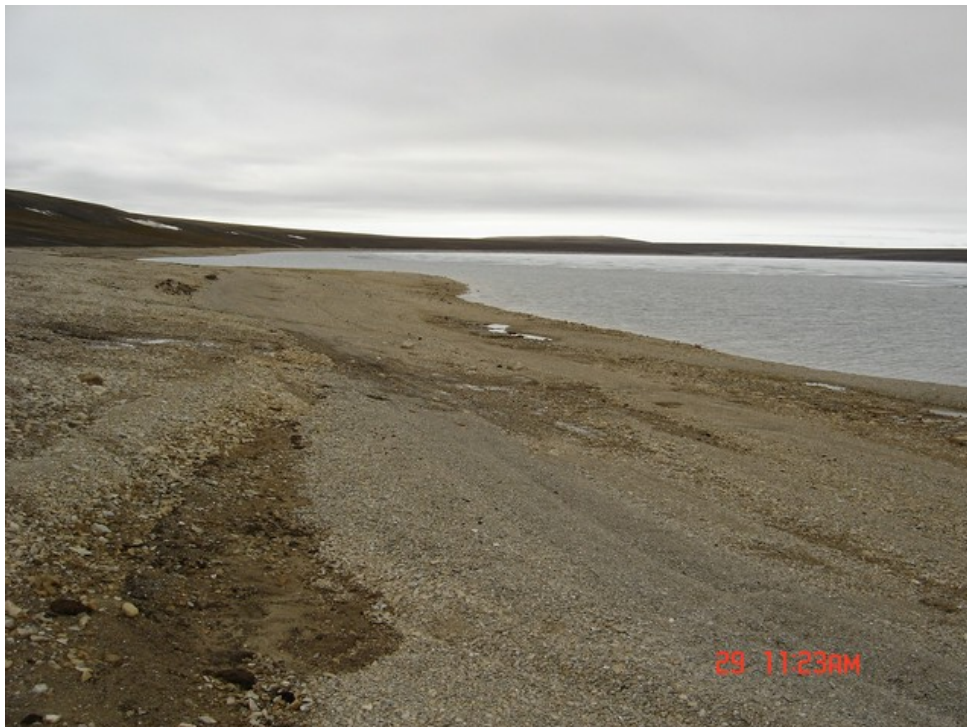
View south at East Quadrant Pin at Station 9 – sediments exposed are coarser than on west shore and less prone to localized erosion.

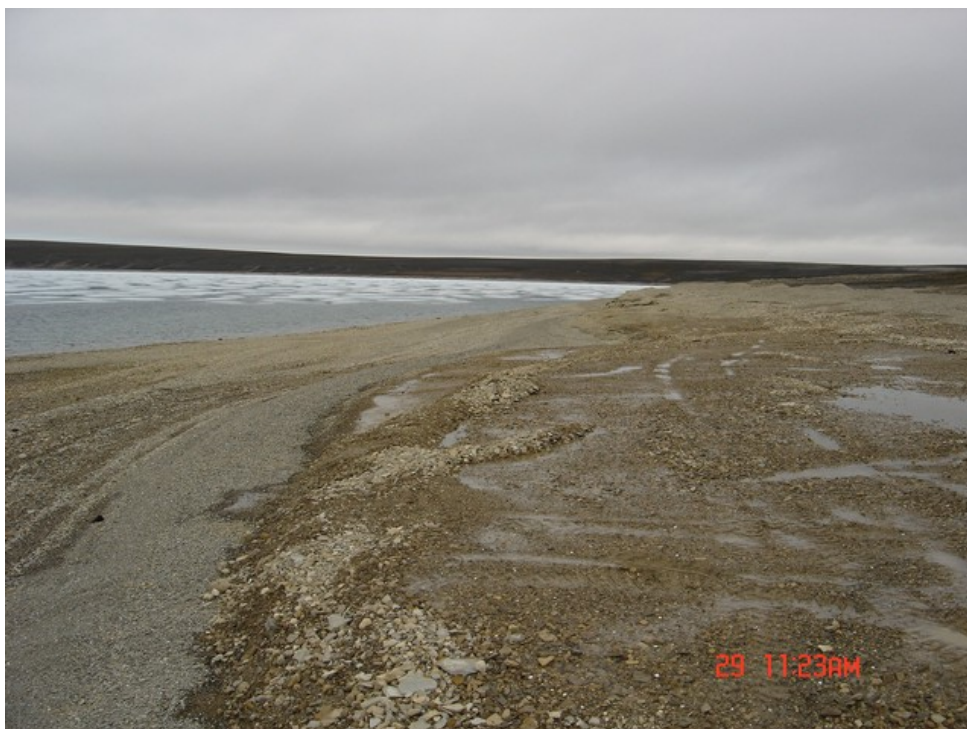
View north at East Quadrant Pin – Station 9.

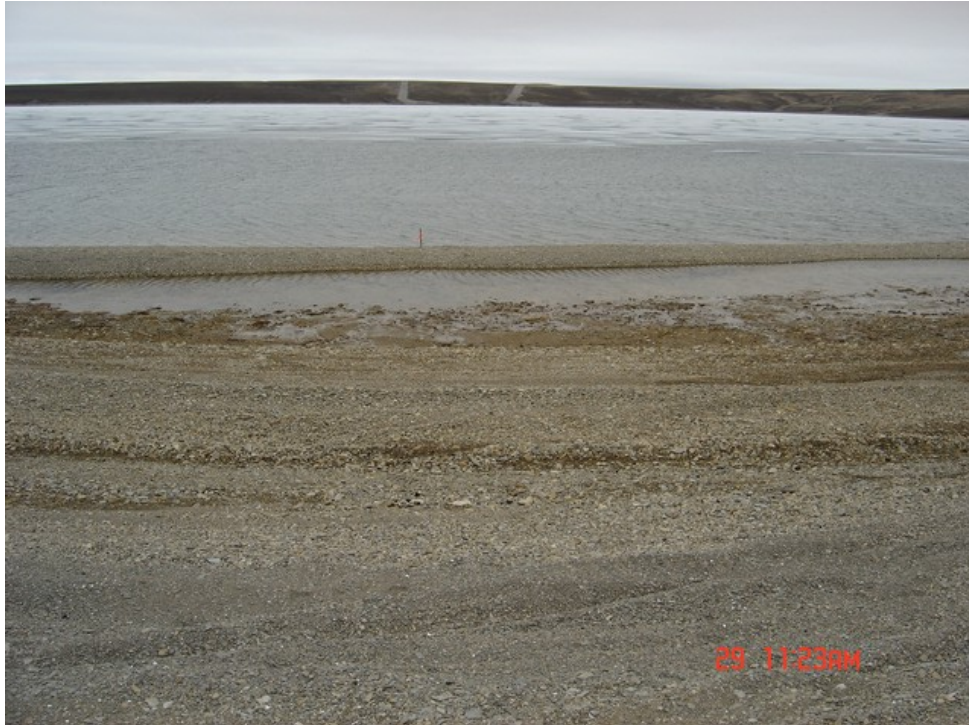
View from pin at East Quadrant (Station 9) where beach has become steeper proceeding southwards along eastern shore, with coarser angular rock fragments.

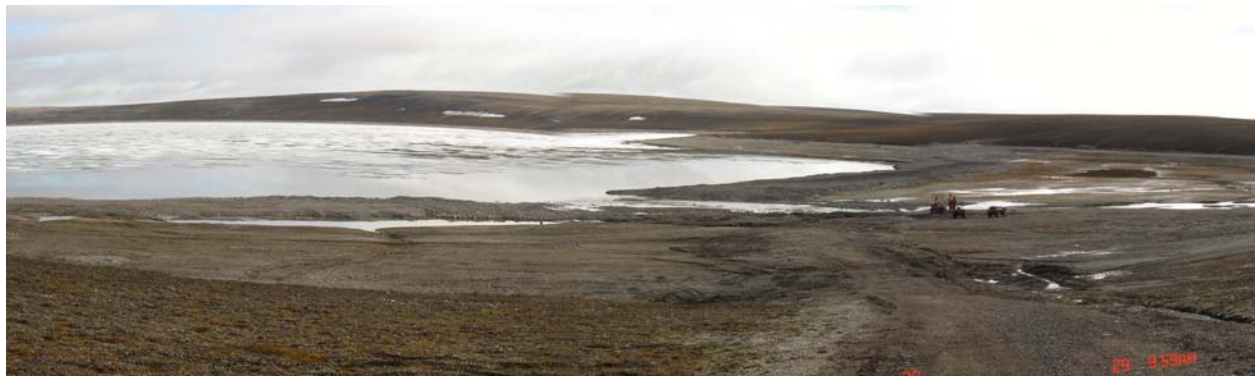
Panoramic view of Garrow Lake at left and wave break structure in the centre from waypoint GLWB1 on the access road on the western valley side slope.

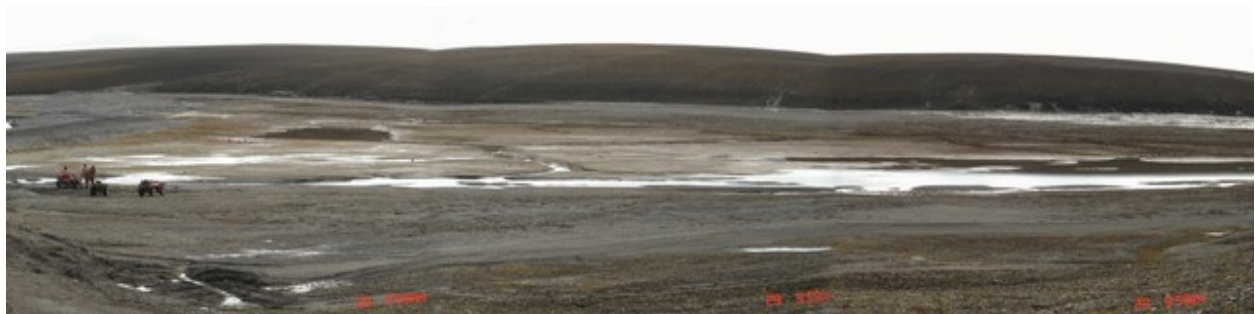
View eastward from waypoint GLWB1 of the channel and drained valley downstream of the wave break structure.

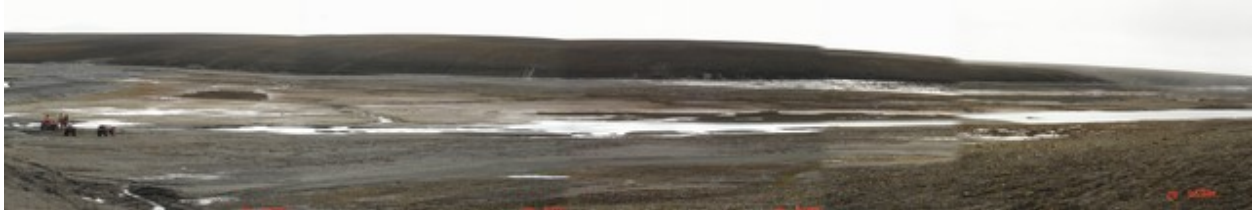
Wider panoramic view from waypoint GLWB1 of valley downstream of wave break structure.

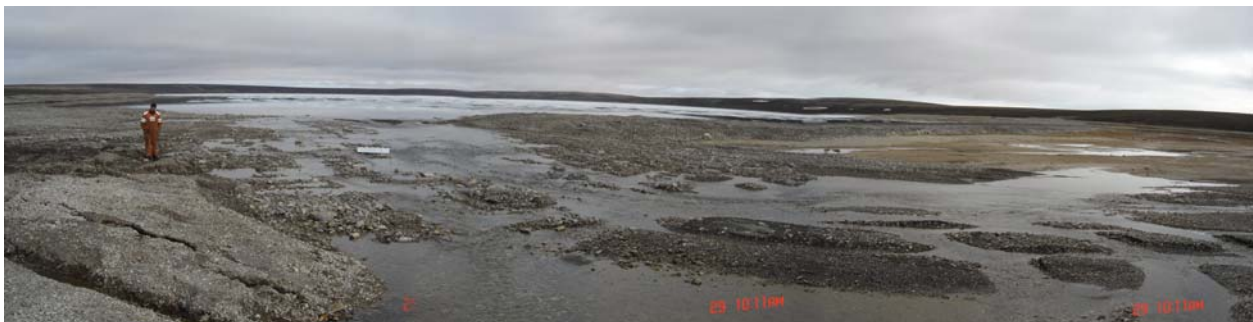
View north and east from waypoint GLWB2 looks upstream at outlet channel with wave break structure extending to the right. Material in channel is gravel sized and flow is only slightly turbid. Water quality sampling indicates that turbidity levels downstream at the main dam were low, evidenced by TSS measurements of 3 mg/l, at or below detection, on July 24 and July 31st 2005.

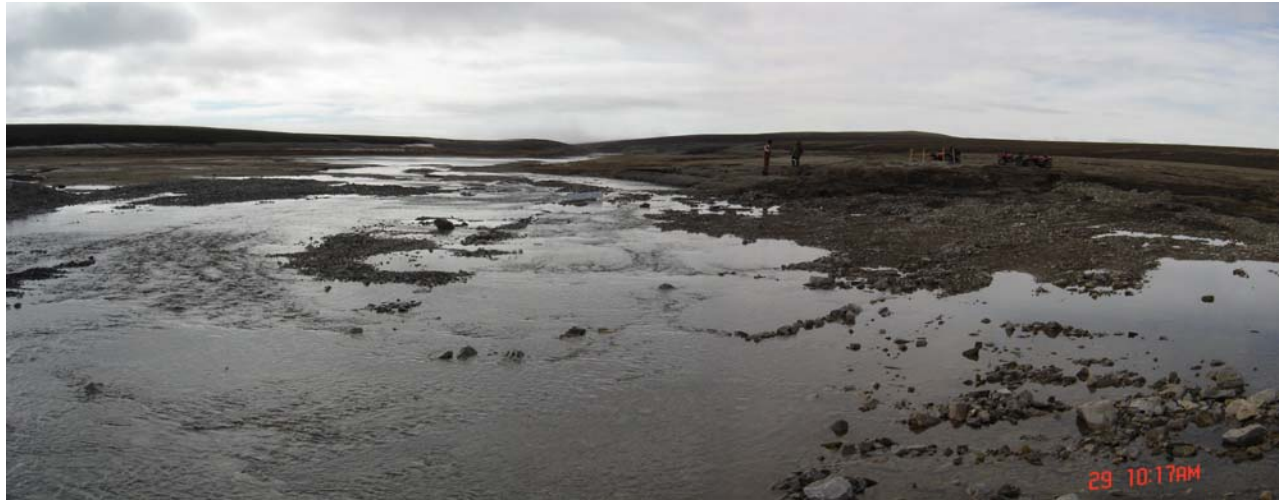
View from waypoint GLWB2a looks downstream from a point in the middle of the outlet channel.

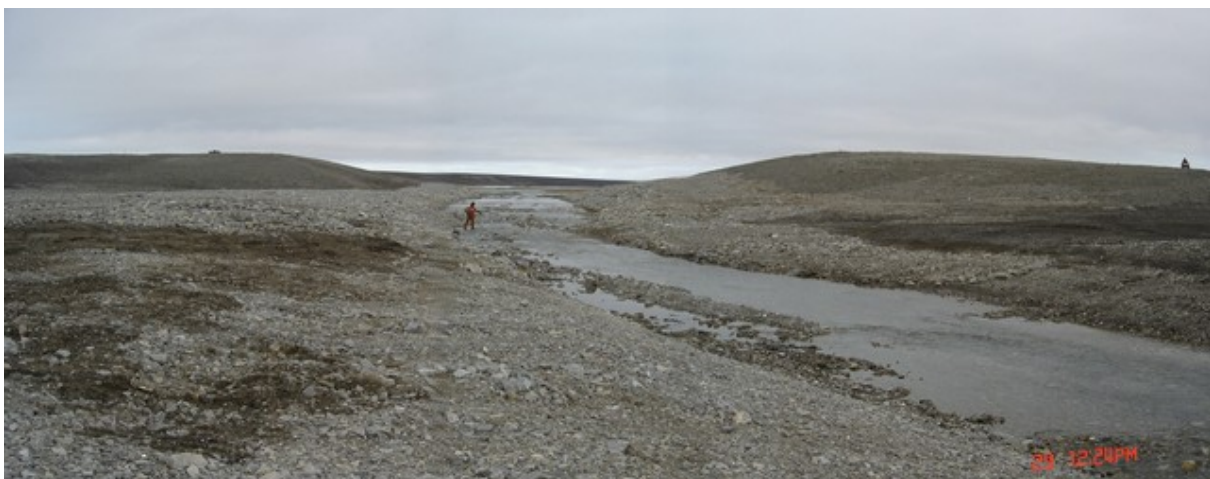
View looking upstream from waypoint GLD4 of overall breached dam and rip-rapped channel.

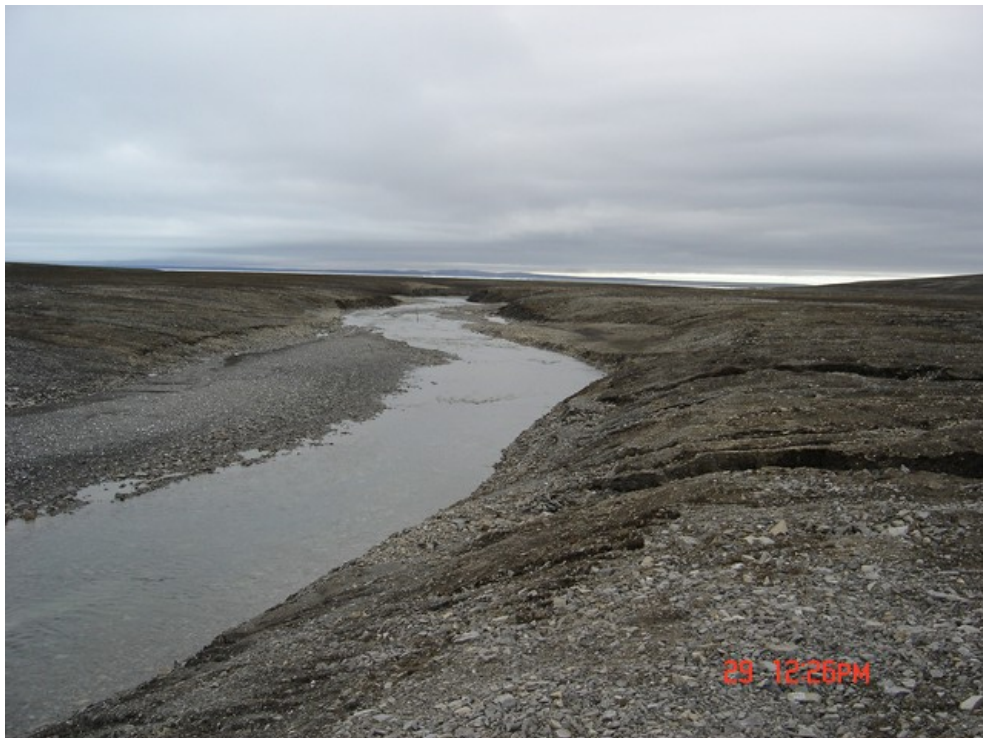
View looking downstream from waypoint GLD4 of lower end of outlet channel.

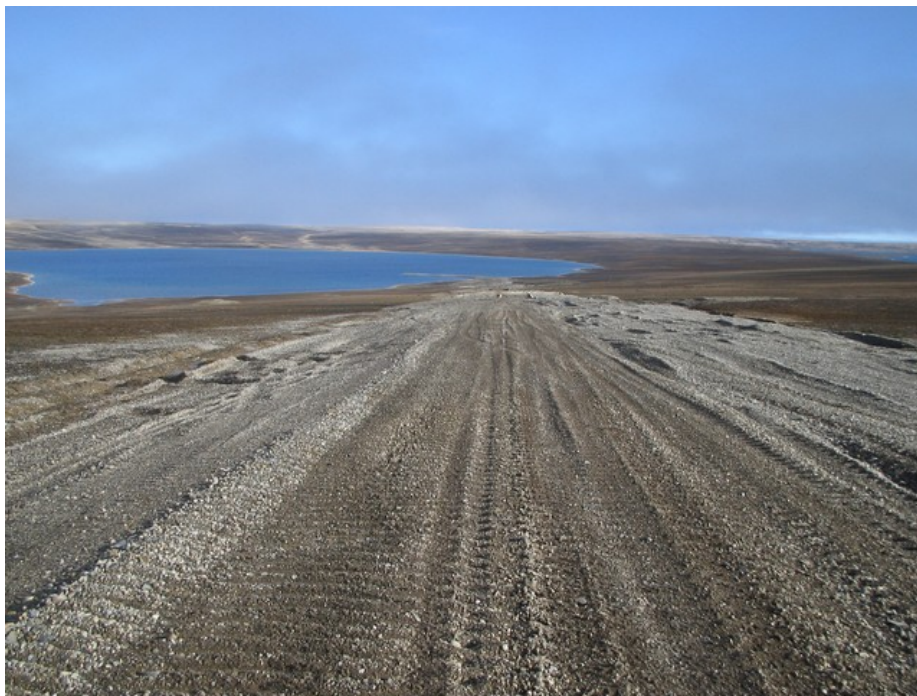
View northeast from a point about 800 m distant from intake causeway, showing good condition of roadway.

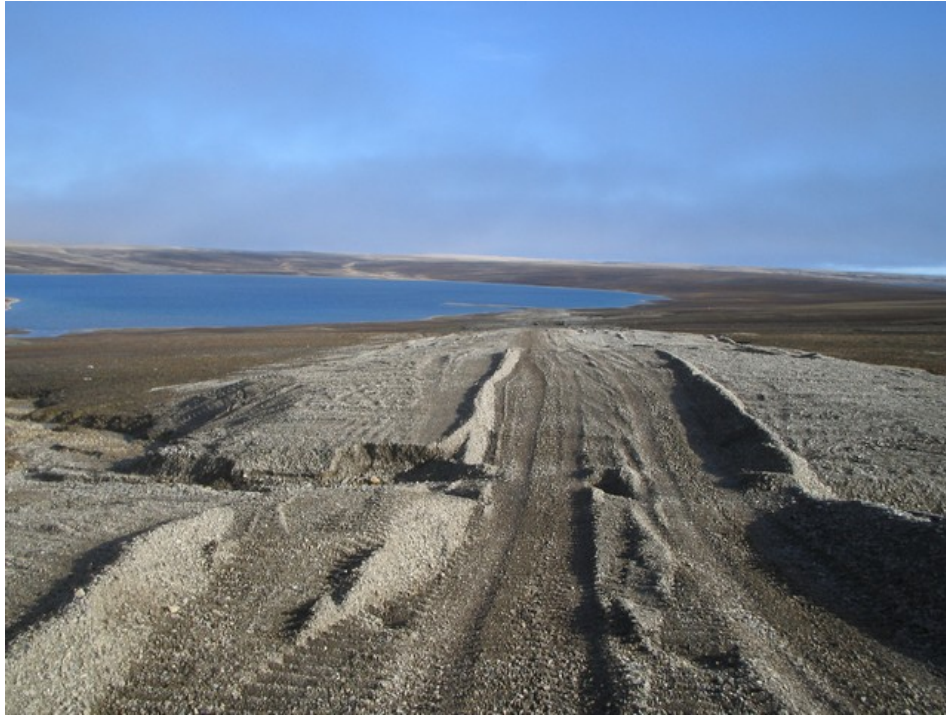
View northeast from about a point 600 m distant from intake causeway, showing a typical drainage swale.

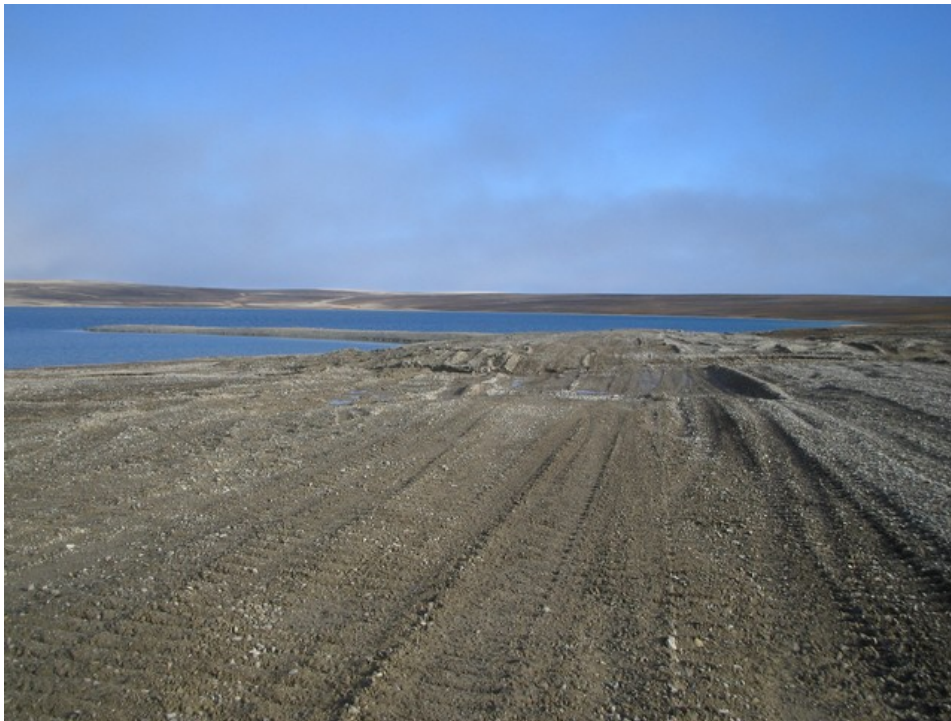
**Access roadway general view to the northeast at about 300 m distance from intake causeway,
which is in good condition.**

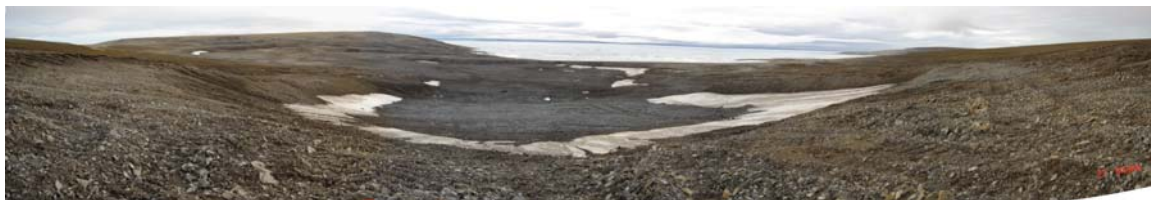
**Panoramic view looking west down slope into extension of New Quarry, from waypoint NQ1 PH2,
shows area of disturbed soil, which appears to be stable.**

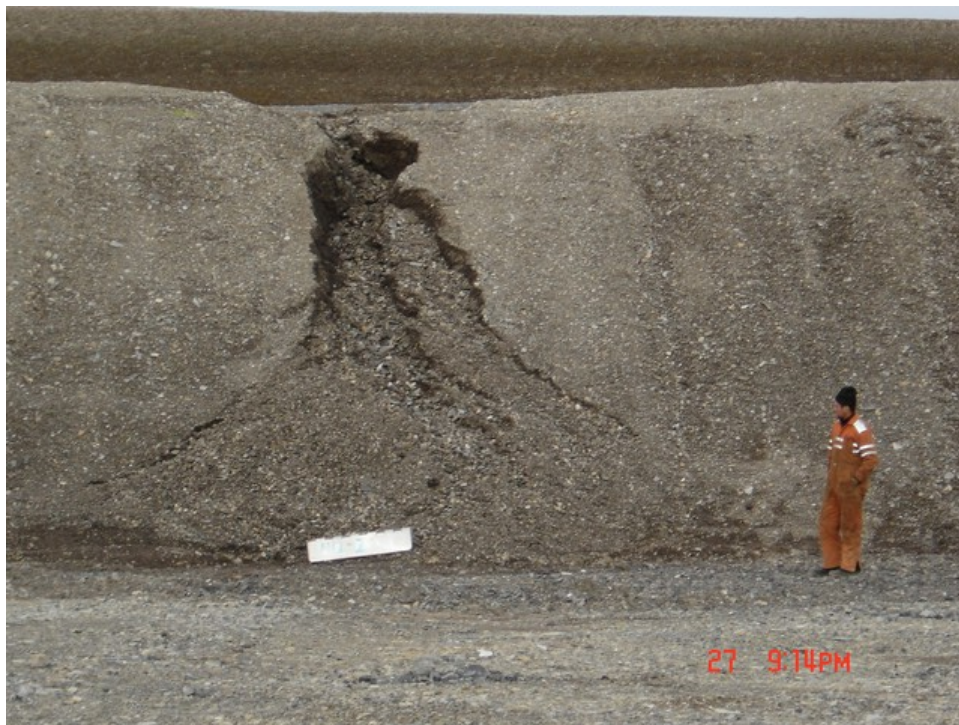
Close-up view of erosion gully at waypoint NQ2 PH1, showing relatively small width, and apparent tendency to be self-armouring.

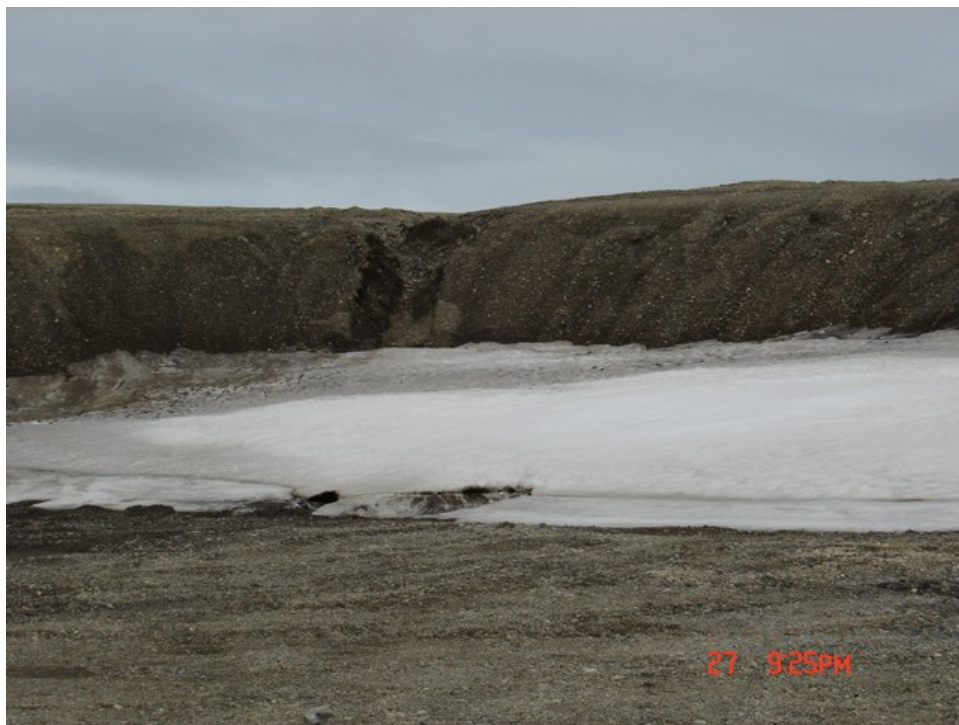
An isolated erosion gully at waypoint NQ3 PH1.

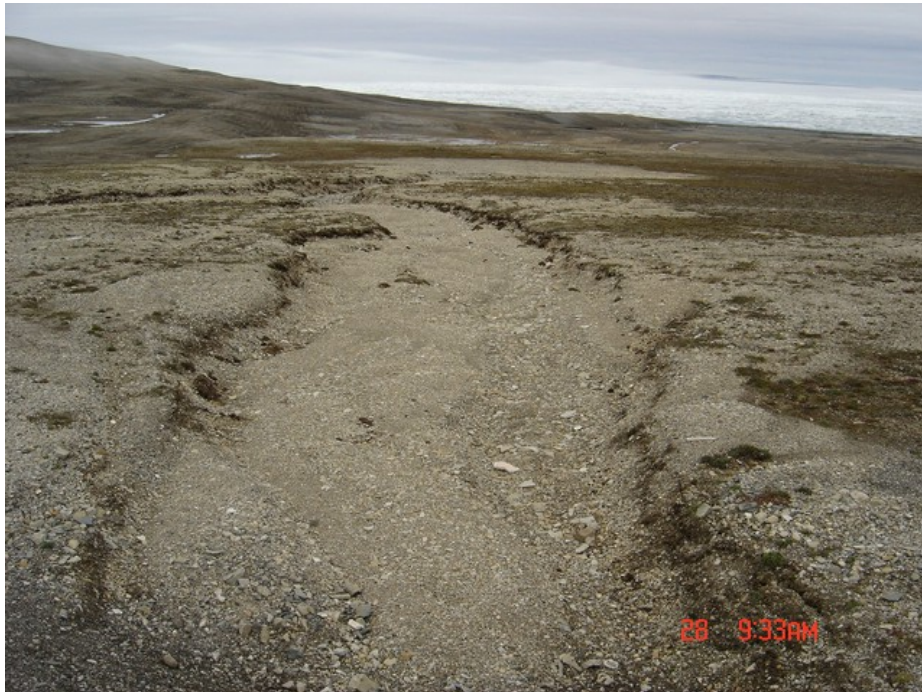
View to northwest at waypoint NQGTOP1 of a thaw/erosion gully on slope between road to Frustration Lake and the new Quarry area. This feature extends down to the top of the fan shown in photographs taken from waypoint NQ6 (see below).

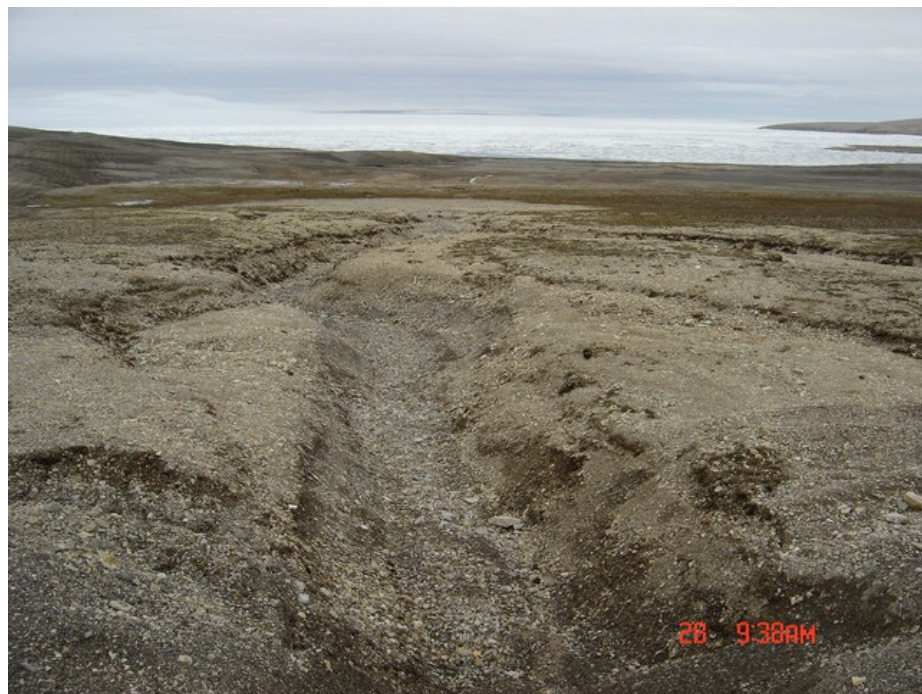
View to northwest from waypoint NQGTOP2 of second thaw/erosion gully adjacent and parallel to the one shown above at waypoint NQGTOP1.

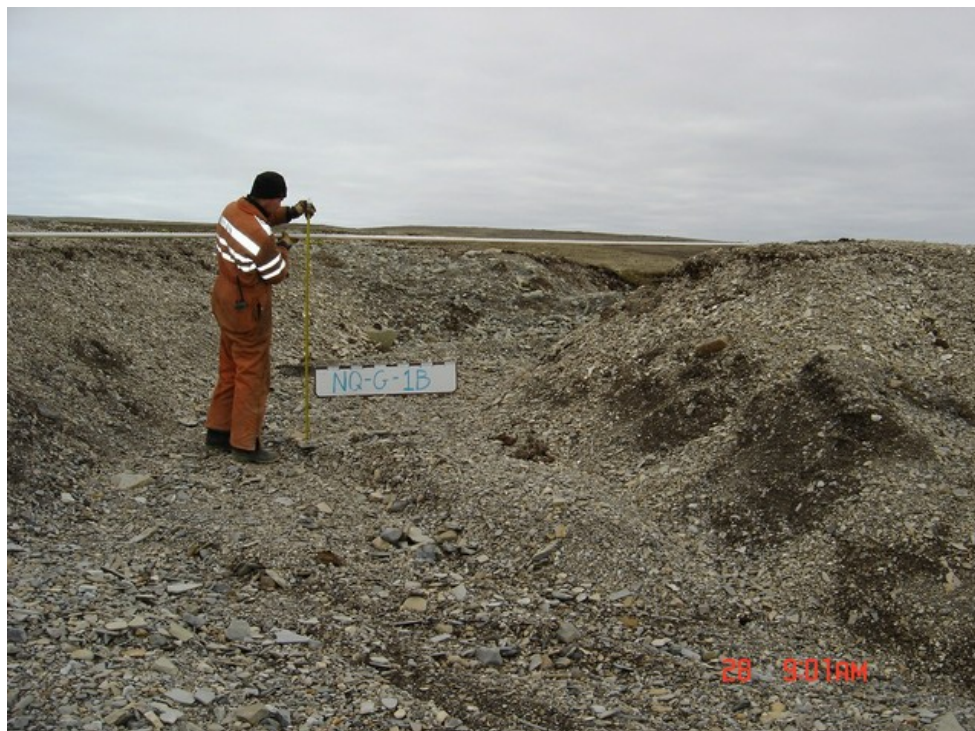
At waypoint NQG1B, depth of gully is 1.4 m, and width is 5.6m at base.

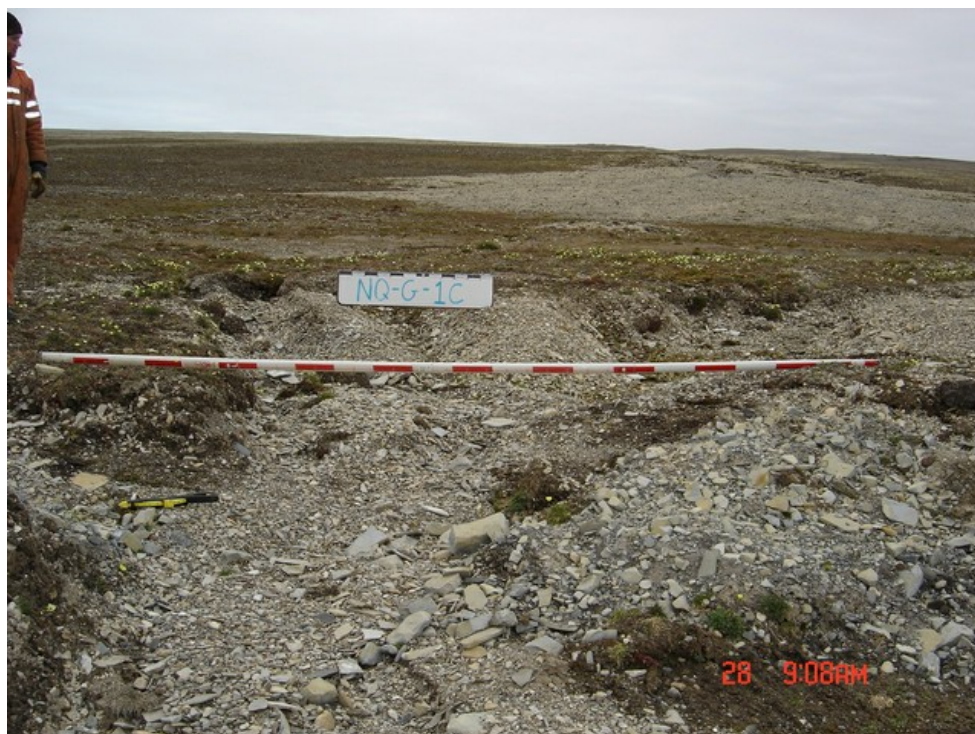
At waypoint NQG1C, depth of gully is 51 cm, and width at base is 3.1 m.

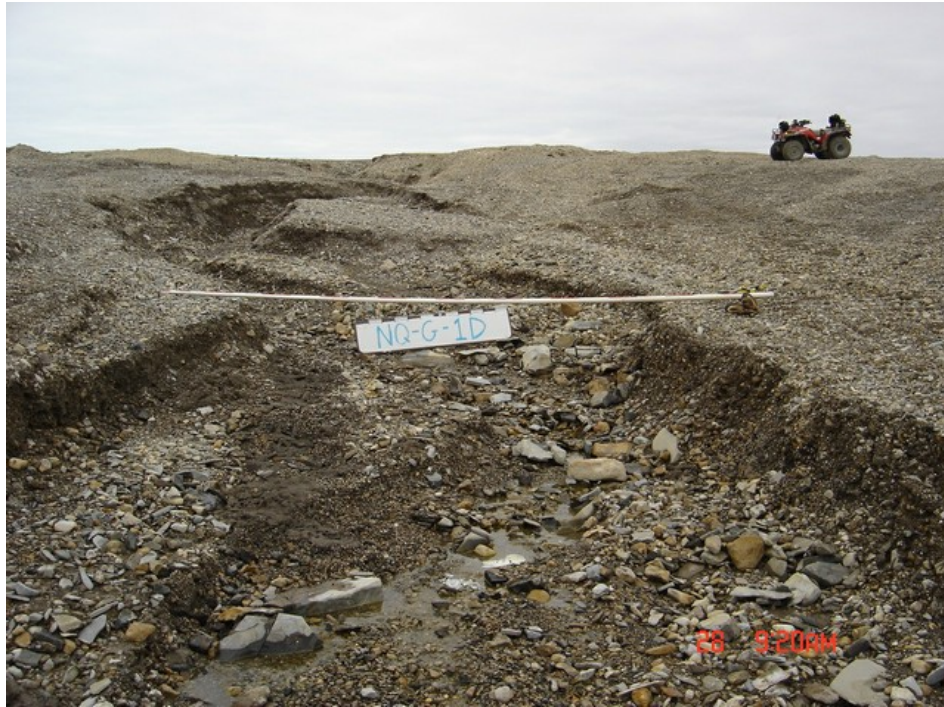
At waypoint NQG1D, depth of gully is 52 cm, and width at base is 3.2 m.
