Report on Post-closure Geotechnical Inspection for Polaris Mine Site in 2005

Reference: **GLL 50508**

December 15, 2005

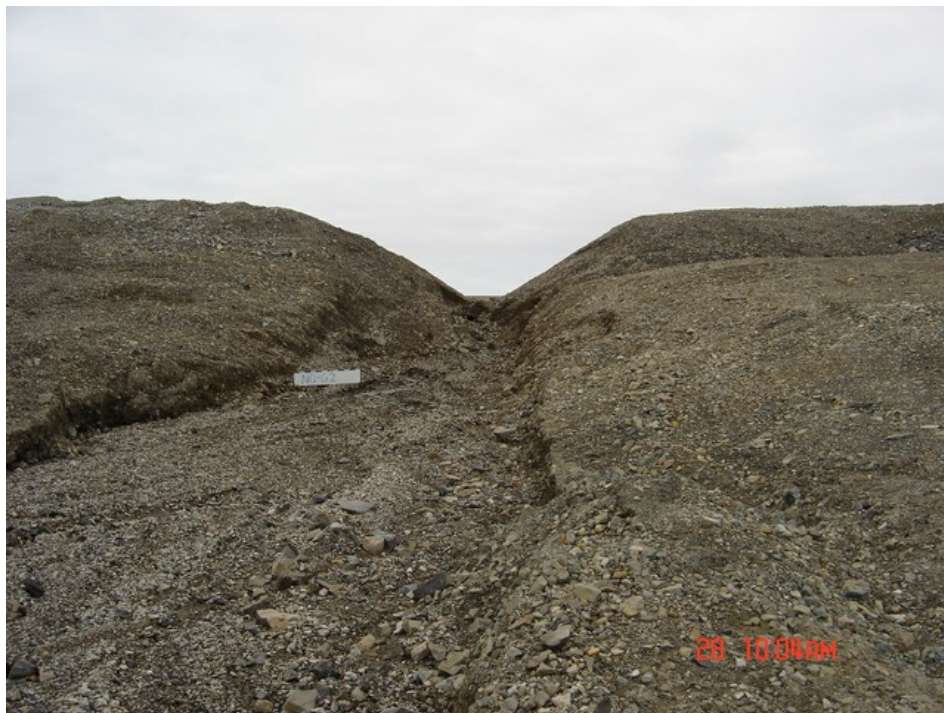
Photo looking west and upstream at waypoint NQG2 shows where drainage from Loon Lake crosses through fill material around the perimeter of the New Quarry area.

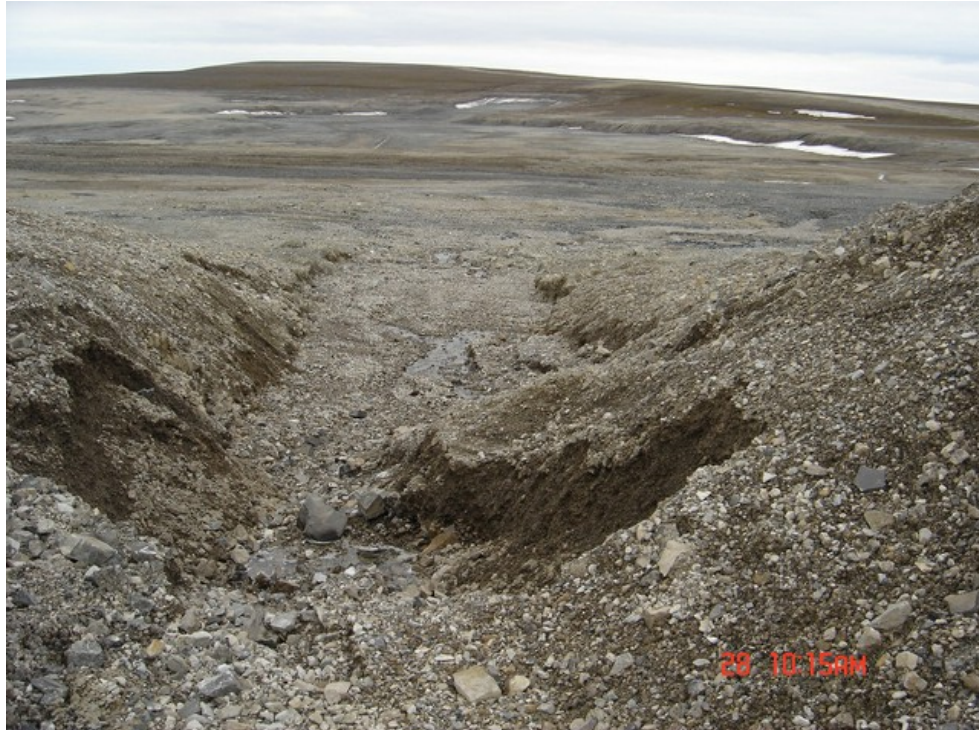
Photo looking downstream from waypoint NQG2CUL, where there is an existing collapsing culvert. While channel appears to self-armouring, the culvert should be removed and sideslopes flattened.

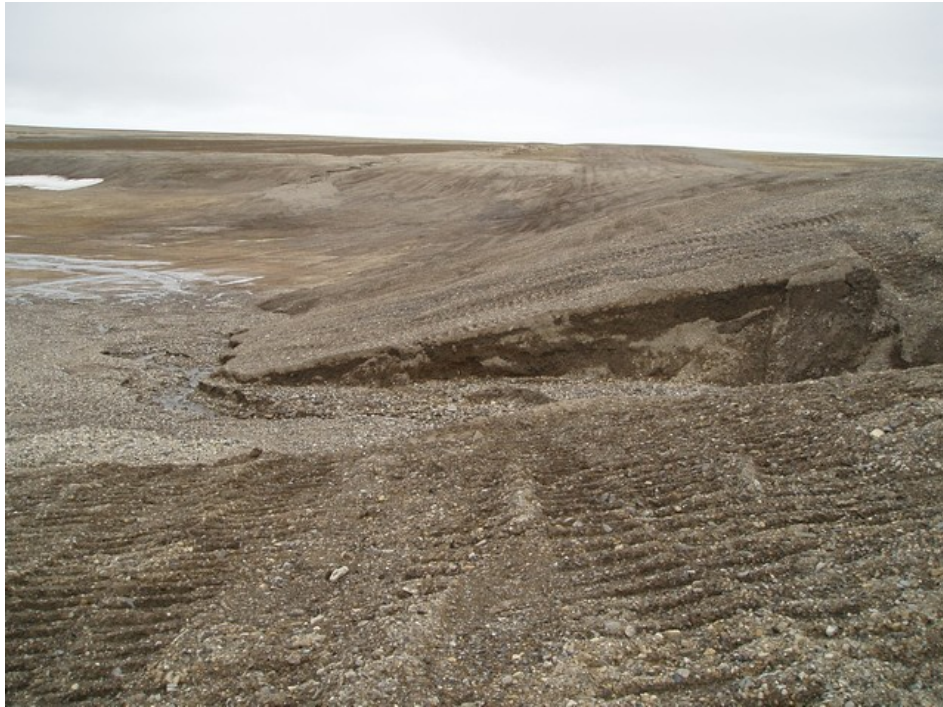
View adjacent and immediately to west of view shown above showing significant erosional down cutting of what appears to be quarry strippings of silty sand and gravels.

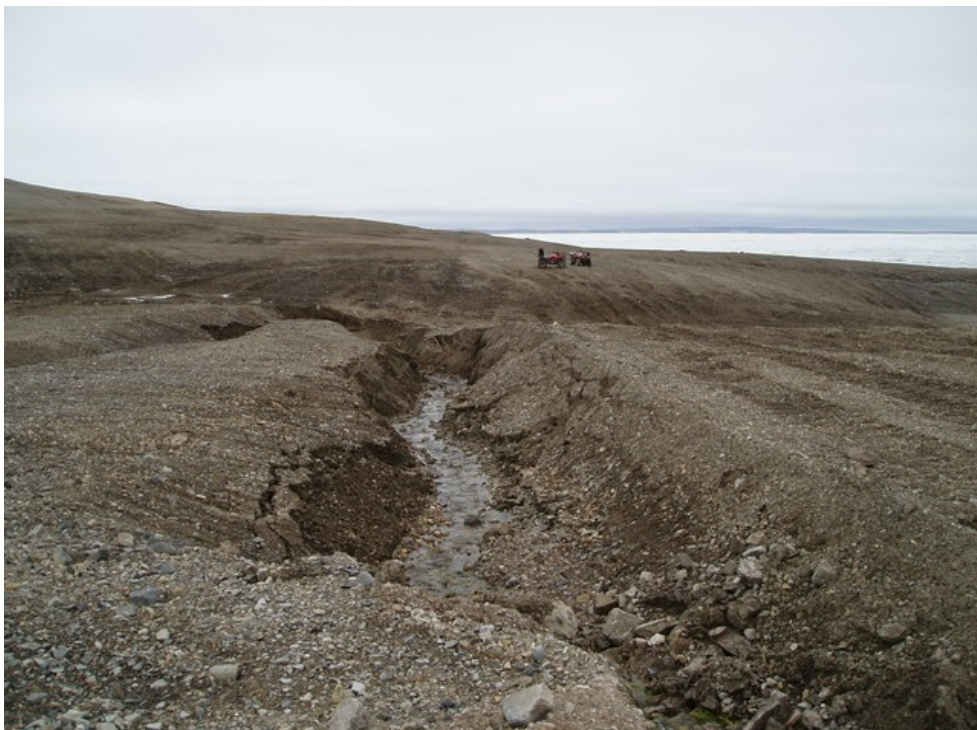
View upstream from view shown above where channel is steepening and deepening.

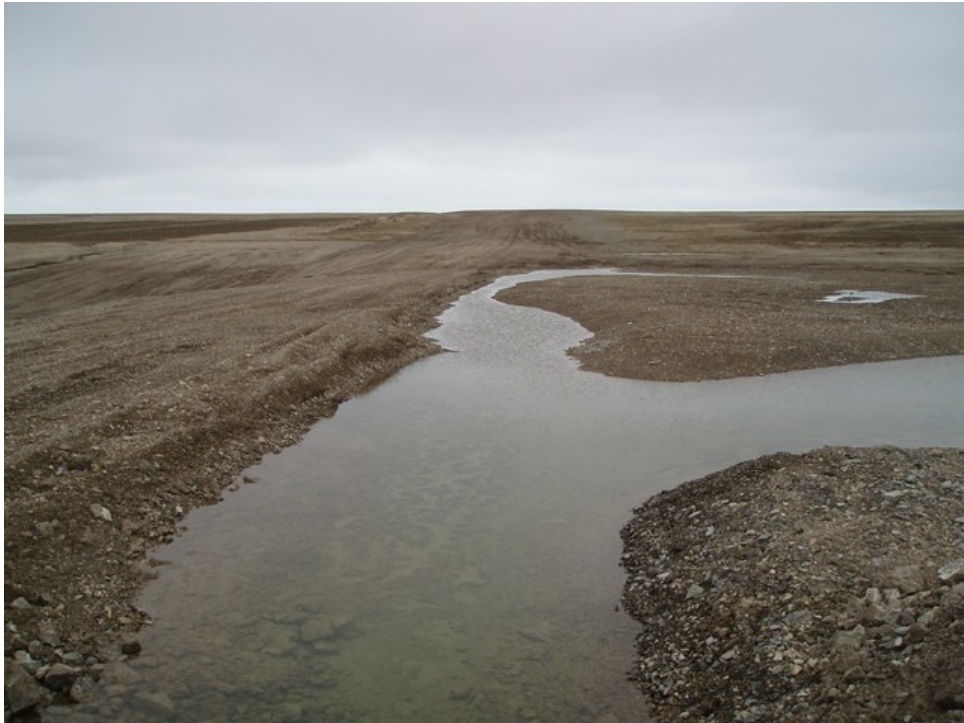
Further upstream, where drainage is ponding behind stripping fill slope. Downstream of this point (behind the photographer) the channel begins to downcut and steepen.

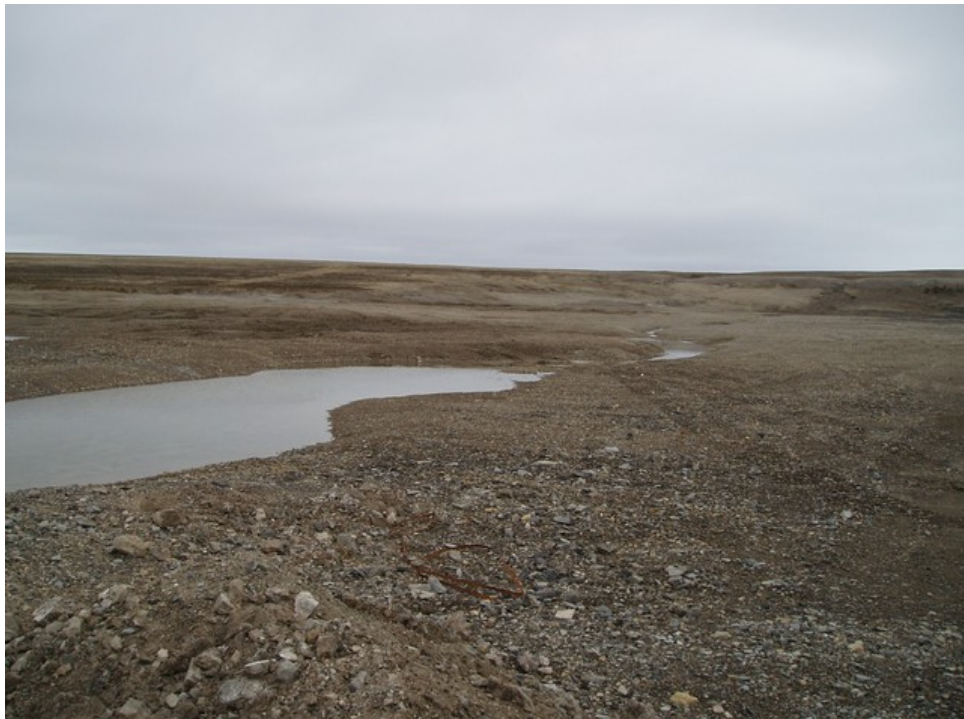
View to the west shows drainage which has formed a meandering pond across the upper and western part of the New Quarry area.

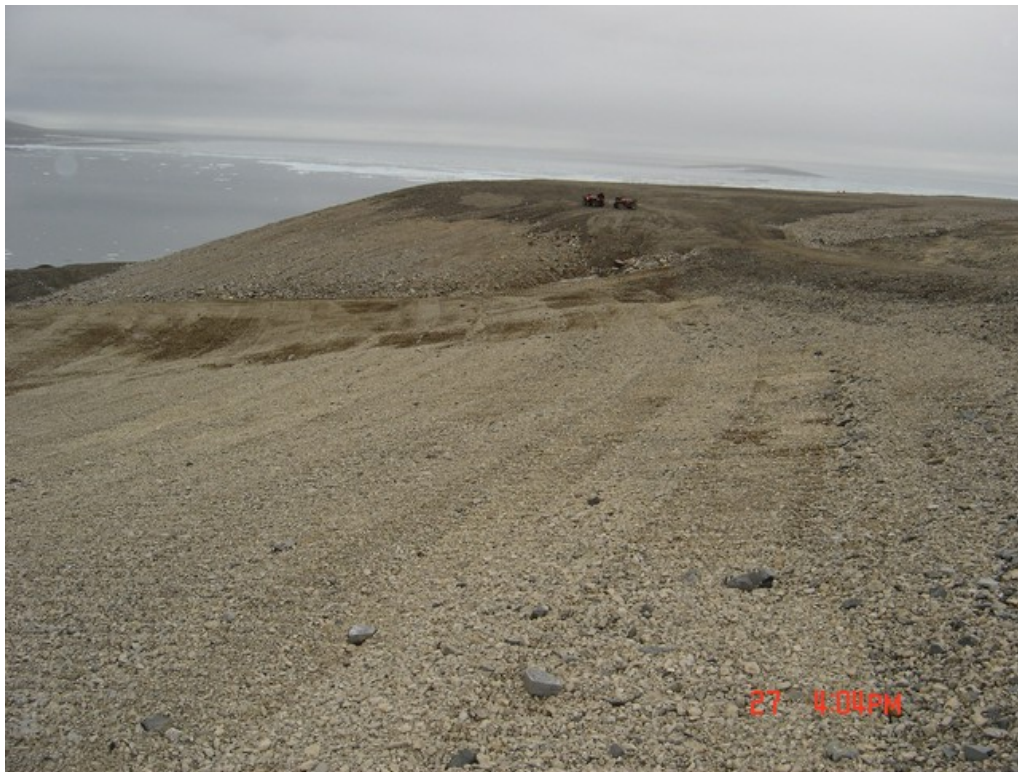
View southwest from waypoint OLFPH2, showing the northeast end slope, which is in good condition.

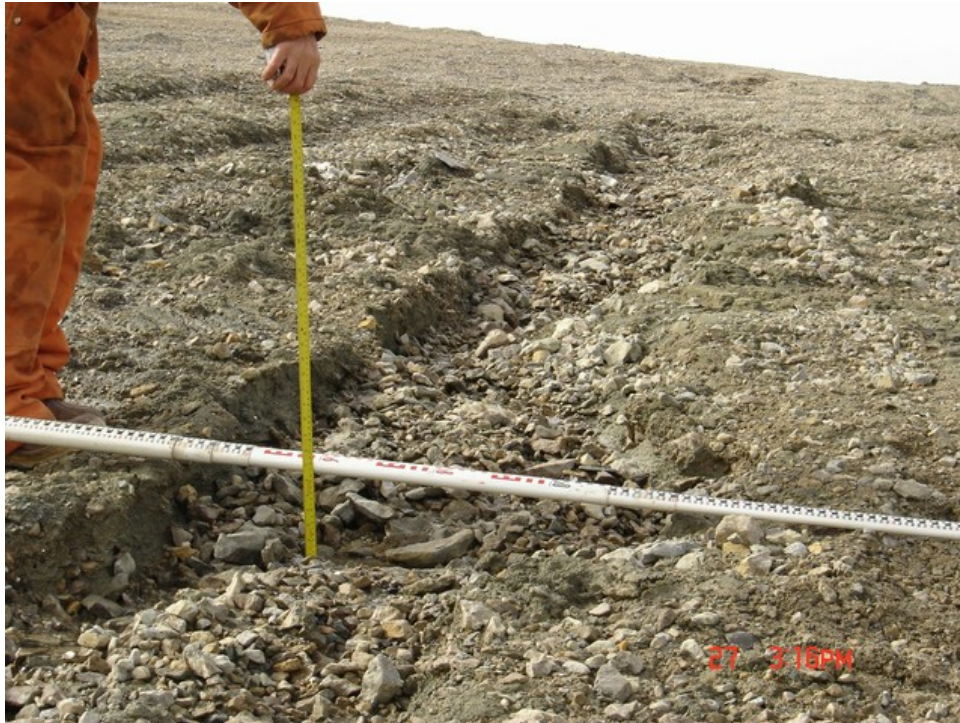
Erosion gully at waypoint OLF GUL1 has a depth of 20 cm.

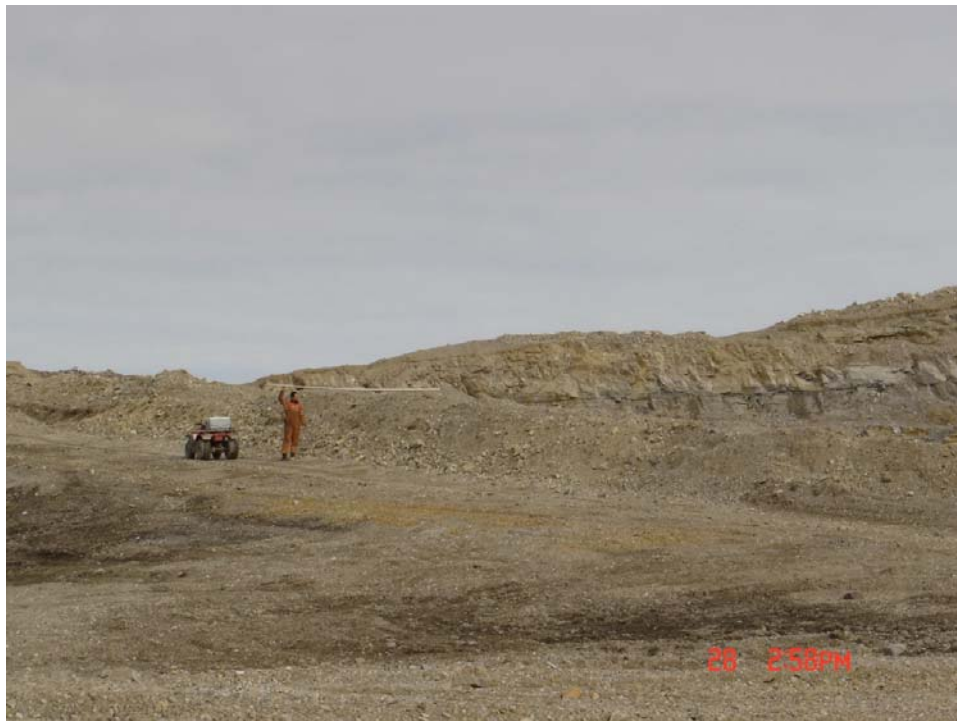
View to north from waypoint LRD5 at entrance to LRD quarry landfill. This illustrates perimeter berm about 1.8 m high that borders the top perimeter edge of the LRD quarry sidewalls.

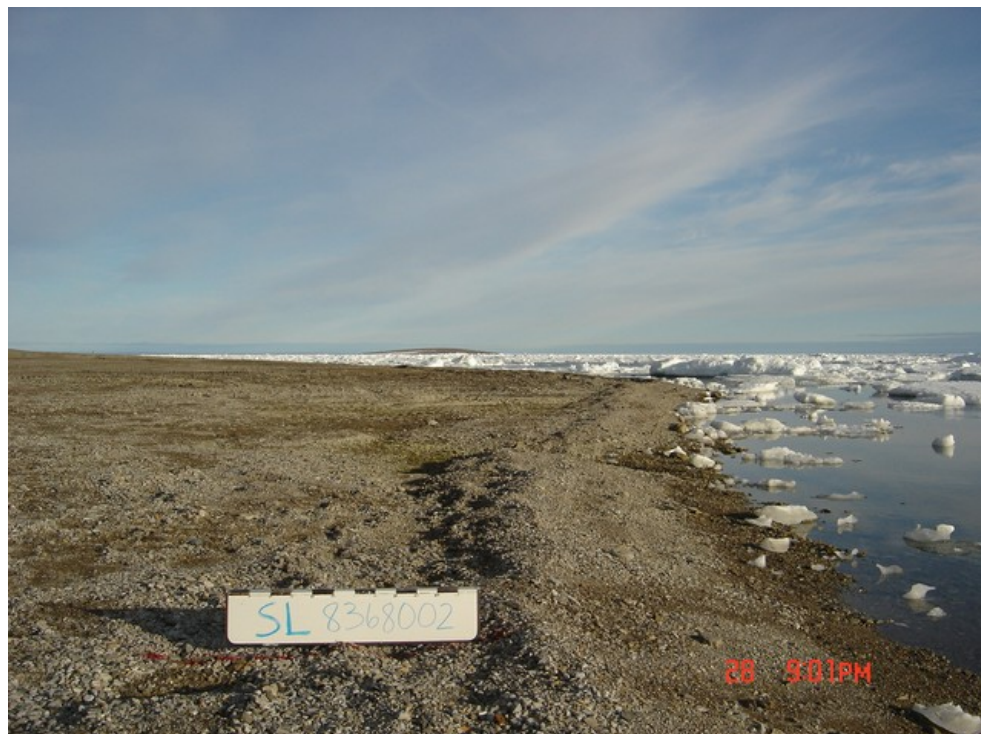
SL-4 North 8 368 000 view to south.

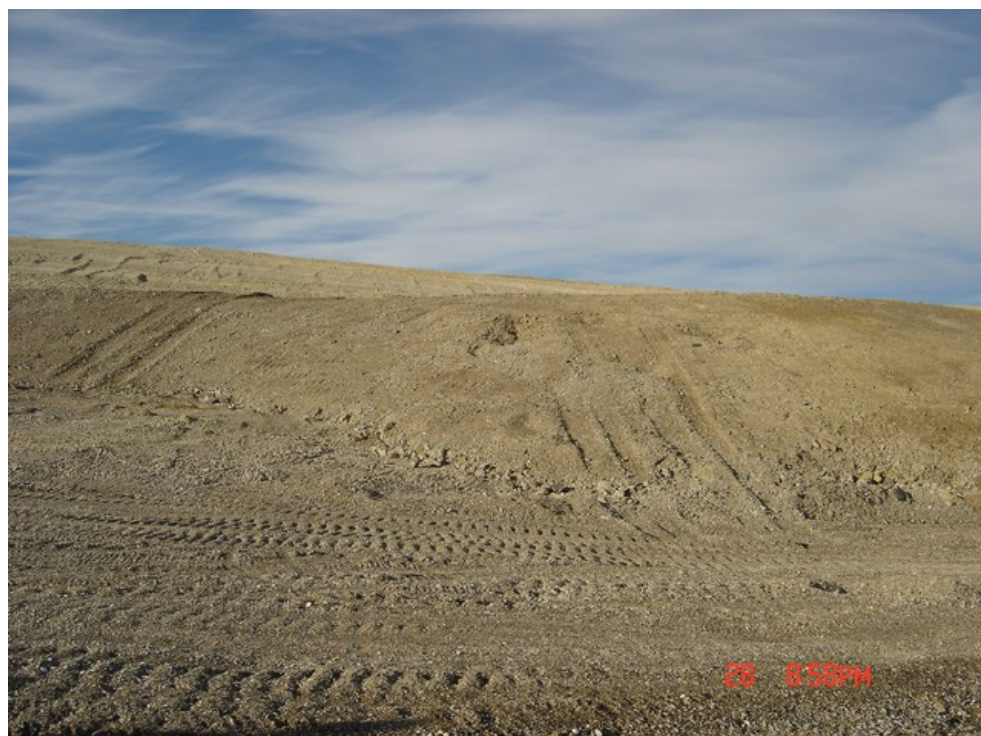
SL-3 North 8 368 100 view to east.

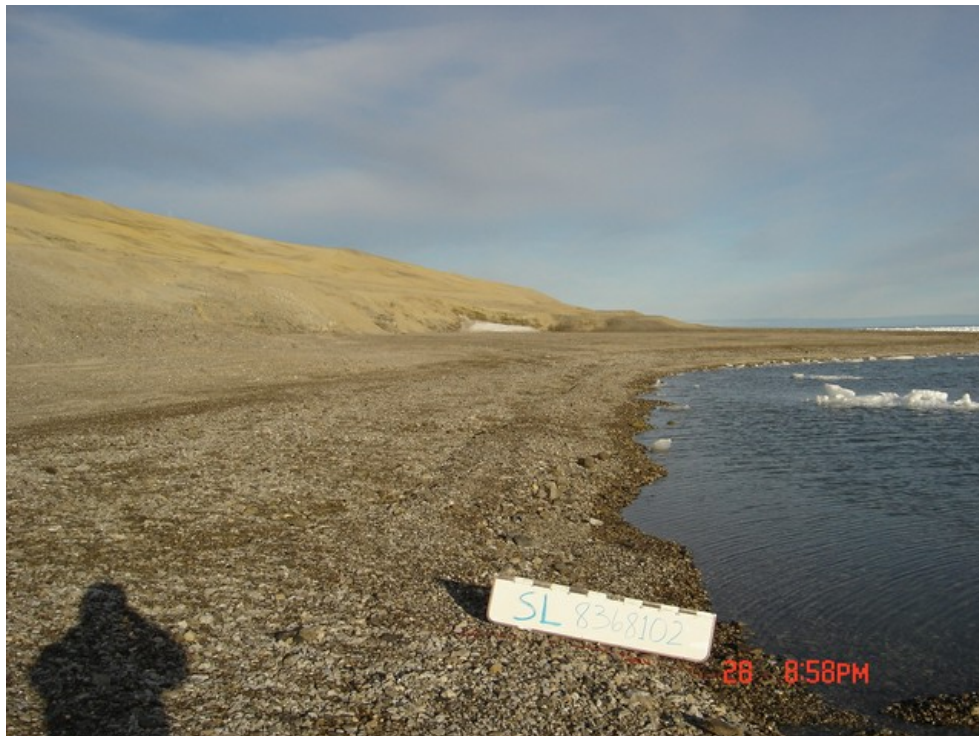
SL-3 North 8 368 100 view to south.

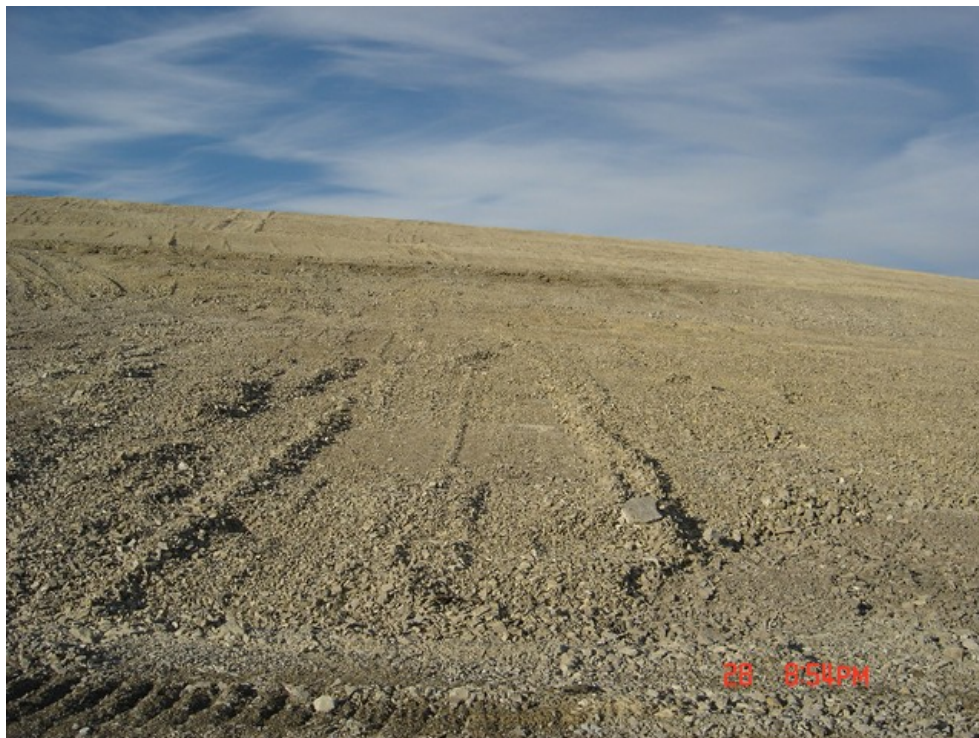
SL-2 North 8 368 200 view to east.

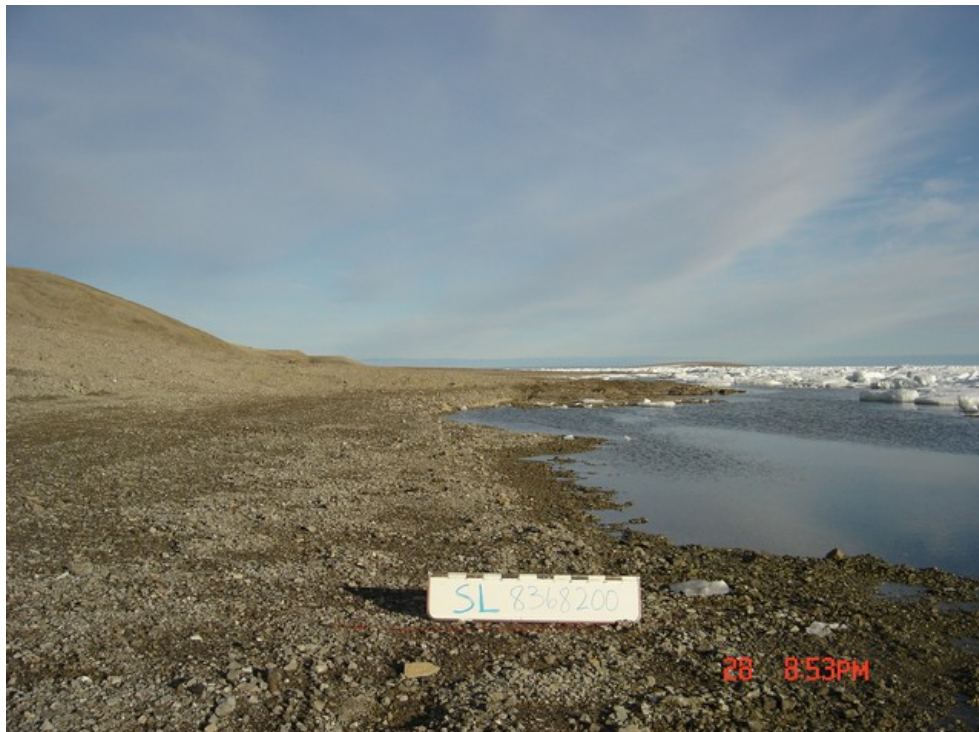
SL-2 North 8 368 200 view to south.

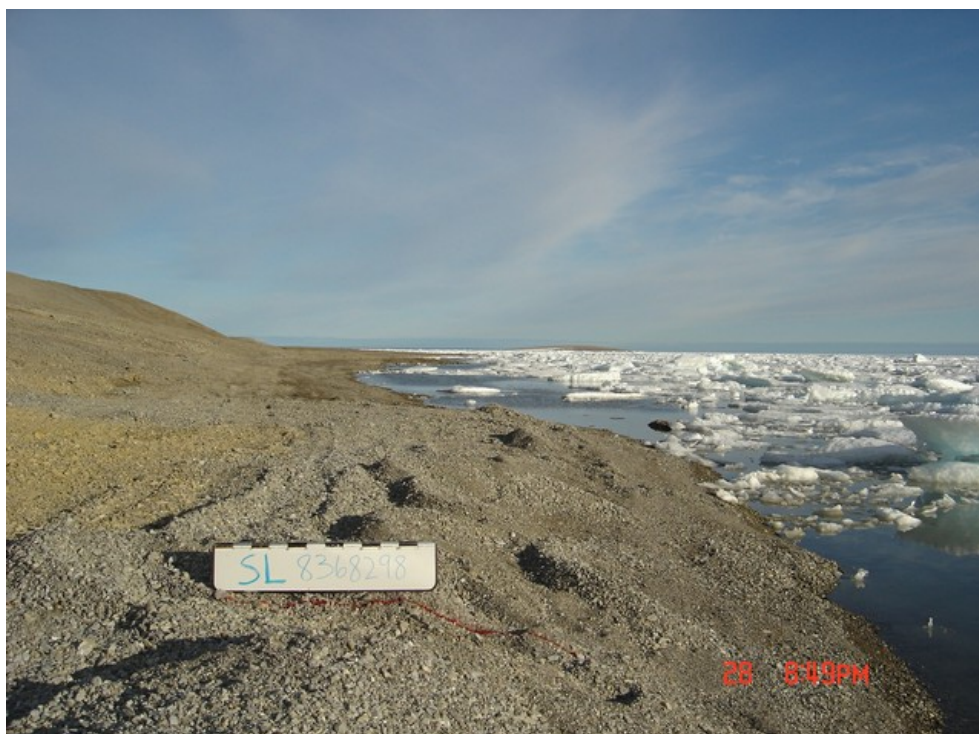
SL-1 North 8 368 300 view to south.
