# **Report on Post-Closure Geotechnical Inspection of Polaris Mine Site in 2007**

Prepared for  
**TeckCominco Metals Ltd.**

Submitted by  
**Gartner Lee Limited**

**October, 2007**

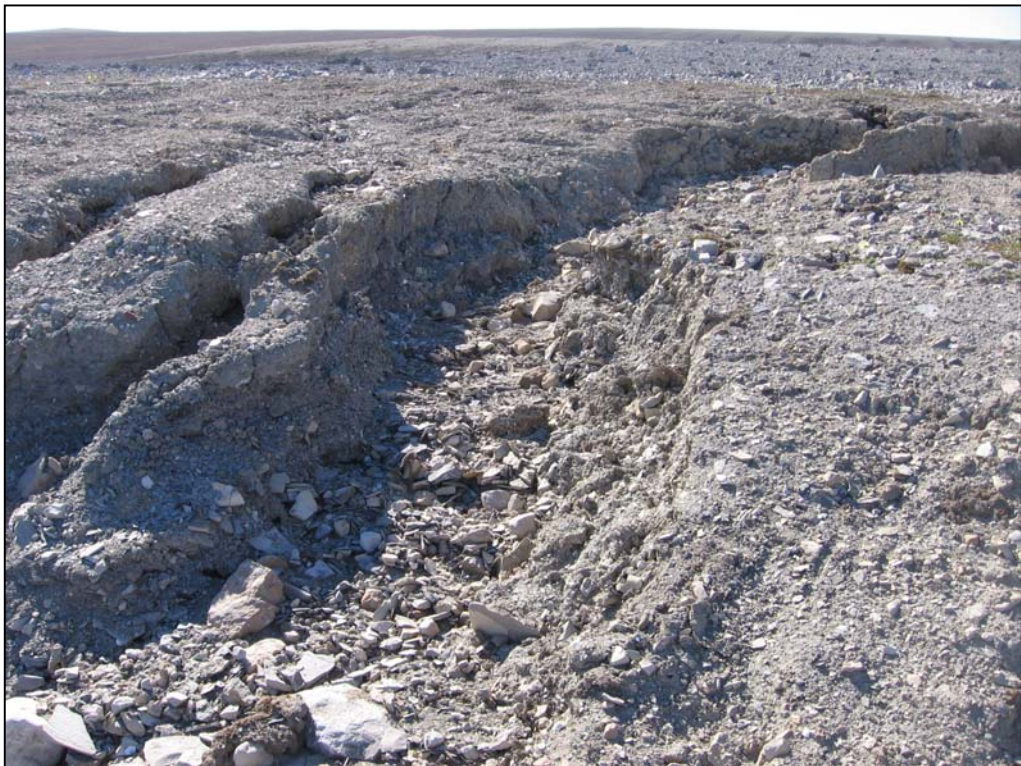
The Garrow Creek surface water sampling station is downstream of the dam (Photograph 1 in Appendix A). Two erosion gullies were observed downstream of the sampling station (Photographs 2 and 3 in Appendix A). These erosion gullies appear to be self-armouring and are an example of natural or normal erosion processes in the area. Maximum erosion gully depth is approximately 0.5 m.

Photo 2 - Northing: 8366835 Easting: 561659 Elevation: 7 m.  
First erosion gully south of sampling location

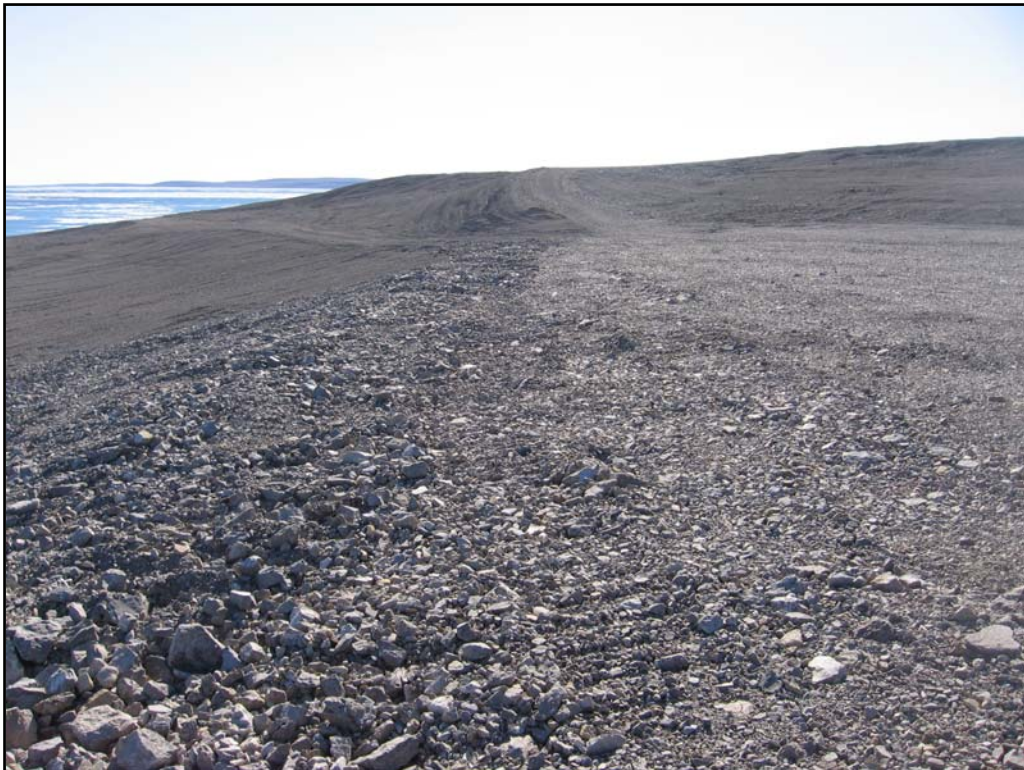
Photo 4 - Northing: 8367368 Easting: 555462 Elevation: 33 m.  
Operational landfill; South end crest of operational landfill

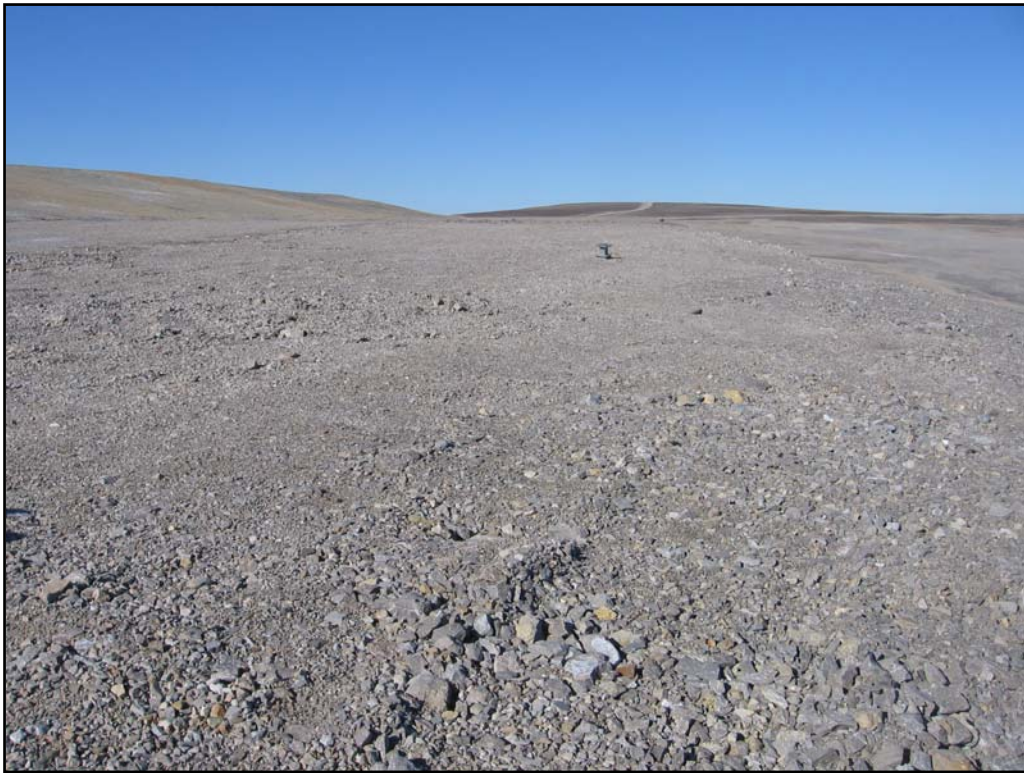
Photo 5 - Northing: 8367368 Easting: 555462 Elevation: 33 m.  
Operational landfill; View from south end towards south thermistor.

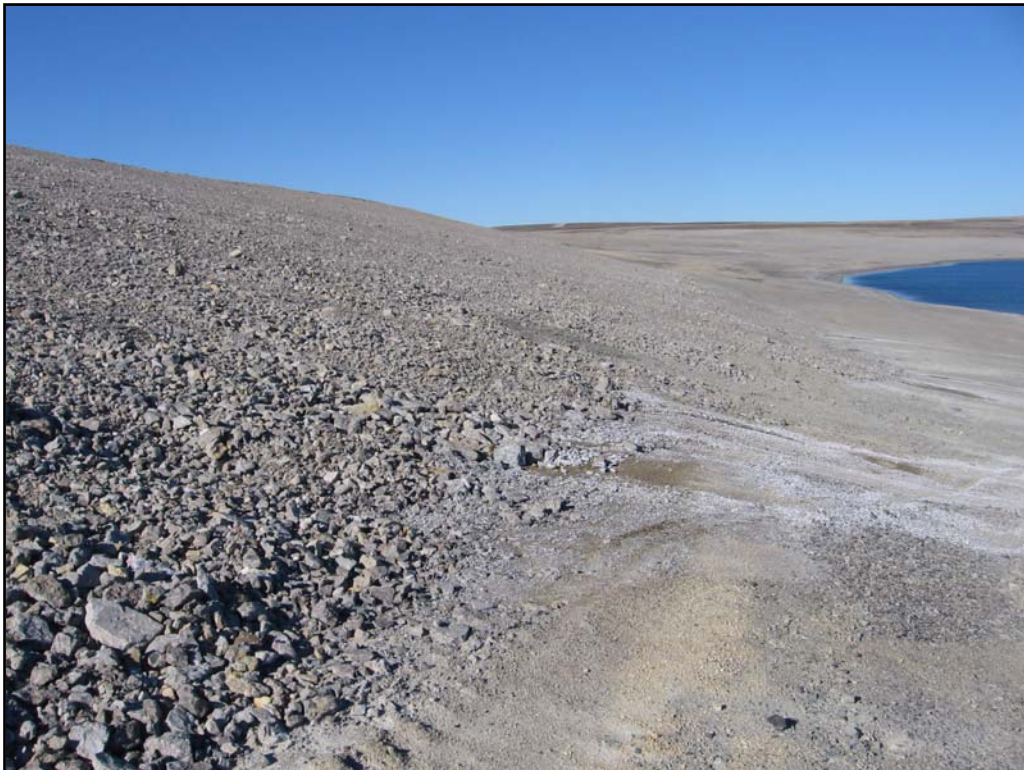
Some minor seepage from the toe of the landfill and associated white precipitate was observed during the July 2007 inspection (Photographs 8 through 10 in Appendix A).

Photo 8 - Northing: 8367408 Easting: 558917 Elevation: 9 m.  
Operational landfill; South toe

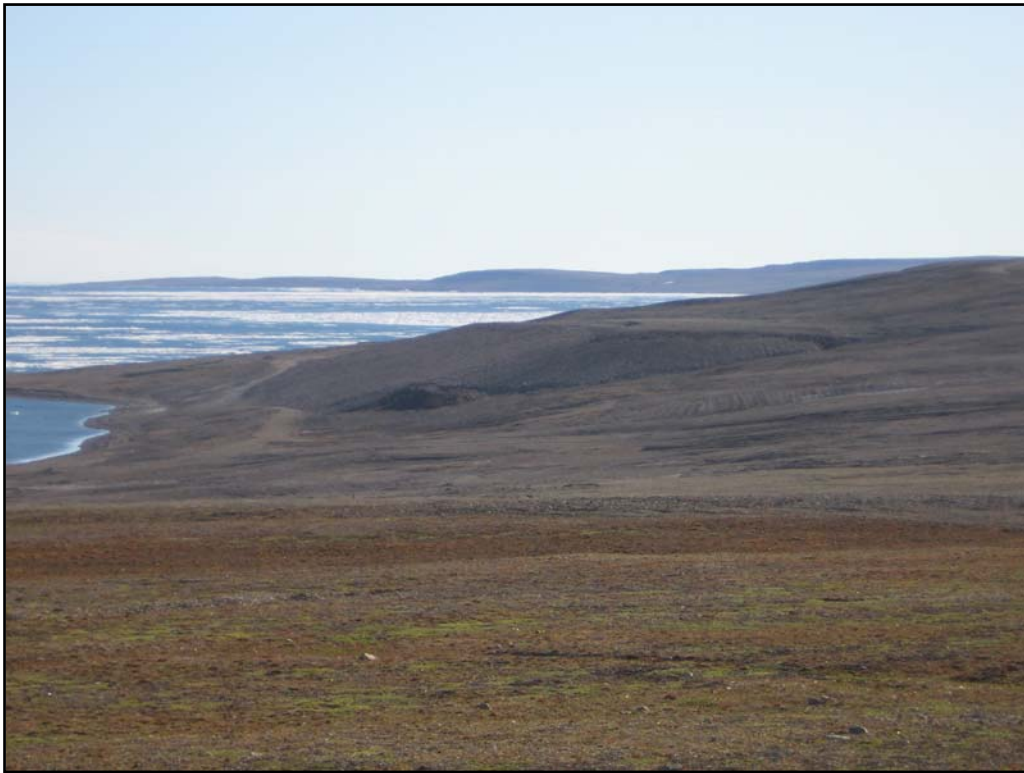
Photo 11 – View of Operational Landfill; facing South from road

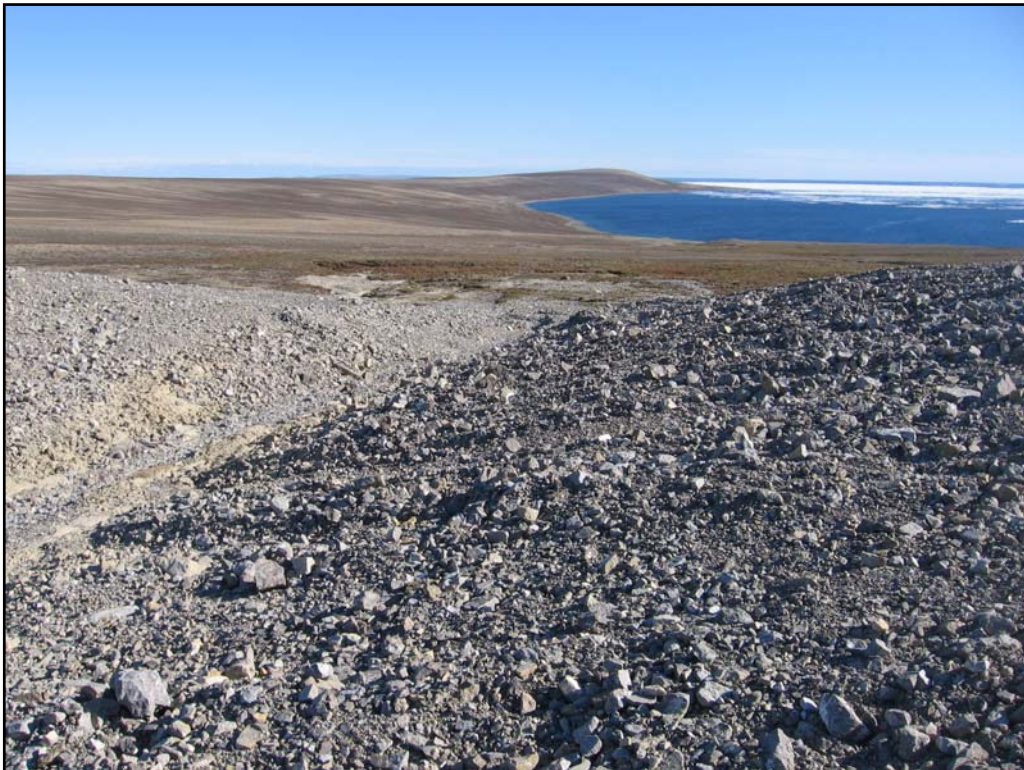
Photo 12 - Northing: 8368751 Easting: 559743 Elevation: 46 m.  
Drainage crossing through road with downstream erosion

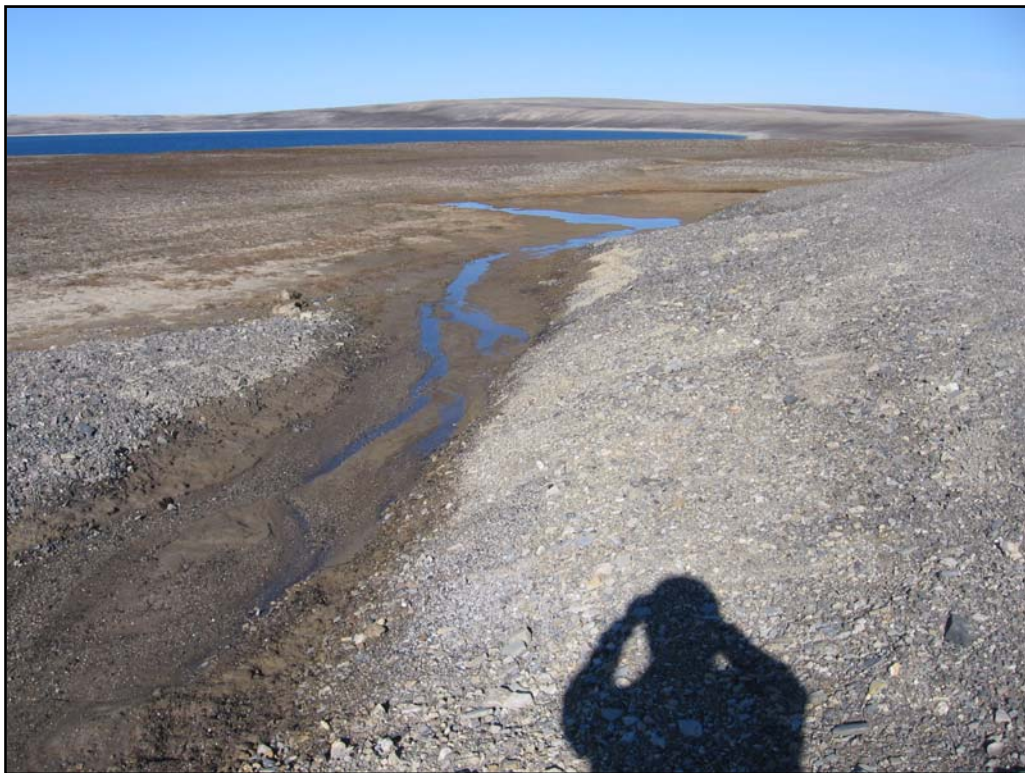
Photo 15- Northing: 8367395 Easting: 561197 Elevation: 36 m.  
Road drainage crossing

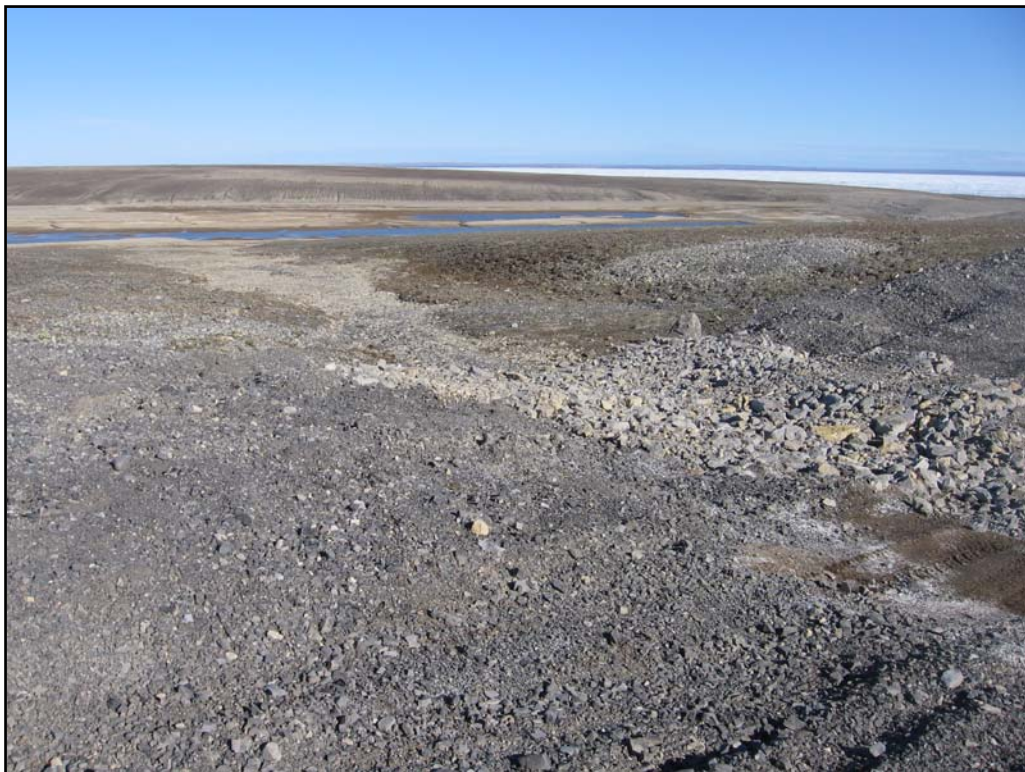
The access road is generally in good condition, with some localised erosion at drainage crossings (Photograph 52 and 53 in Appendix A). Significant erosion gullies identified during previous inspections were repaired in July 2006. Remedial work included regrading slopes, placement of gravel/rip-rap and construction of water bars. The repaired areas appear to be performing well (Photographs 54 through 58 in Appendix A).

Photo 16- Northing: 8367277 Easting: 561320 Elevation: 38 m.  
Repaired road drainage crossing

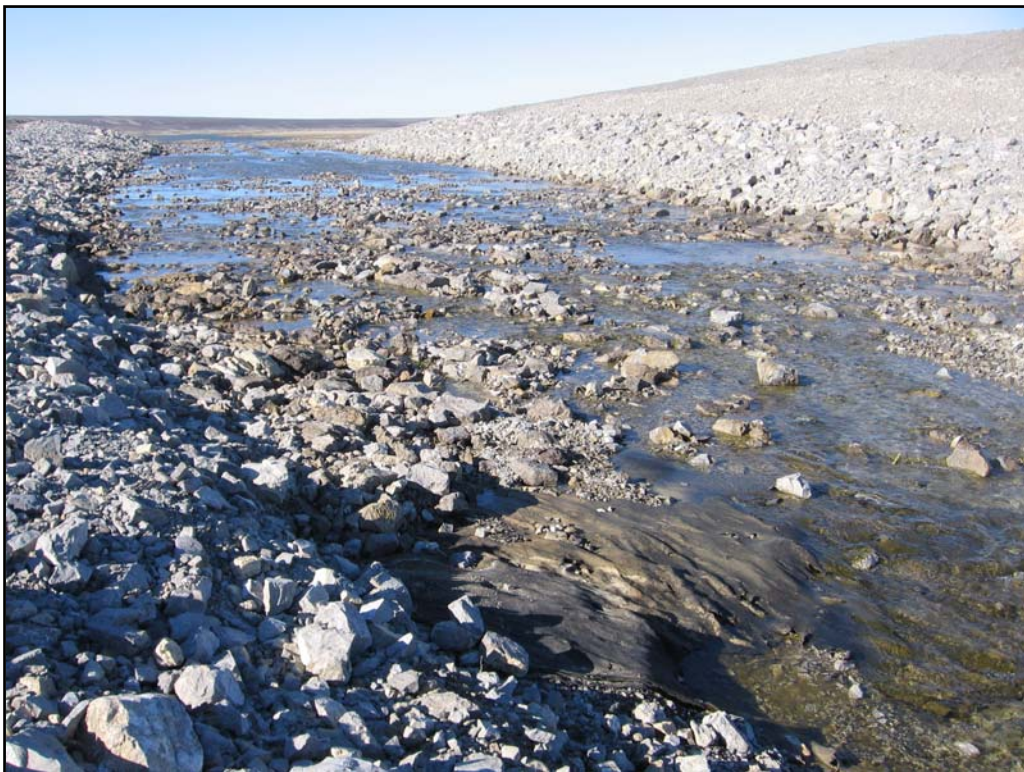
The sideslopes of the breach excavated through the main dam structure are in good condition, free of erosion or signs of major instability. Minor localised slumping observed in 2005 and 2006 appears unchanged. The condition of the dam breach slopes during the July 2007 inspection is documented in Photographs 20 through 25 (Appendix A). A localised section of the invert of the breach channel has a section of exposed geotextile that was observed in 2005 and 2006. The

condition of the exposed geotextile during the July 2007 inspection is documented in Photographs 18 and 19 (Appendix A). It is recommended that the exposed geotextile be covered with rip-rap.

Photo 18- Northing: 8366909 Easting: 561646 Elevation: 15 m.  
Garrow dam; exposed geotextile

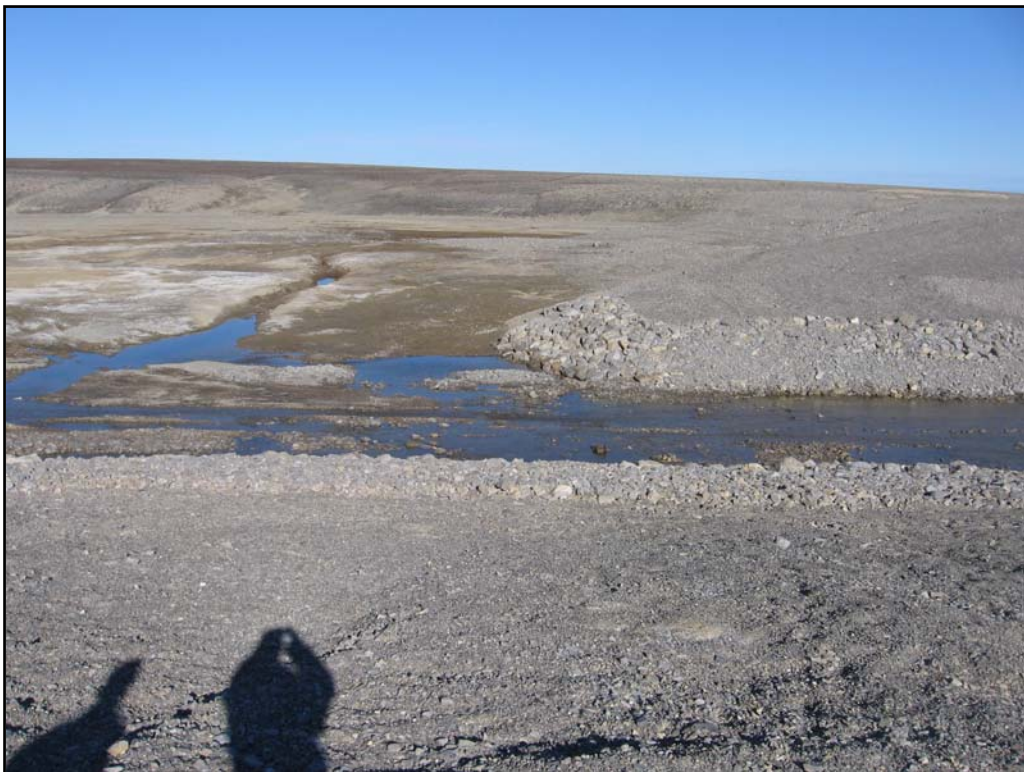
Photo 20- Northing: 8366999 Easting: 561646 Elevation: 15 m.  
Garrow dam; view of Southeast abutment from Northwest abutment

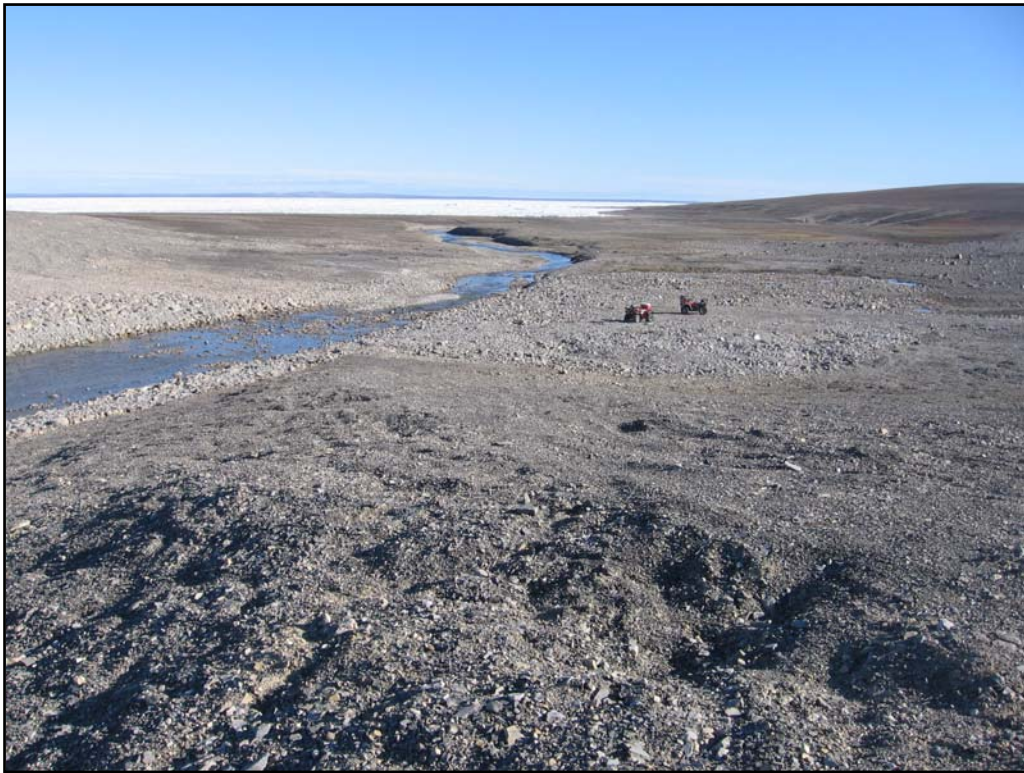
Photo 21- Northing: 8366999 Easting: 561646 Elevation: 15 m.  
Garrow dam; view of Garrow Creek towards ocean

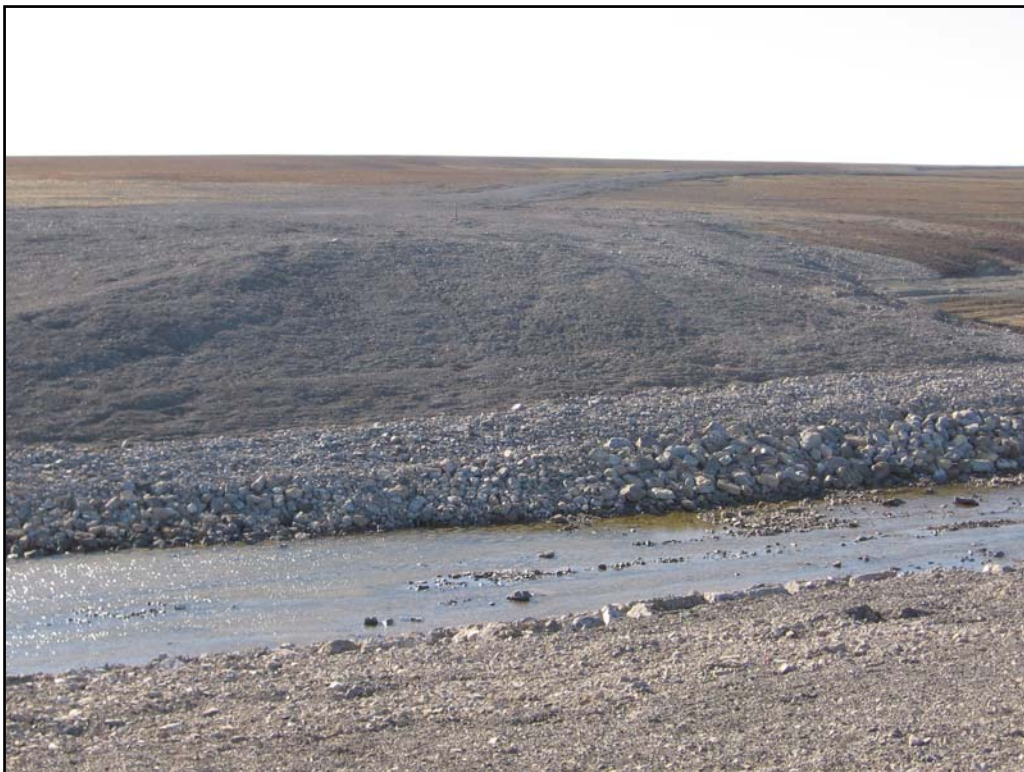
Photo 22- Northing: 8366999 Easting: 561646 Elevation: 15 m.  
Garrow dam; view of Northwest abutment from Southeast abutment

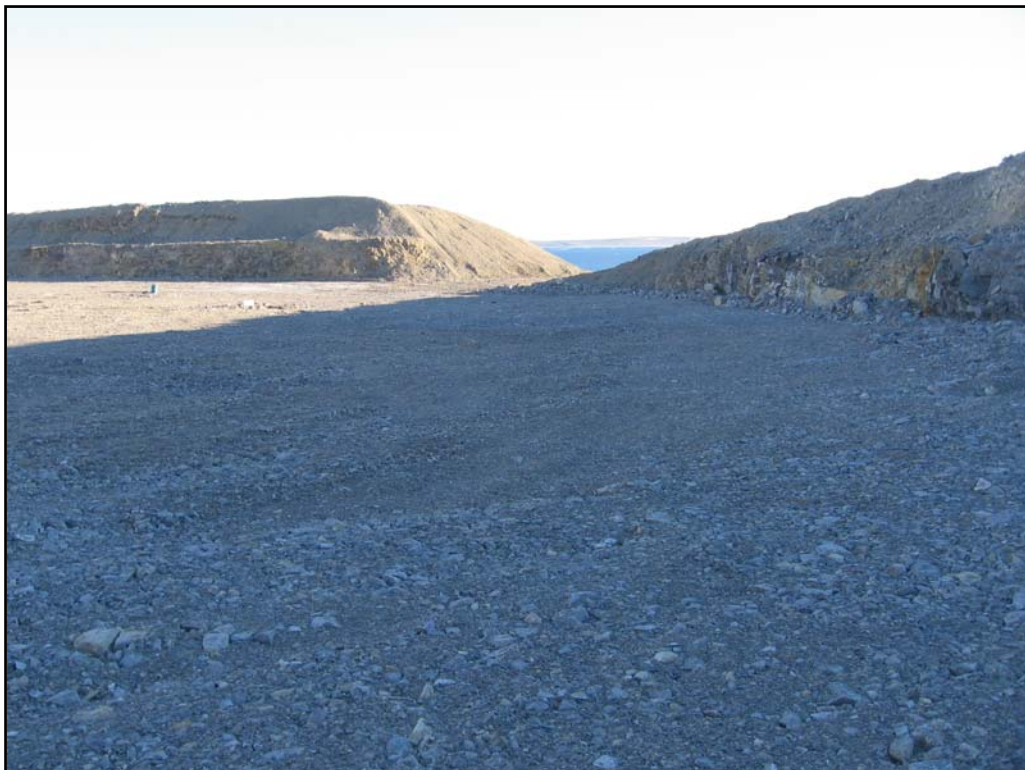
Photo 26- Northing: 8368783 Easting: 557689 Elevation: 30 m.  
Little Red Dog Quarry; facing north

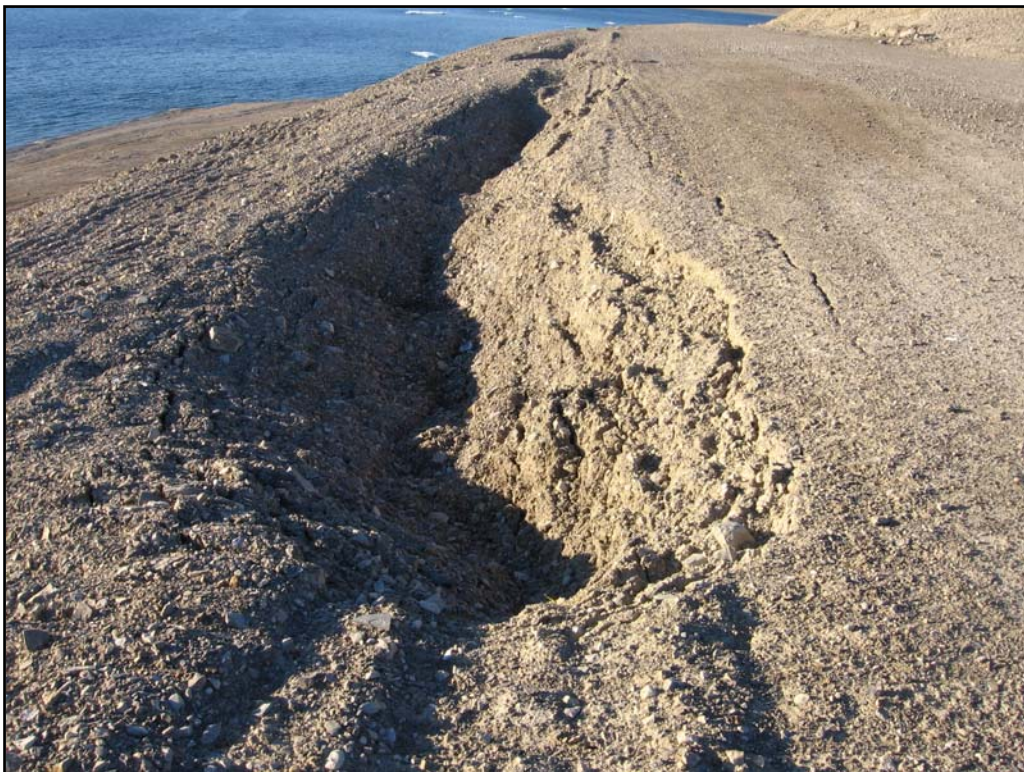
Photo 30- Northing: 8368863 Easting: 557713 Elevation: 38 m.  
Subsidence/slumping along road to Little Red Dog Quarry

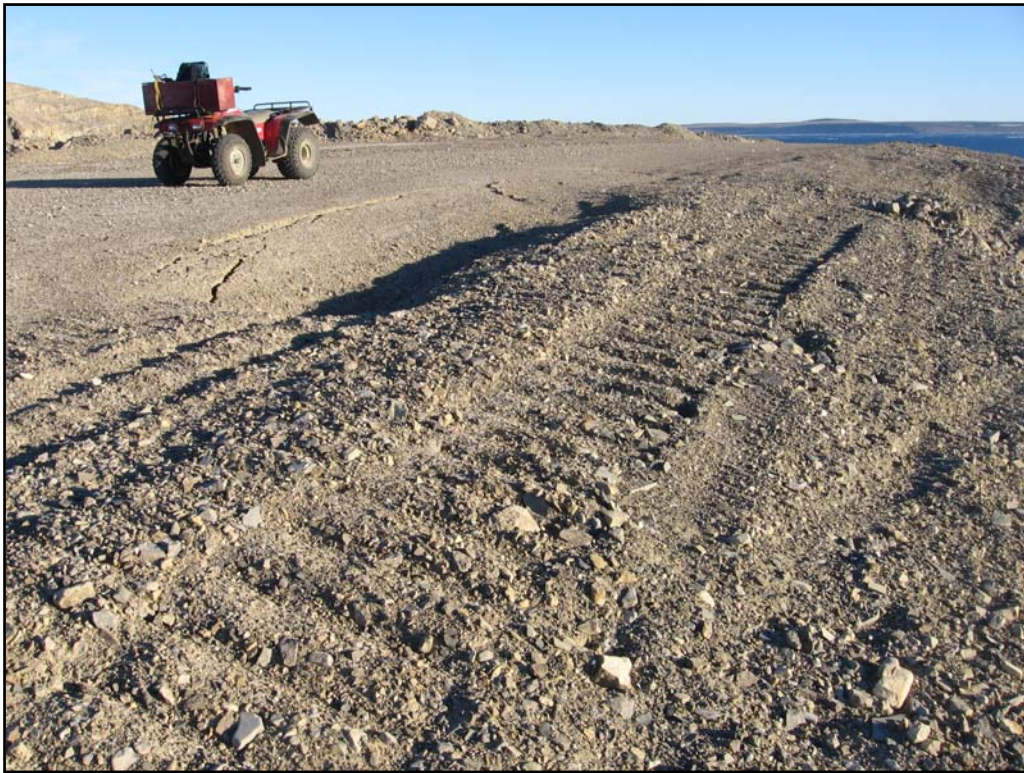
Photo 31- Northing: 8368863 Easting: 557713 Elevation: 38 m.  
Subsidence/slumping along road to Little Red Dog Quarry

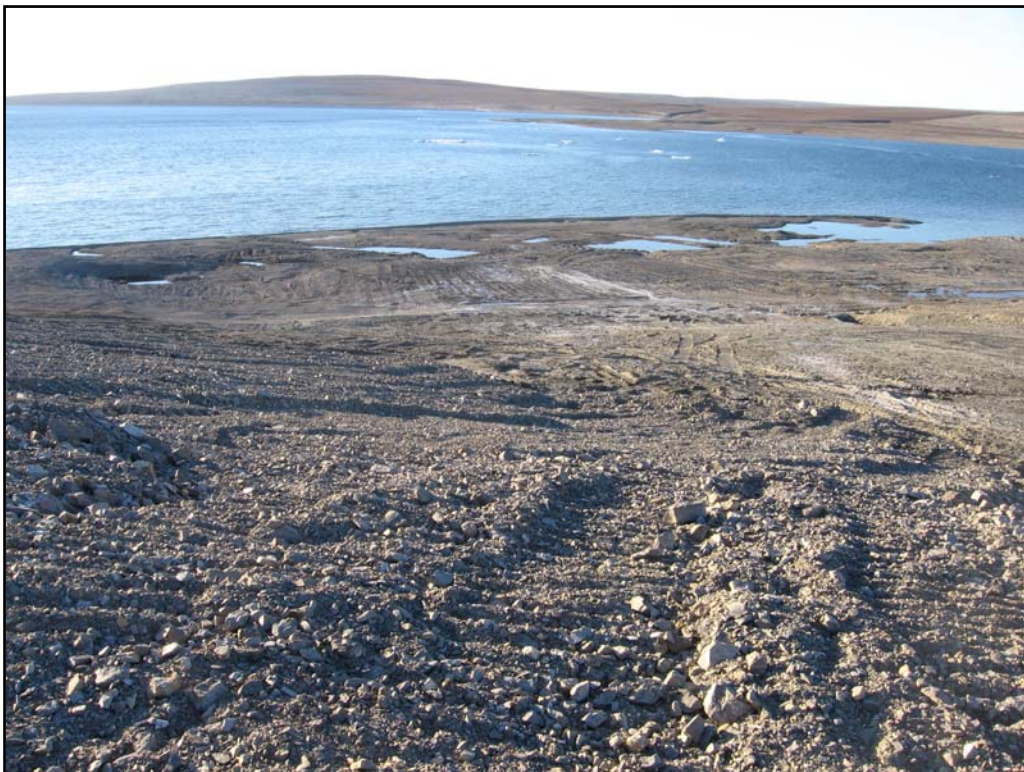
Photo 32- Northing: 8368368953 Easting: 558103 Elevation: 24 m.  
View of shoreline and subsidence area from road

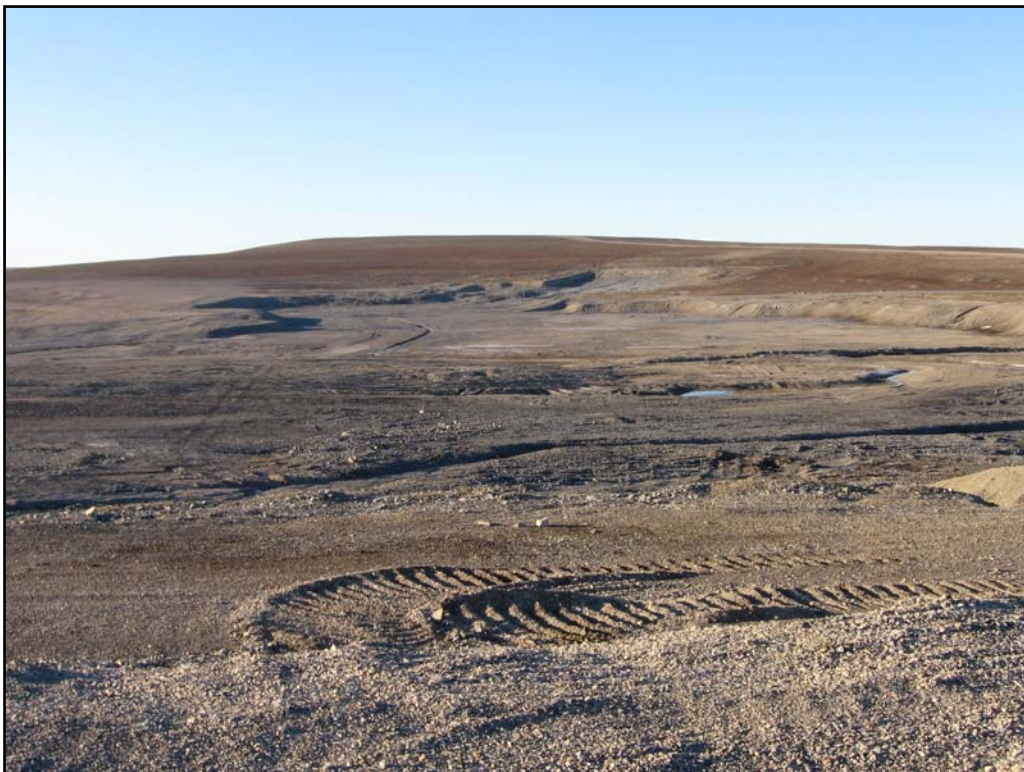
Photo 36- Northing: 8368499 Easting: 558491 Elevation: 49 m.  
View of new quarry

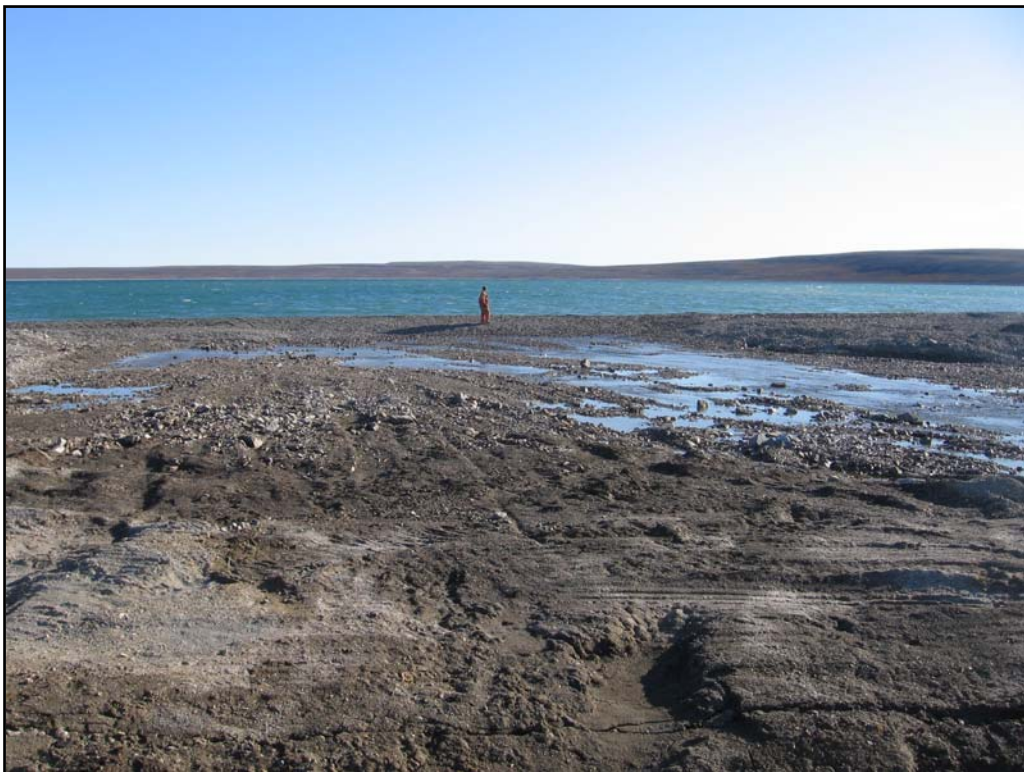
A ridge of gravel deposited across the breached outlet channel was initially observed during the 2006 inspection. The ridge or berm of gravel across the lake outlet appears to have grown since the 2006 inspection. Photographs 38 to 43 in Appendix A document the size and height of the gravel berm at the time of the July 2007 inspection. The mechanism creating the ridge of gravel is likely ice action. It is assumed that ice on the lake is pushed by the wind towards the south shoreline and outlet of the lake relocating gravel from the lake bottom to form a ridge or berm. The relatively coarse nature of the gravel permits a steady flow of water through the gravel ridge from the lake into the creek channel during the summer. However, the gravel ridge appears to be retaining some water and may be influencing the lake water level. As the ridge grows higher and wider, the lake outlet may naturally relocate towards the east end of the wave break structure. The growth of the berm and lake outlet location should continue to be monitored, however this appears to be a natural process that likely also occurred prior to development at the site.

Photo 38- Northing: 8367425 Easting: 561582 Elevation: 11 m.  
Wave break structure; west end (person standing at former outlet)

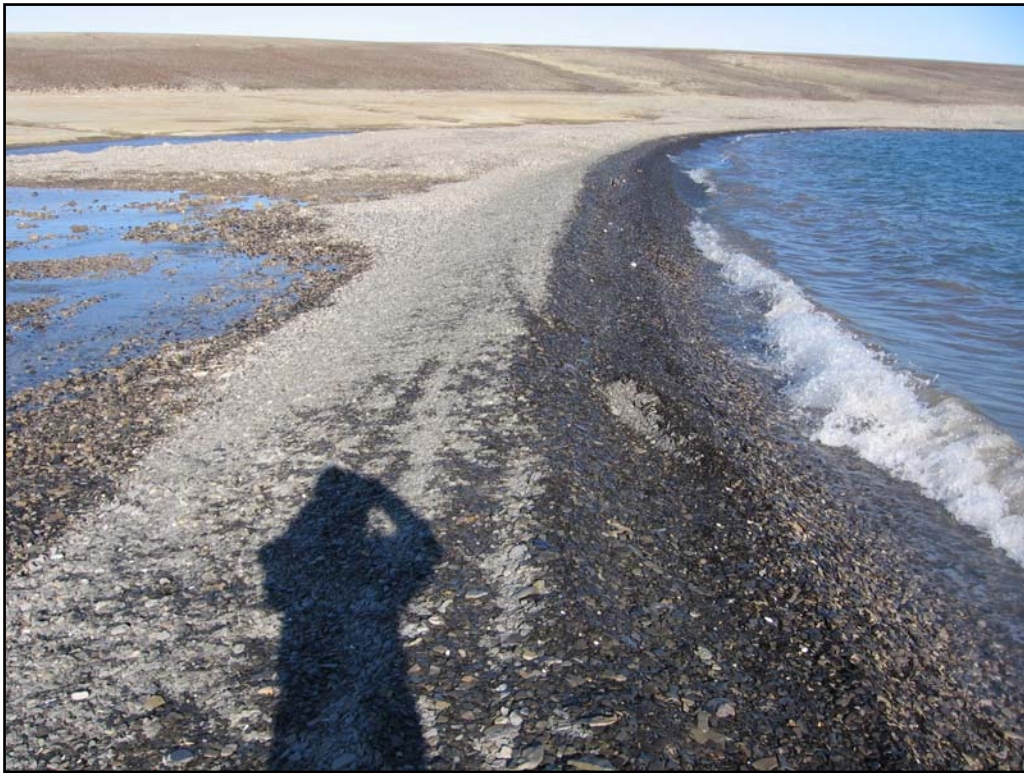
Photo 39- Northing: 8367425 Easting: 561582 Elevation: 11 m.  
Wave break structure; west end facing west

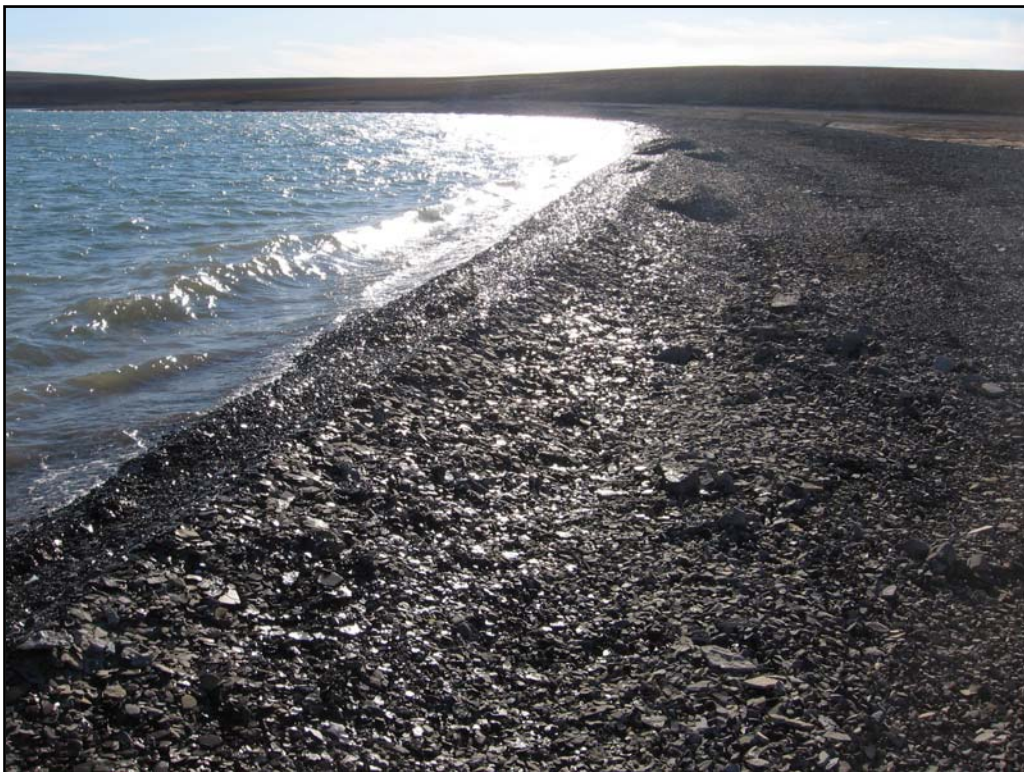
Photo 40- Northing: 8367425 Easting: 561582 Elevation: 11 m.  
Wave break structure; west end facing east

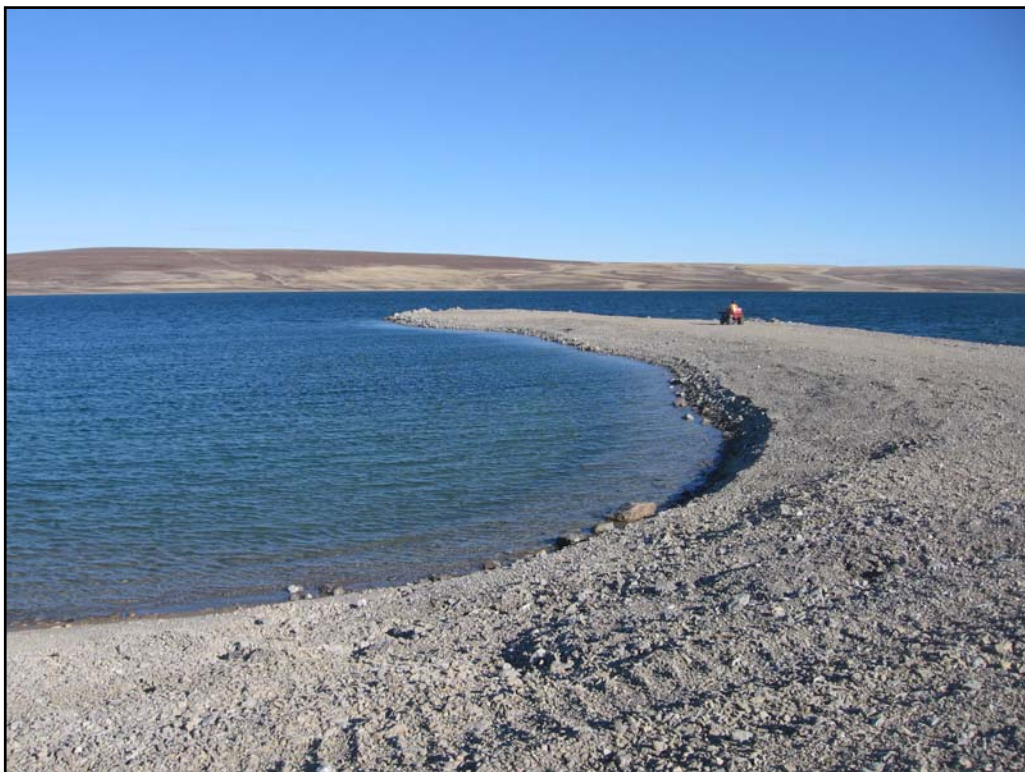
During mining operations, a jetty extending into Frustration Lake supported the mine's freshwater supply pump station. The pump house and associated water lines were removed during reclamation. The site monitoring program includes a requirement to inspect the jetty on an annual basis to ensure that the rate of jetty erosion is gradual and does not contribute significant sediment loading to the lake. During the July 2007 inspection, the embankment forming the jetty was observed to be in a stable condition. Minor erosion consistent with previous inspections was observed at the end and along the sides of the embankment (Photographs 46 through 51 in Appendix A).

Photo 46- Northing: 8367425 Easting: 561582 Elevation: 11 m.  
Frustration Lake Intake; South side of jetty

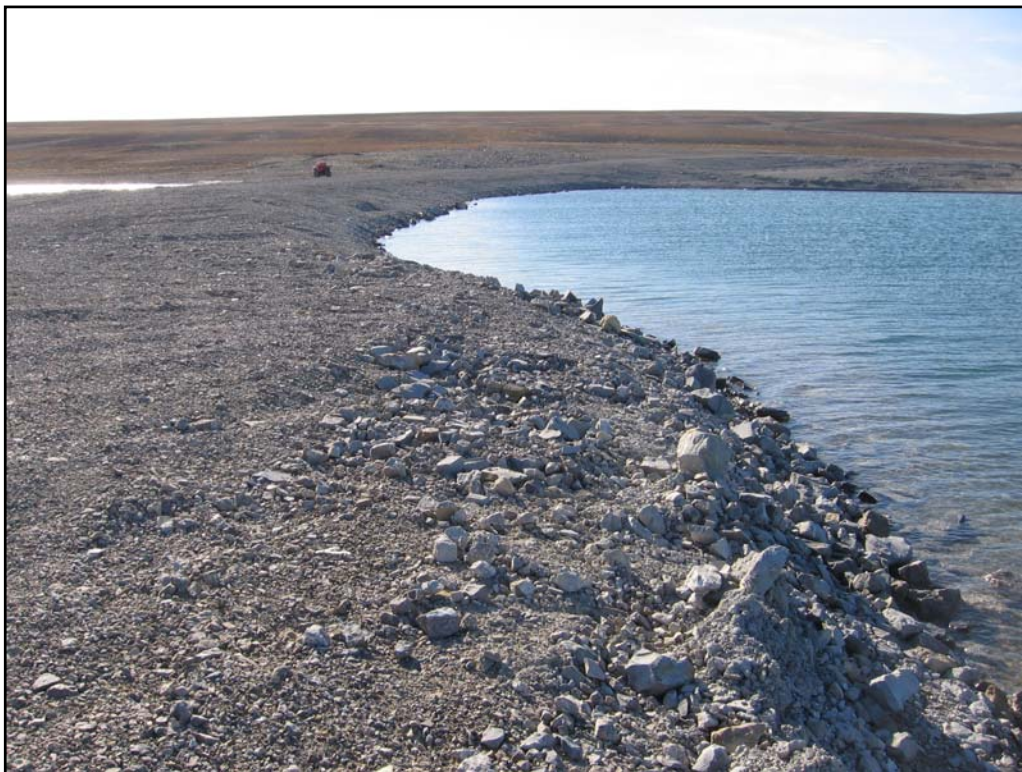
Photo 47- Northing: 8367425 Easting: 561582 Elevation: 11 m.  
Frustration Lake Intake; tip of jetty

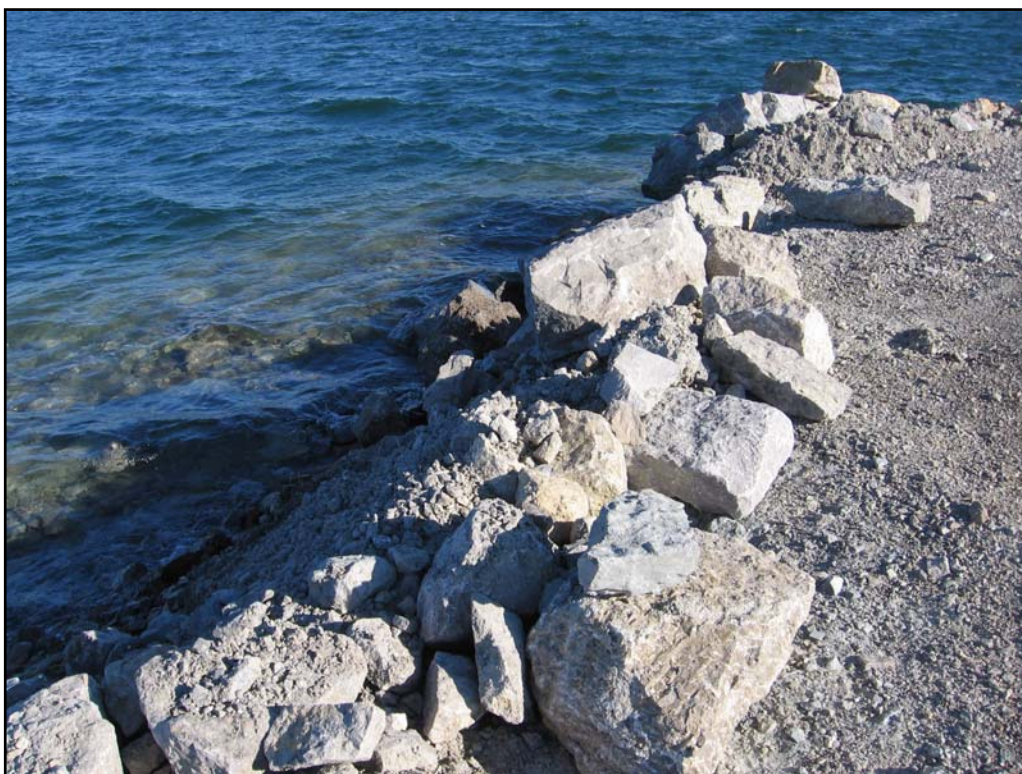
Photo 48- Northing: 8367425 Easting: 561582 Elevation: 11 m.  
Frustration Lake Intake; end of jetty

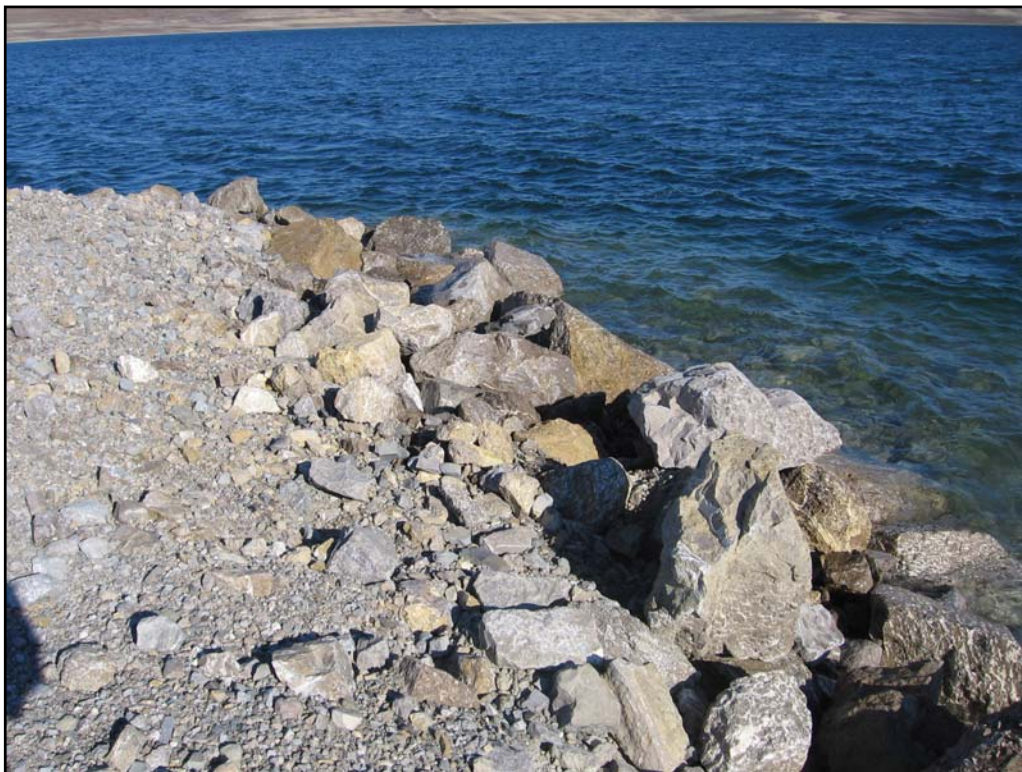
Photo 49- Northing: 8367425 Easting: 561582 Elevation: 11 m.  
Frustration Lake Intake, end of jetty

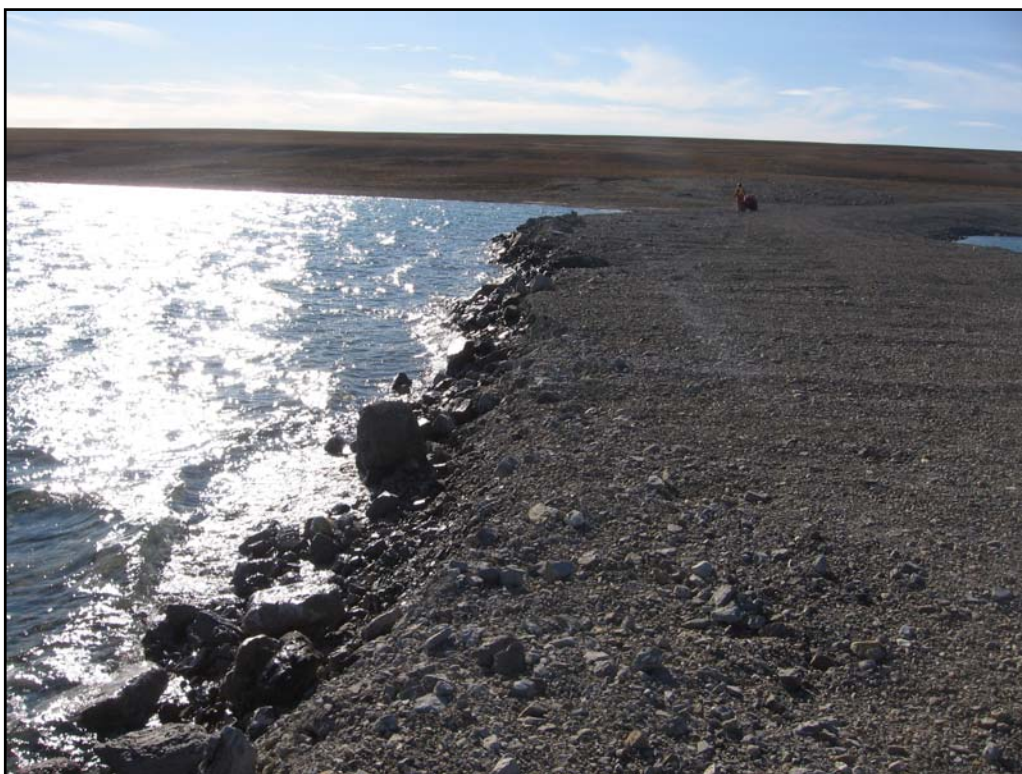
Photo 50- Northing: 8367425 Easting: 561582 Elevation: 11 m.  
Frustration Lake Intake; North side of jetty facing shore

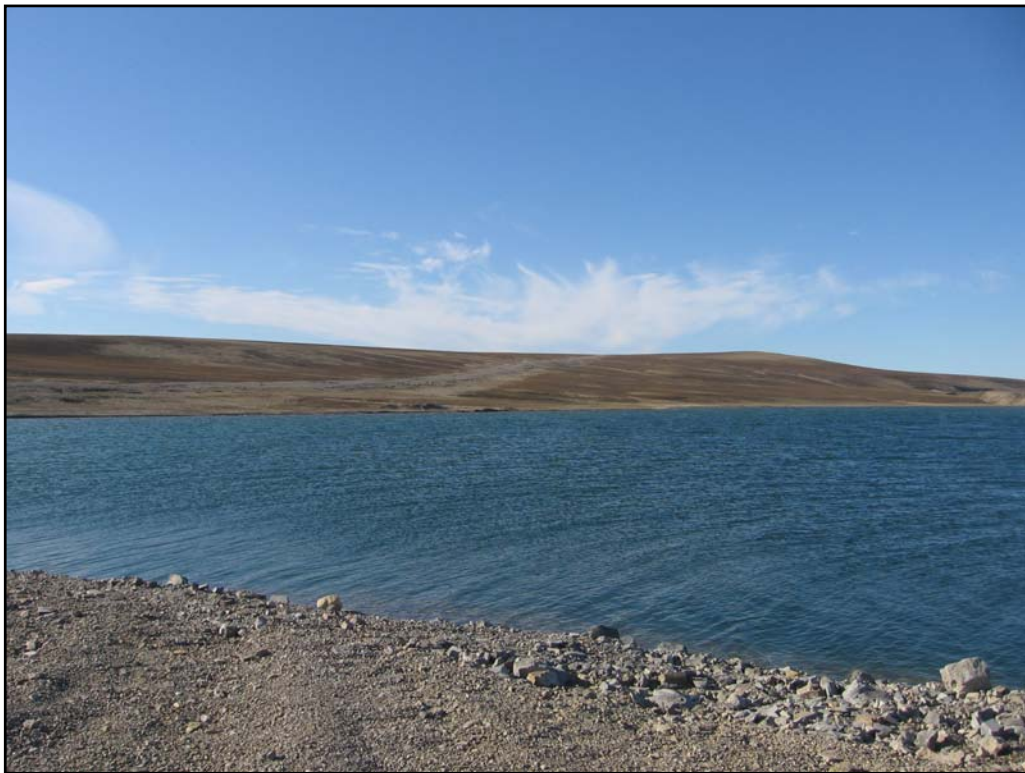
Photo 51- Northing: 8367425 Easting: 561582 Elevation: 11 m.  
Frustration Lake Intake; looking up road from jetty
