# **Report on Post-Closure Geotechnical Inspection of Polaris Mine Site in 2007**

Prepared for  
**TeckCominco Metals Ltd.**

Submitted by  
**Gartner Lee Limited**

**October, 2007**

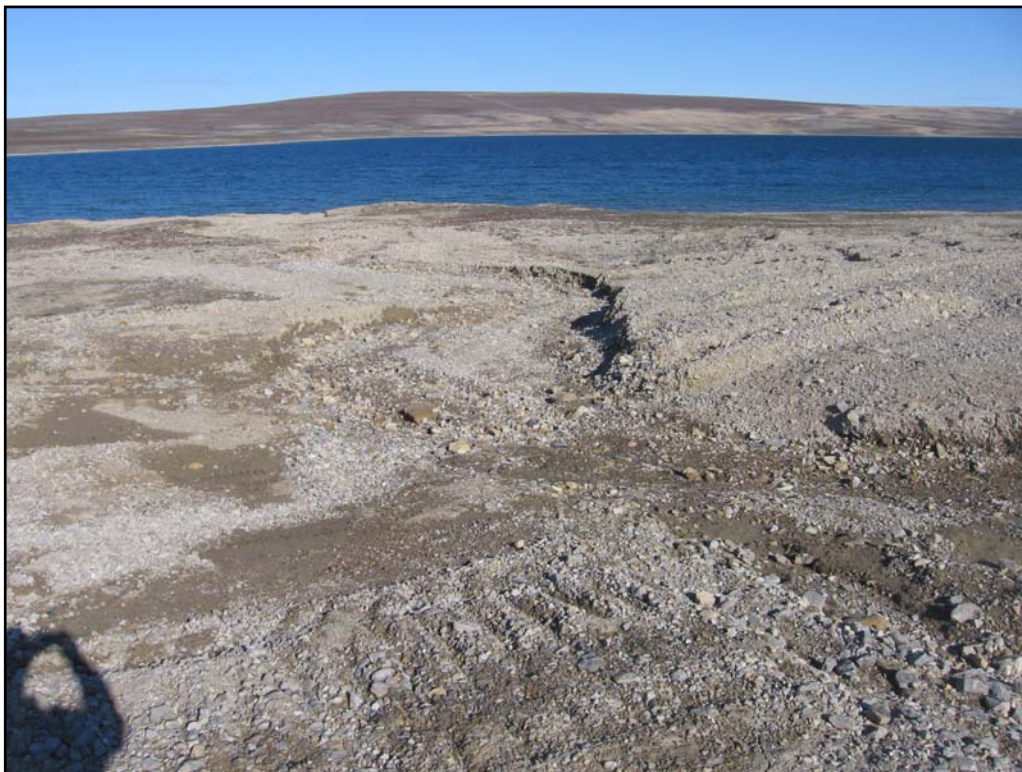
The access road is generally in good condition, with some localised erosion at drainage crossings (Photograph 52 and 53 in Appendix A). Significant erosion gullies identified during previous inspections were repaired in July 2006. Remedial work included regrading slopes, placement of gravel/rip-rap and construction of water bars. The repaired areas appear to be performing well (Photographs 54 through 58 in Appendix A).

Photo 53- Northing: 8371827 Easting: 560363 Elevation: 22 m.  
Frustration Lake access road; erosion gully facing downstream of road

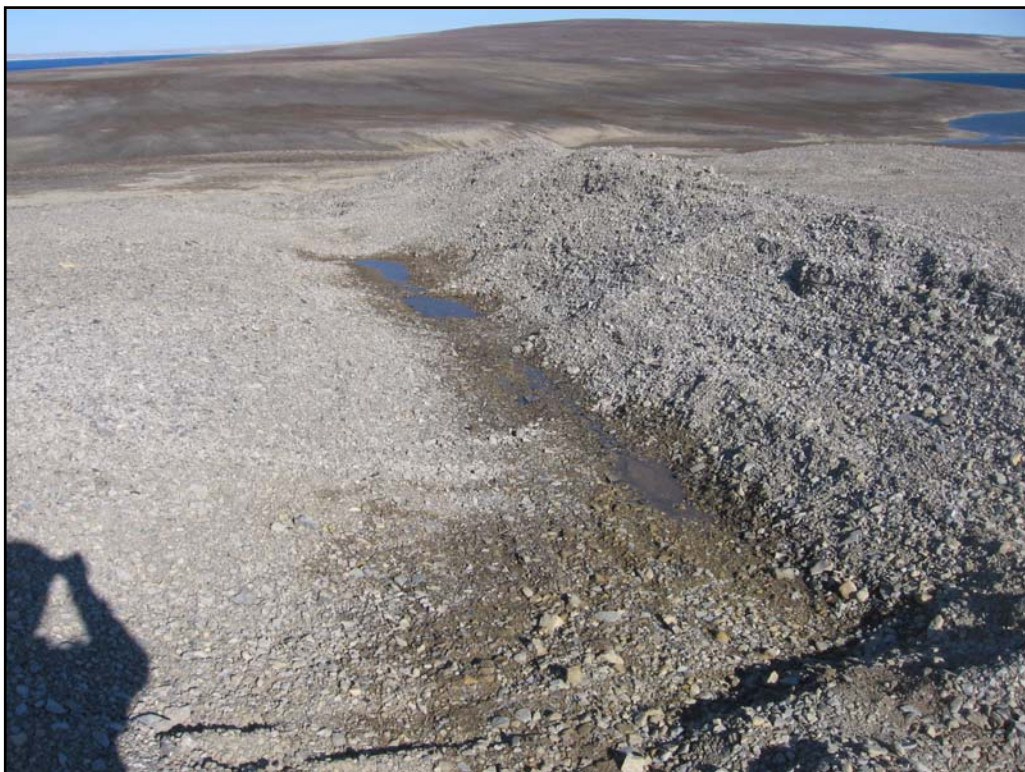
Photo 56- Northing: 8371018 Easting: 560120 Elevation: 57 m.  
Frustration Lake access road; repaired erosion gully with water bar

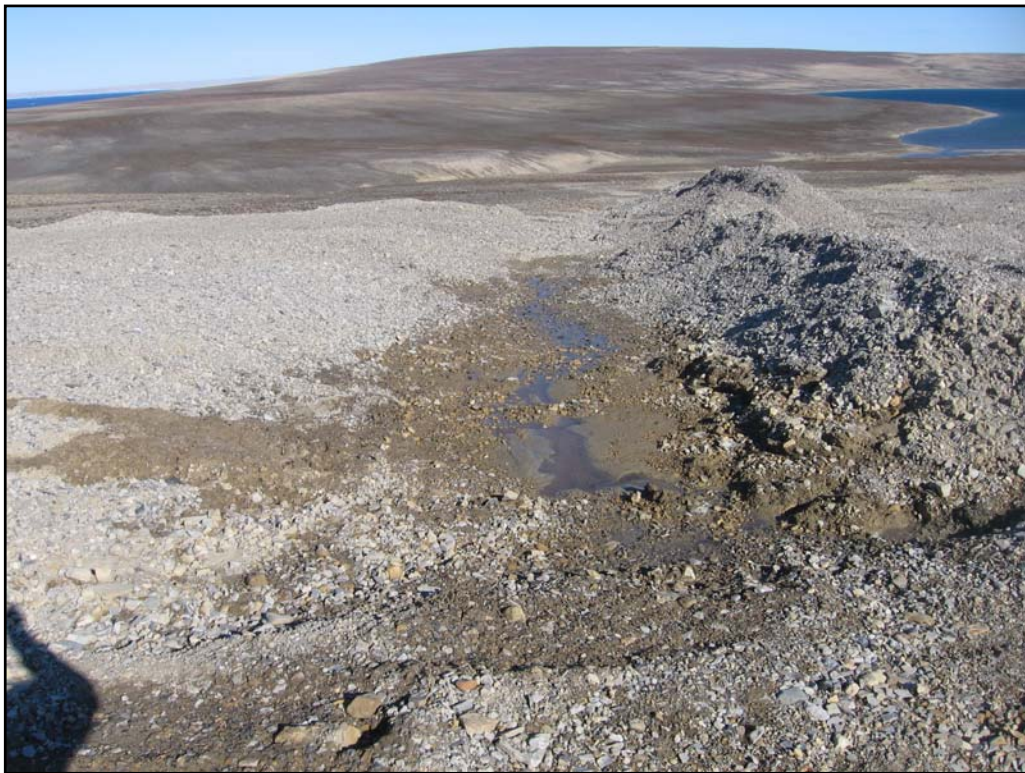
Photo 57- Northing: 8370978 Easting: 560105 Elevation: 60 m.  
Frustration Lake access road; repaired erosion gully with water bar

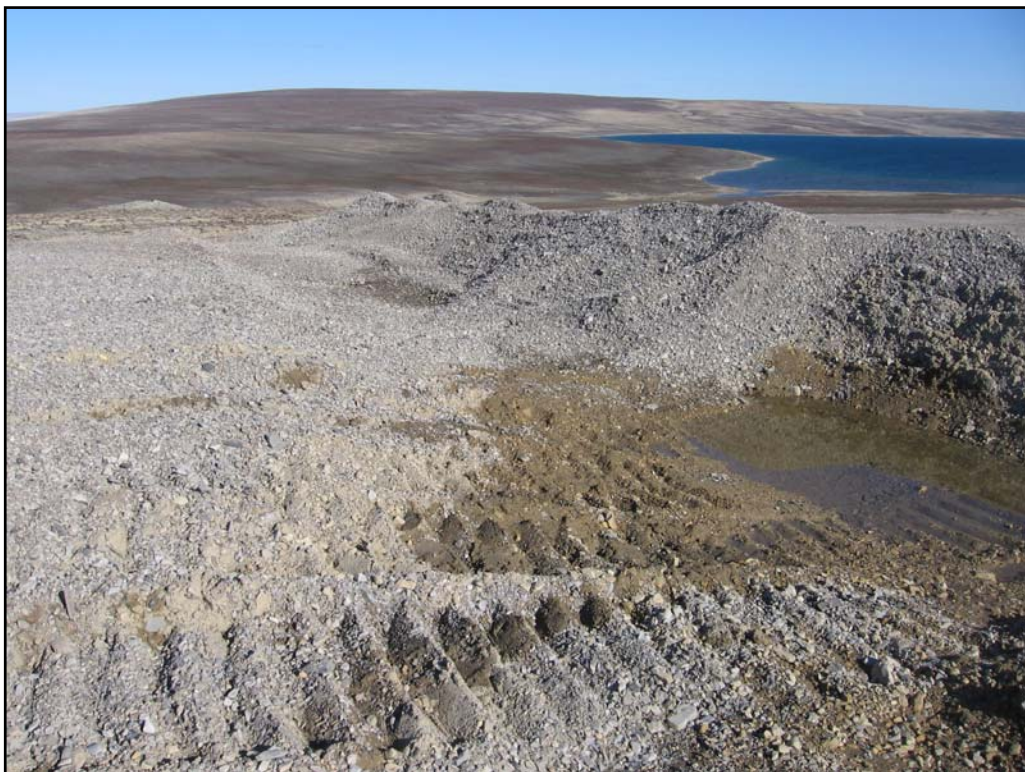
Photo 58- Northing: 8370930 Easting: 560085 Elevation: 61 m.  
Frustration Lake access road; repaired erosion gully with water bar

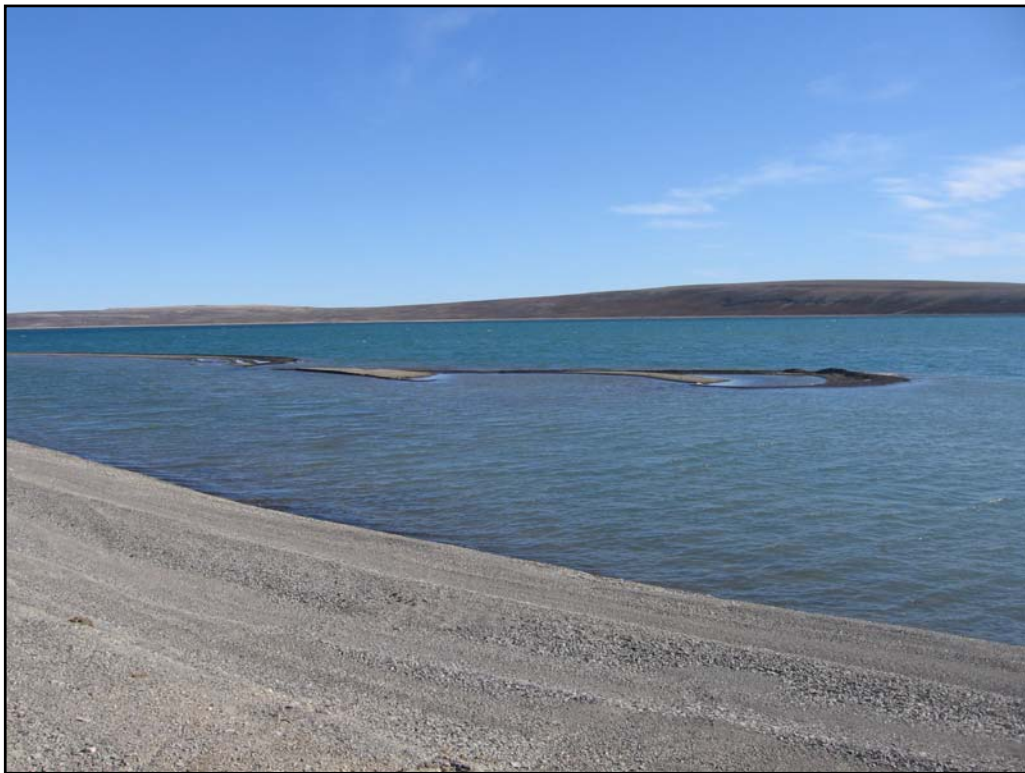
Photo 61- Northing: 8367746 Easting: 561496 Elevation: 10 m.  
Garrow Lake perimeter; new gravel bar

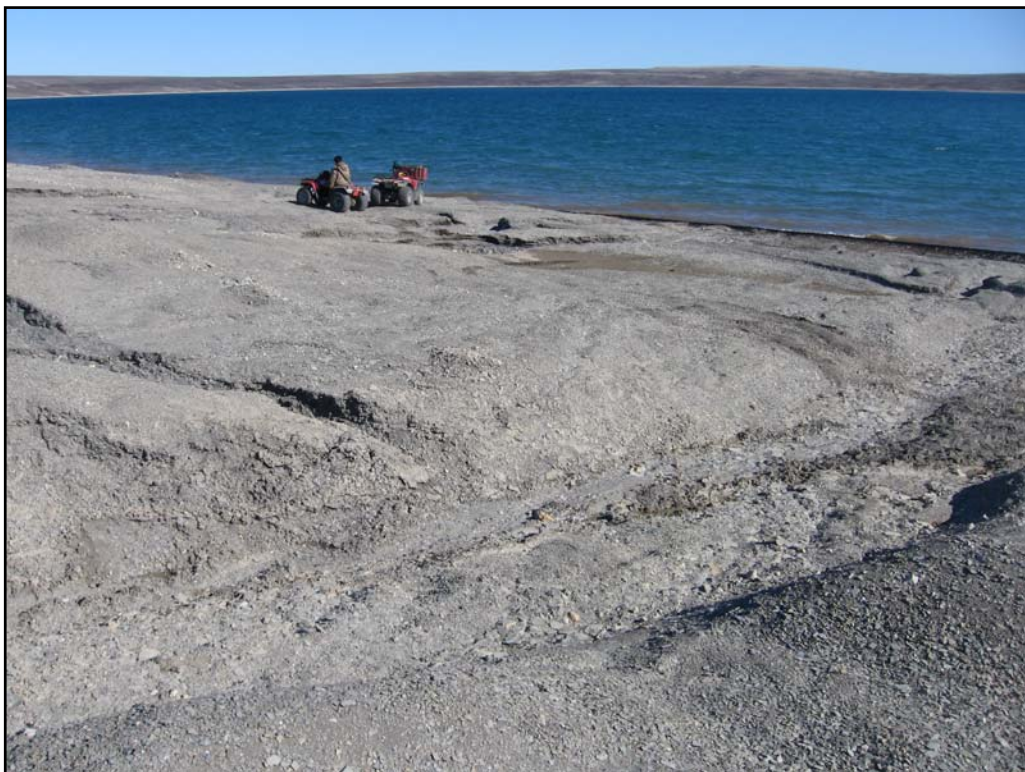
Photo 62- Northing: 8368000 Easting: 561481 Elevation: 11 m.  
Garrow Lake perimeter; thick gravel deposit on shoreline

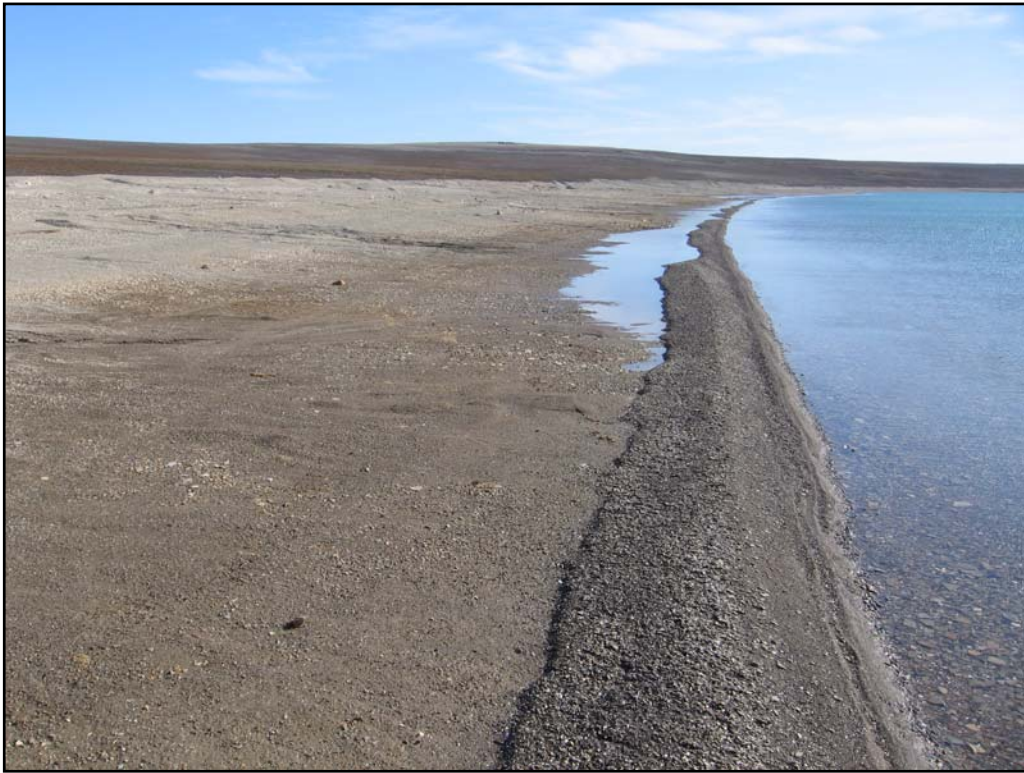
Photo 65- Northing: 8370531 Easting: 561988 Elevation: 10 m.  
Garrow Lake perimeter; small gravel accretion bar along North shore

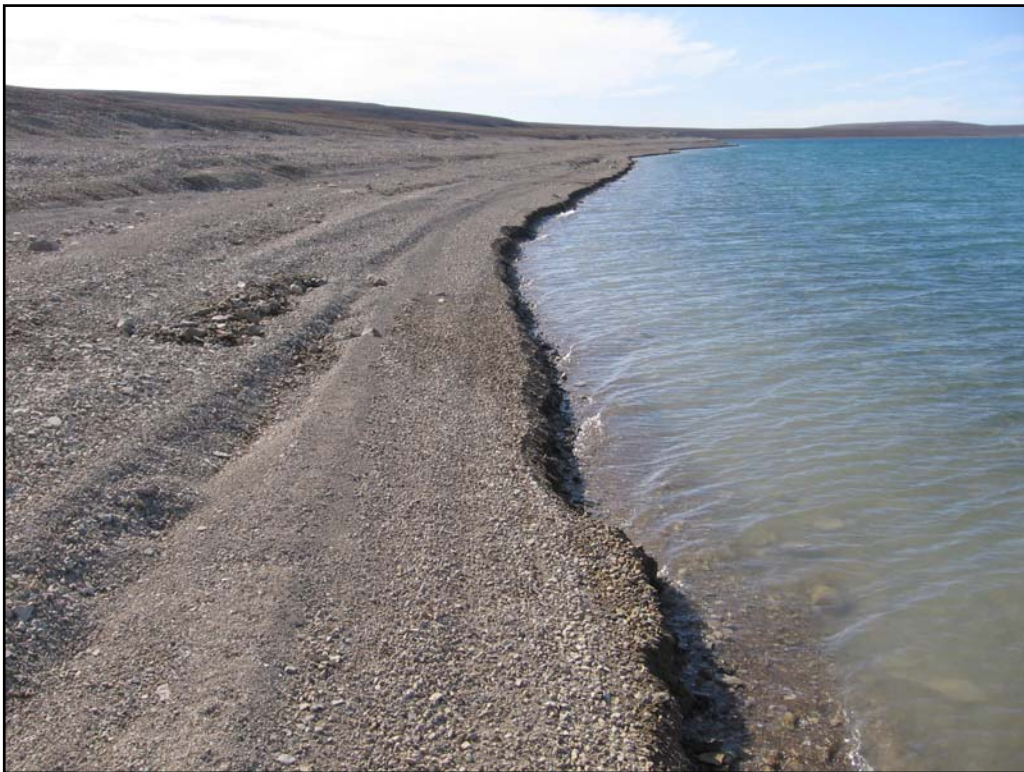
Photo 66- Northing: 8369654 Easting: 562780 Elevation: 10 m.  
Garrow Lake perimeter; Northeast shoreline

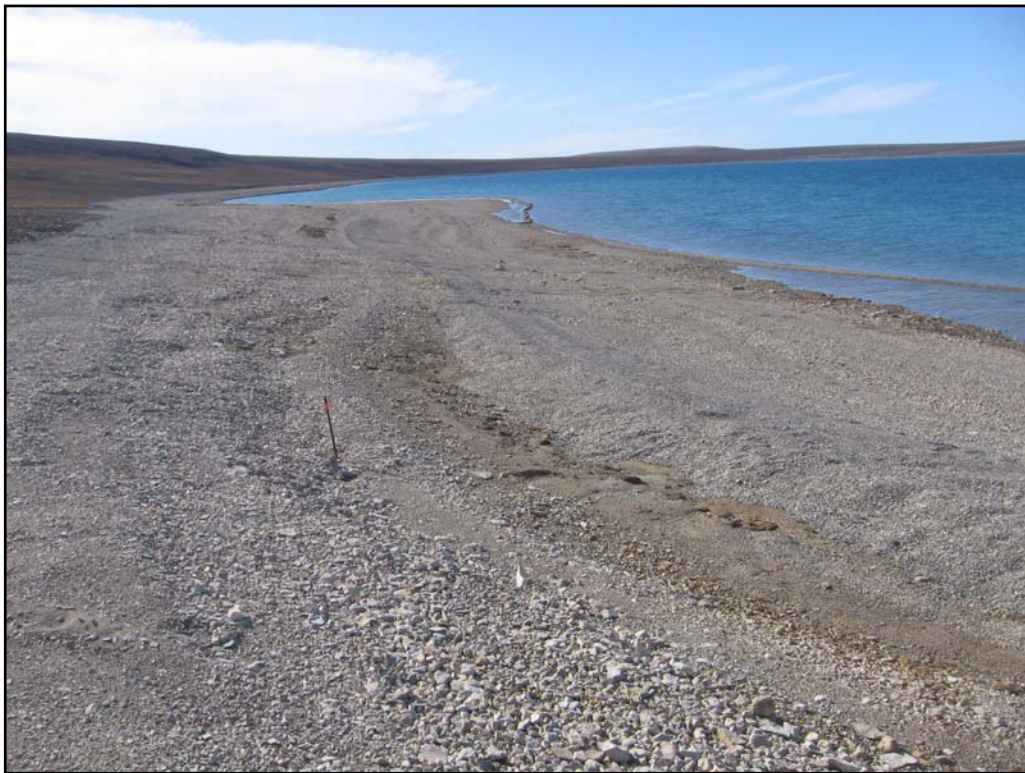
Photo 67- Northing: 8369224 Easting: 562763 Elevation: 12 m.  
Garrow Lake perimeter; East quad pin shoreline

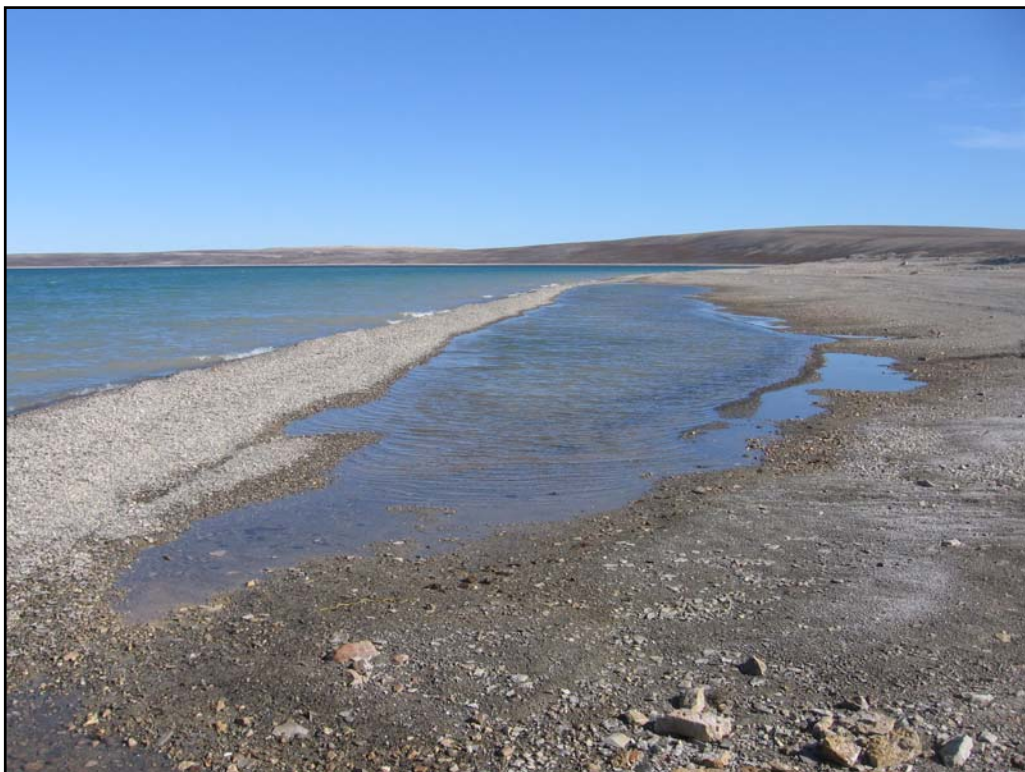
Photo 68- Northing: 8367553 Easting: 561865 Elevation: 9 m.  
Garrow Lake perimeter; Southeast shore near wave break

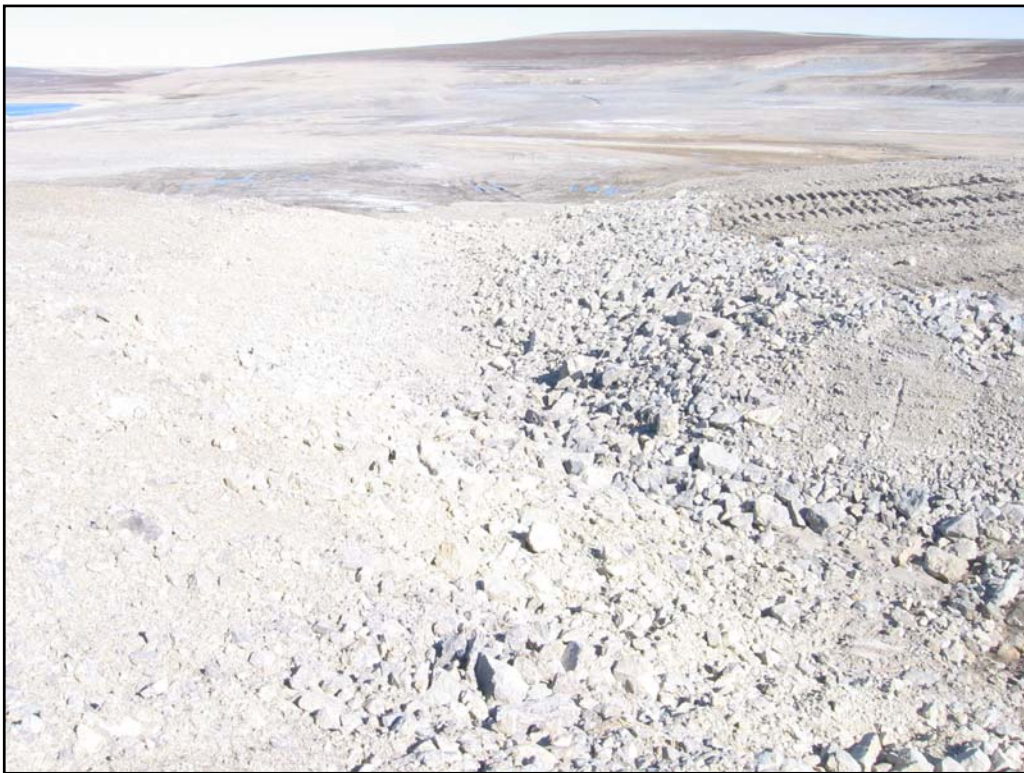
The perimeter sideslopes and floor of the New Quarry area appear to be stable and do not pose a safety hazard to humans or wildlife. Photographs 59, 71, 87, 88 and 89 (Appendix A) illustrate the overall condition of the New Quarry during the 2007 inspection. Erosion on the perimeter sideslopes has previously resulted in some sediment being dispersed across the quarry floor. Erosion gullies at two locations were stabilized in July 2006 by slope regrading and placement of well-graded limestone rockfill as rip-rap protection. The repaired areas appear to be performing well (Photographs 69 through 70 in Appendix A).

Photo 69- Northing: 8368702 Easting: 558670 Elevation: 36 m.  
New quarry; rip-rap repaired gully

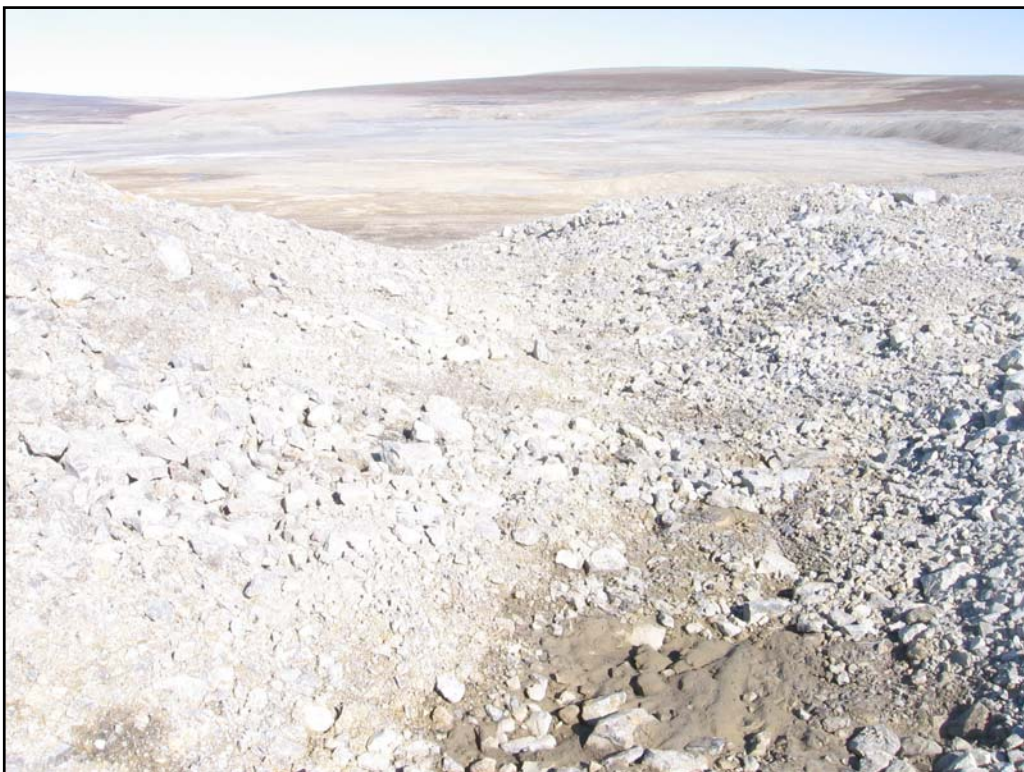
Photo 70- Northing: 8368665 Easting: 558789 Elevation: 32 m.  
New quarry; rip-rap repaired gully

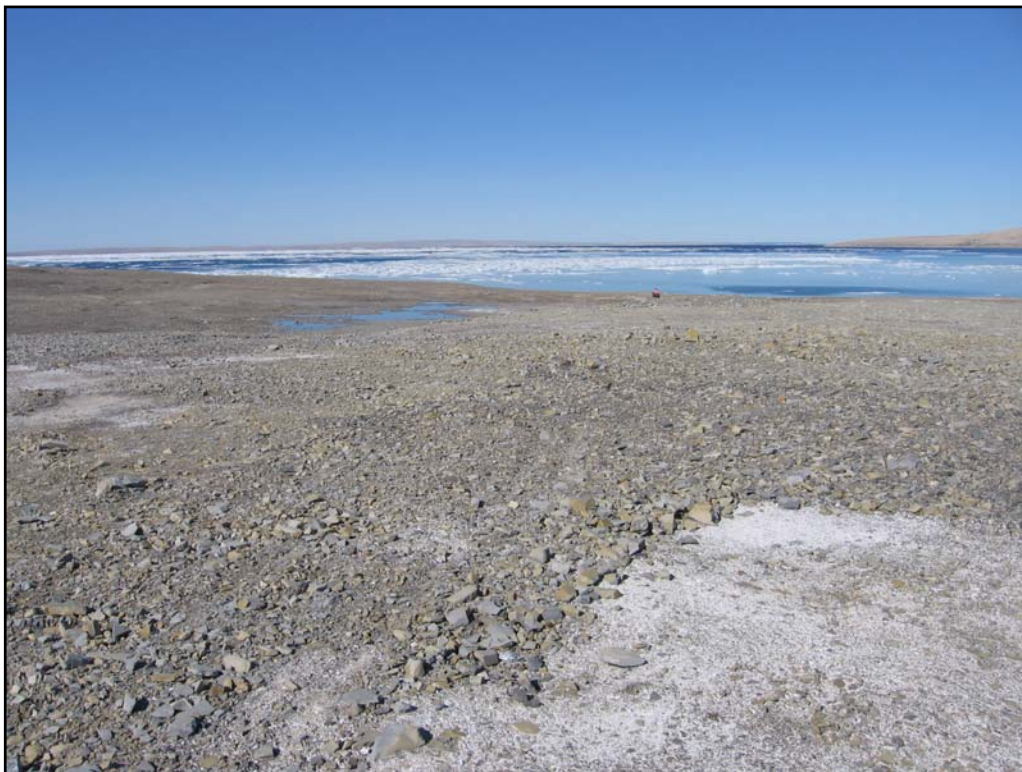
Photographs 73 and 75 (Appendix A) illustrate the general overall condition of the subsidence area with small areas of shallow ponded water.

Photo 73- Northing: 8368922 Easting: 558543 Elevation: 25 m.  
Subsidence area; view towards Ocean

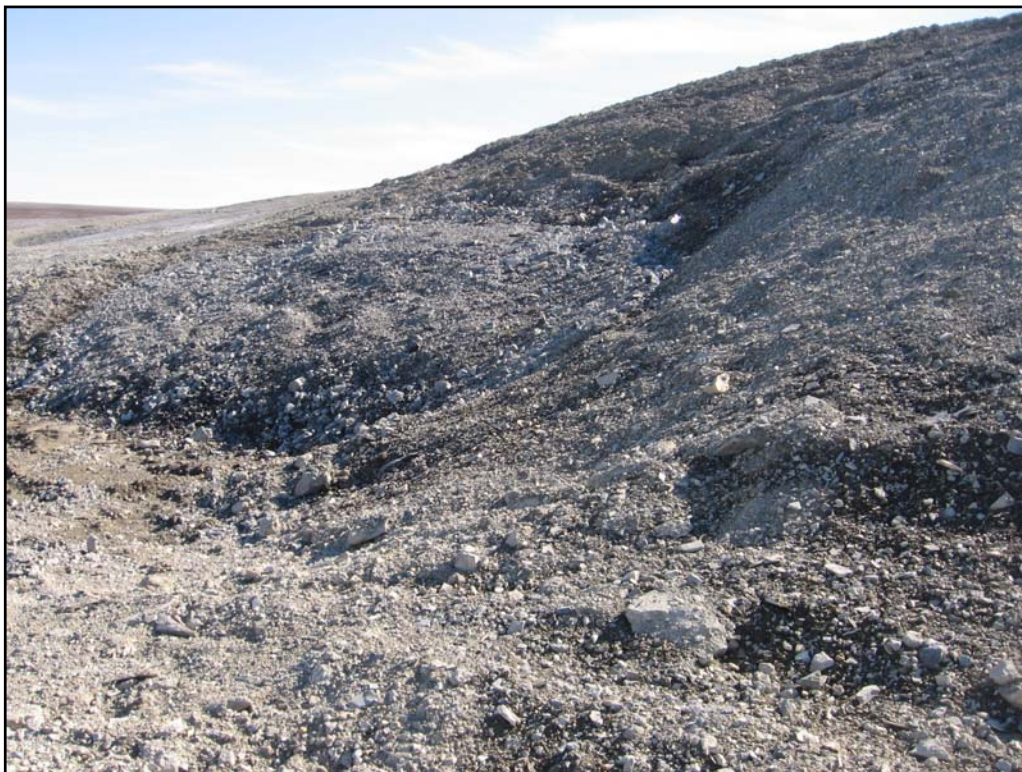
The objective of the annual geotechnical inspection is to look for evidence of settlement, erosion, or instability at the four mine portals that might present a safety risk to humans or wildlife. All of the portals are in good condition, free of any signs of instability or erosion, as documented on Photographs 77, 84, 85 and 86 (Appendix A).

Photo 77- Northing: 8369078 Easting: 558020 Elevation: 12 m.  
North portal

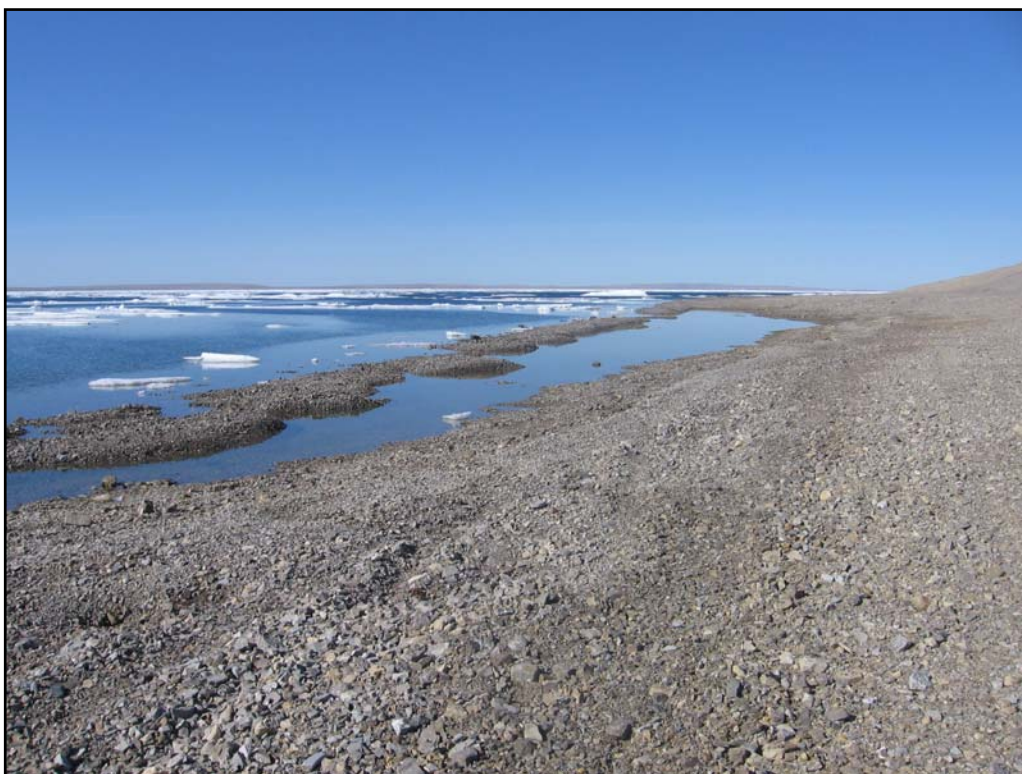
The shoreline and slopes adjacent to the former dock structure were inspected in July 2007. No signs of slope instability or significant erosion were observed (Photographs 79 and 80 in Appendix A). During the July 2007 inspection, a gravel bar about 2 to 10 m from the shoreline (Photograph 78 in Appendix A) and several areas with ponded water as a result of settlement (Photographs 81 through 83 in Appendix A) were observed. The observed changes appear to be related to rearrangement of shoreline gravel by ice-action and thaw-related settlement, respectively. The water adjacent to the shoreline was very clear indicating negligible sediment deposition as a result of erosion activity.

Photo 78- Northing: 8367592 Easting: 558074 Elevation: 4 m.  
Foreshore; gravel bar formation

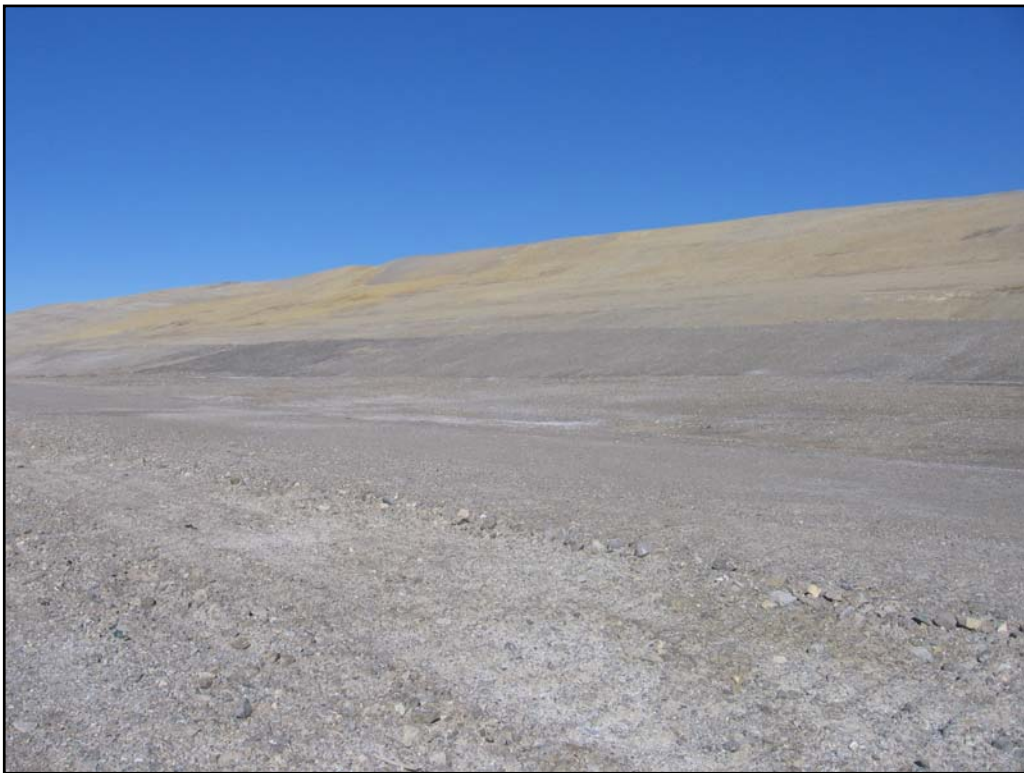
Photo 79- Northing: 8367592 Easting: 558074 Elevation: 4 m.  
Foreshore; concentrate storage building slope facing northeast

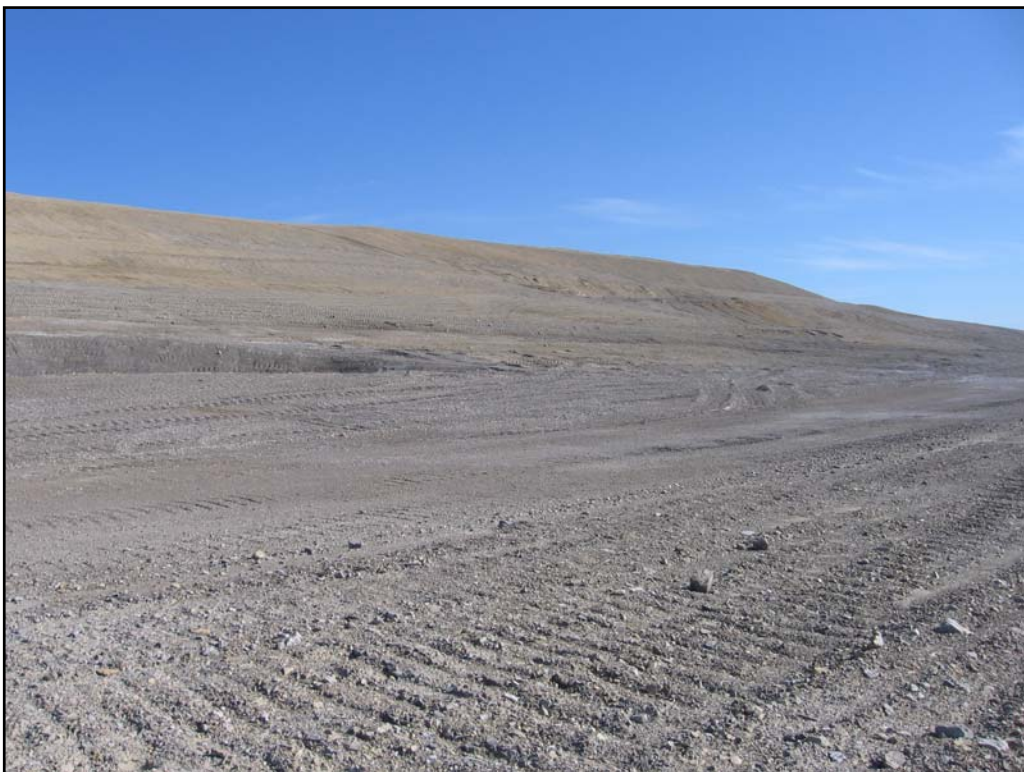
Photo 80- Northing: 8367592 Easting: 558074 Elevation: 4 m.  
Foreshore; concentrate storage building slope facing southeast

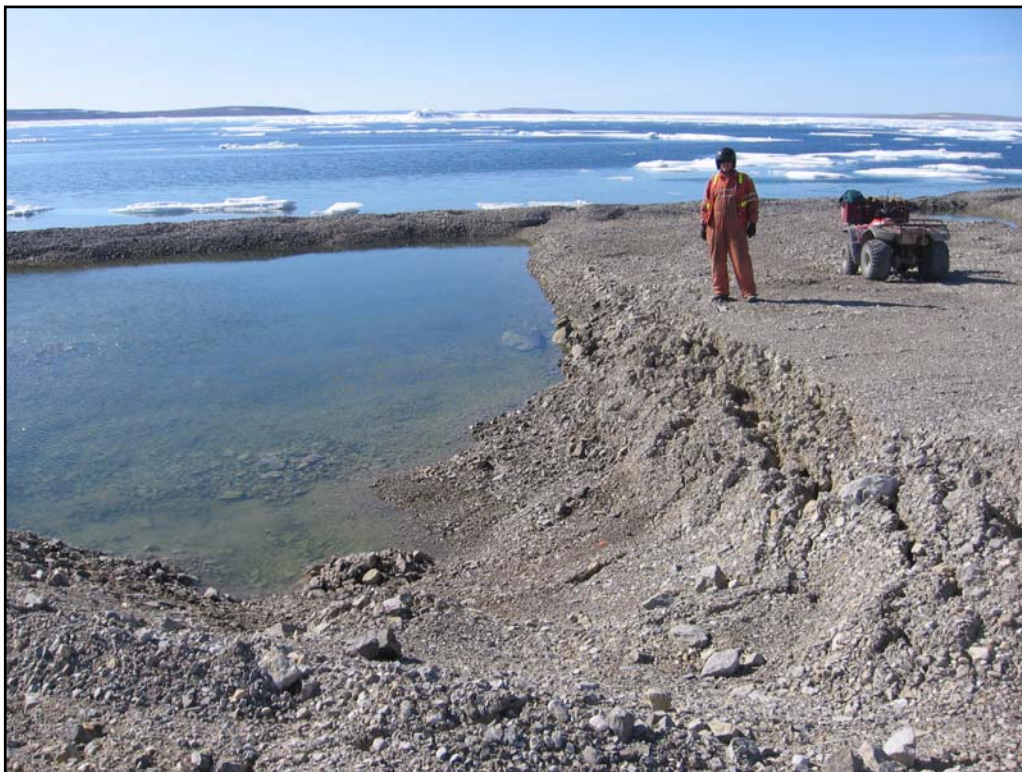
Photo 81- Northing: 8367708 Easting: 557983 Elevation: 3 m.  
Foreshore; large ice thaw settlement

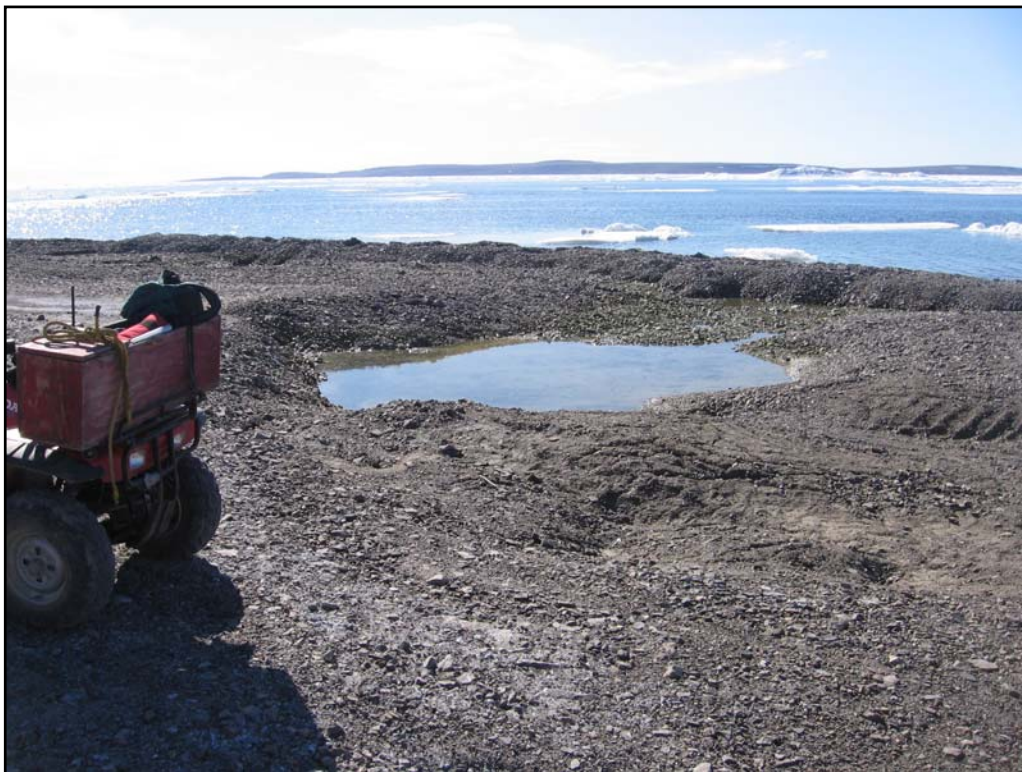
Photo 83- Northing: 8367851 Easting: 557877 Elevation: 4 m.  
Foreshore; ice thaw settlement

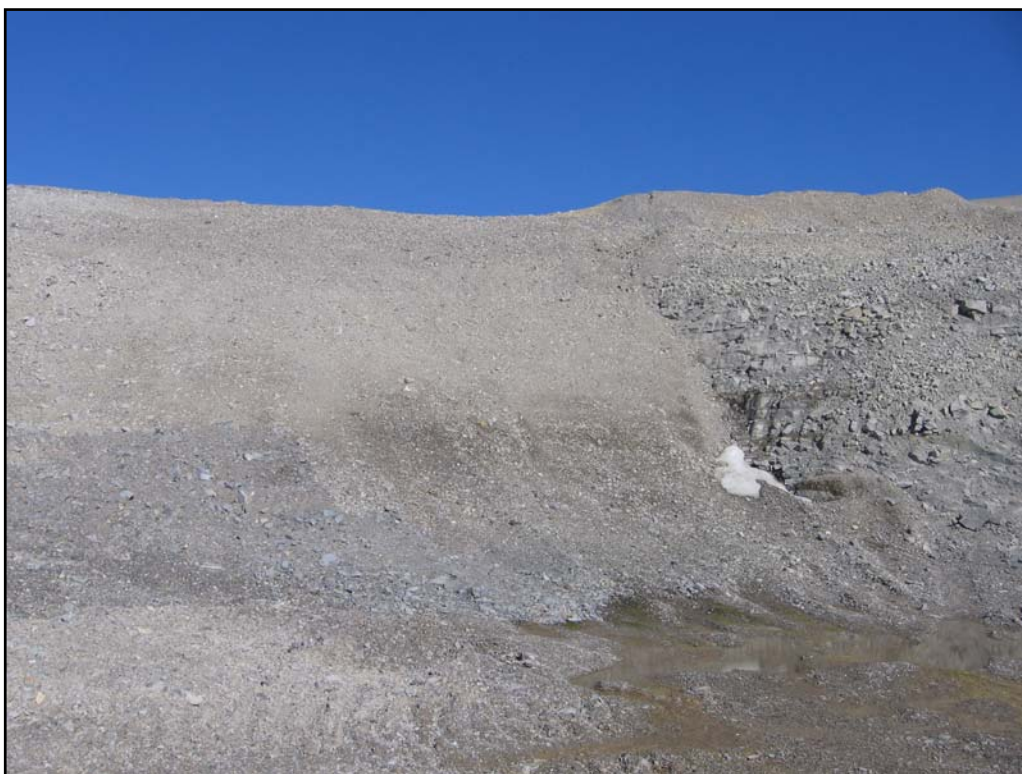
Photo 84- Northing: 8368046 Easting: 557865 Elevation: 6 m.  
Main portal

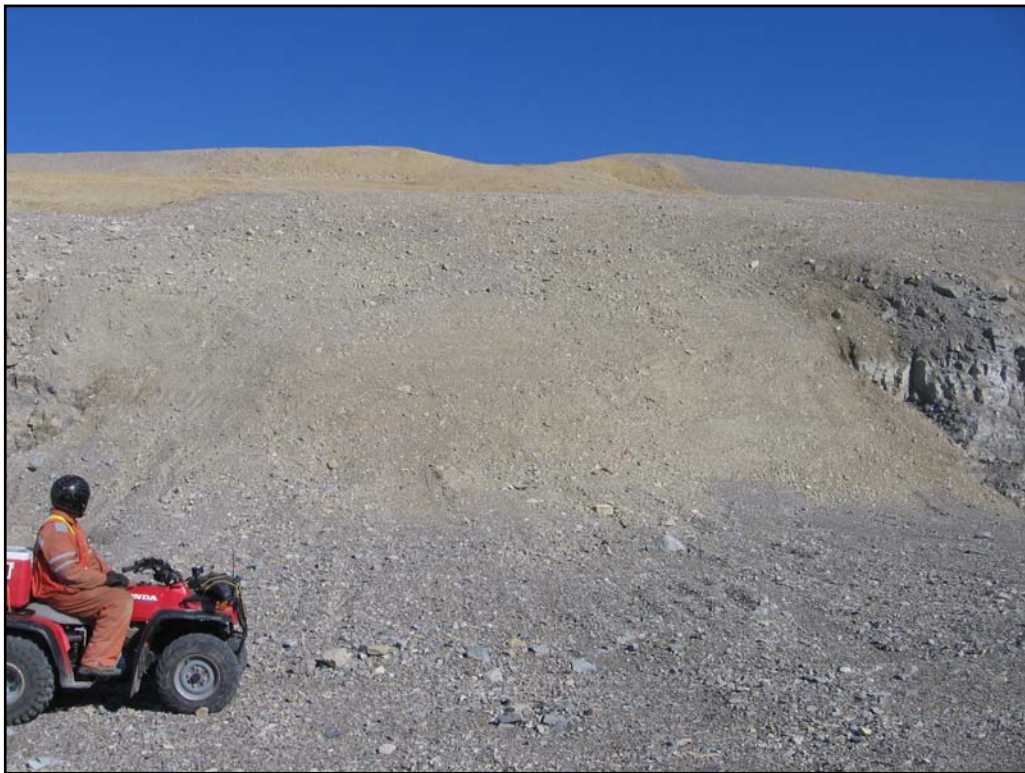
Photo 85- Northing: 8367963 Easting: 557922 Elevation: 8 m.  
Conveyor portal

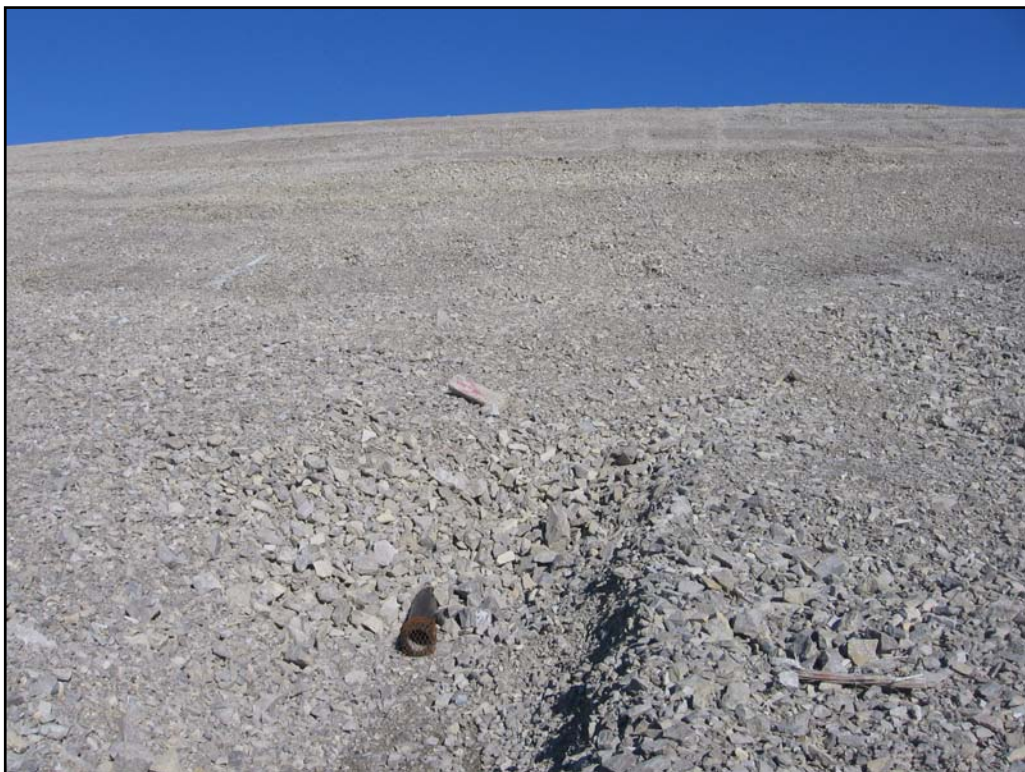
Photo 86- Northing: 8368182 Easting: 557829 Elevation: 26 m.  
Exploration portal

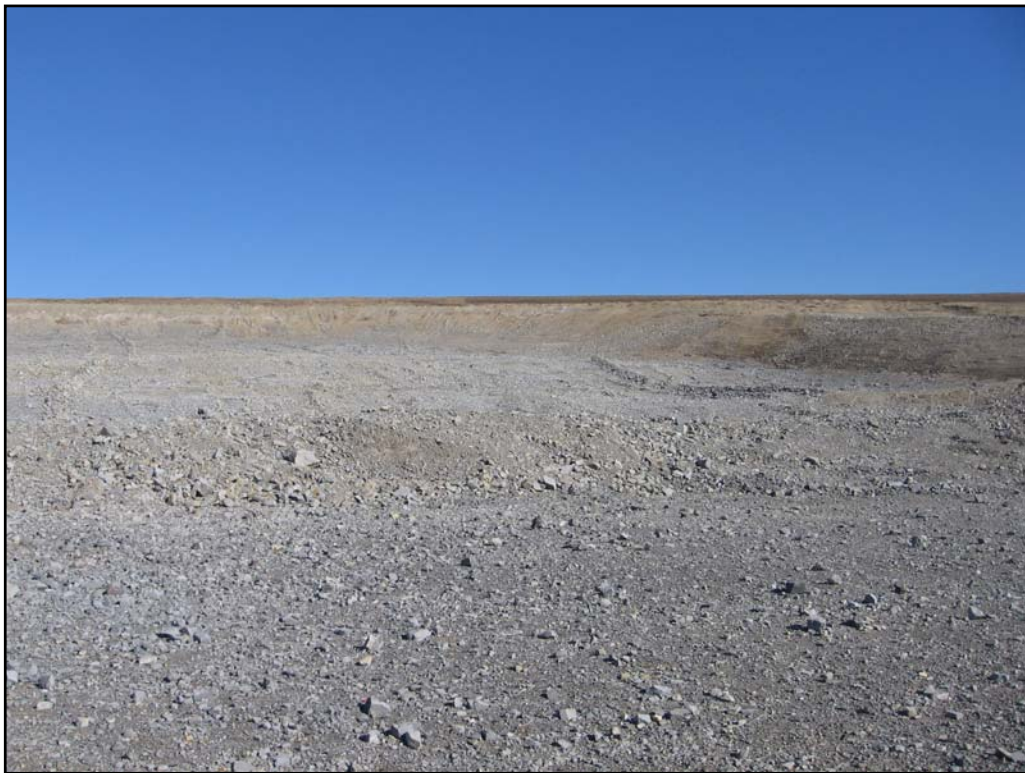
Photo 87- Northing: 8369328 Easting: 559184 Elevation: 26 m.  
New quarry; facing east

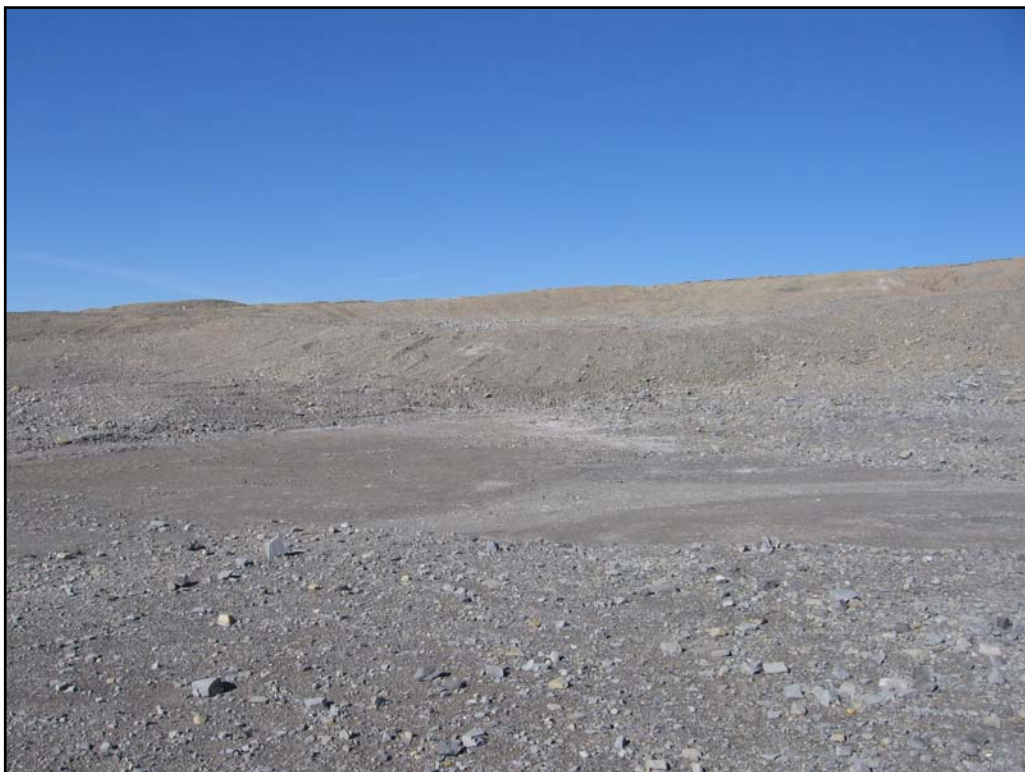
Photo 88- Northing: 8369328 Easting: 559184 Elevation: 26 m.  
New quarry; facing north

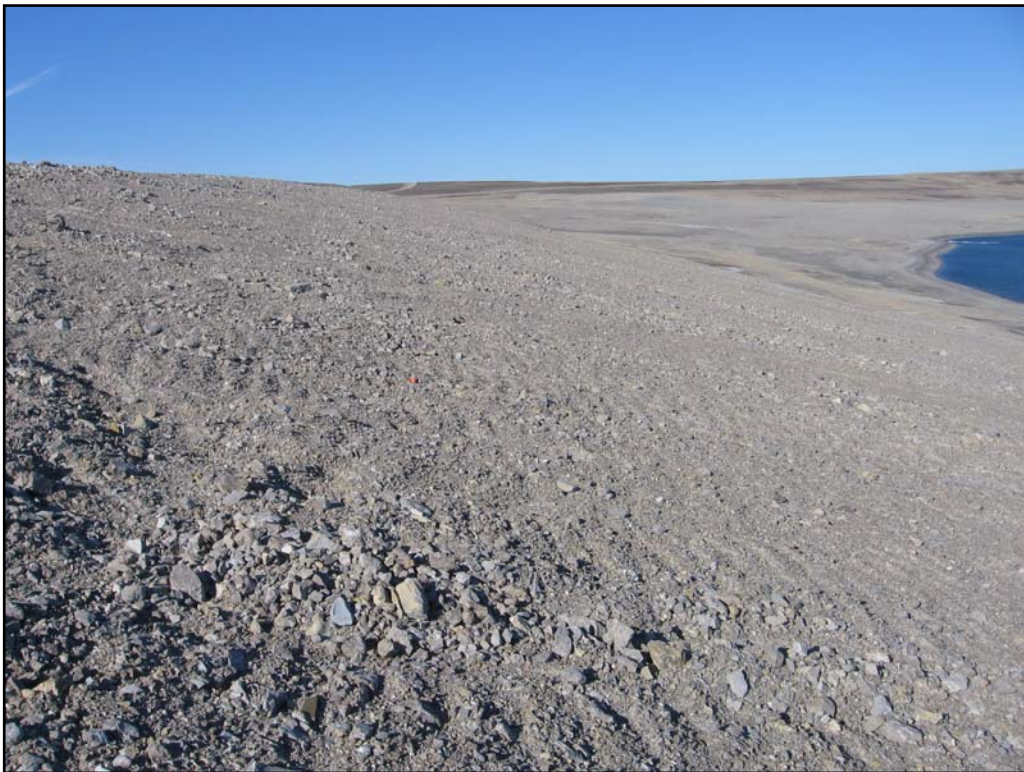
No indications of slope instability were observed at the Operational Landfill during the July 2007 inspection. Indications of slumping or creep were not observed on the landfill slope (Photographs 90 and 91 in Appendix A). No tension cracks or settlement depressions were observed on the landfill crest (Photographs 4 and 5 in Appendix A). Erosion gullies on the slope above the Operational Landfill observed during previous inspections appear to be unchanged and self-armouring. The previously photographed erosion gully at OLF GUL2 (above the landfill) was photographed in July 2007 (Photographs 6 and 7 in Appendix A) and appears to be unchanged with a maximum depth of 0.5 m.

Photo 90- Operational landfill slope; facing northeast

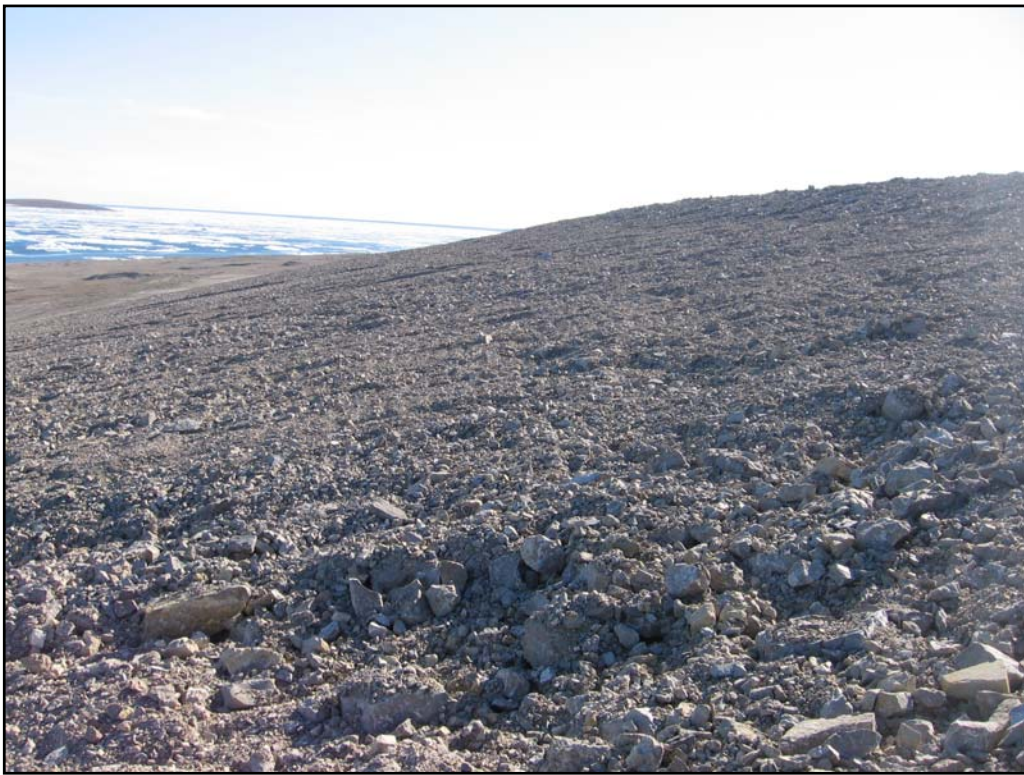
Photo 91- Northing: 8367368 Easting: 558792 Elevation: 33 m.  
Operational landfill slope; facing southwest
