## **APPENDIX 9**

### **Annual Geotechnical Inspection Report**

## Report on Post-Closure Geotechnical Inspection of Polaris Mine Site in 2008

Date: November 11, 2008

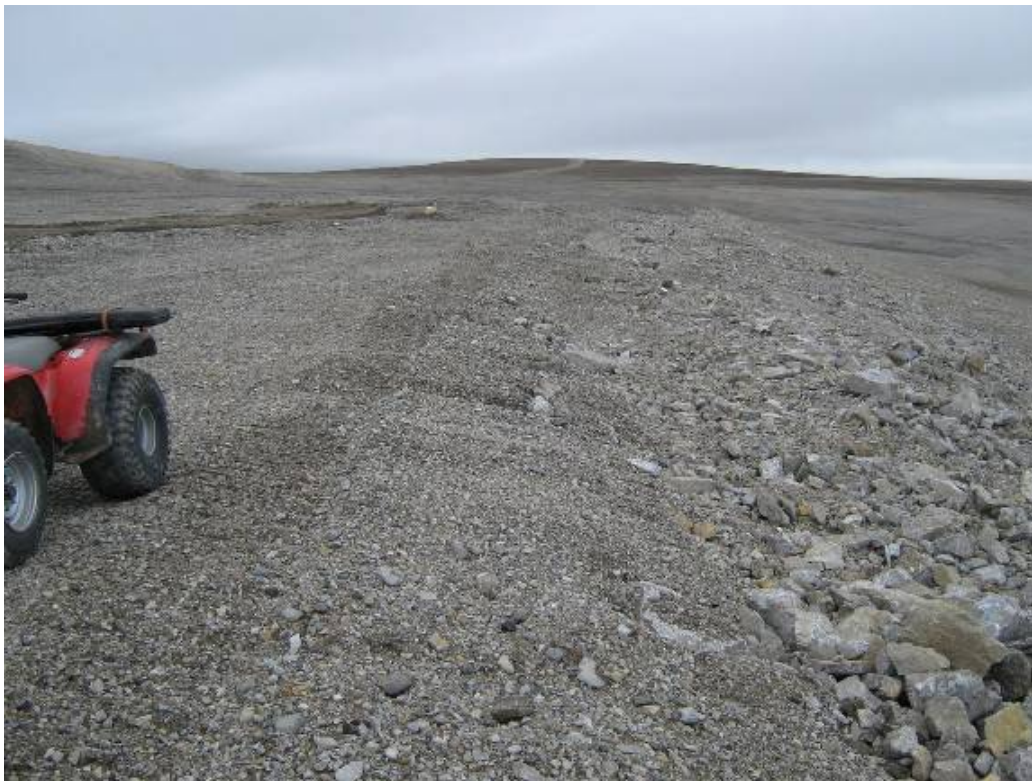
No indications of slope instability were observed at the Operational Landfill during the July 2008 inspection. No tension cracks or settlement depressions were observed on the landfill crest (Photographs 1 through 7 in Appendix A). No indications of erosion or slope instability were observed on the landfill slope (Photographs 8 through 16 in Appendix A).

Photo 3- Northing 558861 Easting 8367561 Elevation 33 m  
Operational landfill: looking north

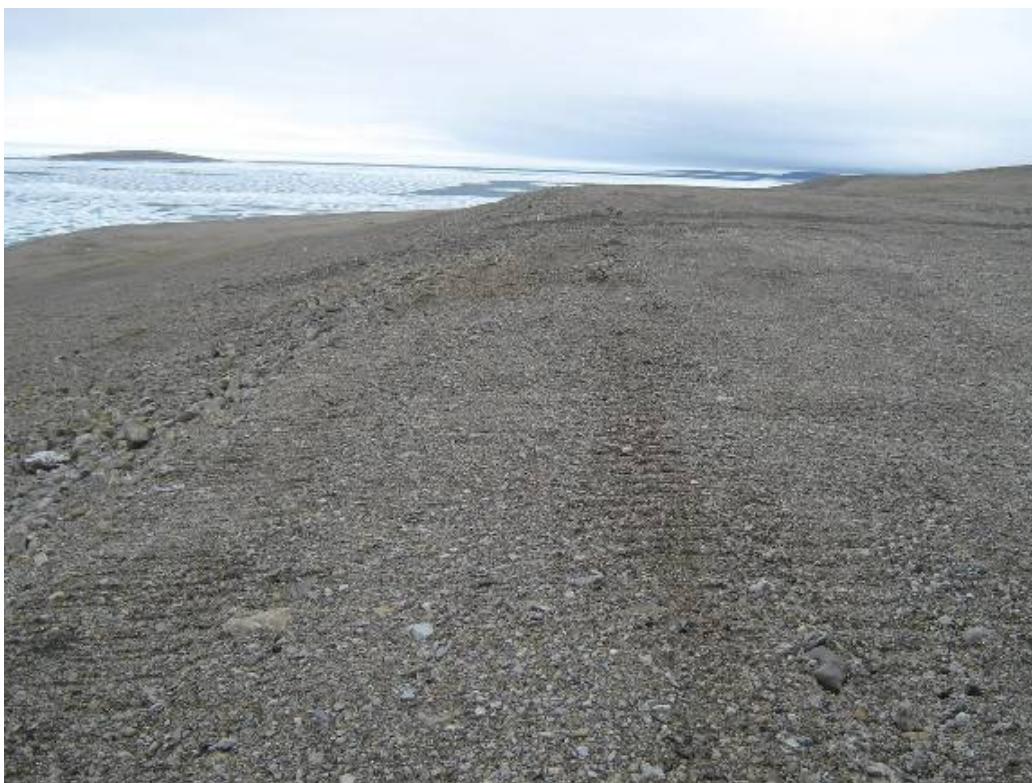
Photo 4- Northing 558861 Easting 8367561 Elevation 33 m  
Operational landfill: looking south

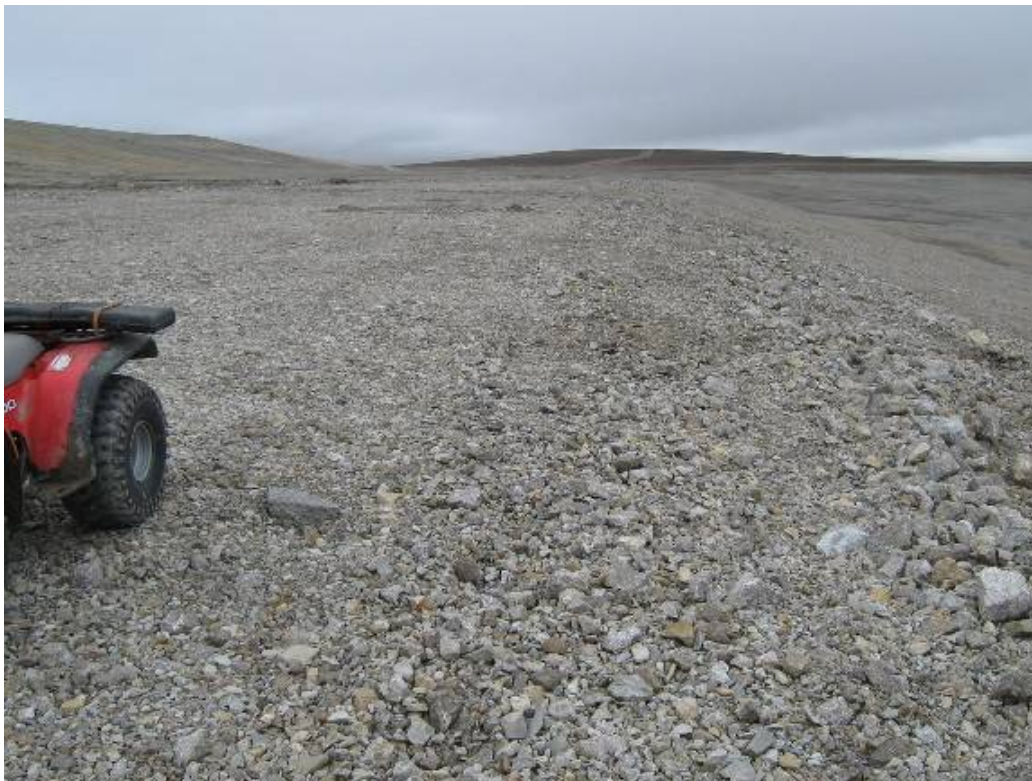
Photo 5- Northing 558828 Easting 8367442 Elevation 42 m  
Operational landfill: looking north

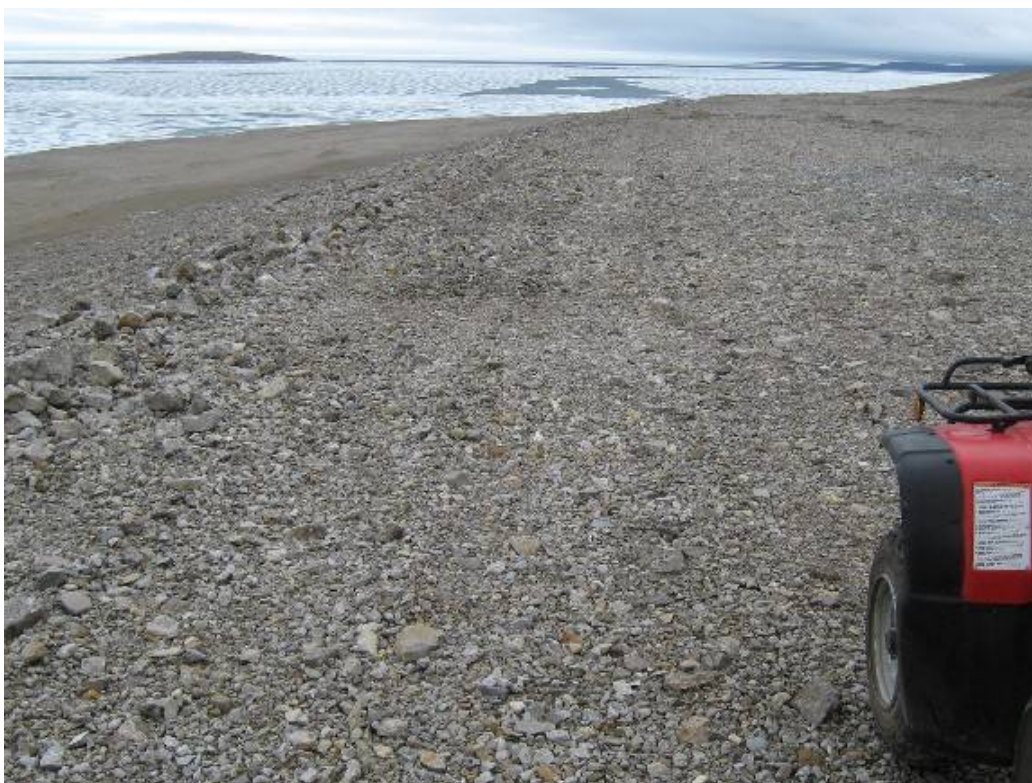
Photo 6- Northing 558828 Easting 8367442 Elevation 42 m  
Operational landfill: looking south

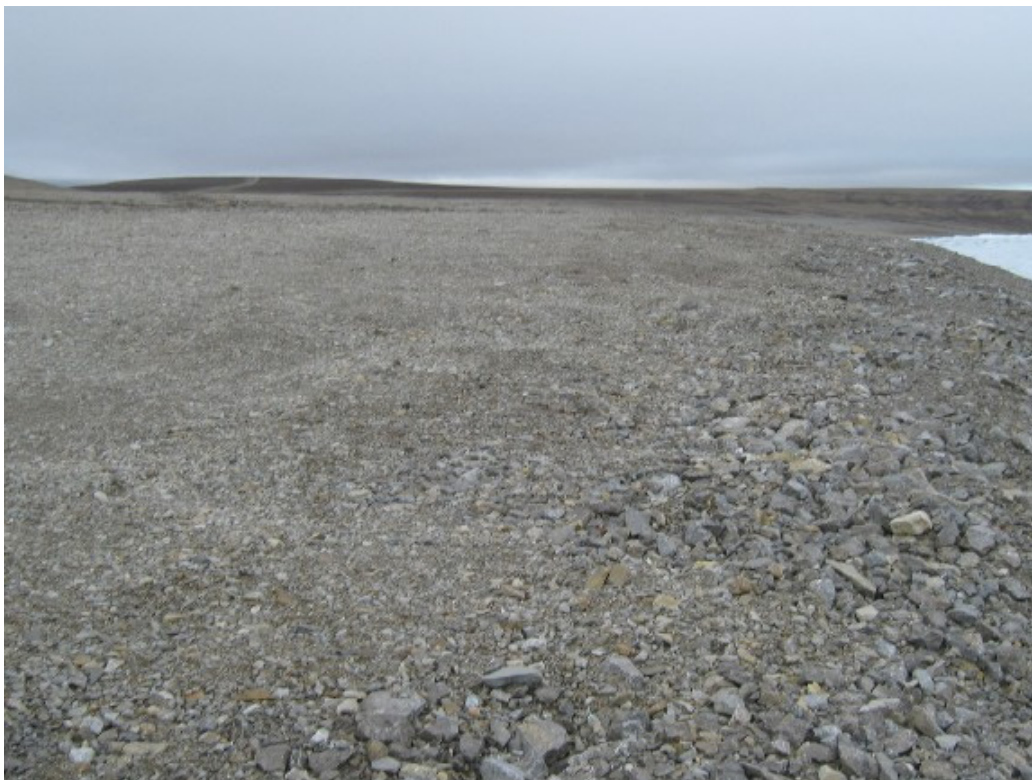
Photo 7- Northing 558759 Easting 8367331 Elevation 33 m  
Operational landfill: south end of landfill looking towards crest

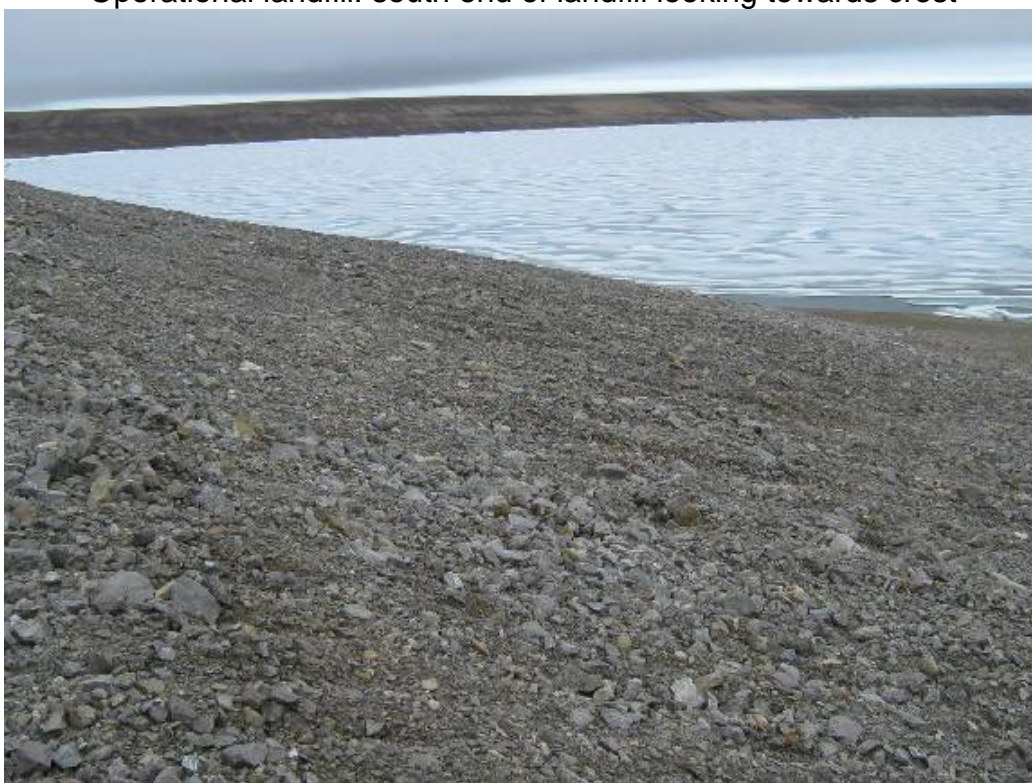
Photo 8- Northing 558759 Easting 8367331 Elevation 33 m  
Operational landfill: south end of landfill looking towards slope

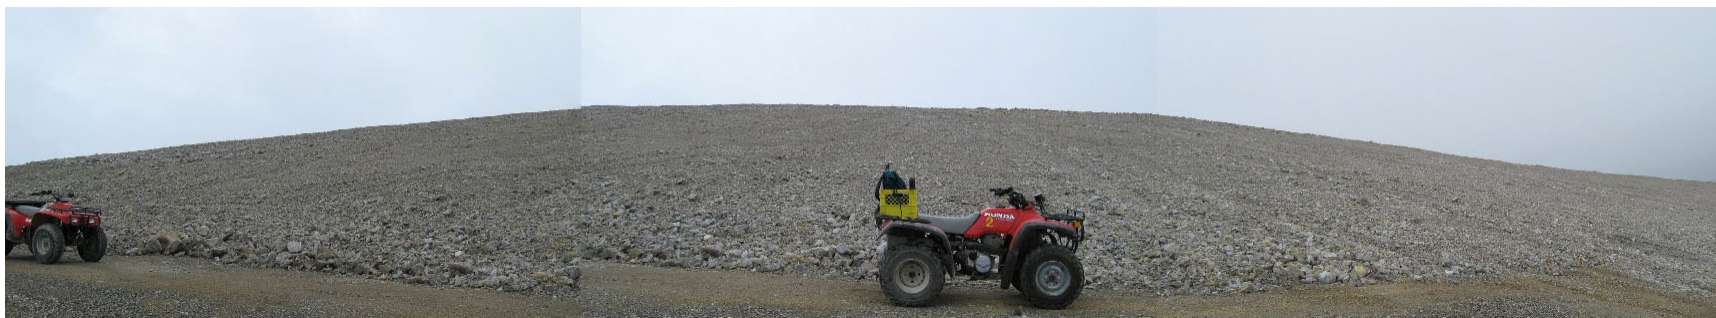
Some minor seepage and associated orange staining was observed along the south toe of the landfill during the July 2008 inspection (Panoramic of Photographs 9 through 11 in Appendix A). A minor erosion gully about 0.5 m wide and 0.3 m deep was observed directly upslope of Waypoint #6 (Panoramic of Photographs 12, 13 and 14 in Appendix A).

No major erosion or indications of slope instability were observed on the landfill slope. Some minor seepage and associated orange staining was observed along the south toe of the landfill during the July 2008 inspection.

Panoramic (Photos 9,10,11)  
Northing 558880 Easting 8367366 Elevation 16 m  
Operational landfill

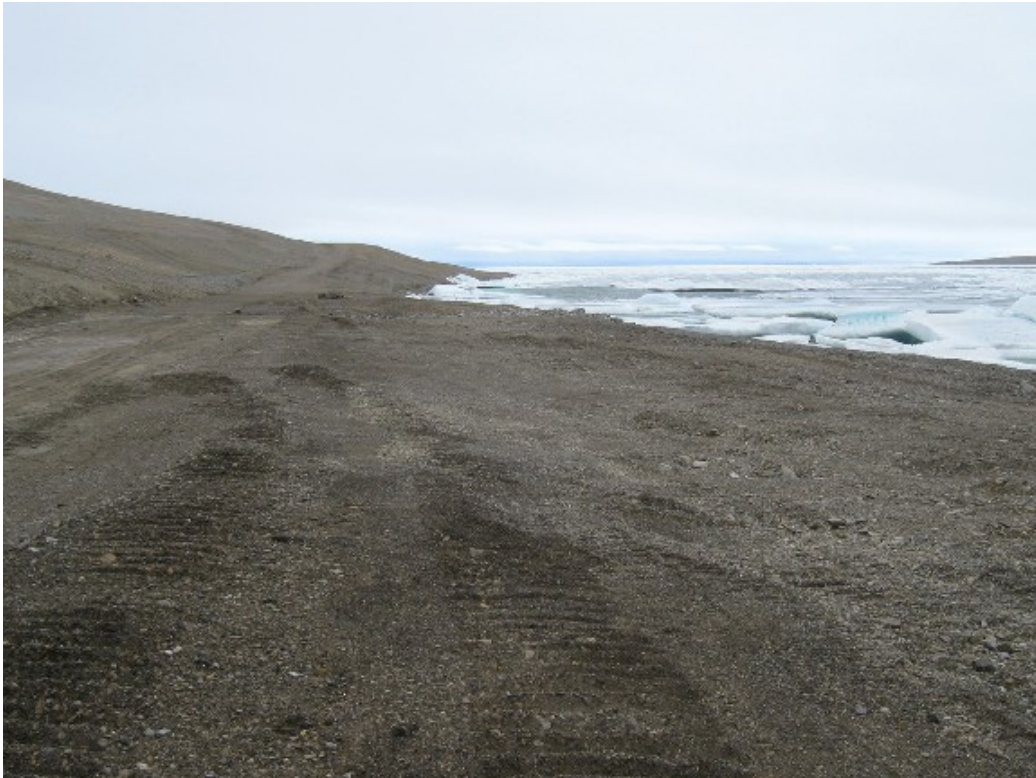
The shoreline and slopes adjacent to the former dock structure were inspected in July 2008. No signs of slope instability or significant erosion of concern were observed (Photographs 17 through 29, 32 and 33 in Appendix A). Gravel bars and thaw settlement along the shoreline were first observed during the July 2007 inspection and changes in response to ocean wave and ice action appear to be ongoing. The water adjacent to the shoreline was very clear indicating suspended sediment as a result of erosion or wave action is not a concern.

Photo 19- Northing 558260 Easting 8367401 Elevation 5 m  
Foreshore: shoreline at south end, view looking south

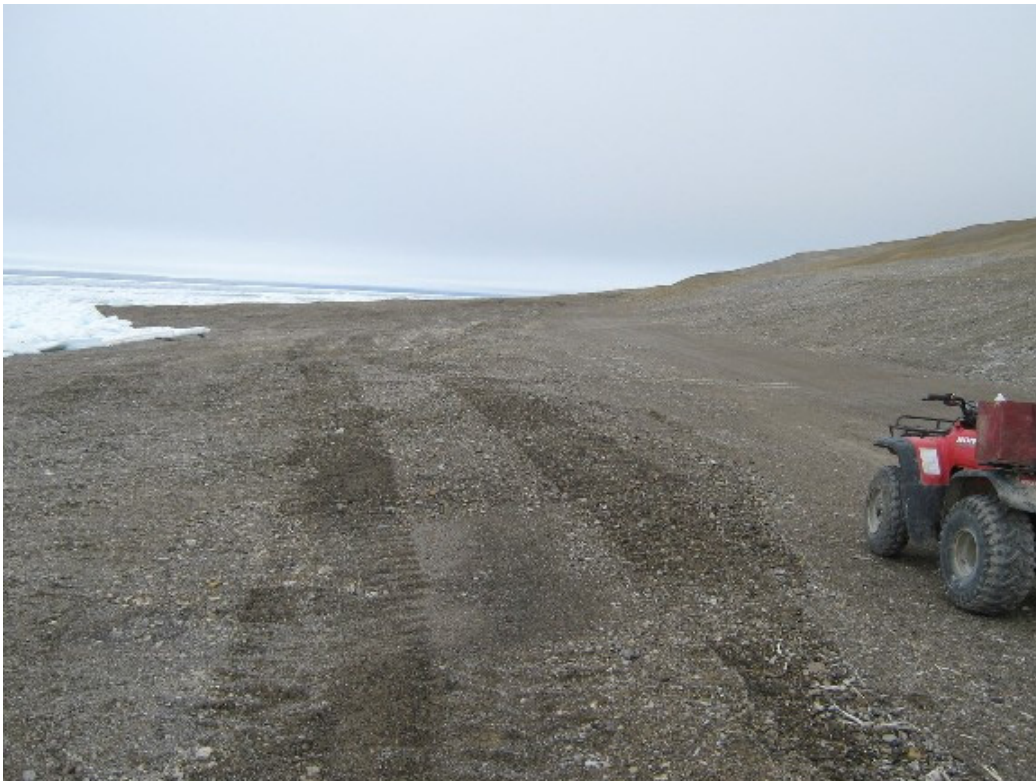
Photo 20- Northing 558260 Easting 8367401 Elevation 5 m  
Foreshore: shoreline at south end, view looking north

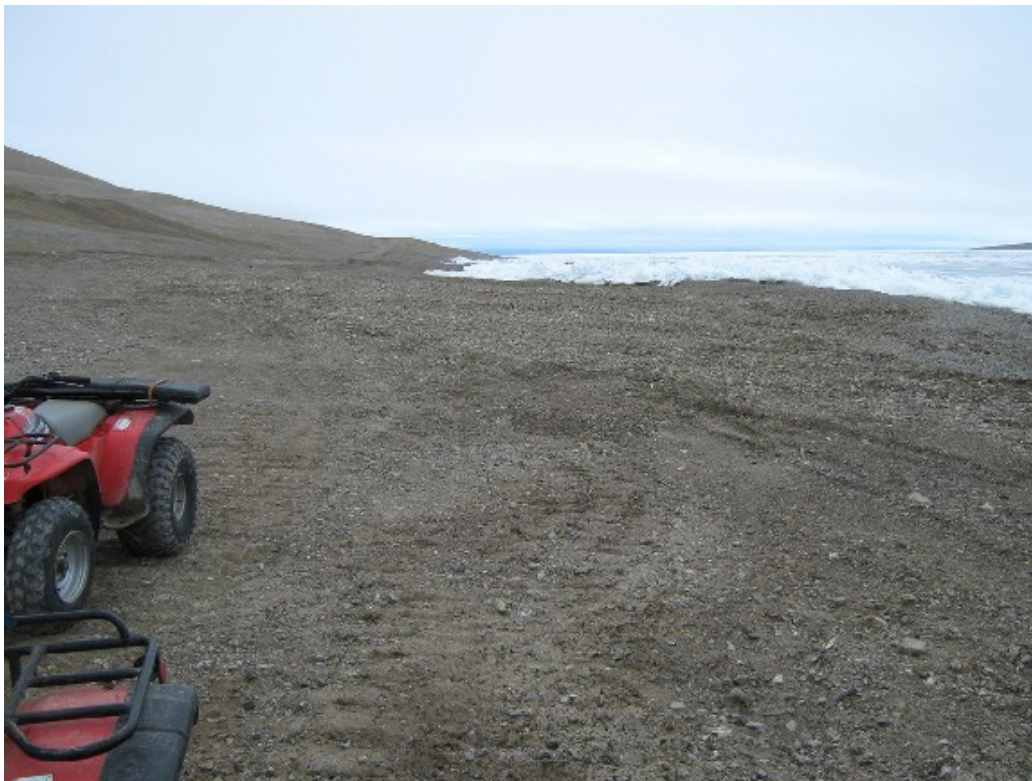
Photo 21- Northing 558119 Easting 8367531 Elevation 8 m  
Foreshore: looking south

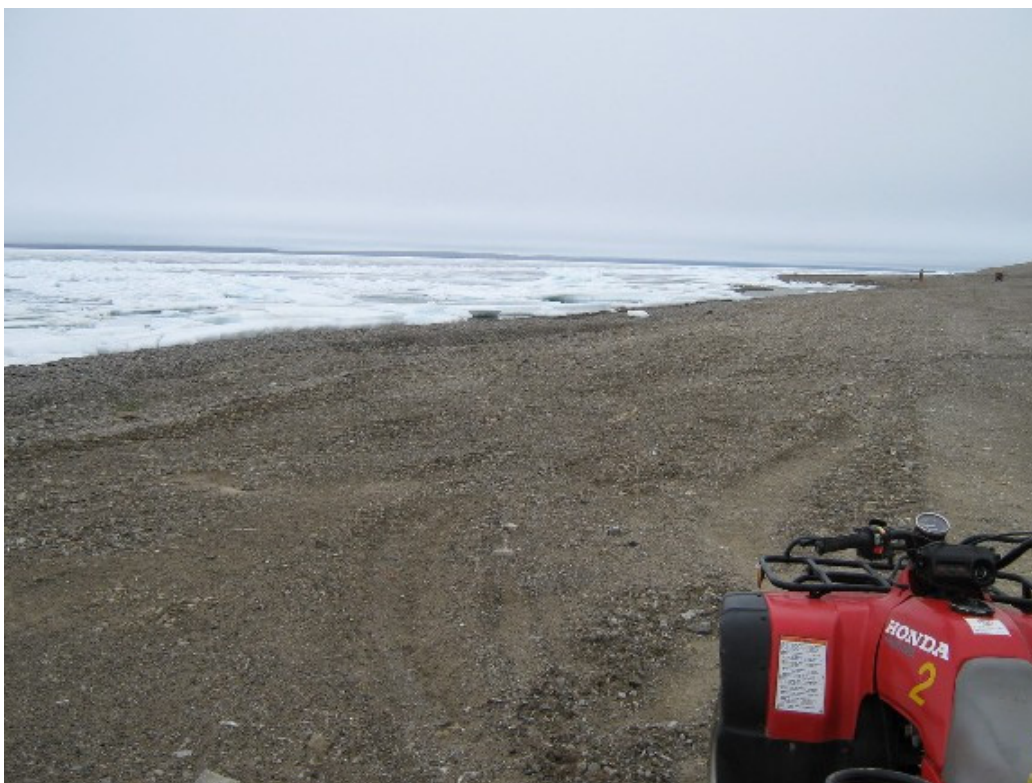
Photo 22- Northing 558119 Easting 8367531 Elevation 8 m  
Foreshore: looking north

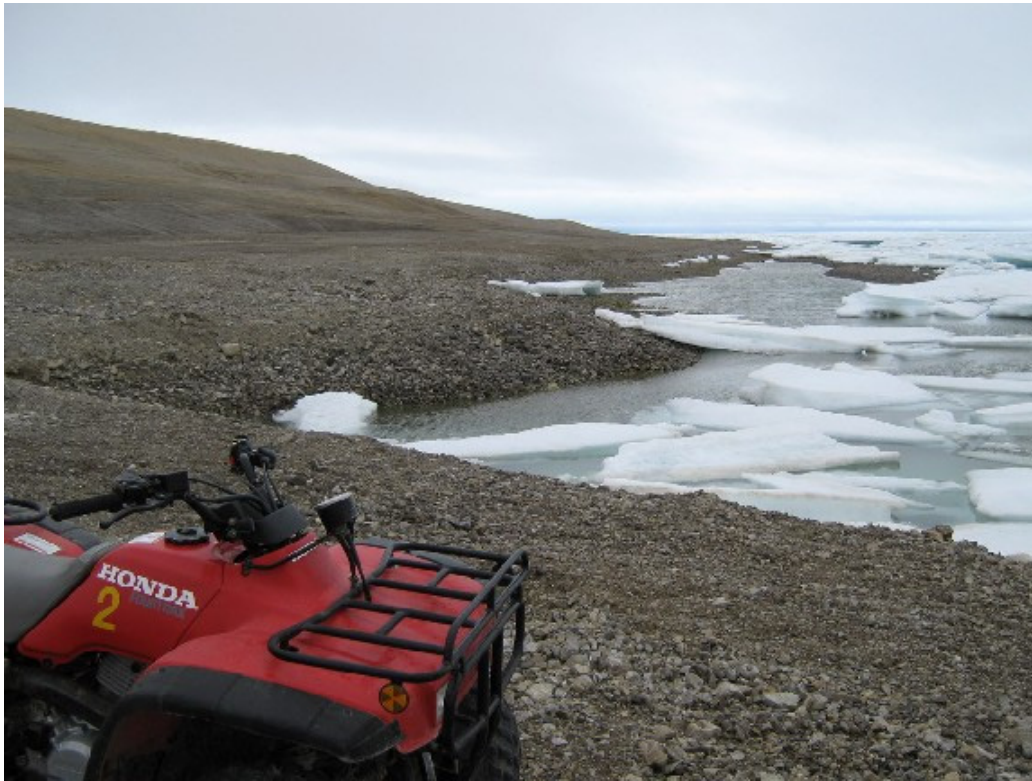
Photo 23- Northing 557983 Easting 8367710 Elevation 8 m  
Foreshore: looking south

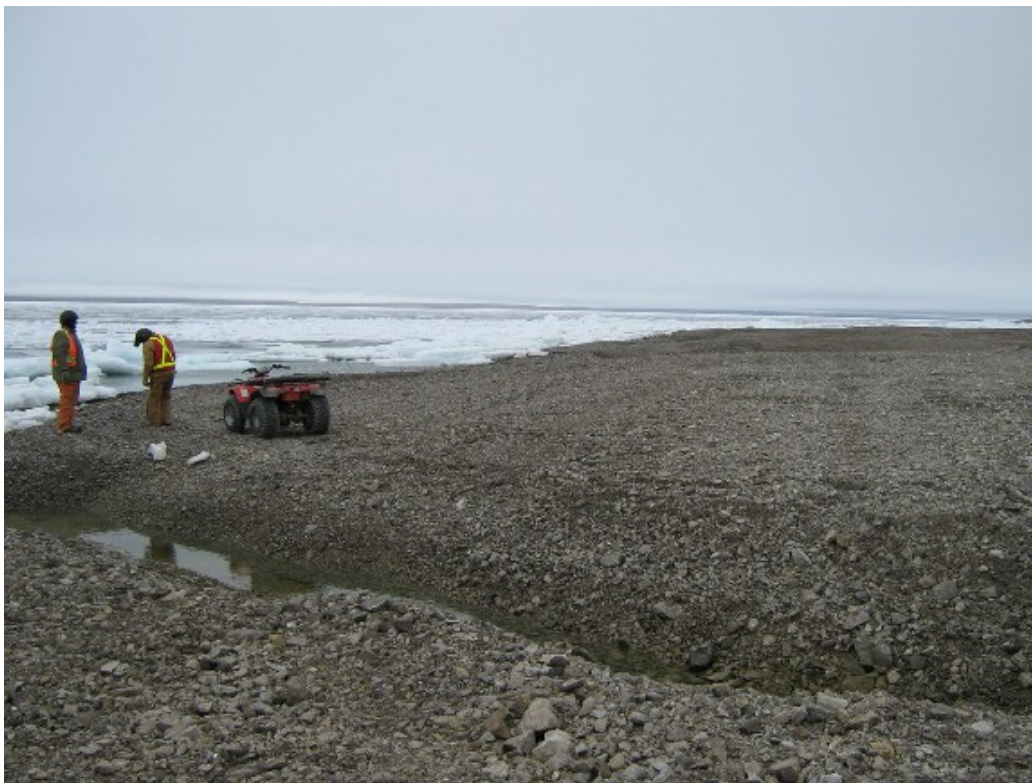
Photo 24- Northing 557983 Easting 8367710 Elevation 8 m  
Foreshore: looking north

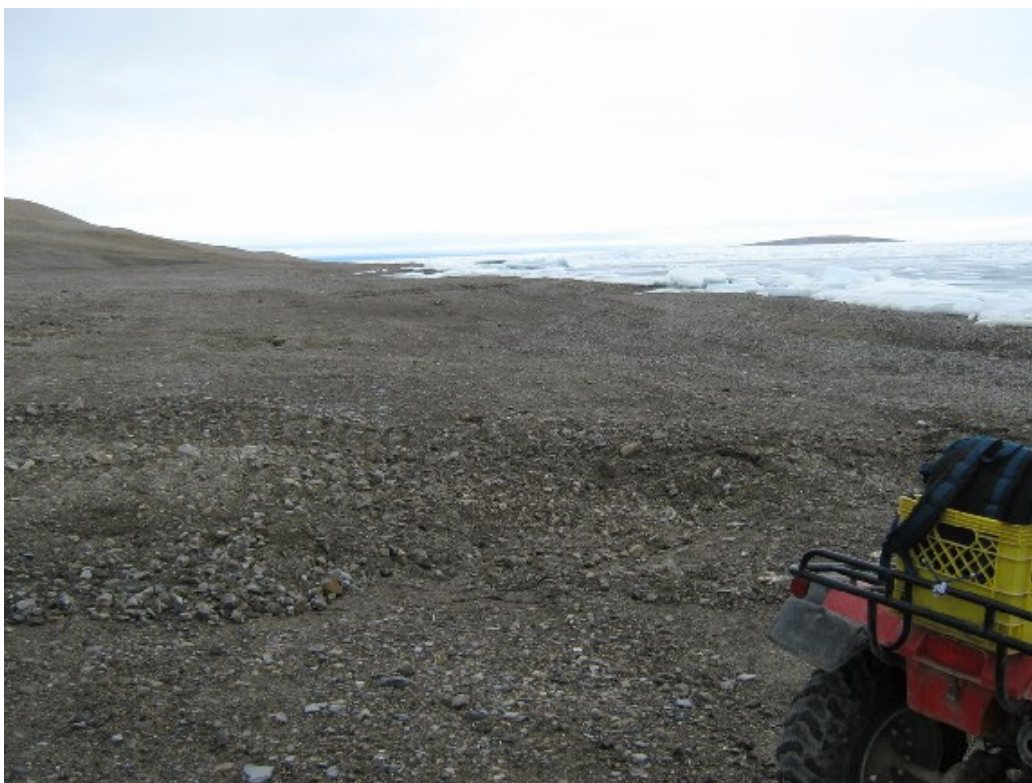
Photo 26- Northing 557912 Easting 8367793 Elevation 7 m  
Foreshore: looking south

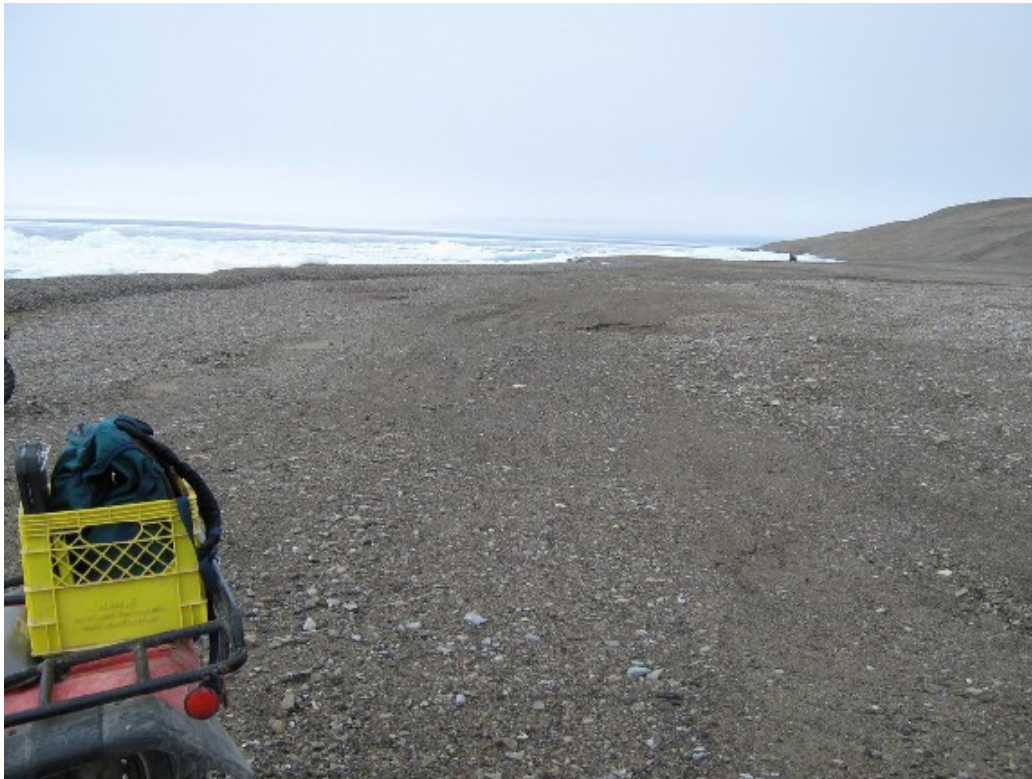
Photo 27- Northing 557912 Easting 8367793 Elevation 7 m  
Foreshore: looking north

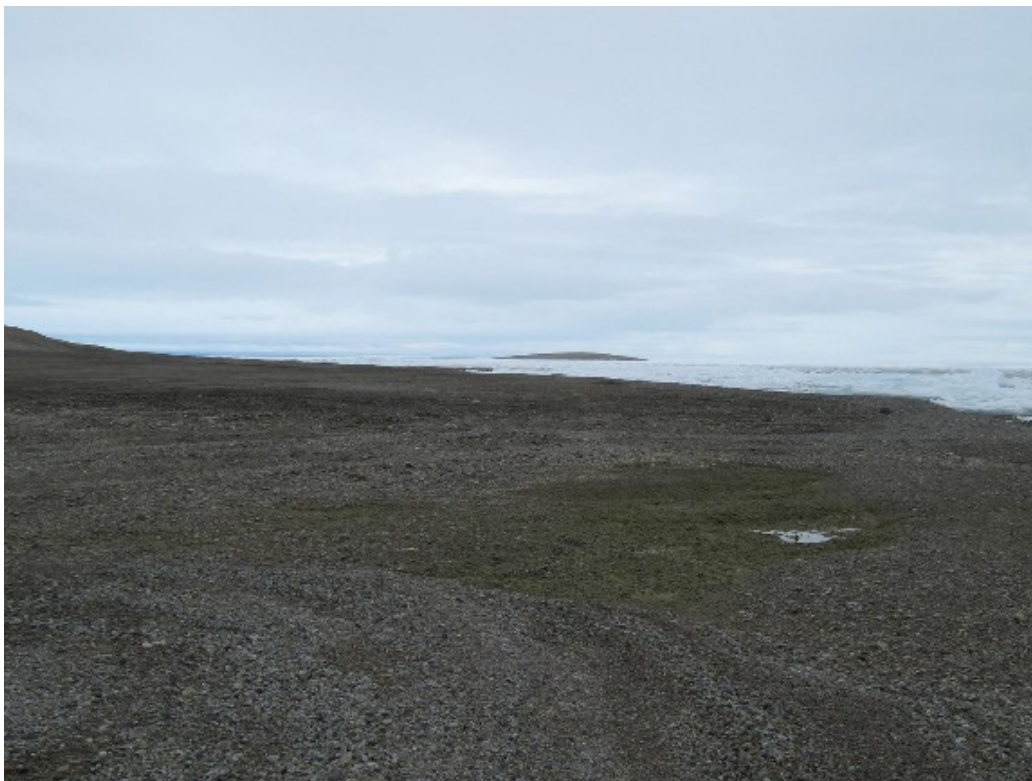
Photo 28- Northing 557807 Easting 8367992 Elevation 2 m  
North end of foreshore looking south

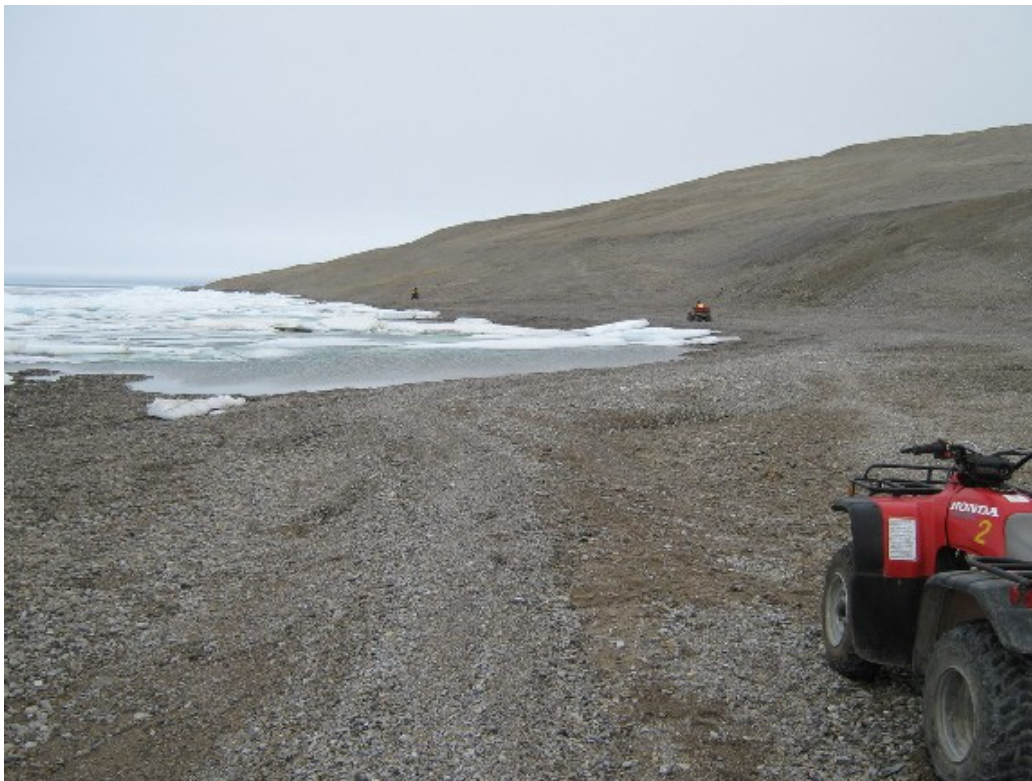
Photo 29- Northing 557807 Easting 8367992 Elevation 2 m  
North end of foreshore looking north

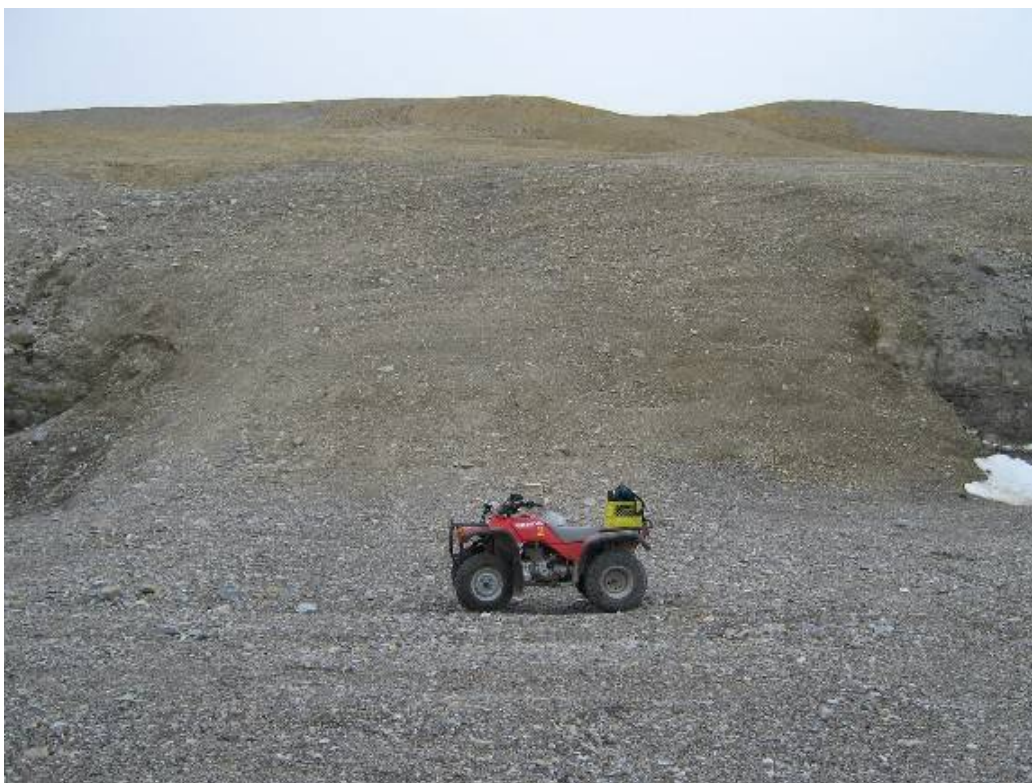
The objective of the annual geotechnical inspection is to look for evidence of settlement, erosion, or slope instability at the four mine portals that might present a safety risk to humans or wildlife. During the July 2008 inspection all of the portals appeared to be in good condition, free of any signs of instability or erosion, as documented on Photographs 30, 31, 34, 43 (Appendix A). Some snow was covering the

Photo 30- Northing 557932 Easting 8367961 Elevation 9 m  
Conveyor portal: covered slope

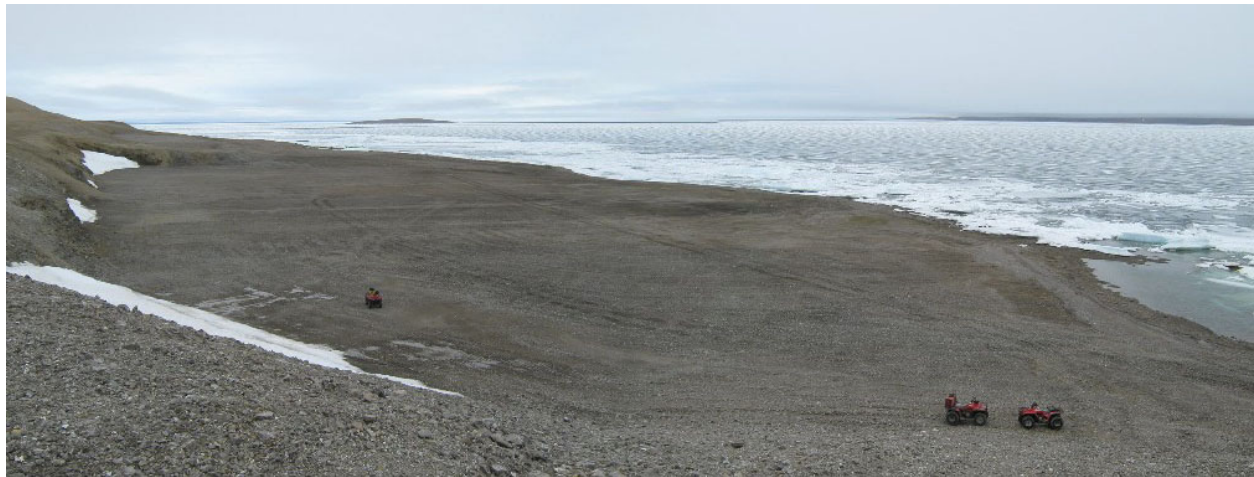
Panoramic (Photos 32&33)- Northing 557860 Easting 8368041 Elevation 7 m  
Foreshore: view from slope above main portal

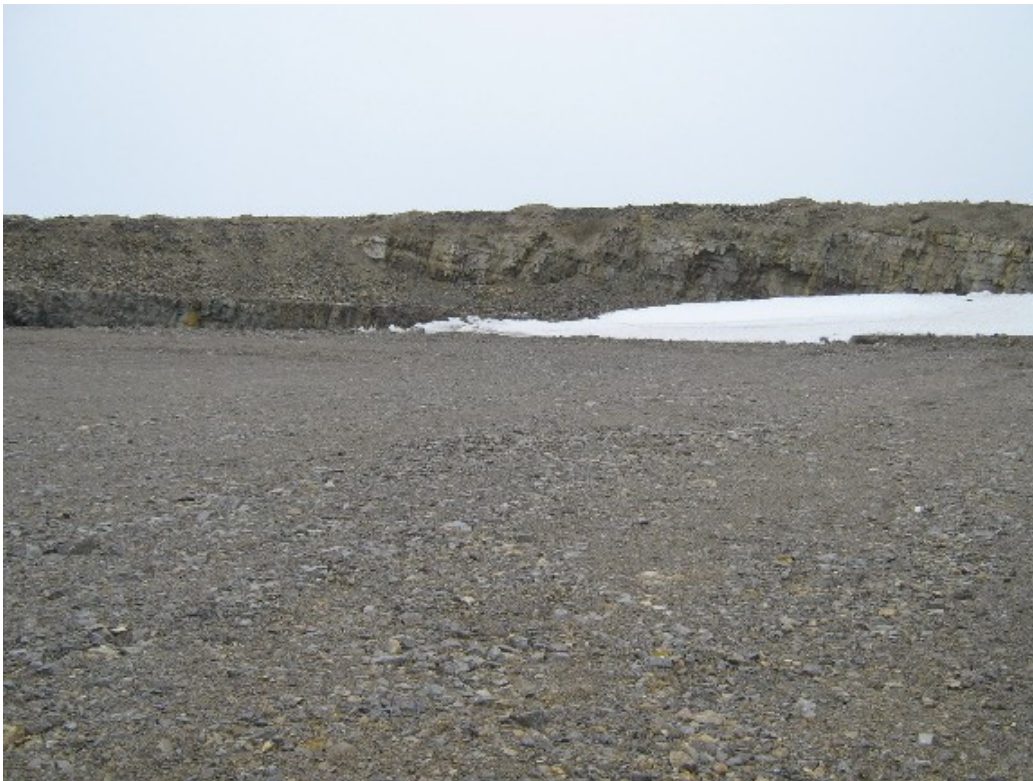
The rockfill cover at the Little Red Dog Quarry Landfill was inspected and shows no indications of instability or settlement. The quarry walls above the final cover do not exhibit indications of instability. Photographs 35 through 42 (Appendix A) documents the conditions observed during the July 2008 inspection. The previously observed 1 m wide by 1 m deep gap along the northeast quarry wall will be filled to grade with rockfill when the collected stockpile of debris is being buried.

Photo 35- Northing 557718 Easting 8368720 Elevation 35 m  
Little Red Dog Quarry: view from debris pile facing ocean

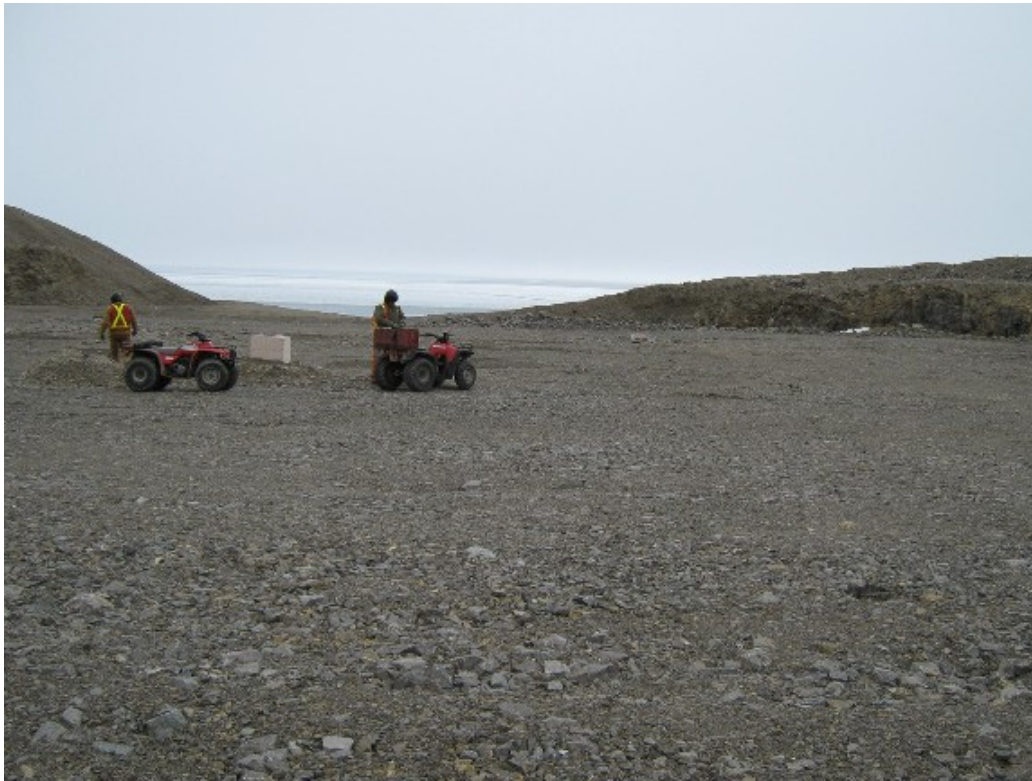
Photo 36- Northing 557718 Easting 8368720 Elevation 35 m  
Little Red Dog Quarry: view from debris pile facing ocean

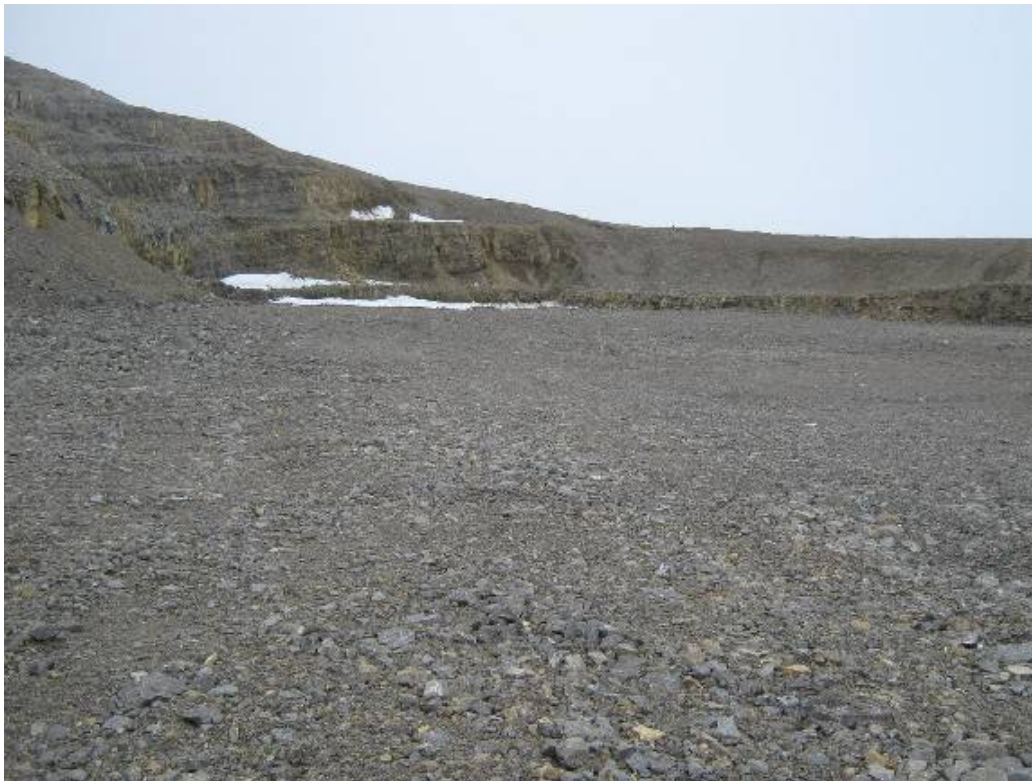
Photo 37- Northing 557718 Easting 8368720 Elevation 35 m  
Little Red Dog Quarry: view from debris pile facing ocean

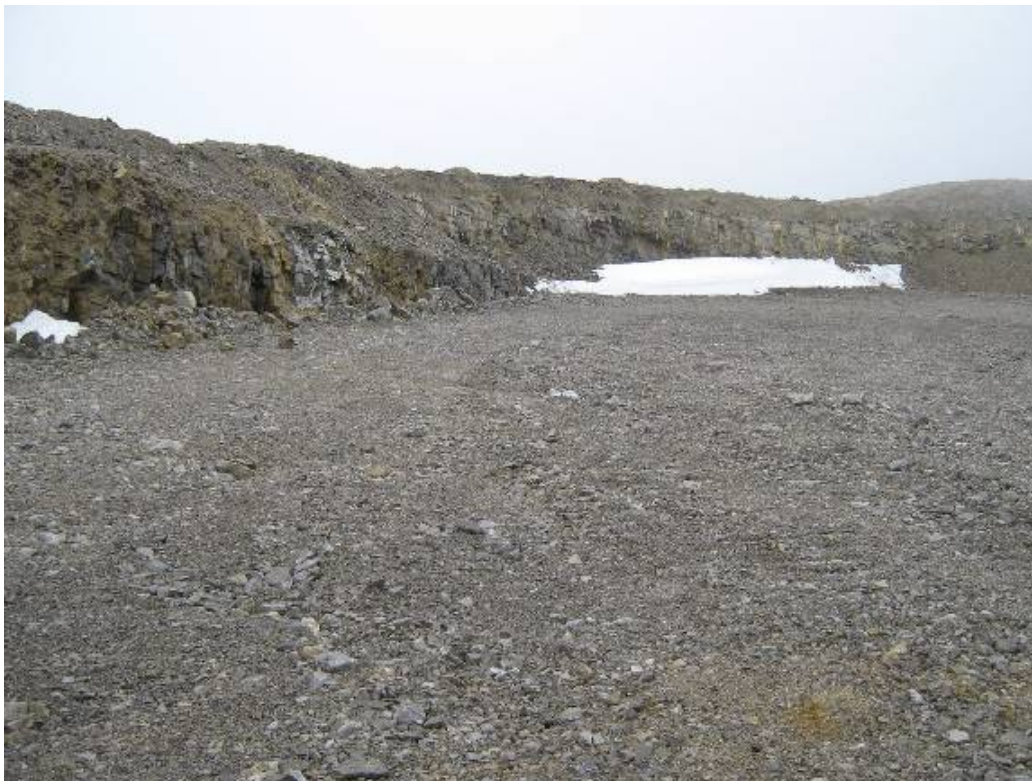
Photo 38- Northing 557628 Easting 8368725 Elevation 36 m  
Little Red Dog Quarry: near entrance to quarry

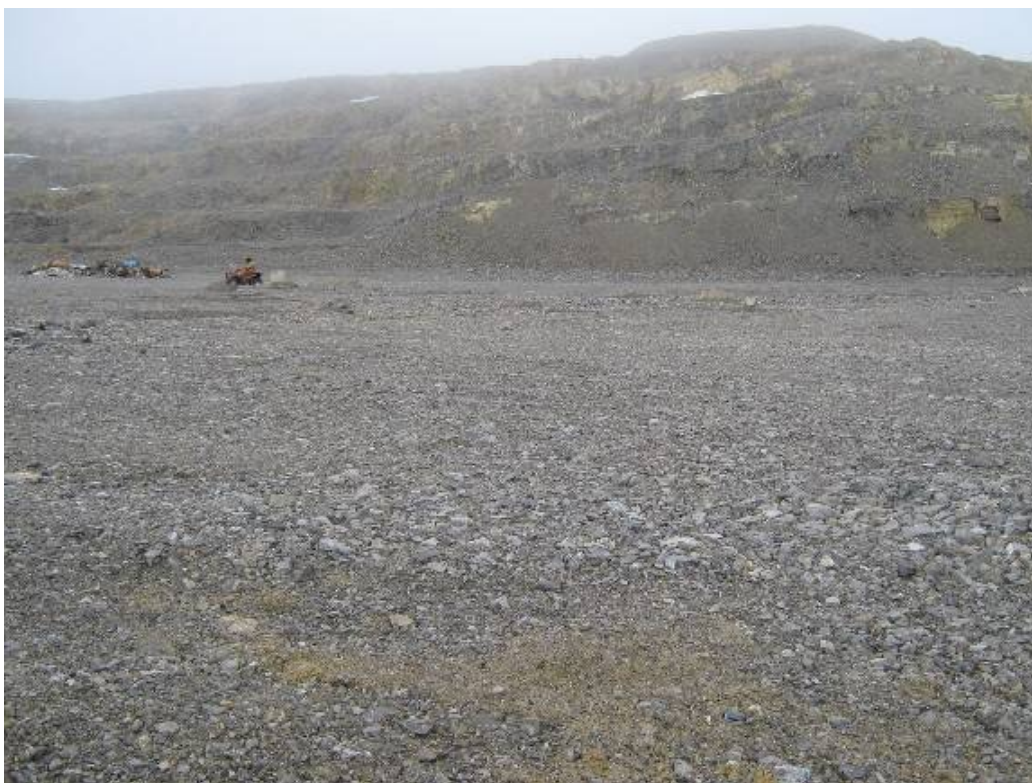
Photo 39- Northing 557628 Easting 8368725 Elevation 36 m  
Little Red Dog Quarry: near entrance to quarry

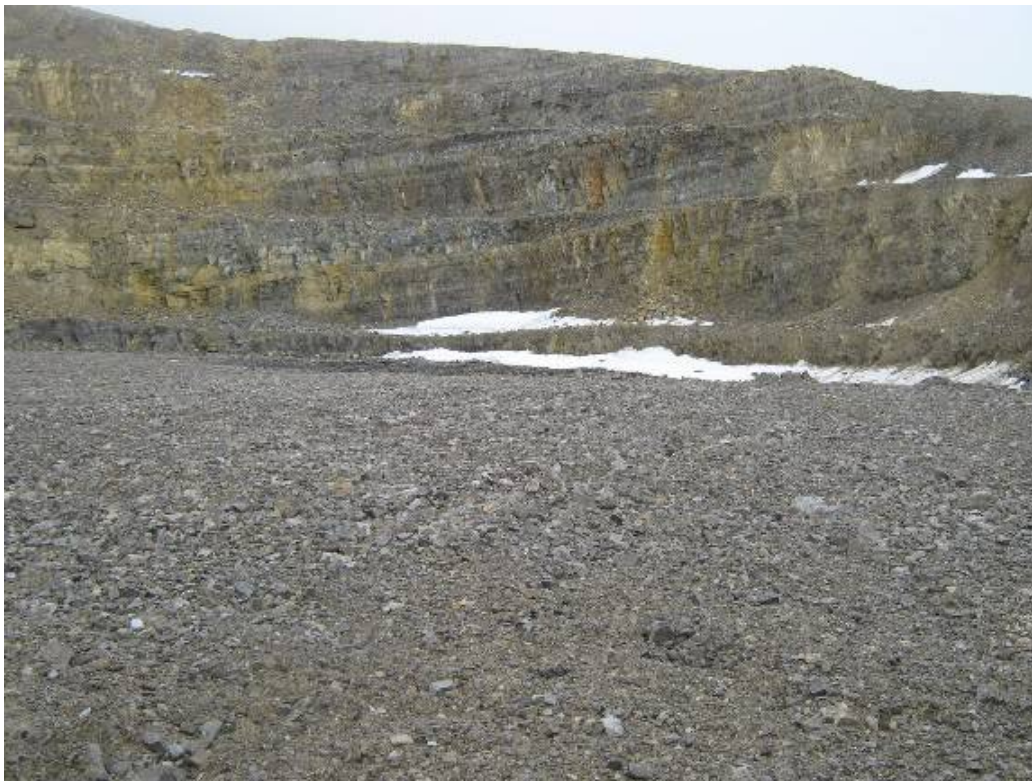
Photo 40- Northing 557650 Easting 8368618 Elevation 43 m  
Little Red Dog Quarry: south end

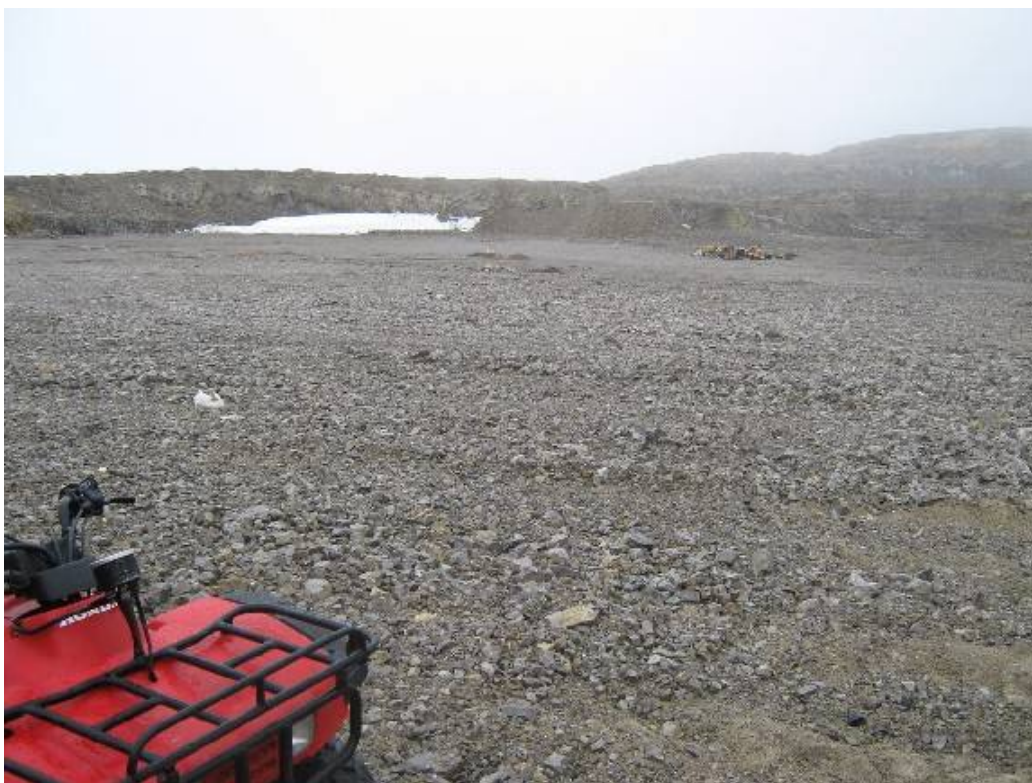
Photo 41- Northing 557650 Easting 8368618 Elevation 43 m  
Little Red Dog Quarry: south end

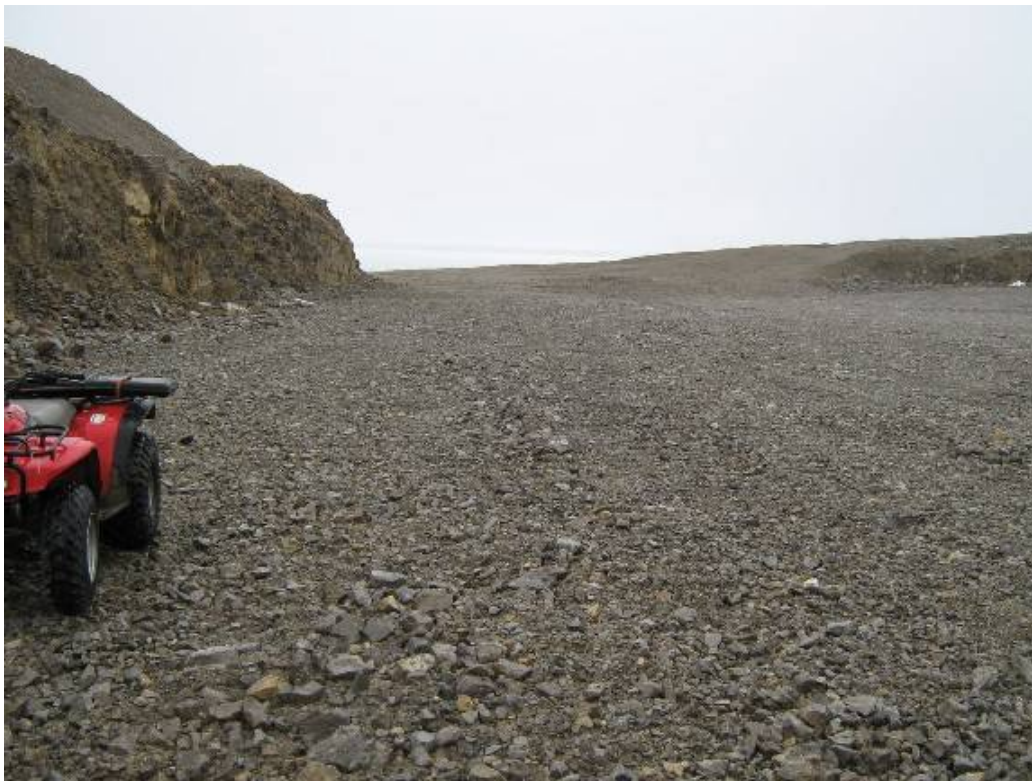
Photo 42- Northing 557650 Easting 8368618 Elevation 43 m  
Little Red Dog Quarry: south end facing exit
