## **APPENDIX 9**

### **Annual Geotechnical Inspection Report**

## Report on Post-Closure Geotechnical Inspection of Polaris Mine Site in 2008

Date: November 11, 2008

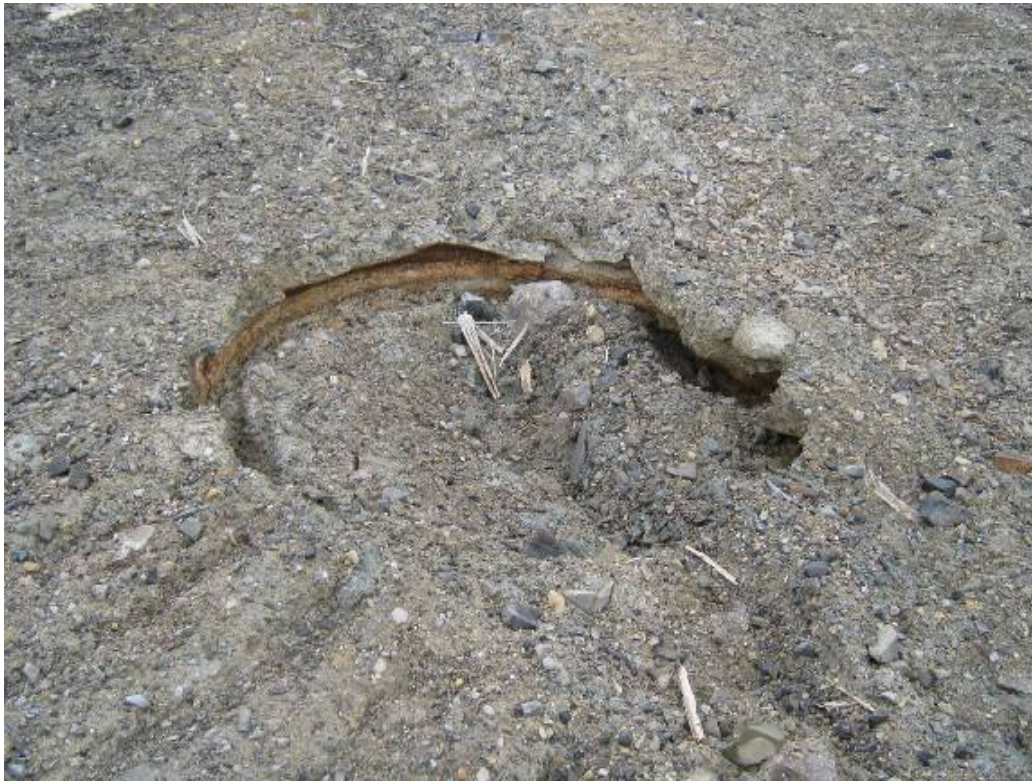
A 1 m diameter metal culvert (Photograph 44 in Appendix A) and a thaw settlement area about 1 m deep and 2 m wide (Photograph 45 in Appendix A) were observed northwest of the subsidence area. Thaw settlement up to 1 m deep was observed in the area of Photographs 46 and 47 (Appendix A). Ponded water in the subsidence area is documented in Photographs 49 and 52 (Appendix A). Previously observed tension cracks around the perimeter of the subsidence area (Photographs 48, 50, 51, 53 and 54 in Appendix A) were less than 0.15 m wide and appear unchanged from previous inspections.

Photo 44- Northing 558151 Easting 8369131 Elevation 12 m  
Subsidence Area: metal vent (about 1 m diameter)

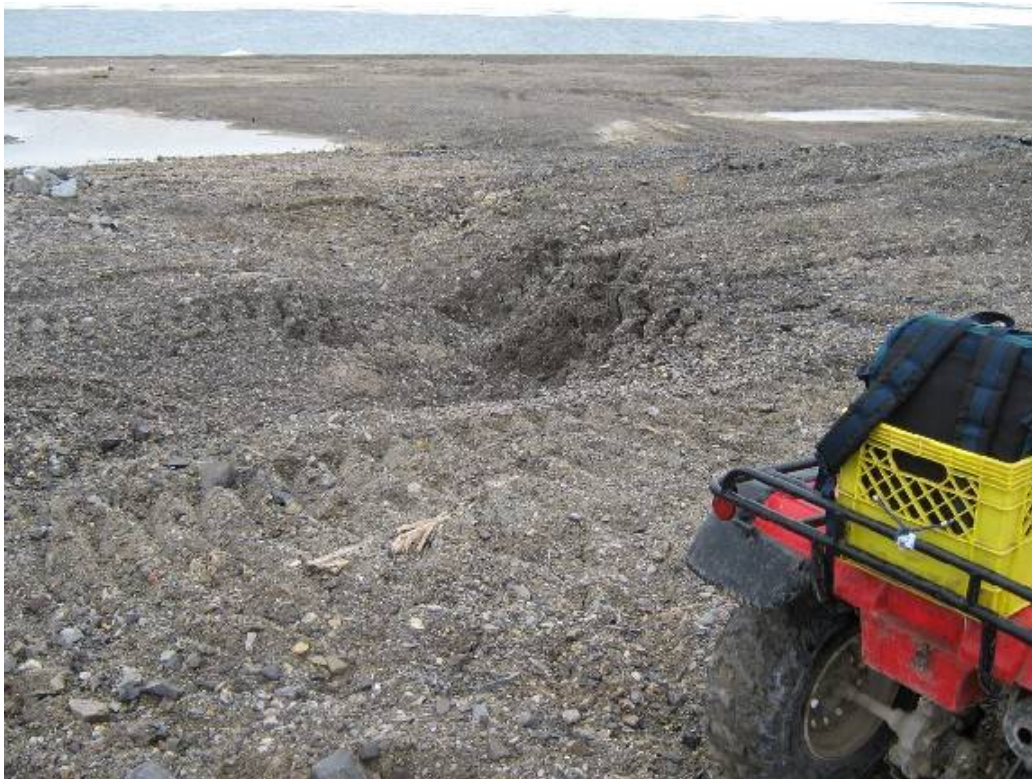
Photo 45- Northing 558151 Easting 8369131 Elevation 12 m  
Subsidence Area: thaw settlement (about 1 m deep and 2 m wide)

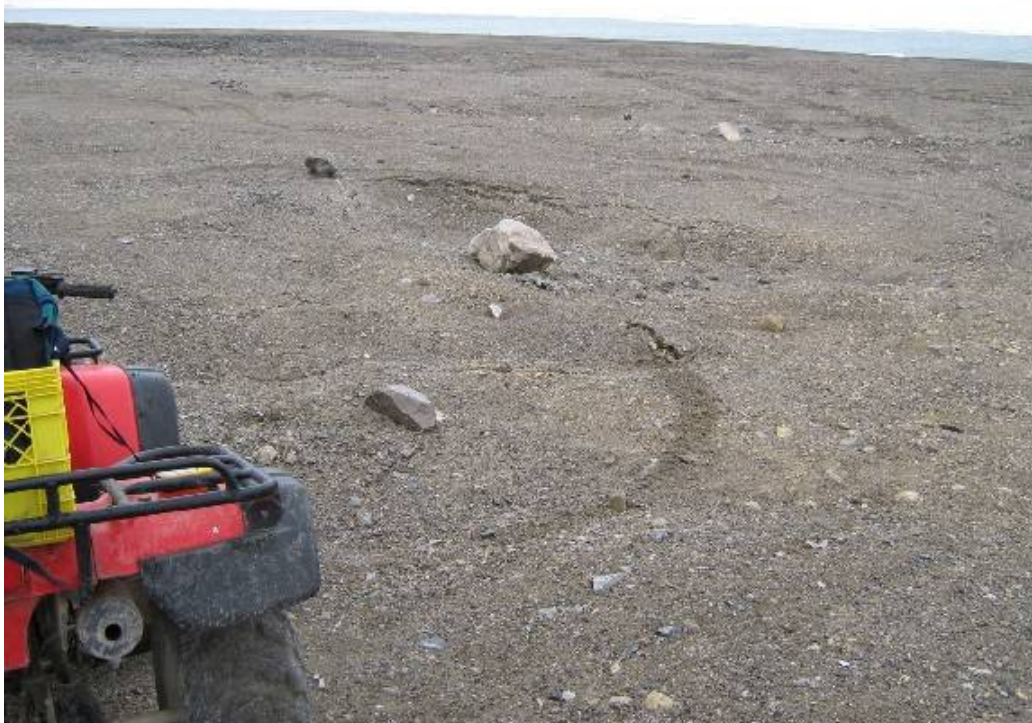
Photo 46- Northing 558318 Easting 8369107 Elevation 11 m  
Subsidence Area: view of thaw settlement towards ocean

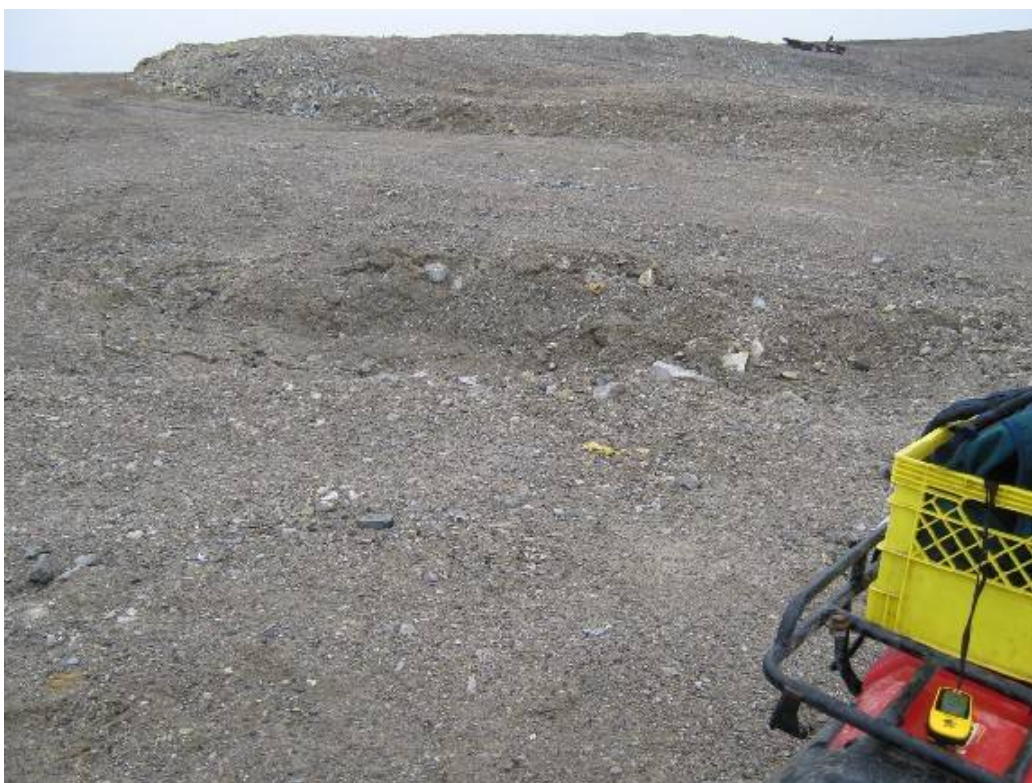
Photo 47- Northing 558318 Easting 8369107 Elevation 11 m  
Subsidence Area: view of thaw settlement

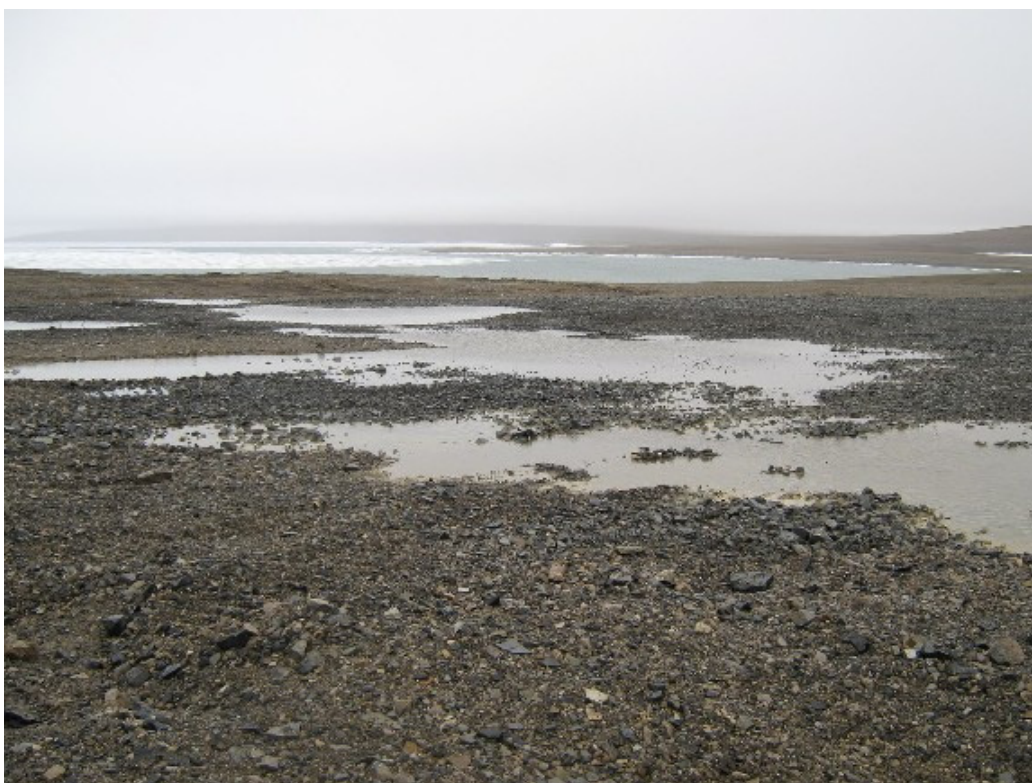
Photo 49- Northing 558447 Easting 8368972 Elevation 13 m  
Subsidence Area: view of ponded water

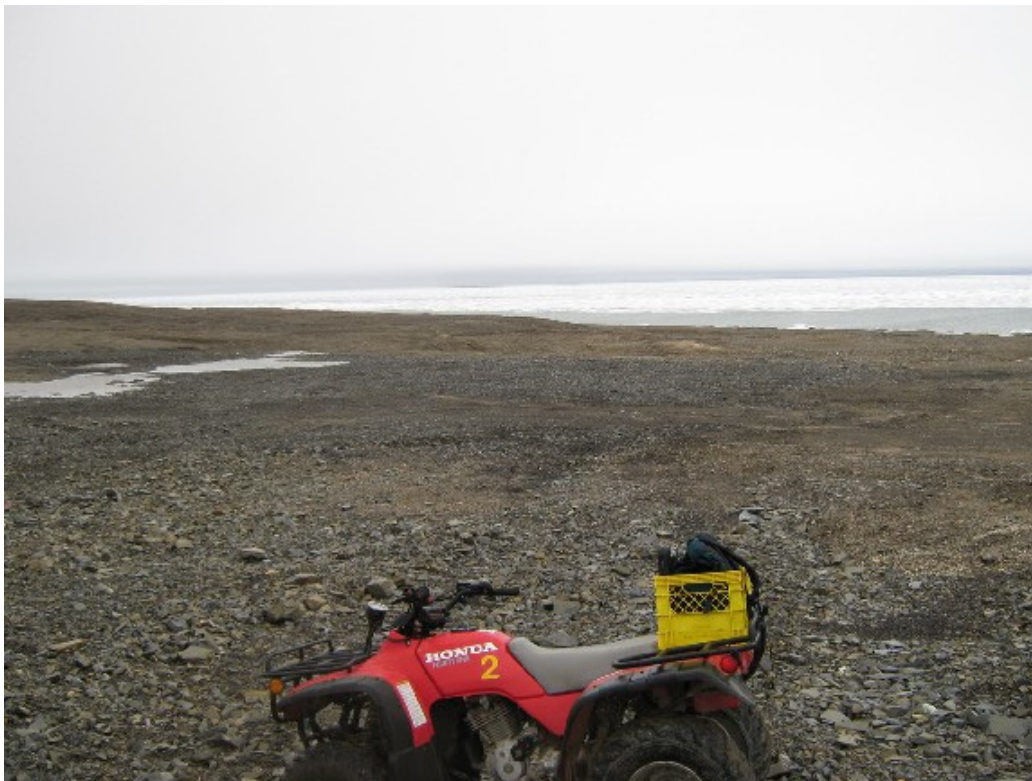
Photo 52- Northing 558515 Easting 8368992 Elevation 17 m  
Subsidence Area: view facing ocean near bench mark

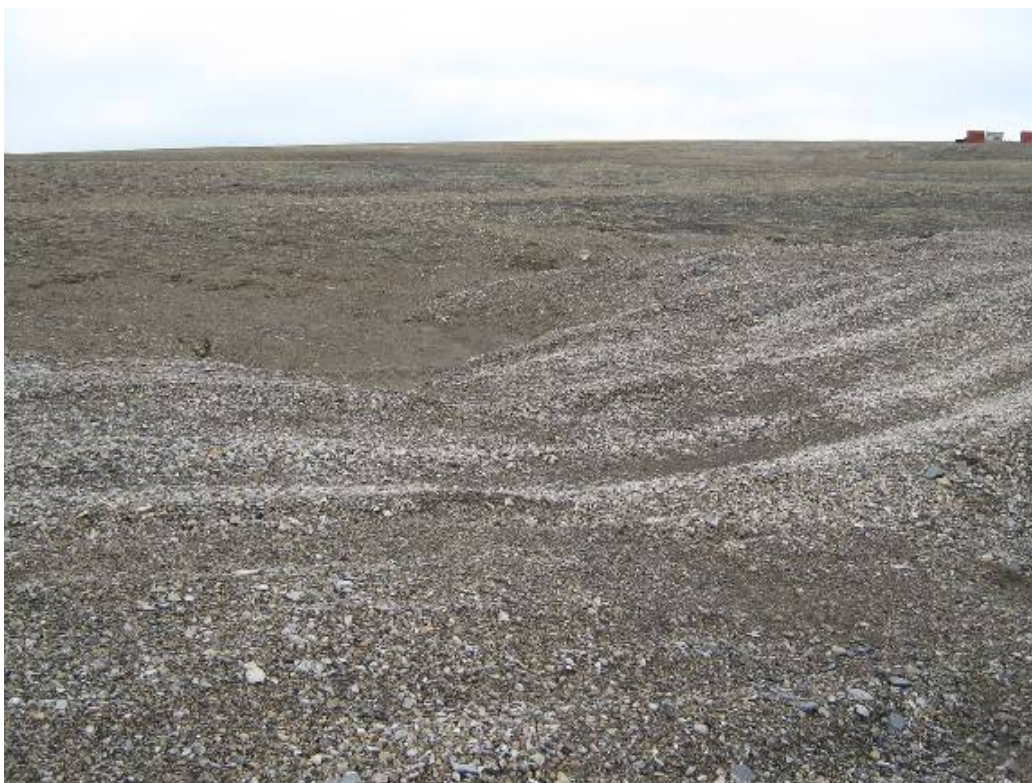
Photo 55- Northing 558725 Easting 8368420 Elevation 41 m  
View up the drainage ditch through the road near camp

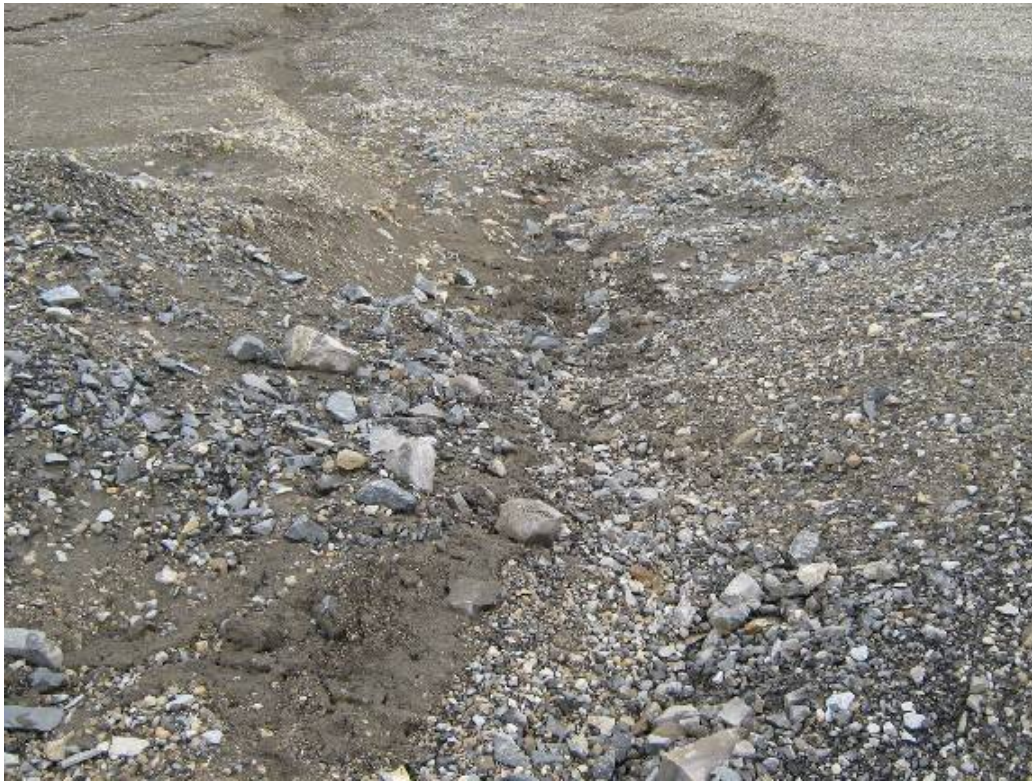
Photo 56- Northing 558725 Easting 8368420 Elevation 41 m  
View down the drainage ditch through the road near camp

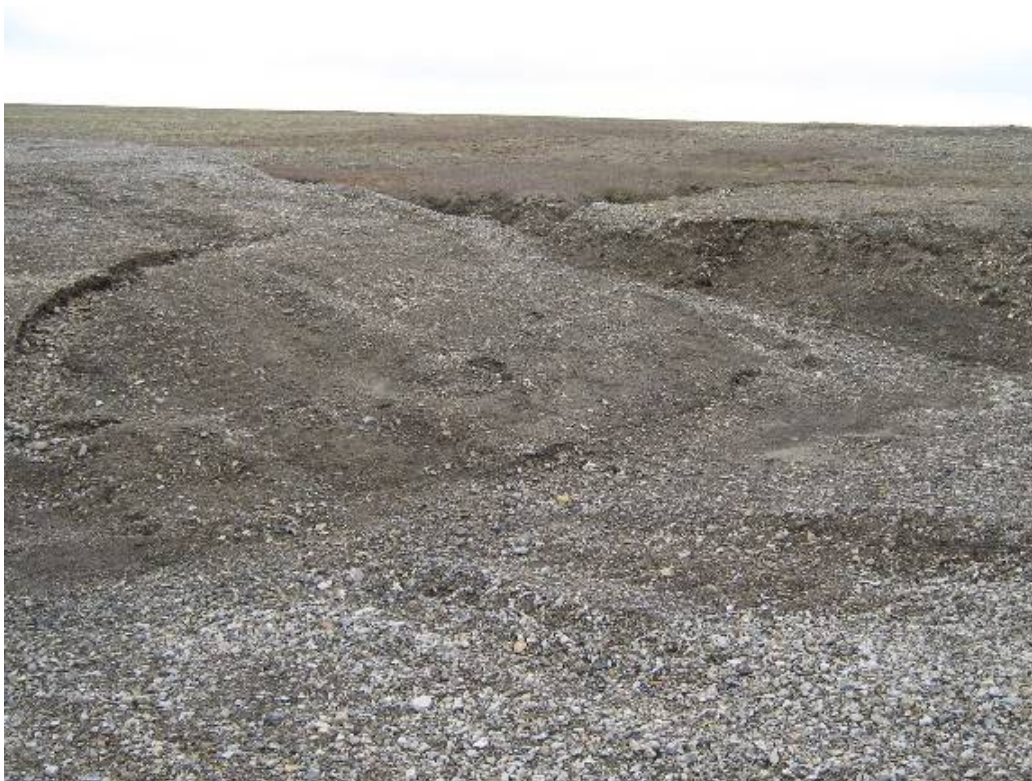
Photo 57- Northing 558758 Easting 8368415 Elevation 41 m  
View up the second drainage ditch through the road near camp

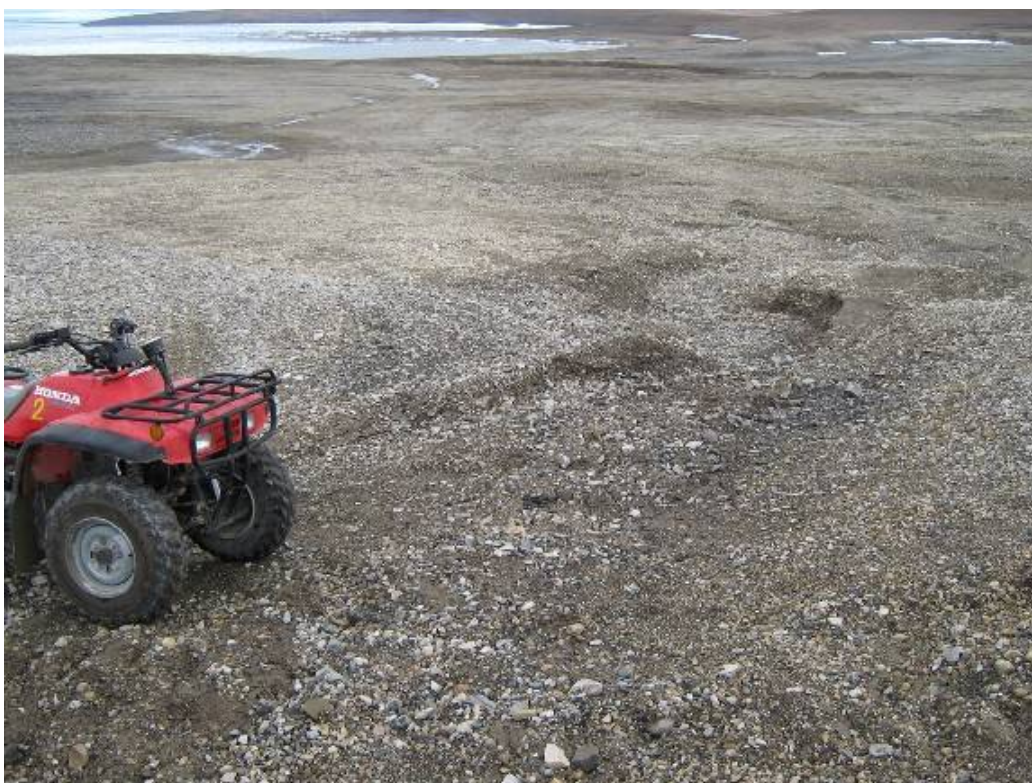
Photo 58- Northing 558758 Easting 8368415 Elevation 41 m  
View down the second drainage ditch through the road near camp

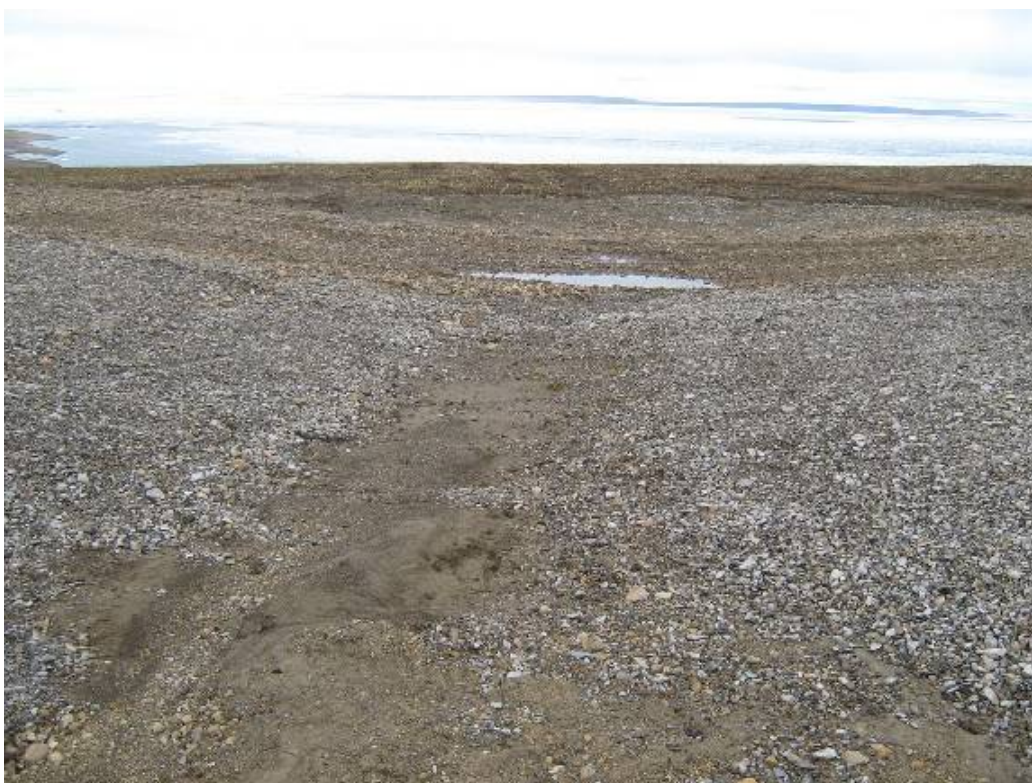
The Frustration Lake access road is generally in good condition, with some localised erosion at drainage crossings. Significant erosion gullies identified during previous inspections were repaired in July 2006. Remedial work included regrading slopes, placement of gravel/rip-rap and construction of water bars. The repaired areas appear to be performing well as documented in Photographs 60 through 71 (Appendix A).

Photo 60- Northing 559591 Easting 8369505 Elevation 72 m  
First ditch on the road to Frustration Lake

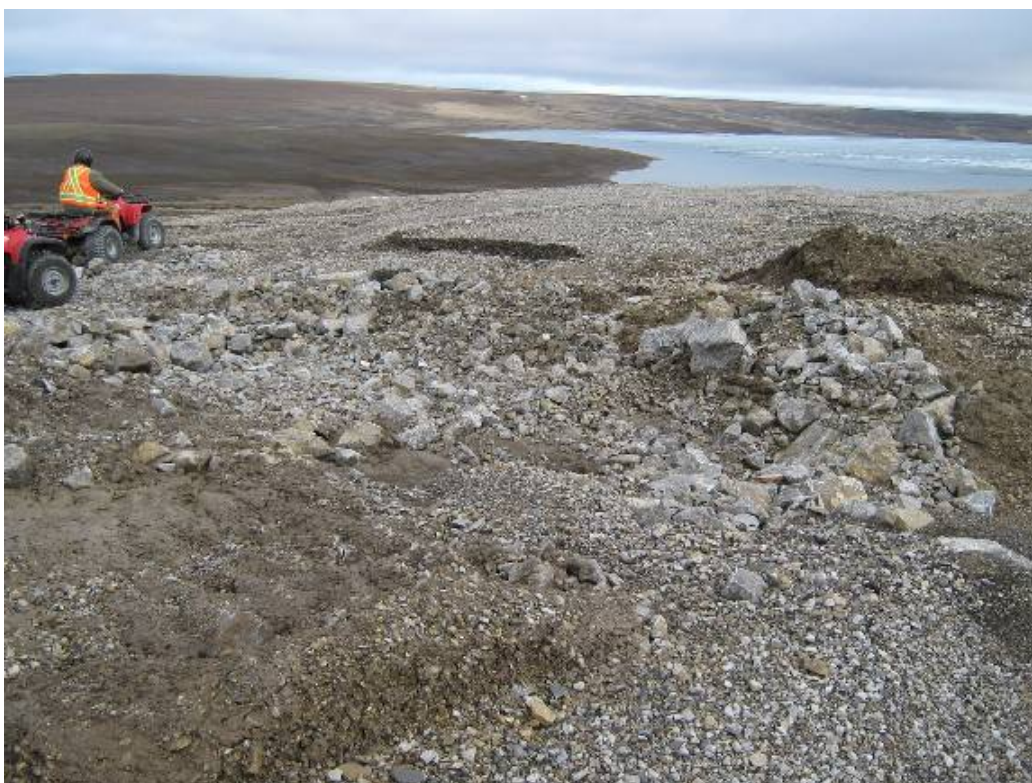
Photo 61- Northing 560057 Easting 8370853 Elevation 62 m  
Second ditch on the road to Frustration Lake

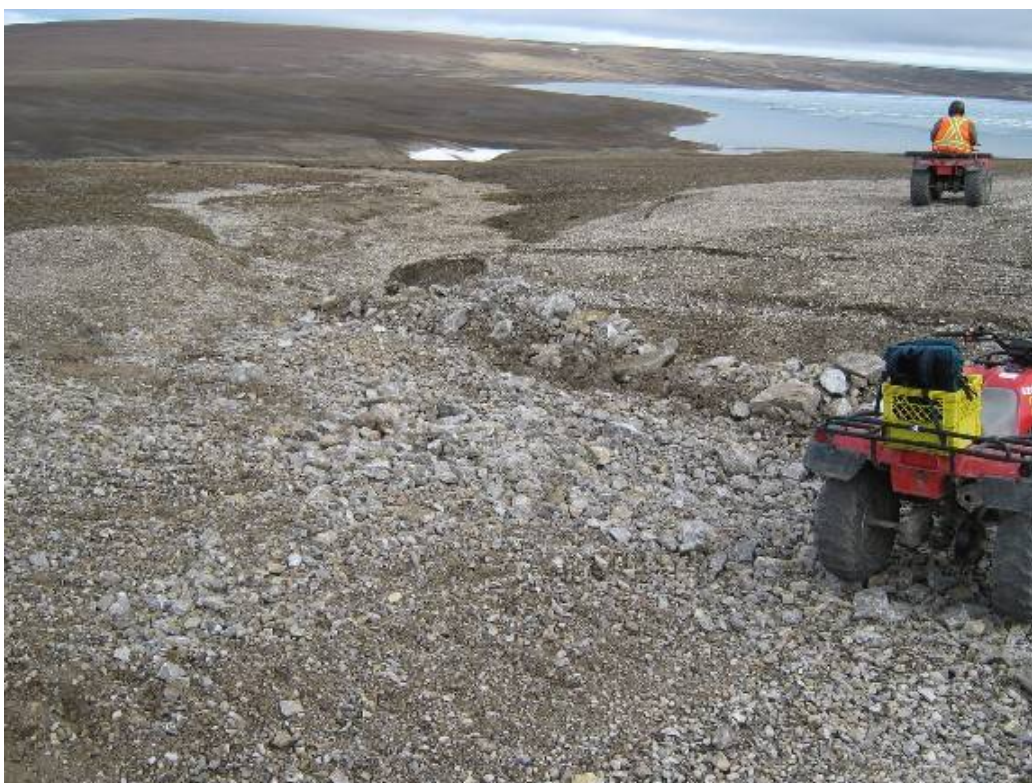
Photo 62- Northing 560057 Easting 8370853 Elevation 62 m  
Third ditch on the road to Frustration Lake

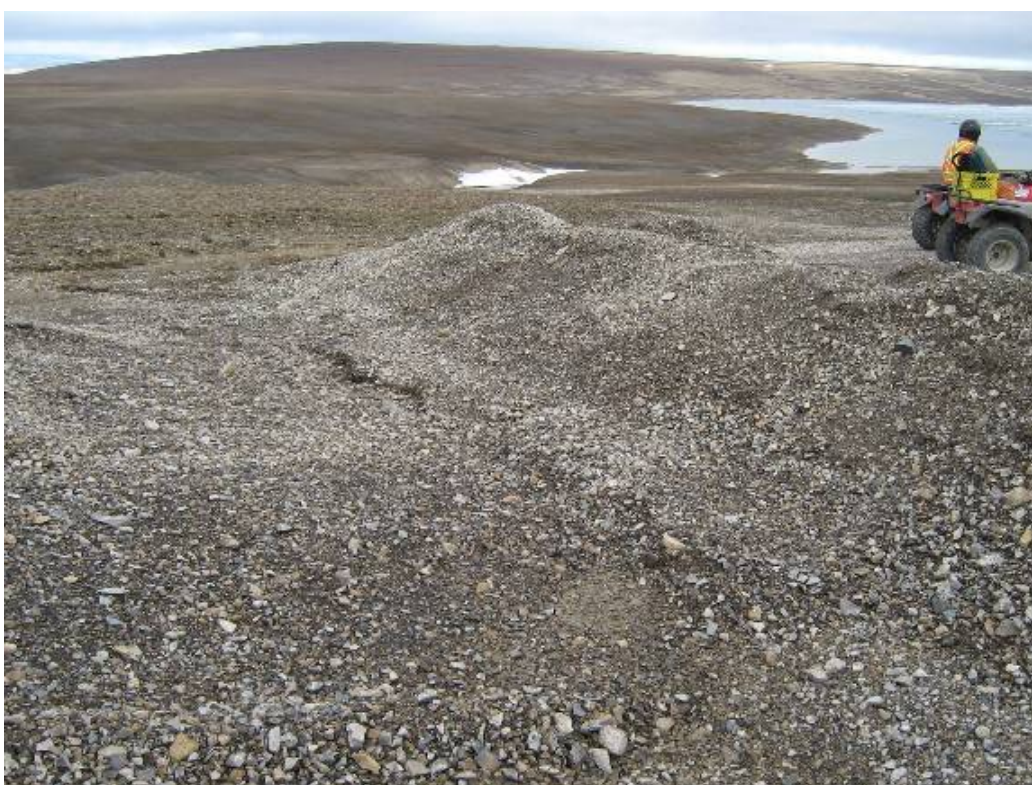
Photo 63- Northing 560086 Easting 8370952 Elevation 59 m  
Fourth ditch on the road to Frustration Lake

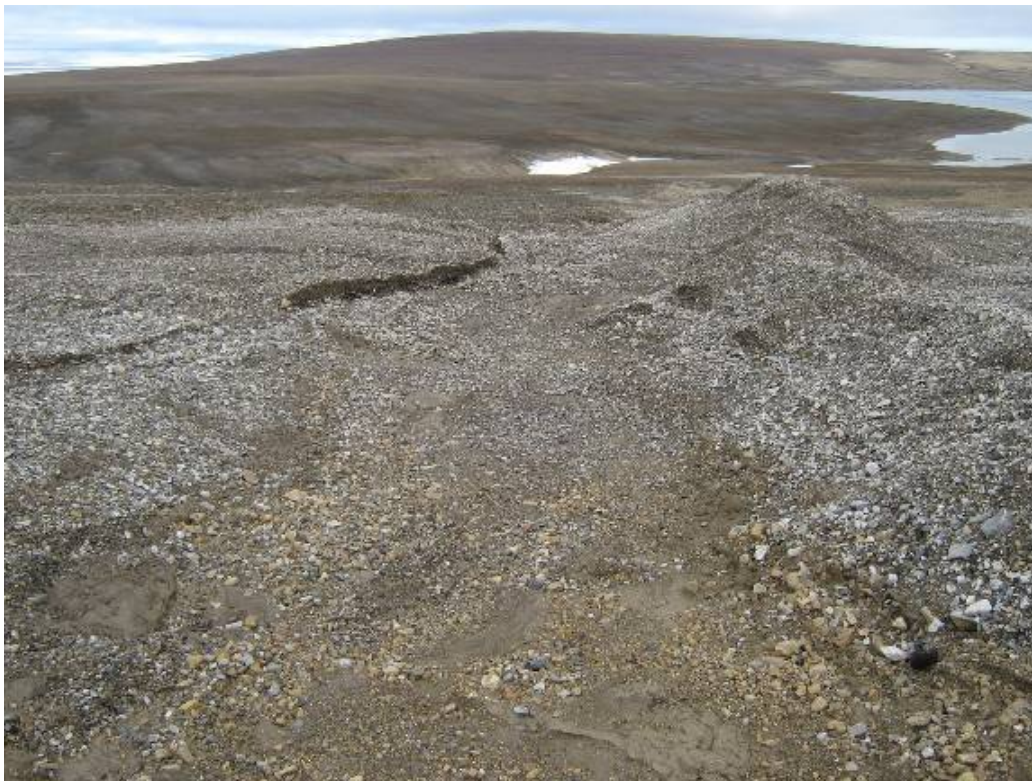
Photo 64- Northing 560105 Easting 8370995 Elevation 55 m  
Fifth ditch on the road to Frustration Lake

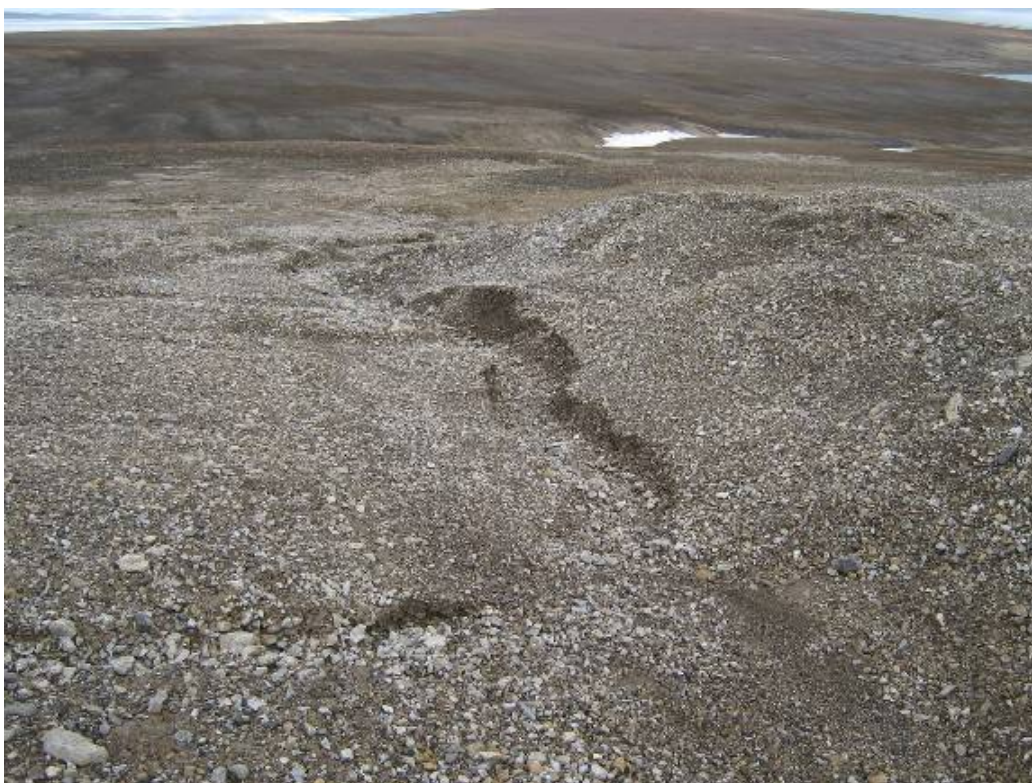
Photo 65- Northing 560110 Easting 8371019 Elevation 54 m  
Sixth ditch on the road to Frustration Lake

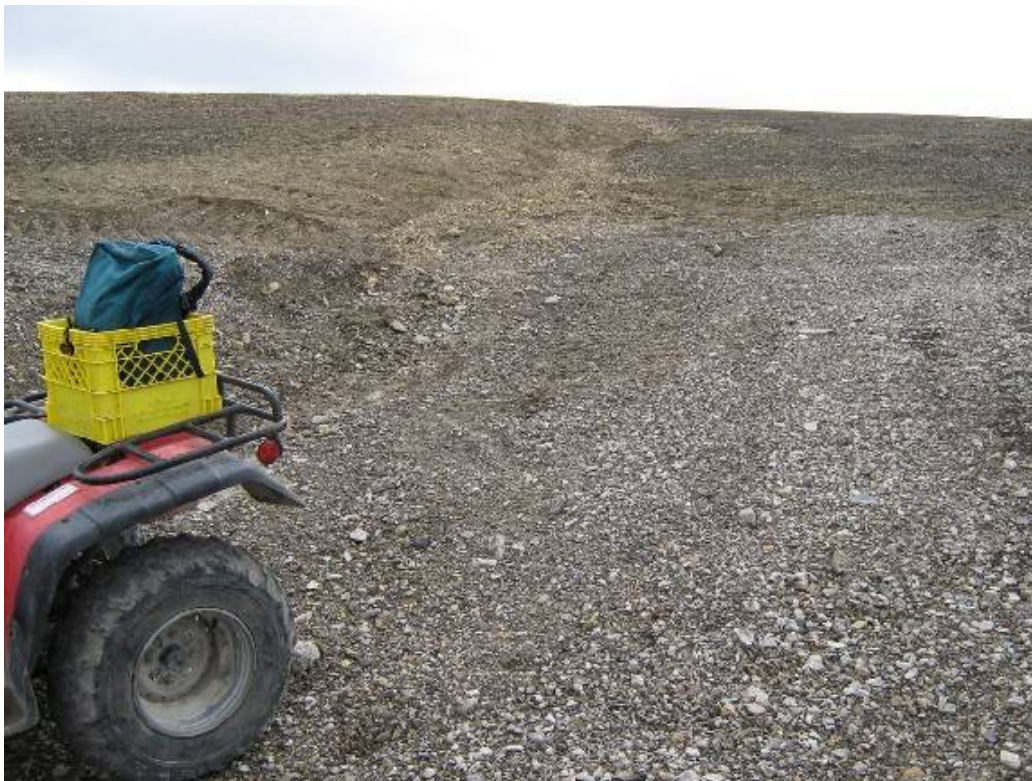
Photo 66- Northing 560123 Easting 8371061 Elevation 49 m  
Seventh ditch on the road to Frustration Lake, looking upstream

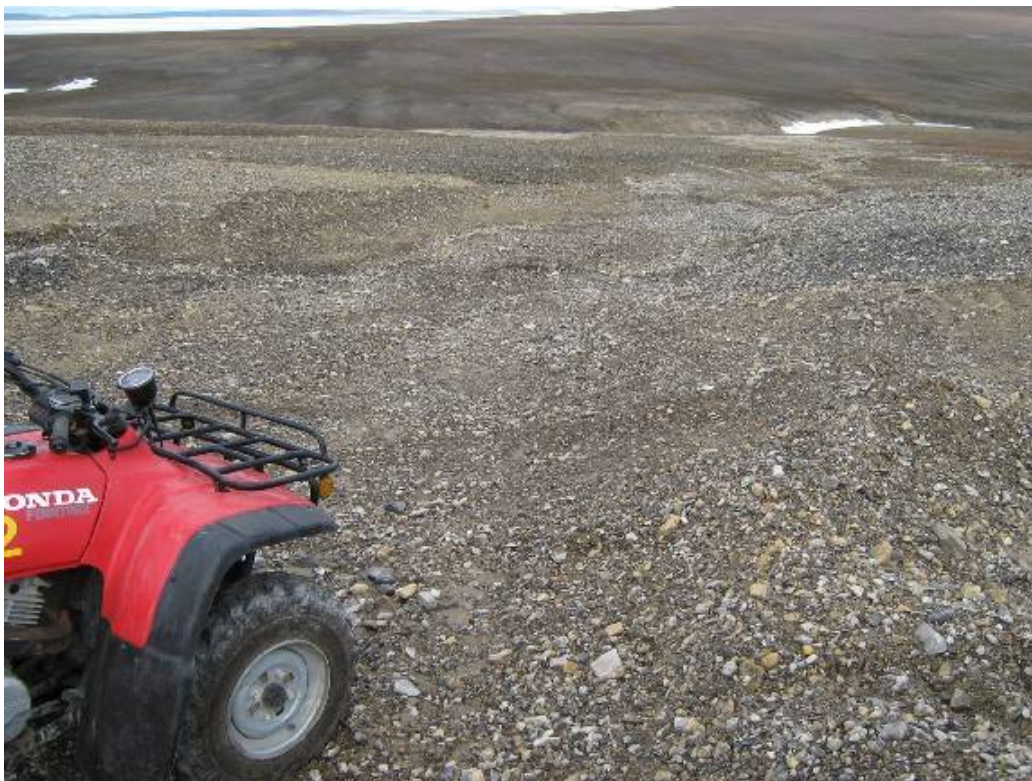
Photo 67- Northing 560123 Easting 8371061 Elevation 49 m  
Seventh ditch on the road to Frustration Lake, looking downstream

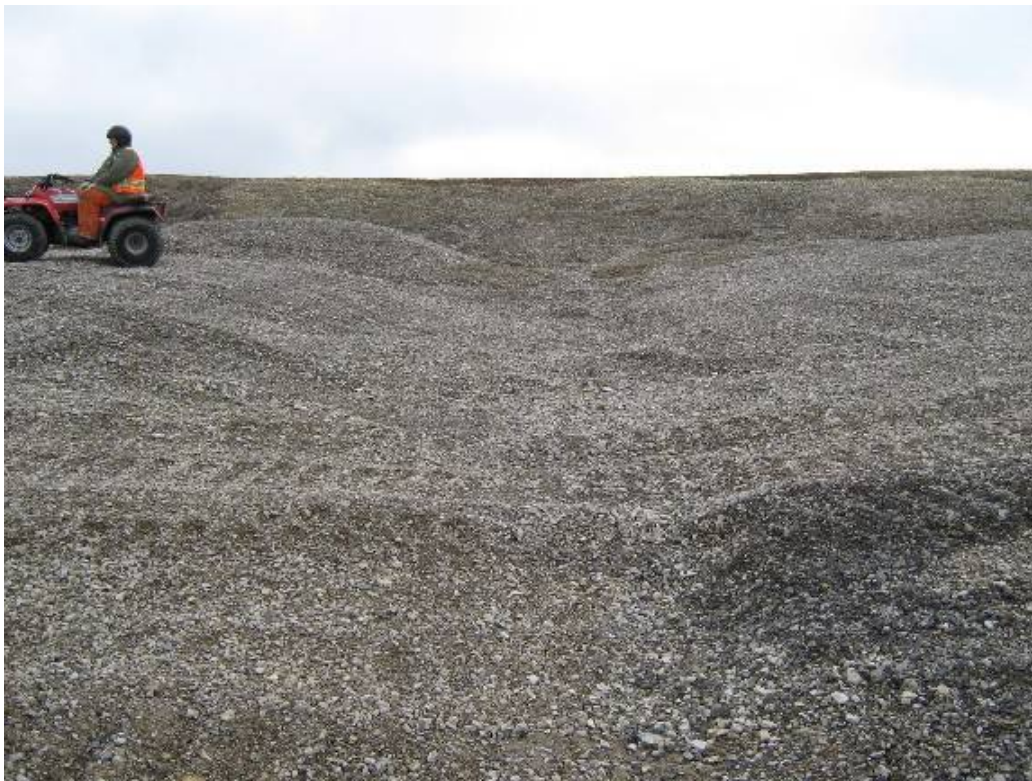
Photo 68- Northing 560146 Easting 8371163 Elevation 42 m  
Eighth ditch on the road to Frustration Lake, looking upstream

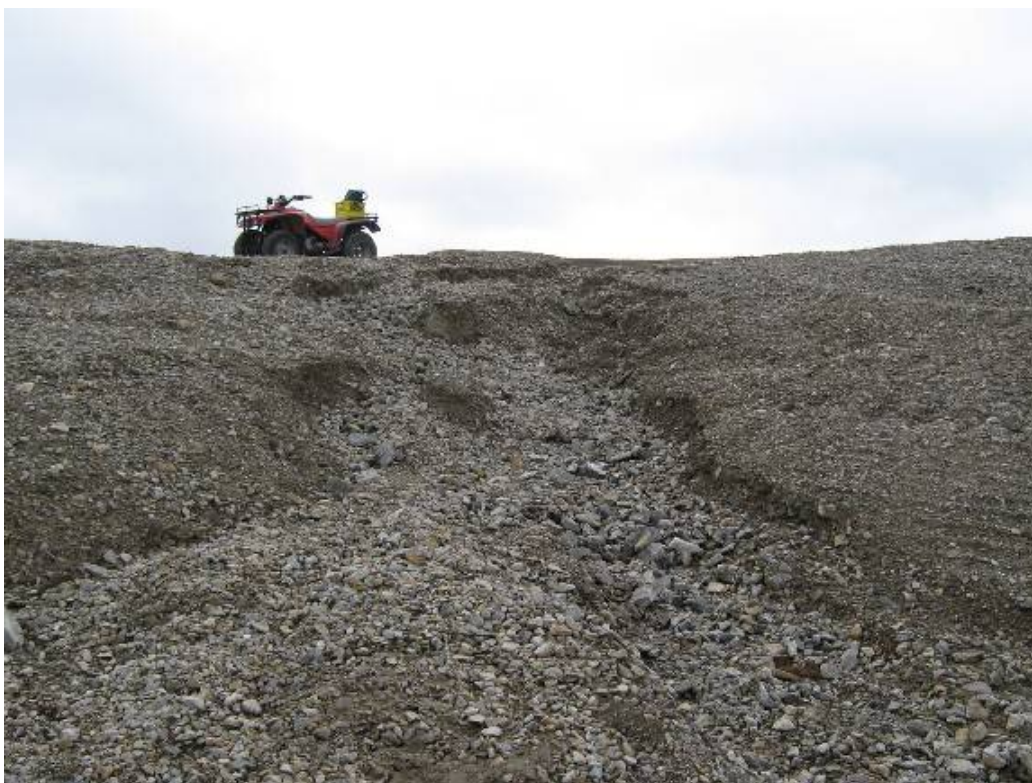
Photo 69- Northing 560185 Easting 8371265 Elevation 42 m  
Eighth ditch on the road to Frustration Lake, looking downstream

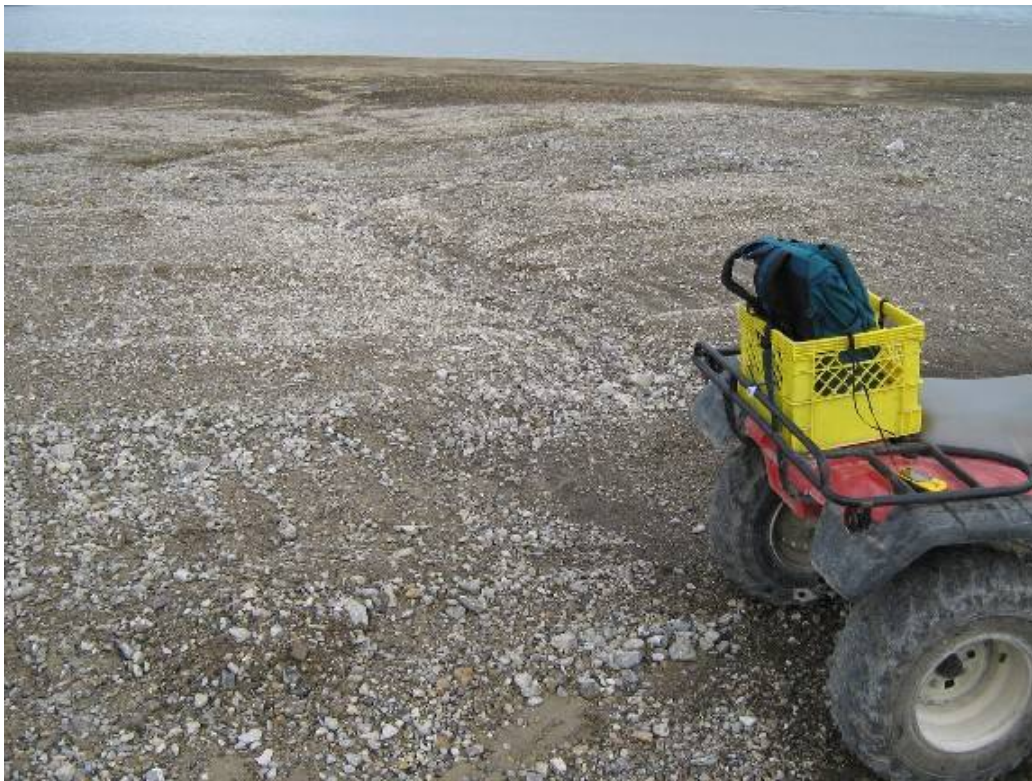
Photo 70- Northing 560296 Easting 8371605 Elevation 21 m  
Thirteenth ditch on the road to Frustration Lake, looking downstream

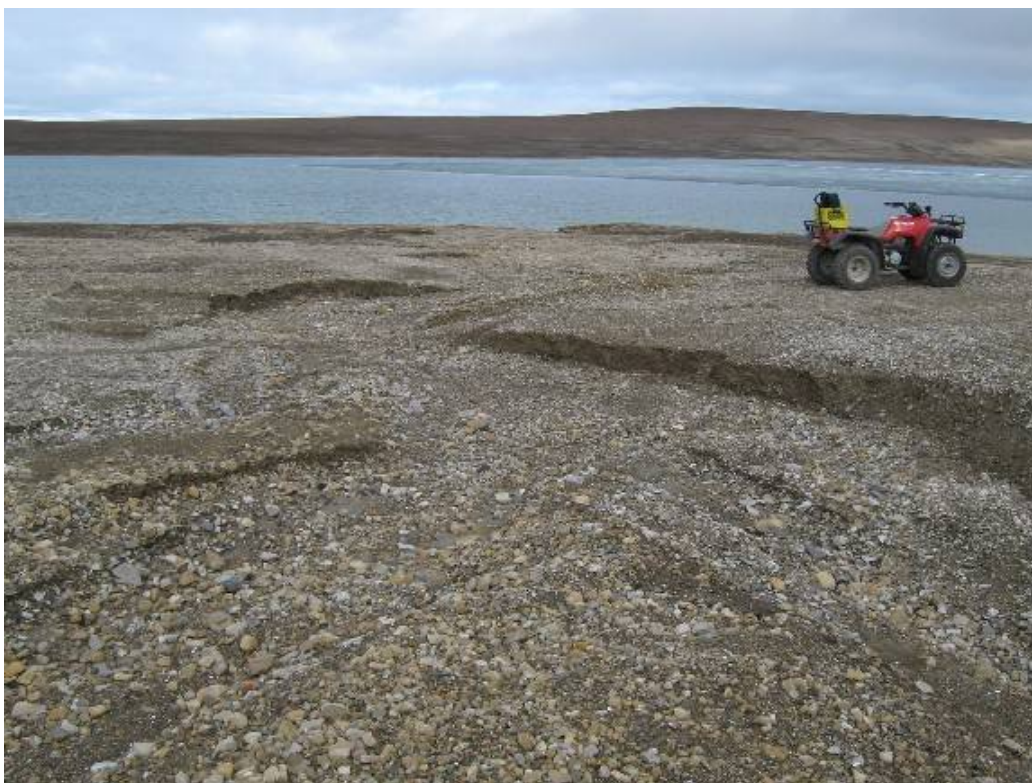
Photo 71- Northing 560358 Easting 8371821 Elevation 19 m  
Fourteenth ditch on the road to Frustration Lake, looking downstream

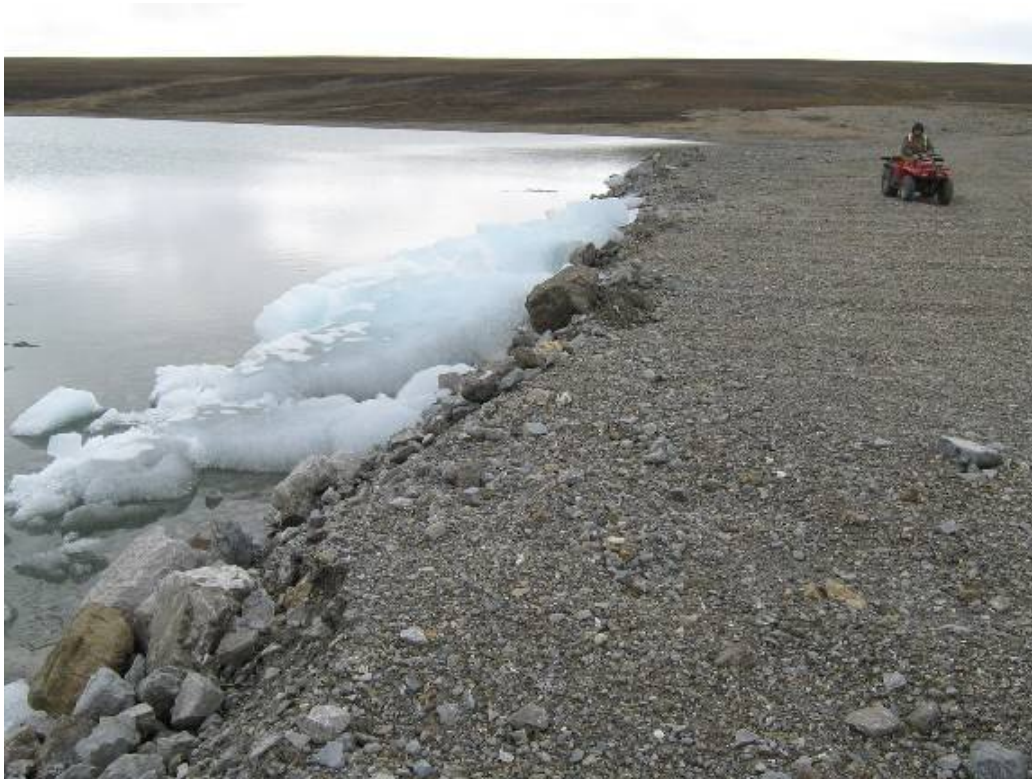
During mining operations, a jetty extending into Frustration Lake supported the mine's freshwater supply pump station. The pump house and associated water lines were removed during reclamation. The site monitoring program includes a requirement to inspect the jetty on an annual basis to ensure that the rate of jetty erosion is gradual and does not contribute significant sediment loading to the lake. During the July 2008 inspection, the embankment forming the jetty was observed to be in a stable condition. Minor erosion consistent with previous inspections was observed at the end and along the sides of the embankment (Photographs 72 through 74 in Appendix A).

Photo 72- Northing 560320 Easting 8372050 Elevation 16 m  
Frustration Lake Jetty: view of the north shore

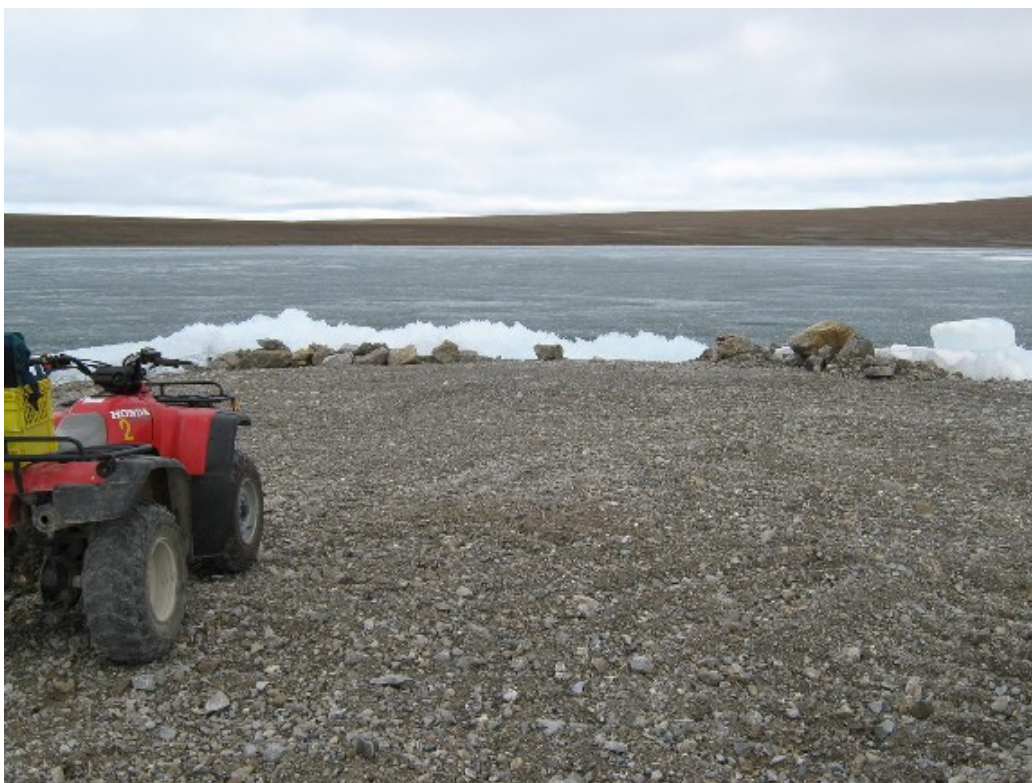
Photo 73- Northing 560320 Easting 8372050 Elevation 16 m  
Frustration Lake Jetty: view of tip with boulders

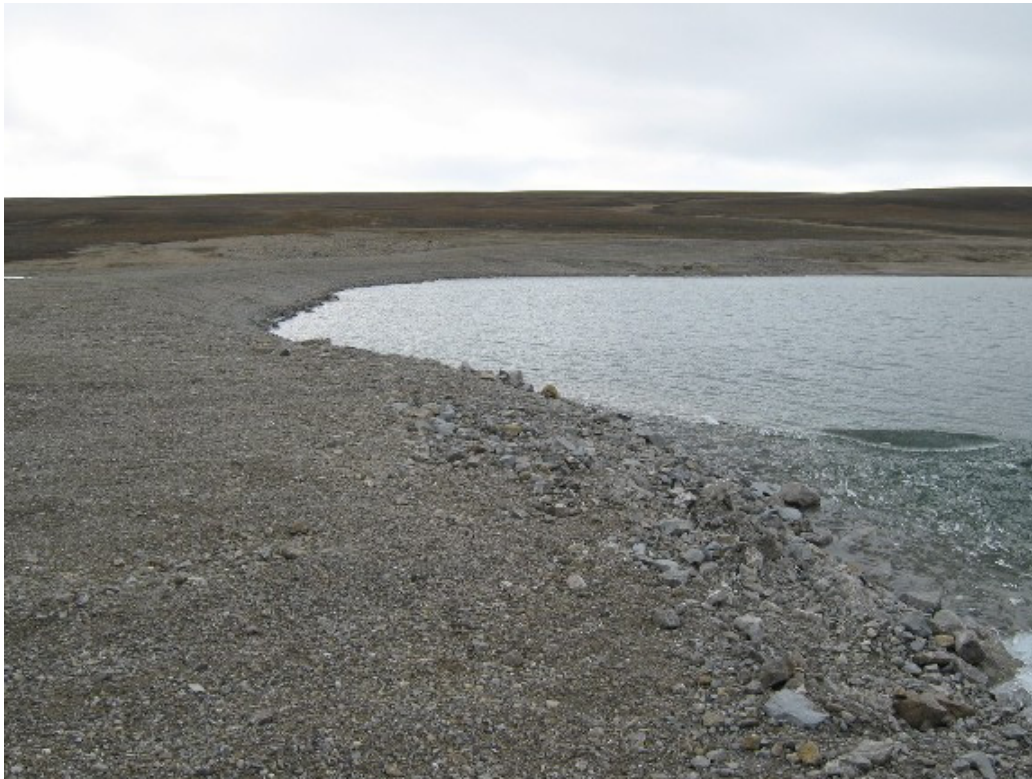
Photo 74- Northing 560320 Easting 8372050 Elevation 16 m  
Frustration Lake Jetty: view of the south shore

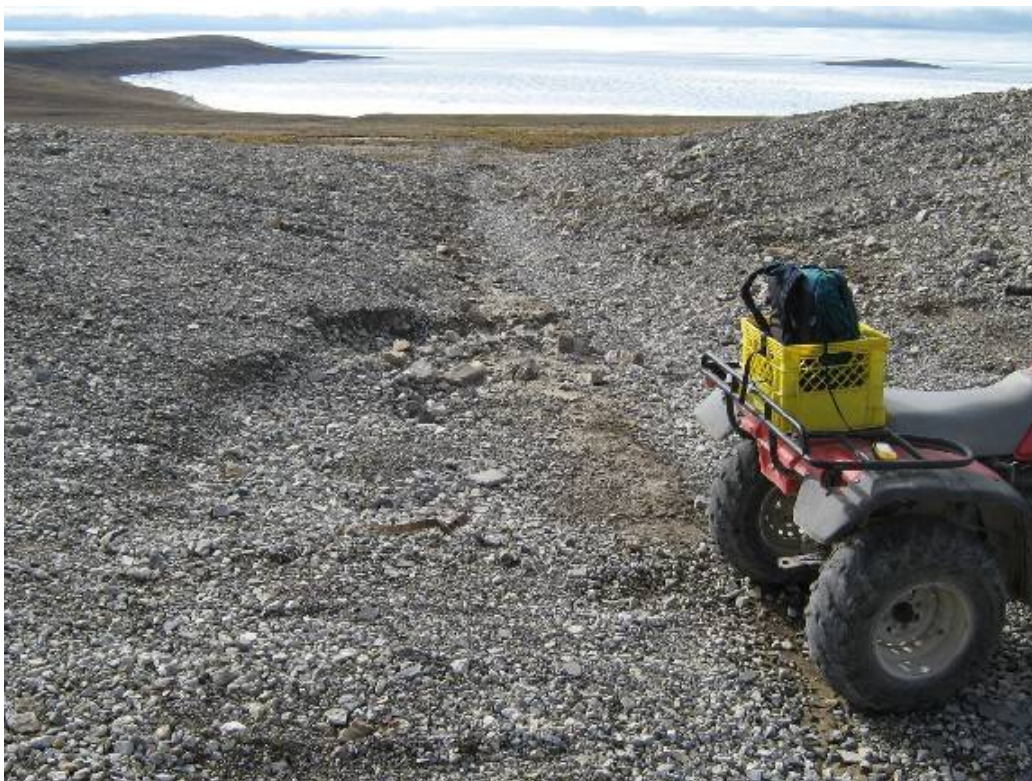
Photo 75- Northing 559761 Easting 8368759 Elevation 47 m  
Road to Garrow Lake, looking downstream from ditch crossing #1

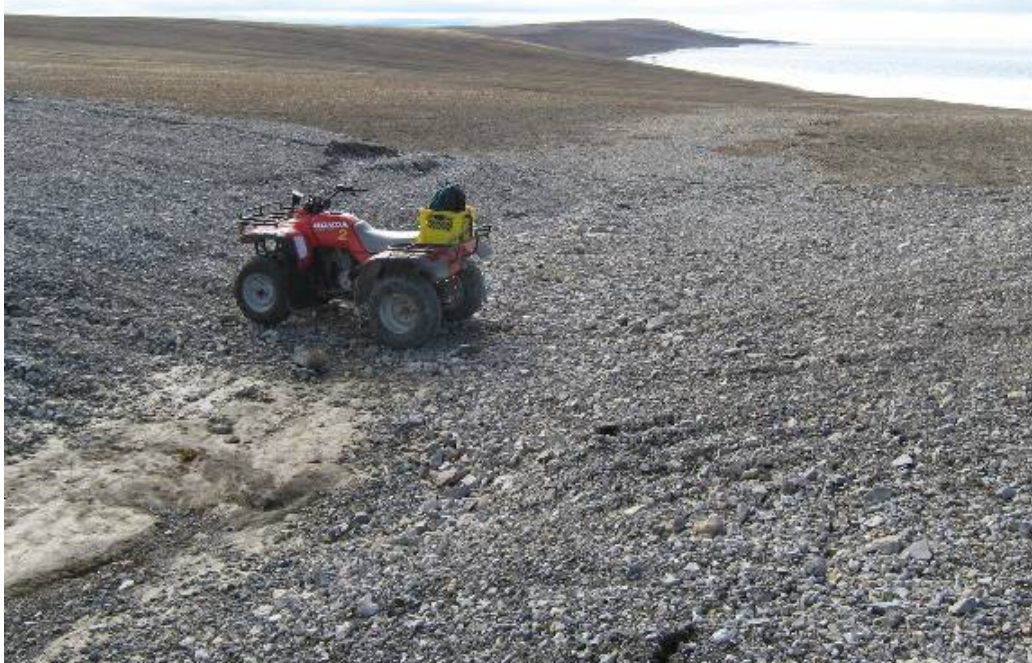
Photo 76- Northing 559984 Easting 8368790 Elevation 49 m  
Road to Garrow Lake, looking downstream from ditch crossing #2
