## **APPENDIX 9**

### **Annual Geotechnical Inspection Report**

## Report on Post-Closure Geotechnical Inspection of Polaris Mine Site in 2008

Date: November 11, 2008

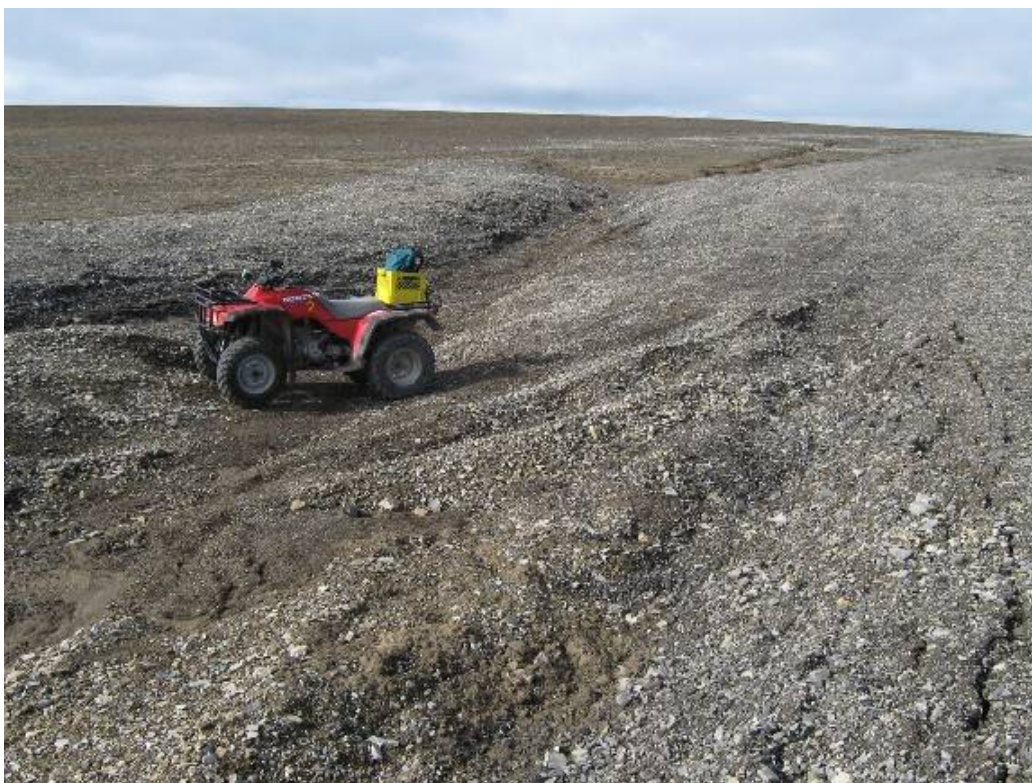
Photo 77- Northing 561186 Easting 8367394 Elevation 26 m  
Road to Garrow Lake, view from ditch crossing #5

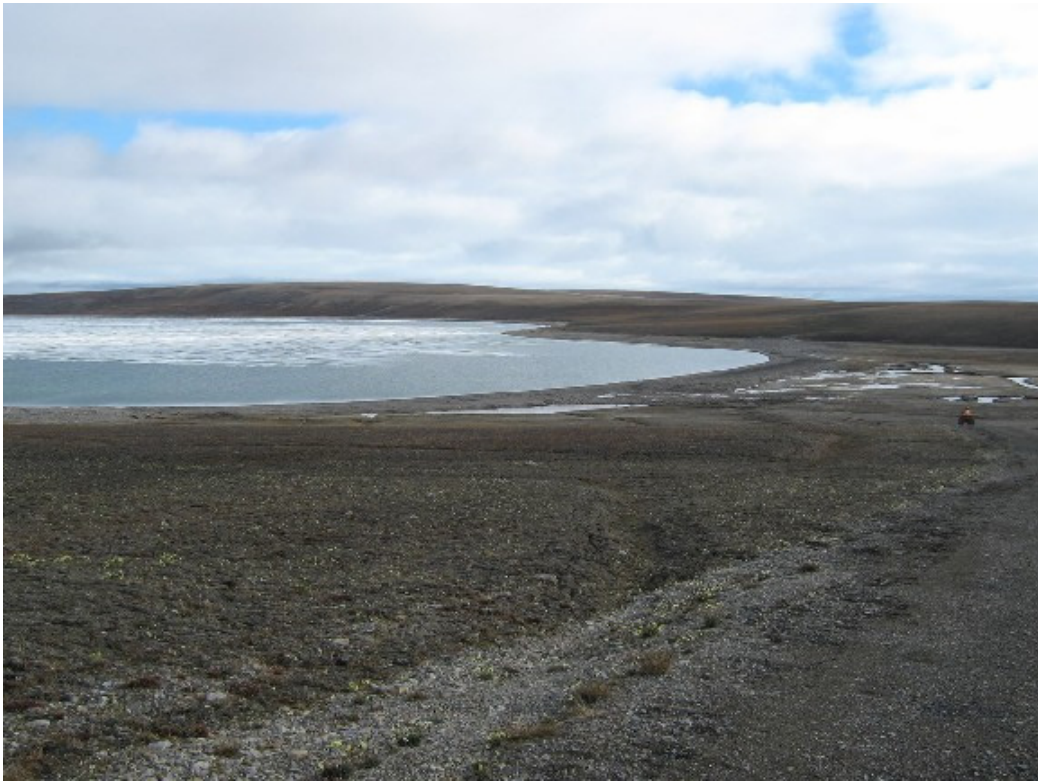
A ridge of gravel deposited across the breached outlet channel was initially observed during the 2006 inspection. The ridge or berm of gravel across the lake outlet appears to be increasing in size each year as a result of additional gravel accumulation. Photographs 78 to 82 in Appendix A document the size and height of the gravel berm at the time of the July 2008 inspection. The mechanism creating the ridge of gravel is likely ice and wave action. It is assumed that ice on the lake is pushed by the wind towards the south shoreline and outlet of the lake relocating gravel from the lake bottom to form a ridge or berm. The relatively coarse nature of the gravel permits a steady flow of water through the gravel ridge from the lake into the creek channel during the summer. However, the gravel ridge appears to be retaining some water and may be influencing the lake water level. Photograph 82 (Appendix A) illustrates a location where seepage through the gravel berm has caused some settlement from piping of the underlying soils. As the gravel berm grows higher and wider, the lake outlet may naturally relocate (e.g., move towards the east end of the wave break structure). The growth of the berm and lake outlet location should continue to be monitored, however this appears to be a natural process that likely also occurred prior to development at the site.

Photo 78- Northing 561186 Easting 8367394 Elevation 26 m  
View of Garrow Lake wave break structure

Previously observed exposed geotextile downstream of Garrow Lake dam was removed in 2008. The ridge of gravel being deposited across the wave break outlet appears to be increasing in size each year as a result of additional gravel accumulation. It is recommended that Teck carry out annual topographic surveys of the wave break structure to monitor material deposition and lake water levels.

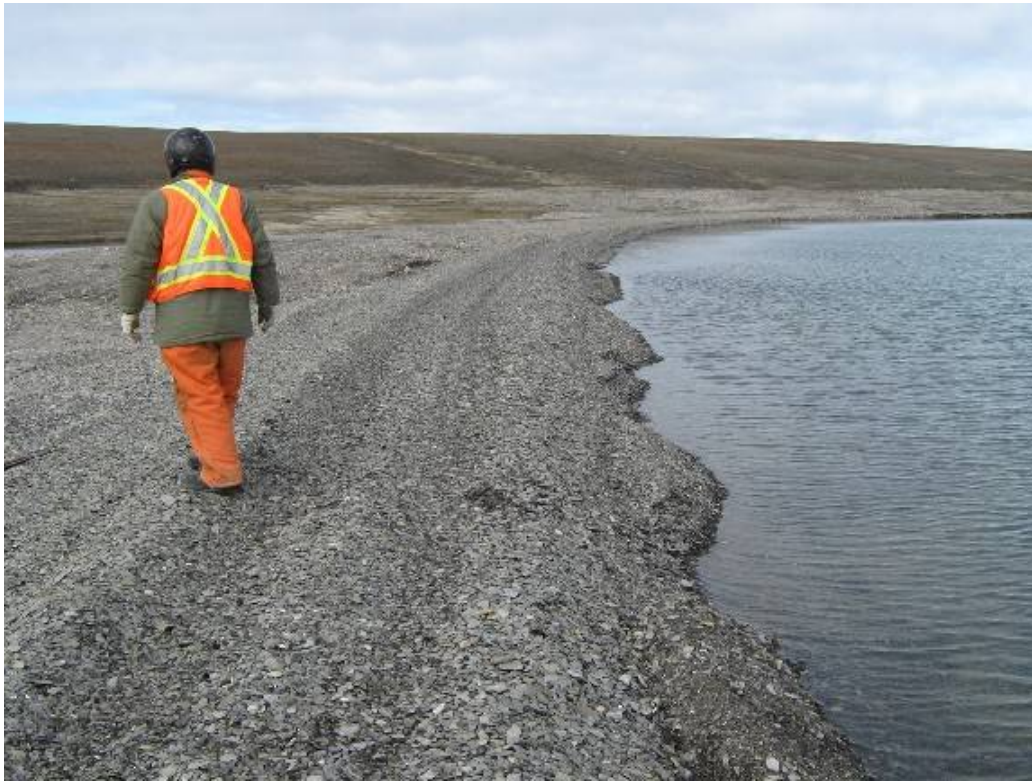
Photo 80- Northing 561569 Easting 8367440 Elevation 8 m  
Crest of deposited gravel berm along wave break structure

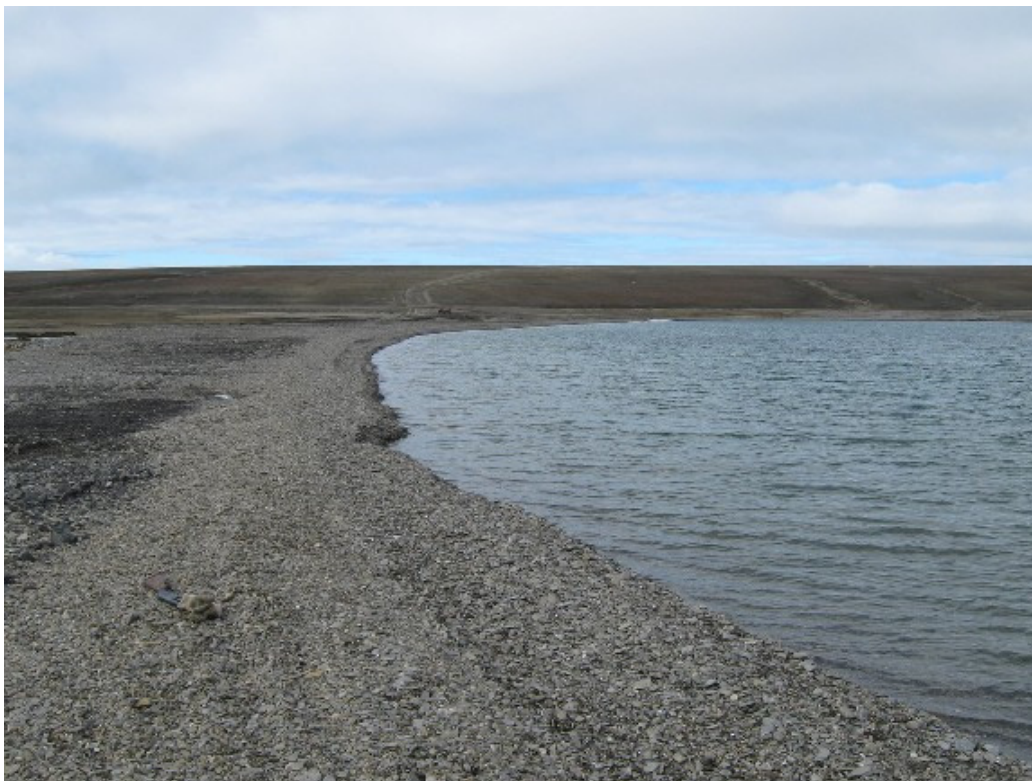
Photo 81- Northing 561569 Easting 8367440 Elevation 8 m  
Crest of deposited gravel berm along wave break structure

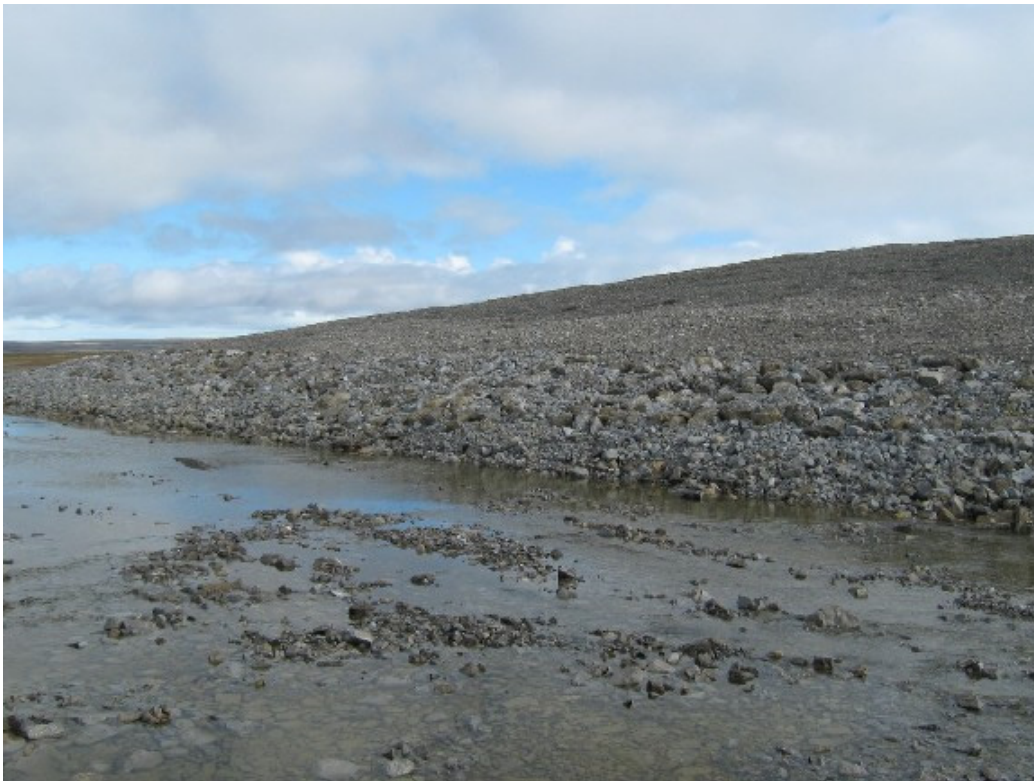
The sideslopes of the breach excavated through the main dam structure are in good condition, free of erosion or signs of major instability. Minor localised slumping observed in 2005 and 2006 appears unchanged. The condition of the dam breach slopes during the July 2008 inspection is documented in Photographs 83 through 87 (Appendix A). A localised section of the invert of the breach channel had a piece of exposed geotextile that was first observed in 2005. The exposed geotextile was cut away and removed in 2008. Photograph 86 (Appendix A) documents the current conditions where the exposed geotextile was removed.

Photo 83- Northing 561646 Easting 8366909 Elevation 15 m  
Garrow Lake Dam: East dam abutment facing upstream to lake

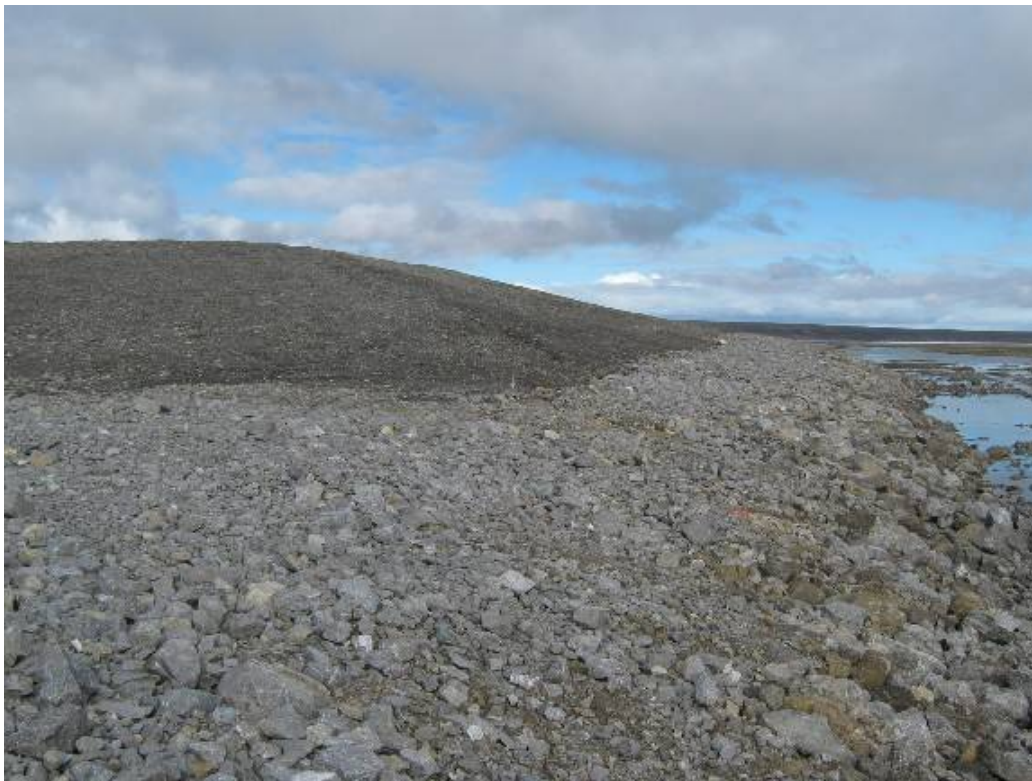
Photo 84- Northing 561646 Easting 8366909 Elevation 15 m  
Garrow Lake Dam: west abutment facing upstream to lake

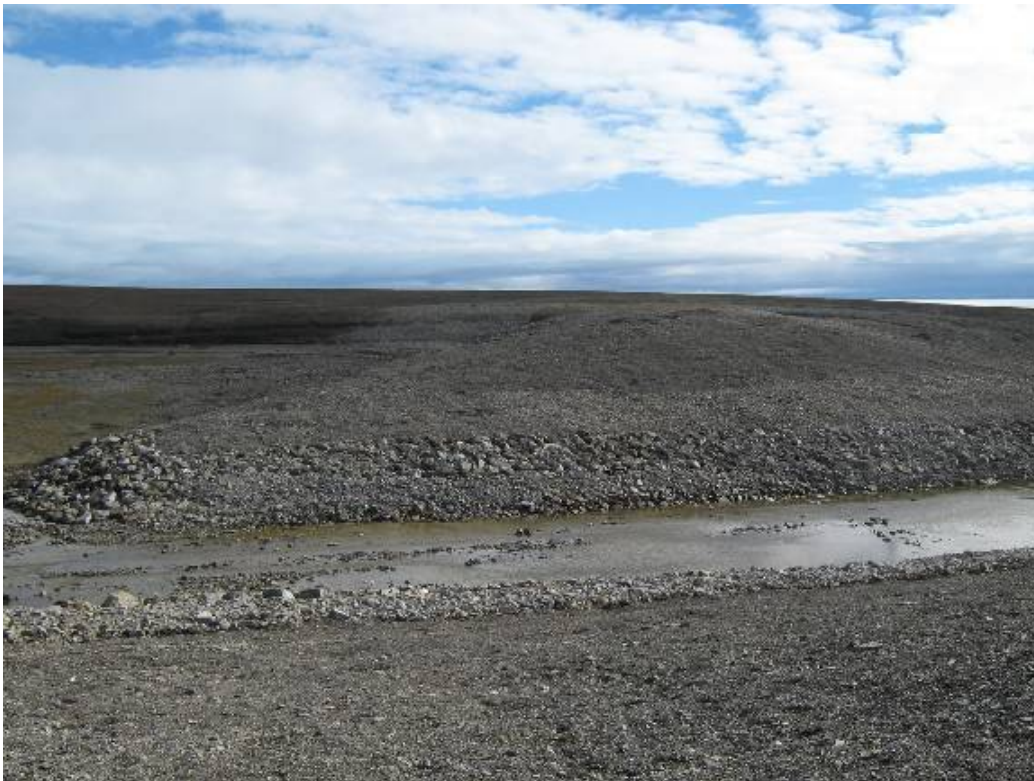
Photo 87- Northing 561646 Easting 8366909 Elevation 15 m  
Garrow Lake Dam facing east abutment from west abutment

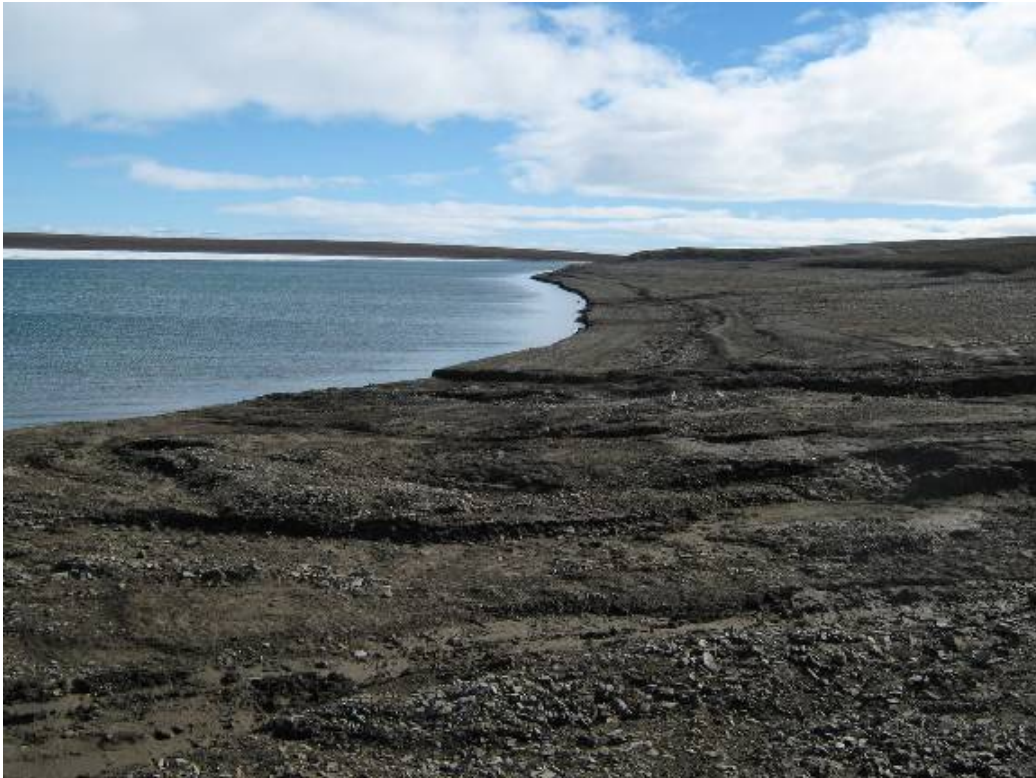
The water level in Garrow Lake has been lowered for the past five years and the shoreline has been exposed to several annual seasonal cycles. The perimeter beach of Garrow Lake was inspected in 2008 with no evidence of significant instability or erosion. Minor erosion was observed where surface water drains into the lake, however no significant erosion or indications of slope instability were observed. Photographs 91 through 105 in Appendix A illustrate typical conditions observed around the lake perimeter. Monitoring of erosion pins was discontinued in 2007 as a result of several years of unchanged measurements indicating stable conditions. Routine sampling of Garrow Creek (i.e., Garrow Lake effluent) for suspended sediment continues as part of the Garrow Creek water quality monitoring program.

Photo 91- Northing 561088 Easting 8368913 Elevation 13 m  
Garrow Lake perimeter, west shore facing south near boat launch

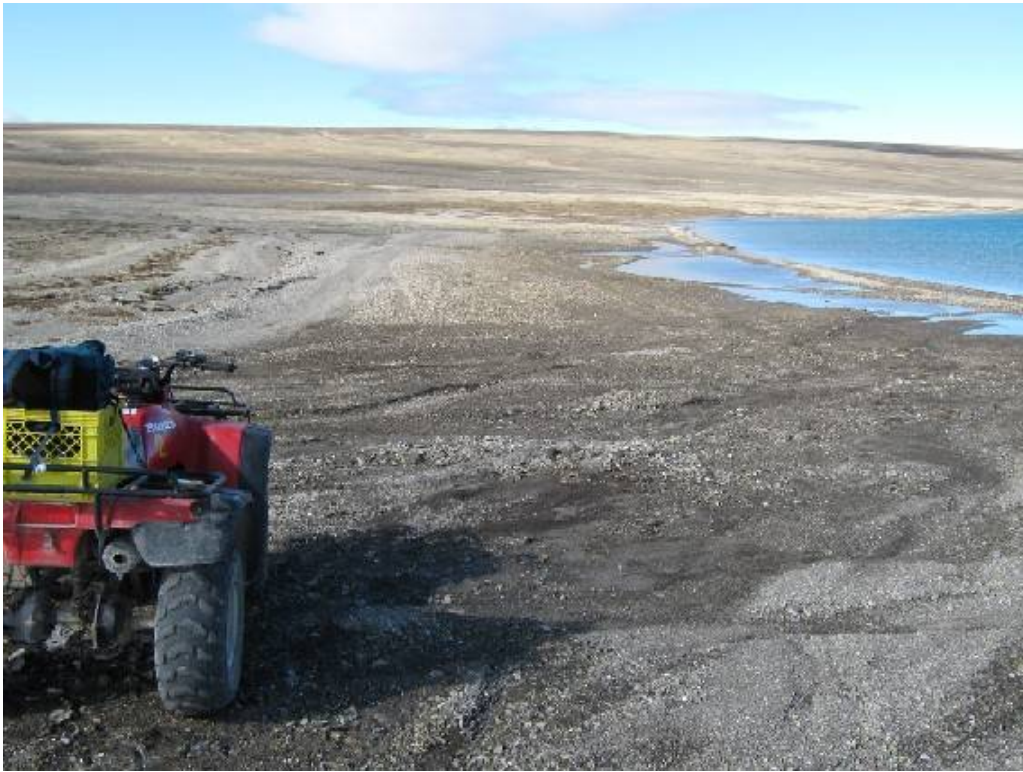
Photo 93- Northing 560960 Easting 8369168 Elevation 9 m  
Garrow Lake perimeter: north of boat launch, west shore facing north

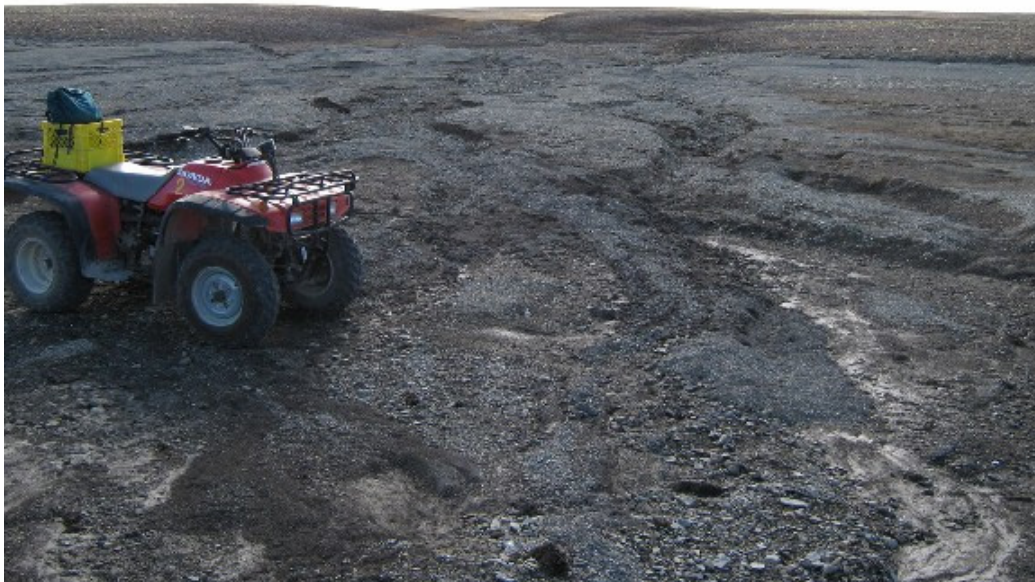
Photo 94- Northing 560960 Easting 8369168 Elevation 9 m  
Garrow Lake perimeter: erosion gully north of boat launch

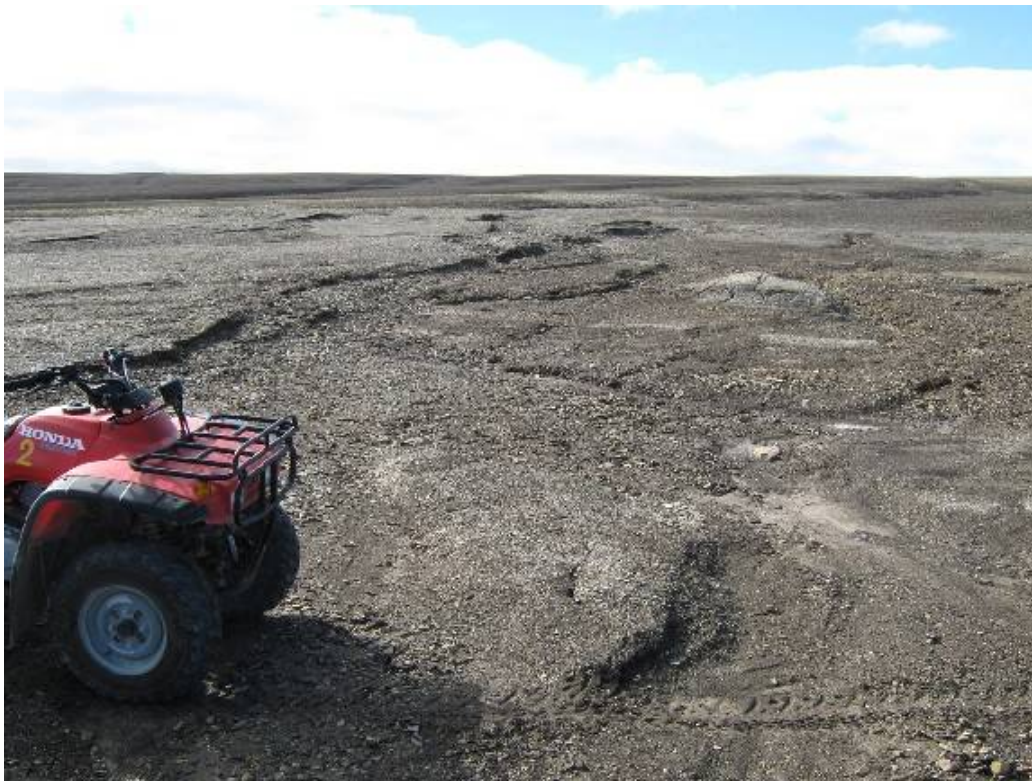
Photo 95- Northing 560961 Easting 8369504 Elevation 8 m  
Garrow Lake perimeter: erosion gully in the NW corner

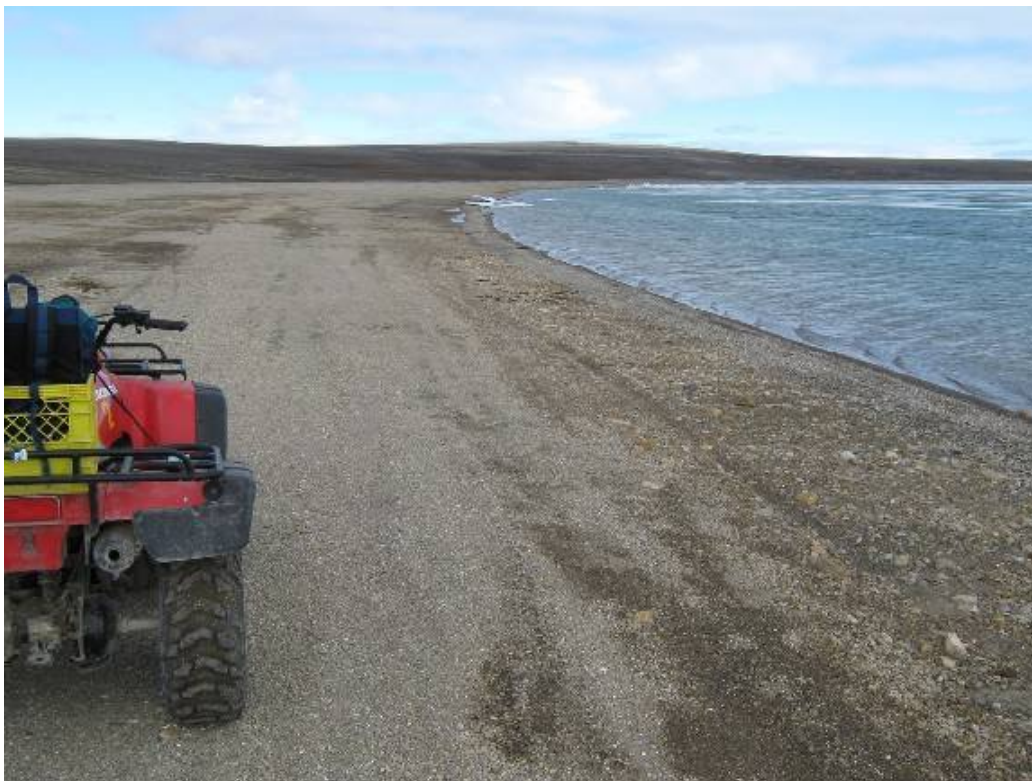
Photo 96- Northing 561583 Easting 8370389 Elevation 8 m  
Garrow Lake perimeter: north shore facing east

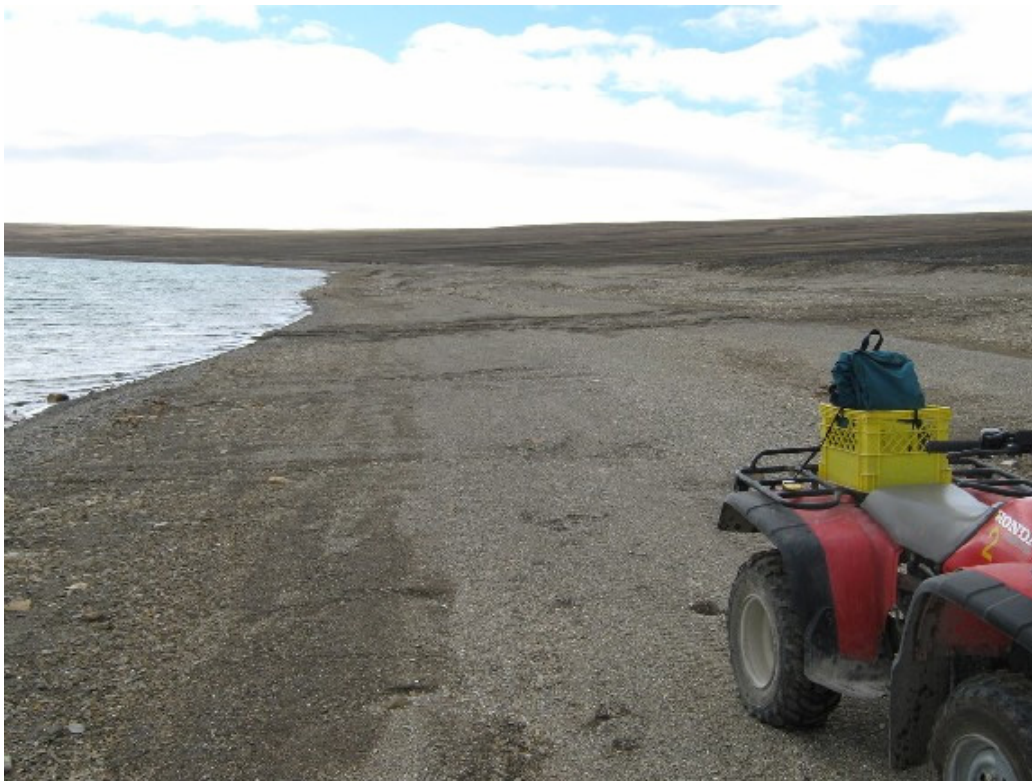
Photo 97- Northing 561583 Easting 8370389 Elevation 8 m  
Garrow Lake perimeter: north shore facing west

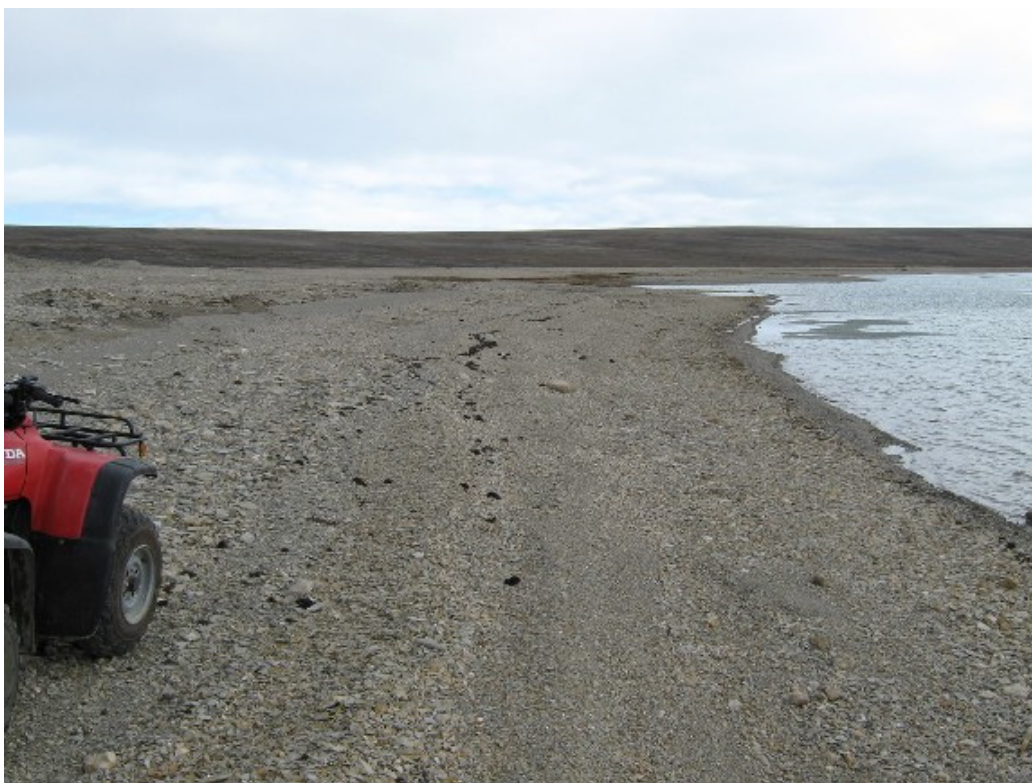
Photo 98- Northing 562614 Easting 8370530 Elevation 13 m  
Garrow Lake perimeter: NE corner facing east

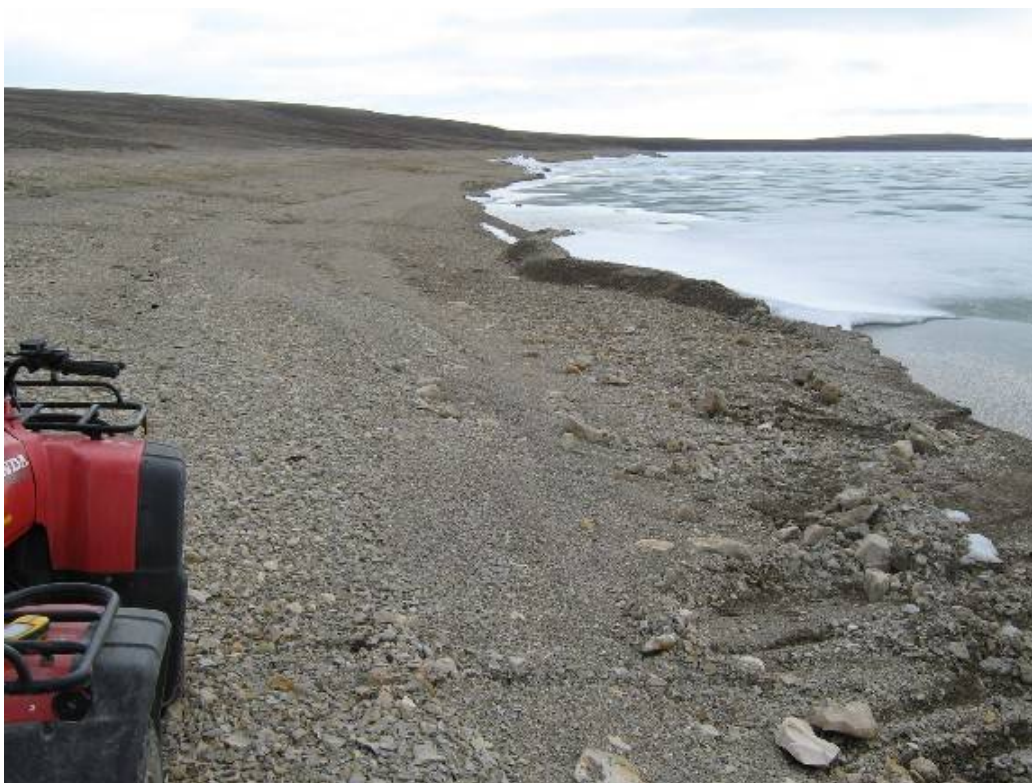
Photo 100- Northing 562776 Easting 8369812 Elevation 16 m  
Garrow Lake perimeter: north end of east shore facing south

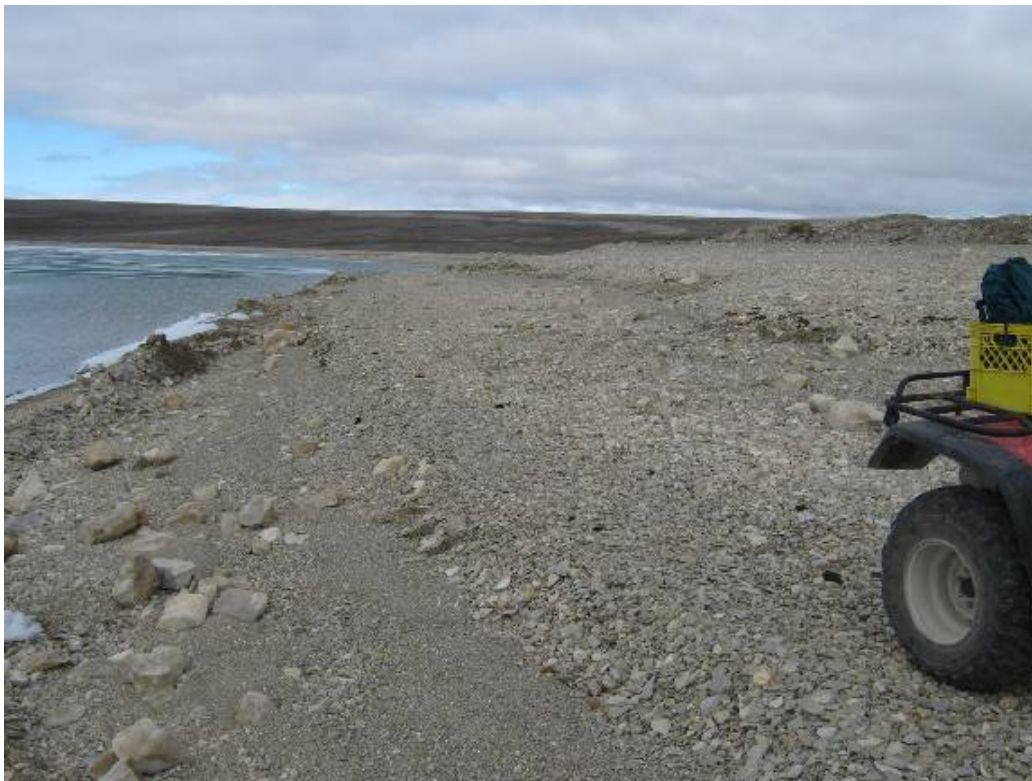
Photo 101- Northing 562776 Easting 8369812 Elevation 16 m  
Garrow Lake perimeter: north end of east shore facing north

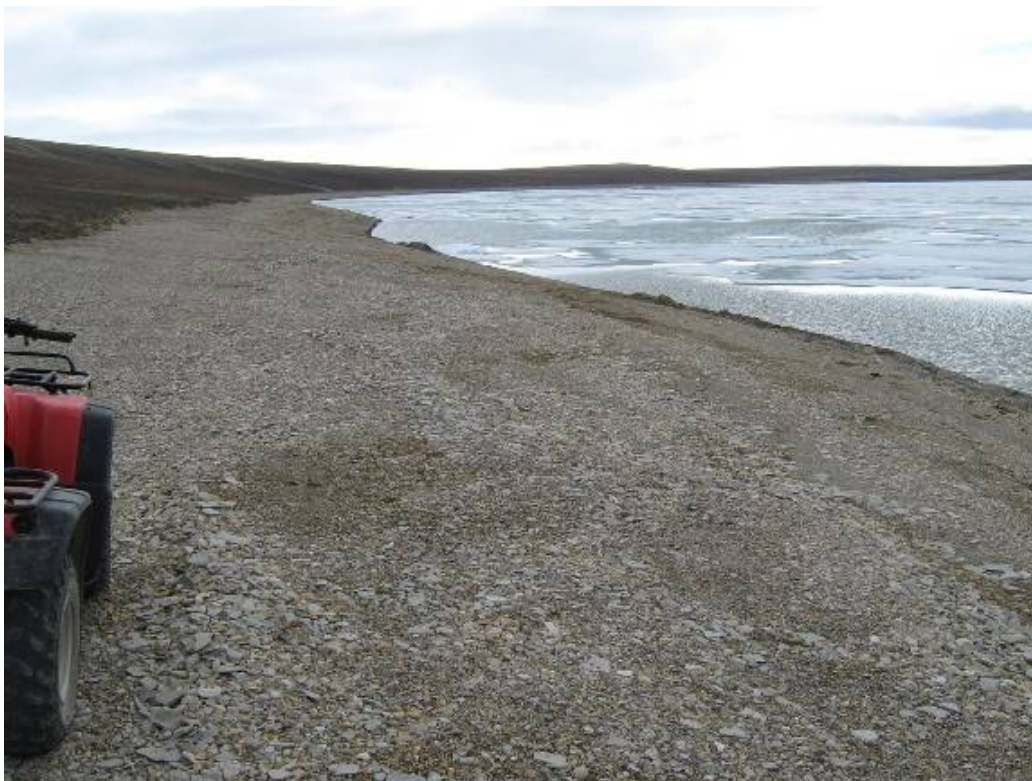
Photo 102- Northing 562759 Easting 8368796 Elevation 14 m  
Garrow Lake perimeter: east shore facing south

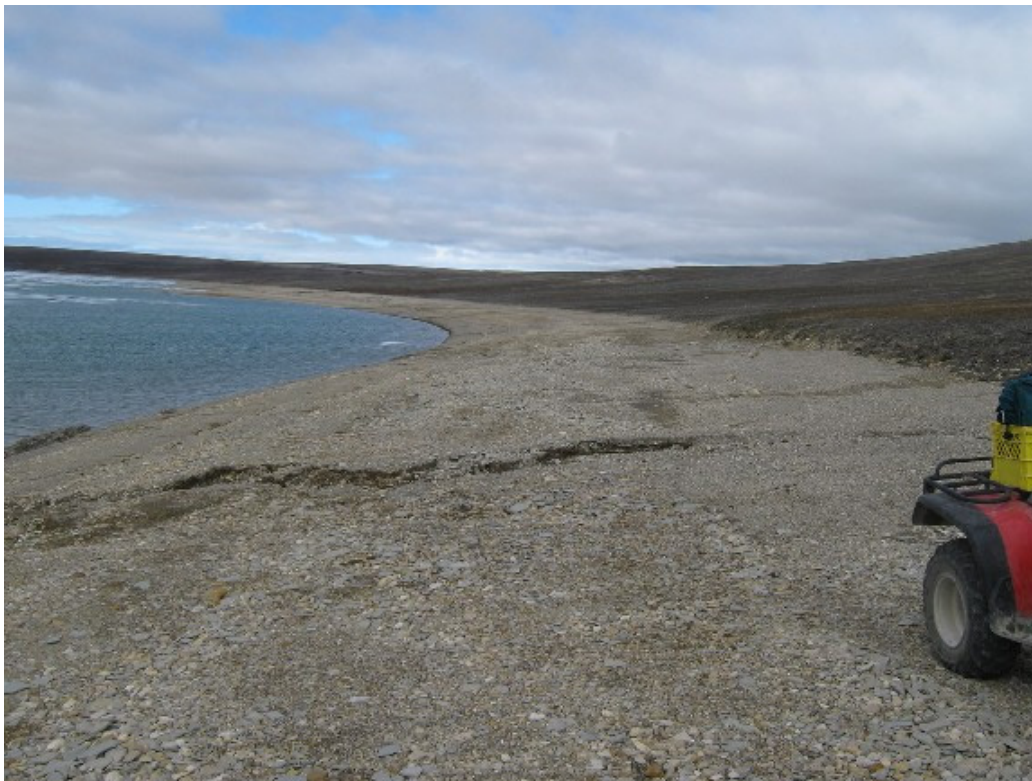
Photo 103- Northing 562759 Easting 8368796 Elevation 14 m  
Garrow Lake perimeter: east shore facing north towards erosion gully

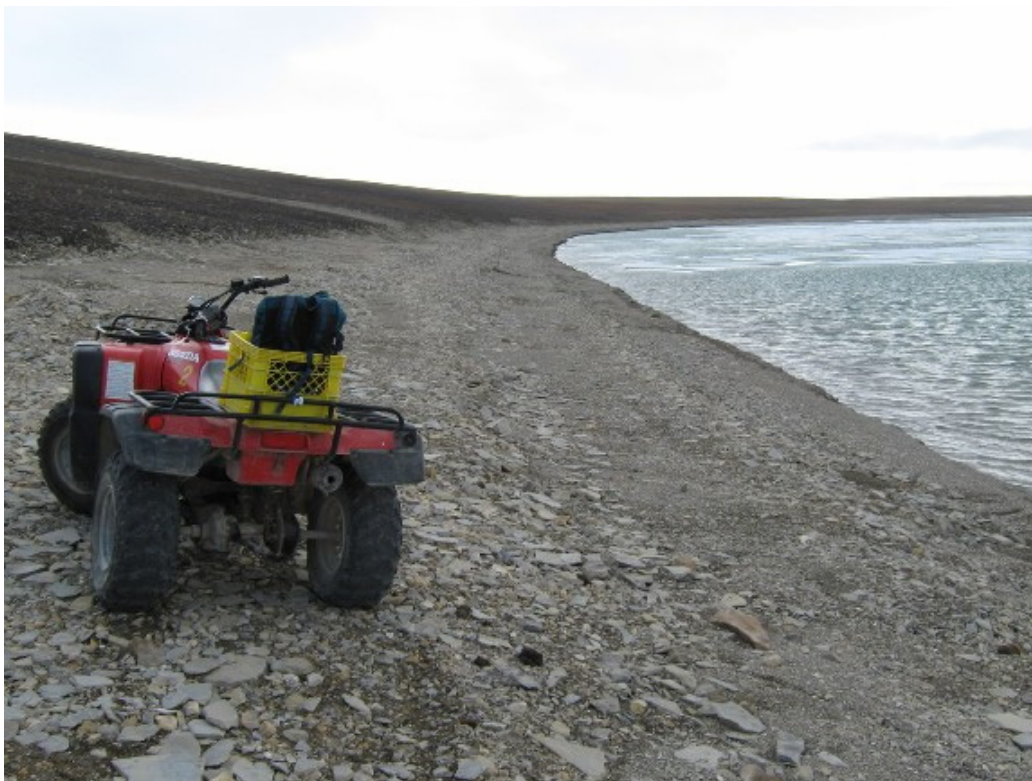
Photo 104- Northing 562675 Easting 8368316 Elevation 18 m  
Garrow Lake perimeter: SE shore facing south

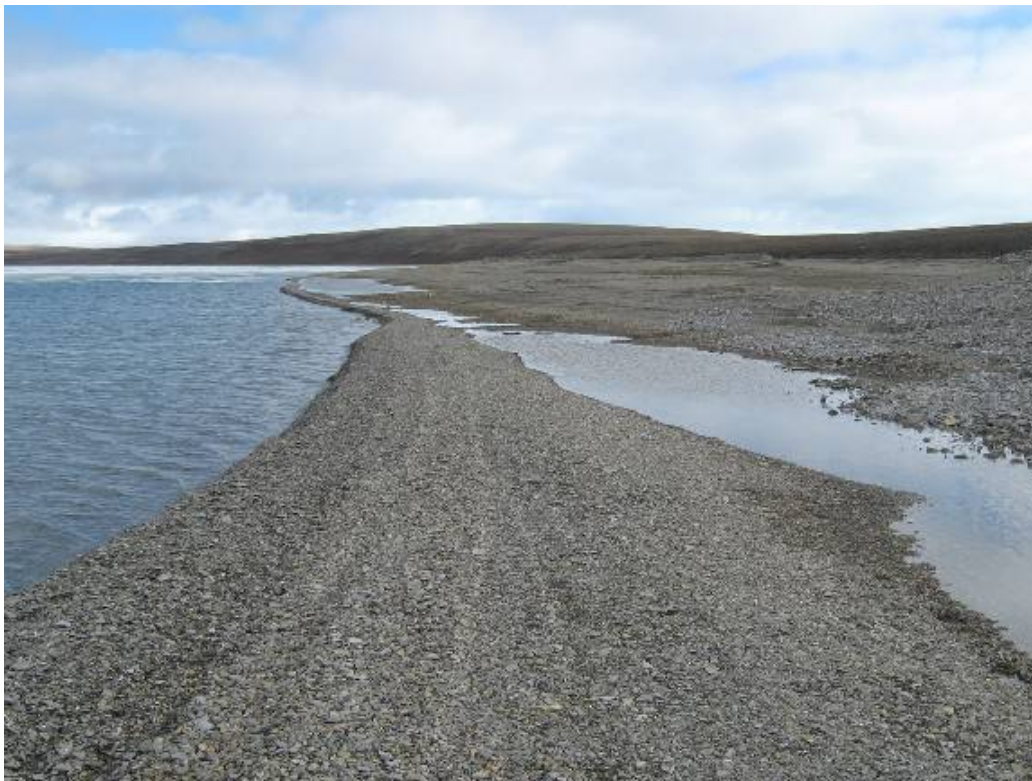
Photo 105- Northing 561569 Easting 8367440 Elevation 8 m  
Garow Lake perimeter: south shore east of wave break structure

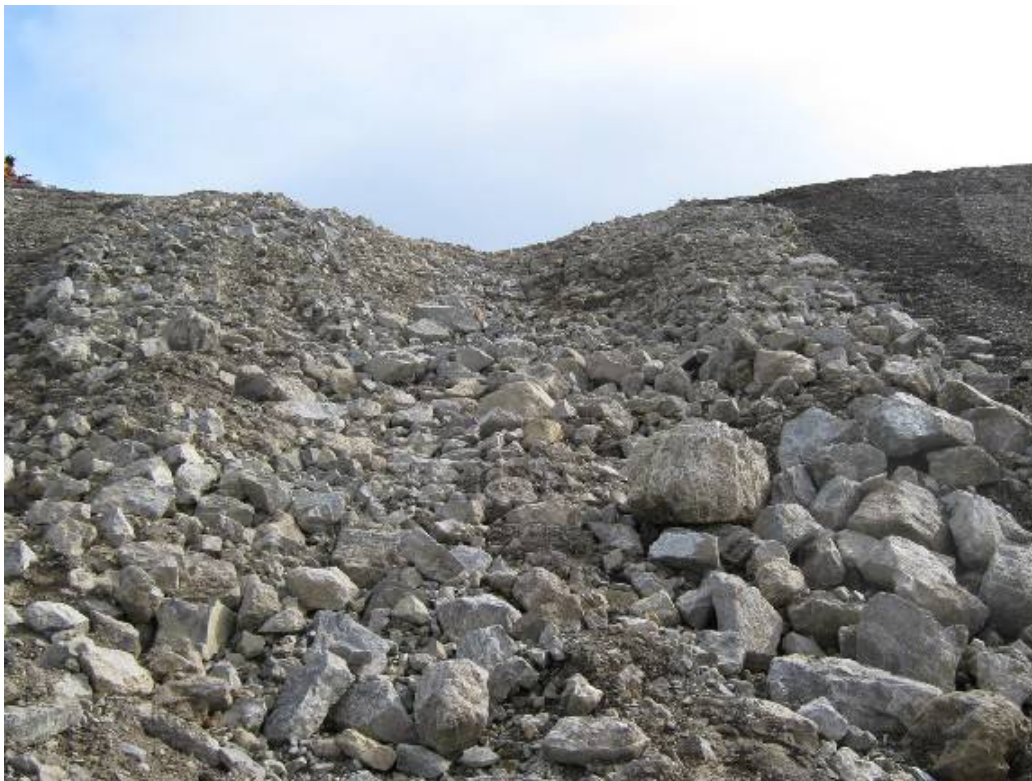
Erosion gullies at two locations along the adjacent road were stabilized in July 2006 by slope regrading and placement of well-graded limestone rockfill as rip-rap protection. The rip-rapped lined ditches appear to be performing well (Photographs 106, 107 and 109 in Appendix A). Erosion gullies (maximum 2 m wide and 0.5 m deep) have formed below the rip-rap lined ditches that appear to be self-armouring (Photographs 108 and 110 in Appendix A).

Photo 107- Northing 558815 Easting 8368653 Elevation 29 m  
New quarry area: view looking up channel slope

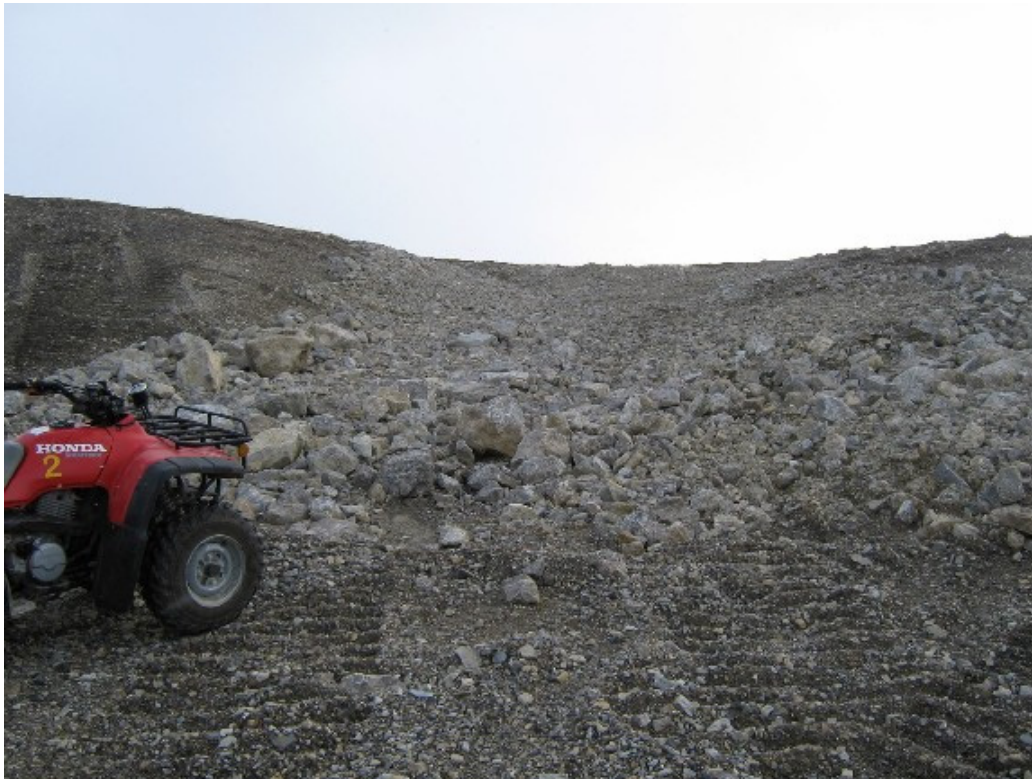
Photo 109- Northing 558699 Easting 8368752 Elevation 28 m  
New quarry area: rip-rap lined drainage ditch

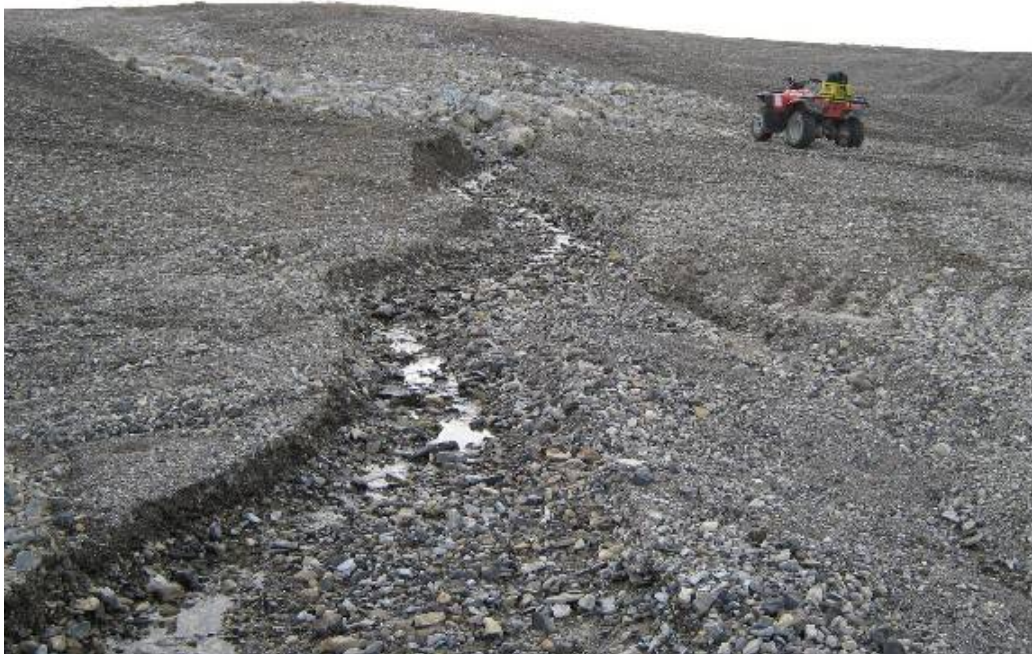
Photo 110- Northing 558699 Easting 8368752 Elevation 28 m  
New quarry area: erosion gully below rip-rap lined ditch

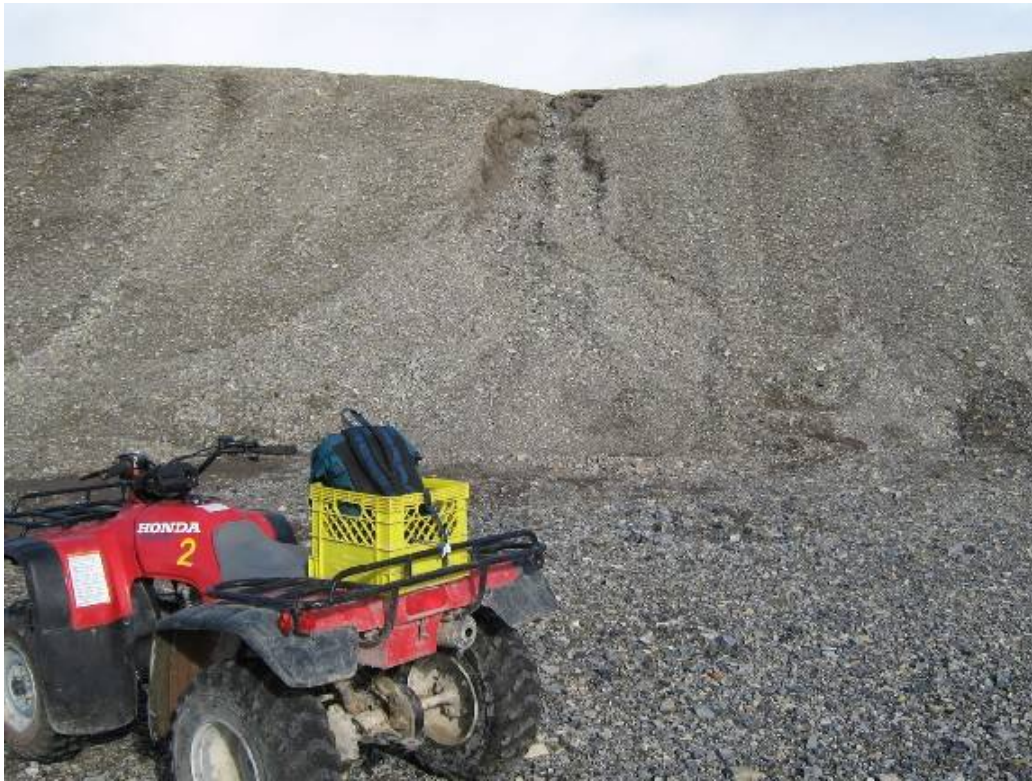
An erosion gully that is about 3 m wide and 1.5 m deep and extends from the crest to toe on the east perimeter slope (Photograph 111 in Appendix A) appears to be unchanged from previous inspections. An area of settlement approximately 1.5 m deep was observed in one location at the toe of the east perimeter slope (Photograph 112 in Appendix A) with an associated tension crack at the crest of the slope above. Sink holes were observed at various locations over the lower half of the west perimeter slope (Photographs 113 and 114 in Appendix A). The sink holes appear to be the result of buried snow and ice that has melted and are not a concern. Meandering erosion gullies were observed over the quarry floor in the vicinity of Photograph 115 (Appendix A). None of the conditions observed during the July 2008 inspection represent an immediate cause for concern but should be monitoring for increased erosion or indications of slope instability.

Photo 111- Northing 559086 Easting 8369039 Elevation 17 m  
New quarry area: erosion gully down quarry perimeter slope

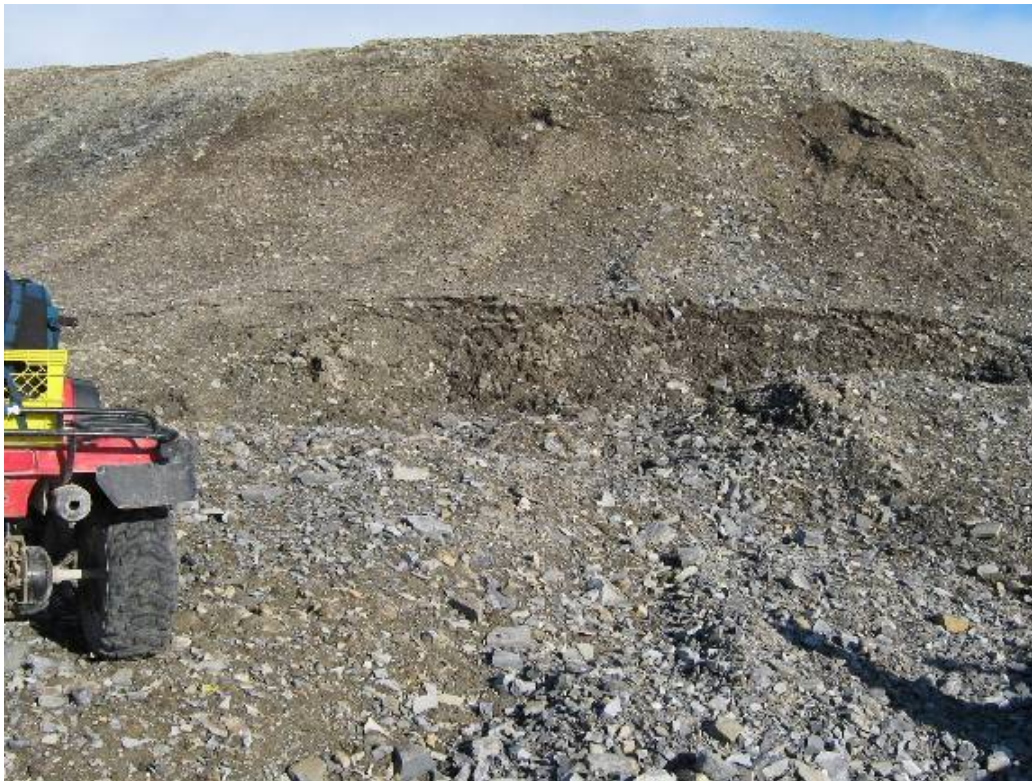
Photo 112- Northing 559102 Easting 8369202 Elevation 15 m  
New quarry area: settlement area at toe of perimeter slope
