October 9, 2014

# Post-Reclamation Geotechnical Inspection

## FORMER POLARIS MINE, NUNAVUT

**Report Number:** 1408454

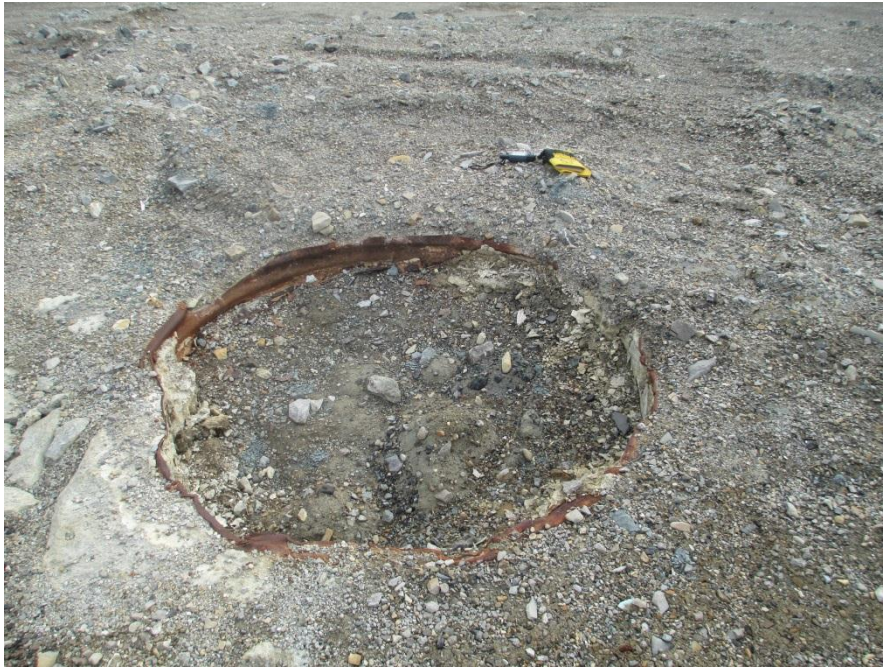
Photo 1, Subsidence Area, Vent/Backfill Raise (WP#1)

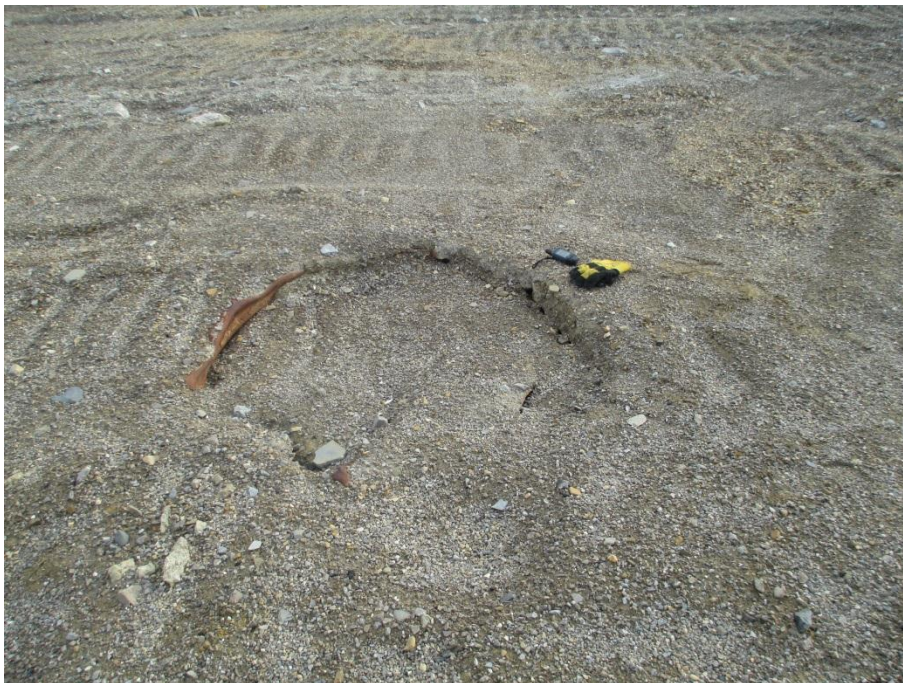
Photo 2, Subsidence Area, Vent/Backfill Raise (WP#2)

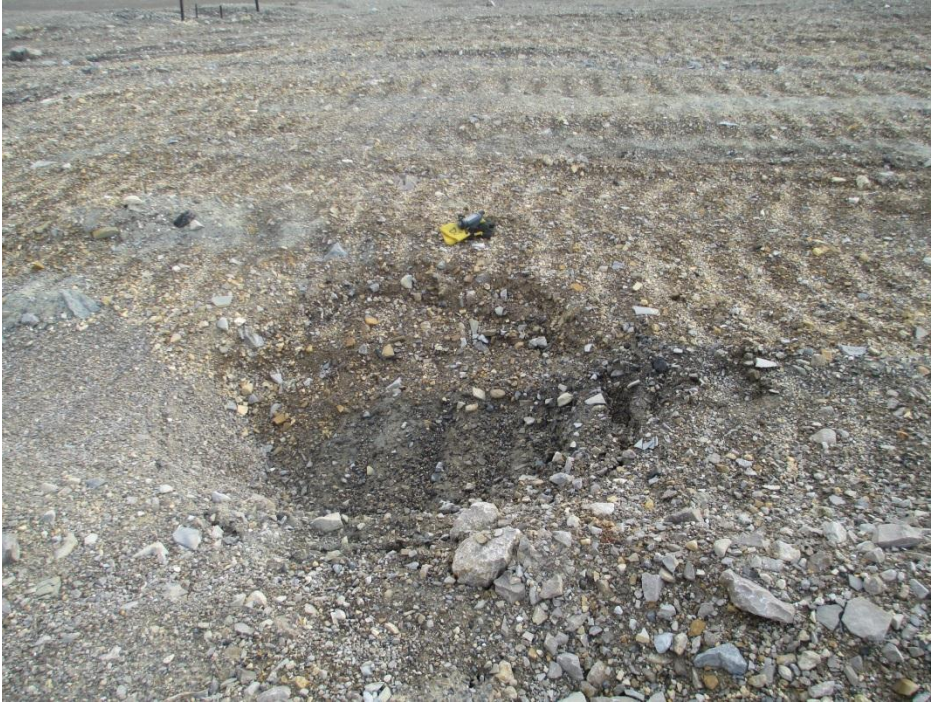
Photo 3, Subsidence Area, Vent/Backfill Raise (WP#3)

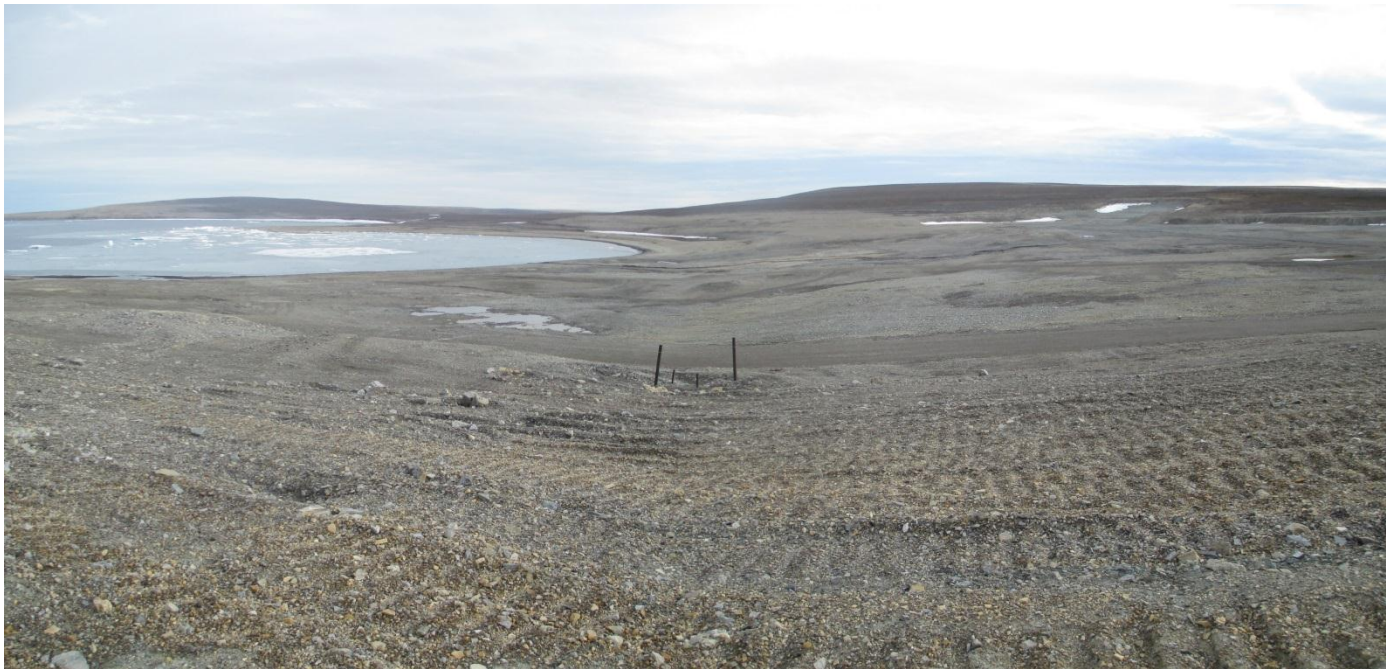
Photo 4, Subsidence Area, panoramic view facing East from WP#3

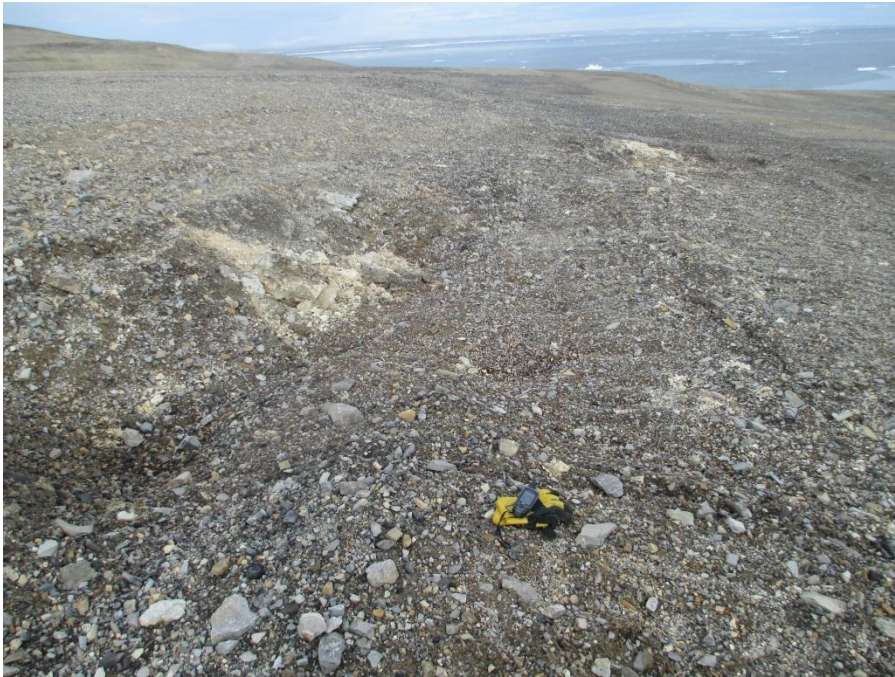
Photo 5, Subsidence Area, thaw settlement area (WP#4)

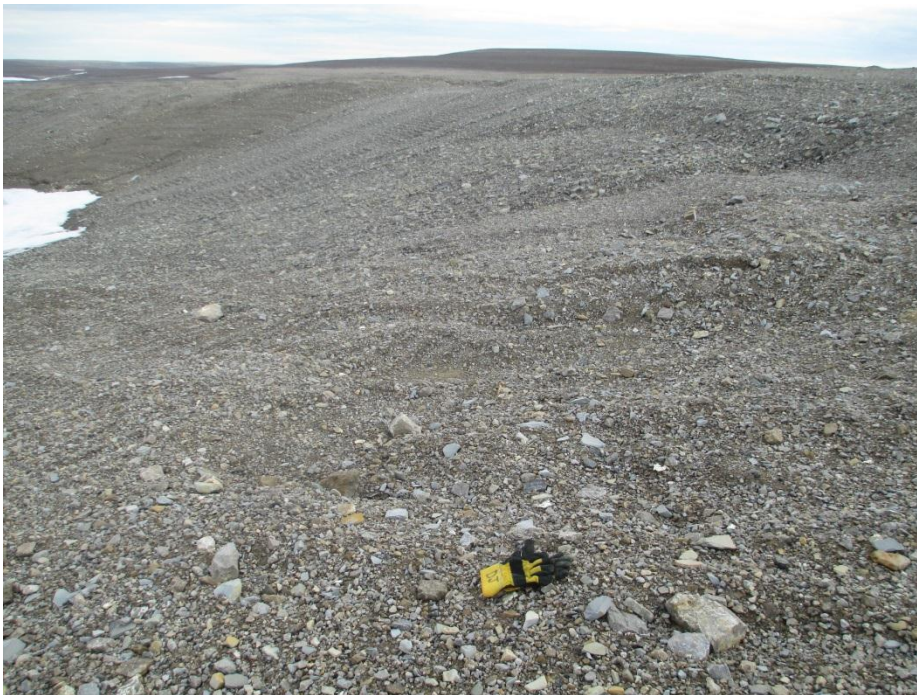
Photo 6, Subsidence Area, graded slope with some thaw settlement (WP#5)

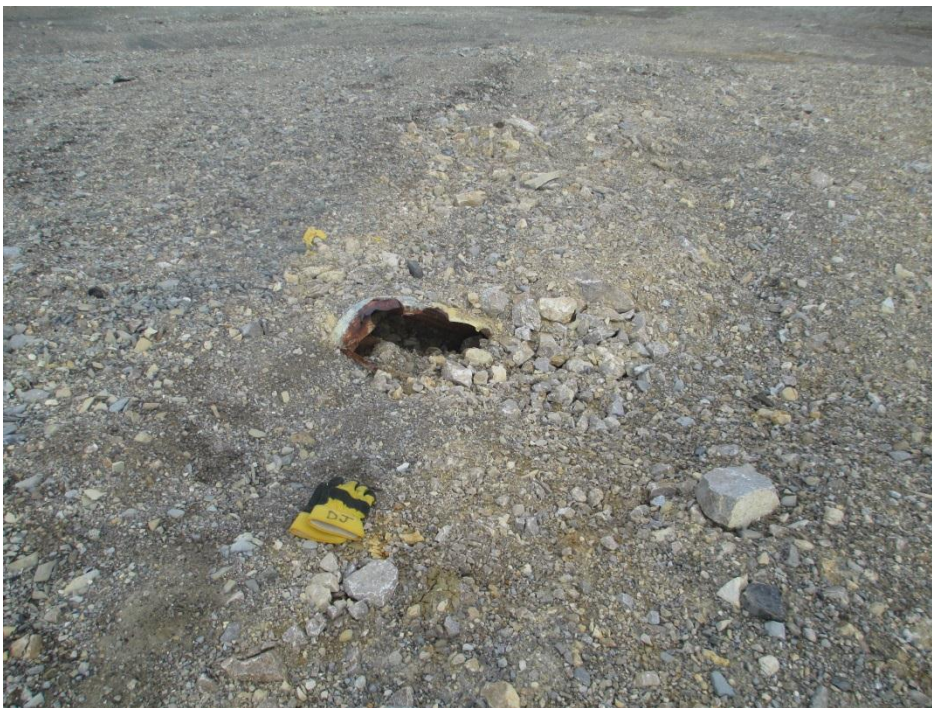
Photo 10, Subsidence Area, Vent/Backfill Raise (WP#9)

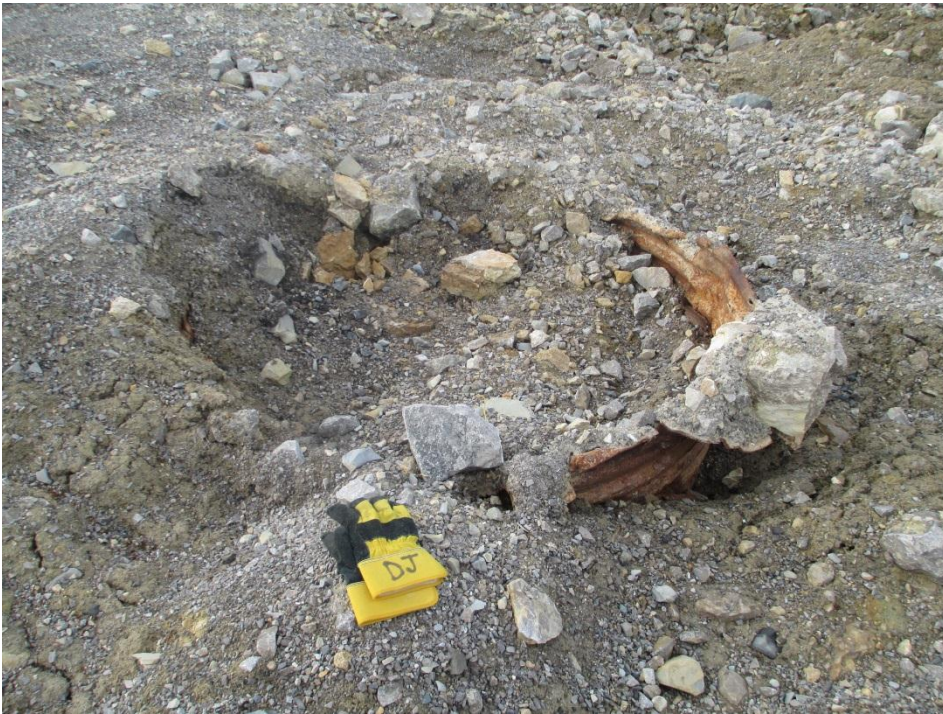
Photo 11, Subsidence Area, Vent/Backfill Raise with exposed CSP (WP#10)

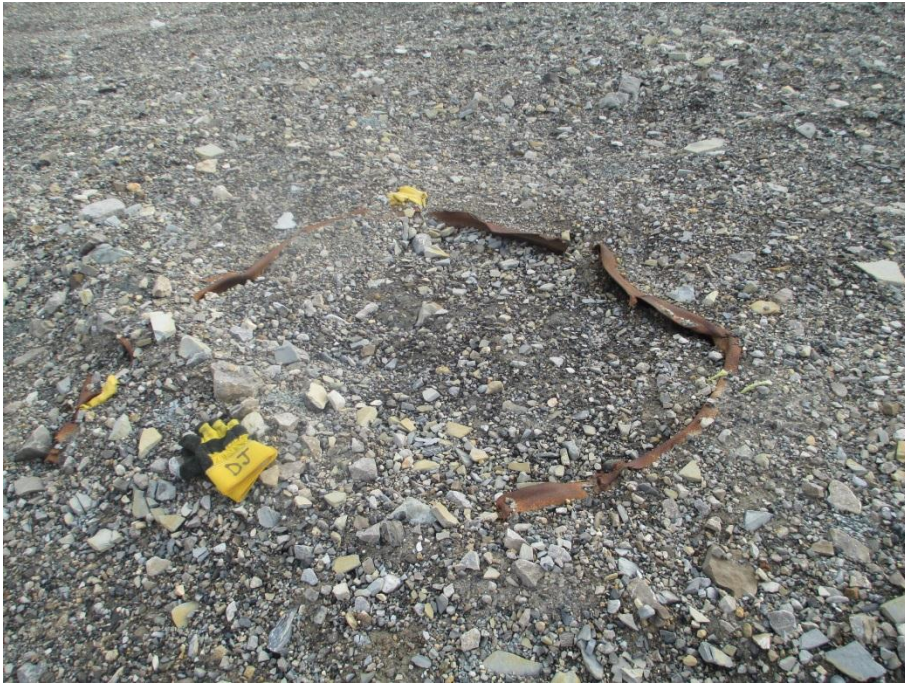
Photo 13, Subsidence Area, Vent/Backfill Raise (WP#12)

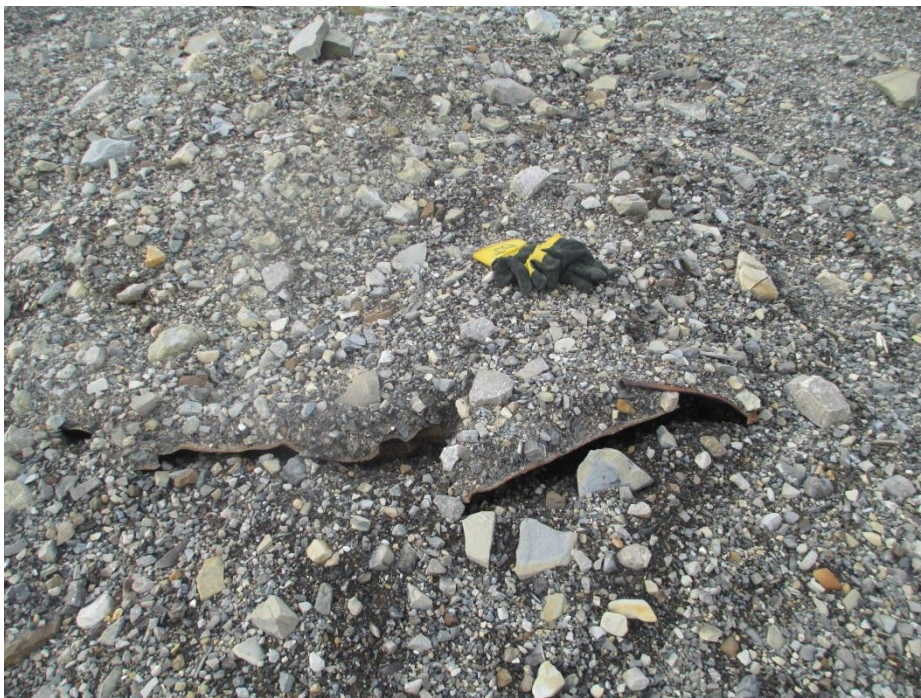
Photo 14, Subsidence Area, Vent/Backfill Raise (WP#13)

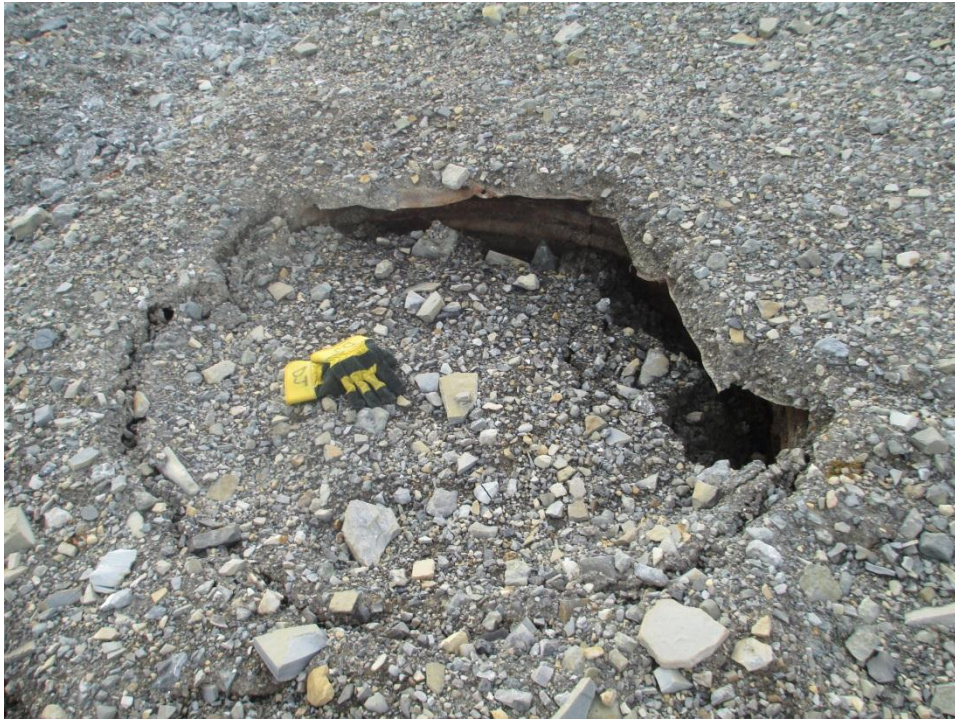
Photo 15, Subsidence Area, Vent/Backfill Raise (WP#14)

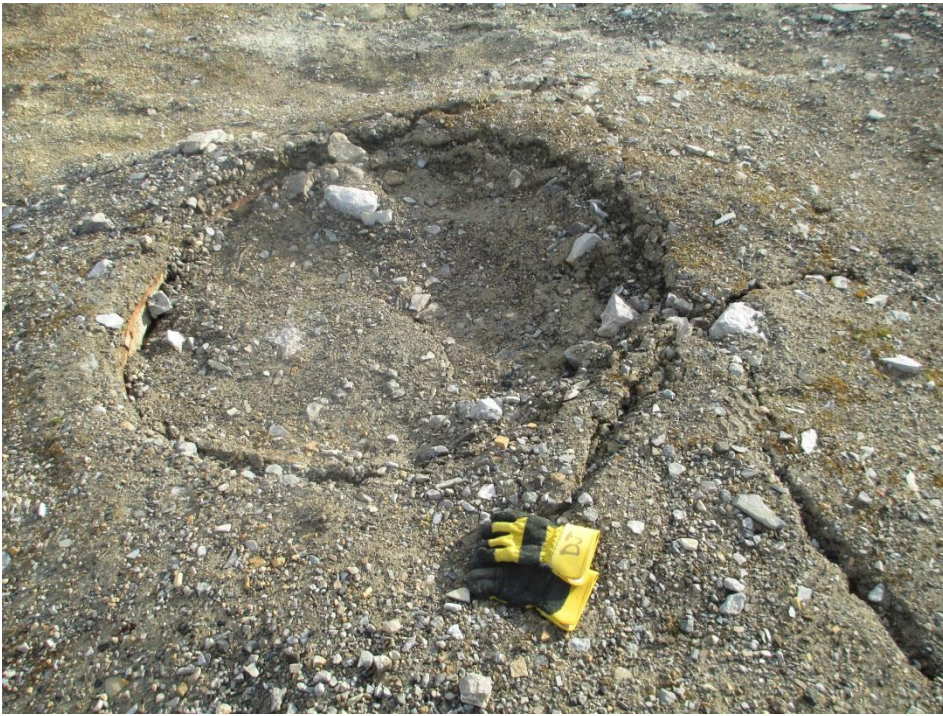
Photo 17, Subsidence Area, Vent/Backfill Raise (WP#15)

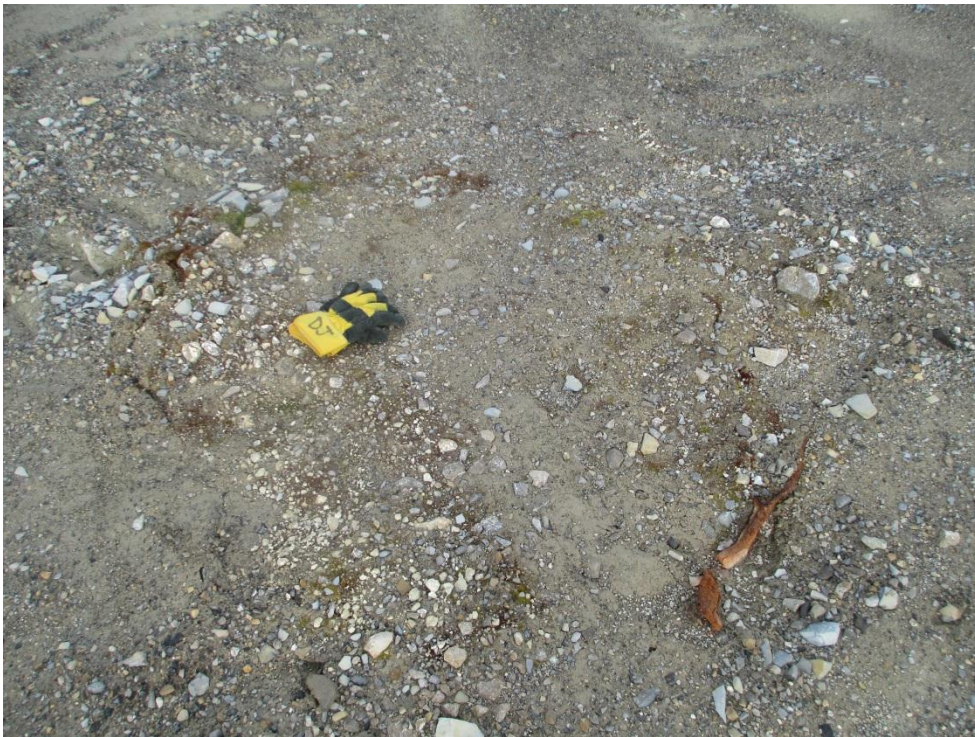
Photo 18, Subsidence Area, Vent/Backfill Raise (WP#16)

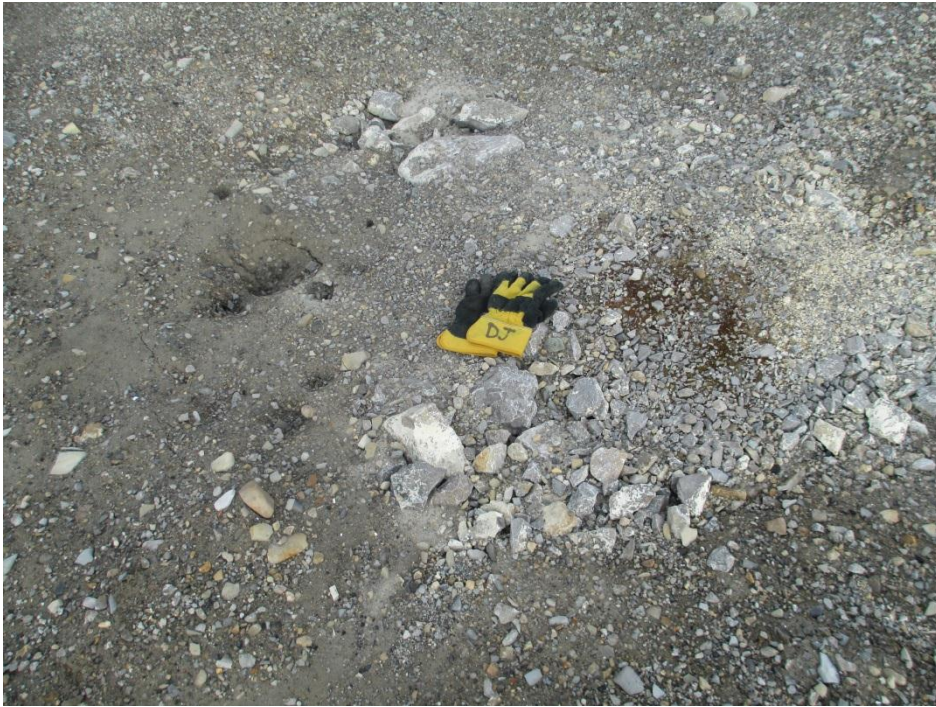
Photo 19, Subsidence Area, Vent/Backfill Raise (WP#17)

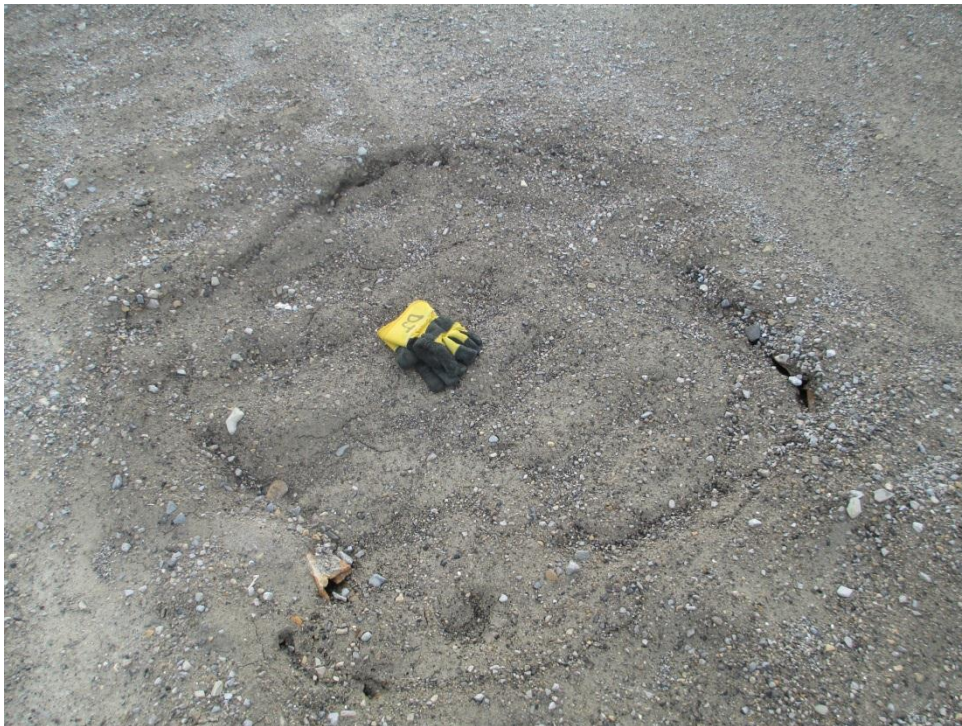
Photo 20, Subsidence Area, Vent/Backfill Raise (WP#18)

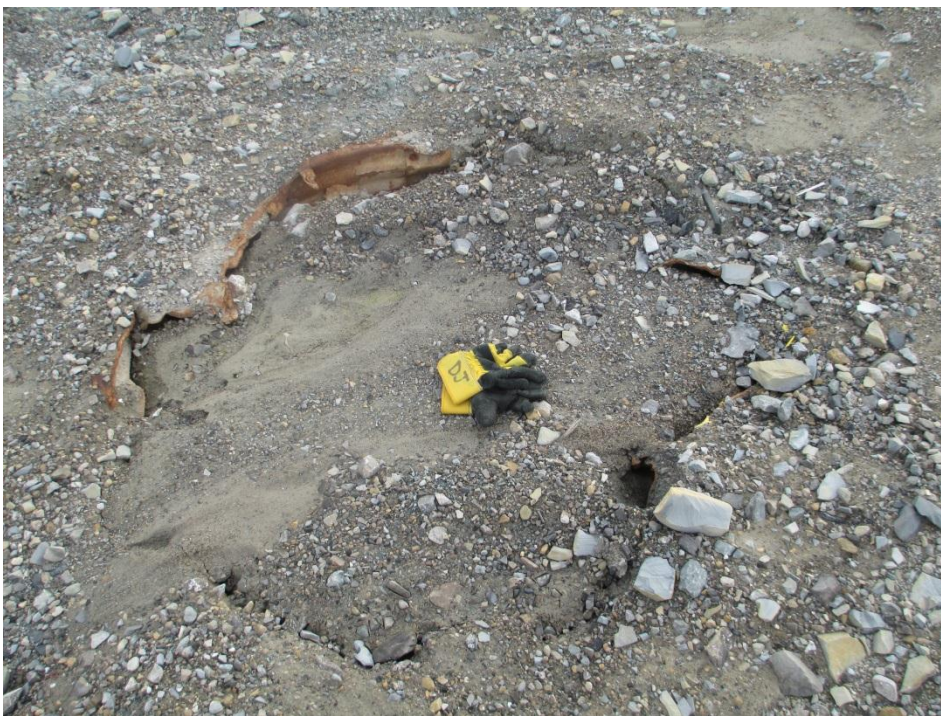
Photo 21, Subsidence Area, Vent/Backfill Raise (WP#19)

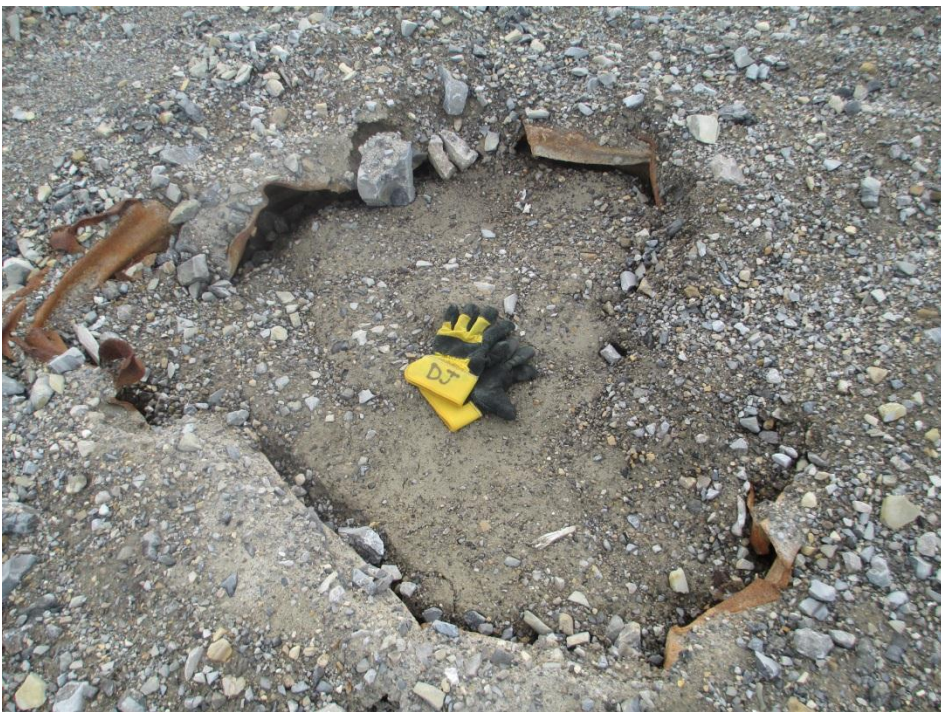
Photo 22, Subsidence Area, Vent/Backfill Raise (WP#20)

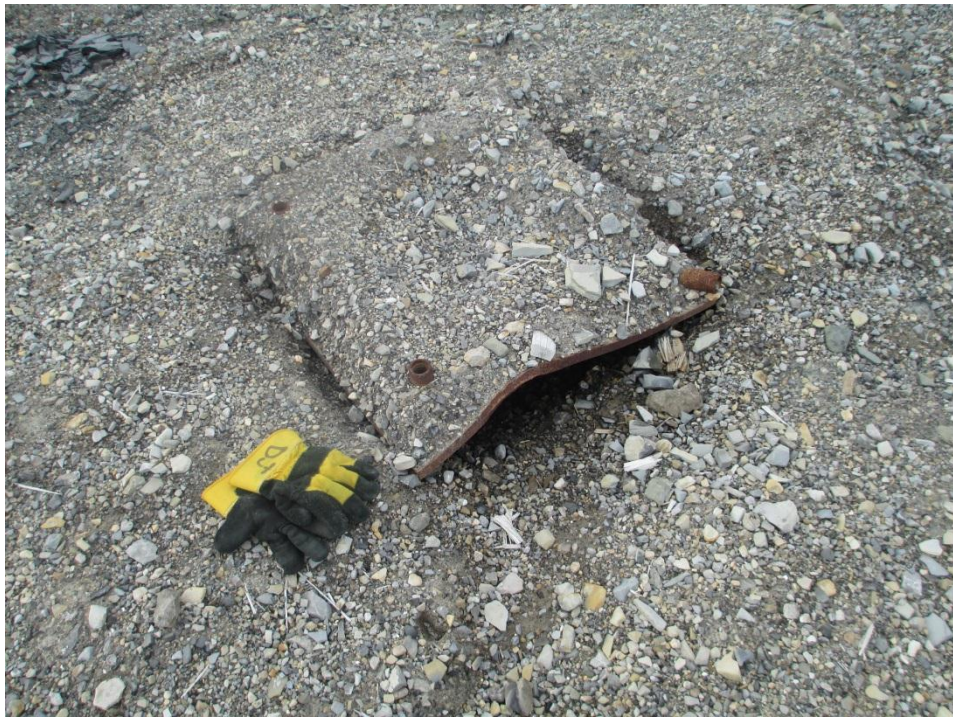
Photo 23, Subsidence Area, Anchored Metal Plate (WP#21)

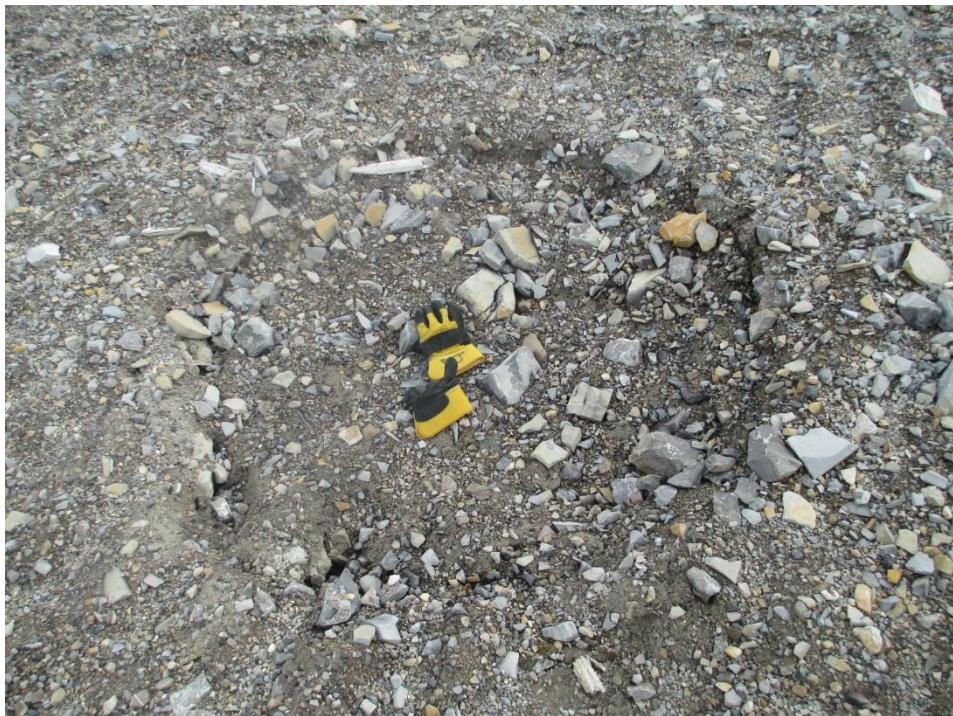
Photo 24, Subsidence Area, Vent/Backfill Raise (WP#22)

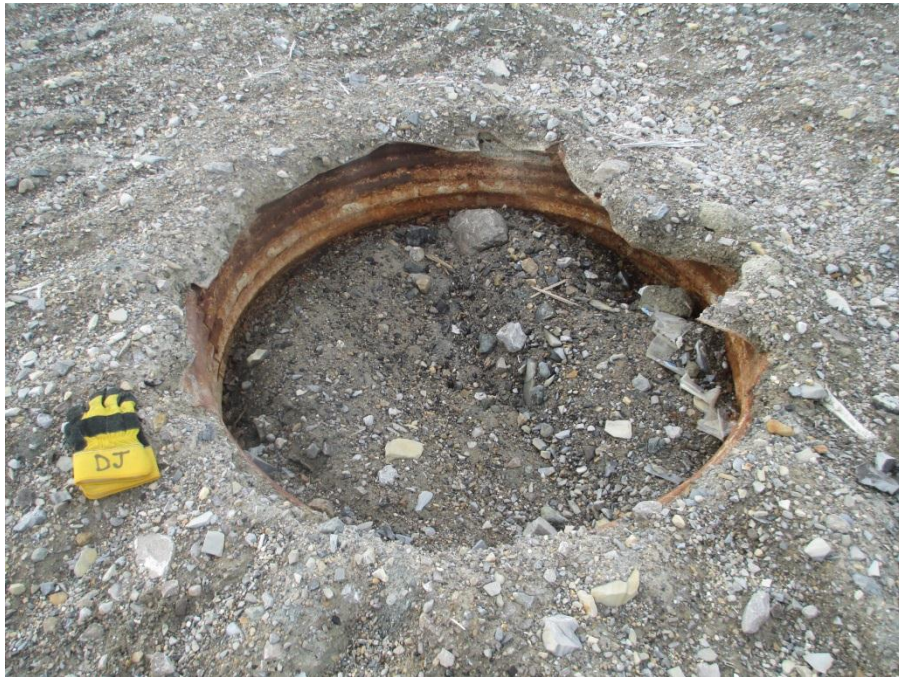
Most of the photographs taken in the subsidence area during the 2014 inspection are of vent/backfill raises that extend to surface. The raise bores are about 1.5 m in diameter and were used to either provide ventilation to the underground mine or deliver rock backfill to mine stopes. Vent/backfill raises have been observed during previous inspections and were not considered a risk to either humans or wildlife so only a few photographs had been taken to document typical conditions. However, the 2014 inspection attempted to photograph and GPS locate all of the vent/backfill raises in the vicinity of the subsidence area for future reference. Most of the vent/raise locations have corrugated steel pipe (CSP) extending slightly above ground surface. This is considered to be the result of near surface thaw settlement of backfill around and inside the CSP. It is assumed that CSP sections were used as casing through the active thaw layer in overburden down to either permafrost or bedrock. It is possible that frost jacking could be pushing the CSP out of the ground at some of the raise locations. However, it is considered more likely that frozen backfill, that may have contained ice and snow, placed around the CSP and down the raise is settling as a result of seasonal thaw. In fact, the CSP sections may have extended above ground surface when they were initially installed during mine operations. The depth of settlement inside the CSP at most raise locations is less than 0.3 m. There are four locations with substantial thaw settlement adjacent to the raise resulting in exposed CSP up to 1 m high (see Photos 31,37,56,59). There is ponded water in some of these thaw settlement depressions beside vent/backfill raises. Previous inspections had observed thaw settlement beside some of the vent/backfill raises, which were assumed to be unchanged since the mine site was decommissioned. However, it appears that the depth of settlement around and inside the CSP at some raise locations may be increasing over time. Even if there has been some post-reclamation settlement at the vent/backfill raises, it is important to note that this settlement is considered to be a result of seasonal thaw of backfill and not related to underground mine subsidence. There are three vent/backfill raise locations with internal settlement (i.e., inside the CSP) more than 0.3 m deep that could potentially pose a risk to either humans or wildlife (see Photos 25, 32, and 57).

Photo 25 , Subsidence Area, Vent/Backfill Raise with 0.3 m internal settlement (WP#23)

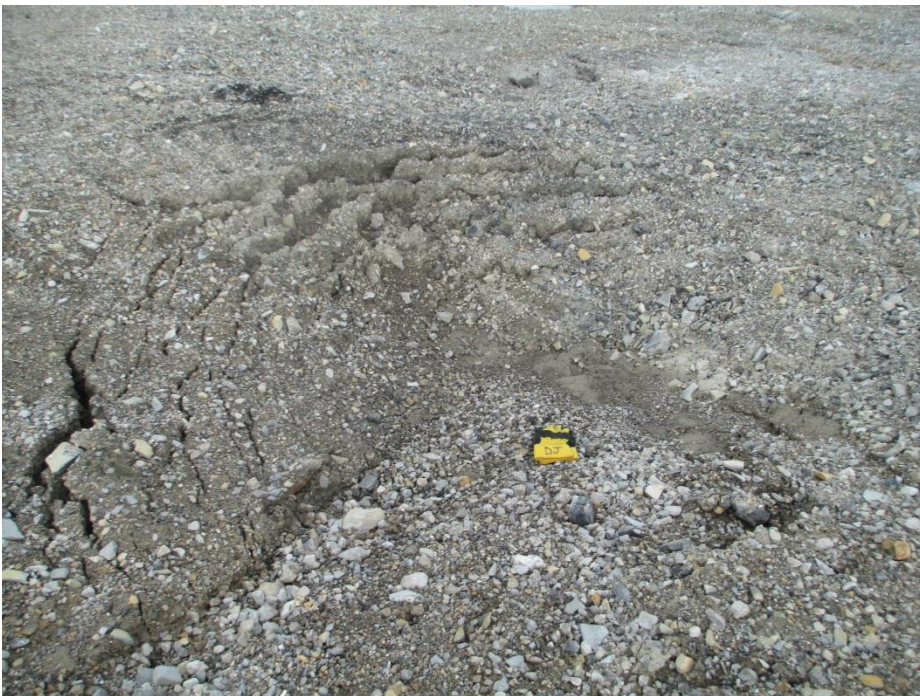
Photo 26, Subsidence Area, thaw settlement ~1m deep (WP#24)

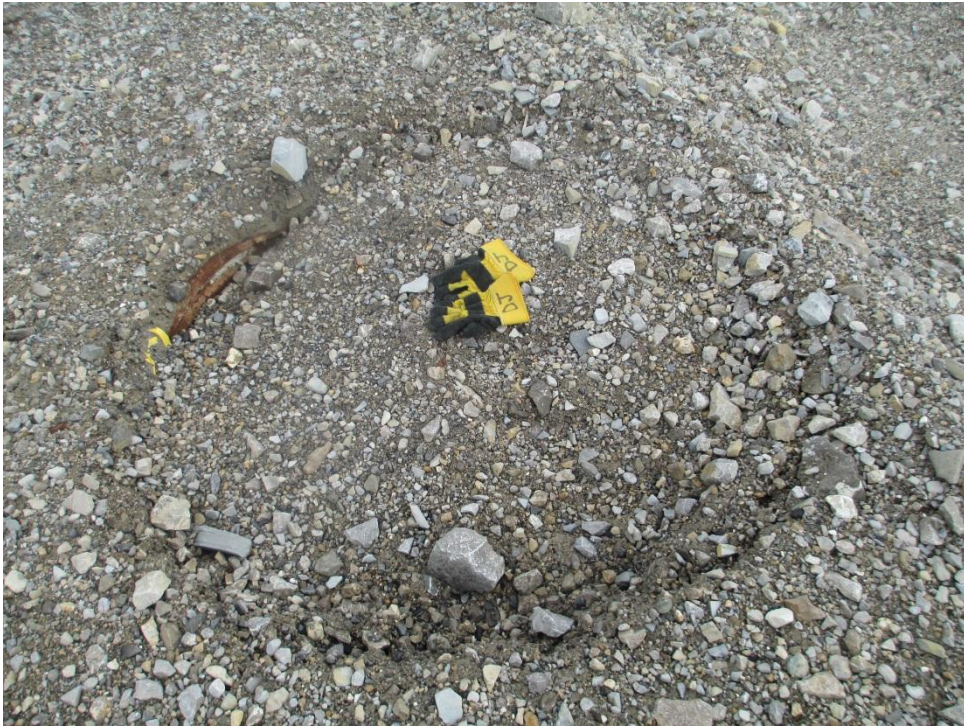
Photo 27, Subsidence Area, Vent/Backfill Raise (WP#25)

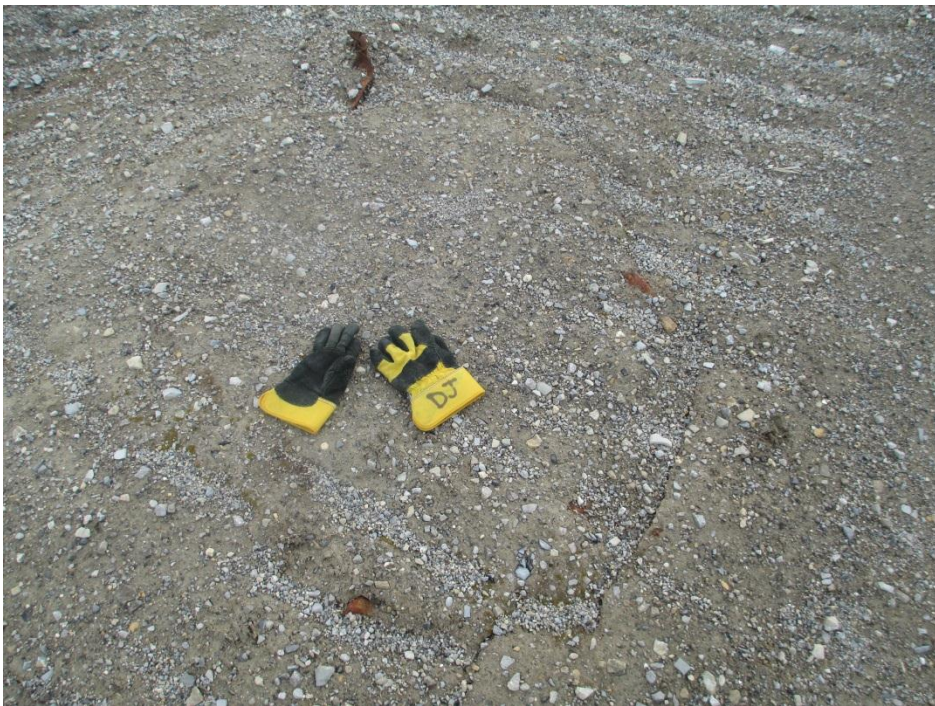
Photo 28, Subsidence Area, Vent/Backfill Raise (WP#26)

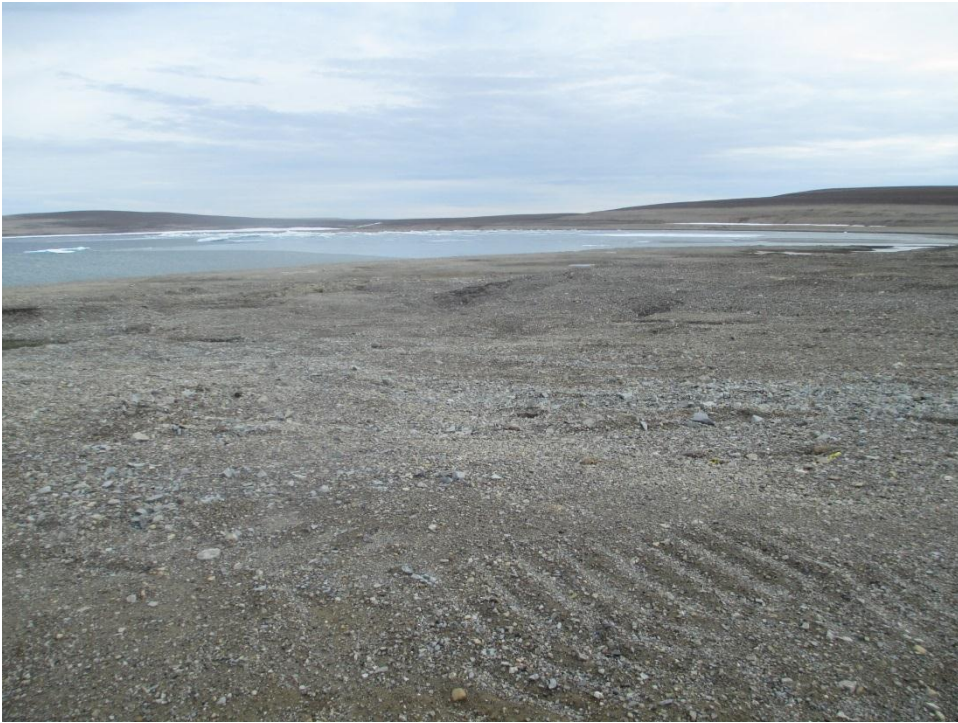
Photo 29, Subsidence Area, facing North from WP#26

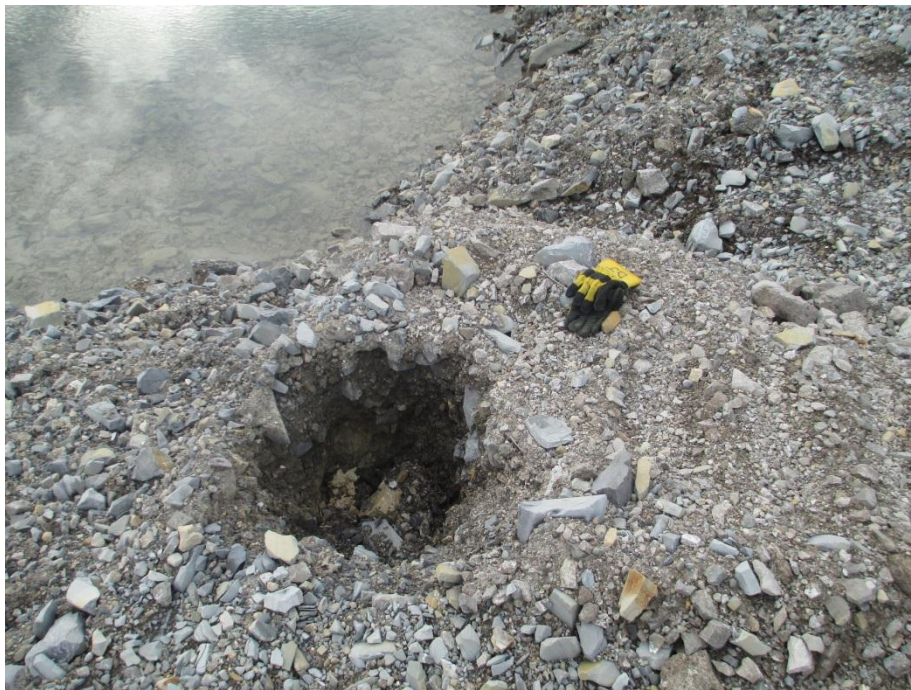
Photo 32, Subsidence Area, Vent/Backfill Raise with ~0.3 m internal settlement (WP#28)

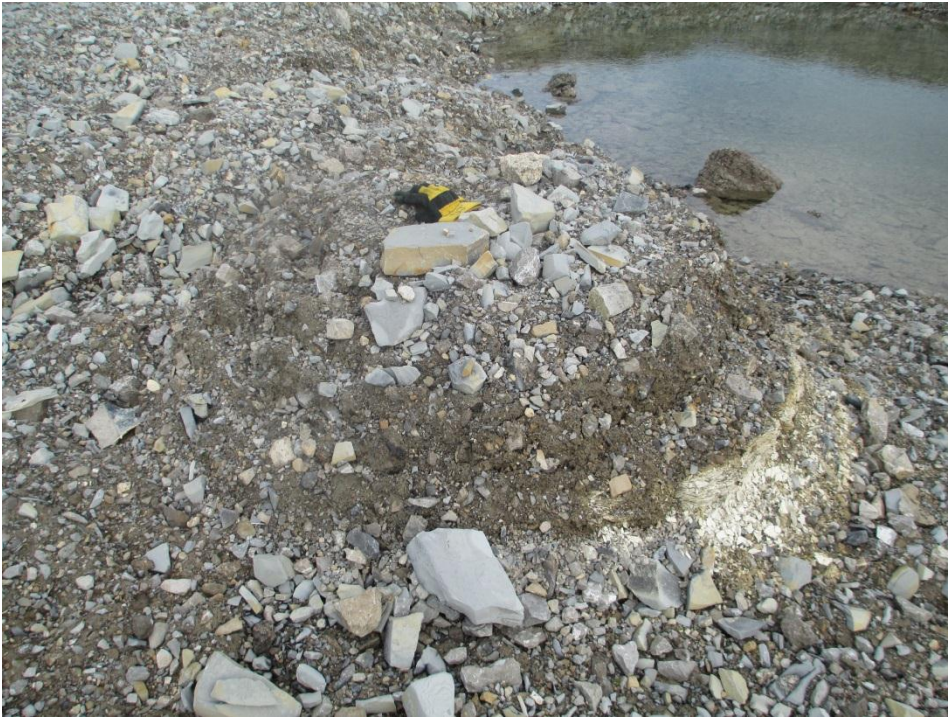
Photo 33, Subsidence Area, Vent/Backfill Raise (WP#29)

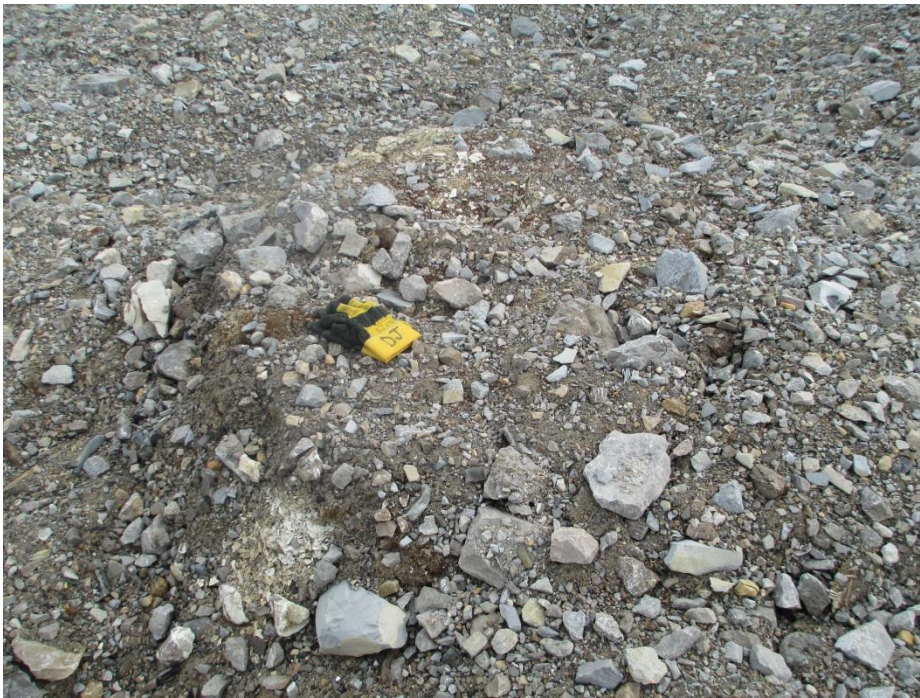
Photo 34, Subsidence Area, Vent/Backfill Raise (WP#30)

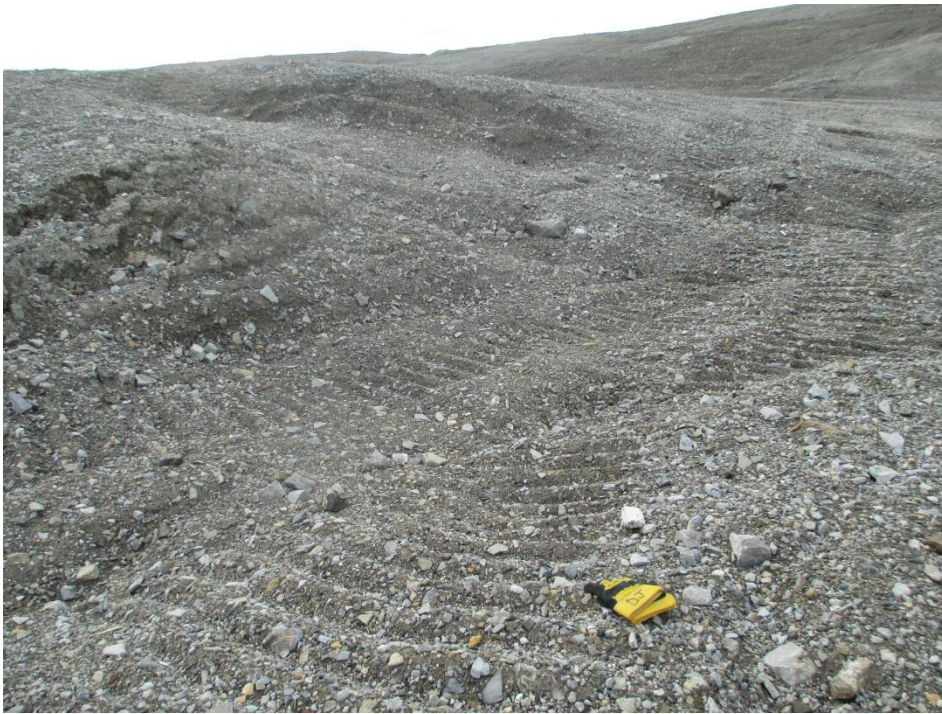
Photo 35, Subsidence Area, graded slope with some thaw settlement (WP#31)

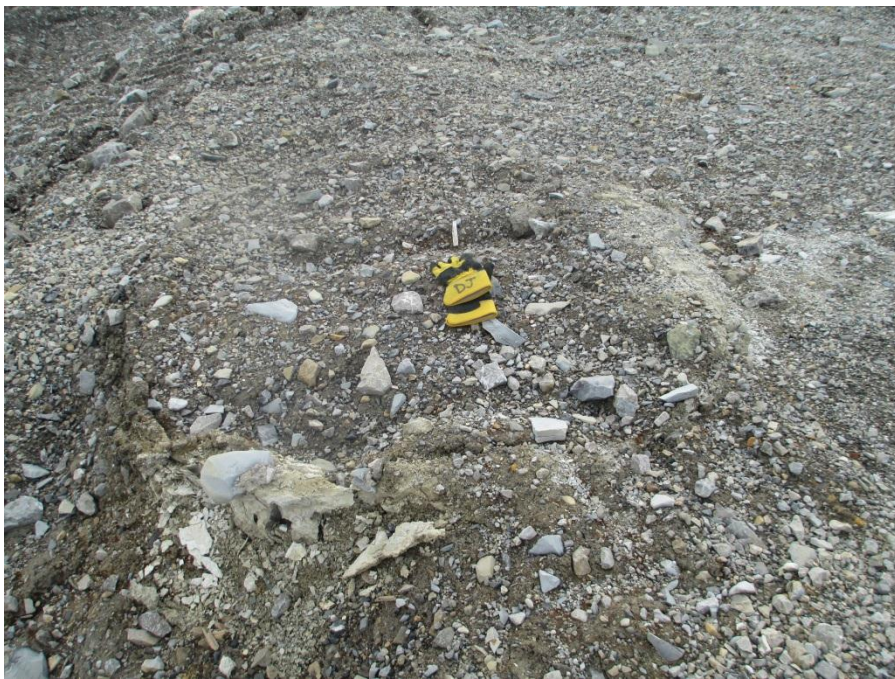
Photo 36, Subsidence Area, Vent/Backfill Raise (WP#32)

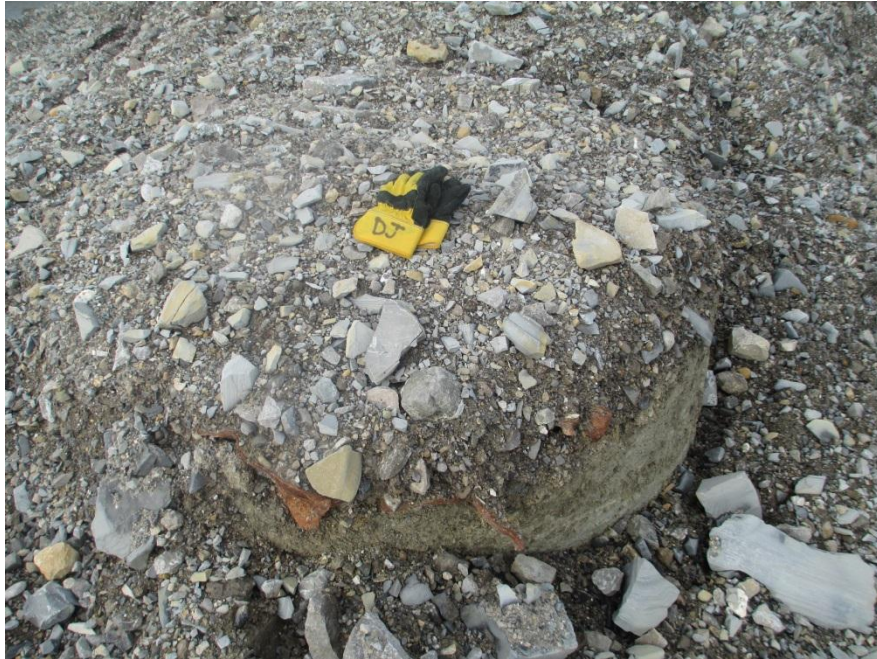
Photo 37, Subsidence Area, Vent/Backfill Raise (WP#32)

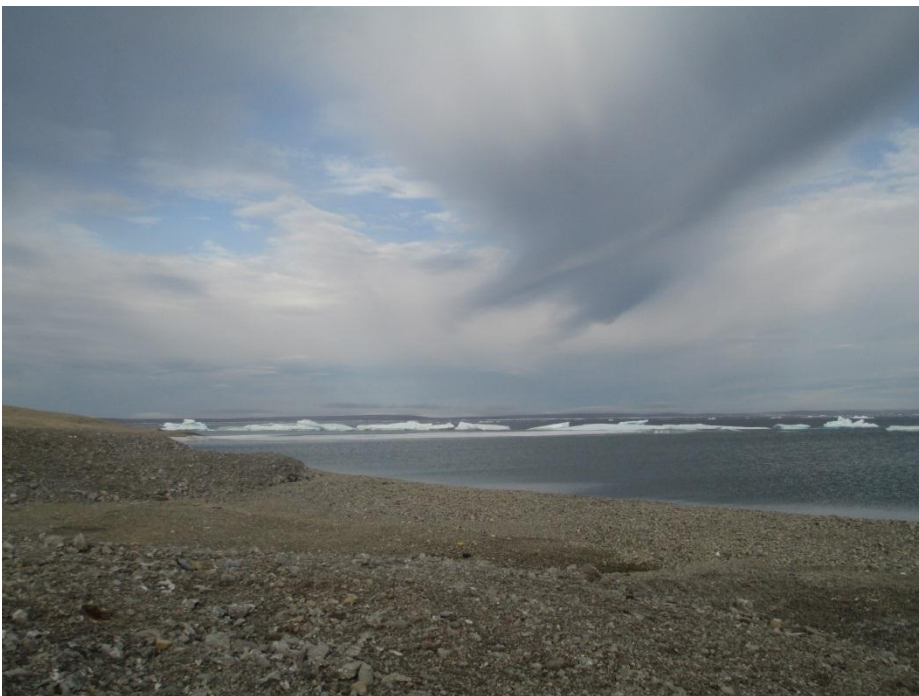
Photo 38, Subsidence Area, facing North from WP#32

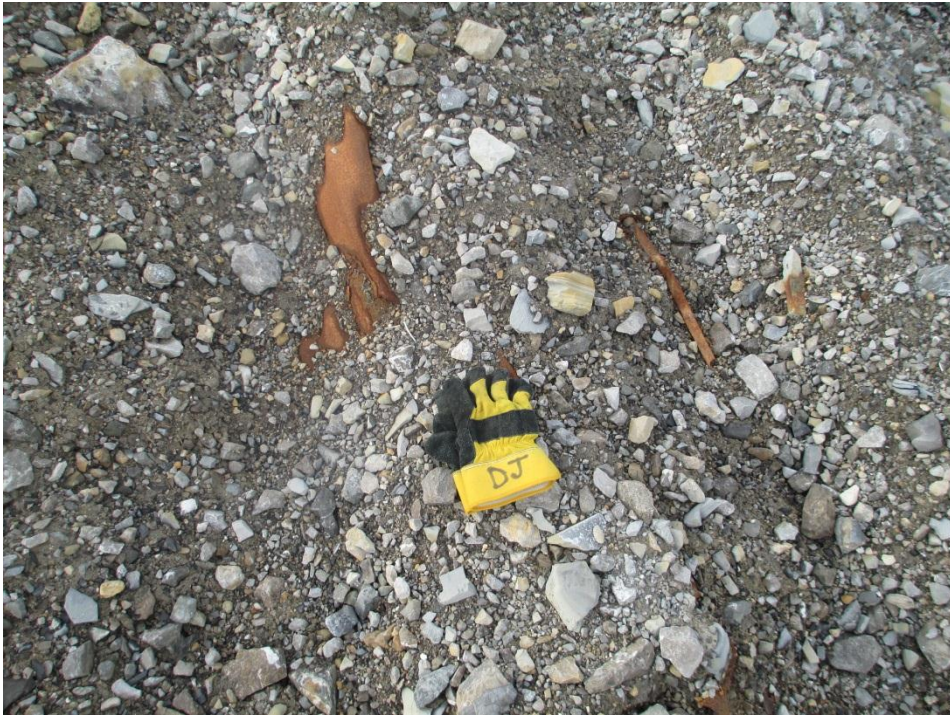
Photo 39, Subsidence Area, Vent/Backfill Raise (WP#33)

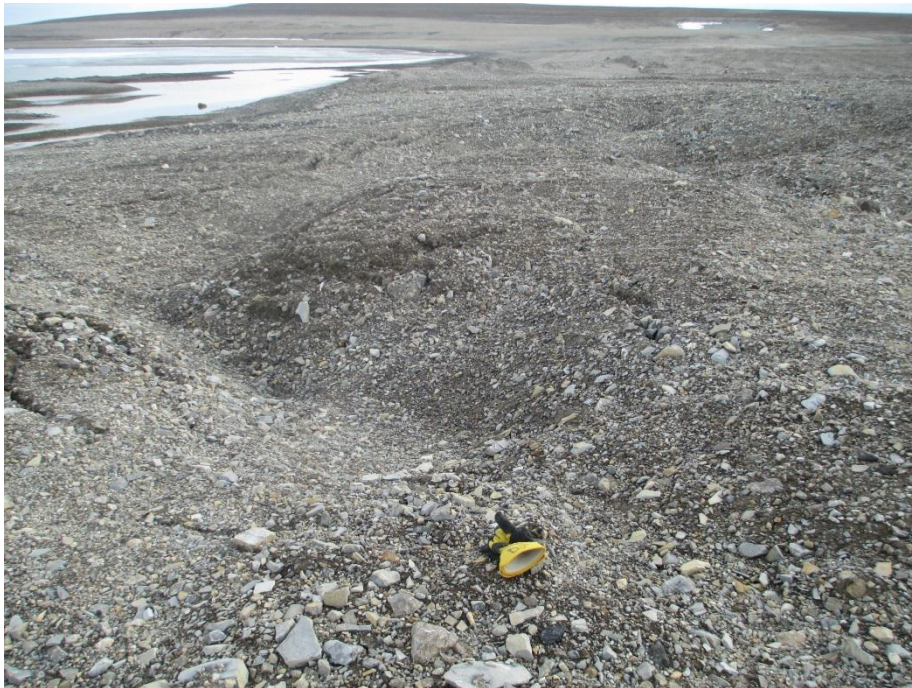
Photo 40, Subsidence Area, thaw settlement ~1m deep (WP#34)
